University Transportation Research Center - Region 2

## Investigation of the Carrs Creek Geofom Project

**Project Title:** Investigation of the Carrs Creek Geofoam Project

1. Report No.	2. Government Accession No.	3. Recipient's Catalog No.	
4. Title and Subtitle <b>Investigation of the I88 Carrs Creek Geof foam Failure</b>		5. Report Date <b>August 20, 2014</b>	6. Performing Organization Code

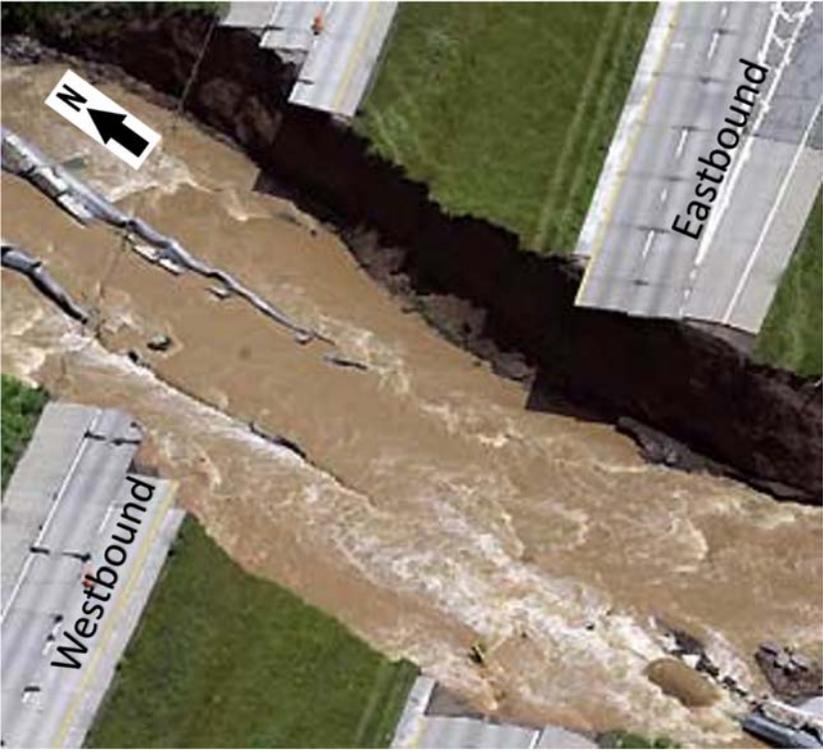
FIGURE 2 The Carrs Creek culvert on I88 collapsed (1). Carrs Creek quickly eroded the road embankment and culvert side fill to form a wide gully.

The I88 culvert at Carrs Creek in Sidney, NY; collapsed during the record Mid-Atlantic States Flood in June 2006 (2). The failure is about 56km (35 miles) northeast of Binghamton (Figure 1). The 9.1m (30ft) wide corrugated metal plate culvert was built in 1974 and had received a rating of 5 out of 7 in the bi-annual NYSDOT survey of 2004. The rating of 5 represents minor deterioration but was otherwise of acceptable structural and functional grade (3). By the early morning of June 28, the Carrs Creek flood stage rose above the inlet and the culvert collapsed (Fig 2). A truck heading east and another traveling west fell into the wide trench formed by the culvert failure and washout of the roadway. Both drivers lost their lives. The I88 section between Sidney and Unadilla, NY was closed. Delaware County was declared a Federal Disaster Area. Labor Day 2006 was established as the target date for rapid construction and reopening of I88.

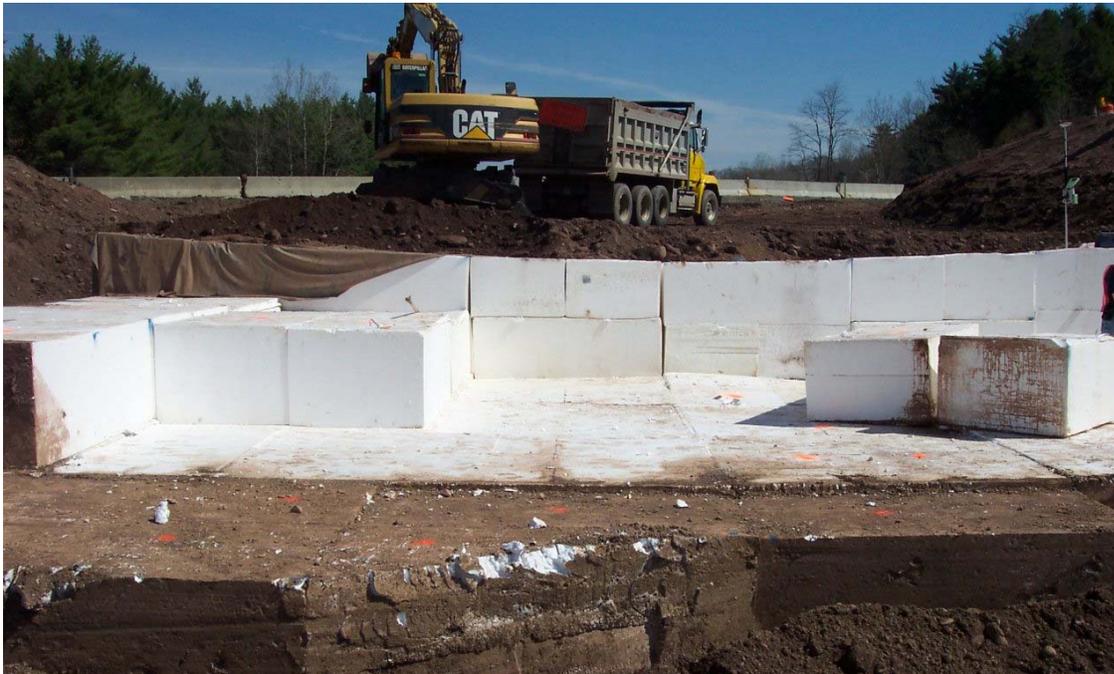
FIGURE 11 Exhumed blocks from eastbound south side slope. Blocks towards the forefront are not as heavily loaded and deformed.

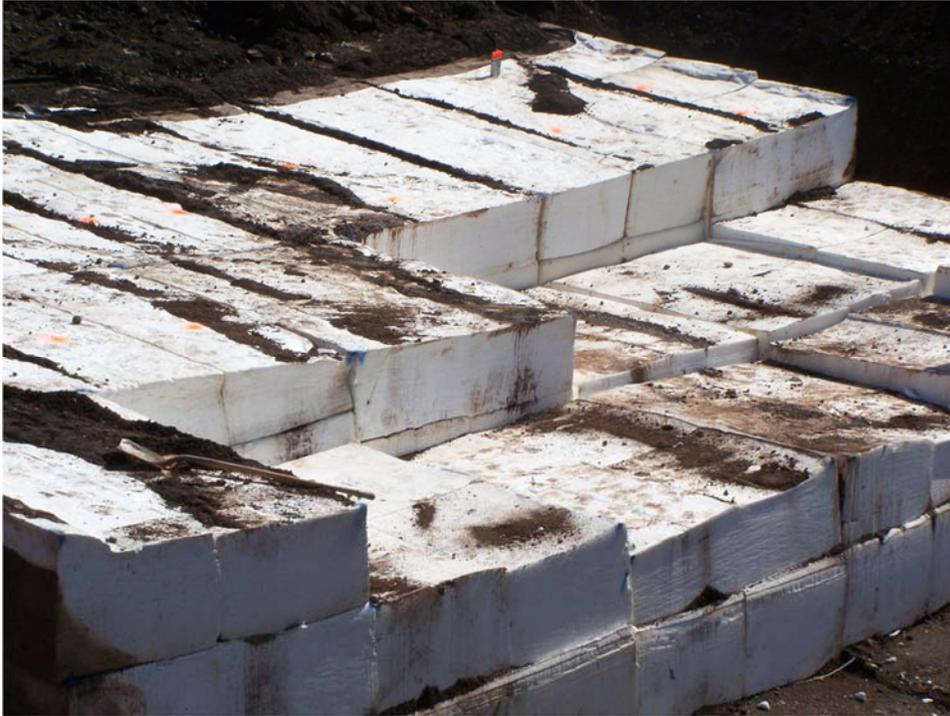
FIGURE 12 Exhumed geofoam from below eastbound I88 roadway. See the unequal deformations of four adjacent blocks behind the shovel at left of center.

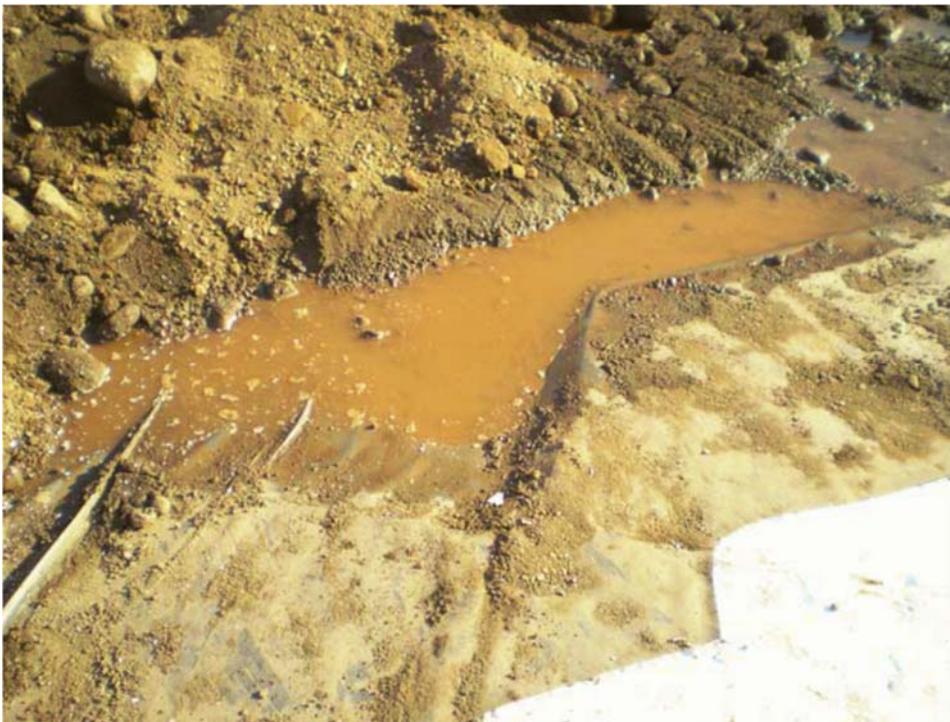
FIGURE 13 Perched water on the geomembrane cover above the geofoam.

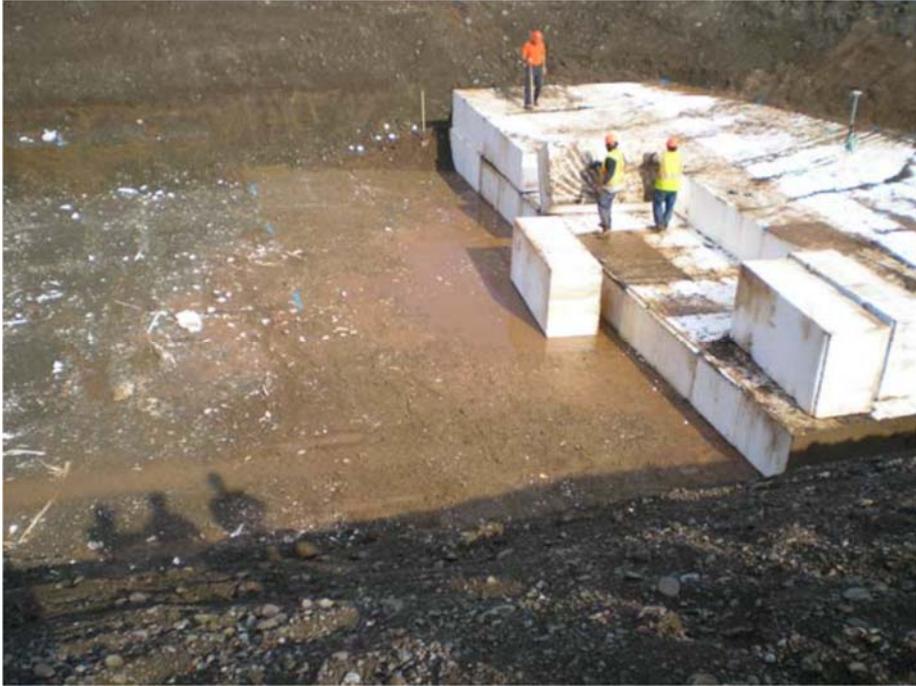
FIGURE 14 Perched water between the culvert top and the geofoam base (1).

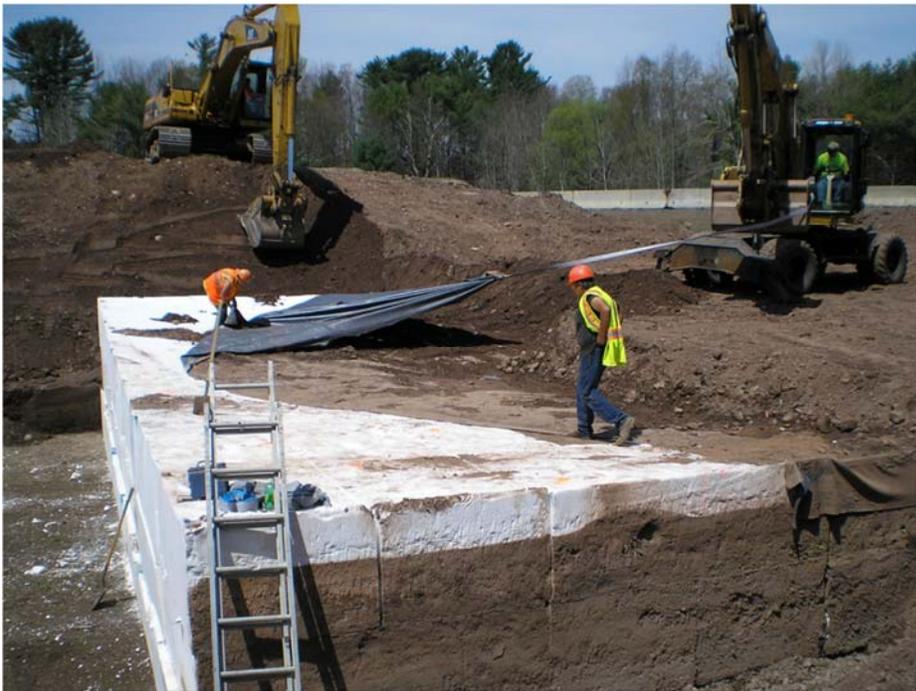
FIGURE 15 Removing the geomembrane cover from the geofoam at the south end of the culvert below the eastbound embankment (1).

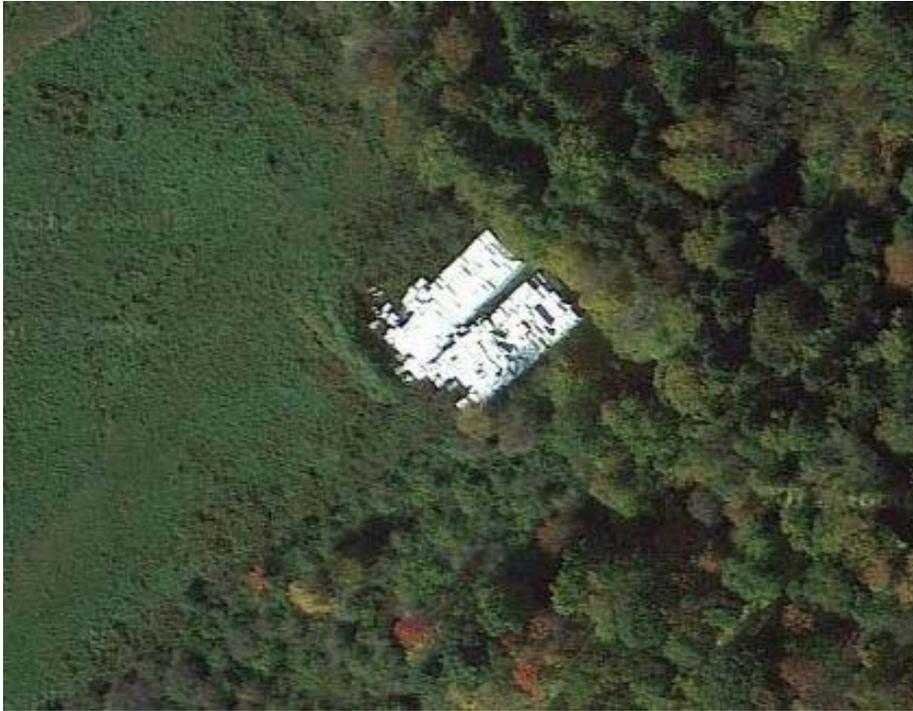
FIGURE 17 Stockpile of exhumed blocks from 2006. (Google Maps 2014).
