## **Evaluation of the Train Signal and Rail Systems for the Anton Anderson Memorial Tunnel**

**July 2014**

**FHWA-AK-RD-14-06**

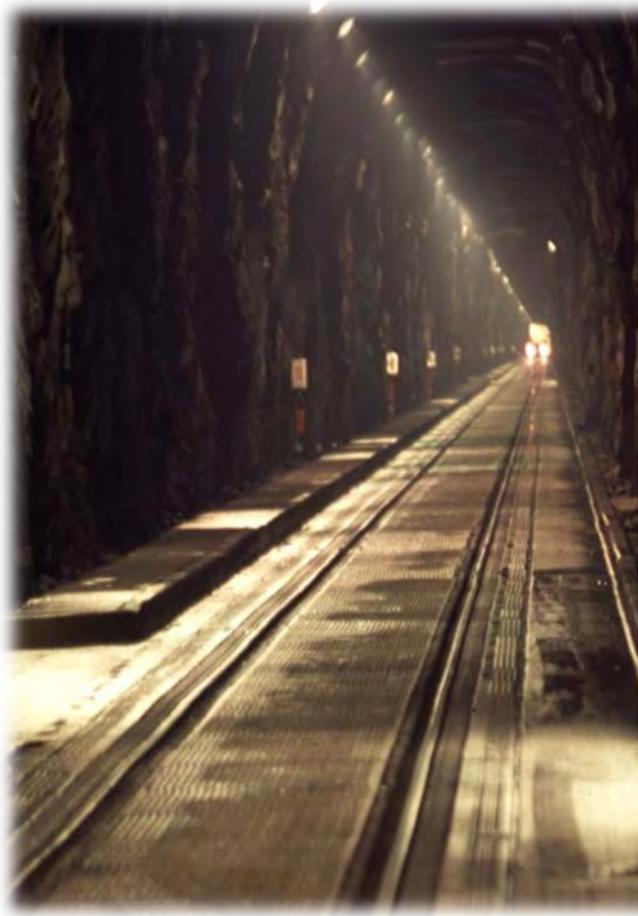
Figure 3 – Tunnel Invert after Construction

Ballast and ties were replaced with pre-cast concrete panel invert system;

Addition of a storm drainage and sub-drain systems to control surface and subsurface water;

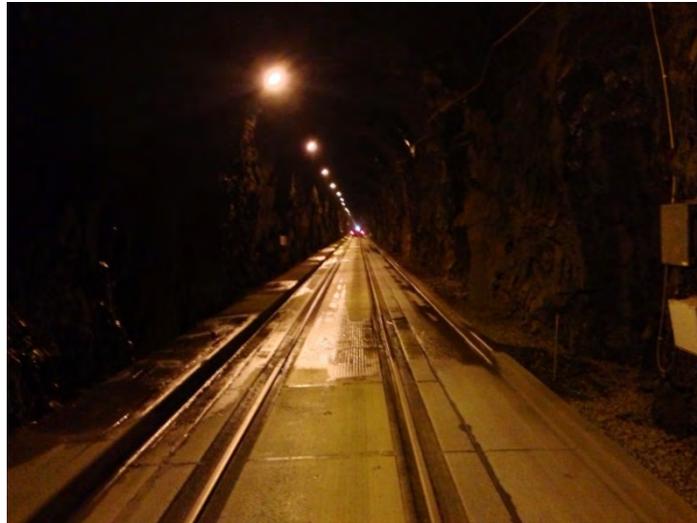
Figure 8 – Water Draining from Tunnel Crown

There is a significant amount of water draining from the tunnel crown and sidewalls which accelerates the wear of the concrete panel surface and saturates the underlying ballast. This may be a factor in panel/rail settlement.

Based on three inspection surveys (Appendix D & E) conducted in December 2012, May 2013 and July 2013, approximately 2,300 lineal feet of the tunnel crown/sidewall leaks water on to the invert. There was significantly less water dripping from the tunnel crown in December than there was in May and July. All of the tunnel crown and sidewall drainage areas identified during the December '12 and May '13 surveys were photographed. (Appendix C)

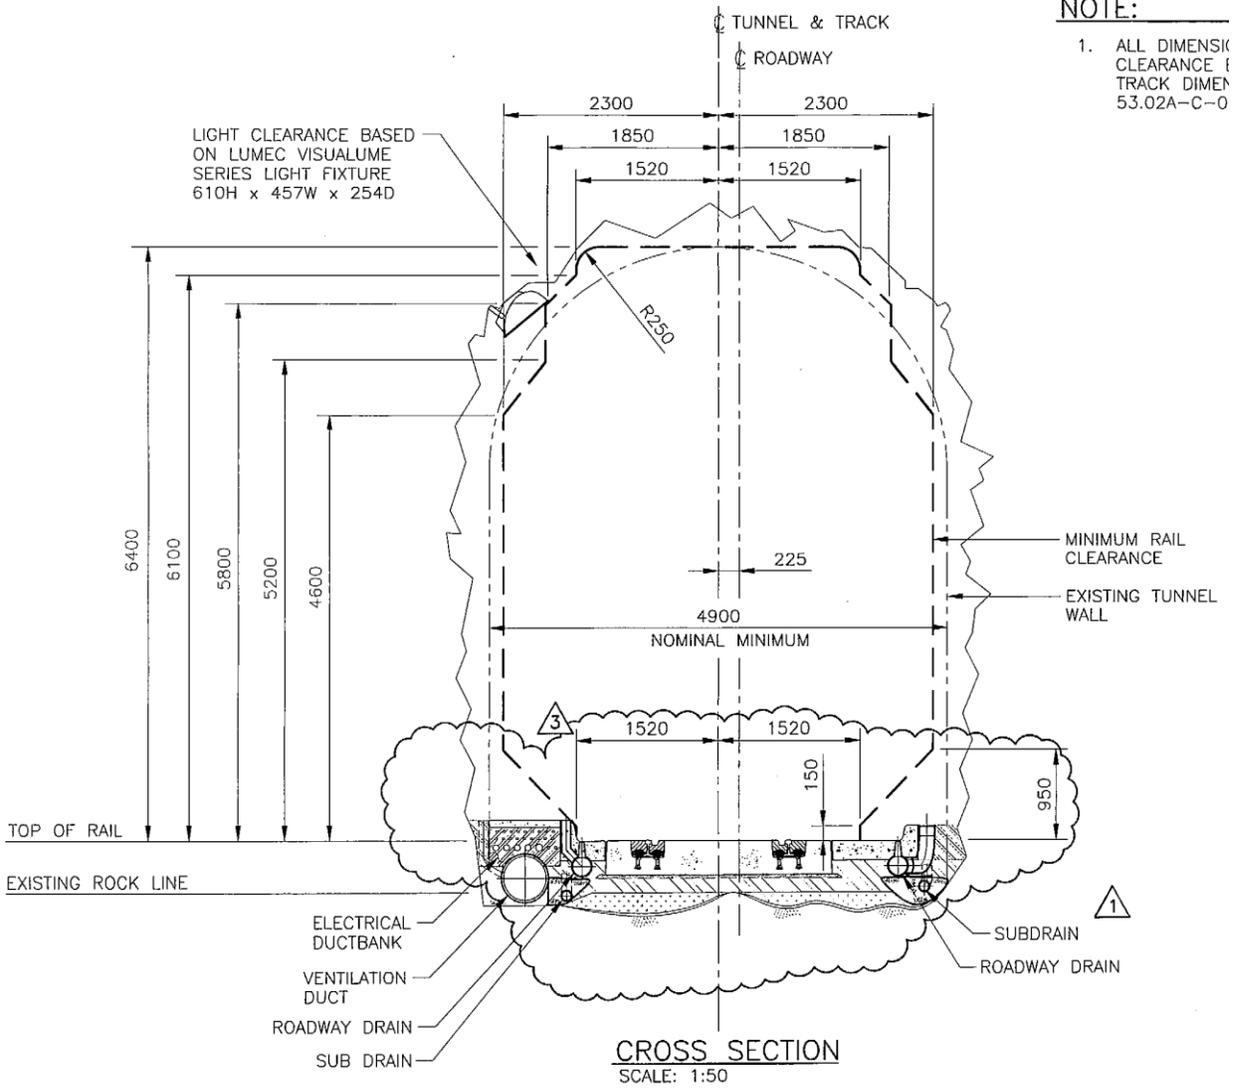
Figure 10 - Tunnel Cross Section

Any future water control systems have to be at least 21' above the tunnel invert to accommodate future double stacking trains (Figure 10). The height of the tunnel crown above the tunnel invert in the wet areas needing additional water panning was generally 21' to 23' above the invert (Appendix D). A more thorough survey needs to be conducted to verify that there is sufficient room for the new water control systems.

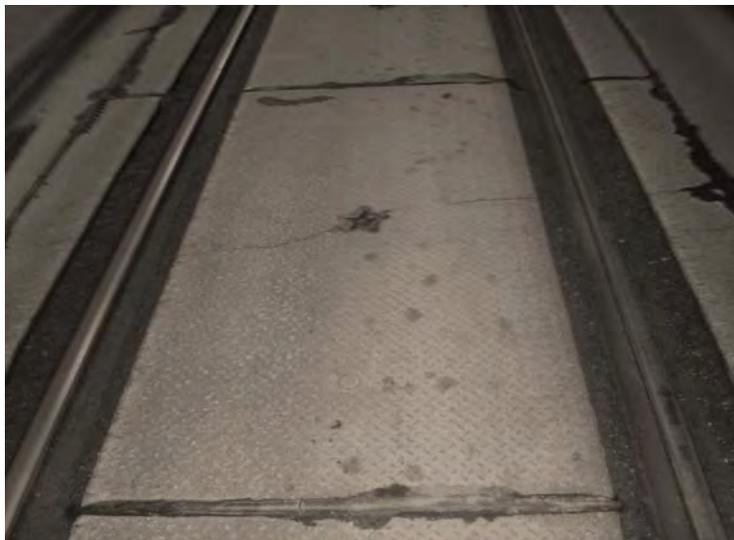
Figure 11 – Cracks in Star Track® Panels

Approximately 15% of the panels are cracked. Most of the cracks are approximately 2 mm wide. It is not known if these cracks occurred during fabrication, installation or after installation. It is not known if these cracks are an indicator of some distress occurring to the tunnel invert or if they allow water migrate and corrode the rebar. There does not appear to be a noticeable pattern or correlation to the cracked panels with areas with visual settlement of rails and panels.

1. Determine if the cracks in the panels are continuing to develop and may be indicative of panel stability problems. A crack survey of the panels conducted every 2 years would determine if cracks are continuing to develop in the panels or if the existing cracks were formed during construction or fabrication. The

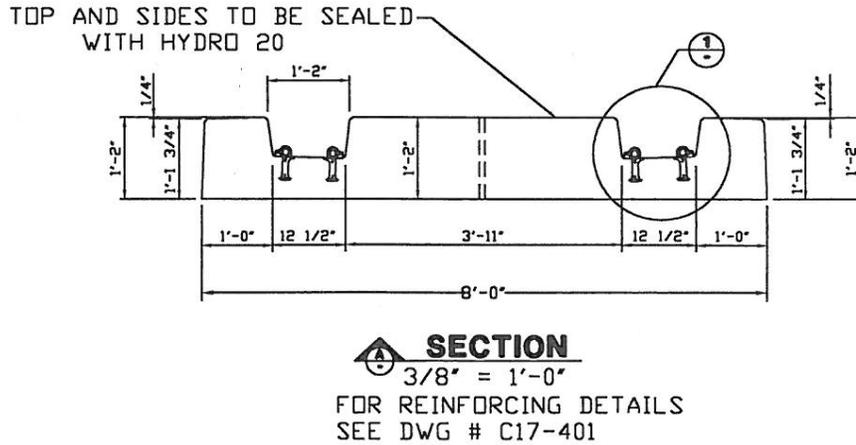
Figure 12 – Cross Section of Star Track® Panel

The Star Track® system used for the Whittier Tunnel is a pre-cast concrete panel that is 8 feet wide (across the track), 7.5 feet long (along the track) and 14 inches thick. The pre-cast panels are cast with two slots for running rails. Three Pandral® e-clips, hooked into shoulders cast into the bottom of the slots, attach each rail to the panel. A 3/16-inch thick continuous polyethylene pad between the base of the rail & concrete panel; and nylon insulators between the Pandral® e-clip and the flange of the rail provide electrical isolation between the rails and concrete panel.

To reduce the exposure to water and minimize corrosion of the rail and Pandral® e-clips clips, asphalt was placed between the side of the rail and the inserts of the concrete panels. At the portals, PPI Rubber Inserts® were used instead of asphalt.

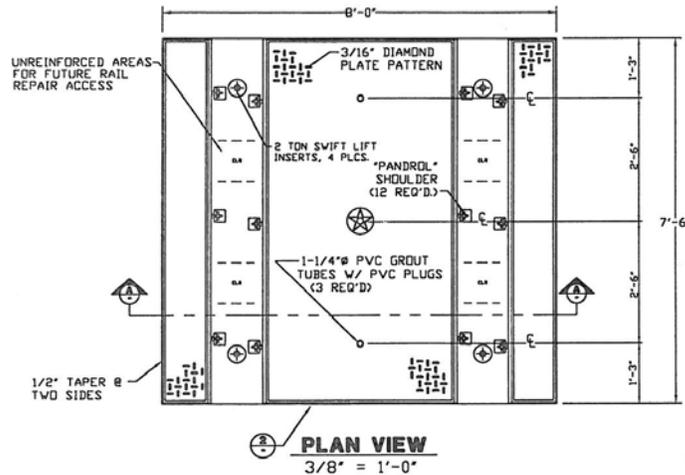
Figure 13 – Plan View of Star Track® Panel

The tunnel invert consists of approximately 1600 Star Track® concrete modules (panels). Star Track®, a modular pre-cast concrete grade-crossing system produced by Oldcastle Precast, has been used to build embedded track at port facilities and numerous railroad grade crossings.

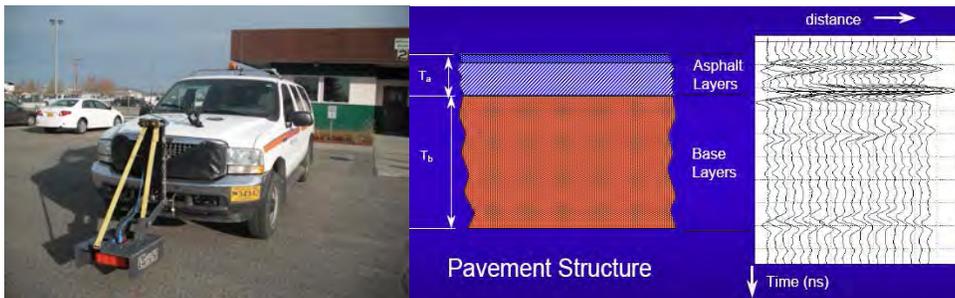
Figure A1 GSSI 400 MHz ground-coupled GPR Test System

The GPR test system owned by AET is a GSSI Roadscan System that consists of a bumper-mounted, 400 MHz ground-coupled antenna and a SIR-20 control and data acquisition processor, featuring dual channels. The GPR processor, including a SIR-20 data acquisition system, wheel-mounted DMI (Distance Measuring Instrument), and a tough book with the SIR-20 Field Program constitutes the newest, most sophisticated GSSI Test System, which fulfills or exceeds all requirements to meet ASTM-4748, ASTM D-6087 Standards. Figure A1 provides a view of this equipment.

The GPR antenna emits a high frequency electromagnetic wave into the material under investigation. The reflected energy caused by changes in the electromagnetic properties within the material is detected by a receiver antenna and recorded for subsequent analysis. The 400 MHz ground-coupled GPR is capable of collecting radar waveforms at more than 100 signals per second, allows for data to be collected at driving speeds along the longitudinal dimension of the geotechnical or bridge decks with the antennas fixed at the rear or in front of the vehicle.

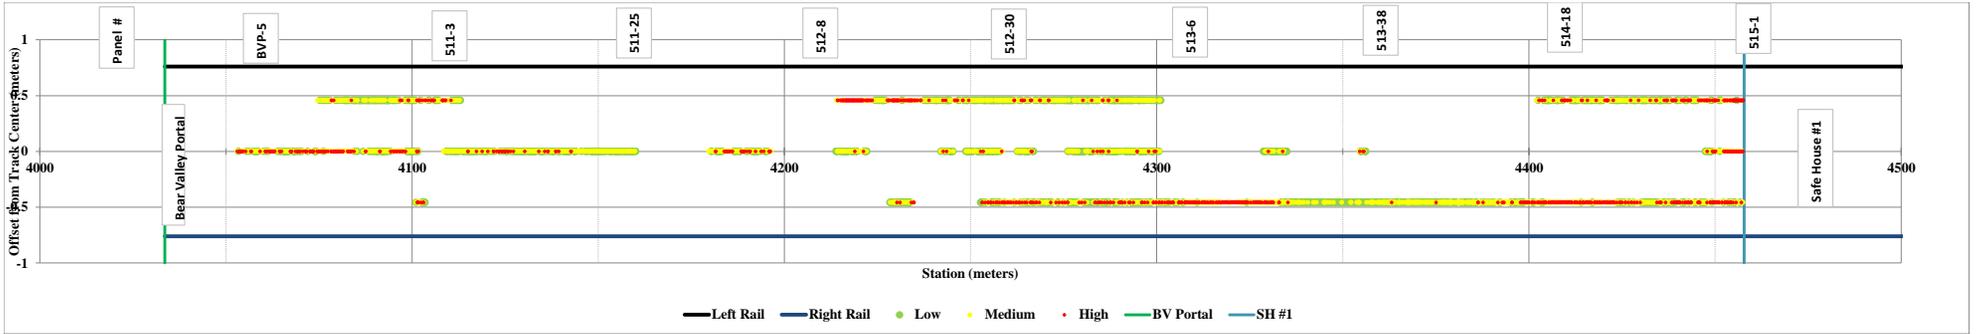
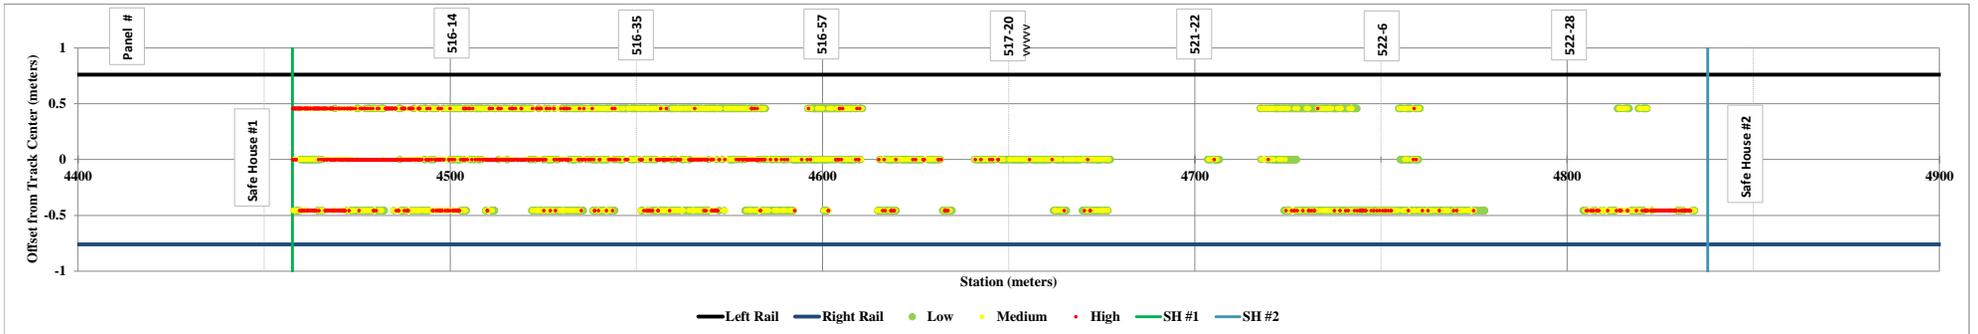
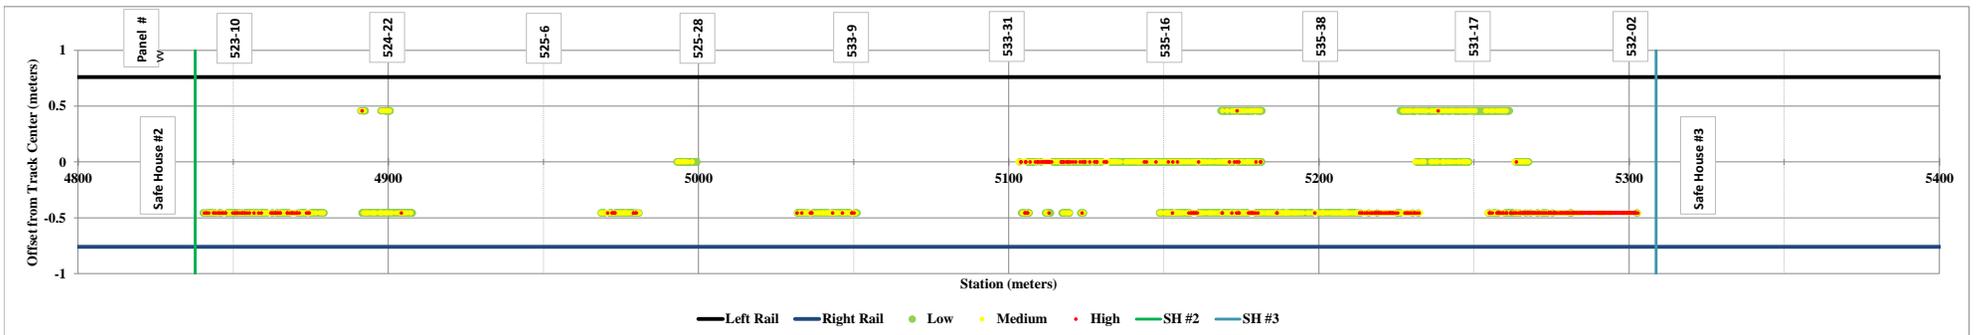
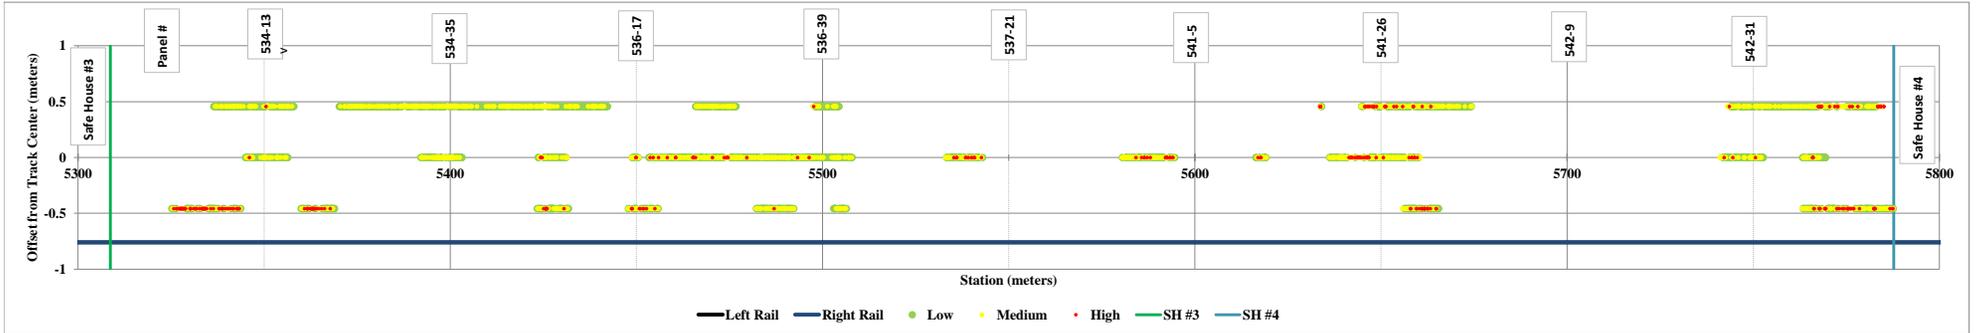
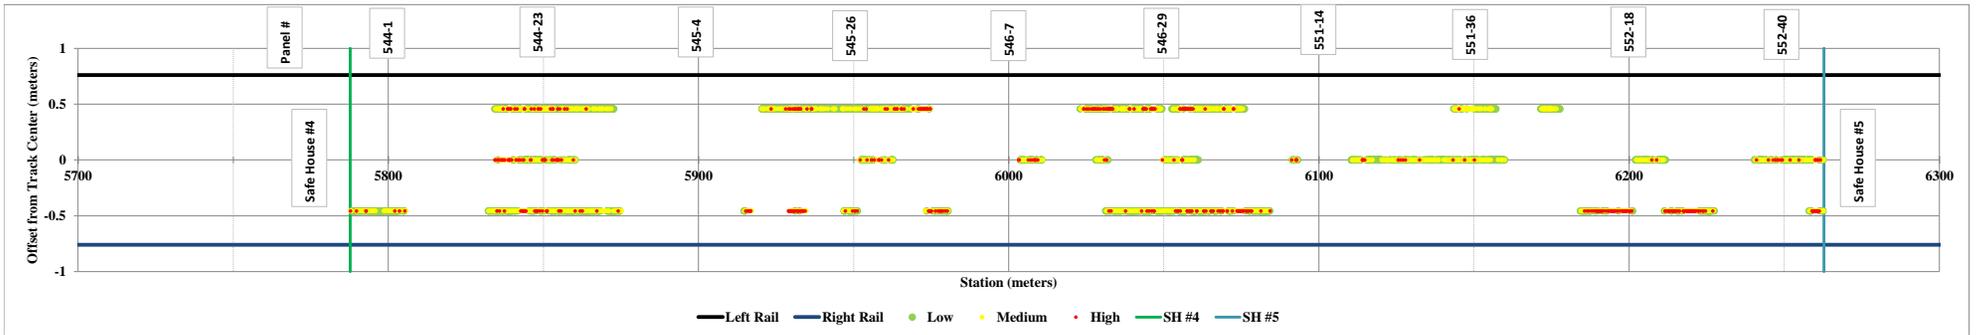
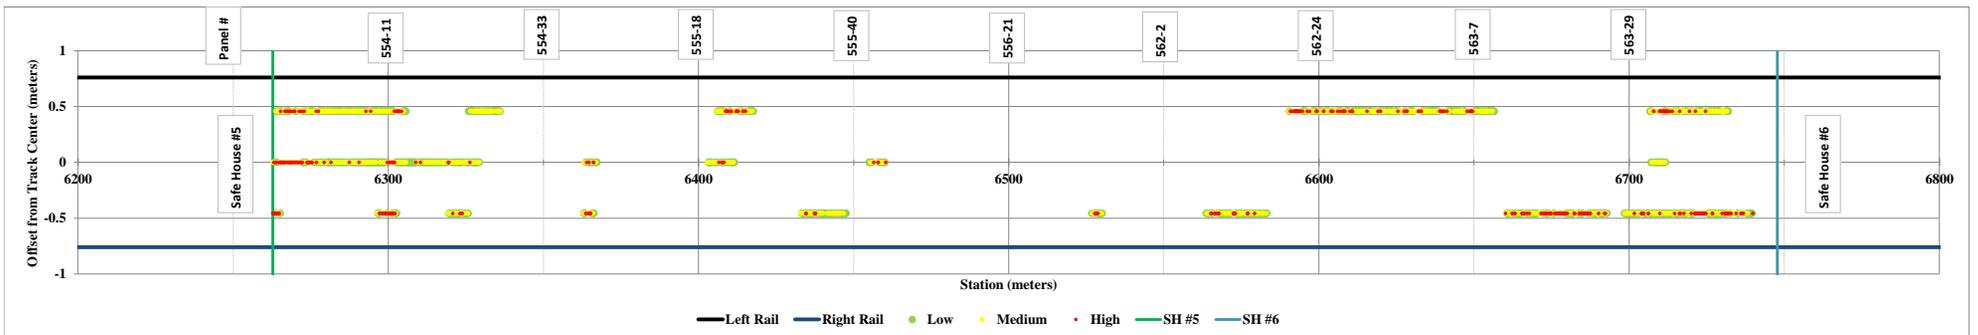
# Whittier Tunnel - Potential Corrosion

There are no visual indications on the panel surface of any rebar corrosion. However, the GPR survey identified several areas of “potential separation” which may be indicative of corrosion of the transverse rebar 8 inches below the panel surface.

3. Determine if the anomalies (“area of separation”) identified in the GPR survey are caused by corrosion of the rebar with chain survey and coring. The primary benefit of this work will be to determine: 1) if the rebar is corroded; 2) if improved water control of the tunnel crown will minimize future corrosion; and 3) the performance life of the invert panels.
