Technical Report 05-07

*Utilizing a Hot Applied Snowmobile Crossing
Mat to Eliminate HMA Abrasion*

Second and Third Interim, December, 2008

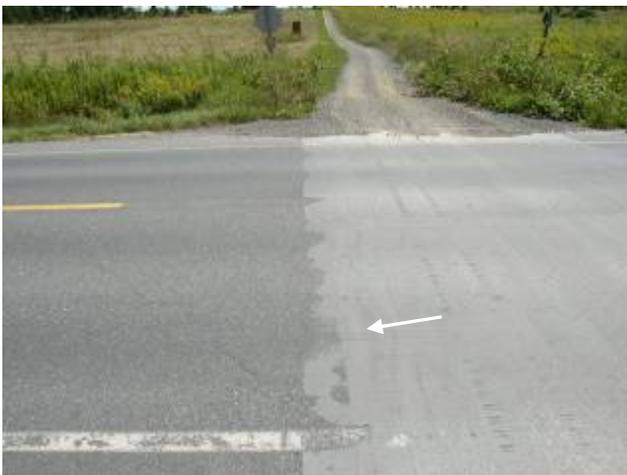
Photo 1: 2007 Leading Edge Wear

In 2007, the leading edge of the mat in both directions had been worn approximately nine inches into the mat between wheel paths and at the center of the roadway (Photo 1). This wear is the result of snow plowing. In 2008, this wear had extended more than 12 inches into the Cleanosol material (Photo 2).

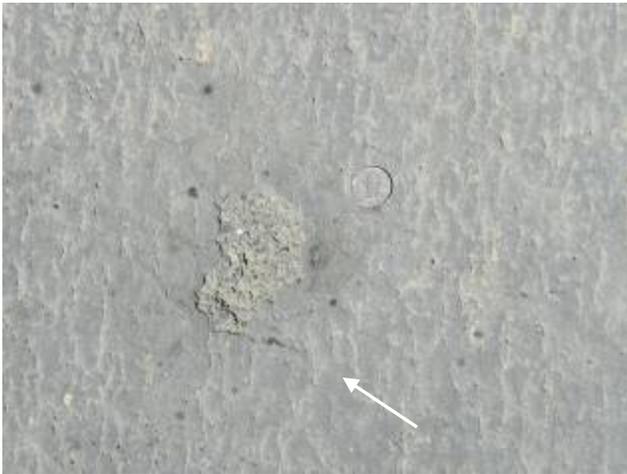
Photo 3: 2007 Mat Deterioration

Six small areas where the Cleanosol mat had worn down to the Hot Mix Asphalt (HMA) surface were identified in 2007. These areas were approximately the size of tennis balls. It is possible these areas originated as bubbles at the time of placement and were sheared off from plow wear (Photo 3).

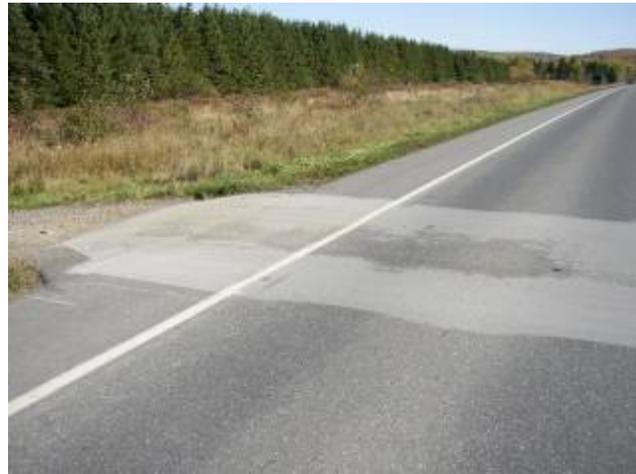
Photo 4: 2008 Mat Wear at North End of Crossing

Areas of exposed HMA became much more prevalent in 2008. The north end of the crossing is worn most significantly and this wear may be from snowmobiles accelerating on the uphill grade to quickly cross the highway (Photo 4).

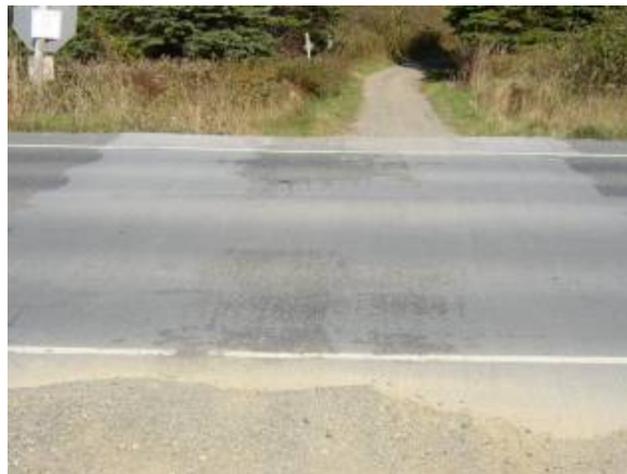
Photo 5: 2008 South to North view.

Overall, this section is not performing as well as the other two sections. Approximately 15 to 20 percent of the crossing surface area has been eroded to the HMA. The uphill orientation of the north approach to the crossing appears to be a cause for this excessive wear. Additionally, the shoulders at this site are not as wide as the other sites; limiting site distance for crossing snowmobiles and prompting operators to inch into the roadway or accelerate quickly to cross. Photo 5 provides a south to north view depicting the additional wear at the north end of the crossing.

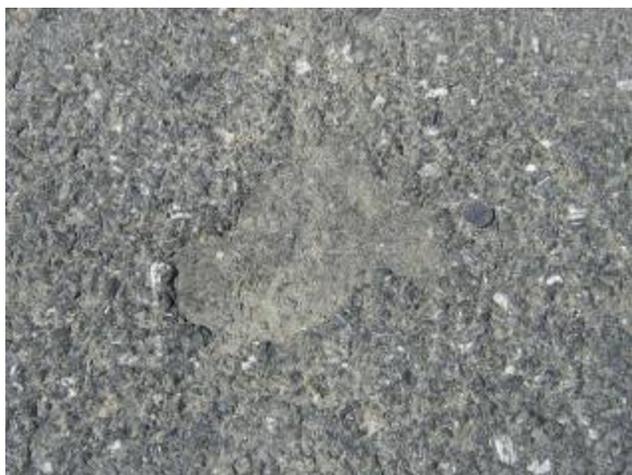
Photo 6: 2007 Softball Sized Worn Area

The 2007 inspection indicated that most, if not all of the crossing appeared to have been patched with HMA. A small, softball size area was identified as being worn down to the HMA binder (Photo 6).

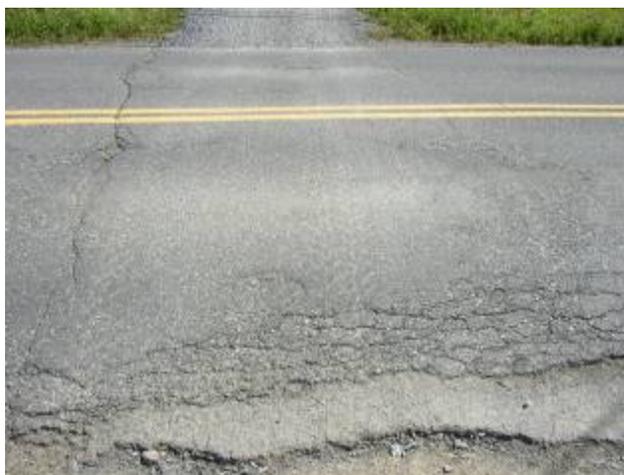
Photo 7: 2007 View North to South

Rutting, throughout the center of the crossing and in the direction of snowmobile travel has been patched (Photo 7). Additional slices, cut into the surface by snowmobile skis are visible in Photo 8.

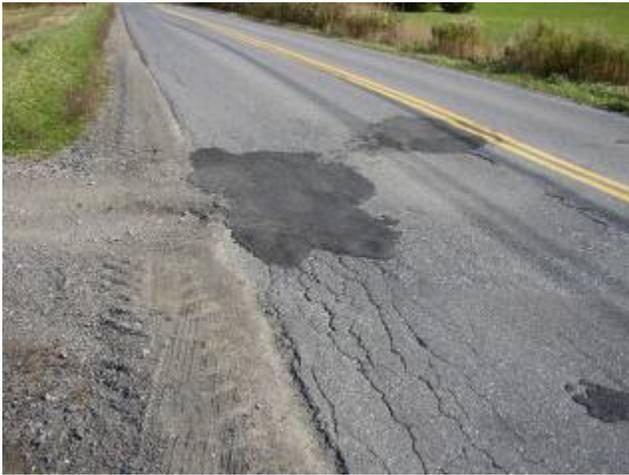
Photo 9: 2008 Patched area at North End

The 2008 evaluation found several patched areas and areas in need of patch. As with the Route 167 experimental crossing, the north end of this crossing has an uphill approach and appears to be sustaining the most damage. Patched areas at the north end of the crossing are visible in Photo 9. Areas in need of patch are visible in Photo 10.

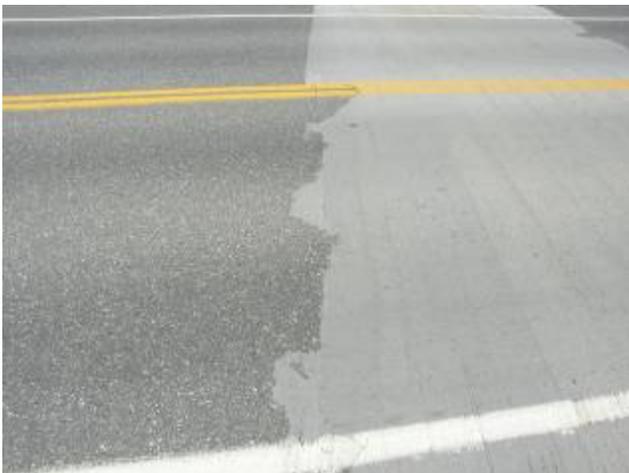
Photo 11: 2007 Leading Edge Wear

The 2007 evaluation found this section to be in generally good condition. As with the other sections, leading edge plow wear has progressed as much as 12 to 15 inches into the Cleanosol mat between wheel paths and at the center of the roadway (Photo 11). Photo 12 shows the progression of leading edge wear at the time of the 2008 inspection. This wear had extended 30 to 36 inches into the mat area.

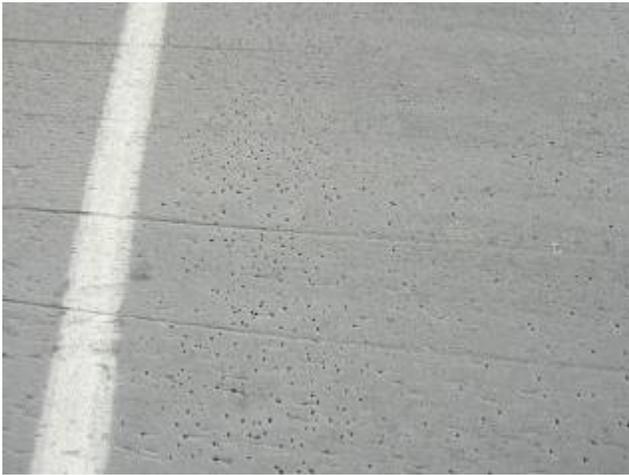
Photo 13: 2007 Pit Hole Damage

Small pit holes and gouges were identified throughout the crossing area in both the 2007 and 2008 inspections. It is believed this damage is being caused by the snowmobile track spikes or studs and the carbide inserts attached to the snowmobile skis for steering control. When the mat area warms from traffic and sunshine, the material becomes more pliable, allowing the studs to penetrate the mat area and carbide inserts to gouge the mat. Photos 13 and 14 show this damage.

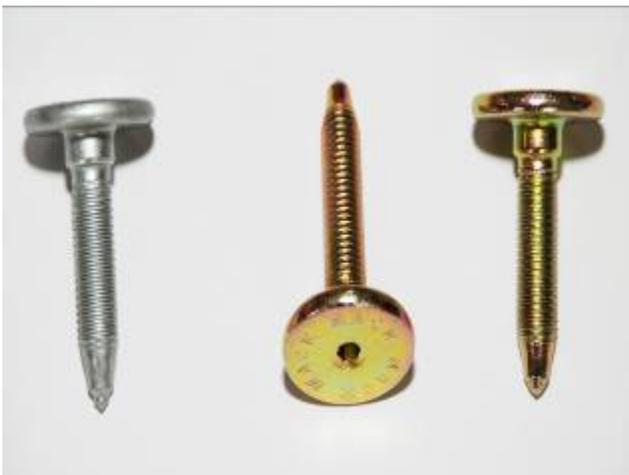
Photo 15: Track Studs (1.25 to 1.50 inches)

Photo 15 shows three typical track studs. An average track has between 96 and 144 studs. Photo 16 shows the carbide inserts attached to the snowmobile skis.

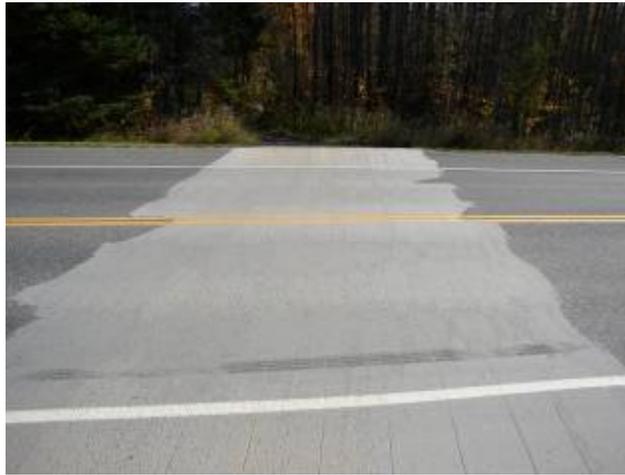
Photo 17: 2008 View Looking East

After three years of exposure, this section continues to perform quite well. The Cleansol product remains mostly intact in the areas of primary snowmobile travel. It is uncertain how the snowmobile traffic volume of this section compares to the other sections. Photo 17 is an overall view of the section, looking in the easterly direction.

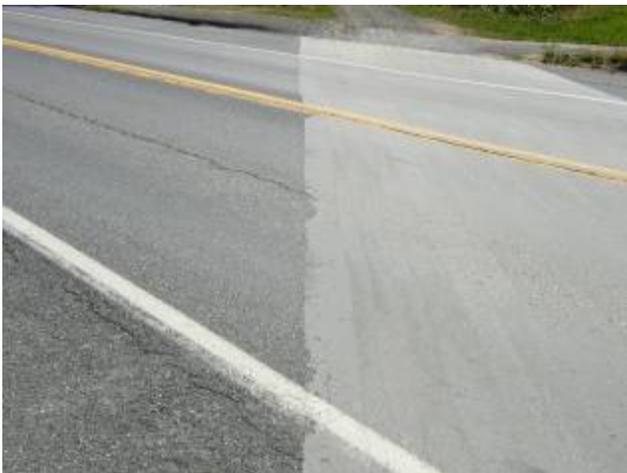
Photo 18: 2007 Leading Edge Wear

For the 2007 and 2008 inspections, this section was found to be in good condition. Leading edge wear at centerline and between wheel paths in 2007 was approximately 6 inches (Photo 18) and extended to 12 to 15 inches in 2008 (Photo 19). This crossing is skewed at a 45 degree angle across the roadway. This may account for the minimal leading edge wear compared to the other two sections.

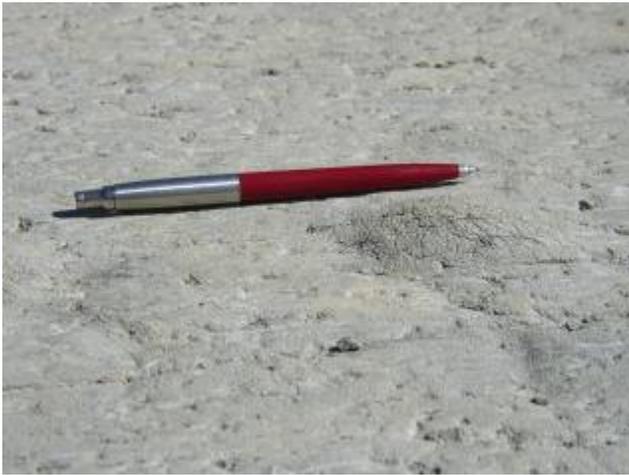
Photo 20: 2007 Pit Holes and Gouged Areas

This section also had pit holes and gouges similar to the other sections (Photo 20). Numerous bubbling areas were identified in both evaluations. In 2008, several of these areas had been sheared off, leaving the HMA surface exposed (Photo 21).

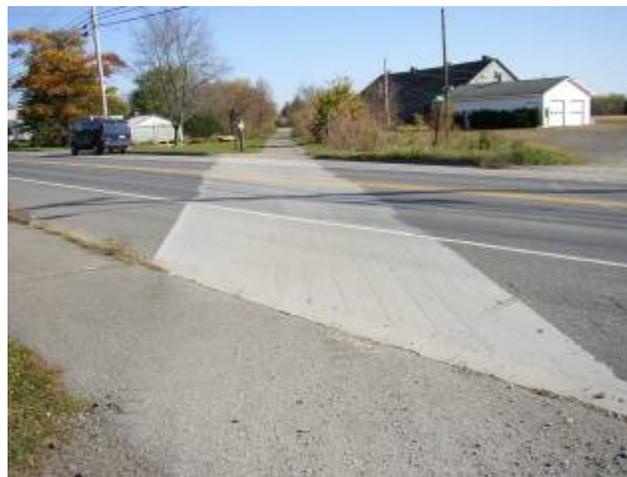
Photo 22: 2008 South to North View

This section is performing well, with little or no visible wear to the Cleanosol mat. The experimental material is continuing to protect the HMA wearing surface. Snowmobile traffic volumes on this section are believed to be the second highest, with only the Presque Isle crossing seeing more traffic. Photo 22 shows a 2008 south to north view of the section.
