**Phase II: Correlation Between Experimental  
and Finite Element Analysis  
Alaska Bridge 255- Chulitna River Bridge**

**FINAL PROJECT REPORT**

**INE/ AUTC 14.04**

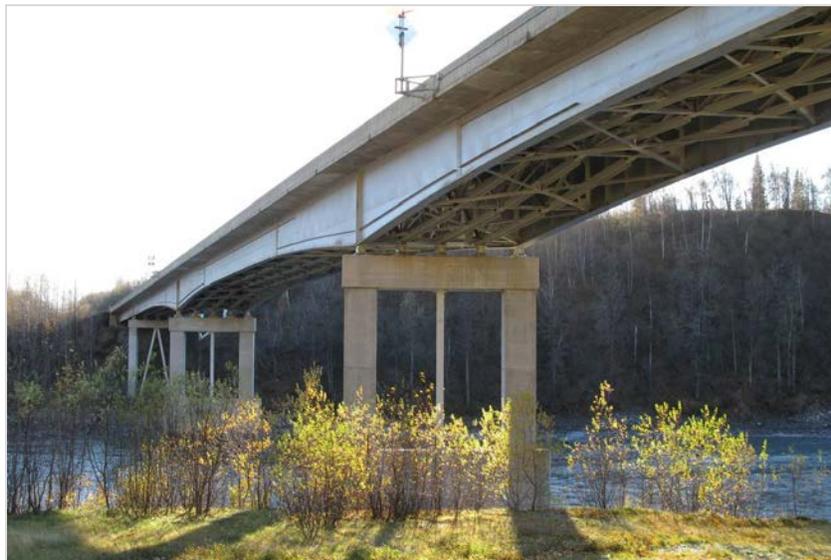
**Figure 1.1** Current picture of the Chulitna River Bridge

In 1993, the bridge deck was widened from a 34-foot cast-in-place concrete deck to a 42-foot 2-inch concrete deck made of precast concrete deck panels. The increased load was accounted for by strengthening the variable depth exterior girders and converting the W21x44 interior stringers to an interior truss girder; the W21x44 became the upper chord of the truss (Fig. 1.1).

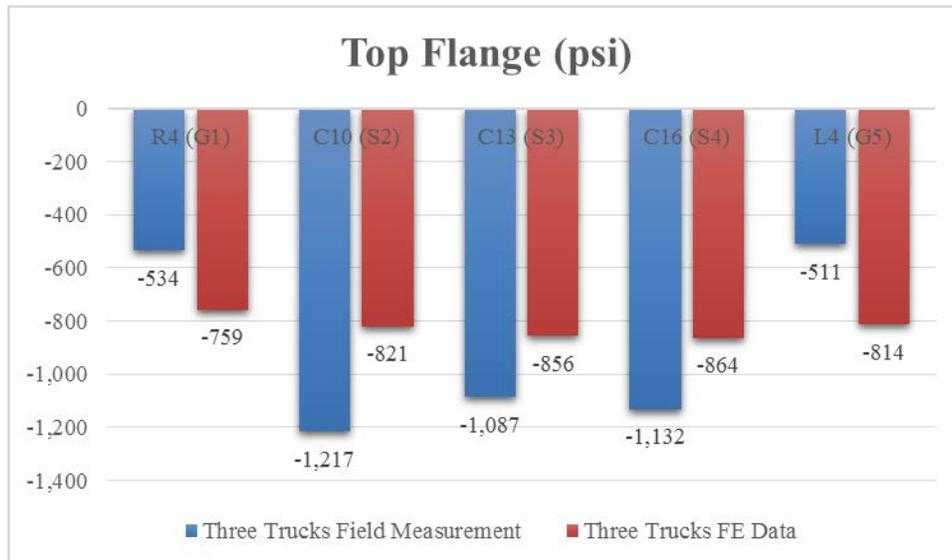
**Figure 3.1** Top flange stress comparison between field measured and calculated values (psi)

Figures 3.1, 3.2, and 3.3 show a comparison between stresses obtained from measured strain data and the “before modification” HDR FEM calculated mid-span stresses. The results indicate that the FEM-calculated stresses carried by the composite trusses are higher than measured; that is, calculated lower chord stresses are higher than measured (Hulsey and Xiao 2013). This finding illustrates that the FEM does not properly represent the distribution of stiffness between the bridge composite stringers and the girders. In consideration of these problems, 14 objective functions (variables) were selected for study. Modifications to the objective functions affected load distribution for the composite trusses and girders.

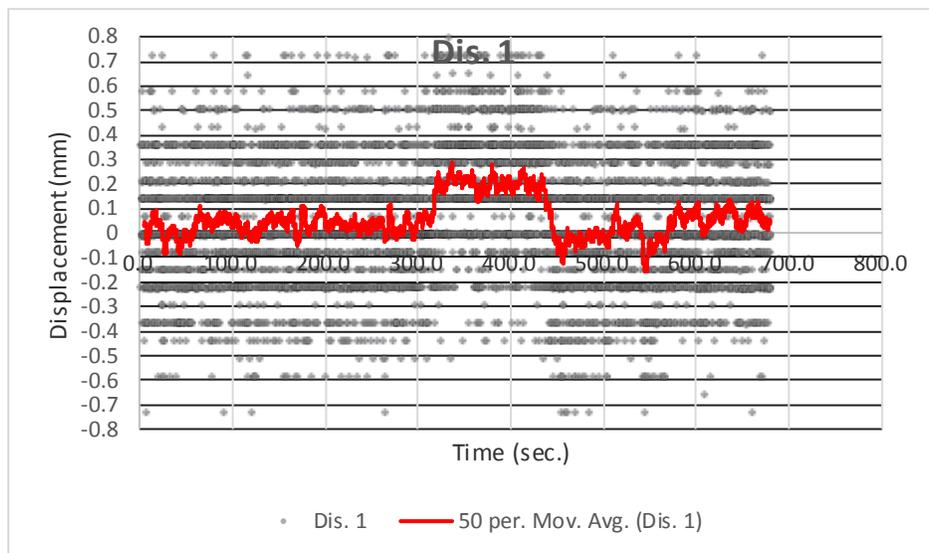
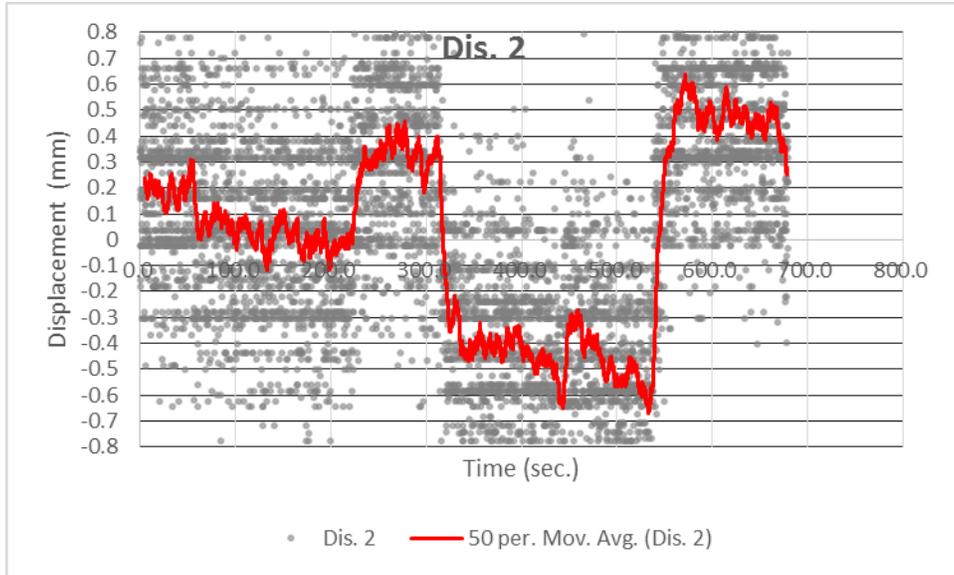
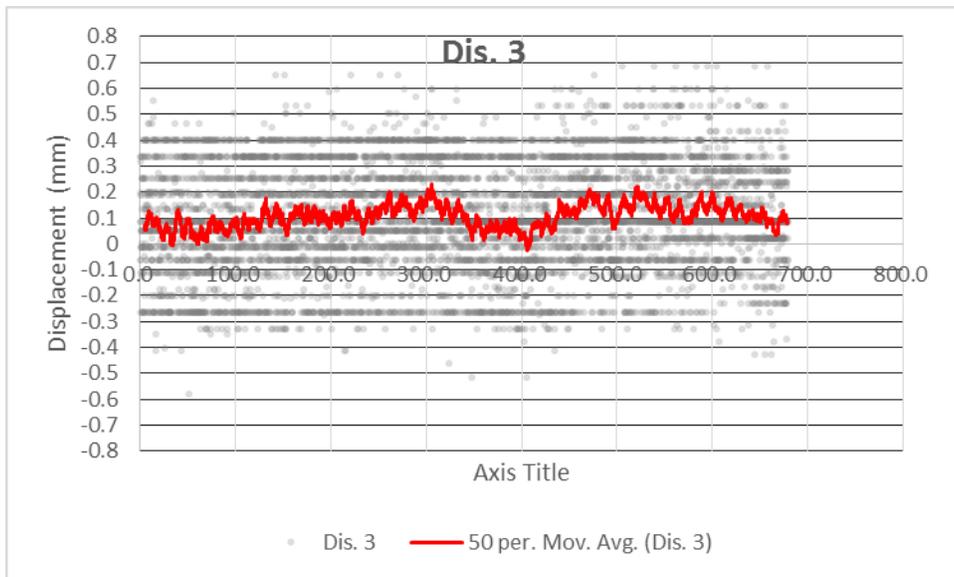
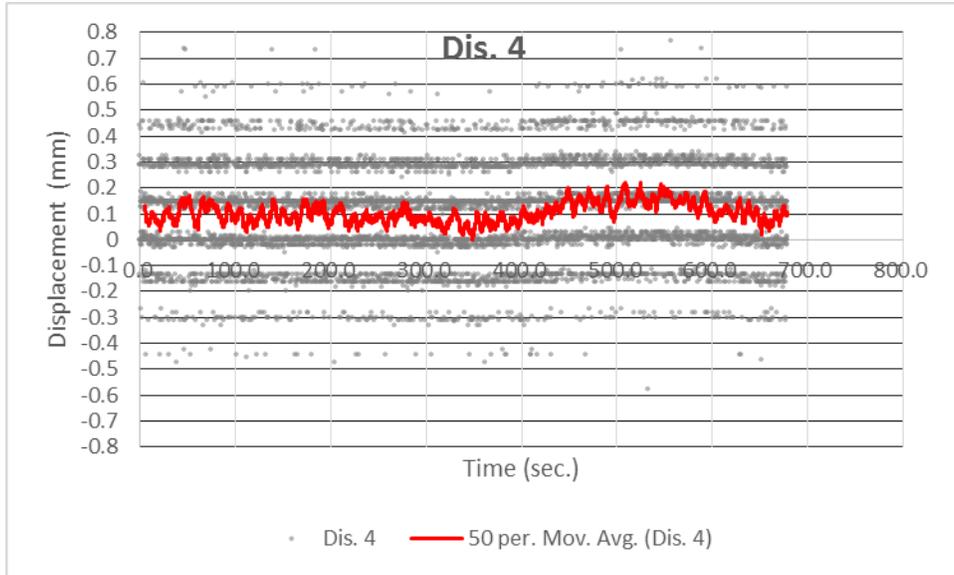
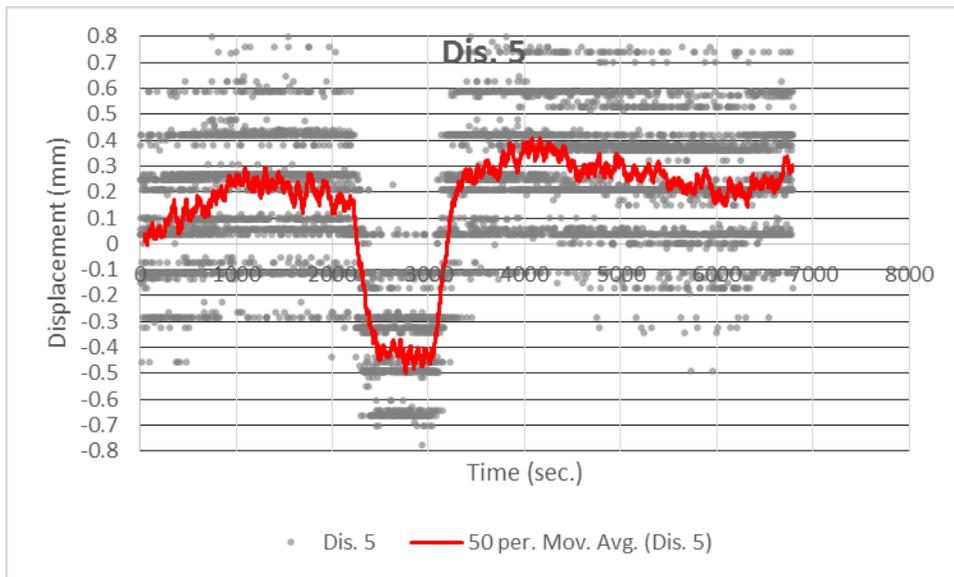
**Figure 5.1** Vertical movement at 5 unconnected bearing supports

For one of the load test cases conducted on September 10, 2012, three heavily loaded trucks traveling side by side crossed the bridge at low speed (Hulsey et al. 2012b). The vertical movement of the five displacement sensors is shown in Figure 5.1a–e. These graphs illustrate the response for an average of 50 data points over time for each of the five bearing locations.

During Phase 1 of this study, we placed five displacement sensors at those locations to measure the movement of the roller bearings in the vertical direction. In addition, we installed eight strain sensors in diagonal members to measure the reaction of the supports and the stresses in the cross frames.

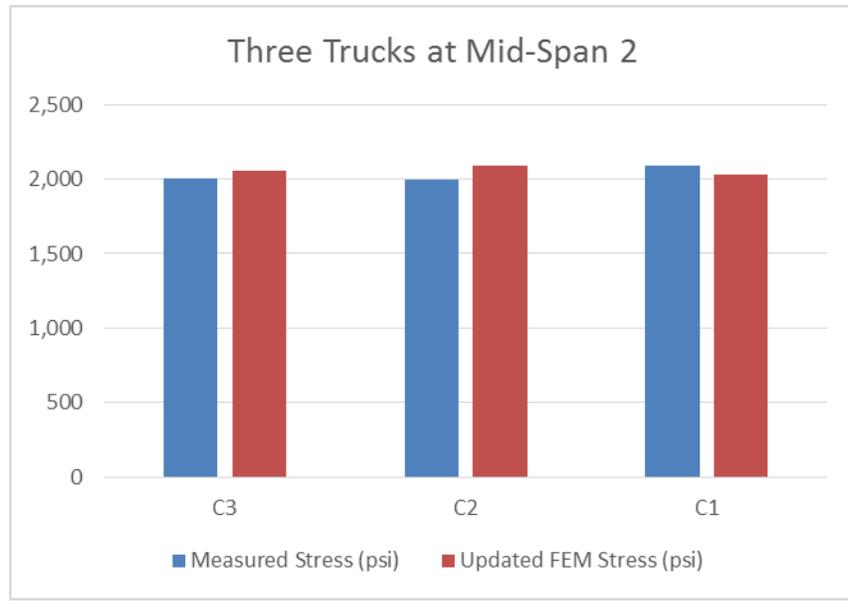
**Figure A.1** Stress results in mid-Span 2 loading condition (psi)

C3	C2	C1
Measured Stress (psi)	2,006	1,994	2,091
updated FEM Stress (psi)	2,056	2,090	2,030
Error (%)	-2.5	-4.8	.9

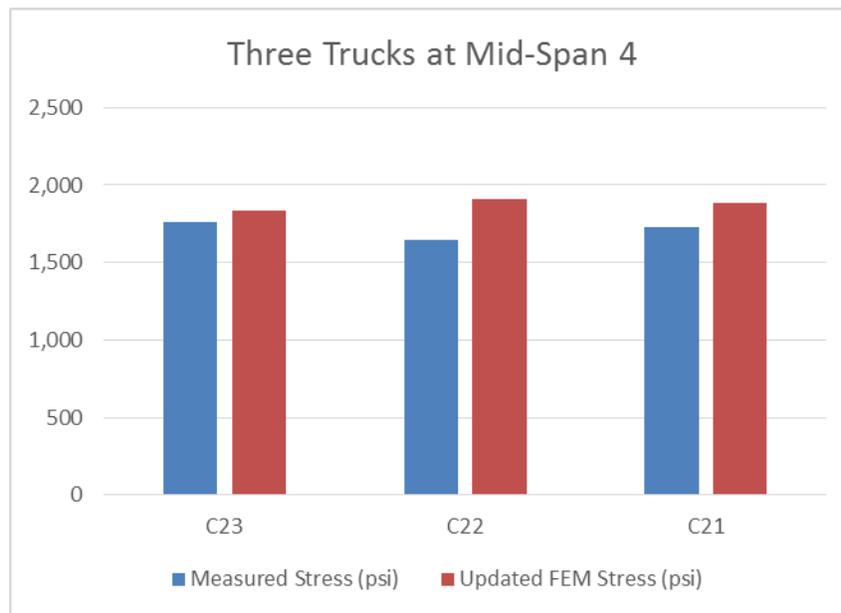
**Figure A.2** Stress results for mid-Span 4 loading condition (psi)

C23	C22	C21
Measured Stress (psi)	1,763	1,646	1,727
Updated FEM Stress (psi)	1,834	1,910	1,883
Error (%)	-4.0	-16.0	-9.0

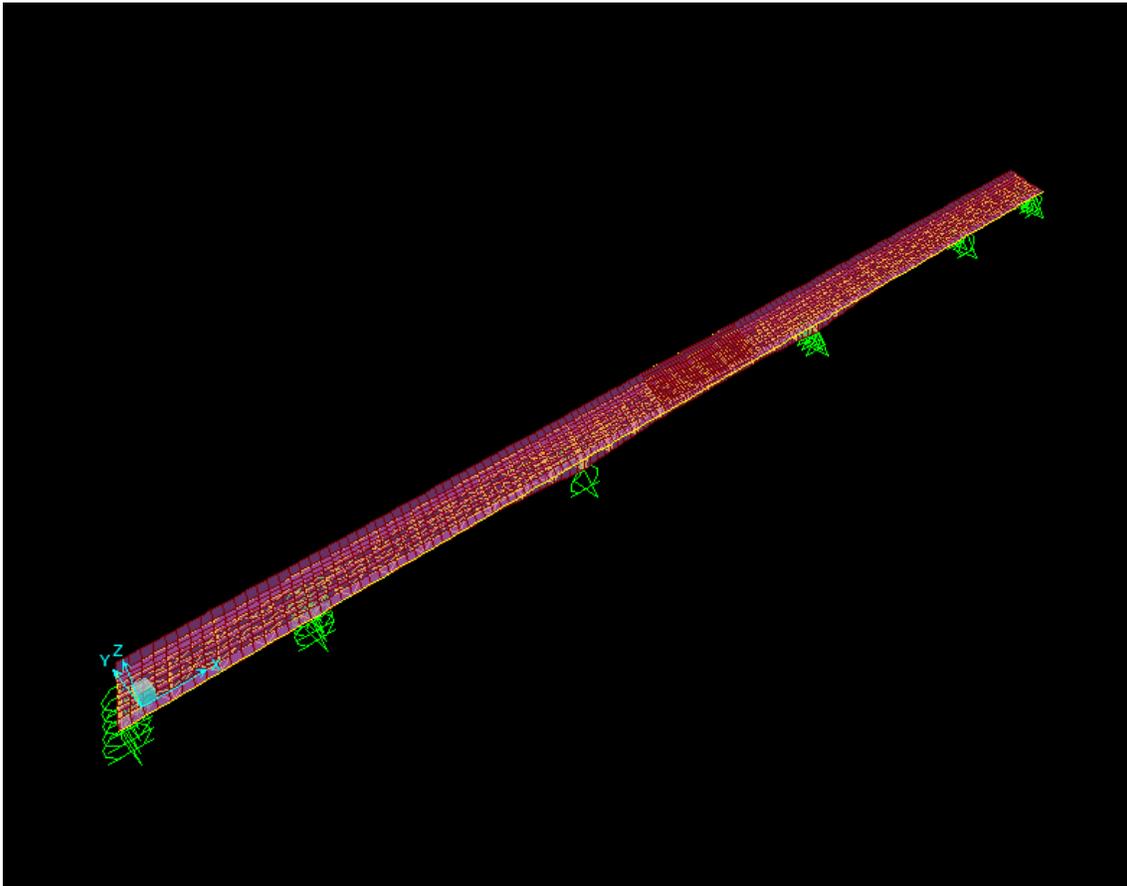
**Figure B.1** Three-dimensional finite element model

It is the purpose of this section to provide the reader with a three-dimensional view and details regarding the calibrated finite element model and its ability to virtually simulate the bridge response to load. The structure is 790 feet long; the bridge deck is 42 feet 2 inches wide. The bridge has 5 spans and is on a 22-degree skew. The model, which is shown in Figure B.1, uses SAP 2000 as the computer program; it has 4,697 nodal points, 4,615 frame elements, and 2,925 areas. Table B.1 shows the number of elements that were used to accurately describe the current condition of this bridge. Tables B.2 and B.3 provide some of the known details about the bridge supporting system.

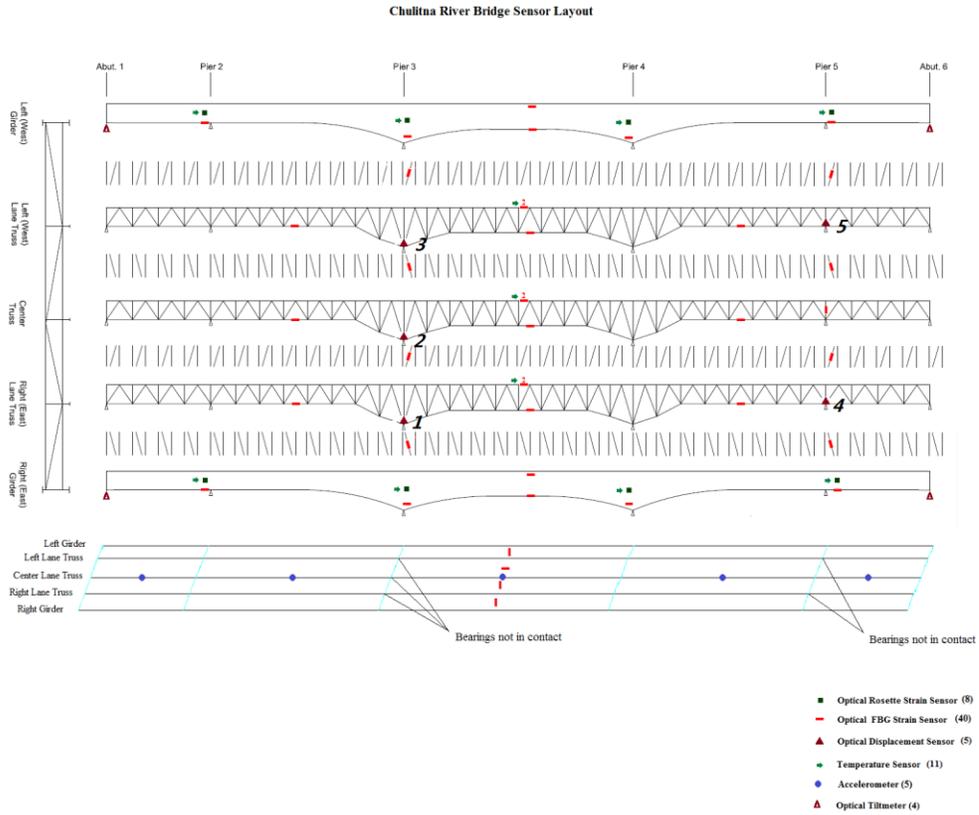
**Figure B.2** Sensor layout and location for five bearing supports with a separation

Locations 2 and 5: At these locations, the bridge is not connected to the supports.

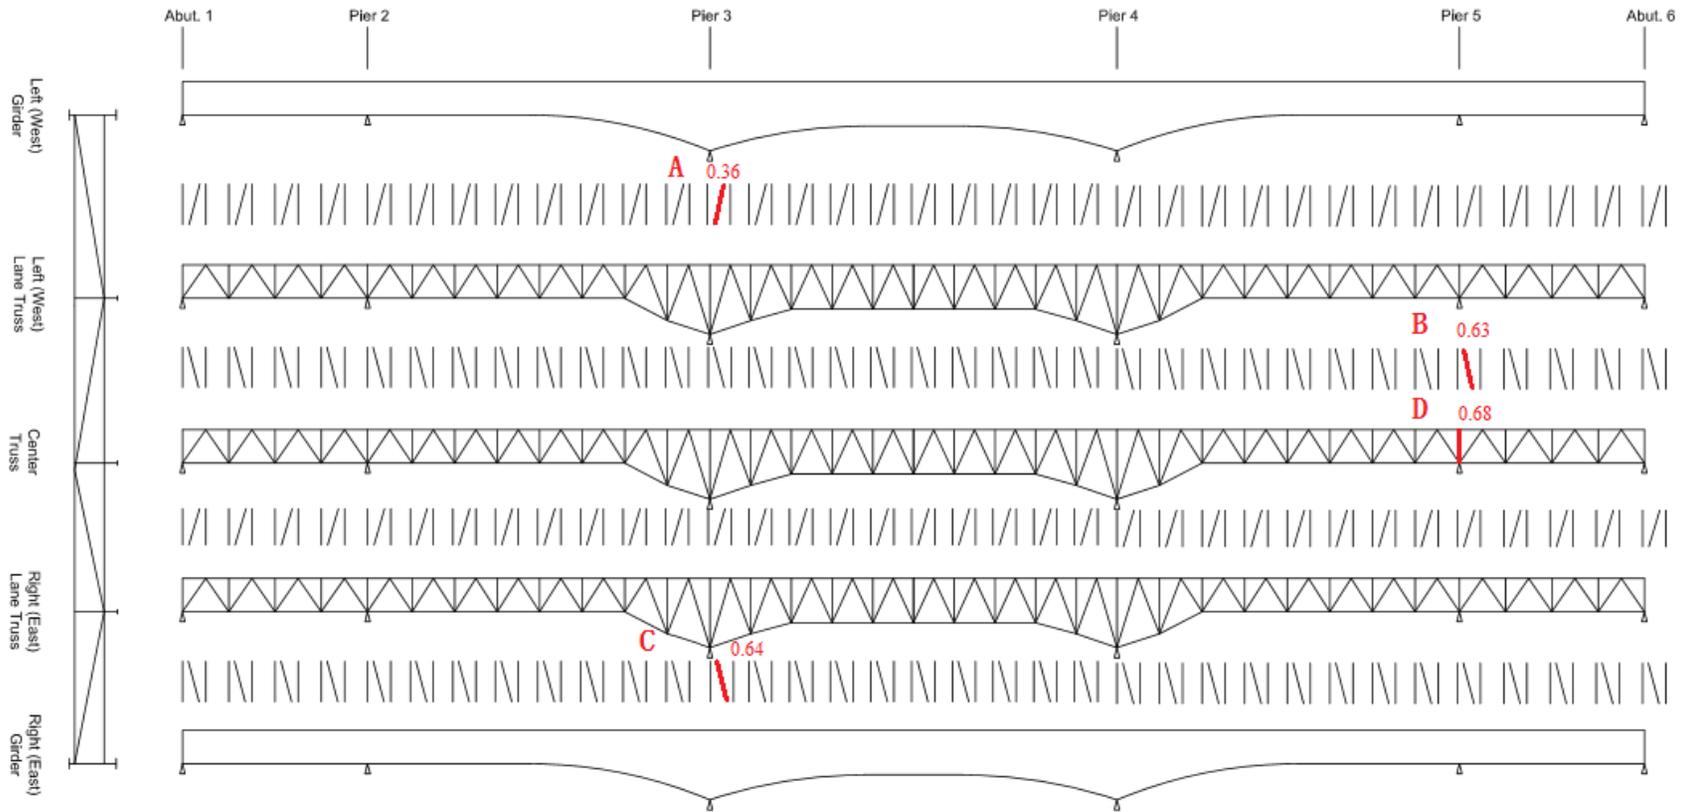
**Figure C.1** Load rating: three lanes, HL-93, as-is

Note: All member rating factors not shown are > 1.00

LRFR HL-93 Operating Rating Factors (<1.00)

(Updated Model - As is Condition for Three Lanes)

Based on the load rating results, four members have a load rating below 1. The dead-load and live-load states of stress values for the HL-93 inventory load (three lanes) are shown in Table C.3. The member locations are in accordance with Figure C.1, which is identified as the figure named HL-93 inventory load rating (as-is condition three lanes).

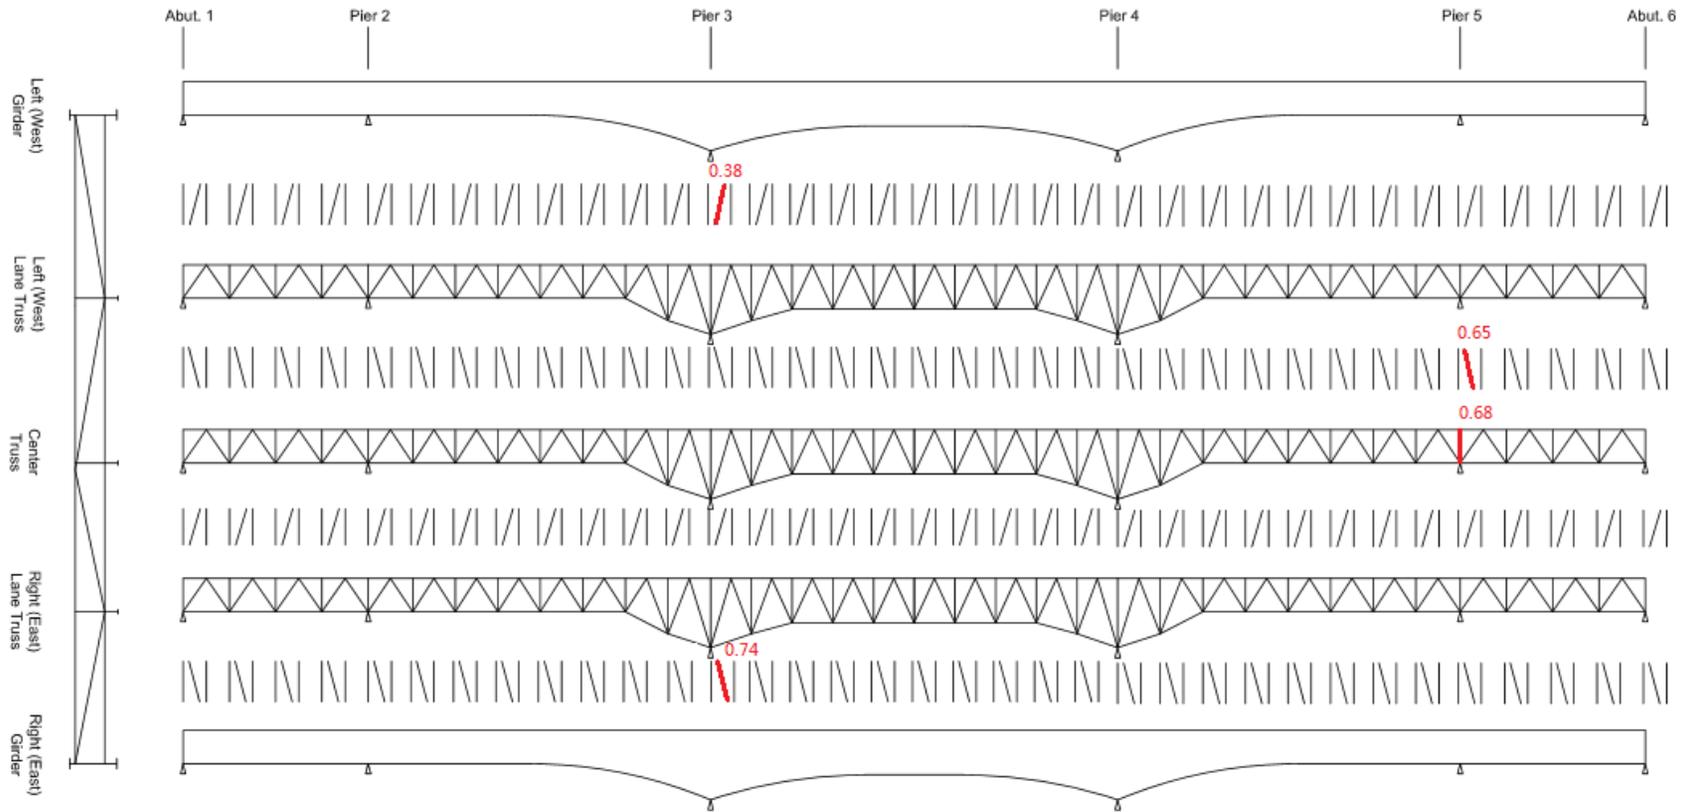
**Figure C.2** Load rating: two lanes, HL-93, as-is

Note: All member rating factors not shown are > 1.00

LRFR HL-93 Operating Rating Factors (<1.00)

(Updated Model - As is Condition for Two Lanes)

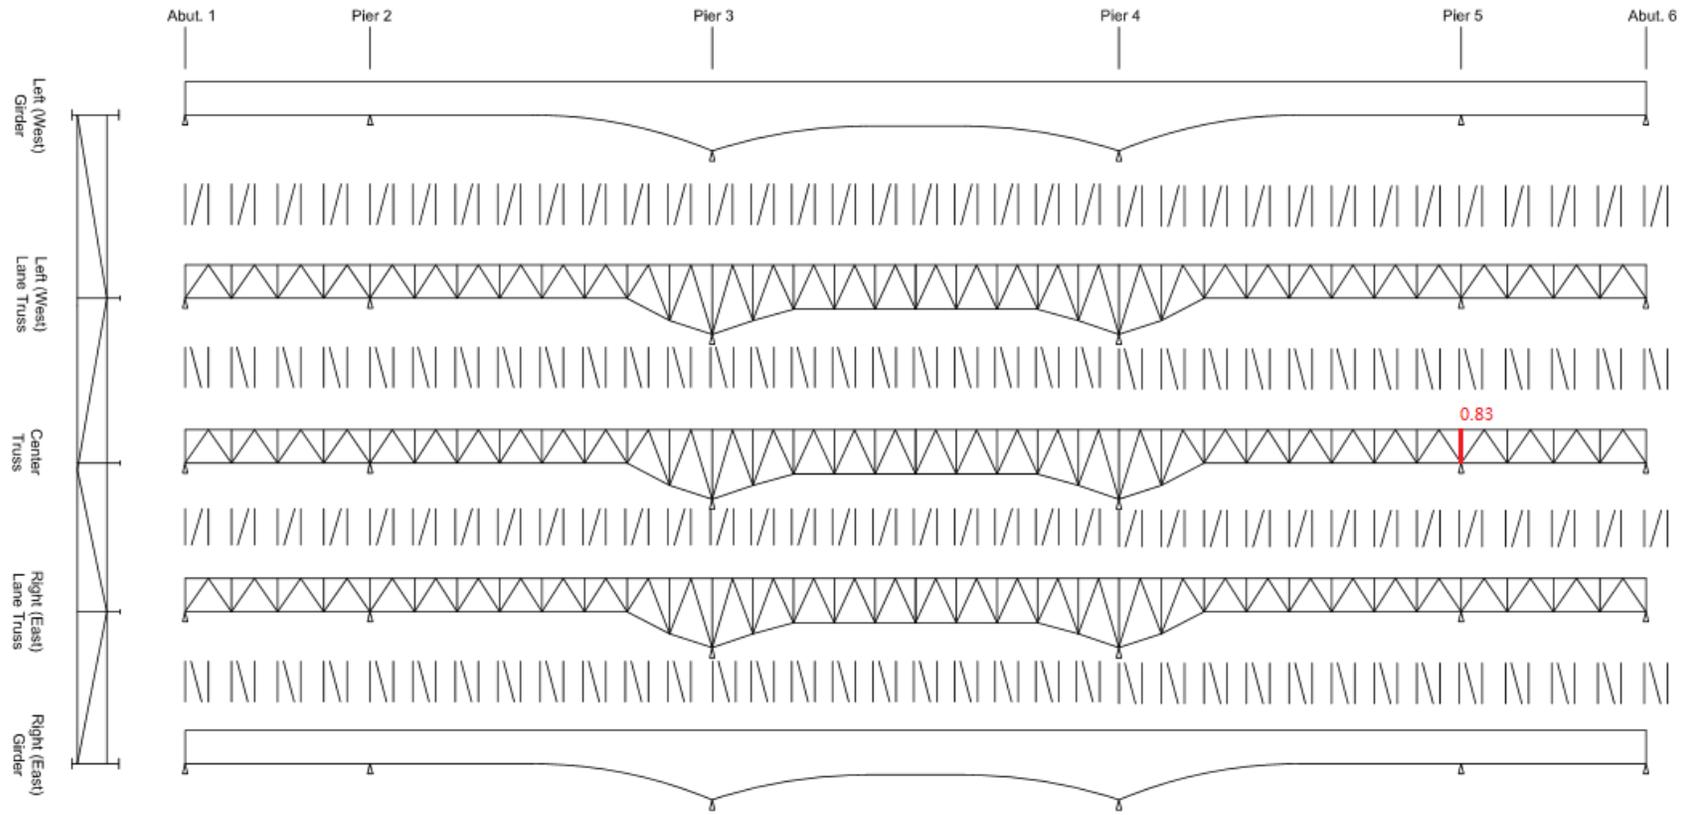
**Figure C.3** Load rating for two lanes with all rocker bearings in contact

Note: All member rating factors not shown are > 1.00

LRFR HL-93 Operating Rating Factors (<1.00)

“Supported” means that we considered all rocker bearings to be in contact with the interior truss girder. This means the 5 rocker bearings would be adjusted to make contact for a no-traffic condition.

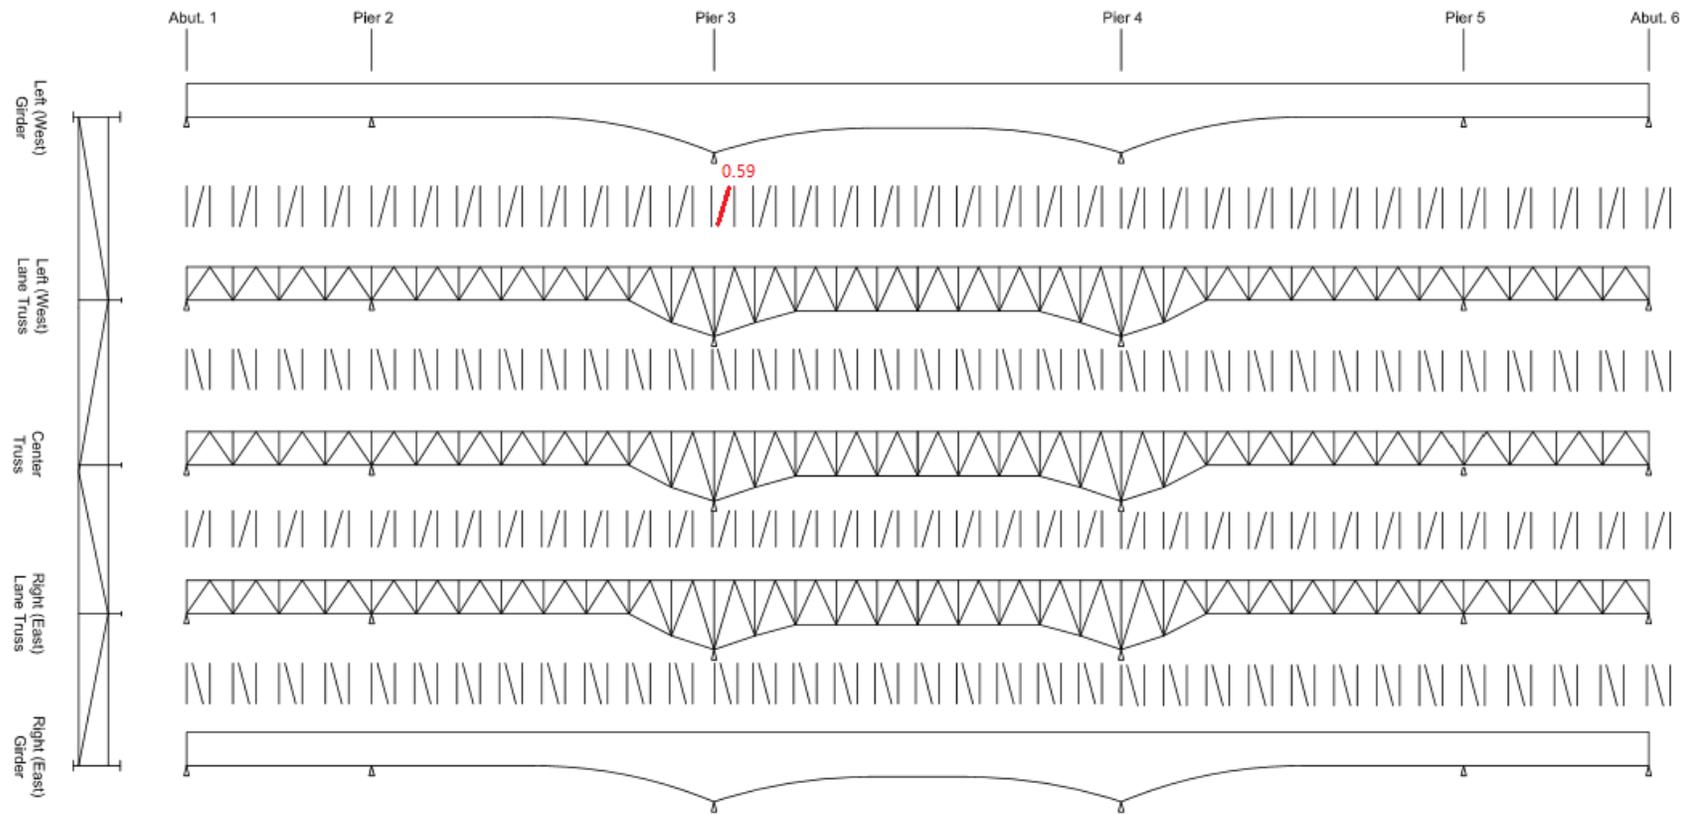
Note: All member rating factors not shown are > 1.00

LRFR Permit Load Rating Factors (<1.00)  
 (Updated Model - As is Condition for One Lane)

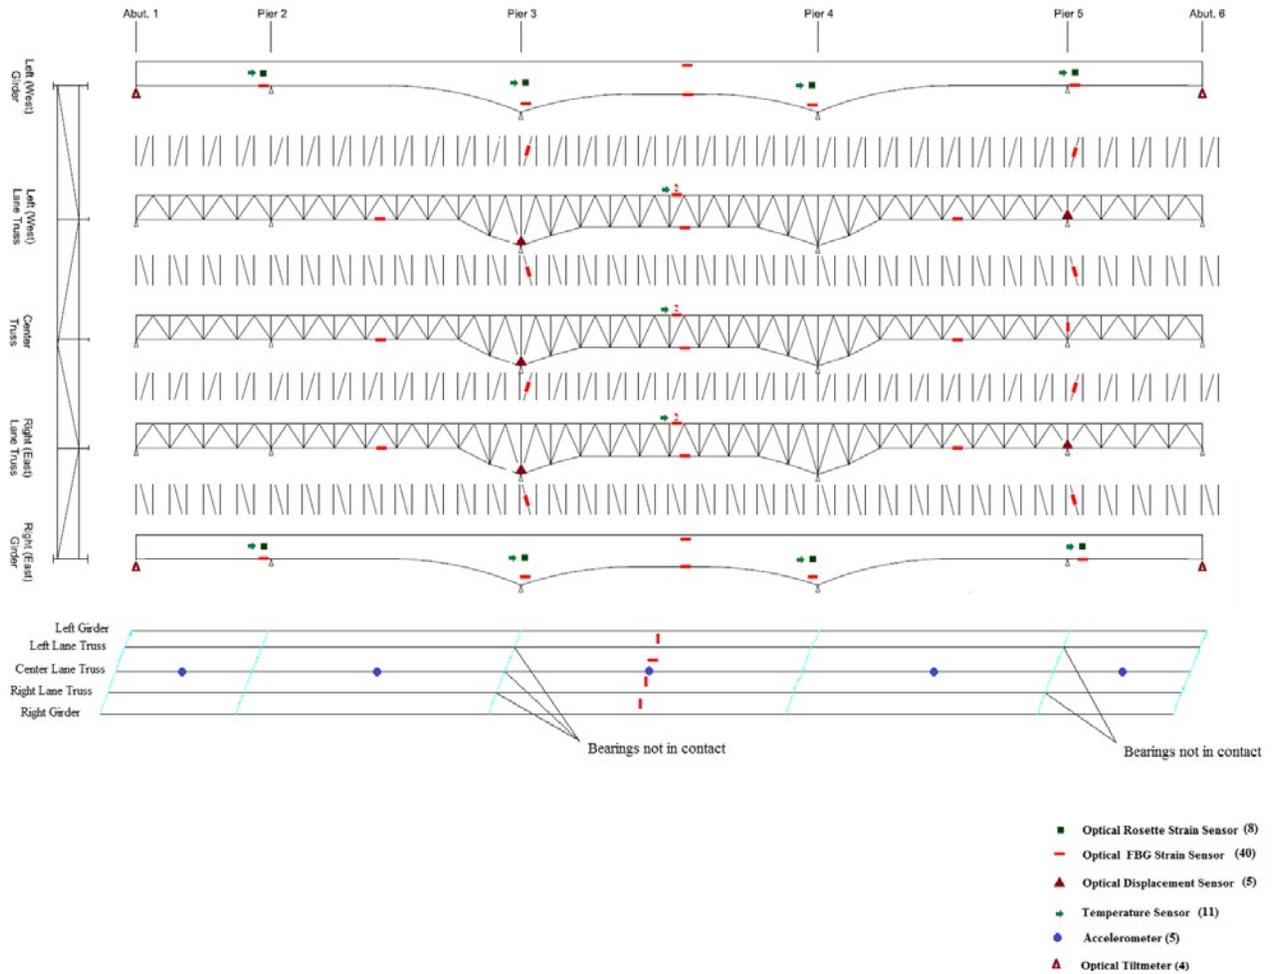
**Figure D.1** Sensor layout

The structural health monitoring system chosen for the Chulitna River Bridge had 73 sensors that were selected in collaboration with ADOT&PF Bridge Design. The sensor layout was to assist in evaluating the load distribution through the structure. Details of the sensor layout are published elsewhere (Xiao et al. 2012). Figure D.1 and Table D.1 shows the sensor layout used to study the response of this bridge.

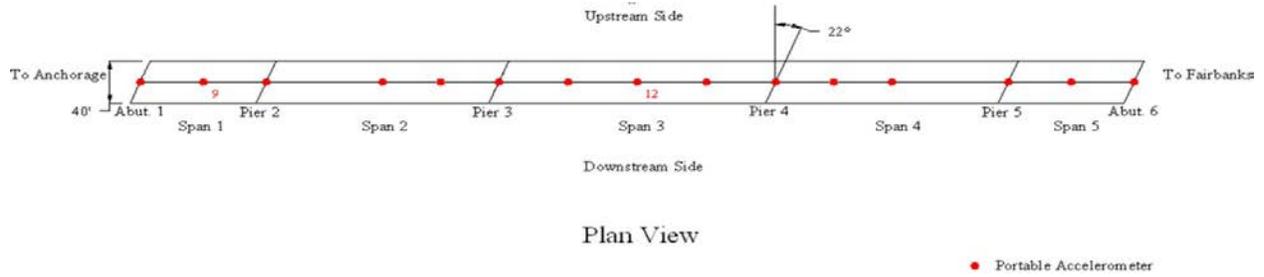
**Figure E.1** Portable accelerometer location and number

Fifteen portable single-axis accelerometers were used for the ambient tests (see Figs. E.1 and E.2). The accelerometers were located at piers and mid-spans. Because Spans 2, 3, and 4 are longer, more data collection points were placed in these spans. All accelerometers were set in a line along the center width of the deck on the flat clean driving surface. Vertical, transverse, and longitudinal accelerations were measured. In each, data were collected three times. Testing details are provided elsewhere (Xiao et al. 2012; Hulsey et al. 2012b; Hulsey et al. 2013a, 2013b; Xiao et al. 2014).

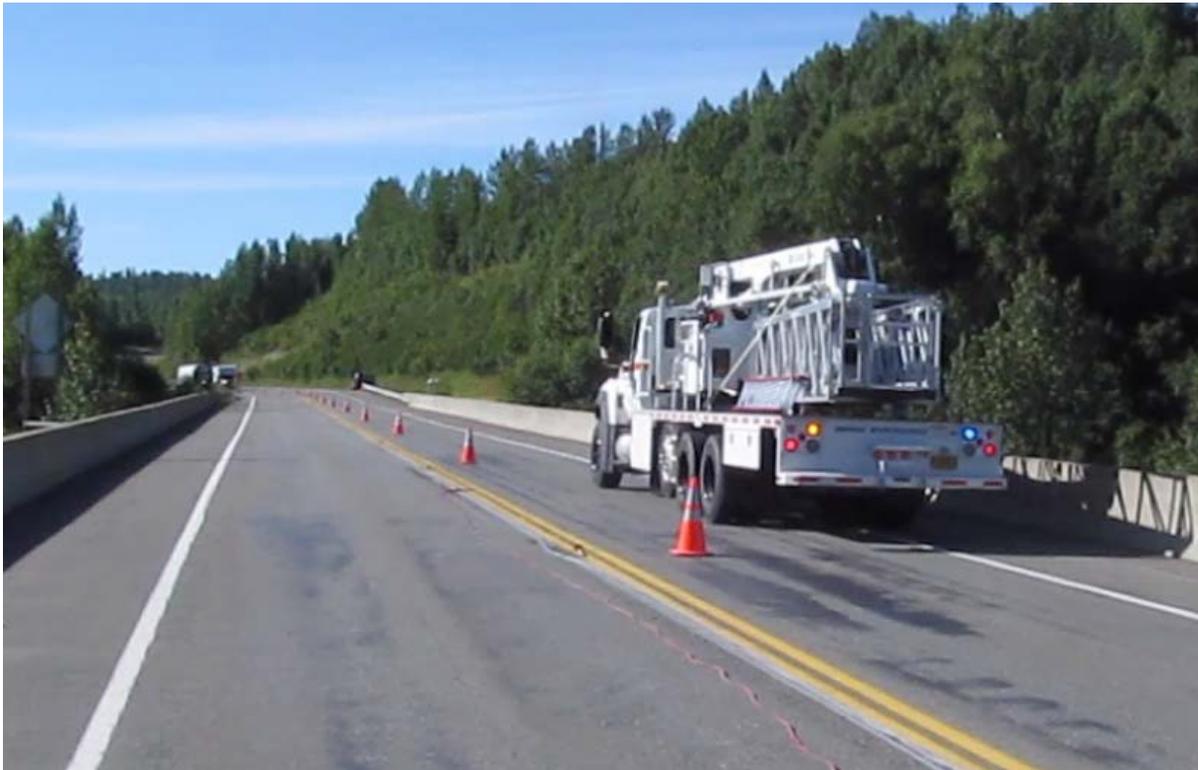
**Figure E.3** A-30 boom truck traveling north for the dynamic ambient test

input. The A-30 boom truck crossed the bridge from Fairbanks to Anchorage (traveling south) in the upstream lane at a speed of 45 mph (Fig. E.3). The bridge was kept closed while the bridge's excitation was monitored until vibration was totally damped out.

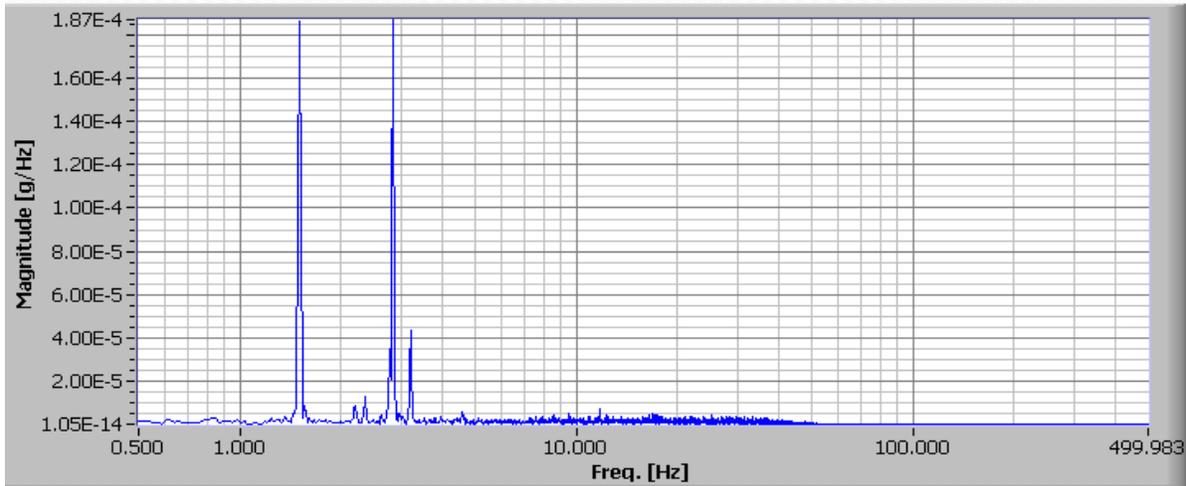
**Figure E.4** FFT for measured vertical acceleration (middle of Span 3; Point 12)

direction in the middle of Span 3 (Point 12). In Figure E.4, we can see multiple peaks, with  $f_1=1.50$  Hz,  $f_2=2.85$  Hz, and  $f_3=3.23$  Hz dominating.

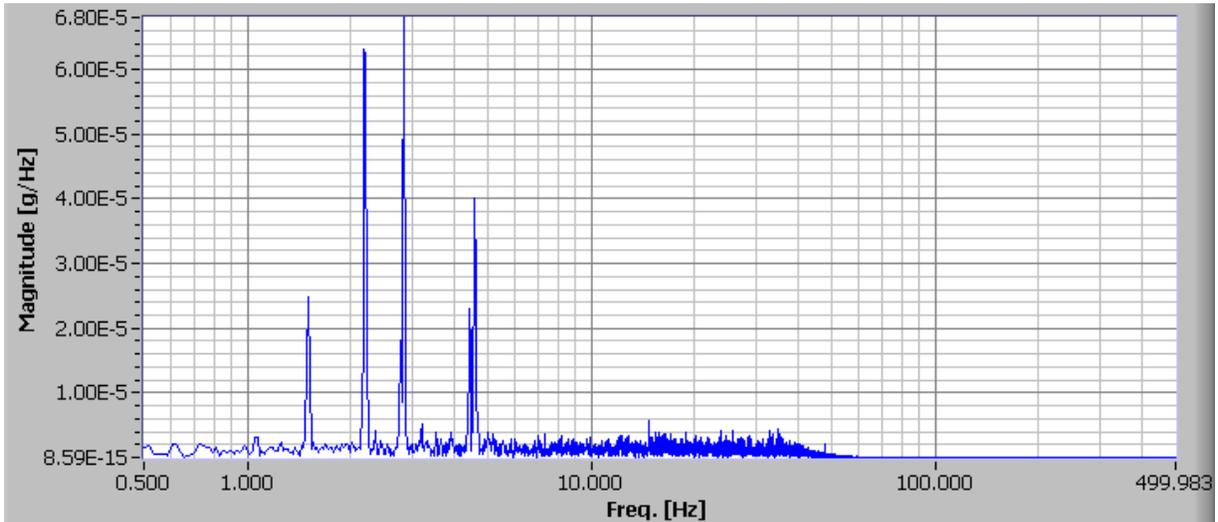
**Figure E.5** FFT for measured vertical acceleration (middle of Span 1, Point 9)

Figure E.5 shows the FFT of a typical measured acceleration signal in the vertical direction in the middle of Span 1 (Point 9). In Figure E.5, we see multiple peaks, with  $f_{1a}=1.50$  Hz,  $f_{2a}=2.20$  Hz,  $f_{3a}=2.85$  Hz, and  $f_{4a}=4.58$  Hz dominating.

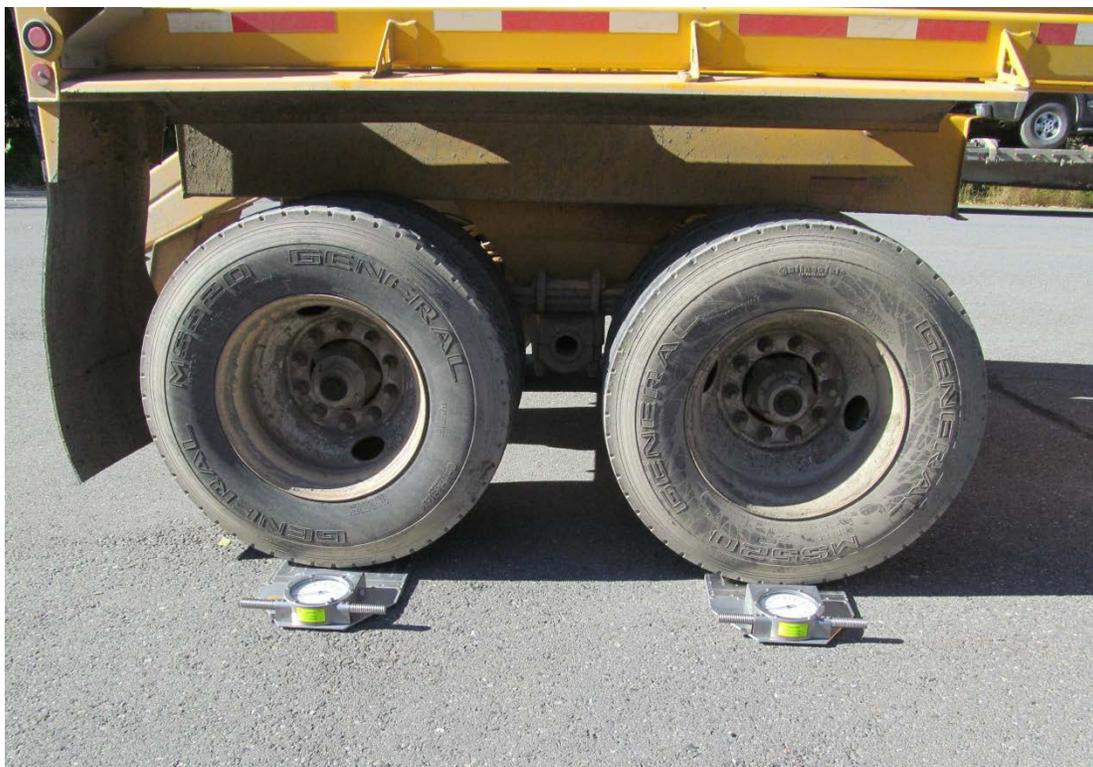
**Figure E.6** Axle weight measured by the wheel load scales

Three ADOT&PF dump trucks were used to load test the Chulitna River Bridge on September 10, 2012. Prior to the load test, three empty ADOT&PF dump trucks were provided for testing the bridge. Each truck-trailer was weighed and measured. Then, the trailers were loaded with sand and the truck-trailers were weighed (this is the load prior to testing). At the end of the day on September 10, after the load test, the three loaded ADOT&PF dump trucks were again weighed. This data provided the researchers with a record of the change in weight over the 8-hour test period. Axle weights were measured with calibrated portable scales provided by the ADOT&PF (see Figs. E.6 and E.7).

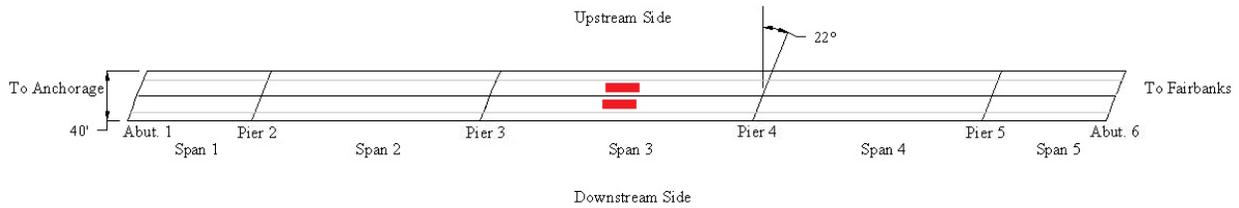
**Figure E.9** Two trucks side-by-side and positioned in Span 3

bridge and Truck No. 36195 was on the upstream side of the bridge (see Tables E.1 through E.3 for truck weight, axle width, and axle spacing).

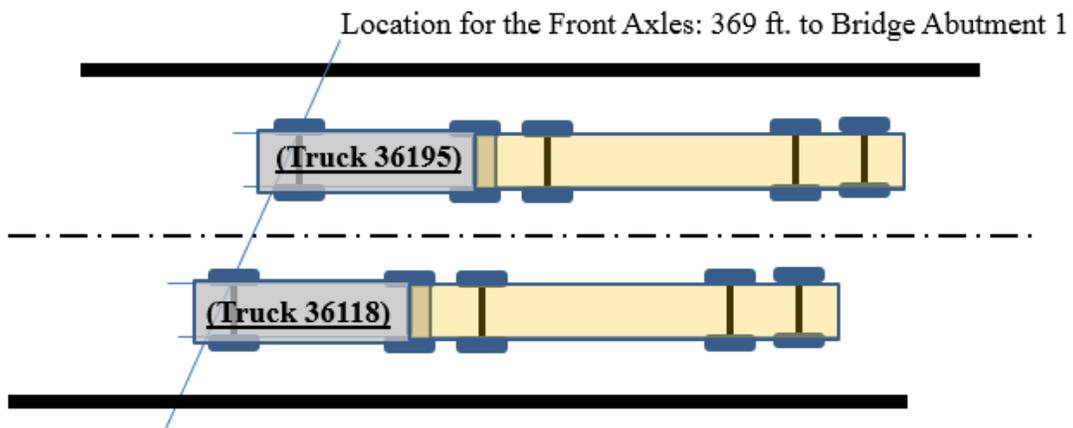
**Figure E.10** Plan view of two trucks at mid-Span 3 southbound

In Trial 1, the ADOT&PF trucks used for testing were stopped and positioned in the middle of Span 3 (between Piers 3 and 4). The front axles were located 369 feet from the south abutment (Abutment 1) (see Figs. E.10 and E.11). A finite element analysis for these same load conditions was conducted. The local calculated strains and displacements were compared with the experimental SHMS response data

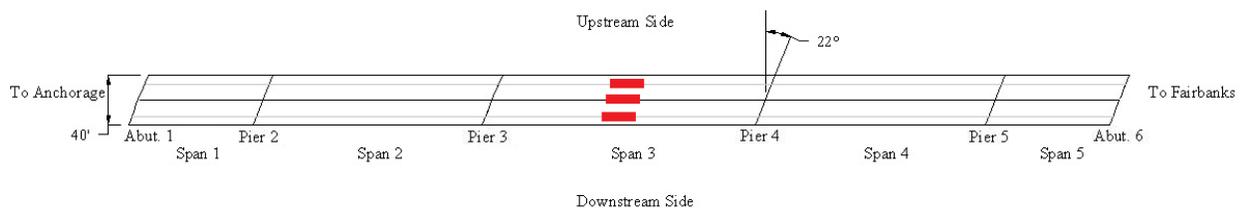
**Figure E.12** Three trucks side by side

Three trucks traveled parallel to the 22 degree skew angle of the bridge. Truck No. 36195 was on the upstream side of the bridge (Fig. E.12). The ADOT&PF loaded trucks moved southbound at 1 mph. We conducted static tests by stopping the trucks for no less than 30 seconds at several pre-determined locations along the length of the bridge. In Trial 17, three trucks were positioned at mid-span of Span 3 (see Figs. E.13 and E.14). We compared FEM calculated values with local SHMS data. Truck No. 36188 was on the middle of the bridge, and Truck No. 35752 was on the downstream side of the bridge (see Figs. E.13 and E.14).

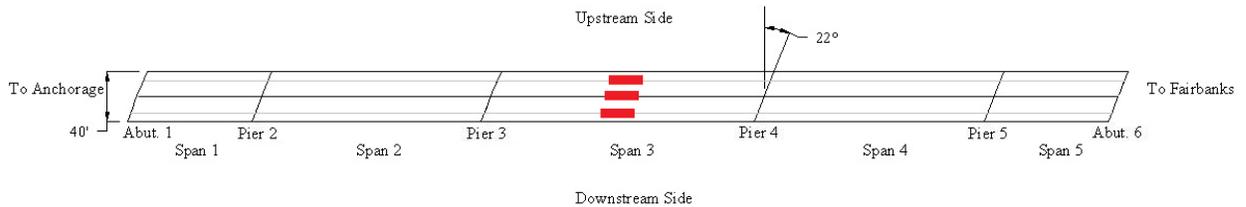
**Figure E.15** Three trucks side by side

In this test, the three ADOT&PF test trucks traveled side by side (Fig. E.15) heading north. Truck No. 36195 was in the downstream lane. Truck No. 36188 was in the middle lane and Truck No. 35752 was in the upstream lane. We requested that they travel as fast as they could safely cross the bridge. The ADOT&PF truck drivers selected a speed of 15 mph for this series of dynamic tests (see Fig. E.15 and Table E.4).

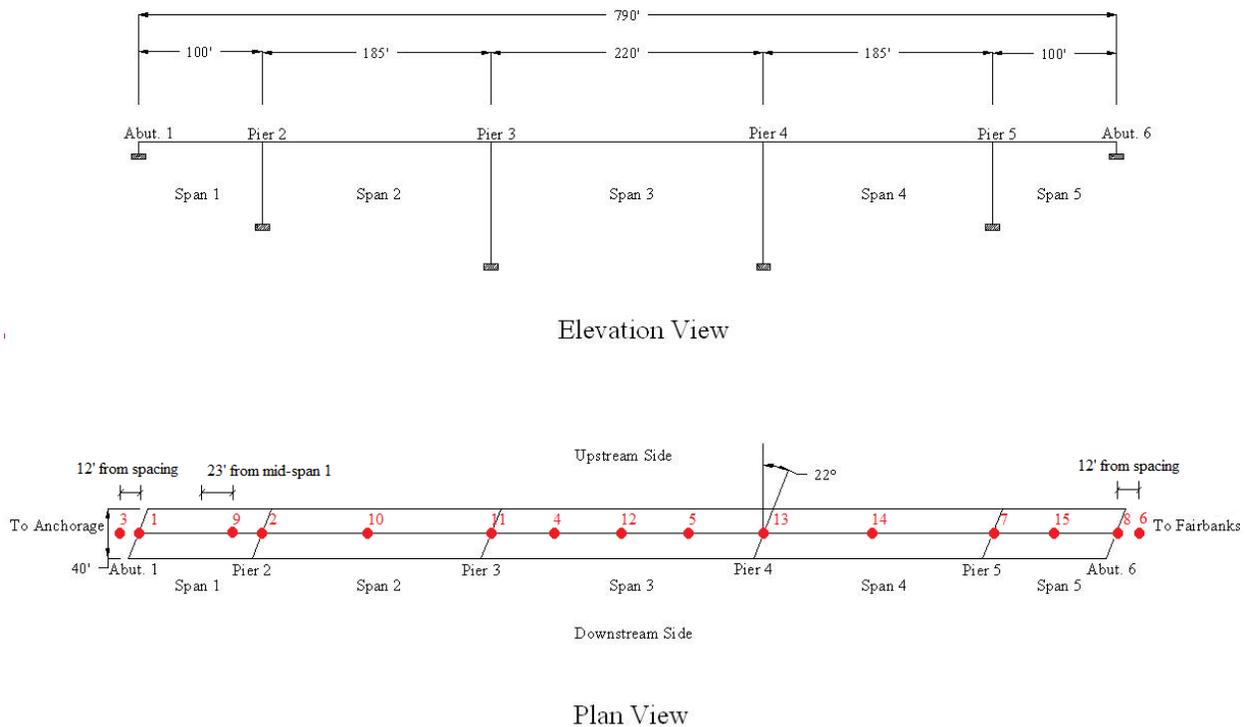
**Figure E.16** Accelerometer layout

In May 2013, we conducted a second “ambient” test on the bridge; the first test was in August 2012. Again, we placed fifteen portable accelerometers in a line along the length of the bridge and located down the center of the driving surface (see Fig. E.16).
