Transit Vehicle-to-Infrastructure (V2I) Applications: Near Term Research and Development

Transit Bus Stop Pedestrian Safety
Application: Operational Concept

Final Report — December 2014

Publication Number: FHWA-JPO-14-174

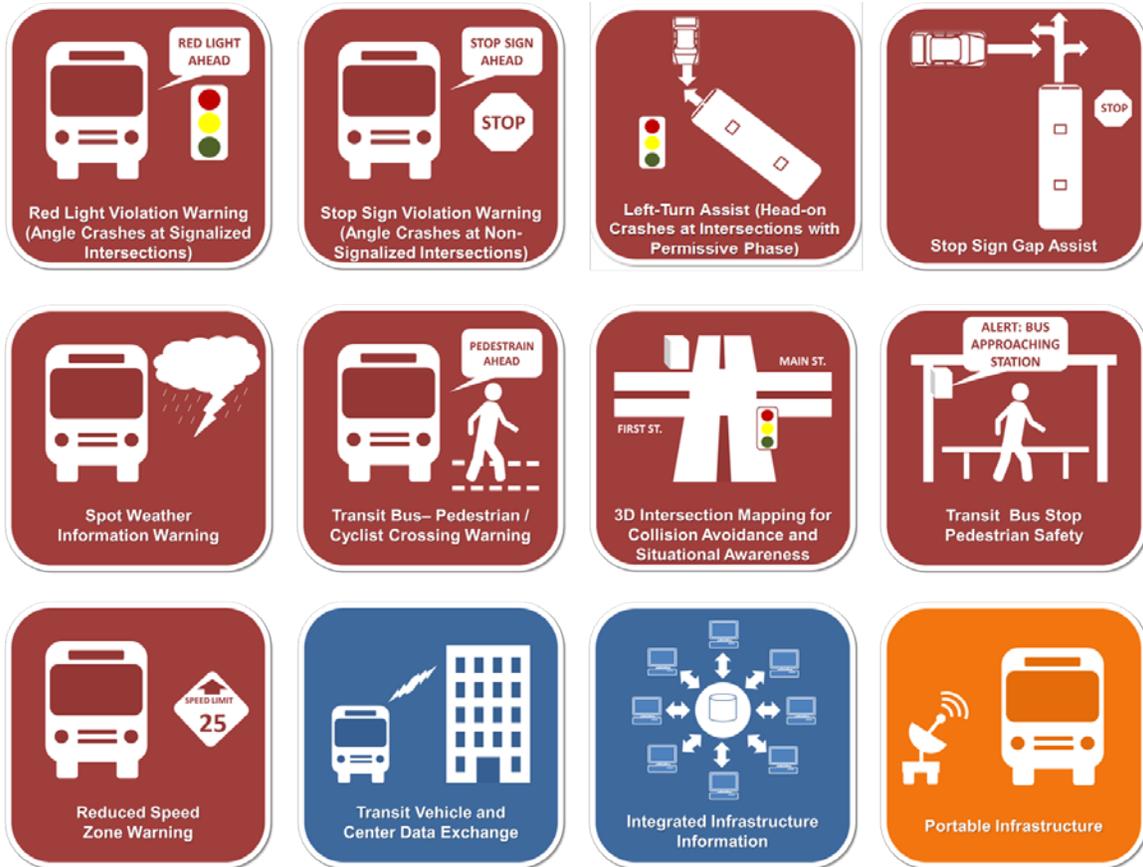
Figure 2-1: Transit V2I Applications (Source: USDOT, 2014).

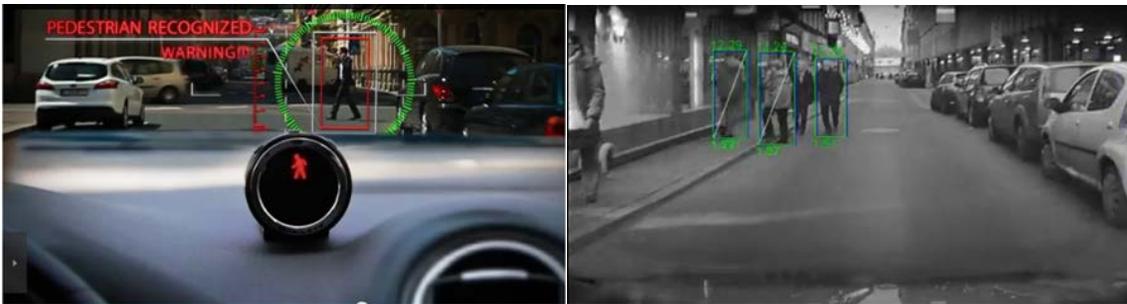
Both static and moving pedestrians can be detected to a range of around 30 meters using Video Graphics Array (VGA) resolution imagers. As higher resolution imagers become available range will scale with imager resolution, making detection ranges of up to 60 meters feasible. Mobileye's first production for Pedestrian detection systems was in 2009 on a range of industrial powered vehicles where 8 EyeQ2 based monocular cameras provide a 360 degree all-round pedestrian detection system to a range of 15 meters and will warn the vehicle operator via Audio/Visual warnings of pedestrian in the vehicles path. The Mobileye system has been installed on 150 transit buses in Israel. [5]

Figure 3-4: Mobileye's Pedestrian Detection System (Source: Mobileye [5])

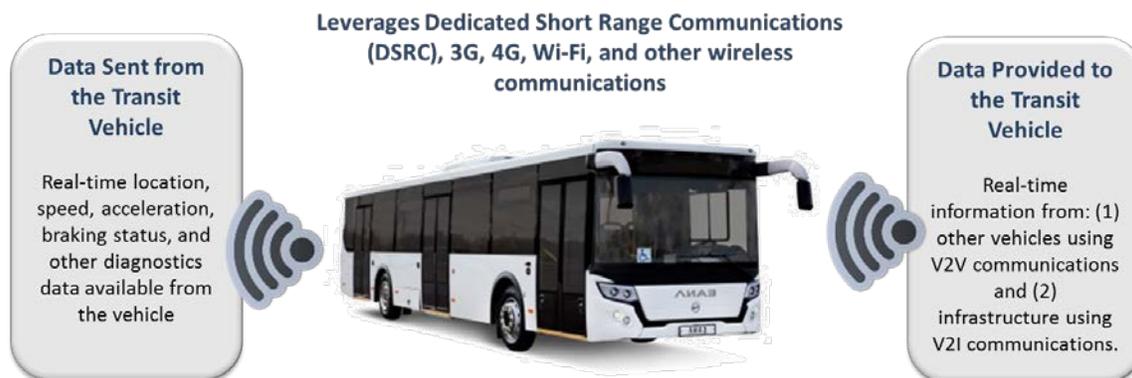
Connected vehicle technologies offer tremendous promise for safety improvements. Connected vehicle technologies function using a V2V and V2I data communications platform that, like the Internet, supports numerous applications, both public and private. This wireless communications platform provides the foundation to integrate data from the infrastructure (e.g., systems located at transit stops/stations) with data from the vehicle (e.g., position, speed, brake status). V2I communications offer an environment rich in vehicle and infrastructure data that can be used by applications residing on the roadside unit to provide pedestrians with alerts to avoid collisions with motor vehicles or transit vehicles.

Figure 4-1: A Connected Transit Vehicle (Source: USDOT, 2014)
