STATE OF MAINE
DEPARTMENT OF TRANSPORTATION

EXPERIMENTAL CONSTRUCTION PROJECT ME 98-08

CONSTRUCTION REPORT

EXPERIMENTAL UTILIZATION OF PERMEABLE BASE

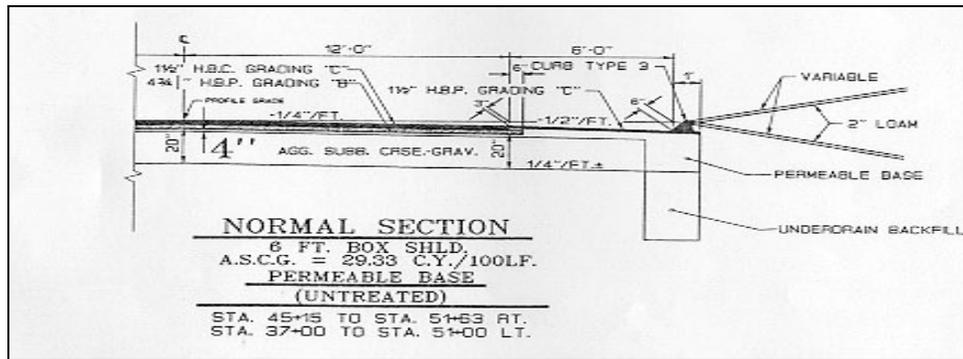
Figure 2 Normal Section Untreated Base

The 4 inch layer of permeable base was placed and compacted in a single layer, between the aggregate subbase and the 6 ¼ inch surface paving. The layer extended laterally to cover the under drain trenches and extended through the shoulder slope. The order of construction was as follows:

The box trenches for the underdrains were excavated after the fine grading was completed. Crushed stone was placed in the trenches in two lifts. The first lift was compacted with one pass by a vibratory whacker, the second by passing over it several times with the tire on the excavator. Compaction appeared to be adequate using this method. Normal sections showing the underdrain trench are shown below. Both untreated and treated sections are depicted.

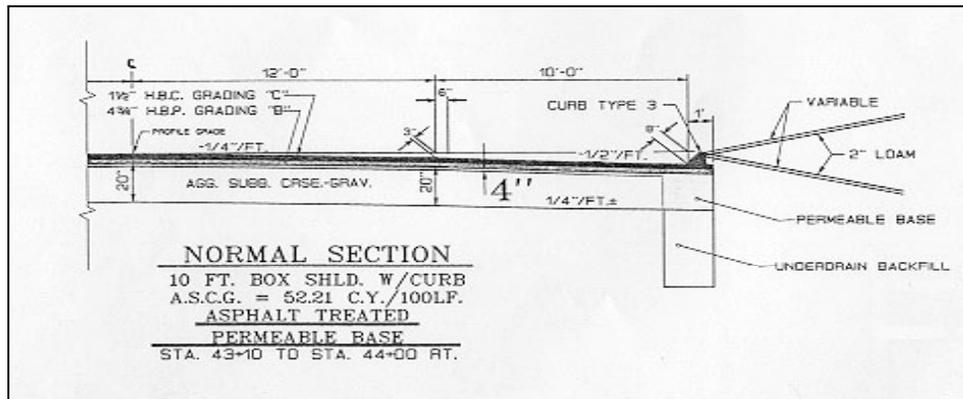
Figure 3 Normal Section Treated Base

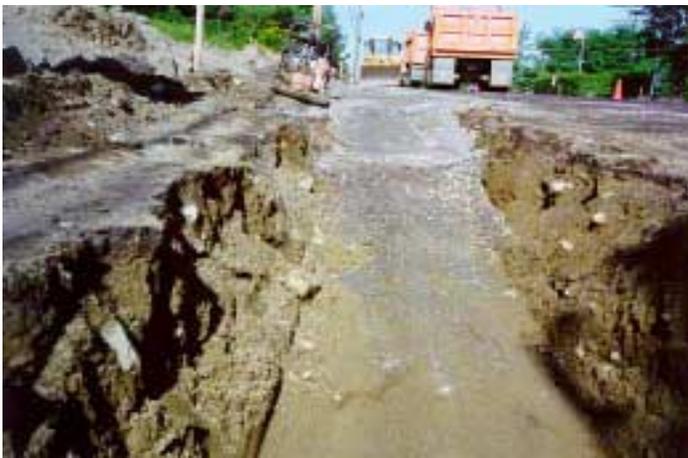
Figure 4 Box Trench Construction

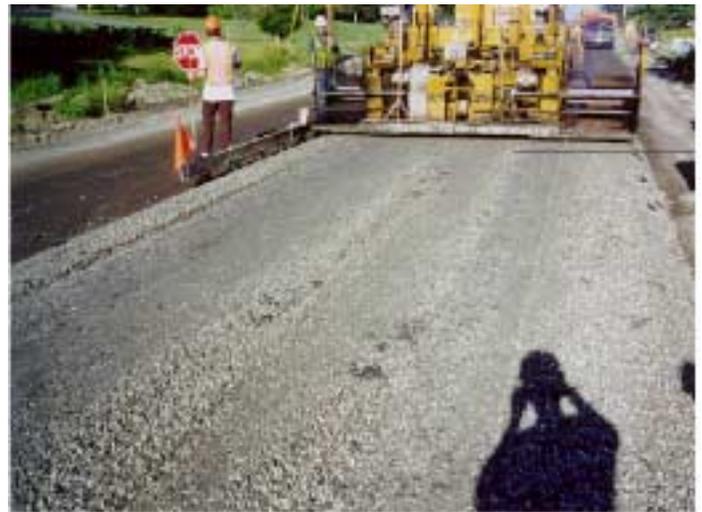
Figure 5 Permeable Base Placement

Both treated and untreated experimental sections were constructed on August 25 and 26, 1998. On the first day test the north side of the road was constructed; on the second day the south side was completed. The permeable sections were made 15 feet wide in the travel lanes and extended over the longitudinal underdrains. The shoulders were finished at a later date. The permeable base was installed using a paving machine for both treated and untreated sections. Installation of both treated and untreated sections test sections on the north side took about 4 ½ hours.

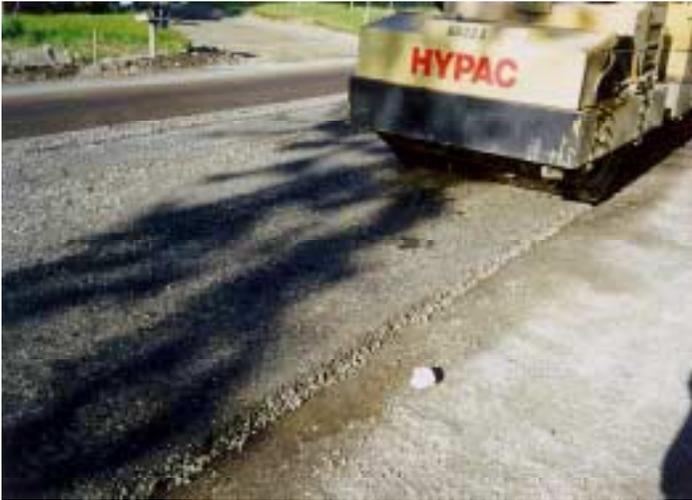
Figure 6 Permeable Base Compaction

Both treated and untreated sections were compacted using five passes of a 10 ton static roller. On the second day, a heated mix was used for the treated section. After placement, the temperature of the mix dropped 50 to 60 degrees very quickly, but then rate of cooling slowed. After two hours it was still at 175°. Two passes of a water truck cooled the material sufficiently to allow compaction. Initially, there was some reluctance to use much water. This proved to be unwarranted since after watering things went better. Since the treated base layer was softer due to heating, only three passes of the static roller were needed. Perhaps another pass might have been warranted as the water truck tires made ½ inch ruts, however, car traffic only left marks on the very edge of the sections.

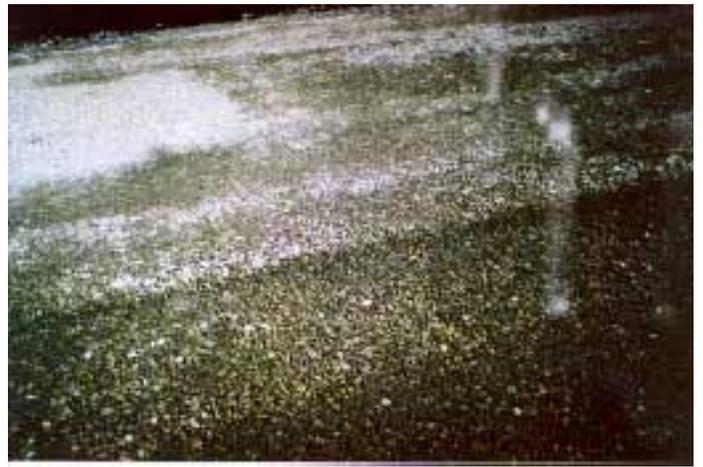
Figure 7 Permeable Base after Compaction

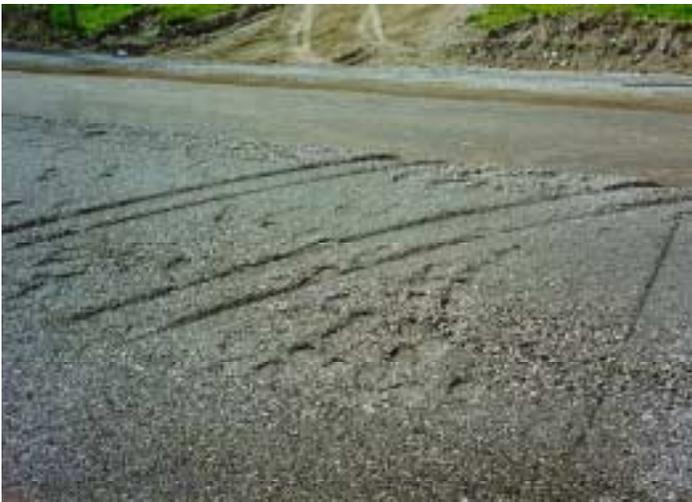
Figure 8 Untreated Base

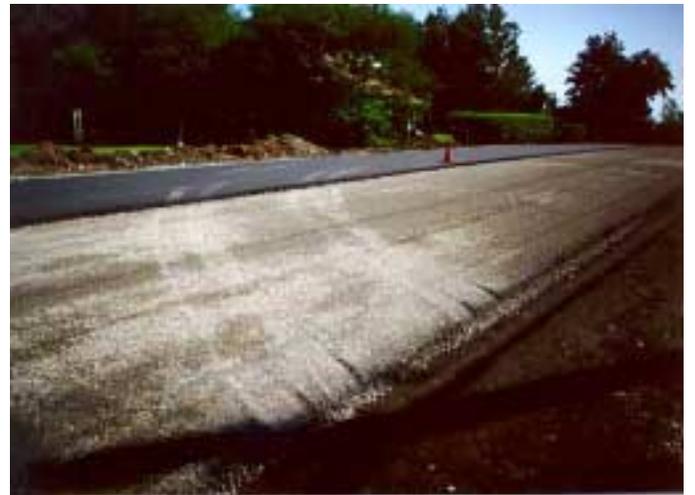
Figure 9 Treated Base

proportion, occasionally there were stones with very little coating; the mix looked like very lean asphalt mix having a very coarse gradation. The untreated permeable base installed more quickly than the treated section since the trucks did not have to wait at the plant. In the treated section, untreated stone was used over the under drain trenches, due to the fact that it would have been impractical for the plant to heat and mix the small amount of stone needed in that section.

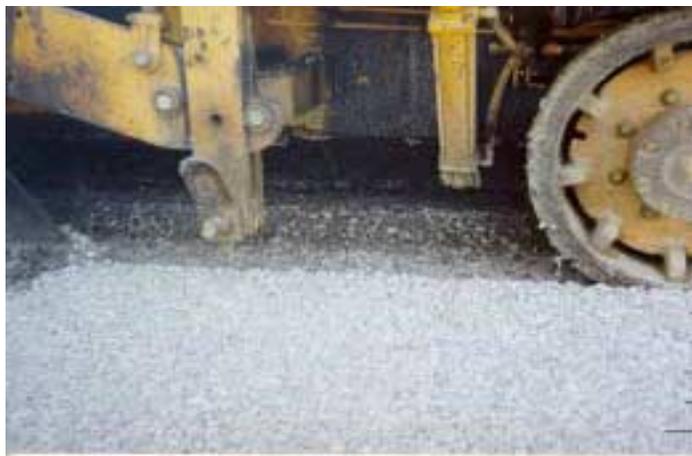
Figure 10 Paver Wheels on Untreated Base

In both treated and untreated sections the stability of the aggregate was a problem. A major problem occurred on the first day when the surface course was placed. The permeable base did not have adequate stability to support the small front wheels of the paver. Ridges of stones were pushed up to the sides of the paver causing thin areas in the surface pavement layer. Workers raked and smoothed the alleviate this problem. Paving was suspended on this section, however, until a tracked paver could be obtained. After switching to the tracked machine the process went more smoothly.

Second, if untreated aggregate is used, a tracked paver must be used to pave over the untreated aggregate. Since untreated aggregate has no adhesion and reduced stability, a wheeled paver will sink into it, forcing aggregate to the sides and reducing final pavement layer thickness. On this project the stability gained from a 2% asphalt mix adhering to the stones was apparent.

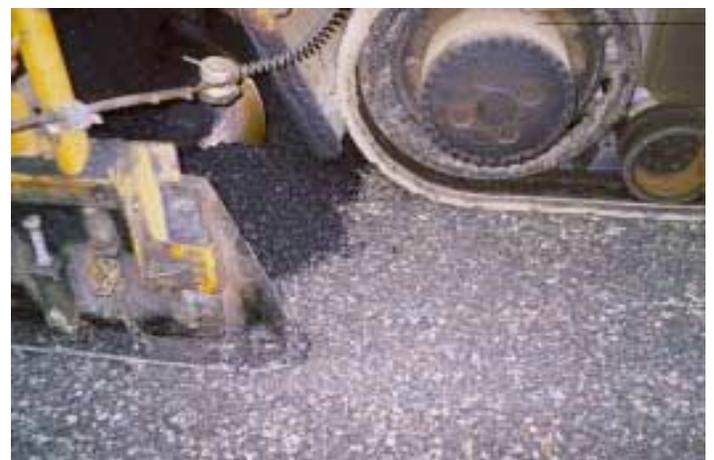
Figure 11 Paver Tracks on Treated Base

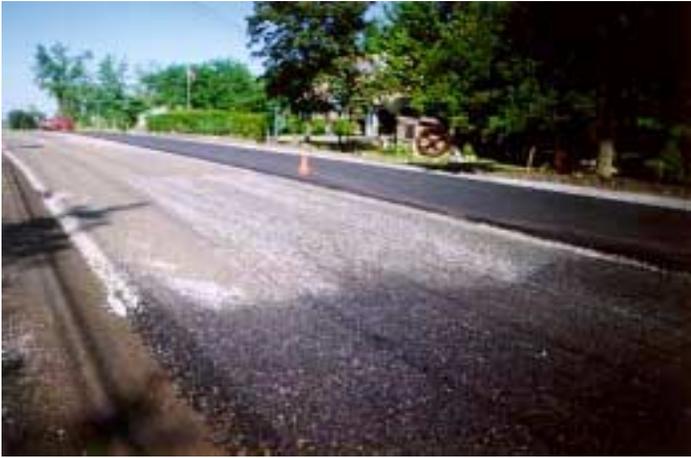
Figure 12 Joining of Treated and Untreated Sections

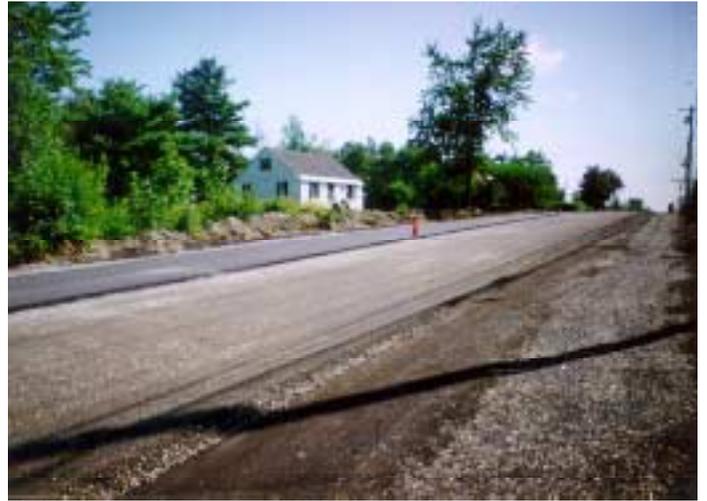
Figure 13 Adjacent Base Sections

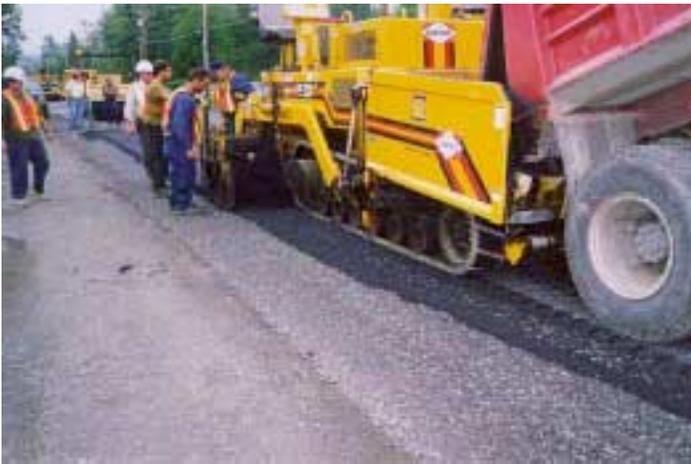
Figure 14 Paving Operation with Tracked Paver

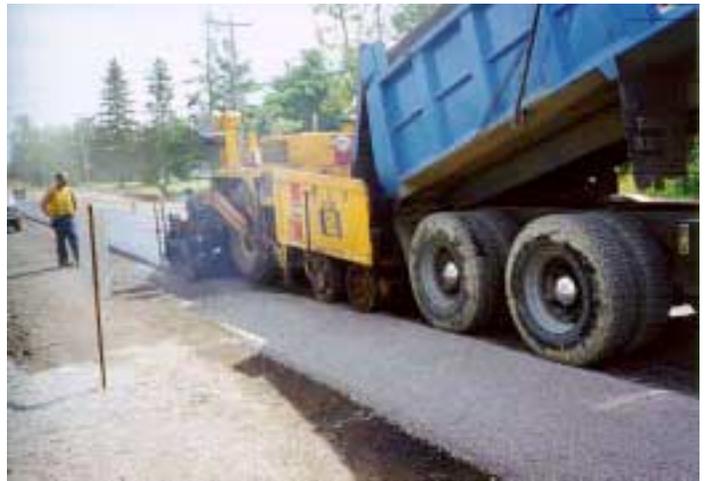
Figure 15 Paving Operation with Wheeled Paver

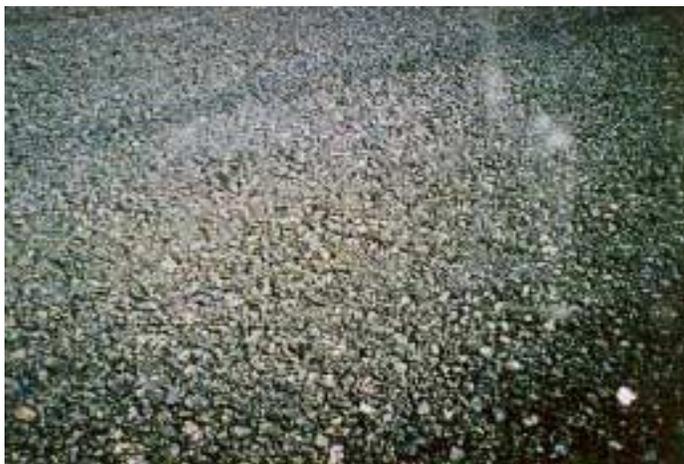
Figure 16 Close-Up of Treated Base

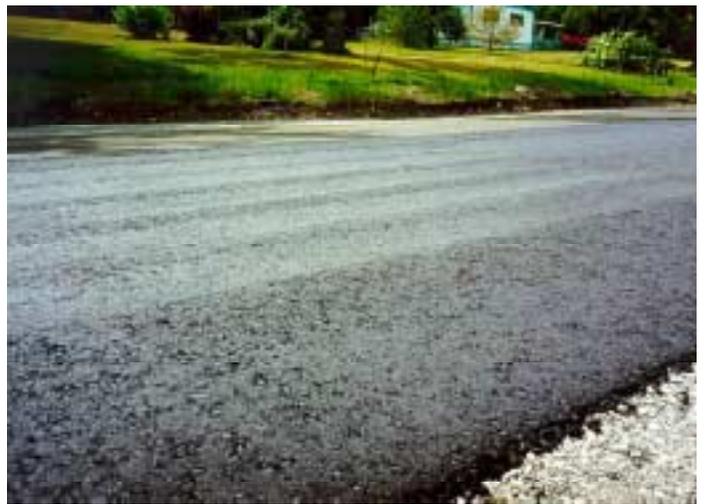
Figure 17 First Pavement Lift over Base

It was originally planned to reduce the total pavement thickness by 1 inch over the treated permeable base due to the structural contribution of the base. This would take advantage of the added structural value of the treated material. However, it was felt that the layer coefficient of the base was not adequate, and probably less than the recommended 0.23 AASHTO standard. In addition, it would have been difficult to match up with the pavement elevation and thickness in the untreated sections, so the pavement layer was not reduced. The construction process is shown in the series of photographs in the Appendix of this report.
