Louisiana Transportation Research Center

Technical Assistance Report No. 13-02TA-P

**Assessment of Mitigating Transverse Joint Faulting on
Portland Cement Concrete Pavement with Polyurethane Foam on
LA 1 Bypass, State Project Number 034-30-0023**

February 2015

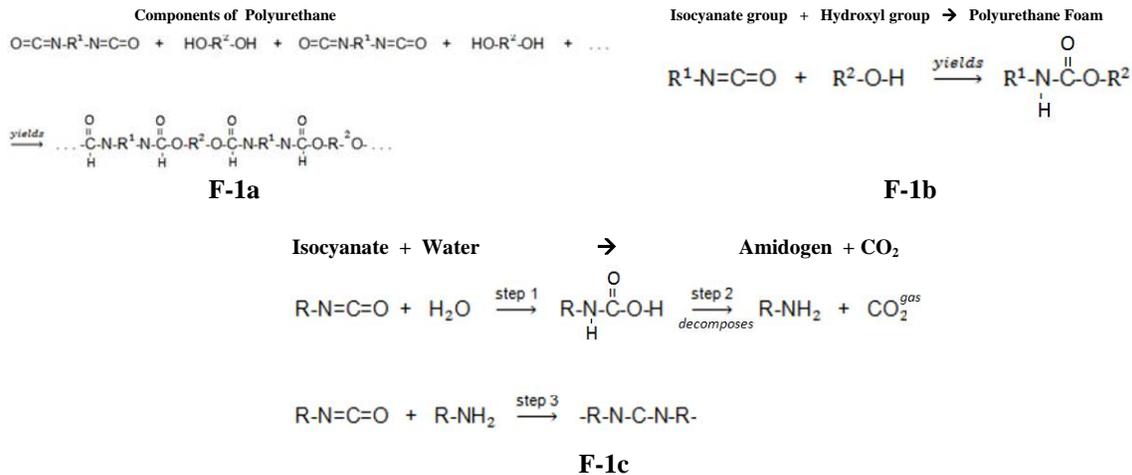
Polyurethane foam (PF) is polyurethane modified by reacting an isocyanate group with a blowing agent such as a hydroxyl group, hydrofluorocarbons (HFC), liquid carbon dioxide, or acetone as shown in Figures 1b and 1c [2-8].

Figure 1
Polyurethane foam properties

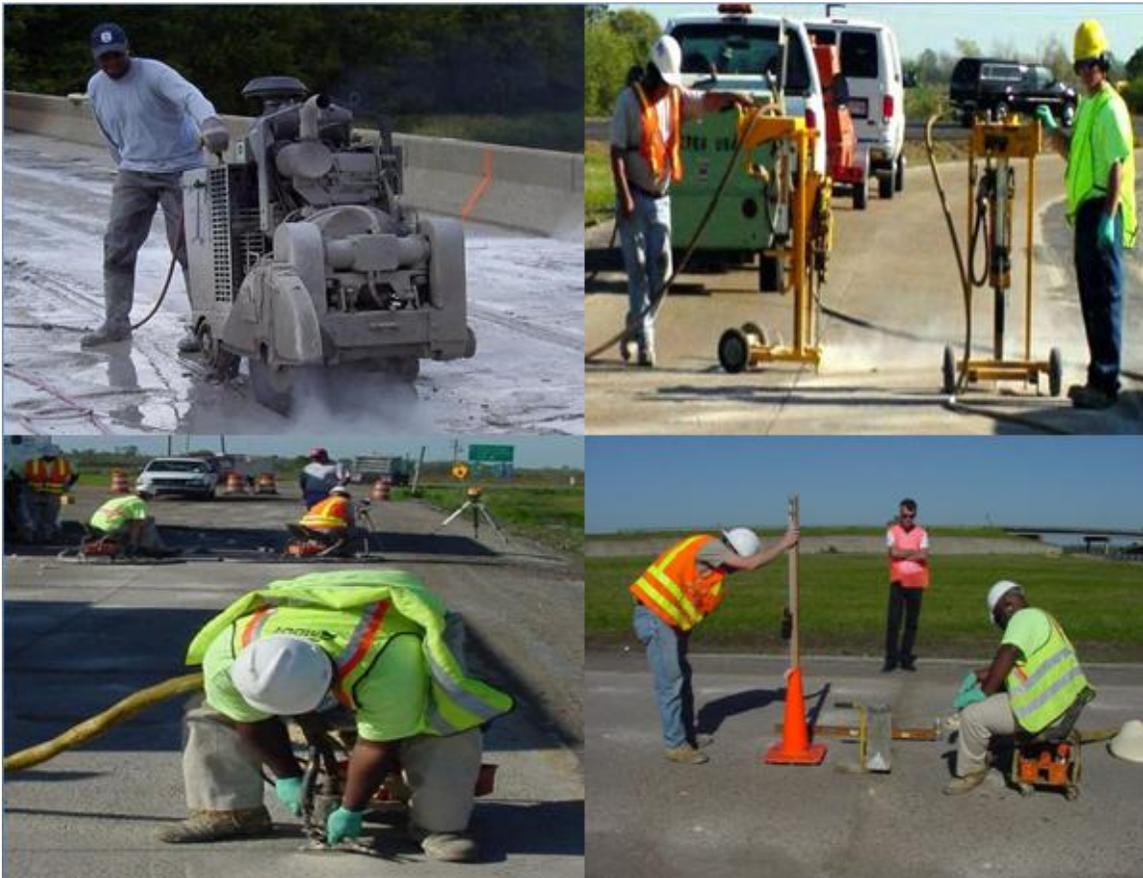
4. Drill holes through the slab and base course in intervals (typically 4 to 6 ft.) (longitudinal and transverse) determined by the PF contractor and/or project specifications.
5. Inject PF material through the holes and simultaneously monitor both changes in the fault height and vertical displacement of the slab. Once the desired fault height (0.25 in.) is reached, stop injecting PF near the joint. PF is then injected at additional slab locations until 1 mm of vertical movement is measured. This is called undersealing and its purpose is to fill any voids that may have been created beneath the slab by lifting the joints to minimize the fault.

Figure 4
PF fault correction process

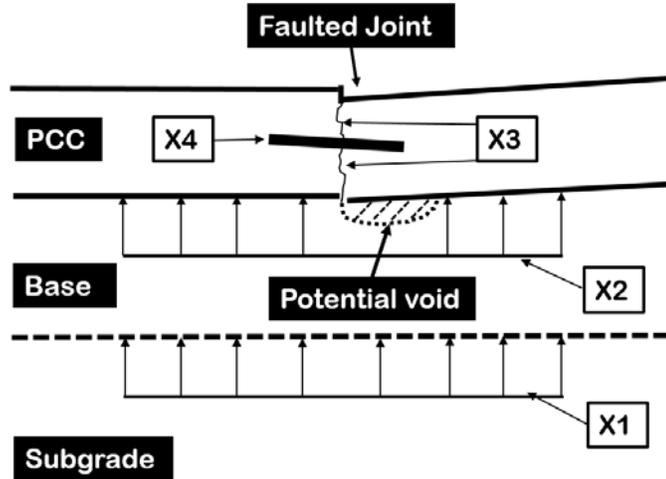
While in service, factors such as traffic loading, seasonal temperature and moisture fluctuations, base course erosion, subgrade erosion, and dowel bar failures lead to faulting at the joints as presented in Figure 6 [9-11].

Figure 6
Faulted joint

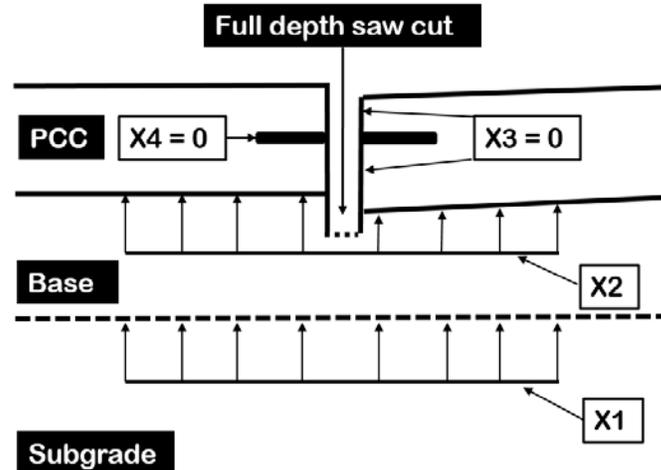
Scenario 2 differs from Scenario 1 in that full depth saw cuts are performed through the joints prior to the PF fault correction process as presented in Figure 7. From there, the PF fault correction process continues uninhibited until the faulting is reduced to at least 0.25 in. On this project, full depth saw cuts were performed at all joints.

Figure 7
Joint with full depth saw cut

During the PF fault reduction process, LTE at the joint is severely reduced due to several factors. First, the full depth saw cut completely eliminates whatever support was available from aggregate interlock (X3) and the dowel bars (X4). Second, PF has a lower dynamic modulus than the subgrade and base course [6-8]. Therefore, once PF is injected into the subgrade, it can expand not only into the subgrade, but also into the base course and voids beneath the PCC slab [7][8]. The addition of PF into the subgrade/base course/void matrix, effectively reduces the support (X1 & X2) thus contributing to a loss in LTE [7][8]. So after the PF fault correction process, LTE is equal to the sum of subgrade-PF (X1) and base course-PF (X2) moduli, with (X1 + X2) after treatment being less than (X1 + X2) before treatment due to the incorporation of PF.

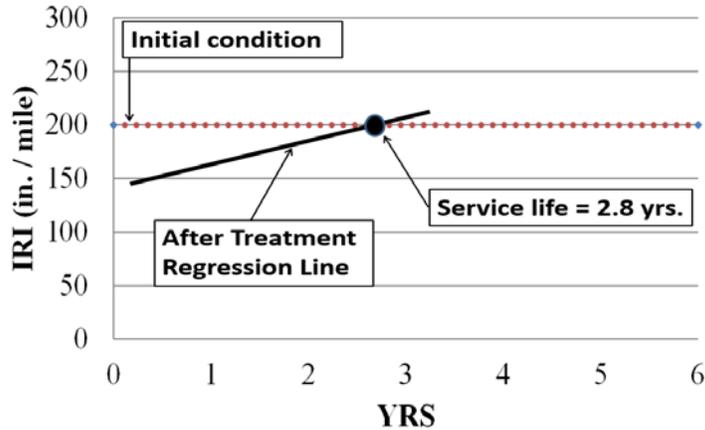
The service life of a treatment was determined from the point of intersection between the initial roadway condition (before treatment) with the after treatment regression line as presented in Figure 9. For example, the intersection of the after treatment regression line with the before treatment (initial condition) IRI value “200” occurred at occurred at 2.8 years. Therefore, the service life of the treatment was 2.8 years.

Figure 9
IRI versus years of service

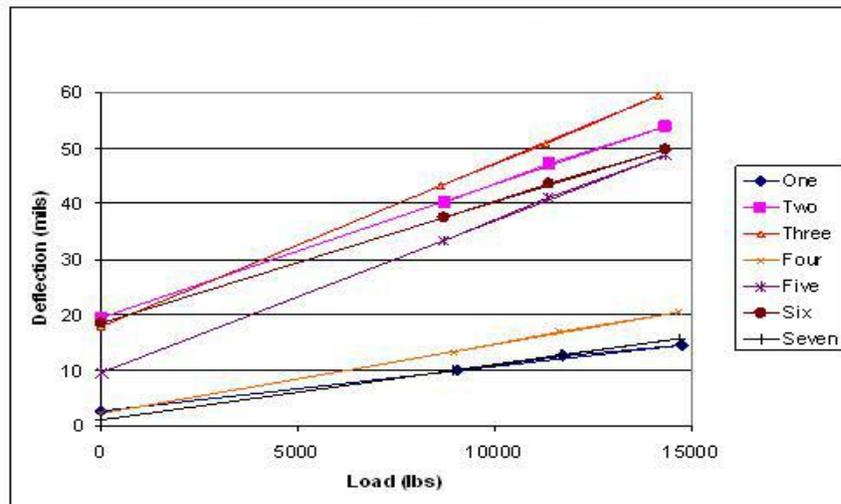
Void potential or loss of subgrade support, hereafter referenced as void potential was determined by plotting the deflections of the first sensor versus load and determining the Y intercept as presented in Figure 10 [7], [16-18]. According to the AASHTO 1993 Pavement Design Guide, a Y intercept value greater than 0.002 in. (2 mils) represents either a void or a loss of support [16]. In a previous study conducted by LTRC, the void potential method was validated with coring [7].

Figure 10
Deflections vs. load

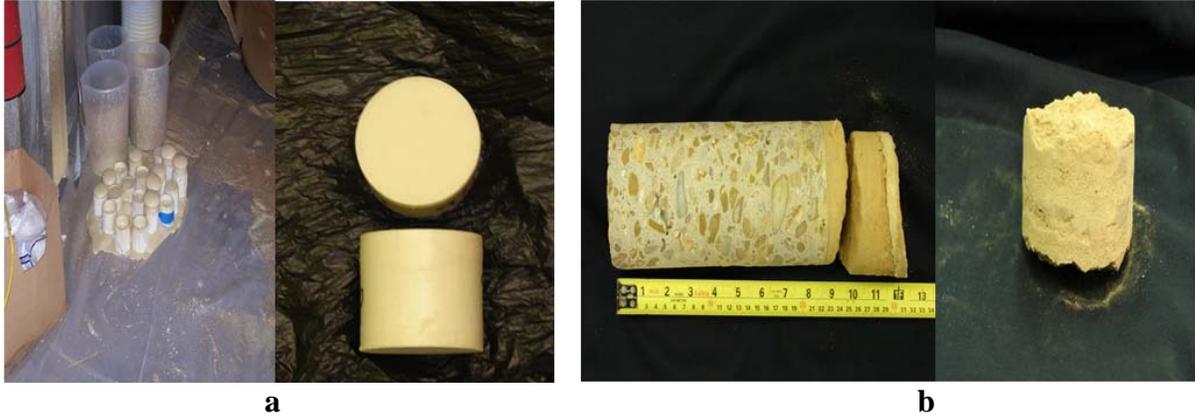
The parameters examined in the ANOVA statistical analysis (free rise versus in-place) were density, UCS at 3 percent strain and UCS at 10 percent strain, which is near ultimate load. The UCS at 3 percent strain is the parameter typically used to evaluate semi-rigid cement base courses in Louisiana.

Figure 11
PF specimens

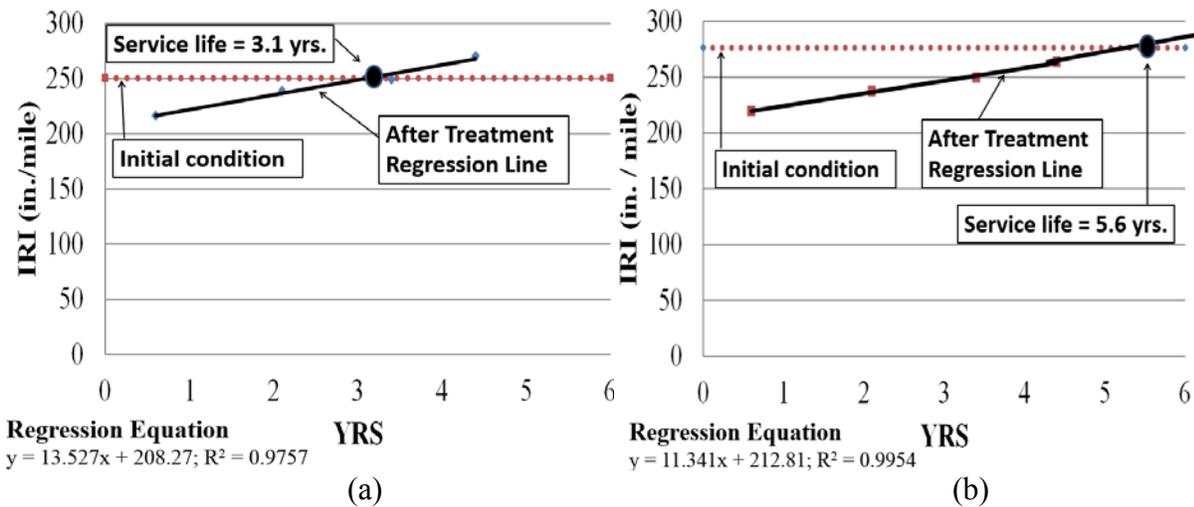
Figure 12
12(a) Northbound IRI regression graph, 12(b) Southbound IRI regression graph

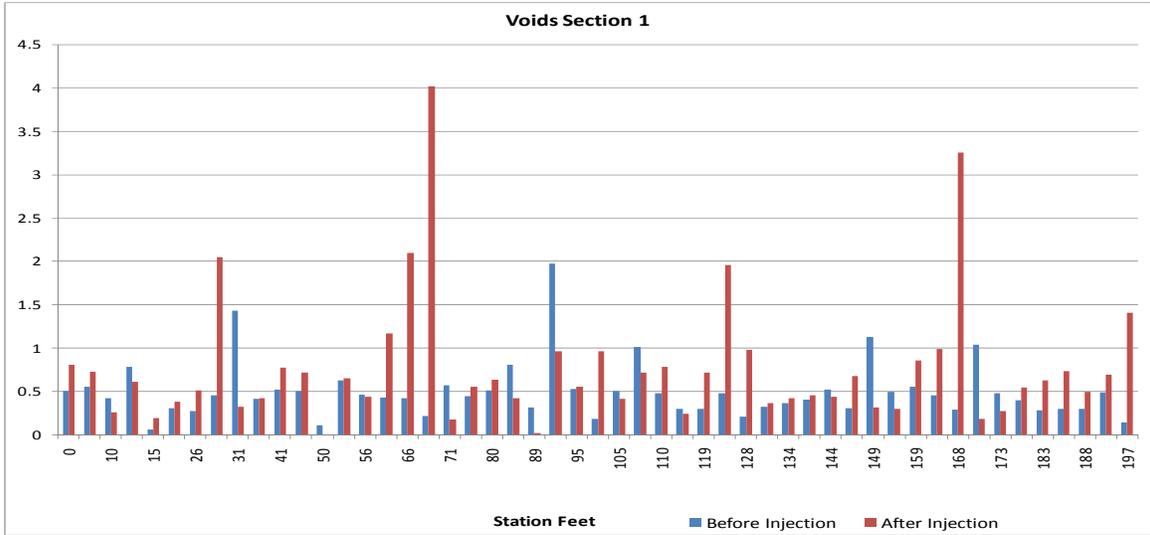
Void Potential. Prior to the fault correction process, tested locations did not indicate a potential for voids, whereas 12 locations did after injection as presented in Figures 15 to 17. This indicates that the potential for voids was increased by approximately 8 percent by the process. This can be attributed to slab uplift movements caused by the fault correction process and issues with filling the voids beneath the slab during the undersealing process.

Figure 15
Void potential test section 1

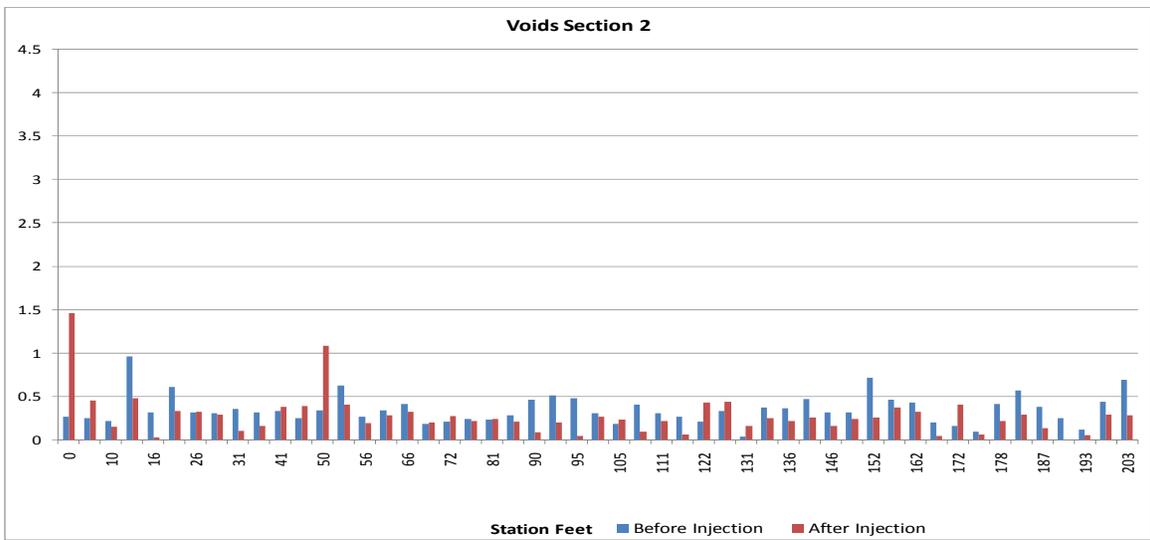
Figure 16
Void potential for test section 2

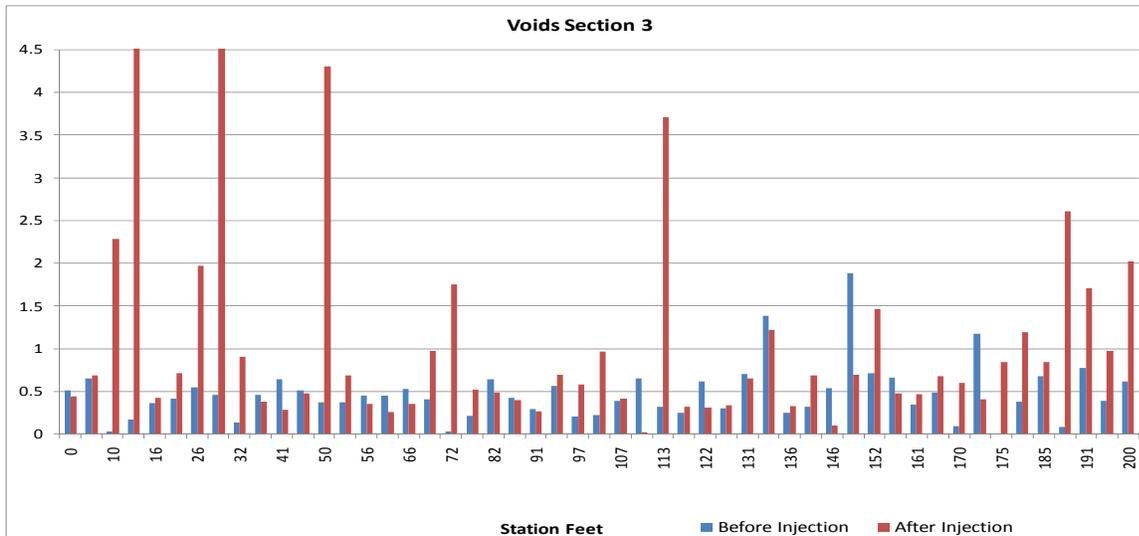
Figure 17
Void potential for test section 3

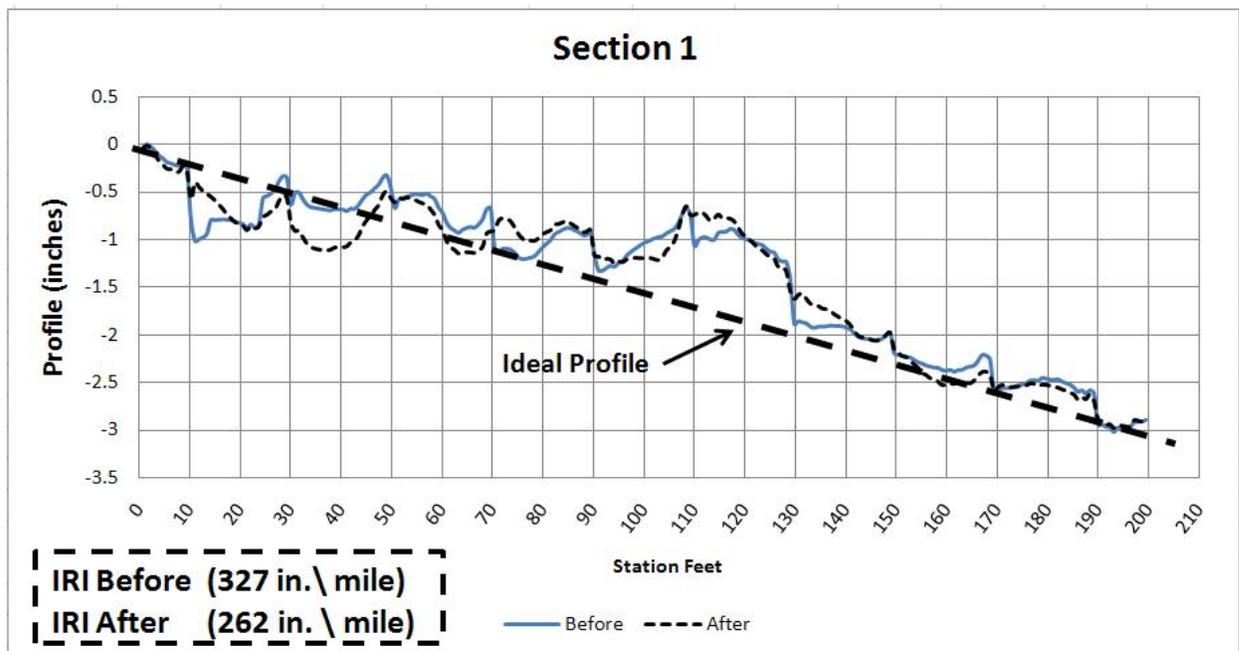
Profile measurements and IRI readings were taken before and after fault corrections on the test sections as shown in Figures 18 to 20. Clearly, the figures illustrate the extreme slab roughness and excessive joint faulting were present before PF injection. The PF process did reduce faulting, but a “bumpy” profile was still present after PF injection. Improvements in ride quality, were realized by the process on the test sections as demonstrated by the reduction of the average IRI from 282 (before treatment) to 192 (after treatment) on the three test sections. However, as previously mentioned, the after treatment IRI did not produce a smooth to moderate (80 to 130) ride, as presented in Table 2. Unless the profile can be corrected during the PF fault correction and undersealing process, smooth or moderate ride quality cannot be obtained on roadways.

Figure 18
Profile and IRI for test section 1 (walking profiler)

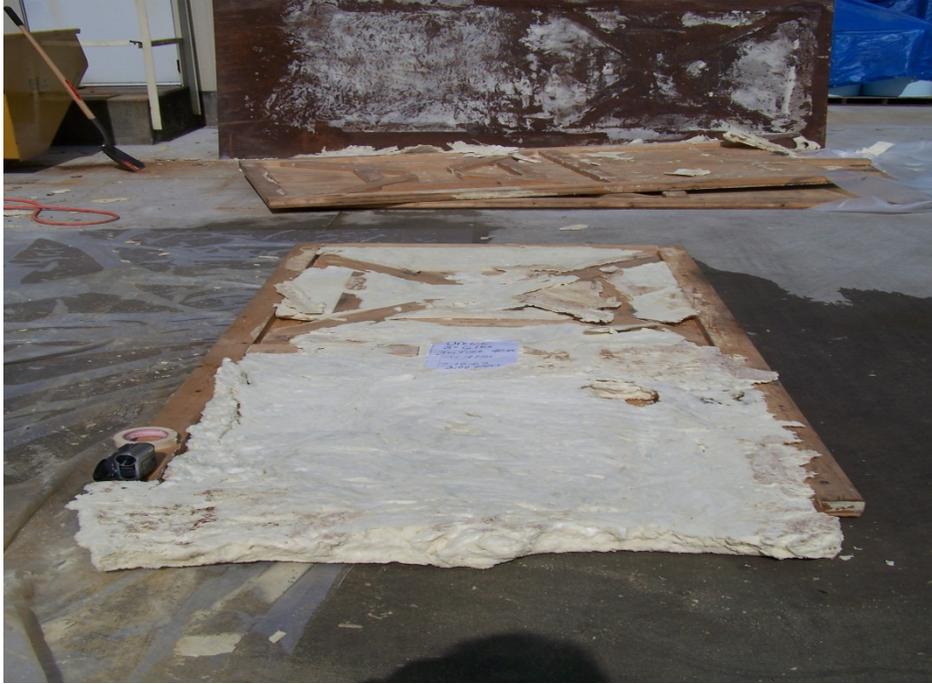
Figure 25
Expanded PF in box

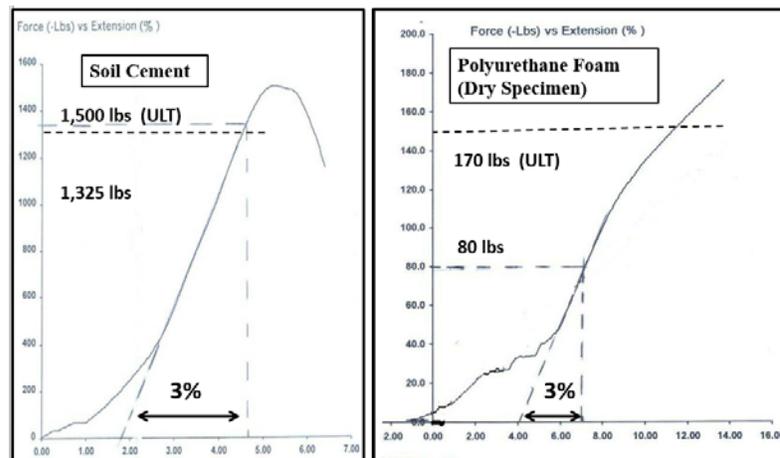
presented in Figure 29. Because of that, the load at three percent strain was also used to determine the UCS of the free rise PF as well. As presented in Table 12, the UCS for 4-, 6-, 8-, and 12-pcf were 65-, 113-, 181-, and 393-psi, respectively. As the density of PF increases so should the UCS, which this experiment has demonstrated. When comparing the UCS of PF with typical UCS design values of soil cement (300 psi) in Louisiana, all UCS values for PF fall below that value.

Figure 29
Load versus extension graphs

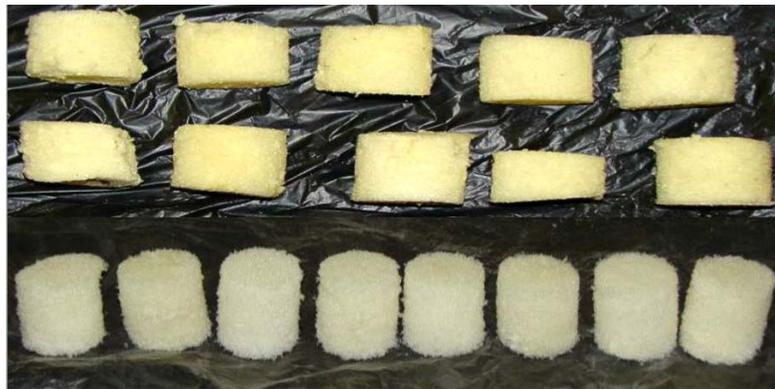
Specimens were obtained from the sample by using a drill and coring device as presented in Figure 31. The cored samples and specimens are presented in Figures 32 and 33. For the barrel test, specimens were available from wet and dry conditions for the densities of 4 and 6 pcf. Dry condition testing only was conducted for the PF densities of 4, 6, 8, and 12 pcf. The specimens obtained met ASTM D1622 standards.

Figure 33
Specimens from barrel test

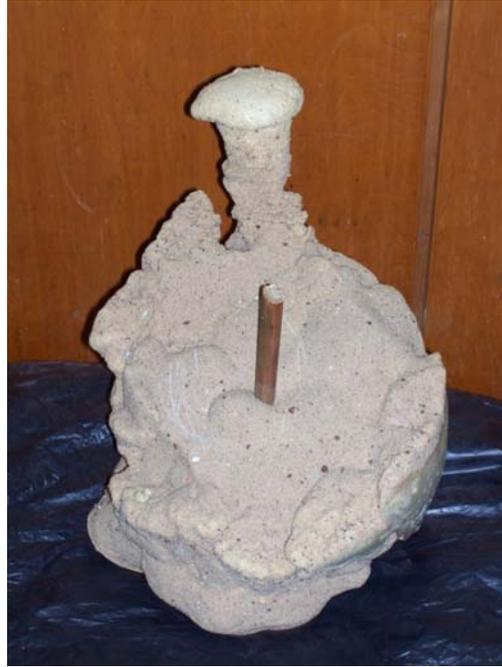
After PF was injected into the sand and allowed to expand, the sand/PF mixture was removed from the bucket, as shown in Figure 35. The sample was cored using a drill and 2-in. diameter core barrel to obtain specimens, as presented in Figures 36 - 38. All four specimens had some tearing and fracturing within them as presented in Figure 37. The sand/PF mixture was heterogeneous throughout the specimens. As presented in Figure 38, approximately 1- to 2-in. of the top and bottom of the specimen were a composite of sand/PF while approximately 3- to 4-in. of the mid region of the specimen was predominately PF, indicating that uniform mixing of sand and PF did not occur during the PF expansion process.

Figure 35
Sand/PF sample

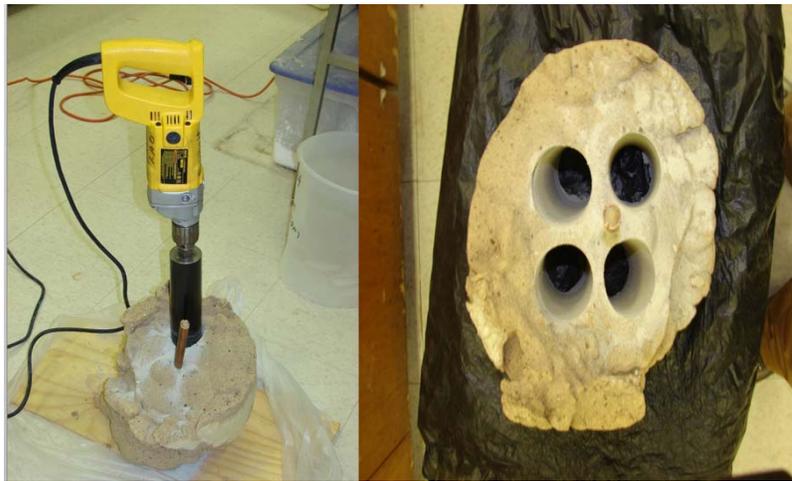
Figure 36
Coring sand/PF bucket sample

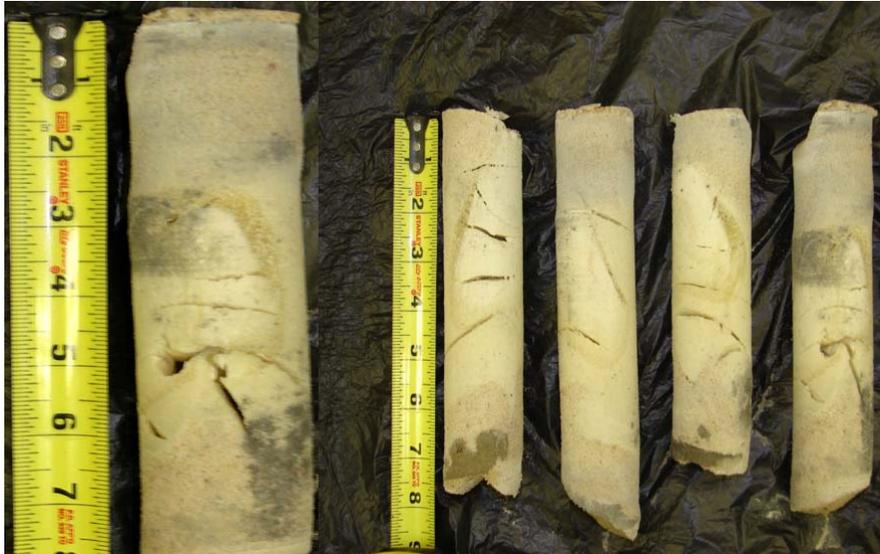
Figure 37
Sand/PF specimens

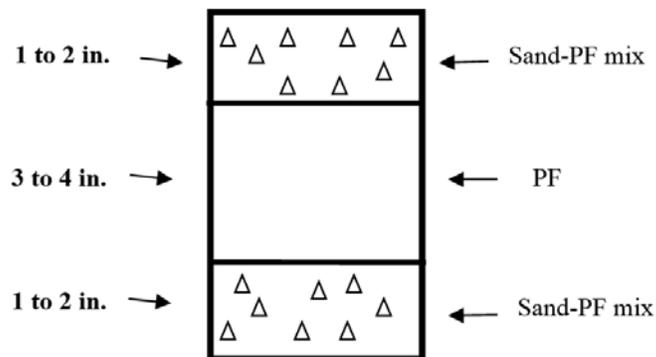
Figure 38
Diagram of sand/PF mixture

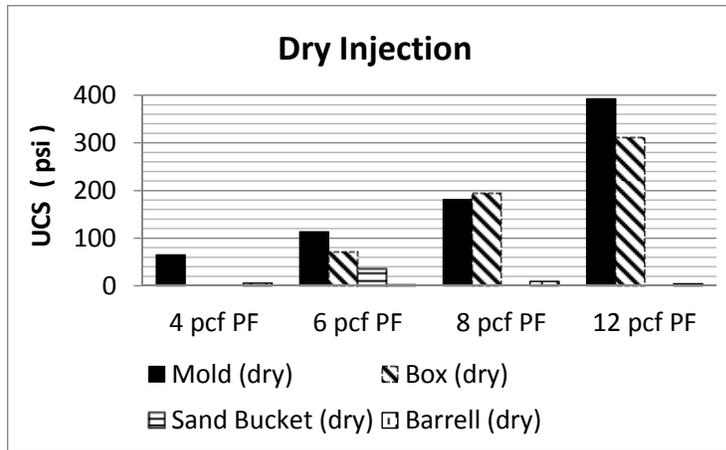
Data were grouped from varying tests and densities in order to provide an overall snapshot of the test results. Beginning with the UCS strengths from molds, box test, sand bucket test, and barrel tests, it was obvious that UCS strengths from the mold specimens exceeded the UCS strengths from the box, barrel and sand bucket test as presented in Figure 39. This implies that if samples were procured from field tests where dry conditions were present, the UCS strengths would be less than in free rise conditions, which the 3-in. diameter molds were postulated to simulate. Regarding density relationships, with the exception of the sand bucket test, densities from the box and barrel tests were generally less than densities from the mold specimens. The results from the testing implies that when confining environments exist both the UCS and density are not increased as originally hypothesized.

Figure 39
UCS dry injection sample comparison

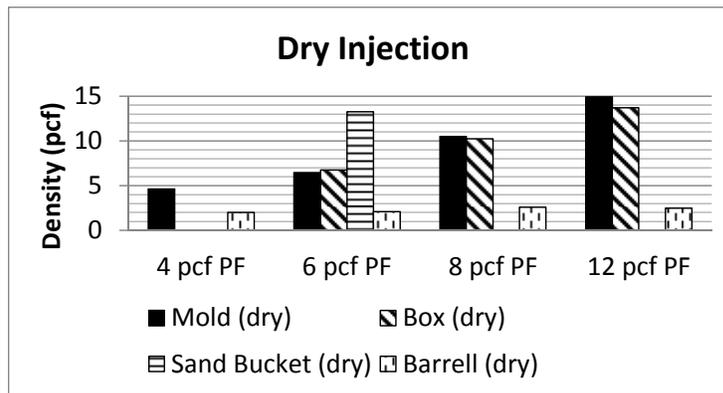
Figure 40
Density dry injection sample comparison

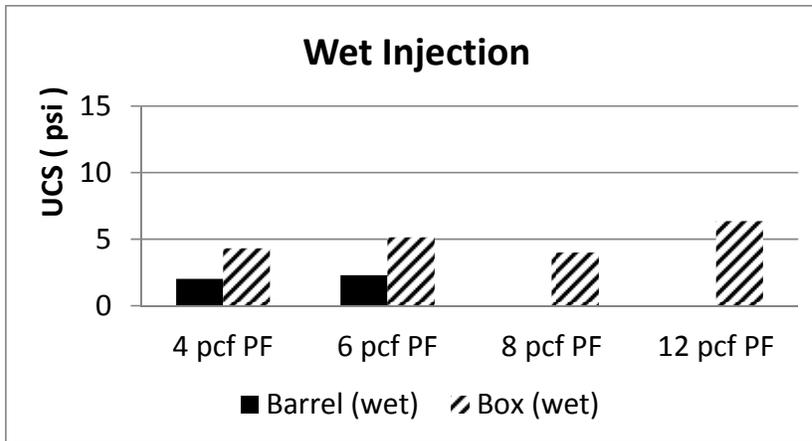
Figures 41 and 42 present the UCS and density results from barrel and box tests when water was present. The UCS strength was higher in the box test than the barrel test at the PF densities of 4, 6, and 12 pcf. Extremely weak UCS strengths were present in all tests. The measured densities from the box tests were larger than the measured densities from the barrel tests. The results of testing from the wet environments indicate that the hydrophobic Uretek 486 used in this experiment was extremely sensitive to water as evidenced from the UCS tests.

Figure 41
UCS wet injection sample comparison

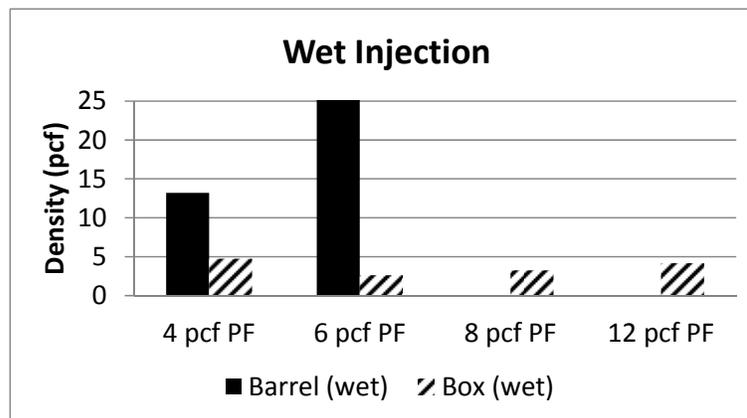
Figure 42
Density wet injection sample comparison

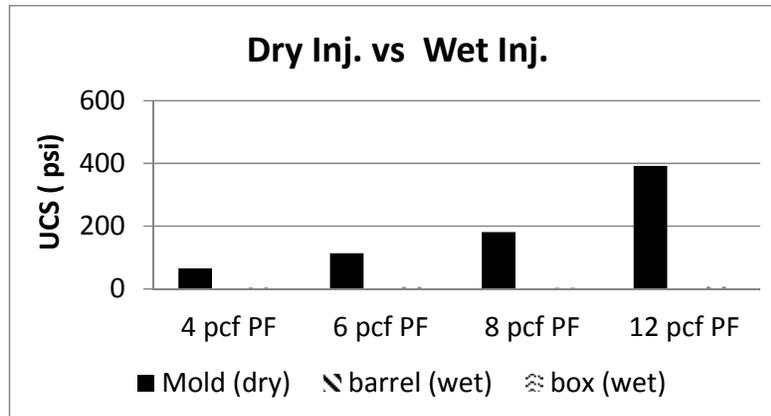
Figures 43 and 44 present comparisons between samples for the molds (dry injection) to samples from the box and barrel when water was present. The UCS strengths from the wet samples were extremely weak when compared to the samples from the molds. The UCS strengths from wet specimens ranged from about 2 to 9 psi implying that wet environments do not allow PF to gain much strength as presented in Figure 43. PF densities ranged from about 2 to 5 pcf when injected into wet environments indicating extreme sensitivity to water, as presented in Figure 44.

Figure 43
UCS wet injection versus dry injection sample comparison

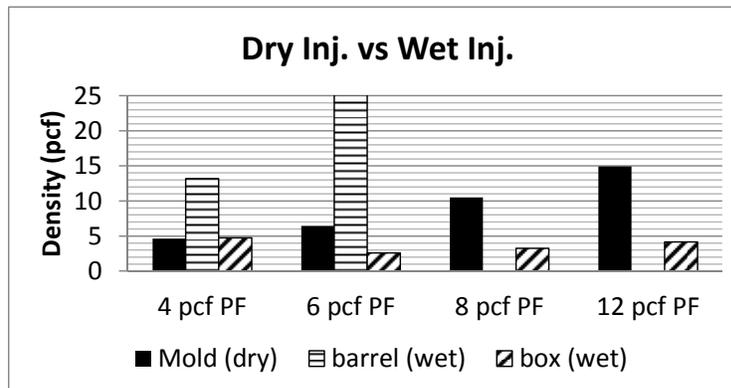
Figure 44
Density wet injection versus dry injection sample comparison
