**GEORGIA DOT RESEARCH PROJECT 11-19
FINAL REPORT**

**COMPREHENSIVE EVALUATION OF THE LONG-
TERM PERFORMANCE OF RUBBERIZED
PAVEMENT**

**PHASE I: LABORATORY STUDY OF RUBBERIZED
ASPHALT MIX PERFORMANCE**

1. Report No.: FHWA-GA-12-1119	2. Government Accession No.	3. Recipient's Catalog No. N/A	
4. Title and Subtitle Comprehensive Evaluation of the Long-Term Performance of Rubberized Pavement: Phase I: Laboratory Study of Rubberized Asphalt Mix Performance		5. Report Date December 2012

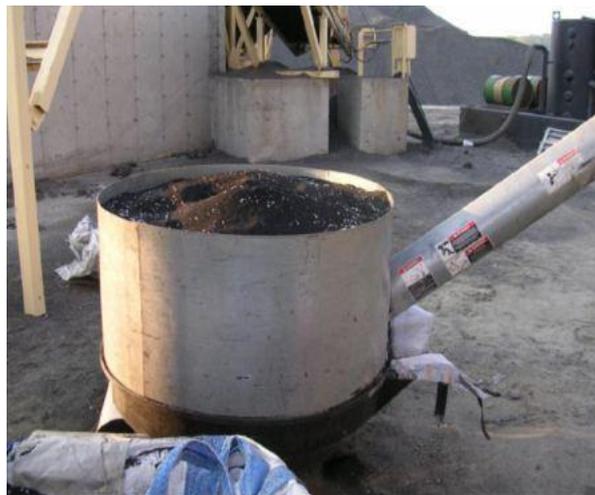
Figure 3-2 Blended Crumb Rubber/TOR Feeder Container (15)

In the dry process, crumb rubber is mixed directly with aggregates in the drum to produce the PEM and SMA. A volumetric feed system was set up at the asphalt plant to incorporate the blended crumb rubber/TOR material into the RAP collar at the drum (Figs. 3-2, 3-3).

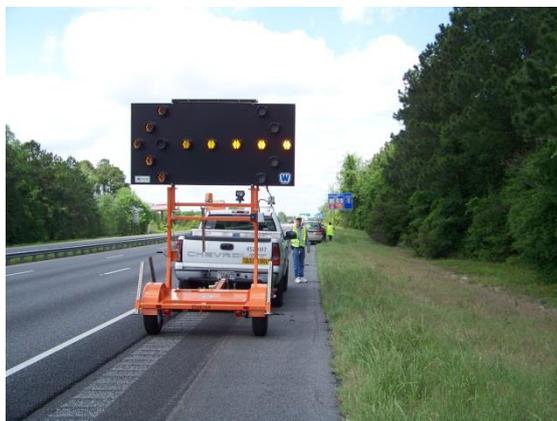
Figure 4-1 Traffic Control for a Preliminary Inspection

To obtain representative pavement sections, a preliminary inspection was conducted. The team stood on the shoulder and recorded distresses with the help of traffic control (Figs. 4-1, 4-2). Eight representative sections were selected for further inspection.

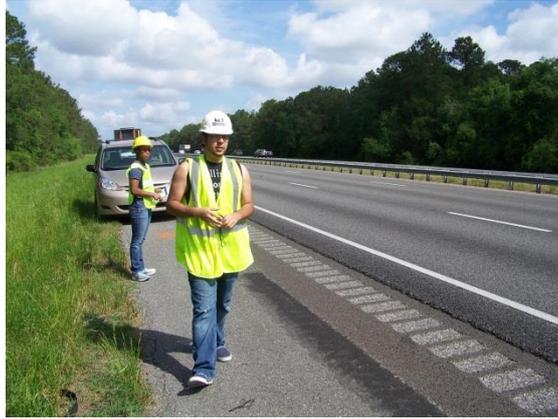
Figure 4-2 Preliminary Inspection

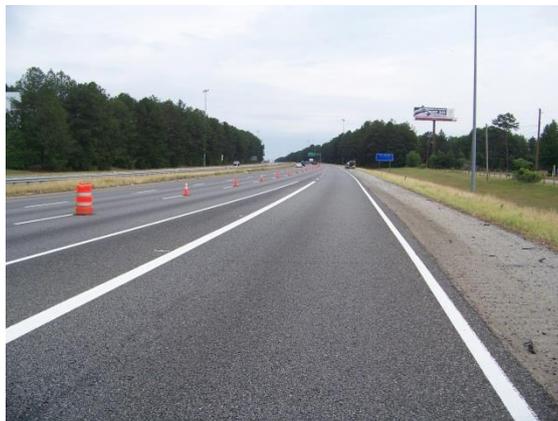
Figure 4-3 Traffic Control for Lane Inspection

During lane inspection, traffic control closed the lane according to the requirement of the FHWA's *Manual on Uniform Traffic Control Devices* (MUTCD) (Fig. 4-3). The inspectors walked in the lanes and inspected in detail the amount and severity of the distresses (Fig. 4-4).

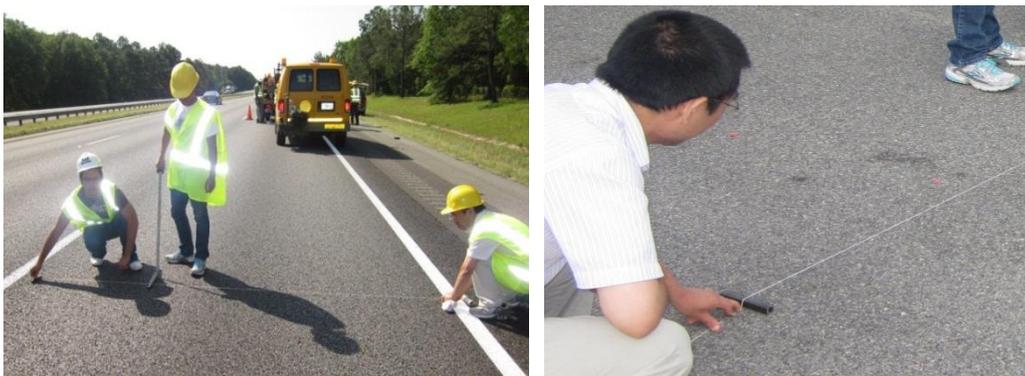
Figure 4-5 Rut Measurement

Rut depth was measured in both sample area wheelpaths and recorded in units of 1/16 inch. Rutting measurements were taken by “blocking” up the stringline using a block of hollow steel pipe (Fig. 4-5).

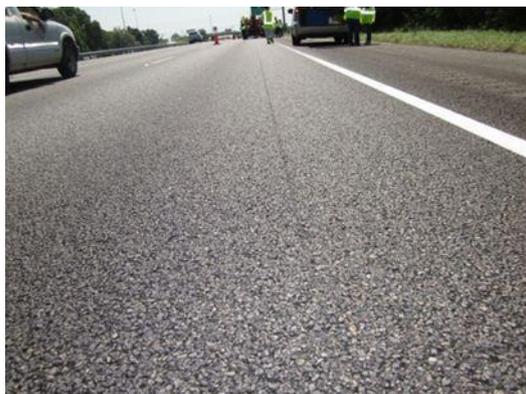
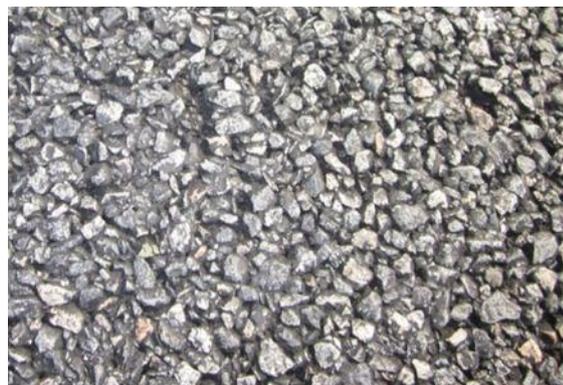
Table 4-1 summarizes I-75 Valdosta pavement performance as measured by rut depth, cracking, raveling, bleeding, pushing, and potholes. After three years' service, the field performance of the rubberized PEM pavement is obviously similar to that of the control PEM pavement. Cracking, raveling, bleeding, pushing, and potholes were not found in either (Figs. 4-6, 4-7), and only two profiles of the control PEM pavement near milepost 10 showed minor rutting at a depth of 1/16 inch.

Figure 4-6 Typical Rubberized PEM Surface, I-75 Valdosta

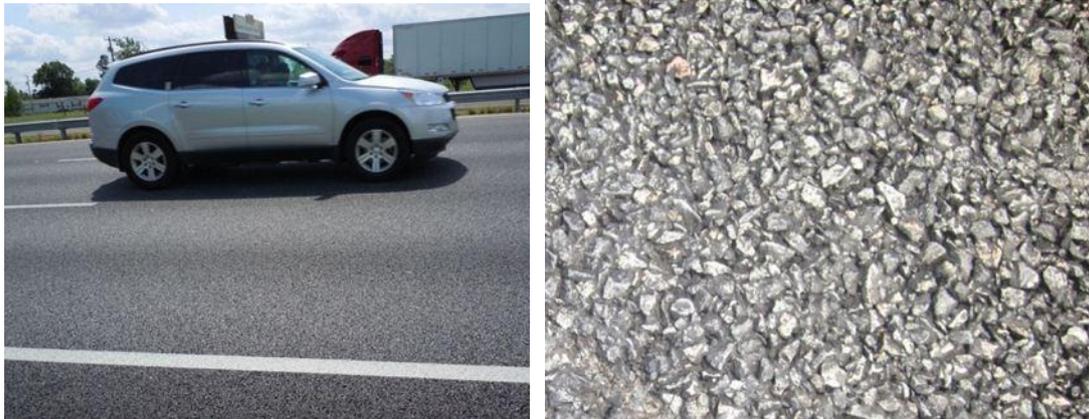
Figure 4-7 Typical Control PEM Surface, I-75 Valdosta

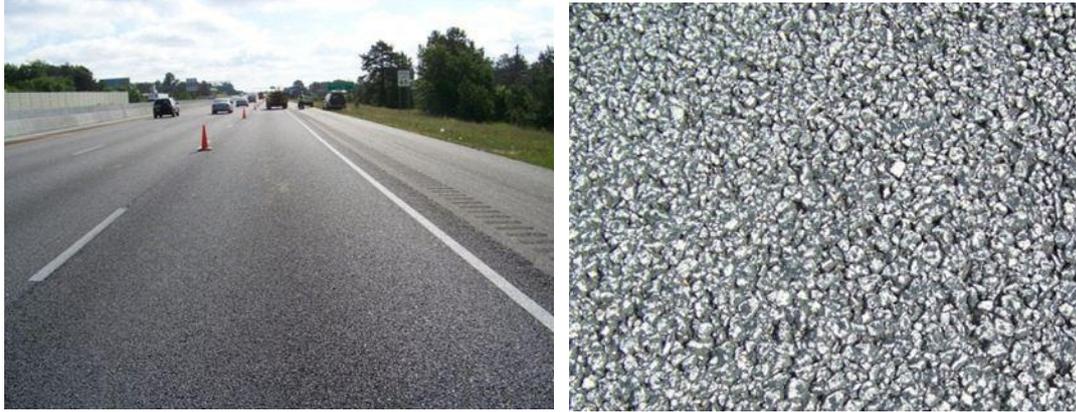
Table 4-2 presents I-20 Augusta field pavement performance as measured by cracking, rut depth, raveling, bleeding, pushing, and potholes. As mentioned, rubberized PEM pavement was placed in both east and westbound lanes, while a rubberized SMA was placed in the eastbound lane, and SMA modified with Styrene Butadiene Styrene (SBS) was placed in the westbound lane. Neither test section showed distress (Figs. 4-8, 4-9).

Figure 4-8 Typical Rubberized PEM Surface with Rubberized SMA Underlayer, I-20 Augusta

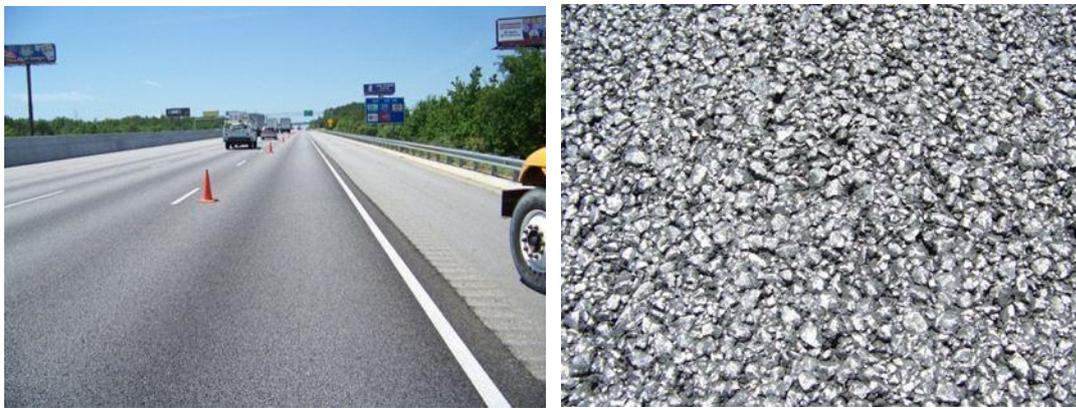
Figure 4-9 Typical Rubberized PEM Surface with Control SMA Underlayer, I-20 Augusta

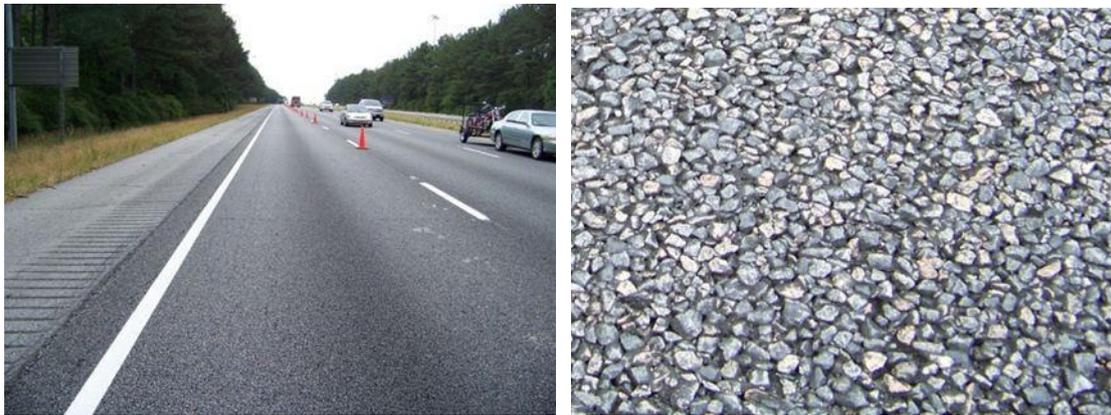
Table 4-3 presents I-75 Perry pavement field performance as measured by cracking, rut depth, raveling, bleeding, pushing, and potholes. Again, the rubberized and control PEM pavements performed similarly after five years in service, except for the raveling occurring 24 feet at the beginning of the rubberized PEM test section where it meets the PMAC. Neither bleeding nor pushing was found in either section (Figs. 4-10, 4-11). Average rut depths for the rubberized and control PEM test sections were 1.2/16 and 2.3/16 inch, respectively, which are still very low. This finding illustrates that the rubberized PEM has slightly better rutting resistance than the control section on I-75 Perry.

Figure 4-10 Typical Rubberized PEM Surface, I-75 Perry

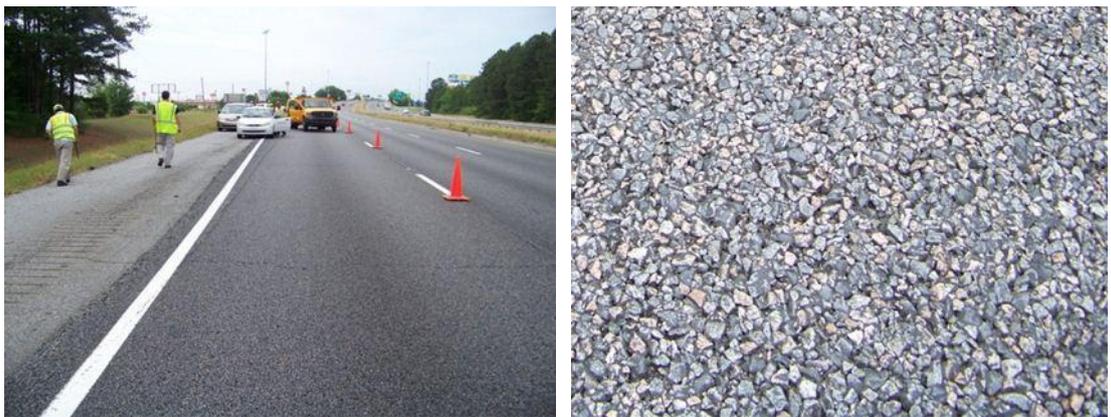
Figure 4-11 Typical Control PEM Surface, I-75 Perry

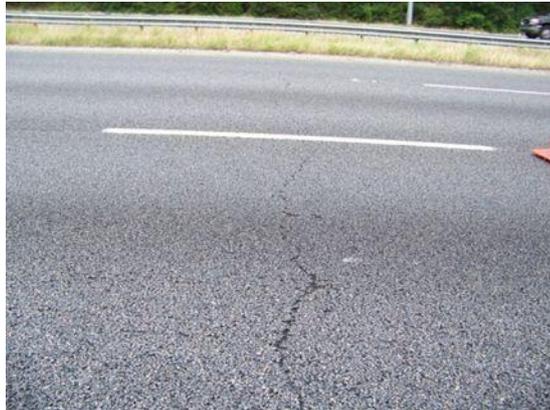
Reflection cracking was observed in both rubberized and control PEM test sections (Fig. 4-12), and the length and severity of reflection cracking were similar. Most cracking crossed over the lane at 30'3" intervals. Widths varied from 0.5" to 2".

Figure 4-12 Reflection Cracking of Rubberized PEM

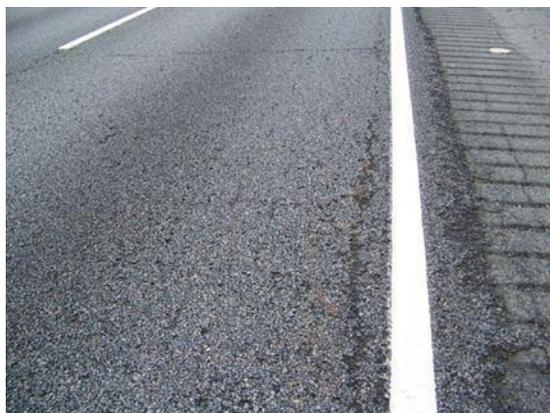
Where the rubberized PEM test section meets the PMAC, about 24 feet of raveling was evident (Fig. 4-13).

Figure 4-13 Raveling in Rubberized PEM

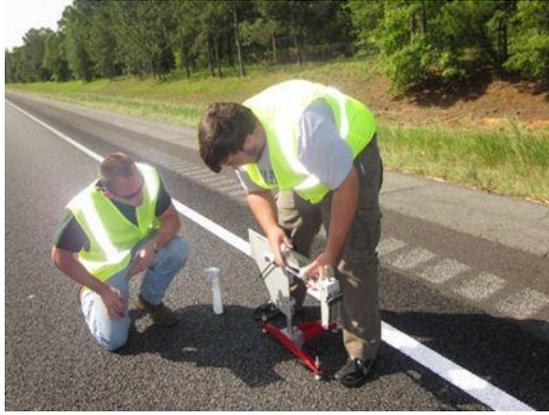
Figure 4-14 Skid Resistance Measurement

Skid resistance in the wheel paths of PEM pavements was measured by a portable skid resistance tester according to AASHTO T 278-90 (2012) (Fig. 4-14).

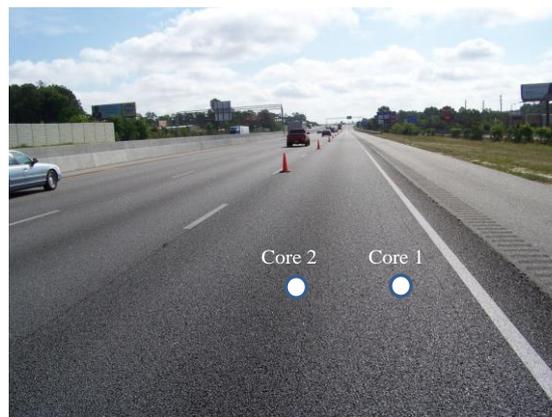
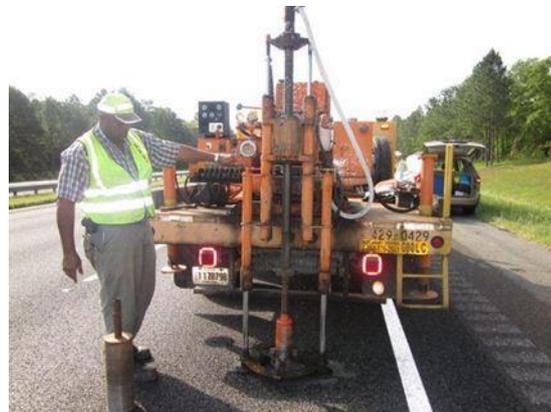
Since wheel paths are subject to repeated traffic loading, their core samples should be different from core samples taken between them. To determine the influence of traffic loading on pavement physical properties and durability, the same numbers of cores were obtained from wheel paths and lane centers in each test section (Figs. 5-1, 5-2).

Figure 5-1 Core Sample Drilling Location

Figure 5-2 Core Sample Drilling

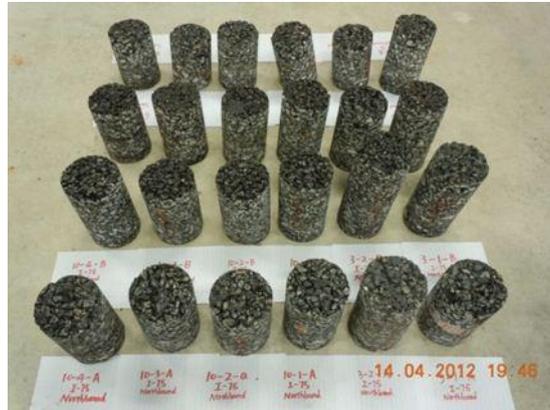
Figure 5-3 24 Cores from I-75 Valdosta

Because sampling on a busy interstate highway requires closing lanes and controlling traffic, the number of cores taken was restricted. A total of 24 samples from I-75 Valdosta, 12 each from the rubberized and control sections, were taken (Fig. 5-3). A total of 12 samples from I-75 Perry, 6 each from sections with rubberized and control SMA underlayers, were taken (Fig. 5-4). For I-20 Augusta, a total of 12 cored samples,

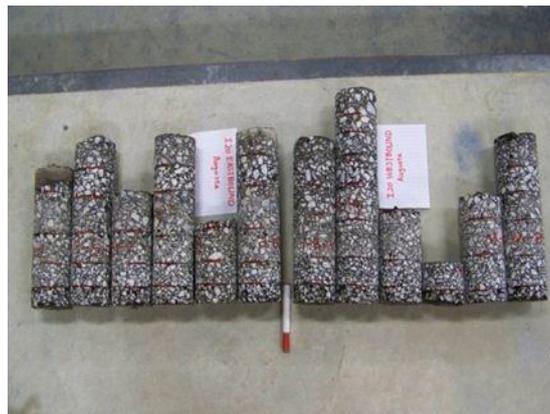
Figure 5-4 12 Cores from I-20 Augusta

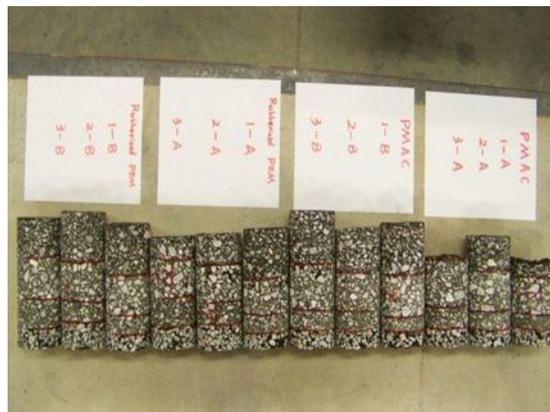
Figure 5-5 12 Cores from I-75 Perry

6 from the rubberized PEM underlaid with rubberized SMA and 6 from that underlaid with PMAC SMA were taken (Fig. 5-5). To measure their properties, the PEM and SMA parts were cut from the core samples.

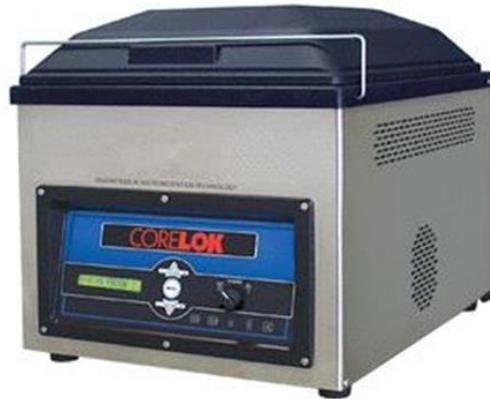
Figure 5-6 Corelok Apparatus

The CoreLok system automatically seals the samples in specially designed, puncture-resistant polymer bags that allow accurate measurement in the water displacement test (Fig. 5-6). The system consists of a vacuum chamber and bags for sealing both beam

samples and 4-6-inch diameter laboratory and field samples. The density of the bag is determined at the factory. Densities measured with the CoreLok system are highly reproducible. The method is ASTM D6752/D6752M-11.

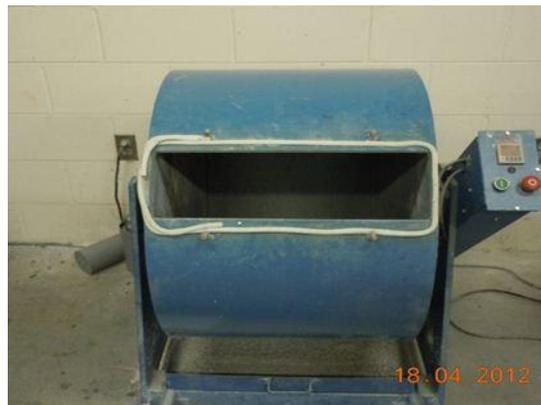
Figure 5-9 Cantabro Apparatus

Cantabro Test. The core sample's potential to ravel was evaluated using the Cantabro test. Normally, the core samples are weighed and placed in a Los Angeles abrasion test machine without steel balls (Fig. 5-9), and the drum turned.

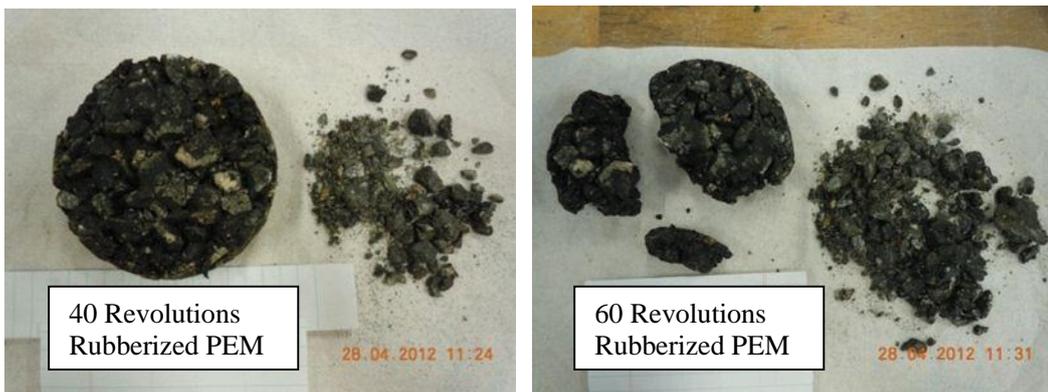
The standard number of revolutions (300) for this study was not adopted because the core samples were much thinner than the standard 2.5 ± 0.05 " thickness. In addition, the test was developed for virgin mixtures; thin and aged samples experience breaking rather than abrasion at high rotations. Figures 5-10 and 5-11 indicate two states of breaking and abrasion at revolutions of 40 and 60, respectively, for both rubberized and control samples. To determine the appropriate number of revolutions for the core samples, we conducted several trials at revolutions ranging from 10 to 60 and used the number at which the samples started to break. It was determined that 40, 10, and 40 were the best parameters for the core samples taken from I-75 Valdosta, I-75 Perry, and I-20 Augusta, respectively.

Figure 5-10 Cantabro Loss at Different Revolutions of Rubberized PEM

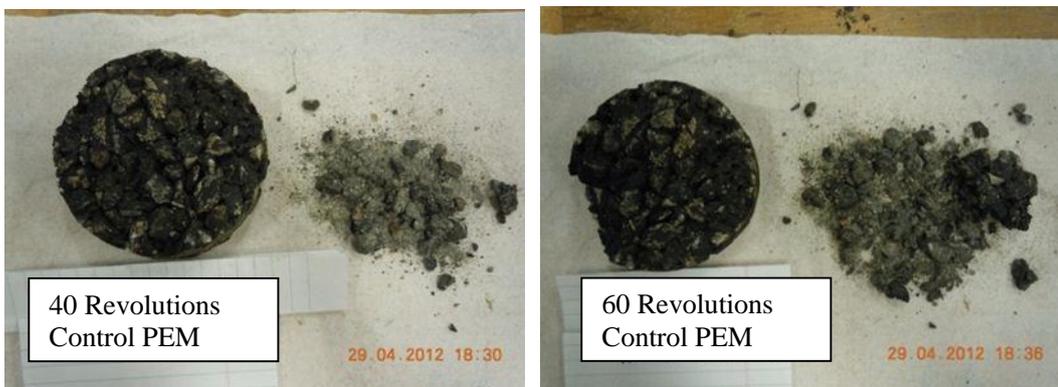
Figure 5-11 Cantabro Loss at Different Revolutions of Control PEM

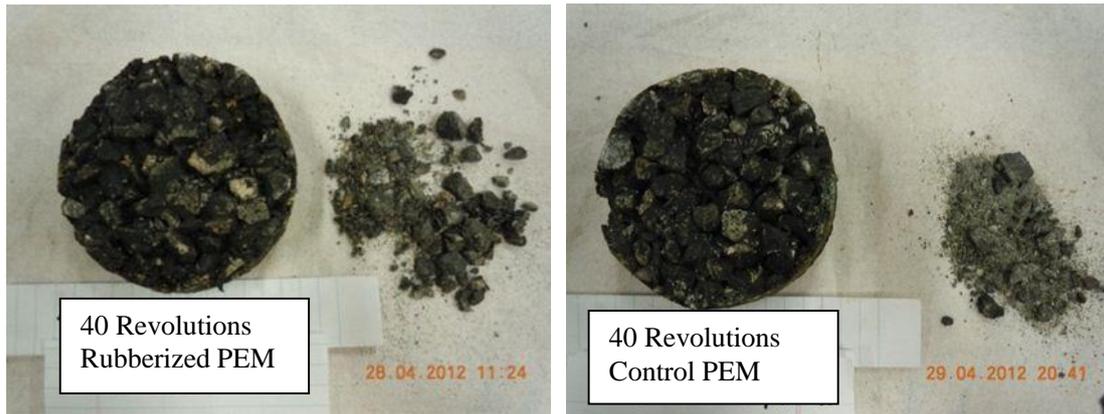
Figure 5-13 Condition of 3-Year Service Cores after 40 Revolutions

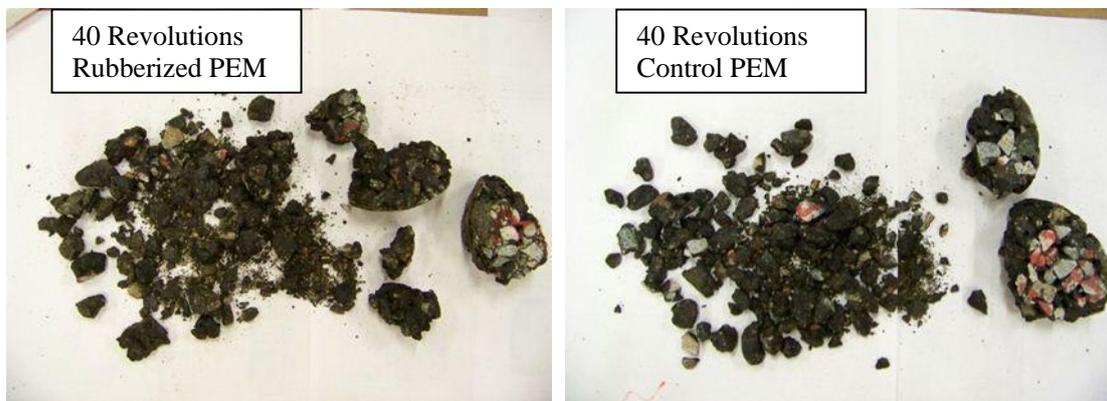
Figure 5-14 Condition of 5-Year Service Cores after 40 Revolutions
