**A REMOTE SENSING AND GIS-ENABLED ASSET  
MANAGEMENT SYSTEM (RS-GAMS) PHASE 2**

**Final Report**

Contract Number: RITARS-11-H-GAT

**Georgia Institute of Technology**

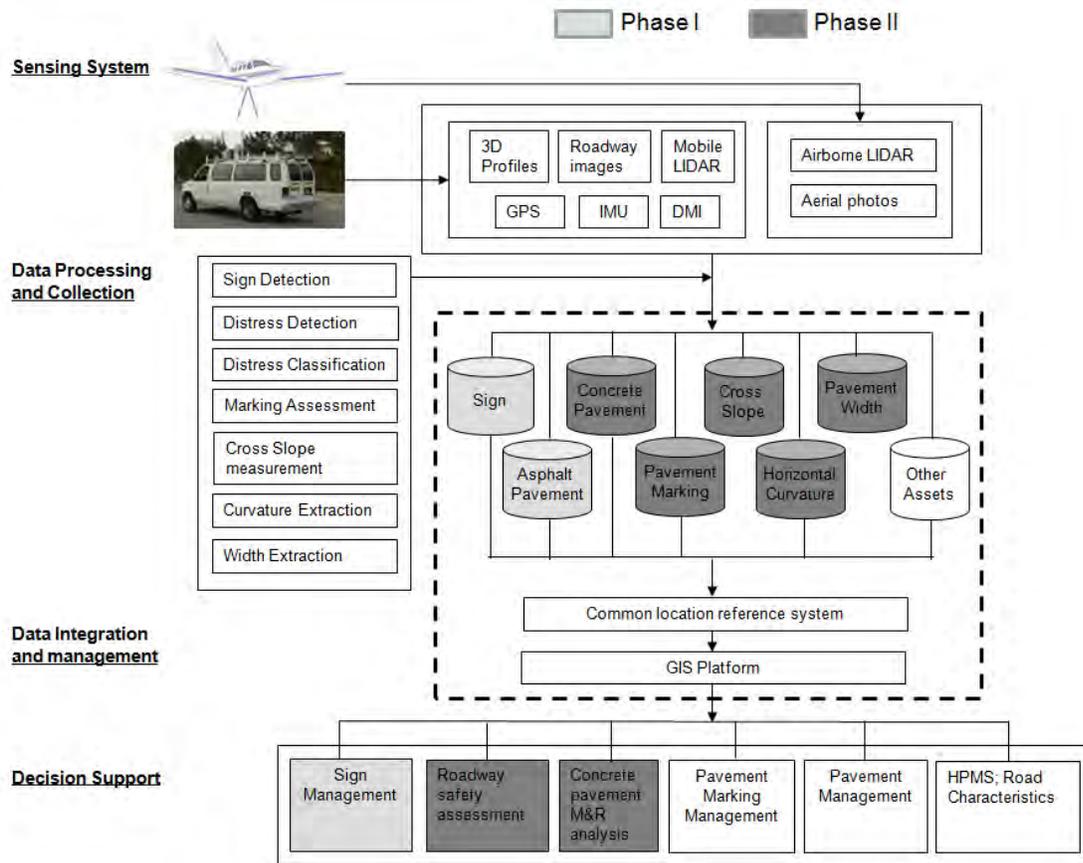
**Figure 1-1 RS-GAMS architecture**

technology (for clarity’s sake, the data collected by a 3D line laser imaging device is called pavement surface laser data, hereafter) and mobile Light Detection and Ranging (LiDAR) technology in assessing pavement surface distresses and roadway geometric characteristics. The first phase of this research project validated the automatic measurement of asphalt pavement rutting, automatic detection of asphalt pavement cracking, and automatic sign traffic sign data collection, as shown by the light grey blocks in Figure 1-1. The validation results in RS-GAMS Phase 1 can be found in the final report by Tsai and Wang (2013). This final report focuses on the validation results of RS-GAMS Phase 2. As shown in Figure 1-1, the dark grey blocks indicate the validated pavement distresses and roadway geometric characteristics (for asphalt pavement, the automatic classification of pavement cracks is also included in RS-GAMS Phase 2).

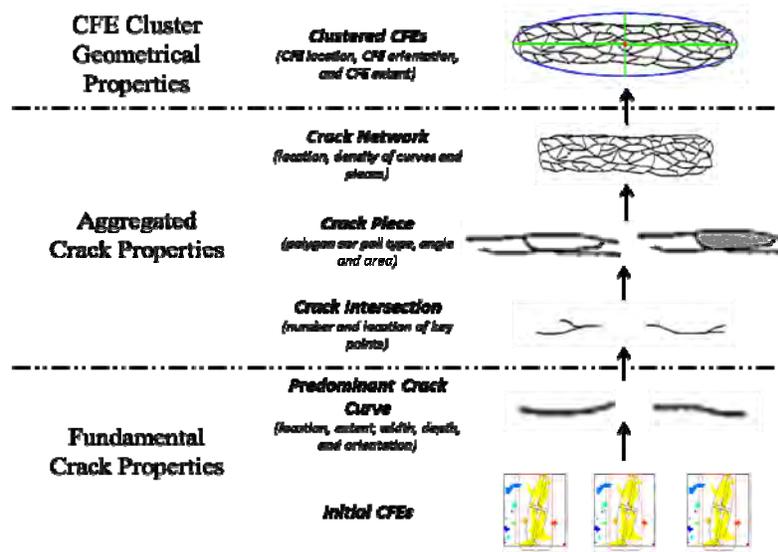
Figure 2-1 Multi-scale crack properties from CFE model (Tsai & Jiang, 2012)

Crack pattern, together with other crack properties, is crucial for differentiating crack types and severity levels in transportation agencies' pavement survey practices. The PI proposed a multi-scale CFE model in a previous study (Tsai & Jiang, 2012). This model topologically provides rich crack properties at three different scales (fundamental crack properties, aggregated crack properties, and clustered CFE geometrical properties) to support the development of an automatic crack classification method. It also standardizes crack performance measures for different transportation agencies and effectively deals with the diversity among different protocols. Figure 2-1 shows crack properties at three scales defined in the CFE model.

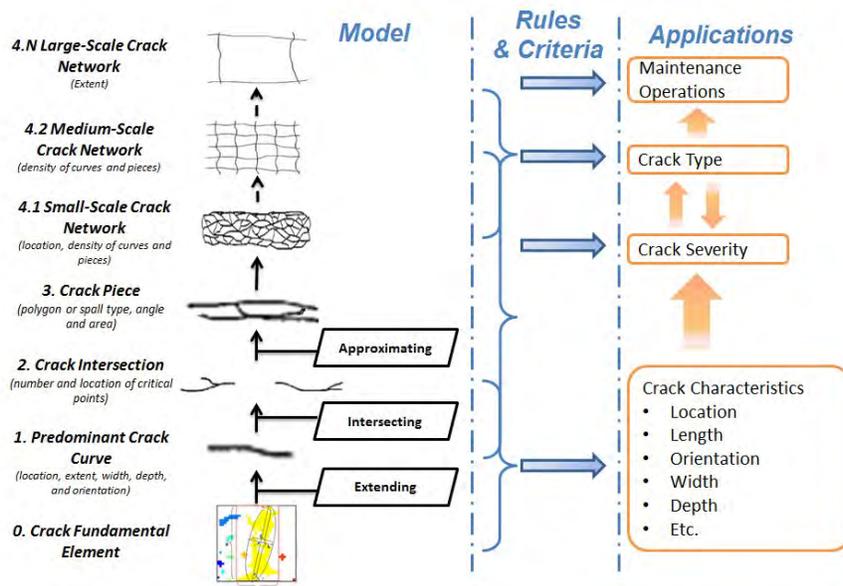
**Figure 2-2 Crack classification using the extracted crack properties**

results from the automatic crack classification and quantification with the field survey results conducted by experienced pavement engineers. The GDOT PACES distress protocol is selected as an example to conduct the validation. Load cracking and block cracking (in GDOT, transverse crack is also categorized as block cracking. For clarity's sake, we use block/transverse (B/T), hereafter), as two predominant asphalt pavement distresses in Georgia, are the focus of this. The crack classification method can be easily extended to other crack-related distresses and protocols.

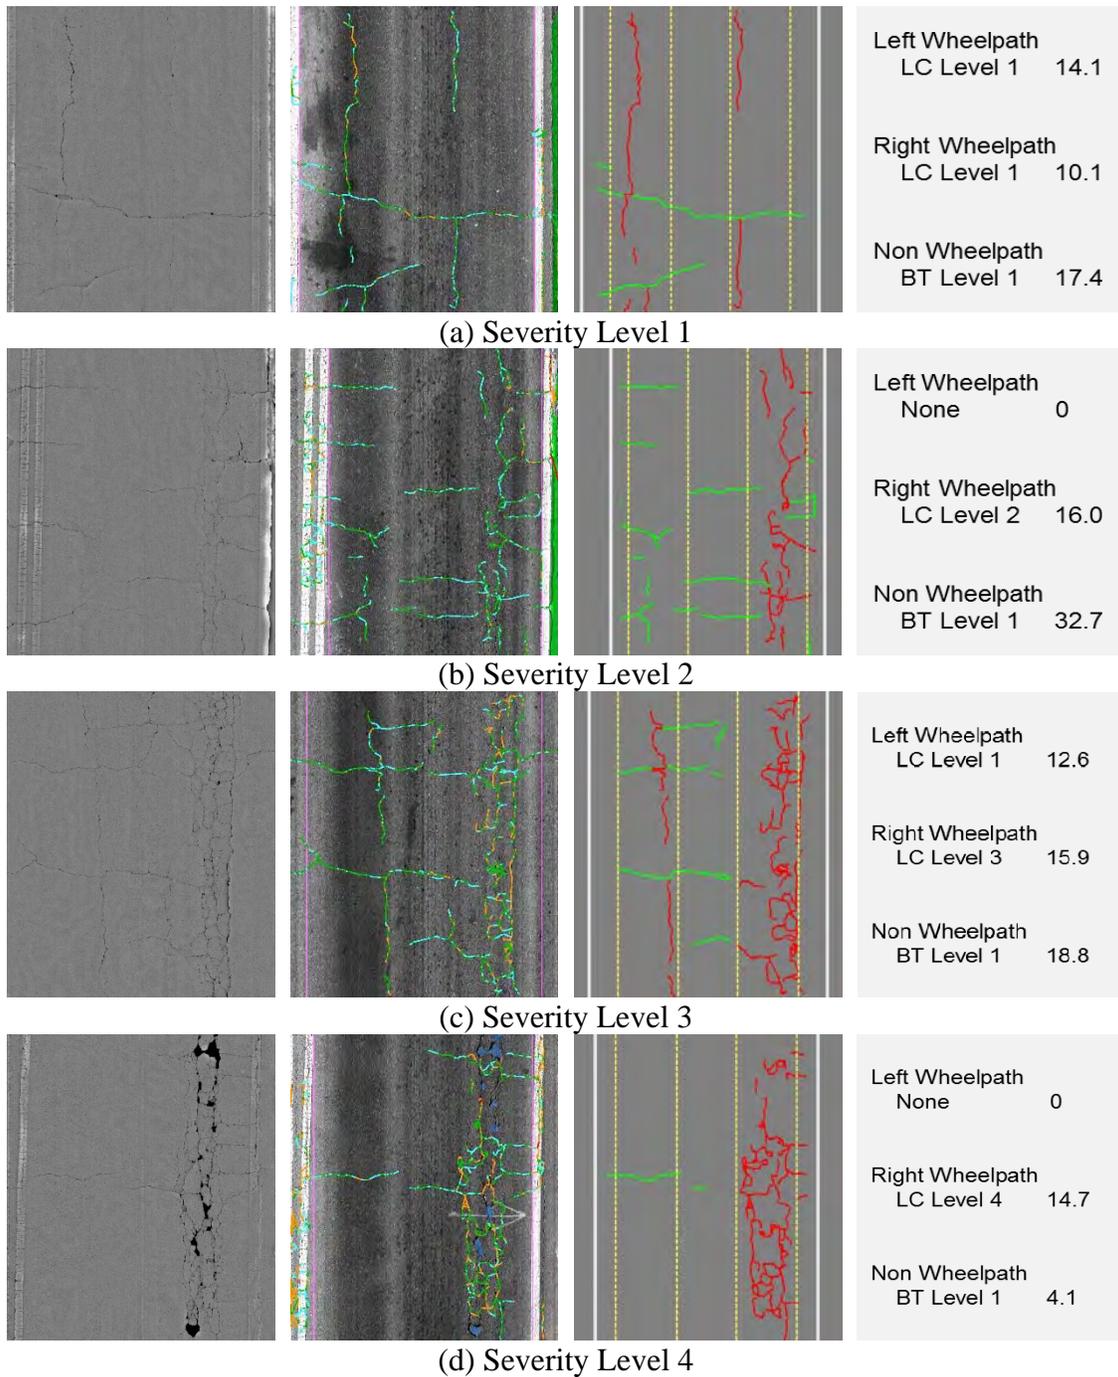
**Figure 2-3 Representative load cracking evaluation outcomes, from left to right: range image, crack map on intensity image, load cracking (red) and B/T cracking (green), and evaluation outcomes (unit: foot)**

cases for load cracking and their automatic classification and quantification outcomes are shown in Figure 2-3.

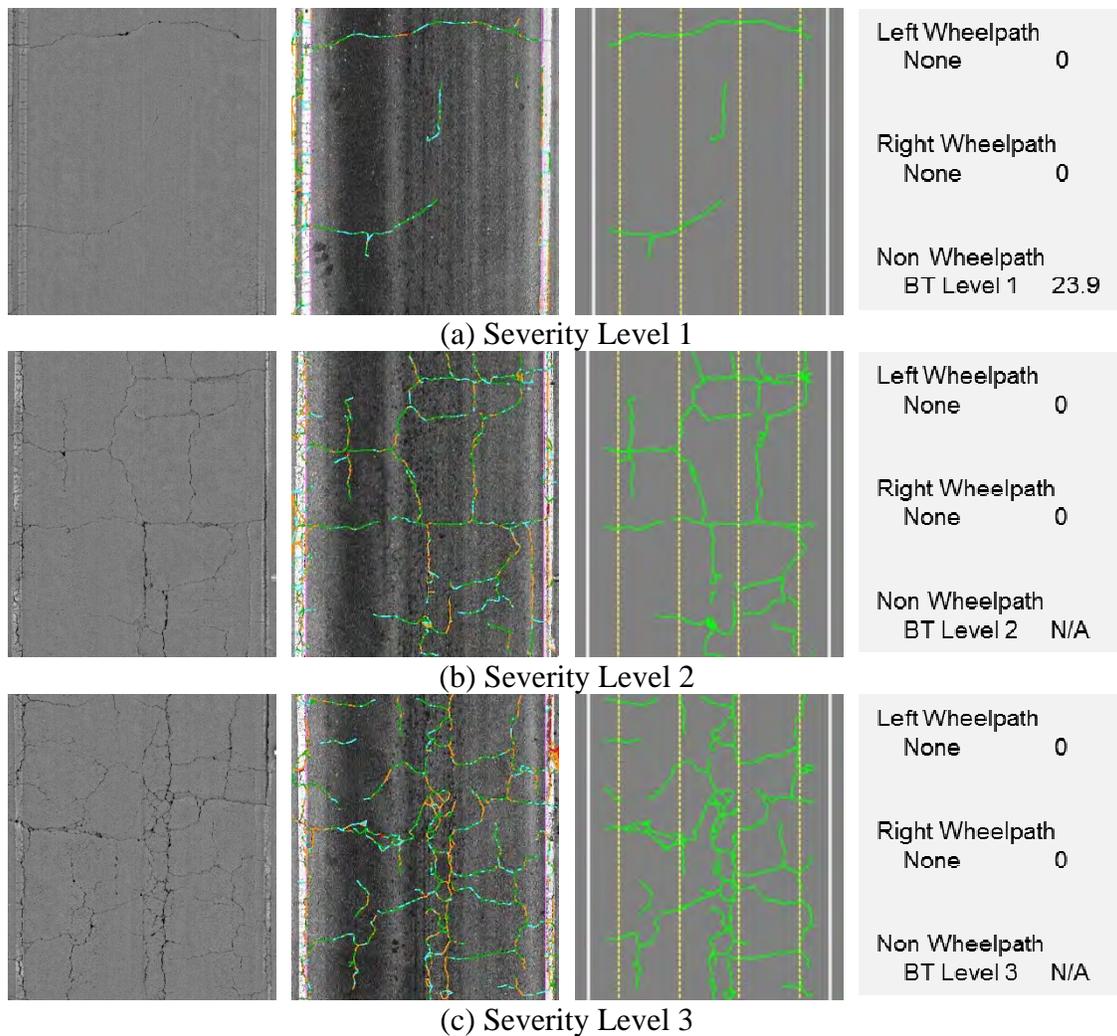
**Figure 2-4 Representative B/T cracking evaluation outcomes, from left to right: range image, crack map on intensity image, load cracking (red) and B/T cracking (green), and evaluation outcomes (unit: foot)**

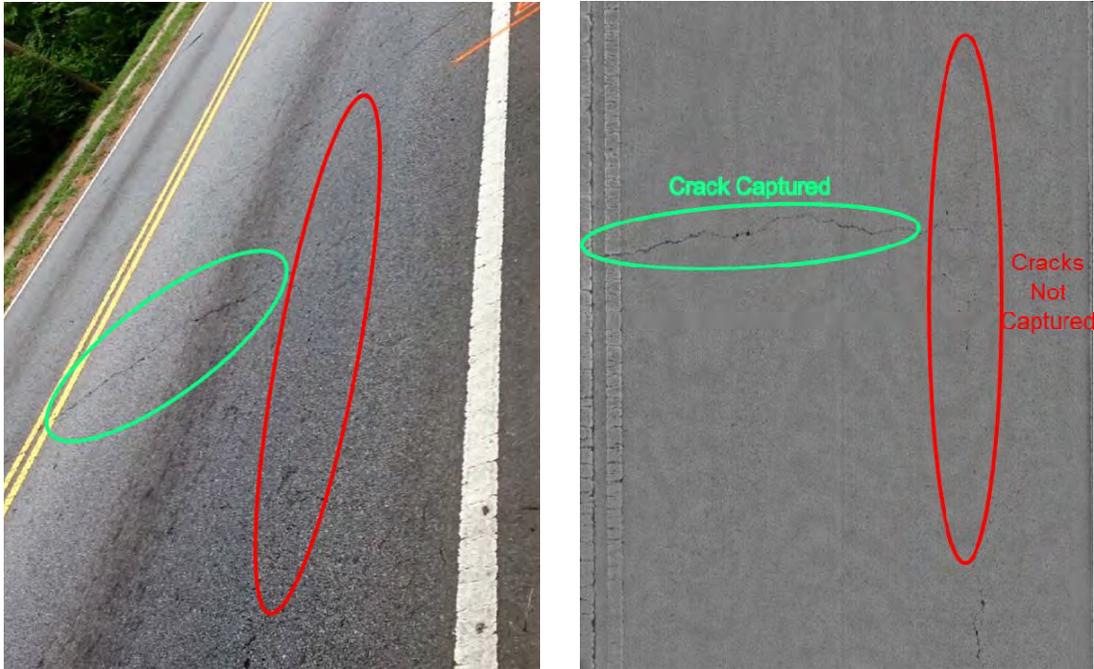
**Figure 2-5 Limitation of current technology on hairline cracking (images from SR236 Site #3)**

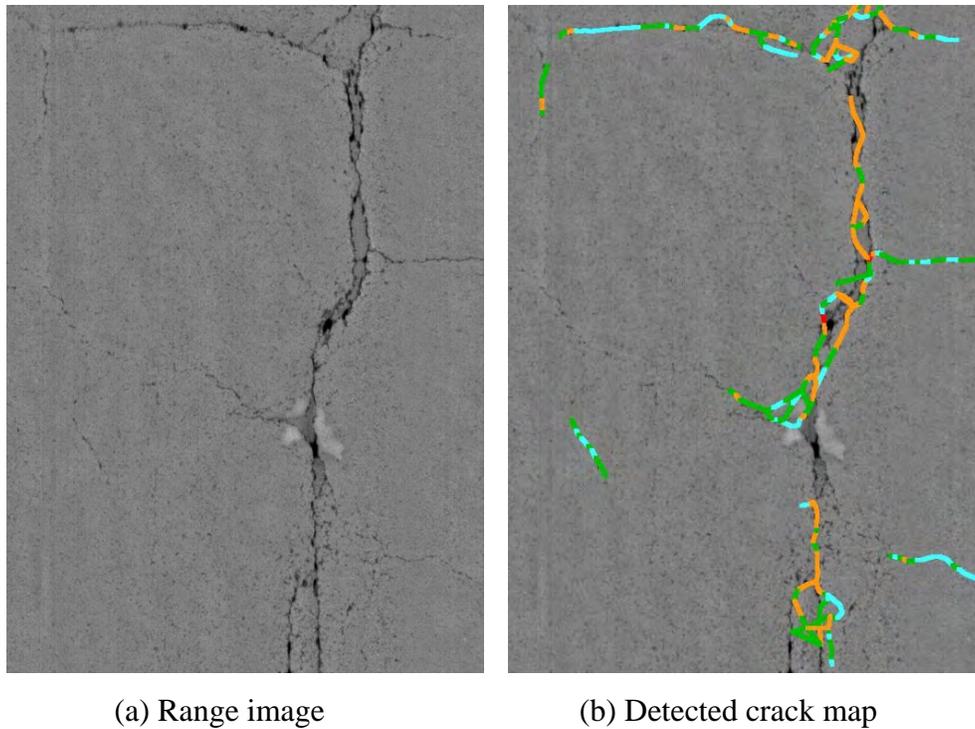
**Figure 2-6 Limitation of crack detection algorithms (images from SR236 Site #2)**

Furthermore, the automatic crack detection algorithm cannot be guaranteed to provide a precise crack map on every image. As shown in Figure 2-6, some cracks are only partially detected, and the pavement areas with clear double crack lines are, also, detected as only a single crack line. The limitation of automatic crack detection also impacts the performance of the subsequent crack classification and measurement.

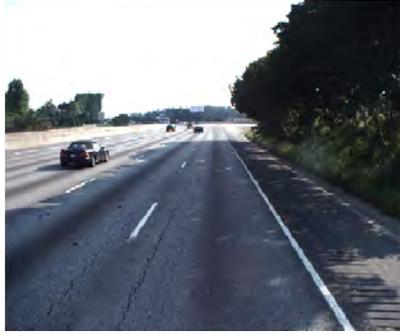
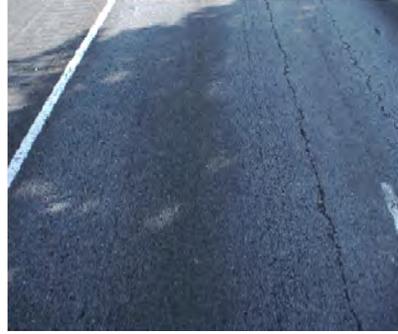
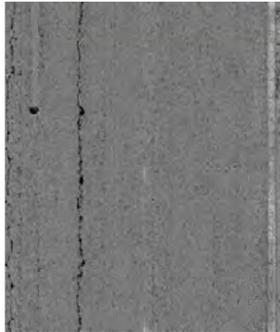
**(a) Load cracking**

**Figure 2-8 Representative samples on the selected interstate test site**

The pavement data is collected on the test site, and the crack classification and quantification is conducted automatically. Figure 2-8 shows some representative samples and the corresponding automatic crack evaluation outcomes. Due to the high traffic volume, it is difficult to conduct a field manual survey to establish the ground truth; therefore, the video-log images from front and back camera are provided for comparison purposes.

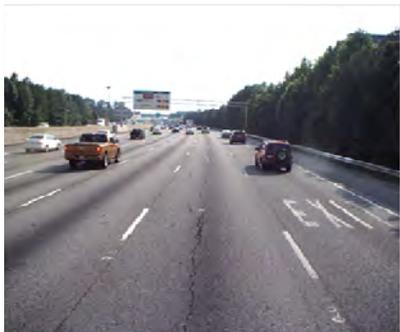
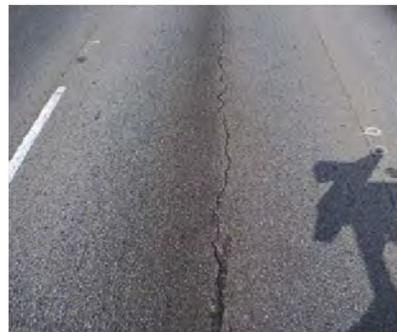
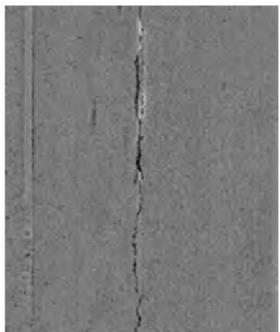
**(b) B/T cracking**

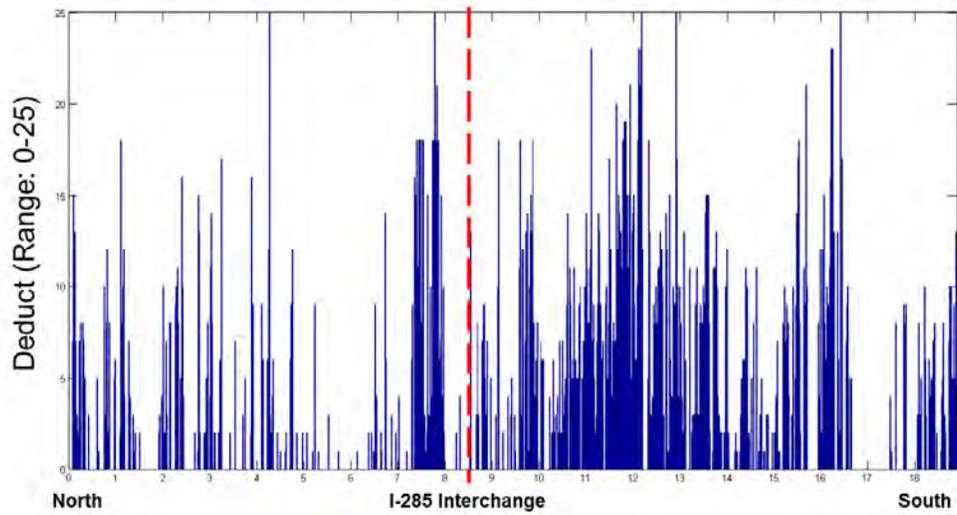
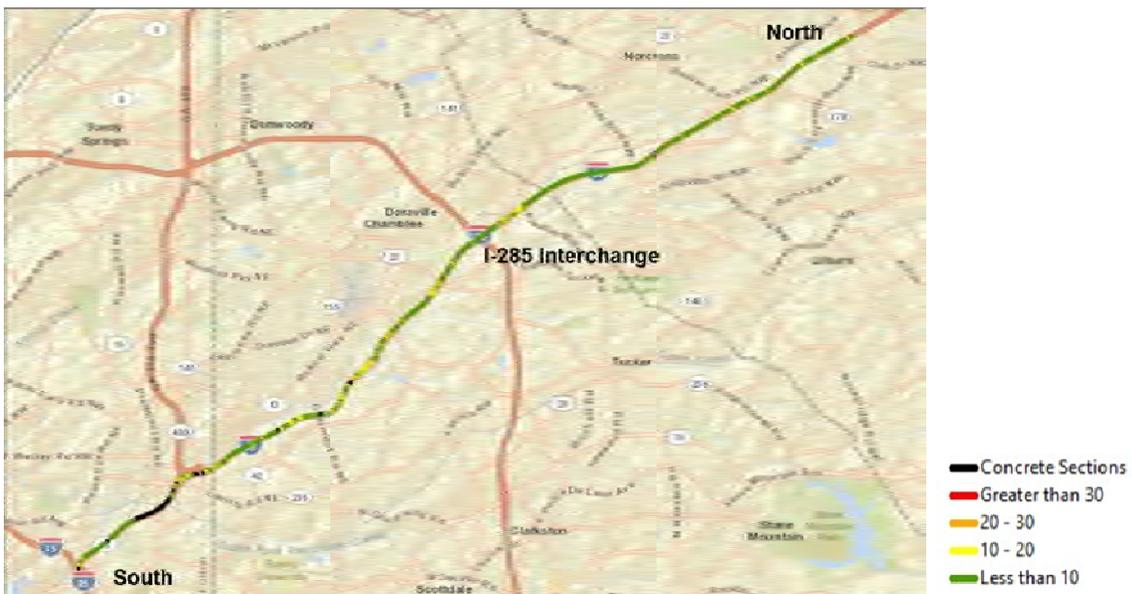
(a) Deduct distribution

(b) GIS visualization

Based on the automatic crack evaluation outcomes, the deduct distribution of load and B/T cracking can be generated and visualized on a GIS map (as shown in Figure 2-9). The pavement condition inside the I-285 perimeter is clearly worse than that of outside I-285. The automatic crack evaluation using 3D pavement data is promising for transforming the sensing data and detected crack map into decision support information; it is especially beneficial on the high-volume-traffic roads, such as interstate highways, where traditional manual surveys are difficult to conduct.

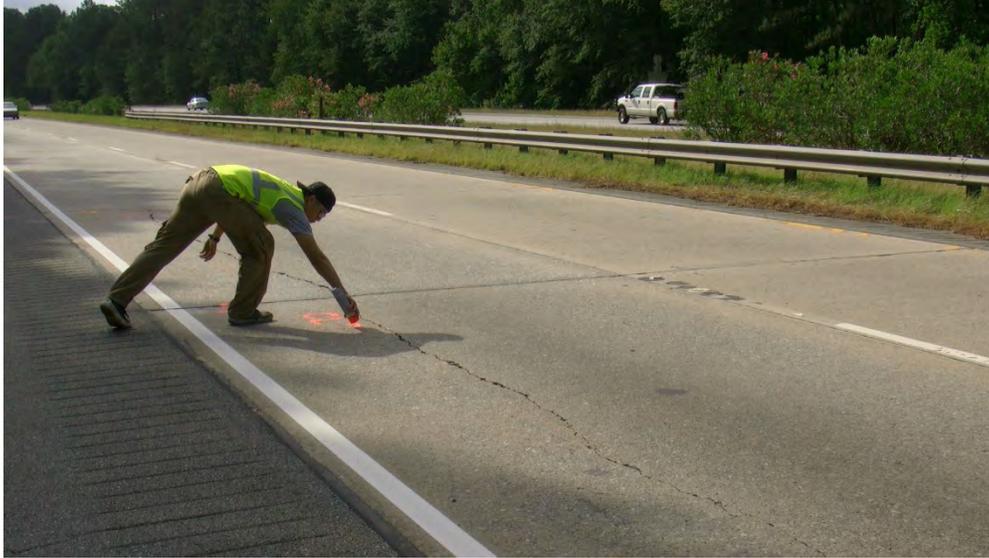
**Figure 3-2 Manually labeling the selected concrete slab for crack detection validation**

On the I-16 test site, we selected a total of 27 slabs westbound from MP159 to MP157; this roadway has representative cracking patterns, most of which are transverse cracking / broken slabs. Each of these slabs is marked with a unique ID for future reference (as shown in Figure 3-2), and the distresses on these slabs are drawn roughly for comparison purposes. On the I-516 test site, we selected a total of 15 slabs northbound from MP3 to MP4. Similarly, each of these slabs was marked with a unique ID. Digital photos of the selected testing sites were taken from the road shoulder to track the detailed distress condition and provided certain reference through the validation.

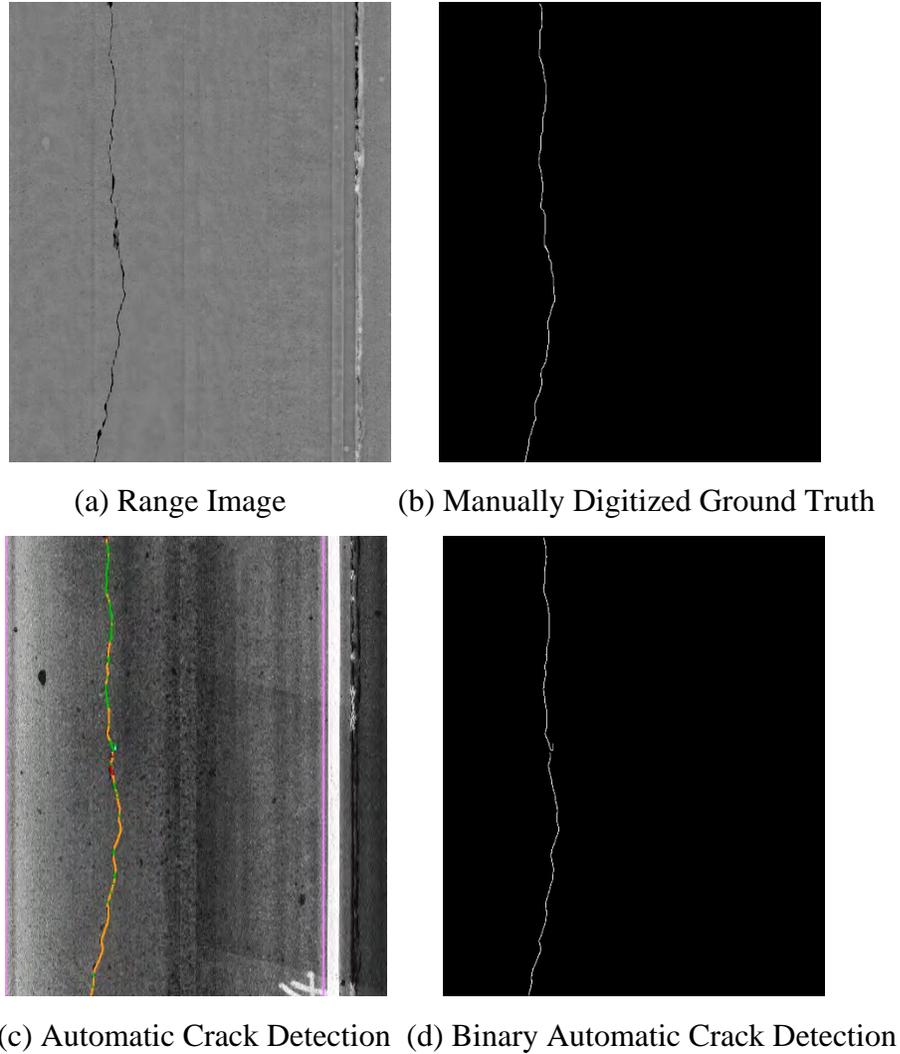
**Figure 3-3 Illustration of evaluation procedure**

- Finally, the two binary crack maps were compared – ground truth and automatic detection. The buffered Hausdorff scoring method was employed to conduct an objective and quantitative evaluation.

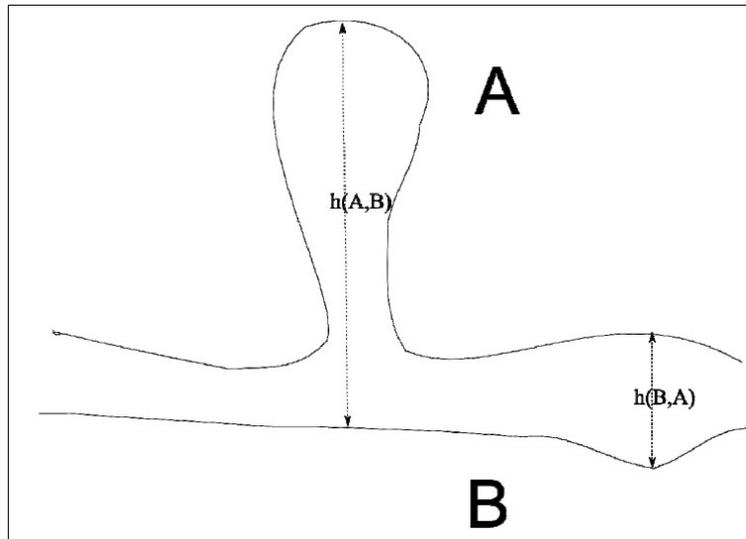
**Figure 3-4 Illustration of Hausdorff distance**

$h(A, B)$  is the greatest of all the small distances from points of A to B and is the greatest of all the small distances from points of B to A. Figure 3-4 illustrates this distance measurement effectively.

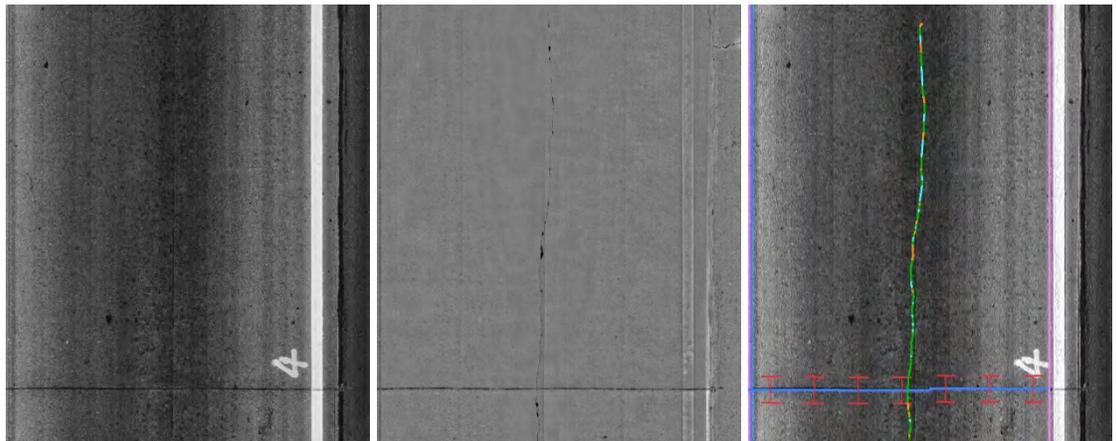
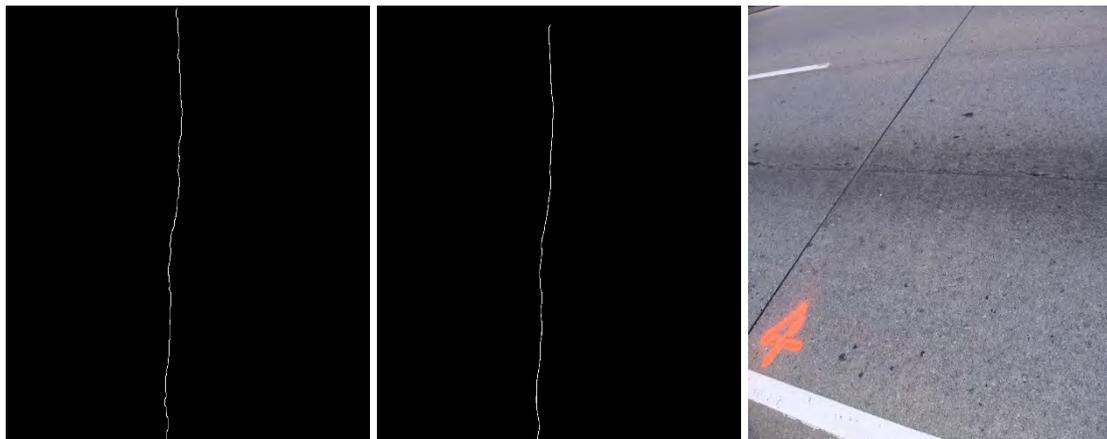
**Figure 3-6 Crack detection on Slab #4 on I-516 test site (Score: 96.5859)**

method also gives a high score of 96.59 on this image, which indicates an accurate detection. Also, the transverse and longitudinal joints are successfully differentiated from the cracks. Similarly, Figure 3-7 shows longitudinal cracking with a large crack width and some spalling. The automatic crack detection shows an accurate outcome, as well, in this case.

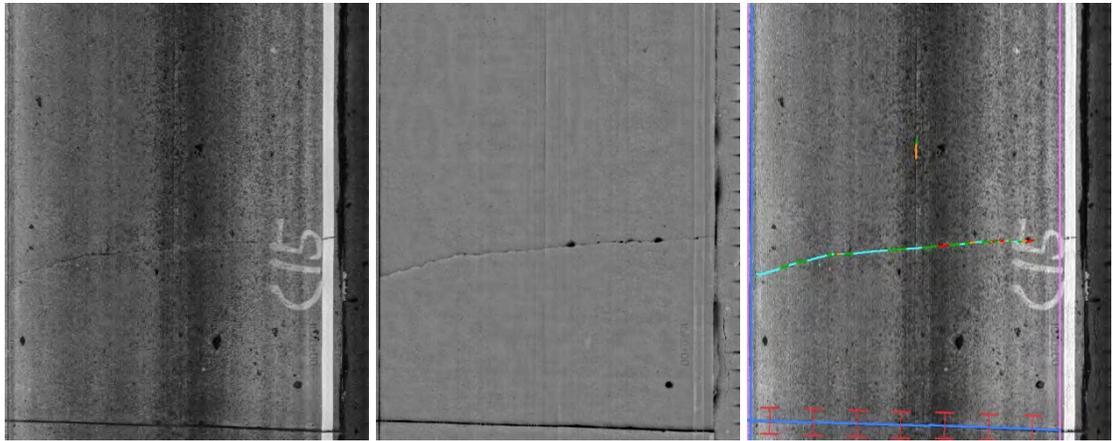
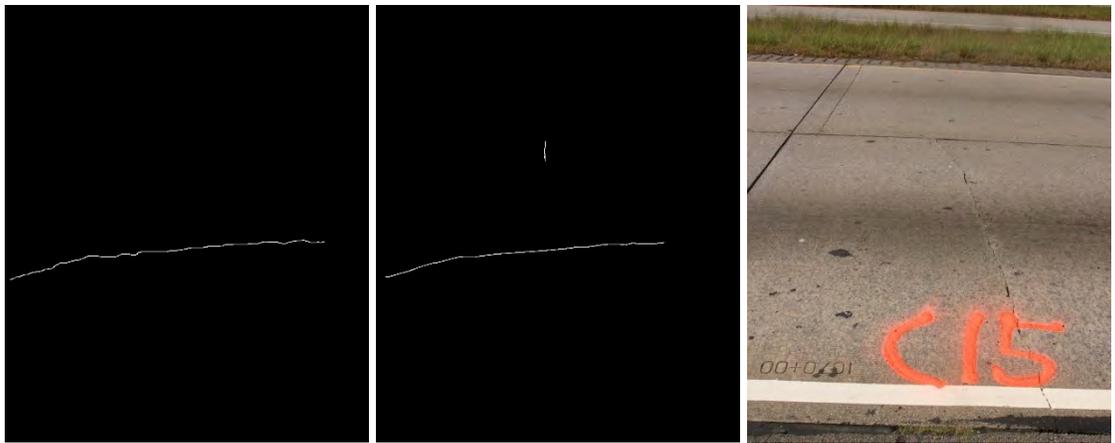
**Figure 3-8 Crack detection on Slab #C15 on I-16 test site (Score: 90.4512)**

high score of 90.45 on this image, which indicates accurate detection. Similarly, Figure 3-9 is a broken slab with a large crack width and severe spalling. This introduces some uncertainty into the crack detection, since some spalling is large enough to be detected separately as spalling (as shown in the blue area on the image). Based on visual inspection, the overall pattern of detected cracks are similar to the one in the ground truth, although some false positives and false negatives are observed. The buffered Hausdorff score on this image is 85.41.

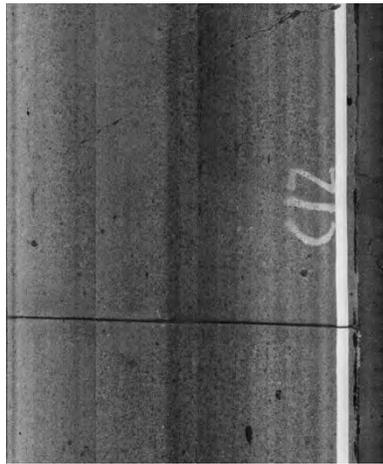
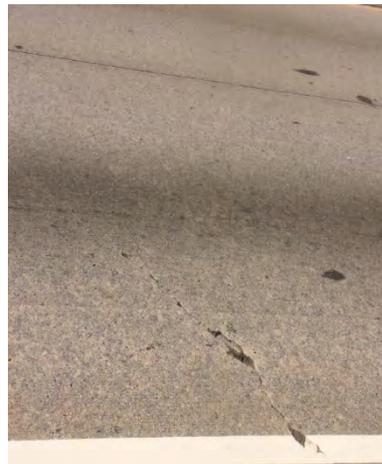
**Figure 3-10 Crack detection on hairline cracking**

the interstate highway. Based on our previous experience on asphalt pavement, cracks with widths below 2 mm are difficult to detect. Figure 3-10 shows a representative case of hairline cracking. The middle part of the transverse crack on the image is hairline. It can be seen that that portion is too thin to be observed, even from the high-resolution digital photos taken from the shoulder. The automatic detection can only extract part of the entire crack line in this case, which leads to a poor buffered Hausdorff score. The hairline cracking issue is better observed on I-16 test site, resulting in an overall, relatively low score on that site; also, the larger data acquisition interval in the driving direction makes it more difficult to capture transverse hairline cracking.

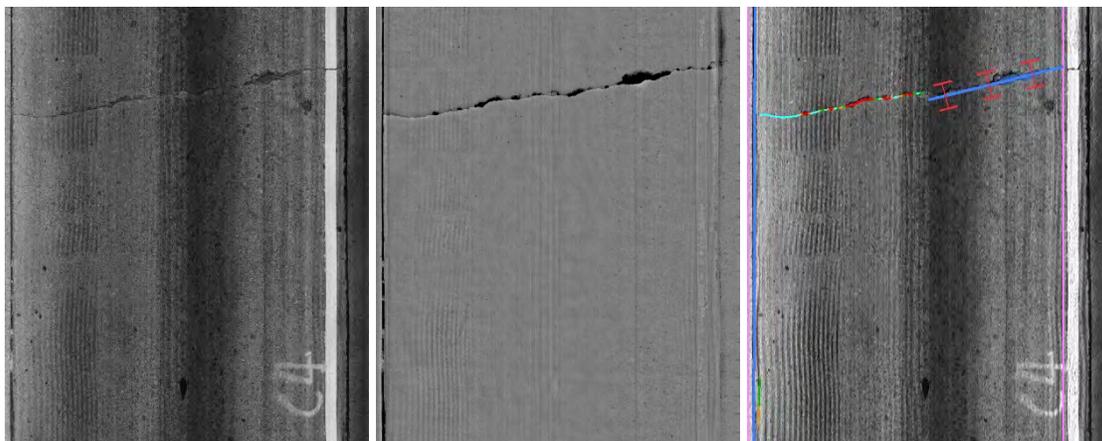
**Figure 3-11 Misclassification of transverse cracking as concrete joint**

Through the experimental tests, several such cases are observed for both transverse cracking and longitudinal cracking. Figure 3-11 shows an example of transverse cracking; the left side of the crack is detected successfully, while the right side is misclassified as a joint. Figure 3-12 shows an example of longitudinal cracking; the top side of the crack is detected successfully, while the bottom side is misclassified as a joint. Based on the experimental results, these false detection cases usually happen under the following two situations: 1) cracks appear to be approximate straight lines and 2) some spalling occurs along the crack and interfere with the crack detection.

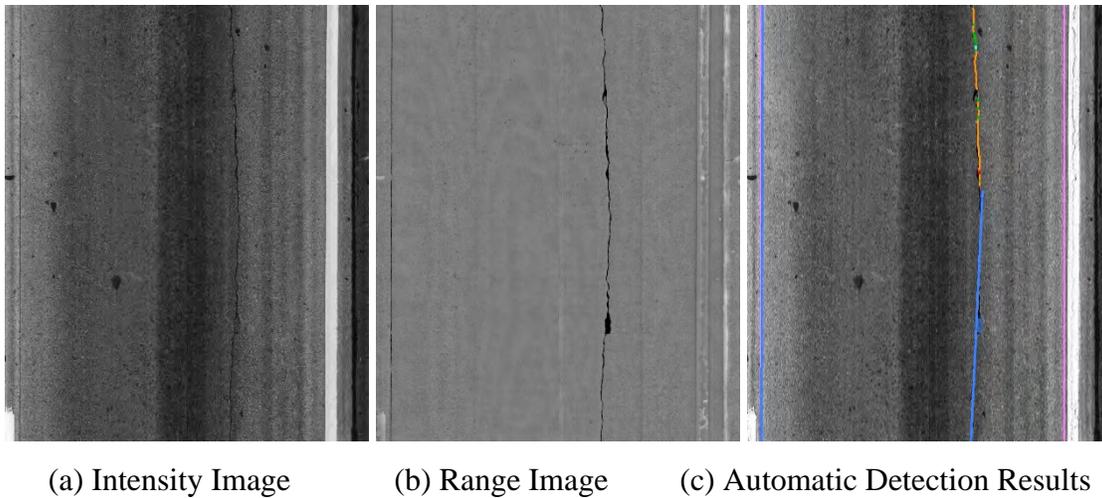
**Figure 3-12 Misclassification of longitudinal cracking as concrete joint**

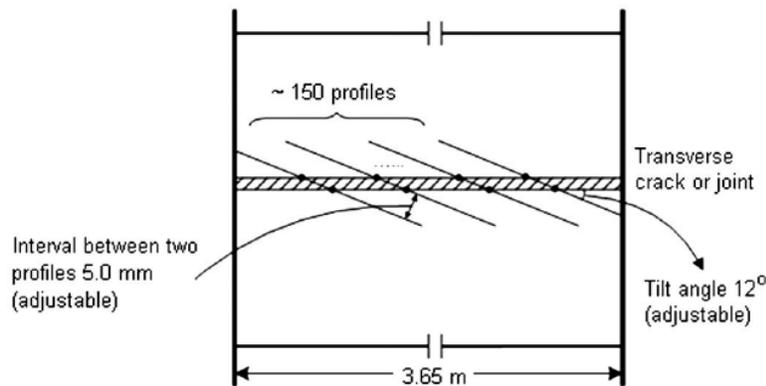
**Figure 3-14 Illustration of the alignment of the 3D continuous laser profiles**

With the advance of sensing technology, the 3D line laser imaging technique creates the potential to use not one single profile but the entire pavement surface to measure the faulting across concrete joints. Figure 3-14 illustrates the basic principle of capturing line laser data along the joints while the vehicle is driving at highway speed, and Figure 3-15 gives an example of the collected pavement surface laser data at the location of a concrete joint. It can be observed that the elevation change of the pavement surface is clearly captured by the laser data, which makes it possible to develop automatic faulting measurement algorithms.

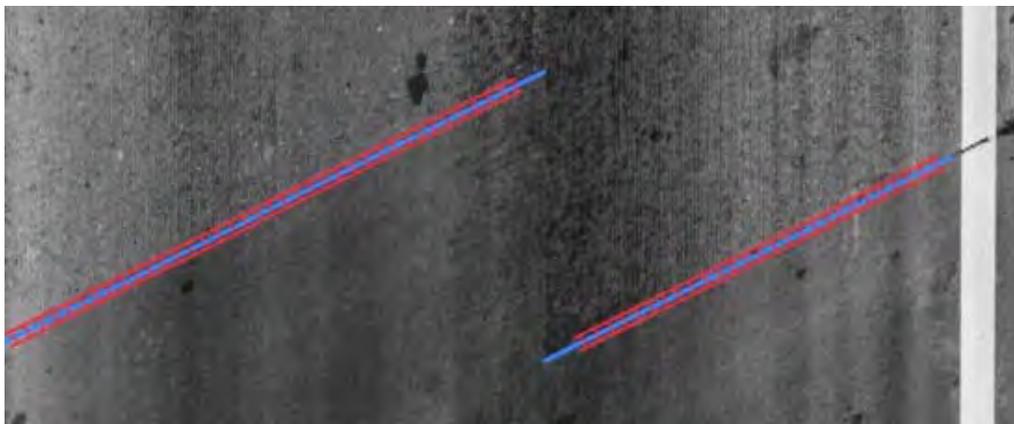
**Figure 3-22 Example of correctly detected cases**

The blue lines in the image indicate the location of the joint, while the red bars indicate the measuring points for faulting; the information will be utilized in the next section. It can be seen

To test the accuracy of the software for detecting transverse joints, we conducted a validation test on a dataset of 941 images. An example of the expected detection result is shown as Figure 3-22.

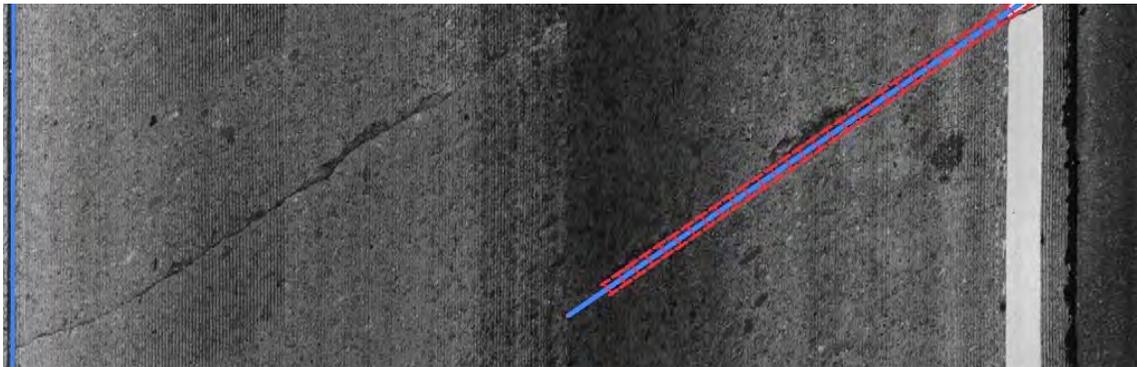
**Figure 3-23 Example of false-positive cases**

To find the reasons for the incorrect detection, we further examined the error cases. Four false-positive cases were big transverse cracks sharing the typical characteristics of joints (shown in Figure 3-23):

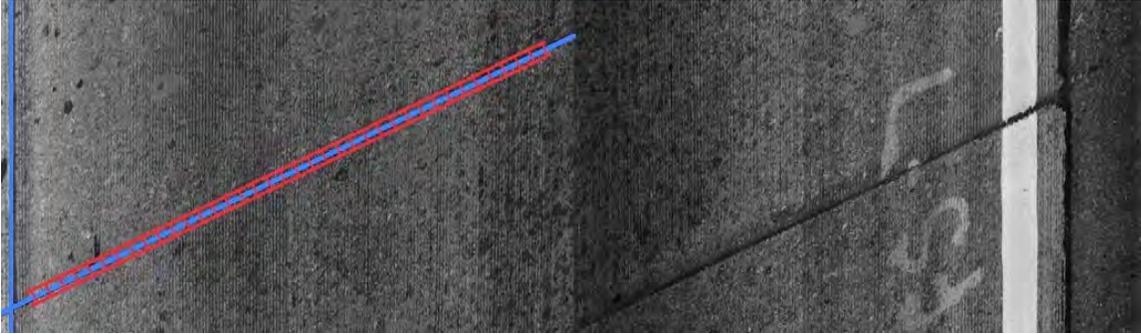
**Figure 3-24 Example of false-negative cases**

Five false-negative cases have the detection results only on one side, as shown in Figure 3-24:

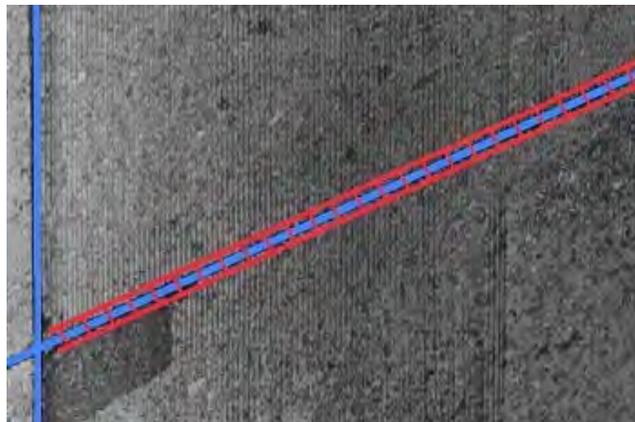
**Figure 3-25 Example of joints with patch**

Some other special cases were also tested. There are 5 images containing joints with asphalt patches (Figure 3-25), and all such cases are detected correctly, which indicates patching may not influence the detection process.

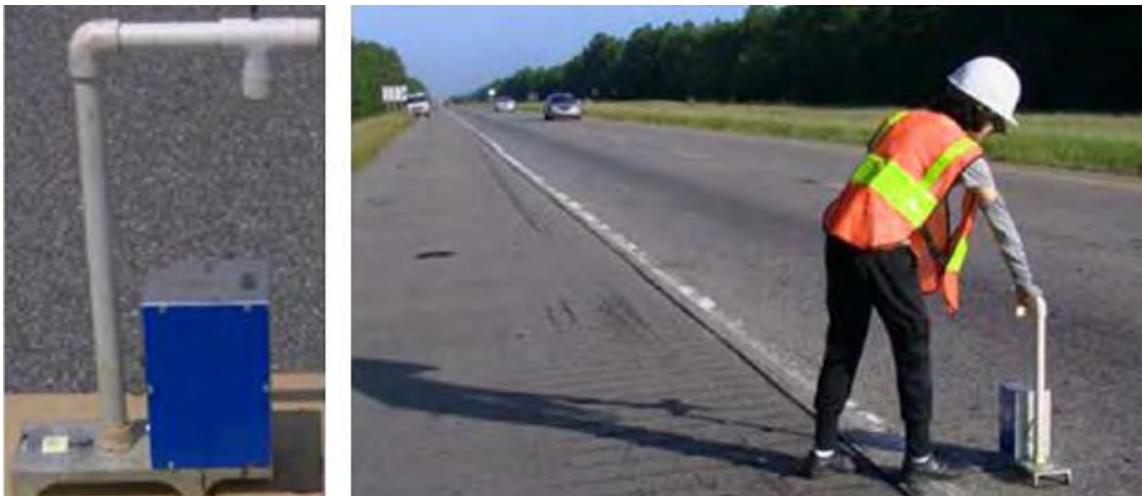
**Figure 3-27 Left: Georgia Faultmeter; Right: Manual measurement on the roadway**

validation test. Three places on the route were selected for manual ground-truth data collection; each of the three places contained 10 continuous concrete slabs. One place is around EB MP159 (Site #1), and the other two spots are on WB MP159 (Site #2) and MP156 (Site #3). All those joints measure are marked with color painting. The Georgia Faultmeter, which has already been introduced in the literature review, was used as the measuring tool, as shown in Figure 3-27.

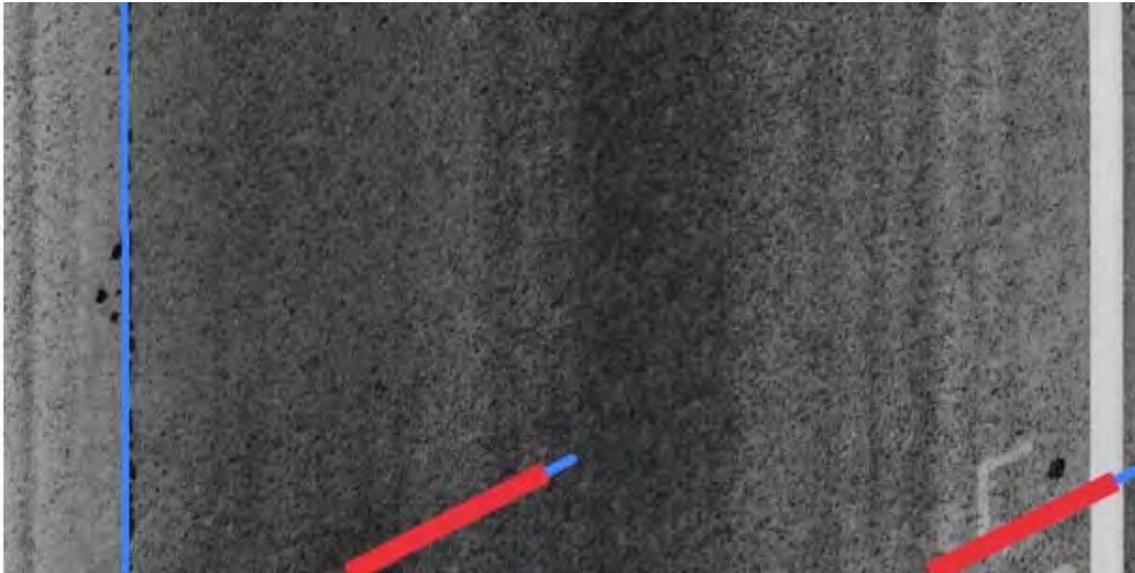
**Figure 3-33 Example of joints with excluded part**

In this test, most cases have been successfully measured, yet three cases in which joints have been successfully detected failed to provide faulting measurement information. Results with the symbol ‘/’ indicate failure to provide faulting information. Most of these problems occurred in joints with a portion outside the image and with a marked location close to the image edge, as shown in Figure 3-33.

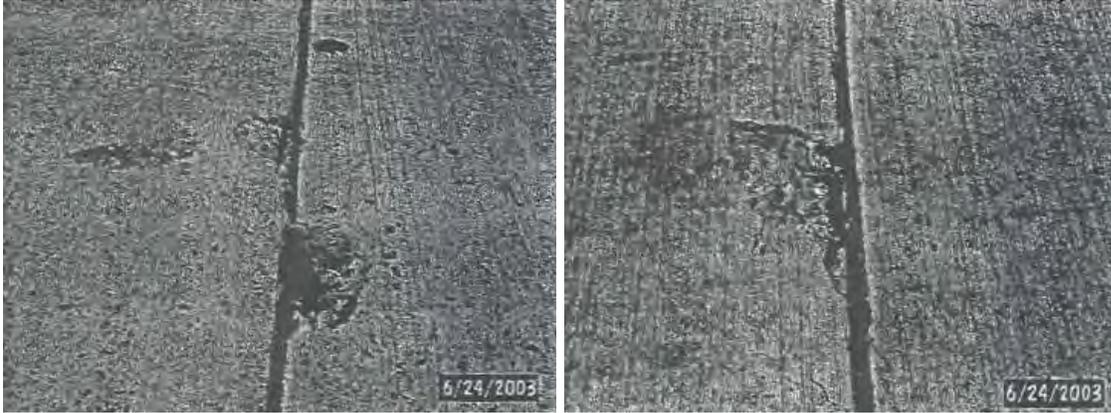
**Figure 3-34 Example of spalling at concrete joint (GDOT 2003)**

Spalling is a common type of concrete pavement distress that usually occurs along the construction joints between concrete slabs. According to the LTPP's definition, spalling refers to cracking, breaking, chipping, or fraying of slab edges within 0.3 m from the face of transverse joints. GDOT defines spalling as the deterioration of concrete at the joint, which usually starts with the breaking or flaking off of the concrete at the joint; as they worsen, raveling and pop-outs occur (as shown in Figure 3-34). Due to its random spatial distribution pattern on the concrete pavement, it is difficult to design a sampling strategy for manual spalling survey. Therefore, automatic spalling detection will help improve the cost-effectiveness of concrete pavement maintenance and enhance roadway safety.

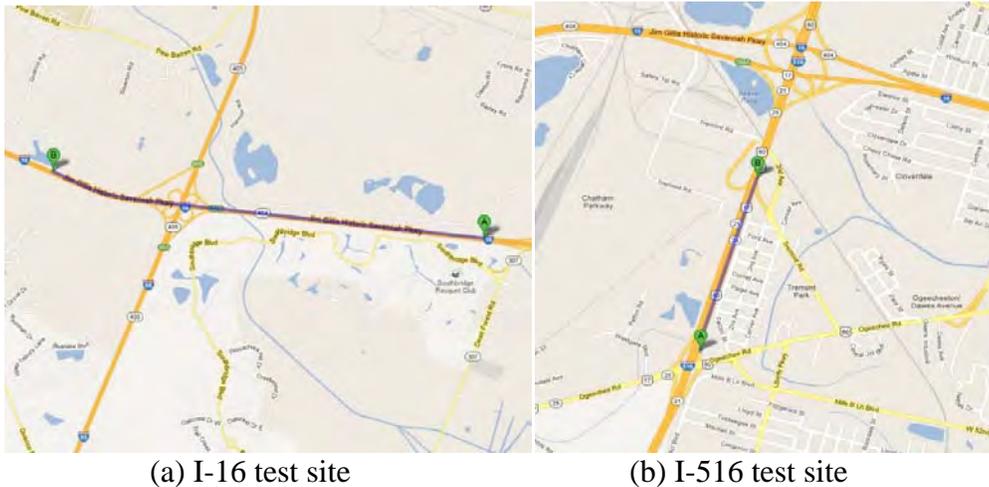
**Figure 3-35 Selected test sites on concrete spalling detection**

The experimental data of the validation test were collected on interstate highways I-16 and I-516 near Savannah, Georgia. Both highways are concrete pavement on the selected test sites (as shown in Figure 3-35).

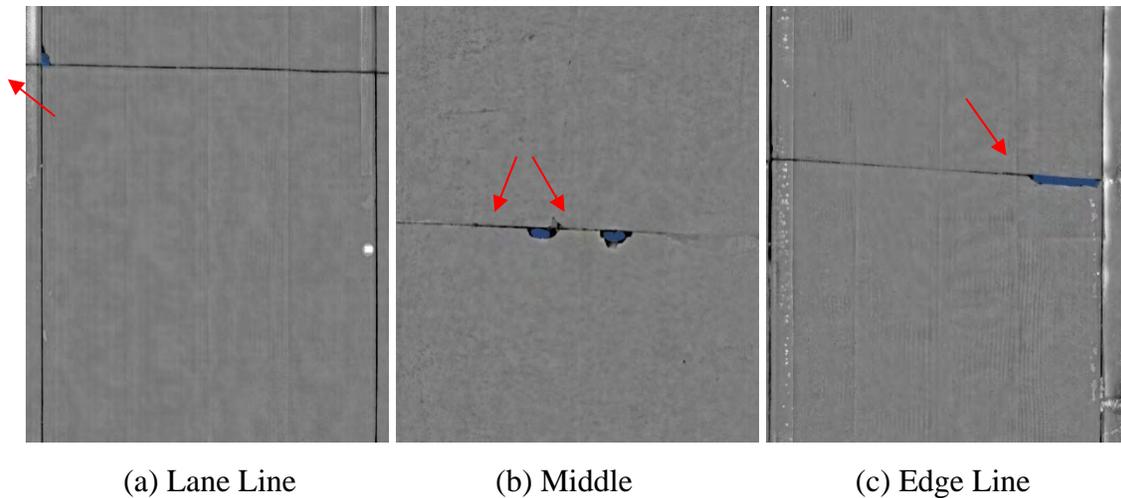
**Figure 3-37 Examples of correctly detected spalling**

Figure 3-37 shows three representative examples of correctly detected spalling. It can be observed that the location and shape of spalling do not have a significant impact on the performance of the automatic spalling detection algorithm. The automatic detection can also extract multiple spalling locations from the same pavement image.

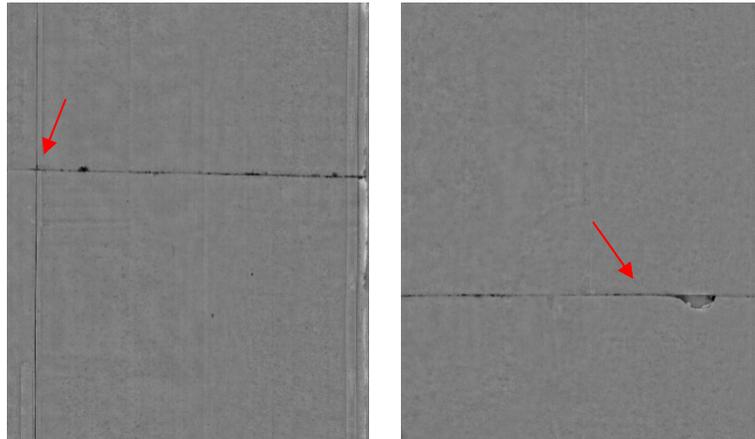
(a) Undersized Spalling      (b) Asphalt-patched Spalling

- Asphalt-patched spalling: as shown in Figure 3-38(b), some spalling sites have already been patched with asphalt in previous maintenance. Although some asphalt patches may not be in good condition, they still reduce the distinctiveness of spalling on concrete pavement and introduce the potential for false positives in spalling detection.

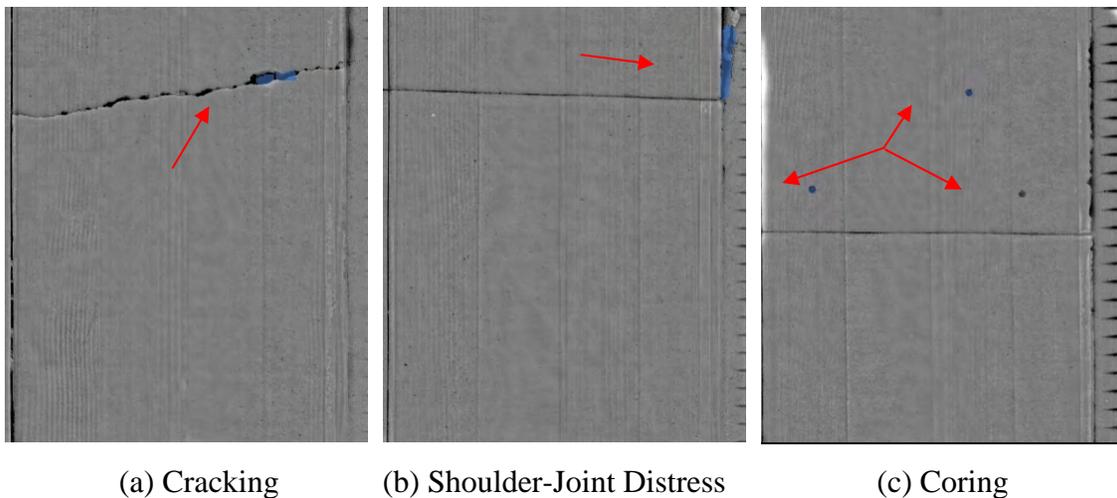
**Figure 3-39 Examples of false positive cases of spalling detection**

Overall, although quite a few false positive cases are observed through the validation test, almost all of them can be eliminated by comparison with the detected joint location; therefore, these false positive cases should not have a significant influence on the real-world implementation of the automatic spalling detection algorithm.

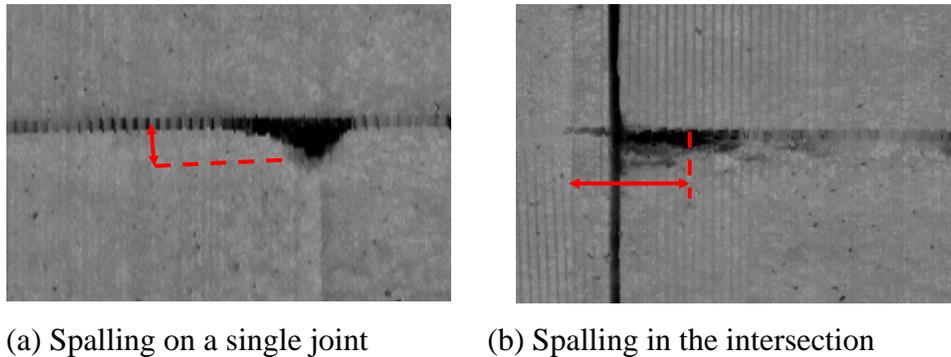
**Figure 3-40 Examples of spalling size measurement**

joints; we use the longer distance to either joint in two directions as the spalling size, shown as Figure 3-40 (b).
