**A REMOTE SENSING AND GIS-ENABLED ASSET  
MANAGEMENT SYSTEM (RS-GAMS) PHASE 2**

**Final Report**

Contract Number: RITARS-11-H-GAT

**Georgia Institute of Technology**

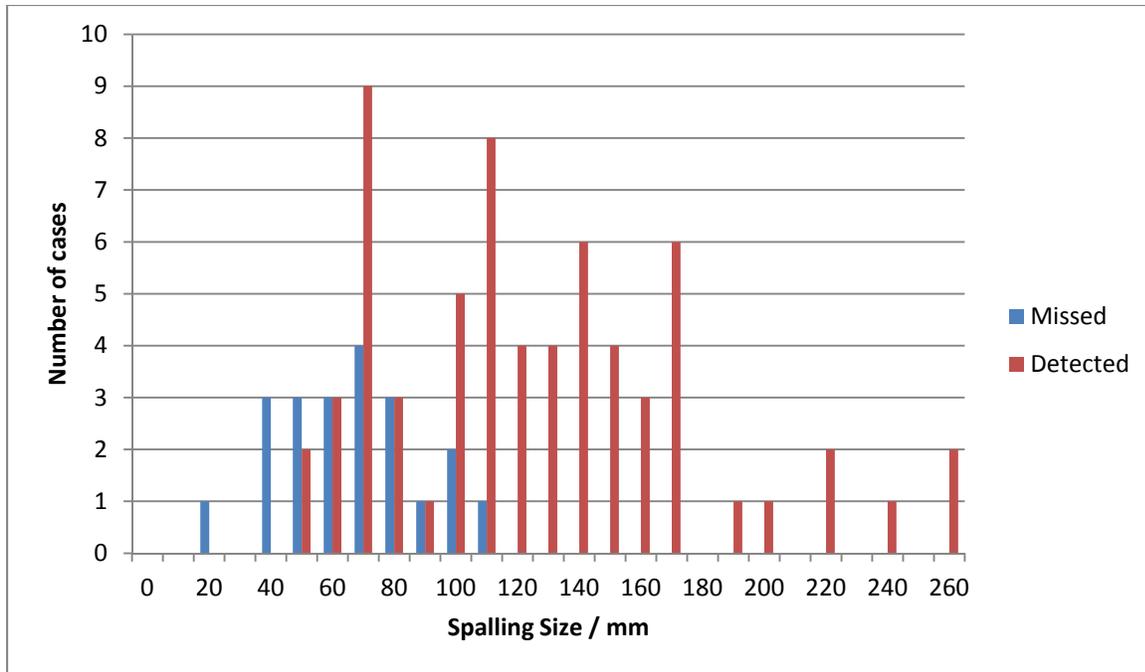
**Figure 3-41 Frequency vs. spalling size**

The detection results are reorganized according to the measured spalling size, and the obtained frequency for each size group is shown in Figure 3-41 and Table 3-8. It can be seen that the software can hardly detect spalling sizes smaller than 50 mm; the software can detect some spalling sizes larger than 50 mm but smaller than 90 mm, but the accuracy is not very good (59%); for spalling sizes larger than 90 mm, the detection accuracy becomes much better (90%). One of the reasons for these results could be that the software module was originally designed for pothole detection; though the spalling has characteristics similar to potholes, spalling tends to be much smaller. So, the pothole detection module may have some internal filtering mechanism that eliminates small candidates and reduce computation time, which won't affect pothole detection but could cause false negative spillings. To examine such an assumption, we developed our own detection algorithm, which successfully detected most of the cases missed by the software module and using the same dataset. The test indicates that the 3D data have the capability to provide desired accuracy for spalling detection, and in cases of small-sized spillings, future algorithm modification may help improve the detection accuracy.

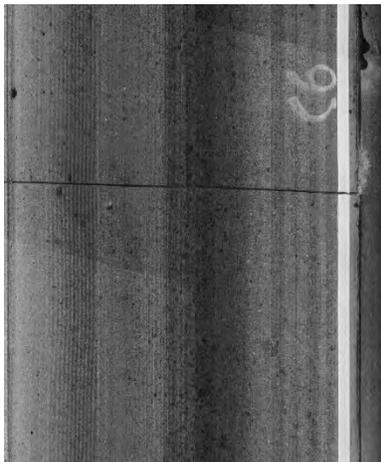
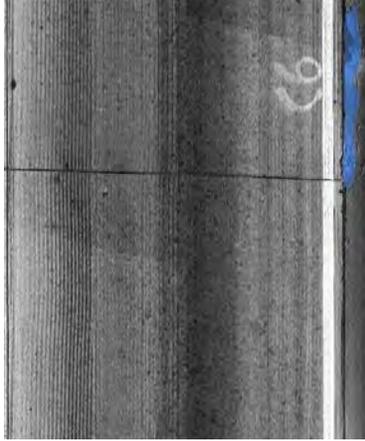
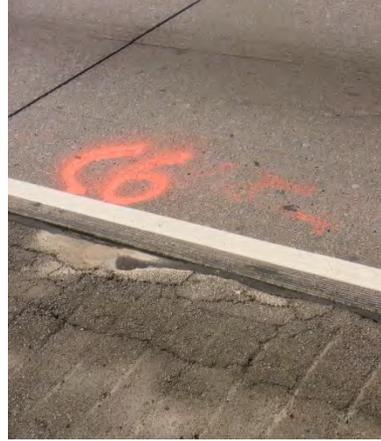
**Figure 3-44 Shoulder-joint distress detection on Slab #C6**

Figure 3-44 to Figure 3-47 show the experimental results of four representative cases. Images (a) and (b) show the intensity and range images of the selected location; Image (c) shows the detected shoulder joint distress (blue area); and Image (d) shows the digital photo at the same location. Based on the experimental results, it can be observed that although it is difficult to identify them in intensity images, shoulder joint distresses appear quite distinctively in range images. Having characteristics similar to spalling (elevation drop), their larger extents and areas actually simplify the automatic detection. Based on visual judgment, the detection results are basically consistent with field observations, including distress maps and digital photos.

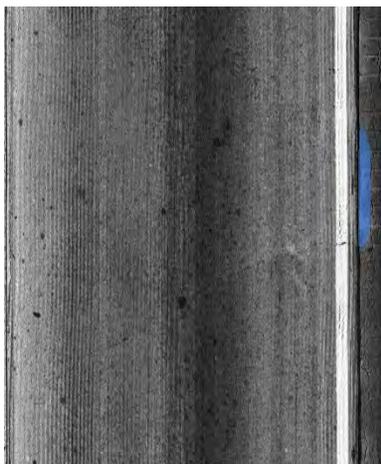
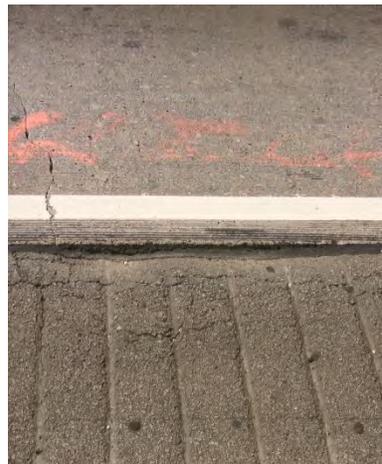
**Figure 3-45 Shoulder-joint distress detection on Slab #C6'**

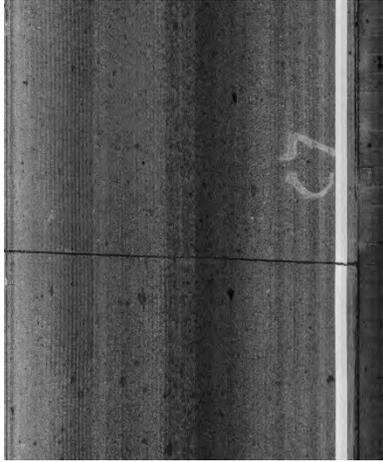
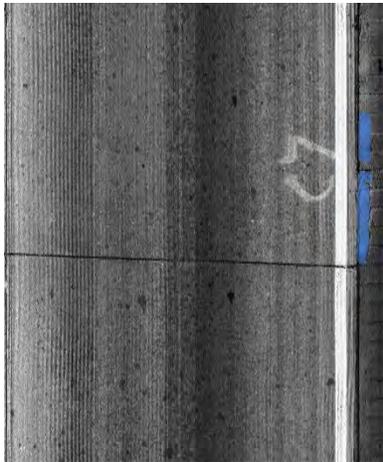
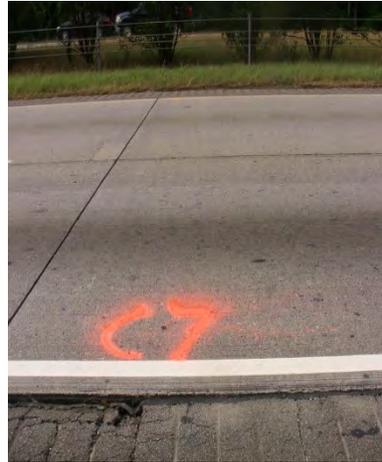
**Figure 3-46 Shoulder-joint distress detection on Slab #C7**

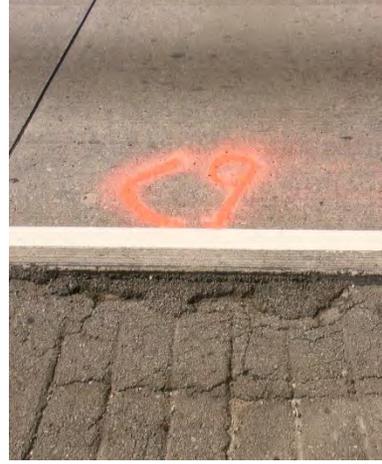
**Figure 3-47 Shoulder-joint distress detection on Slab #C9**

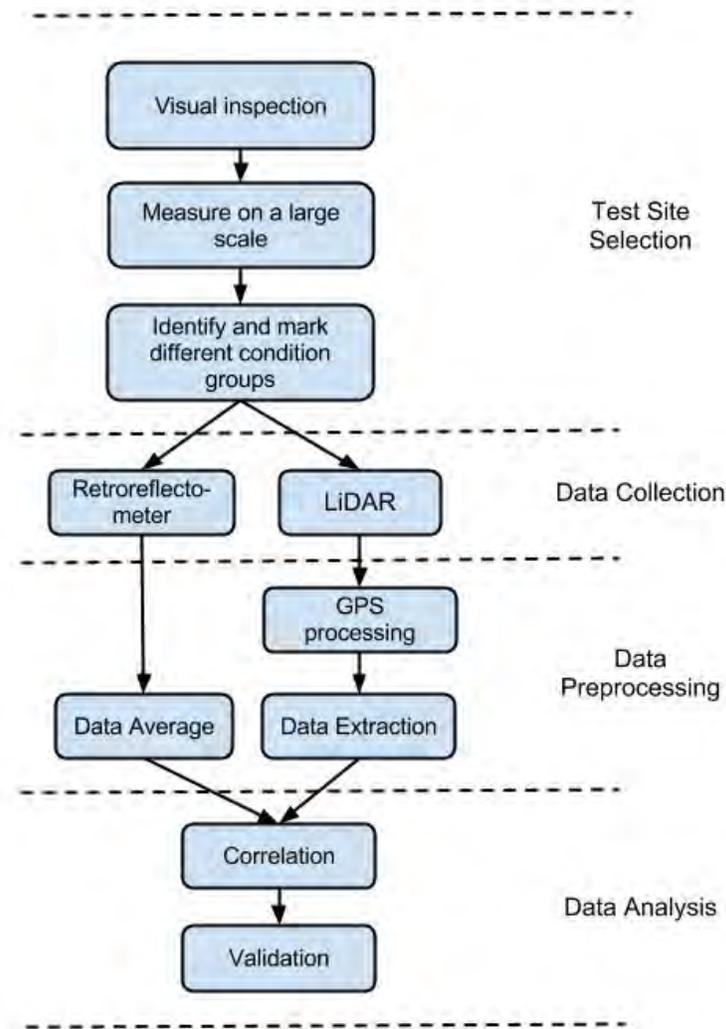
**Figure 4-4 Flowchart of establishing correlation retroreflectivity and retro-intensity**

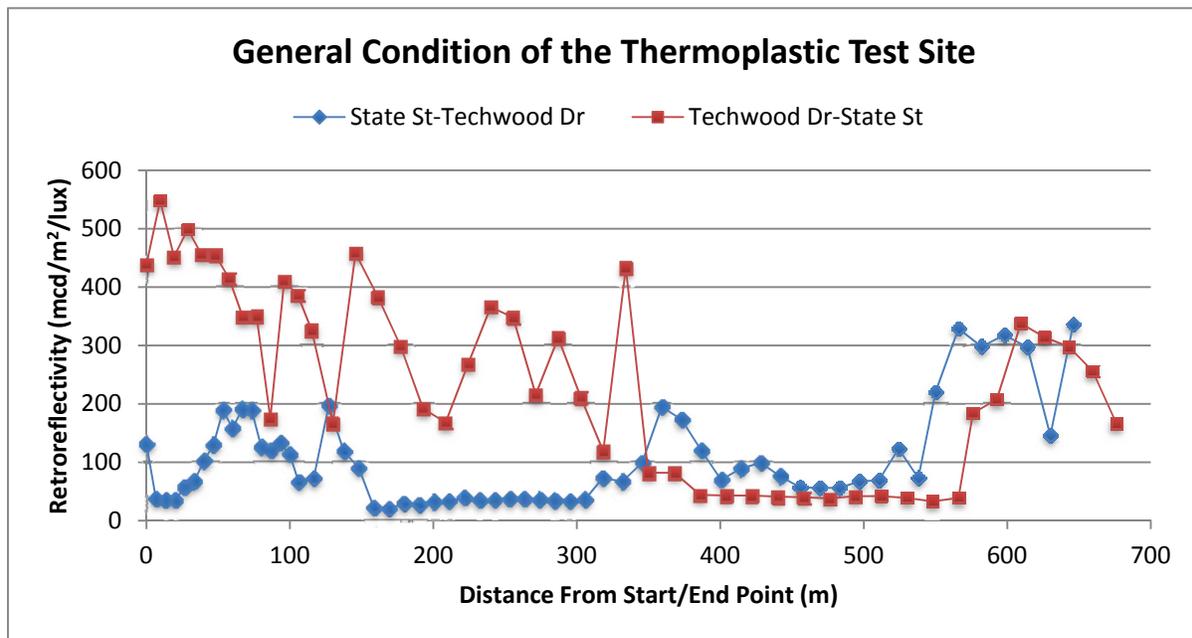
**Figure 4-5 The pavement marking retroreflectivity condition on the Ferst Dr. on Georgia Tech campus**

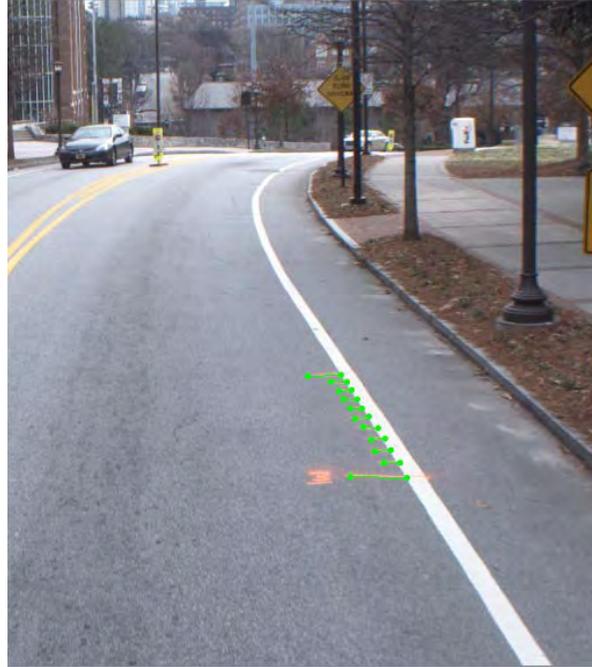
**Figure 4-9** Create a new layer to locate sample site in the video log image

Trimble Trident 3D Analyst software was used to extract the data. All the samples were extracted into a Geographic Information System (GIS) layer through the video log images that were synchronized with the mobile LIDAR, shown as the green line in Figure 4-9. Then, the layer was mapped onto the calibrated LiDAR point-cloud, shown in Figure 4-10. At each sample location, retro-intensity values of the LiDAR points were manually extracted, shown in Figure 4-10. As the LiDAR device used in this study (i.e. Riegl LMS-Q120i) can acquire 10000 points per second, at least three retro-intensity values could be obtained to associate with each sample section (i.e. 1-ft section in the longitudinal direction). For example, the yellow rectangle shown in Figure 4-11 represents the actual 1-foot test section. Although there are ten LiDAR points cast over this section, only the middle point fully cast on the pavement marking can be used for establishing correlation (the highlighted point in red circles shown in Figure 4-11). Consequently, for each 1-foot section, approximately three retro-intensity values are associated. For the points that partially cast over the pavement marking section, the retro-intensity values might not reflect the true retroreflectivity condition because the energy was redirected by both the pavement and pavement marking.

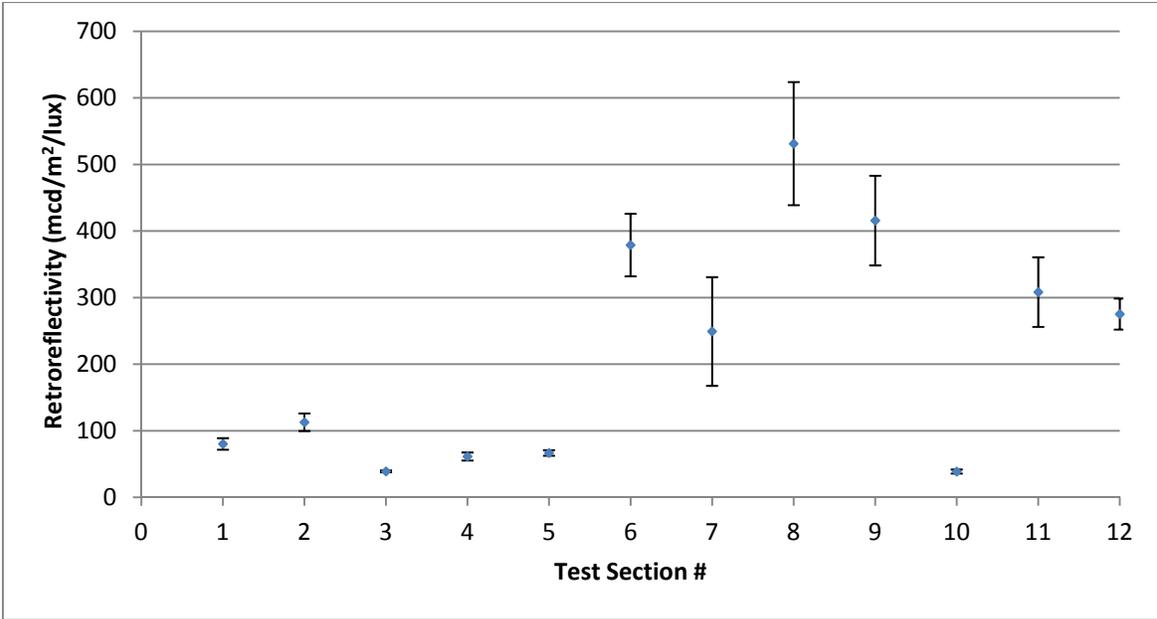
**Figure 4-12 Average retroreflectivity on test sections thermoplastic markings**

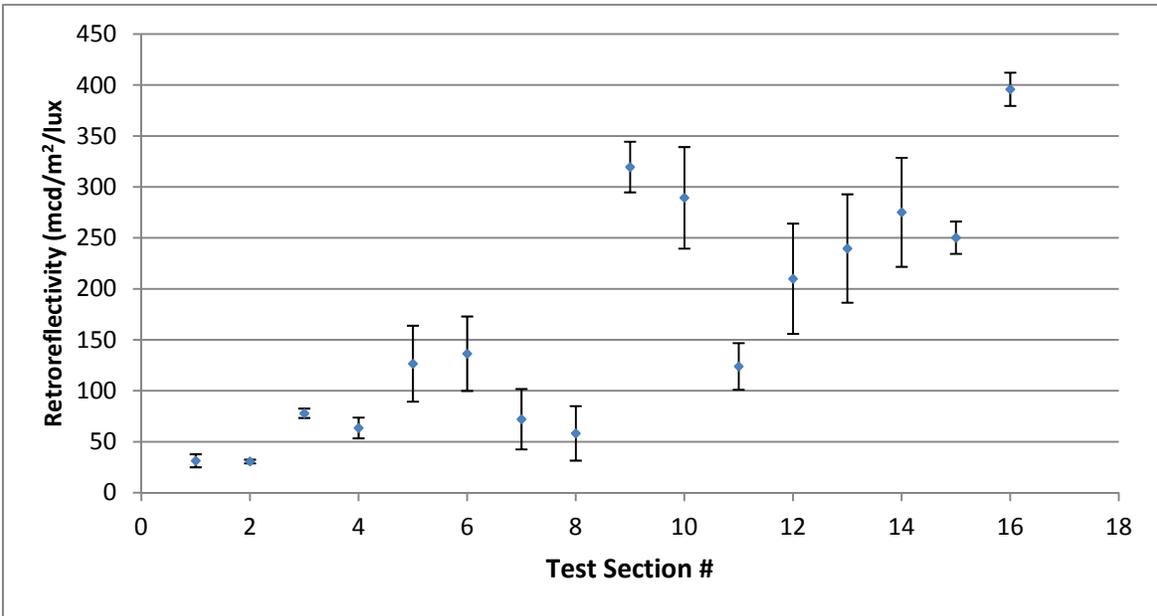
**Figure 4-13 Average retroreflectivity on test sections waterborne paint markings**

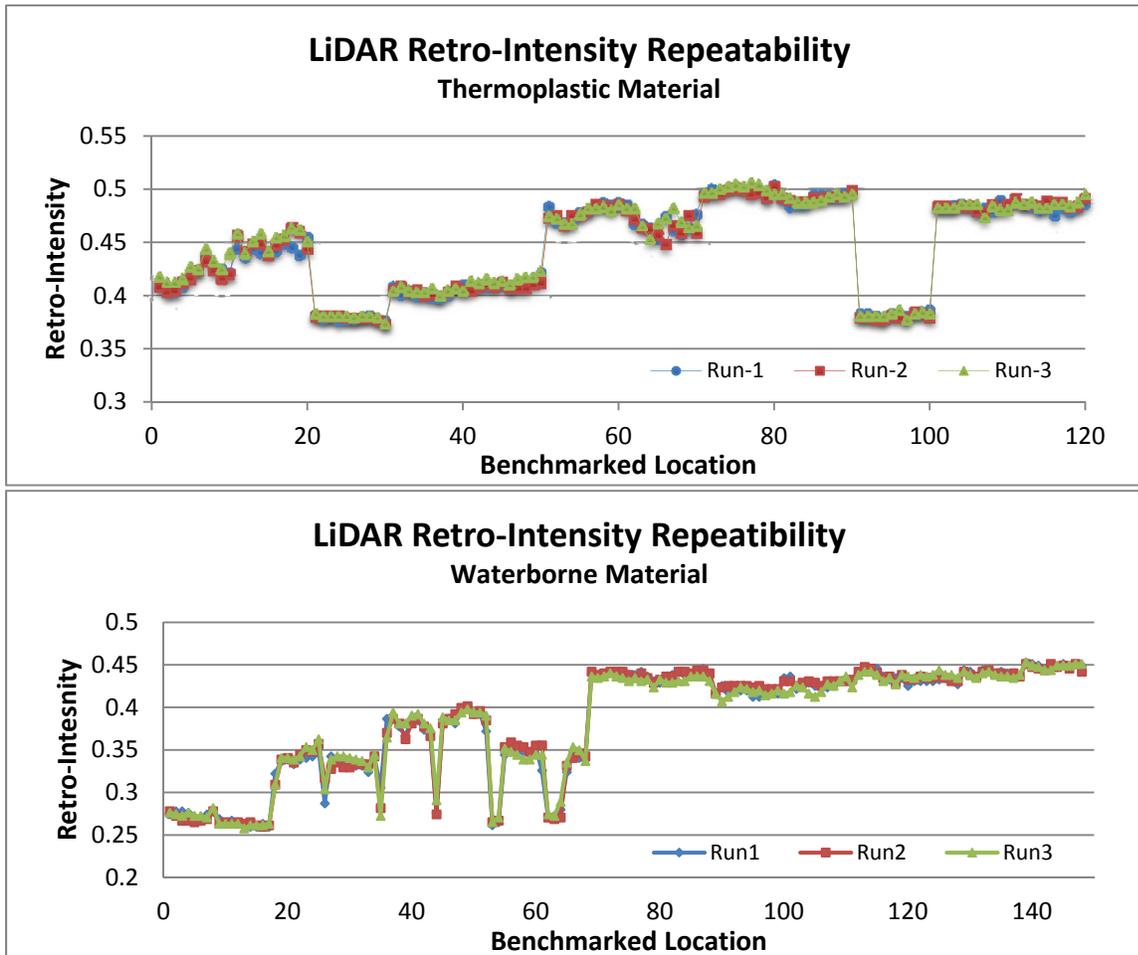
**Figure 4-14 LiDAR retro-intensity repeatability**

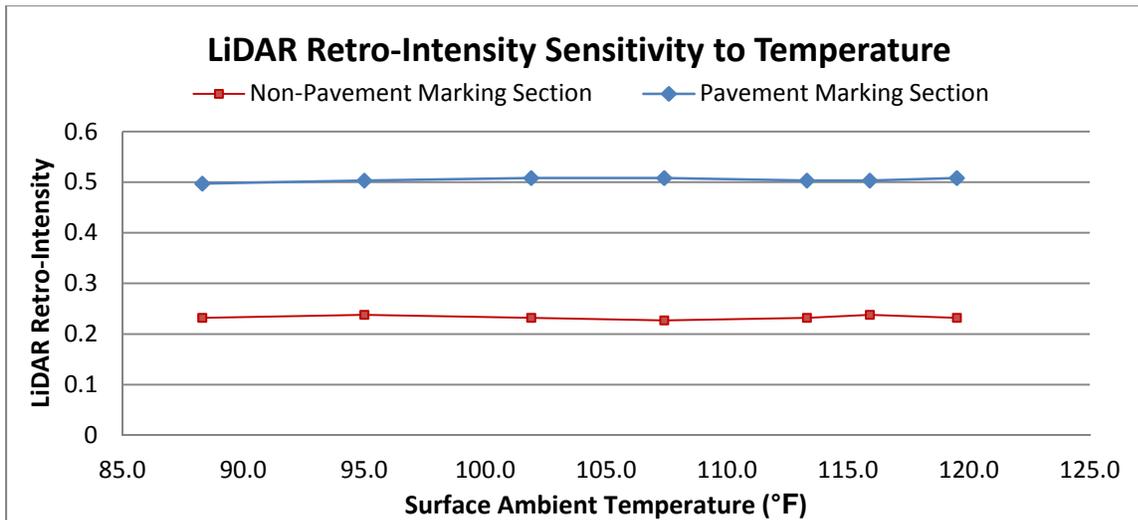
**Figure 4-15 LiDAR retro-intensity sensitivity to ambient temperature**

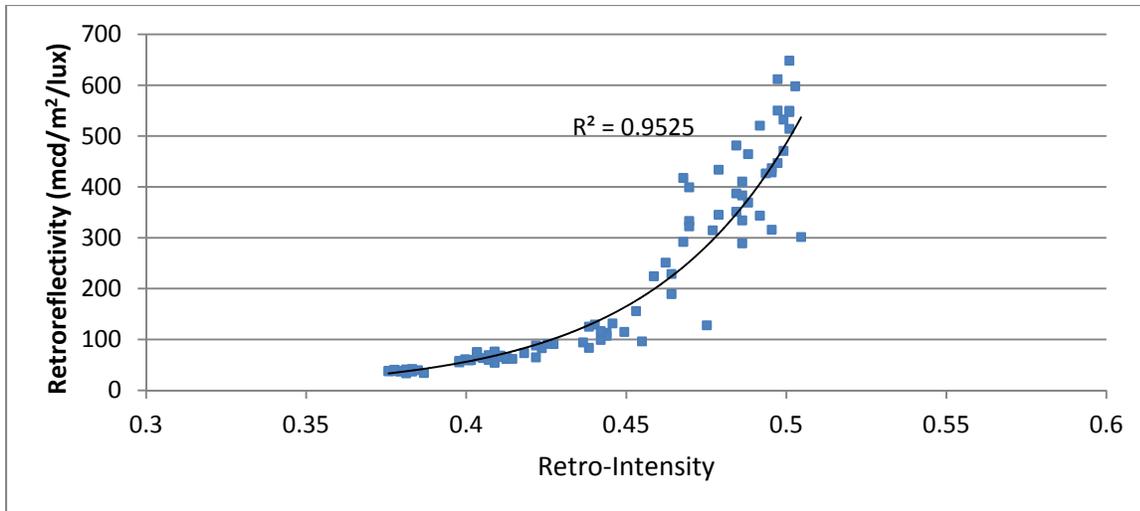
**Figure 4-17 Correlation between retroreflectivity and LiDAR retro-intensity of thermoplastic material**

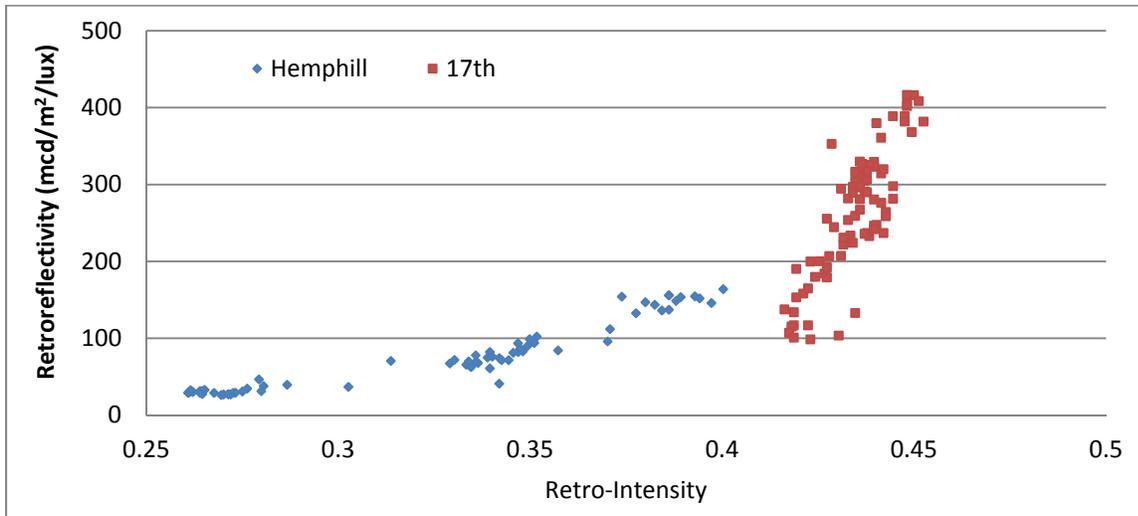
**Figure 4-19 Different retro-intensity responses from different road sections**

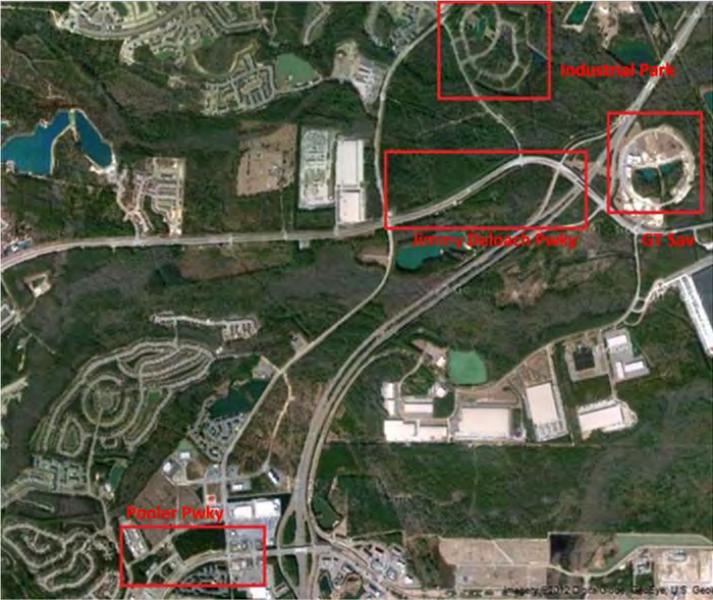
**Figure 5-1 Layout of the assessment data in this study**

To comprehensively assess different technologies, three testing sites were selected to cover representative ranges of the focused characteristics, including the Georgia Tech Savannah campus, Jimmy Deloach Parkway, and Pooler Parkway. Figure 5-1 shows the location of the testing sites.

The ground truth measurements, i.e. pavement width, horizontal curvature and cross slope, were collected at the locations shown in Figure 5-1. For each ground truth location, the average of multiple measurements was taken.

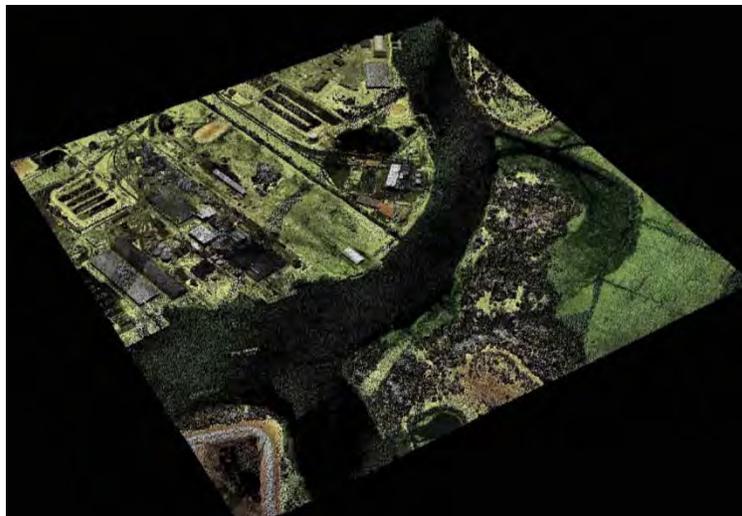
**Figure 5-3 Airborne LiDAR data sample used in this study**

- Airborne LiDAR: The airborne LiDAR data was acquired in the spring, 2009, by Sanborn Map Company for Chatham County, Georgia, for the Metropolitan Planning Commission. The data has a spatial resolution of 0.78 ft in the vertical direction and 2 ft in both the x and y directions. Figure 5-3 shows a sample airborne LiDAR point cloud used in this study.

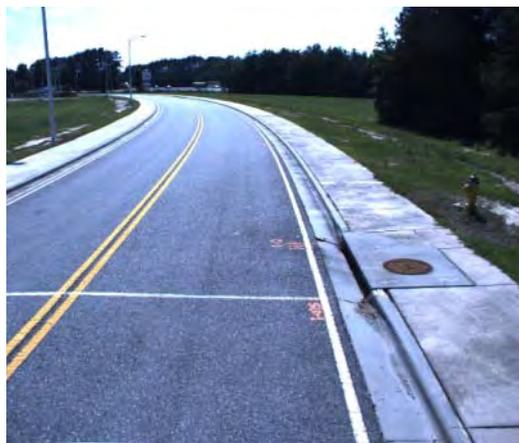
**Figure 5-5 Video log image data sample used in this study**

- Video log Image: The video log image data was acquired using the GTSV. The image data was captured using calibrated cameras (i.e. PTGrey GRAS-50S5c) in the GTSV and which have a resolution of 2,448x2,048. Figure 5-5 shows a sample video log image used in this study.

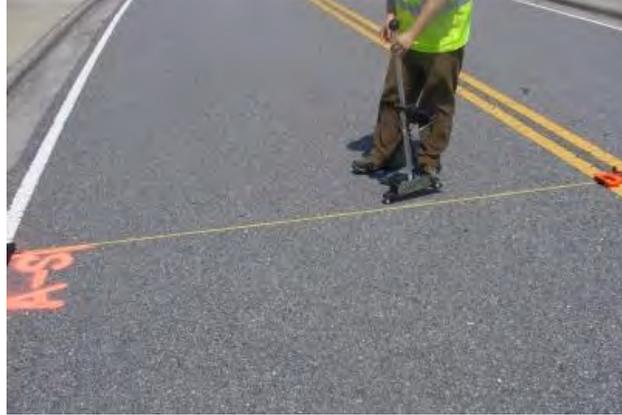
**Figure 5-7 Ground truth measurement using tape for pavement width**

Pavement Width: A tape measure was employed to conduct the measurement. The data collection locations are distributed on the Georgia Tech Savannah campus, Jimmy Deloach Parkway, and Pooler Parkway, consisting of 17 ground truth measurements. Figure 5-7 shows an image of how the pavement width measurement was carried out on the Georgia Tech Savannah campus.

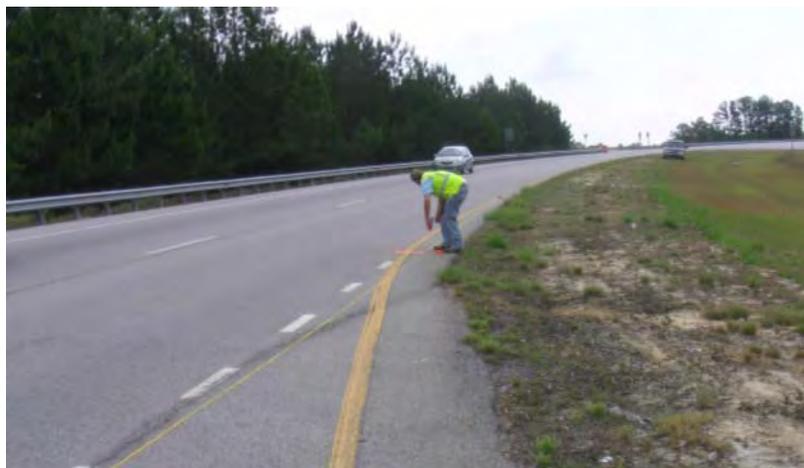
**Figure 5-8 Ground truth measurement using chord-offset method for horizontal curvature**

Horizontal curvature: The chord-offset measurement (Carlson *et al.*, 2005; Ibraheem & Hammodat, 2011) was employed to calculate the horizontal curvature. Using a 100-ft long tape measure, the offset between the arc and the mid-point of the chord was measured. Using the equation  $R=L^2/8m+m/2$ , the radius of the curve, where  $L$  is the chord length and  $m$  was the offset. The chord and offset measurement method was chosen for ground truth measurement, as well as the subsequent sensing data measurement, to provide a consistent comparison among the collected data from different data sources. The data collection locations were distributed on the Georgia Tech Savannah campus, Jimmy Deloach Parkway, and Industrial Park, consisting of 29 ground truth measurements. Figure 5-8 shows an image of how the chord-offset measurement was carried out on Jimmy Deloach Parkway.

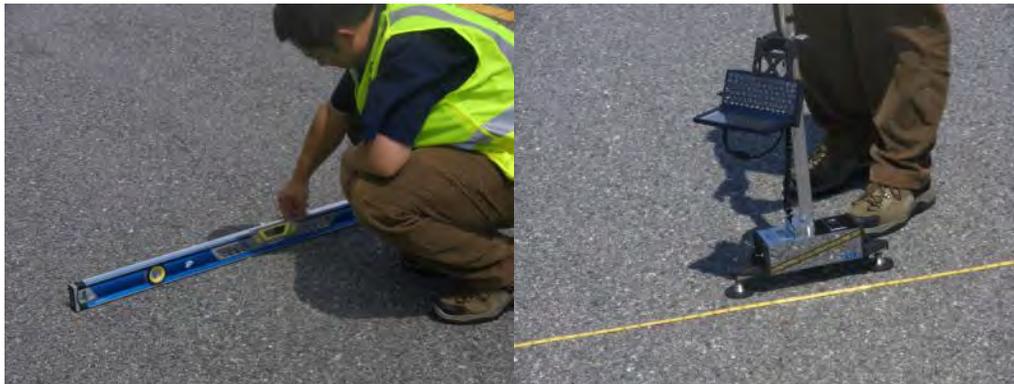
**Figure 5-9 Ground truth measurement using digital level and dipstick for cross slope**

Cross slope: The 4-foot digital level was employed to measure the cross slope, which is also typically used by most of transportation agencies (FDOT, 2008; TxDOT, 2004). The data collection locations were distributed on the Georgia Tech Savannah campus, Jimmy Deloach Parkway, and Pooler Parkway, consisting of 15 ground truth measurements. In addition, to verify the reliability of the digital level on cross slope measurement, a dipstick profiler was employed. Figure 5-9 shows two images of how the cross slope measurement was carried out using digital level and dipstick on the Georgia Tech Savannah campus.

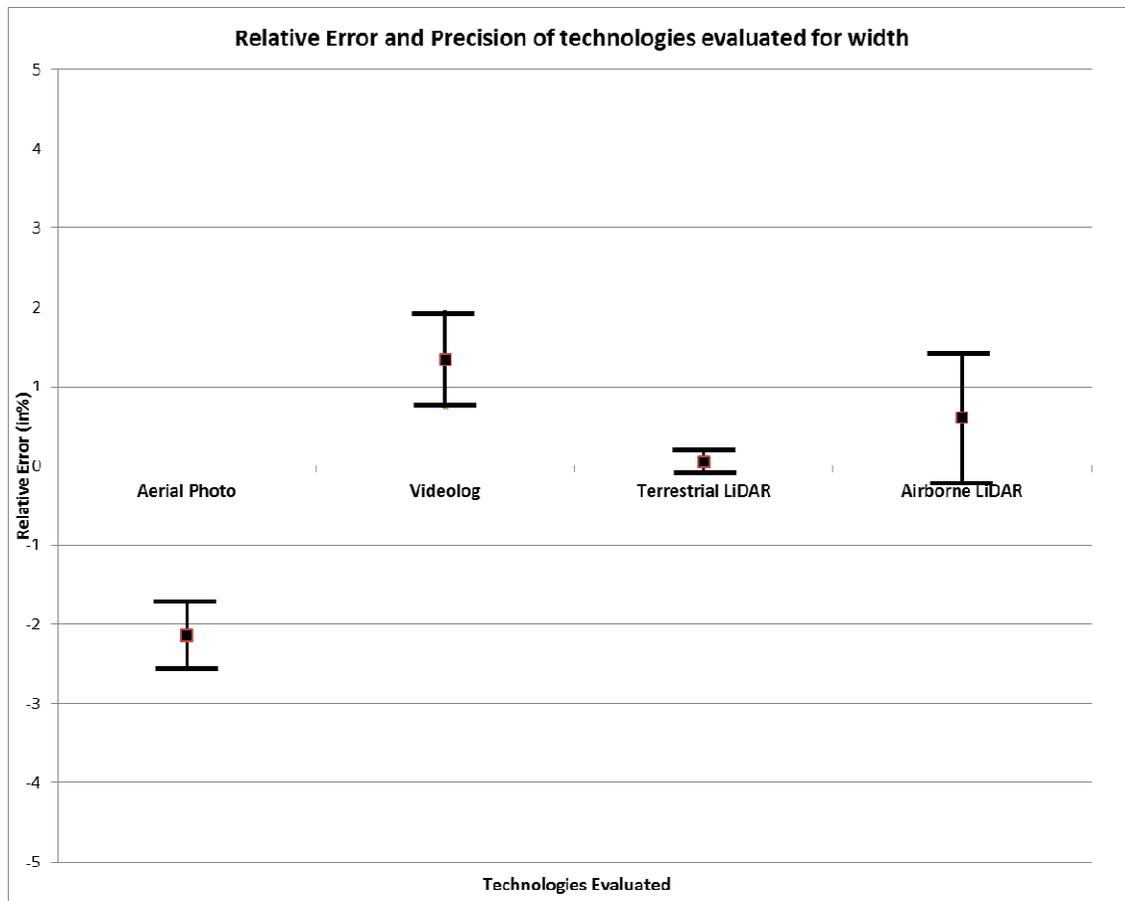
**Figure 5-12 Relative error and 95% confidence interval plot for each sensing technology evaluated for width measurements.**

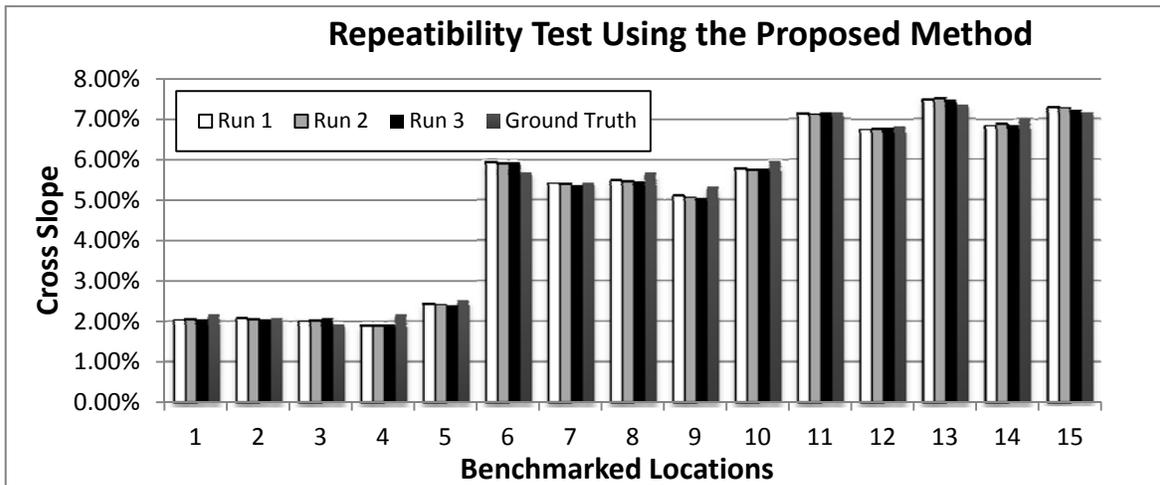
**Figure 5-16 Assessment results of the cross slope measurement repeatability.**

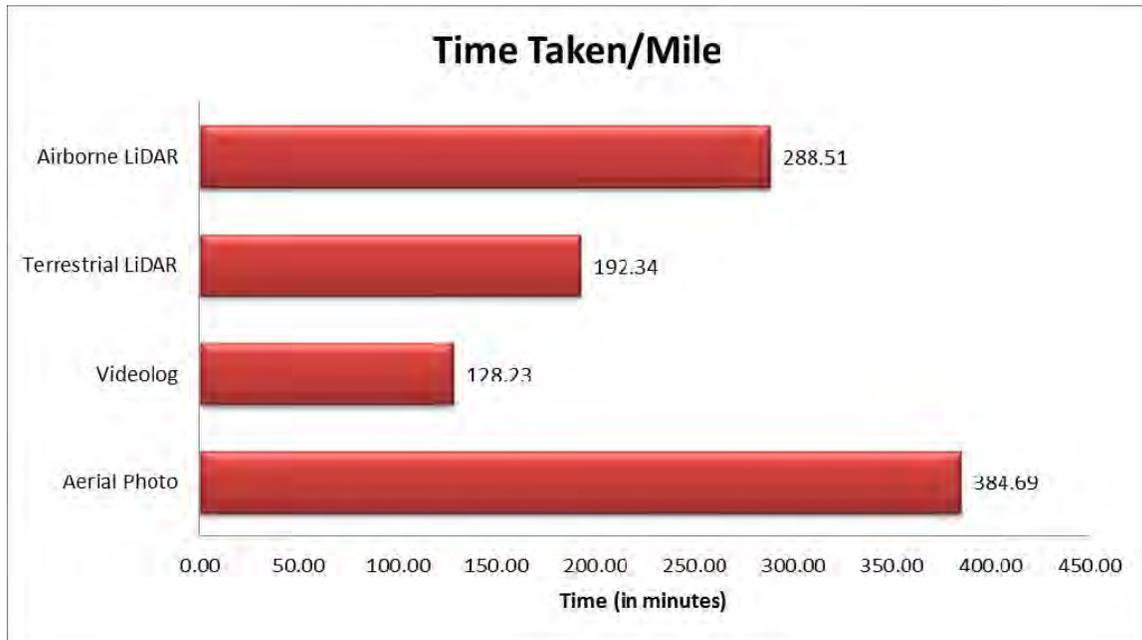
**Figure 5-17 Time taken per mile measure for all the sensing technologies evaluated for width measurements.**

The productivity assessment for width measurements in Figure 5-17 shows that the video log image technology is the quickest to evaluate the width, followed by the mobile LiDAR technology. The airborne LiDAR technology and the aerial photo technology take considerably more time to complete the width measurements. This productivity measure correlates with the resolution of the data and, thus, the ease of identifying the measurement points in the data for measurement.

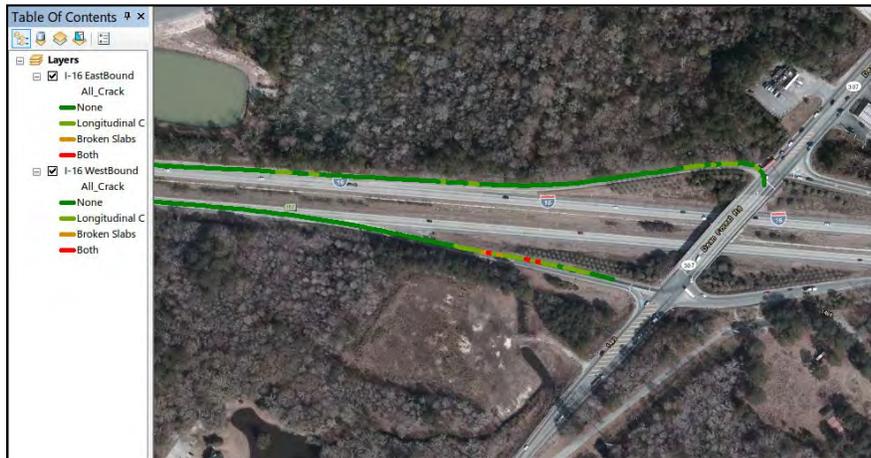
**Figure 6-6 Individual distress query result**

If the user selected the “Query by Distress” option and further selected “All Distresses,” or “All Severities,” the map in Figure 6-6 will be generated.

The legend is also shown in the left side panel. It can be seen that the colored unit section is much smaller. In this demonstration, we only added cracking data; in the future, data of all the distress types will be supported. If the user wants to know all the detailed information about longitudinal cracks above Level 1 on I-16 Eastbound, the “Slab Distress” tab will help. As shown in Figure 6-7, the search results are listed in the left list-box with a section id number and the closet milepost numbers for each slab. By clicking a list item, the pavement image will show on the right side, and a label point indicating the slab location will show on the map instantly. The user could zoom in and out for the convenience of observation; the location of the label point will remain accurate.

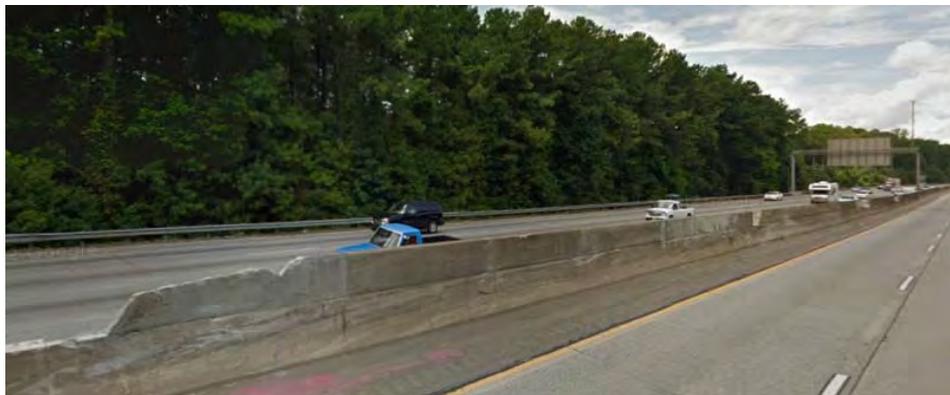
**Figure 7-5 Median scratches shown in the video log image**

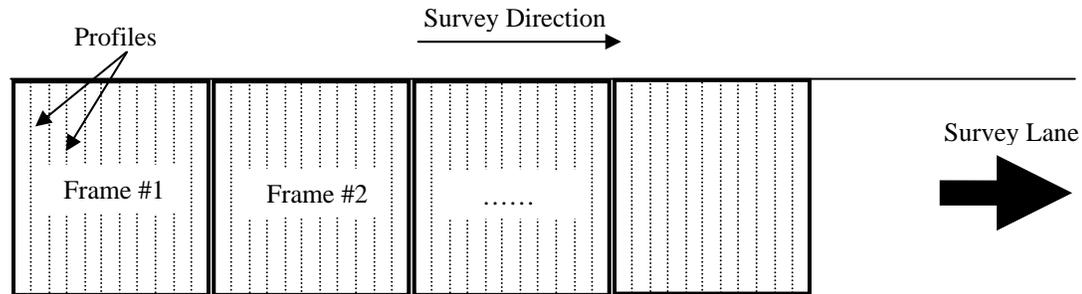
**Figure 8-1 Line laser imaging data organization**

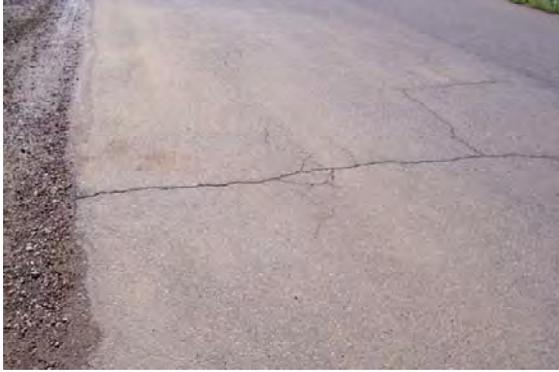
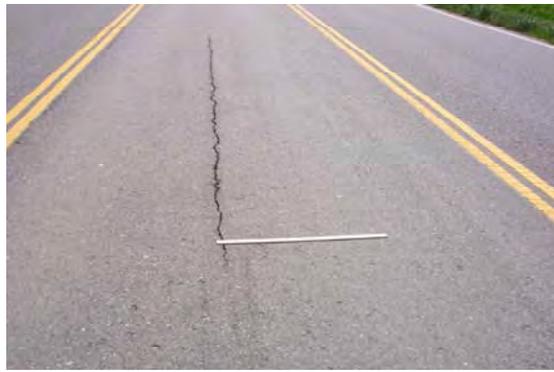
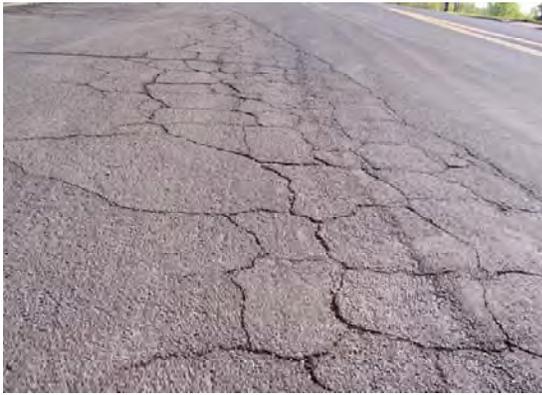
**Figure 1 (a) Transverse Crack (b) Longitudinal Crack (c) Alligator Crack (FHWA 2006)**

The FHWA, Road Inventory Program (RIP), collects roadway condition data on paved asphalt surfaces, including roads, parkways, and parking areas in national parks nationwide. The road surface condition data is collected using an automated data collection vehicle called ARAN. The classification and measurement of all surface condition data is done in intervals of 0.02 miles (105.6 ft) along the route. The cracks are classified into three types: transverse crack, longitudinal crack, and alligator crack. Each of these three types is divided into three severity levels. Table 1 gives the overview of the different types, and Figure 1 shows pavement images corresponding to these types. Transverse cracking occurs predominantly perpendicular to the
