Air-Launched GPR Evaluation for Rapid Assessment of MoDOT Bridge Decks

**AIR-LAUNCHED GPR EVALUATION FOR RAPID ASSESSMENT
OF MODOT BRIDGE DECKS**

Prepared for
Missouri Department of Transportation

MARCH 2015

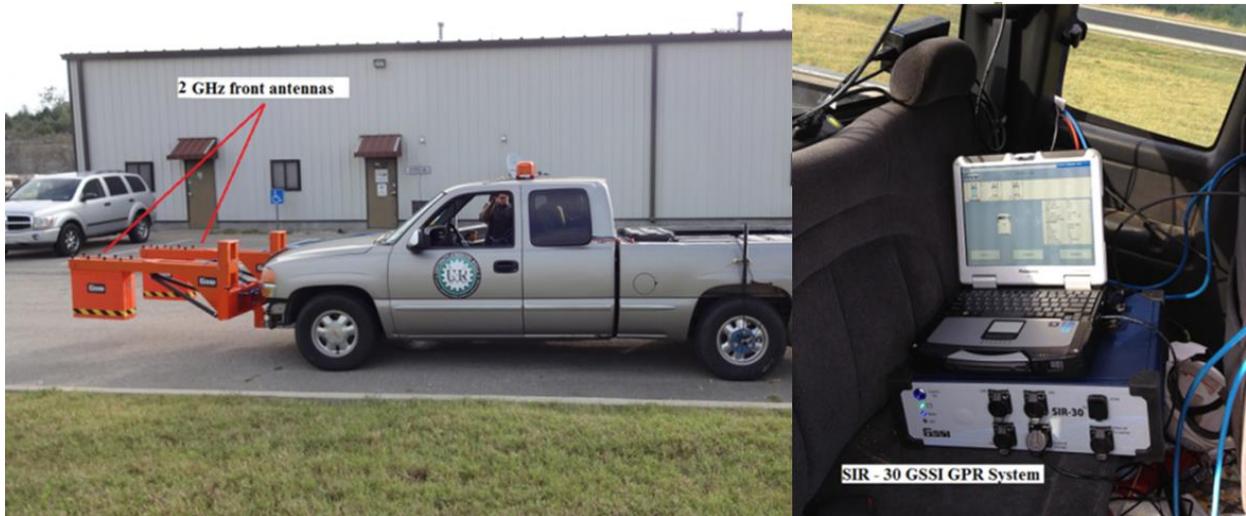
Figure 2-1 GSSI SIR-30 GPR System with two GSSI 2.0 GHz air-coupled horn antennas

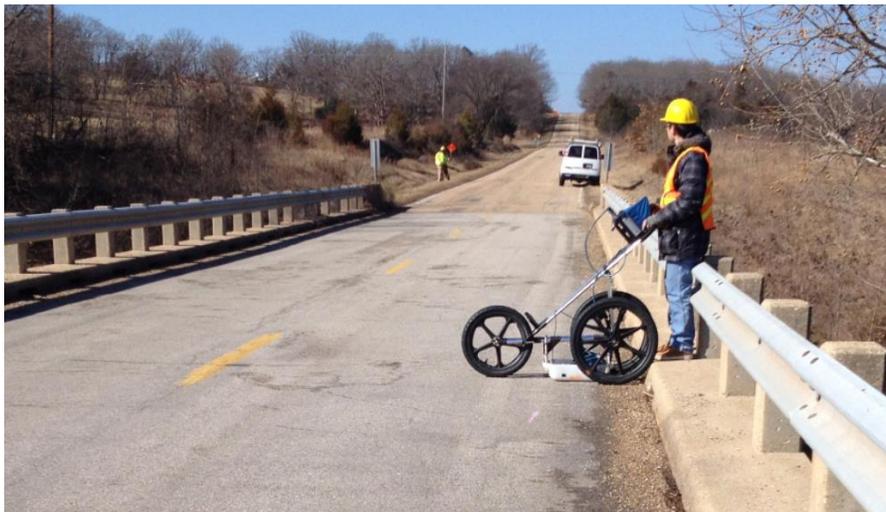
For four bridges, namely Bridges A0569, A3405, A3406, and K0197, GPR data were acquired as part of a previous study using a GSSI SIR-3000 system and a GSSI 1.5 GHz ground-coupled antenna mounted to a push-cart (Figure 2-2). The ground-coupled GPR data were acquired on the top surface of the bridge deck along parallel traverses variably spaced at 0.75 to 2 ft. intervals (depending on the nature of the bridge deck and time constraints). GPR traverses were marked with chalk on the deck surface prior to the start the survey; the cart was pushed along each traverse to acquire data. The GPR traverses were oriented parallel to the direction of traffic flow (i.e., longitudinal direction of the bridge). The primary goal was to map the amplitude and apparent embedment depth of the uppermost layer of transverse rebar (Sneed et al. 2014).

Figure 2-2 GSSI SIR-3000 GPR System with a GSSI 1.5 GHz ground coupled-antenna

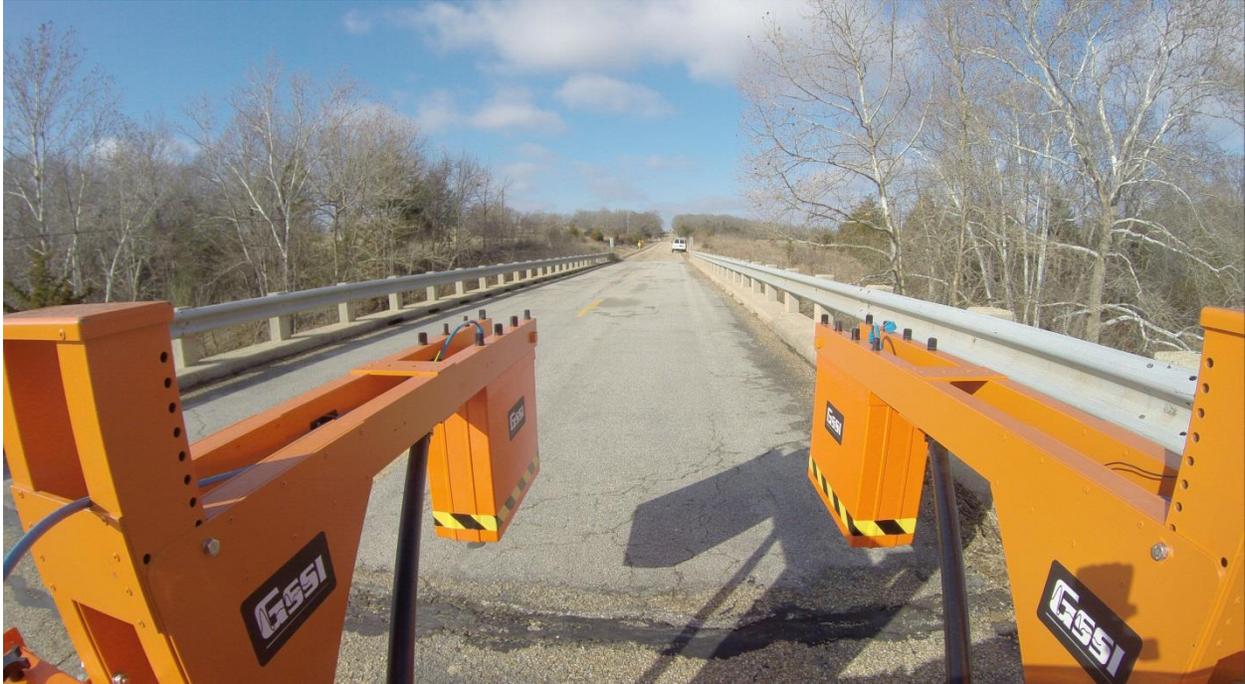
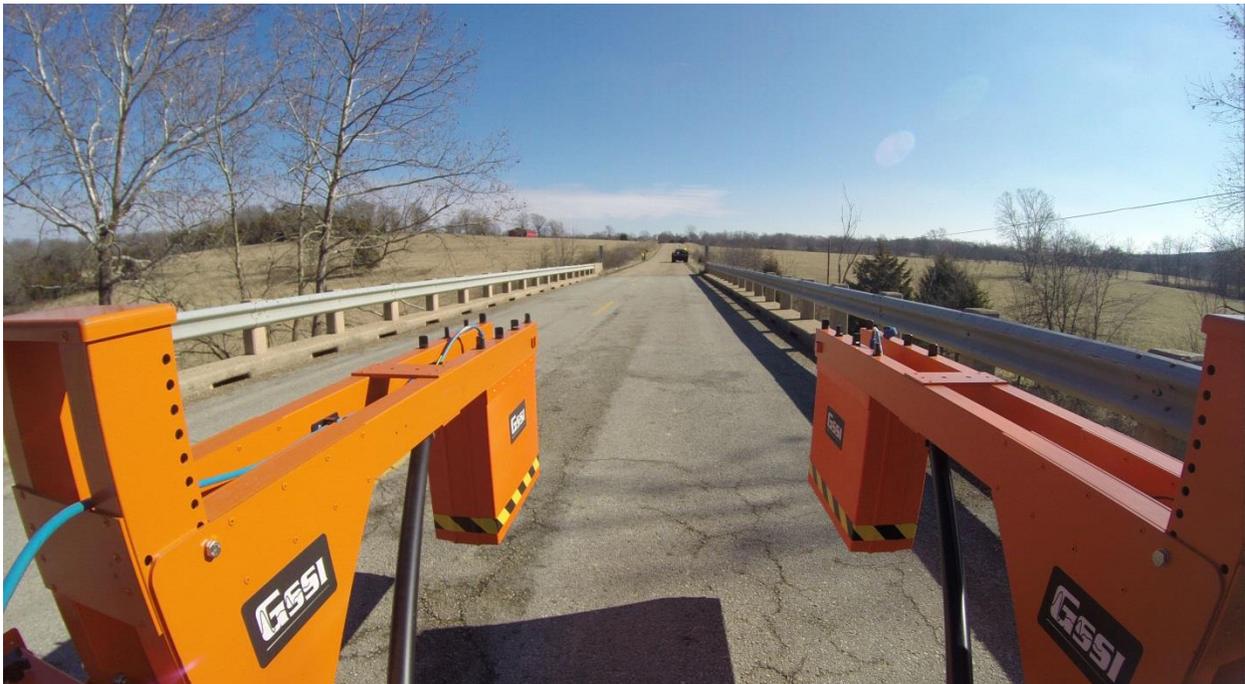
Figure 2-3 Photo of Bridge A0523 bridge deck

Figure 2-4 Photo of Bridge A0523 bridge deck

Other Information	Asphalt overlay had noticeable cracking throughout

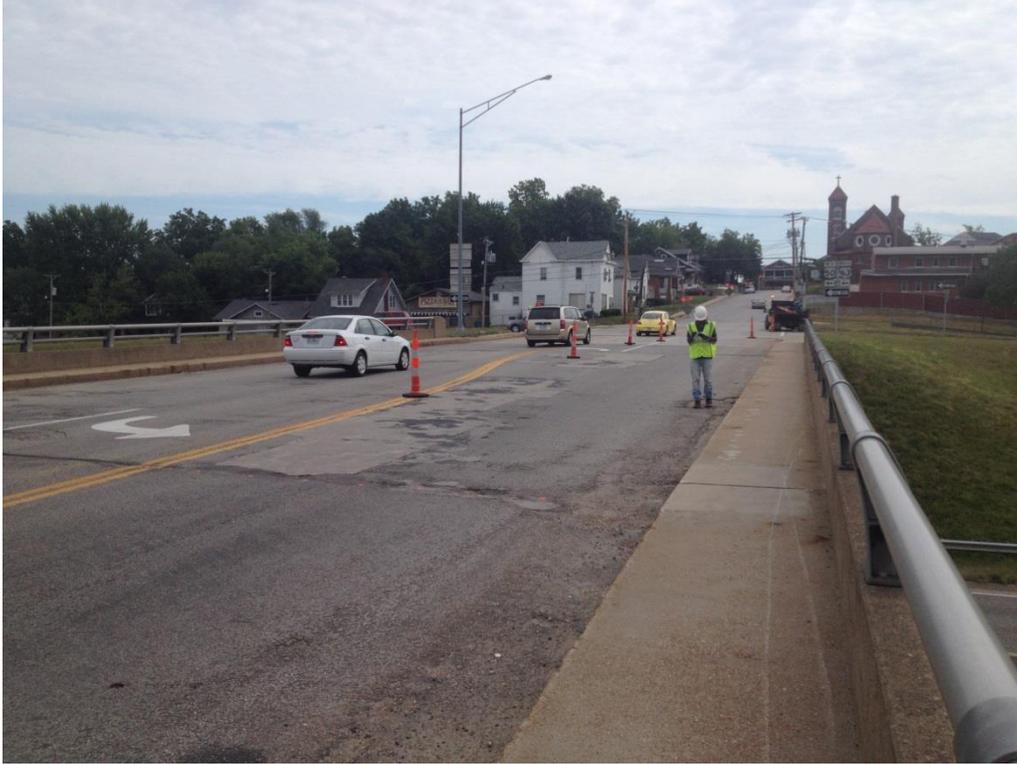
Figure 2-6 Photo of Bridge A0569 bridge deck

Other Information	Asphalt wearing surface was extensively deteriorated at the time of both NDE investigations. Many locations of asphalt rutting and shoving were observed, along with many cracks and potholes.

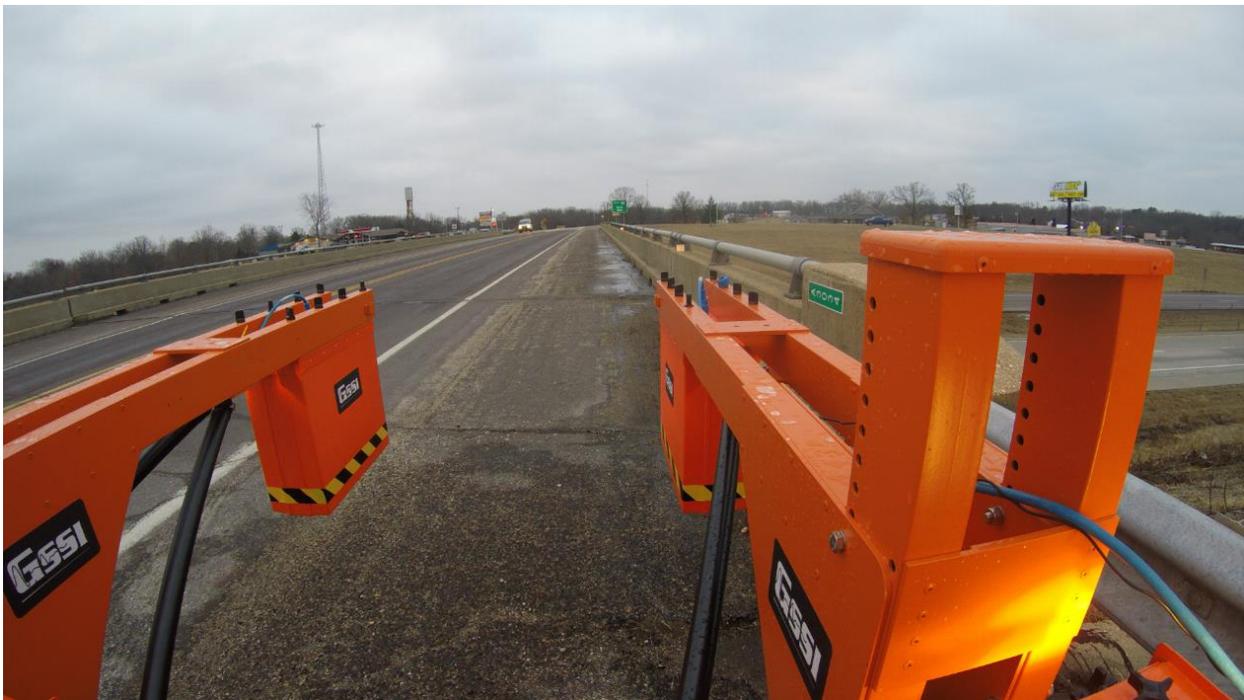
Figure 2-13 Photo of Bridge A3034 bridge deck

Built in 1976, Bridge A3034 is located near Doolittle, Missouri. The 235 ft long bridge carries two lanes of two-way traffic on a 46 ft – 10 in. wide deck. The two-span structure is a steel girder system with a cast-in-place concrete deck with an asphalt wearing surface. The top surface of the deck exhibited cracks and deterioration along the edges at the time of investigation. A photo of the bridge deck is shown in Figure 2-13. Bridge details are summarized in Table 2-5.

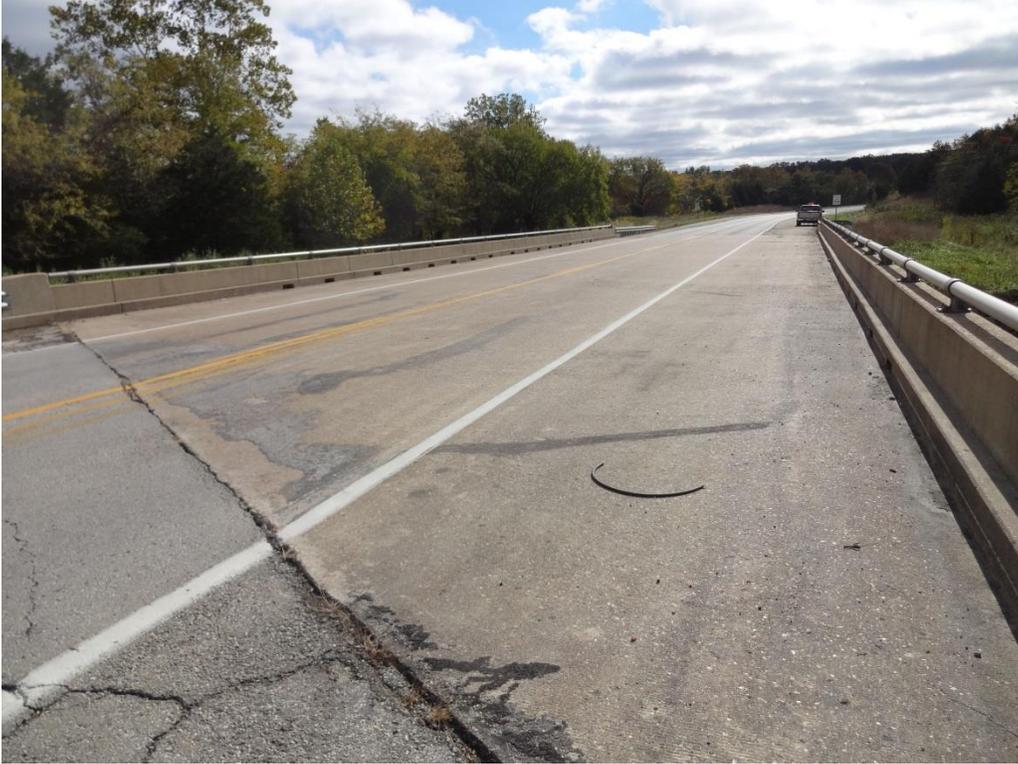
Figure 2-15 Photo of Bridge A3405 bridge deck

Built in 1975, Bridge A3405 is located near St. James, Missouri, and spans a waterway. The bridge carries two lanes of two-way traffic on a 46 ft – 10 in. wide deck. The four-span structure is a continuous cast-in-place concrete slab. The total structure length is 144 ft. A photo of the bridge deck is shown in Figure 2-15. Bridge details are summarized in Table 2-6.

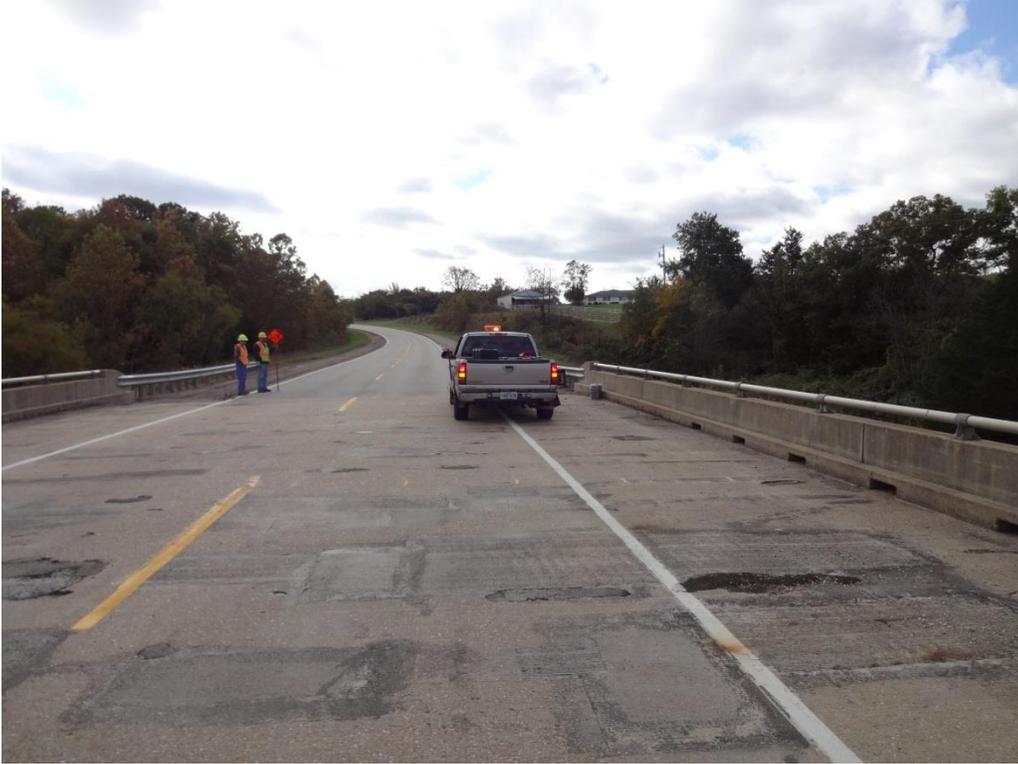
Figure 2-18 Photo of Bridge A3406 bridge deck

Other Information	Severe cracking, spalling, and patches were observed at time of investigation

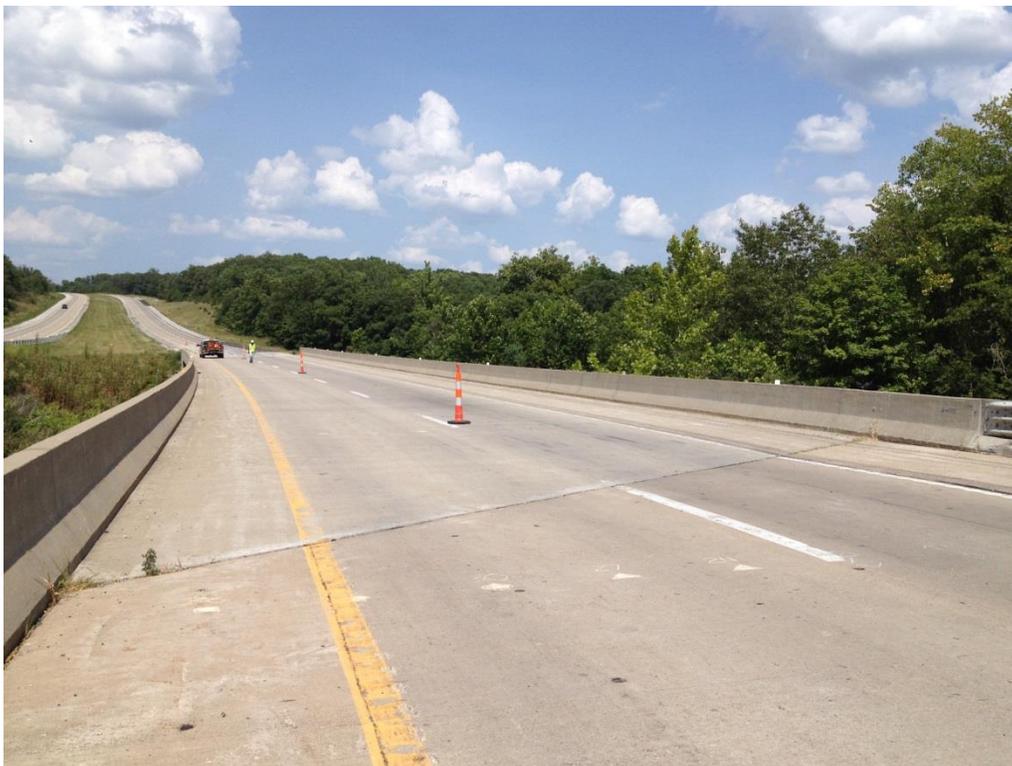
Figure 2-21 Photo of Bridge A4780 bridge deck

Built in 1990, Bridge A4780 is located near Kingdom City (Callaway County), Missouri, and carries highway US 54 over Auxvasse Creek. The 304 ft long bridge carries two lanes of one-way traffic on a 41 ft - 3 in. wide deck. The five-span structure is a continuous prestressed concrete with a cast-in-place concrete deck with a monolithic concrete wearing surface. The bridge is super elevated (sloped down from east to west). A photo of the bridge deck is shown in Figure 2-21. Bridge details are summarized in Table 2-8.

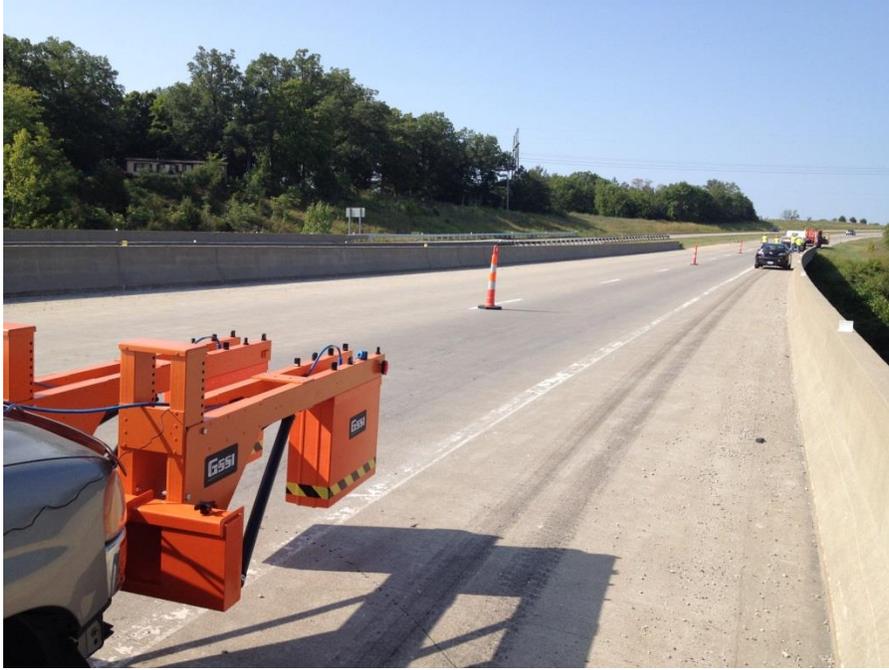
Figure 2-23 Photo of Bridge A4781 bridge deck

Built in 1990, bridge A4781 is located near Kingdom City (Callaway County), Missouri, carries highway US 54 over Auxvasse Creek; parallel to Bridge A4780. The 304 ft long bridge carries two lanes of one-way traffic on a 41 ft – 3 in. feet wide deck. The five-span structure is a continuous prestressed concrete with a cast-in-place concrete deck with a monolithic concrete wearing surface. The bridge is super elevated (sloped down from east to west). A photo of the bridge deck is shown in Figure 2-23. Bridge details are summarized in Table 2-9.
