Bridge-in-a-Backpack™

*Task 8: Investigation of Bridge Performance under
Extreme Temperatures*

Final Report – December 2014

University of Maine's Advanced Structures and Composites Center
Report Number: 15 – 21-1023H

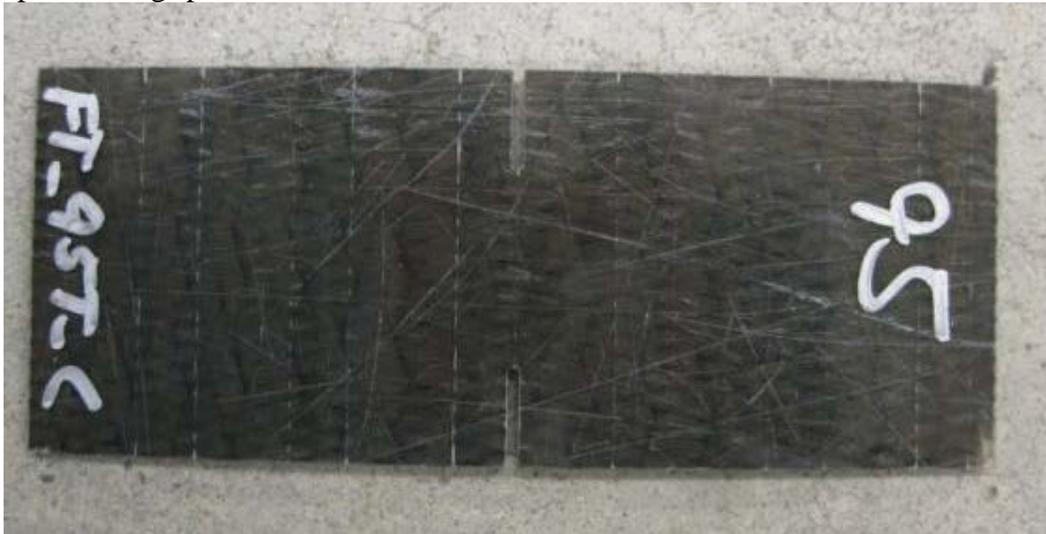
Coupons were cut from a plate of laminated composite. All coupons were 2 inches wide and 5 inches long nominally, with transverse notches cut mid-length as shown in Figure 1. The width of the coupon at the mid-point is nominally 1 inch. This is a modified coupon from the ASTM D3039 tension standard and ensures that tows of carbon fiber in the failure section of the coupon are clamped in the grips of the test machine.

Figure 1 - Typical Coupon Geometry

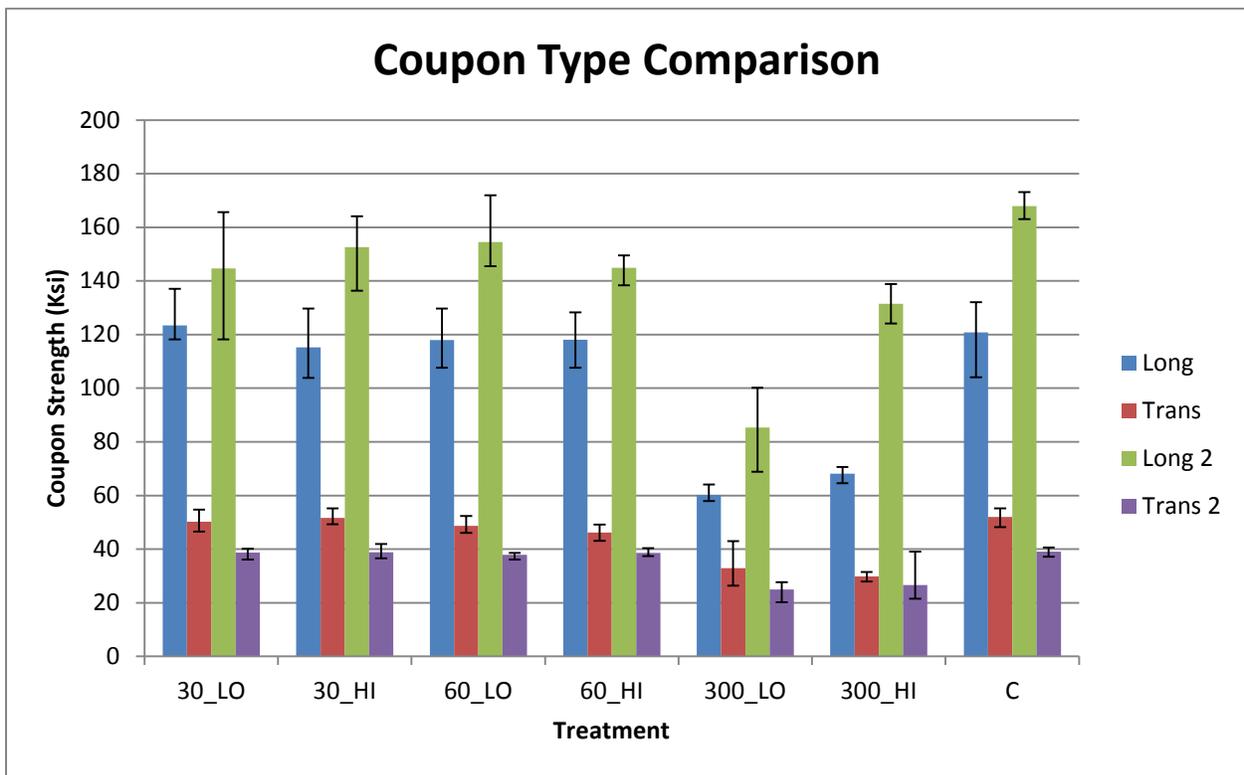
Figure 2 – Chart of Coupon Strength with Various Flame Exposures

After the 300 seconds of exposure, the laminate retains approximately 50% of its original tensile strength. Transverse coupons retained higher tensile strengths when compared to their controls. It should be noted however, that the glass layer was always on the back of the coupon during flame exposure and therefore may not have been exposed to the same extent as the front face did in direct flame.

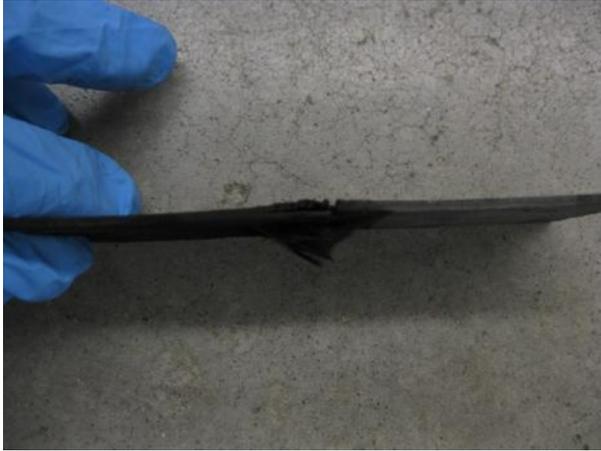
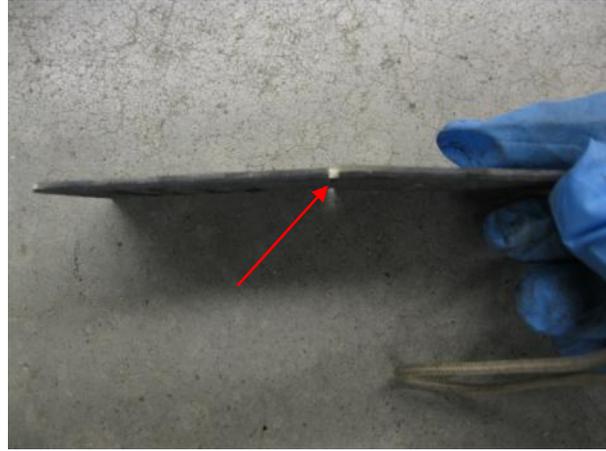
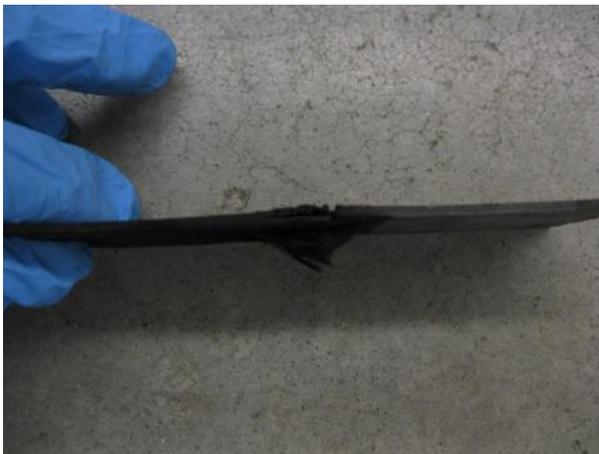
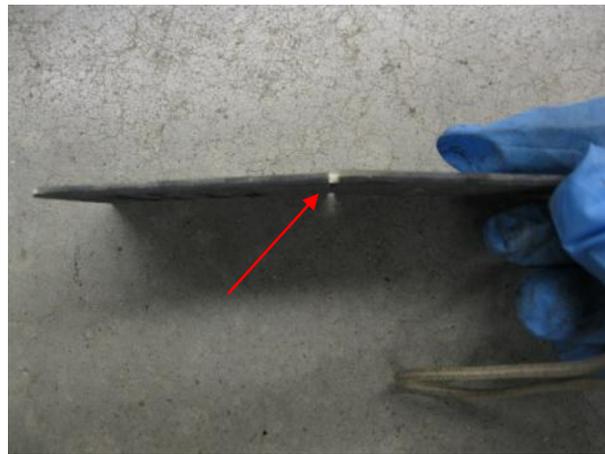
All coupons failed first in the rupture of the fibers nominally in the longitudinal axis of the coupons, which was the desired mode of failure. This is shown in Figure 3 and Figure 4 and again in Figure 5 and Figure 6.

Figure 3 - Failure in carbon layer for longitudinal specimens

Figure 4 - Failure in glass layer for transverse cut coupons

Figure 5 - Failure in carbon layer for longitudinal specimens

Figure 6 - Failure in glass layer for transverse cut coupons

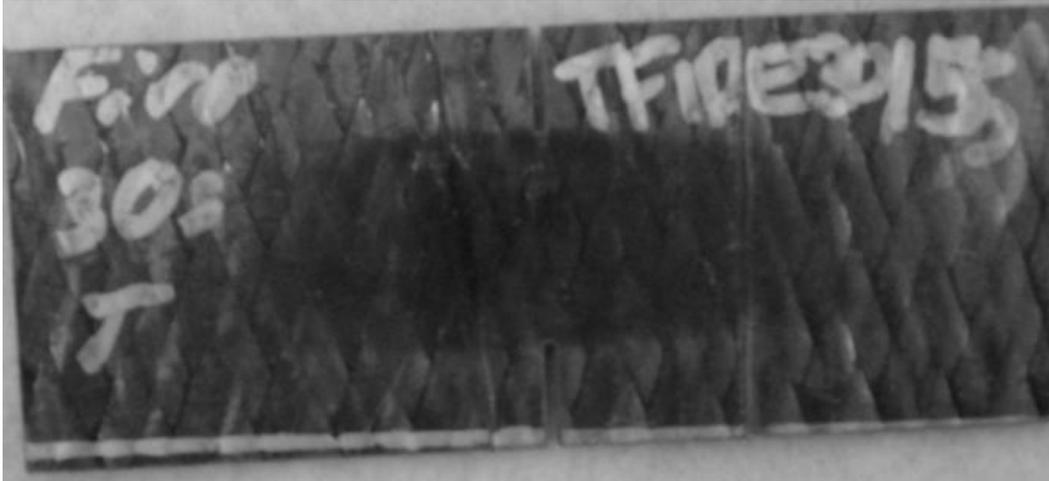
Figure 7 – Typical exposed sample after exposure for 30 seconds

Ignition of the coupons occurred at approximately 60 seconds for coupons in the high position, and at approximately 50 seconds for coupons in the low position. After ignition, the coupons burned for 2 to 3 minutes then self-extinguished, leaving an approximately 2 inch diameter circle of charred material around the center of the coupon, as seen in Figure 7. Coupons exposed for 300 seconds showed significantly more charring and dry fabric could be seen on the surface.

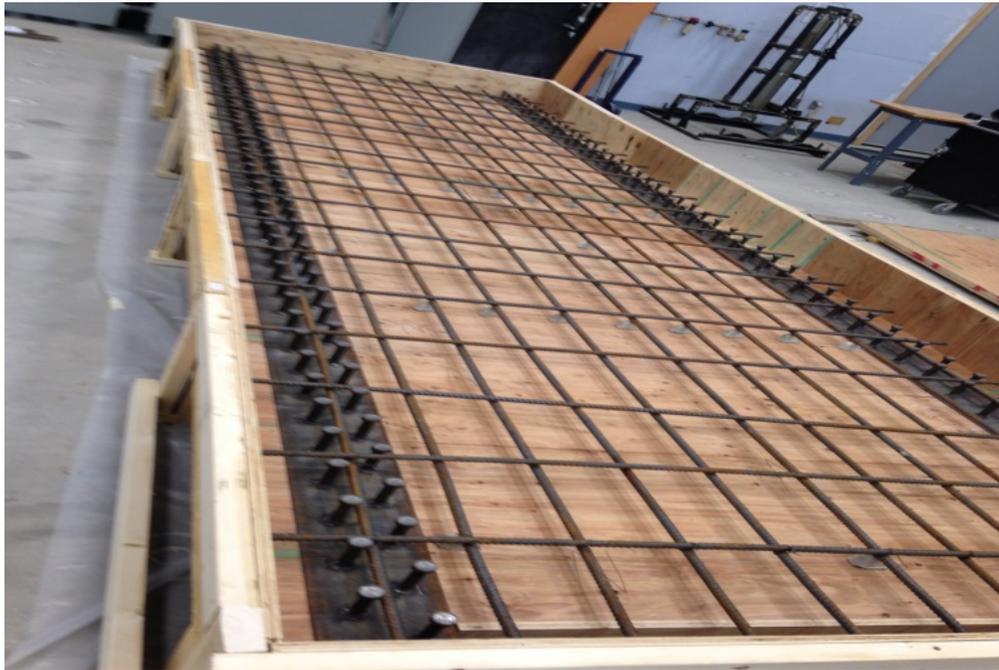
Figure 8 – Bottom mat of reinforcing steel, studs and girders

The composite arch bridge was built with four (4) 6.5” diameter hybrid carbon fiber composite concrete filled tubular arches. Two layers of braided carbon fiber served as the outer layers where they provided tensile reinforcement for the cross section. An approximately six (6) foot square FRP composite and unreinforced concrete deck was placed on top of the arches as seen in Figure 9 (concrete formed but not placed in this photo). The composite decking is a commercially available pultruded glass FRP with a urethane resin.

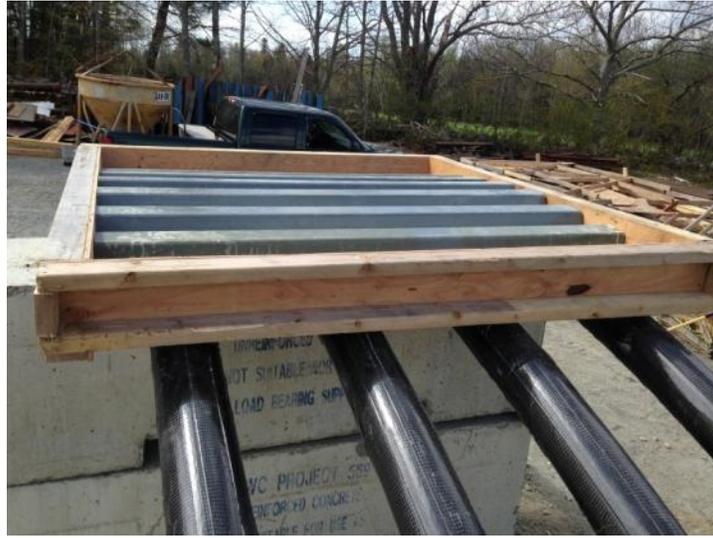
Figure 9 – Decking formed for concrete deck placement

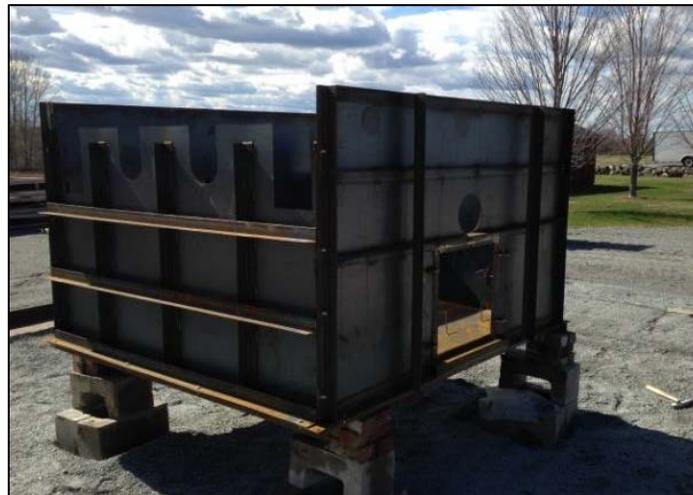
A five-sided box steel burn chamber (Figure 10) was constructed for the test (6'-0" W x 6'-0" L x 4'-0" H). The test setup consisted of the scaled bridge specimen, the burn chamber, and some calibrated concrete blocks used as a static load. The burn chamber was placed below the bridge deck, such that the bridge deck acted as the top of the burn chamber, as seen in Figure 11, Figure 13 and Figure 14. Once the bridge specimen and burn chamber were in place, the static load was then applied to the bridge deck prior to firing up the burn chamber. The burn test was conducted until it hit one of three limits. The three limits were: 1) the time of one hour, 2) until bridge failure occurred or 3) a safety limit was reached.

Figure 10 – Burn chamber without burner or insulation

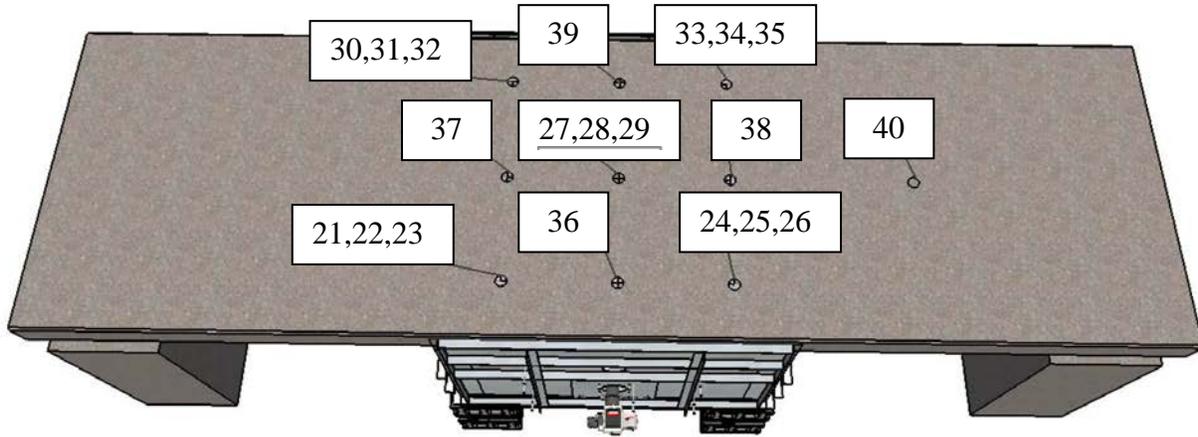
A total of 20 Omega type-K thermocouples were embedded in the bridge deck. The locations of the thermocouples in the slab of the steel bridge are shown in Figure 11 and Figure 12. Each point contains up to three thermocouples. These thermocouples are located at one, three and five inches up from the bottom surface of the bridge deck. A table of their embedment depths is given in Table 7. The thermocouples were placed in three columns across the bridge deck with one column located at the centerline of the bridge and the other two at 22 inches to the left and right of the centerline. Each row has a spacing of 22 inches.

Figure 11 – Embedded thermocouple locations

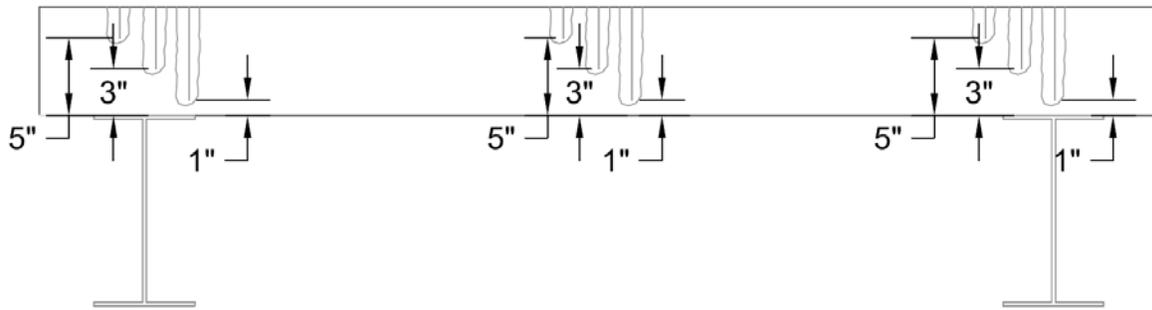
Figure 12 – Bridge transverse section view at midspan showing embedded thermocouples' depth

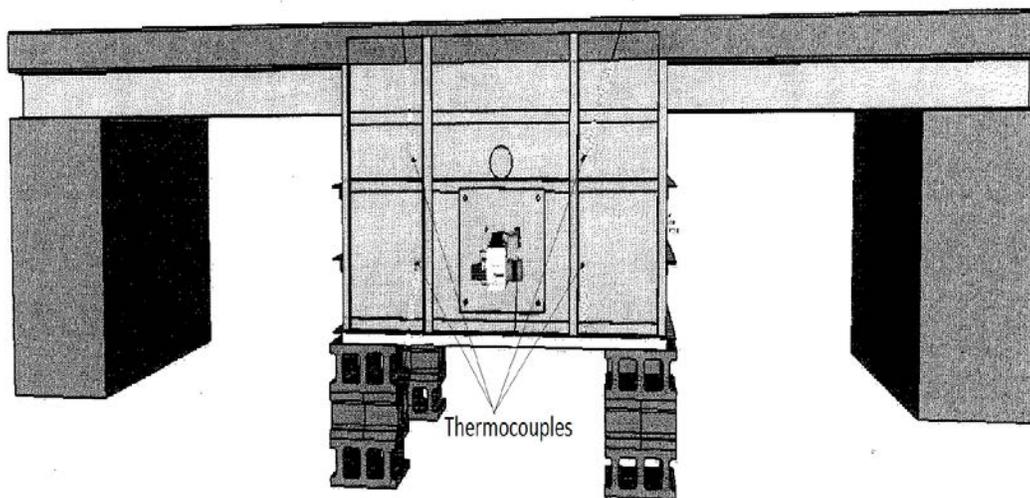
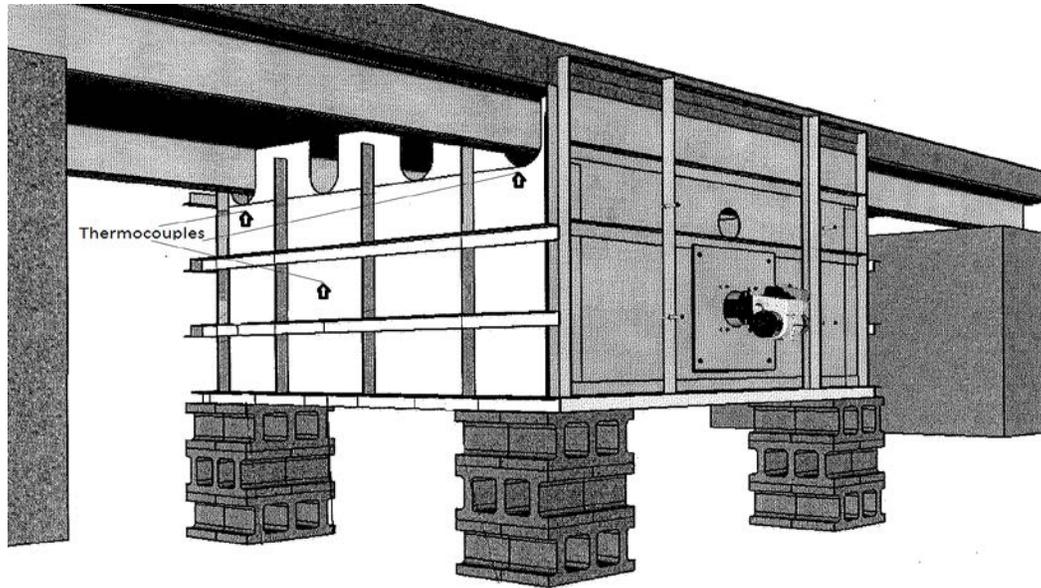
Fourteen thermocouple probes were placed inside the burn chamber to measure the internal air temperature. Figure 13 and Figure 14 show the placement of the thermocouples. Thermocouple placement is symmetric on either side of the chamber (right and left, front and back) and was the same for the steel bridge and composite bridge decks.

Figure 13 – Thermocouple location on front of burn chamber

Figure 14 – Thermocouple location on right and left sides of chamber

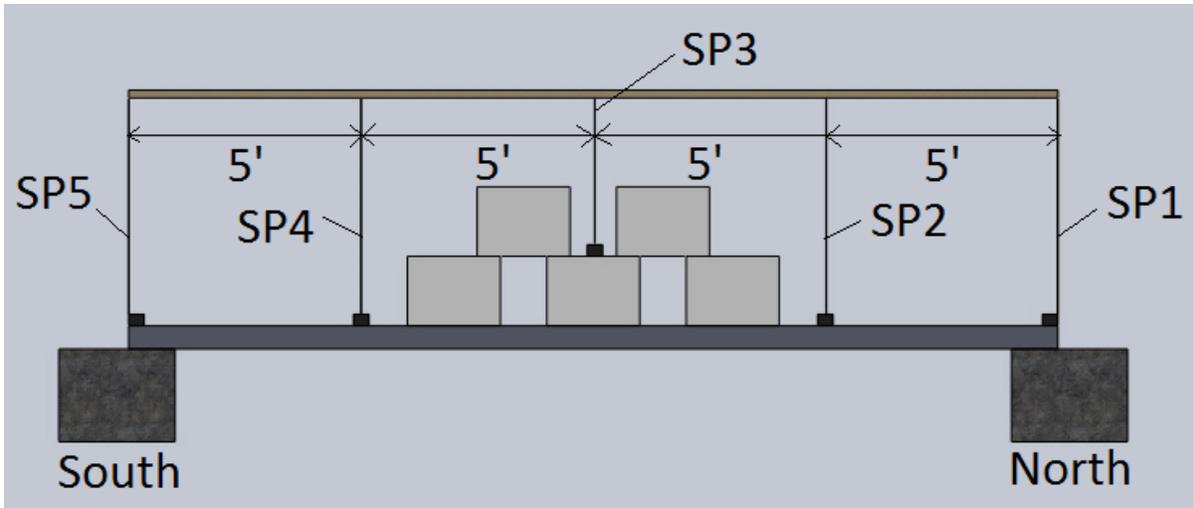
String potentiometers (pots) were located along the centerline of the bridge span to measure the bridge deflection. For the steel bridge, SP1 (string pot 1) & SP5 were located 18 inches in from the left and right ends of the bridge, respectively when facing the burner side of the bridge. SP2 & SP4 were located 23 inches in from the left and right sides of the bridge, respectively. The final string pot, SP3, was placed at the center line and mounted to the center loading block. The string pot locations can be seen in Figure 15 for the steel and composite bridge specimens, respectively.

Figure 15 – String potentiometer locations for steel & concrete bridge

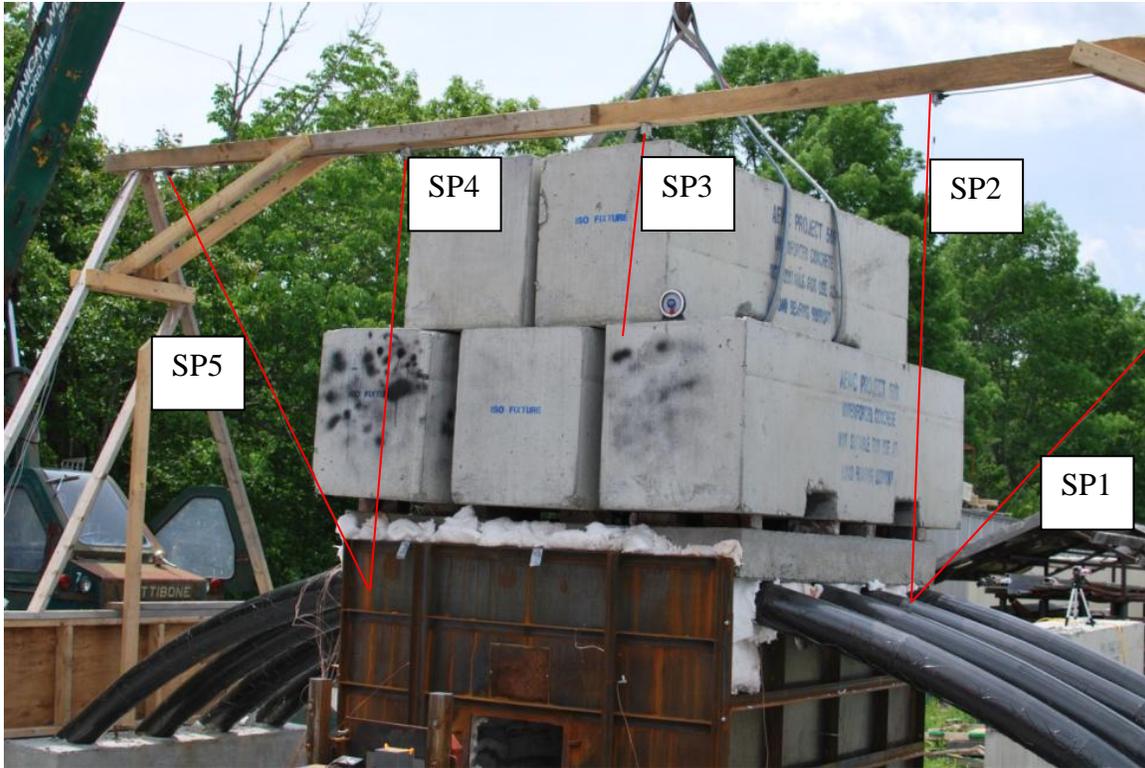
The bridge was tested under a constant load of 23,125 lbs as seen in Figure 16. The loading consisted of five precast concrete blocks that were weighed with a calibrated crane scale when placed on the test specimen. This loading was selected to closely represent 19.3% of the affective undamaged live load capacity of the bridge with no factors. The moment due to the blocks nominally equals the nominal moment capacity of the composite bridge section, M_n , minus the moment due to the bridge self-weight. This percentage was chosen as a practical load that could be applied to both the steel and hybrid FRP arch bridges and is 112% of the dead load moment.

String pots were mounted above the composite arch specimen at the same points on the wooden frame support above the specimen as were used for the steel and concrete specimen. SP1 and SP5 though were attached to the arches at the same points as SP2 and SP4 respectively 5 feet from midspan such that two string pots were attached to that single point and vertical and horizontal deflections could be calculated from the measurements. String pots were attached to the first interior arch from the burner side of the chamber (front) as seen in Figure 16.

Figure 16 – String potentiometer locations for arch test

The five internal sides of the chamber were insulated with Fiberfrax Refractory Ceramic Fiber Insulation. The insulation can be seen in Figure 16, Figure 17 and Figure 18.

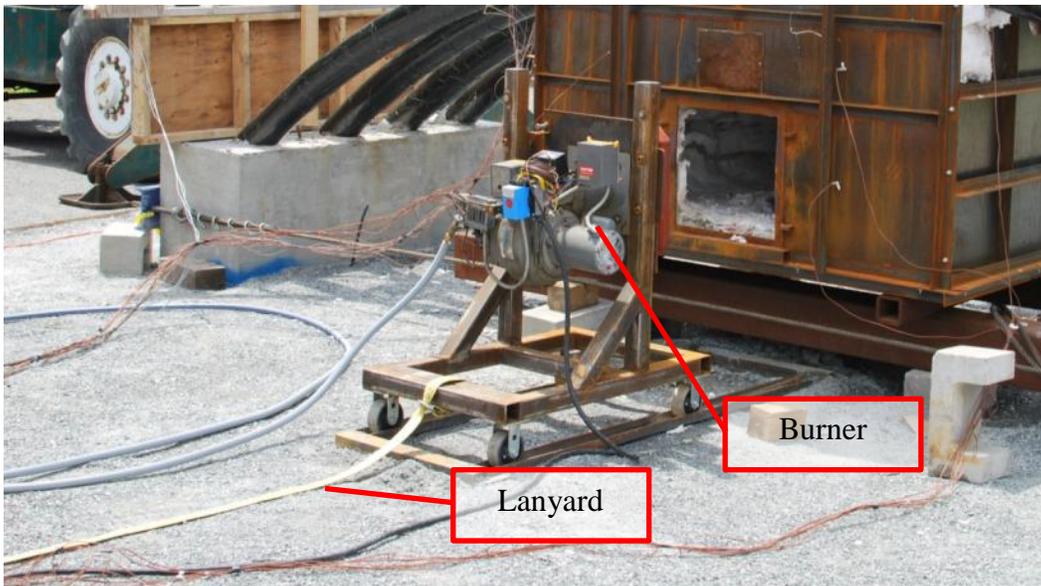
The burner for the chamber was a commercial oil burner with a low and high setting. The three options allowed for it to be off (zero BTU's), low (approx. 956,000 BTU's) and high (approx. 1,560,000 BTU's) during the test. The burner was controlled remotely near the instrumentation controls during the test. The burner was mounted on a custom fabricated rolling cart allowing for it to be pulled from the test if structural failure was imminent. A lanyard was attached to the cart as seen in Figure 17.

Figure 17 – Oil Burner setup

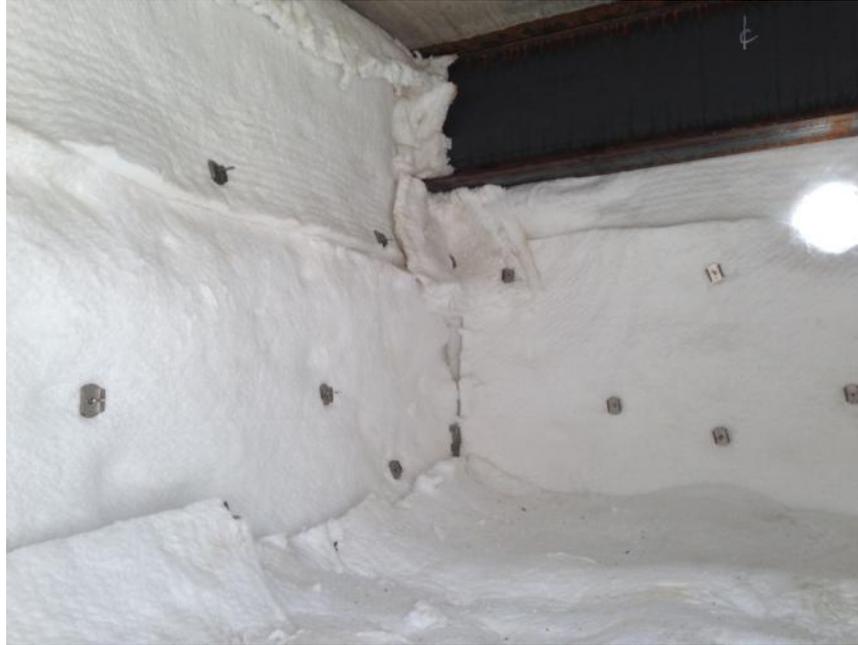
Figure 18 - Interior of chamber prior to steel bridge test

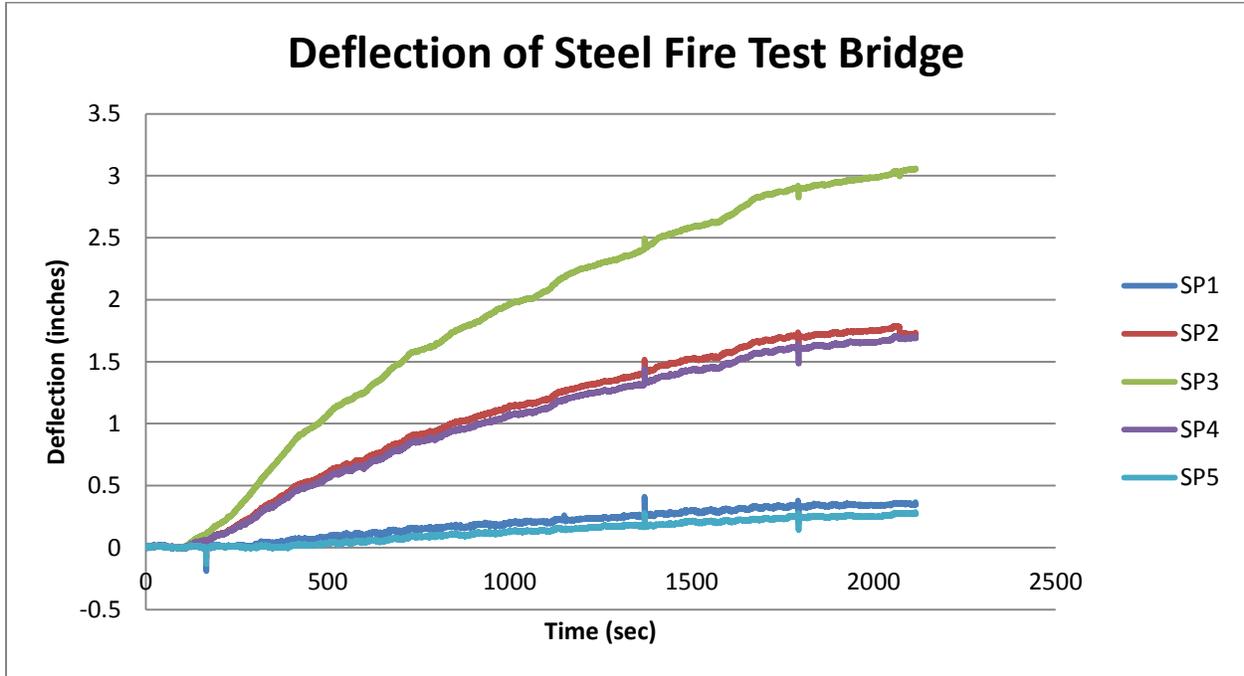
Deflections and air temperatures were monitored continuously during the test. Deflections of the steel bridge test can be seen in Figure 19 where the maximum deflection, SP3, was at the midspan. The deflections grew quickly early in the test, but the rate of deflection slowed as the test progressed. A peep sight provided views up into the chamber, which allowed a webcam to capture video throughout the test. Figure 20 shows the glowing steel girder immediately after the burner was turned off indicating the high temperature of the steel girders. The air temperature recorded by each of the probes inside the chamber can be seen in Figure 21 and ranged between approximately 1400°F and 1600°F once the burn chamber got up to temperature. The sawtooth pattern of the air temperature is due to cycling the burner from low to high to maintain the desired air temperature during the test. Some sensors were not plotted due to expected errors in data collection. Temperatures during the test were not uniform throughout the chamber, with areas toward the back (directly in line of the burner nozzle) receiving the most heat, and the front corners being the coolest.

Figure 19 – Deflection of steel and concrete bridge

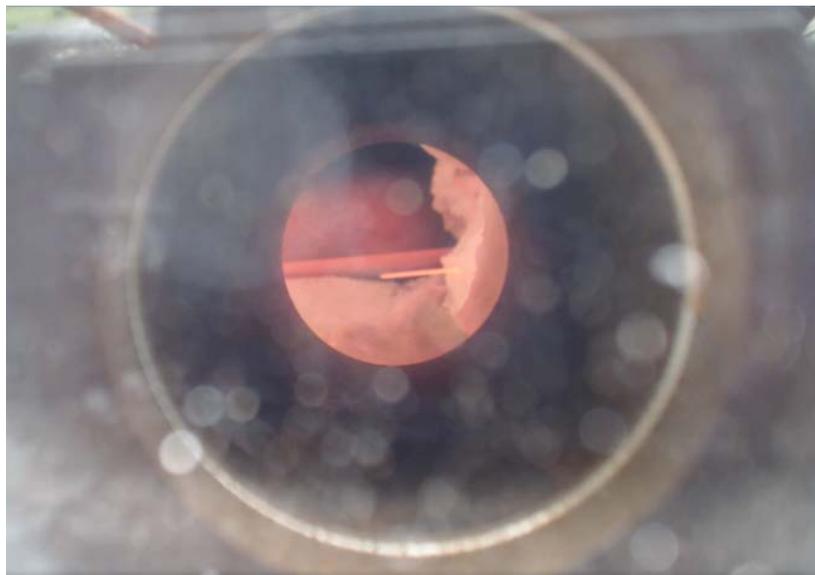
Figure 20 – View through peep sight at bottom of steel girder immediately after turning off burner

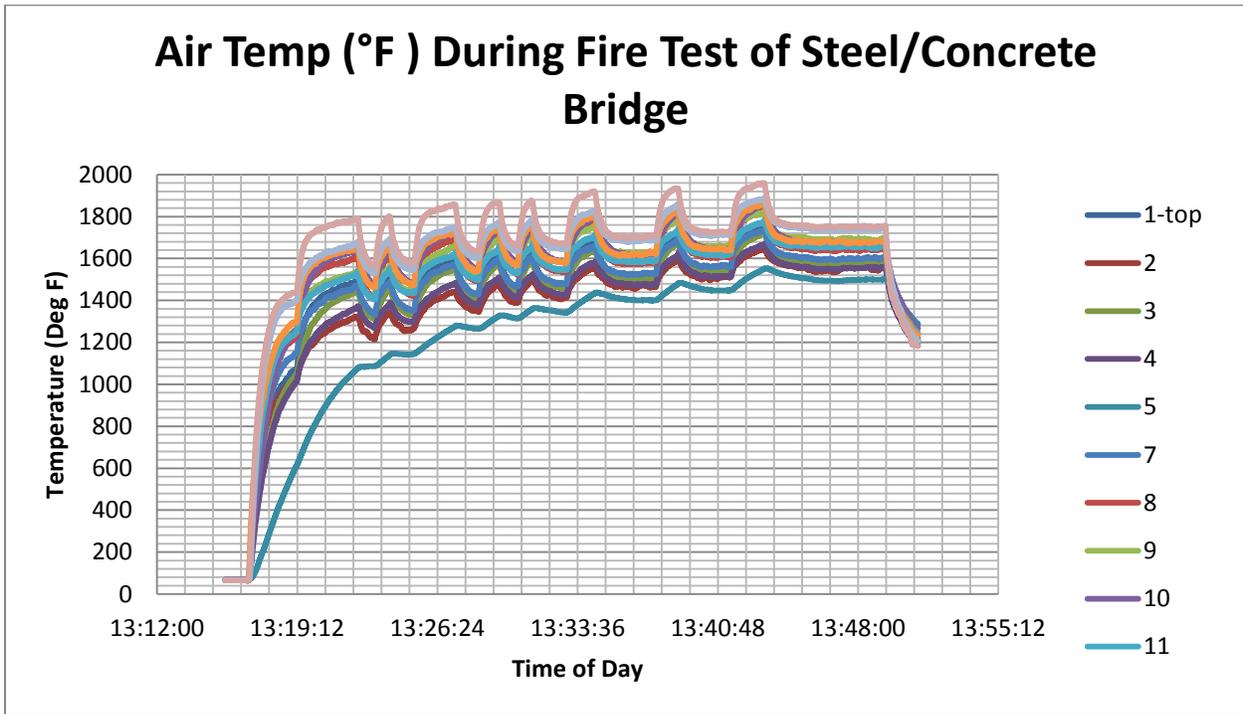
The location of the thermocouples in the burn chamber are given in Table 8 where the number is given for location on each of the faces of the burn chamber. The front and back at four sensors where the sides had 3 sensors. Two sensors on each side were placed close to the underside of the structural members.

Figure 21 – Air temperature during testing of steel and concrete bridge

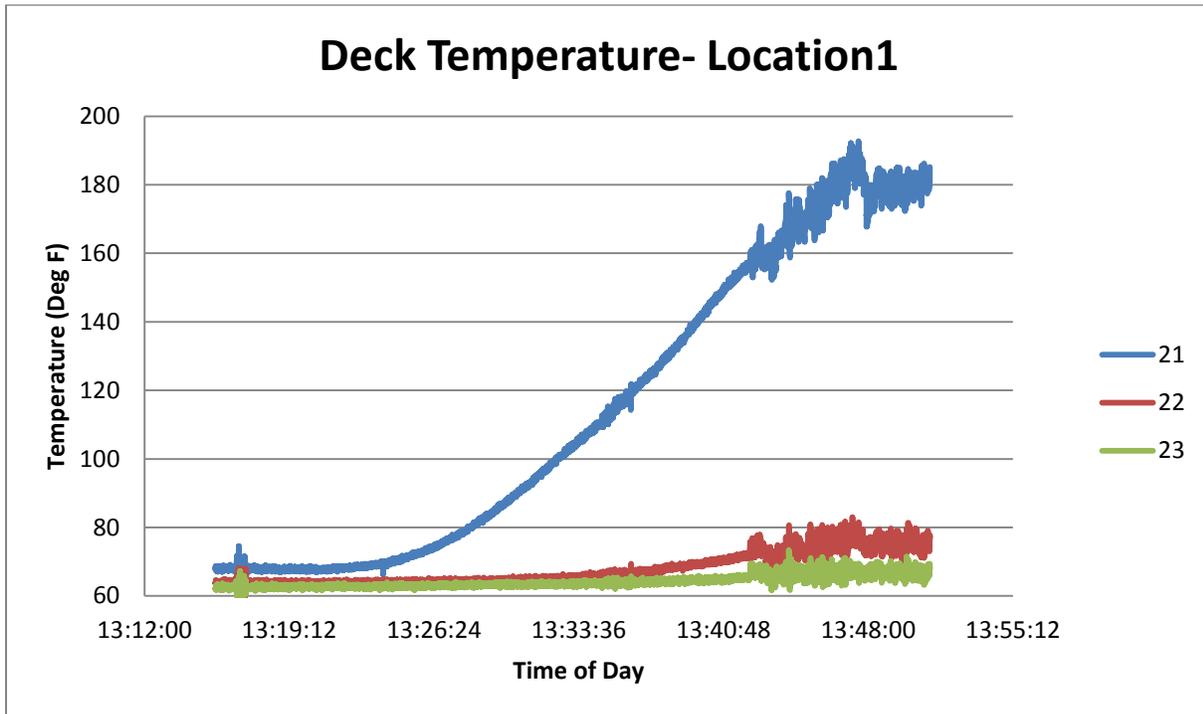
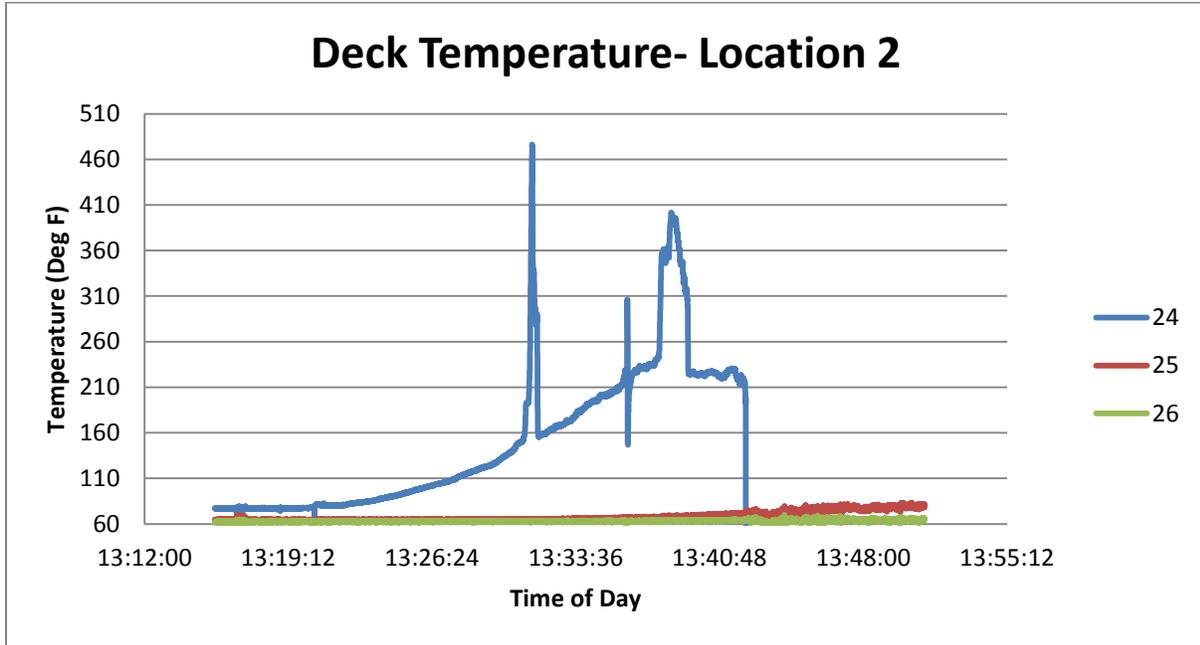
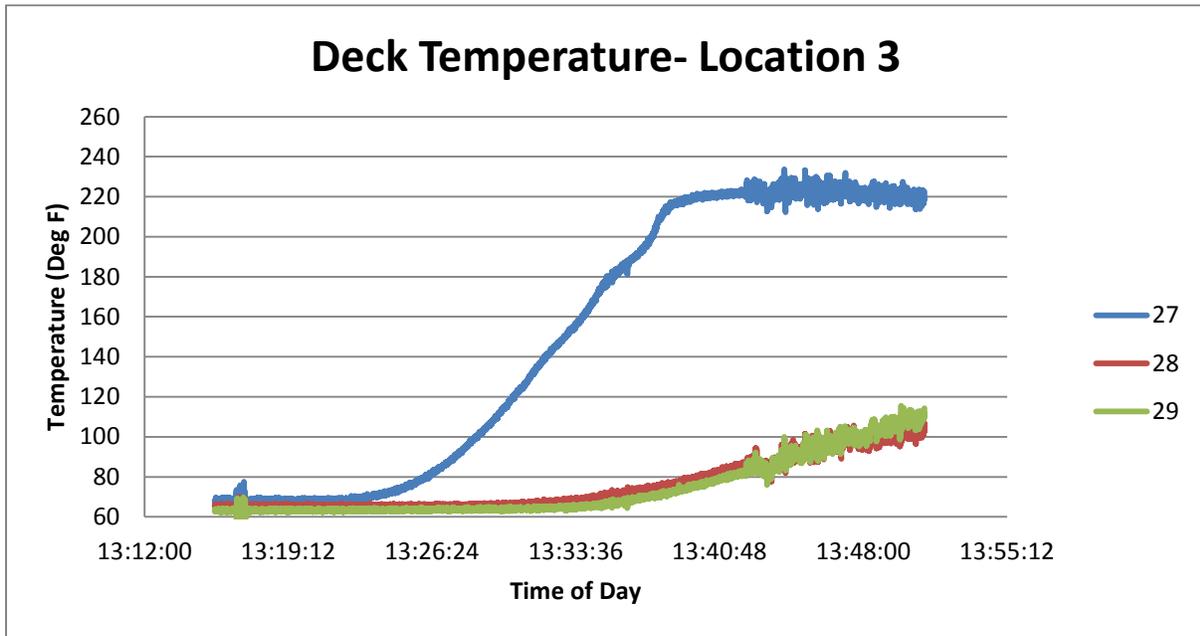
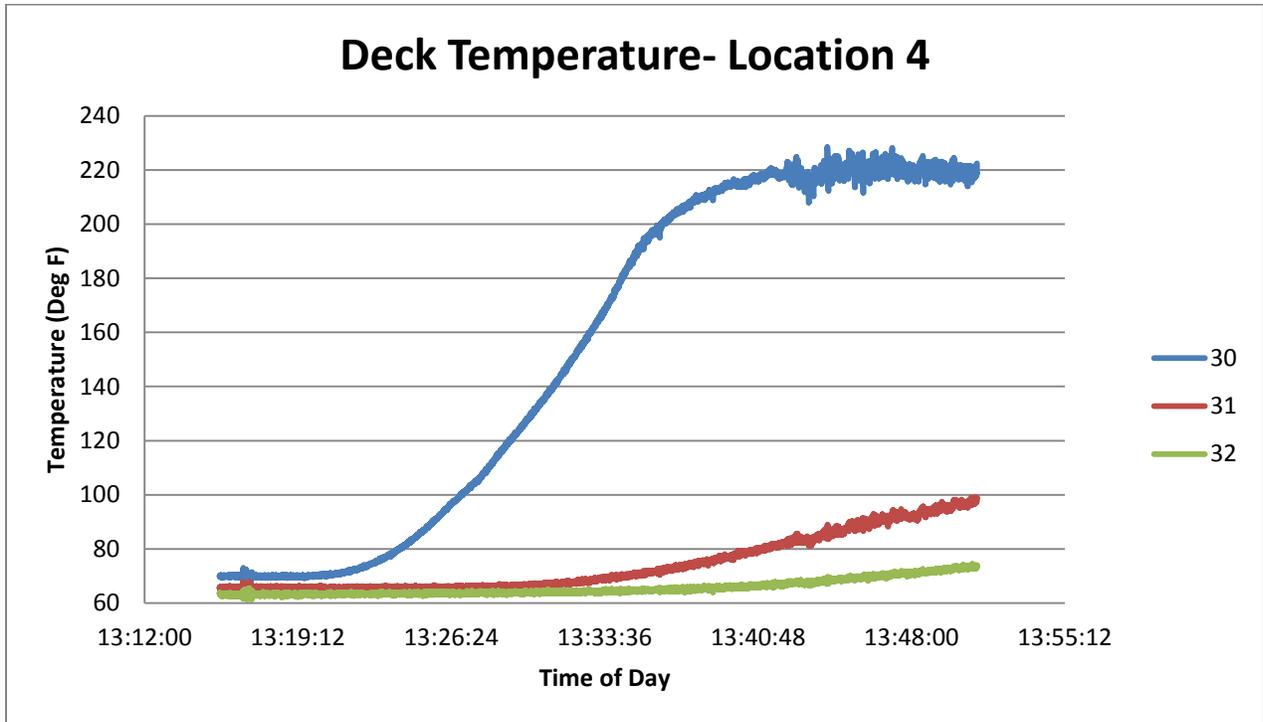
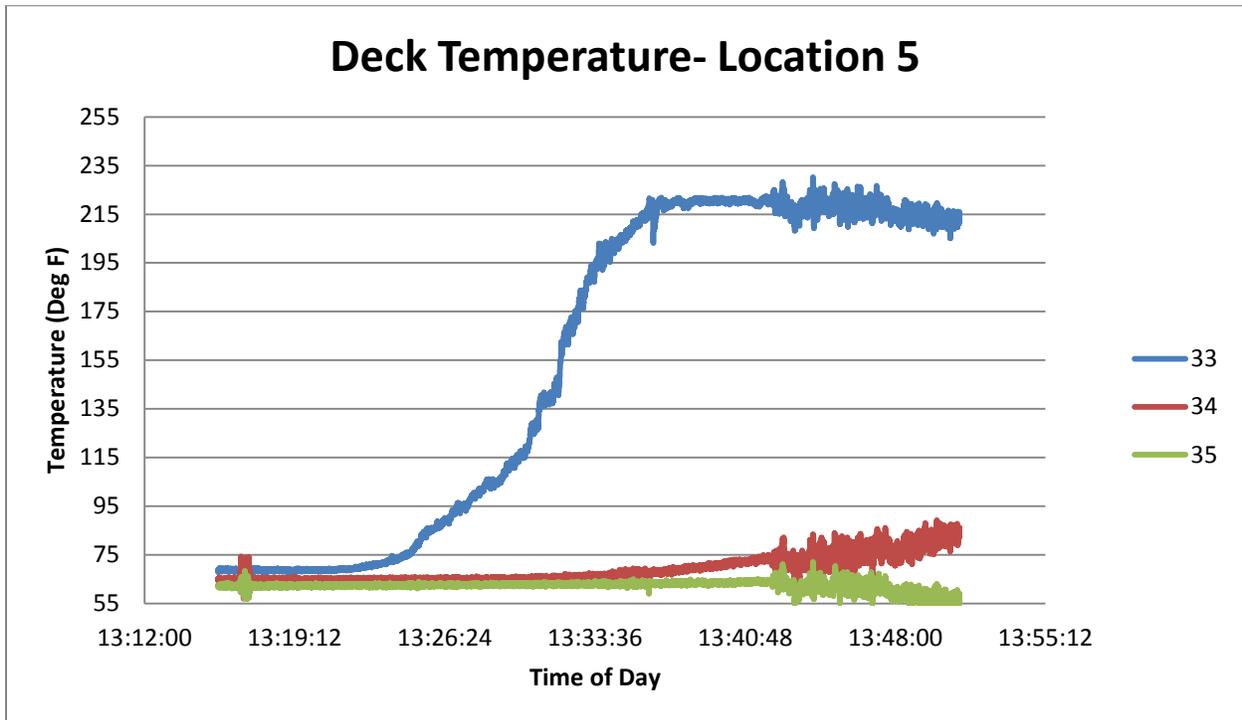
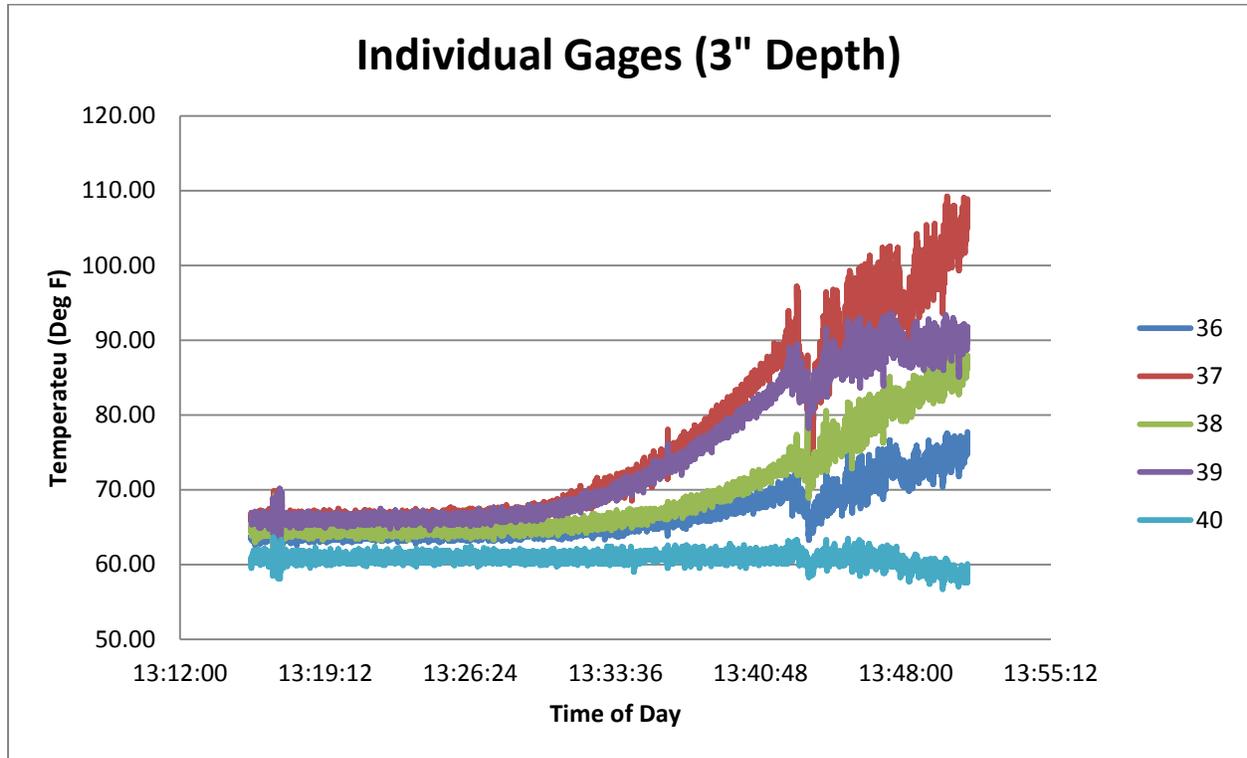
Concrete deck temperatures were also recorded at the three depths in the cross section at various points of the deck. The locations of the embedded thermocouples can be seen in plan and section views in Figure 11 and Figure 12, respectively. Each of the plots in Figure 22, Figure 23, Figure 24, Figure 25 and Figure 26 give the temperature measured for that cross section at depths of 1 inch, 3 inches and 5 inches up from the bottom of the deck. There are some unaccounted for spikes in channel 24 but in general temperatures during this test appeared to plateau in the lower depths of the deck between 180°F and 220°F. Temperature variations at points farther from the bottom surface of the deck showed negligible increases in temperature though temperatures did not plateau in all cases. It is expected that the light rain on the test day had an impact on the deck temperatures during the test. Individual sensors placed in the deck are also shown in Figure 27. Sensor 40 is located outside of the burn chamber.

Figure 22 – Deck temperatures through the depth of concrete deck in location 1

Figure 23– Deck temperatures through the depth of concrete deck in location 2

Figure 24– Deck temperatures through the depth of concrete deck in location 3

Figure 25– Deck temperatures through the depth of concrete deck in location 4

Figure 26– Deck temperatures through the depth of concrete deck in location 5

Figure 27 – Individual embedded thermocouples (3” from bottom face of deck)

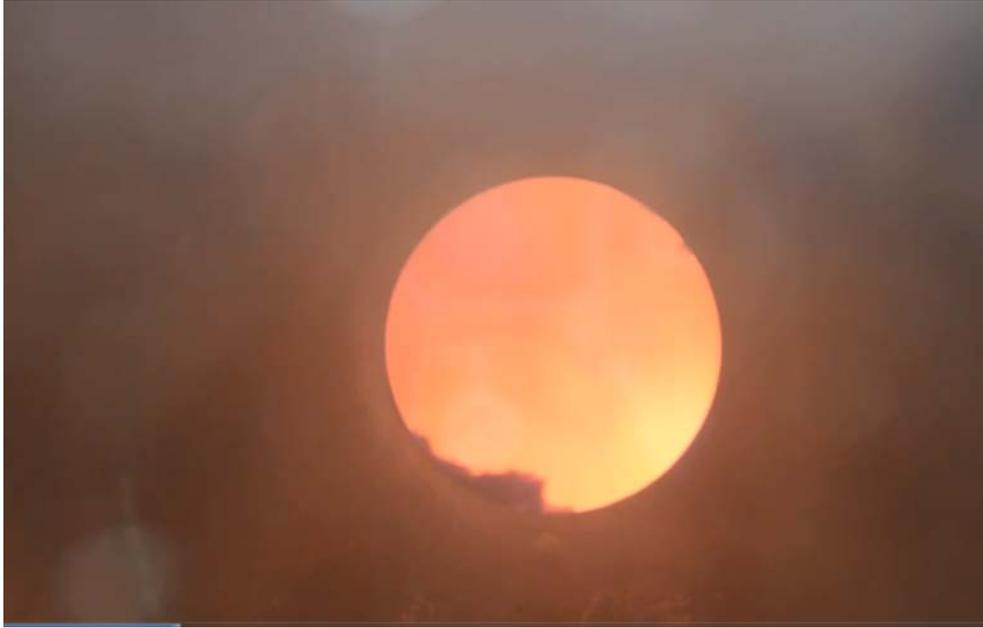
Deflection, air temperature and deck temperature were also recorded throughout the hour long test of the composite arch bridge specimen. The interior of the burn chamber during the test can be seen in Figure 28. This extent of flames was not seen in the steel bridge test. The embedded gages were in similar locations with the exception of gage 40, which was not included in this test. The same fourteen (14) air temperature gages were used in the chamber and the results can be seen in Figure 29. Plots of deck temperature can be seen in Figure 30 through Figure 35. A plot comparing midspan deflection of the steel and concrete arch bridge with the hybrid FRP composite bridge is shown in Figure 36.

Figure 28 – View through peep sight into chamber during composite arch burn test

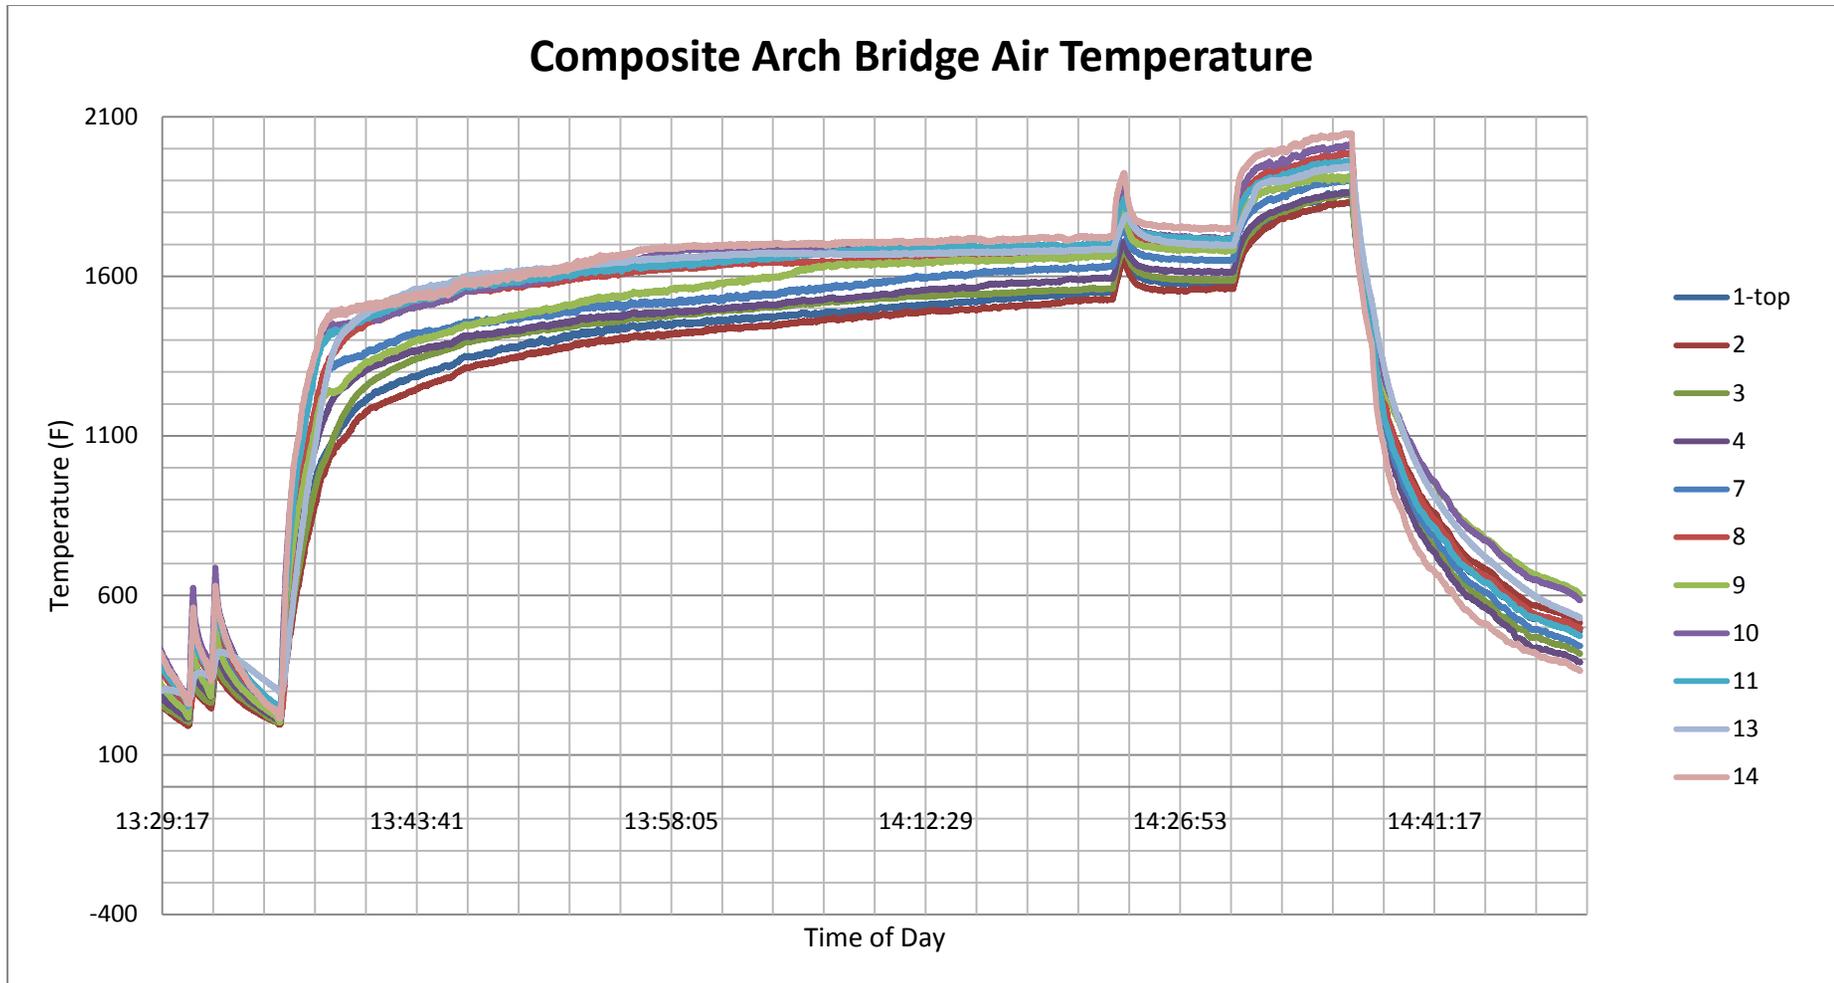
Figure 29 – Air temperature during heating of hybrid FRP composite bridge

The burner did not need to be cycled as in the steel bridge test as temperatures were near the temperatures of the previous test with the burner on low. Smoke production during the test peaked and then dissipated towards the midpoint of the test. The burner was cycled to high during the last 10 minutes of the test. Smoke production and crown deflections increased slightly during this time with increased temperature.
