Bridge-in-a-Backpack™

*Task 8: Investigation of Bridge Performance under
Extreme Temperatures*

Final Report – December 2014

University of Maine's Advanced Structures and Composites Center
Report Number: 15 – 21-1023H

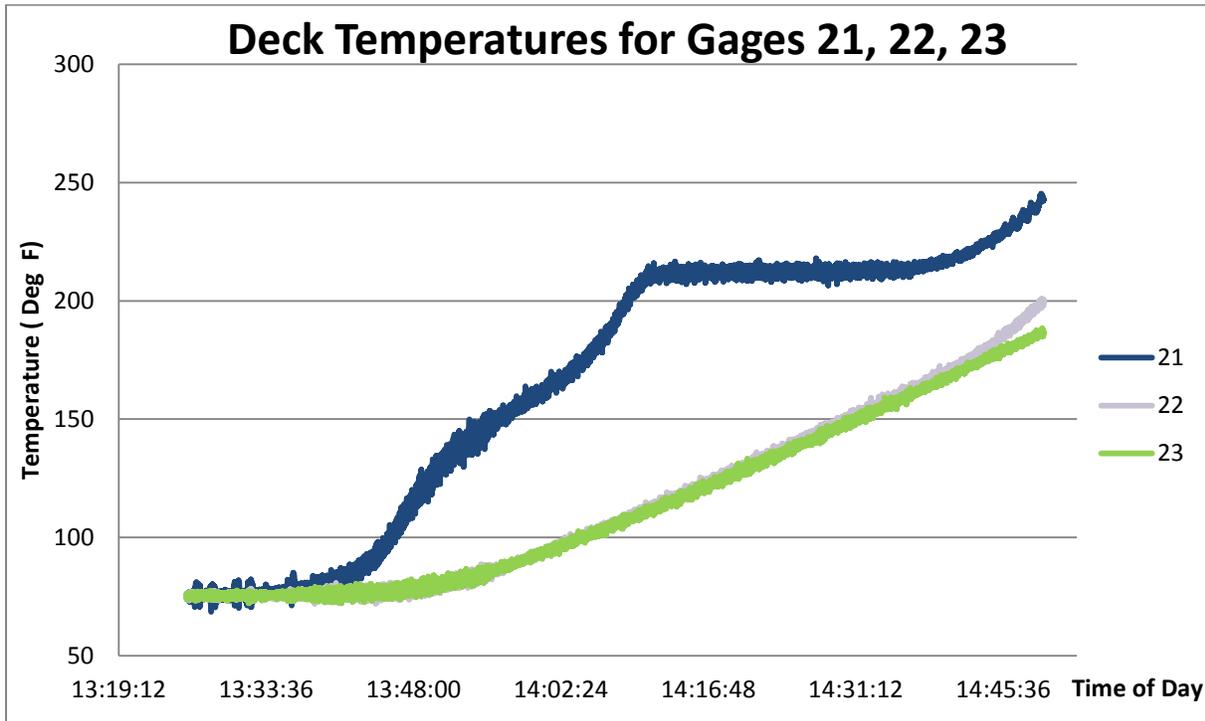
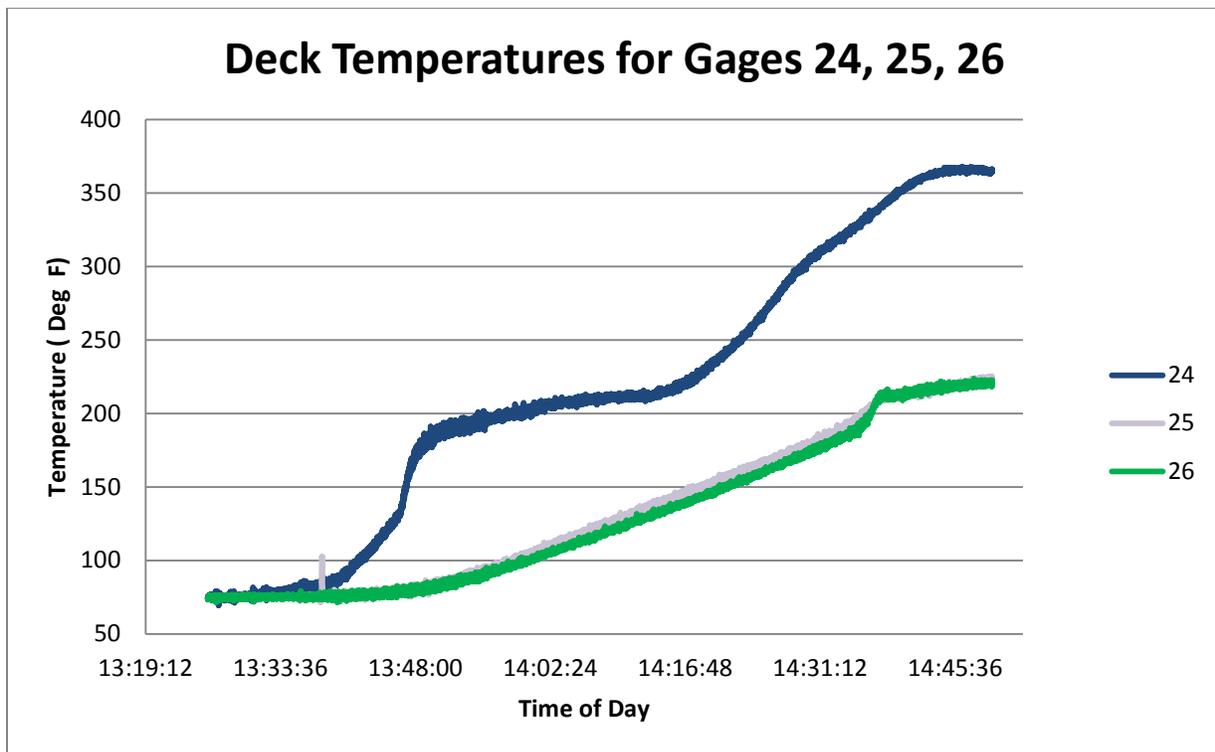
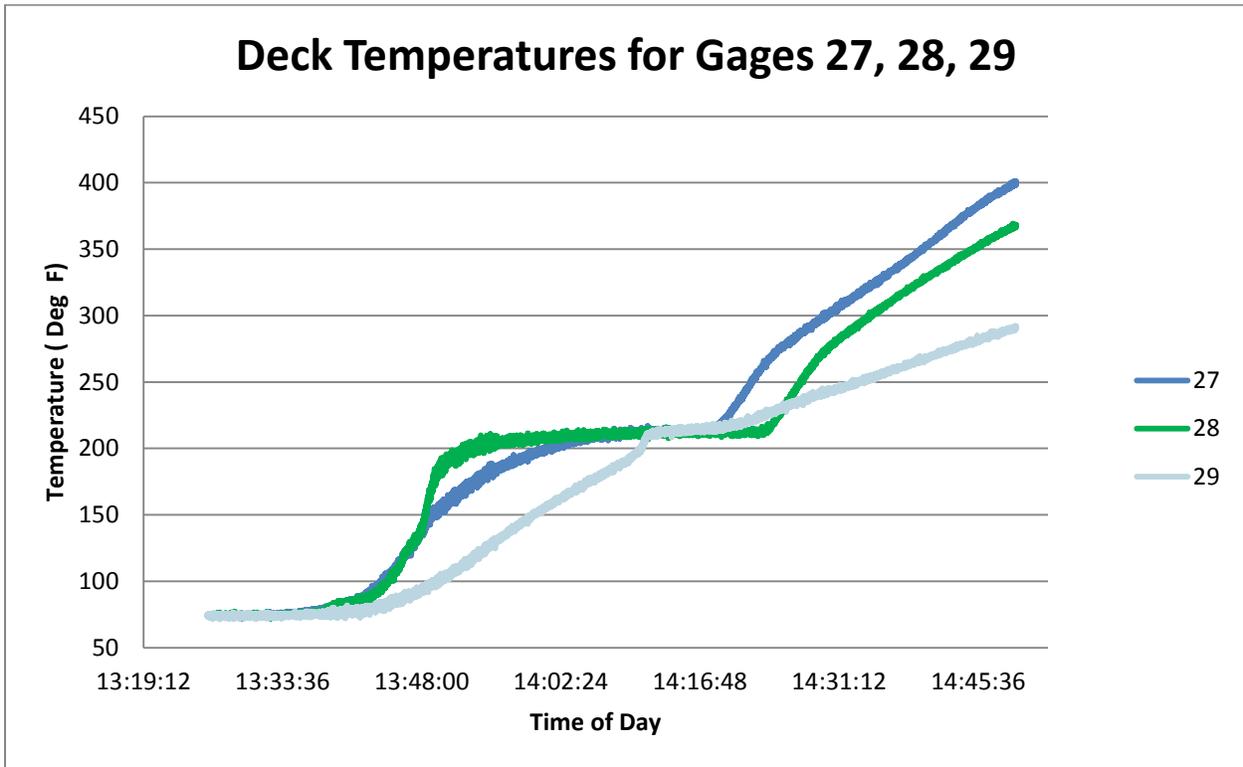
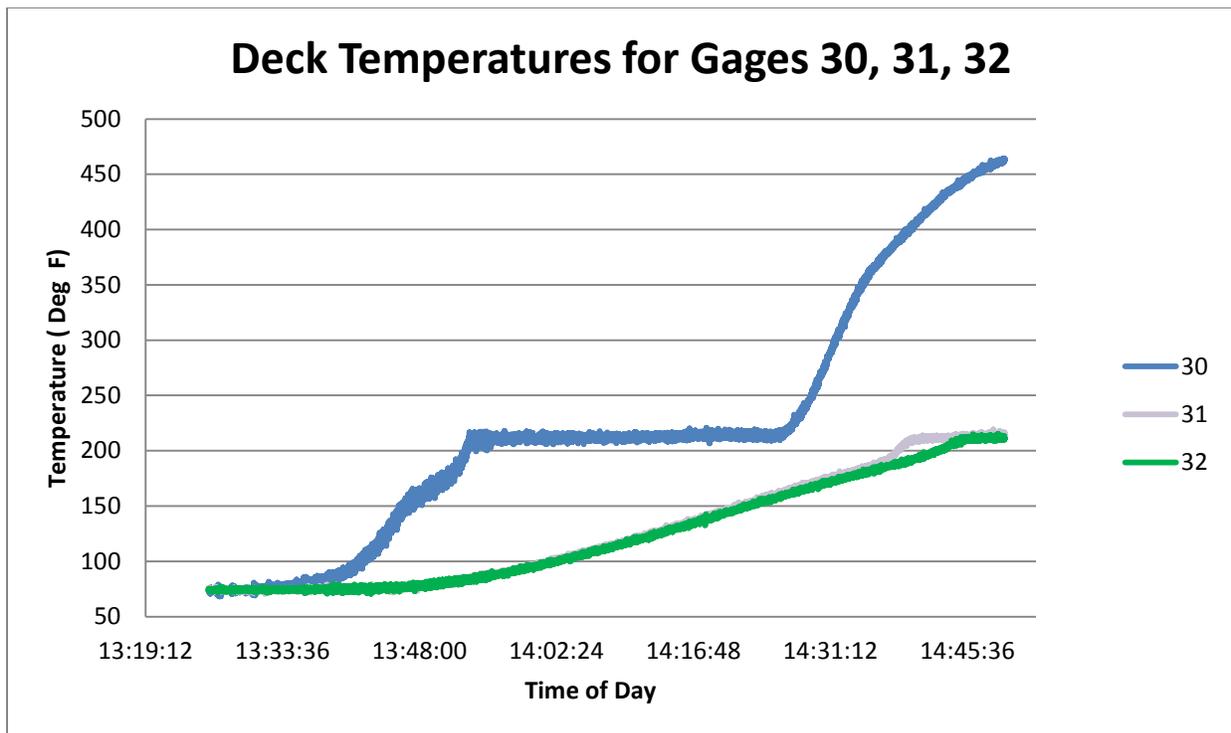
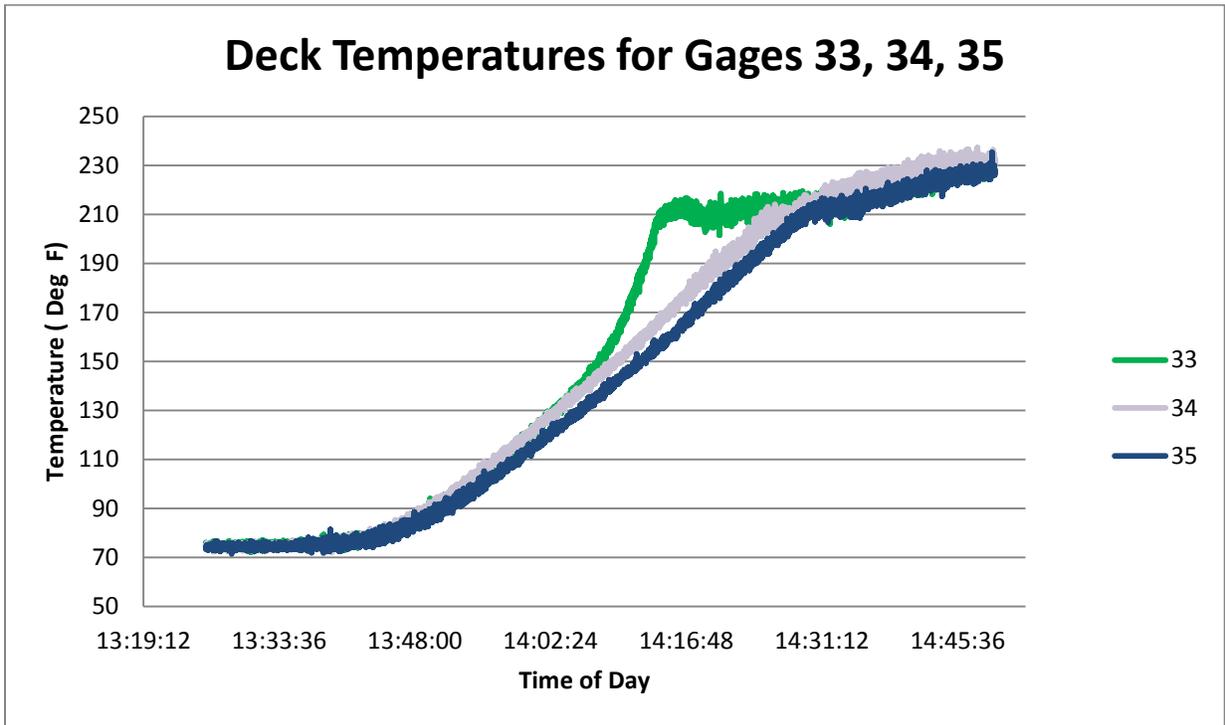
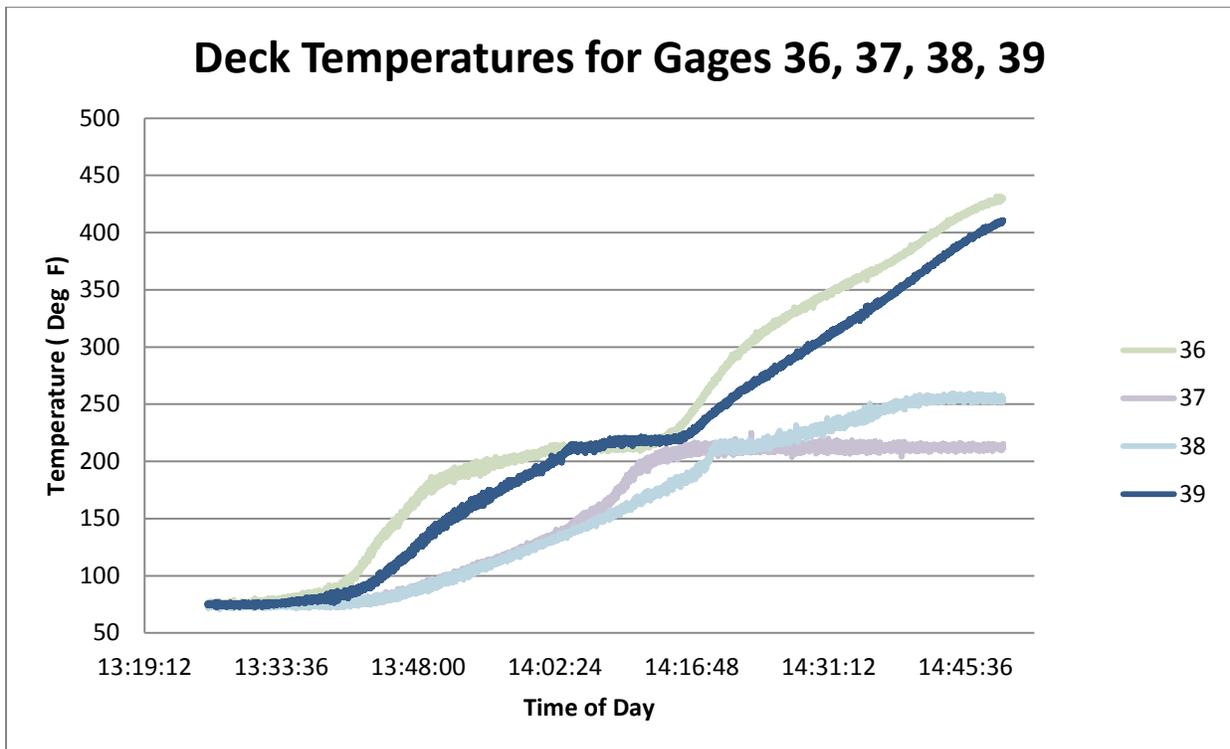
Figure 30 – Temperature versus time for gages 21-23 in concrete deck of FRP arch bridge

Figure 31 - Temperature versus time for gages 24-26 in concrete deck of FRP arch bridge

Figure 32 - Temperature versus time for gages 27-29 in concrete deck of FRP arch bridge

Figure 33 - Temperature versus time for gages 30-32 in concrete deck of FRP arch bridge

Figure 34 - Temperature versus time for gages 33-35 in concrete deck of FRP arch bridge

Figure 35 - Temperature versus time for gages 36-39 in concrete deck of FRP arch bridge

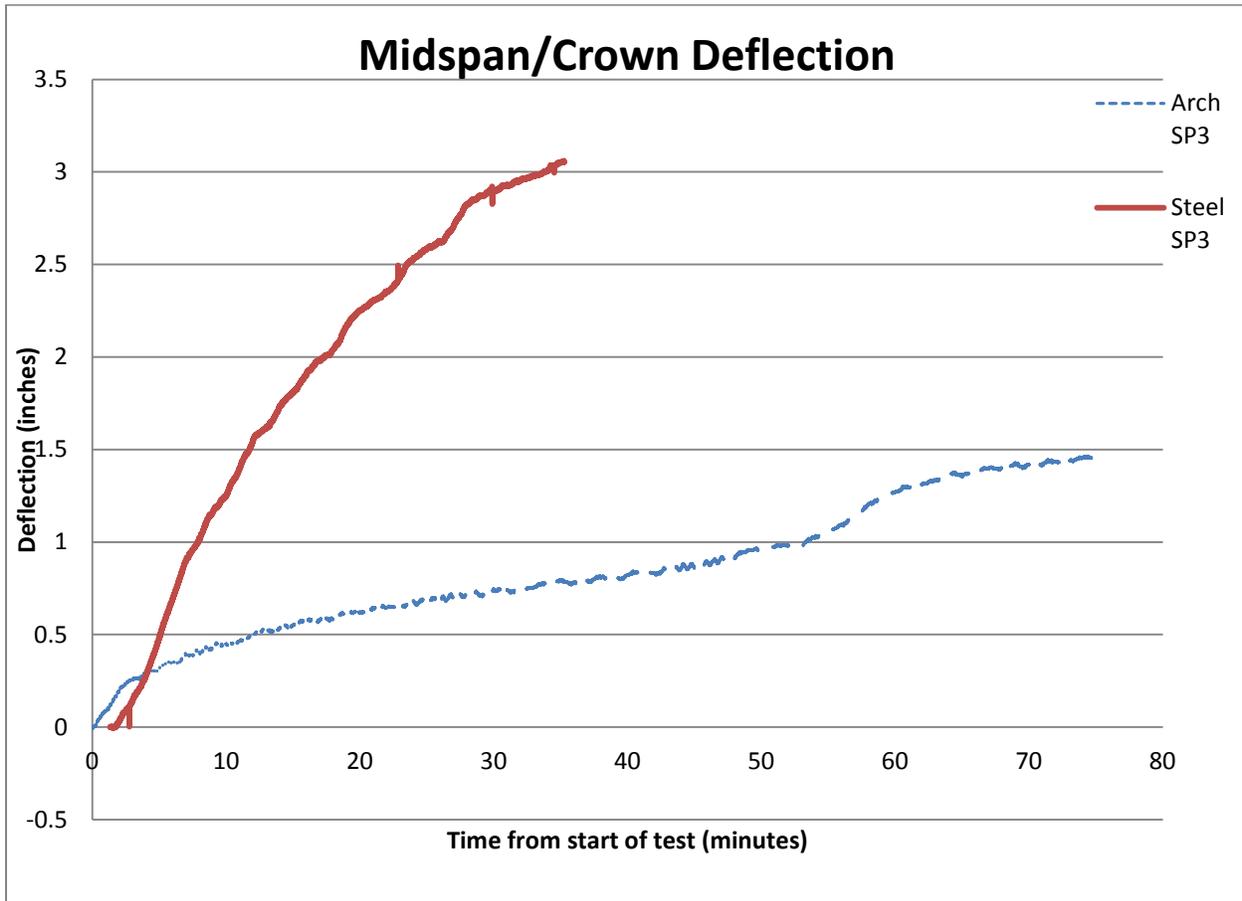
Figure 36 – Deflection of midspan string pot during test

Deflection, air temperature and deck temperature were also recorded throughout the hour long test of the composite arch bridge specimen. The interior of the burn chamber during the test can be seen in Figure 28. This extent of flames was not seen in the steel bridge test. The embedded gages were in similar locations with the exception of gage 40, which was not included in this test. The same fourteen (14) air temperature gages were used in the chamber and the results can be seen in Figure 29. Plots of deck temperature can be seen in Figure 30 through Figure 35. A plot comparing midspan deflection of the steel and concrete arch bridge with the hybrid FRP composite bridge is shown in Figure 36.

Arch crown deflections in addition to that shown in Figure 36 due to dead load, contributed to horizontal movements of the footings as seen in Figure 45. The self-reacting system consisted of steel cables and steel channels bending about their weak axis. The steel channels were not stiff enough due to the offset and overhang required to move the burner in and out of the chamber opening, Figure 46.

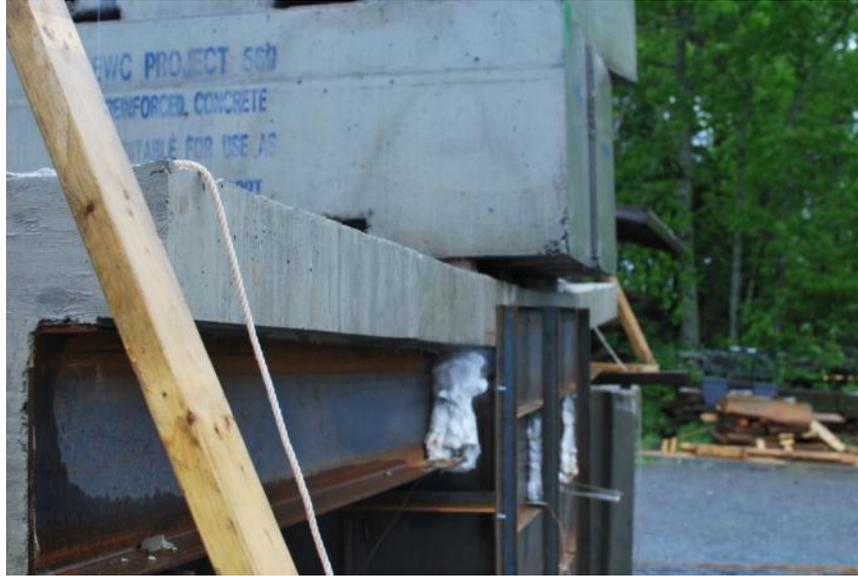
Following the test, the steel girders and deck showed permanent deflections that appeared to be less than the maximum deflections seen during the test as would be expected from contracting steel beams as they cooled and reduced curvature. The bridge specimen can be seen after the test in Figure 37. No spalling of the deck or other damage was witnessed as seen in Figure 38.

Figure 37 – Longitudinal deflections in steel girders following the test

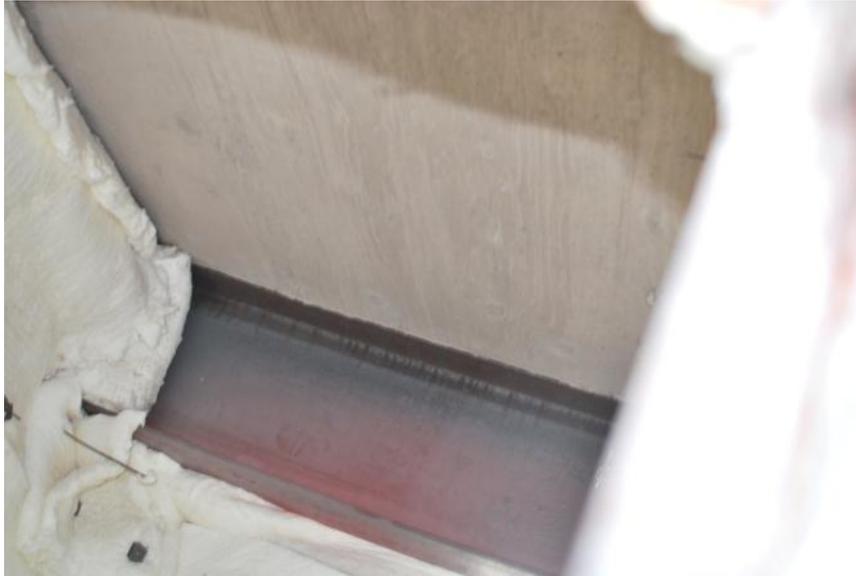
Figure 38 – View under bridge from within the chamber shortly after the steel bridge test

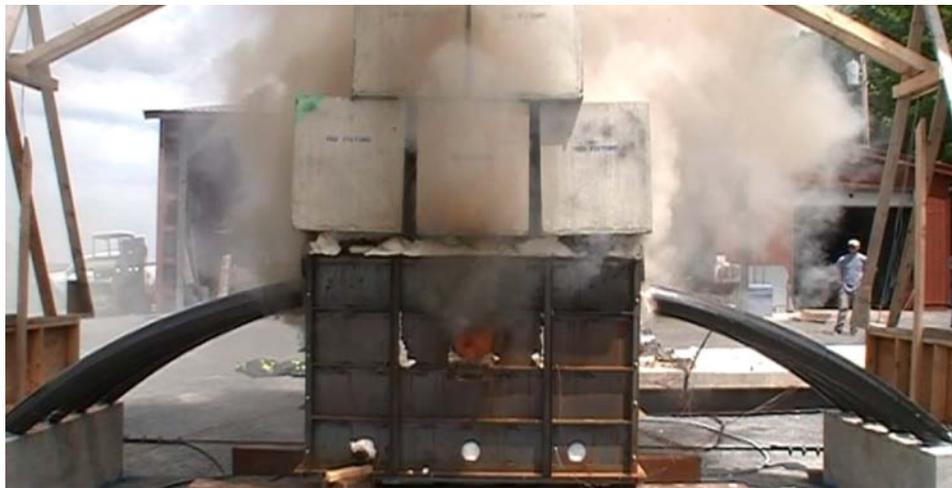
The composite arch bridge showed more obvious deterioration to the arch members due to the heat. Significant smoke production was seen during the test though it reduced in volume until the burner was turned on high (Figure 39).

Figure 39 – Arch bridge test smoke production

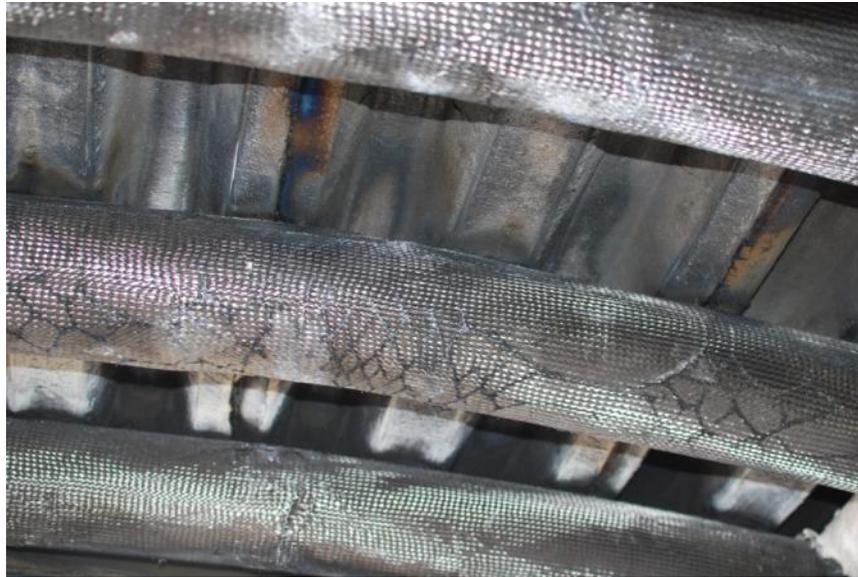
Figure 40 shows the interior of the bridge after the test. It appears most of the resin had burned off and the braided carbon fiber was dry and clean to the touch and loose around the concrete core of the arches. This extended to where the arch extended through the insulation in the chamber as seen in Figure 41.

The decking showed significant deterioration as seen in Figure 40. It was dry and brittle when removed from the arches in the lab. Charring can be seen on the underside and discoloration on the top of the decking. Additional photos of the decking can be seen in Figure 42 and Figure 43.

Figure 40 – Interior of bridge post test

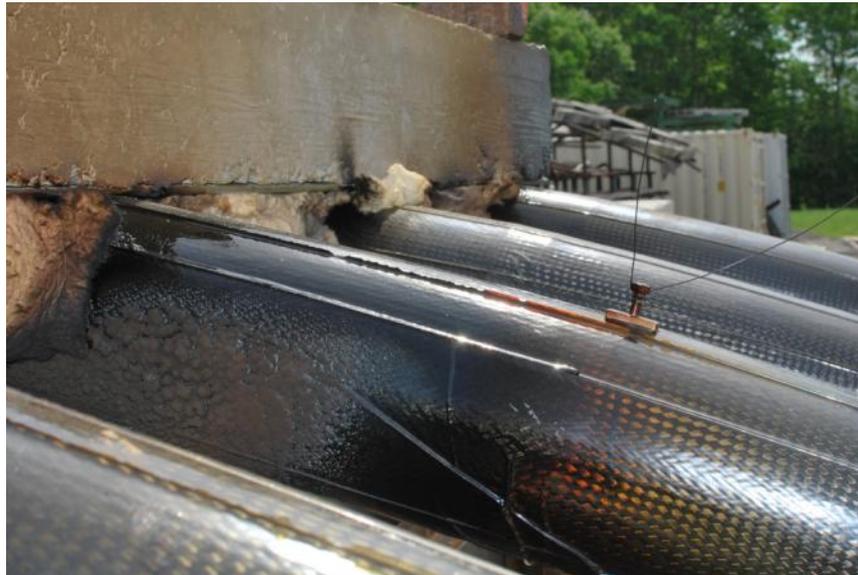
Figure 41 – Arches at interface with chamber

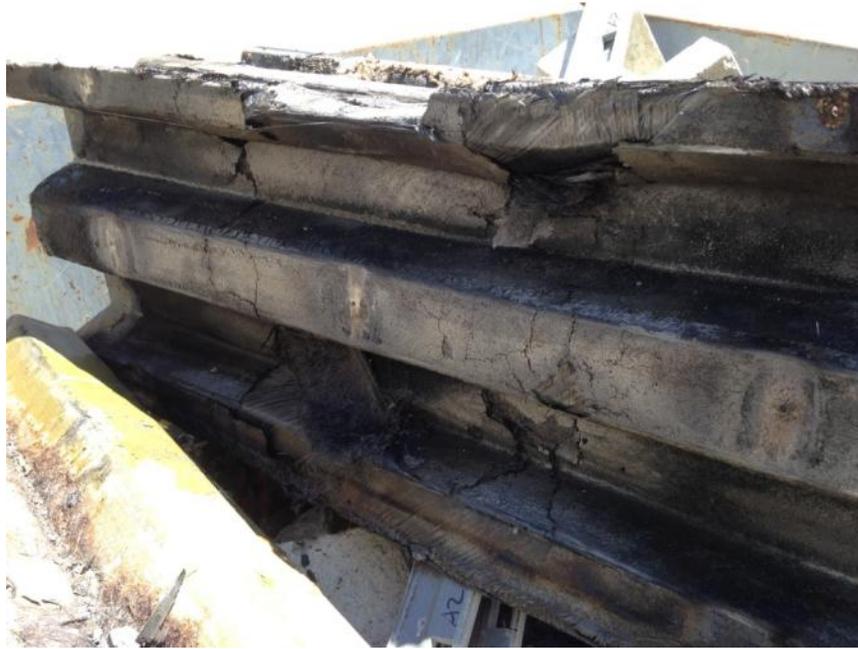
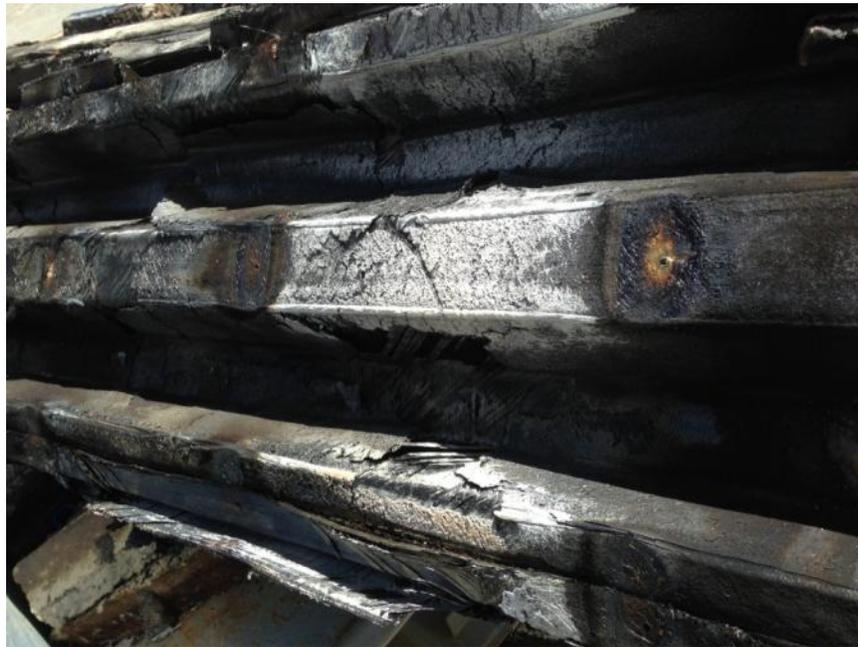
Figure 42 – Underside of decking after removal from the arches

Figure 43 – Underside of second decking panel after removal from arches

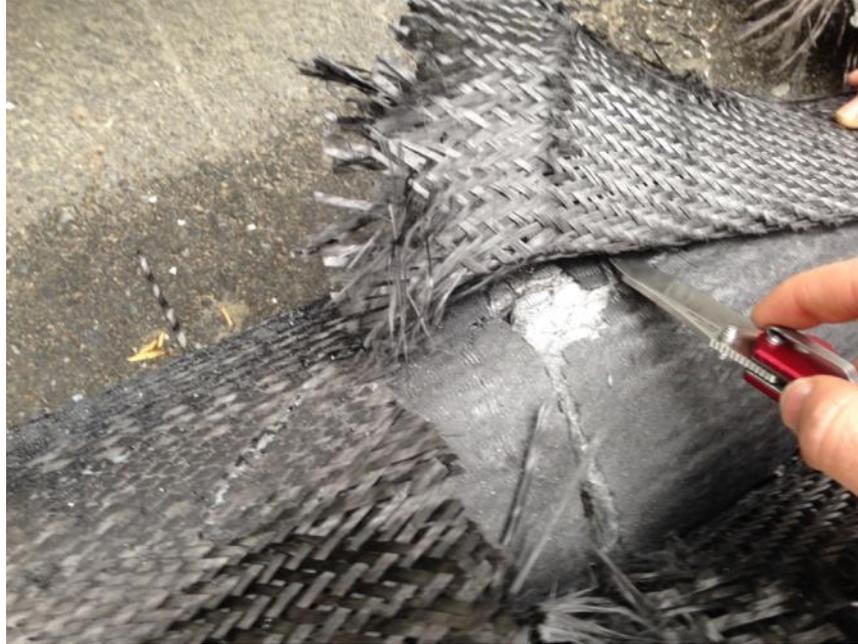
Figure 44 – Inner glass layered charred under the dry carbon fiber

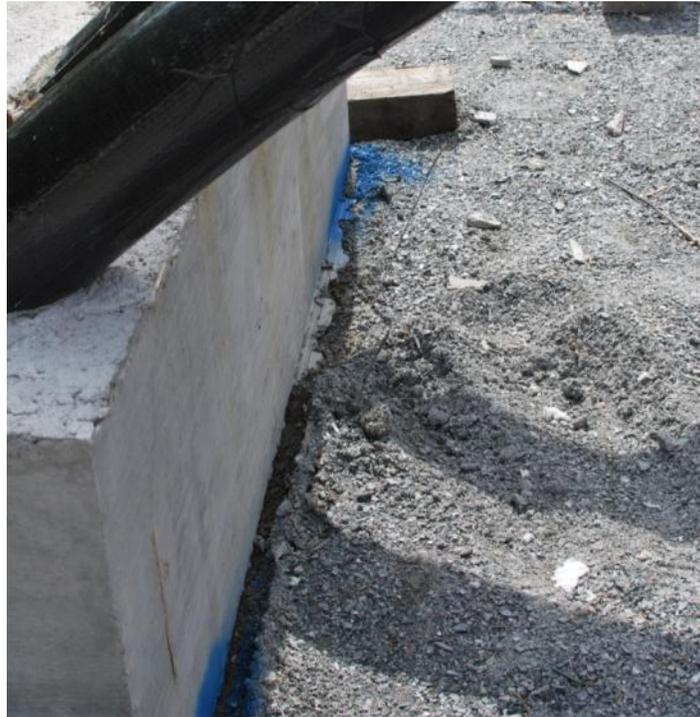
Figure 45 – Horizontal movement of footings during test

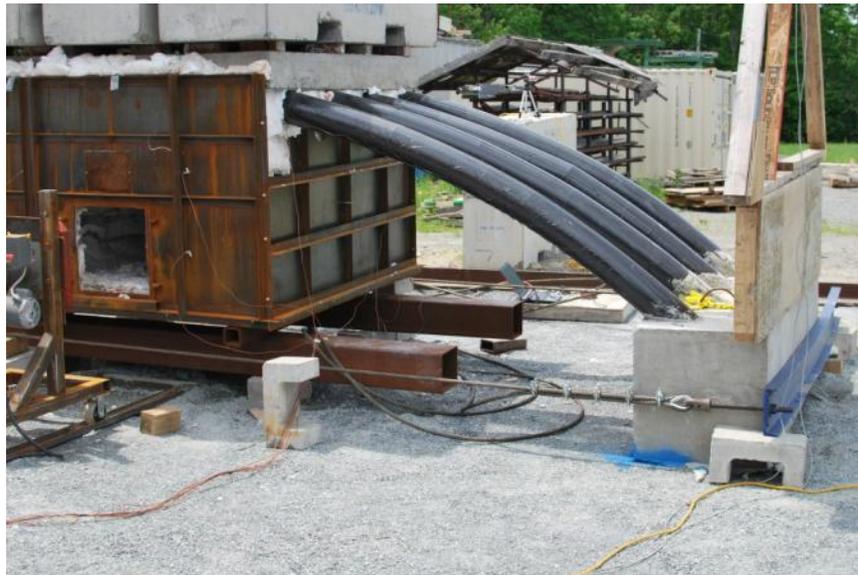
Figure 46 – Self-reacting system with overhang opposite burner

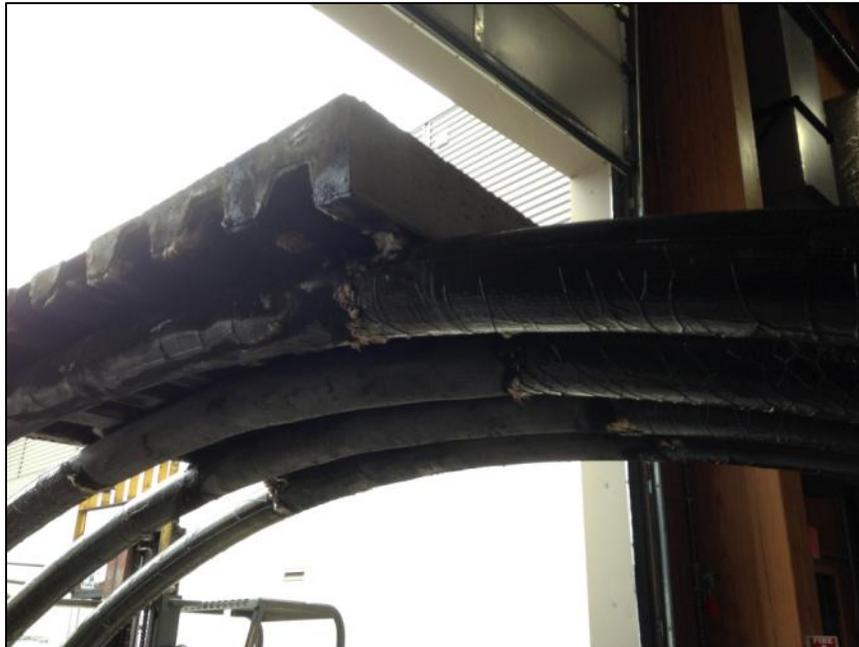
The arch bridge was returned to the structural testing lab as a whole part with four arches embedded in one concrete footing at each end of the span along and with composite and concrete decking attached to the middle six feet of the span as seen in Figure 47.

Figure 47 – Bridge test specimen returning to structural testing lab

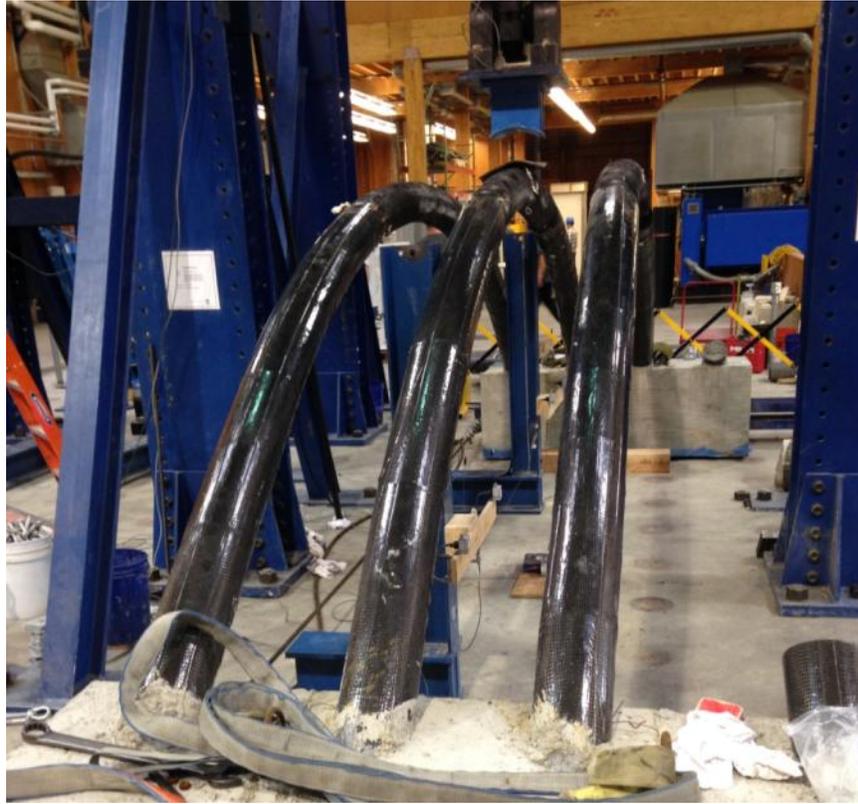
Figure 48 – Arches prior to testing under test frame

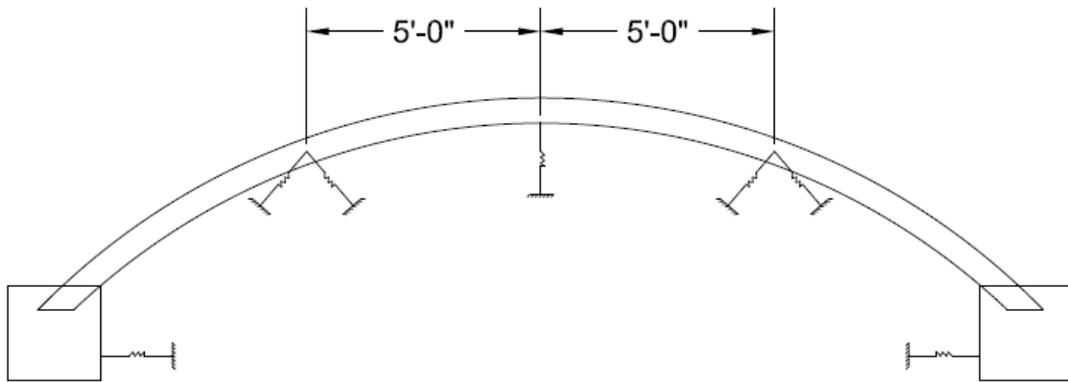
Instrumentation included string pots at the midspan, the shoulders, and the footings in order to measure the crown vertical deflections, the shoulder horizontal and vertical deflections, and the footing spread, respectively (Figure 49).

Figure 49 – String potentiometer locations

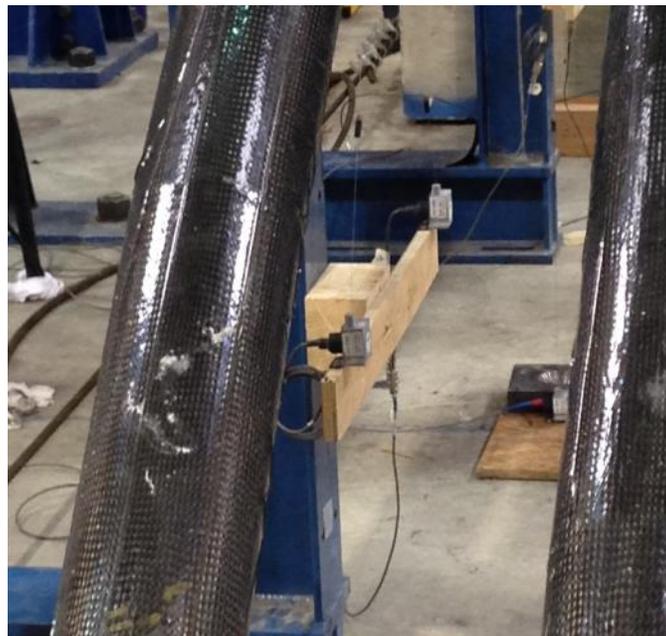
Two string pots were used at the shoulders at a measured angle to capture horizontal and vertical deflections of the mid-height of the arch. This can be seen in Figure 50.

Figure 50 – String potentiometers at shoulders

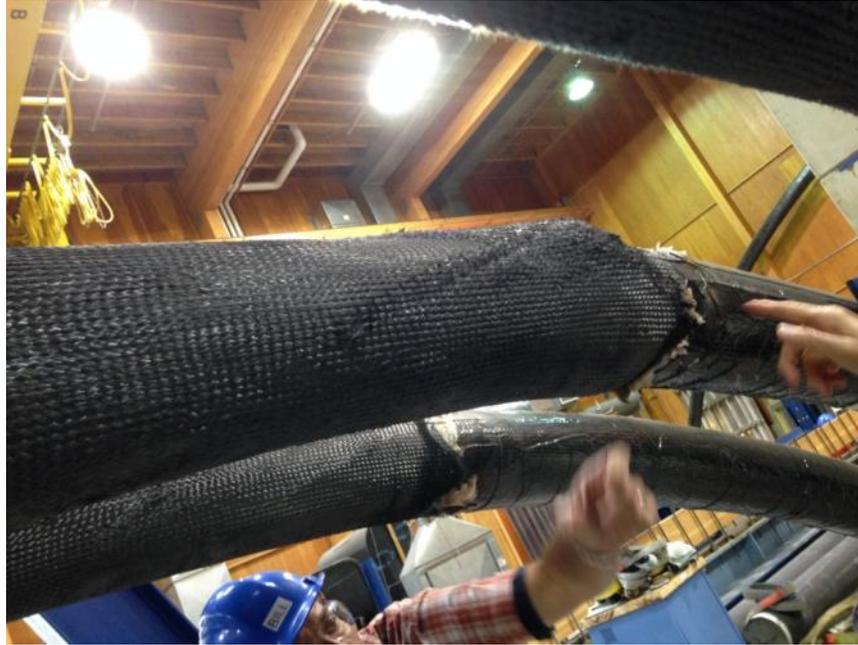
The three arches failed in similar modes which was bending failure at the shoulder where relatively undamaged laminate met the section of the arch inside the chamber during the field test. A typical failure of the three arches can be seen in Figure 51.

Figure 51 – Typical arch failure at shoulder during structural testing

cause failure which occurred at the interface of damaged and undamaged laminate. This was the location where the insulation in the wall of the fire chamber was placed. A simple beam-element finite-element model of the fire damaged arch subjected to this loading predicts a moment at failure of approximately 45.5 kip-in. A previously developed and experimentally verified sectional model of the arch cross-section predicts a bending capacity is 187 kip-in for an undamaged arch.

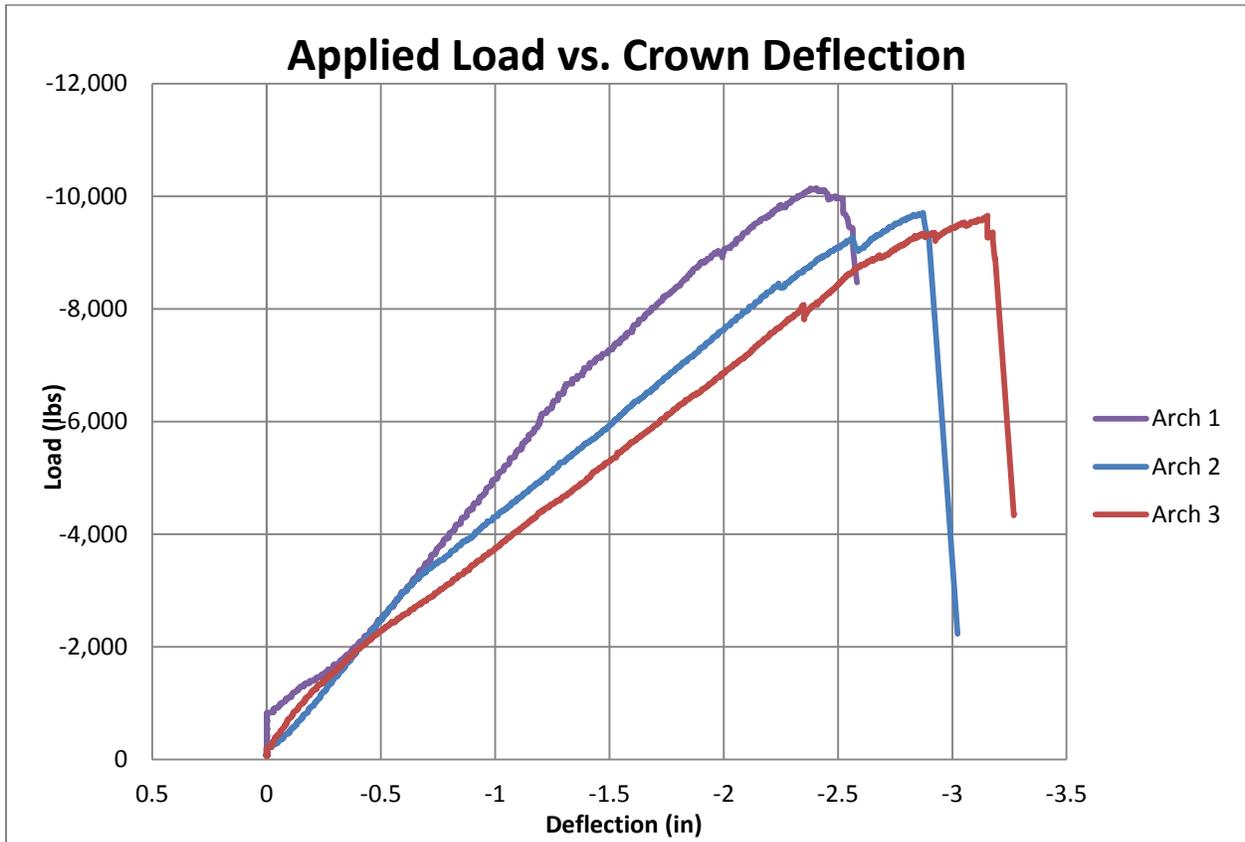
Arch load and deflection data at the crown is plotted for each arch in Figure 52.

Figure 52 – Load versus deflection plots of each arch during structural testing

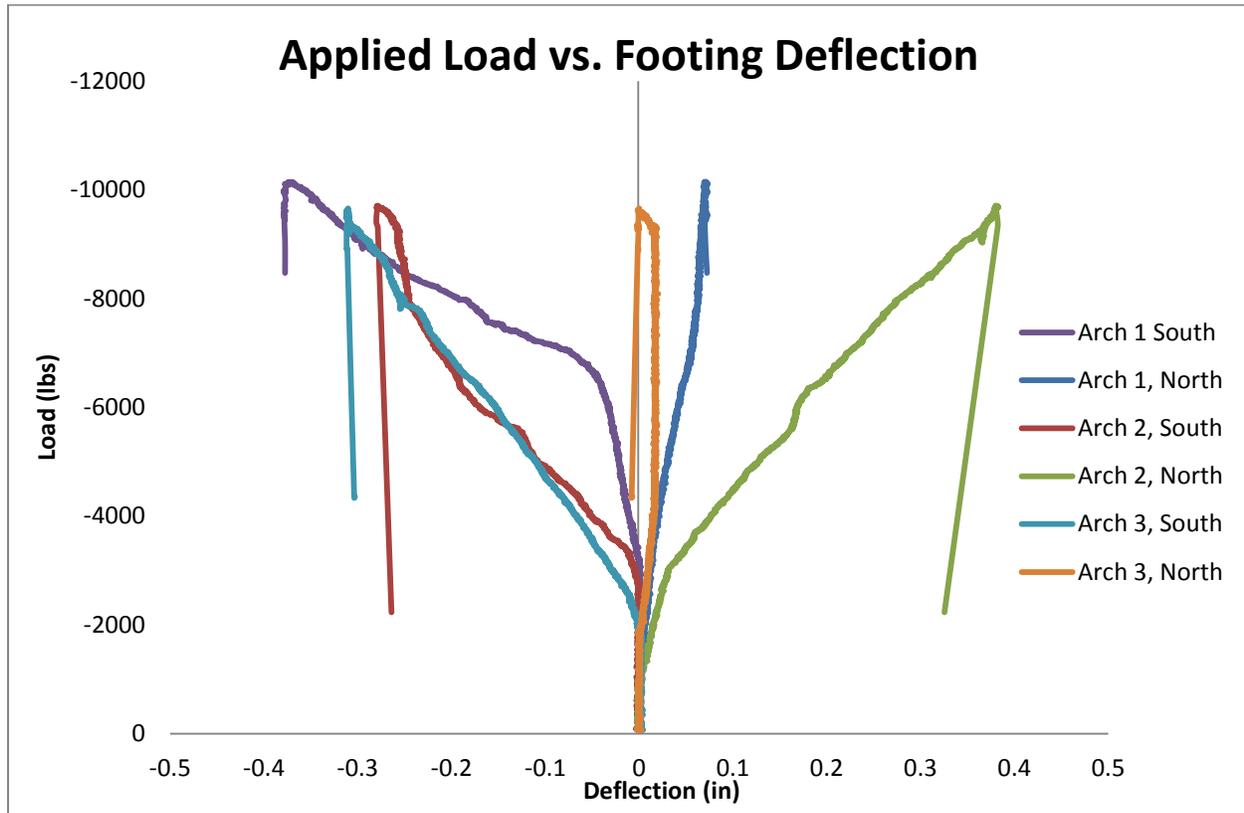
Footing deflections were also measured to document spreading of the arch base during testing as this was not a true pin or fixed condition. Outward spreading of the footings can be seen in Figure 53 where spreading of the North footing can be seen as positive values and spreading of the South footing with load can be seen as increasing negative values.

Figure 53 – Footing deflections

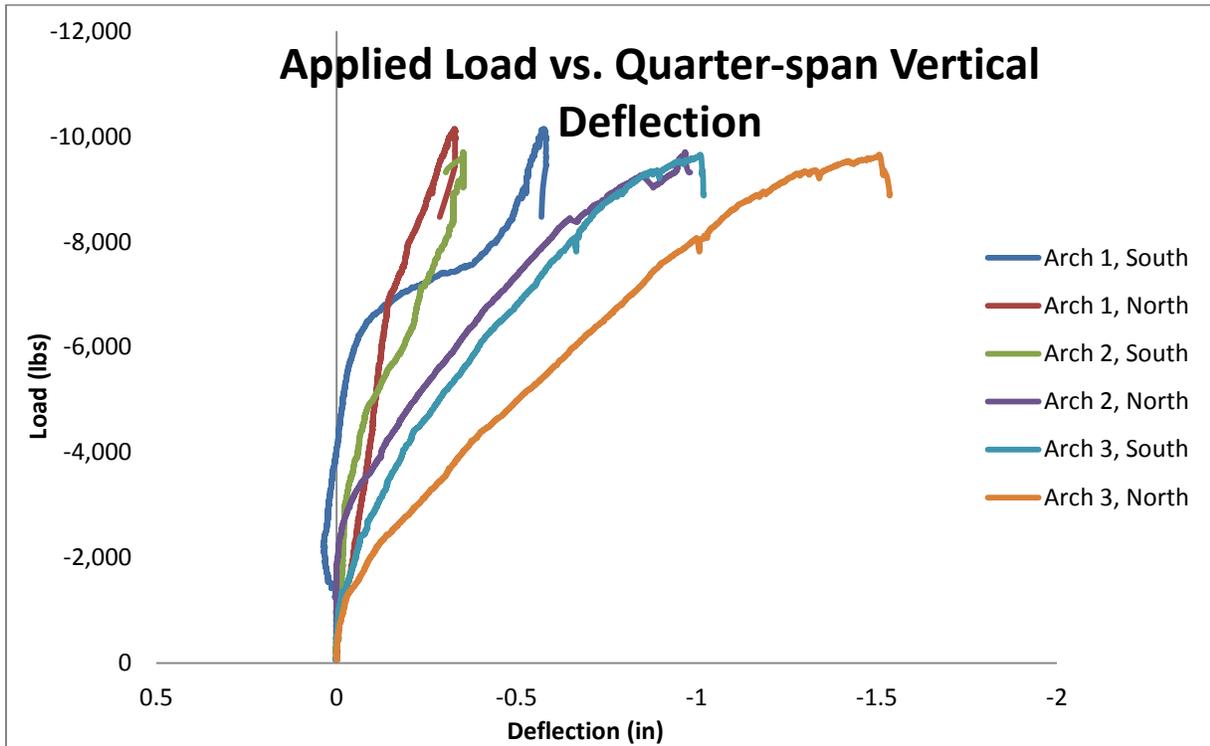
Figure 54 – Load versus shoulder vertical deflection

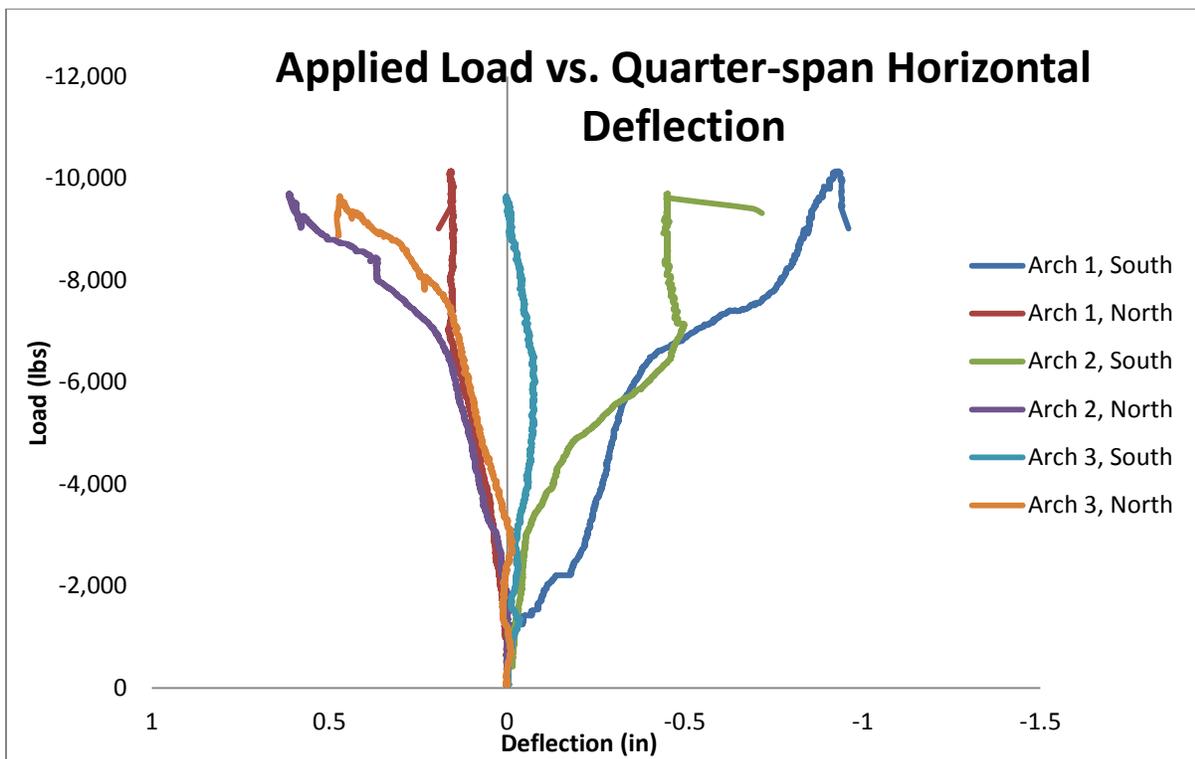
Figure 55 – Applied load versus arch shoulder horizontal deflection

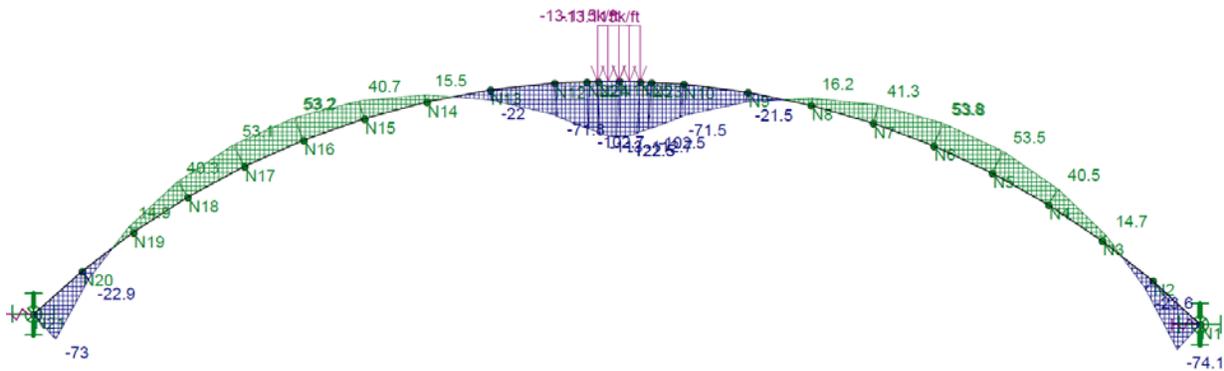
A peak vertical moment was found to be approximately 122.5 kip-in, though there appeared to a significant side load as well due to the asymmetric damaged section. This occurred at the crown where it appeared the resin had been burned off. Peak moments during the test at the shoulders (5 feet from midspan) were interpolated from the results to be 45.5 kip-in.

Figure 56 – RISA 3D model analysis estimating moment during test
