FINAL REPORT ~ FHWA-OK-14-14

3D LASER IMAGING FOR ODOT INTERSTATE NETWORK AT TRUE 1-MM RESOLUTION

Kelvin C.P. Wang, Ph.D., P.E.
Joshua Q. Li, Ph.D.
School of Civil and Environmental Engineering
College of Engineering, Architecture and
Technology
Oklahoma State University

December 2014

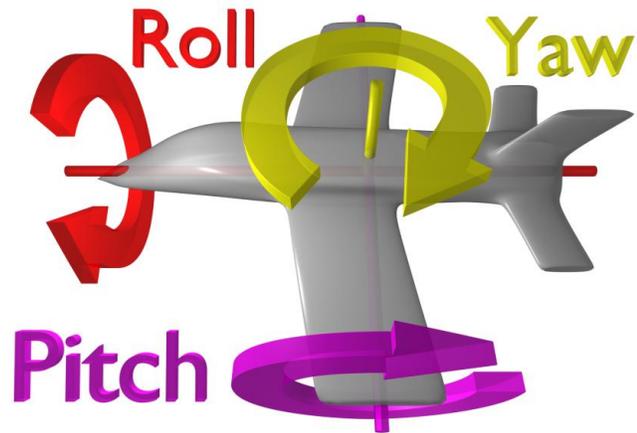
Figure 2.5 IMU Working Principle

In addition to the 3D camera sensors, the positioning data collections including precision gyro, high-frequency differential GPS receiver, Distance Measurement Instrument, and Inertial Measurement Unit (IMU) are incorporated into the 3D Ultra to ensure high geographic accuracy. An IMU is an electronic device that measures and reports on velocity, orientation, and gravitational forces, using a combination of accelerometers and gyroscopes. An IMU allows a GPS to work when GPS-signals are unavailable, such as in tunnels, inside buildings, or when electronic interference is present. IMUs work, in part, by detecting changes in pitch, roll, and yaw (as shown in Figure 2.5), which can be used to determine pavement geometric parameters such as horizontal curves, longitudinal grade, and cross slope. The IMU can provide a refresh rate of 100Hz.

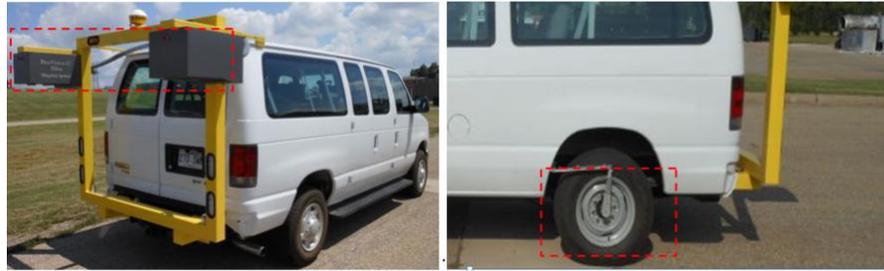
Figure 4.1 High-Speed Inertial Profiler Based on 1mm 3D Data

The 1mm 3D based profiling system consists of full-size passenger van equipped with PaveVision3D sensor cases, in which 3D sensors and accelerometers are located (Figure 4.1). Left side sensor case and right side sensor case measure elevation profile traces in the left wheel path (LWP) and right wheel path (RWP) respectively. Inside the sensor case, accelerometers are mounted in tandem with 3D sensors. The accelerometer has very high resolution, which can sample the vertical acceleration at an average rate of 10 KHz. It needs no external trigger and is highly stable against outside noises. The DMI is mounted on the left wheel of the host vehicle. A data acquisition system is developed based on the three essential devices to collect, process, generate and store profile data for roughness analysis. The sampling interval of the profiling system is 0.5 inch.

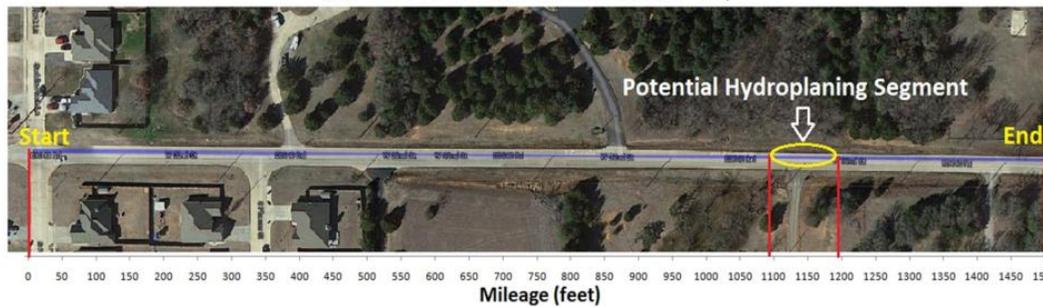
Figure 5.3 Testing Site with Potential Hydroplaning Hazard

Figure 5.3 shows the predicted hydroplaning speeds at one testing site located in Stillwater Oklahoma. The speed limit is 45 mph. Hydroplaning might occur within the segment ranging from 1080ft to 1185ft, as shown in Figure 5.2 (a) where the predicted hydroplaning speed is lower than 45 MPH. The pavement segment with potential hydroplaning risk is marked with a yellow circle in Figure 5.2 (b). Highway agency may post a reduced speed traffic sign at that location to minimize the traffic accident caused by hydroplaning. In addition, pavement engineers may also take other measures such as constructing superior grooving texture to increase the potential hydroplaning speed.

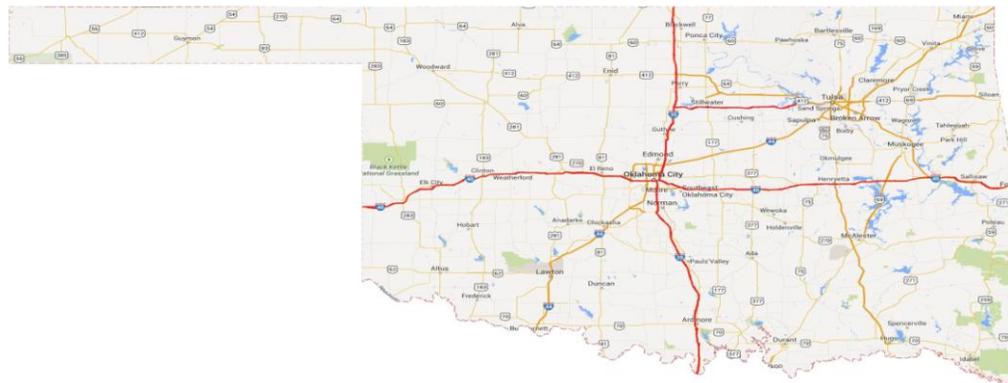
Figure 6.1 Highway Network Survey for ODOT

The data collection for this project includes ODOT interstate network (I-35 and I-40) and State Highway 51 from I-35 to Sand Springs with a total of approximately 1280 center miles, as shown in Figure 6.1 and Table 6.1. Two data collection trips were made to acquire 1mm 3D data collected at highway speed using the PavéVision3D system. The first data collection trip was executed in the beginning of March 2013 and the second in later May 2014. Since all the highways are divided, the data for both directions are collected. As can be seen in Table 6.1, the section lengths calculated based on Google Map and PavéVision3D Ultra system are approximately identical. Recognizing that the pavement surface types (AC or PCC) are constantly changing, the collected data sets for each highway are manually divided into sections based on surface type, subsequently each section is dynamically segmented into uniform segments.

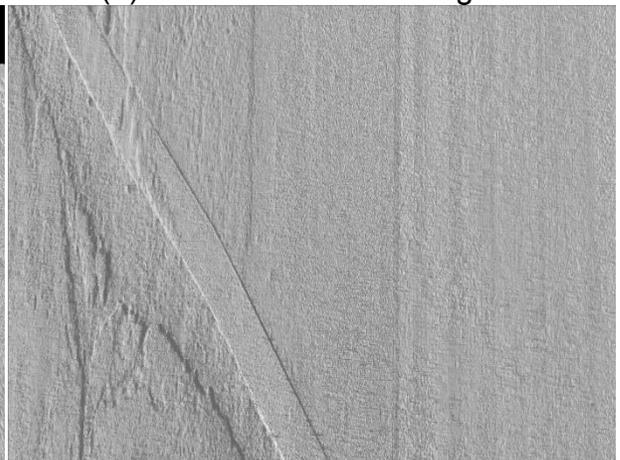
(f) Rotated 1/4 mm 3D Range (Before Correction)

Figure 7.17 South Bound Inner Lane Joint #1 (Boomer Creek Bridge)
