Evaluation of Mobile Work Zone Alarm Systems

A Report on Research Sponsored by

June 2014

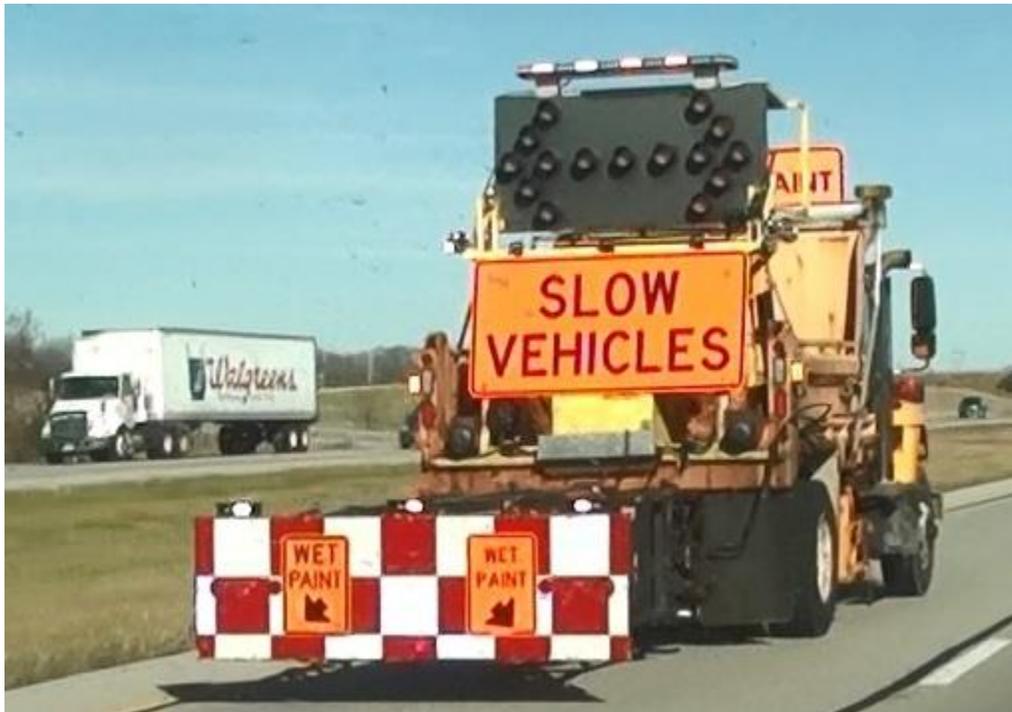
Figure 1.4 TMA with Alarm Device

The Alarm Device, as implemented by the Saint Louis District (Figure 1.4), is a manual system that includes a dual stage warning with lights followed by sound. The TMA driver visually estimates the distance to trailing vehicles by using the number of skips on the lane striping as a reference. The distance from the beginning of one skip to the beginning of the next

skip is 40 ft. The driver first triggers the lights when there is a vehicle within a distance of 1040 ft in the TMA lane. If the highway vehicle continues to approach the TMA vehicle without showing any signs of merging, the TMA driver will trigger the alarm sound when the vehicle is within 520 ft of the TMA vehicle.

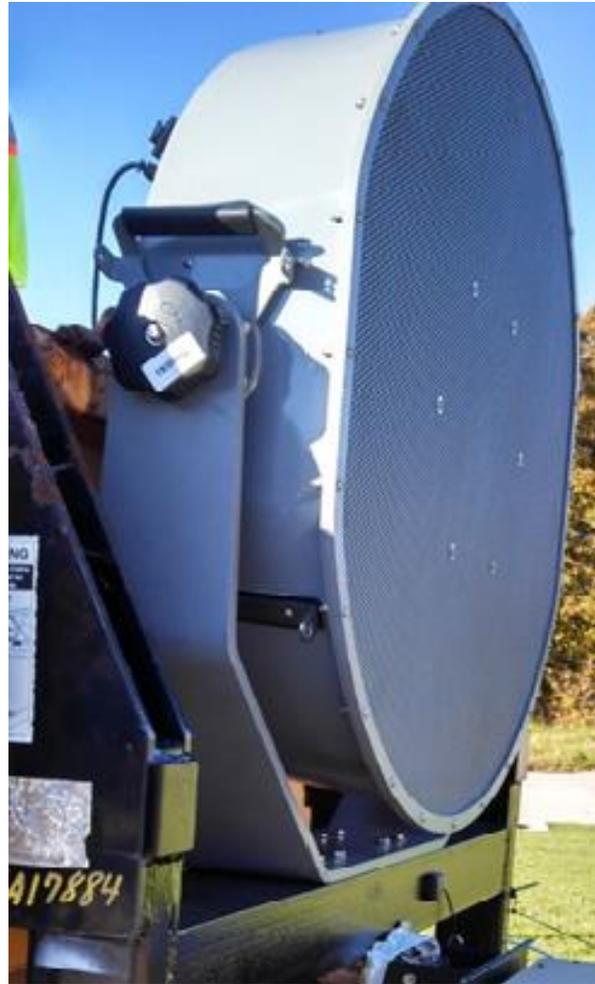
Figure 1.5 DAS Unit

DAS is a device that transmits high-intensity and directional warning sounds. Figure 1.5 shows the DAS unit tested in this research project. The DAS produces sounds that are able to overcome background noise such as road noise. A previous study suggested that a DAS could be used in a highway construction work zone (Phanomchoeng et al., 2008). However, there is no known application of the DAS in a mobile work zone. The volume of the DAS is adjustable and can be limited via device software. The message and alarm sound are customizable. The DAS could potentially be used in a wide range of applications that require the use of a long range and directional public address system. There are several versions of the DAS, including ones producing lower sound levels that are more appropriate for public use. These smaller units are also more affordable. In addition, the DAS unit can be programmed from the factory at a preset maximum sound level to avoid accidental or malicious increase of volume.

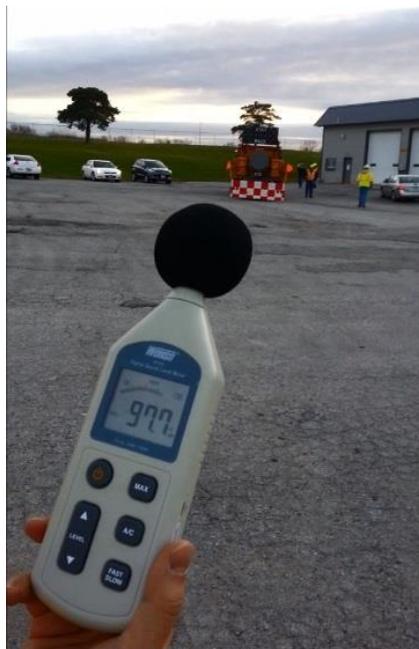
Figure 4.2 Reading decibel level of DAS while walking outside of vehicle

test was performed at a parking lot, a controlled area at which tests were conducted at specified distances. Decibel levels from inside a parked vehicle were taken at distances of 10 ft, 50 ft, and at increments of 50 ft until 600 ft was reached for both the DAS and Alarm Device warning systems. Decibel readings were also taken while walking outside of a vehicle behind the TMA. Decibel level readings were taken at distances of 3 ft, 10 ft, 50 ft, and increments of 50 ft until 600 ft was reached for both the DAS and Alarm Device warning systems. Due to fluctuations in the sound level readings, ten consecutive sound level measurements were recorded at each location, and the average and standard deviation for these measurements were computed. The average sound level for each location was then compared to the sound level standards in order to determine if any distances experienced a sound level that fell outside of OSHA or NIOSH compliance. Figure 4.2 shows a picture of the sound meter that was used to measure the decibel level while walking outside of a vehicle.

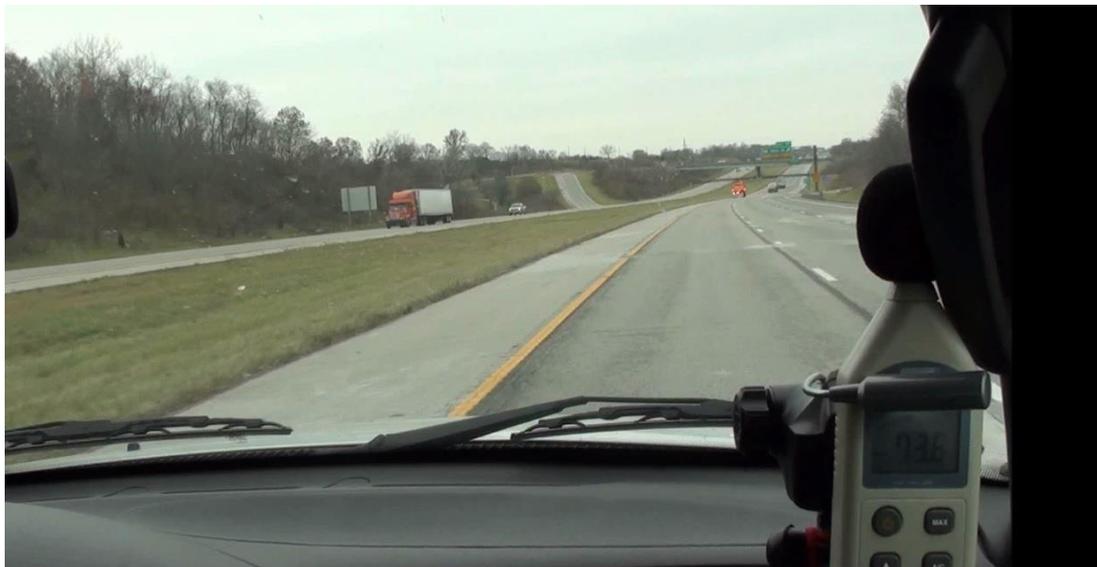
Figure 4.3 Field of view from inside test vehicle

In addition to the sound level parking lot tests, sound levels were also recorded in a test vehicle to evaluate them for compliance with OSHA and NIOSH standards and to investigate the effects of road noise on the sound levels. This was done by having a video camera that recorded the field of view and sound levels inside the test vehicle while passing through the site as shown in Figure 4.3. As the test vehicle approached the TMA vehicle, sound levels were recorded both before and after the alarm sounded.

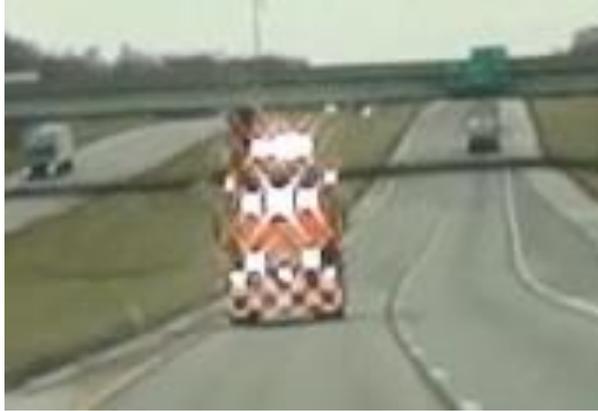
Figure 4.14 Example of a typical warning light setup on TMA truck

Luminance is a measure of light intensity in units of $\frac{cd}{m^2}$ or NITS and was determined for each warning set up. This testing was done to ensure each truck was emitting similar luminance levels to avoid a bias due to a light intensity difference. The luminance levels of the two TMA trucks were found to be comparable. Figure 4.14 shows a typical warning light setup on TMA trucks.

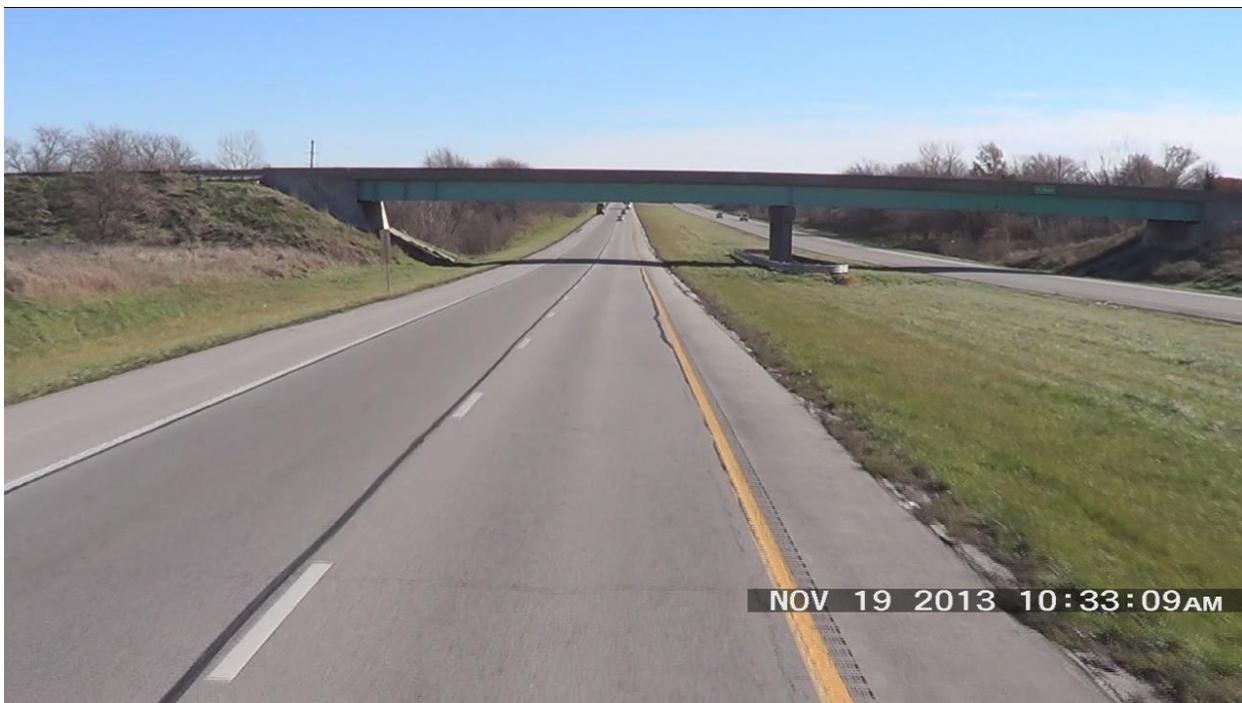
Figure 5.2 Example of video data to be assessed from Alarm Manual setup.

besides merging distances which allowed for analysis of audio data and led to a false alarm and false negative analysis. Manual video data processing also allowed for the collection of vehicle types and roadway geometrics aided in understanding the analysis. As previously mentioned, the photogrammetry is accurate up to distances of approximately 600 ft while active infrared can reach distances of up to 2400 ft depending on the target reflectivity. However, horizontal and vertical curves in the roadway could become an issue in dealing with large distances. Another reason for using photogrammetry was the flexibility of post-processing of videos. The processing of video data allowed for easy replay and analyzing of data to be sure that data was accurate and also facilitated the investigation of undesirable driver maneuvers.

each merge within 15 skips needed to be analyzed further and merges greater than 15 skips were considered the most desirable. However, in looking at Figure 5.2 it is difficult to determine the number of skips greater than 5 skips and therefore there is a need to make it easier to differentiate the farther skips. A calibration process was used to determine the relationship between physical distance and distance on the image. Separate calibrations were performed for the TMA with the Alarm Device and the TMA with the DAS. Each calibration was accomplished by overlaying an image onto the video that had distinct lines at each skip distance. The first step of overlaying was to determine the relationships between actual physical distance and measured distance on the image. This step was done by measuring the skips that were easily differentiated. These points were then plotted and a power trend line for each TMA was applied in order to generate an equation that estimated the image distances of the farther skips. Figure 5.3 shows the regression function for the TMA with the Alarm Device.

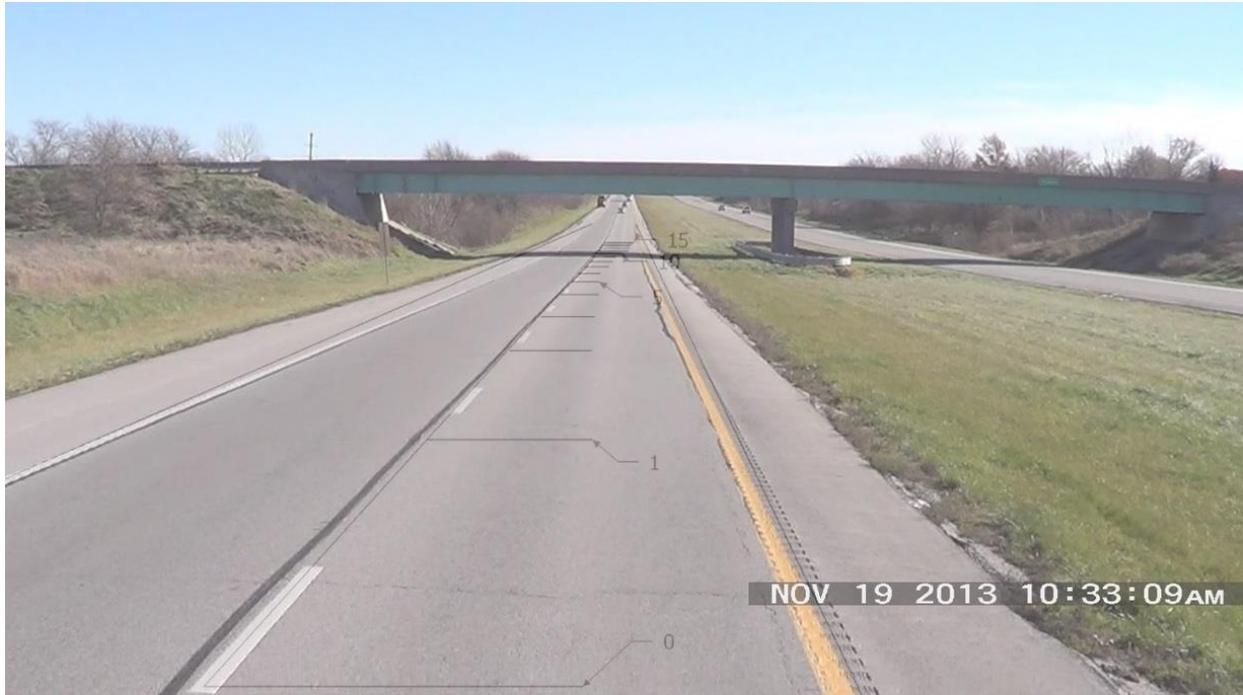
Figure 5.5 Resulting image to be used in vehicle merging analysis for TMA with Alarm Device

By overlaying the drawings with the video file, each skip was easily identified. An example of this combined image for the TMA with the Alarm Device is shown in Figure 5.5.

This resulting image allowed for the determination of vehicle merging distances.

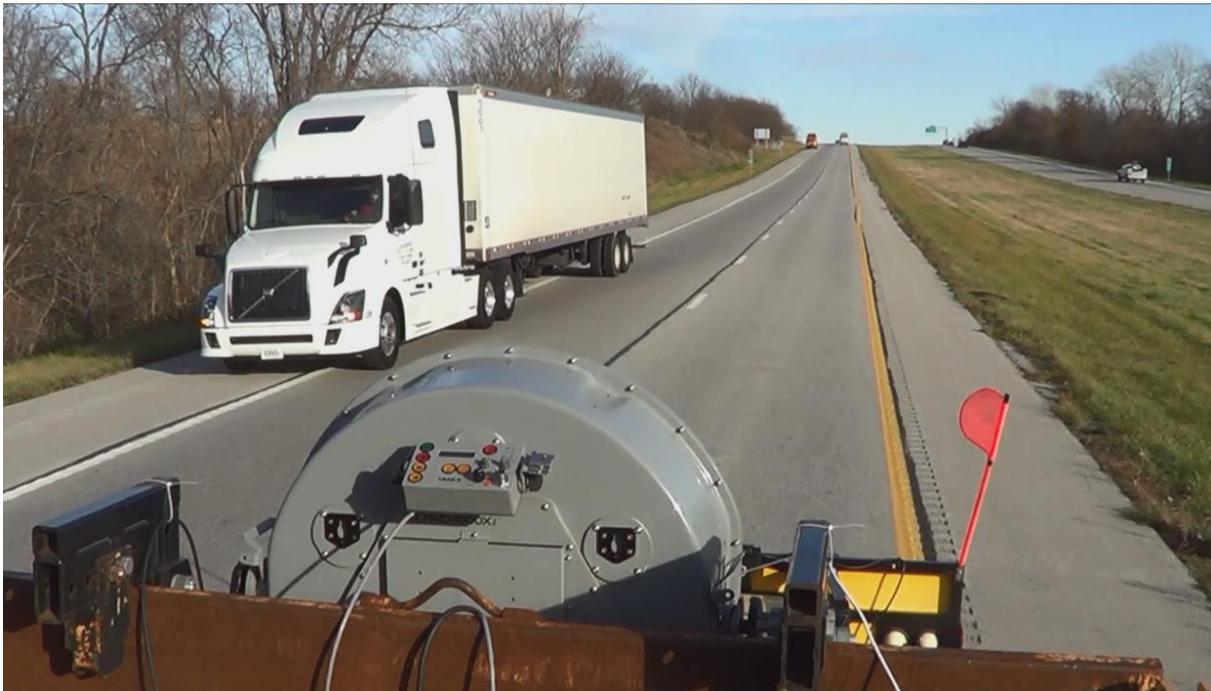
Figure 5.7 Example of vehicle passing TMA on shoulder

Some undesirable driving behaviors were observed with the DAS setups. While the DAS Continuous setup was in operation, some drivers were observed passing the TMA on the shoulder, giving the TMA an additional amount of space while passing. An example of this behavior is shown in Figure 5.7. This behavior could be due to drivers reacting to the presence of a mobile work zone and/or to the alarm and the “Slow Vehicles Ahead” audio message. Some

vehicles dramatically decreased their speed as they moved over to the shoulder to match the speed of the work vehicles. MoDOT personnel indicated that this type of driving behavior has been observed during routine striping operations, so the behavior may not be due to the presence of the mobile work zone alarm.

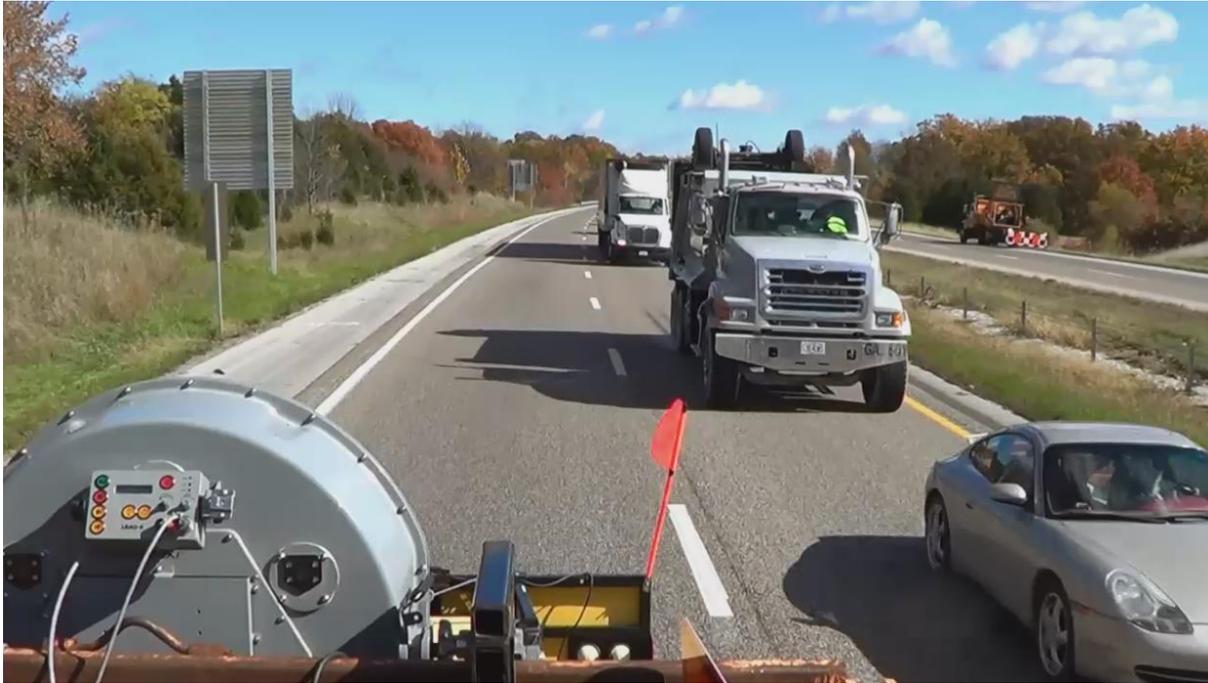
Figure 5.8 Sudden breaking by silver car caused dump truck to have to quickly and forcefully apply the brakes

When the DAS Actuated setup was in effect, some drivers were seen to perform emergency driving maneuvers such as quick merges or swerving, perhaps because drivers were startled by the actuation and reacted to the unexpected DAS sound. Sudden merges or swerving are undesirable from both traffic operations and traffic safety perspectives. An instance in which a driver in a silver car was startled and suddenly applied brakes was seen with the DAS Actuated. What made this example undesirable was the fact that a dump truck was closely behind the silver car that was startled, making the dump truck driver have to suddenly apply the brakes as well. However, the traffic situation in front of the silver car could not be determined

from the video so it is possible that this vehicle was reacting to another event. Therefore, it is unclear whether this undesirable driving maneuver was due to the presence of the DAS Actuated mobile alarm. An image of this event is shown in Figure 5.8.
