5. Top of Deck Evaluation using Photogrammetry and Thermography

5.3 BridgeGuard Passive Infrared Thermography

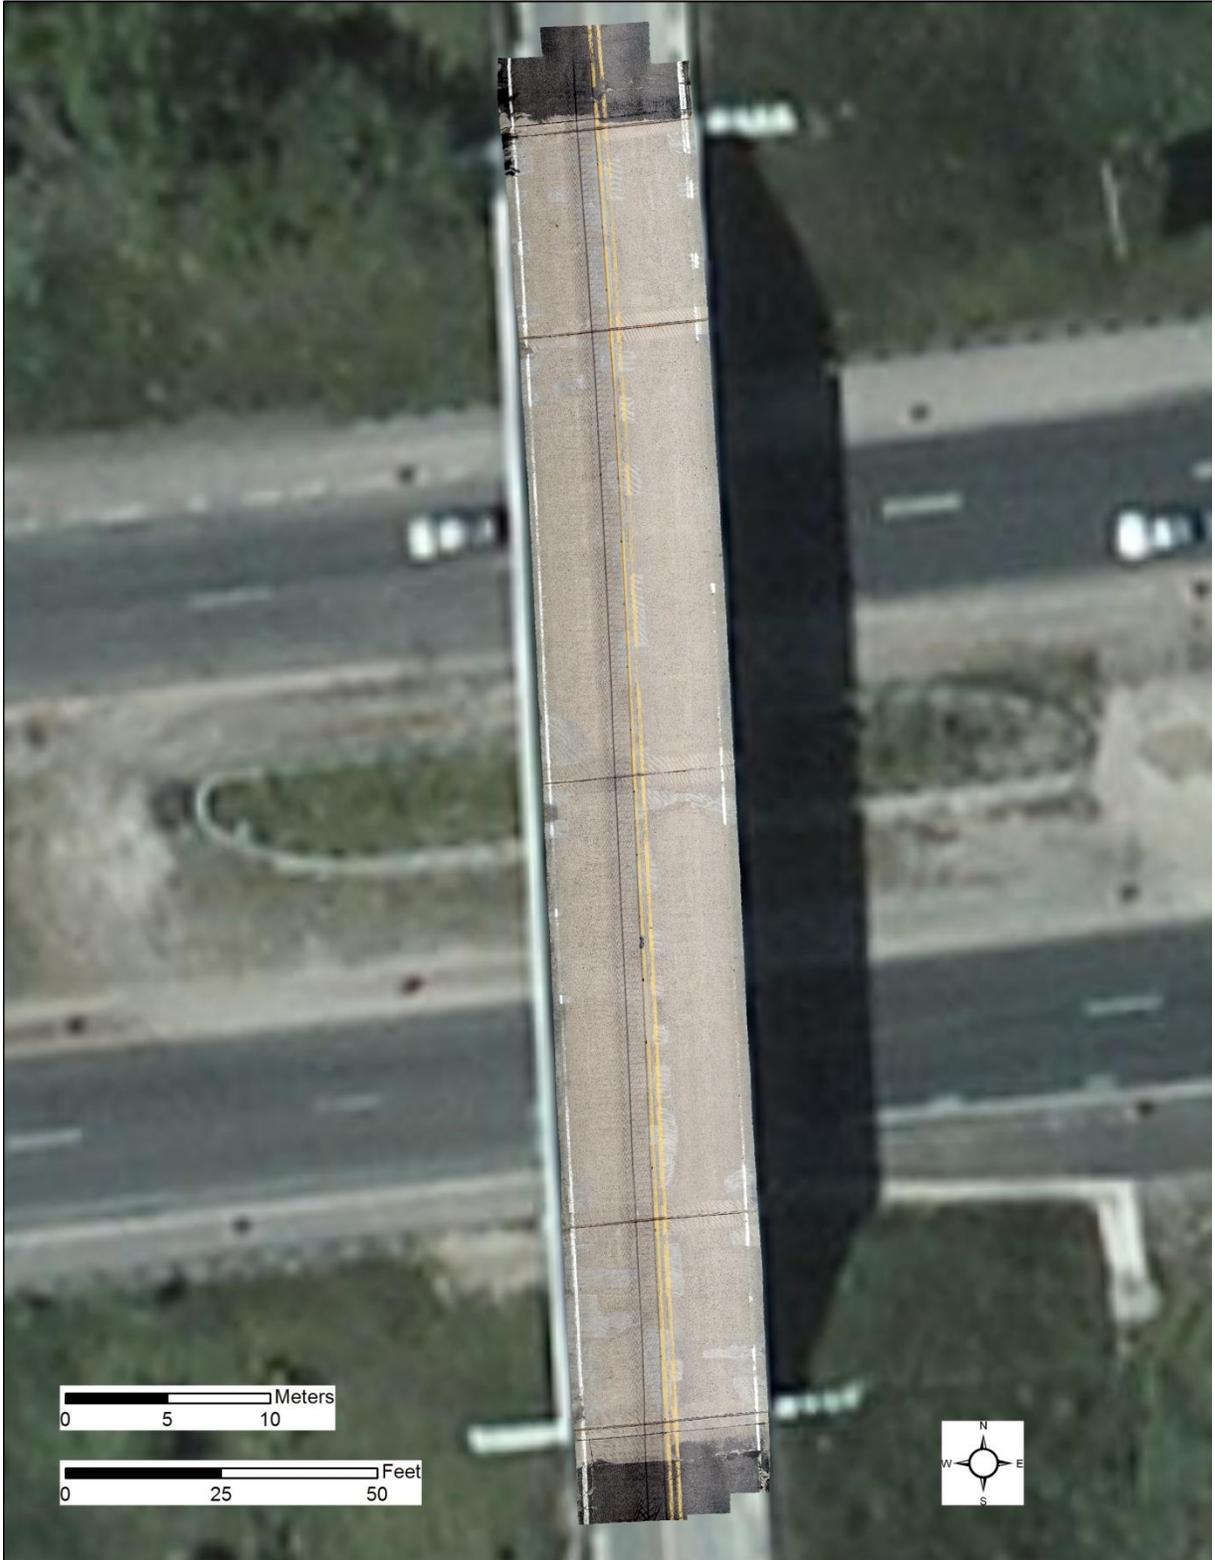
Figure 5-1: Orthoimage of Freer Rd Generated from Imagery Collected from the RED Epic.

This third run down the middle was conducted to increase the overlap between all of the imagery. The effect would be that instead of a single feature only represented in at least five images in a single "flight line" (i.e., a driver over the bridge), it would also be represented in another flight line with at least five more images. The result is that there is greater than 100% overlap in the imagery, which would increase the chances of the software to correctly align the images and calculate depth (Figure 5-1 and Figure 5-2).

Using the new imagery from the Freer Road structure, Agisoft was able to correctly align the photos and create a DEM of the bridge deck. It confirmed that under situations where the bridge deck is in good conditions and contains very little or no distresses it is difficult to reconstruct 3DOBS outputs without additional imagery overlap. For bridges with significant spalls or other features, only a single pass per lane is needed, as there would be enough 3D information in the imagery for accurate reconstruction. Table 5-1 below is a table displaying the minimum distress sizes that 3DOBS Near Highway Speed can resolve.

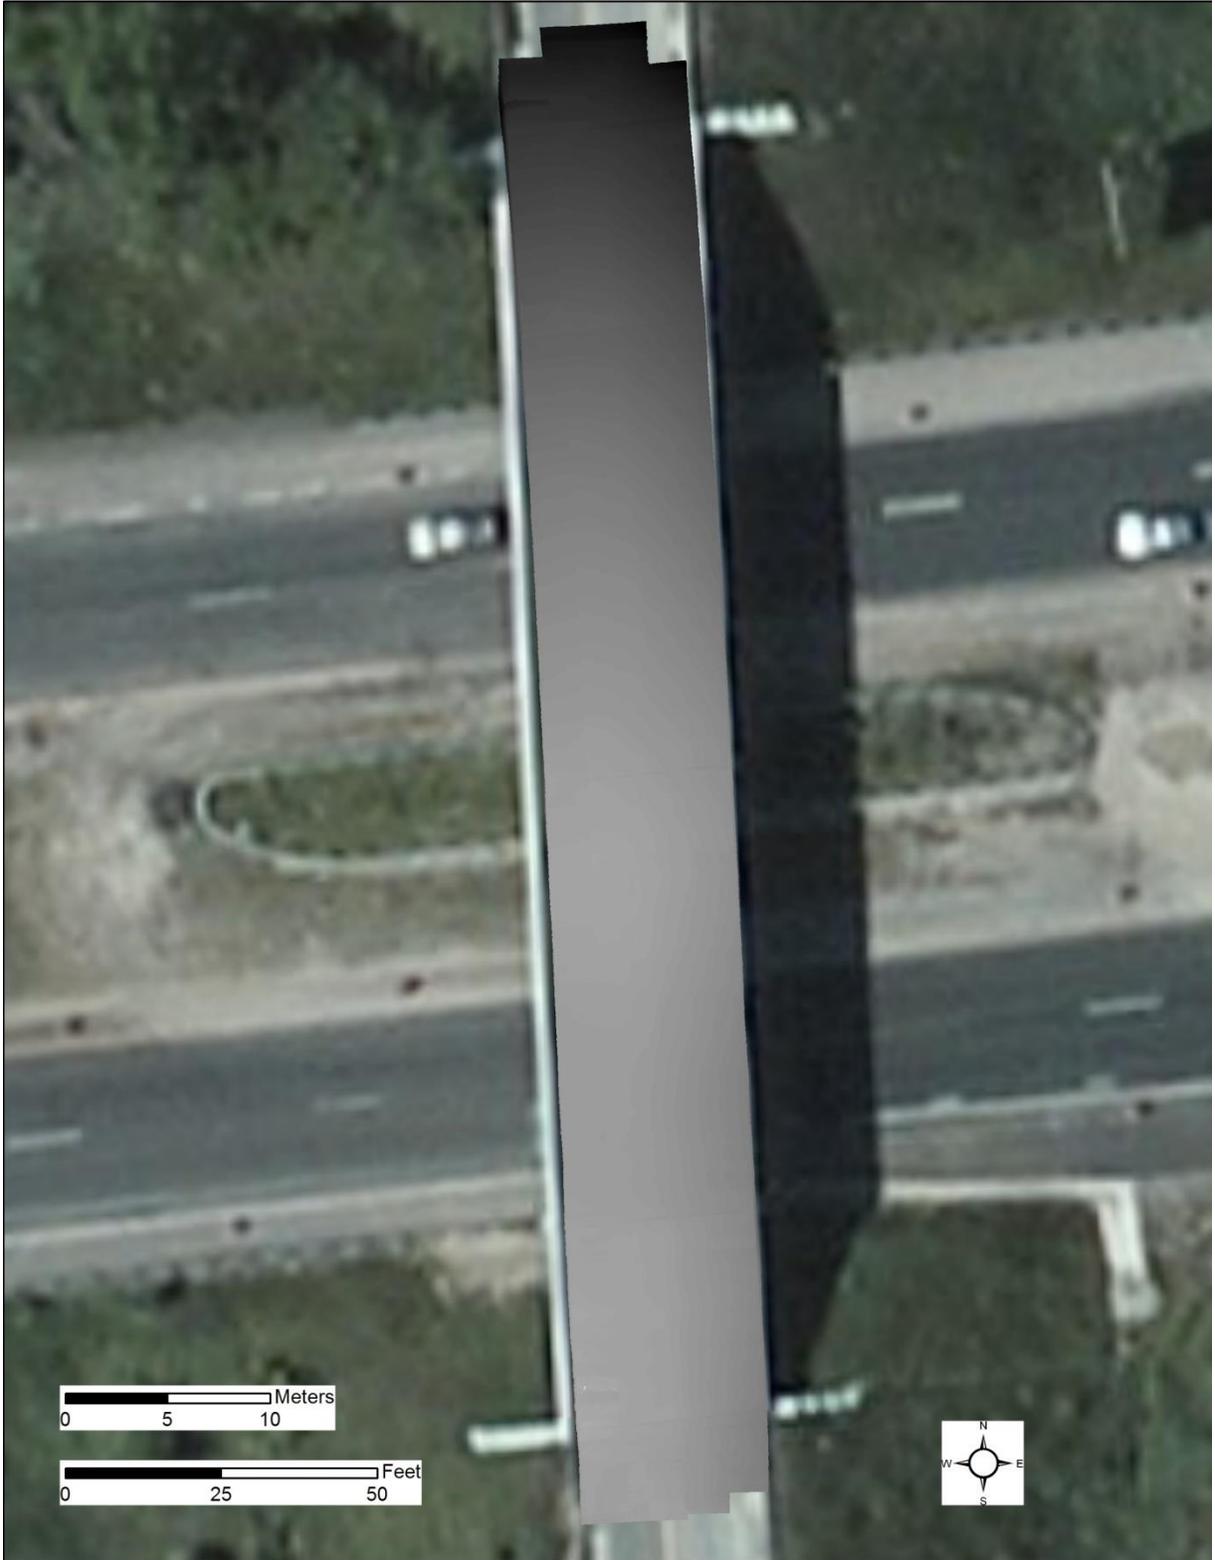
Figure 5-2: DEM of Freer Rd Generated from Imagery Collected from the RED Epic.

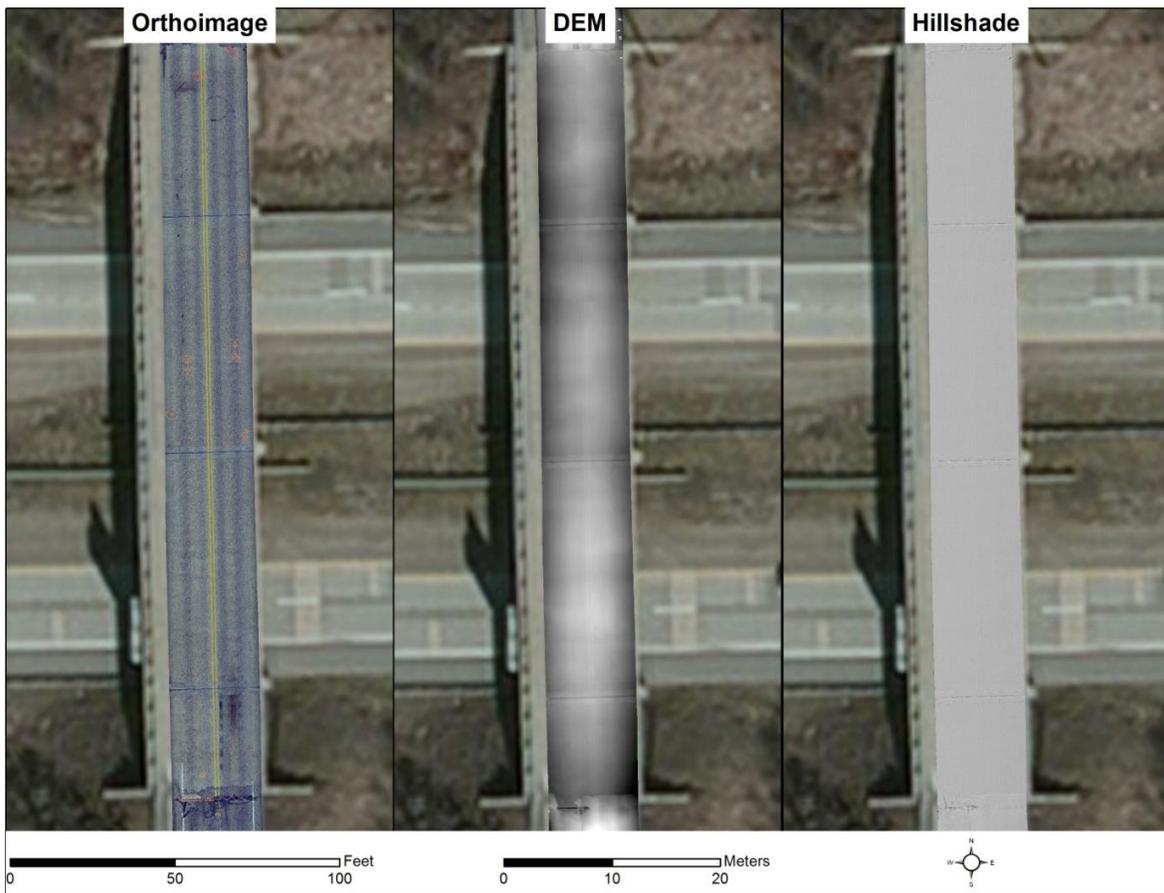
Figure 5-3: Overview of the Orthoimage, DEM and Hillshade Layers Generated from 3DOBS High Resolution over Maryland Ave.

The imagery collected from 3DOBS high-res was processed through Agisoft to generate an orthoimage, DEM and hillshade of Maryland Ave (Figure 5-3) and Freer Rd (Figure 5-5). The resulting x,y resolution of the Agisoft output is 0.5 mm and is shown in detail in Figure 5-4 and Figure 5-6.

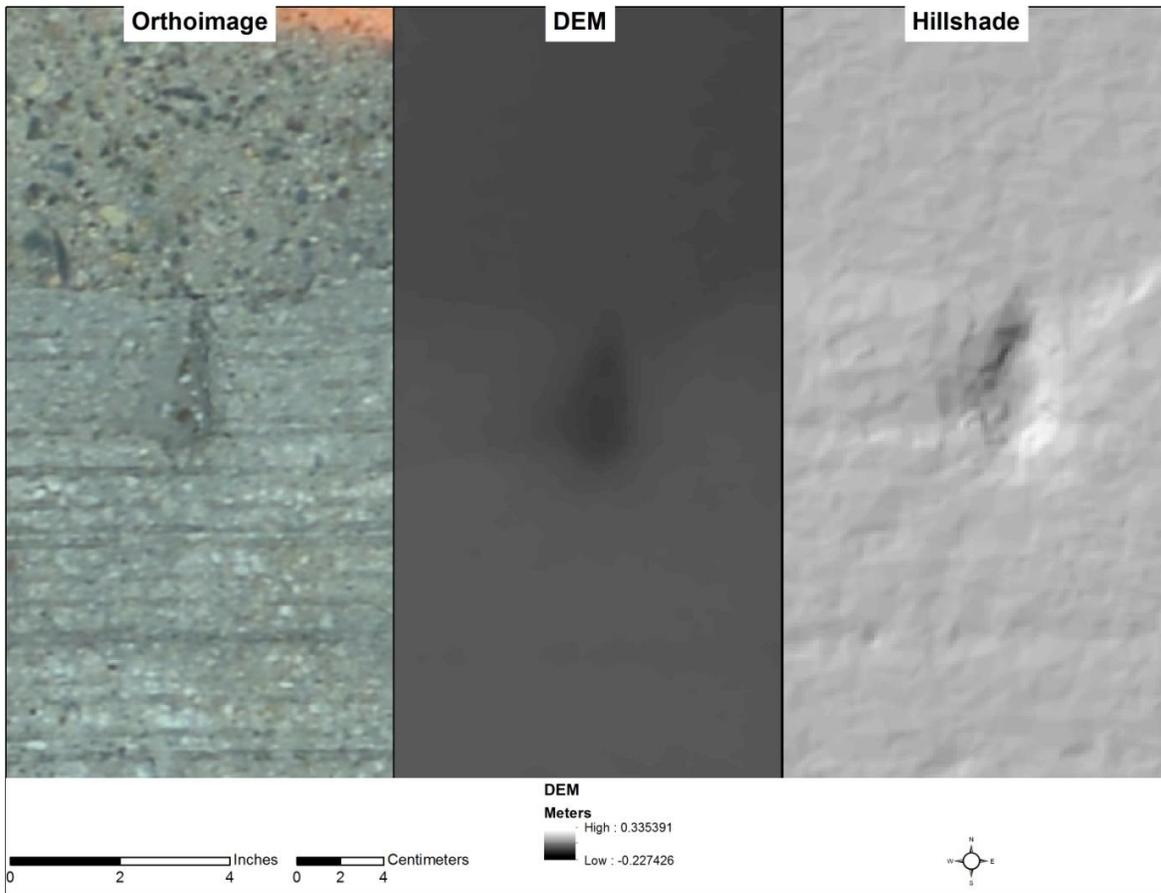
Figure 5-4: Zoomed In View of the Orthoimage, DEM and Hillshade Layers Generated from 3DOBS High Resolution over Maryland Showing 0.5 mm Resolution of the Outputs.

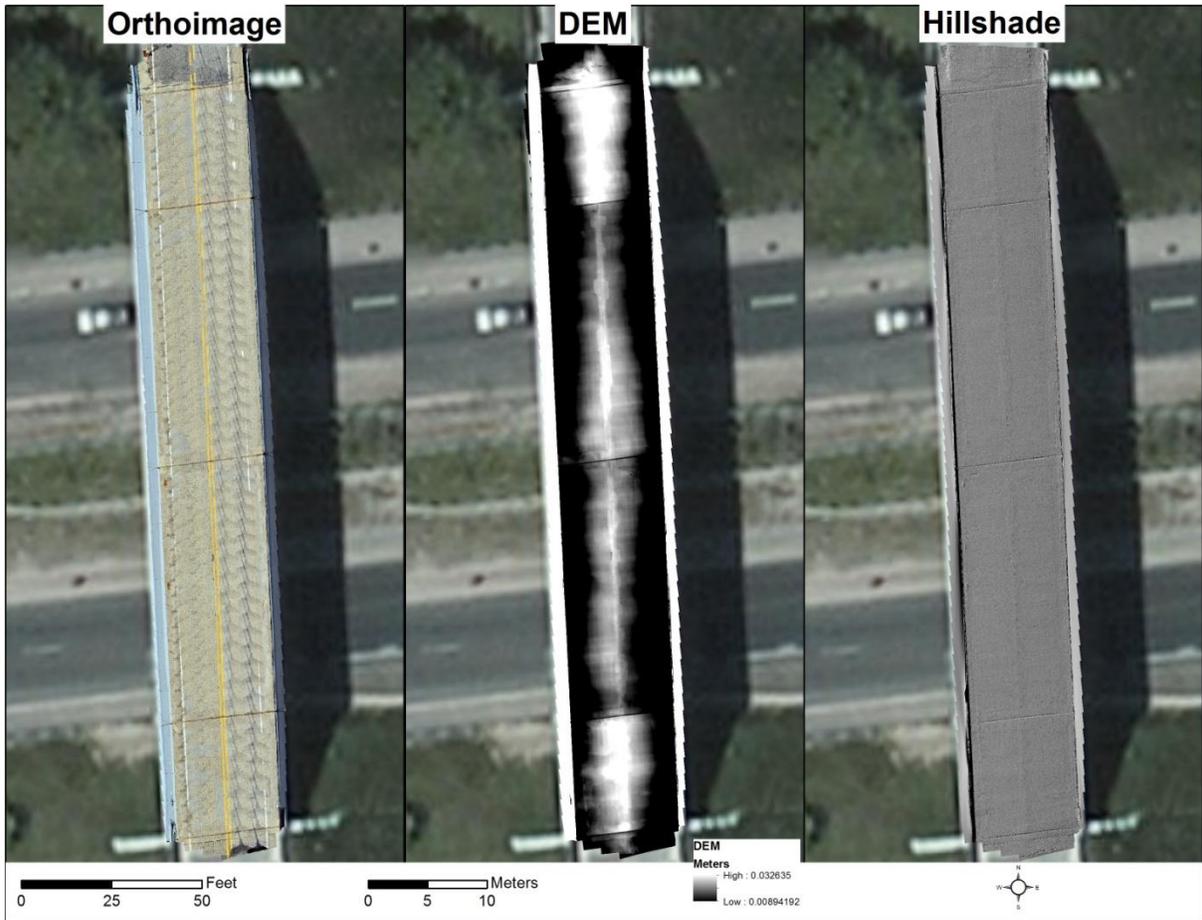
Figure 5-5: Overview of the Orthoimage, DEM and Hillshade Layers Generated from 3DOBS High Resolution over Freer Road.

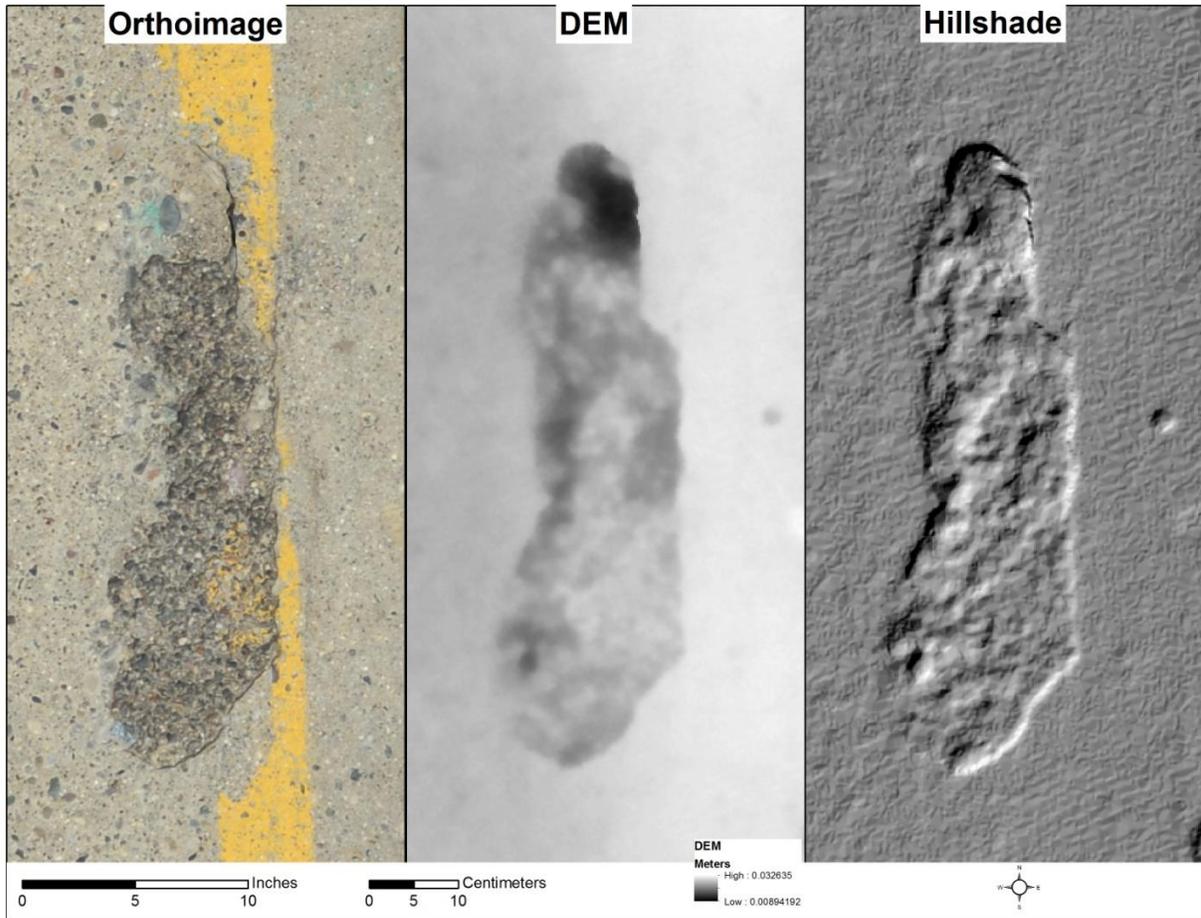
Figure 5-6: Zoomed in View of the Orthoimage, DEM and Hillshade Layers Generated from 3DOBS High Resolution over Freer Rd. showing 0.5 mm Resolution of the Outputs.

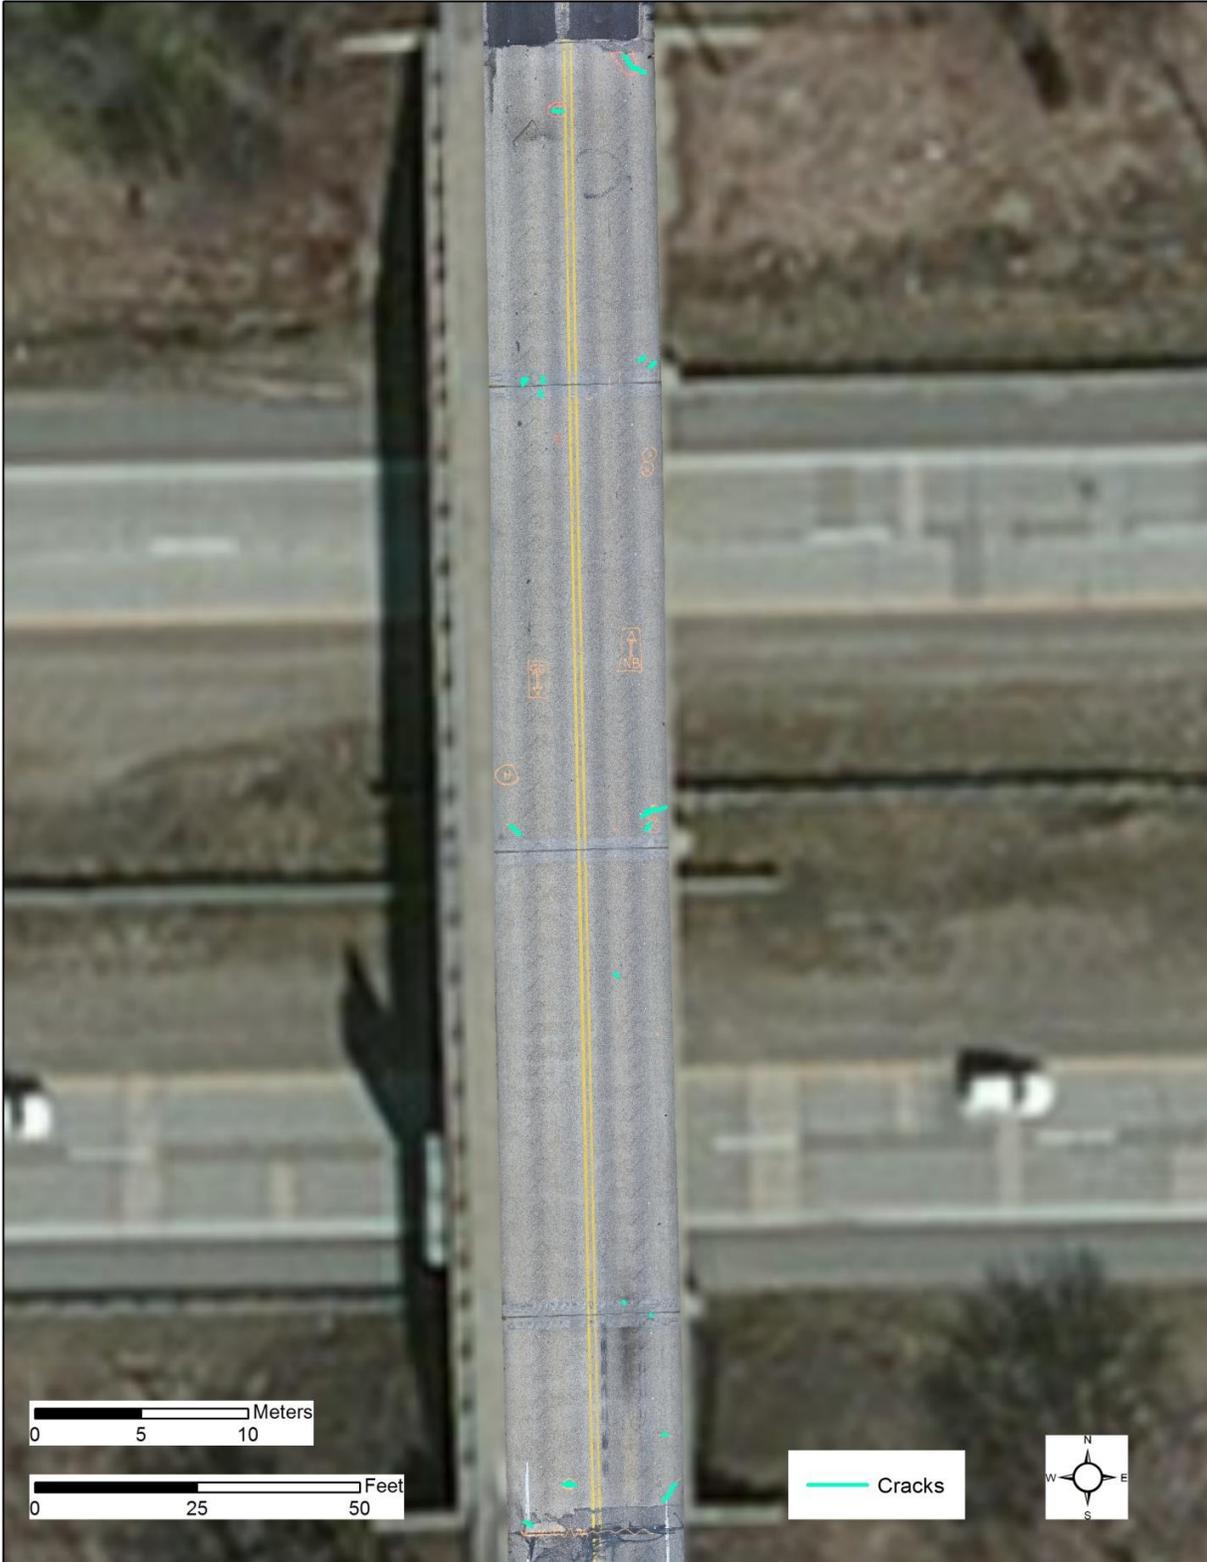
Figure 5-7: Detected Cracks on Maryland Ave.

Crack detection was performed through visual inspection of the orthoimagery. With a resolution of 0.5 mm the smallest crack that could be seen is at least 1 mm or just over 1/32nd of an inch. Smaller cracks are not detectable since there needs to be at least two pixels over the crack in order for the crack to show in the imagery. For Maryland Ave (Figure 5-7) where MDOT marked some of the cracking, a visual inspection of the orthoimage located more cracking. Freer Rd also had some cracking but it was not marked by MDOT prior to the field data collection (Figure 5-8). Table 5-2 below is a table displaying the minimum distress sizes that 3DOBS High Resolution can resolve.

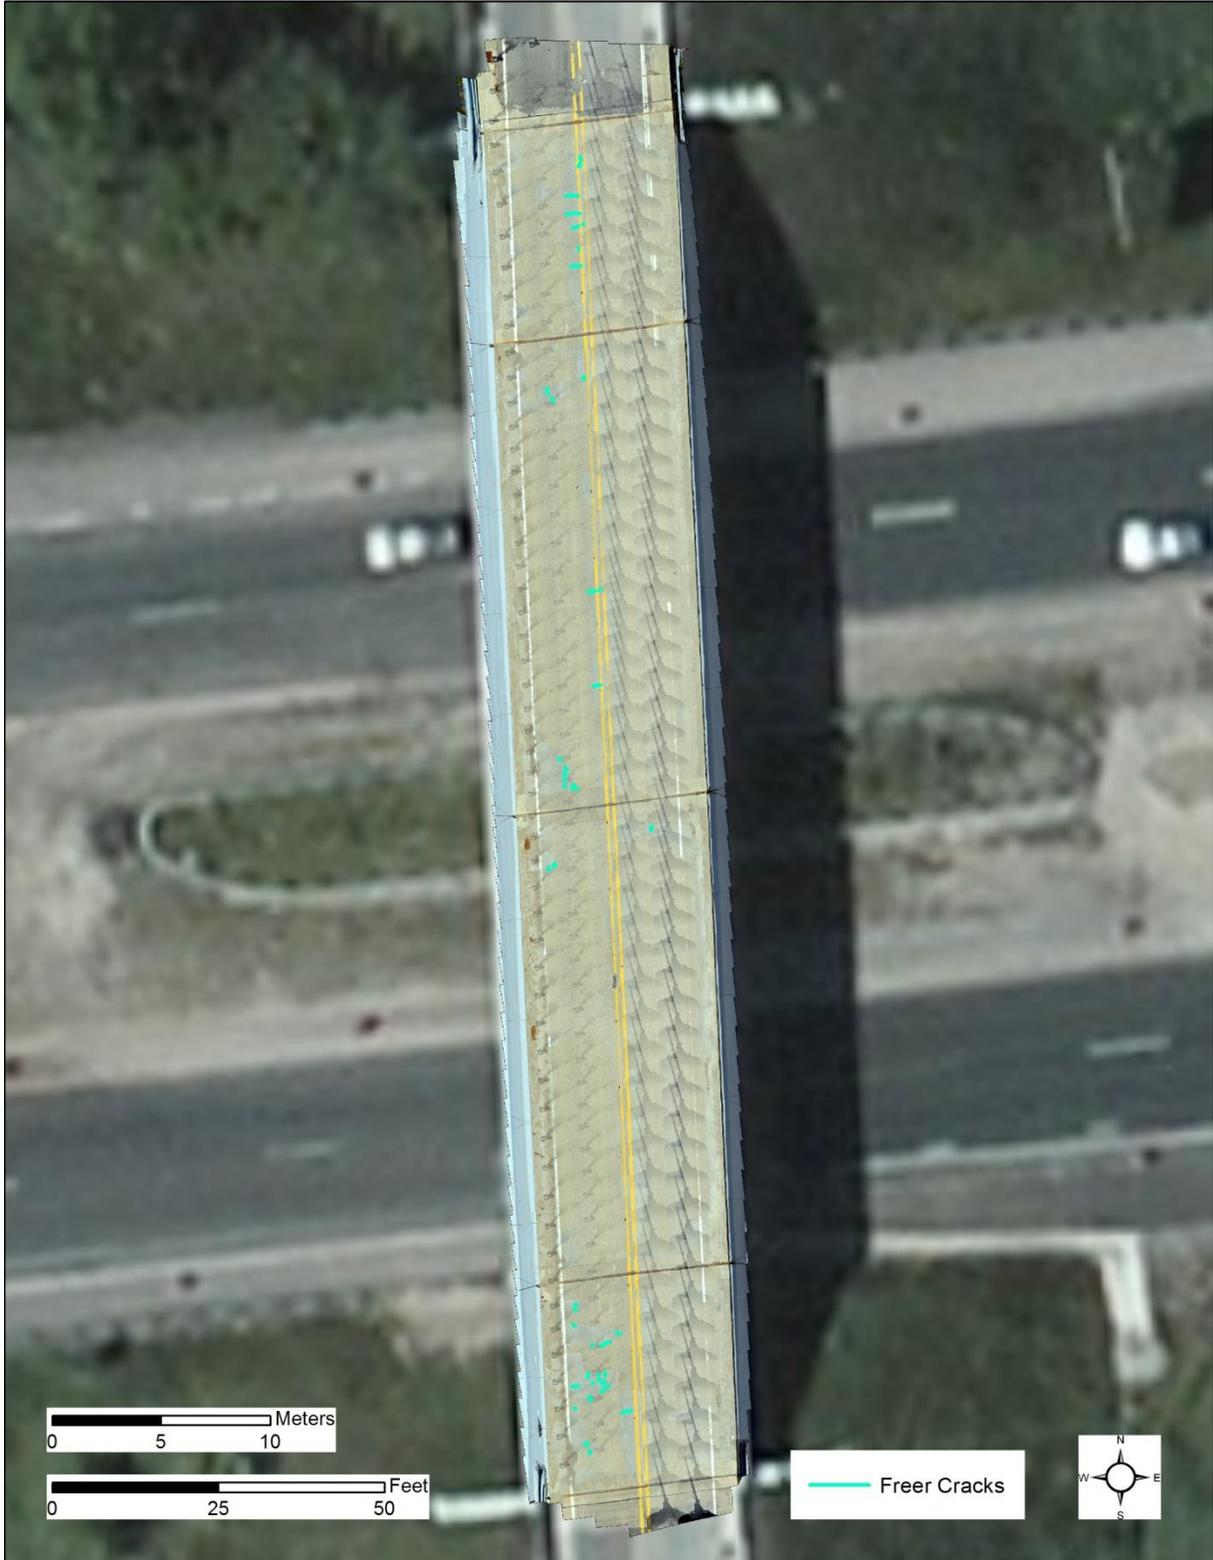
Figure 5-8: Detected Cracks on Freer Rd.

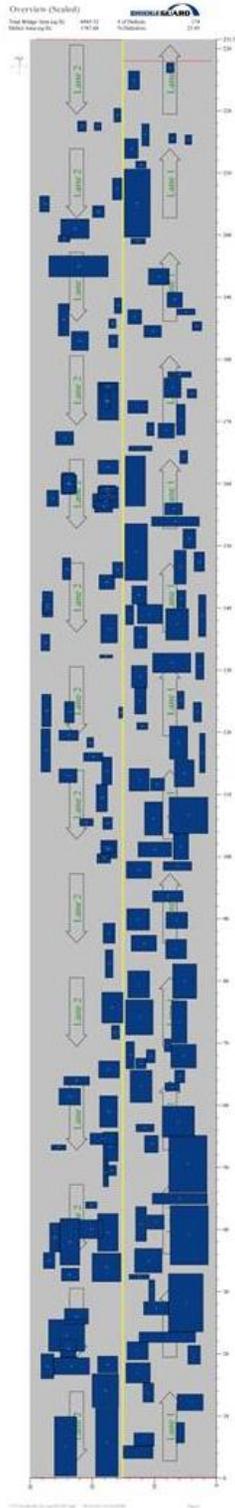
Figure 5-9: Location of Potential Delaminations as Determined by BridgeGuards Thermal Survey on 20 Mile Rd.

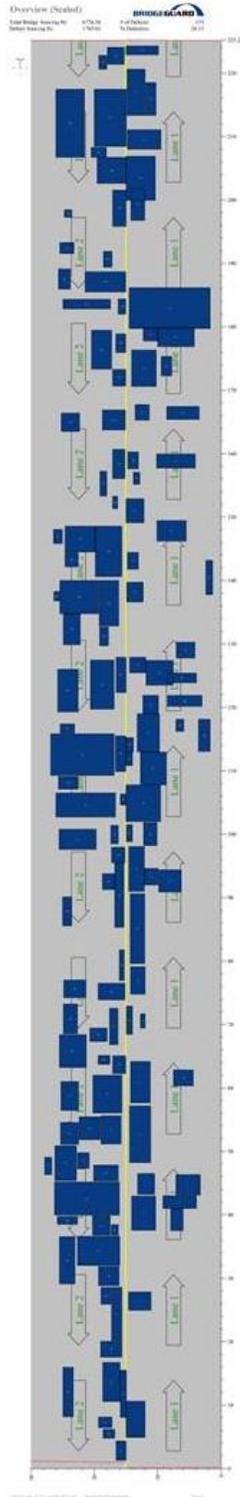
Figure 5-10: Location of Potential Delaminations as Determined by BridgeGuards Thermal Survey on 24 Mile Rd.

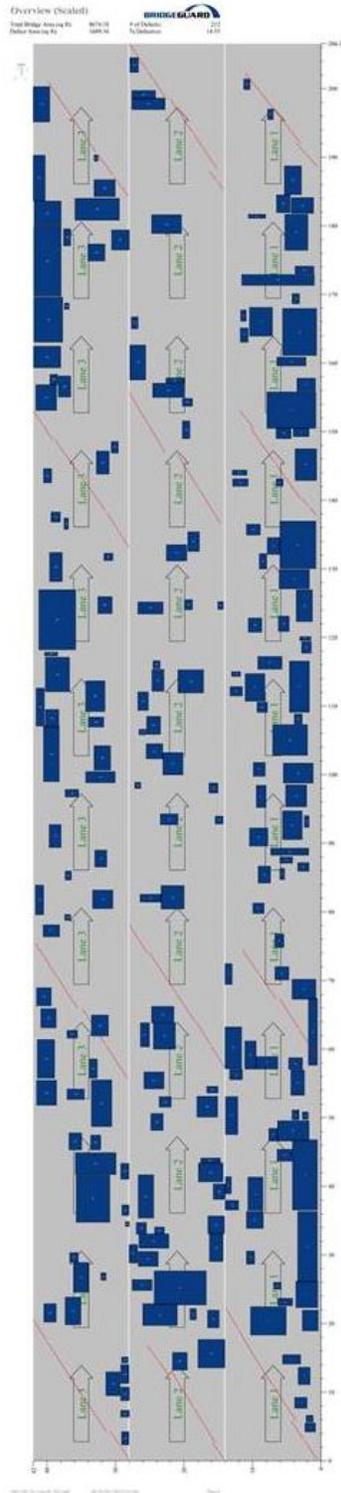
Figure 5-11: North Bound Lanes of US-131 Showing Potential Delaminations from the BridgeGuard Survey.

US-131 consists of two bridges, each with its own report. For the north bound lanes the BridgeGuard assessment determined there was 1,609 ft² of potential delaminations (Figure 11). The south bound lanes contained 989 ft² of potential delaminations according to BridgeGuard's analysis (Figure 12). By comparison MDOT reported there was 2,072 ft² for the north bound lanes and 759 ft² for the south bound lanes.

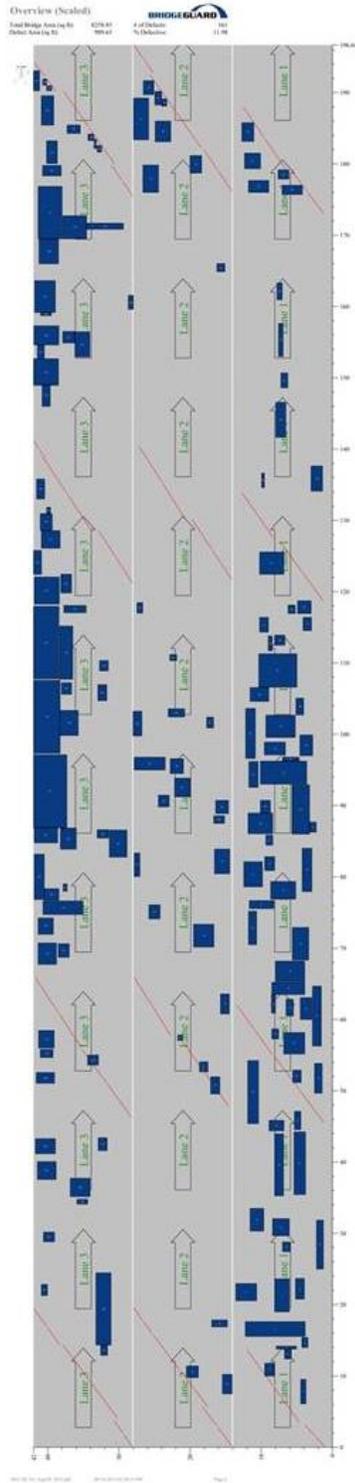
Figure 5-12: South Bound Lanes of US-131 Showing Potential Delaminations from the BridgeGuard Survey.

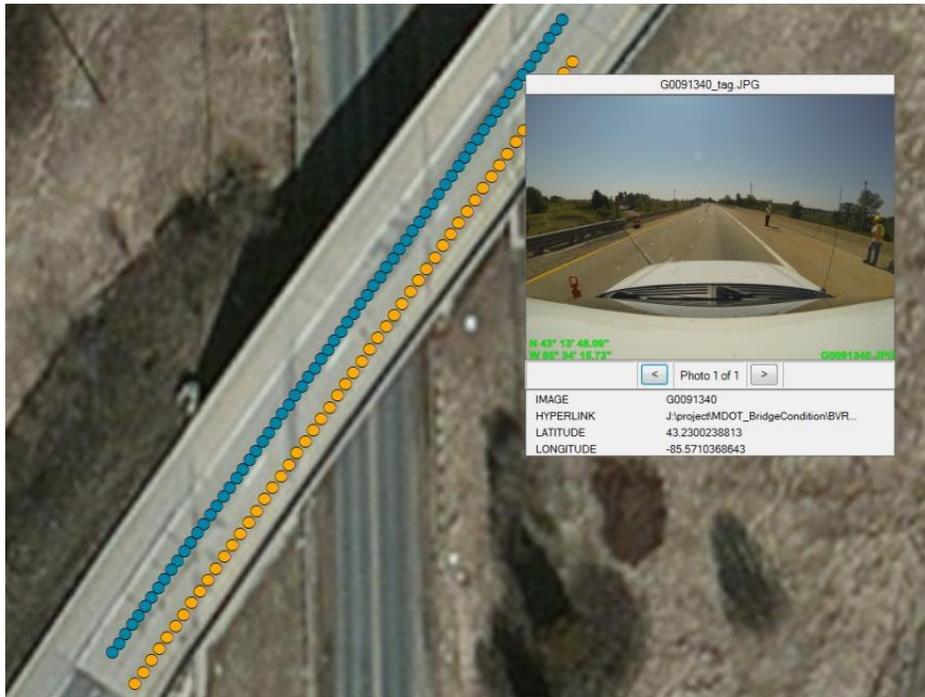
Figure 5-13: BridgeViewer Collect on US-131 near Grand Rapids, MI. For this Collect the Cameras were Mounted to the Roof of the Vehicle since the Hood was not Steel.

Imagery collected with BridgeViewer was geotagged using the track log from the GPS used in the vehicle. The geotagging process produces a shapefile of the picture locations as well as watermarked pictures that include the Lat/Lon and date/time (Figure 5-13). The imagery from the two cameras was also separated into right and left as they were mounted (Figure 5-14). Because there was only one GPS, the photos were tagged to the center of each lane. The shapefile is then edited to separate the right and left cameras to represent the offset as they were collected.

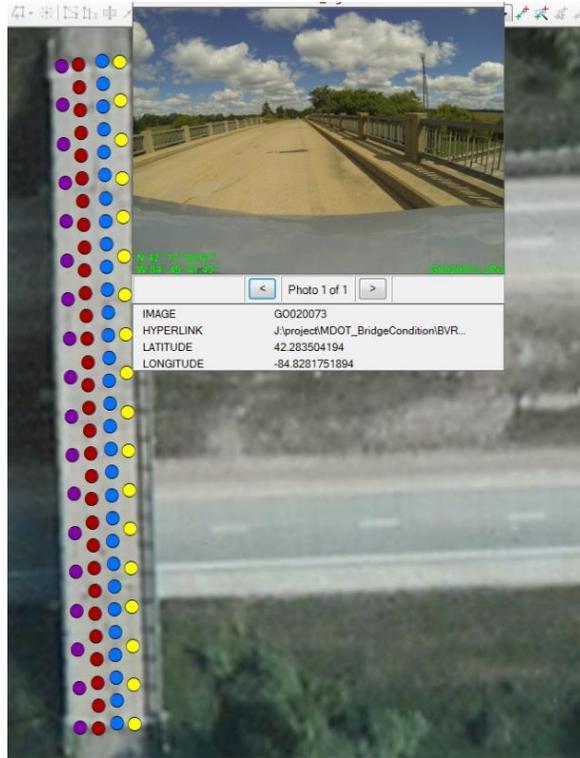
Figure 5-14: BridgeViewer collect of 24 Mile Rd near Marshall, MI.

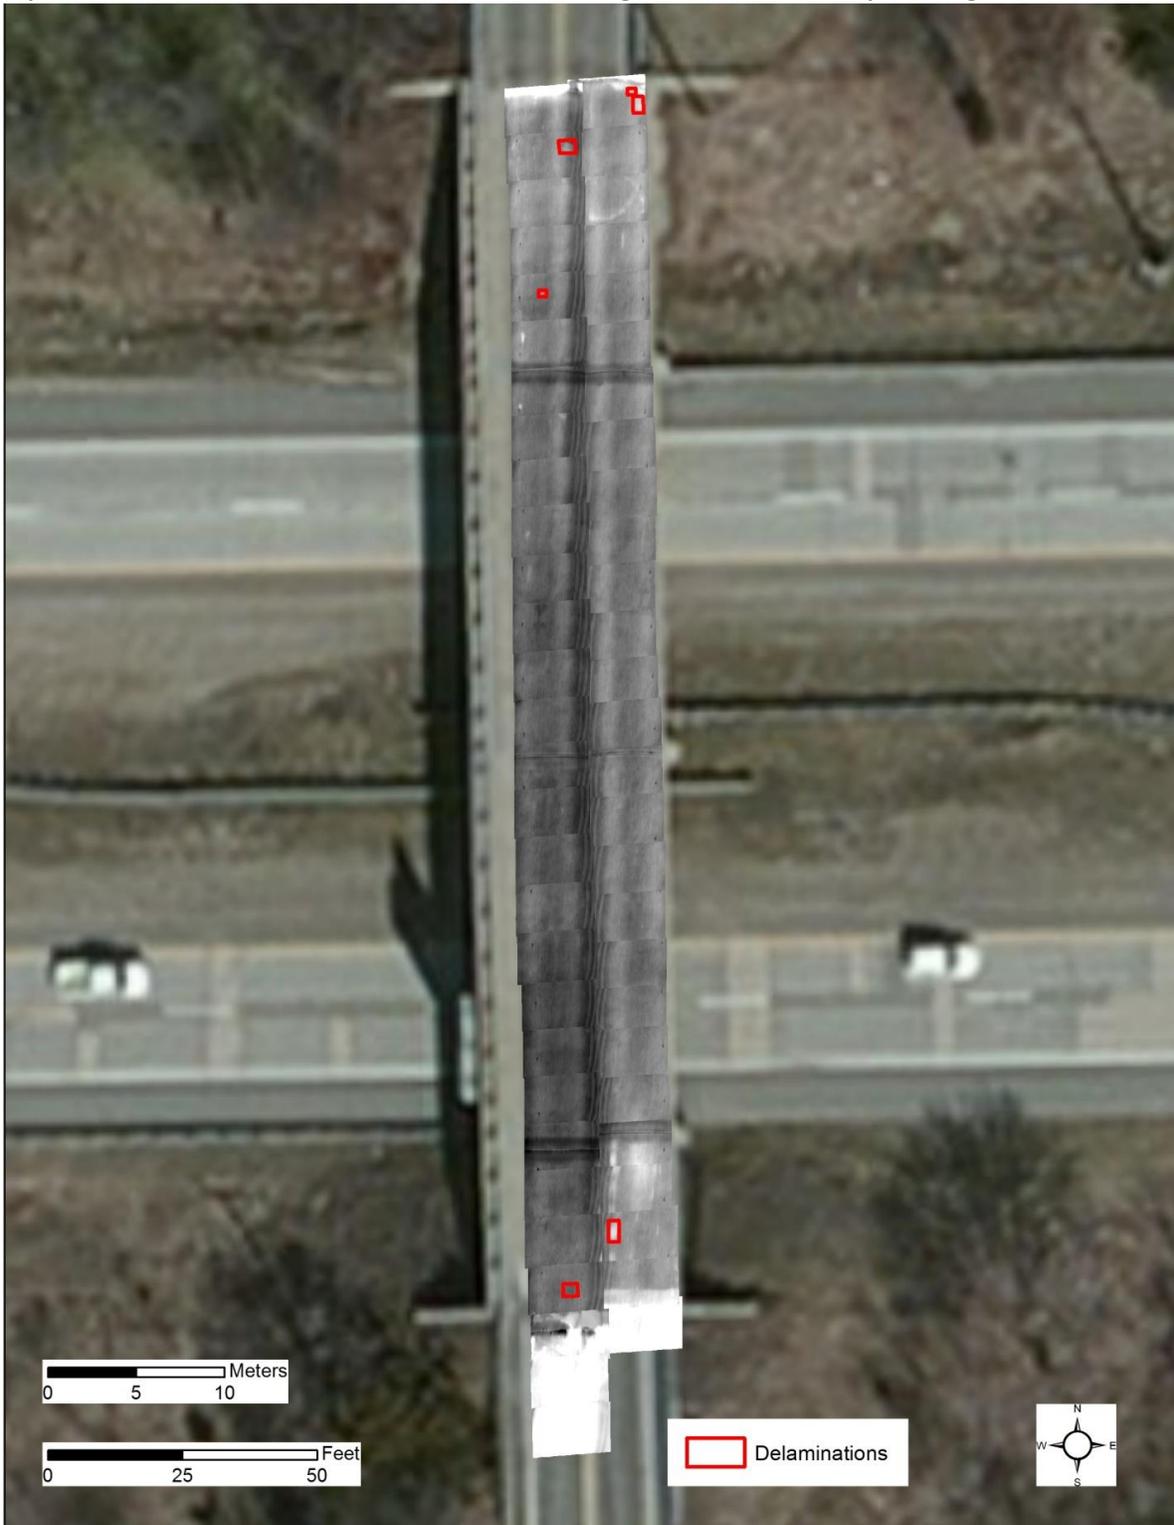
Figure 5-15: BridgeGuard Imagery as Georeferenced Layers with Delaminations Shapefile.

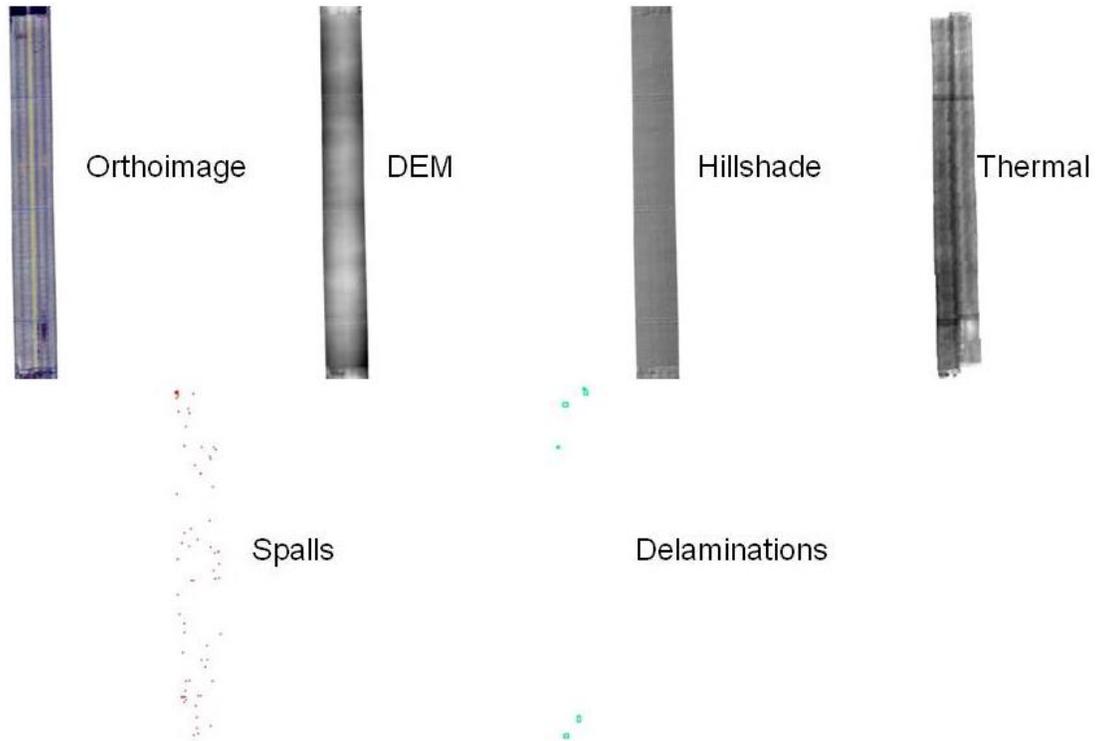
Figure 5-16: All of the Data Sets Created from the Combined System.

analyze spalls and delaminations simultaneously (Figure 5-16). Spalls and delaminations can easily be visualized while overlaid on the orthoimage or the thermal layers (Figure 5-17).

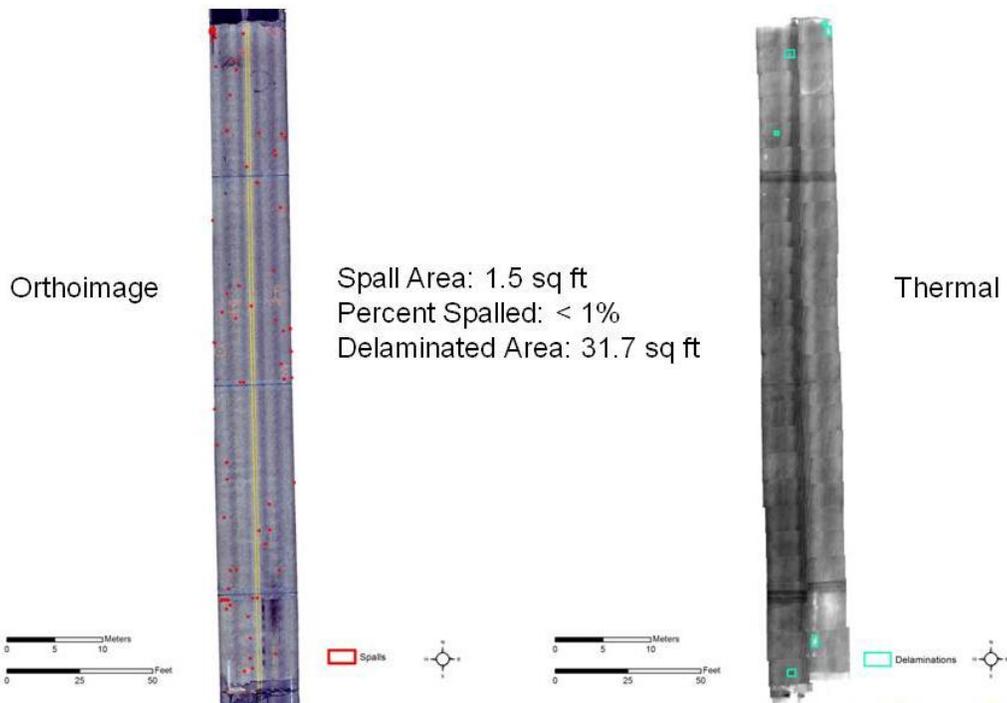
Figure 5-17: Comparison of the Results Generated from 3DOBS High Speed and the BridgeGuard Thermal Cameras as a Combined System over Maryland Ave.

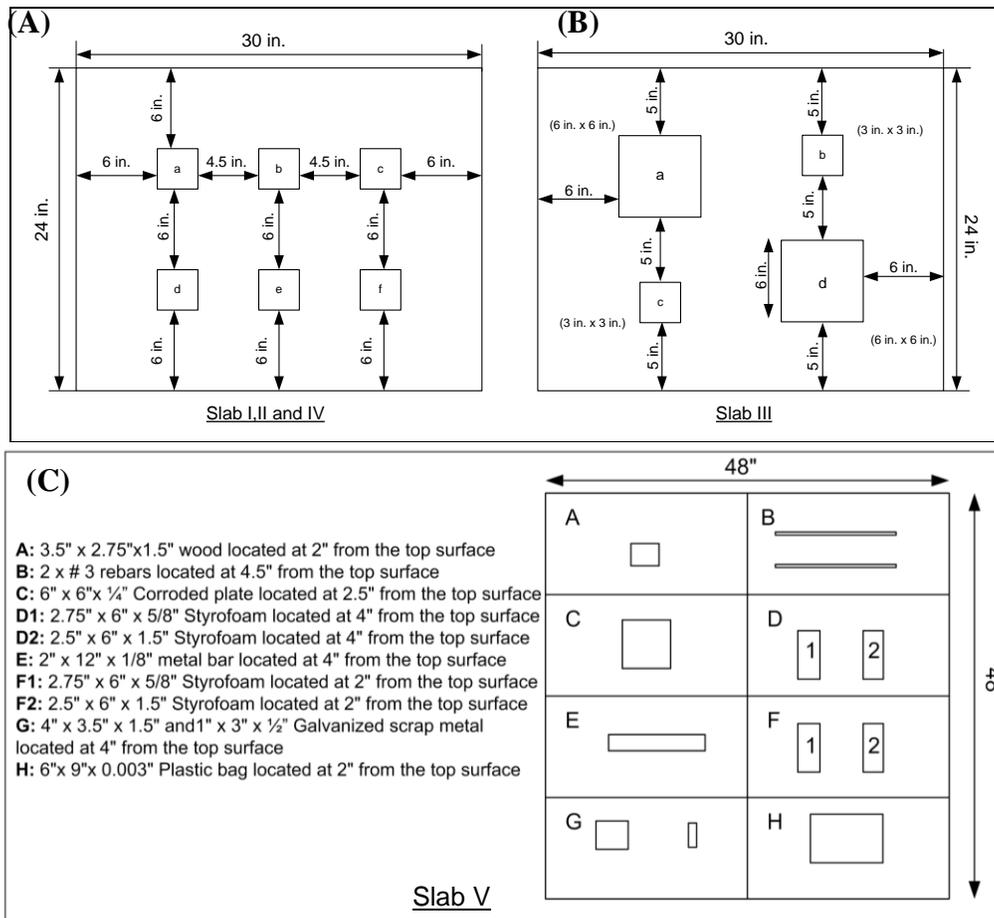
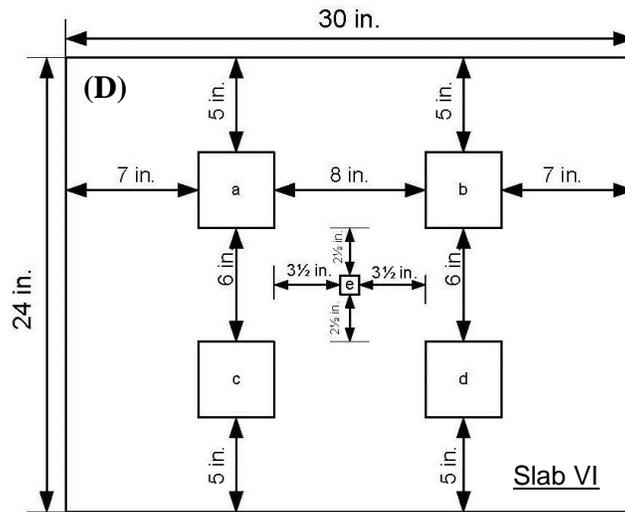
The plan layout for Slabs I-VI are shown in Figure 6-1. All simulated delaminations shown in Figure 6-1 (A) are 3 in. x 3 in. x 3/8 in. Styrofoam blocks. The selected defect size allowed for the placement of six delaminations in the concrete slab with sufficient distance to the edges of the specimen. Simulated delaminations in Slabs I-IV were placed at varying depths inside the concrete slabs. The Styrofoam was positioned at these various depths using fishing line and concrete was cast around the blocks. Care was taken when placing concrete to ensure the simulated delaminations remained level to the surface of the specimen and at the planned height.

(a, b, c, d) 4 in. x 4 in. x 3/8 in. Styrofoam
 (e) 1 in. x 1 in. x 3/8 in. Styrofoam

Test specimen III was constructed using Styrofoam blocks of different sizes. Simulated delaminations (a) and (d) in the plan layout for Slab III (Figure 6-1 (B)) have dimensions of 6 in. x 6 in. x 3/8 in. while delaminations (b) and (c) have dimension of 3 in. x 3 in. x 3/8 in. These sizes were selected to investigate the effects of delamination size and depth on defect detection using active IR thermography.

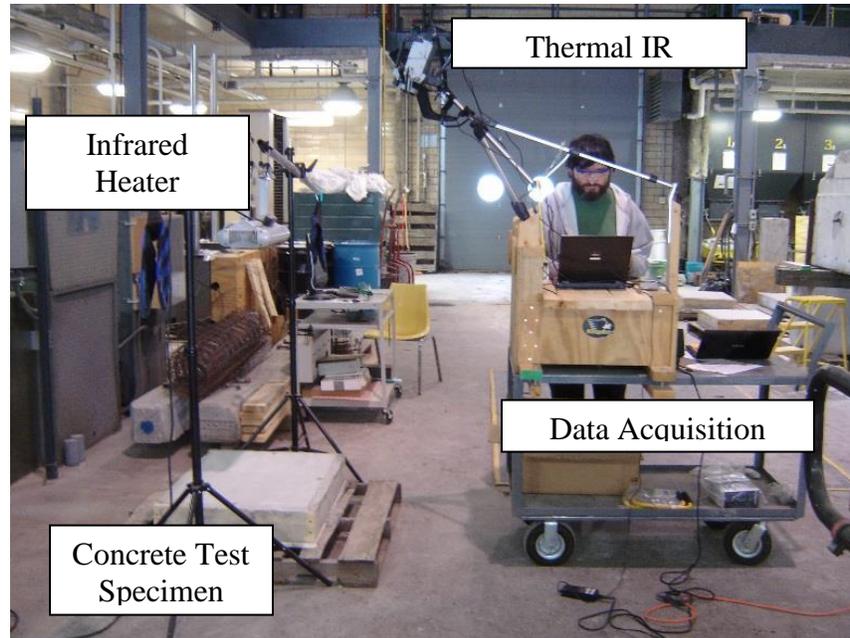
top of a wheeled cart to allow for camera repositioning. A camera angle of approximately 20° to 30° from vertical was used to ensure the image of the heater was not captured. This relatively small angle was necessary to analyze the relative shapes, locations, and depths of the simulated delaminations. Figure 6-2 shows the laboratory experimental set-up.

Figure 6-2: Experimental Laboratory Set-Up.

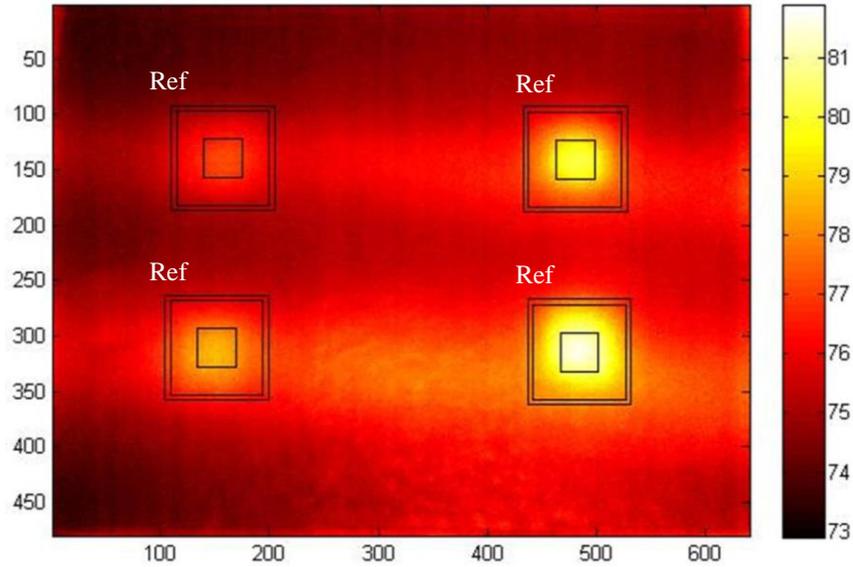
Figure 6-3: Selected Delamination Area and Background Reference Area for Slab VI used to Calculate Absolute Contrast.

The representative area above a simulated defect was selected throughout all laboratory experiments using subjective interpretation based on the size and shape of the simulated delaminations and on the visible areas of temperature contrast between suspected delamination and areas of sound concrete in the thermal infrared images (Vaghefi and Ahlborn 2013). It should be noted that the intention of the bounded area above the defect is to calculate absolute contrast with respect to the reference background area and is not necessarily an accurate representation of the actual size of the subsurface defect. The background reference area for each individual delamination can also be located subjectively, however, for this study, the reference area was defined as a rectangular box-shape around each delaminated area with a thickness of 5 pixels. This shape was chosen to account for non-uniform heating patterns across the concrete surface. Once the delaminated area and background reference area were selected, Equation 1 was used to construct an absolute contrast graph. Figure 6-3 shows the background reference area configuration on a thermal infrared image taken 6.5 minutes after the heater was turned off during one of the laboratory tests. The figure was produced in Matlab using data obtained from the ThermaCAM software. “Ref” indicates the background reference area (sound concrete) close to the delamination that was considered for determining the temperature of the background and the absolute contrast of each delamination.
