5. Top of Deck Evaluation using Photogrammetry and Thermography

5.3 BridgeGuard Passive Infrared Thermography

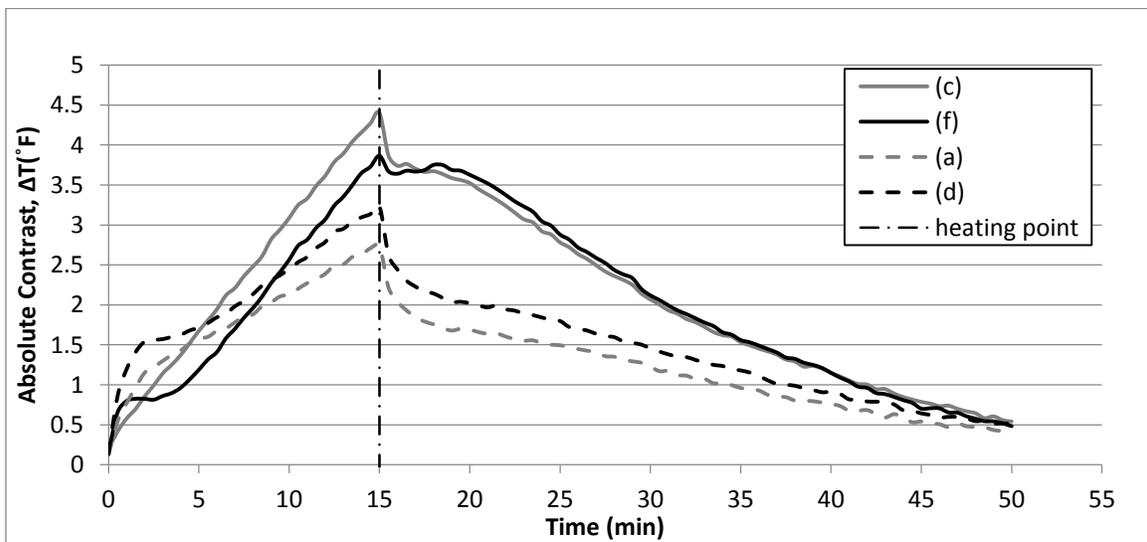
Figure 6-4 shows the absolute contrast variation of delaminations for one of the laboratory experiments using a reference background. Absolute contrast graphs are obtained to determine the observation time of each simulated delamination and to estimate the depth of delaminations relative to one another based on the values of maximum absolute contrast. For example, from the graphs presented in Figure 6-4, it can be seen that delaminations (c) and (f) appeared with higher absolute contrast values than delaminations (a) and (d) and can therefore be estimated as deeper defects.

Figure 6-4: Absolute Contrast Variation above Simulated Delaminations for one of the Conducted Laboratory Tests.

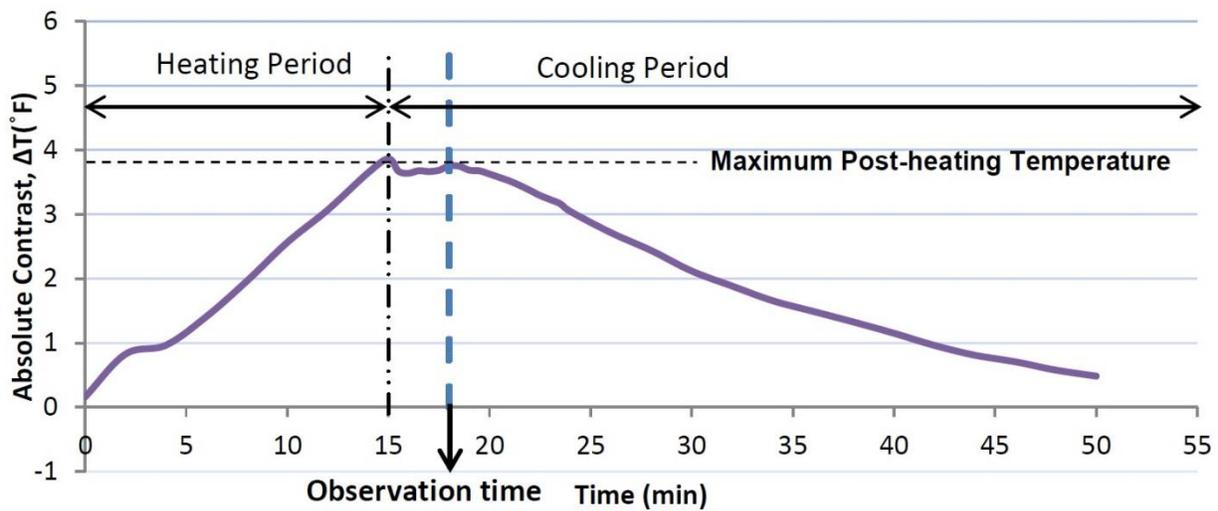
Observation time is defined as the time at which delaminated areas appear on a thermal infrared image with the maximum absolute contrast after the heating period of active IR thermography or at the vertex of negative convexity of the absolute contrast variation graphs (Vaghefi 2013). Observation time is determined by monitoring the absolute contrast of each suspected delamination during both the heating and cooling periods of active IR testing. Because observation time is dependent on the interpretation of the absolute contrast graphs, the method of calculating absolute contrast and the subjective selection of defect areas and sound concrete background reference areas will have an effect on estimating this time step value (Vaghefi 2013). Figure 6-5 shows a diagram depicting the process of determining the observation time using an absolute contrast graph.

Figure 6-5: Definition of Observation Time Shown on an Absolute Contrast versus Time Graph Obtained from an Active IR Thermography Test.

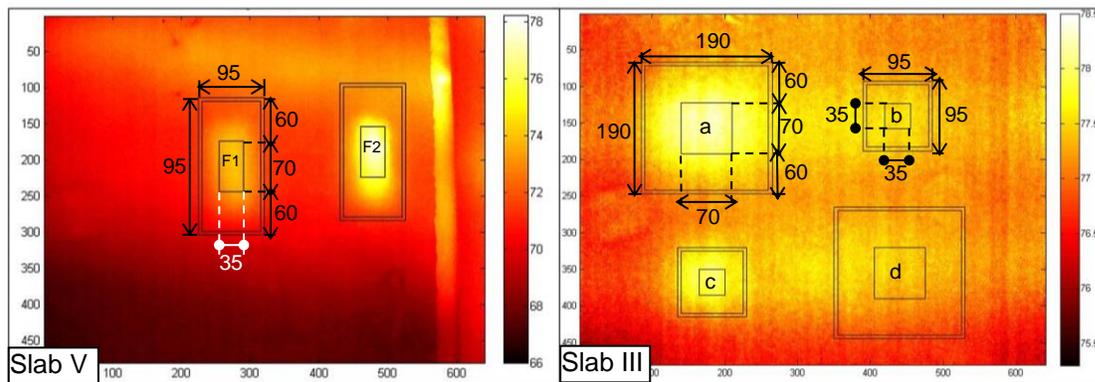
Upon completion of active IR thermography testing on test slabs I-V, areas of suspected delamination and background reference areas were identified. Figure 6-6 shows the selected delamination areas and background reference areas for test slabs V and III. The dimensions, given in pixels, of the selected areas are also shown on the figure.

Figure 6-6: Boundaries Selected for Areas of Delamination and the Associated Background Reference Areas for Concrete Test Slabs V and III.

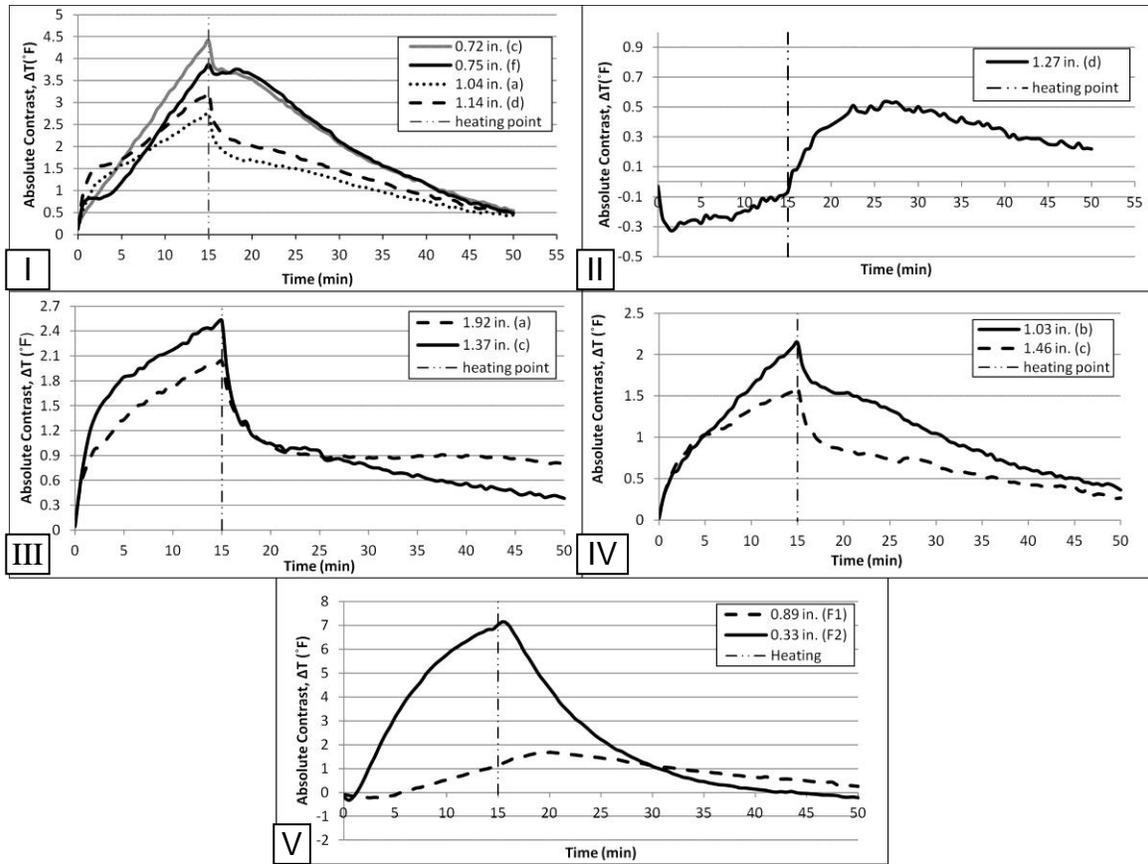
Average temperature within the selected areas was monitored over both the heating and cooling periods at 30 second intervals, and absolute contrast between the suspected delaminated area and reference background was determined and plotted. Figure 6-7 shows the absolute contrast of delaminated areas that were apparent on thermal infrared images collected from each slab. The depth of the delamination presented on the plots indicates the measured depth of the delaminations obtained by coring. From the absolute contrast graphs in Figure 6-7, observation time was estimated for the eleven simulated delaminations that were apparent in the recorded thermal images. The estimated observation times are presented in Table 6-4.

Figure 6-7: Absolute Contrast Variation above each Simulated Delamination during Active IR Thermography Testing on Test Slabs I-V.

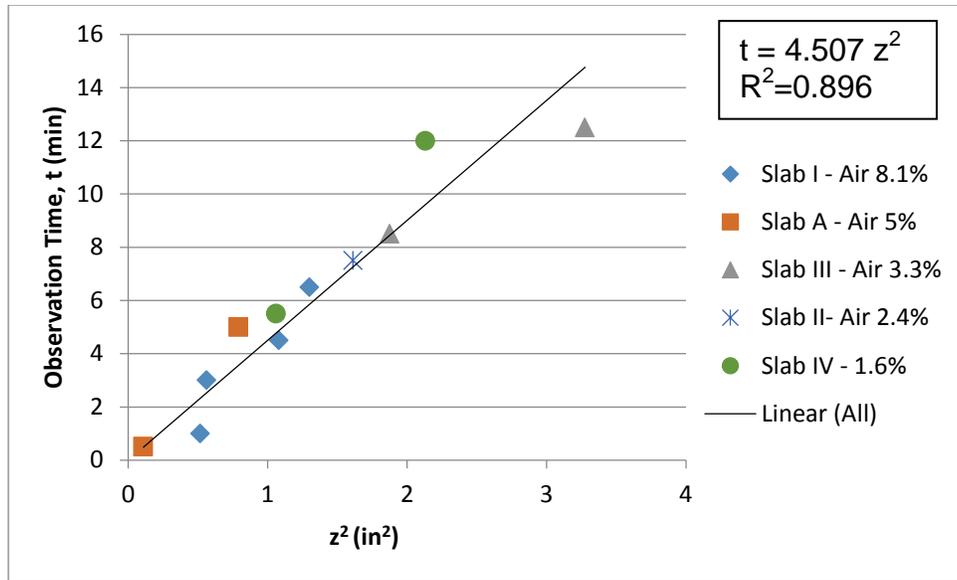
From the results of the active IR thermography testing, it can be seen that the observation time for delaminations appeared between 0 and 12.5 minutes after the heat source was turned off. This observed time period can help in identifying the time at which thermal infrared images should be captured to obtain the vertex of negative convexity on the thermal infrared images, specifically in situations where location and size of the delamination are of interest rather than the depth of the delamination. Note that the time period determined from the results of this study is specific to the heat source and the selected distance between the concrete slab surface and the heat source (3.5 ft). Additional studies must be conducted to generalized the relationship between the observation time period, heater, heater distance, and diffusivity of the concrete.

Figure 6-8: Observation Time Versus the Square of the Depth of each Detected in Active IR Thermography Testing of Test Slabs I-V.

According to Equation 2, observation time (t) has a quadratic relationship with the depth of the defect (z). To discuss and prove the relationship between the observation time and the depth of the defect, the observation time for each delamination was plotted against the square of the delamination depth obtained from ground truth information. A linear regression line was then drawn to obtain the accuracy of the relationship between t and z^2 and estimate the thermal diffusivity for the concrete laboratory test specimens.

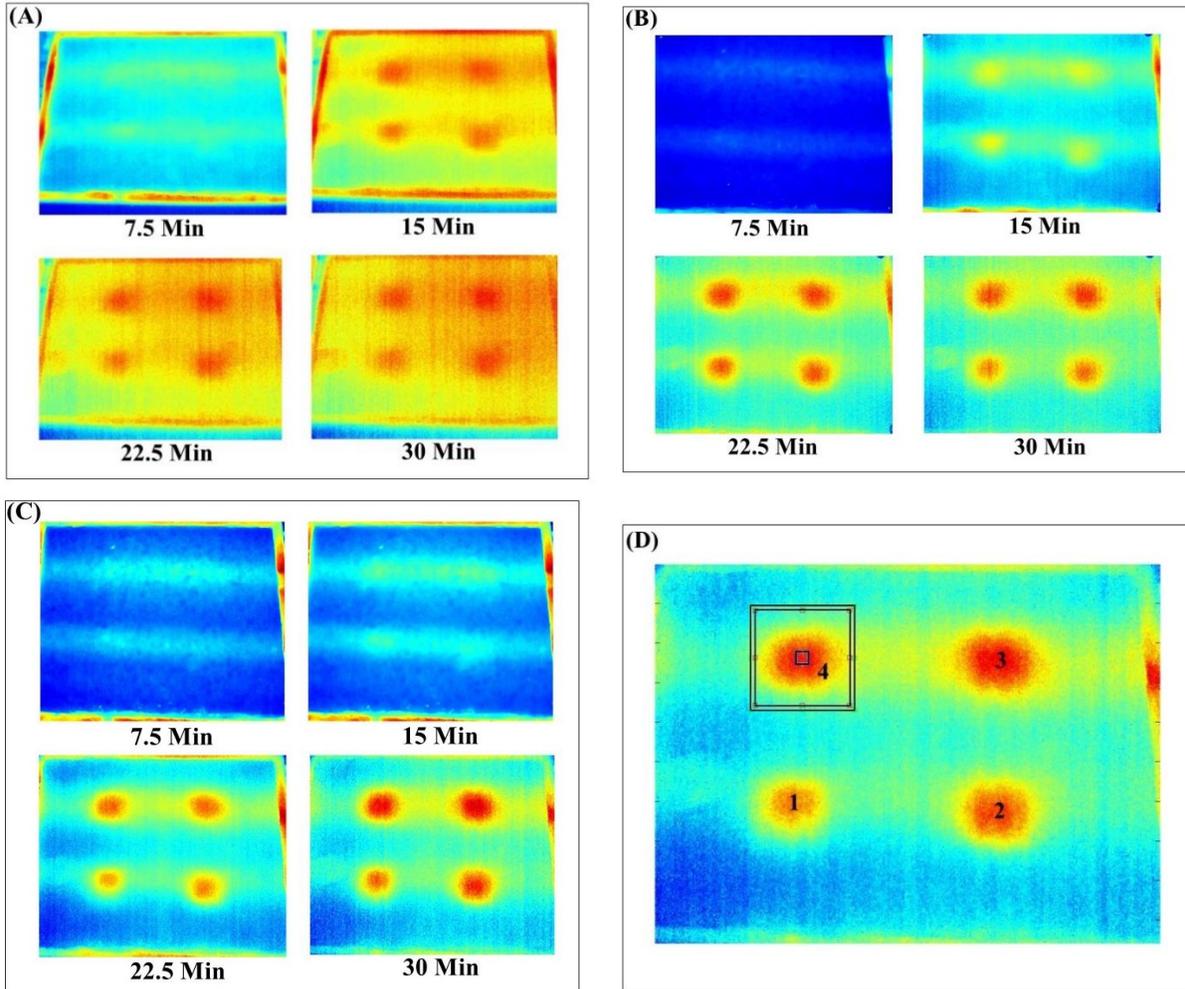
Areas of suspected delamination and sound concrete background reference areas were selected upon completion of active IR thermography testing on test slab VI using shortened heat times. These areas were monitored throughout the testing period and absolute contrast graphs were constructed. Results from the 5 minute and 10 minute tests were then compared to the 15 minute control test. Thermal images obtained from laboratory testing and the analysis areas selected for Delamination 4 can be seen in Figure 6-9. The absolute contrast graphs for each of the four simulated delaminations are shown in Figure 6-10 for the 5 minute, 10 minute and 15 minute tests. After construction of the absolute contrast figures, observation times were estimated for each delamination. The estimated observation times are reported in Table 6-6.

Figure 6-9: Thermal Images Captured during Parametric Experiment 1 (A) 5 Min. Heat Impulse (B) 10 Min. Heat Impulse (C) 15 Min. Heat Impulse Control Test (D) Delamination Numbering System and Selected Areas for Analysis for Delamination 4.

It should be noted that the 1 in. x 1 in. simulated delamination located in the center of test slab VI did not appear in any of the active IR thermography tests conducted to investigate heat impulse duration. With a width-to-depth ratio of less than two, it was expected that this Styrofoam block would not be detected using current analysis procedures based on the findings of previous laboratory tests. Additional width-to-depth delamination studies are recommended using test slab VI, specifically with a focus on the 1 in. x 1 in. simulated delamination, for improvements in testing procedures to detect delaminations with a width-to-depth ratio less than two. It should also be noticed that thermal images collected in this experiment show a heat concentrated boarder around the test specimen. Test specimen VI was constructed using 2 x 4

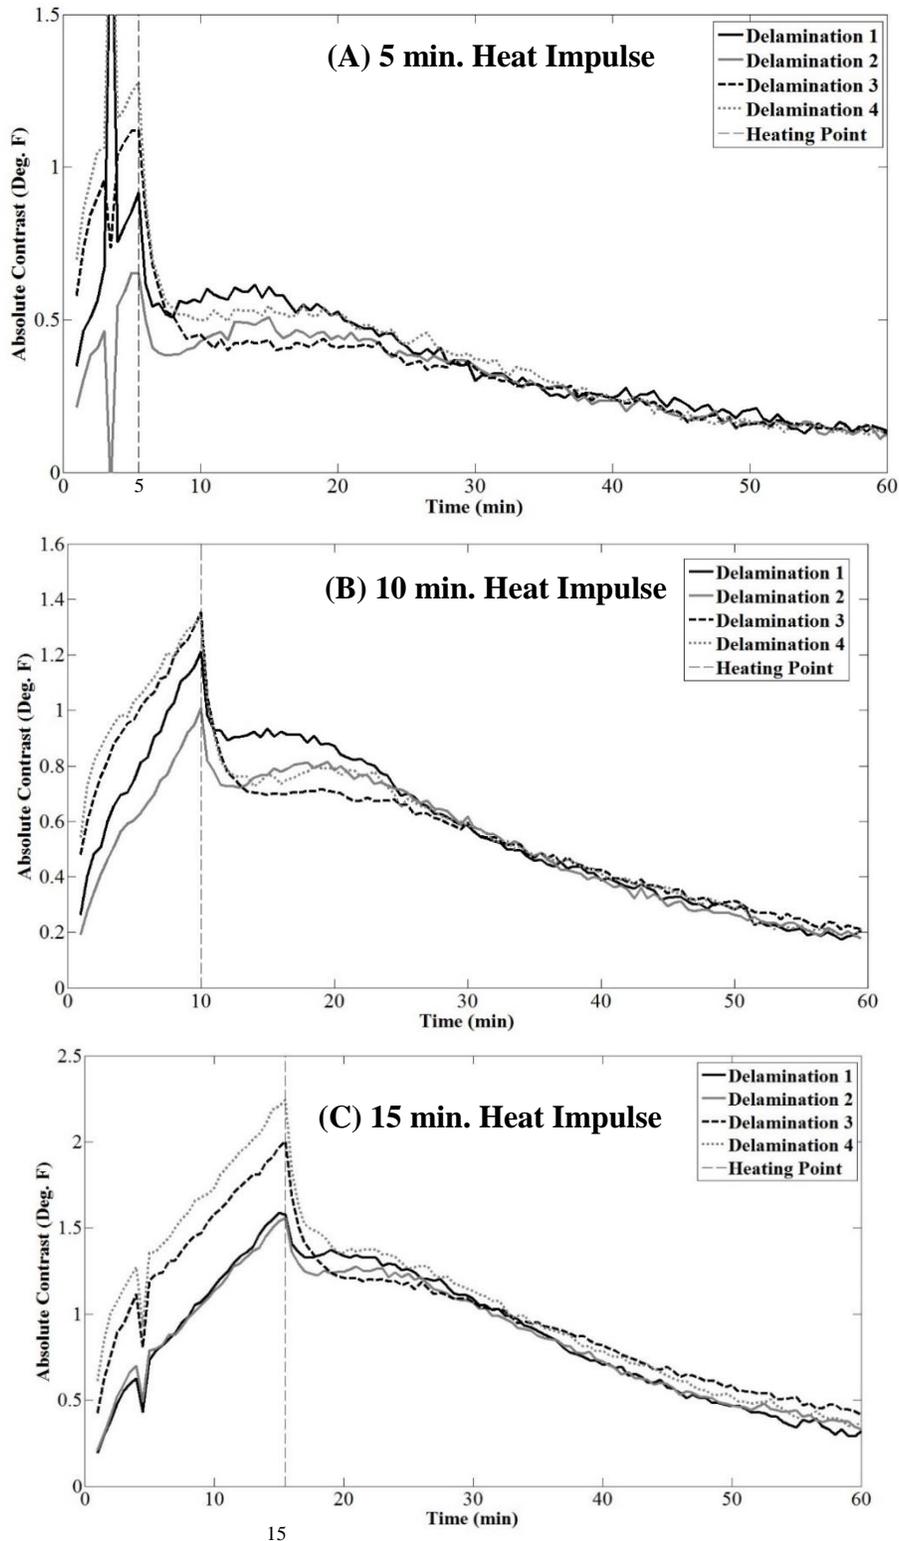
Figure 6-10: Absolute Contrast Graphs Constructed from Heat Impulse Durations of (A) 5 Minutes (B) 10 Minutes and (C) 15 Minutes

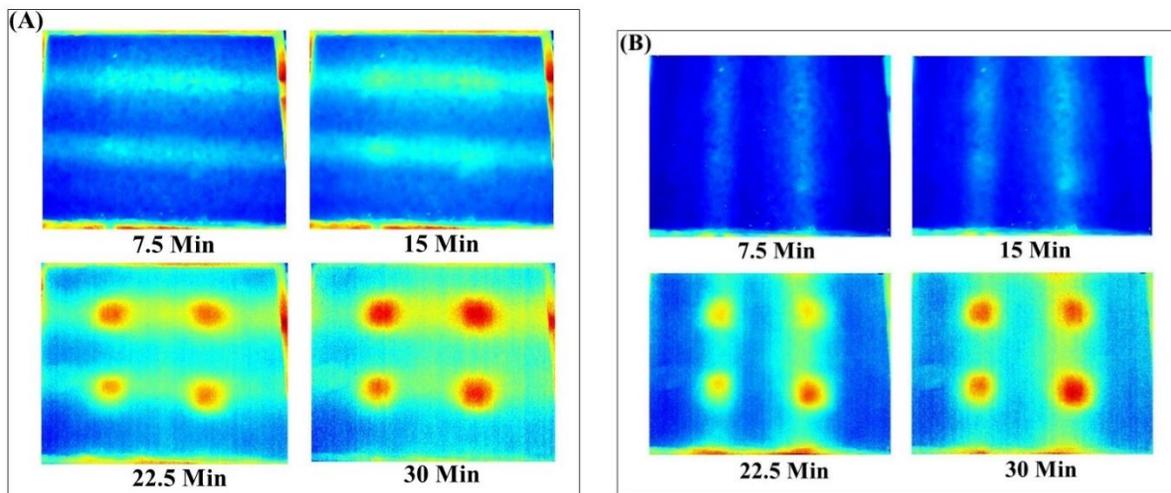
To determine the effects of rotating the heater on thermal concentrations and banding on the specimen surface, visual analysis procedures were used upon completion of active IR thermography testing on concrete test Slab VI. Results were compared to the 15 min. heat time control test with the heater in its original test set-up position. Four thermal images captured from both the control test and rotated heater test are shown in Figure 6-11.

Figure 6-11: Thermal Images Captured during Parametric Study 2 (A) Control Test with Original Heater Position (B) Test with Rotated Heater Position.

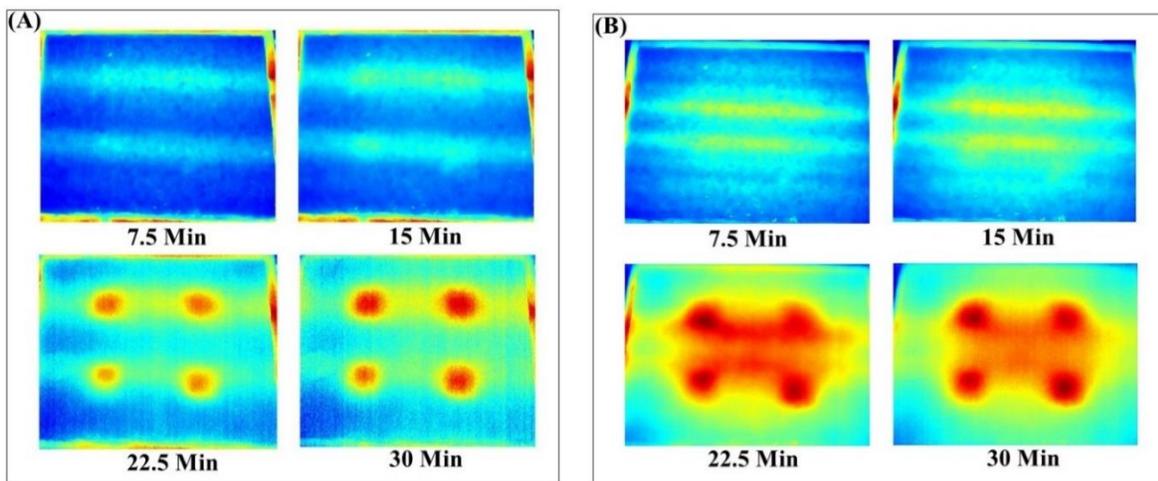
Figure 6-12: Thermal Images Captured During Parametric Experiment 3 (A) Control Test with Heater Placed 3.5 ft. from Test Specimen Surface (B) Heater Placed 2 ft. from Test Specimen Surface.

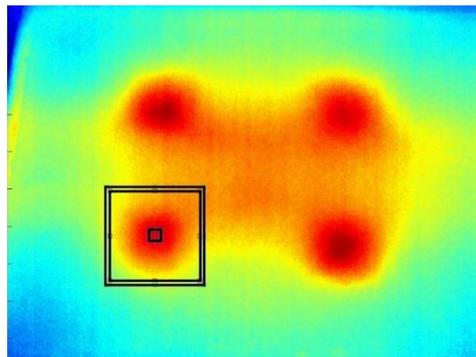
Figure 6-13: Selected Area of Suspected Delamination and Sound Concrete Area for the Active IR Test Conducted on Test Slab VI Using a 2 ft. Heater Distance from the Specimen Surface.

Upon completion of active IR thermography testing, areas of suspected delamination and sound concrete background reference areas were selected. These areas were monitored throughout the testing period and absolute contrast graphs were constructed. Results from the test were then compared to the control test with the heater positioned 3.5 ft. from the concrete surface. Thermal images obtained from laboratory testing and the representative areas selected for analysis are shown in Figure 6-12 and Figure 6-13 respectively. The absolute contrast graphs for each simulated delamination in concrete slab VI are shown in Figure 6-14 for the heater positioned 3.5 ft. and 2 ft from the specimen surface. After construction of the absolute contrast figures, observation times were estimated for each delamination and are reported in Table 6-9.

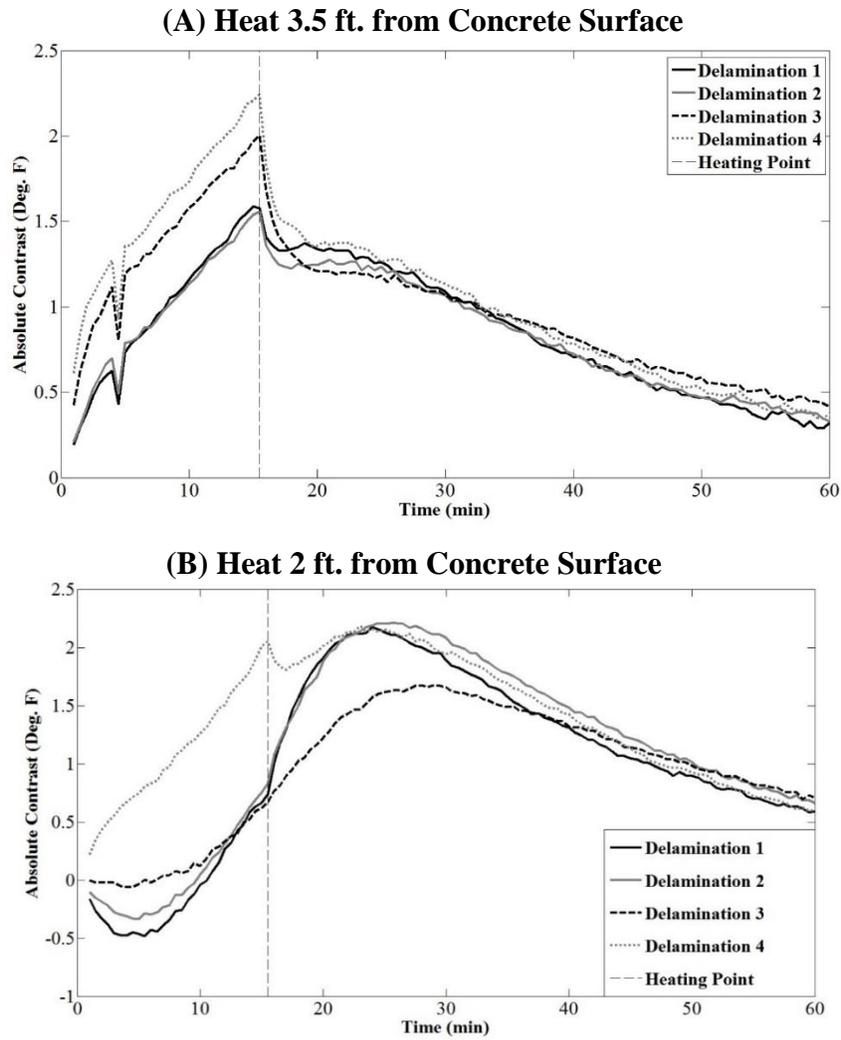
Figure 6-14: Absolute contrast graphs constructed from heater distances of (A) 3.5 ft and (B) 2 ft.

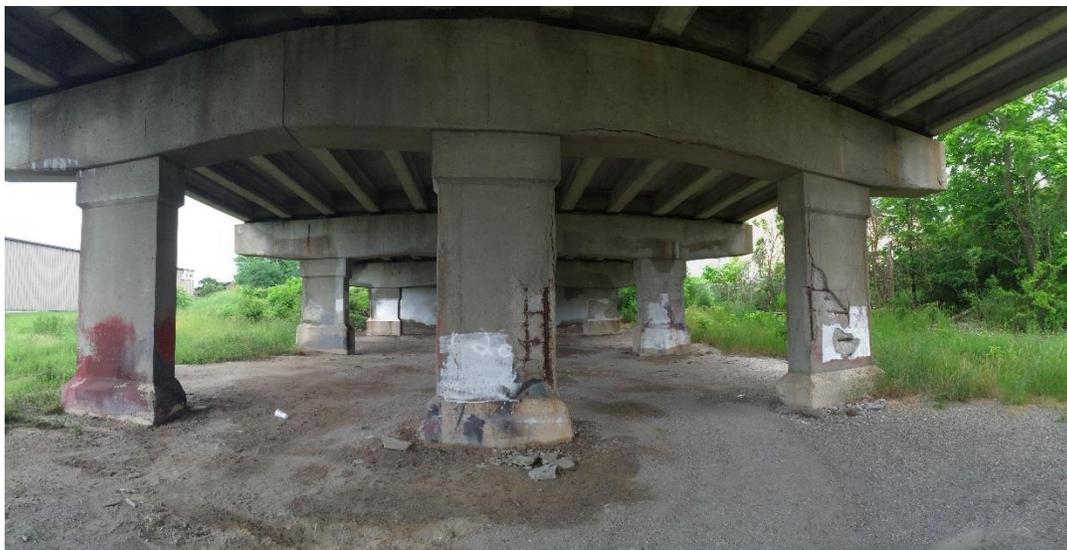
Constructed in 1960, this bridge is a multiple span structure. Main spans of the structure over US-131 are composed of steel beams while approach spans were constructed using prestressed concrete beams. The bridge spans a total length of 1,035 ft and is 58.4 ft wide (MDOT 2012). Figure 6-15 shows the east side concrete beam approach structure and current condition of Pier 22.

Figure 6-15: Precast Concrete Approach Spans under Franklin Street Bridge.

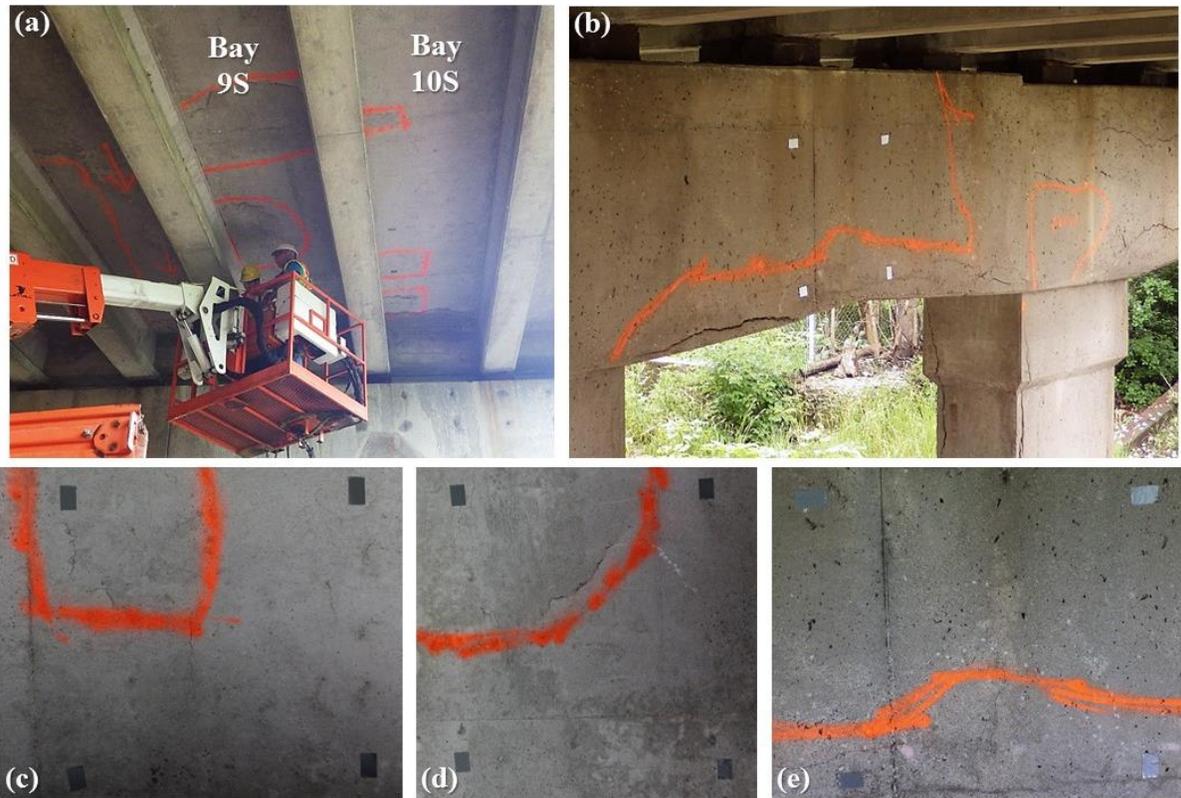
From the results of the ground truth testing, three test locations on span 22W of the Franklin Street bridge were selected for the application of active IR thermography to the underside of a concrete bridge deck and pier cap. The lack of surface moisture was used as a primary criteria during the selection process. The selected test locations are described in the following sections and are shown in Figure 6-16.

Figure 6-16: (a) Underside of the Franklin Street Bridge Deck. (b) Delamination on Pier 22. (c) Test Location A: Underside of Bridge Deck in Bay 10S. (d) Test Location B: Underside of Bridge Deck in Bay 9S. (e) Test Location C: Pier Cap of Pier 22.

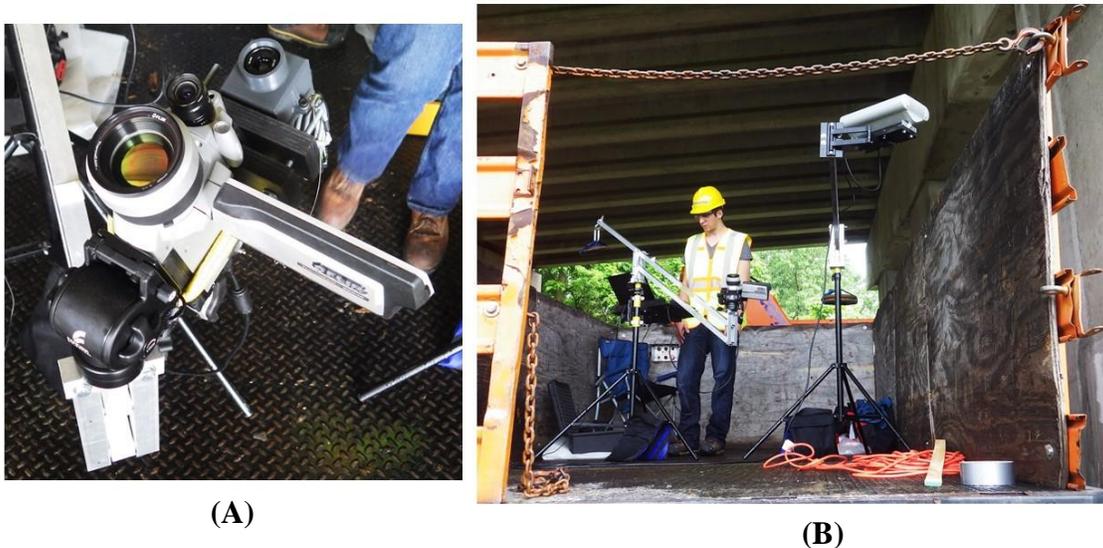
Two thermal cameras, the high resolution FLIR SC640 used in laboratory studies and a compact lower resolution camera, were used to conduct the tests on the underside of a bridge deck and pier cap. The results from each camera were compared to the ground truth information provided by the Michigan Department of Transportation (MDOT) and the findings were used to make recommendations on the future implementation of active IR thermography for detecting delaminations on bridge superstructure elements not exposed to sunlight. To provide the necessary heat impulse to the selected concrete test areas, the Solaira infrared heater was utilized as the heating effects of this heater were well understood from laboratory investigations. Both the thermal cameras and heater were mounted to the portable support arms fabricated for lab tests. The test equipment and mounting system are shown in Figure 6-17.

Figure 6-17: (A) FLIR SC640 and FLIR Tau 2 Thermal Infrared Cameras (B) Tripod Mounted Solaira Infrared Heater and Thermal Infrared Cameras.

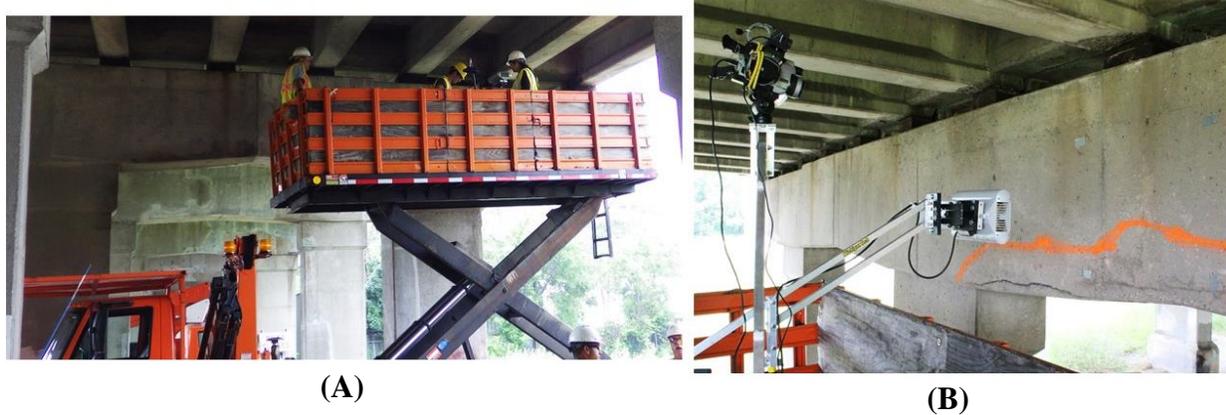
To access the underside of the bridge deck and pier cap, MDOT provided a scissor lift truck on the scheduled test date. The hydraulically powered lift platform provided ample space for the tripod mounted heater and cameras as well as a 2000 W generator used to power test equipment. The positioning of the heater and thermal infrared cameras for the pier cap test, as well as the lift truck used to provide access to test locations, can be seen in Figure 6-18.

Figure 6-18: (A) Platform Lift Truck (B) Active IR Thermography Test Set-Up for a Franklin Street Bridge Pier Cap.

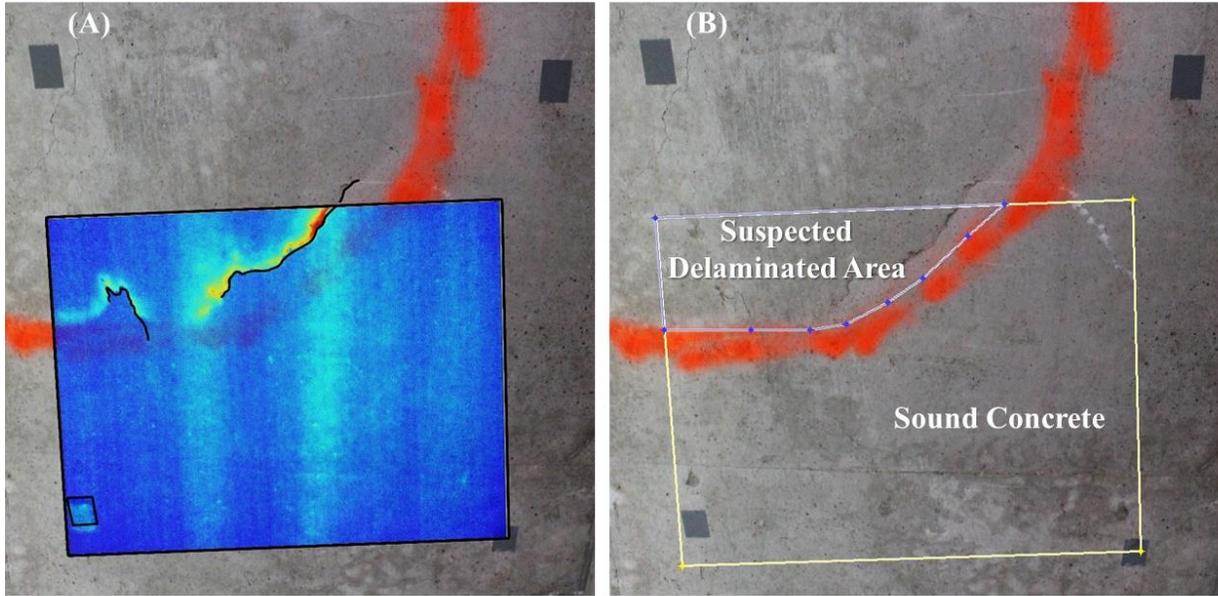
All processing of the optical images and thermal images was conducted in MATLAB. A simple polygon method was used to determine the percent of delamination on the bridge deck underside and pier cap. No specific polygonal shape was used during analysis, instead, a polygon most similar to the shape of the delamination was constructed. The thermal IR image and optical image correlation of the FLIR SC640 data collected during test B1 as well as the polygon method for determining percent of delamination based on ground truth information can be seen in Figure 6-19. The paint marks placed by MDOT inspectors is seen in Figure 6-19 (B).

Figure 6-19: (A) Thermal and Optical Image Correlation of FLIR SC640 Using Surface Cracking at Test Location B. (B) Polygon Method for Determining Delamination Percent Based on Ground Truth Information.

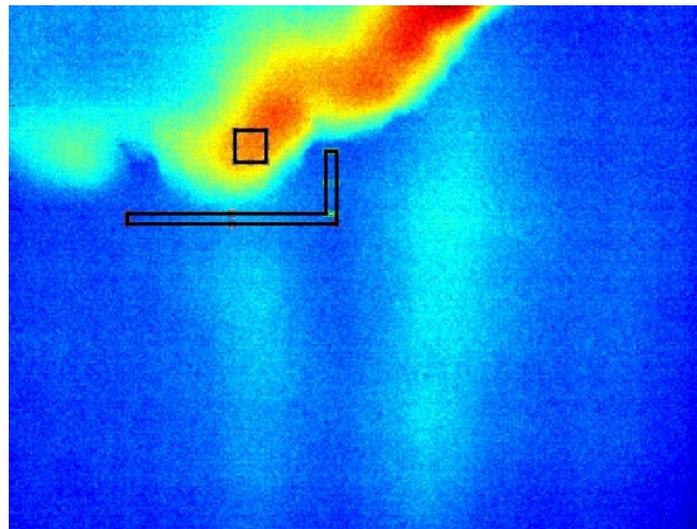
To determine the feasibility of using the active IR surface heating method to predict the depth of delaminations on an in-service bridge, depth analysis procedures similar to those developed in laboratory studies were used and are described in earlier sections. All processing of thermal images was conducted in MATLAB. The notable difference between the processing of field data and laboratory data was the selection of a sound concrete background reference area. The background reference area for laboratory studies was selected as a box-shaped polygon surrounding the suspected area of delamination. This analysis shape was selected based on the shape of the simulated Styrofoam delaminations. Due to the geometry and position of delamination in thermal images collected during the field application, a box-shaped polygon could not be used as a reference area. Instead, an L-shape polygon was used as a background reference area. Because the relative shapes of delamination at each selected test location differed, the dimensions and orientation of the L-shaped polygon used during analysis varied. However, a thickness of 5 pixels was used for each of the L-shaped analysis areas for consistency. Figure 6-20 shows the analysis areas selected for a thermal image acquired by the FLIR SC640 during test B1 of the field demonstration.

Figure 6-20: Analysis Areas Selected for Test B1 Captured by the FLIR SC640 Thermal Imaging Camera.

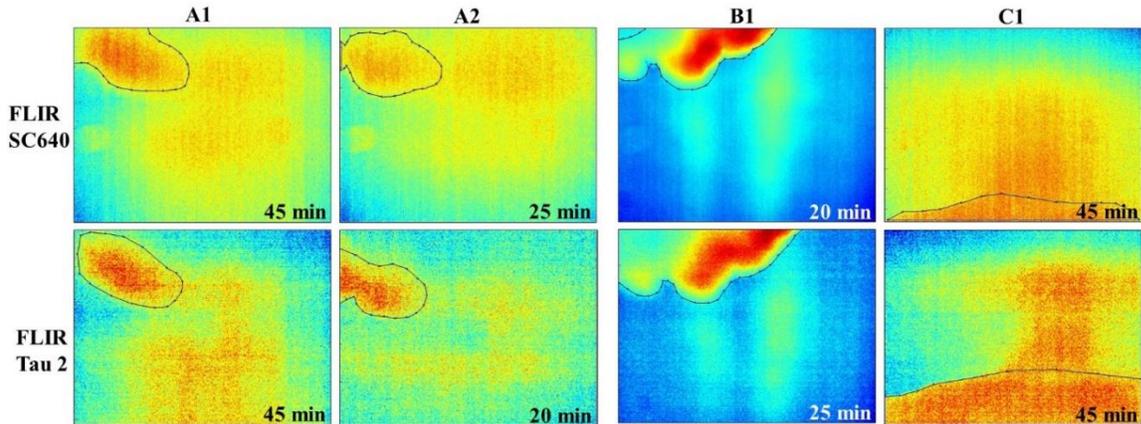
Figure 6-21: Maximum Delamination Areas using Simple Polygon Method for Thermal Image Processing.

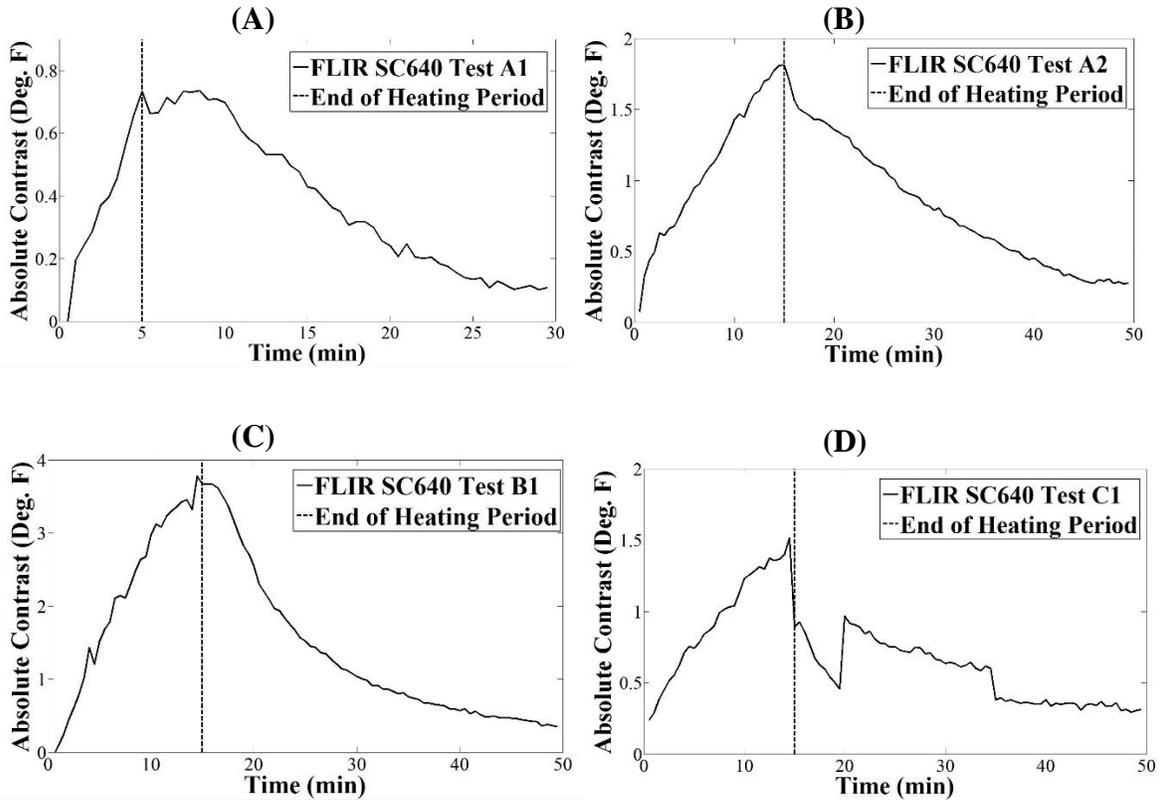
Figure 6-22: FLIR SC640 Absolute Contrast Graphs from Active IR Thermography Field Demonstration Testing (A) Test A1: 5 min. Heat Time (B) Test A2: 15 min. Heat Time (C) Test B1: 15 min. Heat Time (D) Test C1: 15 min. Heat Time.

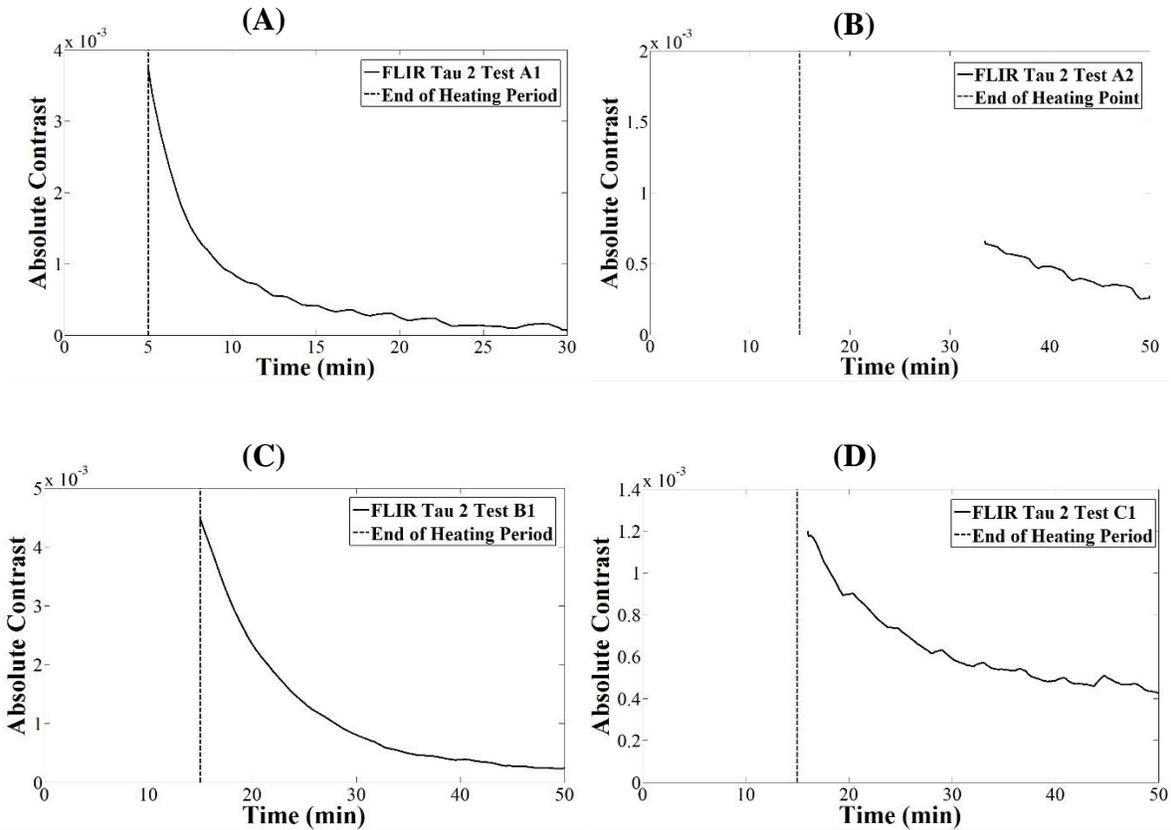
began acquiring data at the end of the heating phase, the absolute contrast graphs for this camera represent only the cooling phase of testing. This starting time of acquisition for the FLIR Tau 2 was adequate for the objectives of this study as the observation time needed for depth analysis is determined from the cooling phase of testing. It should be mentioned again that the FLIR Tau 2 was turned on 18 minutes after the end of the heating phase due to oversight for test A2 and the data collected for this test is shown in Figure 6-23 (B).

Figure 6-23: FLIR Tau 2 Absolute Contrast Graphs from Active IR Thermography Field Demonstration Testing (A) Test A1: 5 min. Heat Time (B) Test A2: 15 min. Heat Time (C) Test B1: 15 min. Heat Time (D) Test C1: 15 min. Heat Time.

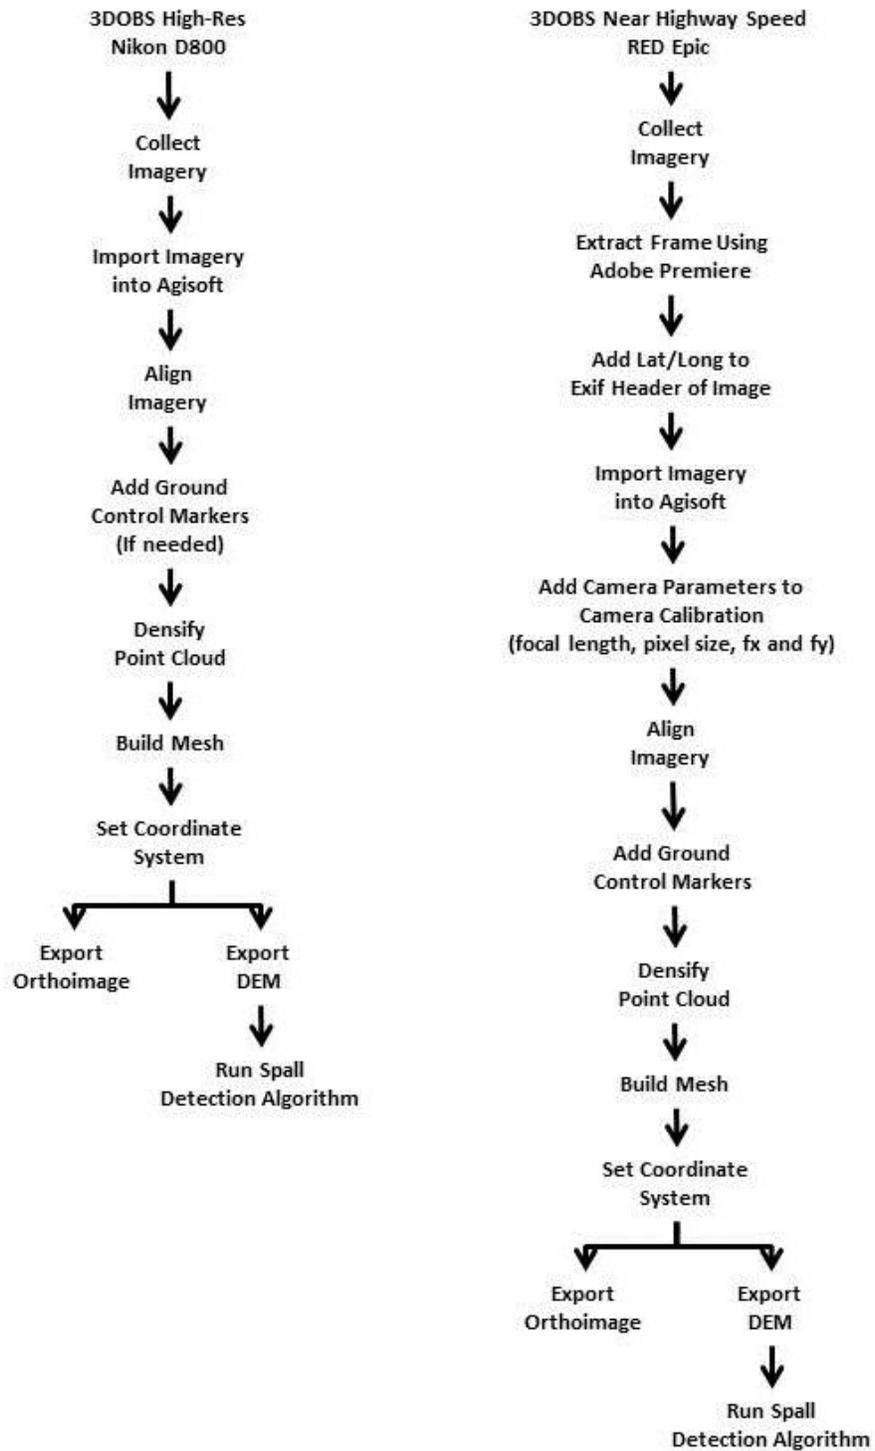
Figure 7-1: Flow Chart Showing the Processing Steps for the High Resolution and Near Highway Speeds Versions of 3DOBS.
