Technical Assistance Report 14-01 TA-P

Joor Road Noise Level Assessment

S.P Project 817-08-0023

LA 946 (Joor Road)

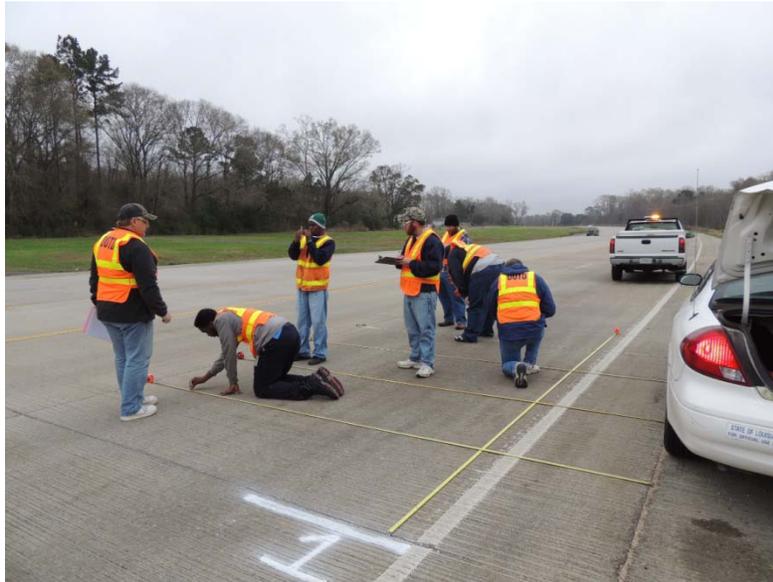
Figure 4
PCC tine measurements

Spacing between tines and tine widths were determined by examining photographs taken of the slabs as presented in Figures 4, 6, and 7. A tape with metric units was placed on the pavement slab (approximately 20 ft. in length) from joint to joint and photographed with a 16.1 megapixel camera as presented in Figure 6. The spacing between each tine was recorded into an excel sheet and used in the statistical analyses, which in this case included a statistical test for randomness [19, 20, 21]. Tine widths were tabulated by recording the width of the first tine from the joint and measuring the tine nearest each foot mark on the tape as it progressed along the slab, which generally produced about 20 tine width measurements per slab. Both the spacing between tines and test for randomness were conducted to determine if DOTD section 601 specifications were met. Since DOTD does not specify a specific tine spacing sequence such as "32/19/22/25/35/22/22/22/22/25/35/13/38 mm," an assessment for that could not be conducted. The researchers did attempt to identify if any pattern of tining intervals was present.

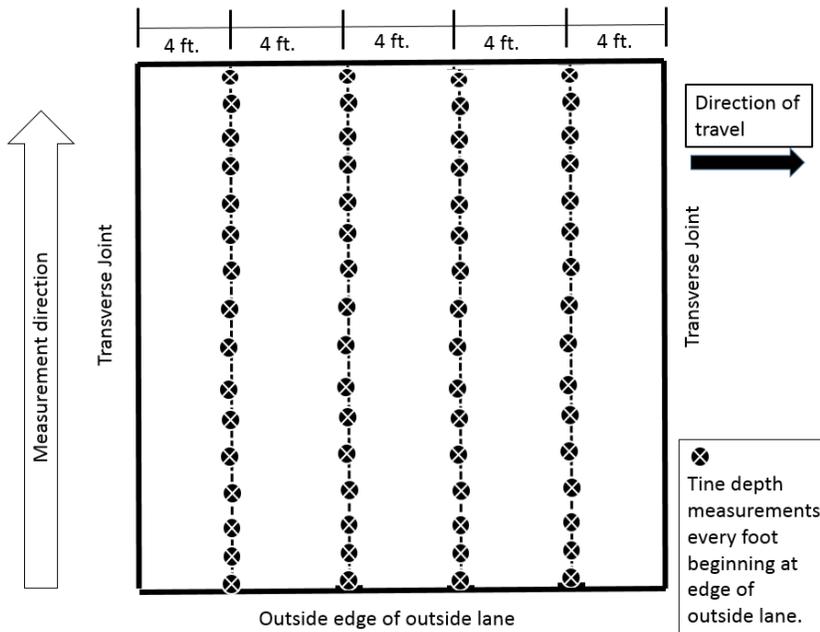
Figure 5
PCC tine depth measurement

Grids were laid out on the selected PCC slabs and tine depth measurements were taken in accordance with DOTD TR 229M/229-97 from the edge of the slab to the centerline at one foot intervals as presented in Figures 4 and 5. The field data were transferred from field notes into an excel sheet. The collected data were used in statistical analyses (described later) as well as to determine if the tine depths were within the range (3 mm to 5 mm) specified in DOTD Section 601 [18].

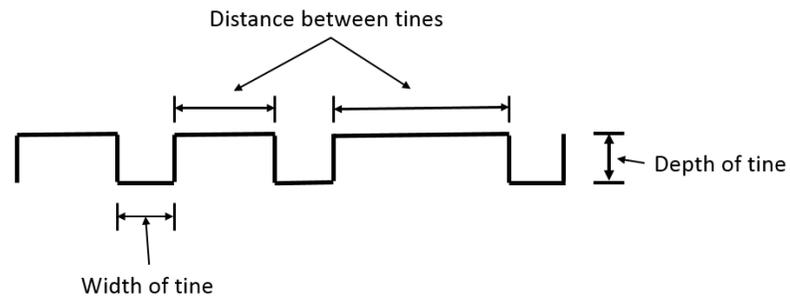
Figure 7

Schemata of tine depth, width, and distance between tines

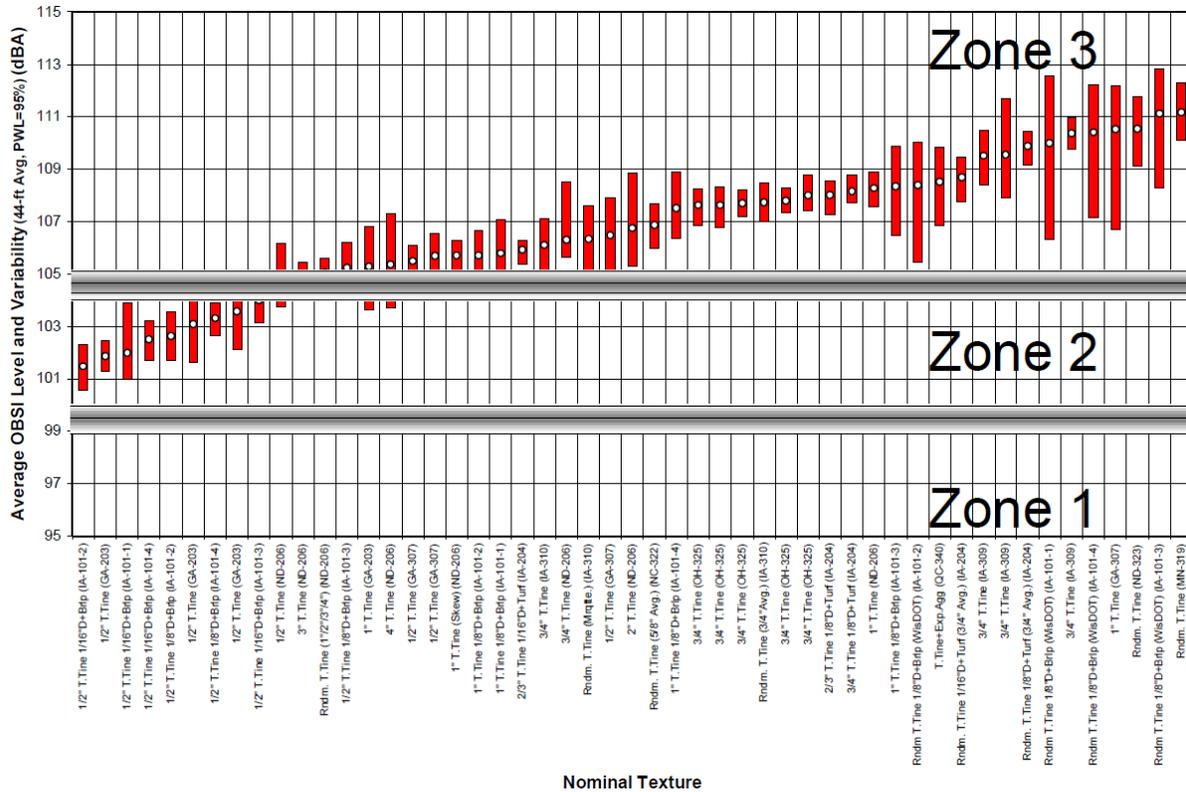
Figure 9
OBSI measurements on transverse tinned pavements

In a publication by the National Concrete Pavement Technology Center, OBSI noise based measurements were divided into three categories, (low, middle, and high) as presented in Table 6 [26, 27]. Figure 9 presents the OBSI data set with rankings used for transverse tined PCC pavement for informational purposes only. These rankings will be used as a benchmark to evaluate the OBSI noise measurements taken on Joor Road.

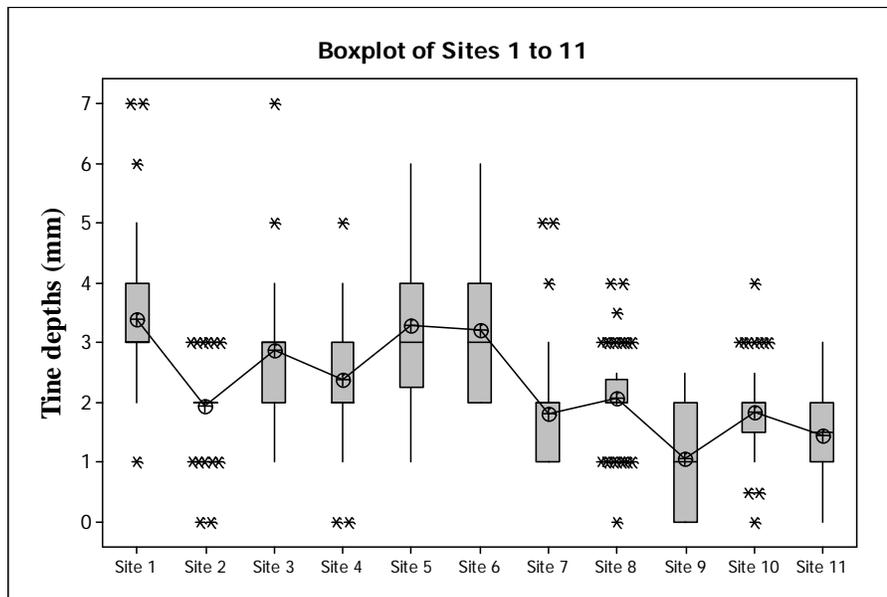
Figure 10
Box plot of tine depth data

Tine depth measurements were taken at seven sites on Joor Road with sites 1 to 6 in the noisy area and Site 7 outside the noisy area. Four sites were assessed on O'Neal Lane (Sites 8 to 11). Table 8 presents the descriptive statistics (average and standard deviation) for all eleven sites along with the results from the statistical analysis (Tukey grouping) [19]. The Tukey method assigns a letter to each site. Sites with similar letters means that no statistical difference existed while sites with different letters indicate that statistical differences exist. Figures 10 and 11 present boxplots and histograms, respectively, for all 11 sites and Appendix B contains histograms for each individual site. Table 9 presents the results of the specification check.

Regarding sites (1 to 7) associated with Joor Road, the statistical analysis indicated that with the exception of Site 2, the tine depths for the sites in the noisy area were significantly different from Site 7 (quiet area) with Site 7 having the least tine depth. The tine depths were similar between Sites 1,3, 5, and 6 and similar between Sites 3 and 4. Sites 2 and 4 were similar to Site 8 on O'Neal Lane. Sites 1 to 7 were evaluated to determine if they conformed to DOTD Section 601 specifications as presented in Table 10 [18]. The results indicated that all seven sites did not conform to DOTD specifications. All seven sites had tine depths less than 3 mm with only a few having tine depths greater than 5 mm. Though shallow depths can reduce noise emissions, tine depths greater than 6 mm are generally associated with excessive noise emissions. Based on that, it is the authors' opinion that tine depth was not the source of excessive noise on Joor Road [8].

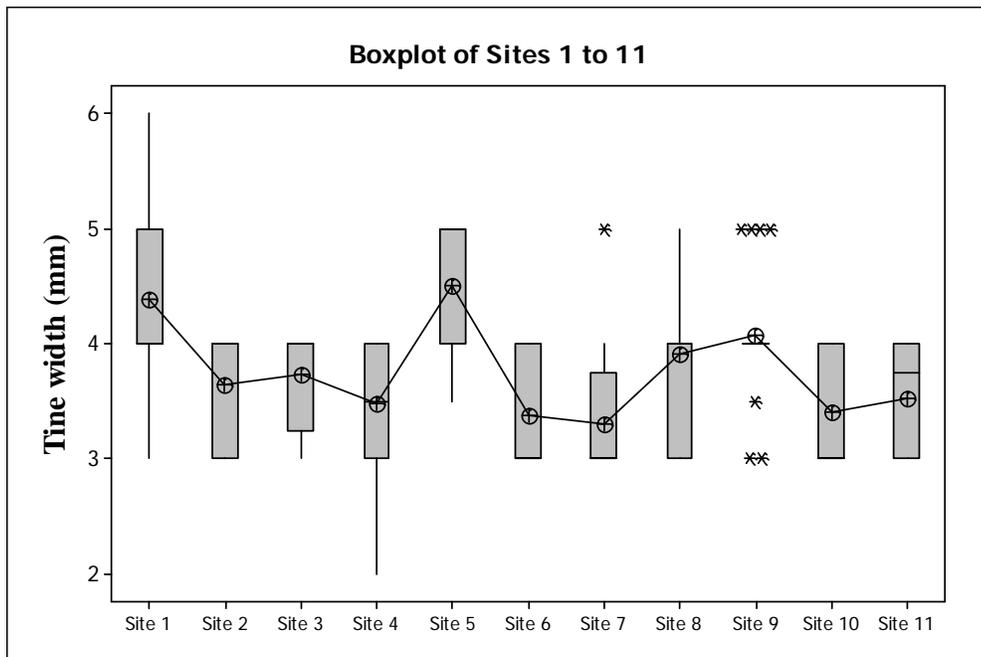
Figure 12
Tine width box plots

Tine width measurements were taken at seven sites on Joor Road with Sites 1 to 6 in the noisy area and Site 7 outside the noisy area. Four sites were assessed on O'Neal Lane (Sites 8 to 11). As previously mentioned, measurements were taken by examining photographs as presented in Figure 6. Table 10 presents the descriptive statistics (average and standard deviation) for all eleven sites along with the results from the statistical analysis (Tukey grouping) [19]. The Tukey method assigns a letter to each site. Sites with similar letters means that no statistical difference existed while sites with different letters indicate that statistical differences exist. Figures 12 and 13 present boxplots and histograms, respectively, for all 11 sites and Appendix C contains histograms for each individual site. Table 11 presents the results of the specification check.

On the Joor Road sites, Sites 1 and 5, Sites 2, 3, 4, and 6, and Sites 2, 3, 6, and 7 are similar. There were many similar grouping overlaps between Joor Road and O'Neal Lane, with Sites 1,5, and 9, Sites 1, 8, and 9, Sites 2, 3, 8, 9, and 11, Sites 2, 3, 4, 6, 8, 10, and 11, and Sites 2, 3, 4, 6, 7, 10, and 11 having statistical similarities. There was a broader range of sites statistically grouped together than with the tine depth data sets.

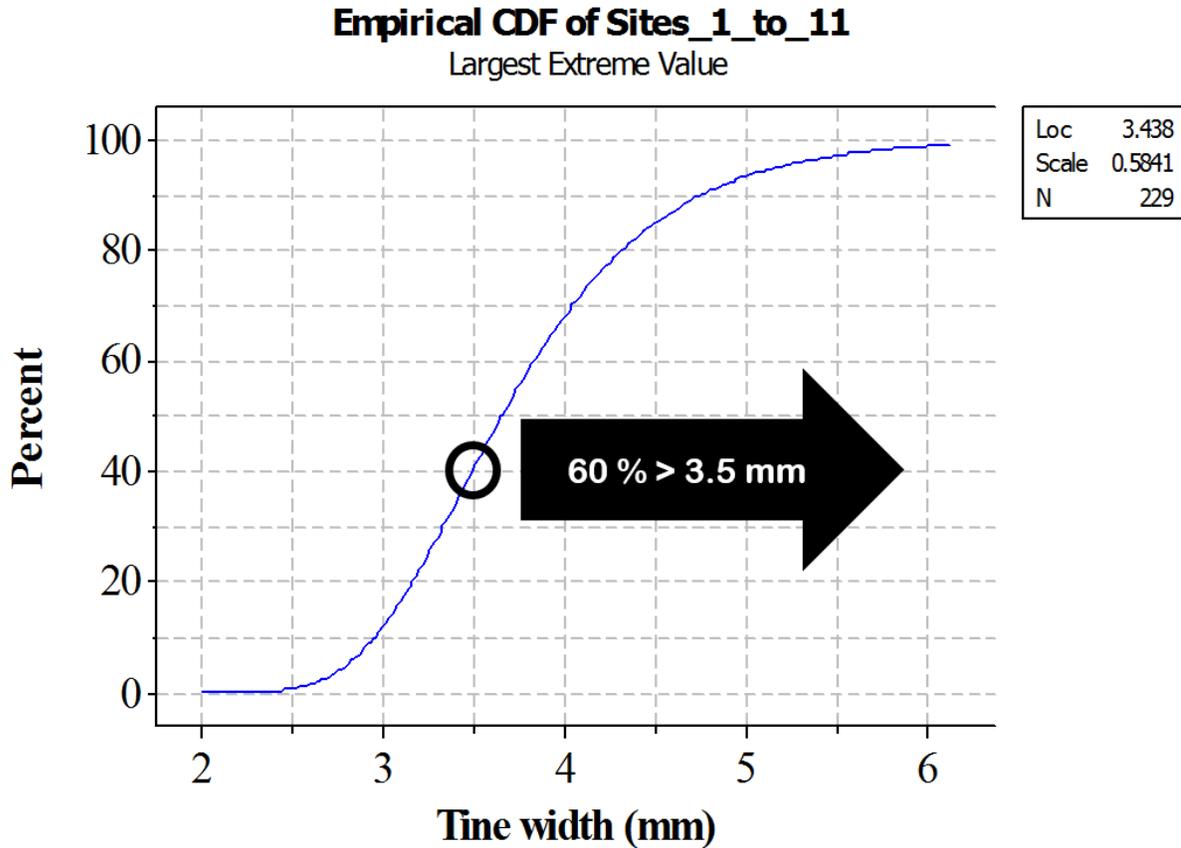
Figure 14
Cumulative distribution function of tine widths (mm)

As presented in Table 11, all sites had tine widths greater than the 3.5 mm maximum specified in DOTD Section 601 and therefore did not meet that specification. Cumulative distribution functions (CDF) were created for Joor Road alone and Joor Road in combination with O'Neal Lane data, both yielding similar CDF's. With that being the case, the CDF (Sites 1 to 11) presented in Figure 14 was used to illustrate the fact that 60 percent of the tines were over the 3.5 mm maximum specified by DOTD and recommended by FHWA [8, 18]. It has been demonstrated that as tine width increases so does sound emission [5]. The authors postulate that the excessive tine widths are one of three pavement surface parameters contributing to the excessive noise on this project, discussed in detail later.

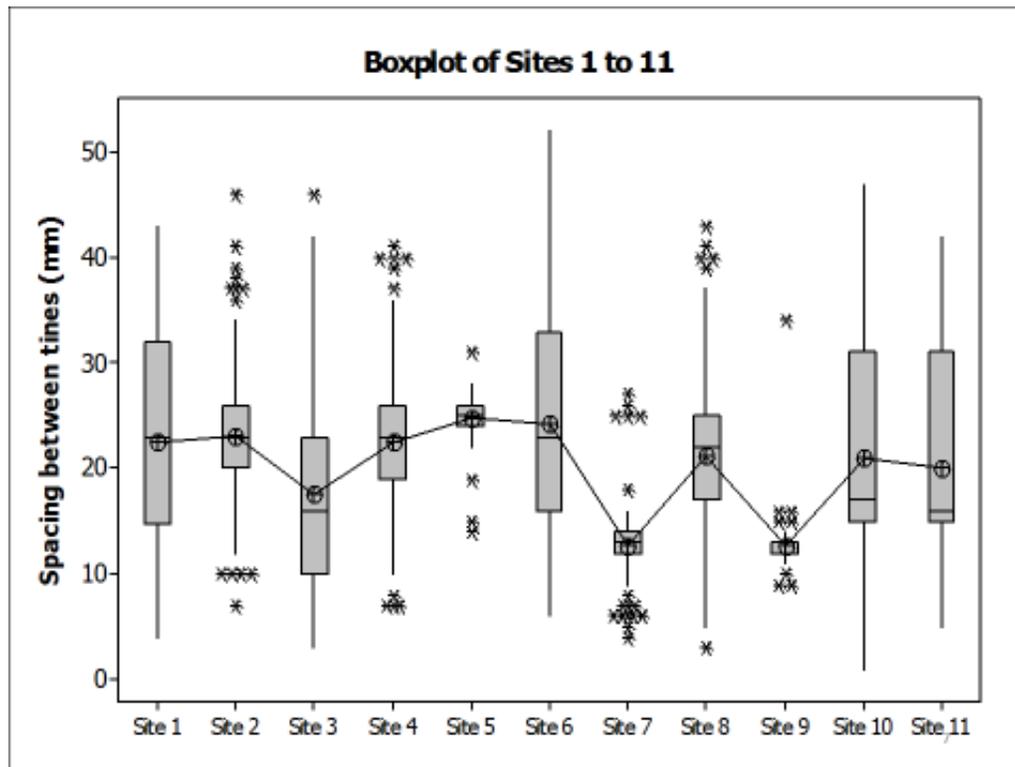
Figure 15
Box plot of spacing between tines

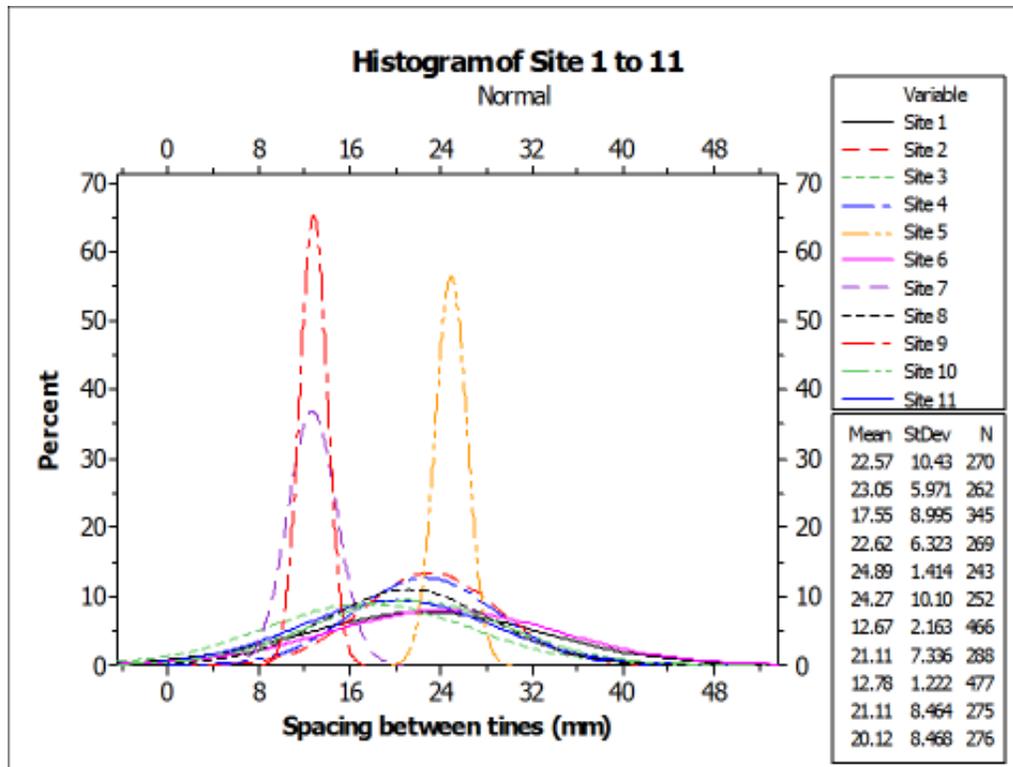
Figure 16
Histograms of tine spacing

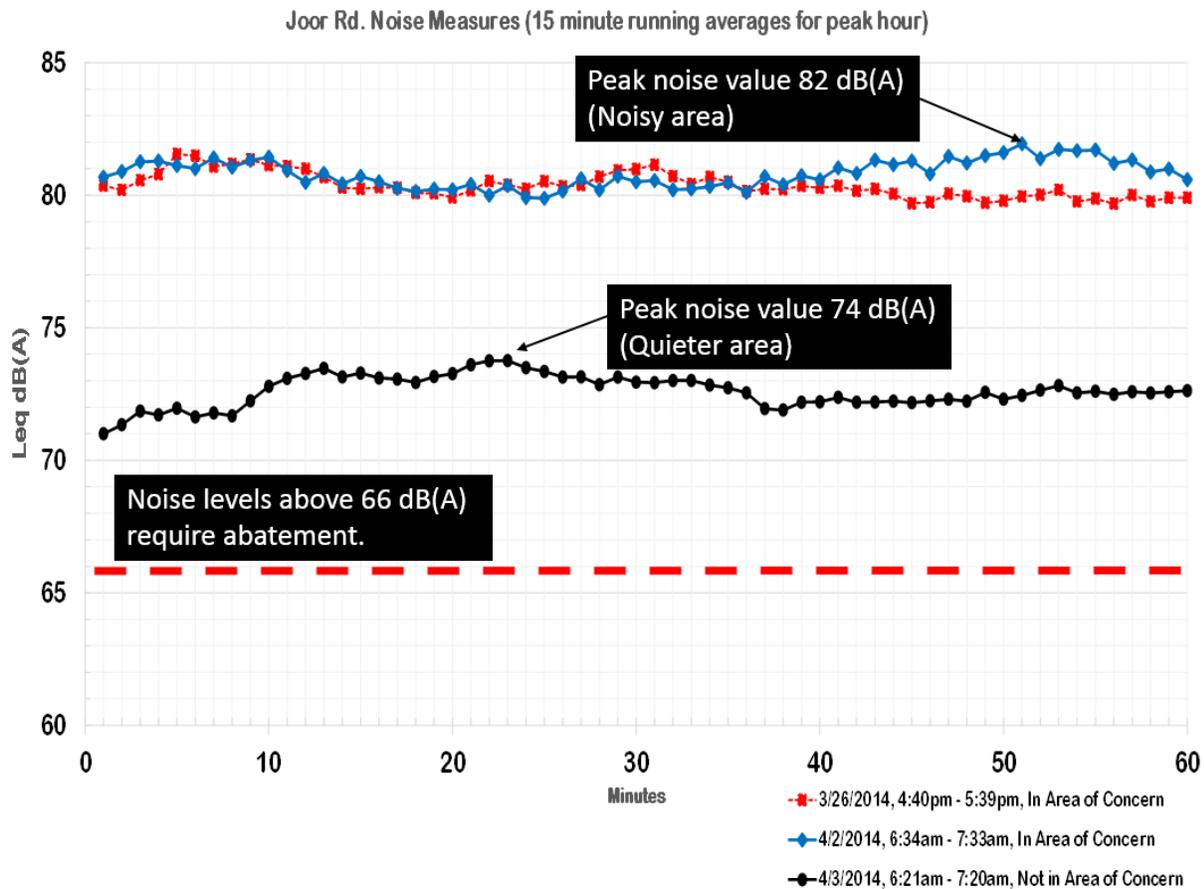
Figure 17
Pass by noise measurements

Pass by noise measurements were taken between the hours of 6 am to 9 am and 4 pm to 6 pm in the noisy area and between 6 am and 9 am in the quieter area [22, 23, 24]. In accordance with FHWA guidelines, 15 minute running averages from the peak hour were calculated for the noise parameter Leq (dBA) and the highest Leq value from those readings should be used as the Leq for that location. Figure 17 presents the results from noise testing on Joor Road. The peak noise value for the noisy area on Joor Road is 82 dBA while the peak noise value in the quieter area is 74 dBA. Both areas exceed DOTD and FHWA noise level guidelines for residential areas, but there is a considerable difference in magnitude between 82 and 74 dBA, 251 percent to be exact in terms of sound pressure. Additionally no complaints about noise levels have been reported regarding noise levels outside the “noisy area” on Joor Road.

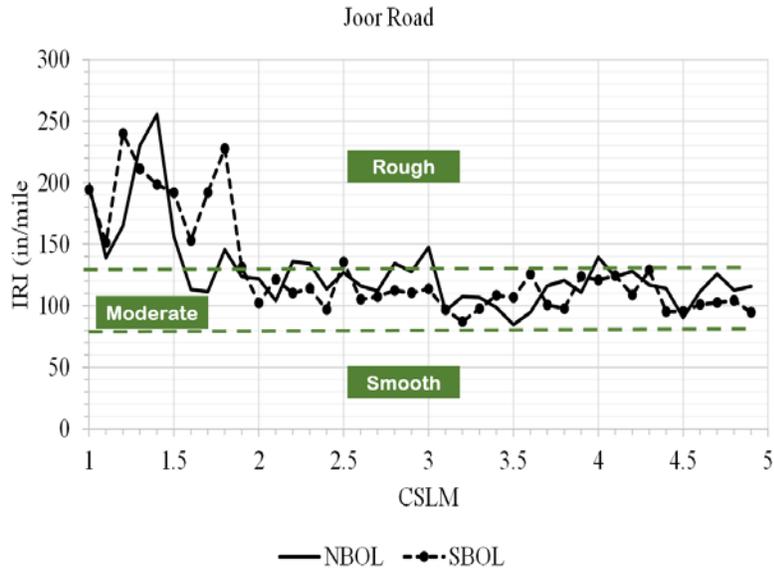
Figure 19
IRI values

Joor Road was assessed with a high speed profiler to obtain IRI values and macrotexture (mean texture depth, MTD) as presented in Figures 19 to 21. The IRI in the quieter area (CSLM 1 to 1.9) was quite rough with an average IRI of 168 and 196 in the north and southbound lanes, respectively [28]. In the noisy areas (CSLM 1.91 to 5.05), the IRI can be considered moderate with the northbound lane having an average IRI of 117 and the southbound lane having an IRI of 109.

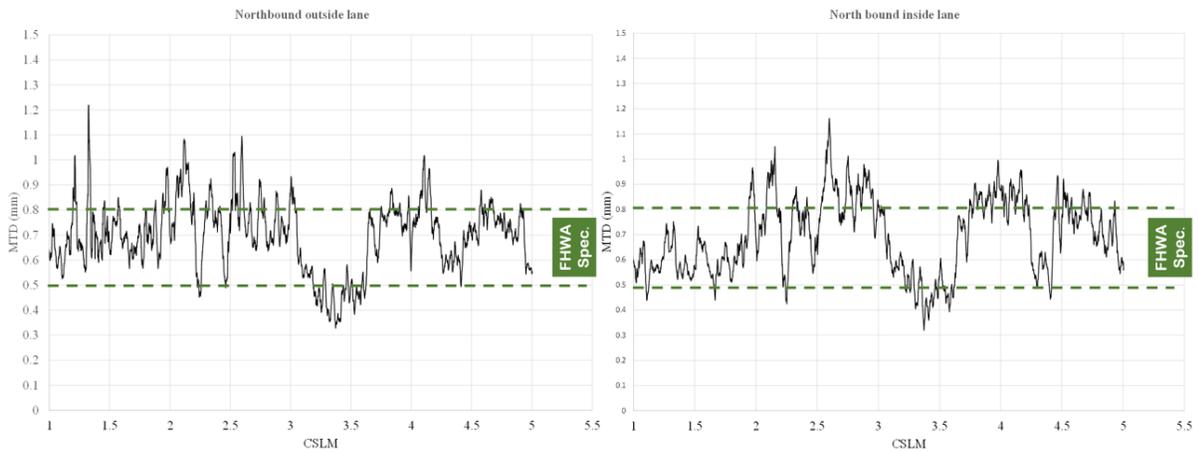
Figure 20
Northbound macrotexture values

Pavement macrotexture readings are presented in Figures 20 and 21. Using the FHWA recommended ranges of 0.5 to 0.8 mm for MTD as a guide, the macrotexture in both the noisy and quieter areas generally fits within the range recommended by FHWA [8]. Macrotexture above 0.8 can cause excessive noise emissions while macrotexture below 0.5 may cause hydroplaning when the pavement is wet.
