Report No. FHWA-KS-04-1
FINAL REPORT

PERFORMANCE INVESTIGATION OF A FIBER REINFORCED COMPOSITE HONEYCOMB DECK FOR BRIDGE APPLICATIONS

Ondřej Kalný, M.S.C.E.
Robert J. Peterman, Ph.D., P.E.
Kansas State University

KANSAS DEPARTMENT OF TRANSPORTATION

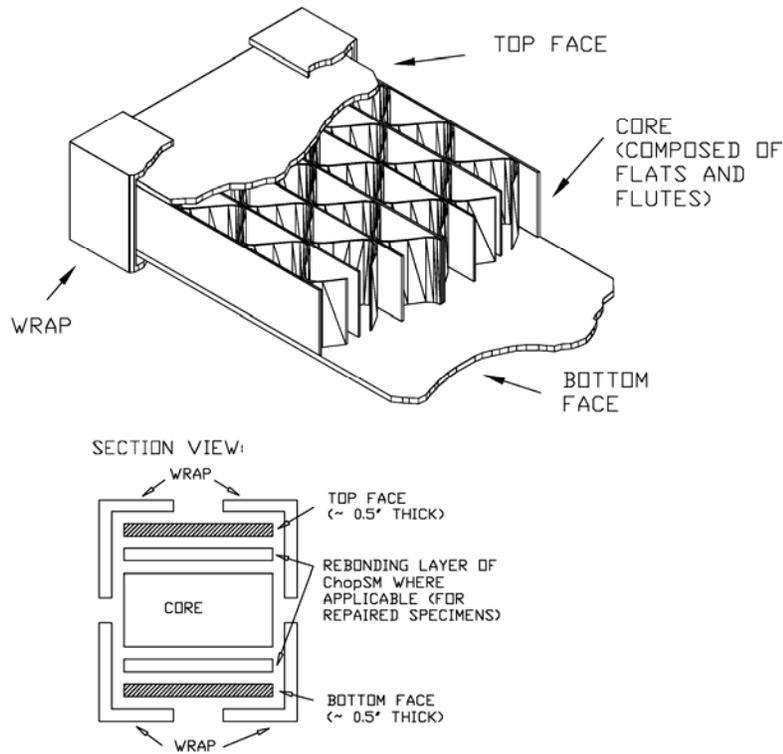
Figure 2.1: Sandwich Panel Geometry and Wrap Modification

The sandwich panels (Figure 2.1) are composed of two outer faces (which primarily provide the flexural rigidity) and a core that is used to maintain the distance between the faces and to carry shear. The corrugated core is typically manufactured of Chop Strand Mat (ChopSM) and consists of alternating flat and sinusoidal plates (referred to as flats and flutes, respectively). Each plate is laminated separately. Flats and flutes are bonded together by placing a cured flat on top of a wet flute and allowing the assembly to cure. The whole core is then manufactured by sequentially bonding the flat-flute assemblages together using polyurethane adhesive.

Some panels were repaired and tested again. Repair of panels was deemed plausible, since typical flexural failures occurred at the bond interface between the core and face, leaving the core and face laminates virtually untouched. During the repair procedure, each face was totally removed from the core and re-bonded back using an additional layer of 3-oz ChopSM. Then, external wraps were applied over the edges (Figure 2.1).

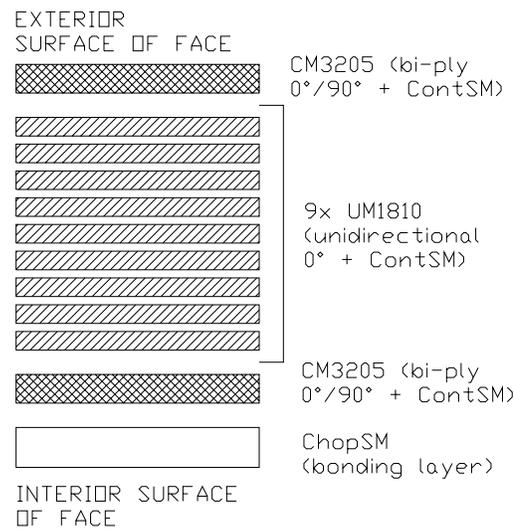
Figure 2.2: Face Lay-up Schedule (for 1/2-in Thick Face)

The top and bottom faces are fabricated by consecutively stacking resin-soaked plies (according to lay-up schedule shown in Figure 2.2) on top of each other. Then, the sandwich panel is constructed by placing the core sections on top of the face laminate while the resin is still wet. The core is then pressed into the face laminate using dead weight and is allowed to cure.

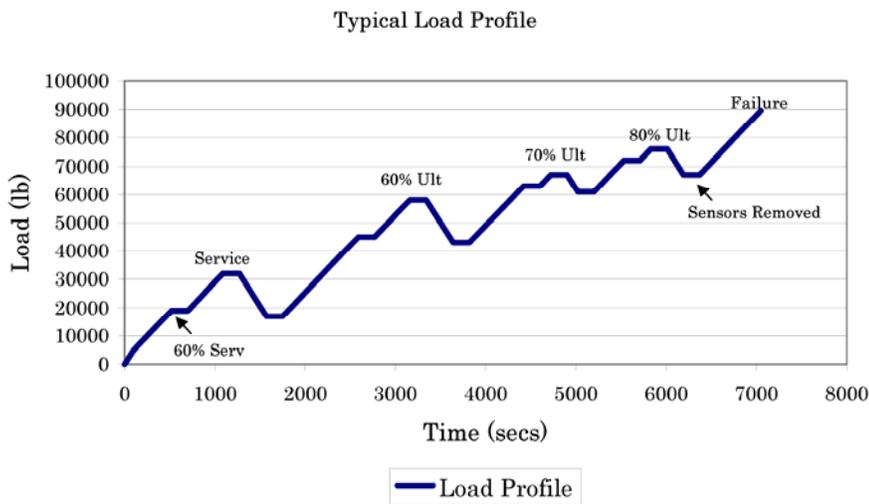
Figure 2.3: Load Profile for Acoustic Emission Monitoring (Graph Provided by G. Ramirez, University of Kansas)

Acoustic Emission (AE) data were recorded for the majority of the tests. For the purpose of AE, a special loading profile (consisting of load holds, load drops and load increases, refer to Fig. 2.3) was designed to assess AE signature characteristics such as Felicity Ratio.

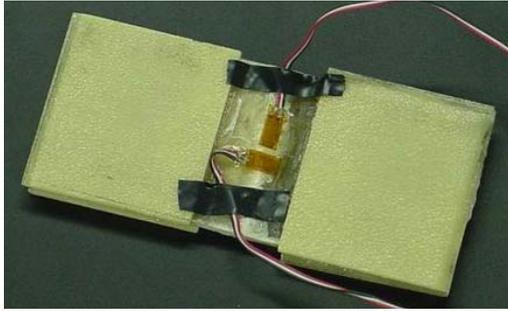
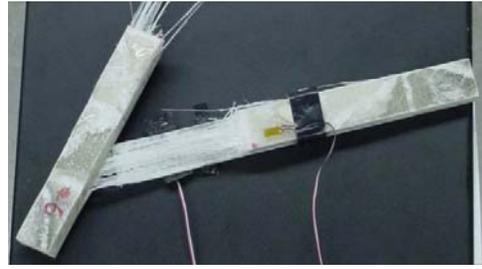
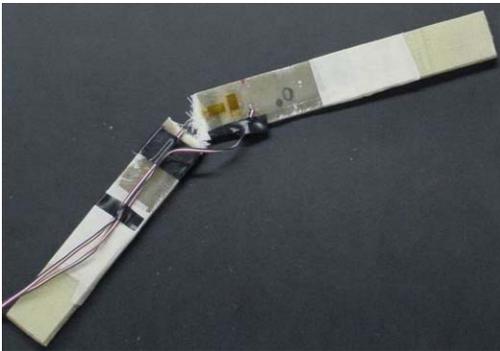
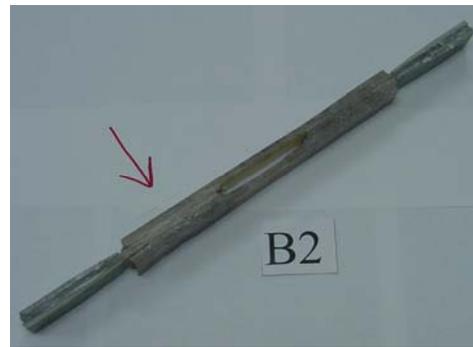
Figure 2.4: Coupons Tested

Coupon tests on the actual manufactured core and face laminates (Figure 2.4) provided material properties at the highest point of the fabrication process. This is believed to represent the actual values more closely, because manual fabrication may result in imperfections that can influence stiffness properties.

(a) Compression Coupon of Core Laminate

(b) Tension Coupon of Face Laminate

(c) Tension Coupon of Core Laminate

(d) Double Lap Secondarily Bonded Shear Coupon

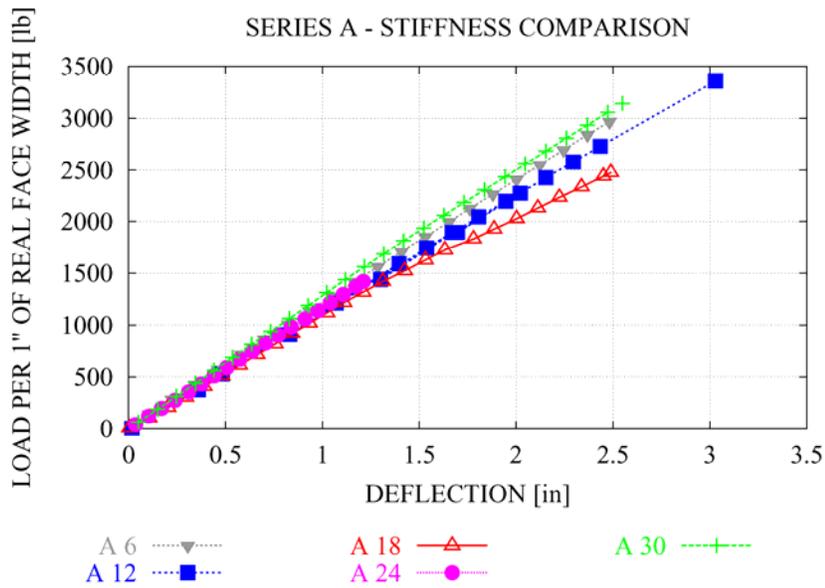
Figure 3.1: Stiffness Comparison of Specimens Tested in Series A

First, the stiffness per unit width is very consistent among all five specimens until a midspan deflection of about 1.2-in (30.5 mm) was reached, which corresponds to a span-to-deflection (L/d) ratio of 80. Taking into account the current design requirement of $L/d = 800$, we conclude that the stiffness is very consistent in the design load range. Also, all specimens behaved linearly up to the point at which their stiffness' began to diverge. Beyond this point, at higher load levels, small non-linearities (i.e. softening) were observed (especially for specimen *A18*).

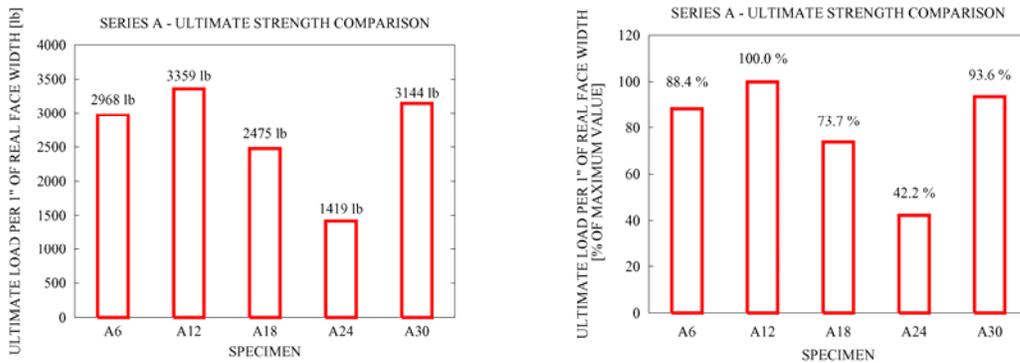
Figure 3.2: Comparison of Ultimate Load per Unit Width for Specimens of Series A

Second, the ultimate strength values (per unit width) of the panels can be obtained from Figure 3.2 and Table 3.2. Compared to stiffness values, the ultimate strength per unit width embodies a significantly greater variance among the specimens of *Series A*. To understand this phenomenon, it is important to note that all decks were manufactured manually and that the failure mode of all specimens was a horizontal shear failure between the core and face panels. Quality due to the manual fabrication process would likely have the widest variation in the connection details of the panel, as the amount of resin, its proper distribution, and clamping force are all controlled by human decisions. Moreover, the resins generally have a greater variance in mechanical properties than do glass fibers. Since resin is the only means of transferring forces between the core and face laminates, and failure was always observed to initiate and propagate in these un-reinforced connection details, the greater variation in ultimate load carrying capacity is understandable.

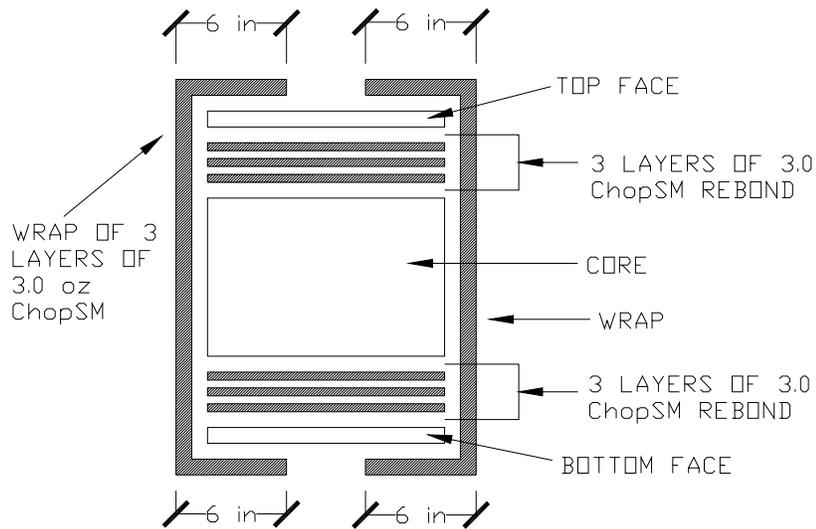
Figure 3.3: Schematic Drawing Showing the Re-bonding Layers and Wraps for the Repaired Specimens of Series A

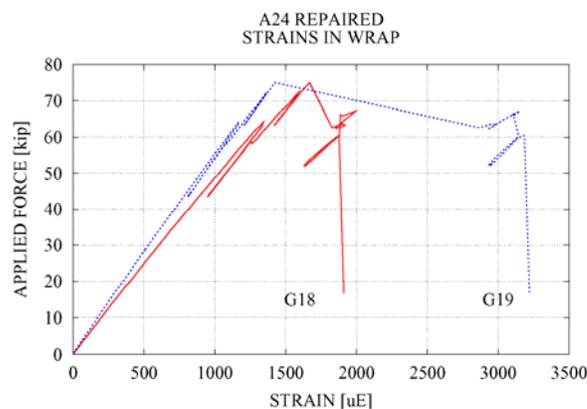
closer to the edge, and G19, below G18, further from the edge) mounted vertically on the wrap on the side of the panel. Until the maximum load 75 kips (333 kN) the tensile strain in the gages is essentially due to Poisson's ratio. Then, a sudden increase in strain from about 1,400 $\mu\epsilon$ to almost 3,000 $\mu\epsilon$ occurs as the load drops, indicating that the wrap is suddenly picking up increased tension. The specimen could sustain further loading in deflection control (from 1.614-in (41 mm) to 1.937-in (49 mm)), but never exceeded the previous peak load (see graphs in Appendix B). Ultimate flexural failure occurred when the wrap failed in bond and delaminated from the bottom face of the panel (see Appendix B).

Figure 3.4: Development of Tension in the Wrap for A24 Repaired Specimen

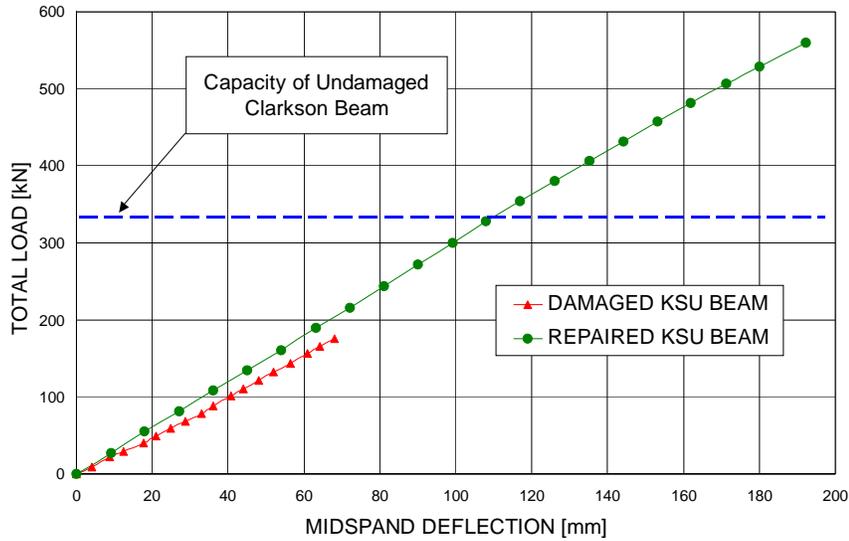
**Figure 3.5: Total Load vs. Deflection
(Comparison of Damaged, Repaired and Clarkson 32-ft-long Beams)**

Figure 3.5 shows that the *Repaired Beam* was a little stiffer than the *Damaged Beam*. This is reasonable, since the *Repaired Beam* contained one extra flat plus the rebonding layer. Ultimate loads for the three beams are also apparent from Figure 3.5.

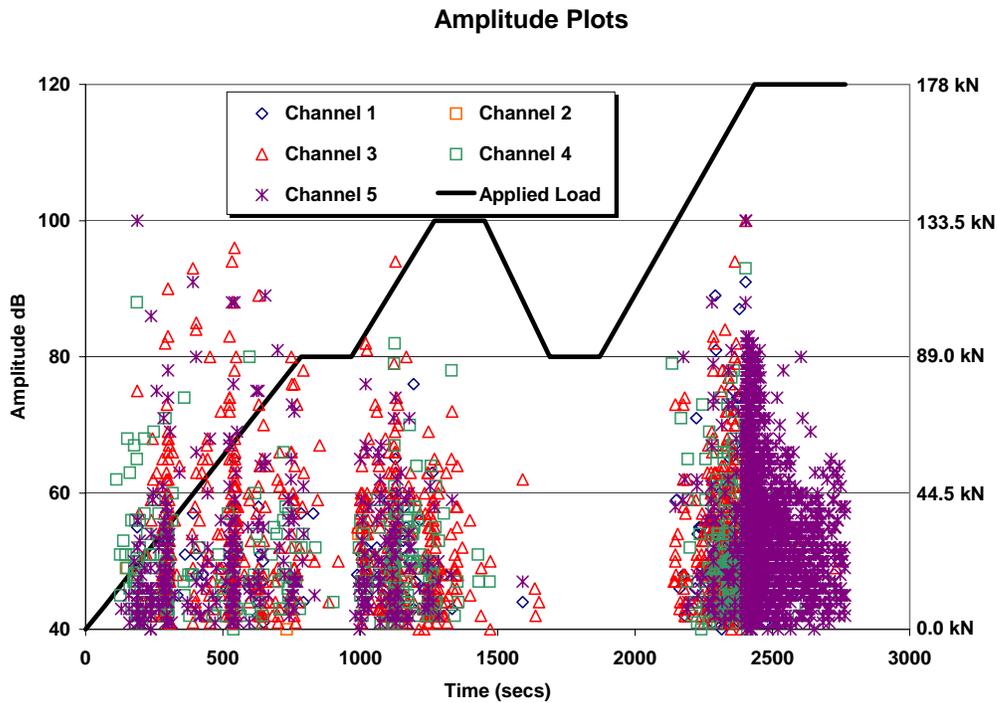
**Figure 3.6: AE Results for Damaged Beam - Amplitude vs. Time
(Graph Provided by G. Ramirez, University of Kansas)**

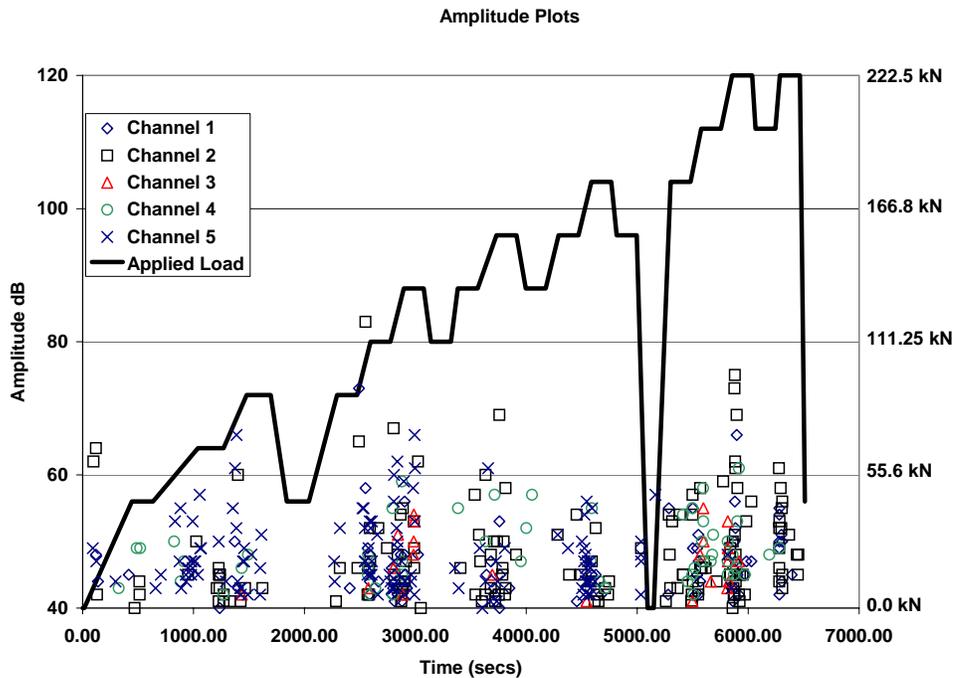
Figure 3.7: AE Results for Repaired Beam - Amplitude vs. Time (Graph Provided by G. Ramirez, University of Kansas)

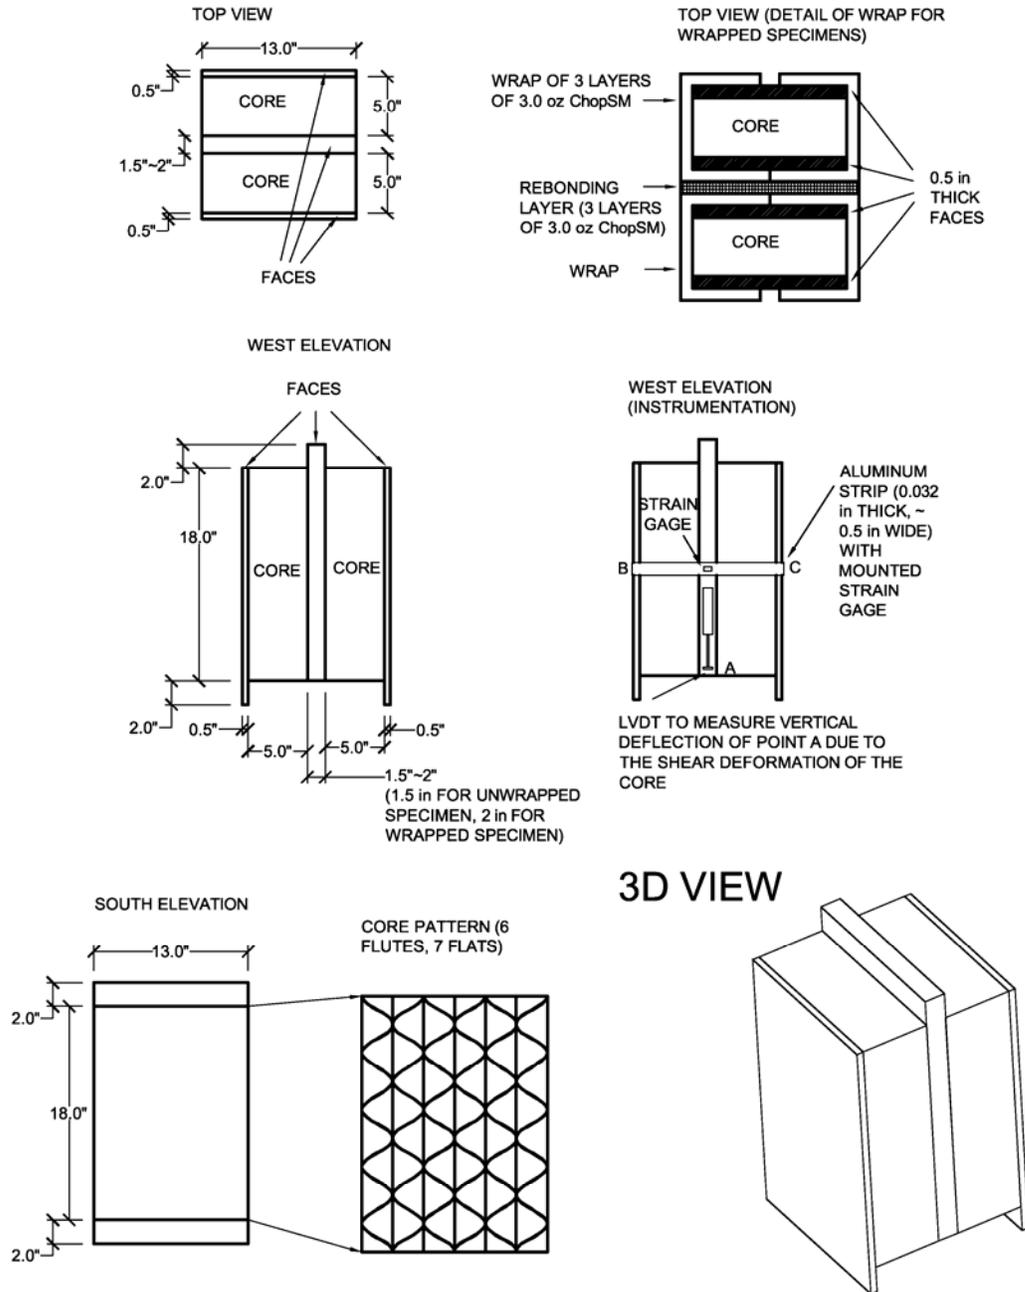
Figure 3.8: Double Shear Specimen

Each *Double-Shear* specimen was essentially composed of two smaller FRPH panels [each 18-in (450 mm) long, 13-in (330 mm) wide and 6-in (150 mm) deep] “glued” on top of each other. The two most external faces extended over the core about 2-in (50 mm) in one longitudinal direction, while the two internal (glued together) faces extended the same distance in opposite longitudinal direction (see Figure 3.8). The face extensions in longitudinal direction were used to provide contact loading area and to accommodate shear deformation.

The original test plan was to conduct tests on the “unconfined” specimens *A1*, *A2*, *A3*, *C1*, *C2* and *C3* first. Specimens would be placed in the testing machine and the load would be statically applied to the I-Beam until failure occurred. Specimens for the “unconfined” test would be instrumented with two LVDTs to measure shear deformation of the core and two aluminum strips with strain gages to determine relative deformations between the external most faces (see Figure 3.8 for specimen dimensions and instrumentation).

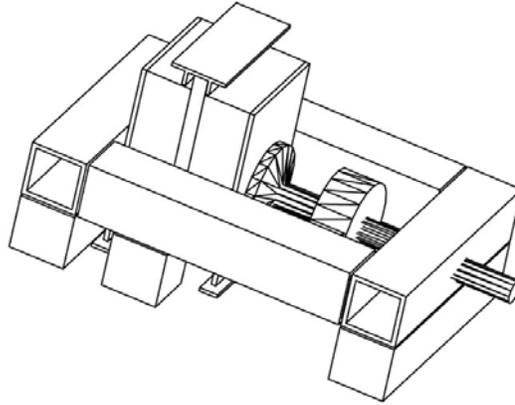
Figure 3.9: Double Shear Specimen - Test Setup For “Confined Test” (2-in Thick Steel Plates Would Be Placed Along the External Faces to Ensure Proper Transfer of Lateral Force to the Load Cell)

During the second test, specimens *A4*, *A5* and *A6* would be placed inside steel frame with a load cell (Figure 3.9) to measure the lateral force that is being developed by face core separation prior to ultimate shear failure. The steel frame was designed to be very stiff relative to the panels in order to confine the specimens and to measure the maximum lateral force. Under the anticipated maximum load of 50 kips, the longitudinal extension of the steel frame was designed to be only 0.005-in. The original plan was however changed as a result of the findings during the first few tests. These changes are explained in the following paragraphs.

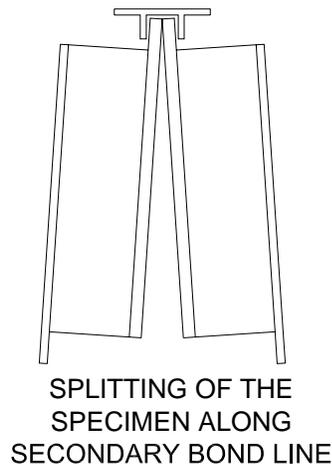
Figure 3.10: Splitting of the Double-Shear Specimen

A1 was the first specimen tested. During the loading of A1, a sudden increase of strain in the aluminum strip (from essentially 0 $\mu\epsilon$ to about 1; 300 $\mu\epsilon$) occurred. This was associated with splitting of the specimen along the glue line between the two halves (see Figure 3.10).

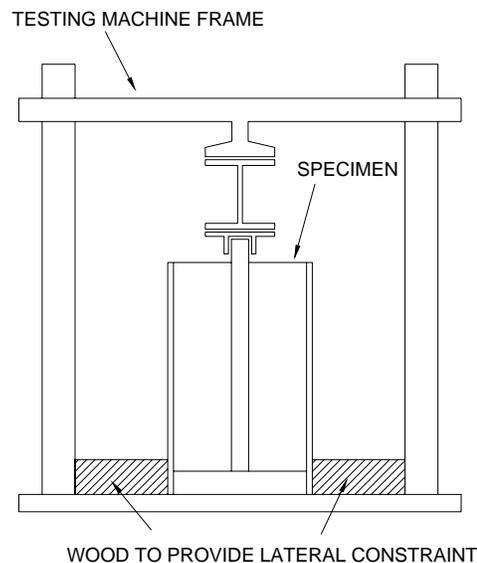
Figure 3.11: Lateral Constraint for Double-Shear Specimen A3

A3 specimen was tested the same day as *A1* specimen and because no C-Clamps or steel frame were available, wood was placed between the bottom of the specimen and the frame of the testing machine to prevent the splitting described earlier:

Placing the external constraints (wood in this case) around the specimen had two effects. (a) The desired effect was that splitting along the secondarily bonded interface was prevented. (b) The undesired effect was that the whole specimen was somewhat clamped and the shear friction, as described in Chapter 4, could have taken place. This was an unwanted effect for the unwrapped specimens. Thus, under this loading condition, the effect of shear friction due to the wrap (for the wrapped specimens) could not be directly compared to unwrapped specimens

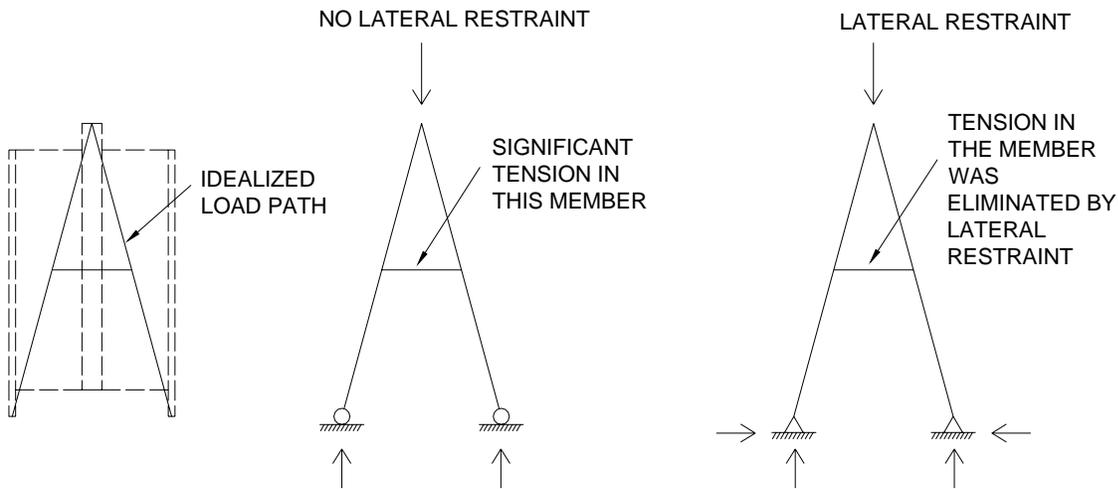
Figure 3.13: Impact of Lateral Constraint on Double-Shear Specimens

through the specimen.” Specimen A2 failed in shear between the core and face. The fact that the secondarily bonded interface split in the middle indicates that there was still tension being developed between the two halves of the shear specimen, even though it was held together at the top and bottom (refer to Figure 3.13).

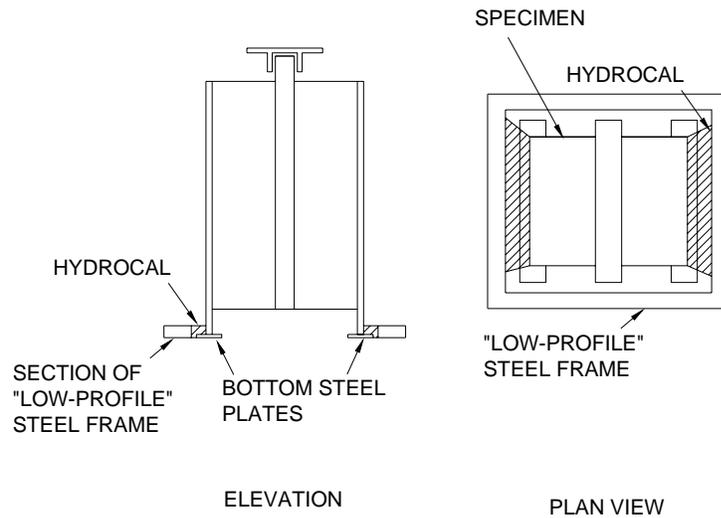
Figure 3.14: Lateral Restraint of Double-Shear Specimens by a Steel Frame

As a result of the observations from specimens A1 and A2, the researchers decided to use external lateral constraint in the form of a “low-profile” steel frame. The gap between specimen and “low-profile” frame was then filled by hydrocal (see Figure 3.14). By keeping the frame as “shallow” as possible and by placing it around the very bottom of the specimen (below the level of the core), the clamping effect would be greatly reduced.

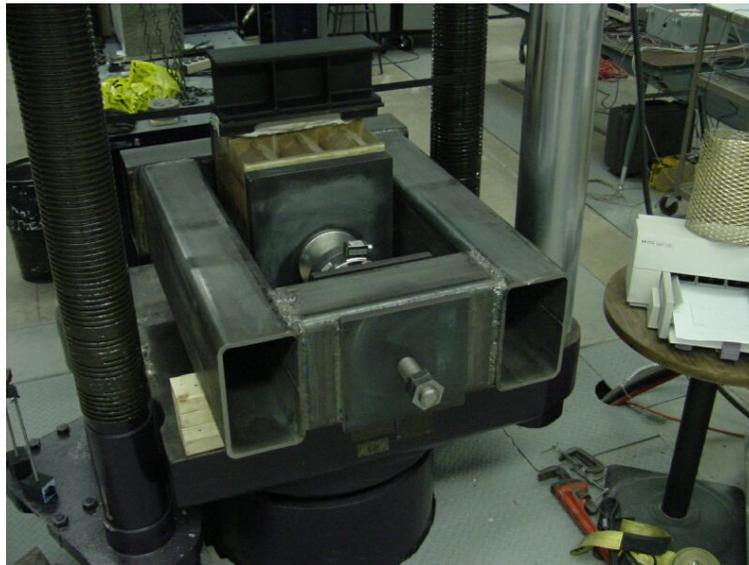
Figure 3.15: Overall View of Confined Double-Shear Specimen, Steel Plates and Confining Steel Frame

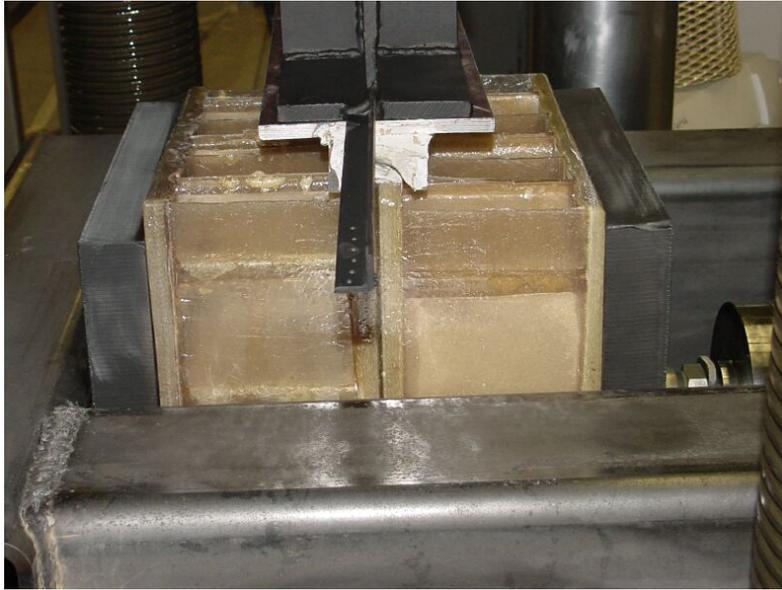
Figure 3.16: Detail of the Spreader Beam, Steel Plates and Top Portion of Confined Double-Shear Specimen

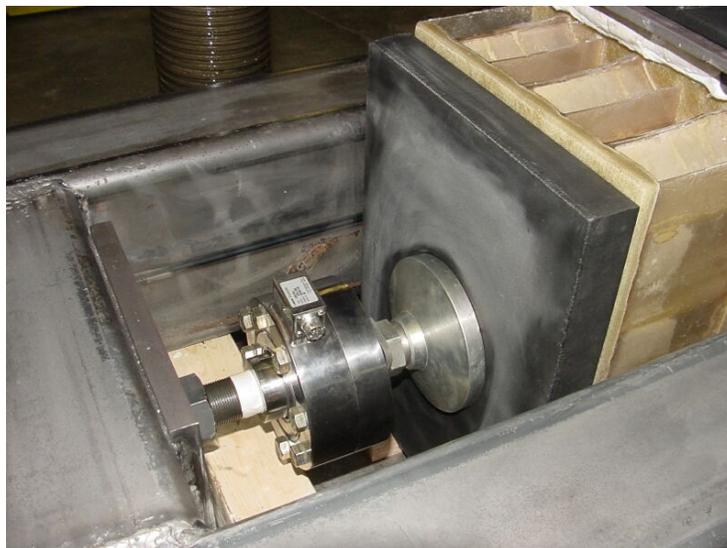
Figure 3.17: Load Cell to Measure Lateral Force Developed by Confined Double-Shear Specimen

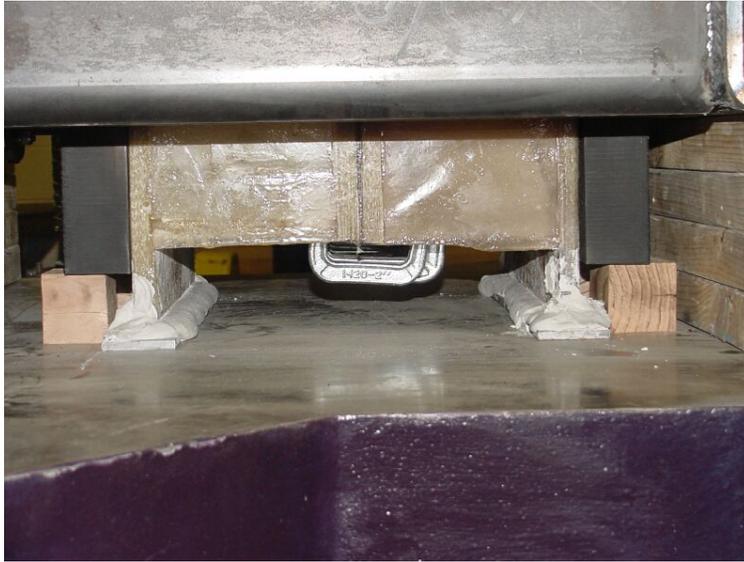
Figure 3.18: Detail of the Bottom Portion of Confined Double-Shear Specimen, Steel Plates are Supported on Wooden Blocks (Photo)

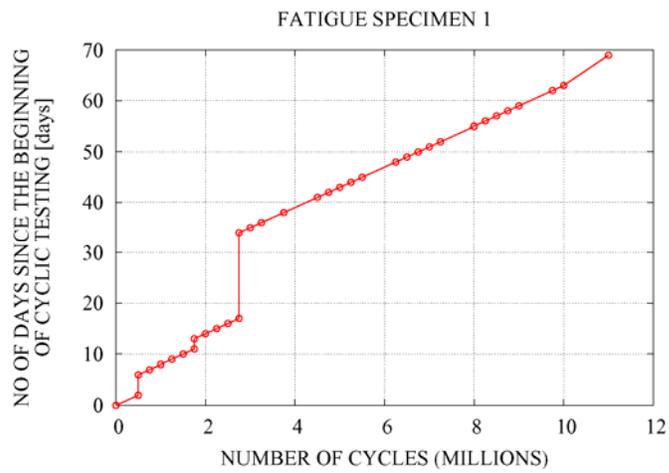
Figure 3.19: Number of Days Between Beginning of the Test and Each Static Reading vs. Number of Accumulated Cycles (Fatigue Specimen 1)

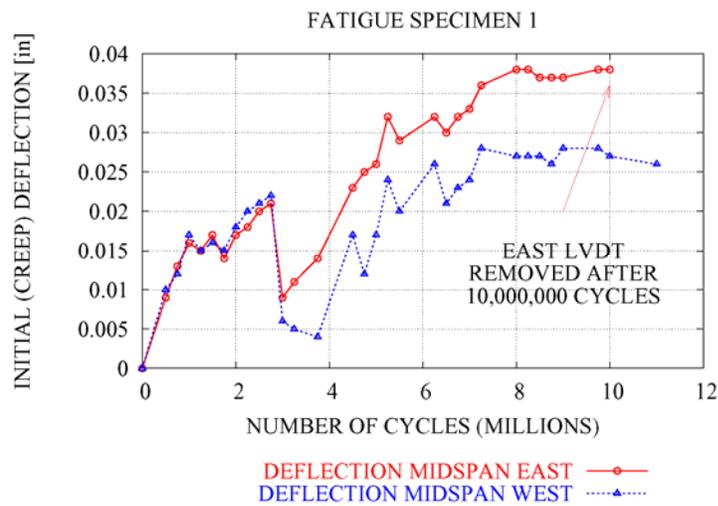
While a small change in the initial deflection (likely due to creep) was detected for *Fatigue Specimen 1*, there was essentially no softening of the structure during the 11,000,000 cycles of load. This can be concluded from the graphs of load vs. midspan deflection and load vs. strain (Figures 3.21 and 3.22) recorded during static tests that were conducted throughout the cyclic loading.

Figure 3.20: Initial (Creep) Deflection on the Beam Prior to Each Static Test vs. No. of Applied Cycles (Fatigue Specimen 1)

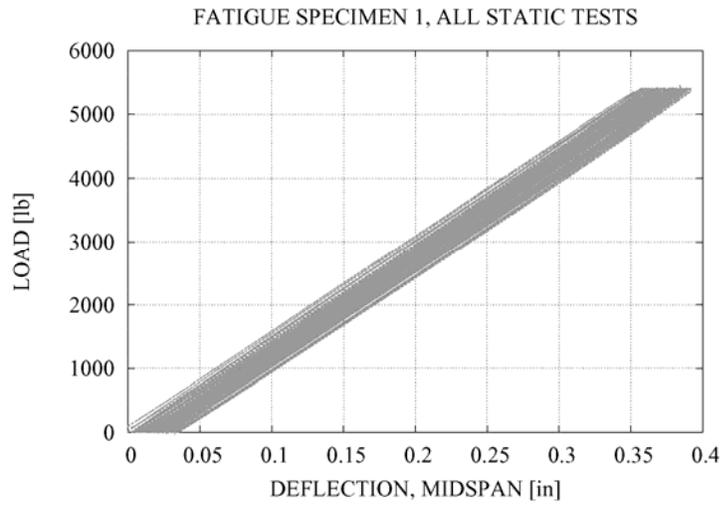
Figure 3.21: Load vs. Deflection for All Static Loadings (Fatigue Specimen 1)

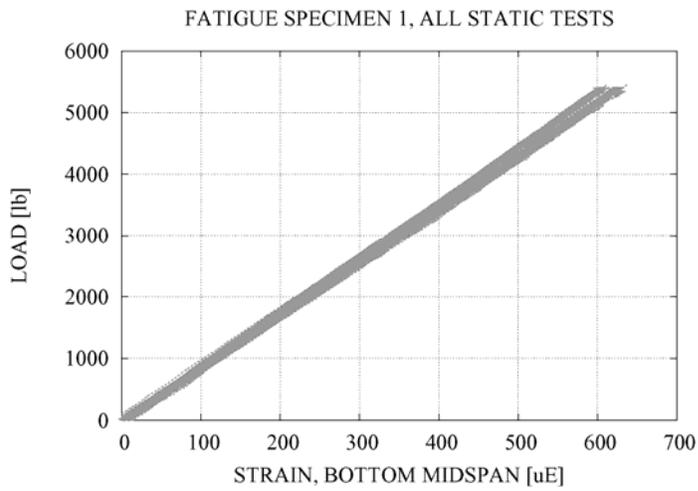
Figure 3.22: Load vs. Strain for All Static Loadings (Fatigue Specimen 1)

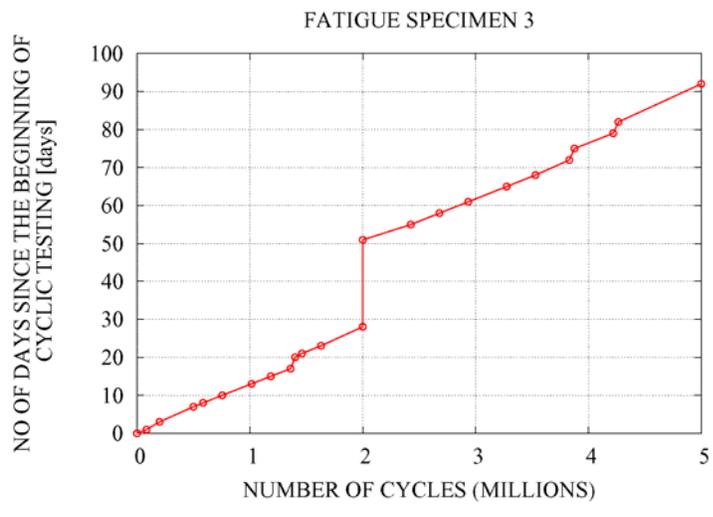
Figure 3.23: Number of Days Between Beginning of the Test and Each Static Reading vs. Number of Accumulated Cycles (Fatigue Specimen 3)

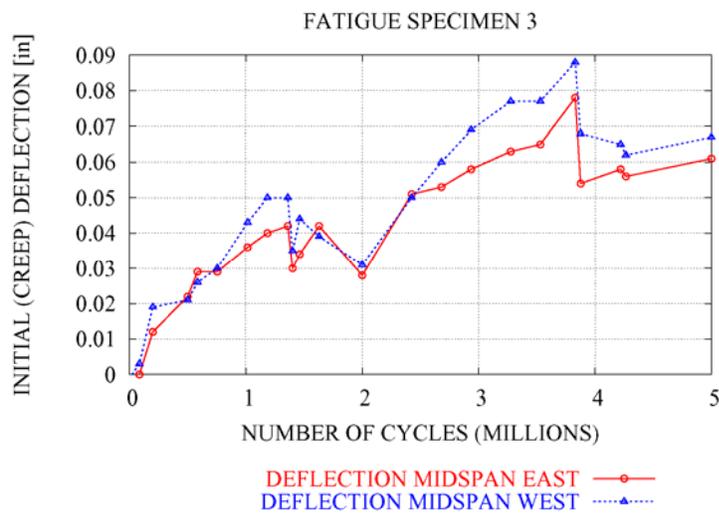
Between 3 and 5 millions cycles, the hydraulic loading system experienced several shutdowns as a result of exceeding preset error limits in the test controller. These resulted in extended periods of rest for the deck between two static tests. This is the probable reason for the “recoverable” creep deflection noted during this period (refer to Figure 3.24).

Figure 3.24: Initial (Creep) Deflection on the Beam Prior to Each Static Test vs. No. of Applied Cycles (Fatigue Specimen 3)
