The Ohio Department of Transportation Office of Research & Development Executive Summary Report

Investigation of Pavement Cracking on SR-4 and Demonstration of Multi-Head Breaker in Fracturing Reinforced PCC Pavements Before AC Overlay

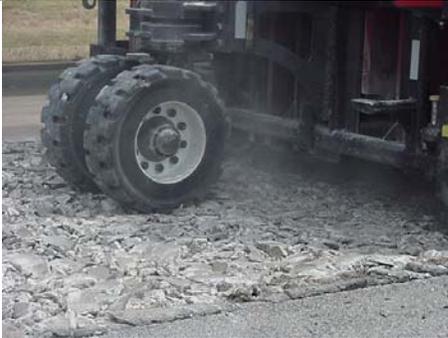
To accomplish these objectives, a program of field evaluations was undertaken on the SR-4 project and three other test projects. On two of the latter projects (I-70 in Madison County and I-71 in Fayette County), the MHB equipment was used to break the pavement; on the third project (SR-36 in Coshocton County), the RPB equipment was used.

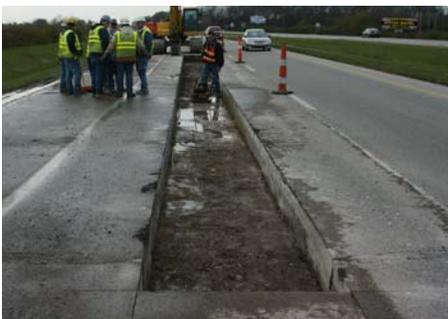
At each test site, a test pit was dug and a visual assessment of the condition of the fractured pavement overlay and subbase/subgrade was made. Measurements were made of the fracturing pattern at the surface of the concrete and gradation tests were performed to determine the particle size distribution at various depths within the fractured slab. On the MHB and RPB projects, deflection tests were performed to determine the effect of the observed breaking patterns on the stiffness of the pavement layers.
