*The Ohio Department of Transportation
Office of Research & Development
Final Report*

**Phase 1: Proof of Concept Validation of Methodology to
Examine the Responsible Use of Recycle in Corrugated
Polyethylene (PE) Drainage Pipe**

State Job No.: 134255

**Research Agency:
Jana Laboratories Inc.**

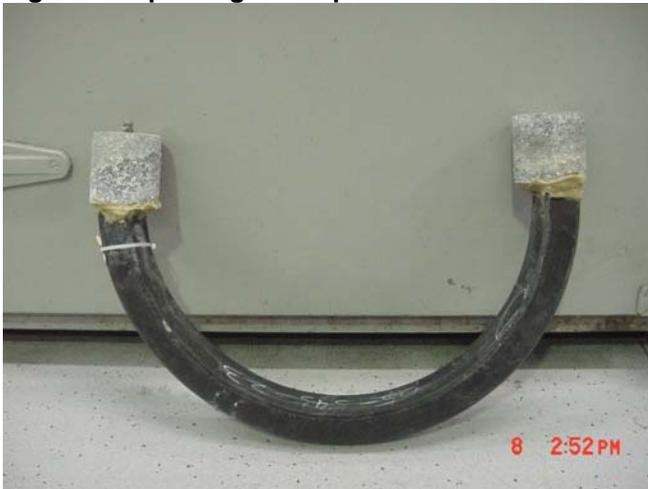
Figure 1: Pipe Ring Test Specimen

The test method developed introduces a load at the high stress area between the inner and outer pipe walls by means of an internal pressure. A ring of the pipe corrugation is cut out of the pipe. The vent hole (if present) is removed. Both ends of the pipe ring are capped and sealed, as shown in Figure 1, and the corrugation is subjected to an internal pressure. Pressure testing of the pipe ring is conducted in general accordance with ASTM D1598-02. Testing is conducted at multiple temperature and pressure conditions and the applicability of the Rate Process Method in modeling the resulting data is examined.

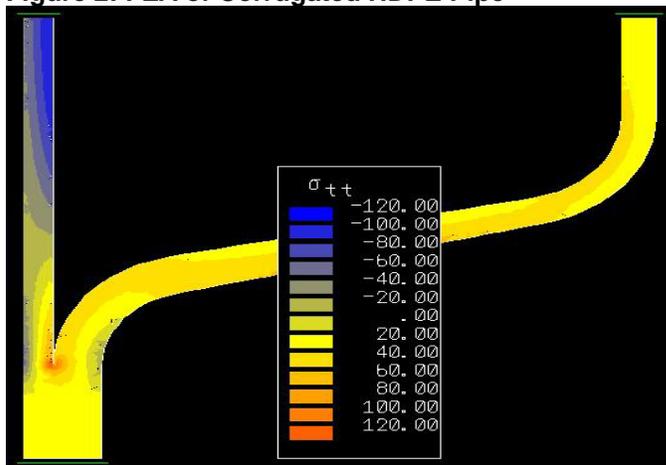
Figure 2: FEA of Corrugated HDPE Pipe

In this research project, FEA of the profile geometry of the corrugated HDPE pipe that would be tested in the research program was also conducted to determine the area of highest stress. A correlation between the internal pressure that would

be applied during the test and the stress observed by FEA in the corrugated pipe was also developed. The results showed that the internal applied pressure generated tensile bending stresses at the notch tip between the liner and crown of the profile. These stresses are from approximately 100 to 120 times the applied pressure directly at the liner-corrugation connection. The results are shown in Figure 2. This pressure to stress ratio may be dependent on the specific geometry of the pipe and, therefore, the FEA analysis would be product specific. Based on these results it is possible to estimate the corresponding stress at the tip of the notch when an internal pressure is applied. Every one psig of internal pressure corresponds to a stress of 120 psi at the tip of the notch. If the internal pressure is 10 psig, then the corresponding stress is 1,200 psi.

The FEA model, however, does not reliably predict the failure of field samples. For buried pipes, the maximum stresses enforced by loading conditions are developed on the inner surface of the liner elements where they connect to the corrugation valley, whereas for the laboratory test samples the stresses develop on the soil-side of the liner elements at that connection.

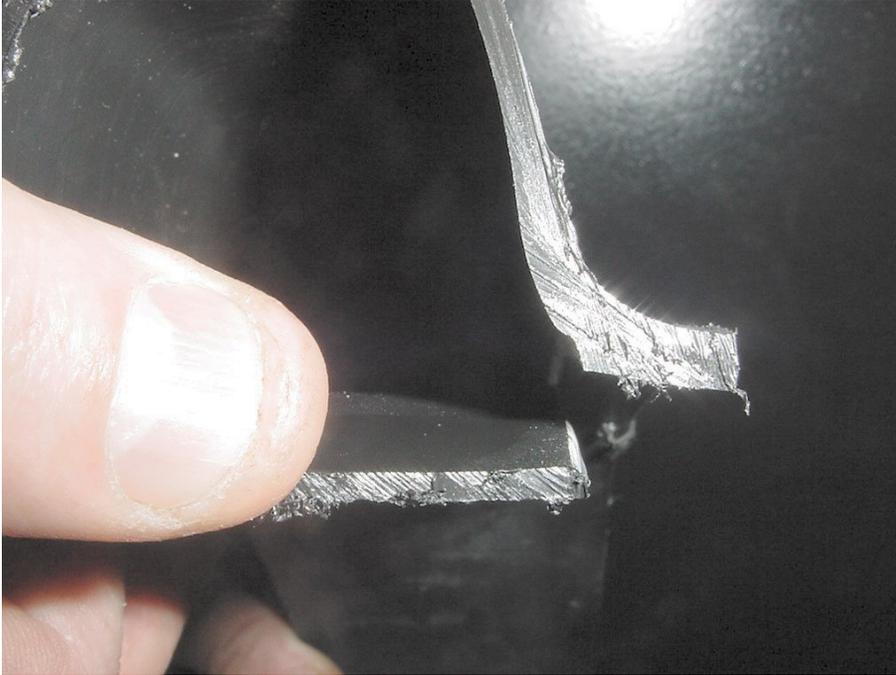
Figure 3: Optical Image of a Laboratory Sample Showing Cross-section with Failure Point

In developing a laboratory test method to project the performance of recycled materials in corrugated HDPE pipe, it is necessary to ensure that the failure mode in the laboratory method is the same as field observations, regardless of the resin. For laboratory testing it is observed that if the load (internal pressure) is high then a ductile failure occurs in the liner wall. This is the same failure mode observed in solid wall PE pipe when a high internal pressure is introduced inside the pipe. When a lower internal pressure is applied, the failure mode found was a crack that formed at the high stress area between the crown and the liner, also known as the notch tip, and then continued to grow slowly through the liner wall, as shown in Figures 3 and 4.

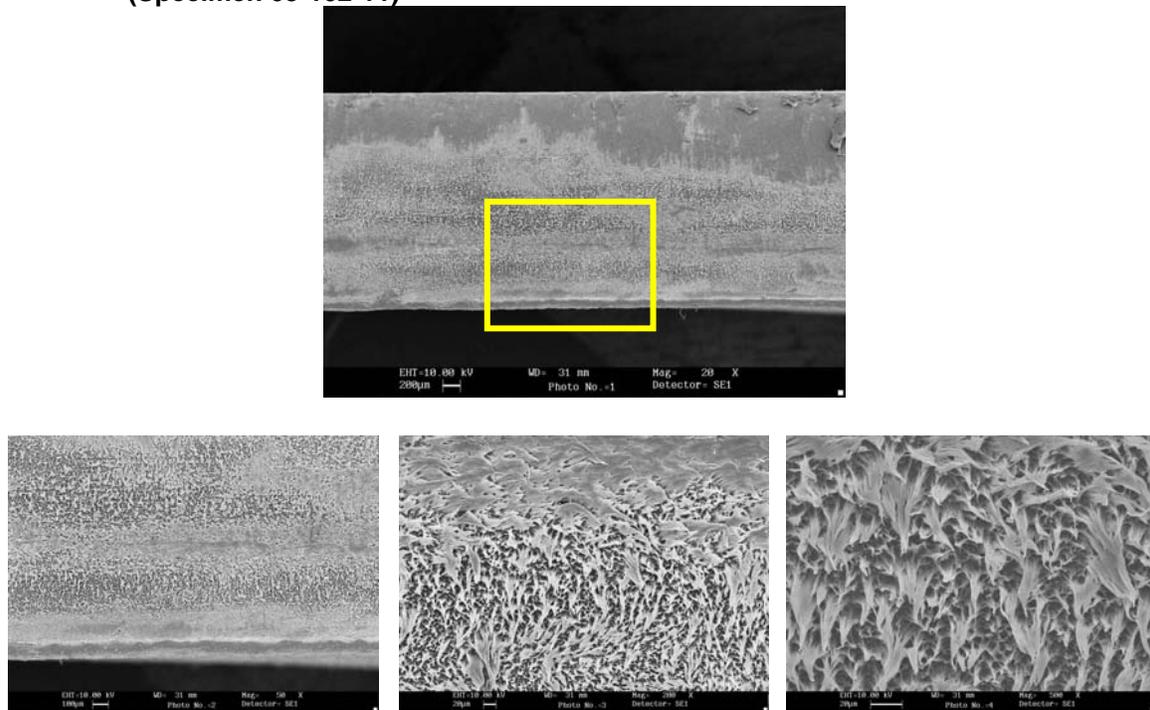
Figure 5: SEM Images of the Fracture Surface for a Laboratory Generated Failure (Specimen 05-102-11)

Scanning Electron Microscopy (SEM) photos were taken across this inner liner where the crack propagated and are shown in Figure 5. These SEM photos show the microfibril structure typical of the SCG failure mode and indicate that SCG was indeed the failure mode in this corrugated HDPE pipe ring failure. For the pipe ring laboratory failure, the crack is observed to initiate at the stress concentration area between the crown and the liner. The crack then propagates

through the liner wall and around the circumference of the pipe. The failure mechanism is observed to be SCG. Figure 6 shows the SEM analysis of SCG observed under field service conditions. The general failure location and SCG mechanism as observed for the laboratory specimen are observed. The SCG mechanism for the pipe ring test method appears, therefore, to be consistent with the SCG mechanism observed in corrugated HDPE pipe exhumed from service. The implications of duplicating the SCG failure mode in the pipe ring laboratory test method are significant suggesting that the testing methodology can be used with proper modeling approaches to project SCG resistance in corrugated HDPE pipe. Additional SEM photographs are provided in Appendix B.

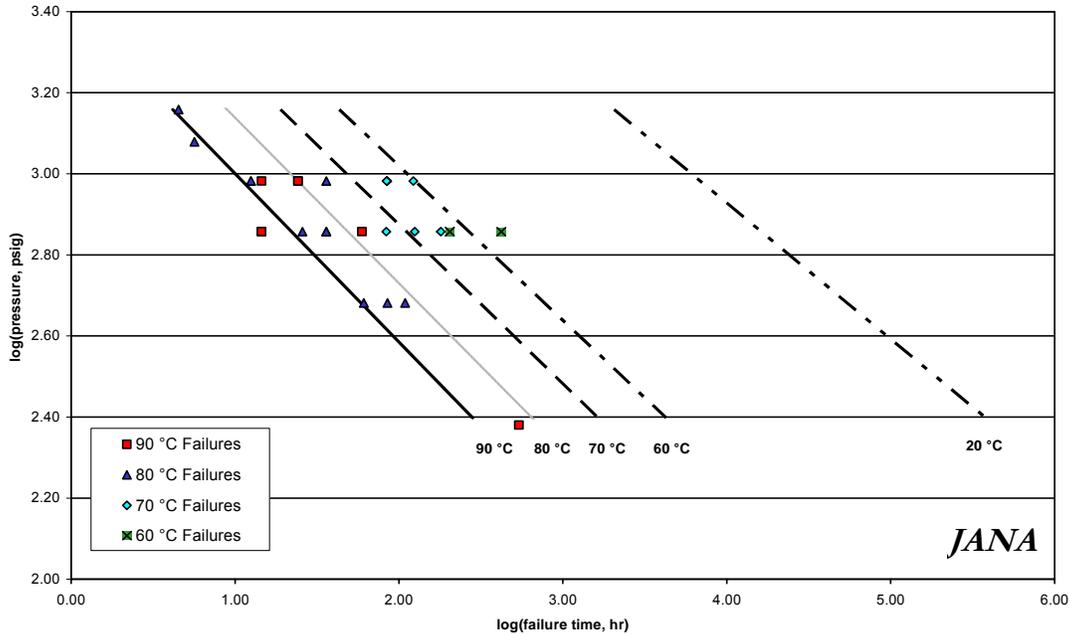
Figure 7: RPM Analysis of HDPE Corrugated Pipe Containing Recycle

The elevated temperature data and RPM projections are shown graphically in Figure 7. The lines are the slope of the brittle or SCG curve as predicted by the regression. The 68 °F (20 °C) regression line is the projected SCG performance curve of the corrugated HDPE pipe with recycle at a typical end-use temperature. From this 68 °F (20 °C) regression line, one can determine the projected average

failure time for this same SCG failure mode at a selected stress and at an average ground temperature of 68 °F (20 °C). Since the three RPM coefficients are known, any desired average ground temperature may be selected for the projection.

The failure data for the pipe containing recycle generated using the pipe ring test method was fitted to the three-coefficient Rate Process Method model. The regression equation is:

$$\text{Log (Failure Time)} = - 10.6574 + 6,856/T - 874.0/T * \text{Log (Hoop Stress)}$$

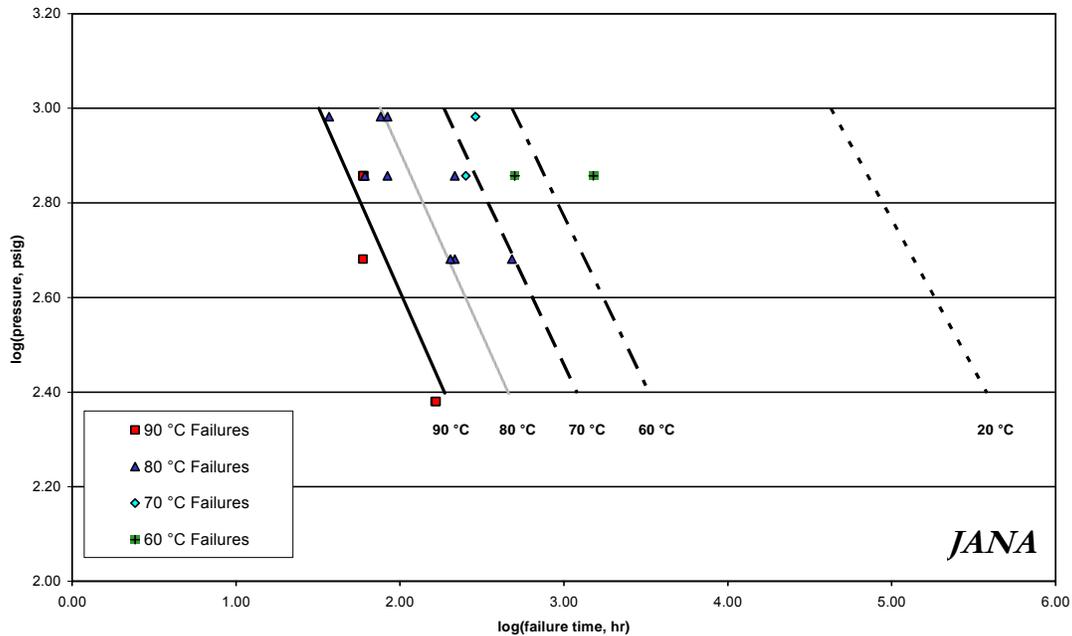
Figure 8: RPM Analysis of Control HDPE Corrugated Pipe

The elevated temperature data and RPM projection at 68 °F (20 °C) are shown graphically in Figure 8. These regression lines are based on the three coefficients of the RPM model for the control pipe. All failure modes are SCG that initiated in the notch between the liner and crown and propagated through the liner wall as was the case with the pipe containing recycle. This 68 °F (20 °C) regression line is the projected SCG performance curve of the control HDPE corrugated pipe at typical end-use temperature. From this 68 °F (20 °C) regression line, one can determine the projected average failure time for this same SCG failure mode at the selected stress and at an average ground temperature of 68 °F (20 °C). Again, since the three RPM coefficients are known, any desired average ground temperature may be selected for the projection.

The failure data for the control pipe generated using the pipe ring test method, was fitted to the three-coefficient Rate Process Method model. The regression equation is:

$$\text{Log (Failure Time)} = - 11.5773 + 6,142/T - 463.7/T * \text{Log (Hoop Stress)}$$

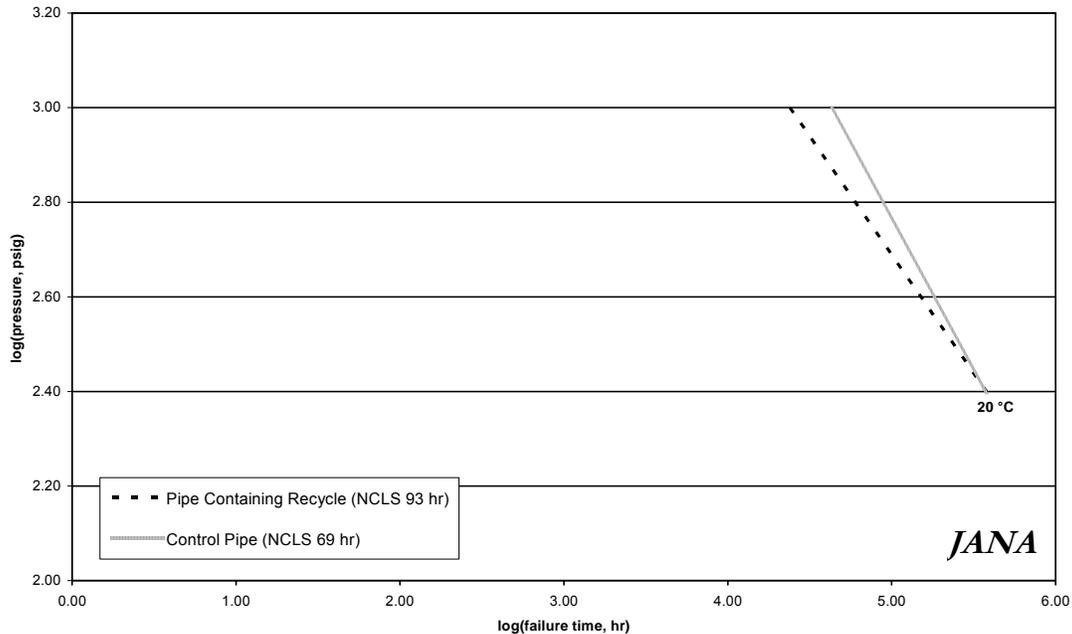
Figure 9: RPM Projection Comparison

Using the regression equations for the two materials, it may be possible to determine the effect of recycled materials on HDPE corrugated pipe. This has been done in Figure 9 with a comparison of the 68 °F (20 °C) regression lines of the control pipe and pipe containing recycle. This plot shows that both lines are virtually overlapping and given the error inherent in the extrapolations the differences are not likely to be significant. There is significant scatter within both data sets ($R^2 = 0.8$) and the level of scatter is higher than typically seen for solid wall pipe in similar analyses. This scatter is likely attributable to limitations in the test methodology and inherent variability between test specimens. Refinement of the methodology, and in particular pressure control, to reduce variability is recommended.

The known NCLS values at 122 °F (50 °C) for the resins used in the pipes tested showed an approximately 30% higher NCLS value for the pipe with recycle compared to the control. This difference is likely somewhat significant, however, the NCLS test has within laboratory repeatability of about 20% (ASTM F2136-05). As discussed above, the RPM projections at 68 °F (20 °C) in this project have shown no significant differences between the two pipe products so a correlation between the NCLS and the RPM projections can not be performed. However, a correlation between the two may not be technically correct. It is well known in solid wall pipe testing that the crack initiation period can be a very significant portion of the time to failure in SCG type failures. The period of crack initiation is not evaluated in the NCLS test, as the sample is pre-notched.

Therefore, the RPM methodology applied in this project would be able to evaluate the performance of materials and the susceptibility to crack initiation of the finished product.
