**DISTRICT 3-0 INVESTIGATION OF FIBER-WRAP TECHNOLOGY  
FOR BRIDGE REPAIR AND REHABILITATION (Phase-I)**

**Final Report**

**February 10, 2006**

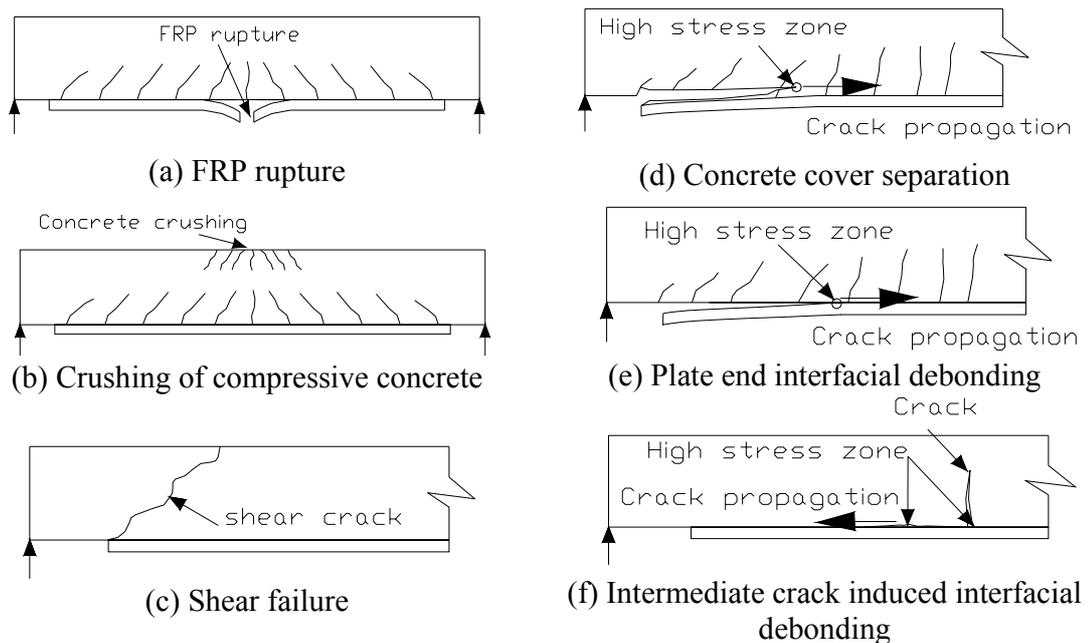
initiates at or near one of the plate ends, and (b) intermediate crack induced interfacial debonding that initiates at an intermediate flexural or flexural-shear crack and then propagate from such a crack towards the plate end. The first type of debonding is referred to as *plate end debonding* and the second is referred to as *intermediate crack induced interfacial debonding*. Of these two failure modes, plate end debonding is by far the more commonly reported failure mode. Although less commonly reported, failures by intermediate crack induced debonding are likely to control the strength of a significant portion of FRP-strengthened beams. The design approach is to selectively control more desirable and predictable failure modes ((a)-FRP rupture, (b)-concrete crushing and (c)-shear) while avoiding premature debonding failure modes ((d) and (e)) and flexural induced debonding (f).

Fig. I.A.1.1 Failure modes of FRP-strengthened RC beams (Smith and Teng, 2002a).

The *analytical methods* have been directed mainly to the problem of *plate-end debonding* (see Fig. I.A.1.1 (d) and (e)), and to a lesser extend to *mid-span debonding* (Fig. I.A.1.1 (f)). Of the two plate end debonding failure modes, failure by concrete cover separation (case (d)) is far more commonly reported (Ritchie et al. 1991, Sharif et al. 1994, Garden et al. 1997, Tumialan et al. 1999, Nguyen et al. 2001). It is generally believed that this failure is initiated by formation of a crack at or near the plate end, due to high interfacial shear and normal stresses caused by abrupt termination of the plate (Varastehpour and Hamelin 1997, Saadatmanesh and Malek 1998, Tumialan et al. 1999, Mukhopadhyaya and Swamy 2001). Once a crack forms in the concrete at or near the plate end, the crack will propagate to the level of the tension reinforcement and then progresses horizontally along the level of the reinforcement, resulting in the separation of the concrete cover. Figure I.A.1.3 shows the detached plate end, where the tension reinforcement of the beam can be clearly seen in the close-up view. Debonding between the FRP plate and the RC beam (Fig. I.A.1.1 (e)), is also believed to be initiated by high interfacial stresses near the plate end that exceed the strength of the weakest element, generally concrete. Upon debonding, a thin layer of concrete often remains attached to the plate (Fig. I.A.1.4). Plate-end debonding failures were first observed in RC beams bonded with steel plates and much research has been done for this case which is also relevant to FRP-plated RC beams.

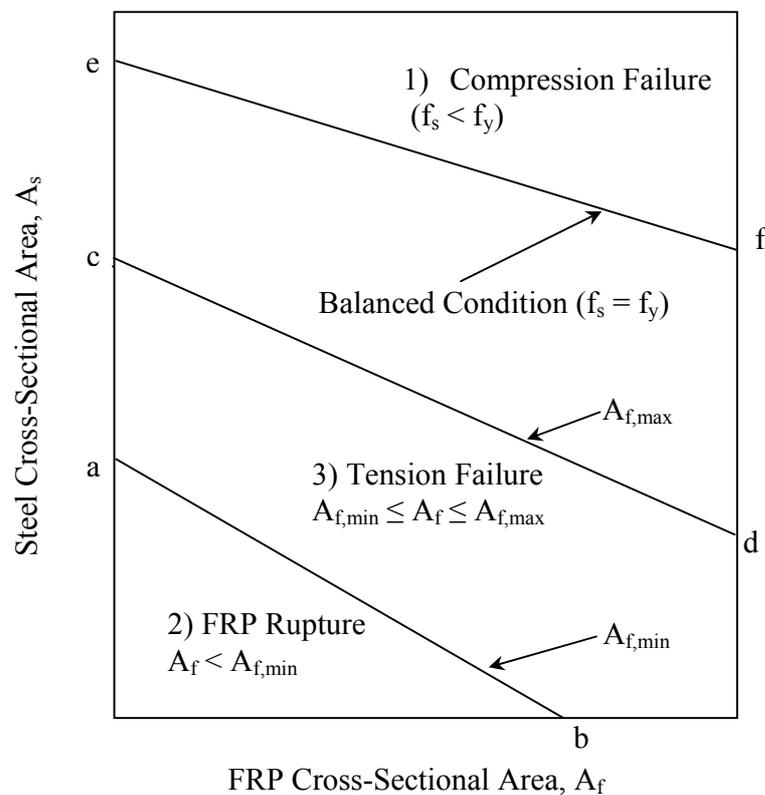
To avoid the compression failure mechanism, the cross-sectional area of the bonded FRP laminate cannot exceed the maximum FRP cross-sectional area for the section  $A_{f,max}$ , as illustrated by line cd in Fig. I.A.1.2. By assuming that the beam is properly detailed with respect to FRP plate anchorage, shear reinforcement, and epoxy bonding so as to preclude failure modes 4–6, the only possible failure modes are tension failure and FRP rupture. Although the tension failure mechanism is preferable, because it is more ductile, the FRP rupture mode can dominate if the bonded FRP cross-sectional area is less than the minimum FRP area for the cross section,  $A_{f,min}$ .

Fig. I.A.1.2 Qualitative-Three Modes of Failure (El-Mihilmy et al. 2000).

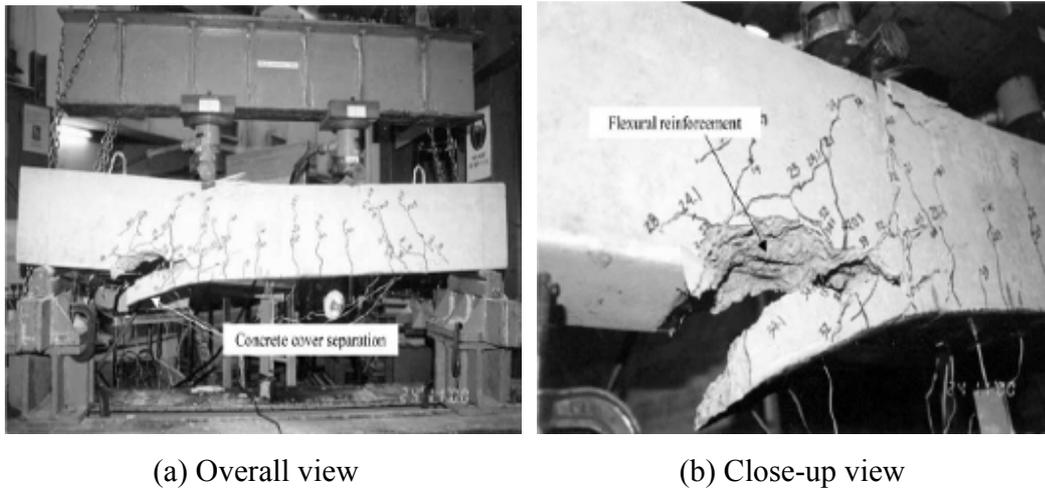
Fig. I.A.1.3 Concrete cover separation of FRP-plated RC beams (Smith and Teng 2002a).

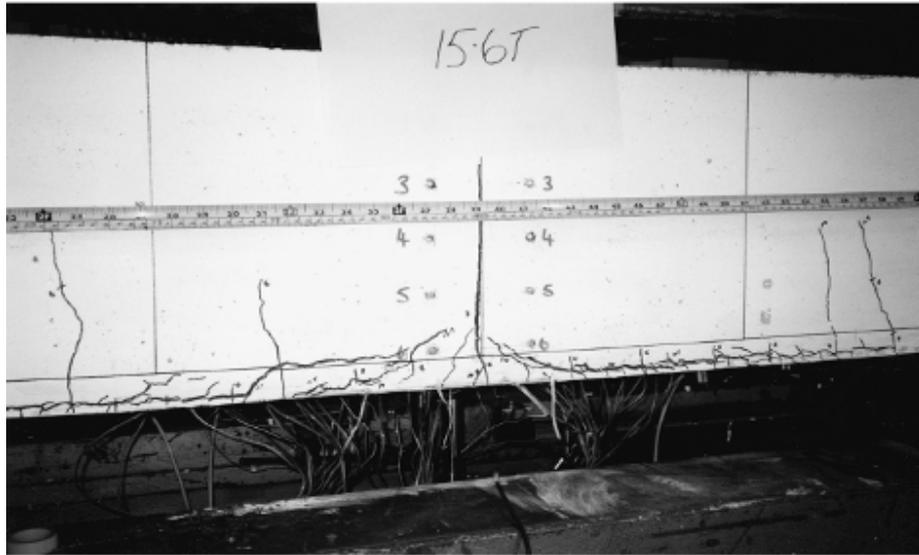
Fig. I.A.1.5 Mid-span debonding of FRP-plated RC beam (Sebastian 2001)

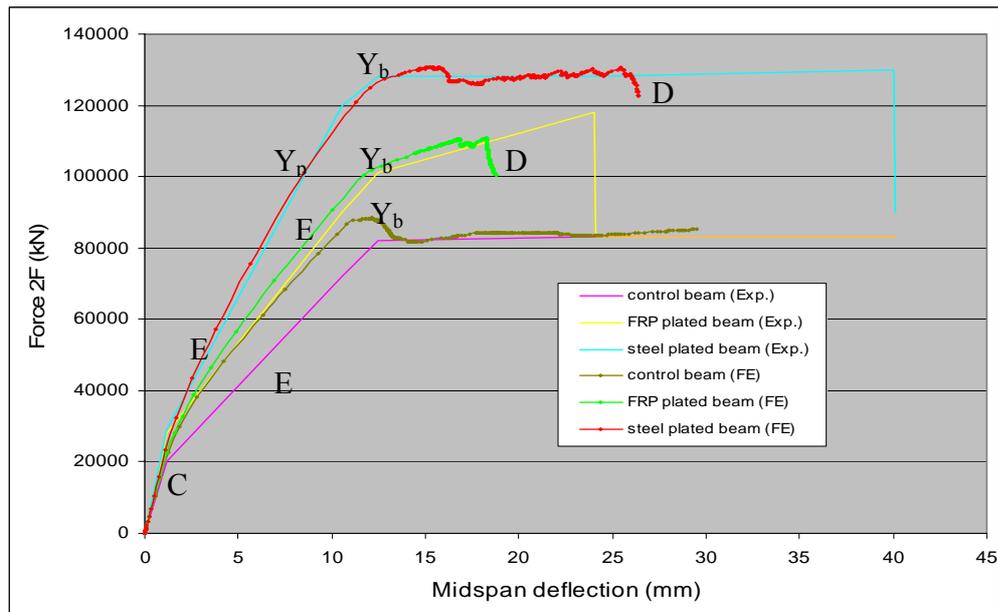
takes place across a cohesive zone resisted by cohesive tractions. Using this element, they predicted the experimental response of concrete beams tested under 4-point bending by Zarnic et al. (1999), that included control RC beams and CFRP-reinforced and steel-reinforced beams. The results for load-deflection are shown in Fig. I.A.1.6. This element is also able to represent the evolution of crack patterns for all cases.

Fig.I.A.1.6 Numerical results with CZM (Wang and Davalos 2003).

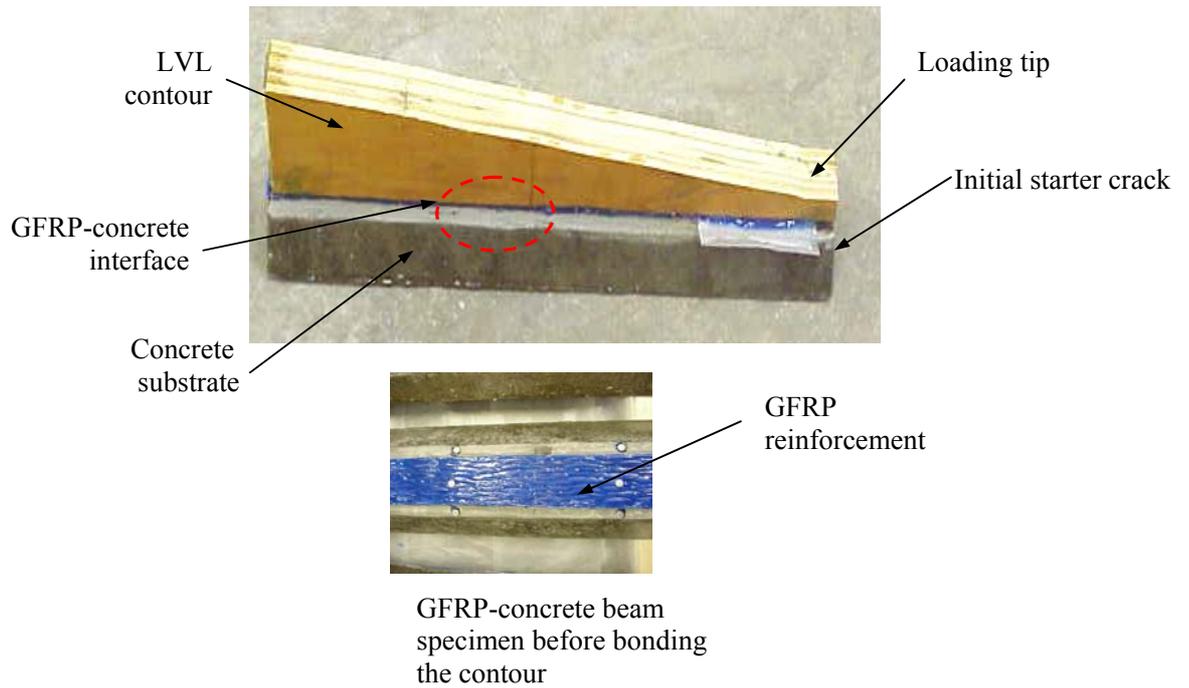
Fig.I.A.1.7 Single contoured-cantilever beam(SCCB) specimen.

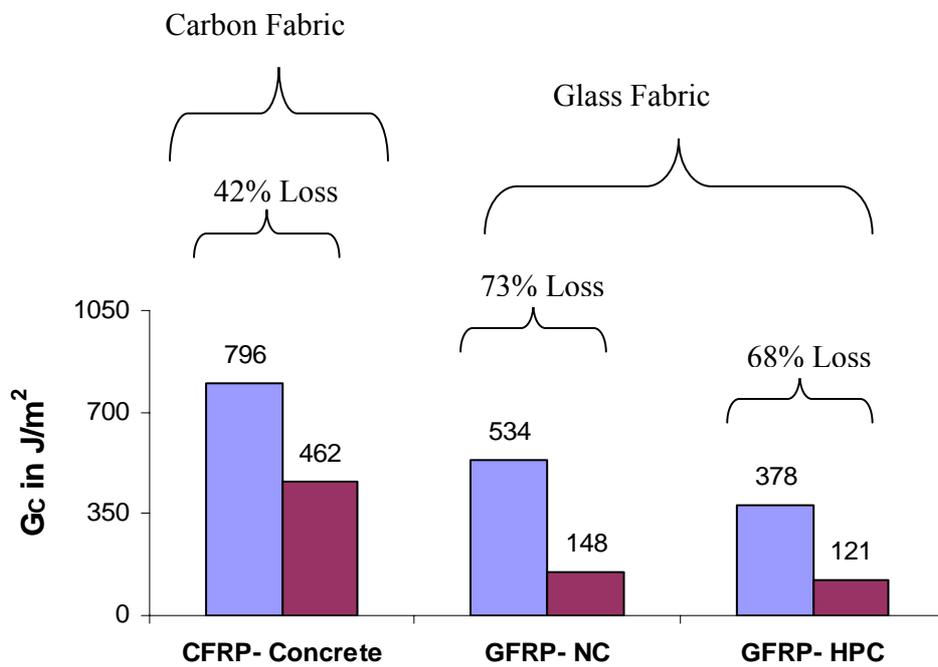
Fig. I.A.1.8 Decrease in Fracture Energy ( $G_c$ ) after 30 Wet-Dry Cycles.

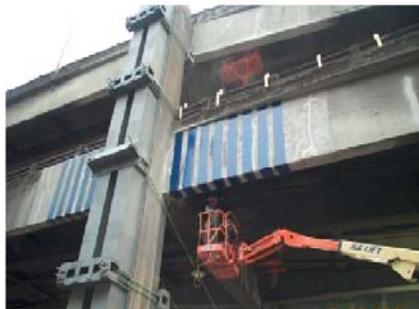
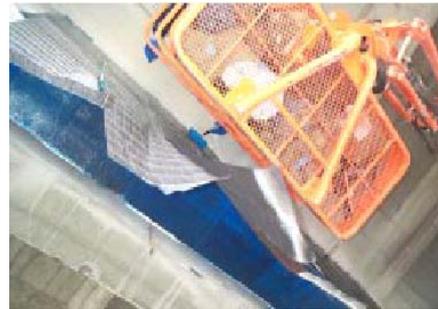
Fig. I.A.1.9 Repair of earthquake damaged Alaskan Way Viaduct.

The 48-year-old State Route 99 Alaskan Way Viaduct suffered damage as a result of the February 28, 2001 Nisqually earthquake of magnitude 6.8 Richter. MBrace carbon fiber wrap was used to reinforce the crossbeams and edge beams of the four damaged piers (Project supervised by Mr. Tysl while working at Watson Bowman Acme). The longitudinally oriented carbon fiber plies were bonded to the underside of the crossbeams to augment positive bending moment capacities. Transversely oriented U-shaped plies were bonded to both the crossbeams and edge beams to augment their vertical shear capacities (see Fig. I.A.1.9).

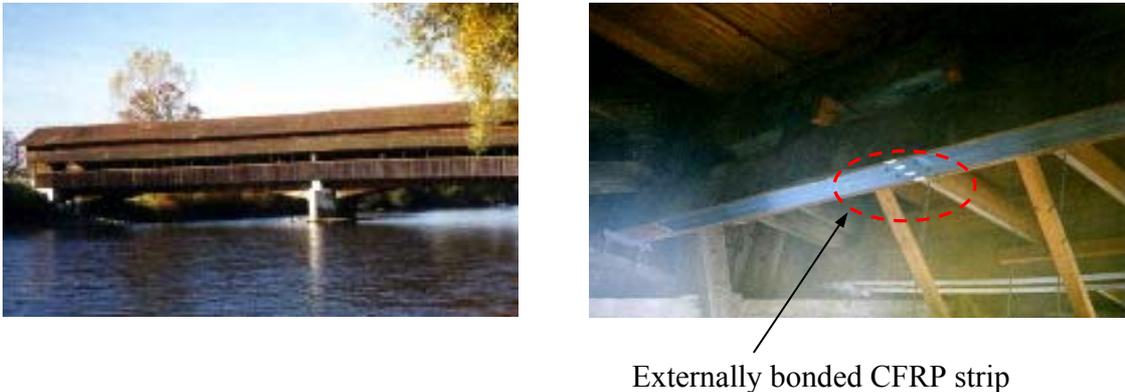
Fig. I.A.1.10 Sinns covered timber bridge.

Illustrated in Fig. I.A.1.10 is the Sinns covered wooden arch bridge in Switzerland, built in 1807; this bridge was successfully rehabilitated in 1992 by externally reinforcing with CFRP plates bonded to the transverse crossbeams.

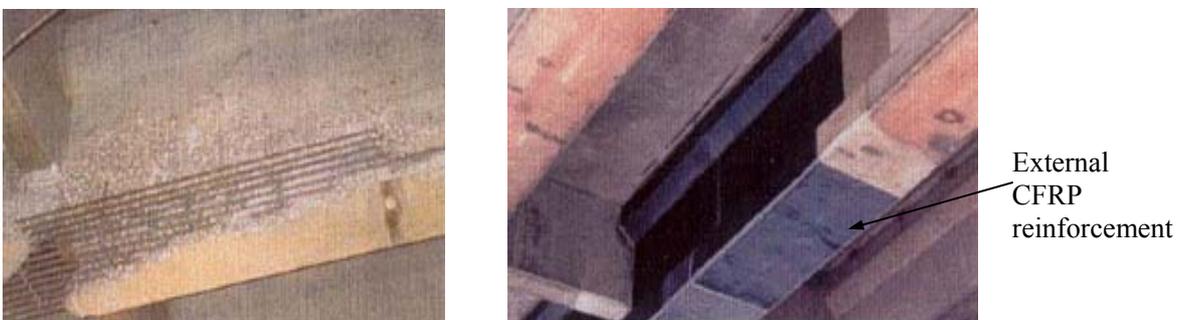
Figure I.A.1.11 shows the underside of a bridge in Florida damaged by vehicles that exceeded the height limit (NC State Univ. web site). This retrofit project was led by Prof. Mirmiran with collaboration among the NC State Univ., SDR Engineering Consultants, Univ. of Missouri-Rolla and Univ. of California-San Diego. The bridge was externally reinforced with CFRP, and was regularly tested to evaluate the performance of the strengthened components, indicating enhanced performance of the bridge structure.

Fig. I.A.1.11 Repair of bridge in Florida with CFRP.

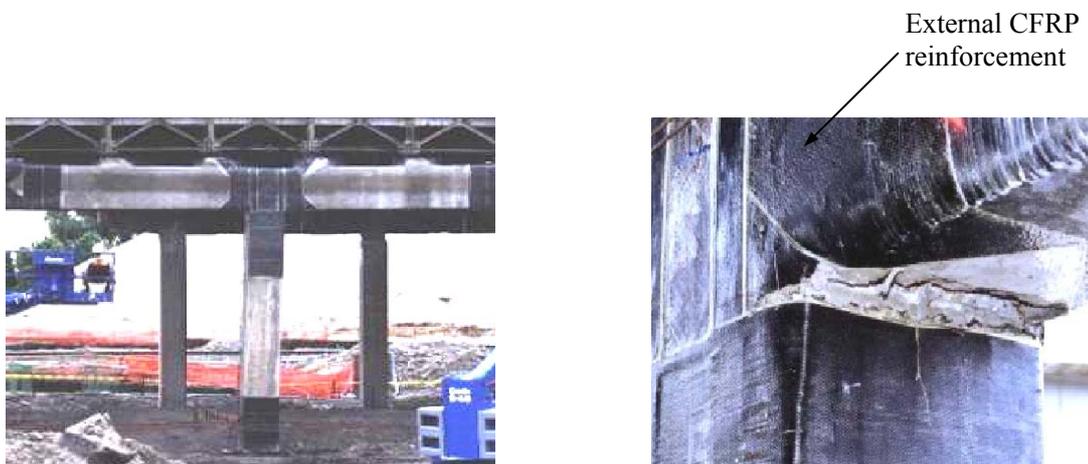
The South Temple Bridge in Salt Lake City was damaged due to earthquake; the bridge bent was retrofitted using carbon FRP (see Fig. I.A.1.12). The in-situ tests showed that externally bonded CFRP composites can greatly enhance the ductility of the bridge bents. In addition, the cap beam-column joint shear capacity was enhanced, overall damage was controlled, and a residual strength was left to support the dead load. A 35% increase in shear strength was observed for joints retrofitted with CFRP. The in-situ tests proved that the design of the composite was successful and provided strong evidence that the retrofit using CFRP composites is a viable option for improving the seismic performance of reinforced concrete bridges (Univ. of Utah website).

Fig. I.A.1.12 South Temple Bridge.

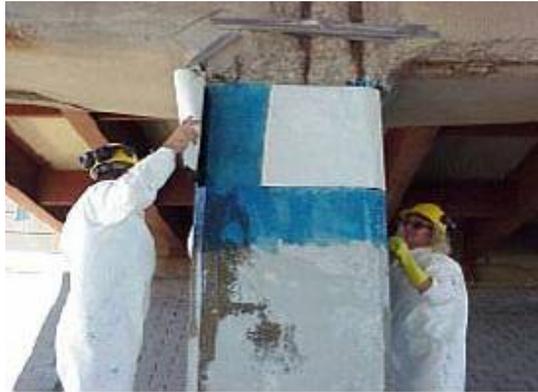
Fig. I.A.1.13 Column repair of bridge over I-96.

The columns shown in Figure I.A.1.13 are located on Lansing Road in Lansing, Michigan under the I-96 overpass (Bridge ID S09 and S10 of 23152). These columns had considerable surface spalling and the reinforcement was exposed at several locations. After superficial repairs to the column surface, two columns were wrapped with two layers of carbon fiber sheets, and two were wrapped with three layers of glass fiber sheets. The wrapped columns showed significant improvement in strength.

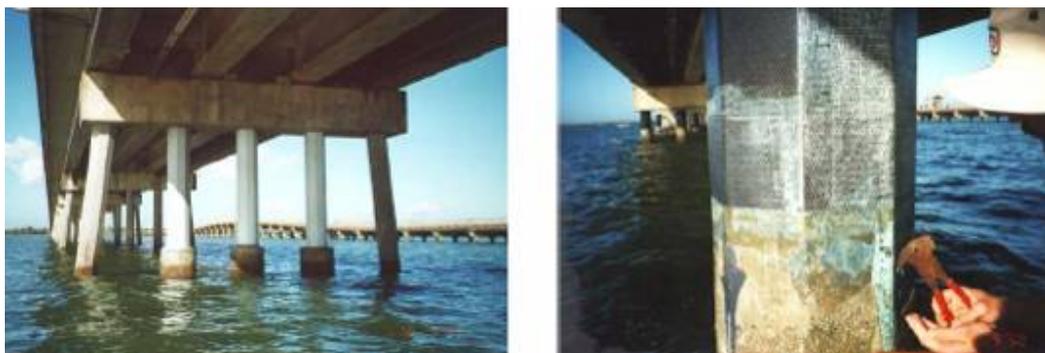
The Houghton Highway Bridge is a dual carriageway bridge in Australia linking Queensland's capital Brisbane with the northern shire of Redcliffe. A routine inspection carried out in 1991 identified deterioration of the prestressed concrete piles due to exposure to marine water. There was evident internal cracking and spalling of concrete thus exposing the reinforcing steel to marine environment. In 2000, these piles were externally reinforced with carbon FRP (see Figure I.A.1.14).

Fig. I.A.1.14 Houghton Highway Bridge.

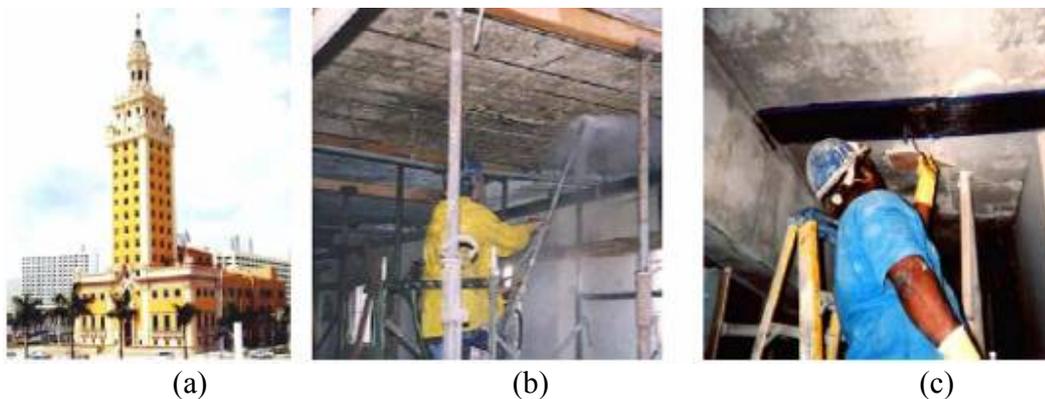
Beam repairs were required throughout the Freedom Tower structure, including concrete encased I-beams on certain floors in the office tower portion (Fig. I.A.1.15). All delaminated and spalled concrete was removed from the beams. Beams supporting the library level were externally bonded with a composite carbon fiber-reinforced plastic strengthening system to withstand the additional load-bearing requirements. The thin cross-section of CFRP strengthening system made it possible to conceal their presence and preserve the beauty of the existing structure. Thus, the Freedom Tower has been successfully restored to its ancient glory with minimum possible alteration in its external appearance.

Fig. I.A.1.15 (a)Freedom Tower, (b)Deteriorated beam & slab, (c)Application of CFRP.

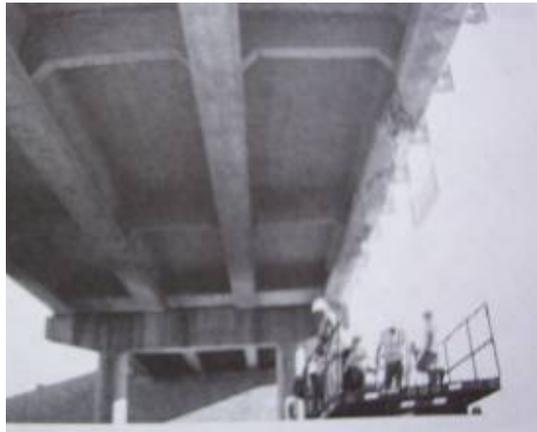
Fig. I.A.1.16 Exterior Girder Bottom Flange after Impact with Over-height Vehicle/Payload.

An external beam of the Farm-to-Market 1927 bridge was severely damaged by an over-height vehicle on January 17, 2002. The beam's web and the bottom flange near the middle of the span between two diaphragms were fractured into several pieces as shown in Figures I.A.1.16 and I.A.1.17. The maintenance engineer proposed one layer of CFRP composite in addition to the normal repair method to restore the shear strength and the integrity of the beam. The direction of the longitudinal fiber was perpendicular to the longitudinal beam axis (vertical to the web) because the CFRP was intended for shear strengthening. Patching of the concrete and the epoxy injection took four days; CFRP composite installation took one day. The total cost was \$47,000, which included \$22,000

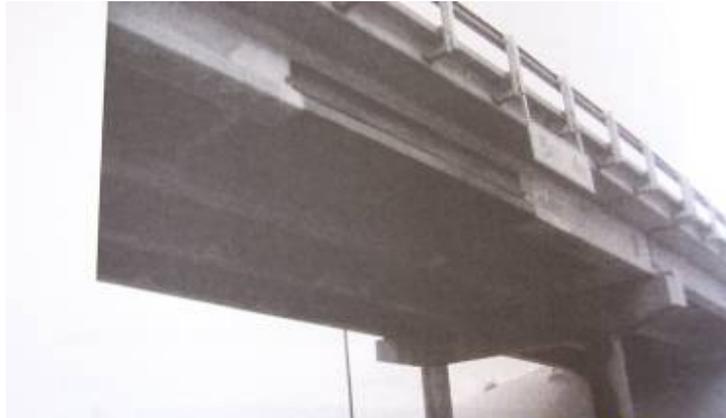
Fig. I.A.1.18 Damaged External Girder after Completed Repair Work.

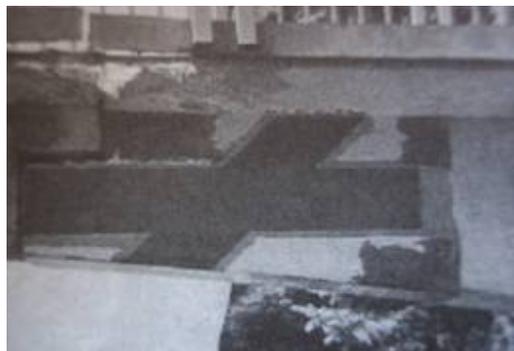
Fig. I.A.1.20 (a) Application of CFRP Sheets.

The Jacques Lodge Pedestrian Bridge in Calgary, Alberta, consists of a precast concrete “drop-in” girder supported by a cantilevered girder at each end. As shown in Fig. I.A.1.19, the concrete corbels supporting the main girder exhibited cracking due to unexpected friction forces and a lack of sufficient internal diagonal steel reinforcement. The direction of the fibers in the applied sheets was consistent with the ordination of the deficient reinforcing steel. The configuration of the CFRP sheets is shown in Fig. I.A.1.20 (a). A single horizontal layer and a diagonal layer of CFRP sheets were required for each side of the corbel, as shown in Fig. I.A.1.20 (a). In order to repair the concrete corbels, the entire main span was jacked up. After cleaning and preparing the concrete surface, Replark™ CFRP sheets were applied as shown in Fig. I.A.1.20 (a). After curing of the epoxy impregnating the CFRP sheets, a protective coating was applied, and the jacks supporting the main span were removed, as shown in Fig. I.A.1.20 (b). Repair of the bridge was completed in 6 weeks at a total cost of \$20,000.

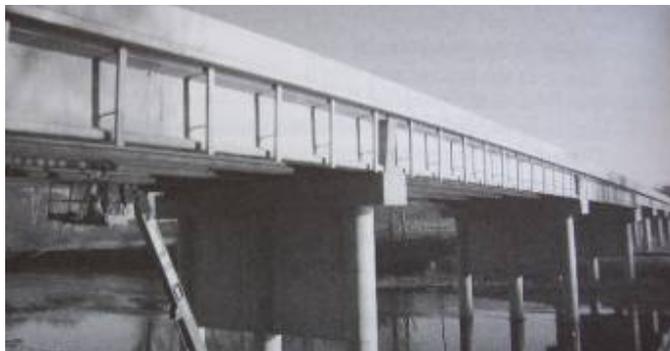
Fig. I.A.1.21 Bridge A5657.

The original ultimate flexural capacity of an accidentally impact-damaged PC girder of Bridge A5657 (see Fig. I.A.1.21) located on Route 28 over the Gasconade River, South of Dixon MO was restored. Two prestressing tendons in the central girder of the North

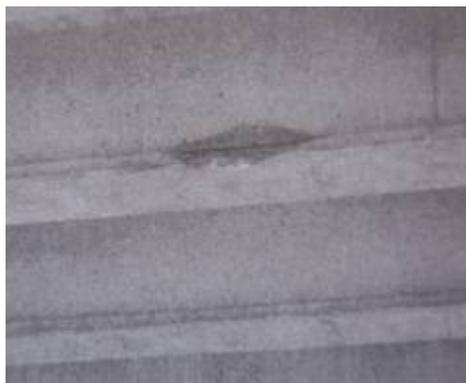
Fig. I.A.1.22 Damaged Area in the Girder.

span of the bridge were fractured due to the impact, as shown in Fig. I.A.1.22. Figures I.A.1.23 and I.A.1.24 show the installation of the FRP laminates and the U-wrap used to hold in place the flexural reinforcement, respectively.

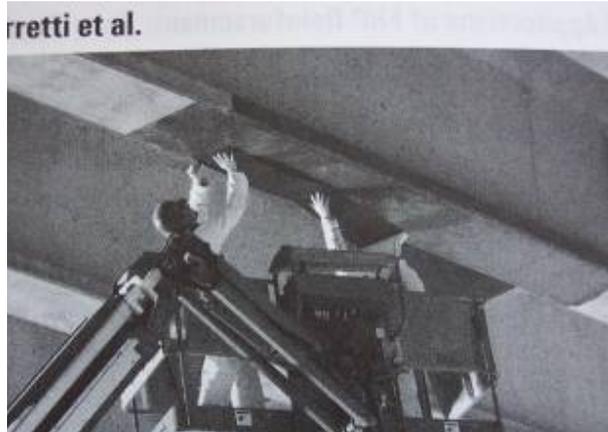
Fig. I.A.1.23 Installation of the Flexural Reinforcement.

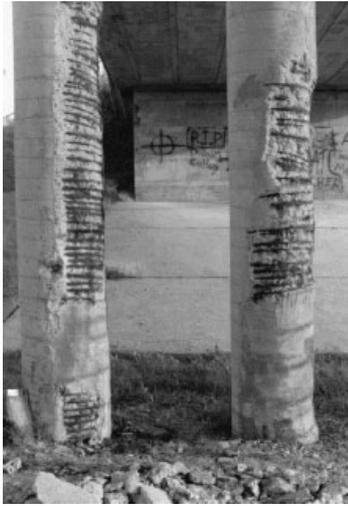
Fig. I.A.1.25 View of corroded columns, Highway 10 overpass, Quebec, Canada.

In August 1996, nine of twelve corrosion-damaged circular columns (Fig. I.A.1.25) of an overpass located on Highway 10 in Quebec were repaired in three weeks, using FRP composites. Damage to the 6-m-high, 760-mm diameter reinforced columns was the result of splashing of salt contaminated by vehicular traffic in winter. Innovative fiber optic sensors were used for instrumenting the columns. Four of the columns were wrapped with carbon and five with glass fiber (Fig. I.A.1.26). Fiber optic sensors were installed on four of the rehabilitated columns. Deformations of the columns due to temperature variation, effects of loading and corrosion of reinforcement were monitored on a regular basis. The performance of the columns since repair has been excellent.

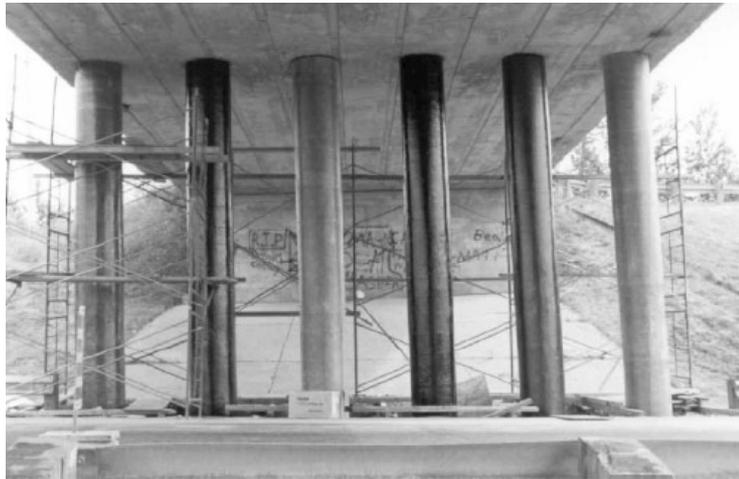
Fig. I.A.1.26 View of wrapped columns, Highway 10 overpass, Quebec, Canada.

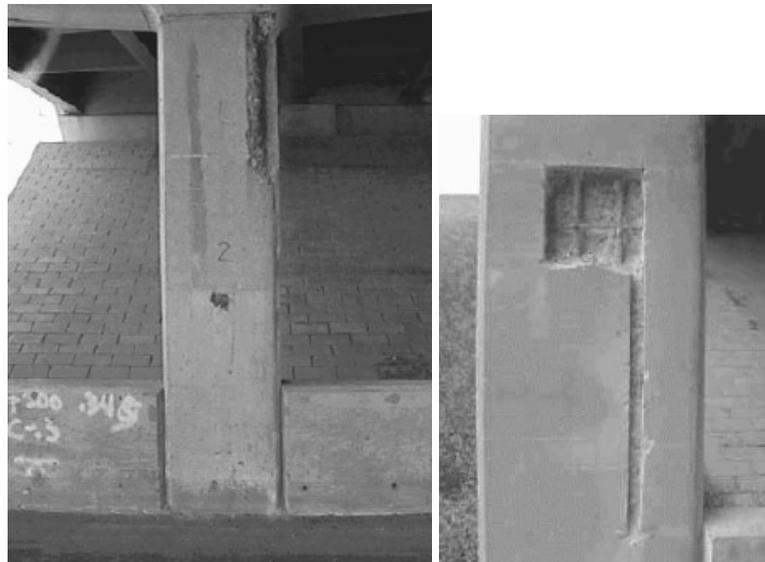
The Michigan Department of Transportation (MDOT) used FRP to repair four corrosion-damaged columns on Lansing Road, Lansing, MI under the I-96 overpass. The repaired reinforced columns were  $81 \times 81$  cm. Corrosion damage was relatively minor, comprising spalls and corner crack (Fig. I.A.1.27 (a)). All columns were instrumented on one face with corrosion probes manufactured by Rohrback Cosasco Systems, Inc. The probes were located at the same level of the existing reinforcement about 2m above the road surface (Fig. I.A.1.27 (b)). Superficial repairs were first carried out with patching material to

Fig. I.A.1.27 (a) Corrosion damage in East Bound Pier; (b) Preparation for installing corrosion probes and wiring; (c) View of repaired columns (left) carbon and glass (right).

which chloride had been added to match the pre-existing chloride in the columns. Two columns were wrapped with two layers of unidirectional carbon fiber sheets (MBRACE CF-130) and two others with three layers of unidirectional glass (FYFE SHE 51, TYFO S). Two additional unwrapped rectangular columns 96.5×81 cm were retained as controls. The repairs were completed in July 1999 (Fig. I.A.1.27 (c)).

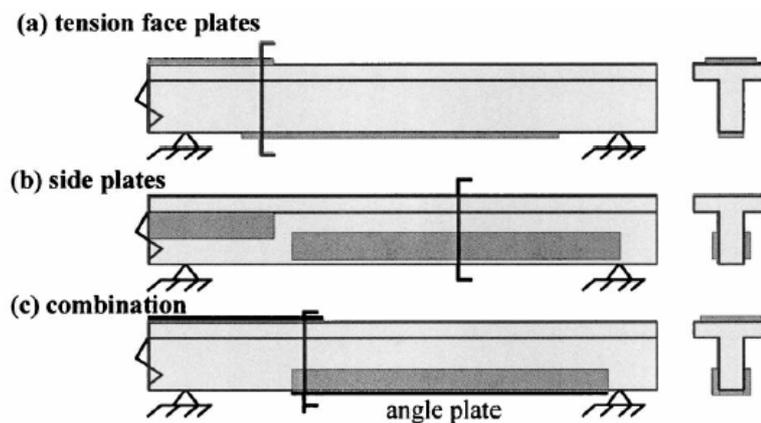
Fig. I.B.1.2 Plate positions (Oehlers 2001).

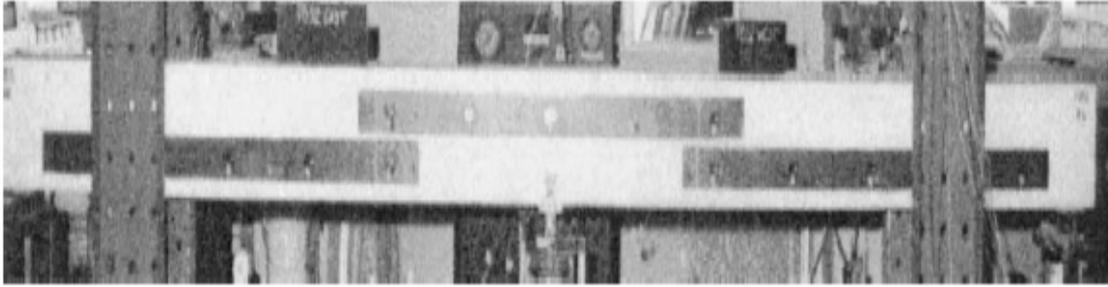
Terminating the plates at the points of contraflexure as shown in Fig. I.B.1.4 ensures that the plate ends do not debond due to flexural peeling, but shear peeling and axial peeling are still of concern.

Fig. I.B.1.4 Plated continuous beam (Oehlers 2001).

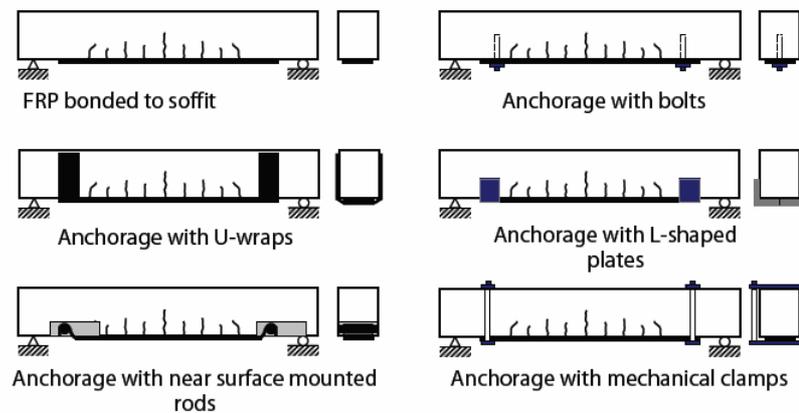
For shear strengthening of concrete members, the ends of FRP strips shall be adequately anchored to develop the design forces in the strips (Bridge Manual 2003). In a situation where a slab overlies a beam being strengthened (as with T-beams), the preferred approach is for intermittent slots to be cut in the slab and the FRP strips passed through the slab and anchored on the slab top surfaces.

Fig.I.B.1.7 Anchorage schemes at laminate ends (Spadea et al. 1998).

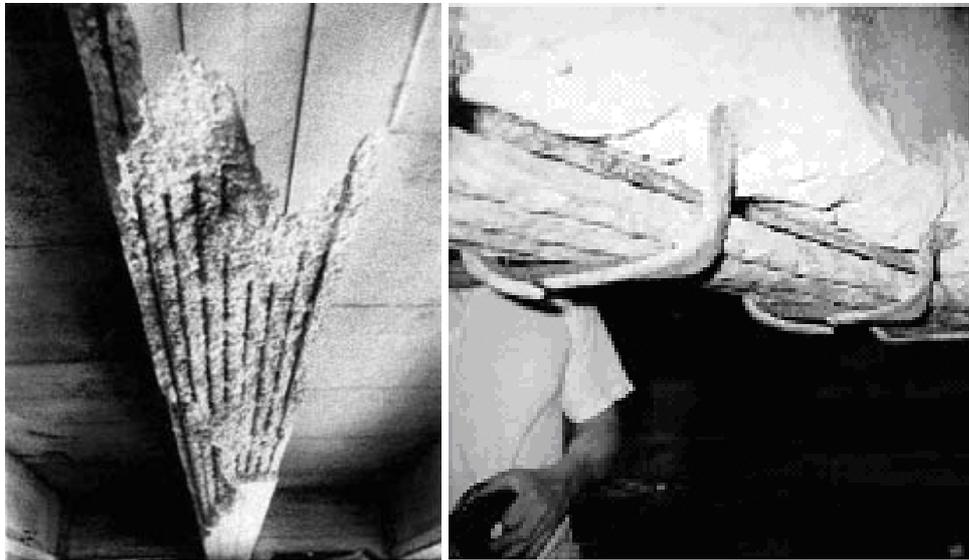
Fig. I.C.1.2. An example of damage that was repaired by the FRP technology [1].

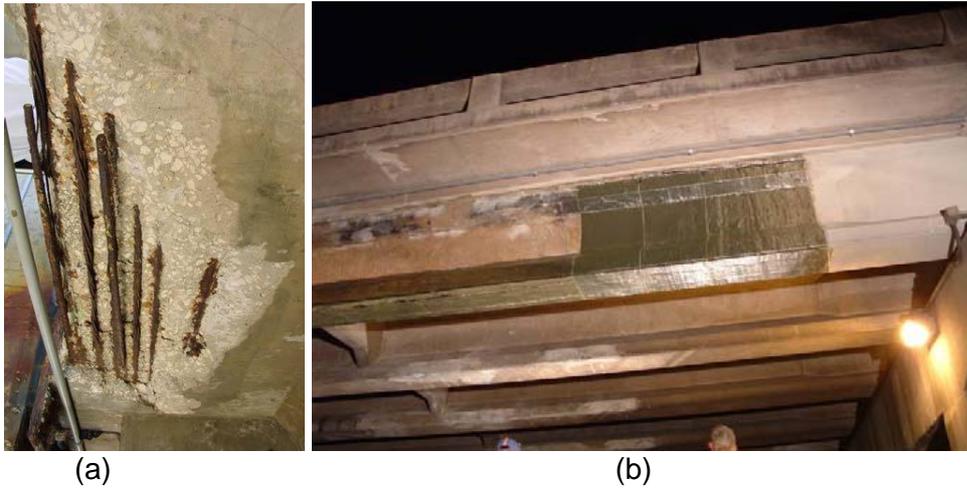
Fig. I.C.1.3. An example of (a) damage and (b) repair by FRP technology [2].

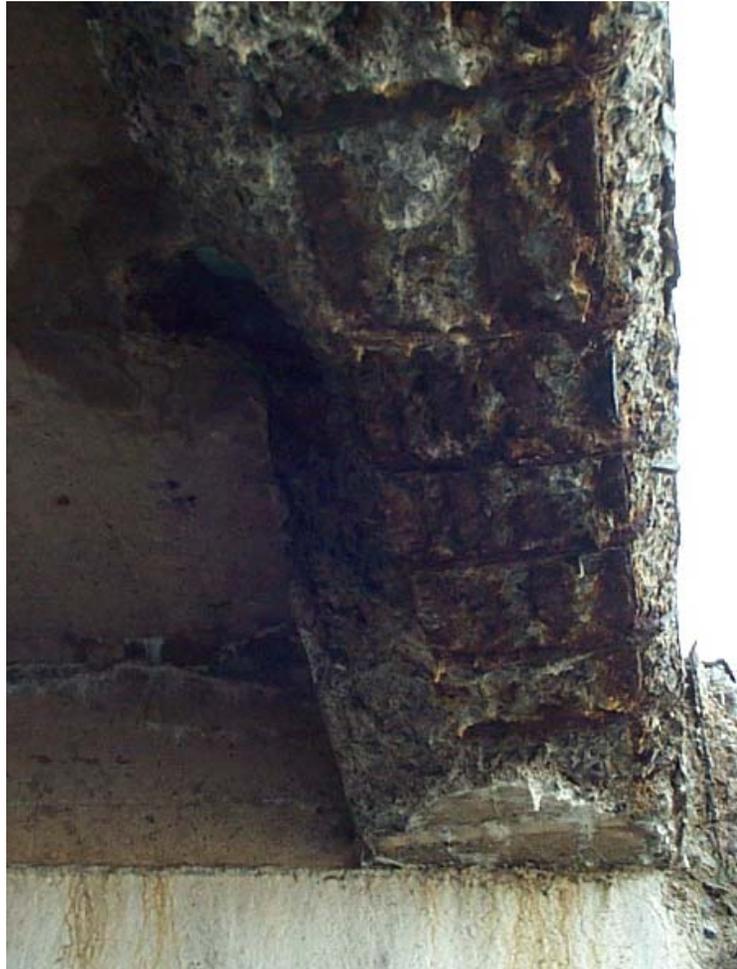
Photo on right: Provided by PennDOT for bridge #59-0045-0310-2011

Note: This is a likely candidate for repair. This bridge scored high because of its large traffic volume and its similarities in damage to the NCHRP Report 514. This bridge ranked high even though it scored relatively low in the span and age category.

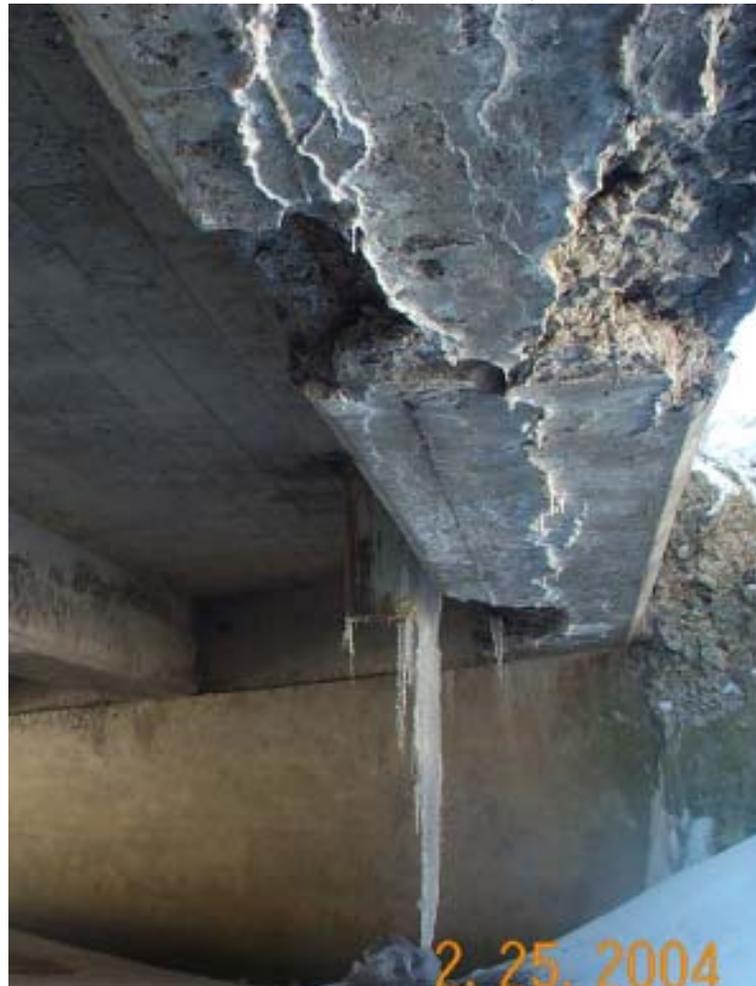
Photo on right: Provided by PennDOT for bridge #54-0522-0090-1932

Note: Though this bridge carries a lot of traffic, and ranks high in the span category, it is ranked into Class #2 because of the extent of the visual damage. This bridge would be suitable for repair by FRP technology.

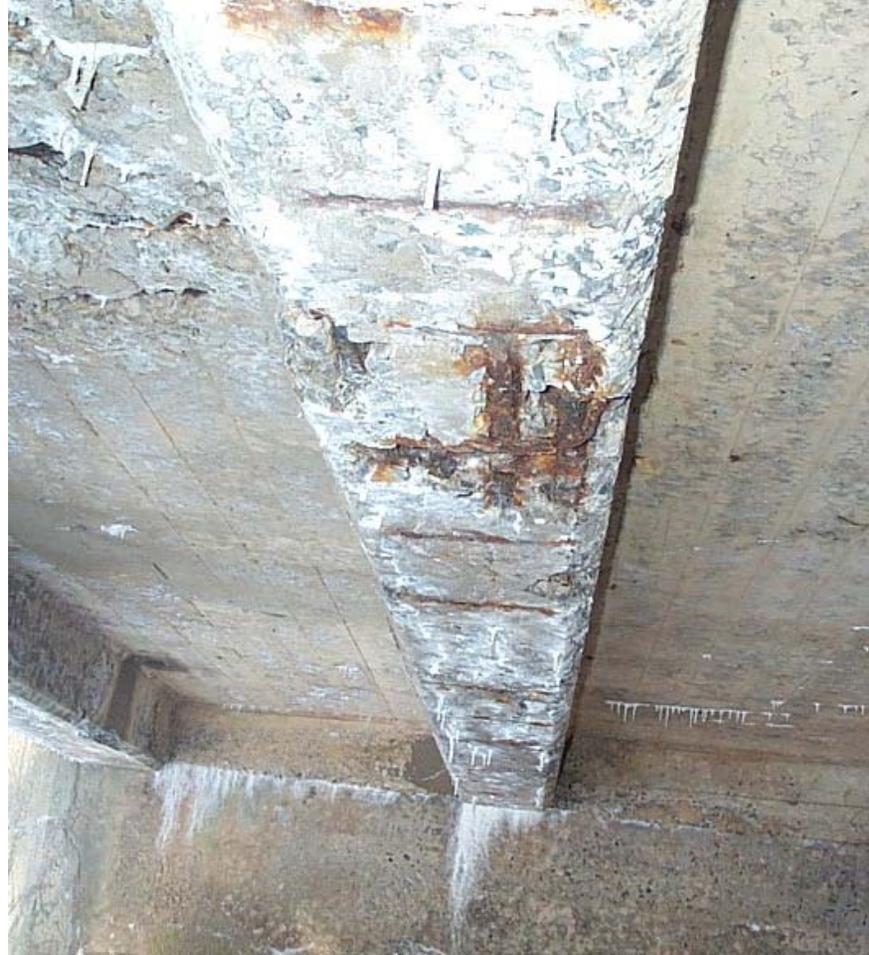
Photo on right: Provided by PennDOT for bridge #19-3008-0100-0039.

Note: This bridge ranked low overall because of low traffic volume, short span, and age. Also, the visual damage was not as severe as many of the other bridges. This is an example of a bridge which may not be a good candidate for the FRP technology.

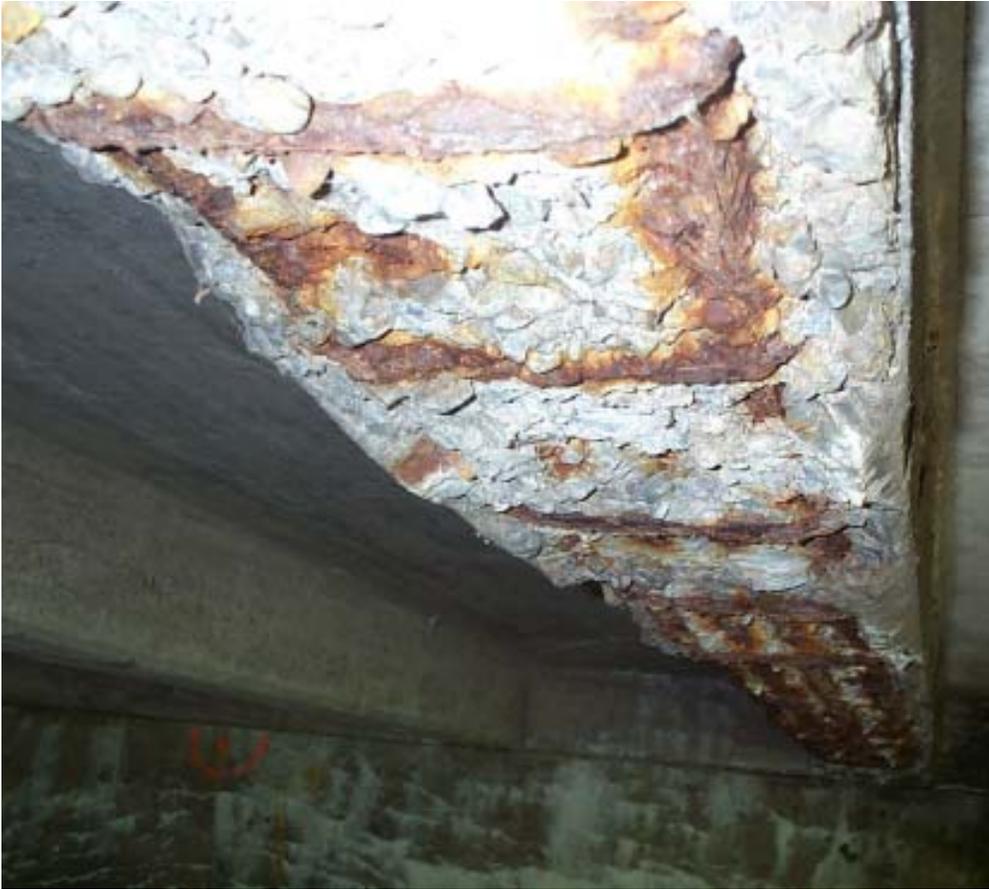
Note: The photos provided show extensive damage to the concrete T-beams. This type and extent of damage is suitable for FRP technology. Bridges with damage type and severity similar to this received a score of 10 out of 10 for visual damage.

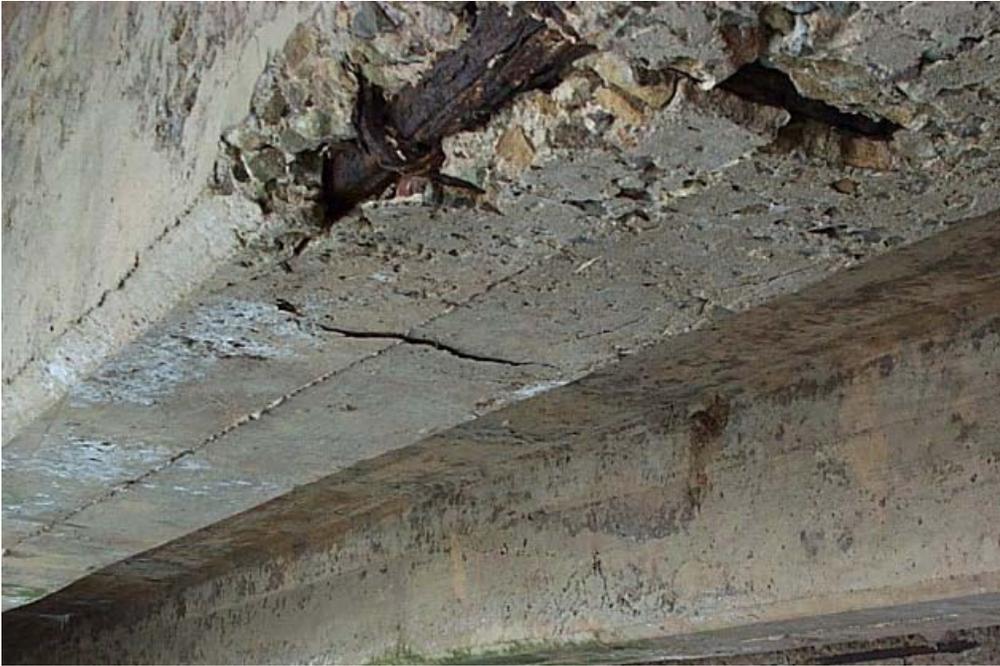
Note: The damage level shown in these photos indicated that these bridges are moderate candidates for repair using the FRP technology. Bridges with damage severity similar to these examples were scored 6.67 out of 10.

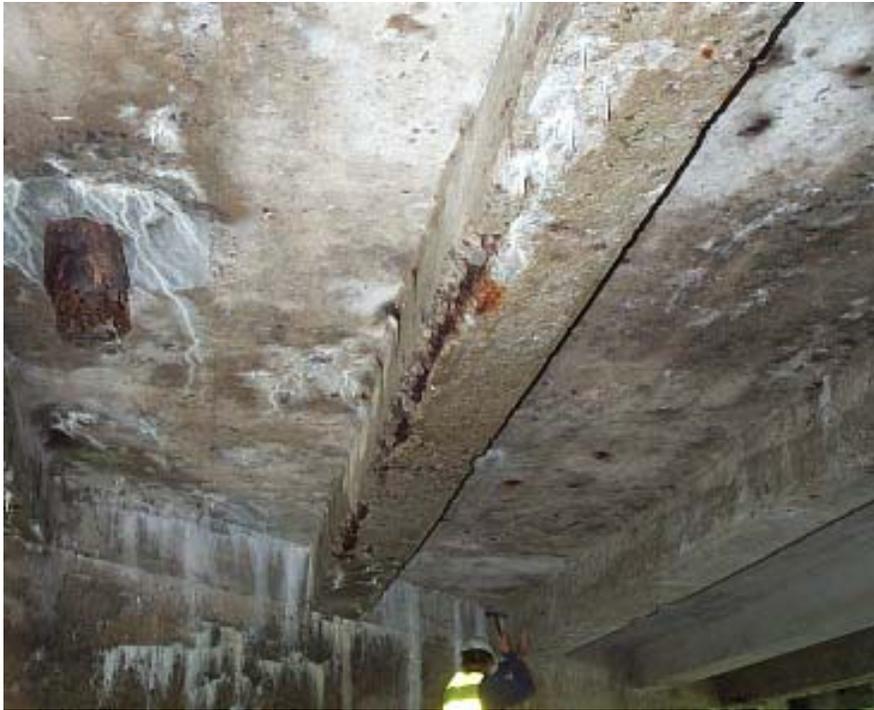
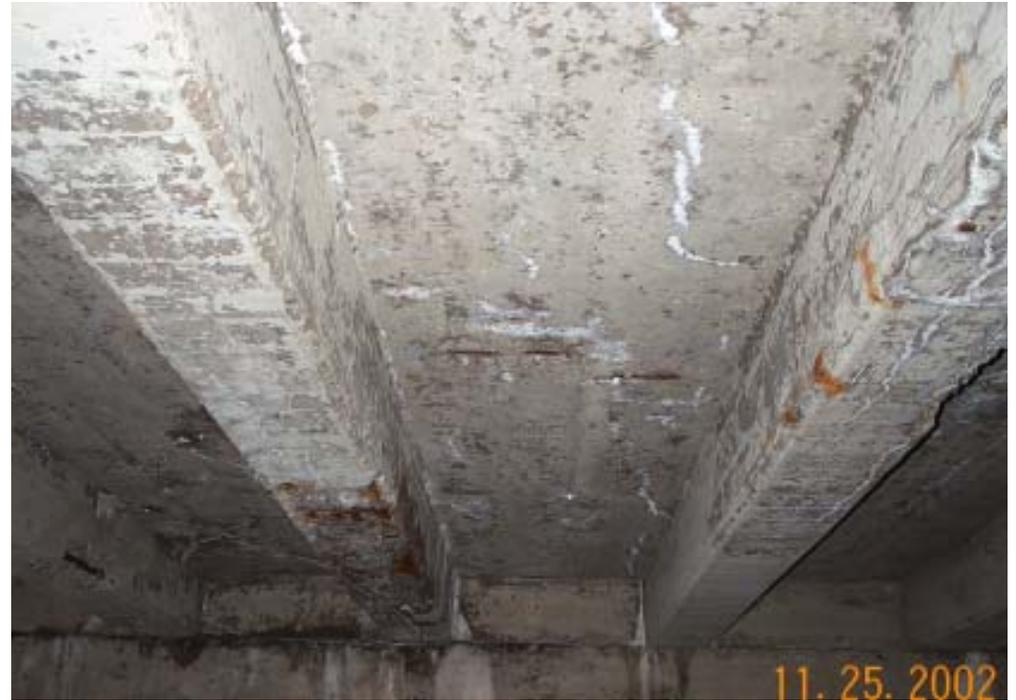
Note: Some of the photographs as shown above indicated low level of damage. Damage of this type may be suited for repair by either FRP technology or conventional methods, but these bridges are not likely candidates for the FRP technology.

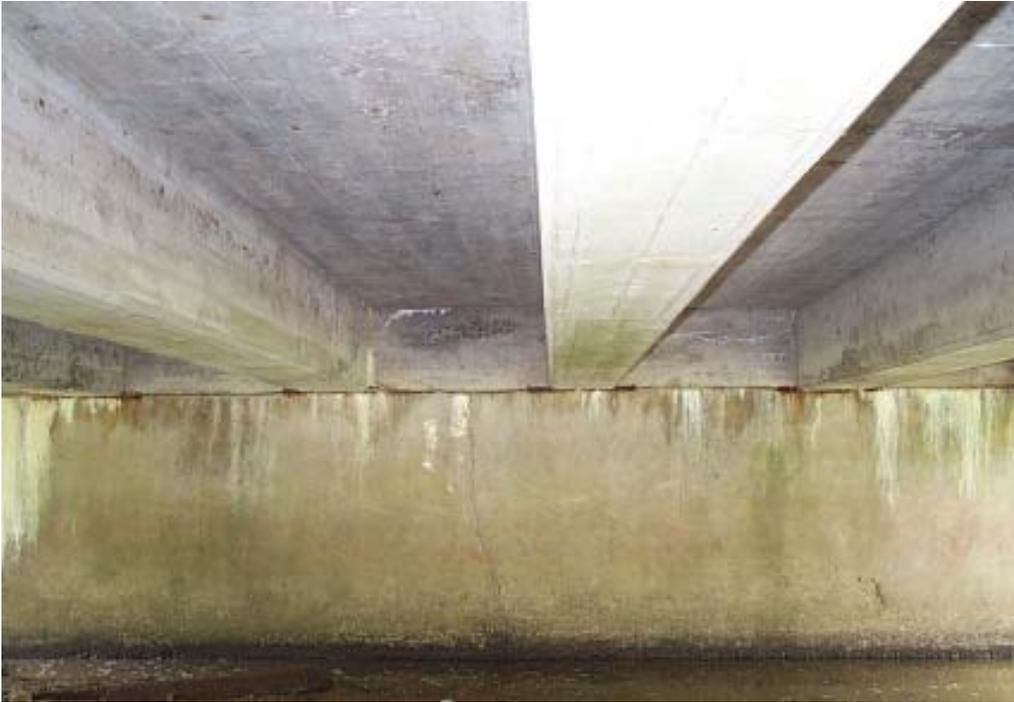
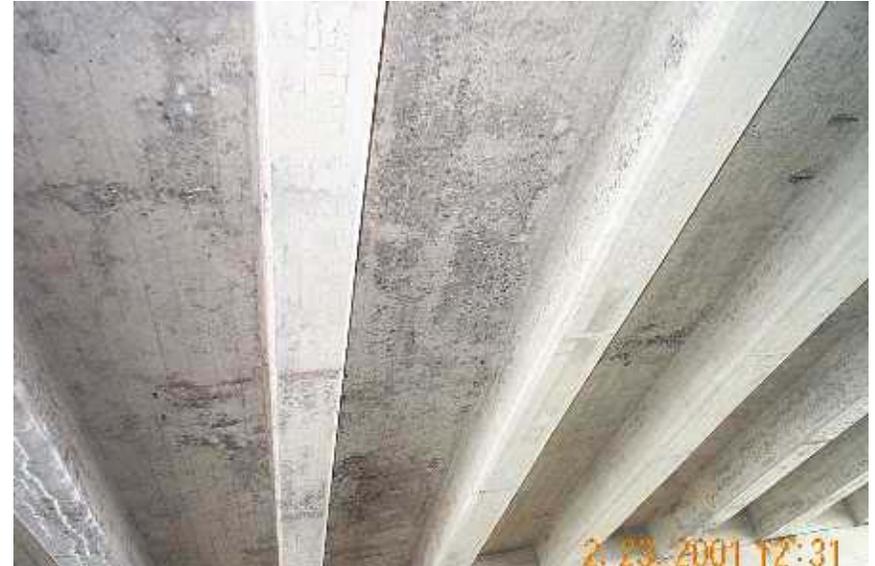
Note: Some of the photographs showed very little or no damage. Bridges of this type were scored 0/10 in the visual damage category, because these bridges in general probably do not require repair.
