**DISTRICT 3-0 INVESTIGATION OF FIBER-WRAP TECHNOLOGY  
FOR BRIDGE REPAIR AND REHABILITATION (Phase-I)**

**Final Report**

**February 10, 2006**

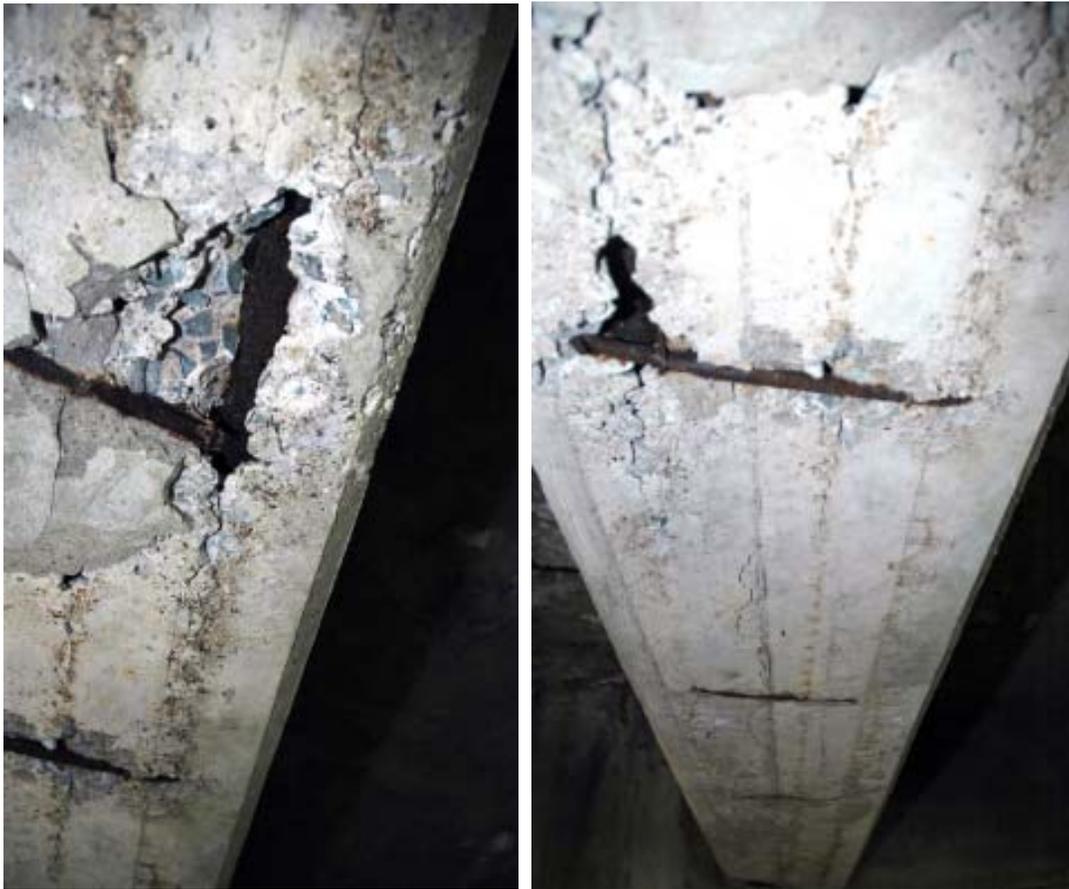
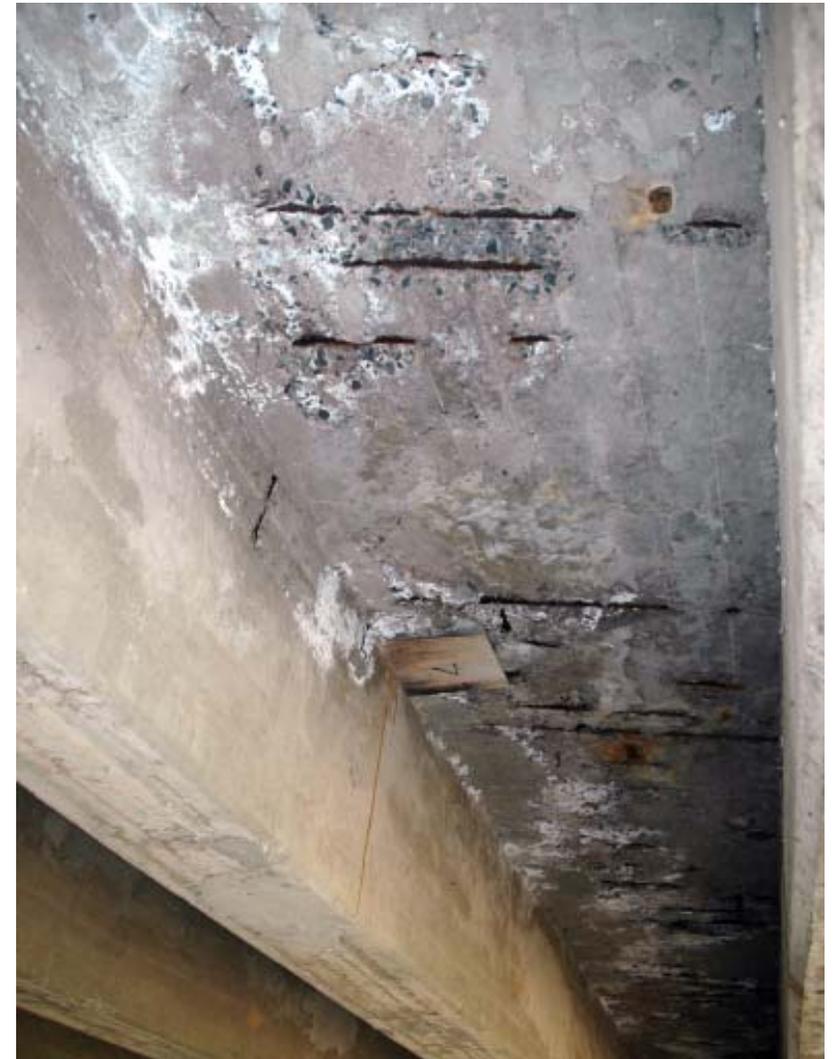
This is an example of a Type 1 ranking. Though this bridge has damage to the beams and deck, the damage is not severe. Also, several of the beams are not damaged at all.

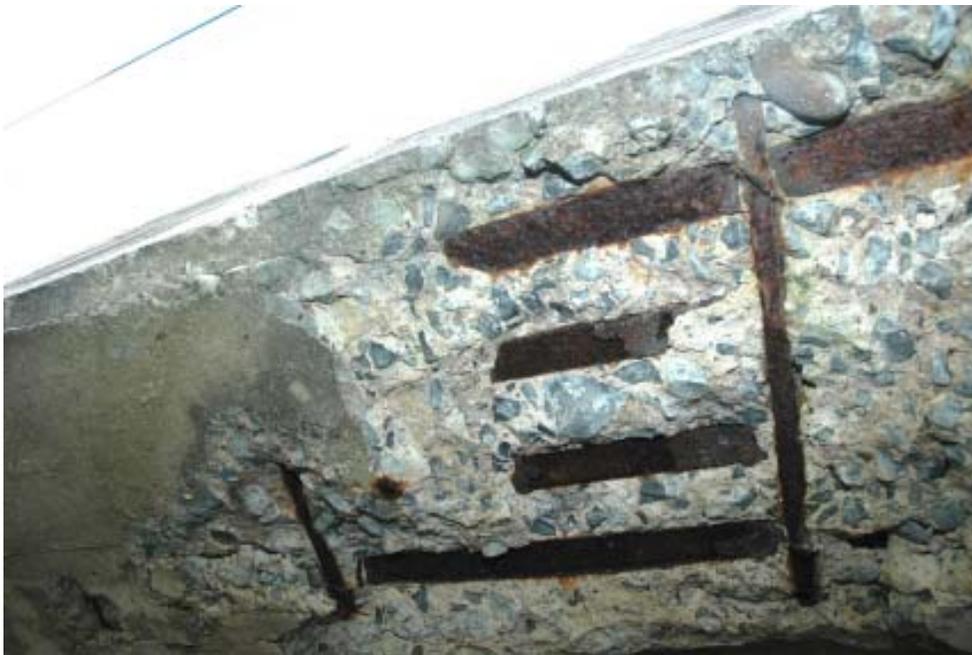
This is an example of a Type 2 ranking. This bridge has moderately damaged exterior beams, however the rest of the beams and deck are in good condition.

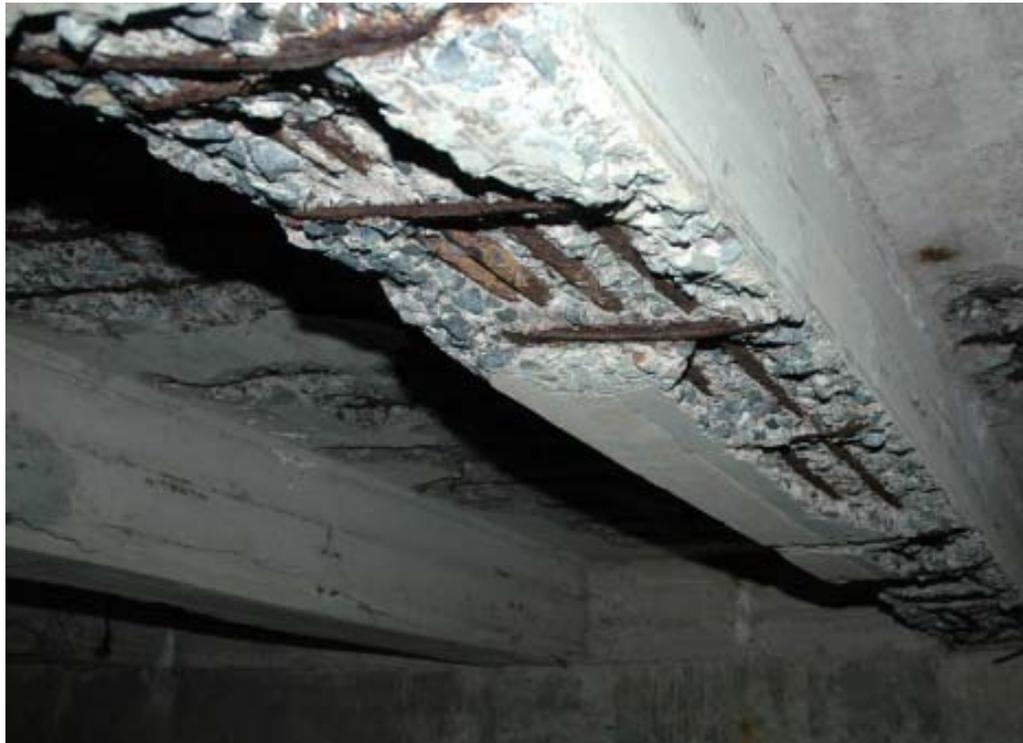
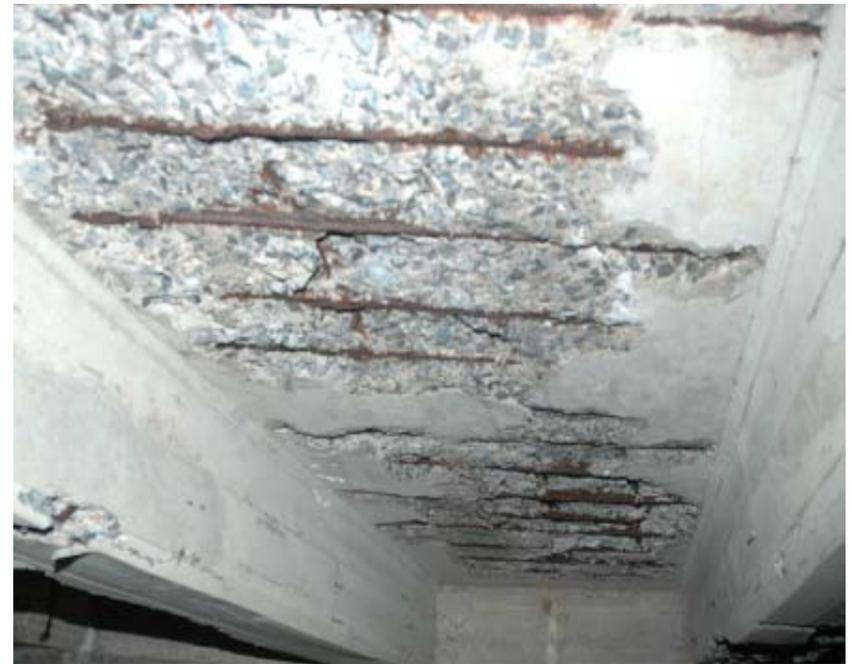
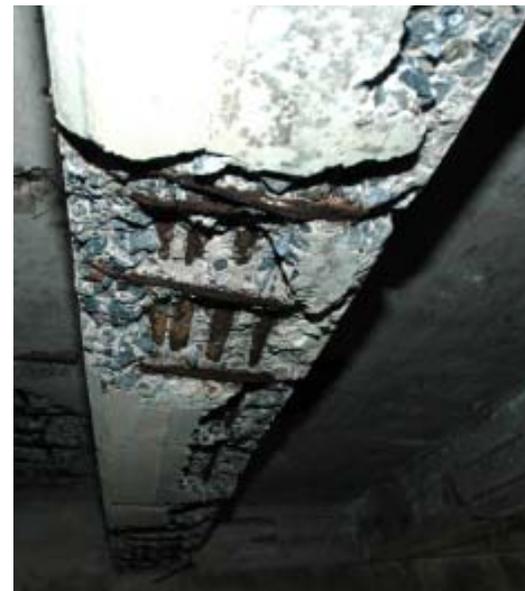
This bridge is a good example of a Type 3 ranking. There is severe damage to both exterior and several interior beams. Also, there is severe damage to the deck. This may be a good candidate bridge for FRP repair. Due to the extent of damage, the repair cost should be considered in relation to replacement cost.

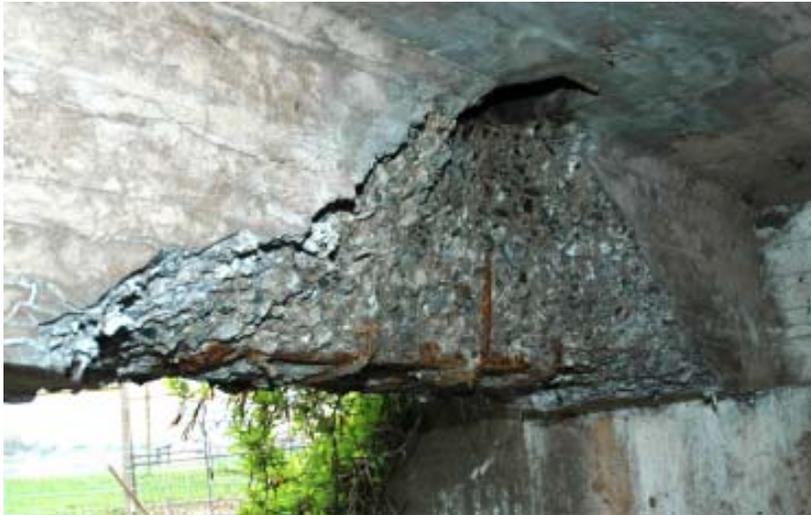
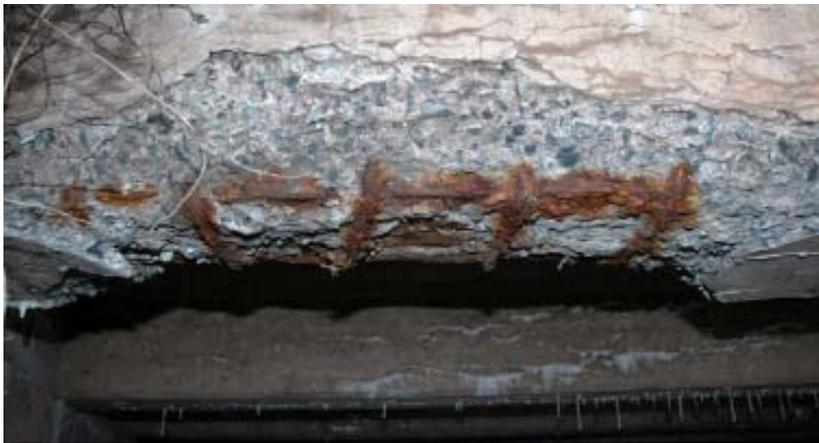
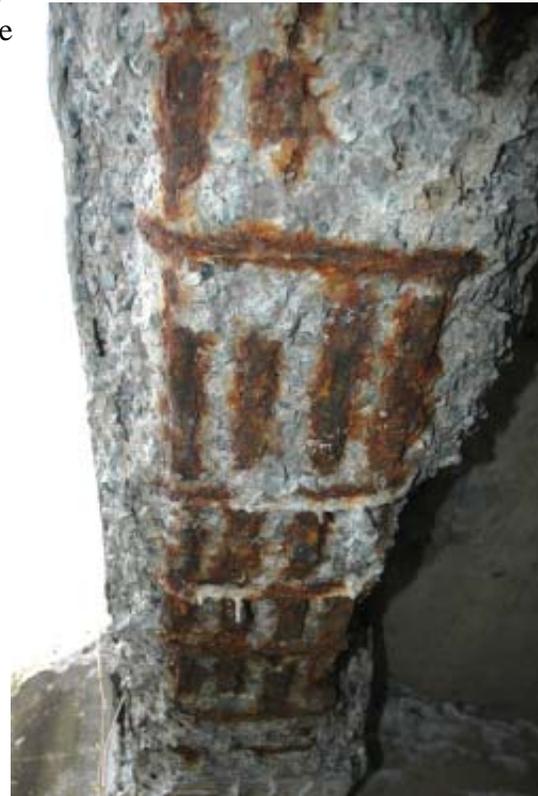
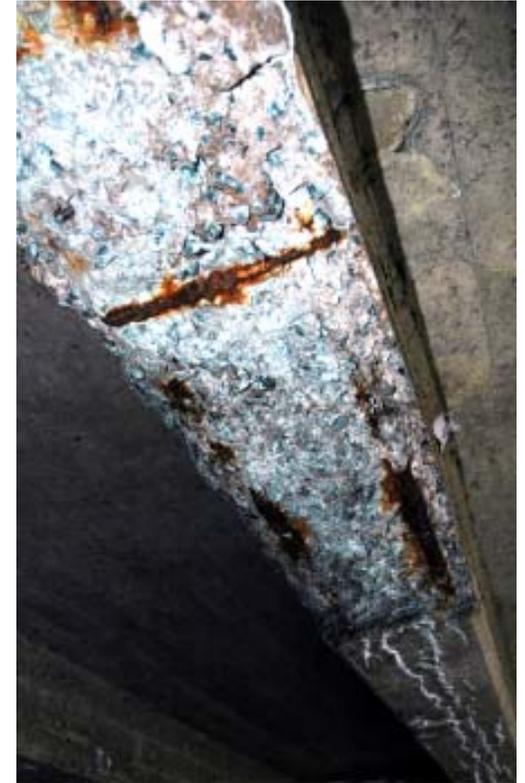
This bridge is a good example of a Type 3 ranking. Both exterior and interior beams have extensive damages. This bridge would be a good candidate for repair using the FRP technology.

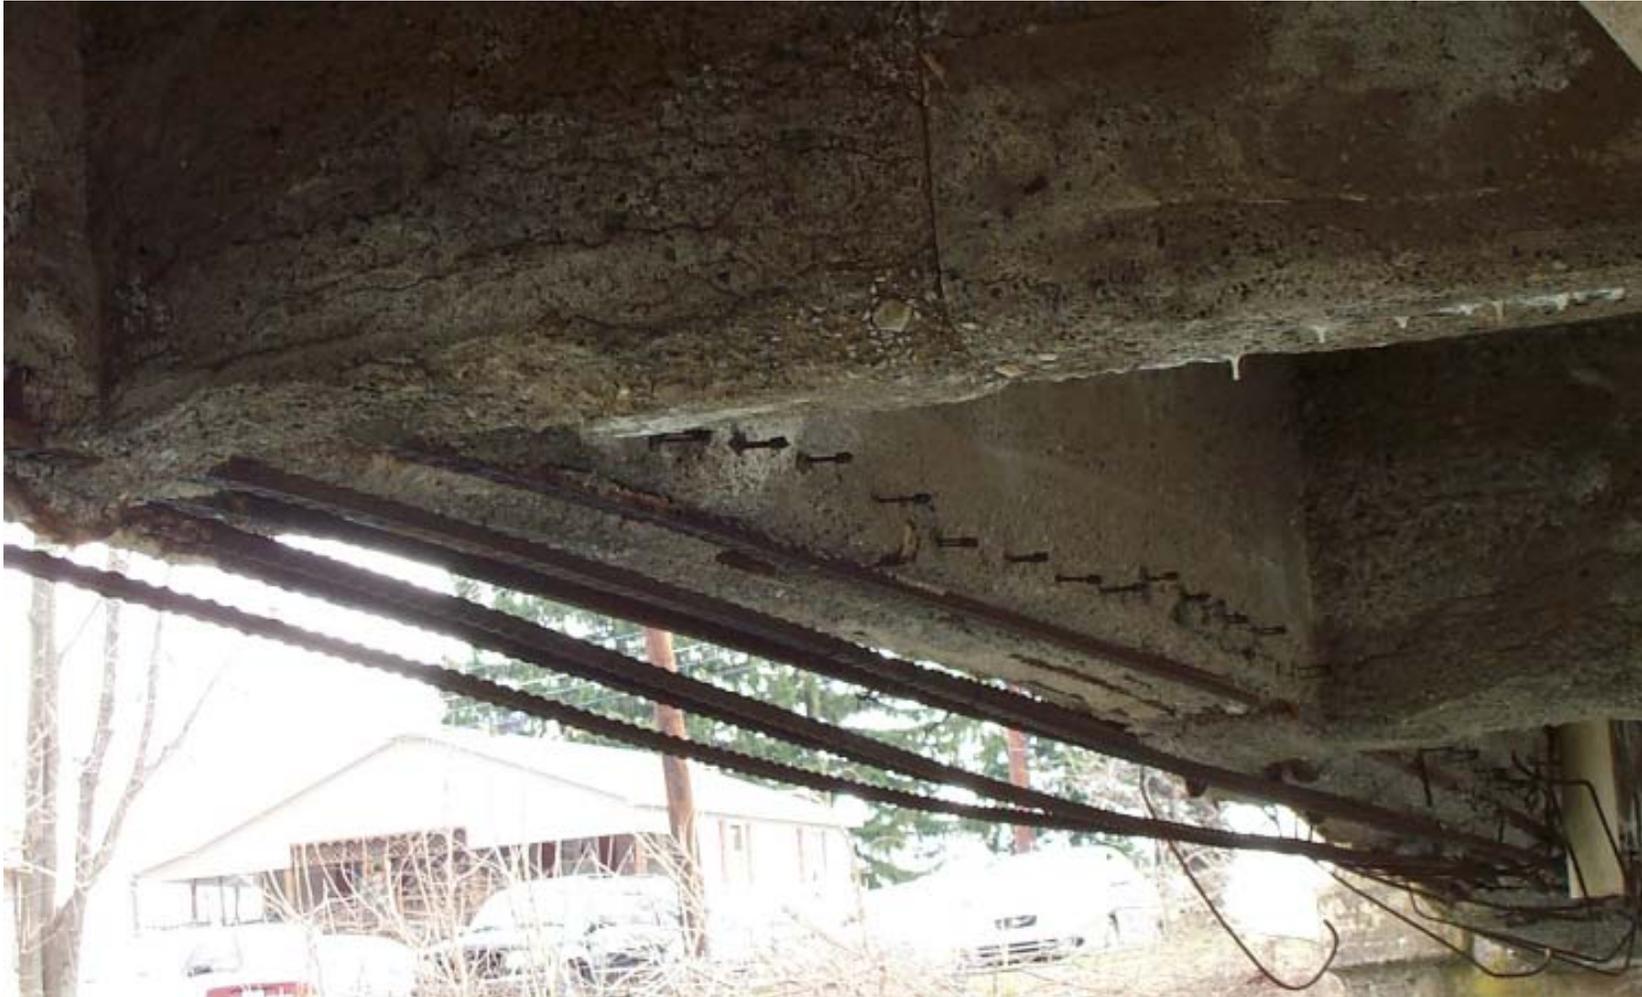
Bridge #19-4003-0010-0082

This is an example of a bridge which has experienced extensive damage to both the concrete and the rebar. This bridge may be better suited for replacement, rather than repair using either the FRP technology or conventional methods.

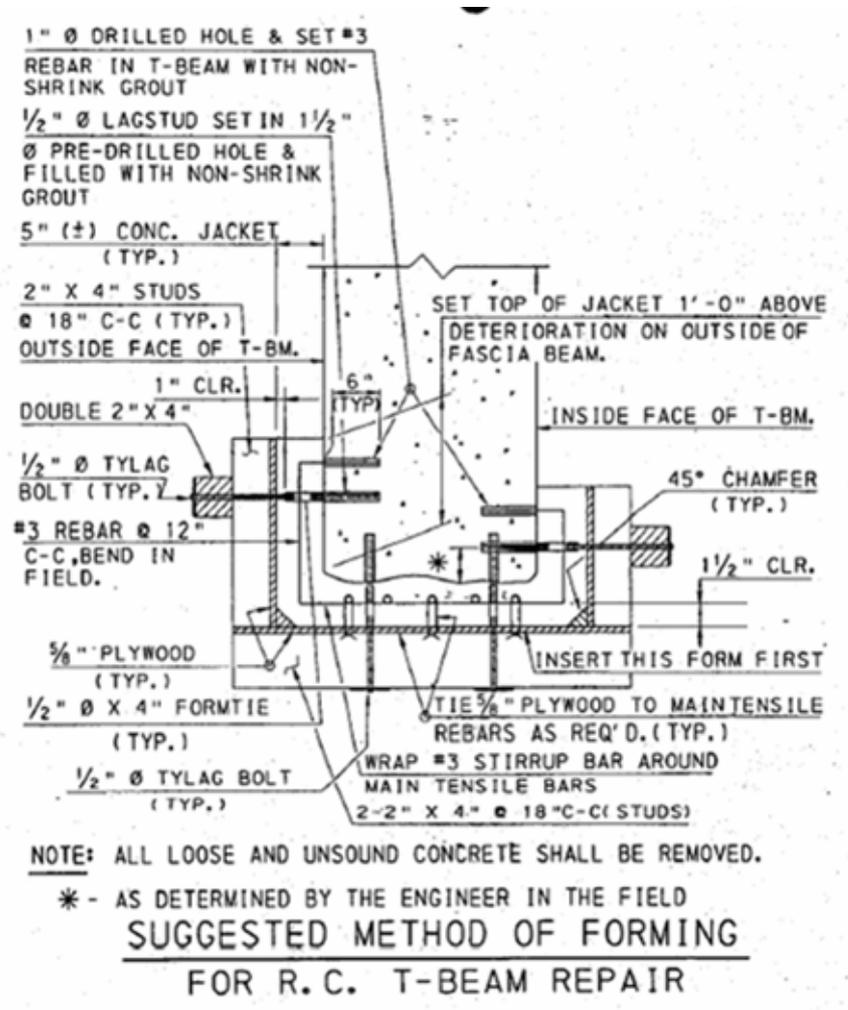
In an effort to prevent further corrosion of steel rebar and deterioration of reinforced concrete T-Beam bridges, a conventional repair technique has been developed and employed. This method involves: removal of all loose and unsound concrete, replacement and/or additional placement of rebar, and placement of formwork to cast a concrete cover or "jacket". Though this process seems quite simple, formwork and repair of rebar requires significant effort. Figure I.D.1.1 shows an example of a suggested formwork provided by PennDOT District-3 for a conventional T-Beam repair.

Fig. I.D.1.1. Formwork Diagram for Conventional Repair by PennDOT District-3.

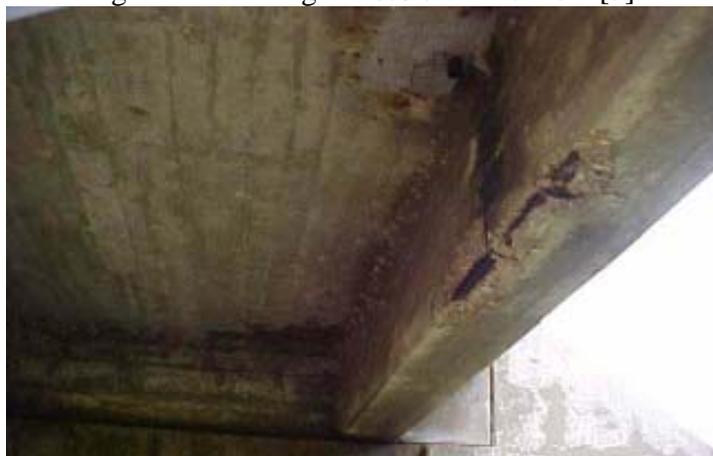
Fig. I.D.2.2. Condition of Exterior Girder of Bridge X-0596-MDOT [3].

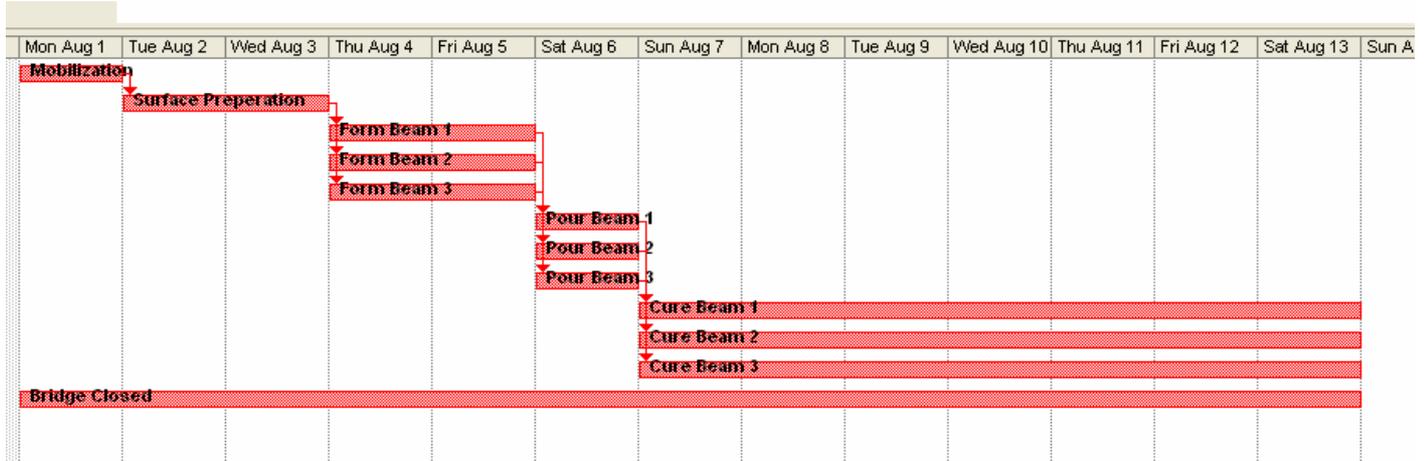
Fig. I.D.3.1. Gantt Chart for Conventional Repair (obtained with [5]).

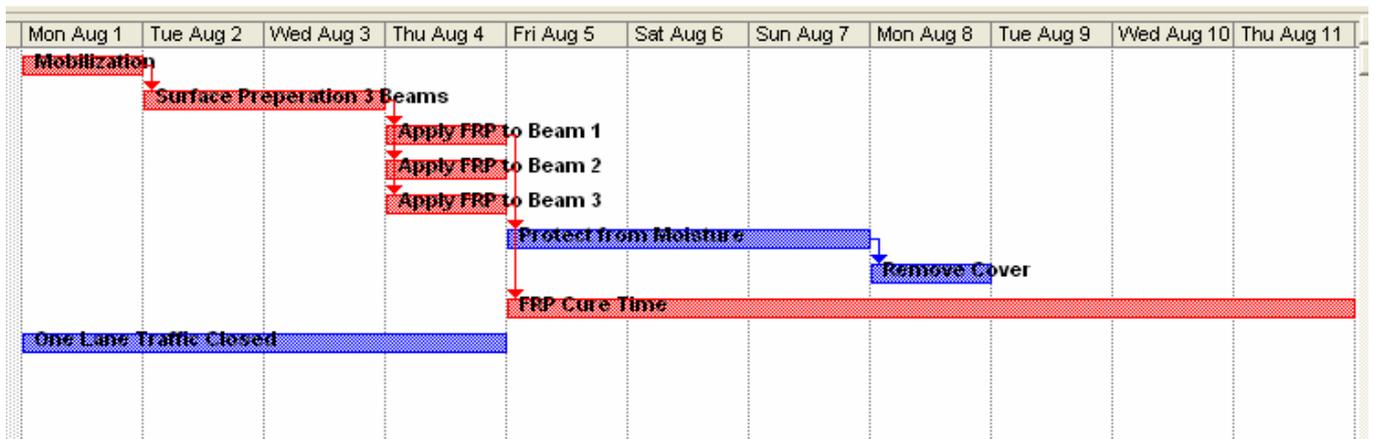
Fig. I.D.3.2. Gantt Chart for Surface-Bonded FRP Technology (obtained with [5]).

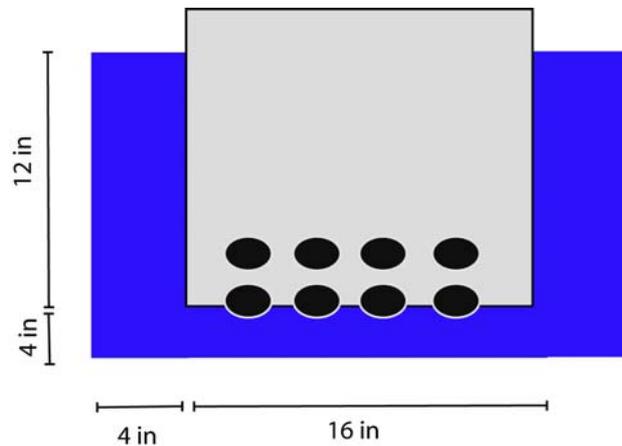
Fig. I.D.3.4. Standard T-Beam Section for Conventional Design Assumptions.

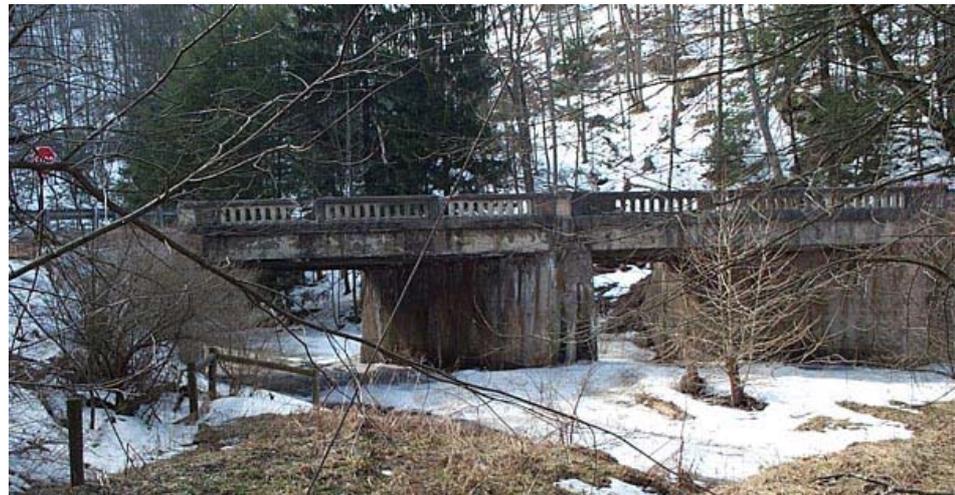
Fig. I.D.3.5. Bridge #41-0118-0230-0644

Because of the type and extent of damage, repair using the conventional method may not be possible; hence the repair will be compared to replacement cost. The total span length of this bridge is 80 feet and there are 7 beams. For complete repair, about 560 feet of beam will be repaired using the FRP technology. Though not considered in the analysis, the damaged center pier may also be a candidate for repair using FRP technology (Figure

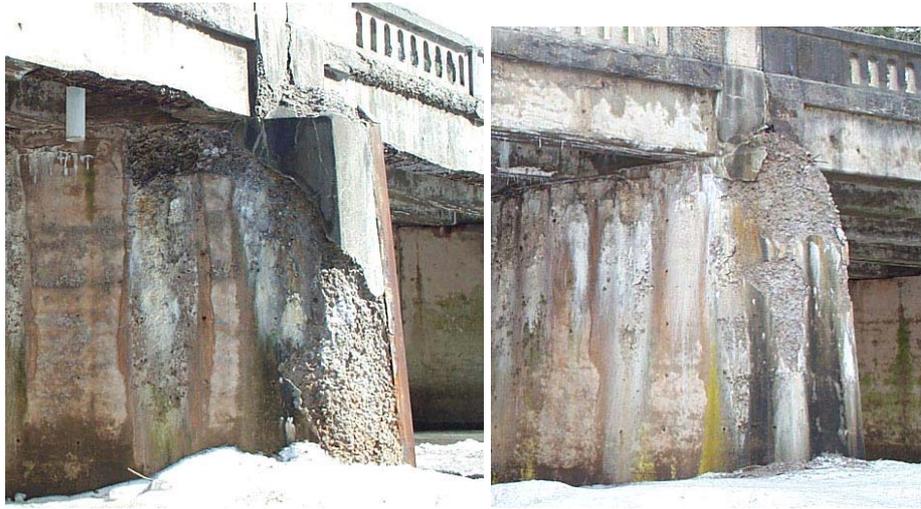
Fig. I.D.3.6. Photo Showing Damage to the Center Pier of Example Bridge #1.

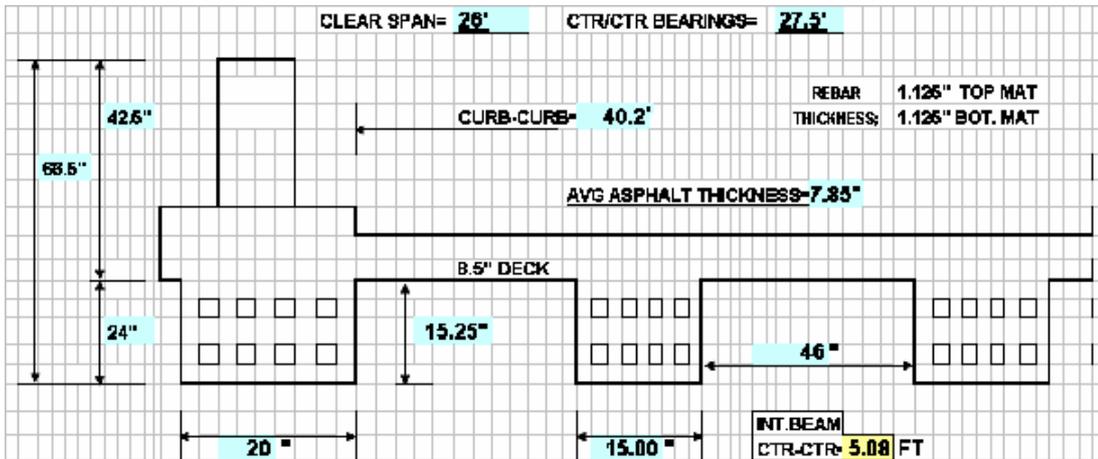
Fig. I.D.3.8 Cross-Sectional Diagram of Bridge #59-0045-0310-2011, Provided by PennDOT District-3.

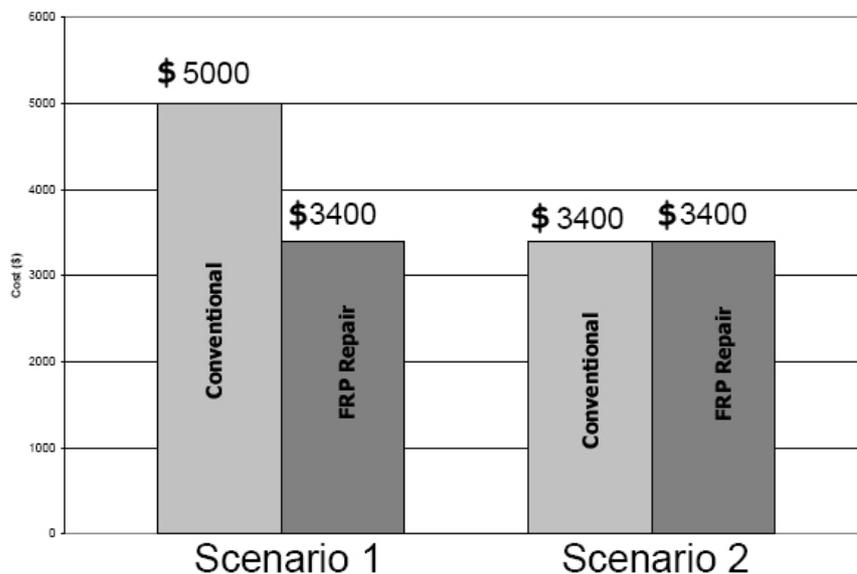
Fig. I.D.3.9. Cost Comparisons Between Conventional and FRP Methods for Example 2, Scenarios 1 and 2.

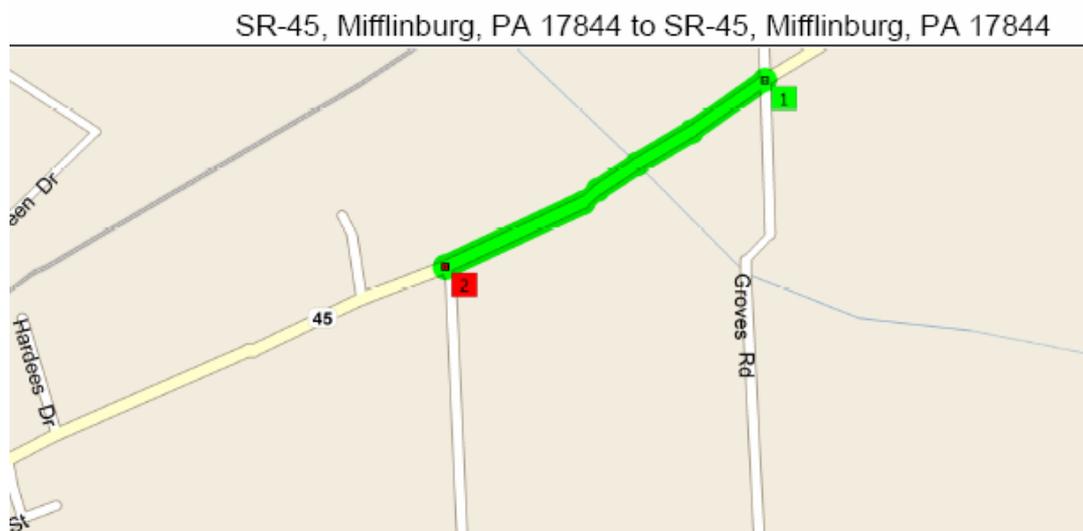
Fig. I.D.3.10. Open Traffic Plans for Example Bridge 2 (distance = 600 yards) [8].

The un-detoured length of highway is 600 yards or 0.35 miles. The proposed detour is 1.5 miles, with a difference of 1.15 miles per vehicle. From information provided by PennDOT, the ADT plus ADTT for this bridge is 10,950 (10,300 ADT and 650 ADTT), resulting in a total of about 12,600 vehicle miles per day. Using the typical IRS rate of \$0.32 per mile, this cost is \$4000 per day.

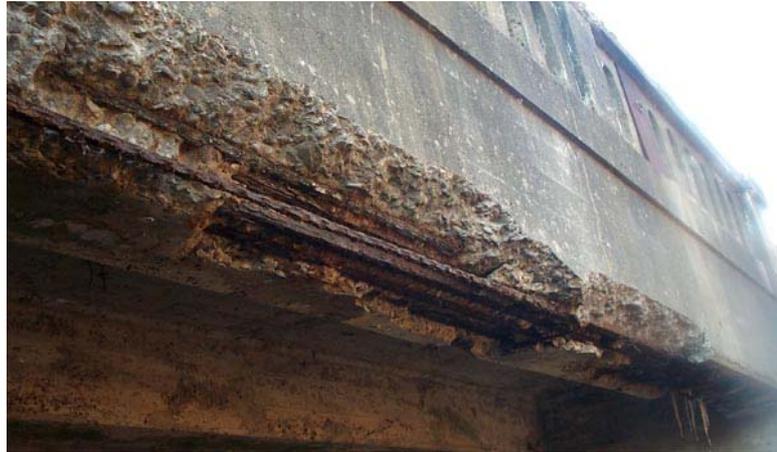
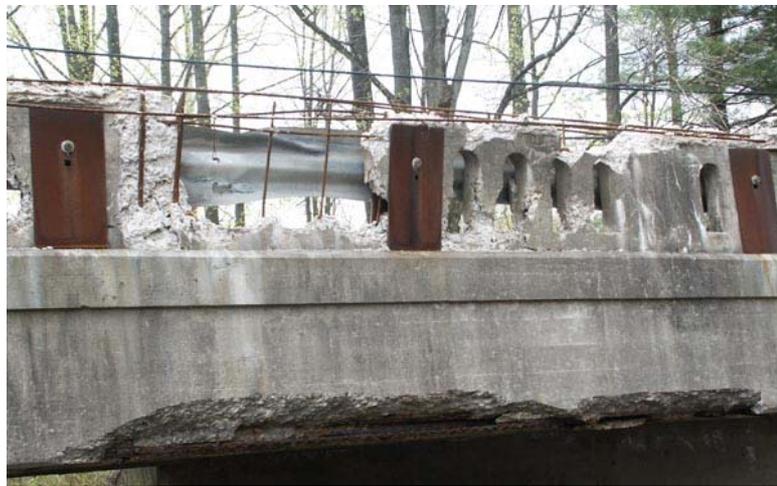
Fig. I.D.3.12. Bridge #41-0118-0020-1109.

From the inventory, Bridge # 41-0118-0020-1109, which shows extensive but localized damage (one beam only), was selected as a Level-3 repair project (Fig. I-D.3.12). This bridge has the following characteristics: Total Span = 31 ft; Year Built = 1930; Number of beams = 7; ADT/ADTT = 5600/410; Overall Classification = 79.8 - Class 1; Visual Rating = 3 (high desire for repair).

This bridge is relatively small and has experienced localized damage typical of the PennDOT inventory (extensive localized damage on exterior beam(s) only.) This bridge is a good candidate for repair using a trained, in-house PennDOT crew. Once trained (such as by participating in the implementation of repairs for Examples 1 and/or 2), PennDOT District-3 “in-house” forces can repair this and many other typical bridges in the inventory using FRP technology. A generalized “first-cost” estimate is provided in this section using design and cost assumptions from Section I-D.3.2 and I-D.3.4.3 respectively.
