Report No. K-TRAN: KU-02-1  
FINAL REPORT

**IDENTIFICATION OF FAILURE PREDICTION CRITERIA  
USING ACOUSTIC EMISSION MONITORING AND  
ANALYSIS OF GFRP BRIDGE DECK PANELS**

Richard S. Gostautas

The University of Kansas  
Lawrence, Kansas

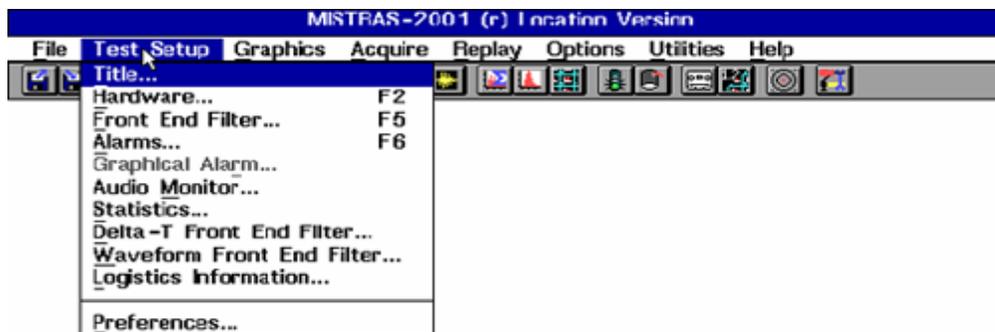
**Figure 2.1: User interface for 'Mistras'**

(decibel); Pre-Amp Gain (db); Sample Rate; Filter (kHz); Pre-Trigger ( $\mu$ s) and Hit Length (k). The fixed threshold defines the minimum decibel level of incoming AE signals that will be recorded by the software. Thus any AE signal below the set threshold will be ignored. The 'pre-amp gain' corresponds to the 2/4/6 preamplifier hardware connected to each channel boosts the incoming voltage of the signal by the designated amount. For a 40 db pre-amp gain, the voltage signal is boosted by 100. The 'sample rate' is that rate at which the PCI DSP-4 board samples waveforms on a per second basis. The 'sample rate' was set to 4 MHz which means that 1 waveform sample is record every  $\frac{1}{4}$   $\mu$ sec. In order to try and eliminate back ground noise, the 'Filter' setting allows for a range of frequencies that will be passed by the preamplifier. These tests used a 'low'

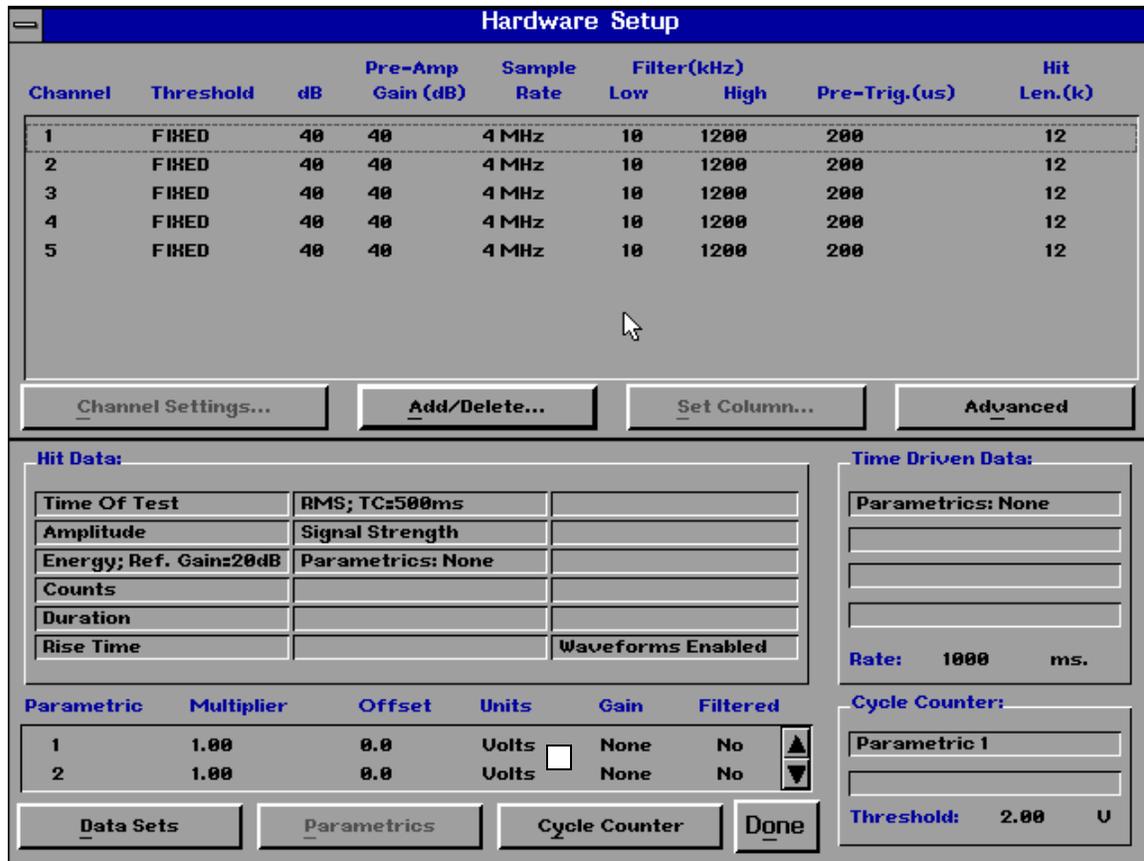
Figure 2.2: User interface for hardware setup

Figure 2-2 shows the typical settings used for each test. As can be seen from Figure 2-2, the software allows for parametric data, such as information from a load cell, to be taken during monitoring. For the purpose of AE monitoring, a special loading profile was designed to assess the AE signature characteristics such as the Kaiser Effect and Felicity ratio. This loading profile contained a series of increasing load rate, load hold, and load drops. The loading scheme was programmed into the load control and was

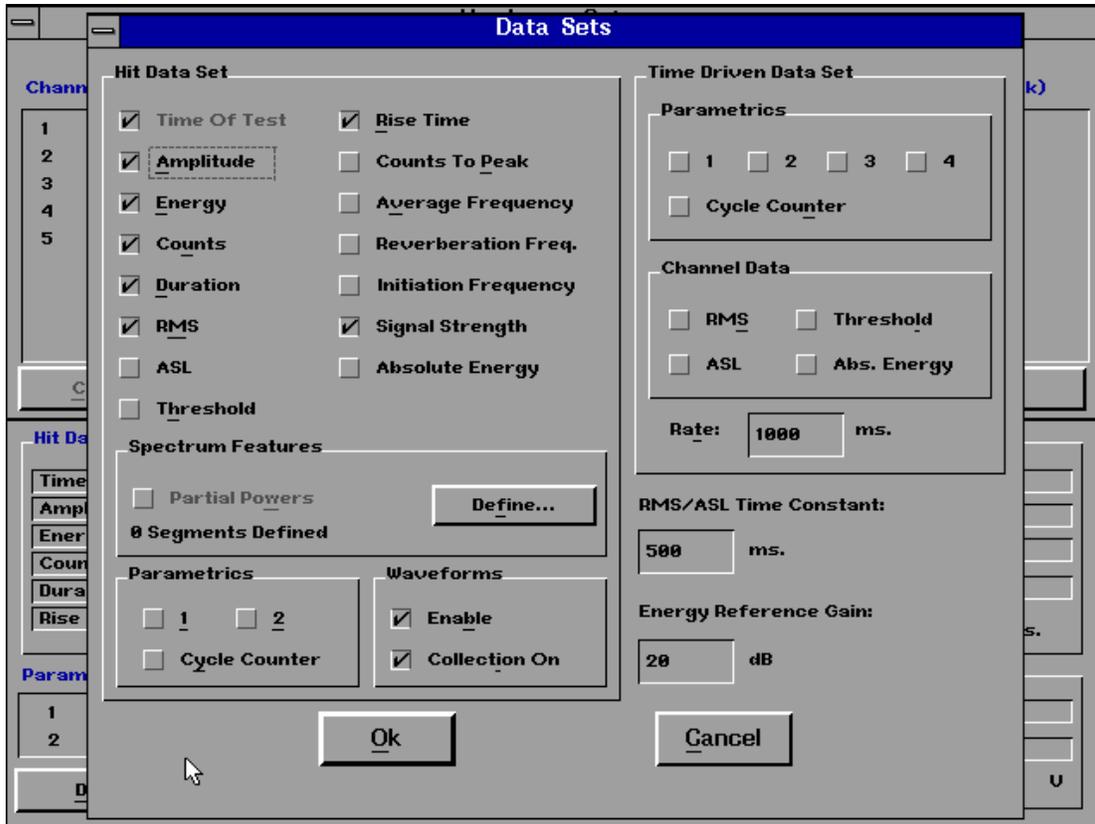
Figure 2.3: User interface for selecting data sets

Continuing under 'Hardware Setup', the next set of parameters are found under the 'Data Sets' button as seen in Figure 2-3. This is a set of fourteen user-selectable features corresponding to the typical parameters associated with an AE waveform. The typical parameters recorded for all tests are: Amplitude, Energy, Counts, Duration,

RMS, Rise Time and Signal Strength. The 'amplitude' is the maximum AE voltage peak in the signal waveform, expressed in db, and expressed using the following relationship:

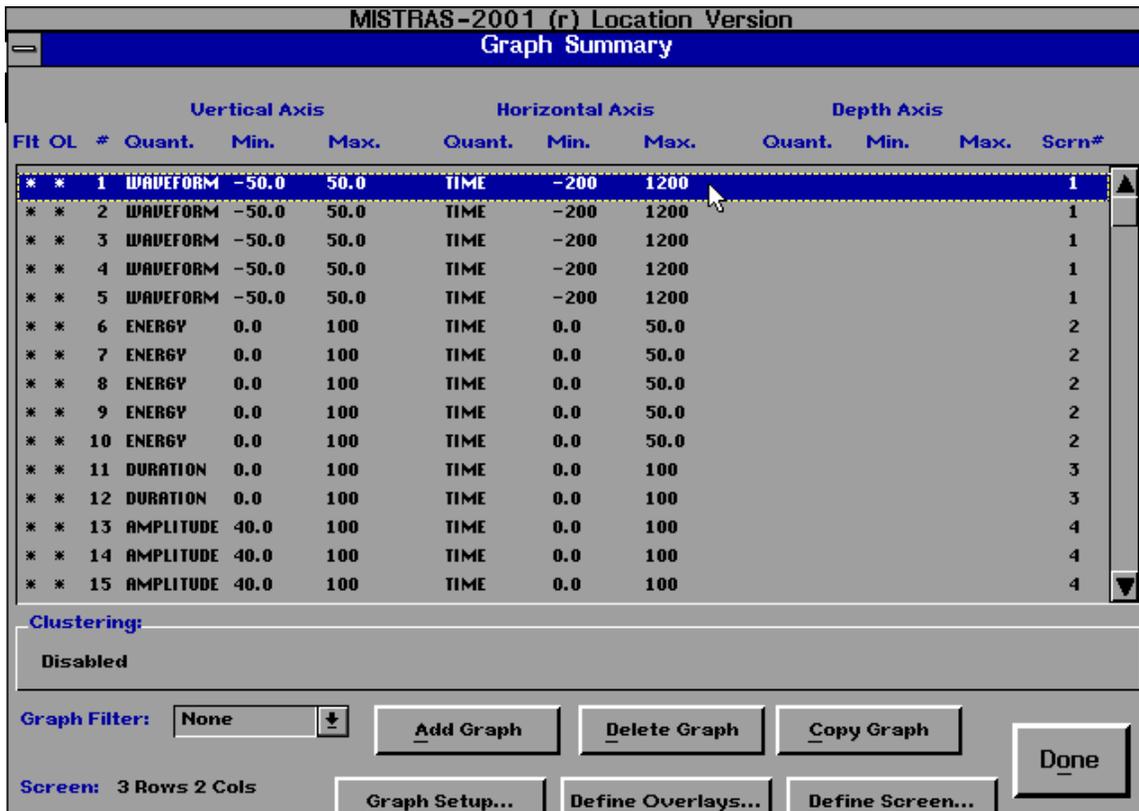
Figure 2.4: User display showing Mistras graph summary

After the hardware information has been configured, the next parameters to set is found in the 'Graphics' menu. Figure 2-4 provides a graph summary for the typical settings used in testing. The function of each graph is to display the data during test monitoring or replay. There were a total of nineteen graphs used during the monitoring process. The typical settings for each type of graph can be found in the Appendix A. The use of the graphs during monitoring allows the investigator to identify patterns in the data that may be useful in analysis. Once all hardware settings and graphs have

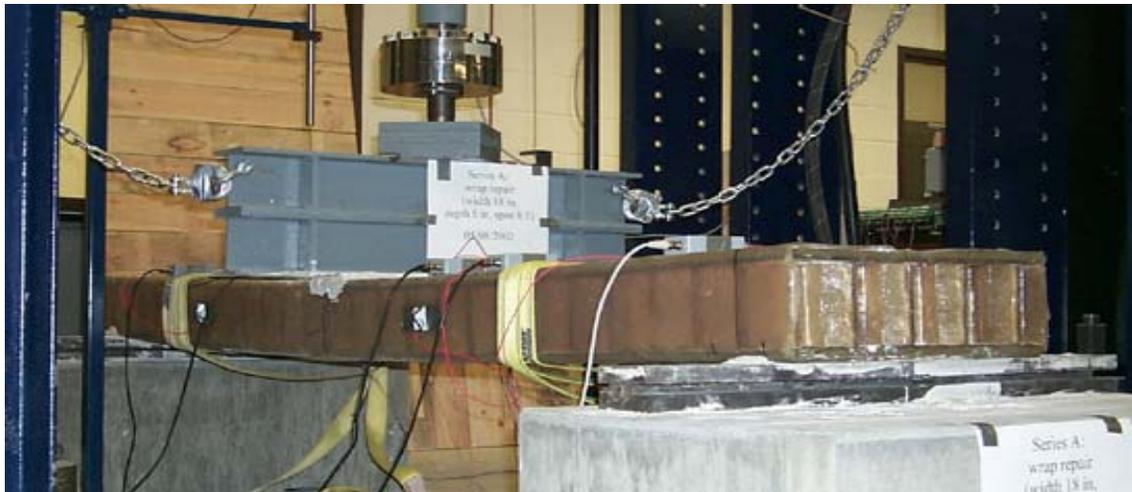
**Figure 2.7: Sensor instrumentation of A18-repaired panel**

The specimens are designated A6, A12, A18, A24 and A30 with the number identifying the nominal width of the specimen in inches and “A” identified the series. The first two tests were on the original manufactured condition of the FRP panels and designated “original” (e.g. A24-Original). The final four tests were performed on the original panels that were loaded to failure and then repaired using an external wrap and which will be called the ‘repaired’ panels. Each specimen was tested as a simply supported three point bending test with an eight-foot span (Fig. 2-7) according to ASTM

Standard C393-00 in order to determine the flexural properties of the sandwich panels being investigated by the K-State research team. For the purpose of AE, a special loading profile (consisting of load holds, load drops and load increases) was designed for each test. Each load hold was conducted for 3 minutes, in which the load was increased or decreased to the next load step. The load, hold, unload sequence (to previous load levels) was designed to assess AE signature characteristics such as Kaiser Effect and Felicity Ratio which are typically used in analysis. The load profiles were based upon a calculated percentage of service and ultimate load. Typically, active monitoring of the specimens included up to 70% of the estimated ultimate load. Sensors were removed before failure to prevent damage.

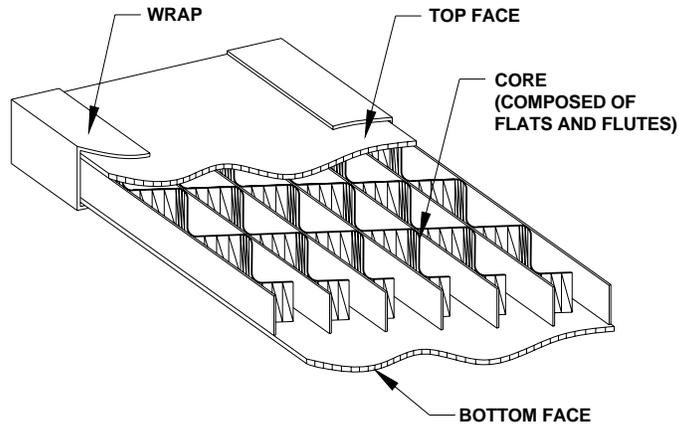
**Figure 2.8: Typical GFRP panel architecture**

The original panels consisted of two outer face panels (for flexural rigidity) and a honeycomb core (for shear). The core consisted of Chop Strand Mat (ChopSM) and consisted of alternating flat and sinusoidal plates (referred to as flats and flutes, respectively). Each flat and flute is laminated separately by placing a cured flat on top of

a wet flute and allowed to cure. The total core is continued by using the flat to flute bonding procedure using a polyurethane adhesive (Figure 2-8). The face panels (top and bottom) are laminated by consecutively stacking resin-soaked plies on top of each other. The total core is then placed on top of the bottom face laminate while the resin is still wet and pressed into the face using dead weight. The materials are then allowed to cure and then the top face laminate is then applied to finish the panel (Fig. 2-9).

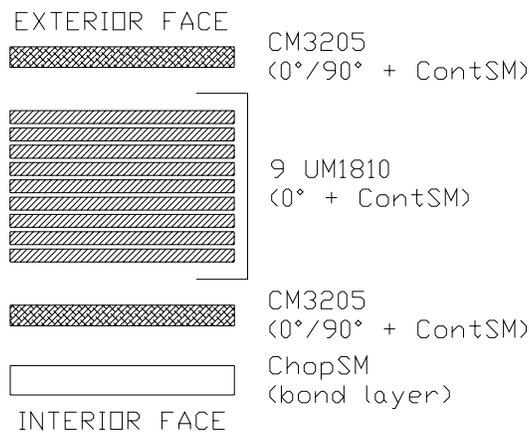
**Figure 2.9: Typical face panel architecture**

E-glass fiber mats were fabricated using four types of architecture. The different types are as follows: The face panels were fabricated as a mat using a combination of (1) bi-directional ( $0^\circ/90^\circ$ ) stitched fabric in an orthogonal direction (balanced number of

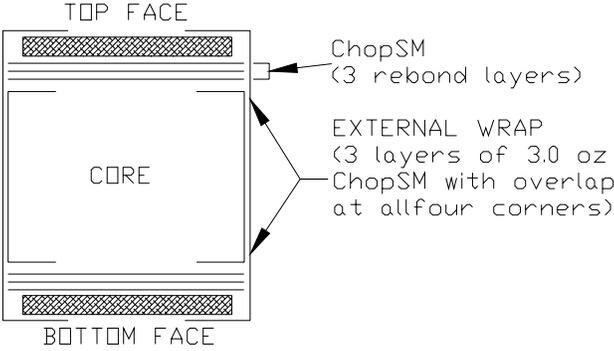
**Figure 2.10: External wrap repair modification**

condition. Thus, for repair, the outer faces were completely removed from the core and rebounded using three additional layers of 3.0 oz. ChopSM. Then the external wrap was applied over and along the edges of the panel (Fig. 2-10).

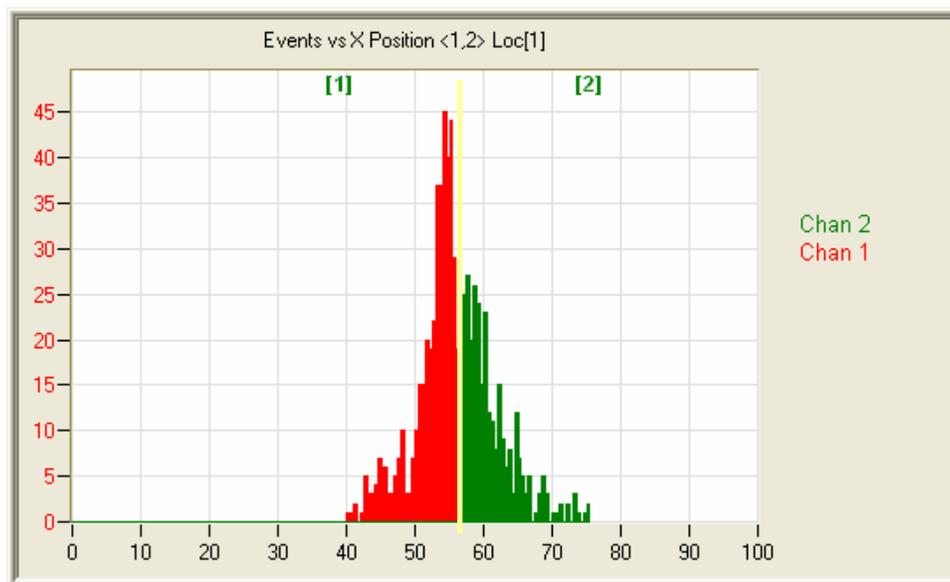
Figure 3.1: Linear location plot for A30-Original panel

surface, the built-in linear location module was used to identify the location of where the majority of the events were taking place. Specifically, a single event will generate a wave that propagates through the material and will eventually be received by both sensors and recorded as two separate hits. Based upon the calculated wave velocity (135,000 in/sec), the module determines which hits correspond to a single event, and which sensor first received the event. The module then plots the location of the event between the two sensors (Figure 3.1). As it can be seen, the majority of the events occurred to the right of the centerline of loading. The built in “replay” function allows the entire data set to be reviewed to determine the propagation sequence in which the events were recorded. For this panel, the population of the graph corresponds in time to the increase in the load and resulting deflection. An additional plot, Figure 3.2, is used to validate the propagation sequence during replay. Figure 3.2 is a cumulative plot of the A30-Original panel which displays three distinct areas in which there was an increase in the number of incoming events.

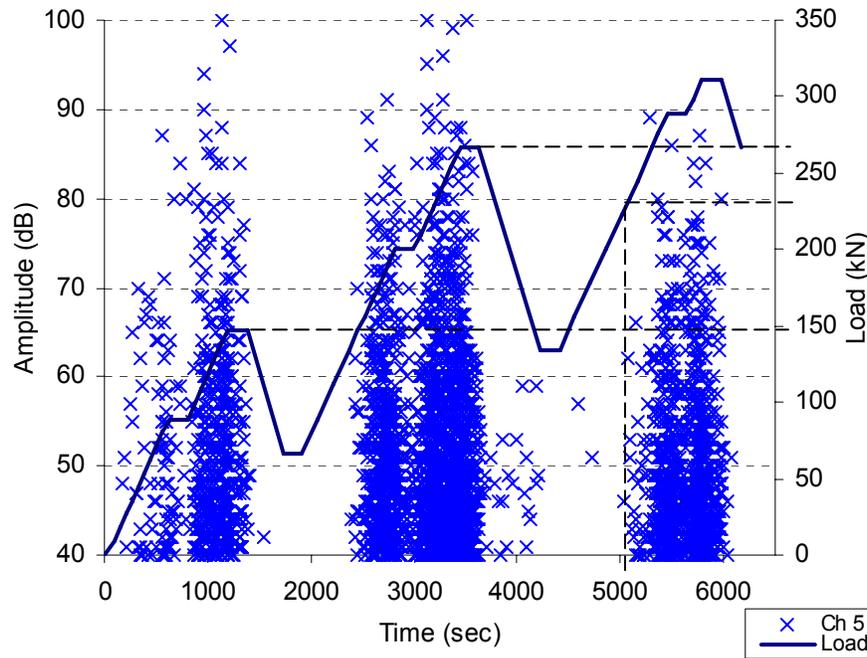
**Figure 3.4: Plot of amplitude versus time**

The first plot used for comparison analysis is a plot of the amplitude of each event in time with the superimposed loading profile (Figure 3.4).

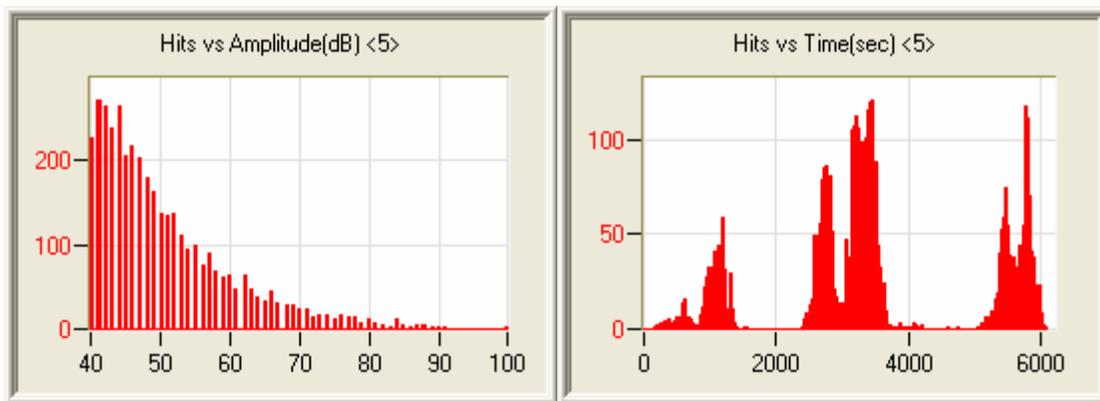
**Figure 3.5: Distribution plots of recorded hits**

damage. A Felicity ratio of one or greater can be interpreted as showing no damage in the structure since the last AE inspection. However, a decreasing FR in later inspections may be indicative of the cumulative, permanent damage and may result in the rejection and removal of the panel. Two additional plots are used to provide the distribution of the events in regards to the amplitude of each hit and the number of hits recorded during monitoring. These plots can be seen in Figure 3.5. It can be noted that the majority of the hits had an amplitude between 40 and 65 dB.

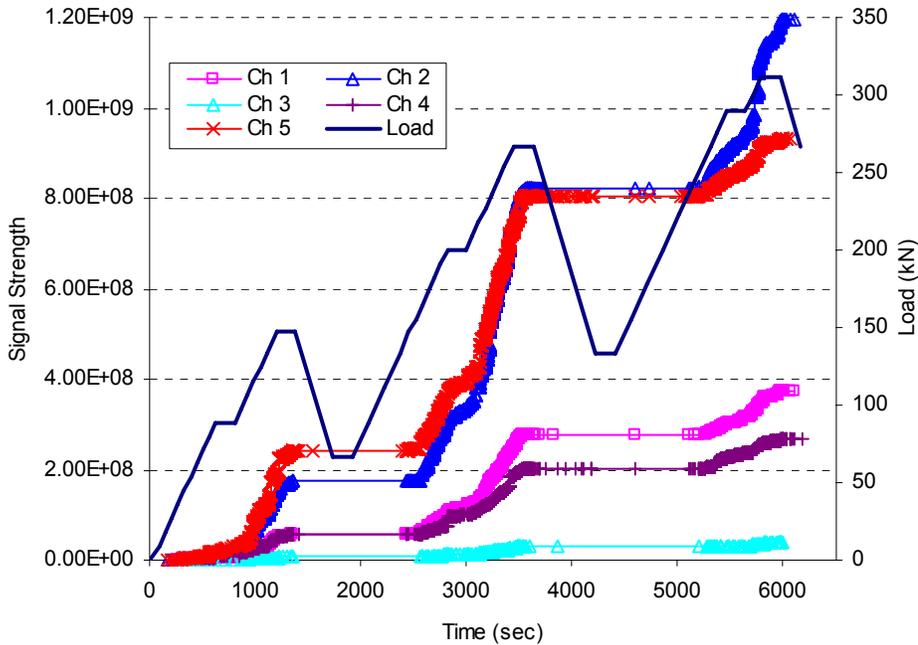
**Figure 3.6: Plot of cumulative signal strength in time for all channels**

The second graph used in this type of analysis is a plot of the cumulative signal strength of the events for each channel. As can be seen from Figure 3.6, channel 2 and channel 5 saw the greatest increases in the cumulative signal strength. Comparing this plot to Figures 3.2 and 3.4, this graph corresponds to what has already been seen in the previous figures.

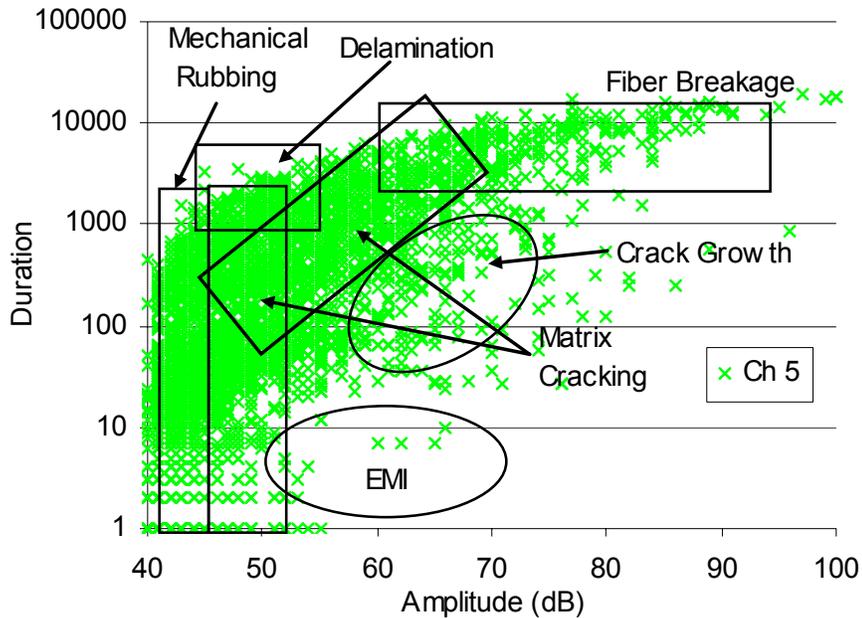
**Figure 3.7: Cross plot of duration versus amplitude**

to medium amplitude tend to signify matrix cracking within the material and is similar to results from other work (Gudmundson, Johnson 2000) and shown in Figure 3.7.

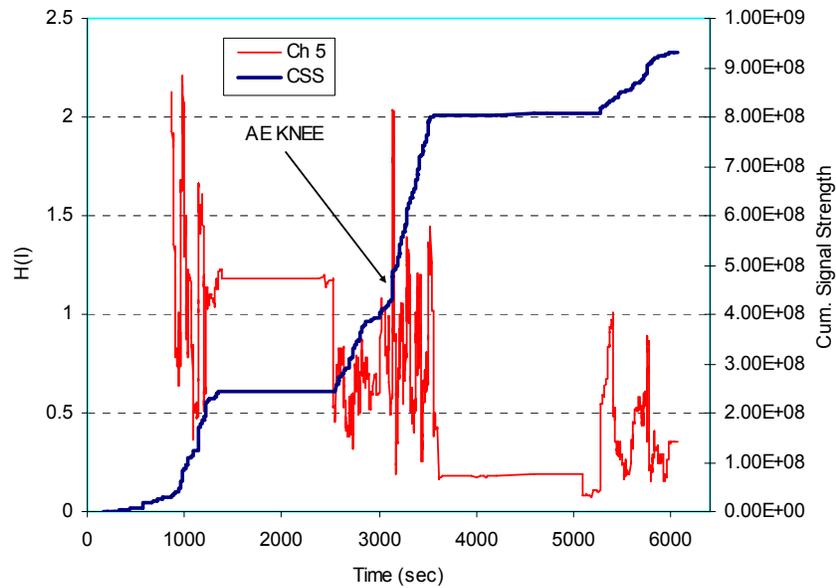
**Figure 3.8: Plot of historic index and cumulative signal strength**

To measure the structural significance of an AE event(s), intensity analysis uses signal strength to calculate two factors known as Historic Index and Severity. The HI compares the average signal strength of the last 20 events to the average signal strength of all the events. This analytical method allows for the determination of a change in slope in the cumulative signal strength curve. During initial loading, the value will be close to unity and will increase sharply at the “knee” in the curve. After the knee, the historic index will decline until the next knee is reached. Reviewing Figure 3.8 several AE knees can be seen but may not necessarily represent significance in terms of possible damage.

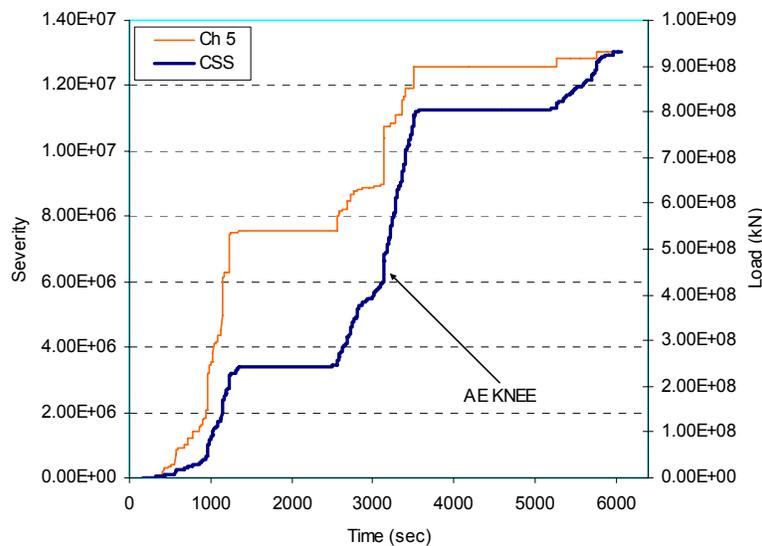
**Figure 3.9: Plot of severity versus cumulative signal strength**

The second graph used in intensity analysis is the calculation and plot of severity with respect to time. The calculation of severity is defined as the average signal strength of the 20 events having the largest value of signal strength. In the case of severity analysis, severity can only increase with the load and a significant increase will identify the onset of increasing severity in terms of structural damage. As with historic index, severity will typically increase at the knee of the cumulate signal strength curve. As damage continues to increase in the panel, severity will increase, but at a slower rate. At the onset of more severe structural damage (such as gross fiber breakage), severity will increase sharply. These trends can be seen in Figure 3.9.

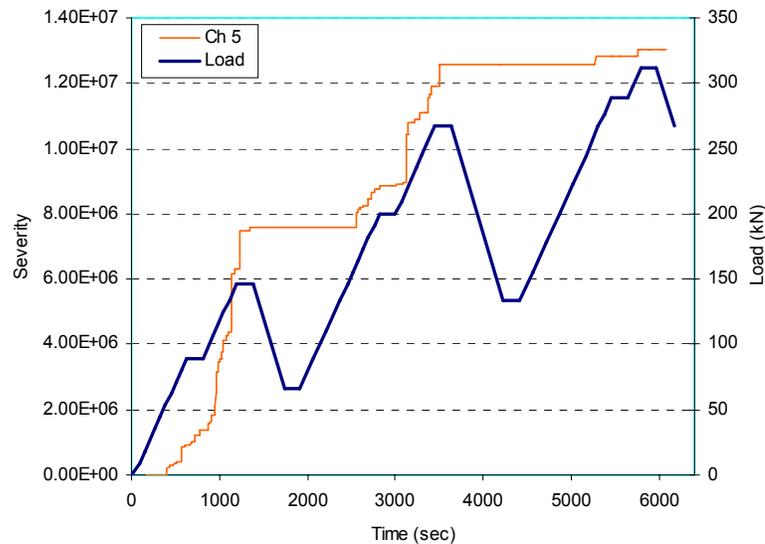
**Figure 3.10: Plot of severity versus load profile**

show this relationship, Figure 3.10 shows a plot of severity with respect to the special load profile.

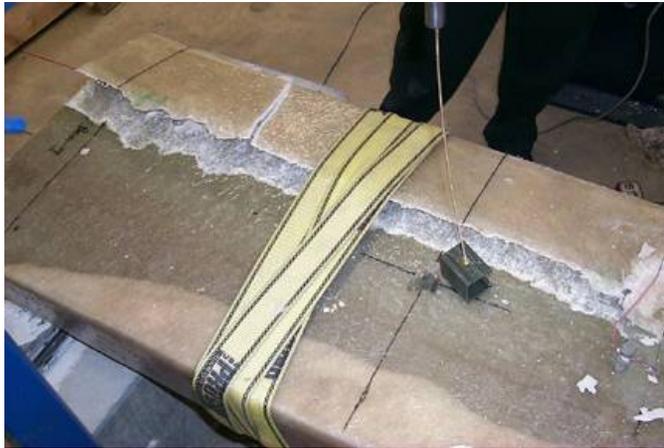
**Figure 3.12: Debonding of wrap along edges**

Additionally, the increases in emissions from the repaired specimens are believed to be associated with the 3 layer, ChopSM external wrap that is applied and bonded with resin. In the case of the A-30 repaired specimen, 63 percent of all the hits recorded were received by sensors located on the external wrap. Part of this increase in emissions is the result of mechanical rubbing of the wrap along the inner core as it begins debonding. A review of the data indicates that failure begins along the centerline of loading with the internal core material debonding from the top and bottom face plates. This forces the load path to the outside panels and into the external wrap. Once the load begins to approach the maximum tensile capacity of the wrap, or the strength of the resin bond, debonding of the external wrap tends to begin at midspan of the panel and slowly begins to expand out towards the supports. This can be seen in Figure 3.12

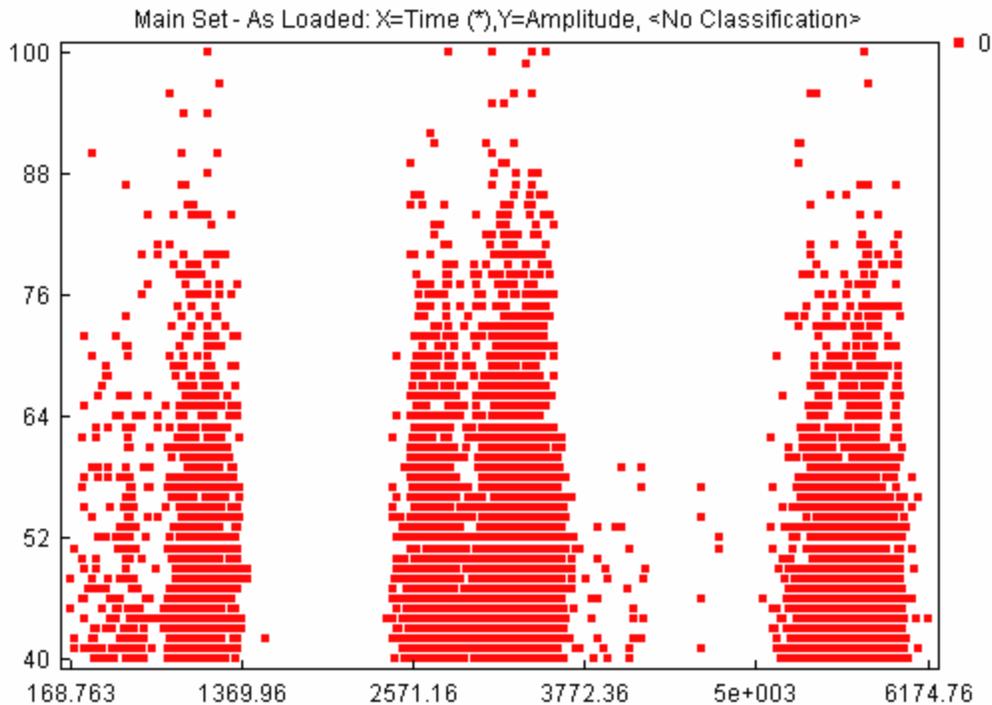
**Figure 3.13: Noesis plot of amplitude versus time**

The original data was loaded into the Noesis software package as an unsupervised method since no classes have been identified. Therefore, the typical features loaded were amplitude, energy, duration, rise time, counts, RMS, signal strength and waveforms. Once the data is loaded, Noesis will display a default graph of the main set of data as loaded into the program. Noesis gives 10 different plot options from a simple scatter graph (Figure 3.13), to distribution, cumulative and line graphs.

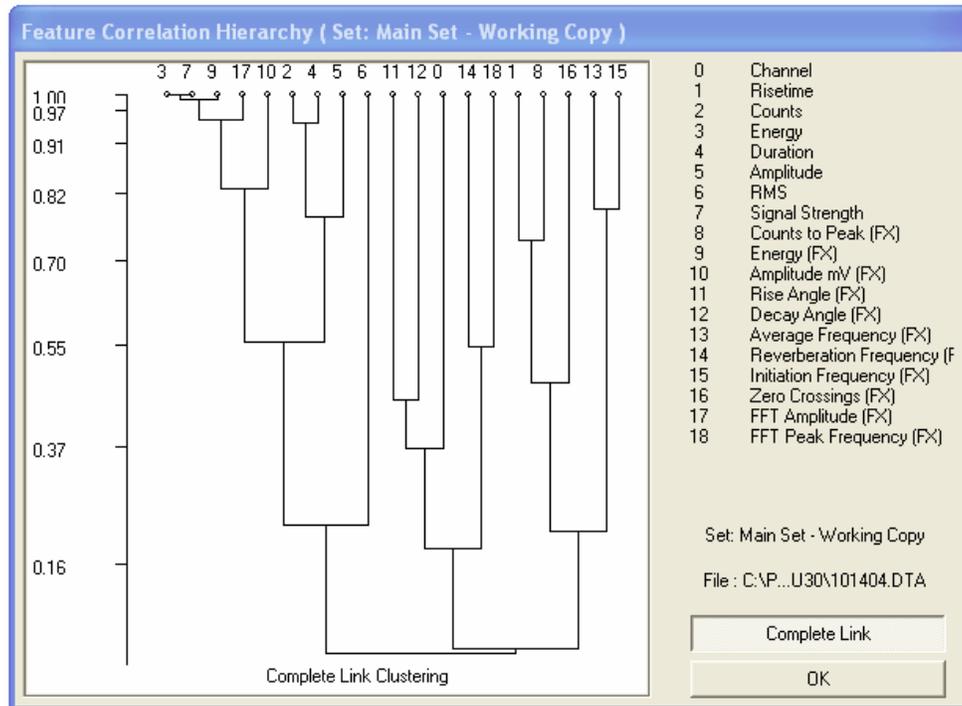
**Figure 3.14: Feature correlation hierarchy**

1 and 2 are filtered. This results in 32.73% of the data being filtered from the main set. To prepare the data for clustering, we switch to the 'Working Copy' data set and look at the feature correlation hierarchy for the available waveform parameters (Figure 3.14).

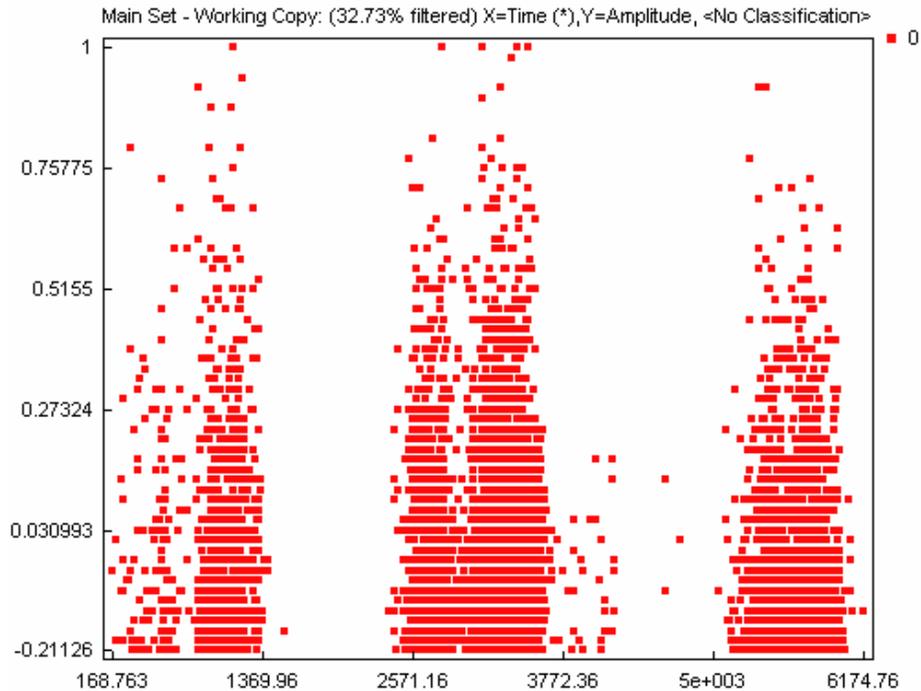
**Figure 3.15: Noesis graph with normalization applied**

Four different normalization schemes, 'Zero Mean', 'Unit Variance', 'Zero to One Range', and '-1 to 1 Range' are available. The '-1 to 1 Range' was used and can be seen in Figure 3.15.

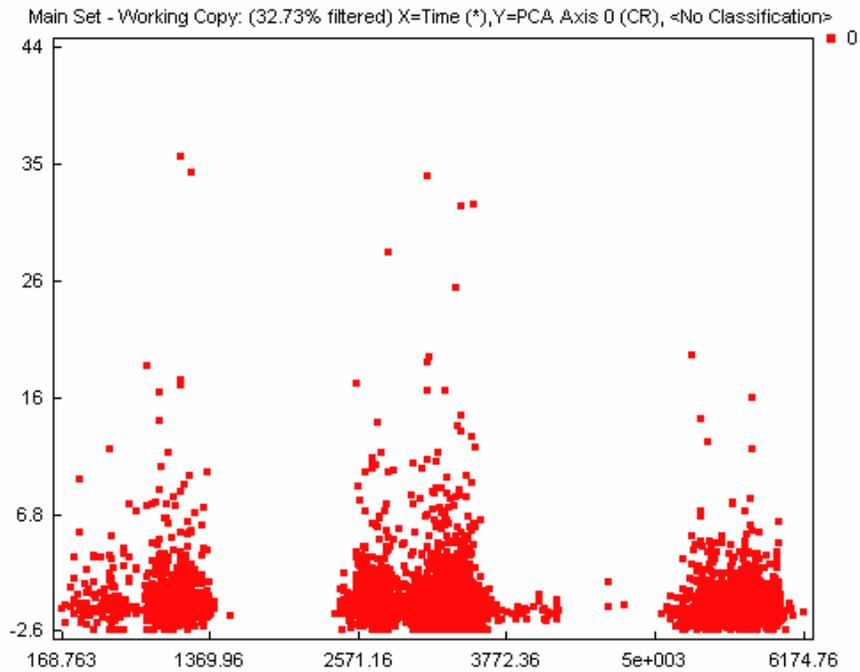
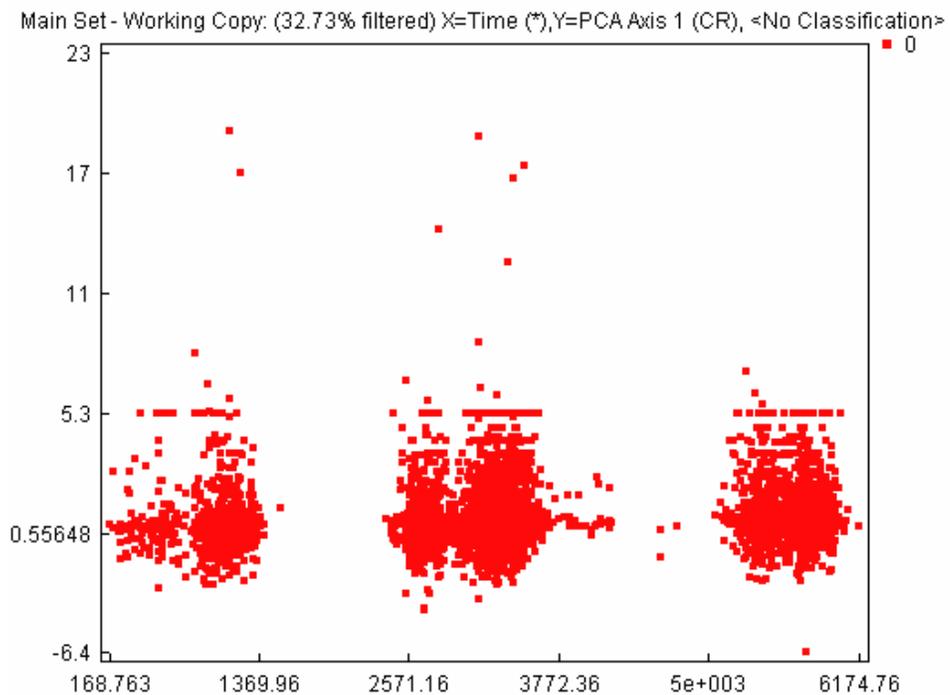
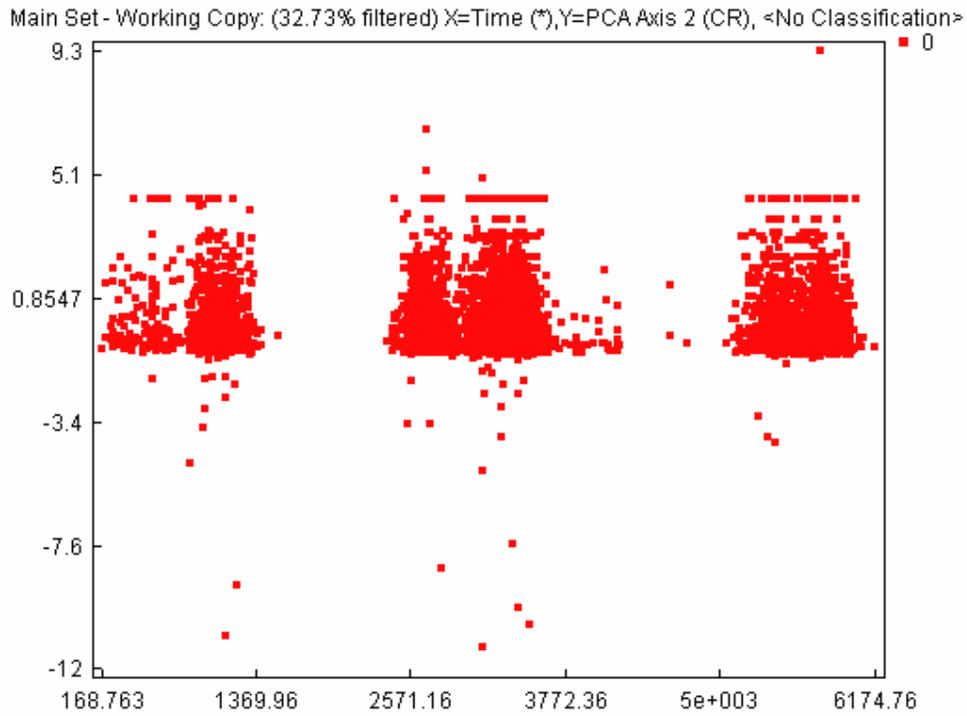
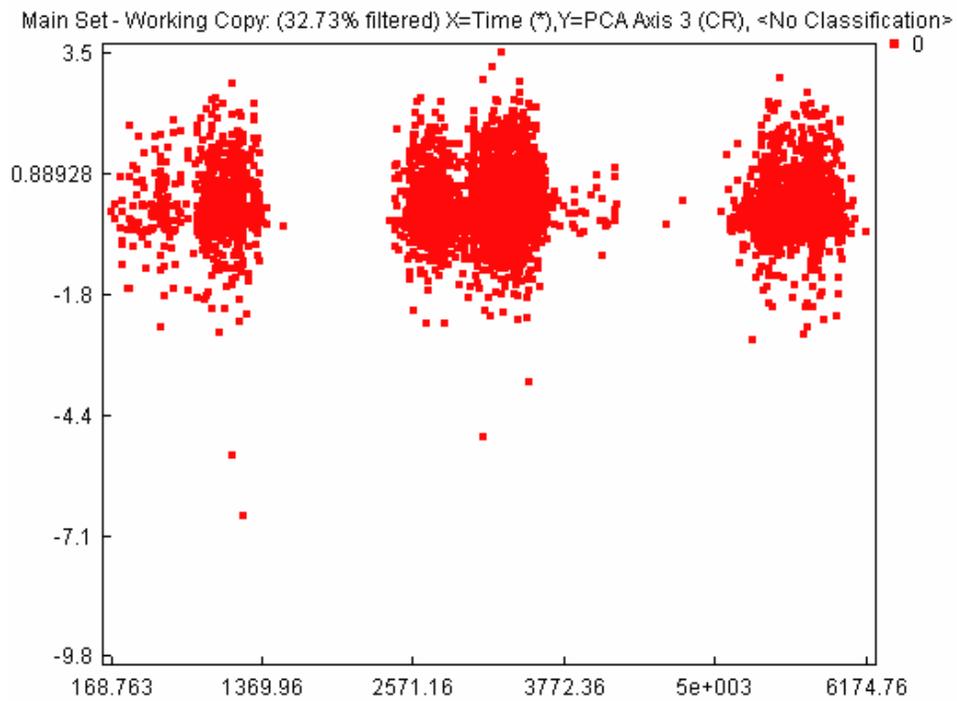
component axes (Figures 3.16, 3.17, 3.18, 3.19). Each axis corresponds to a selected feature.

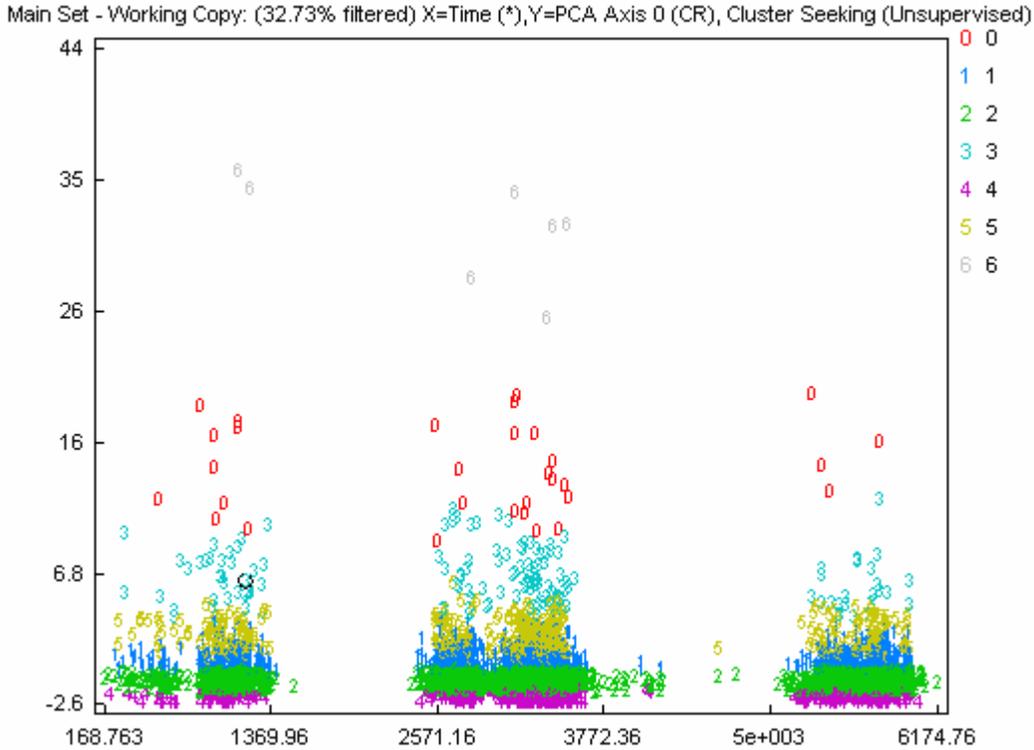
**Figure 3.20: Clustering analysis results – PCA 0**

Now that pre-processing is complete, the data is ready for clustering. The first applied clustering technique is known as 'Cluster Seeking'. Cluster seeking is a heuristic algorithm that starts with a single point from the user defined cluster centers. A new cluster is created if a pattern is sufficiently separated, i.e. the distance between the existing cluster and the new point is greater than the specified threshold. The initial clusters were set to 6, the multiple fraction at 0.9, the minimum prototypes to 10, a radius of 0.5 and the default settings of 100 internal iterations and 20 external iterations. The multiple fraction setting is the data between the maximum radius and the percentage defined by the multiple fraction setting which will remain unclassified and are omitted from the cluster definition process. The minimum number of prototypes is the minimum number of patterns/hits in a single cluster. Clusters with fewer than the minimum number are deleted. The radius setting is the percentage of maximum distance to be used as the threshold distance for the creation of new clusters. Thus the number of clusters can be increased by decreasing the value of the radius parameter. Once all initial settings are set, the clustering technique is run. The first run using this technique generated a total of 7 classes. Each cluster was investigated by looking at the typical waveform found in the cluster to try and identify the failure mechanism within each class (Figure 3.20).

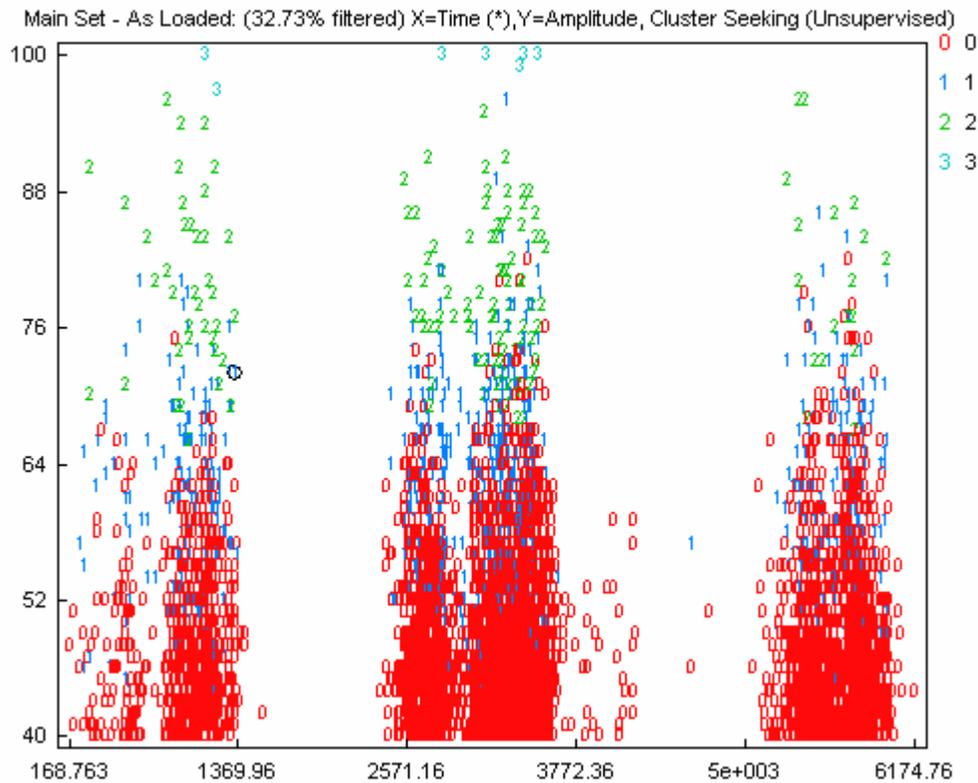
**Figure 3.21: Applied clustering method to original data**

In reviewing previous work by Siron (2003), the above feature statistics in Table 3.6 are similar to their work on identification of damage and failure modes in carbon composites. Based upon their work and the findings above, the following generalizations can be made. Waveforms with low to medium amplitudes (40 to 70 dB) and low duration may represent intra-ply matrix cracking and crack propagation. Waveforms with medium amplitudes (60 to 85 dB) and medium duration may represent increased matrix cracking due to increased damage, and debonding of panel interfaces. Finally, waveforms with high amplitude (85 to 100 db) and medium to high duration may represent individual fiber failure or fiber bundle failure and large area delamination. The resulting classification and clustering technique can be seen in Figure 3.21 in which the method has been applied to the original data.
