Report No. K-TRAN: KU-99-2  
FINAL REPORT

## **FATIGUE PRONE STEEL BRIDGE DETAILS: INVESTIGATION AND RECOMMENDED REPAIRS**

Yuan Zhao  
W. M. Kim Roddis

University of Kansas  
Lawrence, Kansas

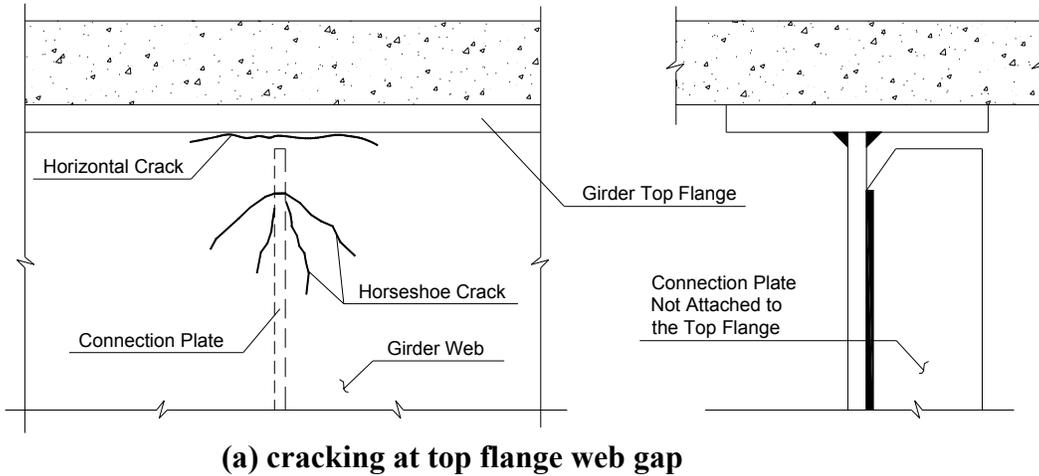
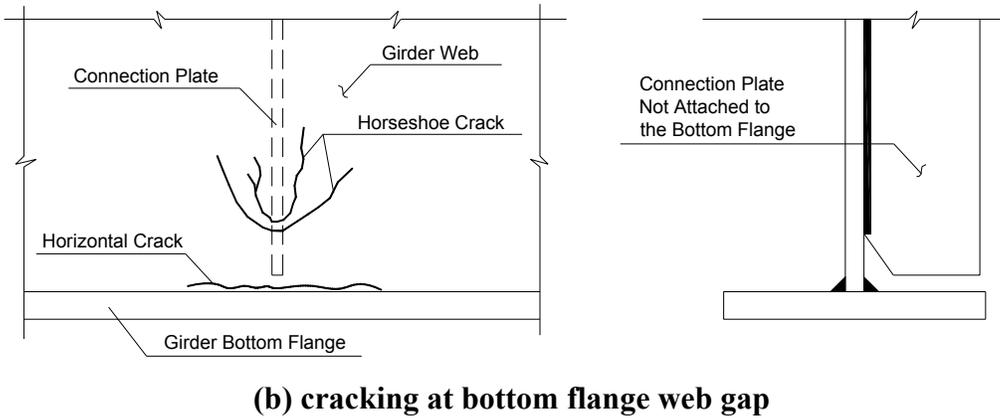
**FIGURE 1-5: Typical Out-of-Plane Crack Details Observed in KDOT Bridges**

3. **Horizontal Cracking at Coped Floor-Beam Flange to Connection Plate Fillet Welds:** This type of cracking was only identified in the Arkansas River Bridge due to the special means used for the floor-beam to girder connections of this bridge. As shown in Figure 1-5(c), the floor-beam is coped at both the top and bottom flanges, and then attached to the connection plate by horizontal and vertical fillet welds. Cracks initiated from the outer edge of the connection plate and then propagated along the horizontal welds towards the girder web. Cracks occurred only at the intermediate floor-beam to exterior girder connections close to girder positive moment regions. This type of connection requires field welding and is no longer used in current bridge design. The girder sections are rolled beams, so cracks were not observed in the small web gaps.

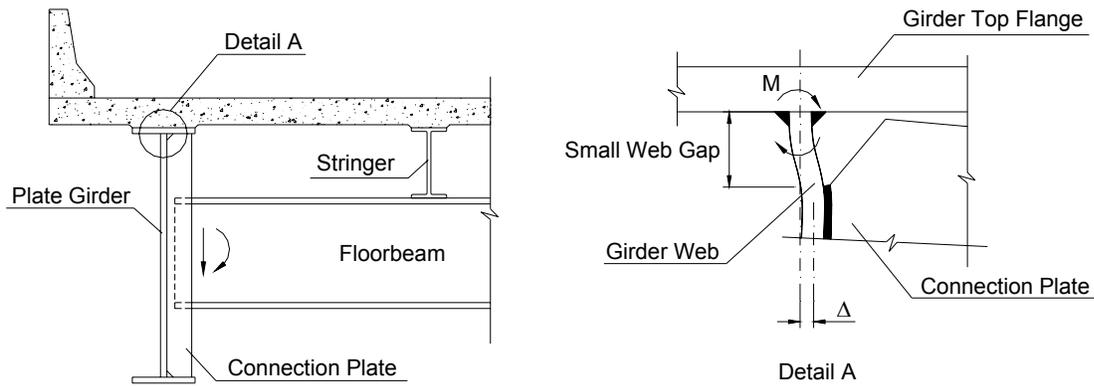
**FIGURE 2-1: Out-of-Plane Distortion in Small Web Gap at Connection Plate End**  
[NCHRP 336, 1990]

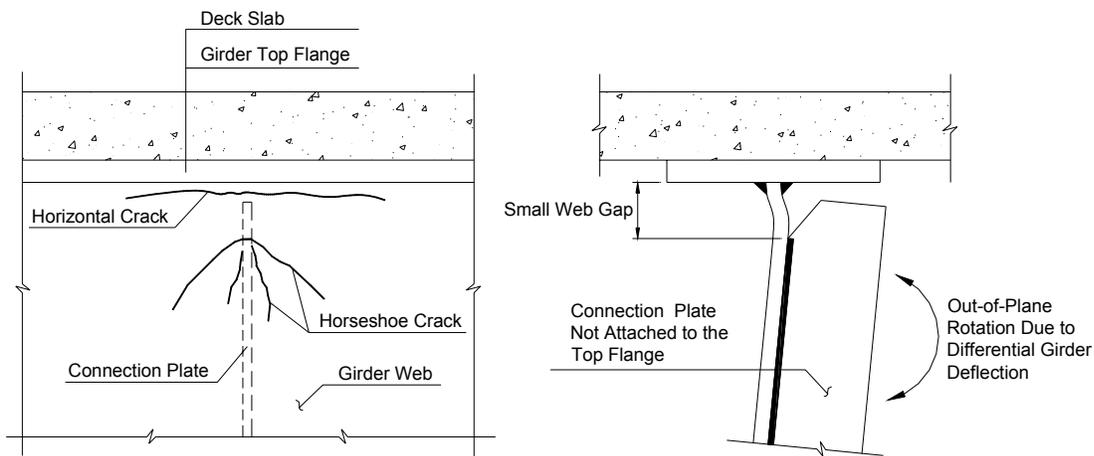
connection plate end, and leading to fatigue cracking. Cracks developed at both the web-to-flange and web-to-connection-plate fillet welds, typically as horizontal or horseshoe cracks, as indicated in Figure 2-2.

**FIGURE 2-2: Development of Horizontal and Horseshoe Cracks Due to Out-of-Plane Distortion**

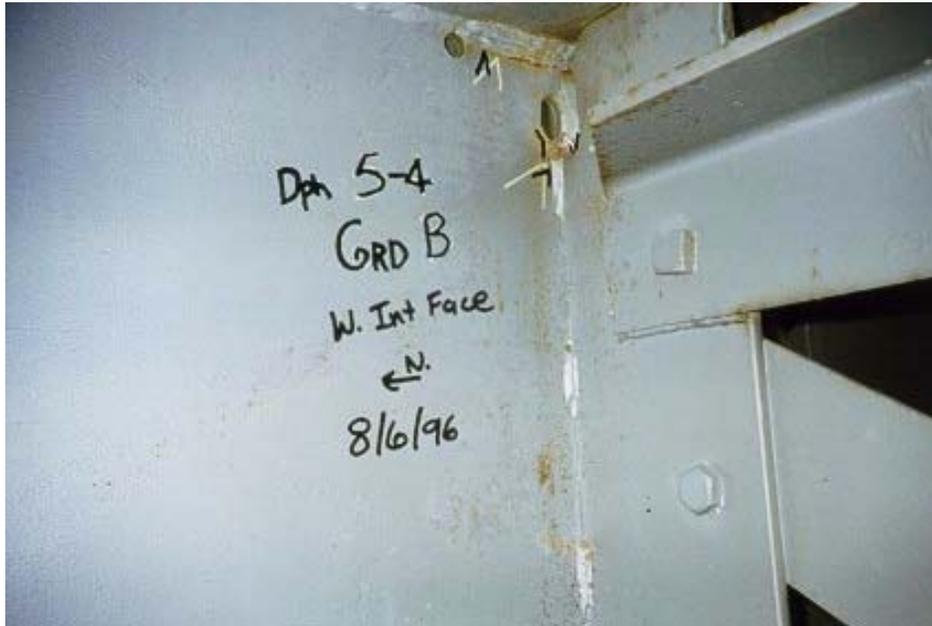
regions, because no girder deflections could occur at bridge piers. 2) Cracks are more easily developed at girder top flanges. This is because the top flange is rigidly embedded into the concrete deck, which restricts it from moving laterally together with the unstiffened small web gap when out-of-plane distortion occurs. The girder bottom flanges are much less constrained compared with the top flanges, and are therefore less susceptible to the distortion-induced fatigue cracking. The photographs in Figure 2-3 illustrate the development of typical horizontal and horseshoe cracks in a KDOT bridge. Crack ends are marked with arrows. The increase in crack length over time can be seen in the difference in location of the light (earlier inspection mark) and dark (later inspection mark) arrow tips.

(a) North Side of Connection Plate

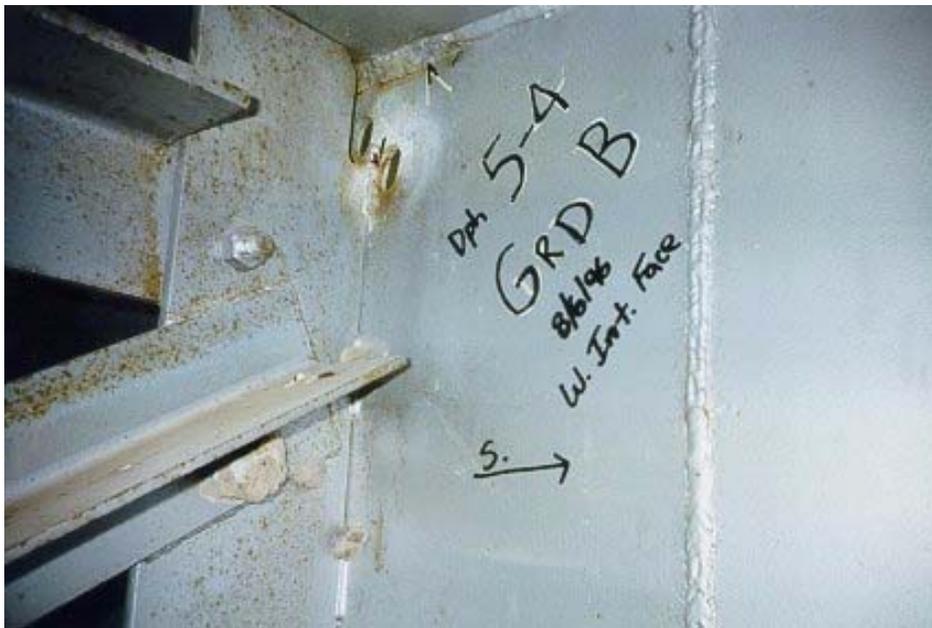
(b) South Side of Connection Plate

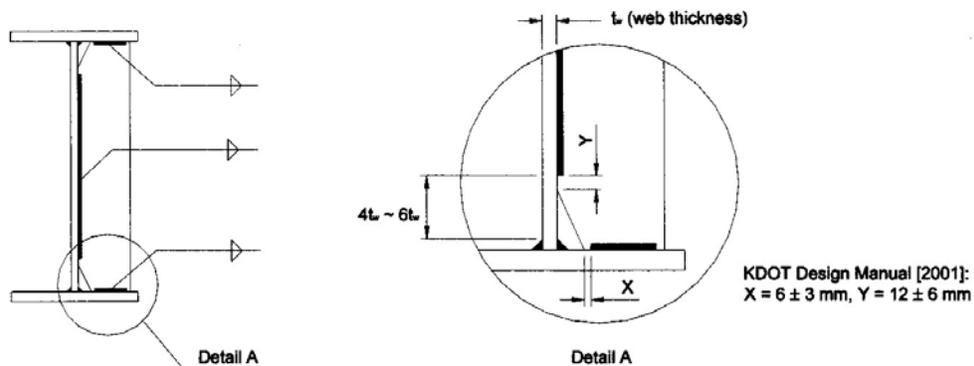
As shown in Figure 2-4, connection plates for diaphragms or cross frames shall be welded to both girder flanges with fillet welds on both sides of the connection plates. The distance between the end of the web-to-connection-plate weld and the near edge of the web-to-flange fillet weld shall not be less than  $4t_w$  or more than  $6t_w$  [AASHTO LRFD 6.10.8.1.1, 1998; or AASHTO Standard Specifications 10.34.4.9, 1996]. The connection plate to girder flange fillet weld is an AASHTO fatigue Category C' detail [AASHTO LRFD, 1998]. As long as the girder tension flange stress ranges at these locations are less than Category C' fatigue resistance, this fully welded connection plate detail is preferred because it is the easiest for fabrication. Notice that the horizontal and vertical fillet welds must be terminated at the lengths of X and Y, respectively, from the clipped ends to avoid fatigue problems at the connection plate. Different DOTs may specify the X and Y dimensions differently. KDOT requires 6 mm ( $\frac{1}{4}$  in.) for X and 12 mm ( $\frac{1}{2}$  in.) for Y short of the clip ends [KDOT Design Manual, 2001].

**FIGURE 2-4: Connection Plate Welded to Both Girder Flanges**

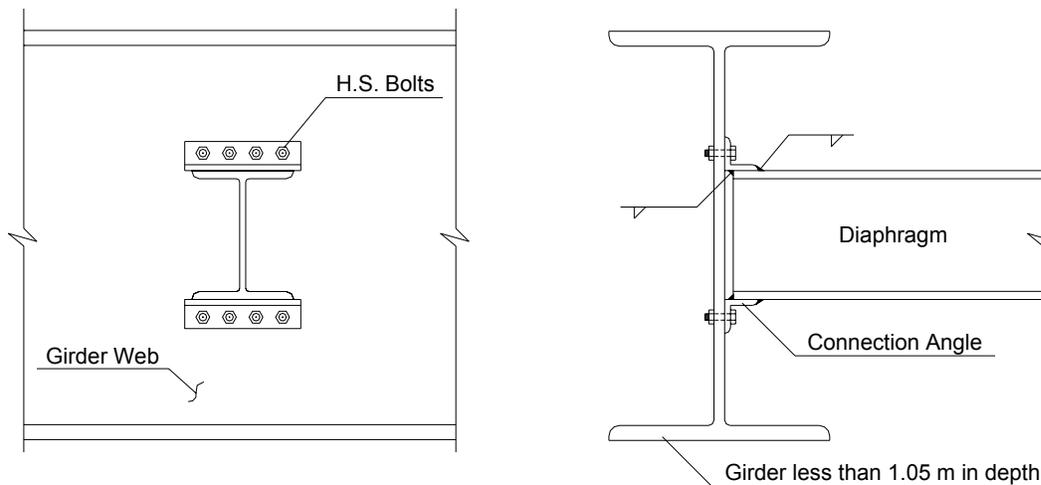
transmitting forces from the transverse members into the longitudinal girders. Either transverse connection plates or angles are used and are welded or bolted to both the web and flanges, so that the girder cross sections are rigid enough to resist the out-of-plane distortion. The detail shown in Figure 2-7, however, is purposely designed to make the girder section more flexible. The diaphragm is shop welded to the connection angles and then field bolted directly to the girder web. No transverse connection plates or angles are used therefore the excessive constraints at the web-to-flange intersections are released. The forces transmitted by the diaphragm are evenly distributed to the girder web by high strength bolts, thus the effect of stress concentration at the web gap is extremely reduced. As long as the open web section between the flange and the diaphragm is deep enough, the secondary stresses developed in this portion of the girder web would not induce fatigue cracks. This detail is used by Illinois DOT for rolled beams or welded plate girders less than 1.05 m (3.5 ft) in depth. The policy of Illinois DOT is to minimize the use of transverse intermediate stiffeners by thickening the girder webs, since this is usually more economical for fabrication. Therefore, web buckling and torsion usually are not problems for these shallow girders. In addition, potential fatigue problems with the connection welds perpendicular to the applied tensile stresses could also be avoided by eliminating transverse stiffeners and connection plates.

**FIGURE 2-7: Diaphragm bolted directly to girder web [Illinois DOT]**

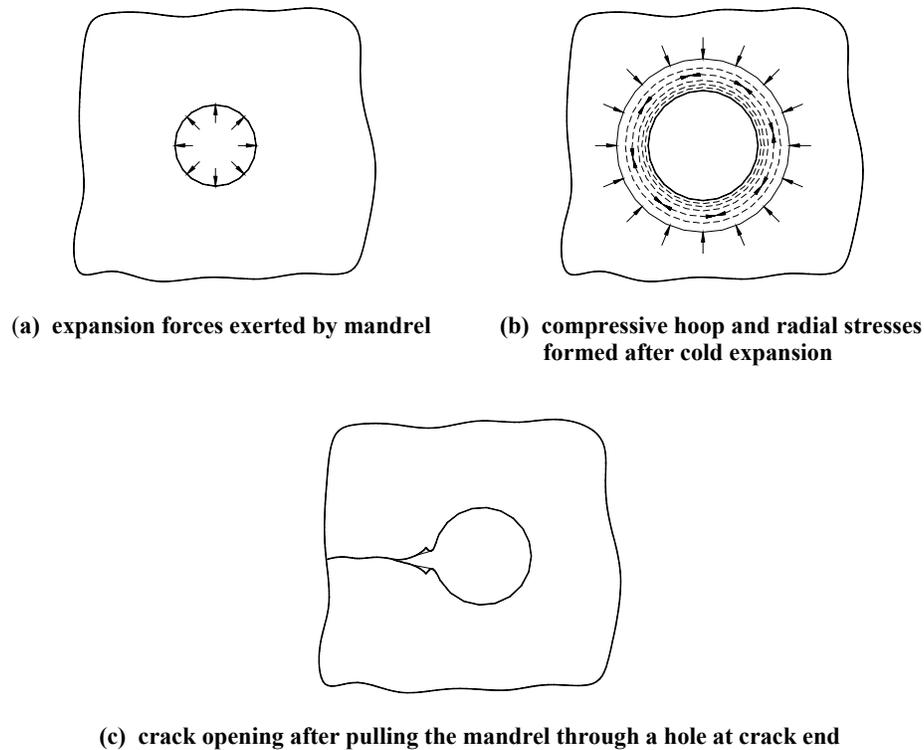
**FIGURE 2-9: Cold Expansion Used to Improve Fatigue Resistance of Drilled Holes**

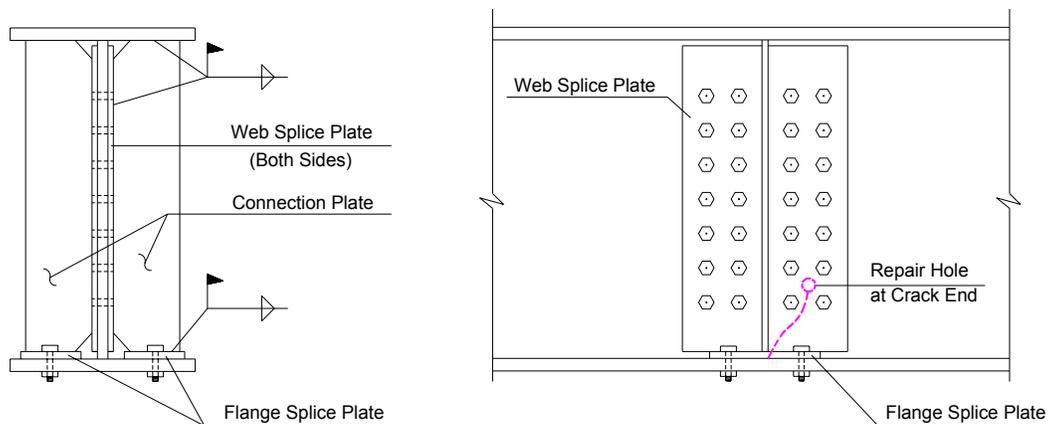
If large fatigue cracks have developed deep into the girder web, the load-carrying capacity of the main structural member is impaired, which may affect the structural integrity of the bridge. This is especially of concern when the cracks are located in a tension zone. As shown in Figure 2-12, the repair can be performed by removing the original connection plates and bolting reinforcing splices (or coverplates) on both sides of the web. New connection plates also need to be connected rigidly to girder flanges, either by welding or bolting. Thus the cracked web is stiffened and the girder section properties are restored by this retrofit.

**FIGURE 2-12: Reinforcing Splices Used for Restoring Girder Section Properties**

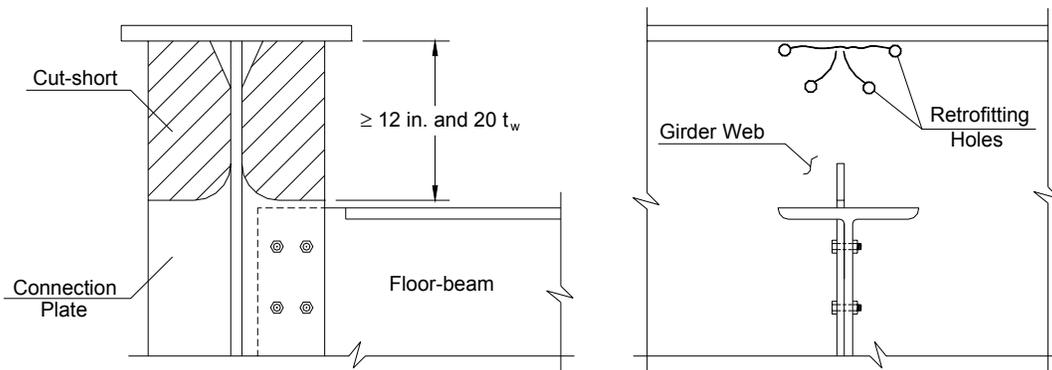
1985], and the Midland County Bridge (Texas) [Keating et al, 1996], were also repaired by employing this approach at the web gap locations. As illustrated in Figure 2-13, part of the connection plate is cut back so that the area of the girder web below the flange is sufficiently flexible to accommodate the out-of-plane rotation. Both field and laboratory tests showed that the secondary stress is significantly reduced after the connection is softened. The cut surface should be well finished to prevent crack reinitiation. To efficiently release the restrained web, a minimum cut-short dimension of 12 in. or 20 times of the web thickness, whichever is larger, is recommended for the connection plate [NCHRP 336, 1990].

**FIGURE 2-13: Releasing Web Gap Stresses by Cutting the Connection Plate Short**

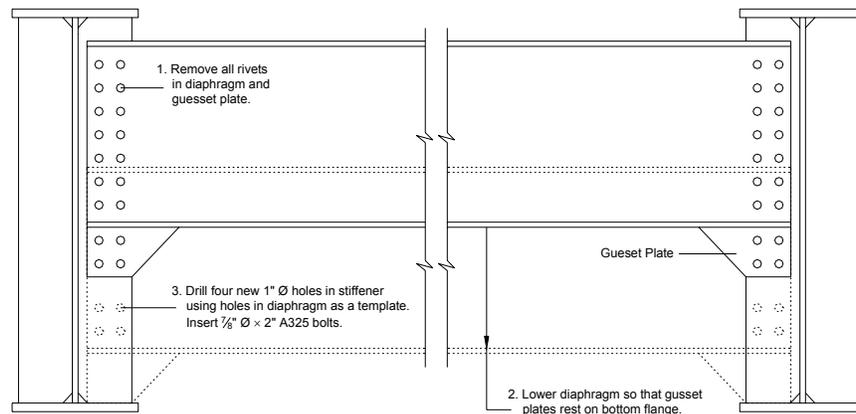
**FIGURE 2-14: Diaphragm Repositioning [Minnesota DOT]**

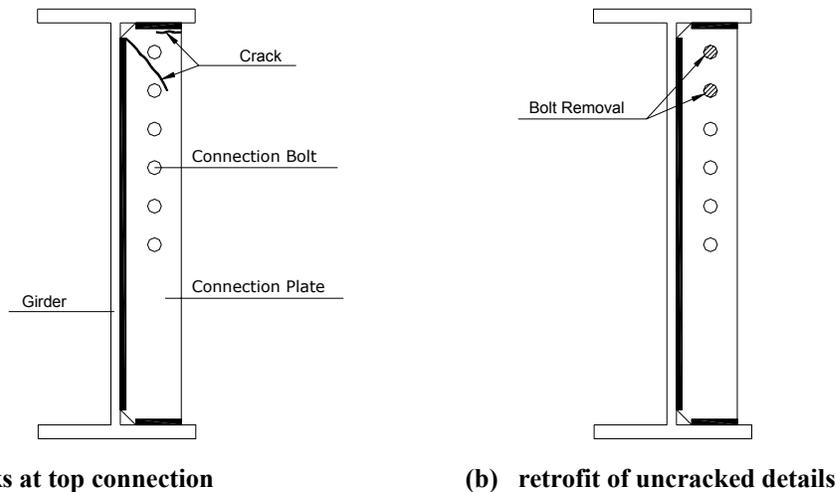
Repair to the uncracked connection plates in those bridges was performed by bolt removal, as shown in Figure 2-16(b), to reduce stress ranges at the critical details; while the cracked locations were repaired by removing a portion of the connection plate so that the constraints at the top connection plate end were relaxed.

**FIGURE 2-16: Connection Plate Detail used by Bridges over I-10 in Phoenix, Arizona**  
[Stallings, 2001]

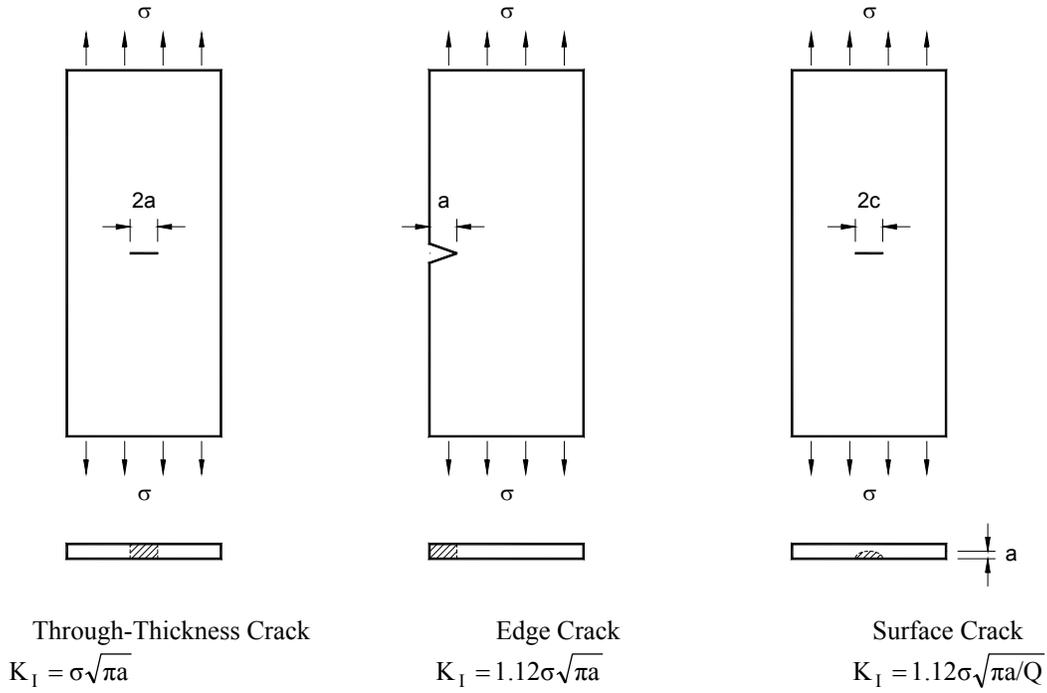
**FIGURE 3-1:  $K_I$  Values for Three Basic Crack Geometries [Barsom and Rolfe, 1999]**

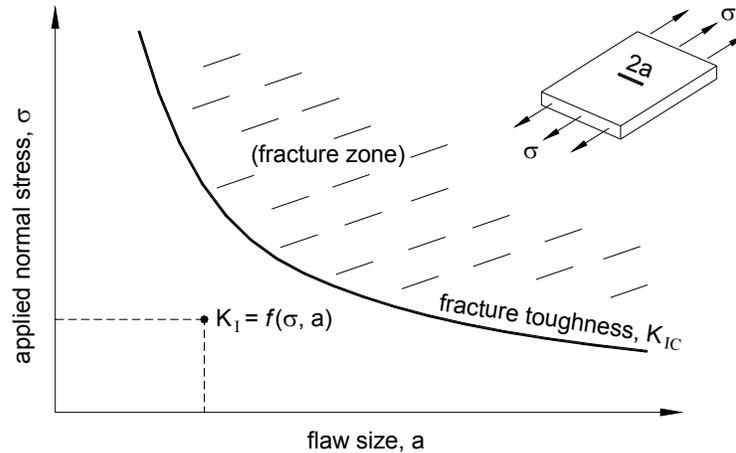
resistant. Figure 3-4 illustrates the relationship between the three governing factors for control of brittle fracture: the applied stress  $\sigma$ , the crack size  $a$ , and the material toughness  $K_{IC}$ .

**FIGURE 3-4: Schematic Relation among Stress, Flaw Size, and Material Toughness**  
[Barsom & Rolfe, 1999]

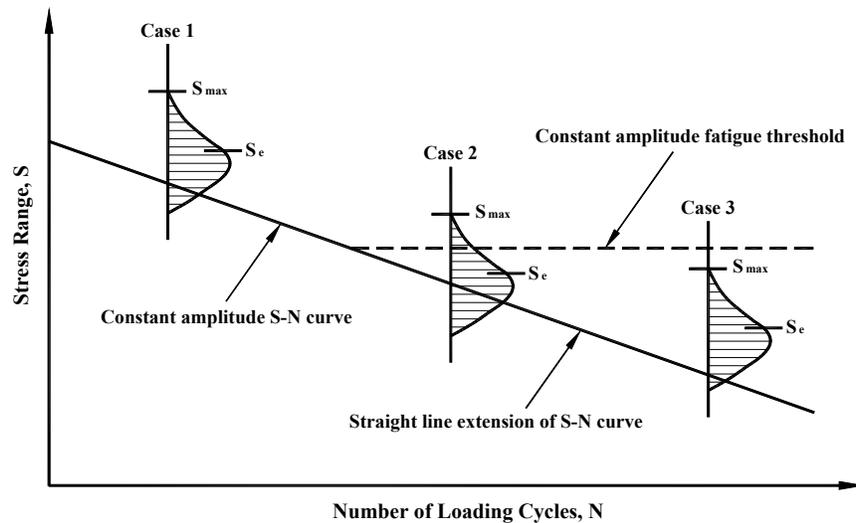
exceedance probability of 0.01%. Obviously Case 1 is in the finite life regime and Case 3 is in the infinite life regime. For Case 2, the effective stress range is below the constant amplitude fatigue threshold  $(\Delta F)_{TH}$ , but more than 0.01% of the stress ranges are over  $(\Delta F)_{TH}$ , thus an infinite life is impossible.

**FIGURE 3-7: Relationship between the Spectrum of Applied Stress Ranges and the  $S$ - $N$  Curve [Dexter & Fisher, 2000]**

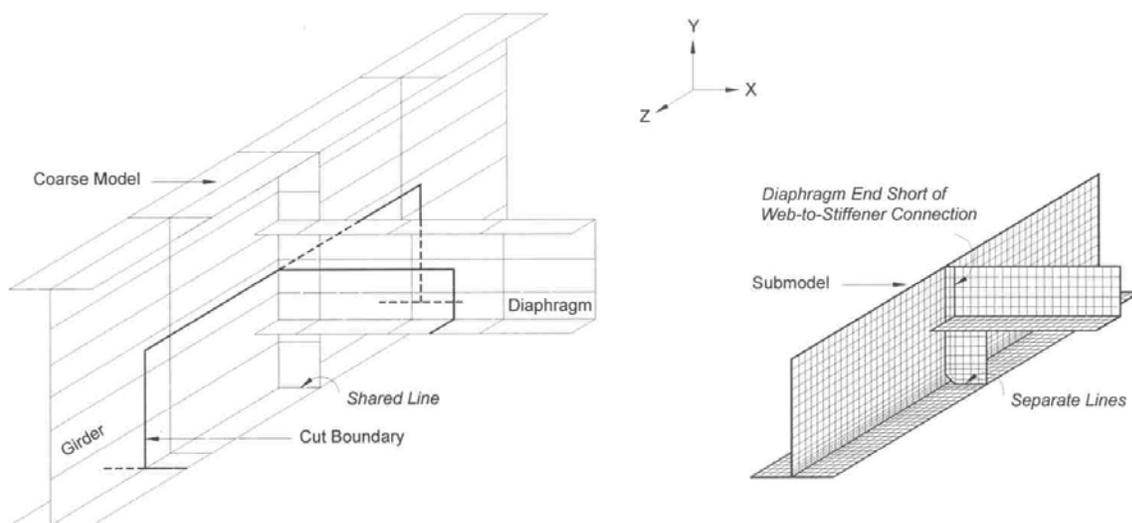
Figure 4-8 shows the schematic relationship between the coarse model and the submodel. The connection stiffener to girder web and flange intersection is the area subjected to high stress gradient, therefore the submodel only needs to include part of the structural components around this region. The bold lines in Figure 4-8(a) represent a cut boundary on the coarse model. The area within this boundary is abstracted and finely meshed for the formation of the submodel, as shown in Figure 4-8(b). The element type, material properties, and geometry coordinates of the submodel should be kept the same as those of the corresponding coarse model along the cut boundary. The geometry inside the submodel, however, can be changed when necessary. Comparing Figures 4-8(a) and (b), it can be observed that there are three places that are modified during the submodeling: the inside corner of the connection stiffener end is clipped; the diaphragm is terminated short of the web-to-stiffener connection so that only the stiffener is directly connected to the web; and the bottom stiffener end is separated from the flange. The coarse model would be cumbersome if these local details had to be considered. Yet for the submodel it is not difficult to implement these details. As long as the modified regions are away from the cut boundary, the results are not significantly affected.

**FIGURE 4-8: Coarse Model vs. Submodel**

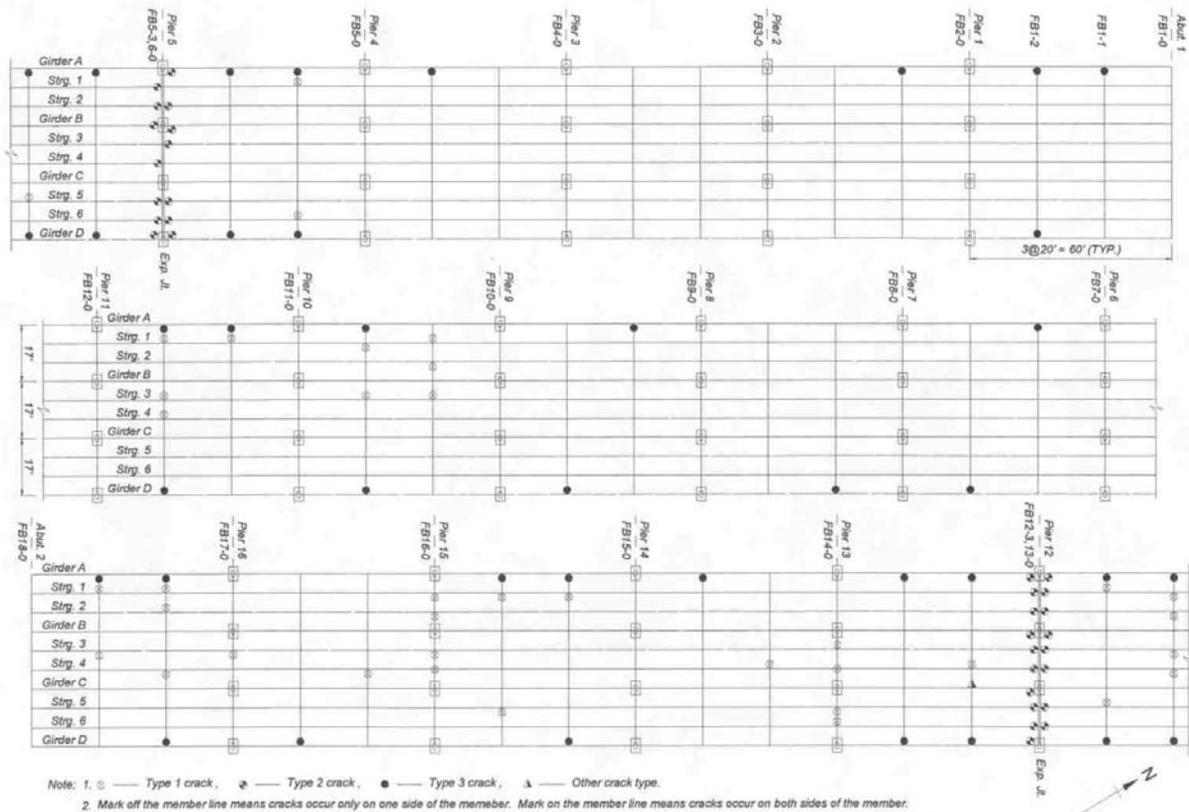
**FIGURE 5-1: Frame Plan and Crack Distribution of the Arkansas River Bridge**

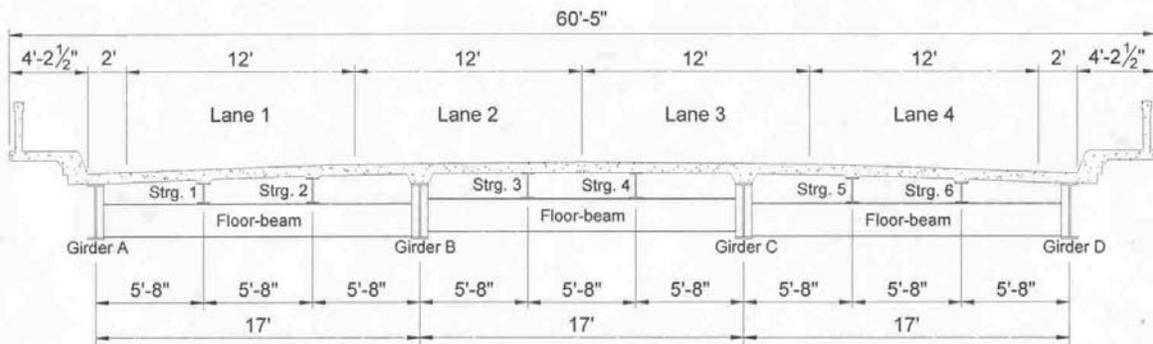
one on each side of the bridge, is 4 ft 2½ in. wide. Thus the total bridge cross section width is 60 ft 5 in. All of the main structural members are rolled steel sections. The girder sections are W36×160 and W36×170, the floor-beams are W21×68 and W21×62, and the stringers are W14×43 and W16×45. Girder transverse stiffeners are used as floor-beam connection plates.

**FIGURE 5-2: Cross Section of the Arkansas River Bridge**

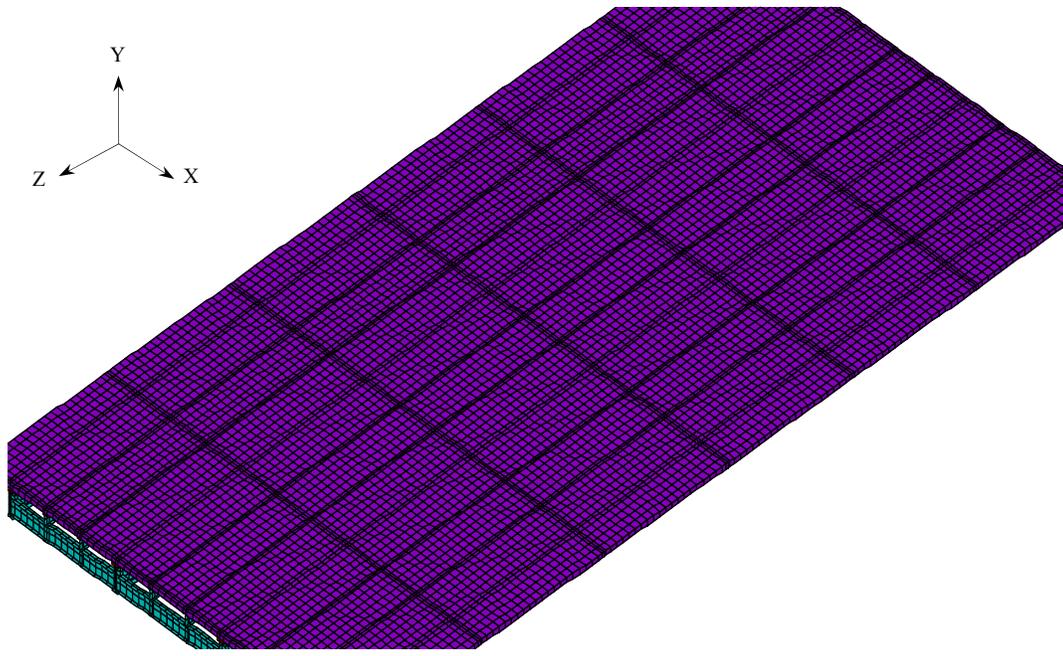
(a) isometric view of the coarse model

**FIGURE 5-7: Coarse Model of the Arkansas River Bridge Superstructure from Pier No. 10 to 12**

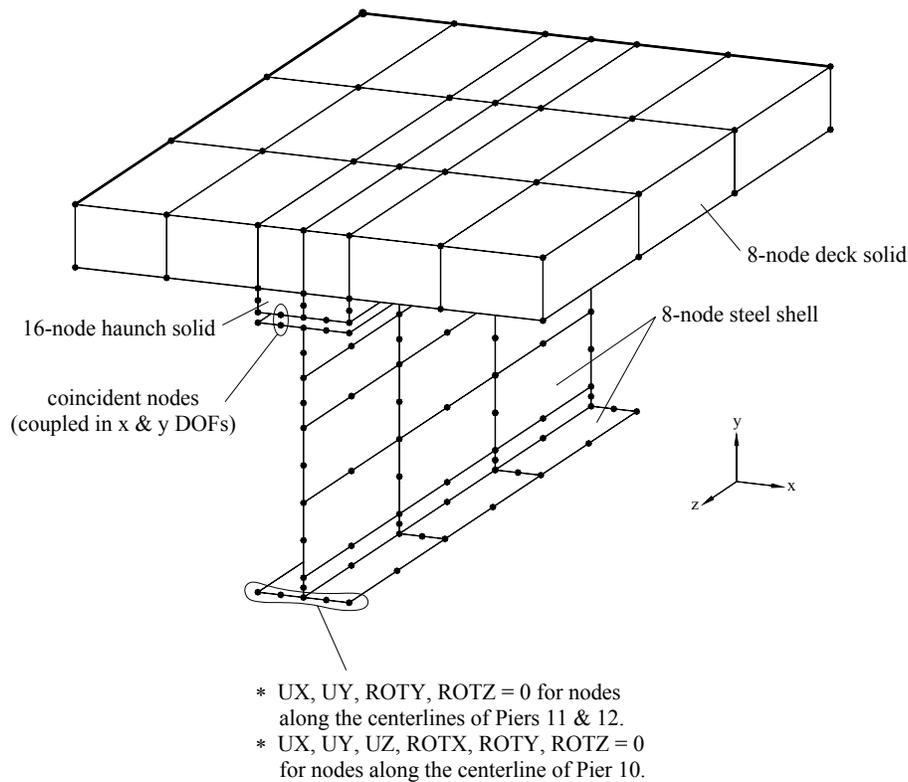
**FIGURE 5-8: Element Combination at a Typical Girder Section for the Coarse Model**

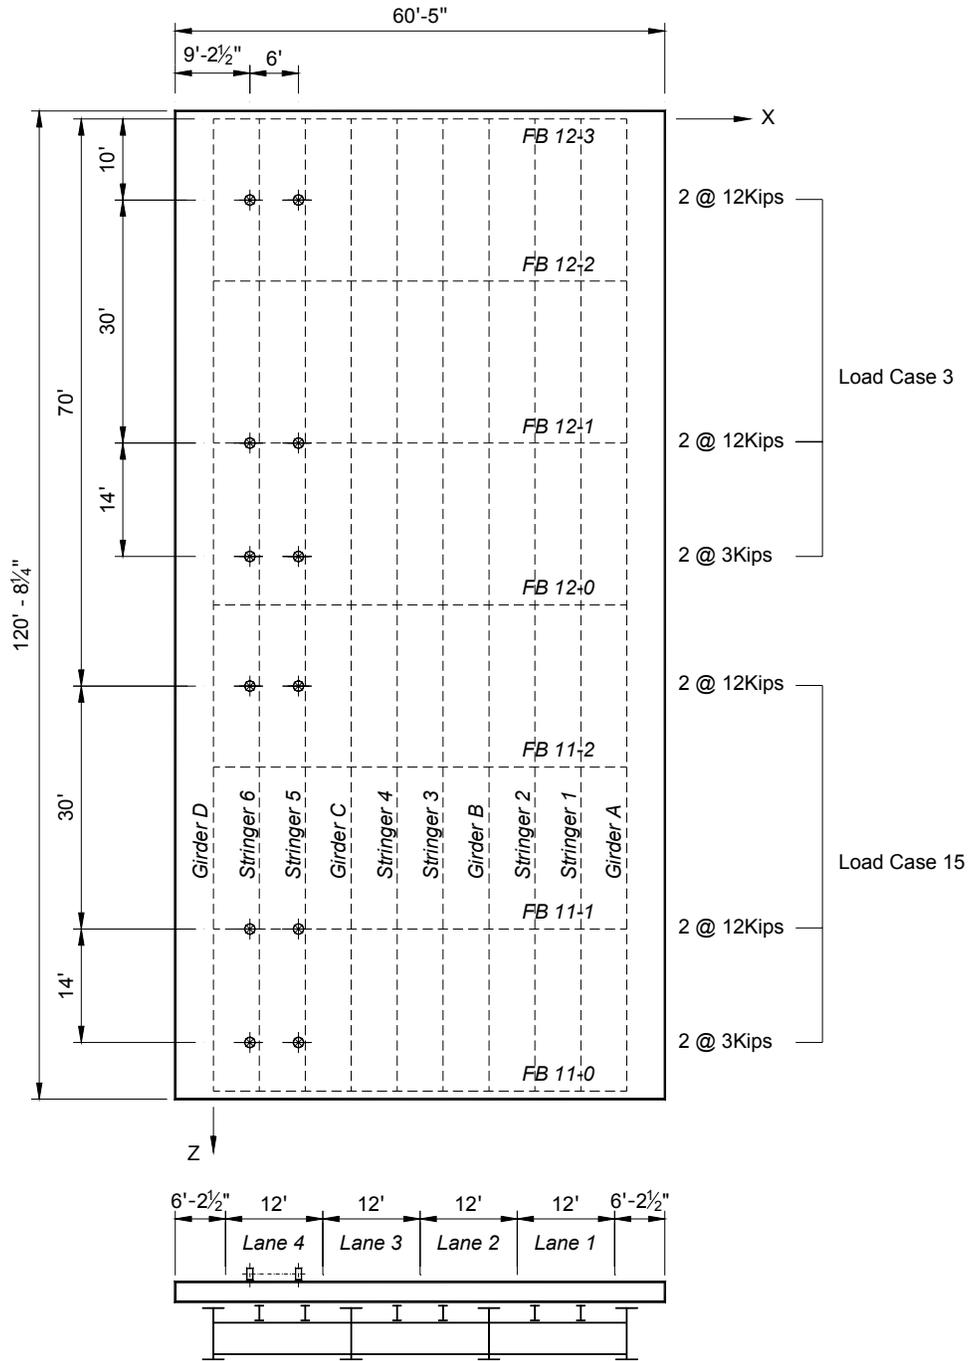
An HS15 fatigue truck is applied to conduct the coarse model analysis. As shown in Figure 5-9, the truck is positioned at the center of Lane 4, the driving lane close to Girder D. The distance between the exterior wheels and the deck edge is 9 ft 2½ in. Wheel loads are applied directly as nodal forces on top of the deck elements. Twenty load cases are performed by moving the truck from Pier No. 12 to Pier No. 10 in increments of 5 ft. The crack opening stresses for all the floor-beam to exterior girder connections are examined and the highest stress range is observed at Floor-beam 12-1 to Girder D connection, with the maximum stress occurring at load case 3 and the minimum stress occurring at load case 15. Figure 5-9 shows the truck location of these two load cases.

**FIGURE 5-9: Truck Location for Load Cases 3 and 15**

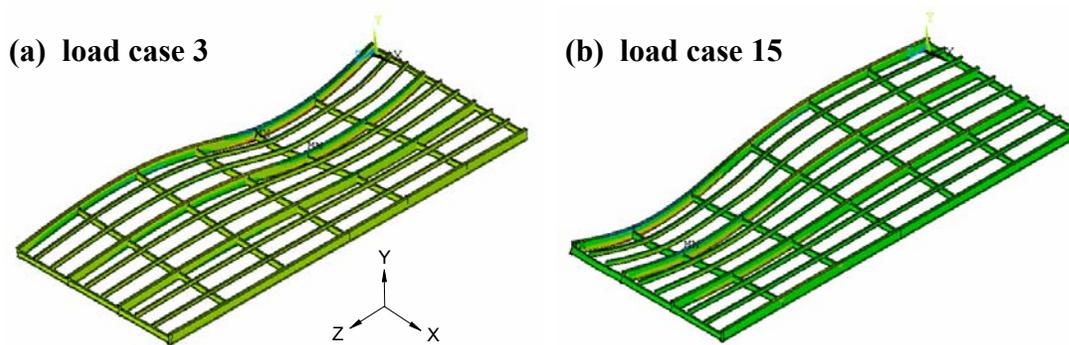
load case 3. The stress concentration is located at the floor-beam top flange to girder connection plate intersection, marked by point C in the figure. This is also the place where the out-of-plane fatigue cracking initiates in the actual bridge detail. Crack opening stress is in the vertical Y direction because the crack grows horizontally. For each load case, the extreme Y-stress occurring at point C could either be in tension, if the out-of-plane bending moment is negative at the floor-beam end; or in compression, if the out-of-plane bending moment is positive at the connection. The relative sliding between the haunch bottom surface and the girder (or stringer) top flange can also be observed from Figure 5-11.

**Figure 5-10 Deflection of steel members (deck elements are hidden)**

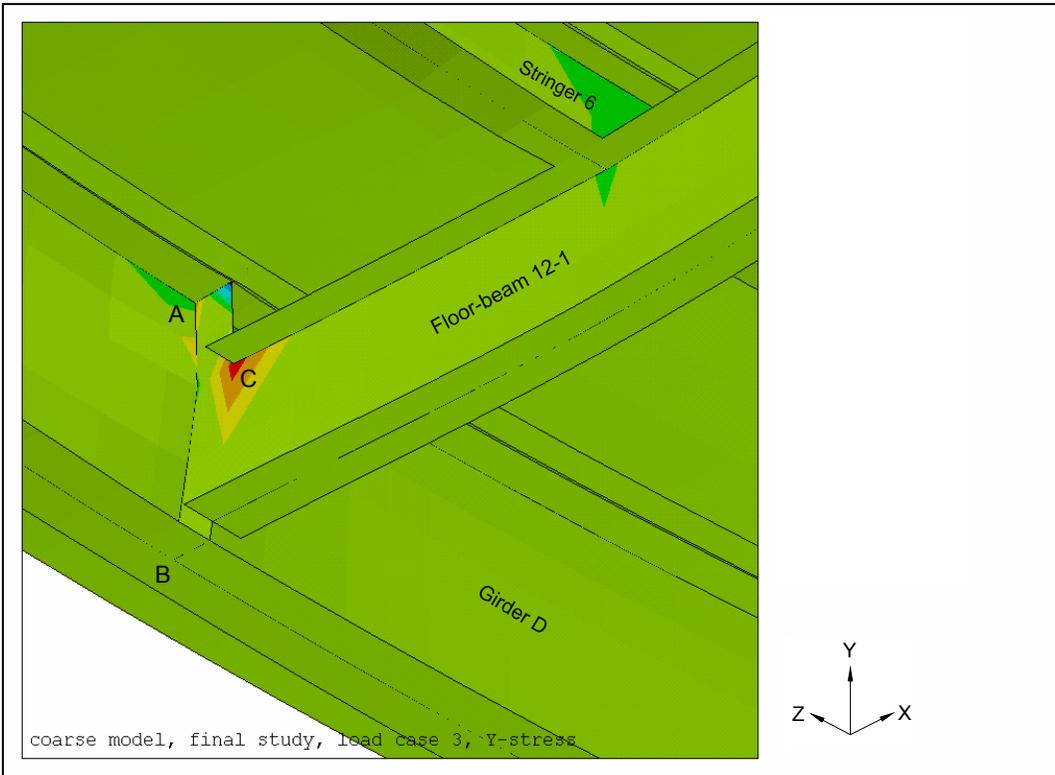
load case 3 for the specified locations of both the noncomposite and composite models. The bending stresses for the noncomposite case are -1.939 ksi at point A and 1.902 ksi at point B, which shows a symmetric stress distribution along the girder height. The bending stresses at the same girder section for the composite situation, however, are much lower, as can be predicted due to the interaction between the girder section and the deck slab. The top flange stress is 0.028 ksi at point A and the bottom flange stress is 1.371 ksi at point B. The neutral axis, therefore, lies above the steel section. Another big difference between the two models can be observed from the vertical girder deflection at this connection: 0.194 in. for the noncomposite condition, but only 0.076 in. for the composite condition. The in-plane flexural stiffness is increased significantly due to the bridge composite action. However, the performance caused by the out-of-plane distortion at this floor-beam to girder connection does not show much difference between the noncomposite and composite analysis results. The out-of-plane crack opening stress at point C is 3.783 ksi for the noncomposite model, and 3.294 ksi for the composite model. Only a small variation is observed. The same comparison procedure is then carried out to look at the results of other load cases and also at other floor-beam to girder connections. In most cases, the investigation shows a great difference between the noncomposite and composite results of the girder in-plane bending stress and vertical deflection. The out-of-plane bending stress, however, is not affected much by the composite or noncomposite action of this bridge.

**FIGURE 5-11: Stress Concentration Occurring at Floor-Beam 12-1 to Girder D Connection at Load Case 3 (viewed from underneath the bridge)**

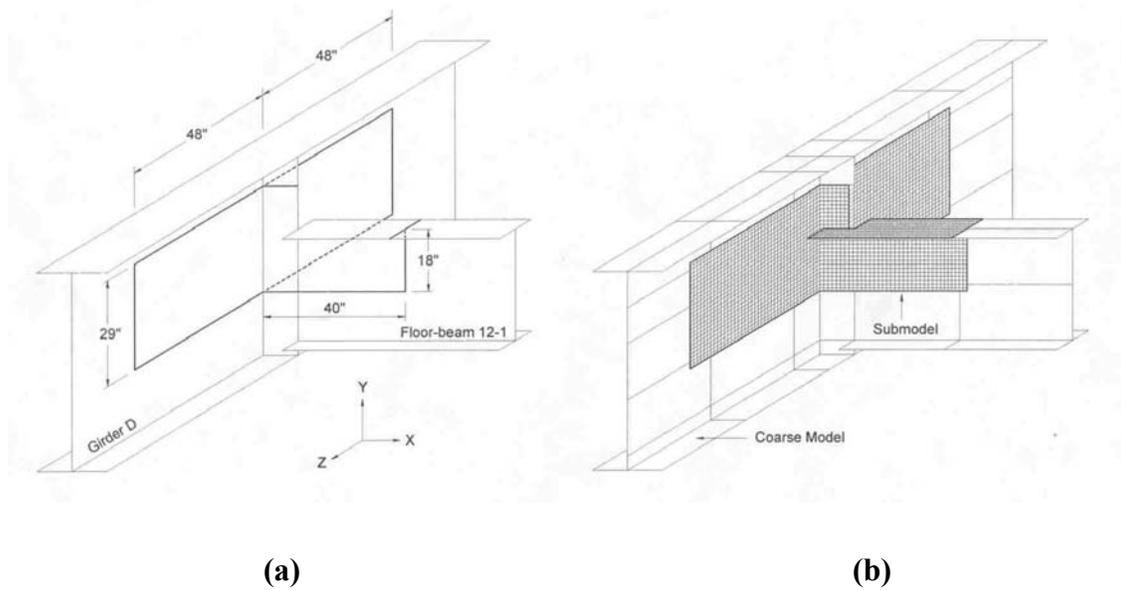
**FIGURE 5-12: Submodeling of the Crack Region**

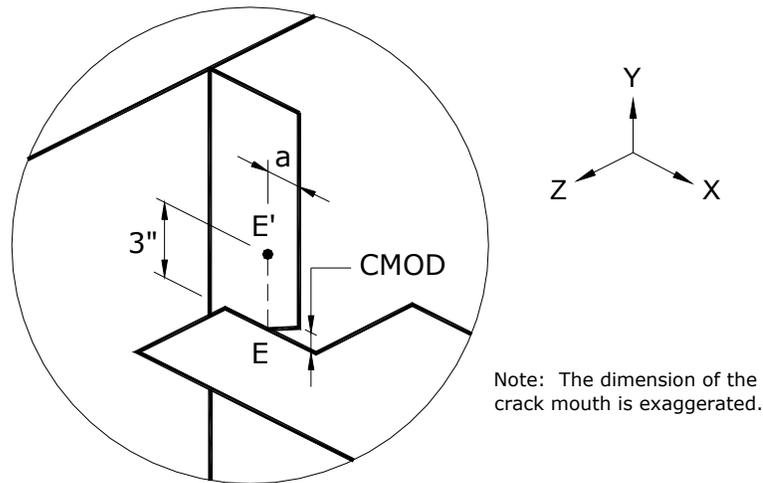
**FIGURE 5-16: Schematic Showing Locations for Normal Stress and CMOD Measurement**

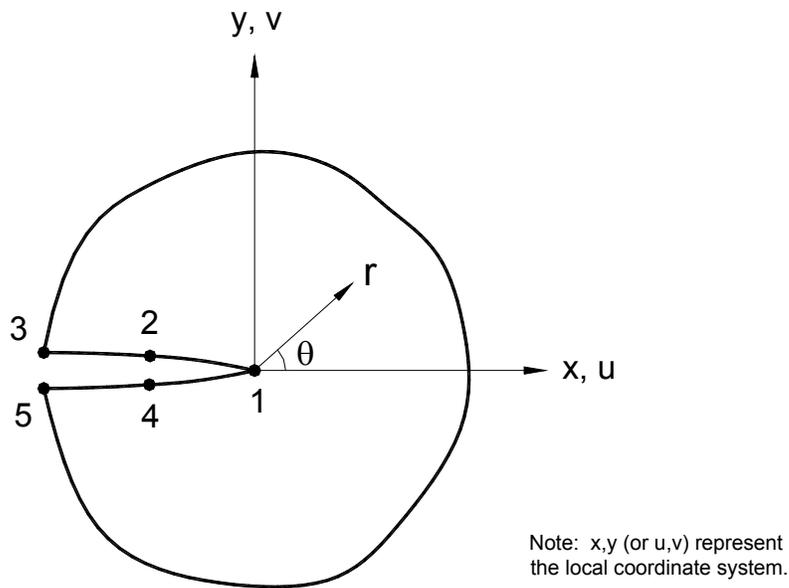
**FIGURE 5-17: ANSYS Typical Path Definition for a Full Crack Model**

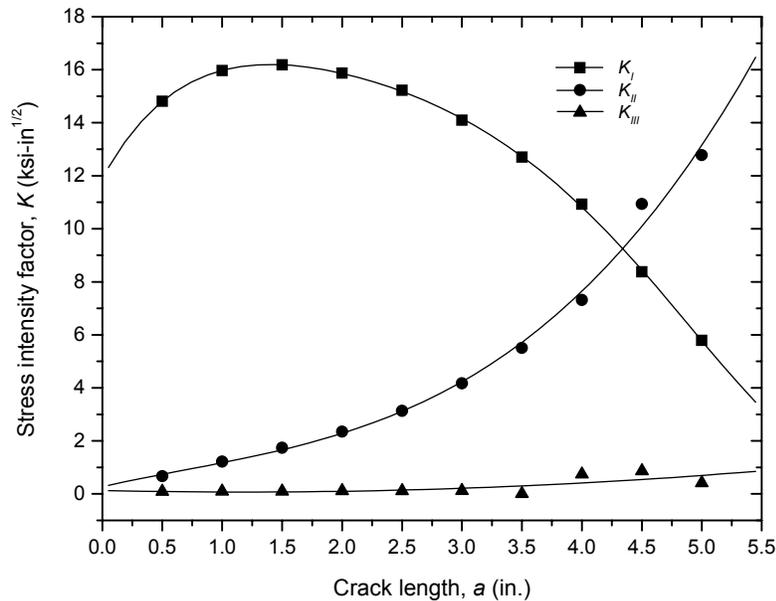
**FIGURE 5-19: ANSYS Stress Intensity Factor Results for Three Basic Crack Modes**

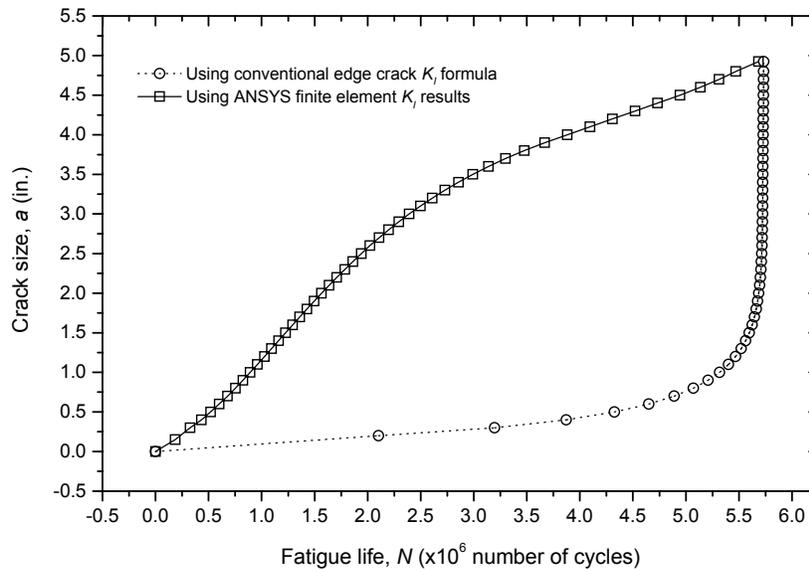
**FIGURE 5-23: Fatigue Crack Growth Curves Obtained by Using Different  $K_I$  Approaches**

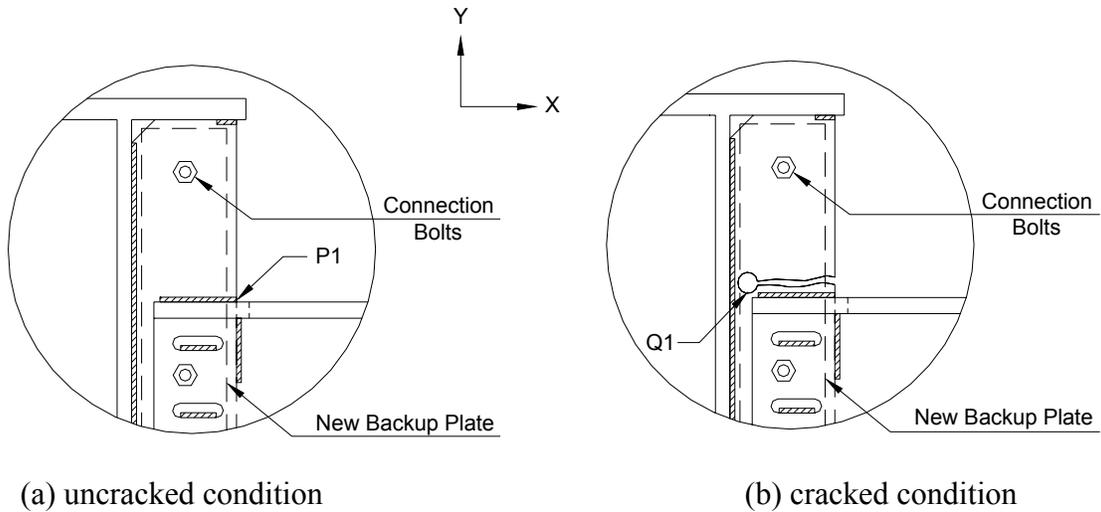
**FIGURE 5-25: Maximum Stress Range Locations for Repair Plan 1**

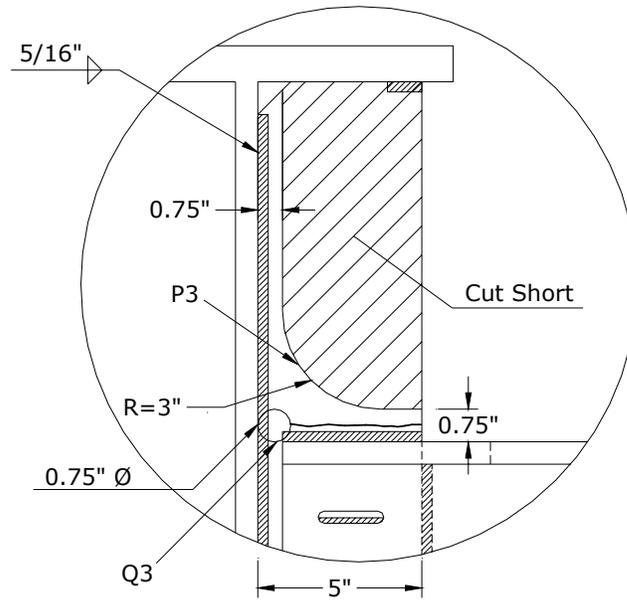
**FIGURE 5-27: Repair Plan 3: Cut Short Stiffener Partially and Drill Holes**

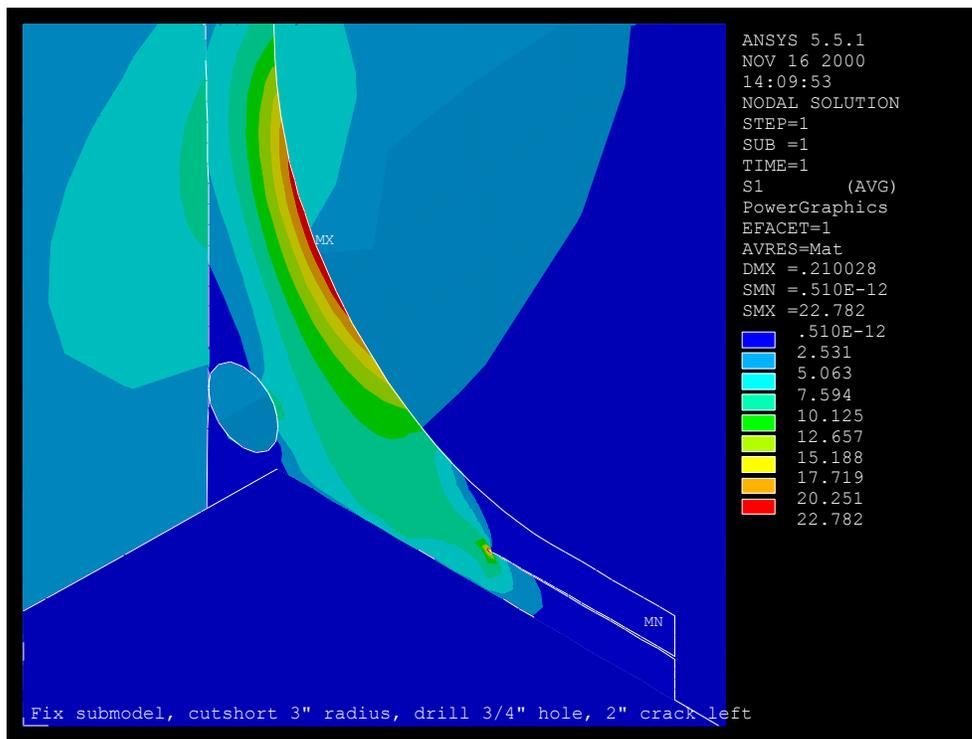
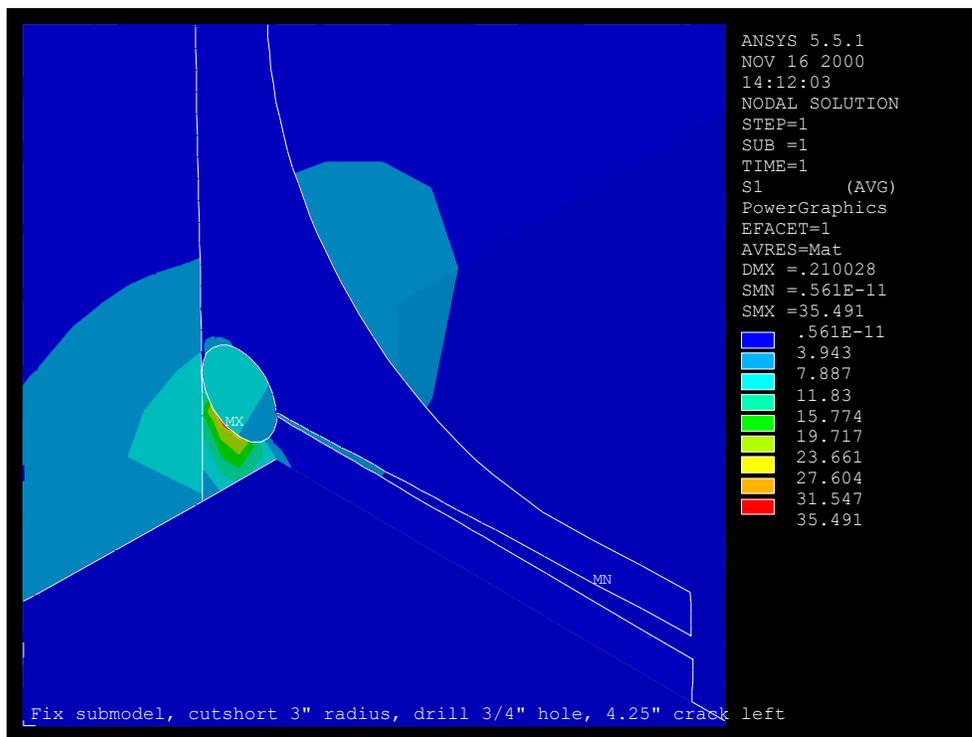
FIGURE 5-28: ANSYS Load Case 3, 1<sup>st</sup> Principal Stress Solution for Repair Plan 3

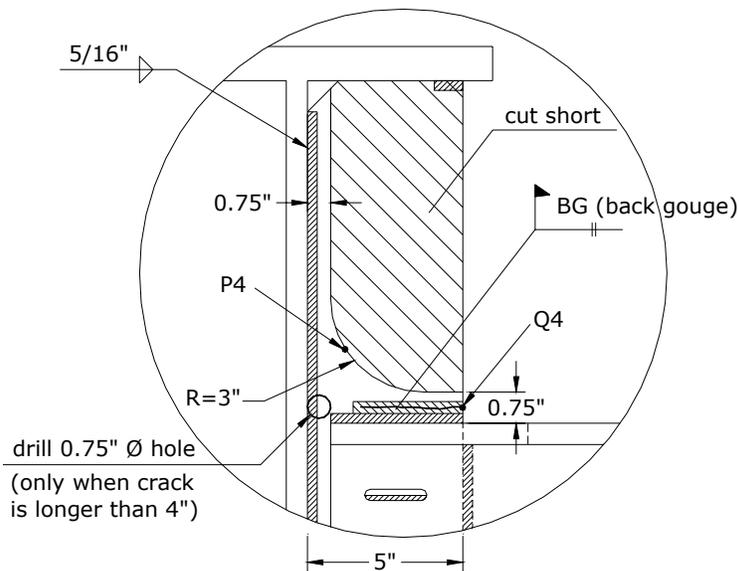
**FIGURE 5-29: Repair Plan 4: Cut Short Stiffener Partially and Re-weld the Crack**
