Report No. K-TRAN: KU-99-2  
FINAL REPORT

## **FATIGUE PRONE STEEL BRIDGE DETAILS: INVESTIGATION AND RECOMMENDED REPAIRS**

Yuan Zhao  
W. M. Kim Roddis

University of Kansas  
Lawrence, Kansas

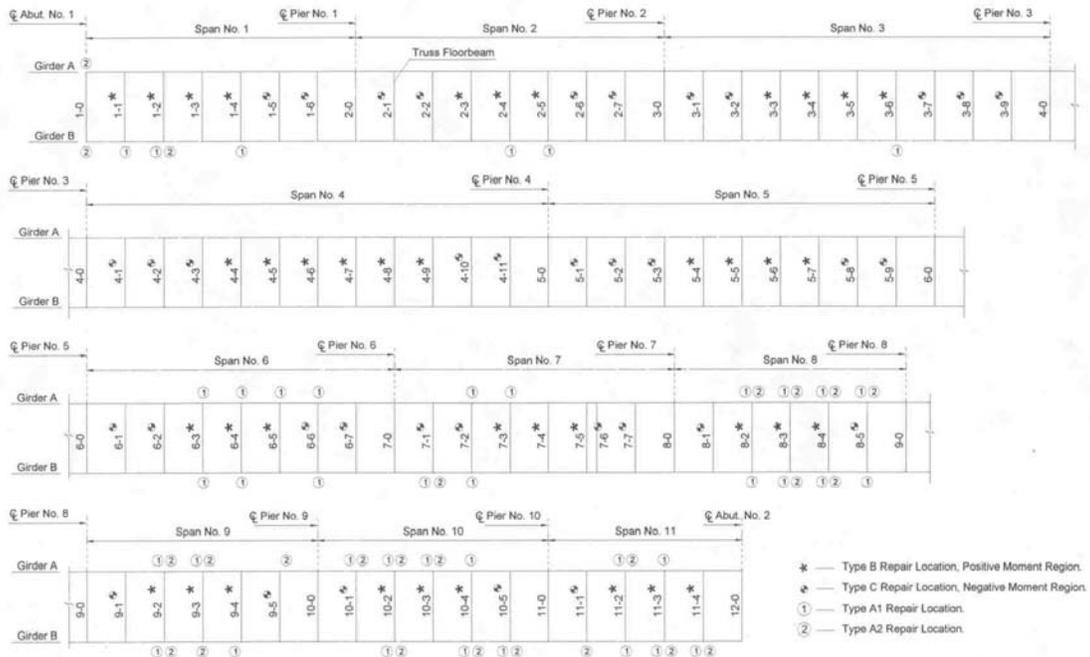
**FIGURE 6-1: Framing Plan and Retrofit Locations of the Westgate Bridge**

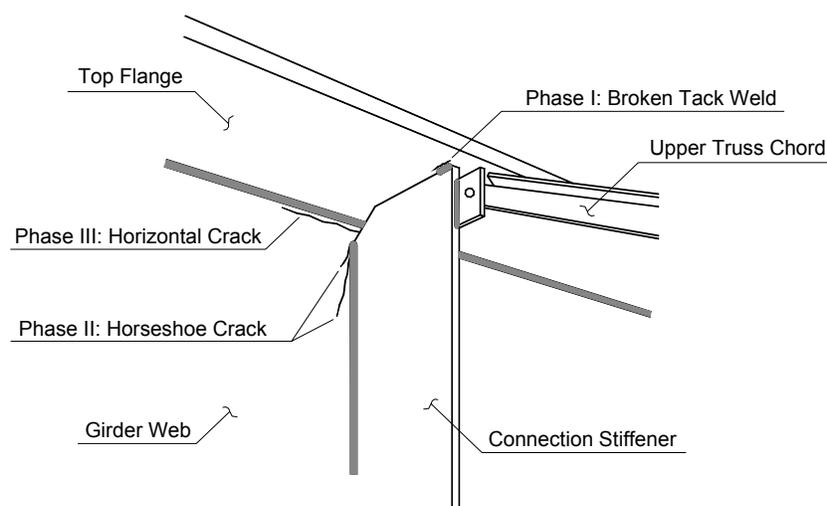
**FIGURE 6-3: Crack Growth Near the Girder Top Flange Connection**

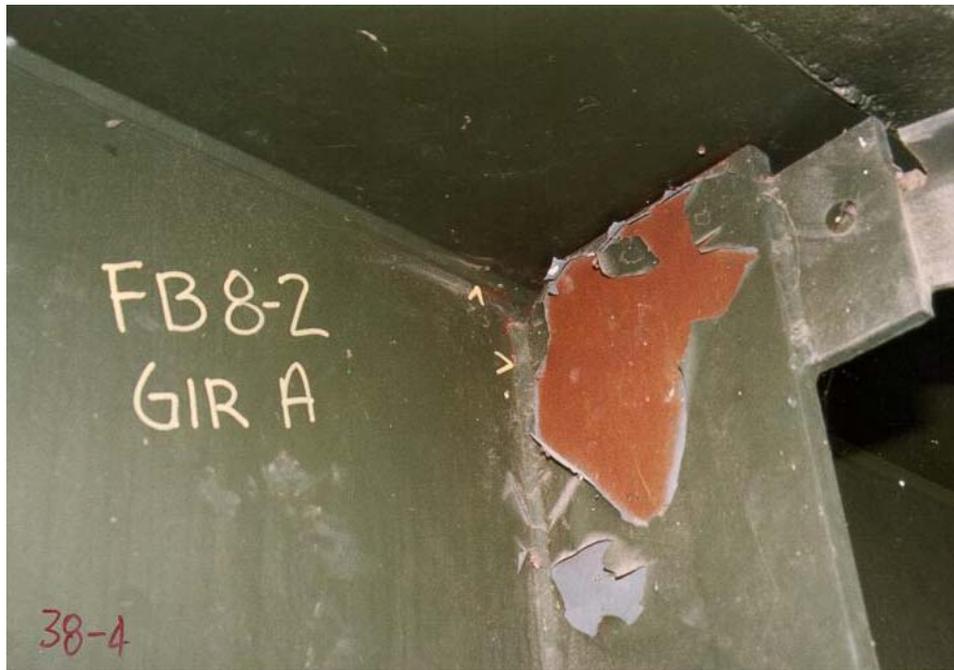
(a) horizontal and horseshoe cracks on the interior girder web side

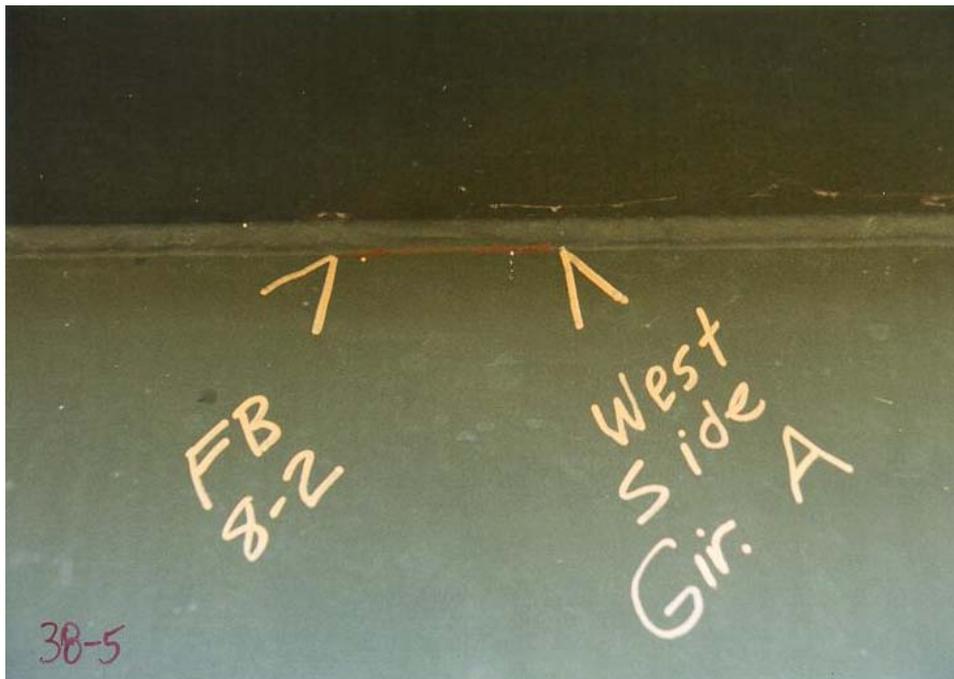
(b) horizontal crack on the exterior girder web side

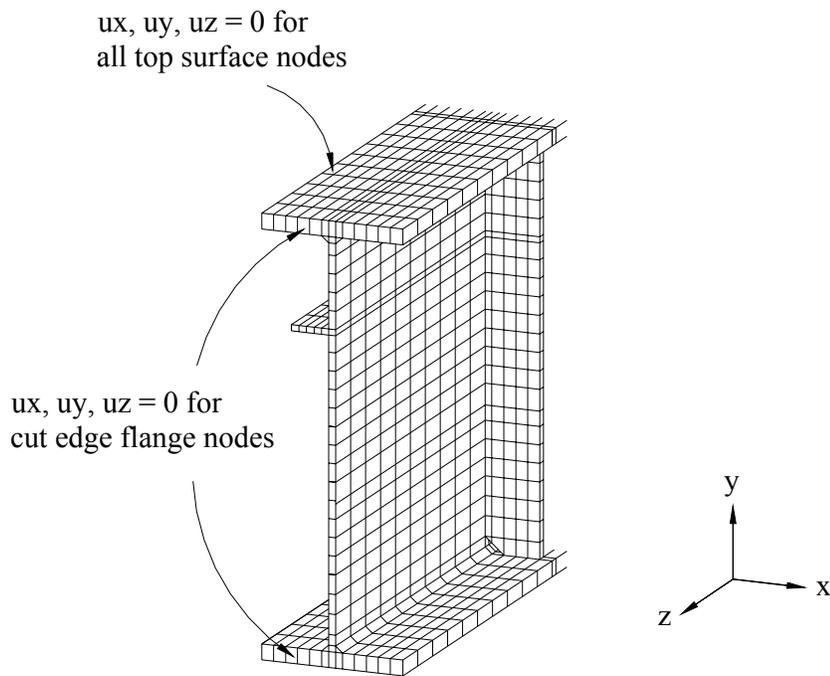
**FIGURE 6-7: Boundary Conditions for the Finite Element Model**

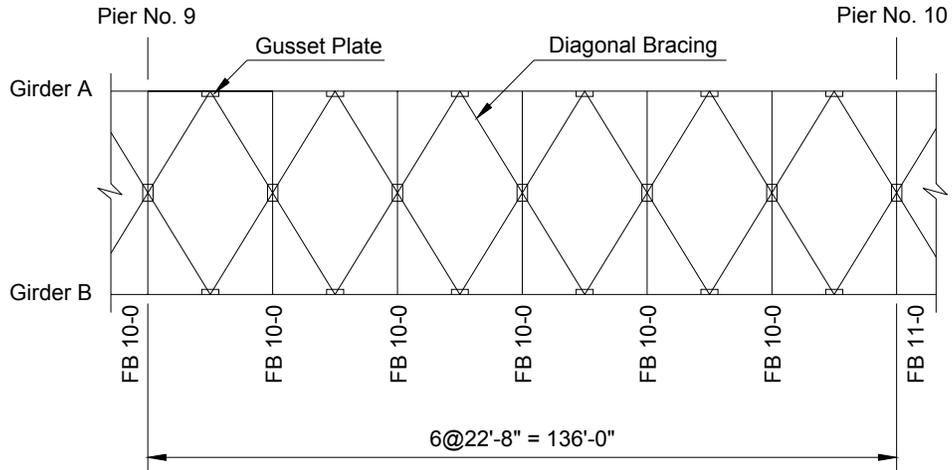
**FIGURE 6-8: Framing Plan for Diagonal Bracings in Span No. 10**

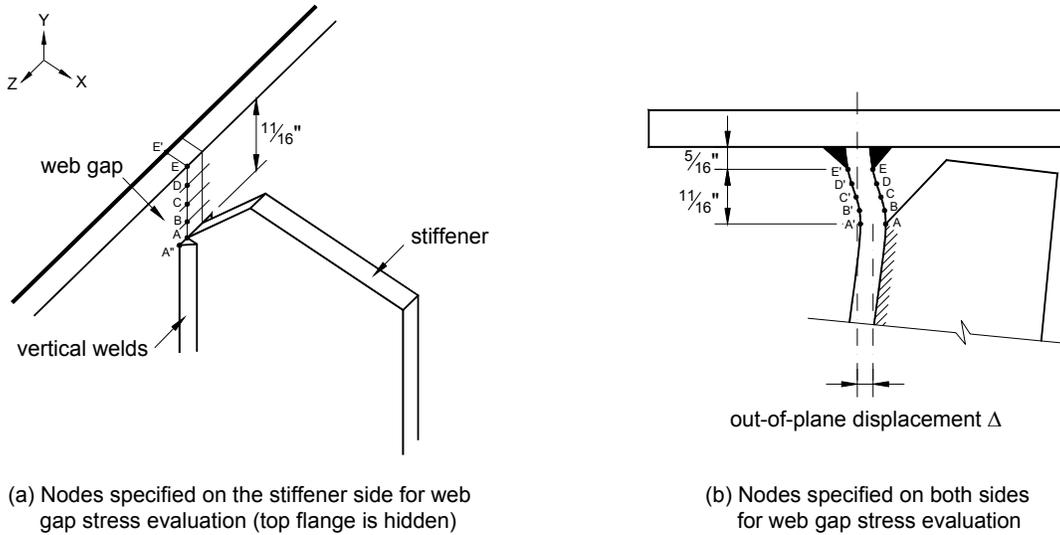
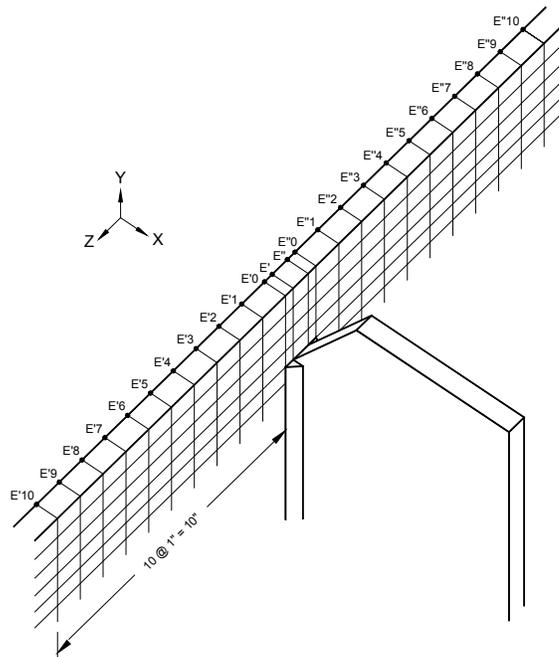
**FIGURE 6-11: Nodes in the Web Gap Specified for Stress Analysis**

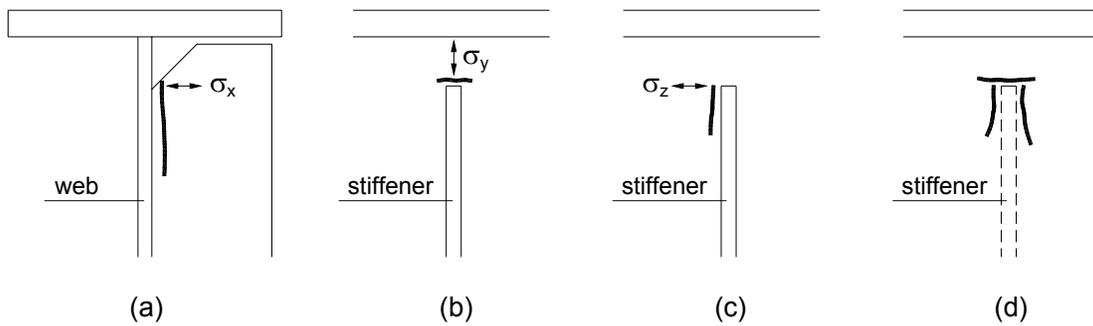
**FIGURE 6-14: Crack Formation Subject to Different Axial Stresses at the Stiffener End**

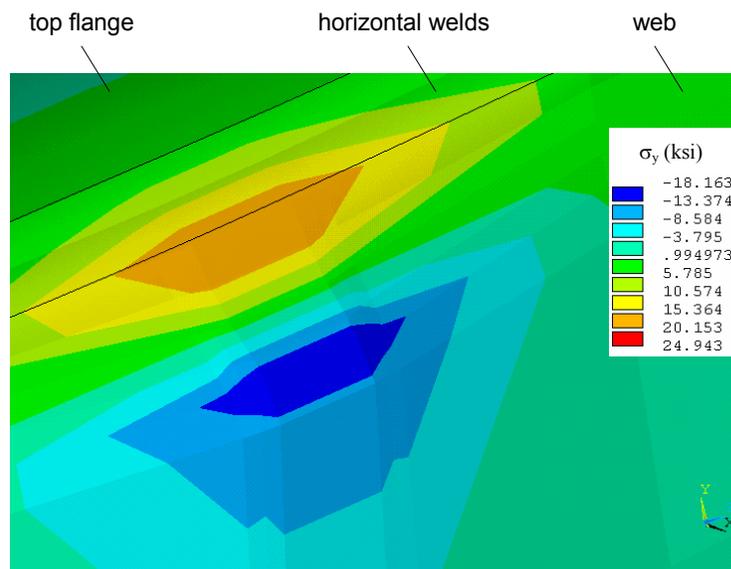
**FIGURE 6-15: Model FM1  $\sigma_y$  Contour of Load Case No. 7 on the Exterior Girder Face**

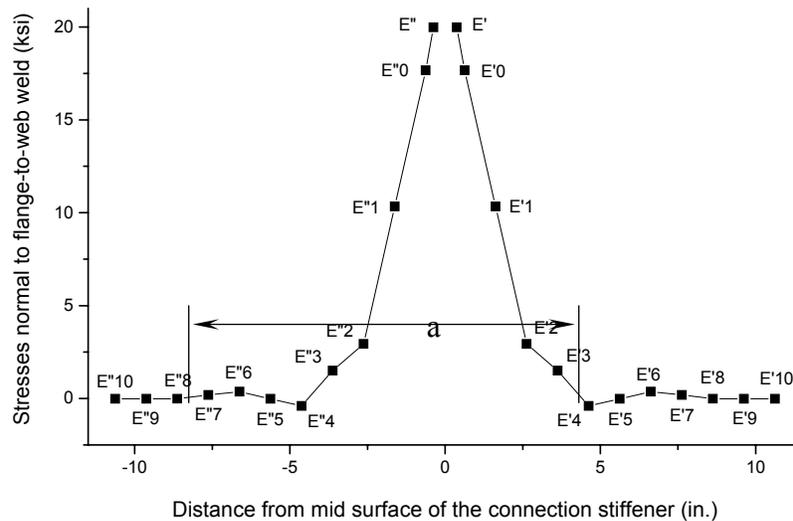
**FIGURE 6-17: Model FM1  $\sigma_y$  Distribution Along the Flange-to-Web Weld Toe at Load Case No.7**

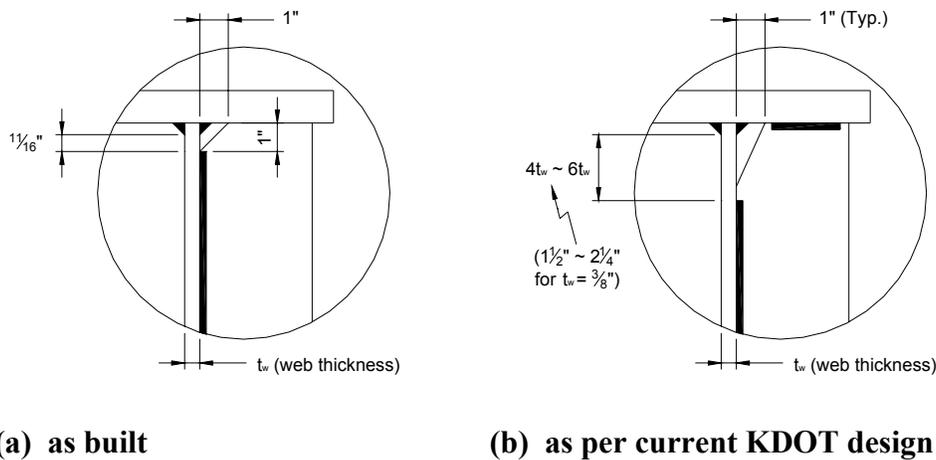
**FIGURE 6-18: Comparison of Web Gap Details Required by KDOT in the Earlier and Current Design**

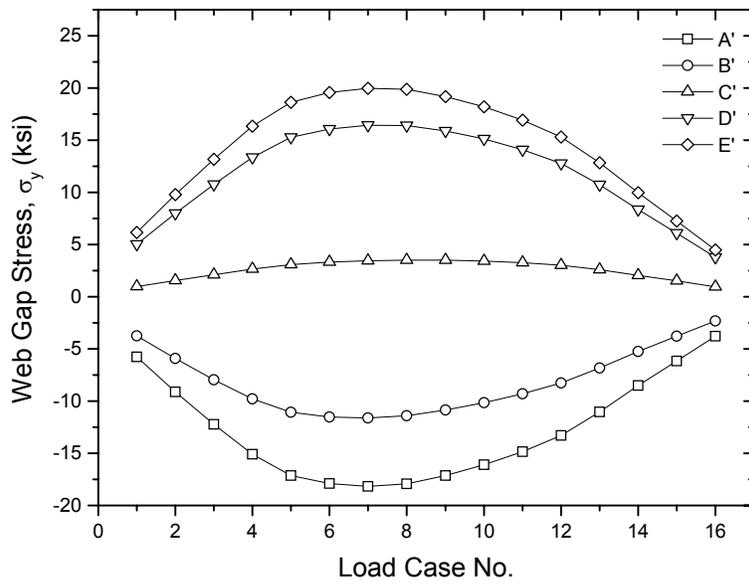
**FIGURE 6-21: Model FM1 Web Gap Stress Variation for Nodes on the Exterior Web Side**

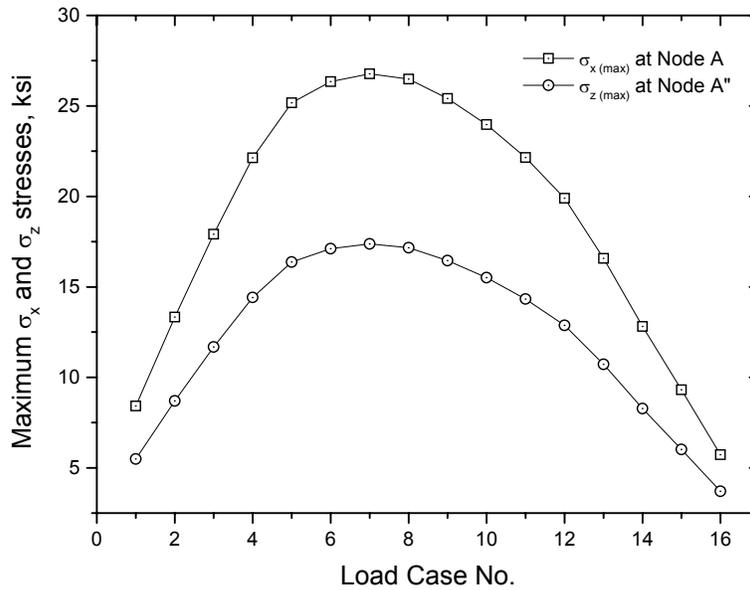
**FIGURE 6-22: Model FM1 Maximum  $\sigma_x$  and  $\sigma_z$  Stress Variation**

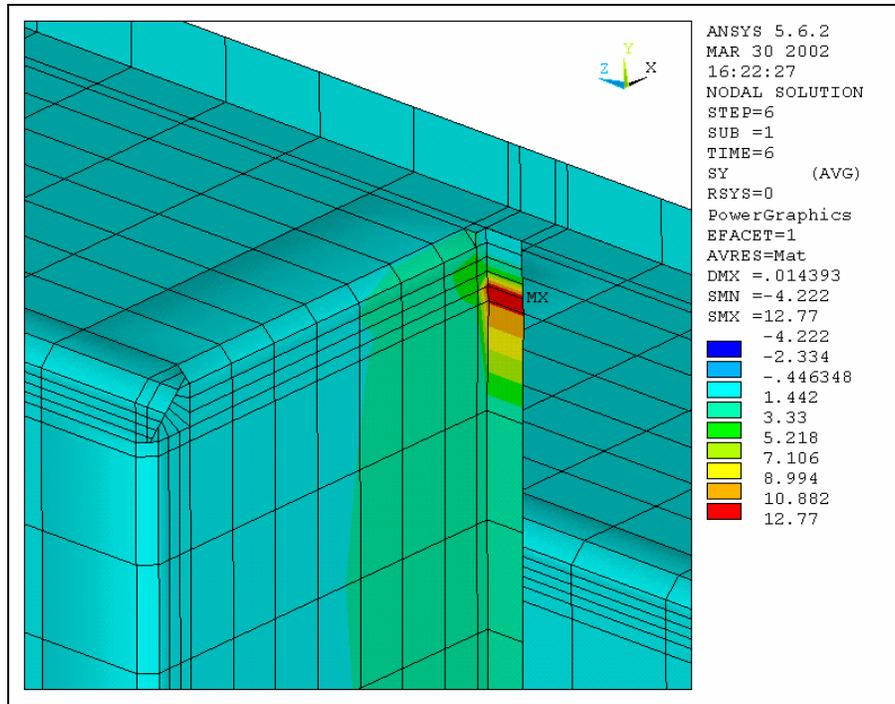
**Figure 6-25: ANSYS  $\sigma_y$  Stress Contour for Model FM1-w at Load Case No. 6**

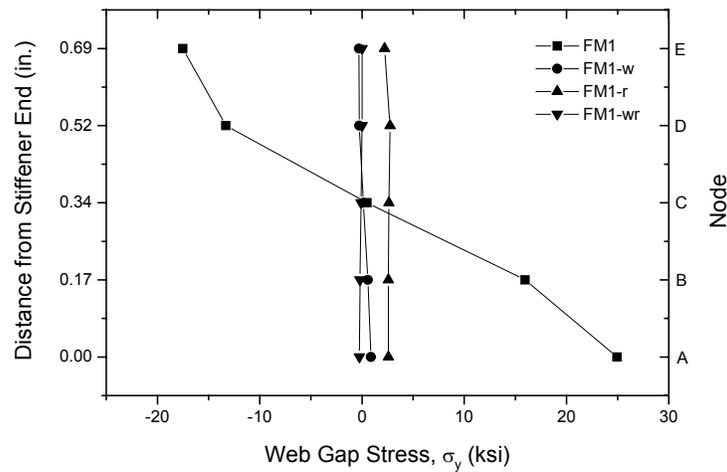
**FIGURE 6-26: Load Case No. 7 Web Gap Stress Gradient of FM1 Model Series on Interior Web Side**

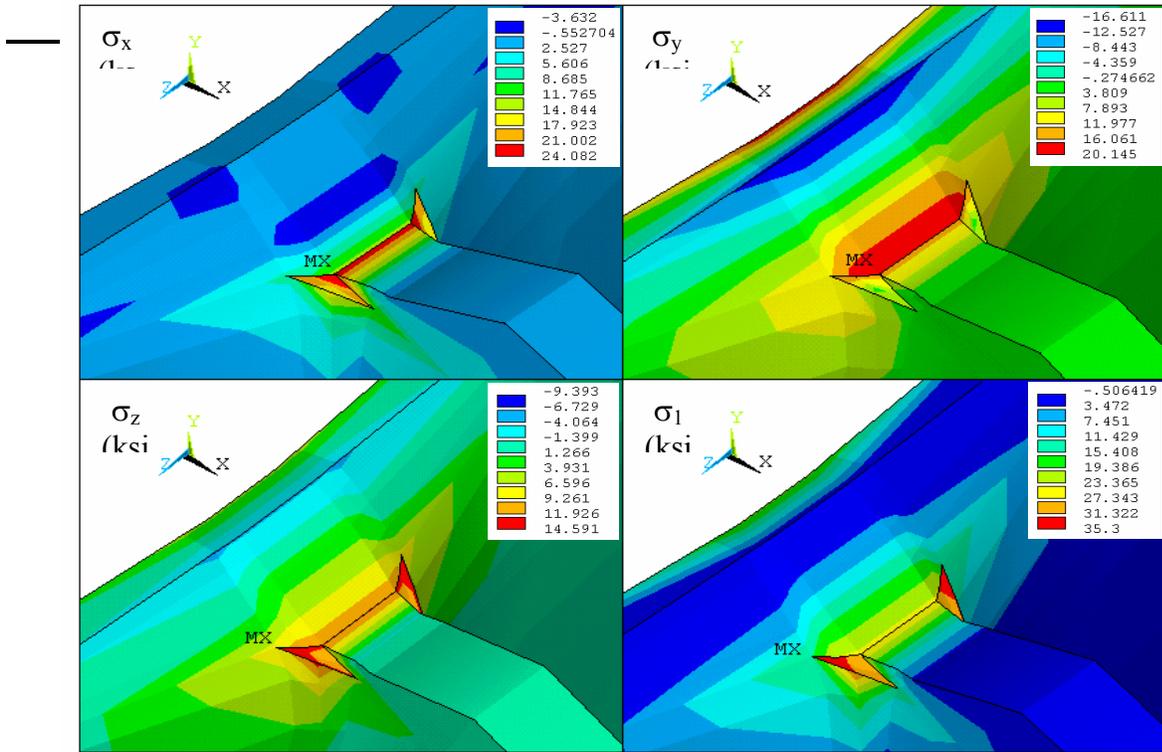
**FIGURE 6-30: Model FM3 Web Gap Stress Contours for Load Case No. 7**  
(flange elements are hidden)

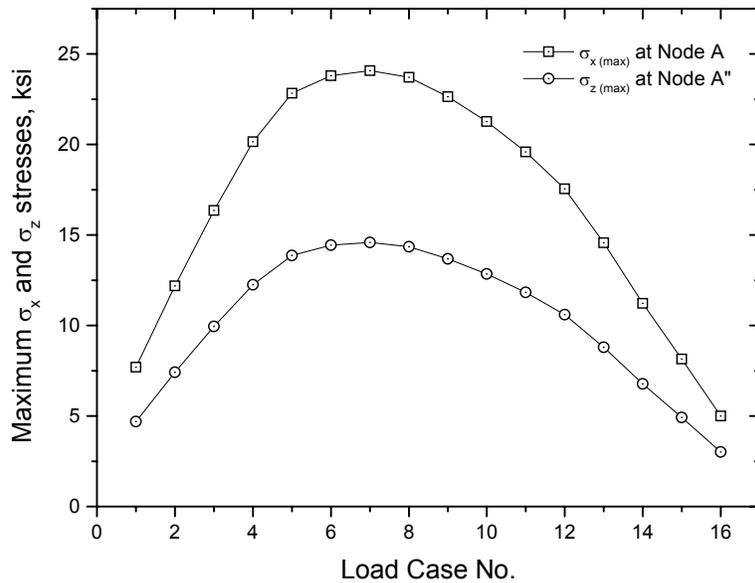
**FIGURE 6-35: Model FM3 Maximum  $\sigma_x$  and  $\sigma_z$  Stress Variation**
