**BRIDGE DECK CORNER CRACKING
ON SKEWED STRUCTURES**

Final Report to
Michigan Department of Transportation

RC-1490

September 2007

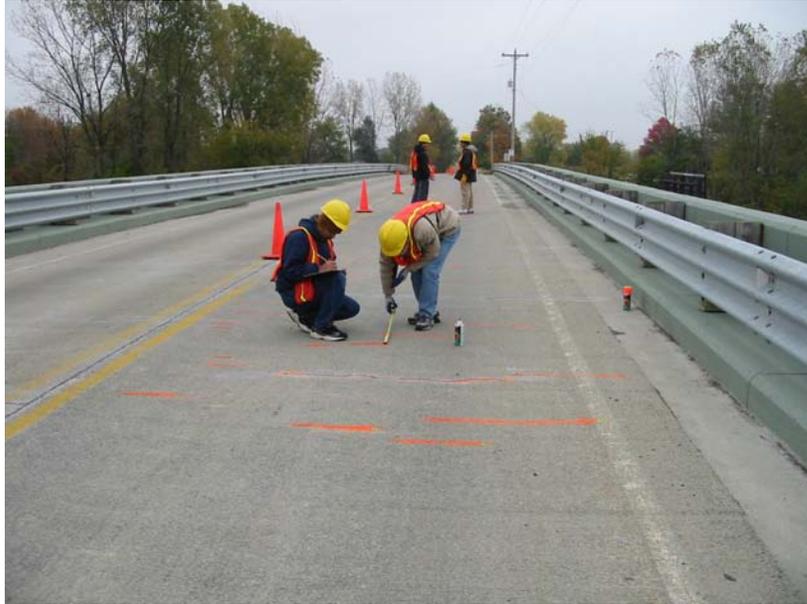
Figure I-1 Concrete Deck Cracking Highlighted Using Orange Paint
(S11 of 12033, Pearl Beach Road over I-96)

2) Relatively lower requirement for maintenance and thus longer service life without maintenance, compared with other common construction materials, such as timber and steel. 3) Acceptable cost-effectiveness. On the other hand, along with increasing experience with concrete, there has been a growing concern with concrete for bridge decks. It is its longevity adversely affected by cracking. Figure I-1 shows an example of such cracking in a concrete bridge deck in Michigan, where cracks were marked using orange paint for a quantitative survey.

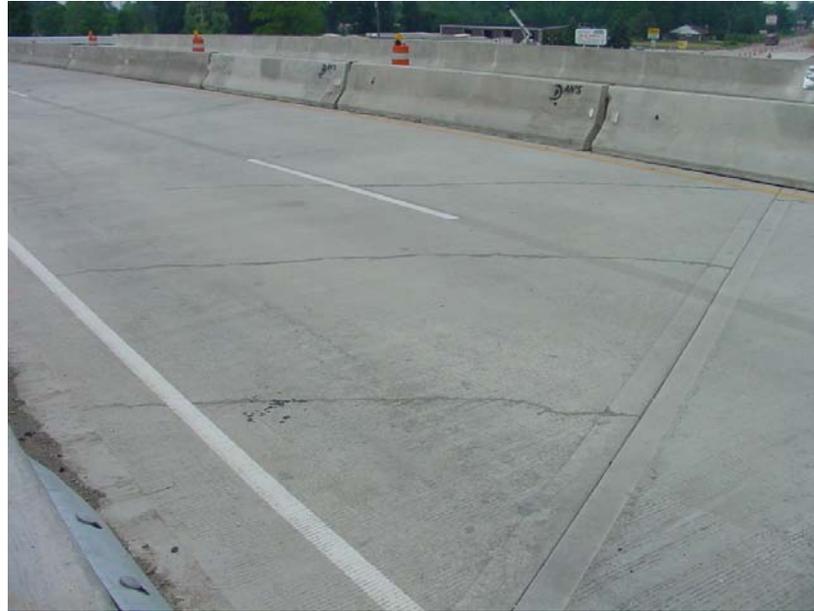
Figure I-2 Corner Cracking of Skewed Concrete Deck
(S10-4 of 77111, I-94 WB over Gratiot in St. Clair County)

In bridges with skew, such cracking has been seen more severe in the corner areas. Figure I-2 shows such cracks of a concrete deck in a bridge with a skew of about 29 degrees. These cracks typically start with a right angle to the deck edge that is along the direction of the supports (an abutment and/or a pier). This research project has a focus on this phenomenon, in order to increase the service life of the bridge deck and the entire structure the deck is supposed to protect.

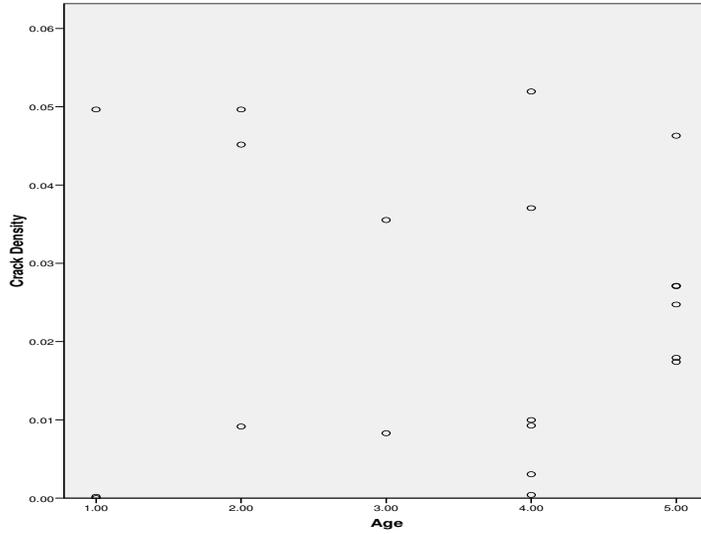
Figure III-24 Relation between Crack Density and Deck Age (yrs) for Skew Bridges

To examine relationships between the crack density and other possible causal factors, Figures III-24 to III-28 plot crack density versus a possible causal factor in each for the 20 skew decks. These factors are deck age, span length, slab thickness, skew angle, and aspect ratio. Inspection of these plots indicates, however, no noticeable statistical correlation between the crack density and any of these parameters.

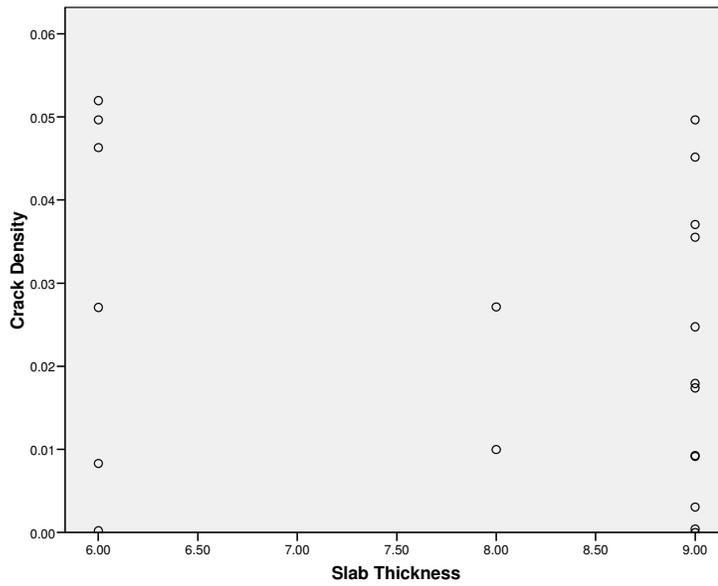
Figure III-25 Relation between Crack Density and Deck Slab Thickness (in.) for Skew Bridges

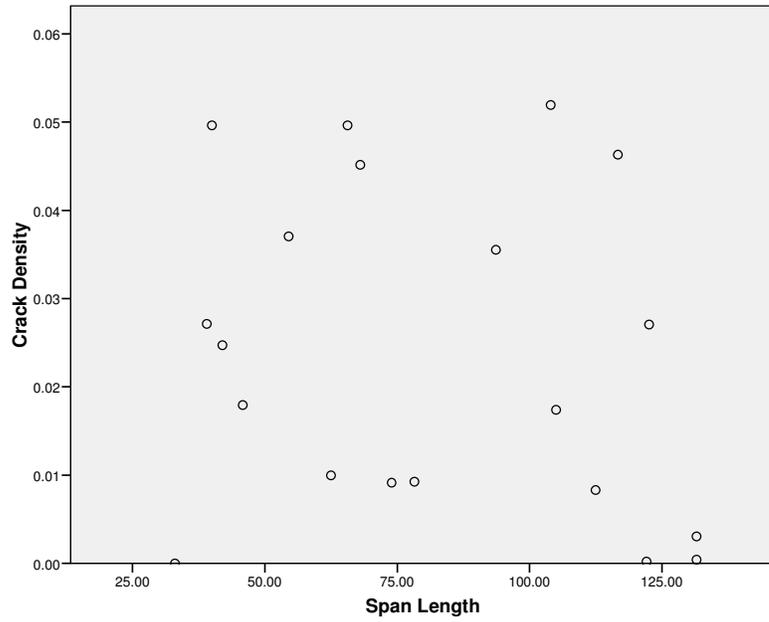
Figure III-26 Relation between Crack Density and Span Length for Skew Bridges

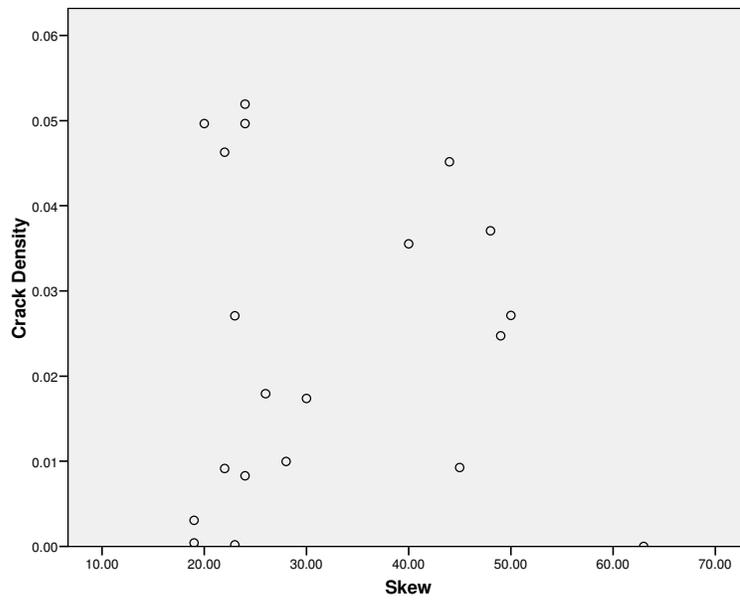
Figure III-27 Relation between Crack Density and Skew Angle (degree) for Skew Bridges

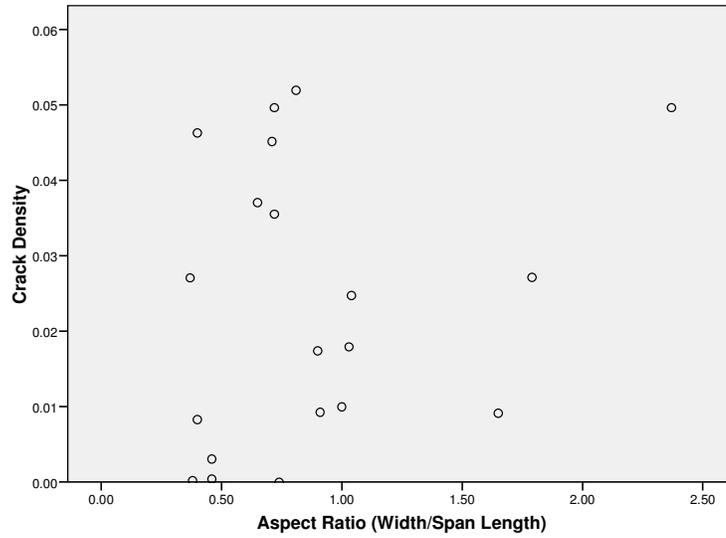
Figure III-28 Relation between Crack Density and Aspect Ratio for Skew Bridges

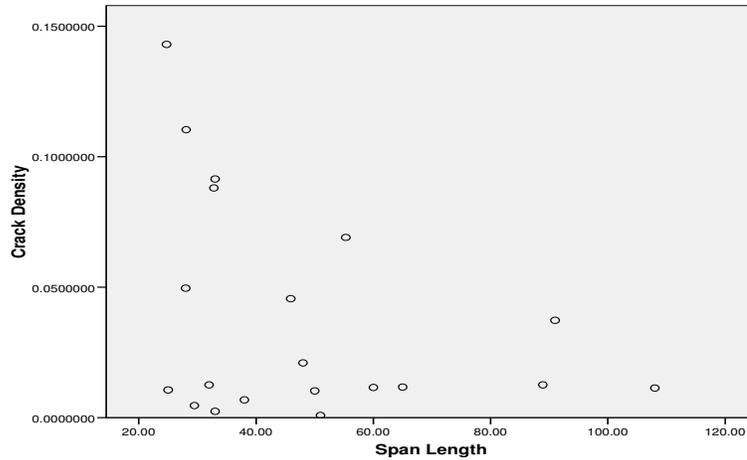
Figure III-31 Relation between Crack Density and Span Length for Straight Bridges

Figures III-29 to III-32 continues this examination for the 20 straight decks covered in this study. It appears that the same conclusion can be drawn, that no apparent correlation is observed between the crack density and any of the possible causal factors.

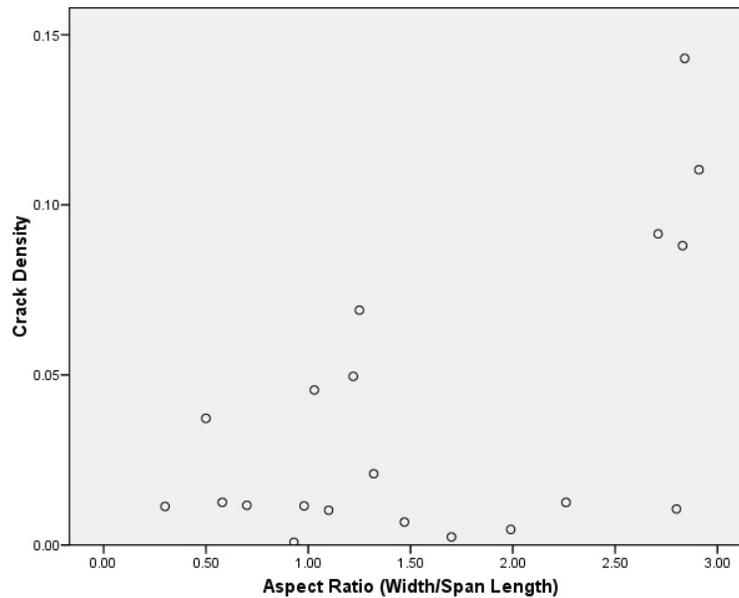
Figure III-32 Relation between Crack Density and Aspect Ratio for Straight Bridges

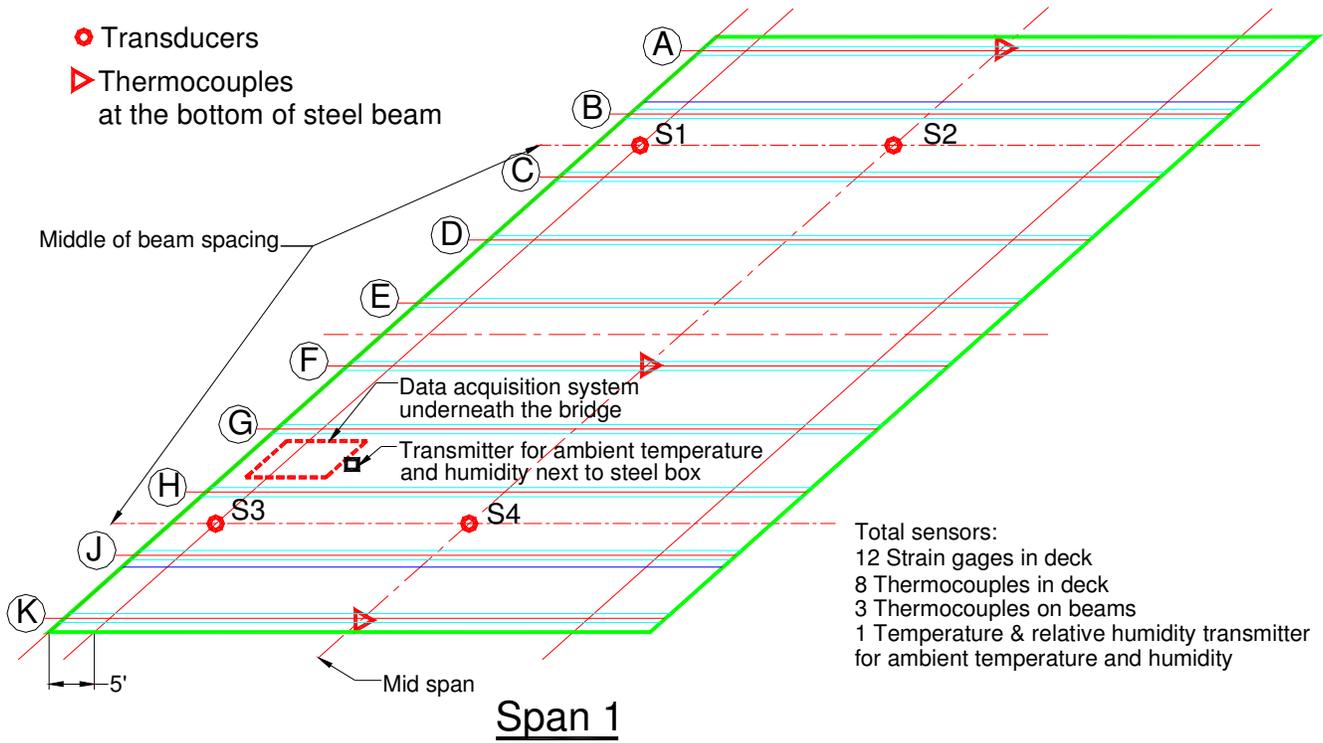
Figure IV-1 Grove Street Bridge (S02-81063) Deck Span 1 and Instrumentation

and M50 bridges hereafter in this report. Figures IV-1 and IV-2 show their deck planes, respectively.

Both the Grove Street and the M-50 bridges were instrumented with 12 separate strain gages in the concrete at four locations identified as S1, S2, S3, and S4 shown in Figures IV-1 and IV-2 respectively. Each of the four locations in the deck had three one-arm strain gages, one at the depth of the top reinforcement in the bridge's longitudinal direction, and the other two at the depth of the lower reinforcement in the longitudinal and transverse directions. Figure IV-3 includes a vertical cross section of the deck to show the detail of this arrangement. The strain gages and locations were selected to provide strain measurements for short and long term behaviors of the deck, as well as possible maximum strain response to truck wheel load.

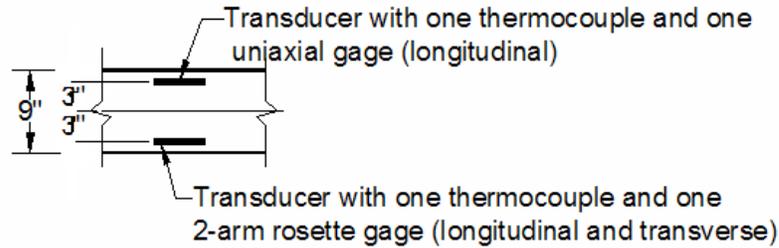
Figure IV-3 Strain Gage and Thermal Couple Depth Locations in Deck

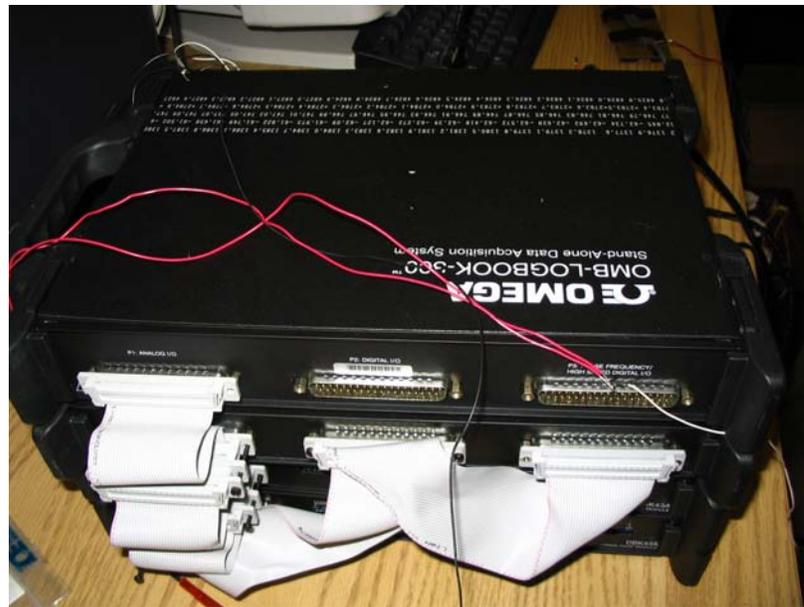
Figure IV-4 Omega Data Logbook System

Temperature, strain, and humidity data were collected for the first three days of concrete deck curing for the Grove Street structure and the M-50 structure. The Grove Street bridge deck was constructed in two phases, one traffic direction in each phase. Phase 1 included the East Bound half of the bridge, including sensor locations S3 and S4 shown in Figure IV-1. For Phase 2 of the bridge, we were able to continue data recording for about 21 days starting from concrete placement. The data were acquired using an Omega Log-book data acquisition system, as shown in Figure IV-4, powered by batteries.

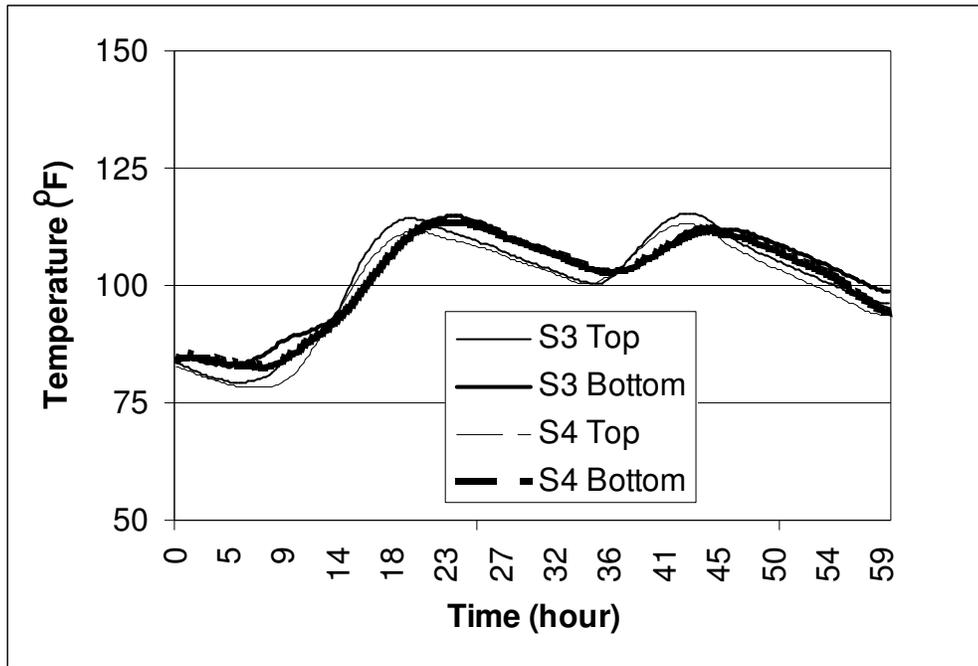
Figure IV-5 Temperature in Deck for Grove Street Bridge (Phase 1 Construction)

Figure IV-5 shows the temperature readings recorded using the thermocouples in the deck and Figure IV-6 for the transducers for the environment condition. Those temperatures marked as S3 and S4 are thermocouples embedded in the concrete deck at the respective locations indicated in Figure IV-1. At each location, two temperature curves are shown, one for the thermal couple at the top- and the other at the bottom-reinforcement level. The other two temperature records in Figure IV-6 were obtained from a thermocouple attached to an exterior beam on the East Bound side and the temperature transmitter underneath the deck near the abutment, also shown in Figure IV-1. Figure IV-7 exhibits the relative humidity readings underneath the bridge deck for the ambient humidity condition.

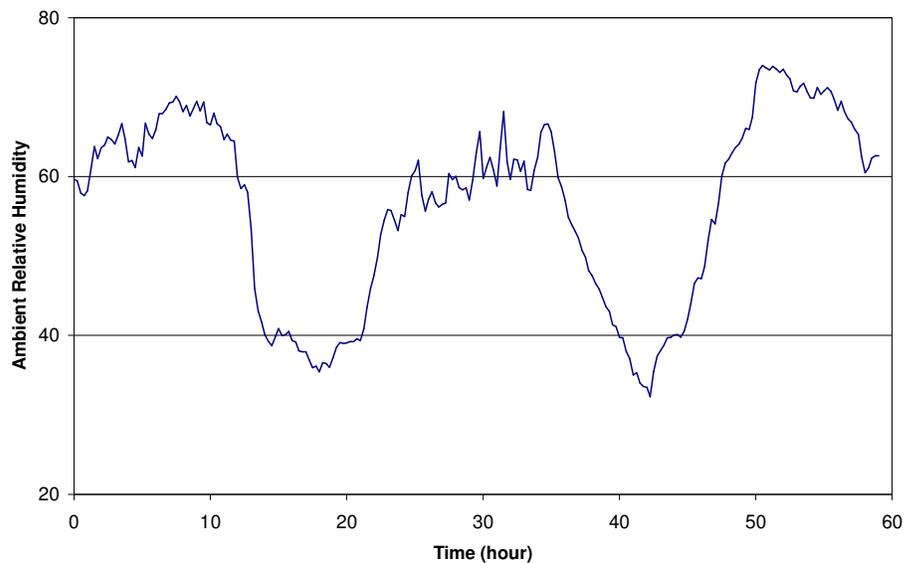
Figure IV-7 Environment Humidity for Grove Street Bridge (Phase 1 Construction)

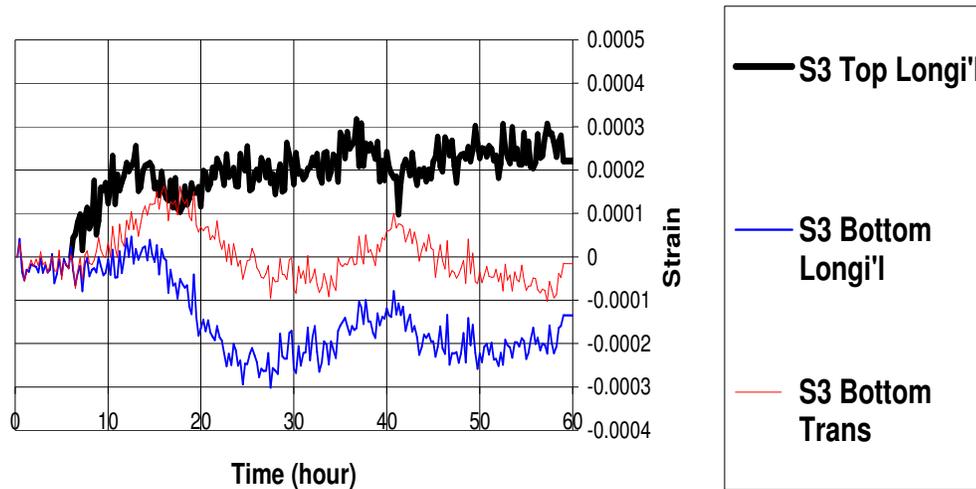
Figure IV-8 Strains at S3 Location in Grove Street Bridge Deck (Phase 1 Construction)

Figure IV-8 shows the concrete strains recorded through the strain gages at location S3 in the deck, for the same time period in Figures IV-5 to IV-7. They appear to follow the daily cycle as well, but not as clearly seen as for the temperatures. The strain gages near the deck bottom surface show a clearer daily cycle than the one near the top surface. The maximum strain for this time period is about ± 300 microstrains.

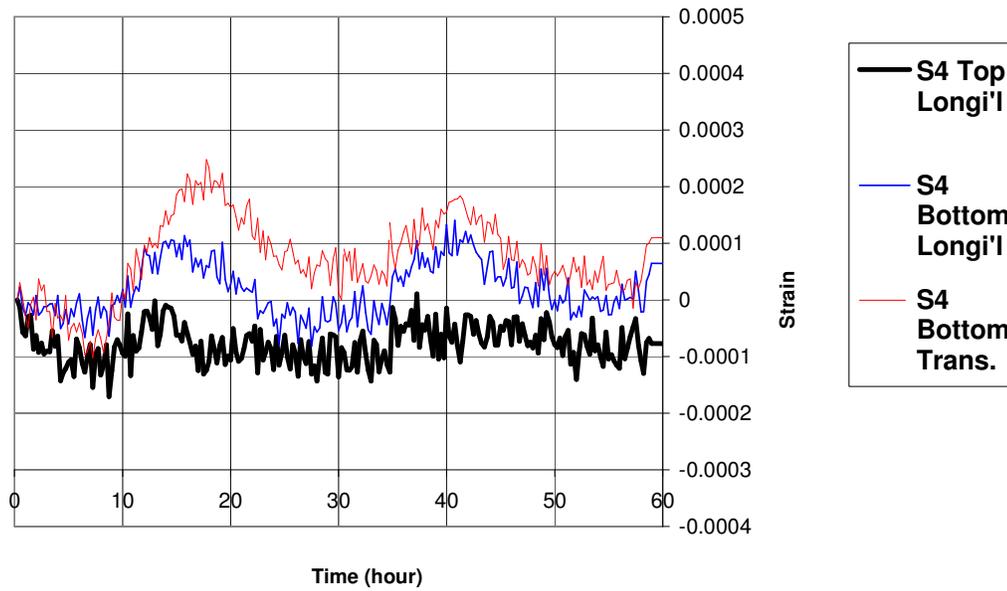
Figure IV-9 Strains at S4 Location in Grove Street Bridge Deck (Phase 1 Construction)

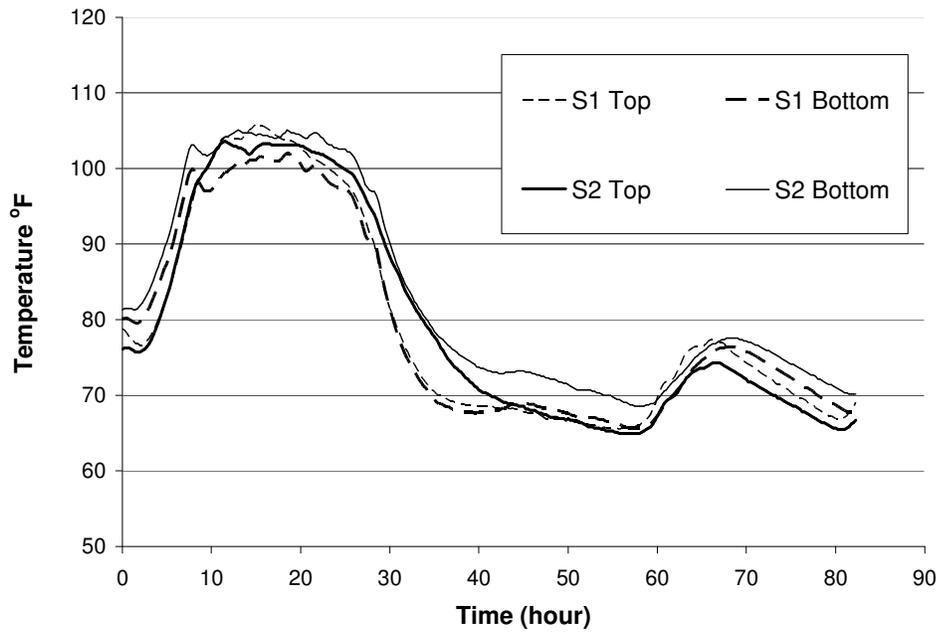
Figure IV-10 Temperature in Deck for M-50 Bridge (Locations S1 and S2)

Figures IV-10 to IV-13 show the temperature and humidity readings for the M50 bridge deck for the first 3 to 4 days. Except the humidity in Figure IV-13, they are grouped in three figures for S1 and S2, S3 and S4, and the environmental locations, respectively. The internal thermal couples at S1 to S4 locations appear to show little cyclic behavior due to the environment, and the external temperature readings exhibit some cyclic behavior largely due to weather. It appears that this deck's hydration process is dominant for the temperature observed, so that the daily cycling in temperature is not clearly seen.

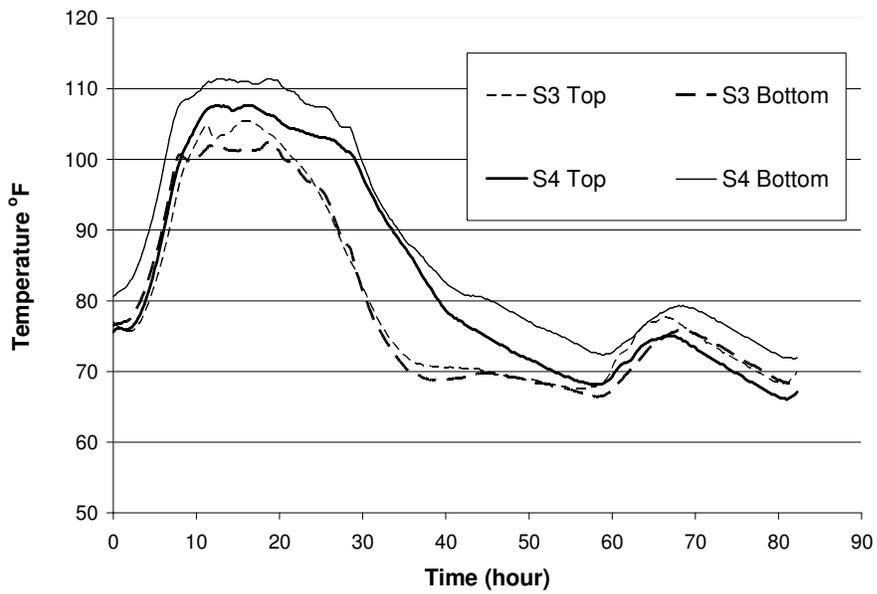
Figure IV-11 Temperature in Deck for M-50 Bridge (Locations S3 and S4)

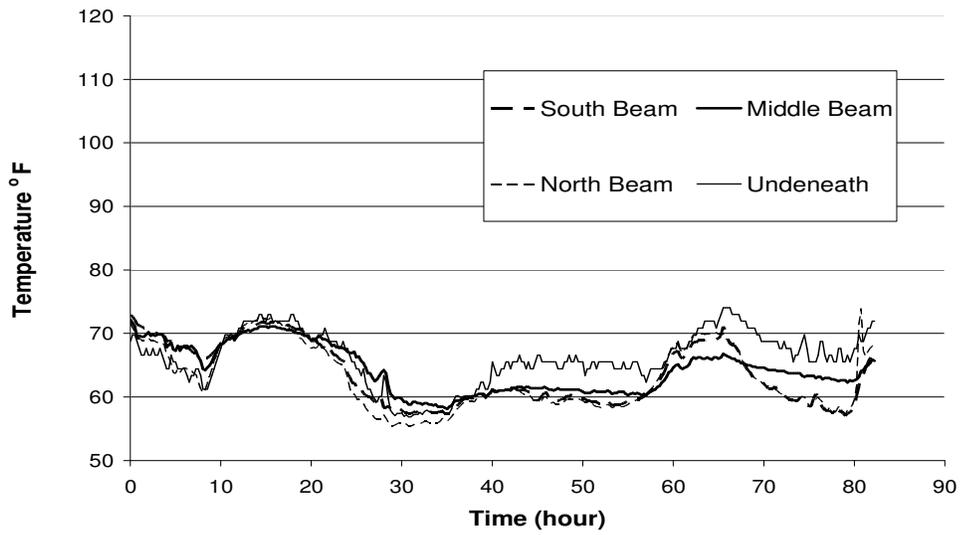
Figure IV-12 Environment Temperature for M-50 Bridge

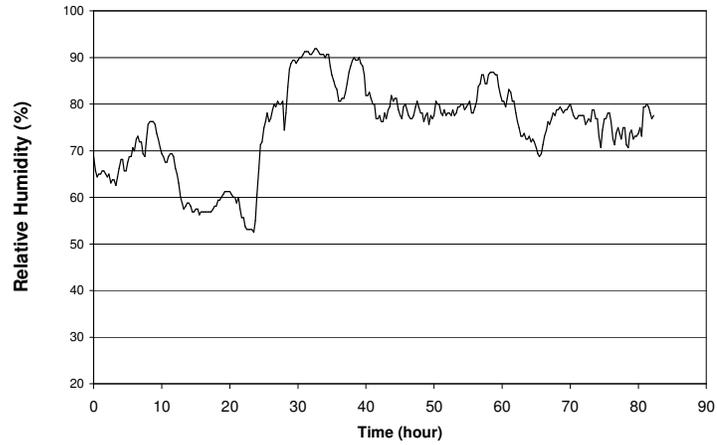
Figure IV-13 Environment Humidity for M-50 Bridge

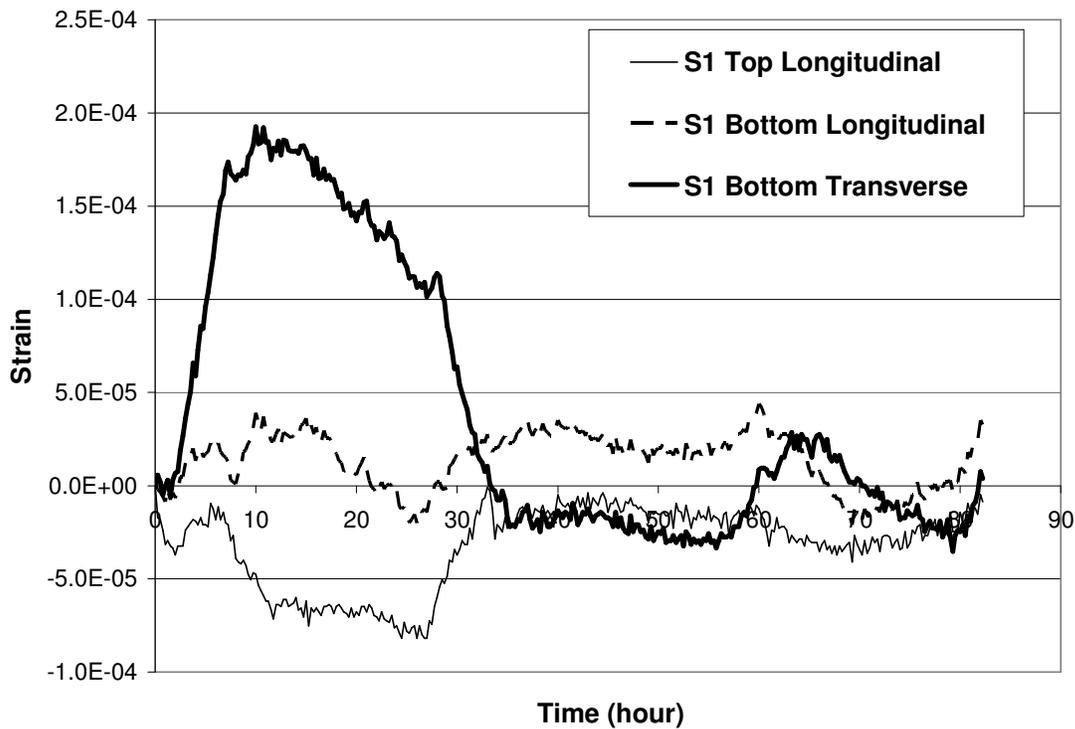
Figure IV-14 Strains at S1 Location in M-50 Bridge Deck

Figures IV-14 to 17 shows the strain readings at the M-50 bridge deck using the strain transducers at locations S1 through S4, respectively. The maximum strains in the M-50 bridge deck are similar to those seen for the Grove Street Bridge, consistent with the temperature readings shown in Figures IV-10 to 12, the strains mainly due to hydration largely reduced at approximately 30 to 35 hours of the deck age.

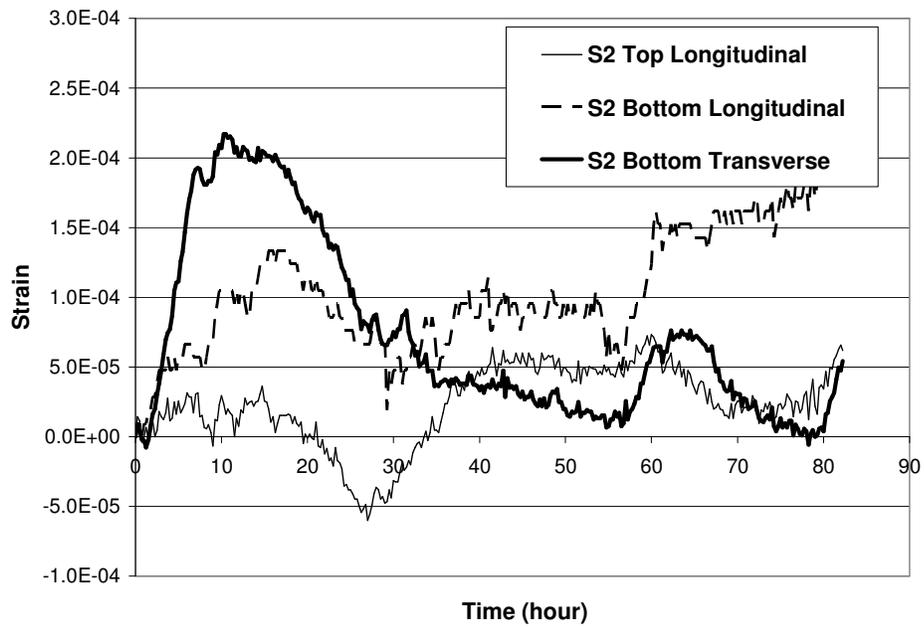
Figure IV-15 Strains at S1 Location in M-50 Bridge Deck

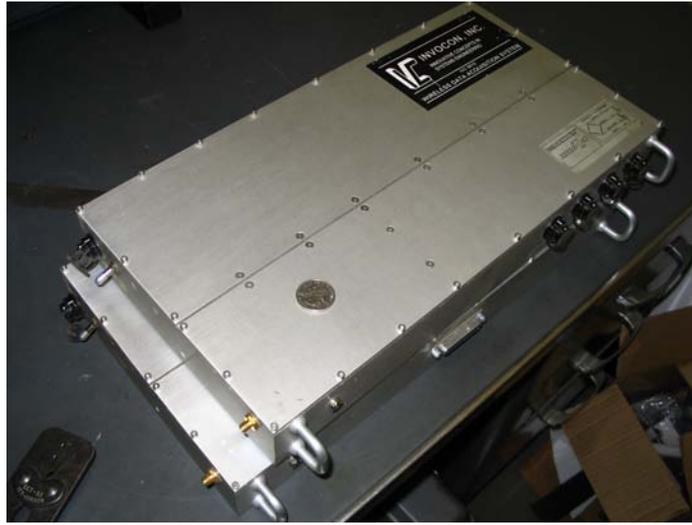
Figure IV-18 Radio-based Invocon Strain Data Acquisition System

The truck load-induced strains were recorded using an Invocon wireless data acquisition system, as shown in Figure IV-18. The reason for the use of this system for load-induced strains is that the Invocon system offers a much higher resolution although its memory capacity is much smaller and not suitable for long-term data acquisition.

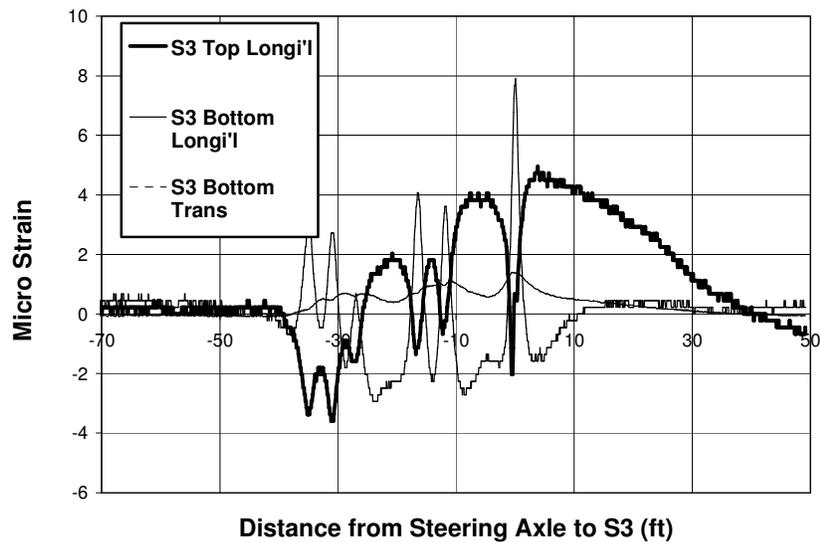
Figure IV-20 Strains at S3 Location in Grove Street Bridge due to Truck Load

Each of these strain curves in Figures IV-20 and 21 shows accordingly six peaks corresponding to the wheels going over the gage in the backward movement for this case. All the gages did not experience much strain, not more than 15 microstrains. Note again that these results were obtained using a data acquisition system with wireless (radio wave) transmission capability. The system records very low noise and is able to pick up small signals as shown.

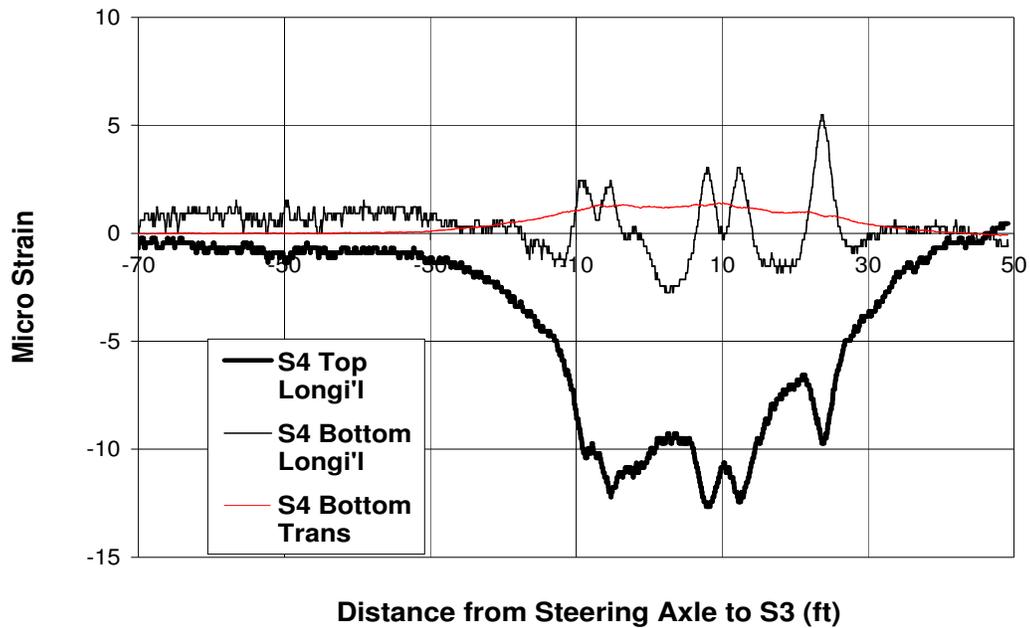
Figure IV-21 Strains at S4 Location in Grove Street Bridge due to Truck Load

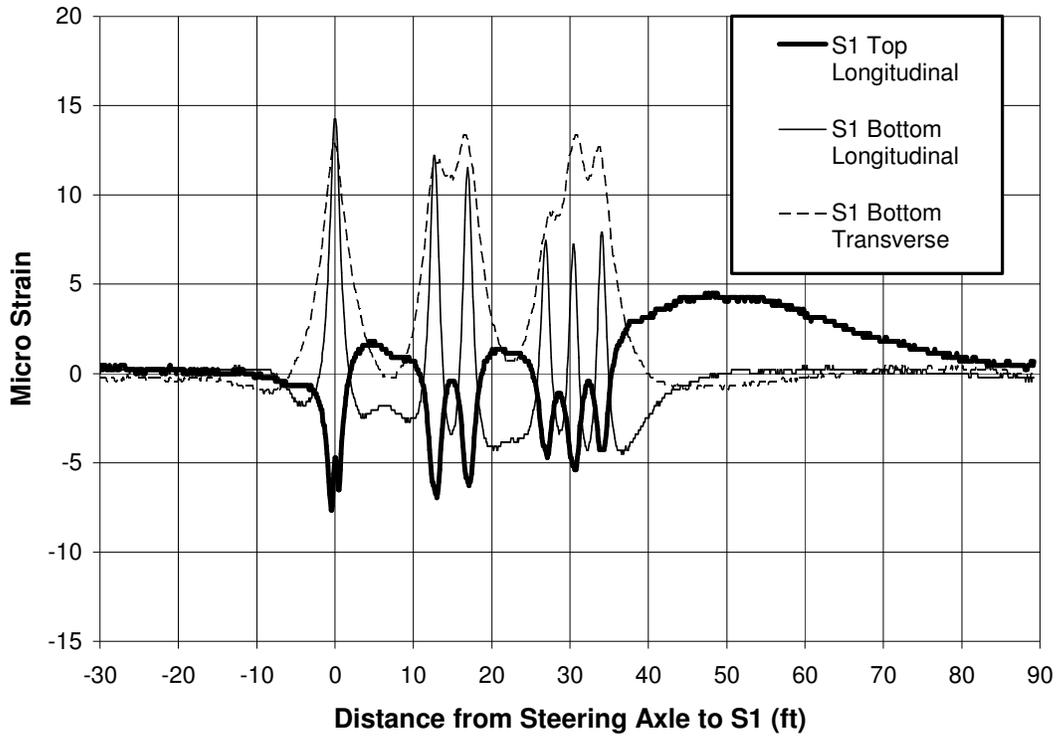
Figure IV-22 Strains at S1 Location in Grove Street Bridge due to Truck Load

For the other half of the deck constructed in Phase 2 about a month later, a different 6-axle truck was used to apply load. The axle weights were 18,000, 16,000, 16,000, 13,000, 13,000, and 13,000 lbs, and the axle spacings were correspondingly 12.17, 4.25, 10.17, 3.75, and 3.75 ft. Figures IV-22 and IV-23 show strain readings at the S1 and S2 locations for a typical truck run. The curves in each figure may be viewed as the influence lines for the strains at each respective location. As observed in Phase 1 load test for the S3 and S4 locations, the maximum strains are below 30 microstrains for both tension (+) and compression (-).

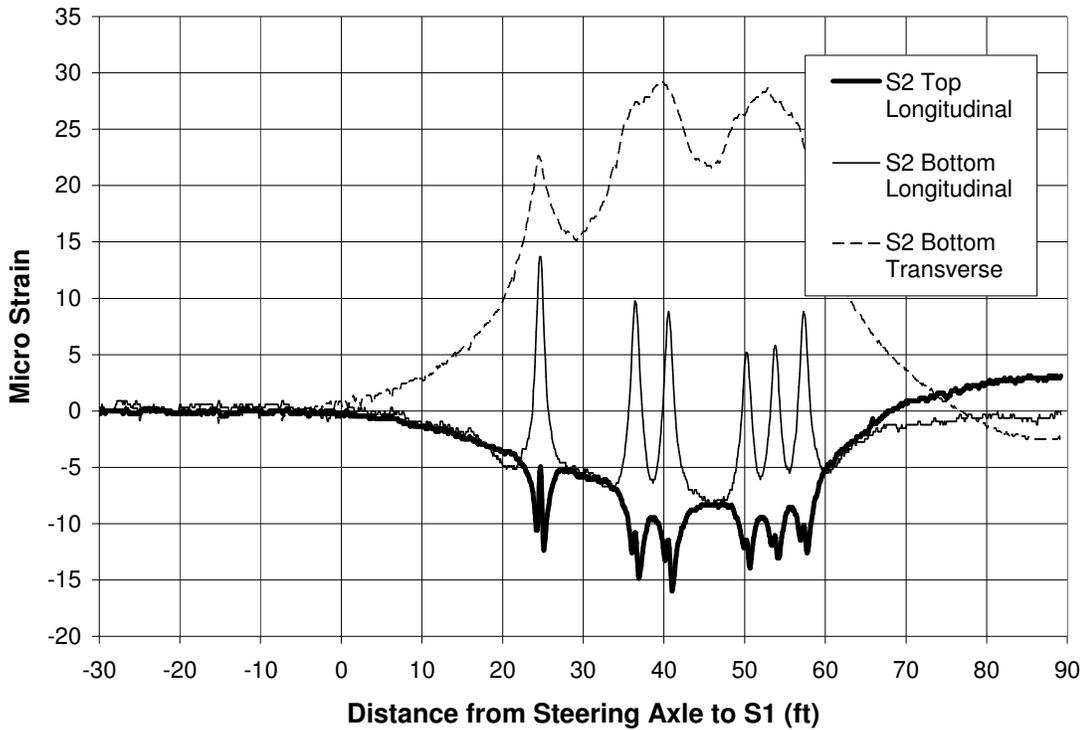
Figure IV-23 Strains at S2 Location in Grove Street Bridge due to Truck Load

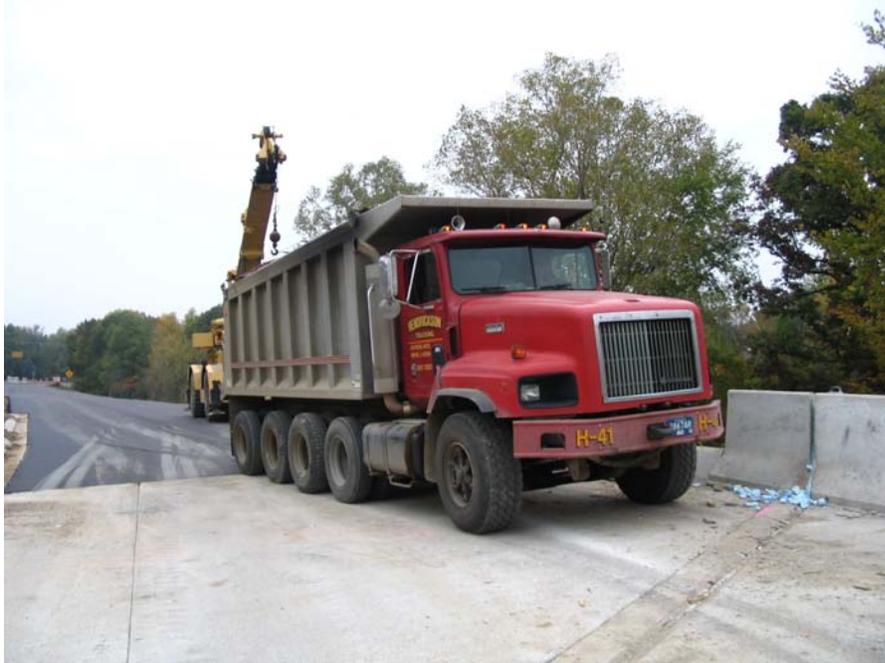
Figure IV-24 A 5-axle Truck Loading M-50 Bridge Deck

For the M-50 Bridge, a 5-axle truck was used for loading the deck, as shown in Figure IV-24. The resulting strains from the embedded strain transducers were recorded using the same approach as for the Grove Street Bridge. Figures IV-25 to IV-28 show the strain readings for a typical truck run on the deck, as influence lines. The observed strains due to truck load are relatively small, as seen for the Grove Street Bridge. They are within -10 (compression) and +20 (tension) microstrains.

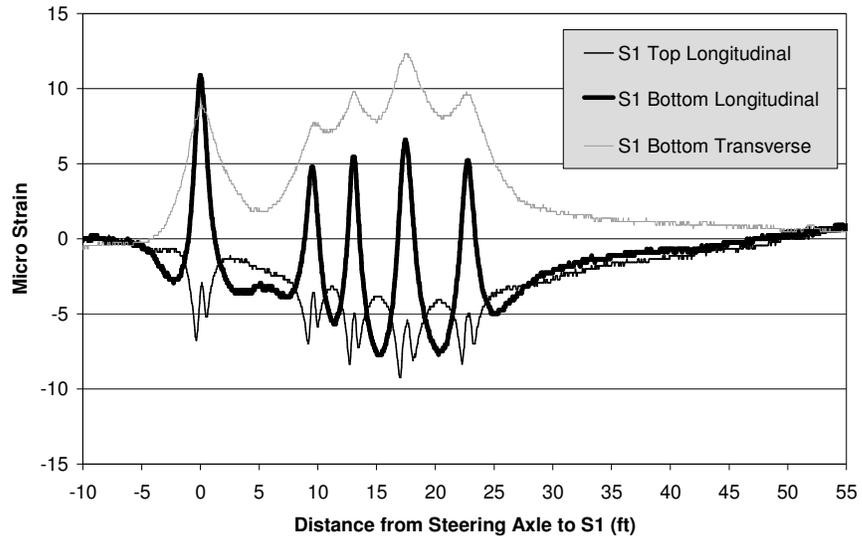
Figure IV-25 Strains at S1 Location in M-50 Bridge Deck due to Truck Load

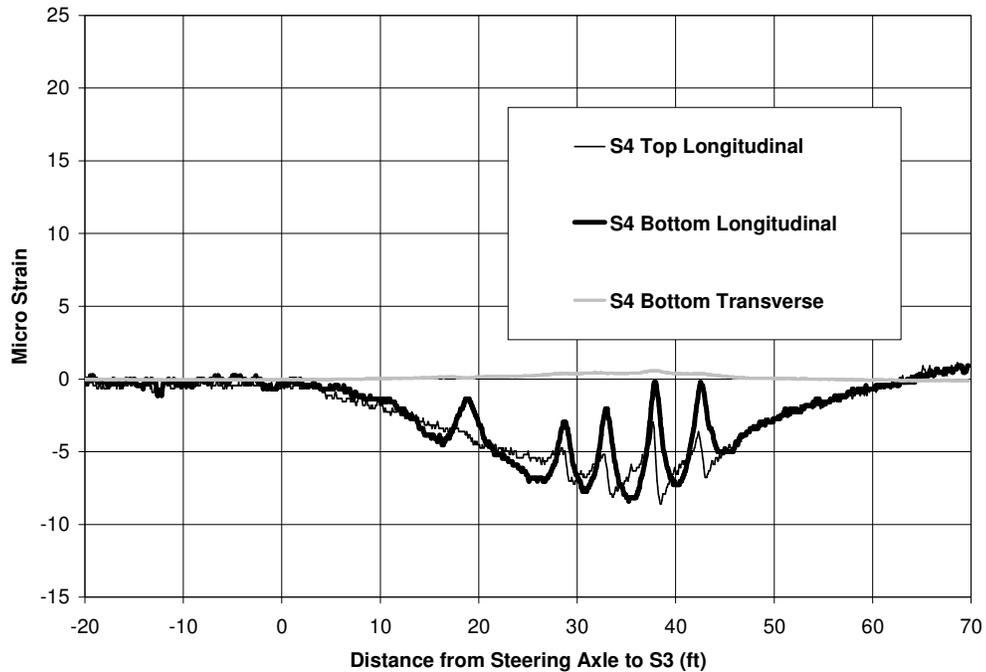
Figure IV-28 Strains at S4 Location in M-50 Bridge Deck due to Truck Load

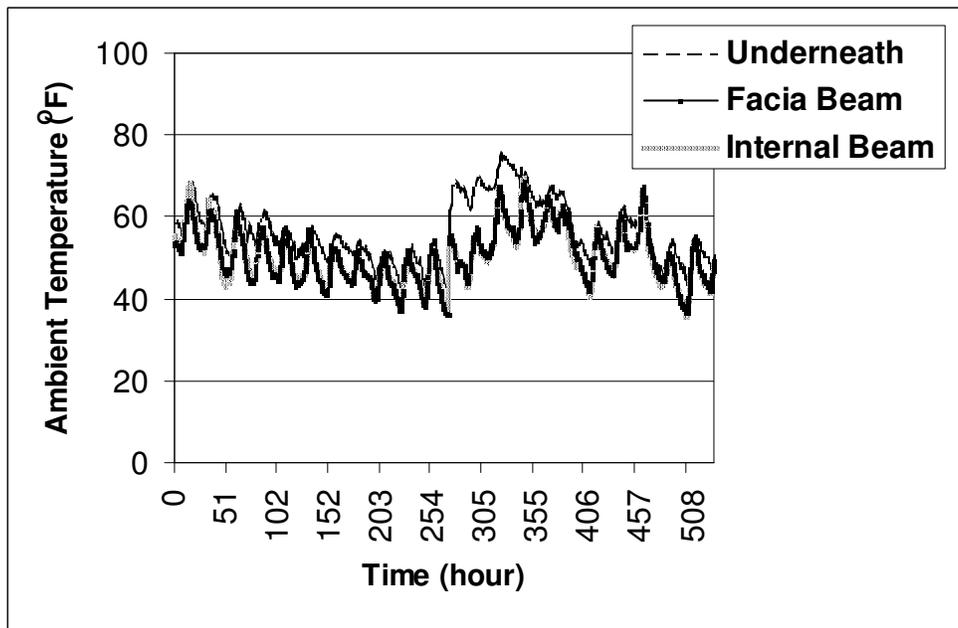
Figure IV-30 Ambient Temperature at Grove Street Bridge (Phase 2)

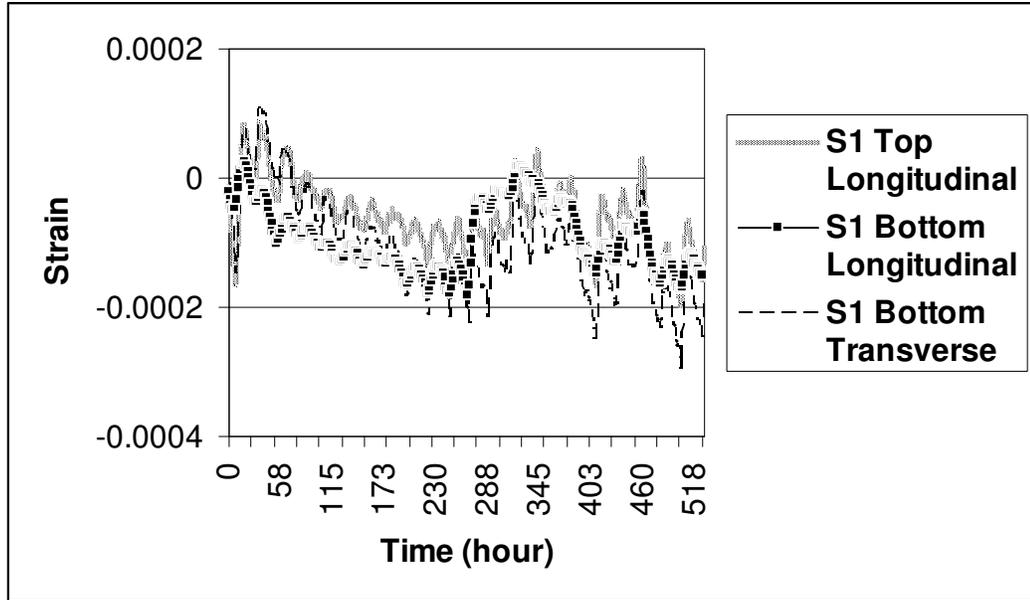
Figure IV-31 Strain Readings at S1 in Grove Street Bridge Deck (Phase 2)

Figures IV-31 and IV-32 show the strain readings at locations S1 and S2. The tensile strains are in the range of about 100 microstrains. Note that the concrete in the S3 and S4 locations completed curing about a month earlier than the S1 and S2 locations.

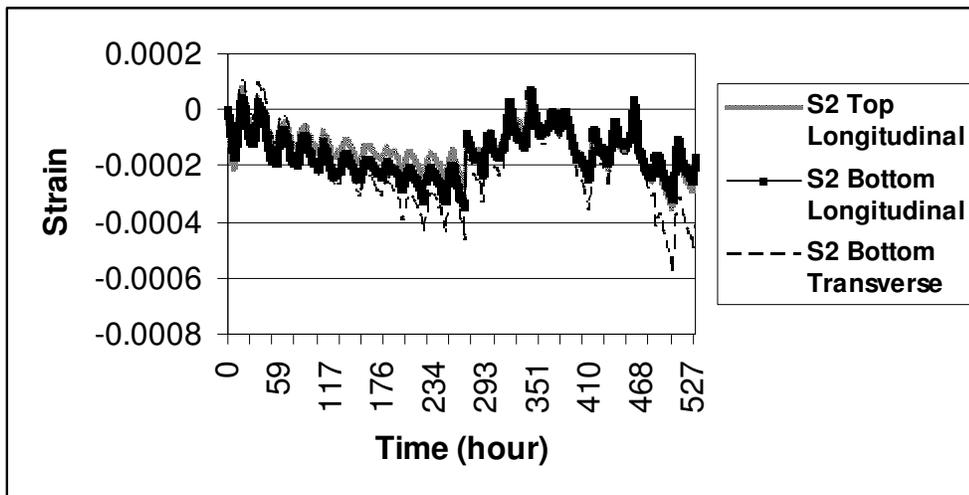
Figure IV-32 Strain Readings at S2 in Grove Street Bridge Deck (Phase 2)

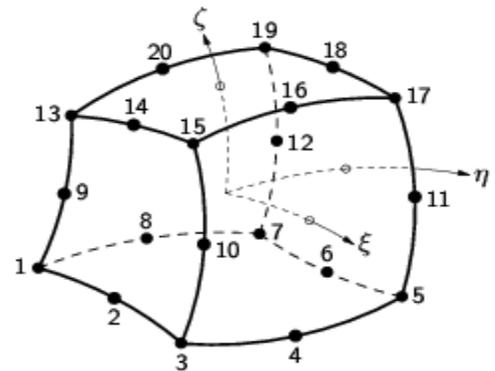
Figure V-1 Definitions of Nodes and Coordinate System for Element CHX 60

where ξ , η , and ζ are the coordinates of a point in the element as shown in Figure V-1.

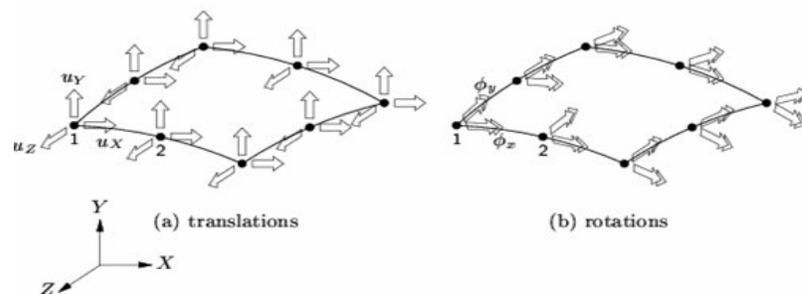
Figure V-2 Displacements and Coordinate System for Curved Shell Element CQ40S

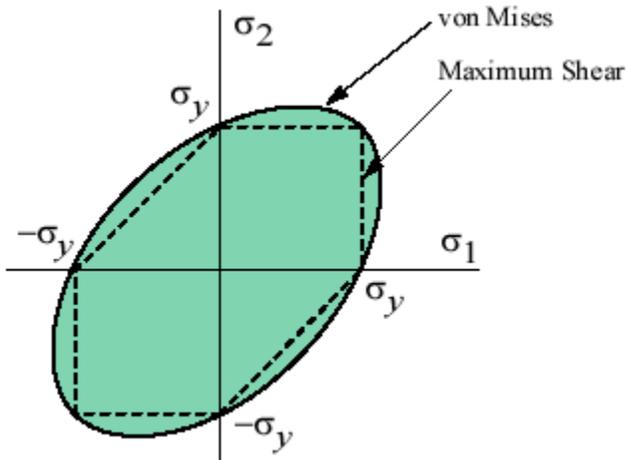
Figure V-3 Maximum Shear and von Mises Criteria for 2-D Stress Condition

where σ_1 , σ_2 , and σ_3 are the three principal stresses due to the loading. For a 2-D situation, the no failure region is given as the inside of the dotted line in Figure V-3.

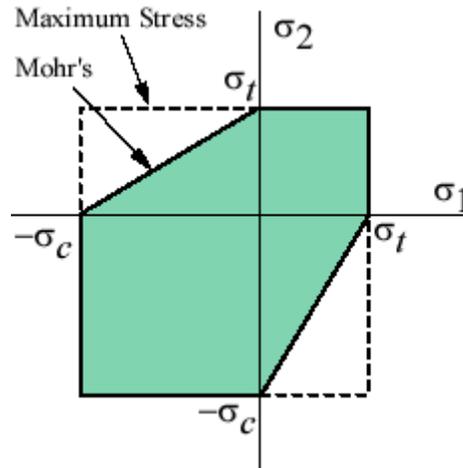
Figure V-4 Maximum Normal Stress and Mohr's Criteria for 2-D Stress Condition

The maximum normal stress criterion is another failure criterion, also known as Coulomb, or Rankine criterion, widely used for failure prediction especially for brittle materials. It states that failure occurs when a maximum normal (principal) stress reaches either the uniaxial tension strength σ_t , or the *uniaxial* compression strength σ_c . For the case of 2-D situation, the no failure region is shown as the inside of the dotted line in Figure V-4, where another failure criterion, known as the Mohr's criterion, is also graphed for comparison.

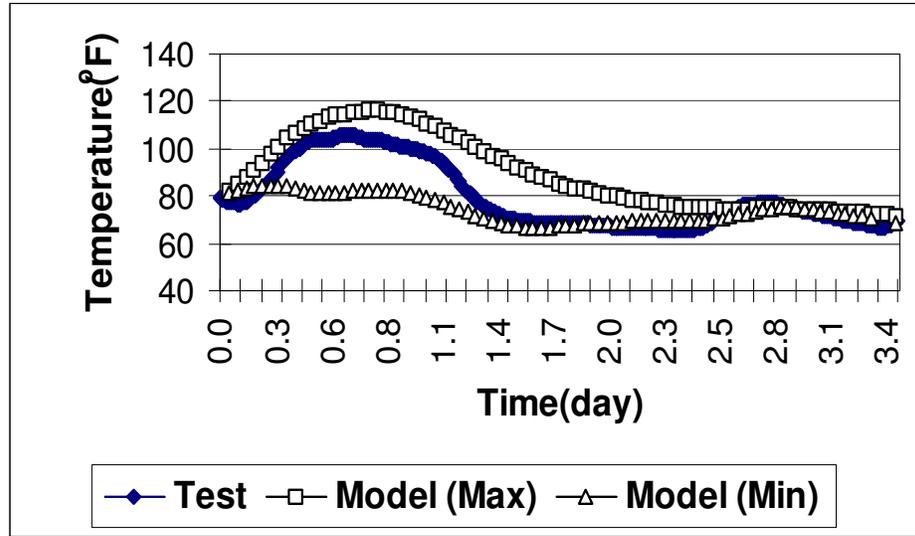
Figure V-5 Comparison for M-50 Bridge Temperature at S1 Top

Figures V-5 to V-12 show the comparison of the temperature results by FEA using DIANA and measurement using the instrumentation presented in Chapter IV for the M-50 bridge. It covers the first three and a half days, in which a significant percentage of the hydration process was believed to have completed. This comparison uses all the available measured data for this bridge. As discussed earlier, a number of material properties were not available so that a minimum and a maximum value was used to try to envelope the responses. These figures include the results using the two respective sets of perceived bounding values.

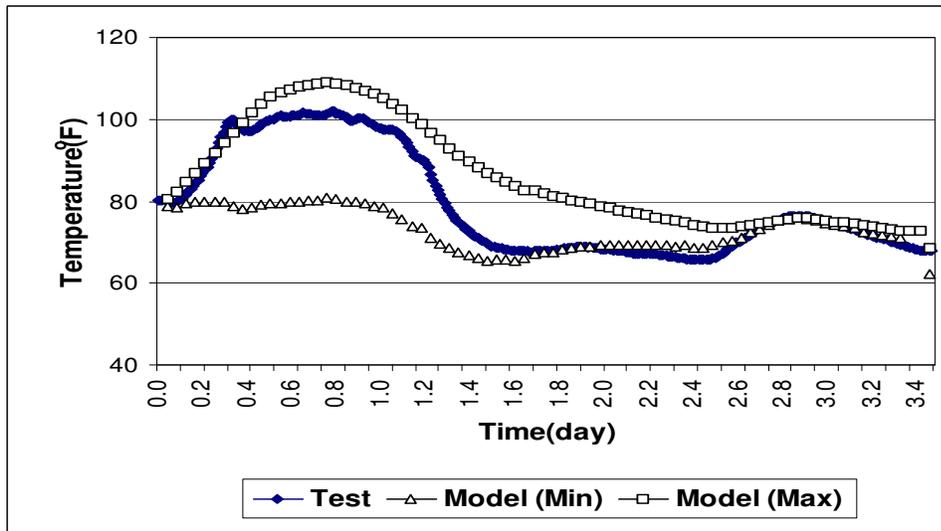
Figure V-6 Comparison for M-50 Bridge Temperature at S1 Bottom
