**BRIDGE DECK CORNER CRACKING
ON SKEWED STRUCTURES**

Final Report to
Michigan Department of Transportation

RC-1490

September 2007

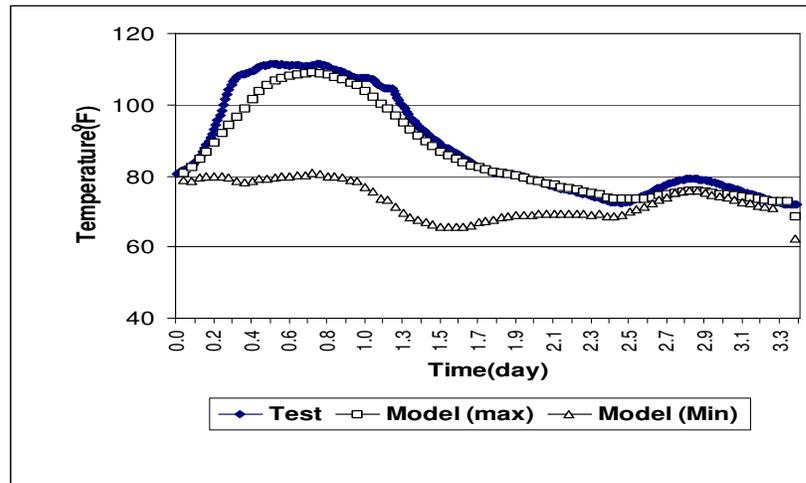
Figure V-12 Comparison for M-50 Bridge Temperature at S4 Bottom

Figures V-5 to V-12 show the comparison of the temperature results by FEA using DIANA and measurement using the instrumentation presented in Chapter IV for the M-50 bridge. It covers the first three and a half days, in which a significant percentage of the hydration process was believed to have completed. This comparison uses all the available measured data for this bridge. As discussed earlier, a number of material properties were not available so that a minimum and a maximum value was used to try to envelope the responses. These figures include the results using the two respective sets of perceived bounding values.

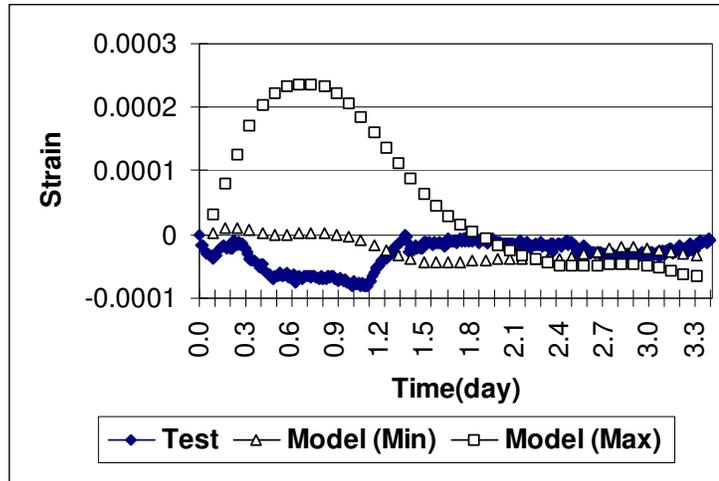
Figure V-13 Comparison for M-50 Bridge Strain at S1 Top Longitudinal

Figures V-13 to V-24 continues this comparison for the strains for the M-50 bridge during the same time period, obtained using FEA and physical measurement. The FEA again used the minimum and maximum cases defined earlier to indicate a range of the response strain. As seen, the FEA results for strain do not match with the test results as well as for the temperature, although the minimum and maximum cases do show that the measurement results are close to or within the range. Similarly to the temperature results, the strain results for the minimum and maximum cases also show a more significant difference during the first two days of hydration than the rest of time. Note also that Figures V-17 and V-20 show steady increase in strain after 1.5 days. This may be due to drifting of the strain measurement for a long period of time.

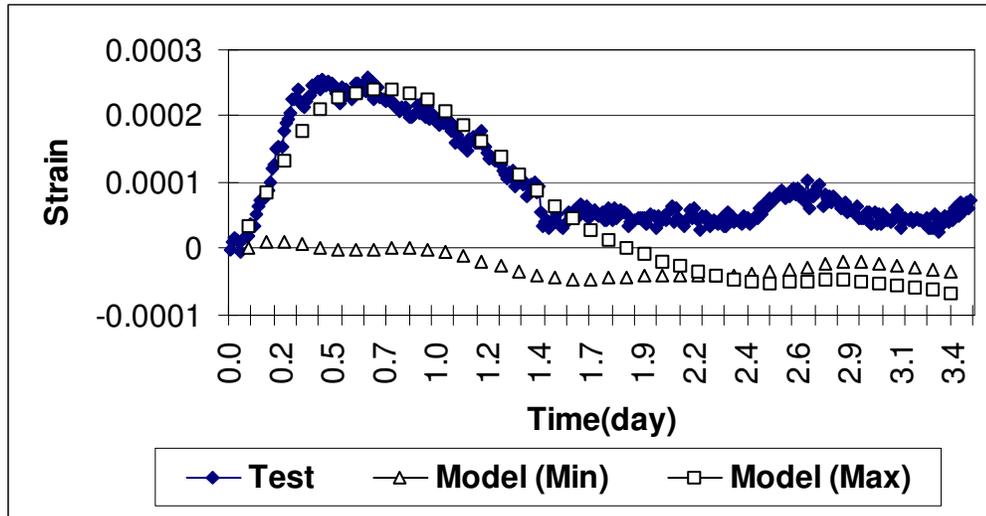
Figure V-19 Comparison for M-50 Bridge Strain at S3 Top Longitudinal

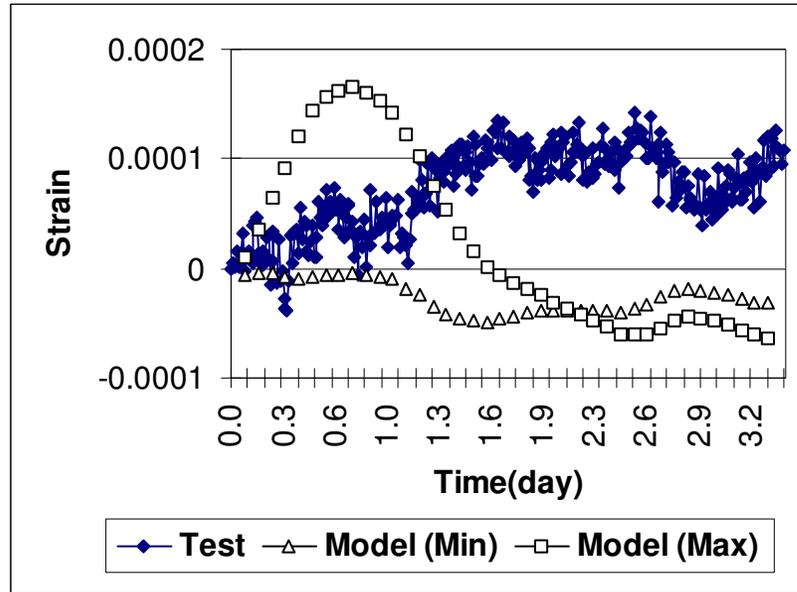
Figure V-20 Comparison for M-50 Bridge Strain at S3 Bottom Longitudinal

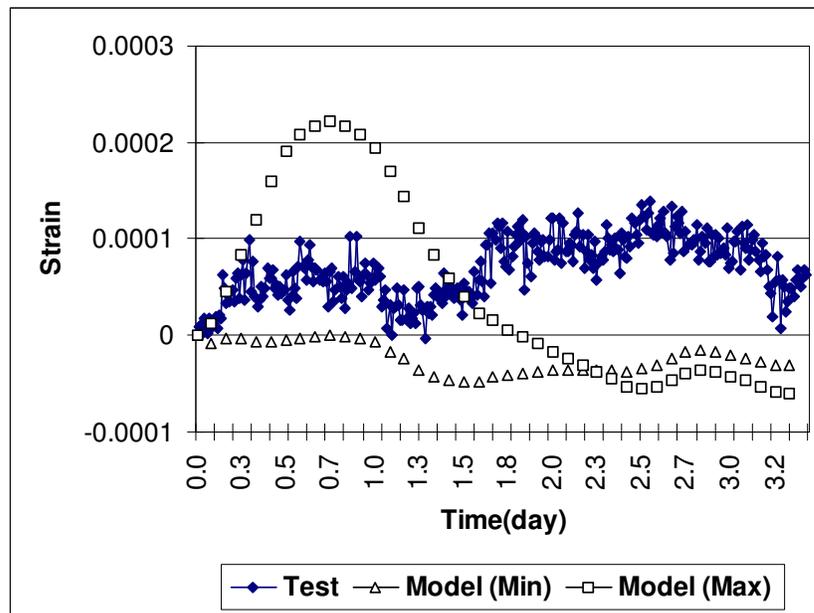
Figure V-21 Comparison for M-50 Bridge Strain at S3 Bottom Transverse

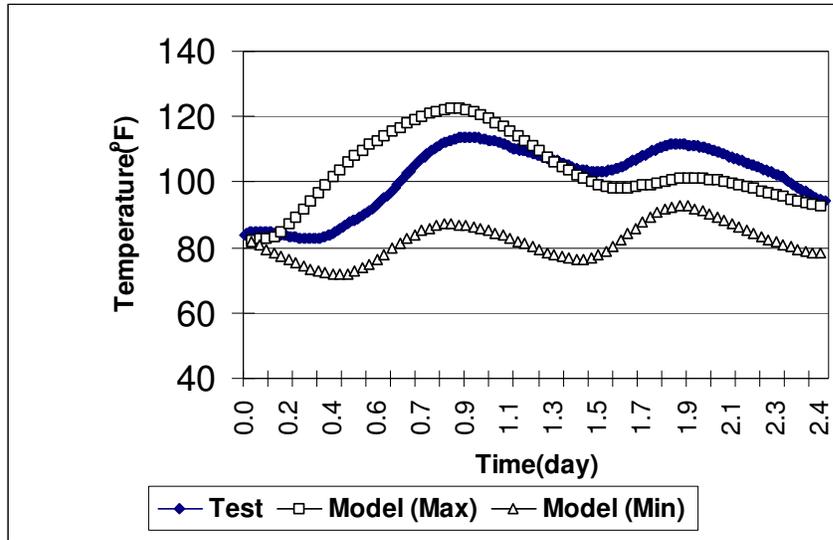
Figure V-28 Comparison for Grove Street Bridge Temperature at S4 Bottom

Temperature recorded at the Grove Street bridge deck exhibits more clearly the daily cycling as seen in Chapter IV. The perceived minimum and maximum responses are able to envelope the first one and a half days where the peak temperature was observed. Figures V-29 to V-32 show the same kind of comparison for the other half of the bridge deck poured later in Phase 2 (West Bound). Note that this half was constructed about a month later than Phase 1 and we were able to continue monitoring the temperature and strain for about 21 days. These four figures show that the minimum and maximum curves better envelope the measured temperature record, compared with Figures V-25 to V-28.

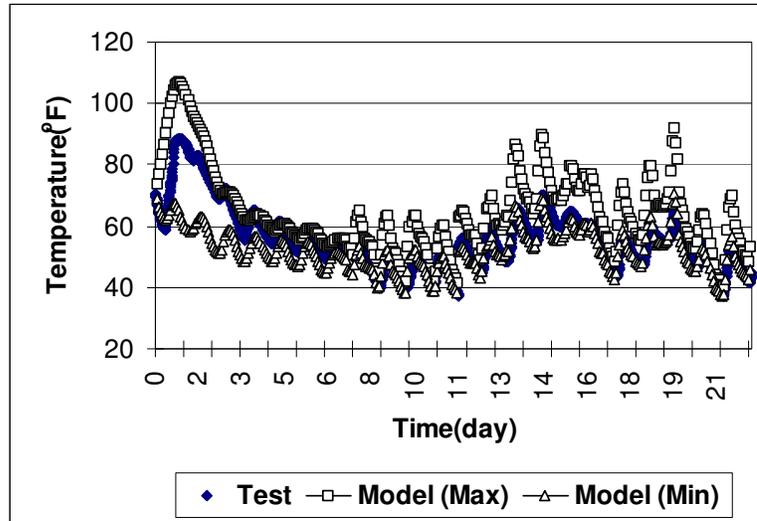
Figure V-29 Comparison for Grove Street Bridge Temperature at S1 Top

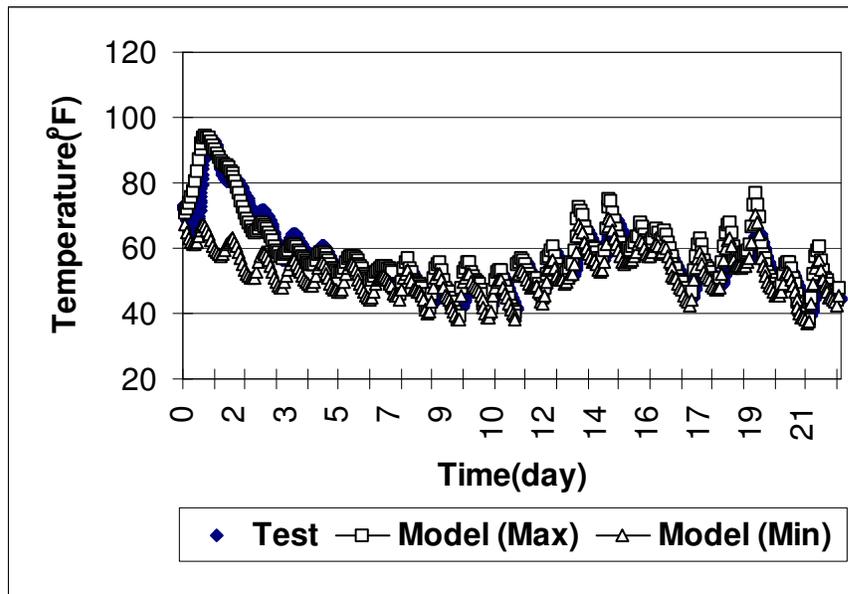
Figure V-30 Comparison for Grove Street Bridge Temperature at S1 Bottom

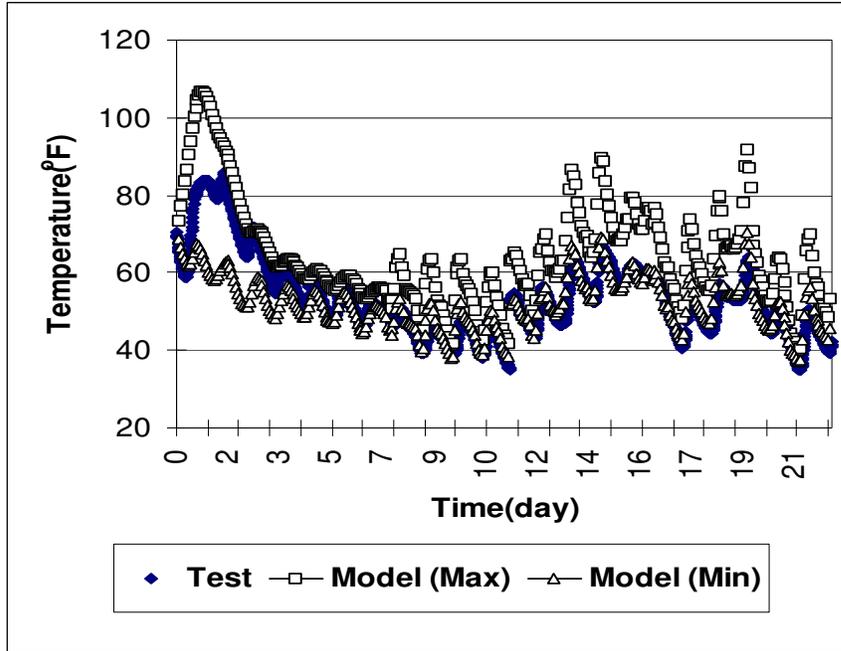
Figure V-31 Comparison for Grove Street Bridge Temperature at S2 Top

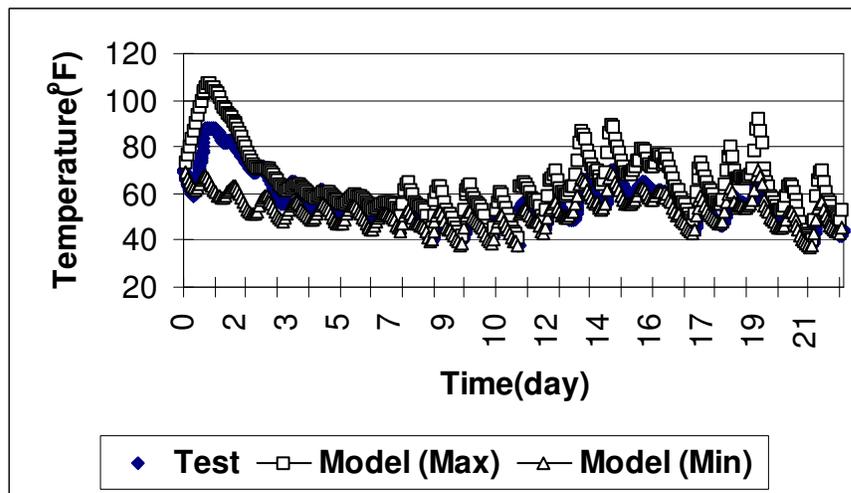
Figure V-32 Comparison for Grove Street Bridge Temperature at S2 Bottom

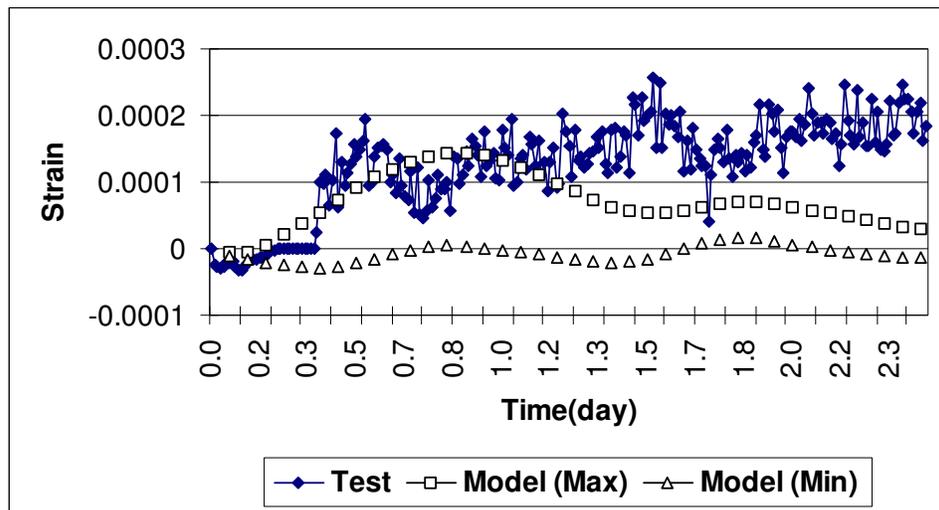
Figure V-33 Comparison for Grove Street Bridge Strain at S3 Top Longitudinal

Figures V-33 to V-38 compare the strains in Phase 1 of the Grove Street bridge between measurement and FEA simulation using DIANA. The measured strains are enveloped between the maximum and minimum curves in Figures V-35 to V-38. In Figure V-35 the measured strain appears to be drifting up with time. Figures V-39 to V-44 shows similar comparison for strains for Phase 2 of the bridge deck. It is seen that during the first one and a half days, the measured strains were bounded by the envelopes shown. Beyond first 2 or 3 days, the envelopes did not do well. Also, it should be noted that the strain prediction by FEA is not as good as the temperature prediction, because the strain computation depends on the temperature as the input, which was discussed earlier in Section V-1.5. In addition, the strain-stress analysis is nonlinear, thus more difficult to model and predict.

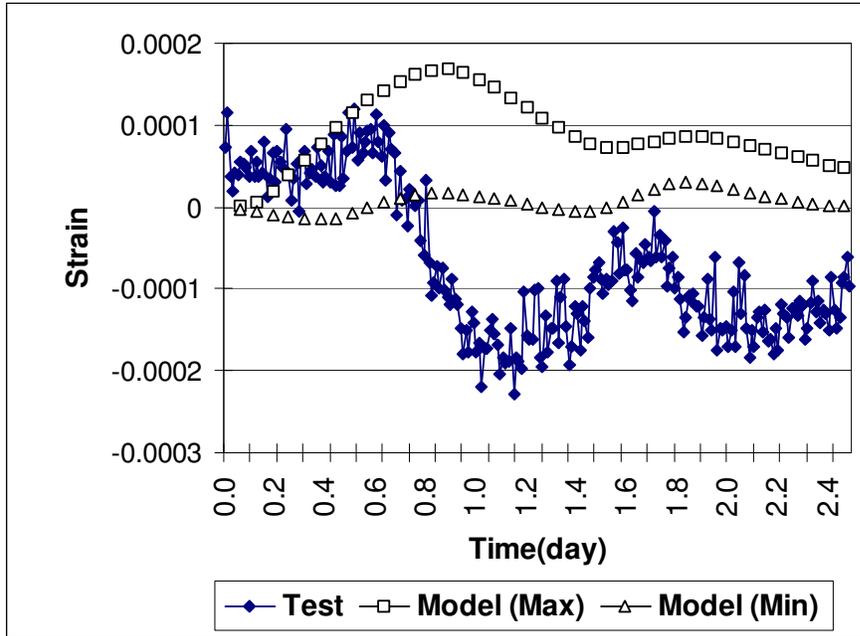
Figure V-34 Comparison for Grove Street Bridge Strain at S3 Bottom Longitudinal

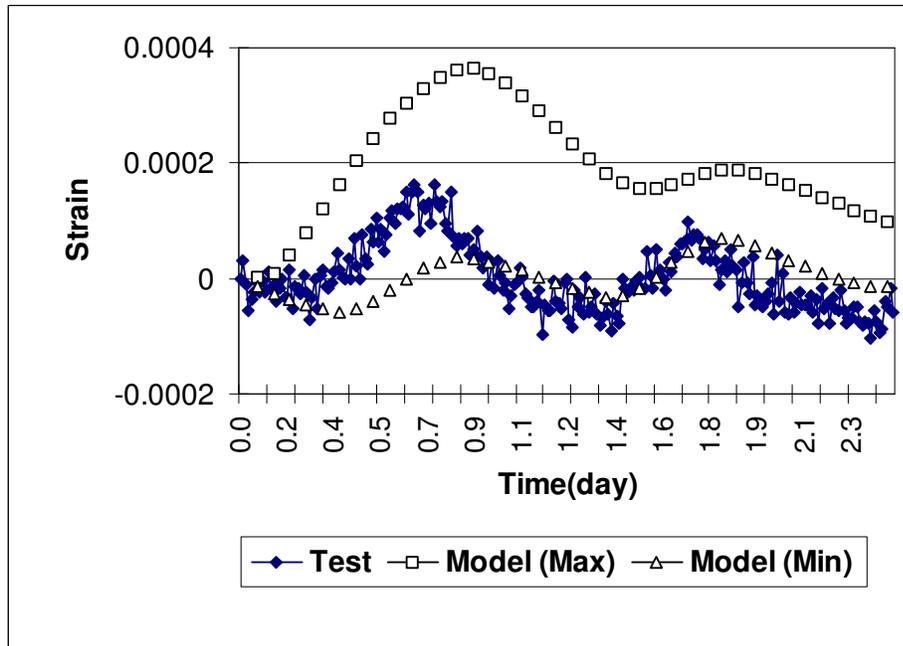
Figure V-35 Comparison for Grove Street Bridge Strain at S3 Bottom Transverse

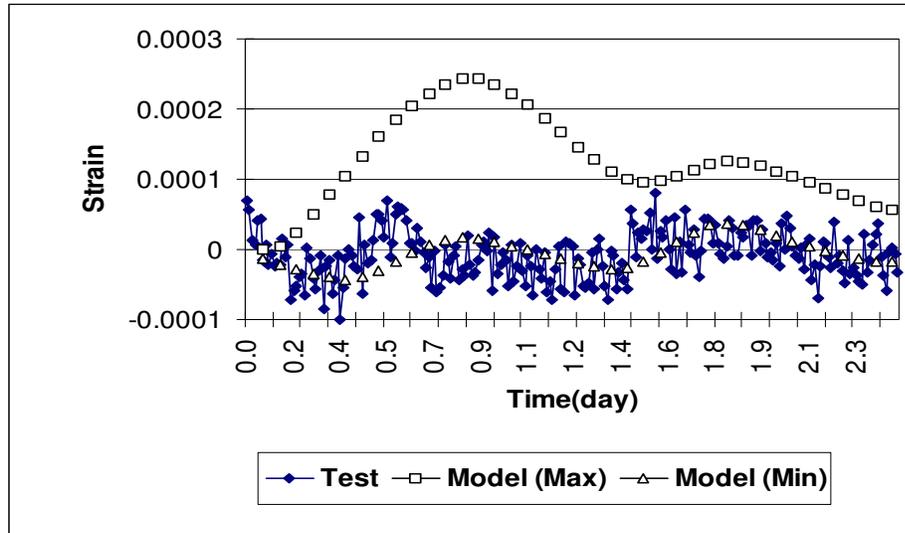
Figure V-36 Comparison for Grove Street Bridge Strain at S4 Top Longitudinal

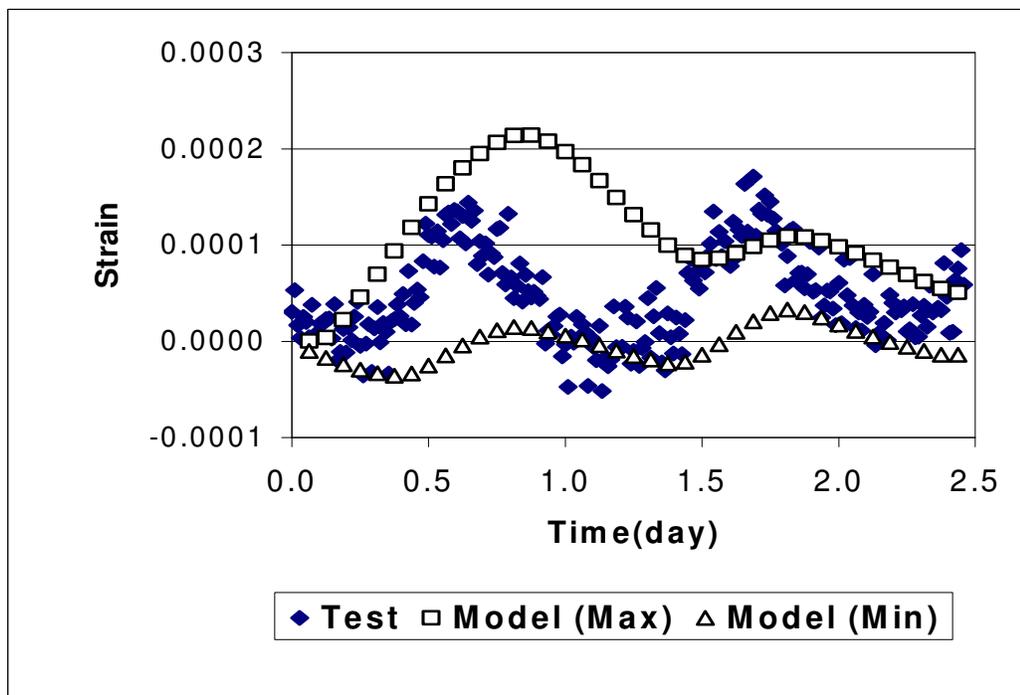
Figure V-37 Comparison for Grove Street Bridge Strain at S4 Bottom Longitudinal

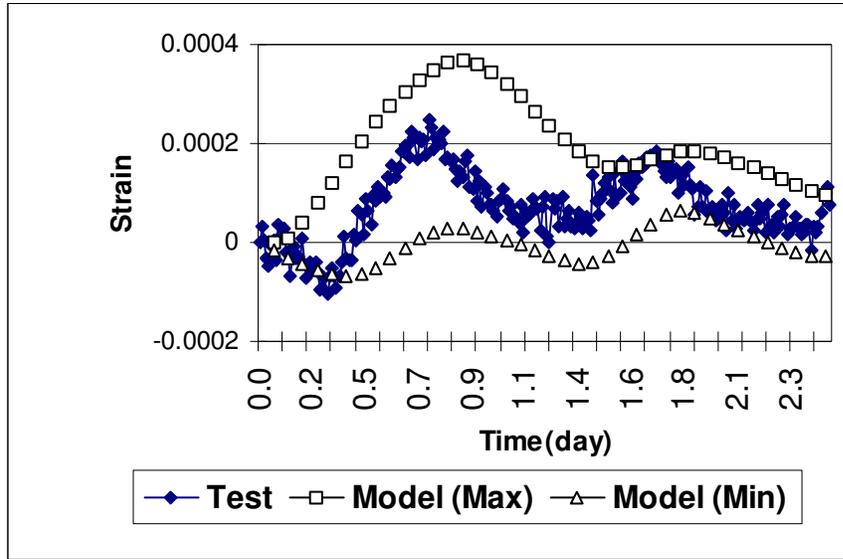
Figure V-38 Comparison for Grove Street Bridge Strain at S4 Bottom Transverse

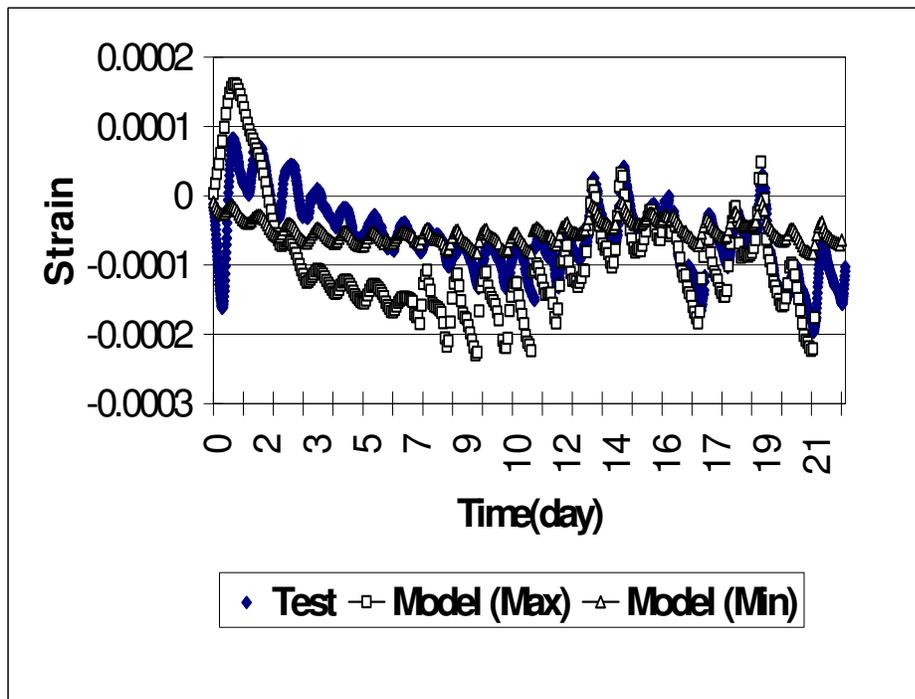
Figure V-39 Comparison for Grove Street Bridge Strain at S1 Top Longitudinal

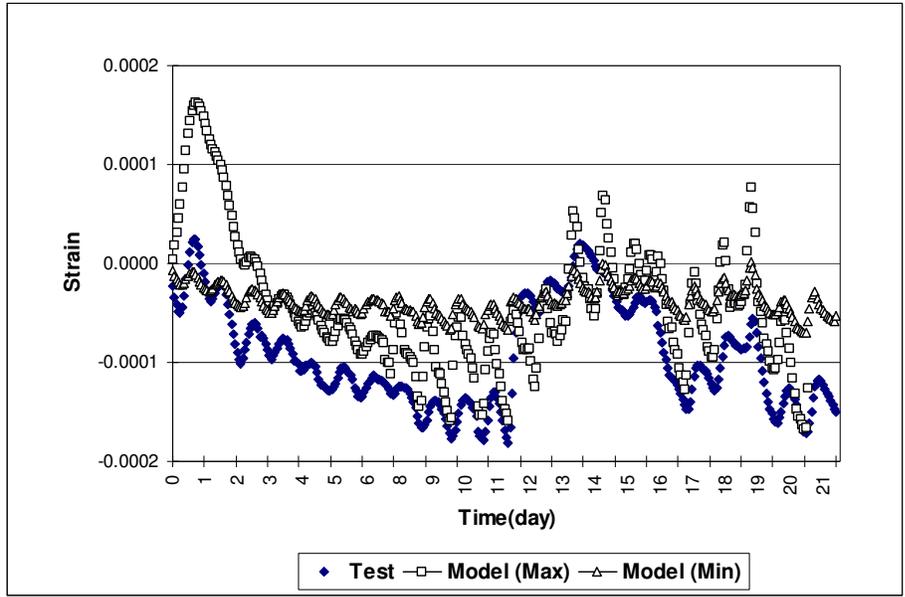
Figure V-40 Comparison for Grove Street Bridge Strain at S1 Bottom Longitudinal

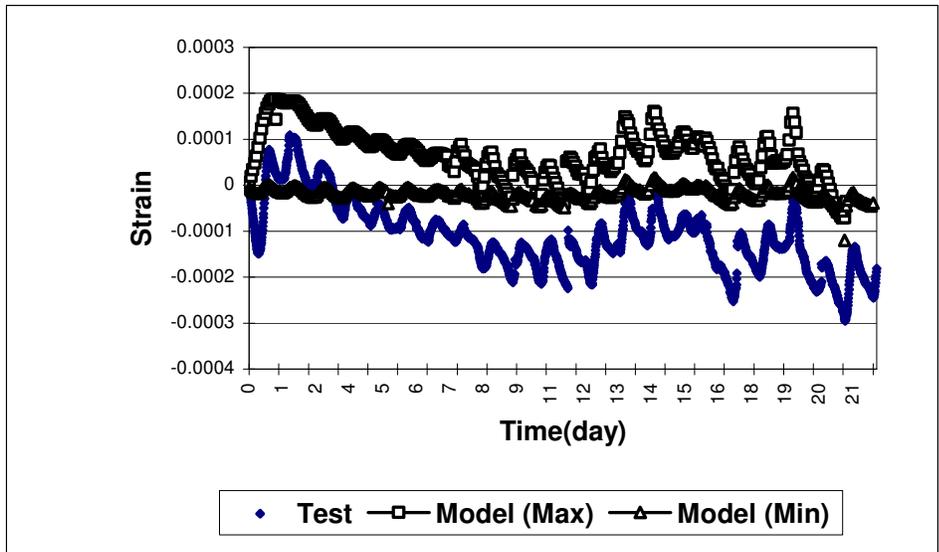
Figure V-41 Comparison for Grove Street Bridge Strain at S1 Bottom Transverse

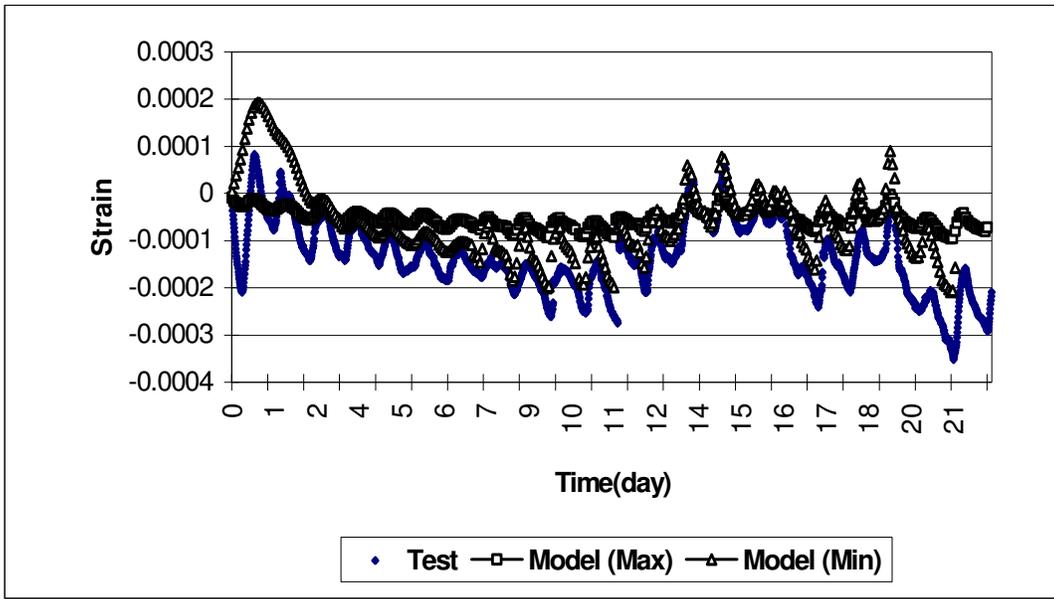
Figure V-42 Comparison for Grove Street Bridge Strain at S2 Top Longitudinal

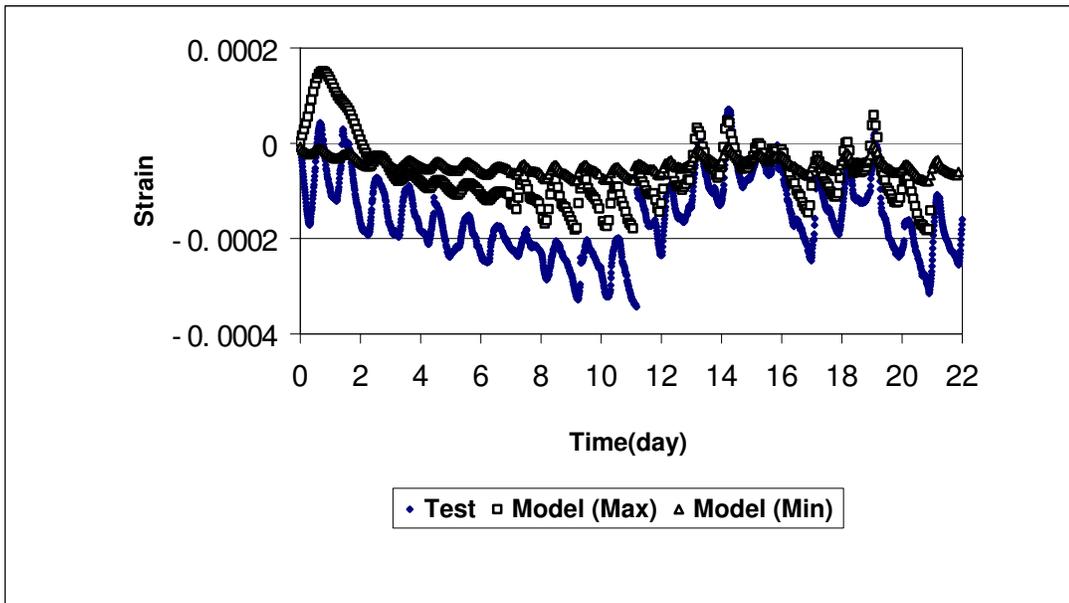
Figure V-43 Comparison for Grove Street Bridge Strain at S2 Bottom Longitudinal

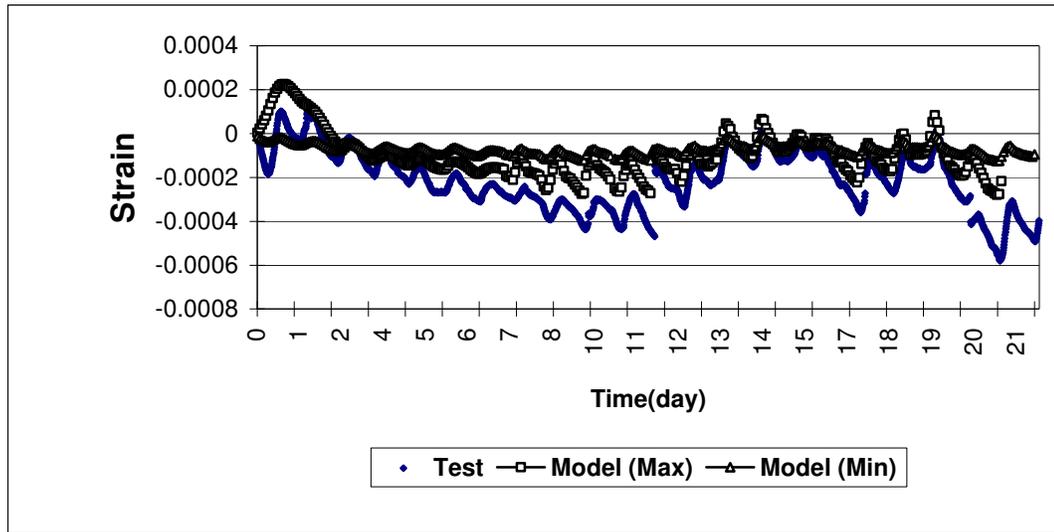
Figure V-44 Comparison for Grove Street Bridge Strain at S2 Bottom Transverse

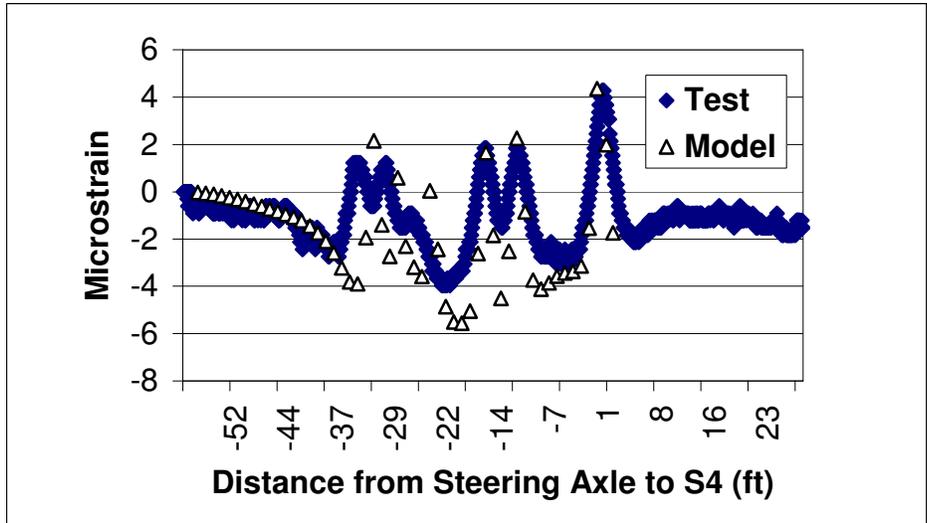
Figure V-49 Comparison of Truck Load Response for Grove Street Bridge S4 Bottom Longitudinal

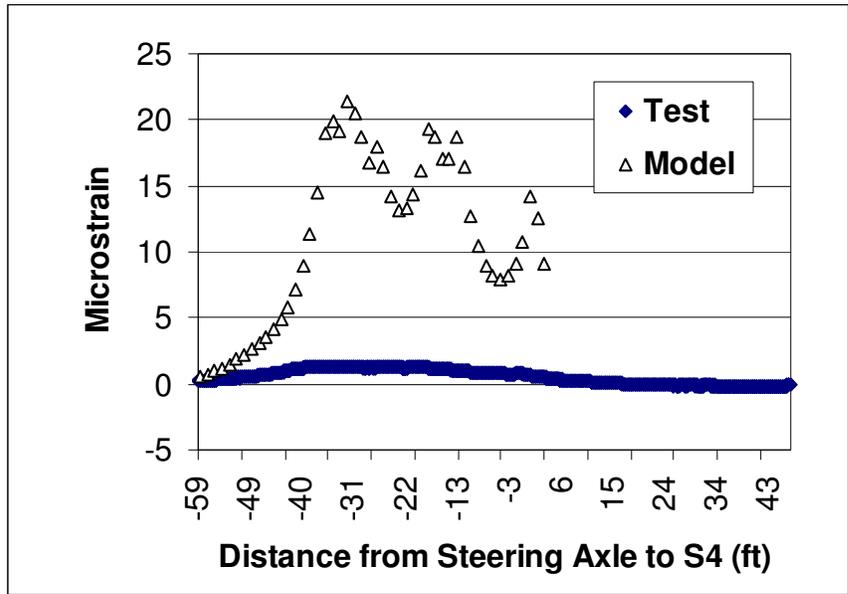
Figure V-50 Comparison of Truck Load Response for Grove Street Bridge S4 Bottom Transverse

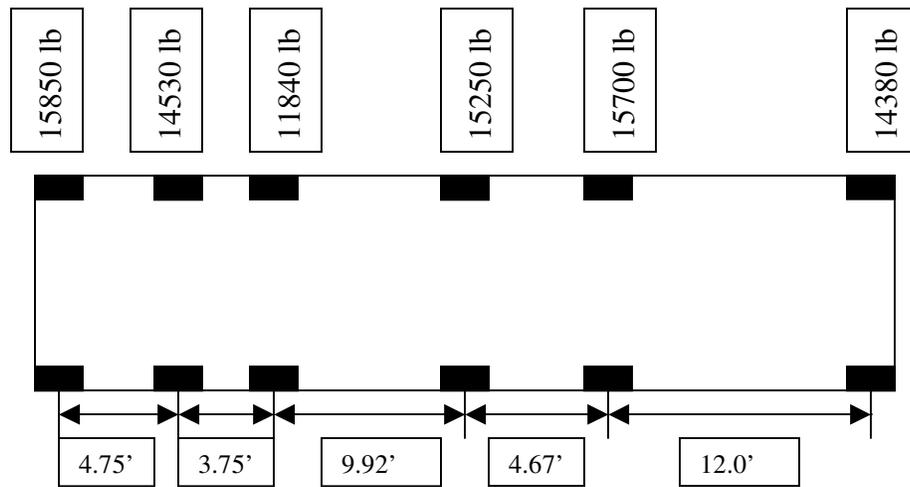
Figure V-51 6-axle Truck for Loading Grove Street Bridge Phase 1 (S3 and S4)

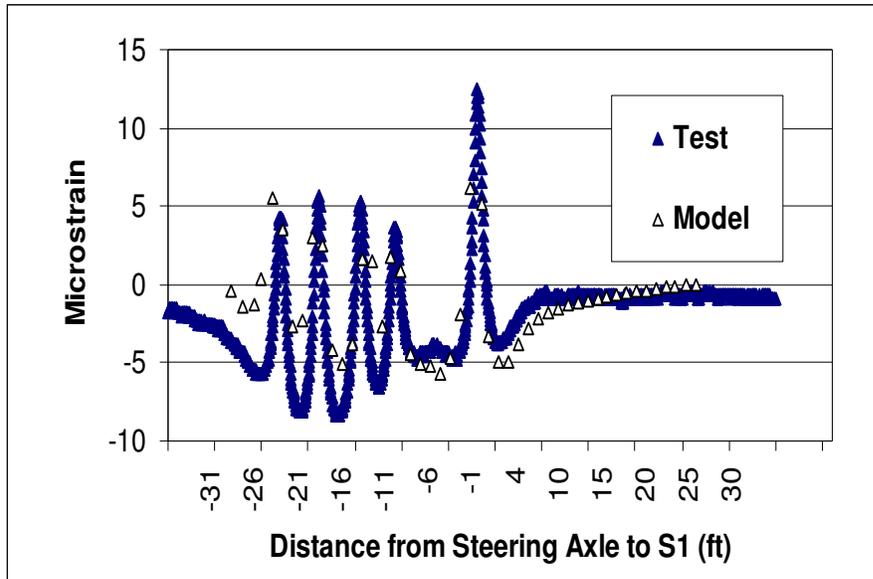
Figure V-61 Comparison of Truck Load Response for M-50 Bridge S1 Bottom Longitudinal

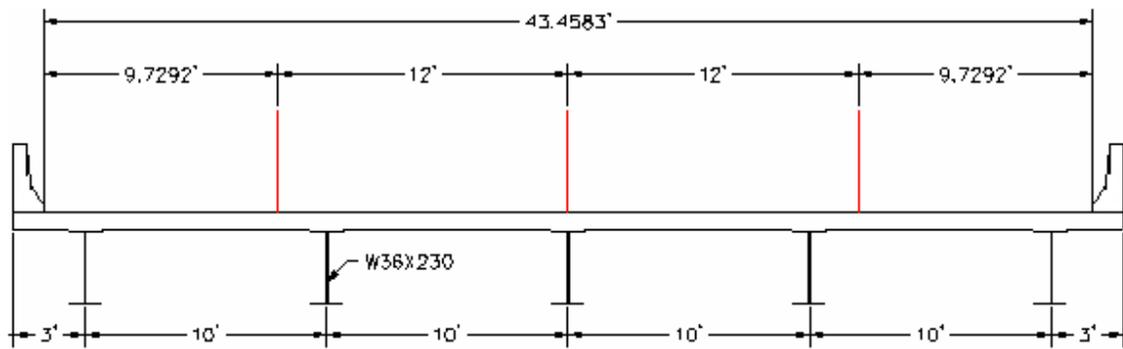
Figure V-72 Cross Section of Generic Steel Bridge with a 9" Concrete Deck on 10' Beam Spacing

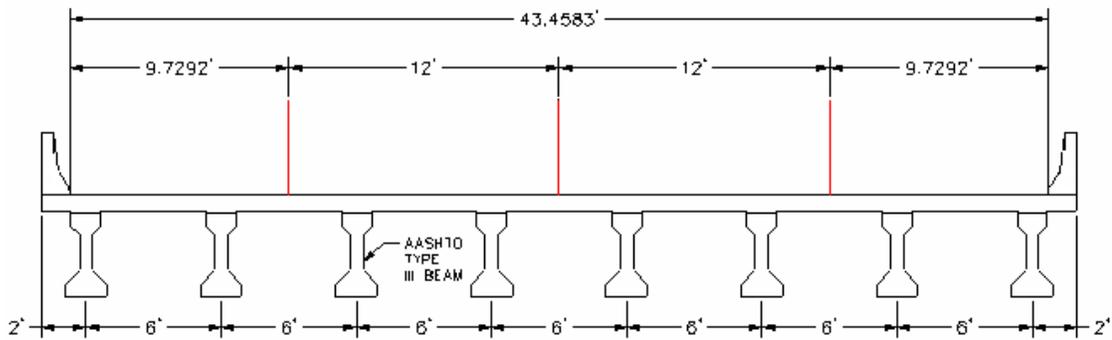
Figure V-75 Cross Section of Generic Prestressed I-Beam Bridge with a 9" Concrete Deck on 6' Beam Spacing

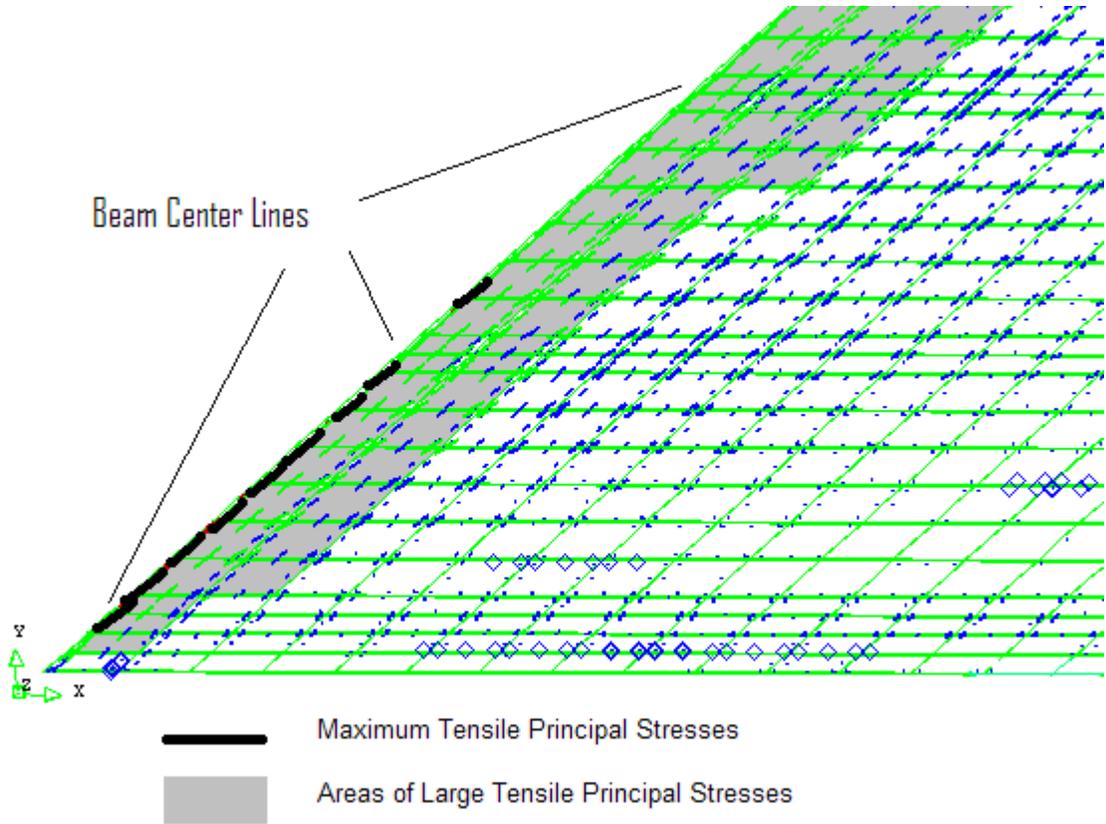
Figure V-76 Grove Street Bridge Principal Stress Directions on Deck Top
(Lines for tensile and diamonds for compressive principal stresses)

Figure V-77 Grove Street Bridge Deck Corner Cracking Observed
Perpendicular to Deck Edge
(Modeled in Figure V-76)
