EVACUATION OF INTERCITY BUSES

January, 1978

FINAL REPORT

U.S. DEPARTMENT OF TRANSPORTATION

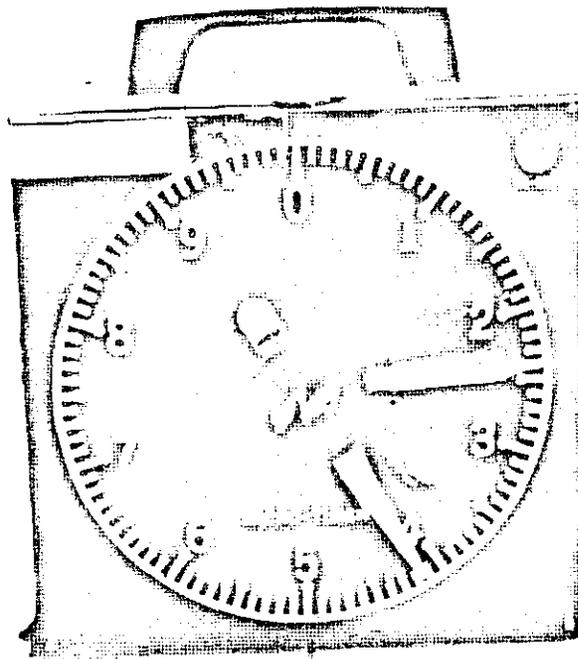
FIGURE 17. VIEW OF TIMER USED TO
PROVIDE MOTION PICTURE TIME BASE

Two large timers were strategically placed to provide a check on the time base on the movie films taken. The timers (Figure 17) had a 10 inch face; where one revolution occurred every one tenth of a minute. The timers were synchronized with the siren and signal lamp.

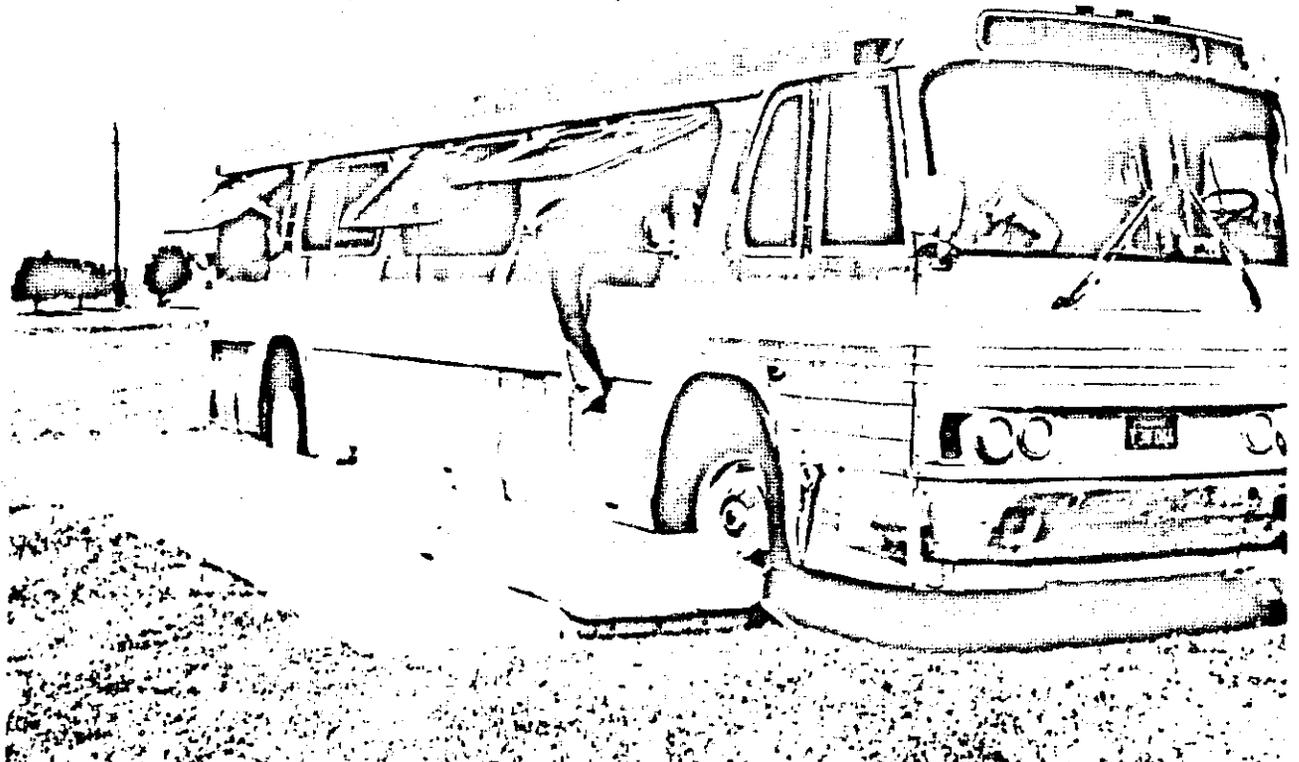
FIGURE 20. VIEW OF MATTRESSES
TO CUSHION SUBJECT FALLS

Used mattresses were placed along both sides and front of the bus to provide a landing position for the subjects when they jumped from the bus during the test (Figure 20). Mattresses were placed under the bus for support to minimize damage to the bus during the turnover. Mattresses were placed below the roof hatch emergency exit and the front windshield area to cushion evacuation efforts during the trials when the bus was on its side. The remaining mattresses were stuffed into the window areas on the ground side of the bus where the windows had previously been removed to provide a base safe for the bus occupants.

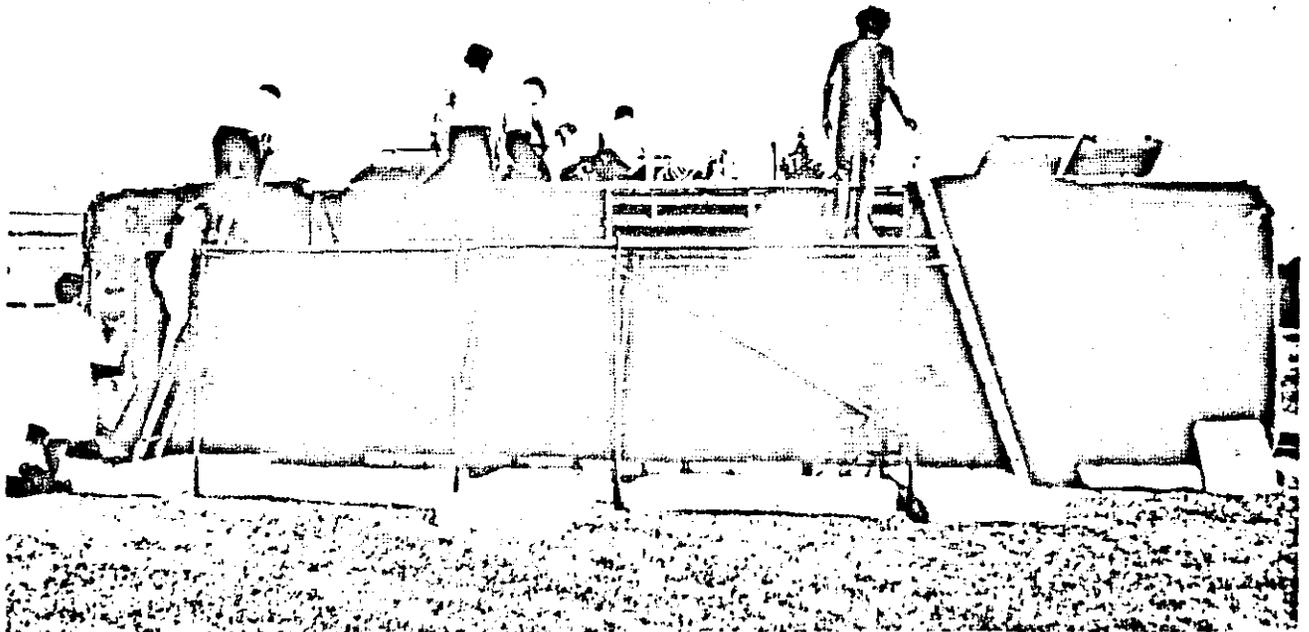
FIGURE 21. VIEW OF SCAFFOLD TO PROVIDE
FOR SUBJECT DISMOUNT FROM BUS

A scaffold was constructed and placed beside the bus undercarriage when trials were conducted with the bus on its side. The scaffold was approximately eight feet above ground, five feet wide and extended from the front wheel well to the rear wheel well (Figure 21). The bus side below the window openings was carpeted to minimize the risk of slipping as passengers moved from the bus to the scaffolding and two ladders were attached to the scaffolding for subject dismount.

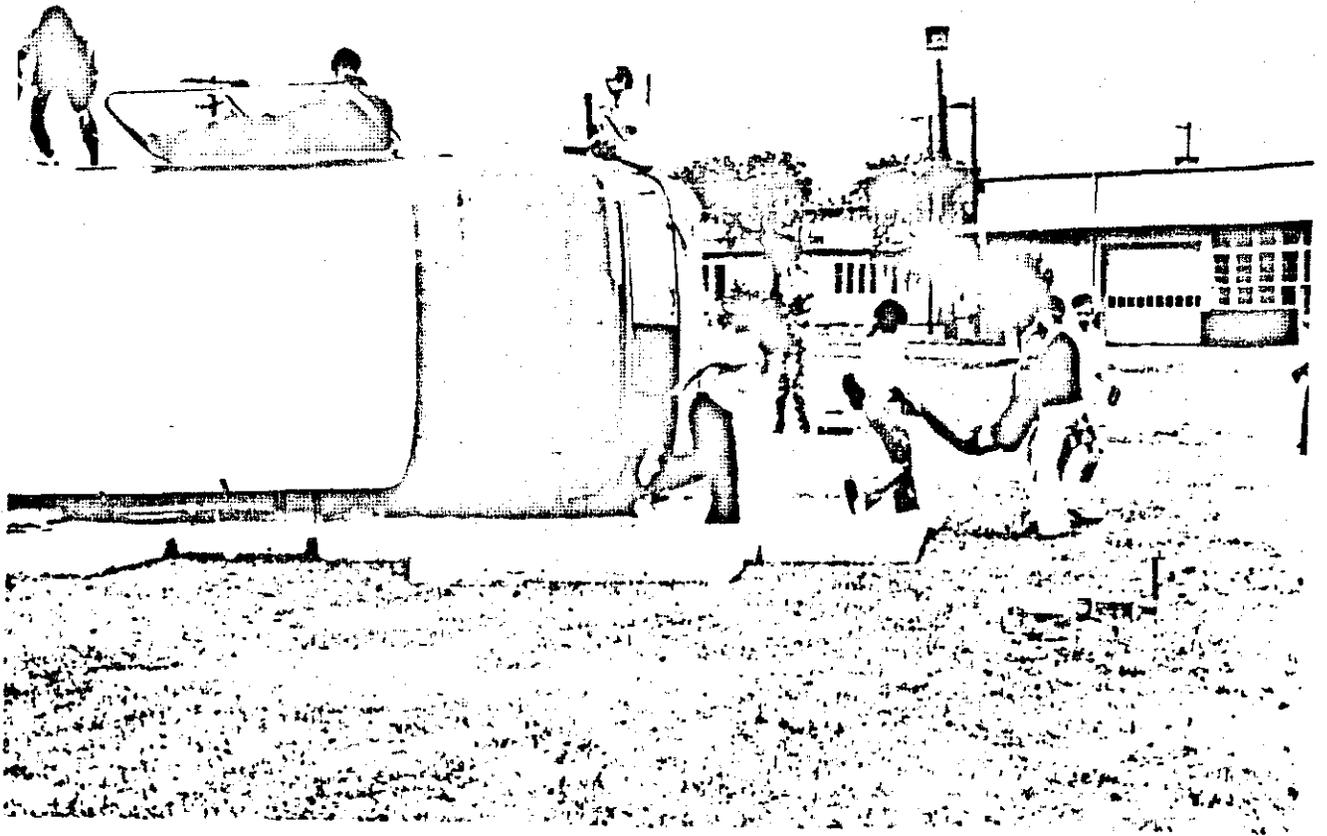
FIGURE 22. VIEW OF SUBJECTS EXITING
VIA FRONT WINDSHIELD

The first important finding of this trial was that passengers were able to kick out the front windshield of the bus and use this opening as an escape route. In this case two females, age 45 and 65 repeatedly kicked the windshield until it was broken and dislodged from the opening. The windshield had been covered prior to the test with a heavy plastic sheet to prevent lacerations if passengers did decide to kick it out and use it as an escape route. Whether this covering encouraged these passengers to be more daring than they would have been in a real evacuation is unknown. However, it seems likely that they would have proceeded in the same way in an actual emergency evacuation, given that they had not been injured in the crash.
