KTC-14-04/FRT 194, SPR388-12-1F

**Sealants, Treatments and Deicing Salt Practices to Limit Bridge Deck
Corrosion and Experimental Deck Sealants and Pier Cap Coating on
Interstate 471**

May 2014

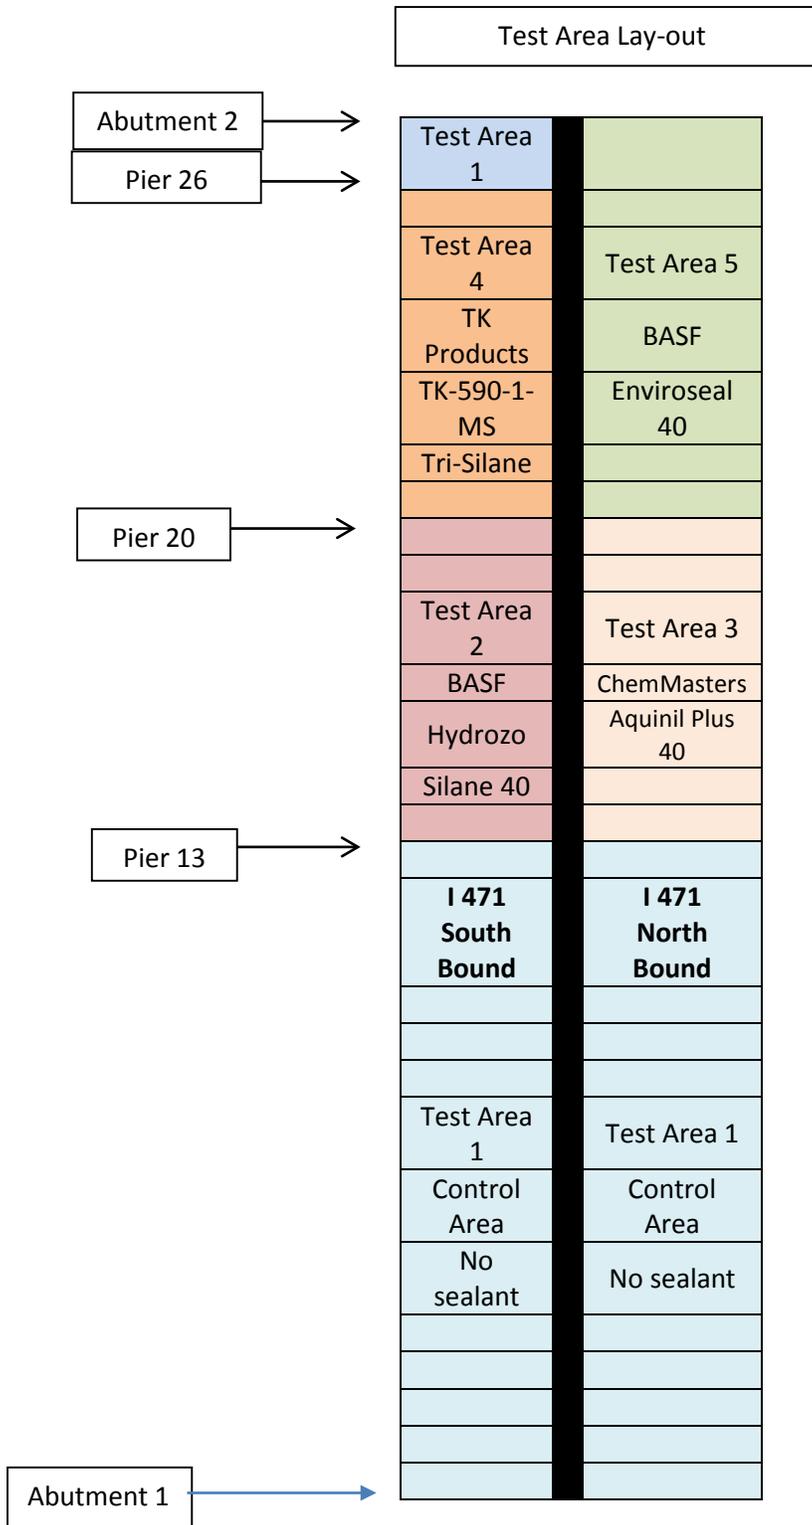
- Test Area 1 – I-471 northbound and south 2 from End Bent 1 to Pier 13. This test area was a control area and did not receive deck sealing.
- Test Area 2 – I-471 southbound from Pier 13 to Pier 20.
- Test Area 3 – I-471 northbound from Pier 13 to Pier 20.
- Test Area 4 – I-471 southbound from Pier 20 to Pier 26 (Pier 26 to End Bent 2 received no sealer).
- Test Area 5 – I-471 northbound from Pier 20 to End Bent 2.

Diagram: Layout of I471 Deck Sealer Test Areas

Due to issues with traffic control, as well as problems with the contractor accessing other work areas, the test areas were modified as follows (see the accompanying diagram):

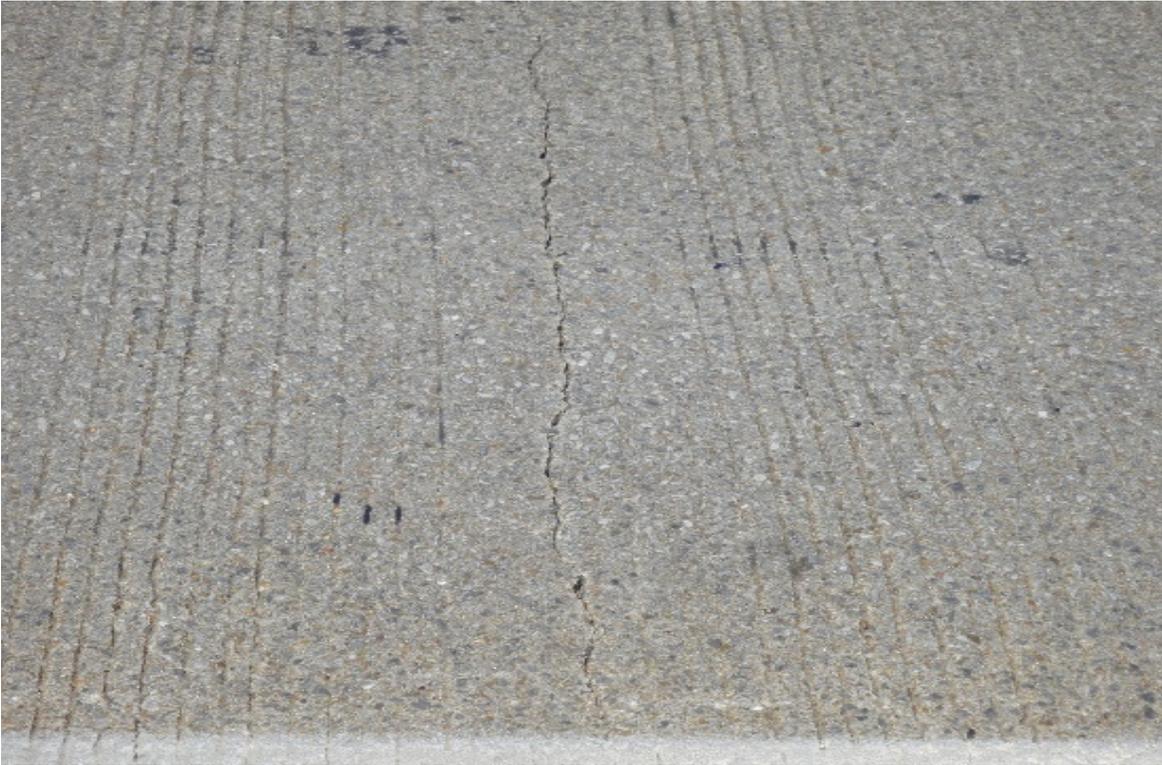
Figure 1 Crack in concrete deck.

Two undesirable conditions emerge when reinforcing steel corrodes. First, the corrosion product expands and creates sufficient internal stresses to break the concrete. This results in cracking (Figure 1), delamination (Figure 2), and spalling (Figure 3). A second problem is that corrosion reduces the cross section of the reinforcing steel to the point – in some cases – where no steel and thus no reinforcement remain (Figure 4).

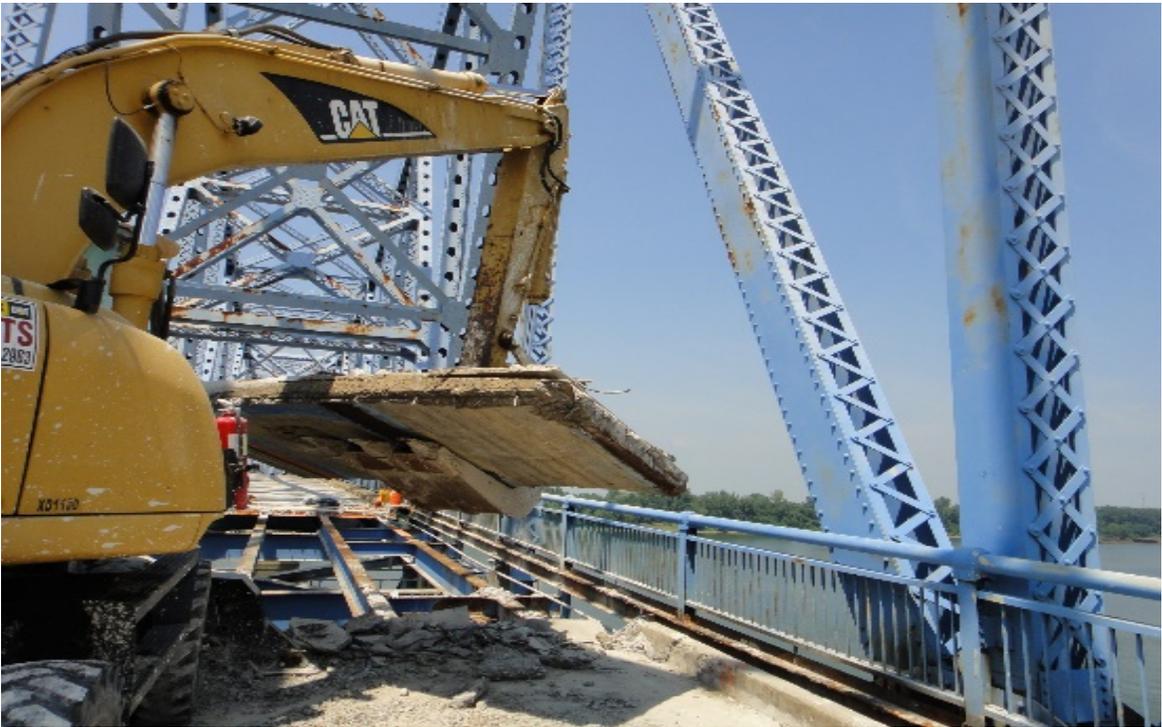
Figure 2 Delamination in concrete deck.

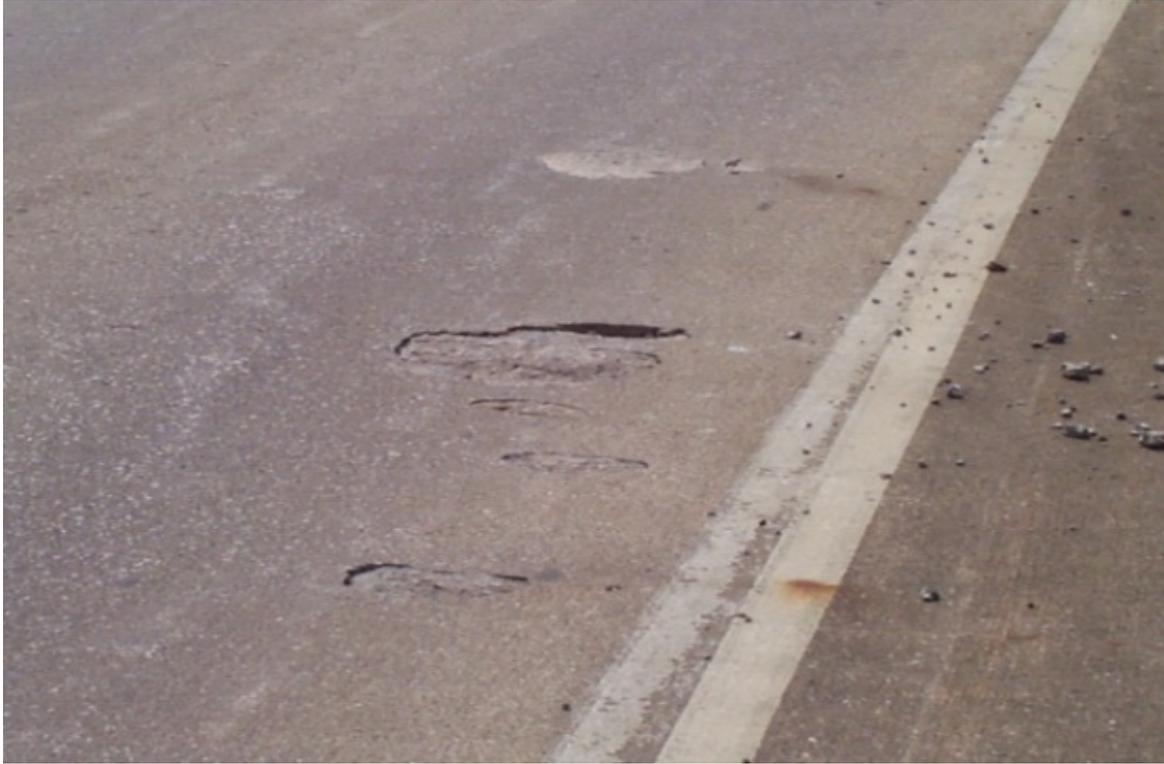
Figure 3 Spalling in concrete bridge deck.

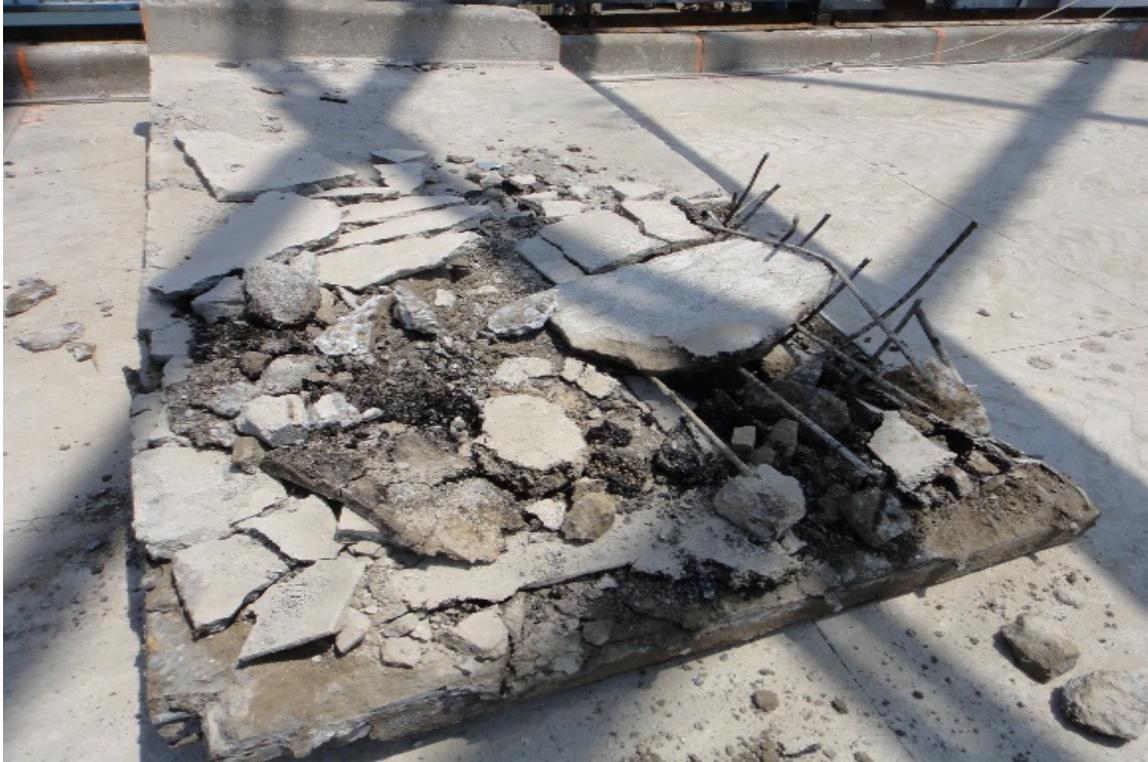
Figure 4 Corroded steel reinforcing in bridge deck.

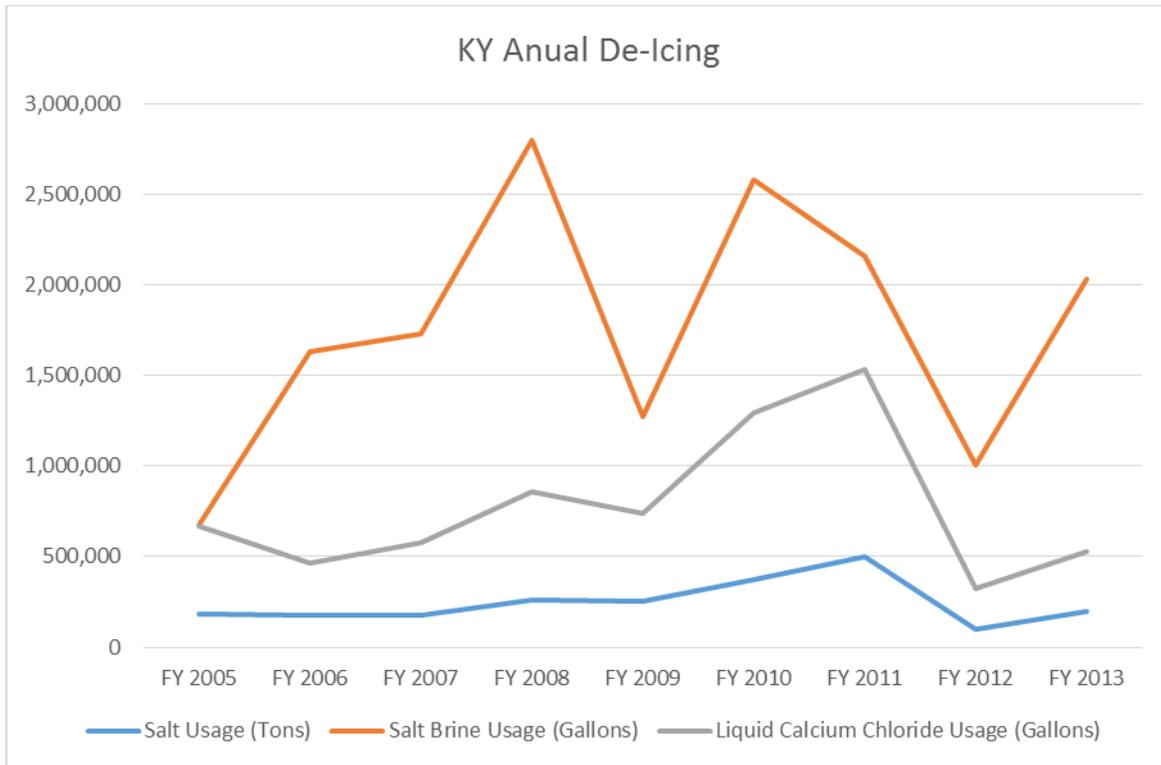
Figure 5 Deicing chemical usage by KYTC districts.

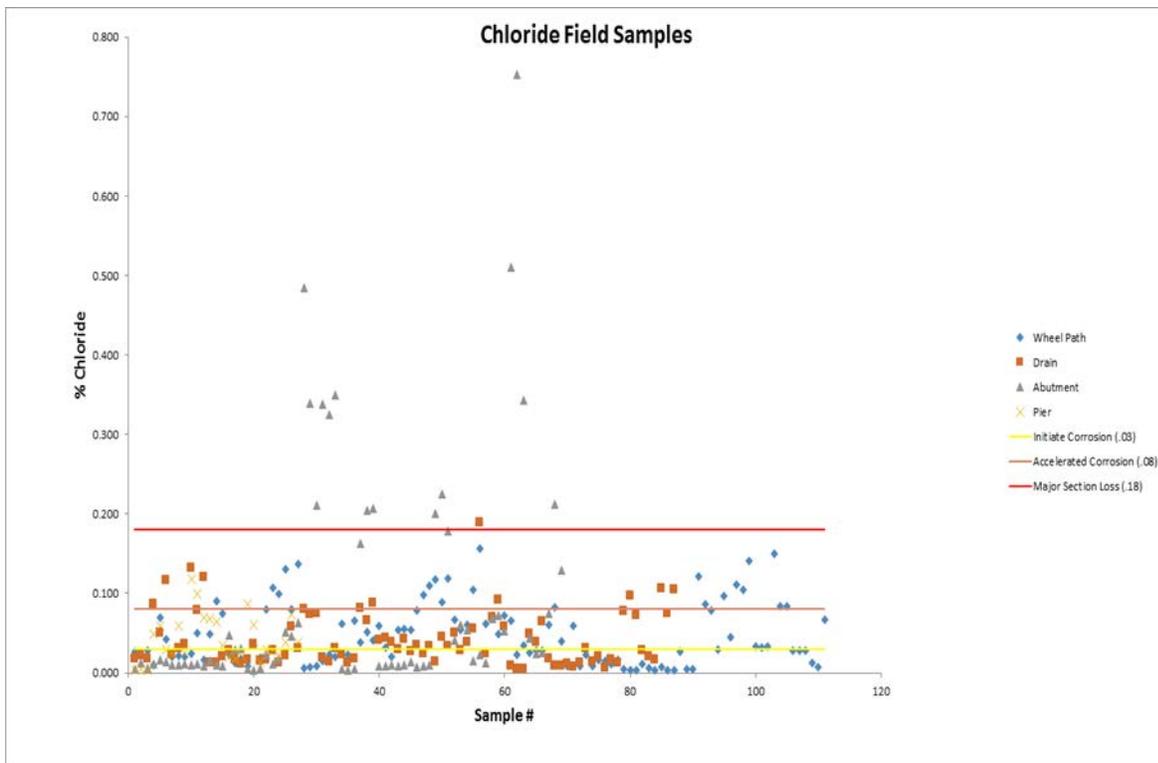
Figure 6 Chloride contamination in KYTC bridges.

By 2012 reinforced structural concrete in KYTC bridges showed visible signs of deterioration, with increasing deck and substructure damage. In 2011, KTC collected samples from 24 KYTC bridges in central Kentucky. Samples were taken from bridge deck wheel paths, deck gutters, abutments, and where accessible, pier caps. The concrete samples were taken at a depth of 1.5 to 2.0 inches. KTC collected samples from the deck gutter and wheel path and both ends of each bridge. Samples were also obtained from one abutment at each bridge and from one pier cap where accessible. These data are more fully discussed in Kentucky Transportation Center Report No: KTC-14-3/SPR406-10-1F. Testing revealed that chloride contamination had greatly increased from 2002 to 2011. As shown in Figure 6, many samples from bridge decks exceeded the 0.03 percent chloride level which initiates rebar corrosion.

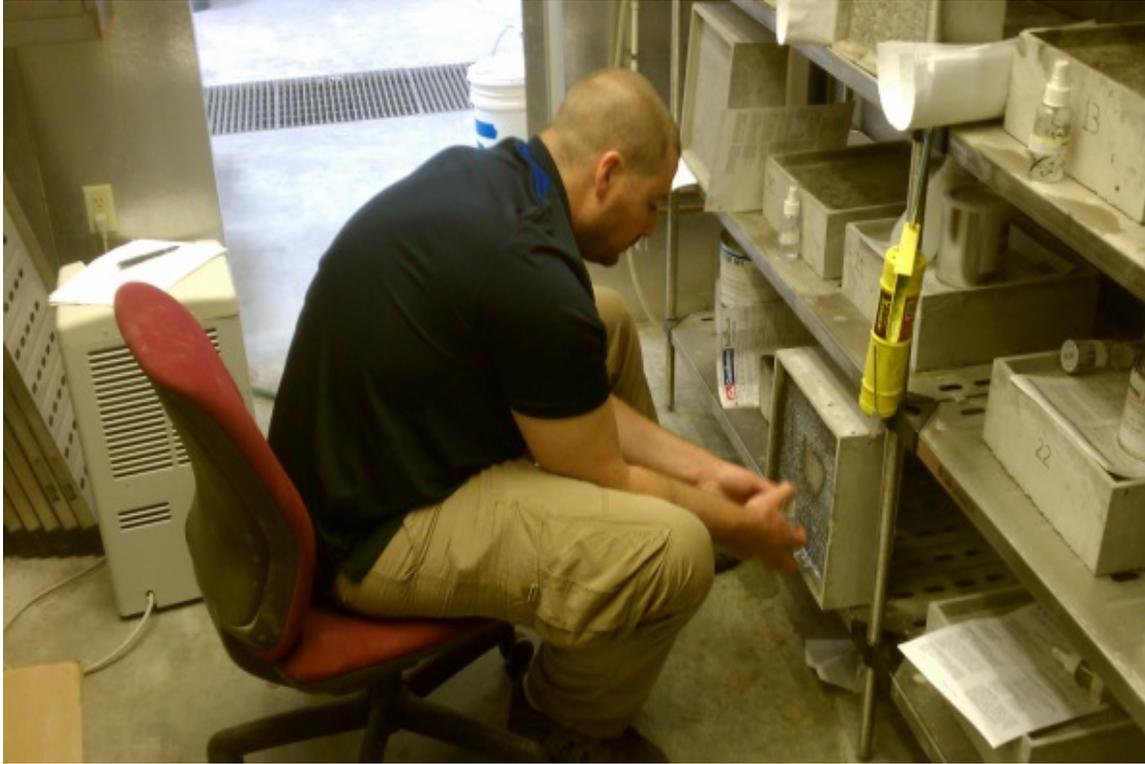
Figure 7 Application of sealant to ponding block.

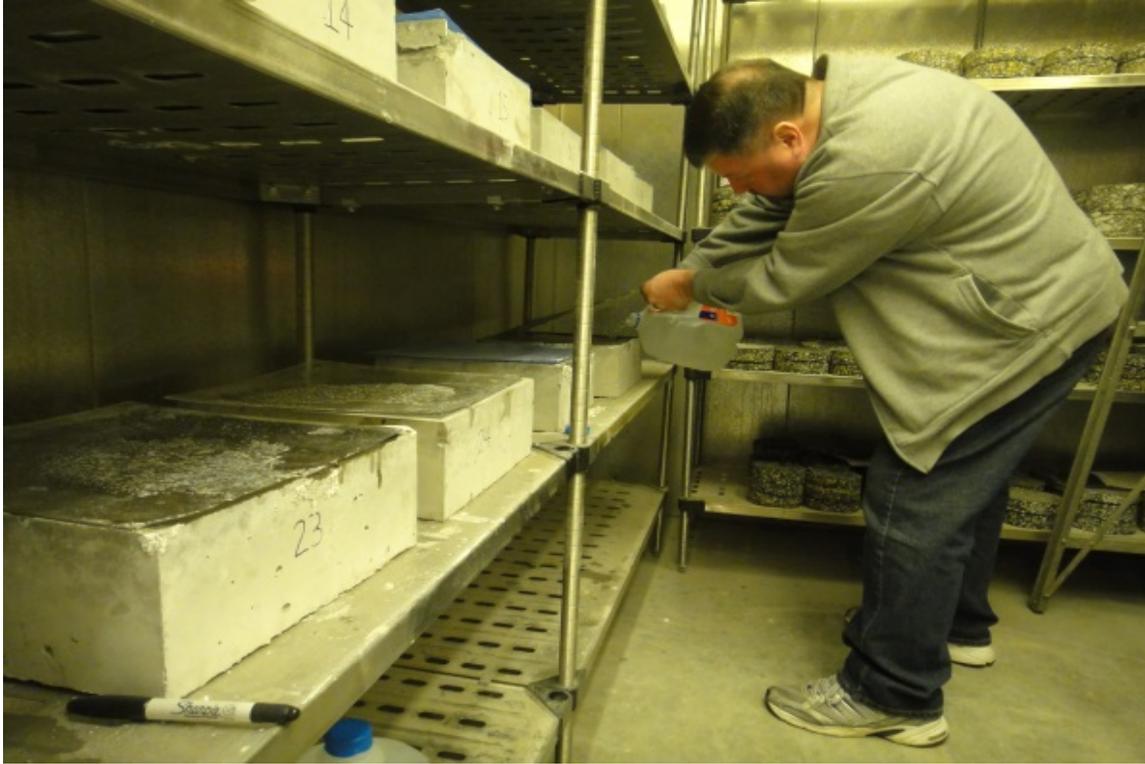
Figure 8 Refilling Sodium Chloride solution.

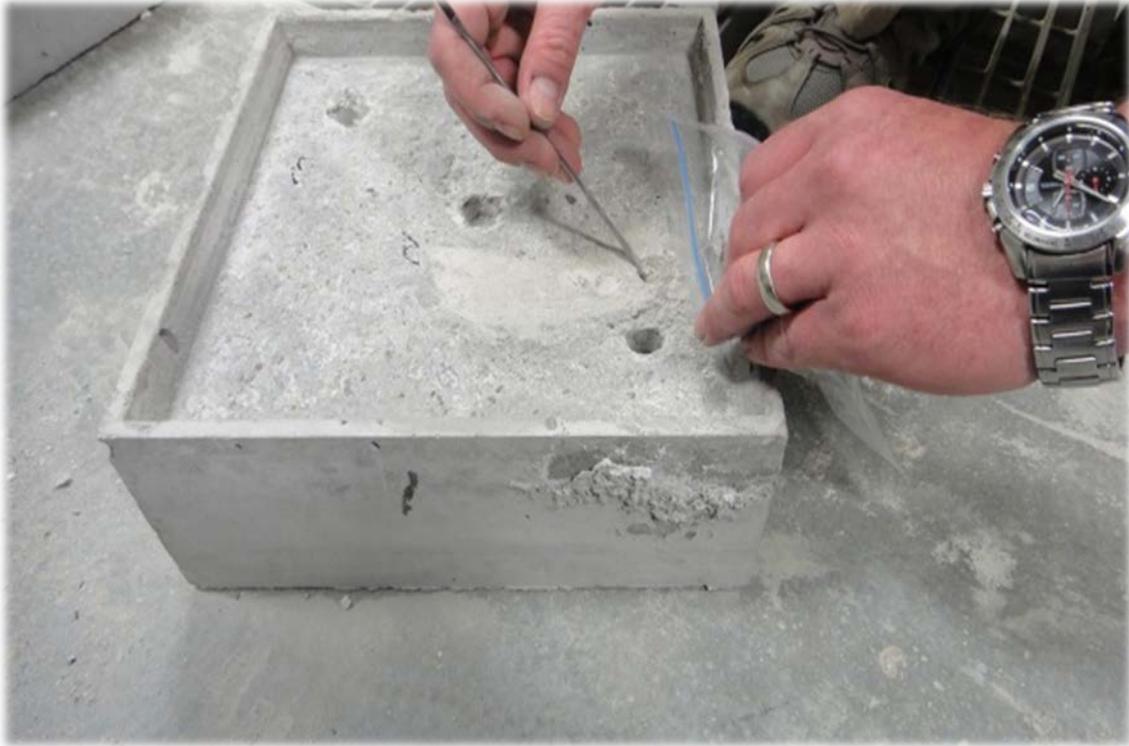
Figure 9 Collecting sample for test content.

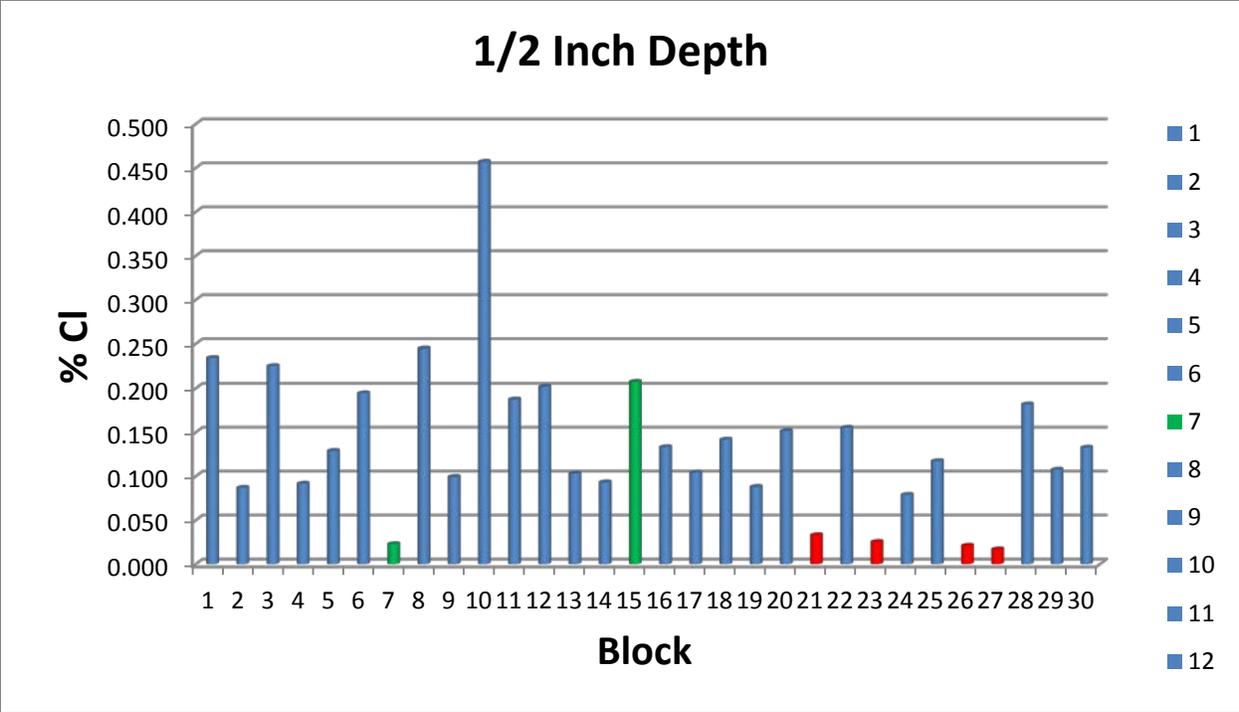
Figure 10. Chloride by percent weight of Concrete at 1/2 inch depth (Germann test results).

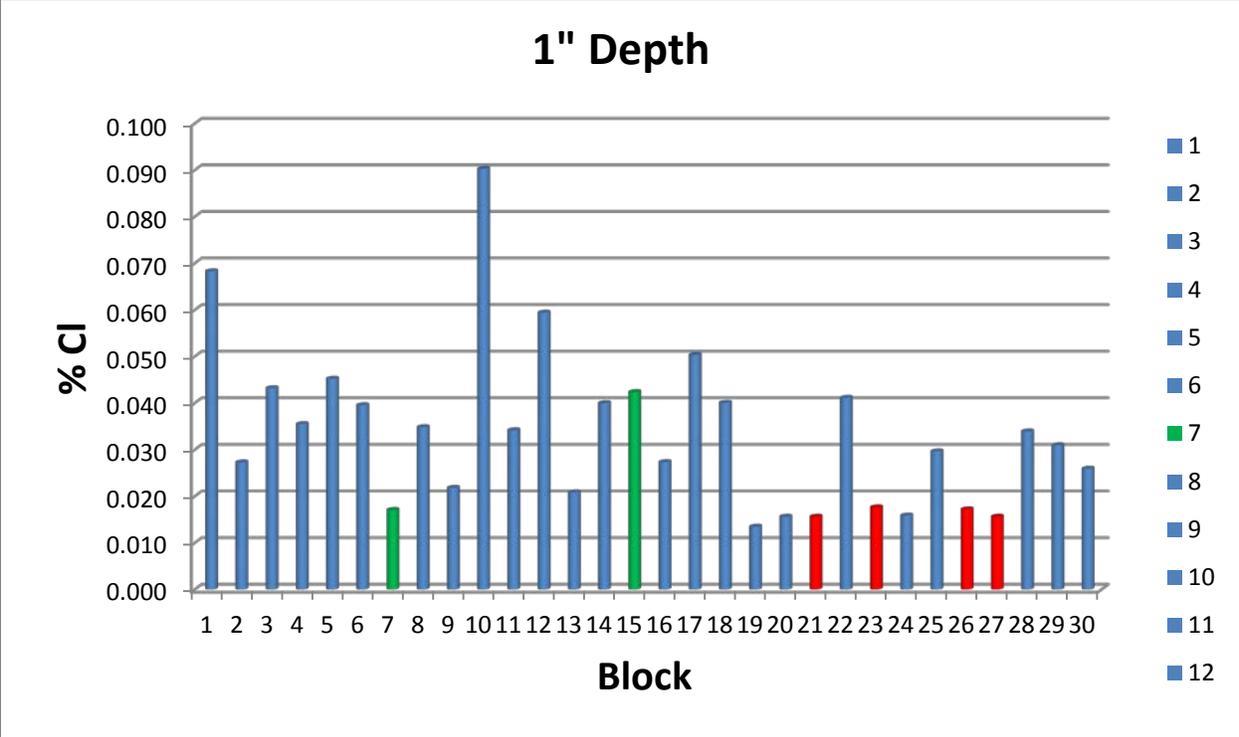
Figure 11. Chloride by percent weight of Concrete at 1 inch depth (Germann test results).

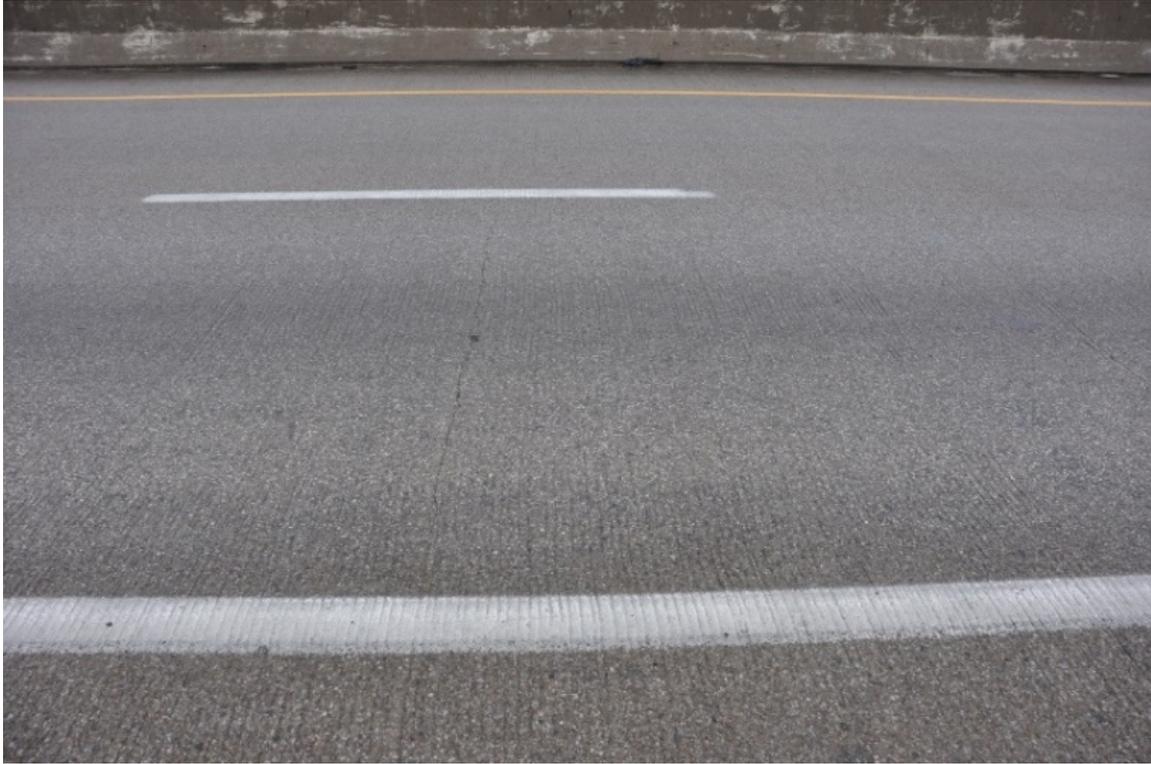
Figure 12. Transverse cracking in negative moment area.

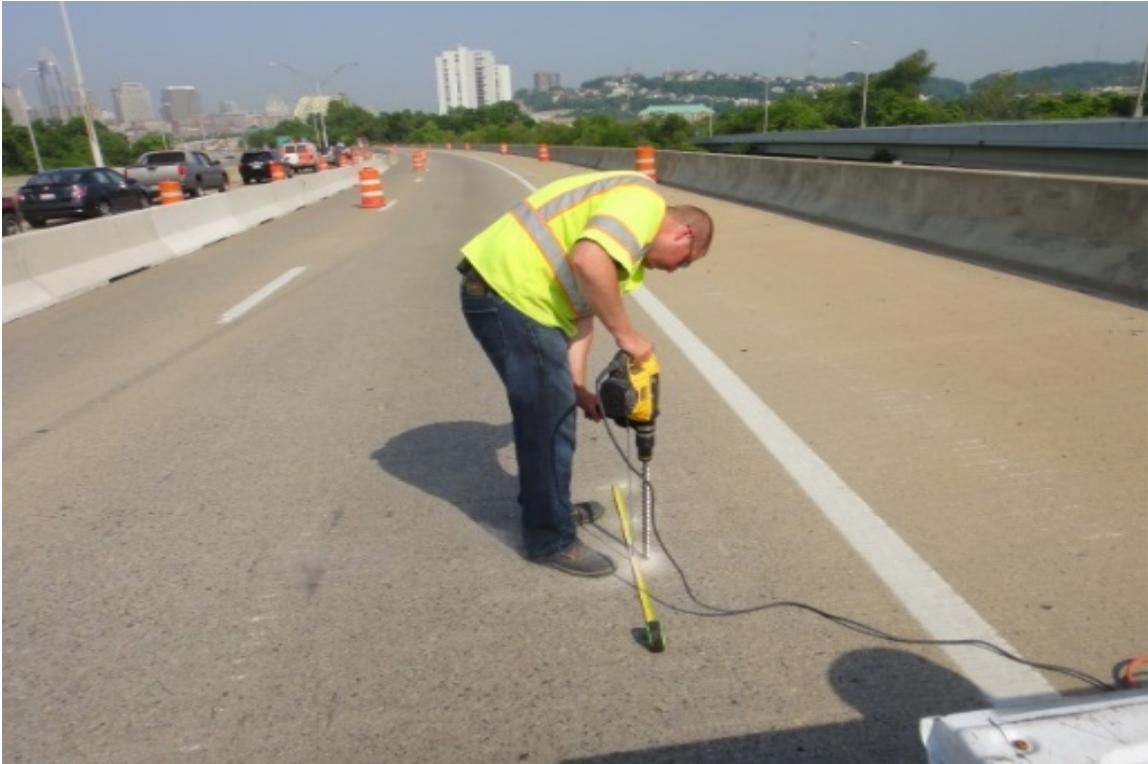
Figure 13. Collecting concrete samples from bridge decks.

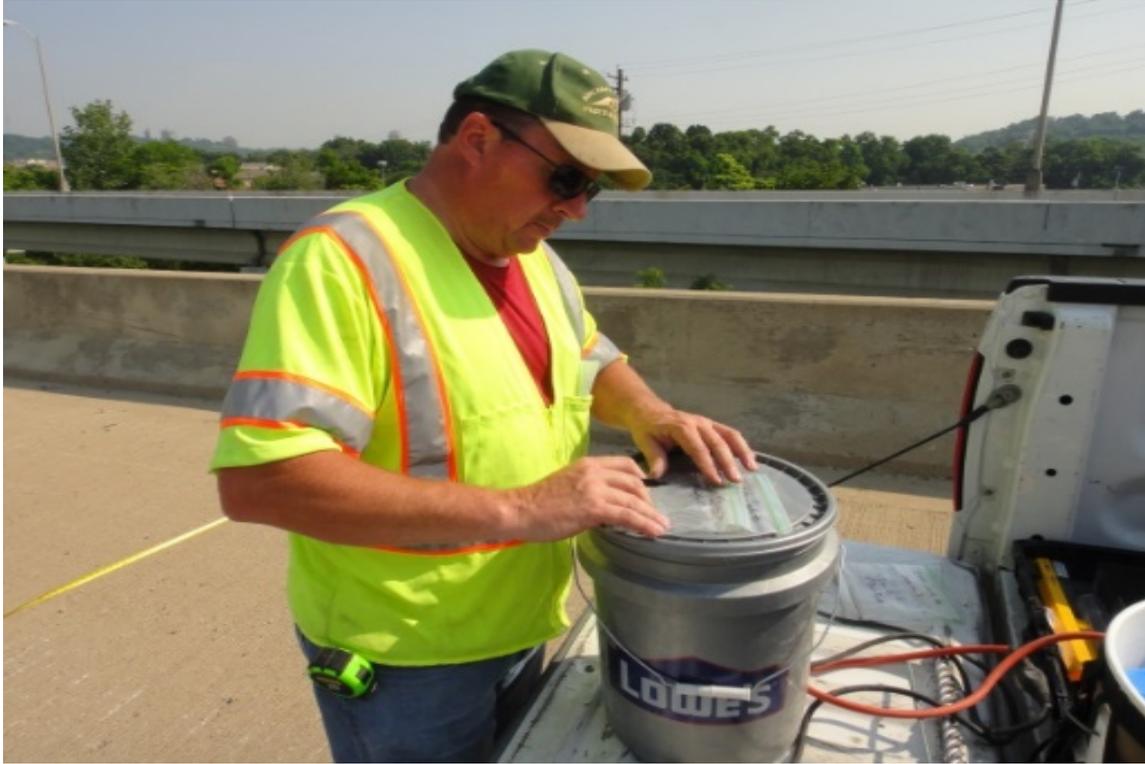
Figure 14. Collecting concrete deck samples.

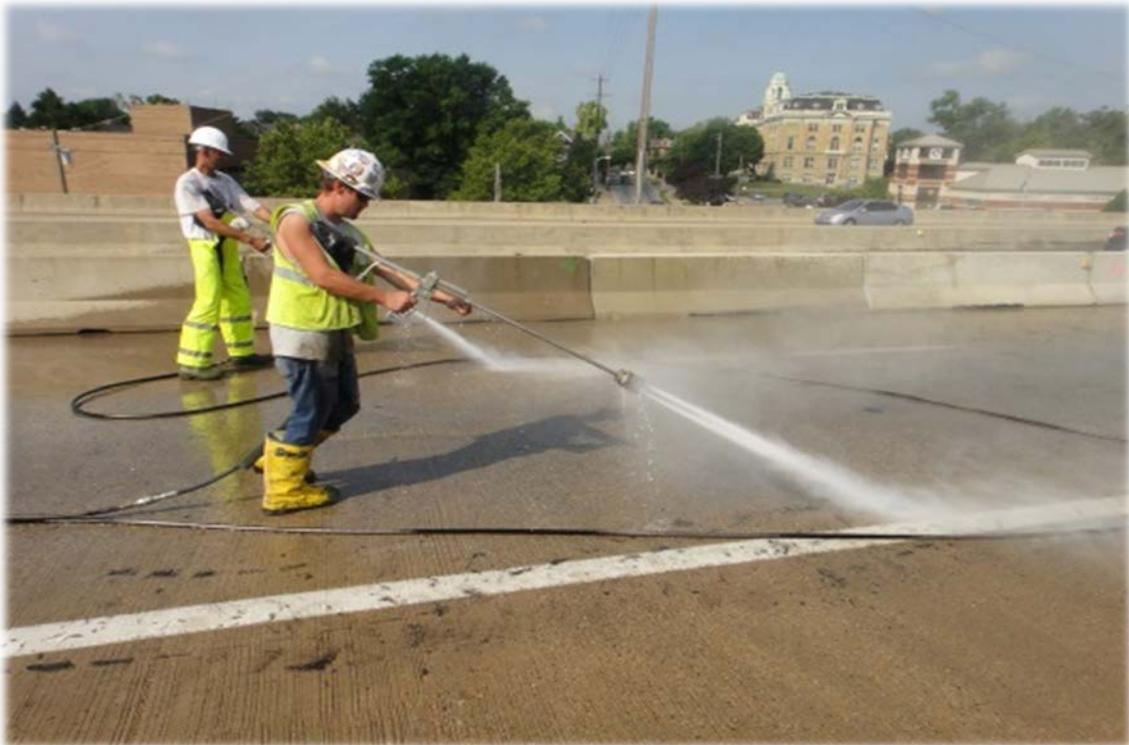
Figure 15. Cleaning bridge deck by pressure washing.

The contractor began pressure washing the two right lanes of the northbound bridge (half of Test Areas 3 & 5) on June 12, 2012 (Figure 15). The contractor used an NLB Corporation Series 125 pressure washer, operating two wands fitted with 0° spinner tips. The pressure washer generated approximately 7,000 psi (Figure 16) and water usage calculated to approximately 6 gallons per minute for each wand. Representatives from BASF and ChemMasters were on site to observe the surface preparation, and both approved of the surface preparation. After completing the pressure washing, the decks were allowed to dry overnight.

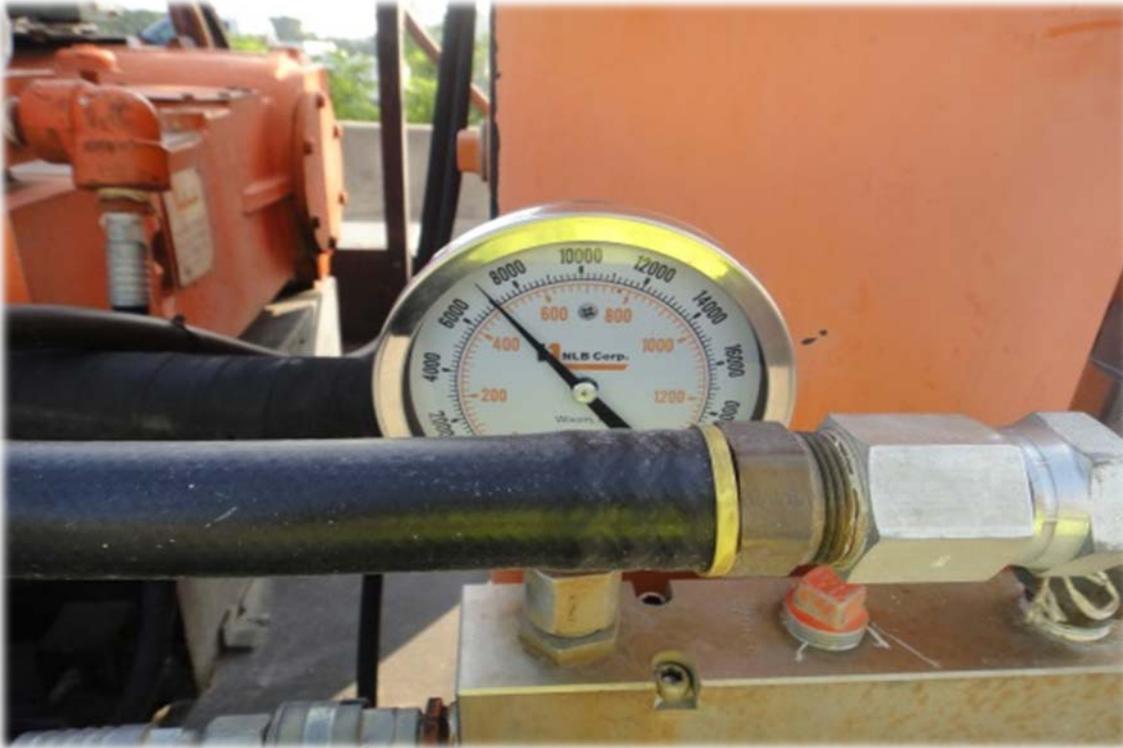
Figure 16. Cleaning water pressure gauge at the washer.

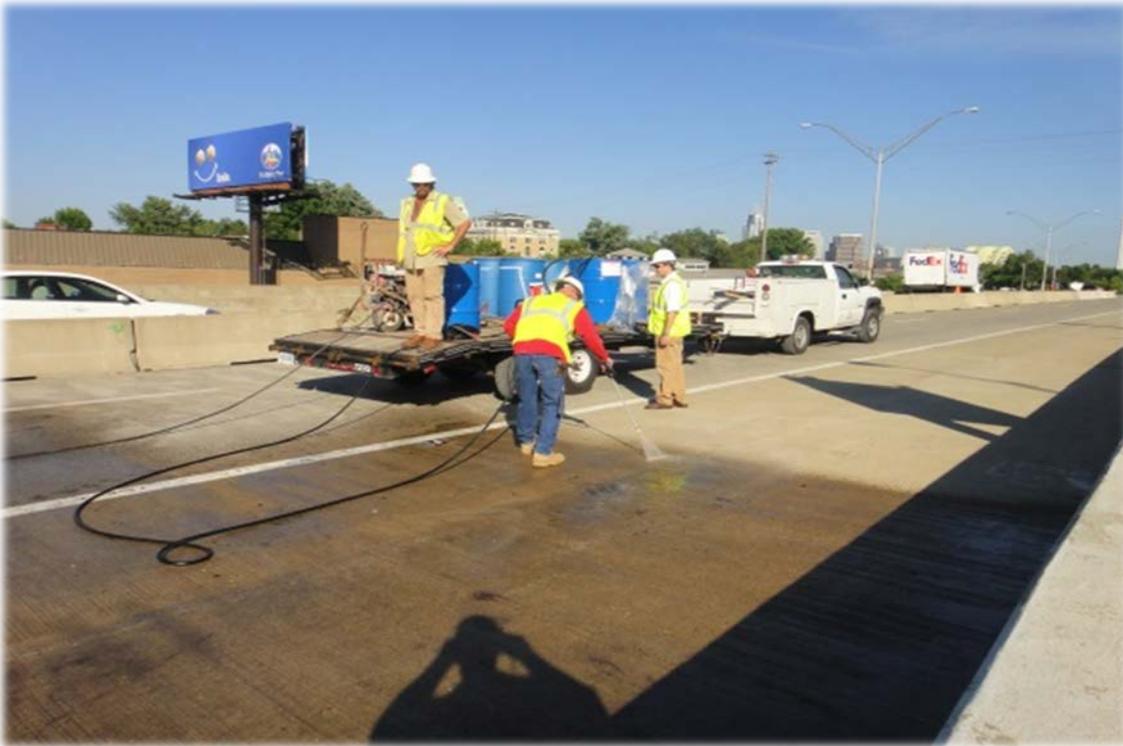
Figure 17. Aquinil Plus 40 sealant application.

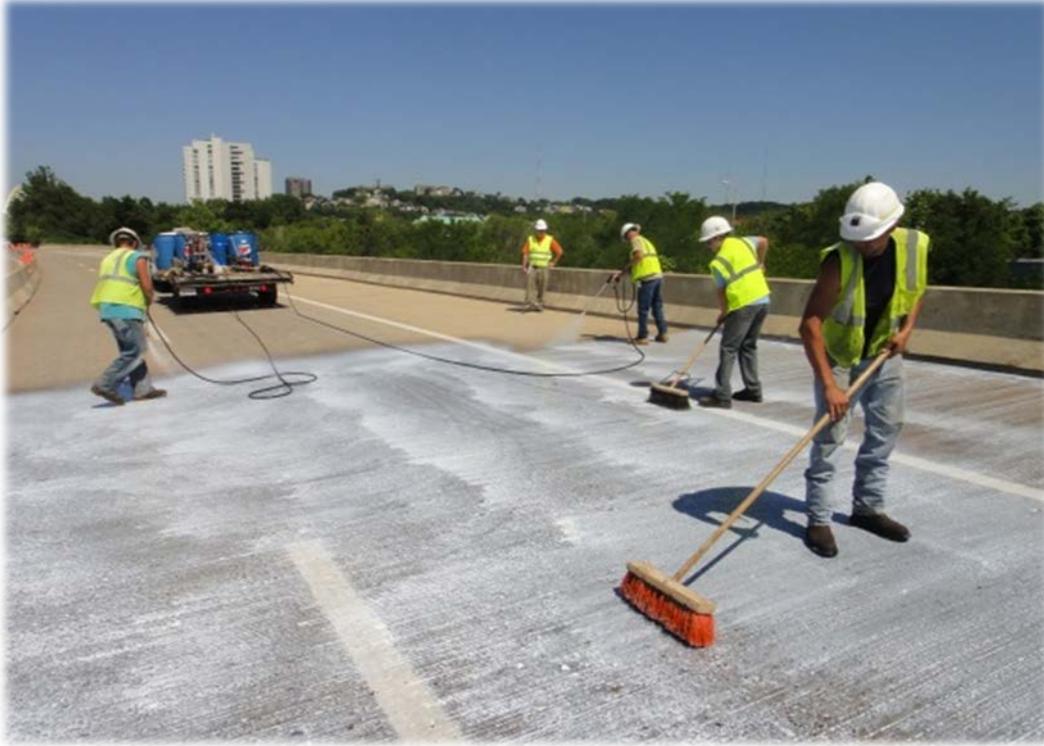
Figure 18. BASF Enviroseal 40 sealant application.

BASF Enviroseal 40 was applied to the two right lanes and shoulder of Test Area 5 beginning at 11:15 AM using the same procedure (Figure 18). The fan tips were changed in an effort to equalize output. The BMS75 used a 45° tip and the Razorback used a 65° tip. The BASF representative advised targeting 100 to 200 ft²/gallon of sealant and recommended using the same target application rate as ChemMasters Aquinil Plus 40. The same method of application was used to achieve the desired application rate. After changing the tip size the

output from the pumps appeared more evenly matched. As recommended by the manufacturer, the contractor used brooms to spread the material evenly over the decks. This sealant was applied to approximately 18,300 ft² and total usage was 160 gallons (114 ft²/gallon). Spray out was completed at 12:30 PM.

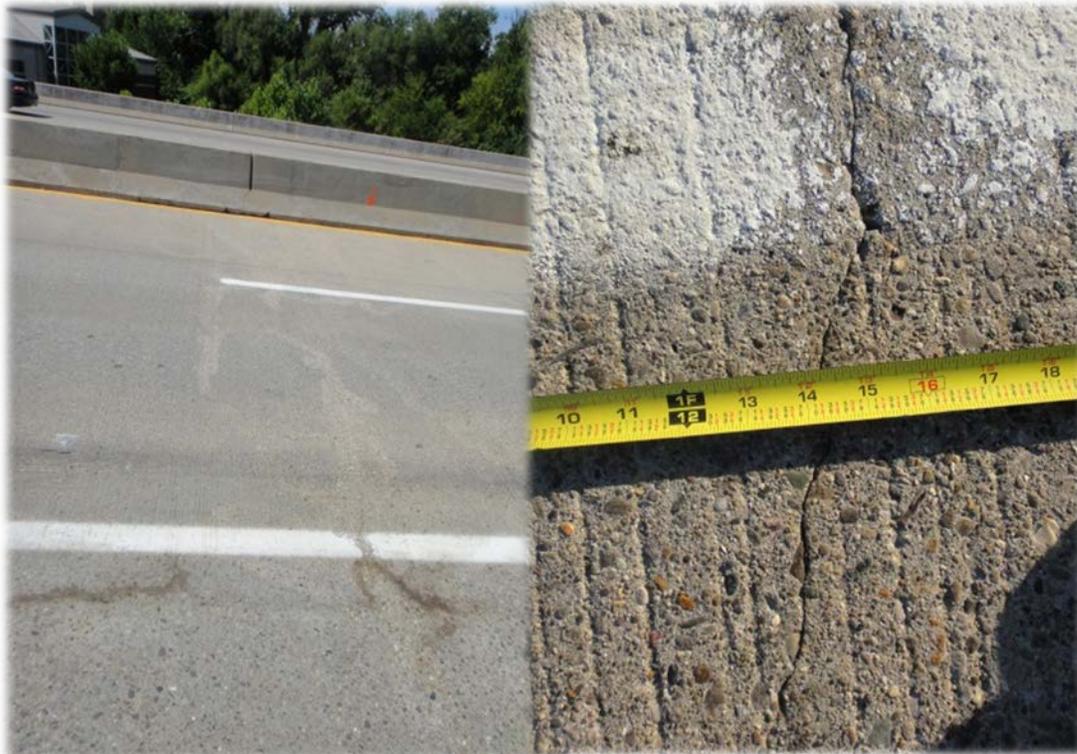
Figure 19. "Pre-washed" crack on the deck.

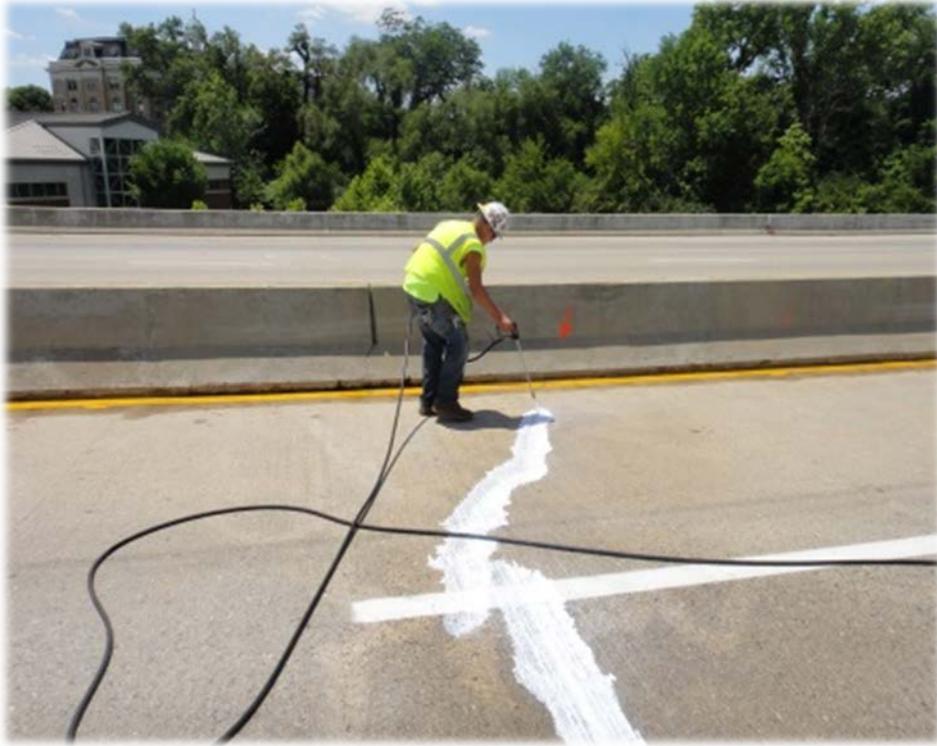
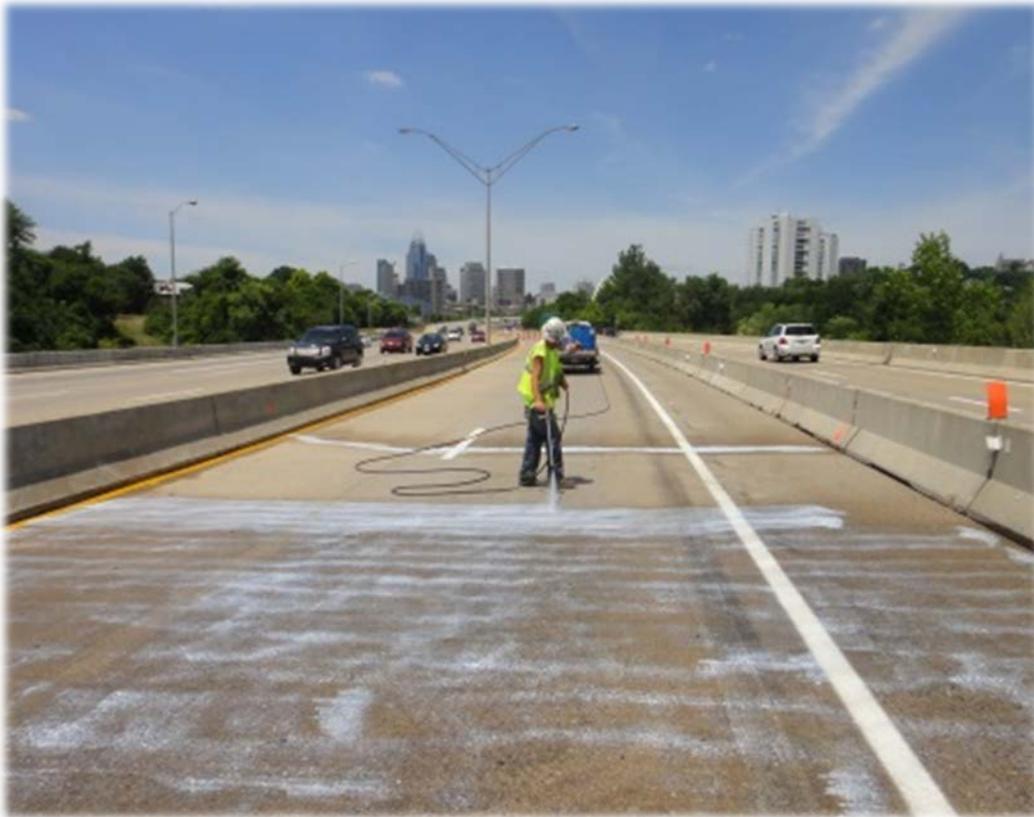
Figure 20. Flooding "Pre-Washed" Crack with pre-sealer.

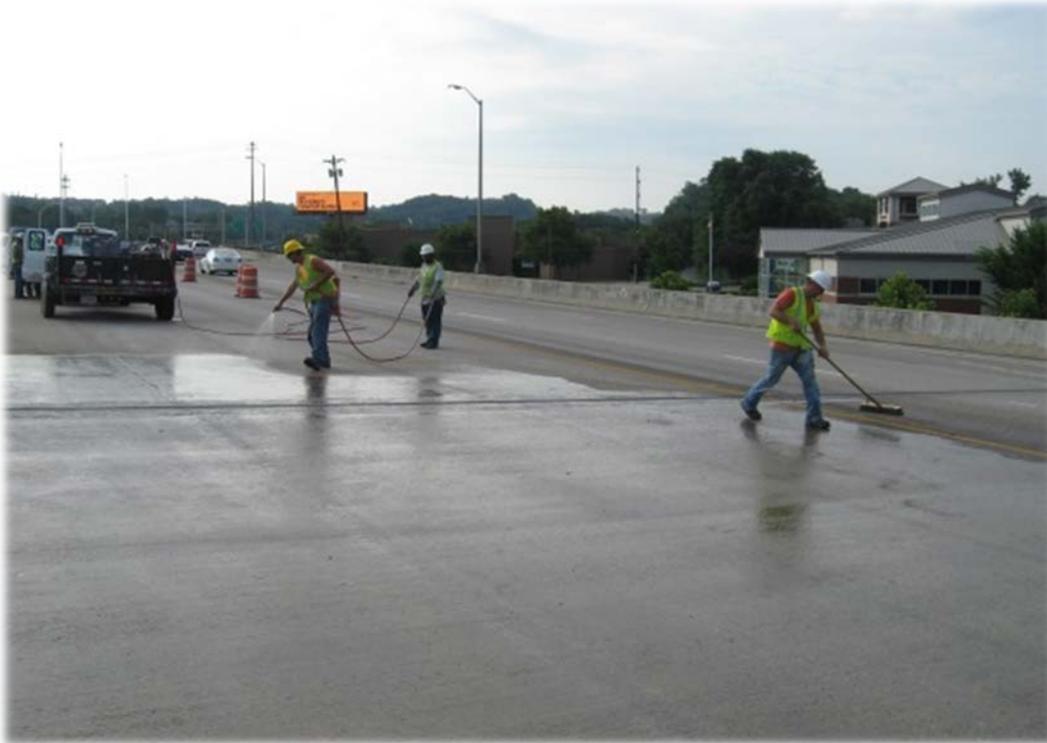
Figure 21. Application of sealant with garden hose.

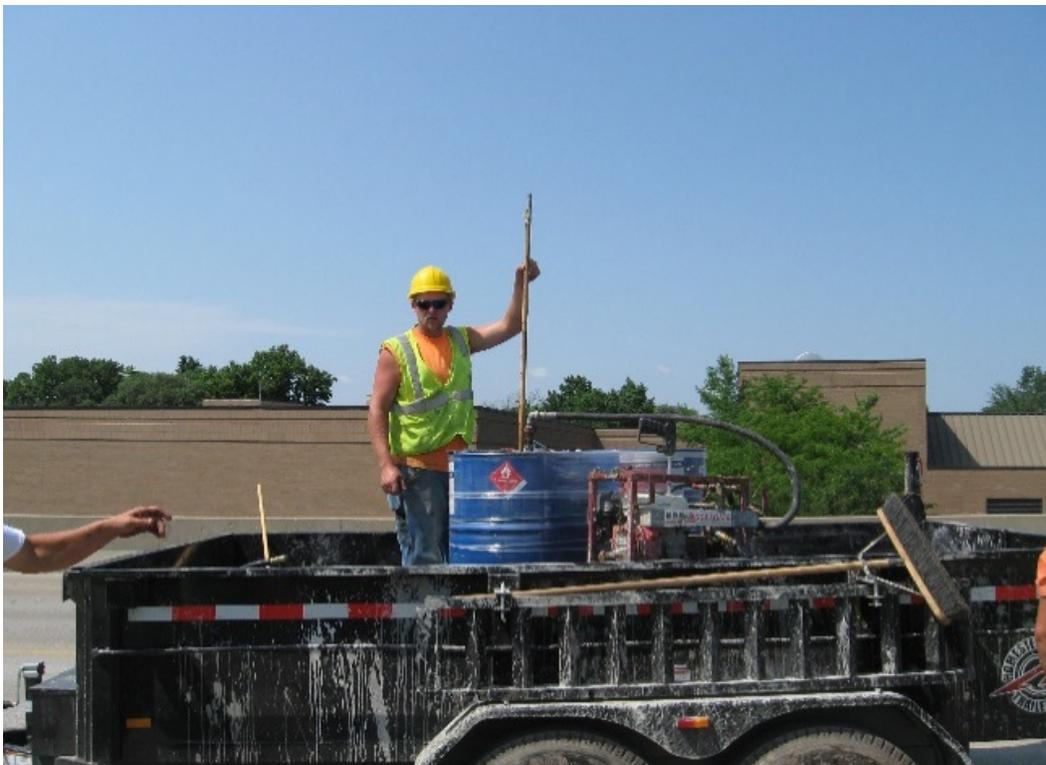
Figure 22. Measurement of sealant applied on the deck.

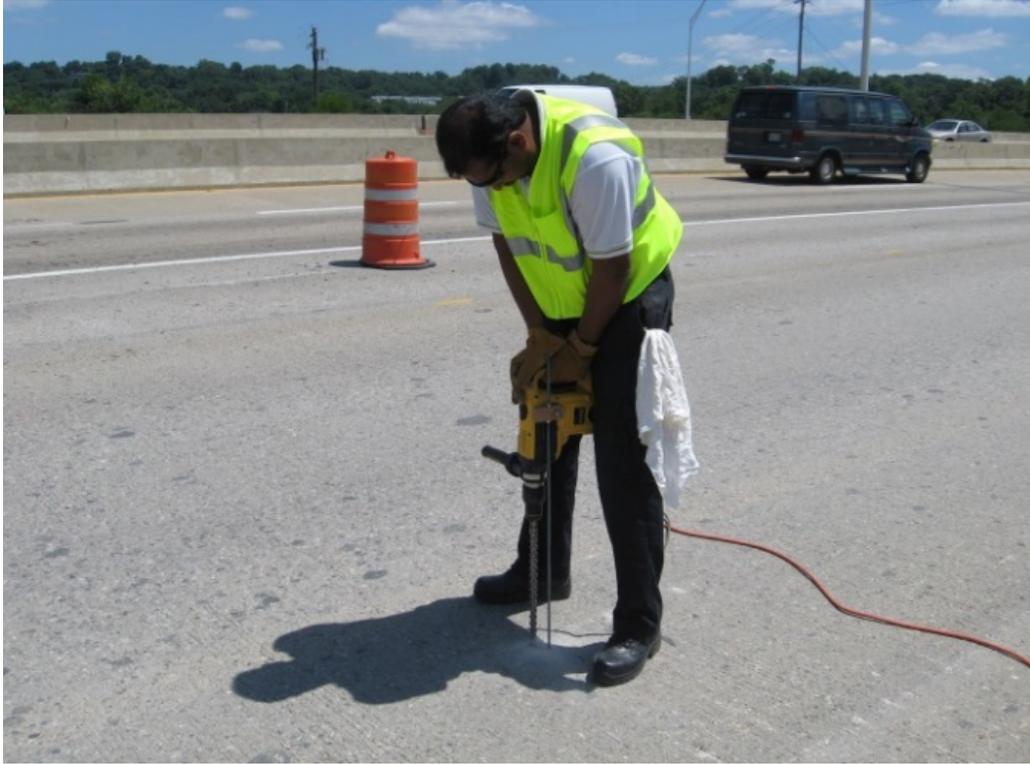
Figure 23. Sample Collection after Deck Sealing.
