KTC-14-04/FRT 194, SPR388-12-1F

**Sealants, Treatments and Deicing Salt Practices to Limit Bridge Deck
Corrosion and Experimental Deck Sealants and Pier Cap Coating on
Interstate 471**

May 2014

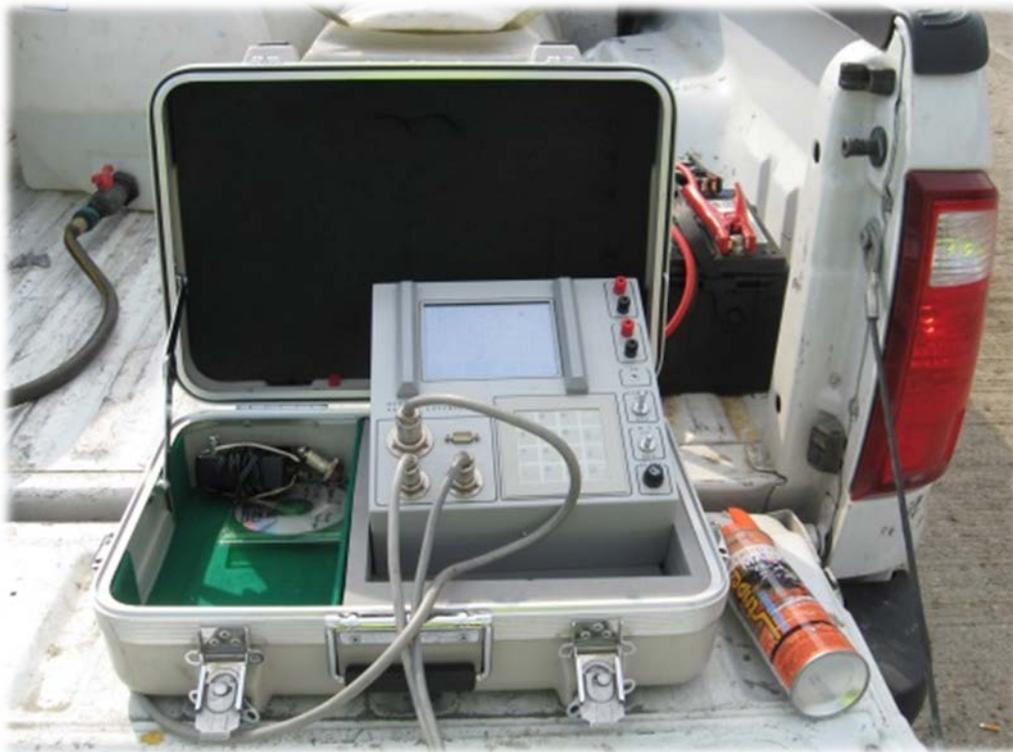
Figure 24. Dynamic Friction Tester.

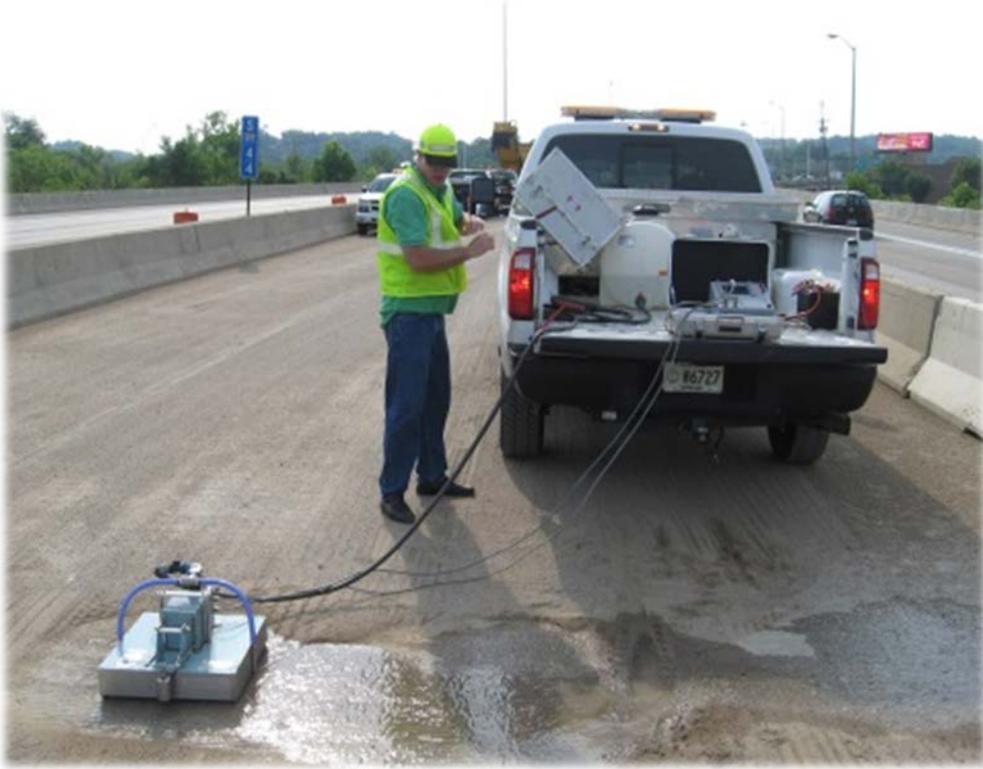
Figure 25. Dynamic Friction Tester in use.

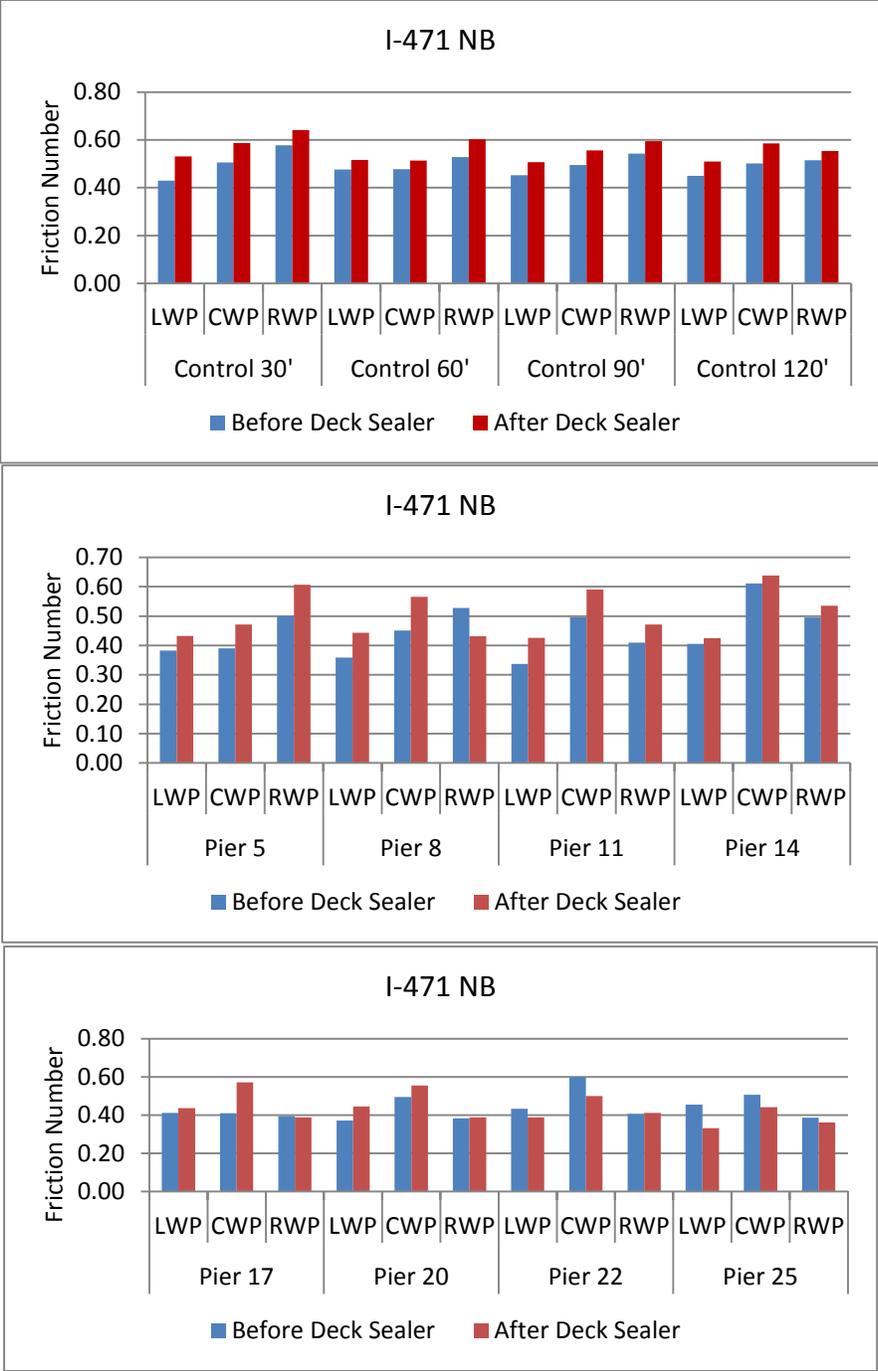
Figure 26. North Bound Friction Test Graph

Control Section (MP 4.415)		
LWP	CWP	RWP
0.53	0.48	0.34

TK Section 1 (MP 4.315)			TK Section 2 (MP 4.365)		
LWP	CWP	RWP	LWP	CWP	RWP
0.37	0.40	0.55	0.34	0.42	0.47

BASF Section 1 (MP 4.21)			BASF Section 2 (MP 4.26)		
LWP	CWP	RWP	LWP	CWP	RWP
0.47	0.38	0.54	0.38	0.54	0.43

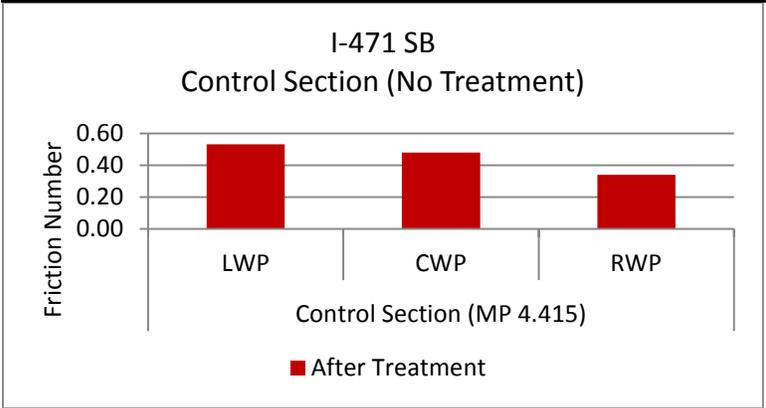
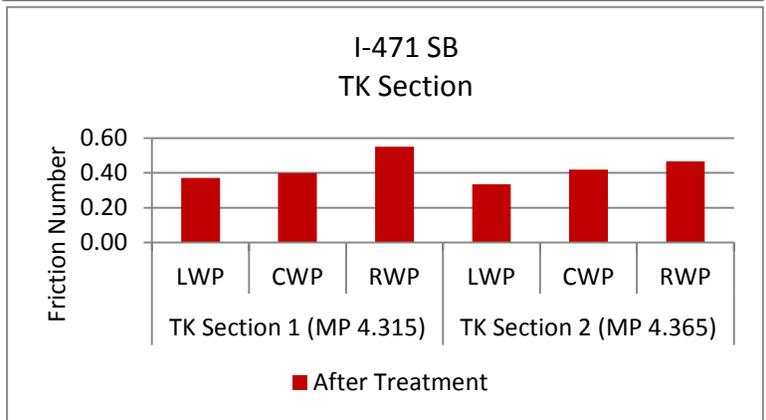
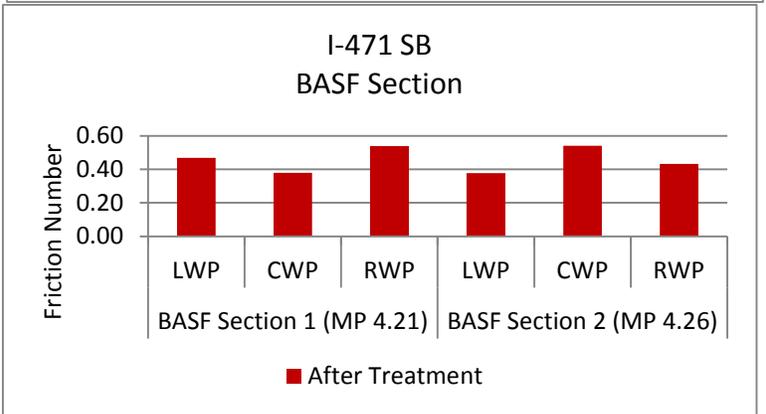
Figure 27: South Bound Friction Test Data
