ALSPAN/CHRYSLER RESEARCH SAFETY VEHICLE PHASE III FINAL TECHNICAL REPORT

Volume II: Technical Discussion

**Calspan Corporation
Advanced Technology Center
P.O. Box 400
Buffalo, New York 14225**

1. Report No. DOT-HS-805-323		2. Government Accession No.		3. Recipient's Catalog No.	
4. Title and Subtitle CALSPAN/CHRYSLER RESEARCH SAFETY VEHICLE PHASE III FINAL TECHNICAL REPORT VOLUME II - TECHNICAL DISCUSSION				5. Report Date April 1980

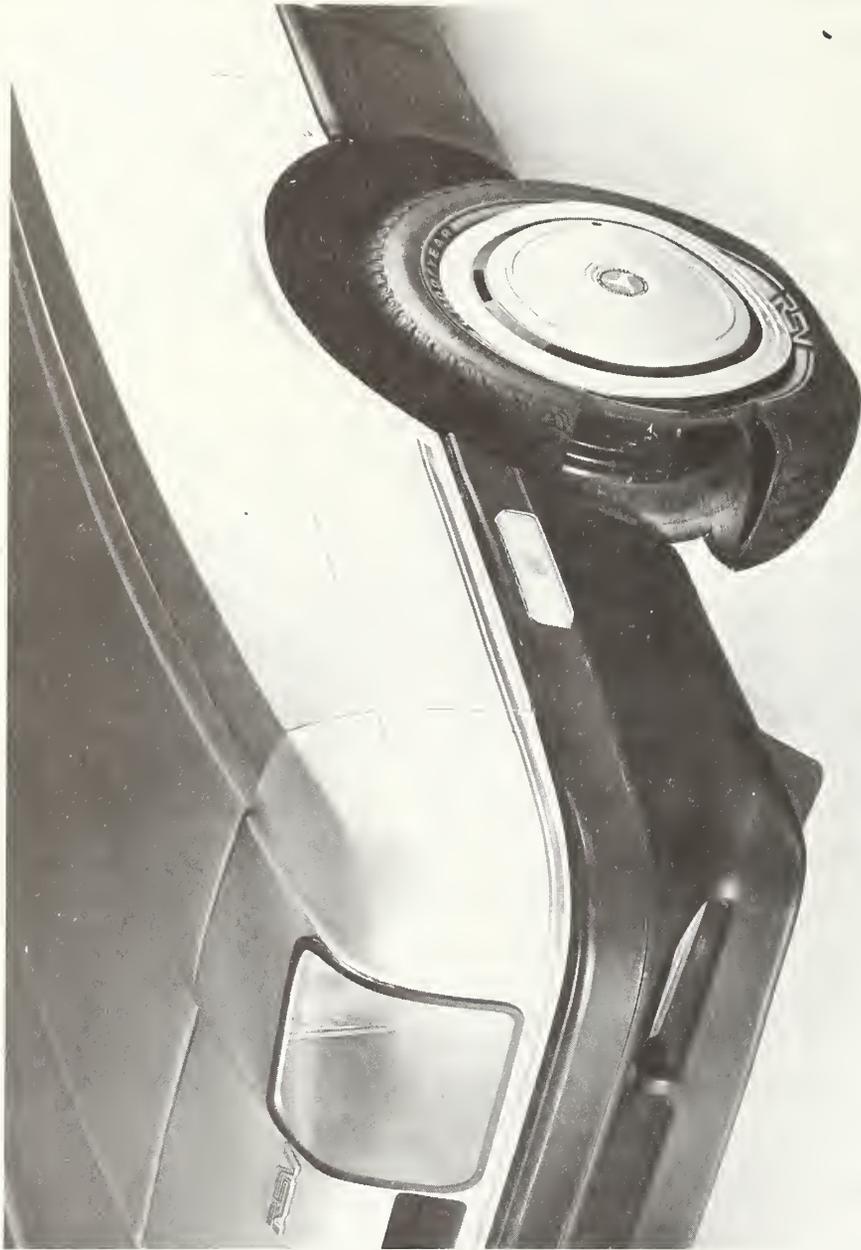
Figure 12 FLATPROOF TIRE

bars and their anchors were also redesigned. The tires were also changed during Phase III. The 14-inch Goodyear runflat tires with internal stabilizers that had been picked in the Phase II design were supplanted by new 13-inch Goodyear flatproof tires capable of supporting the vehicle on their specially designed sidewalls. These new tires were developed to provide a capability for running 40 miles at a maximum of 40 mph after the internal pressure had been depleted. Since there is so little change in vehicle response, a low pressure indicator was added to warn the driver of pressure sufficiently low that it could lead to tire destruction. These various changes are documented in References 4 through 11, 39 and 40. Figure 12 shows the 13-inch flatproof tire supporting the front of the RSV despite removal of a section to show its construction.

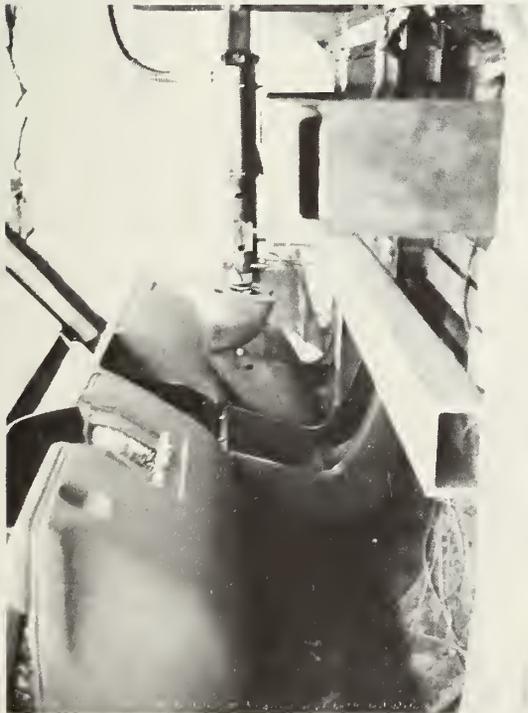
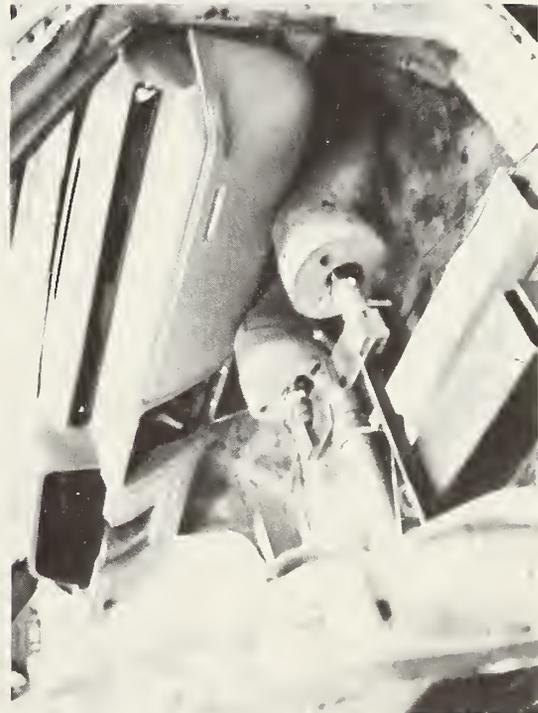
Figure 26 RSV KNEE BLOCKER CRUSH TEST

After the frontal barrier crash of the prototype front structure, another series of static crush tests was performed to develop an appropriate support structure for the knee blocker. Its purpose was to provide the desired kinematic responses of the occupants despite the severe acceleration experienced in the barrier tests. This effort is discussed in Reference 15. Figure 26 shows the manner in which the dummy knees were forced into the knee blocker in the sled buck. The support structure, shown in Figure 27, was developed to provide a resistance to knee motion consistent with the results of the modeling effort discussed previously in Section 5.2. Results of sled tests utilizing this revised knee blocker support are discussed in the next section.

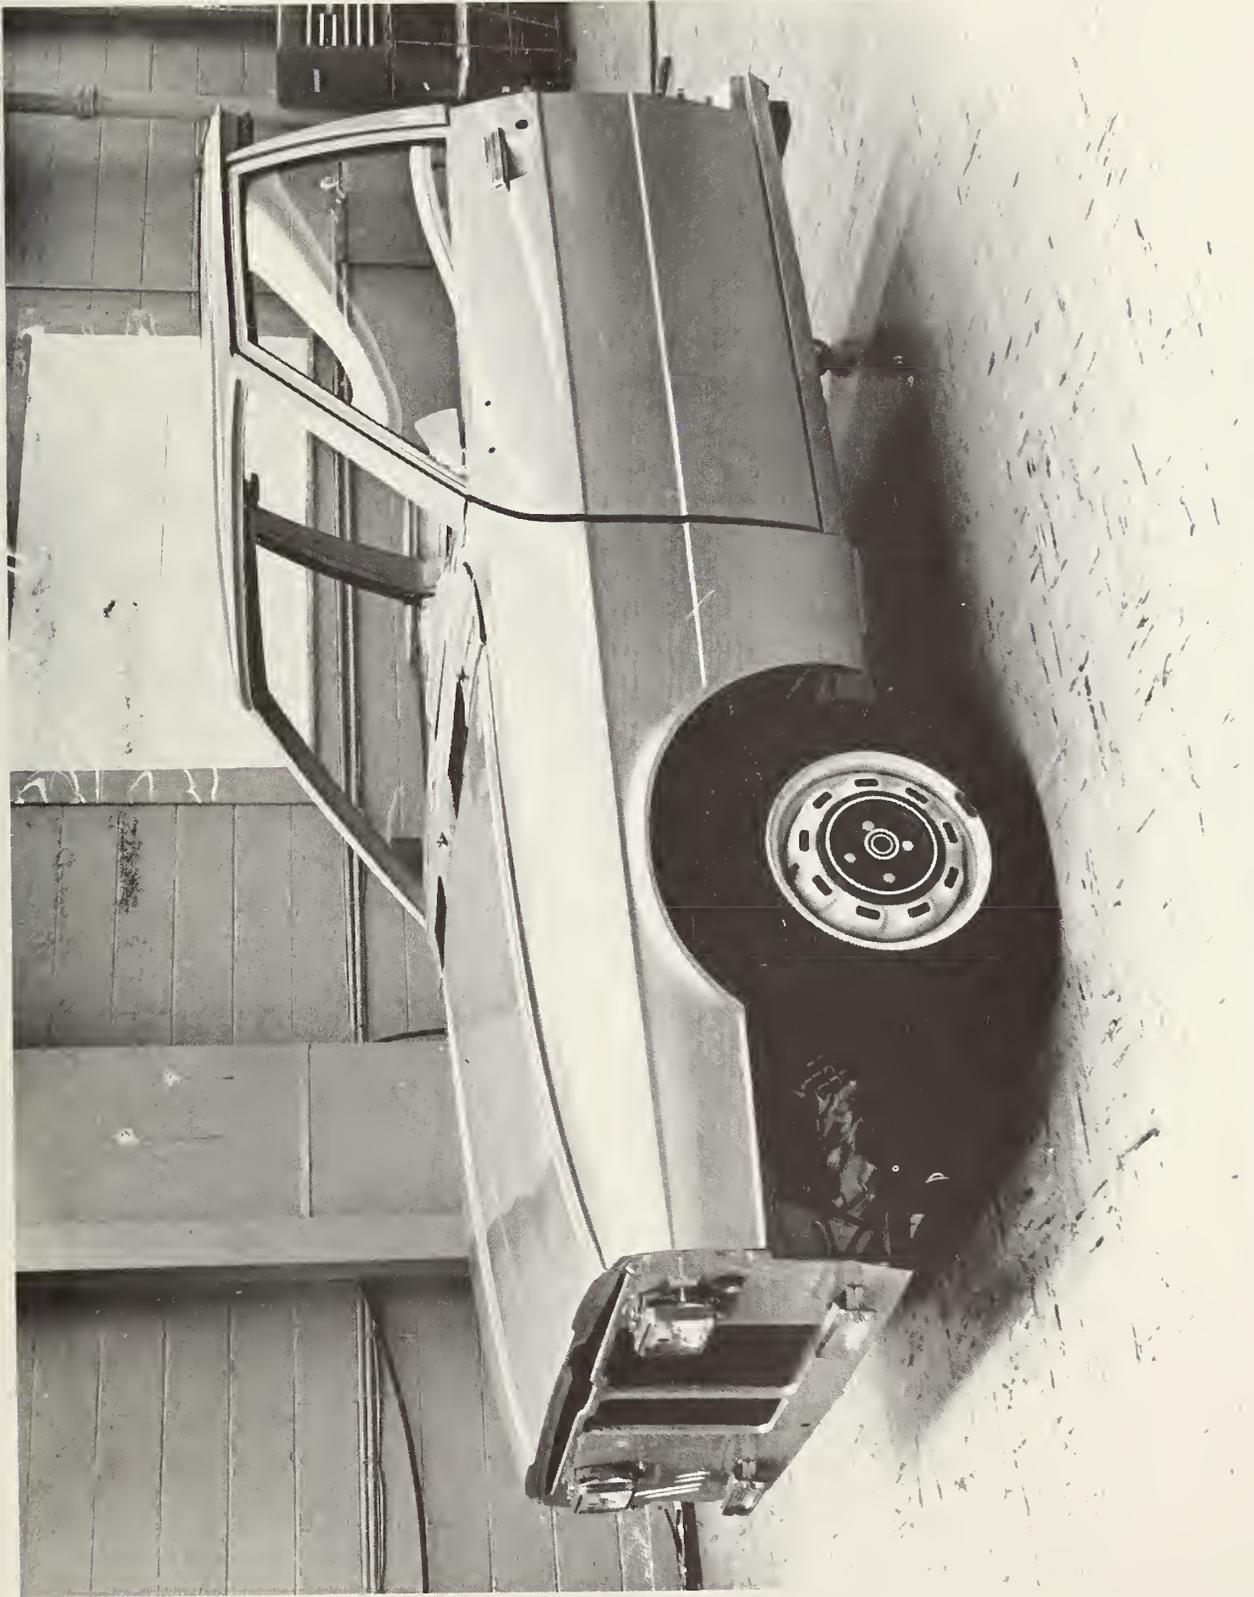
Figure 38 SIDE VIEW OF PEDESTRIAN CRASH BUCK WITHOUT BUMPER,
WINDSHIELD OR MIRRORS

For testing during Phase IV, ten vehicles were fabricated by Creative Industries of Detroit. They consisted of two pedestrian test bucks and eight driveable cars manufactured in accordance with the Build Definition identified in Section 13.1 below. The fabrication of all test cars was completed by April 1979 and delivery of the last RSV to NHTSA on 8 May 1979. Delivery dates are indicated on Figure 5, the RSV Phase III Schedule, and in Section 14. The car is shown in Figures 1 through 4; Figure 38 shows one of the pedestrian test bucks just prior to completion.
