Report No. FHWA-RD-73-24

# DIAGRAMMATIC GUIDE SIGNS FOR USE ON CONTROLLED ACCESS HIGHWAYS.

## III. Traffic Engineering Evaluation of Diagrammatic Guide Signs.

Part 2. The I-495 (Capital Beltway)/I-70S Field Study.

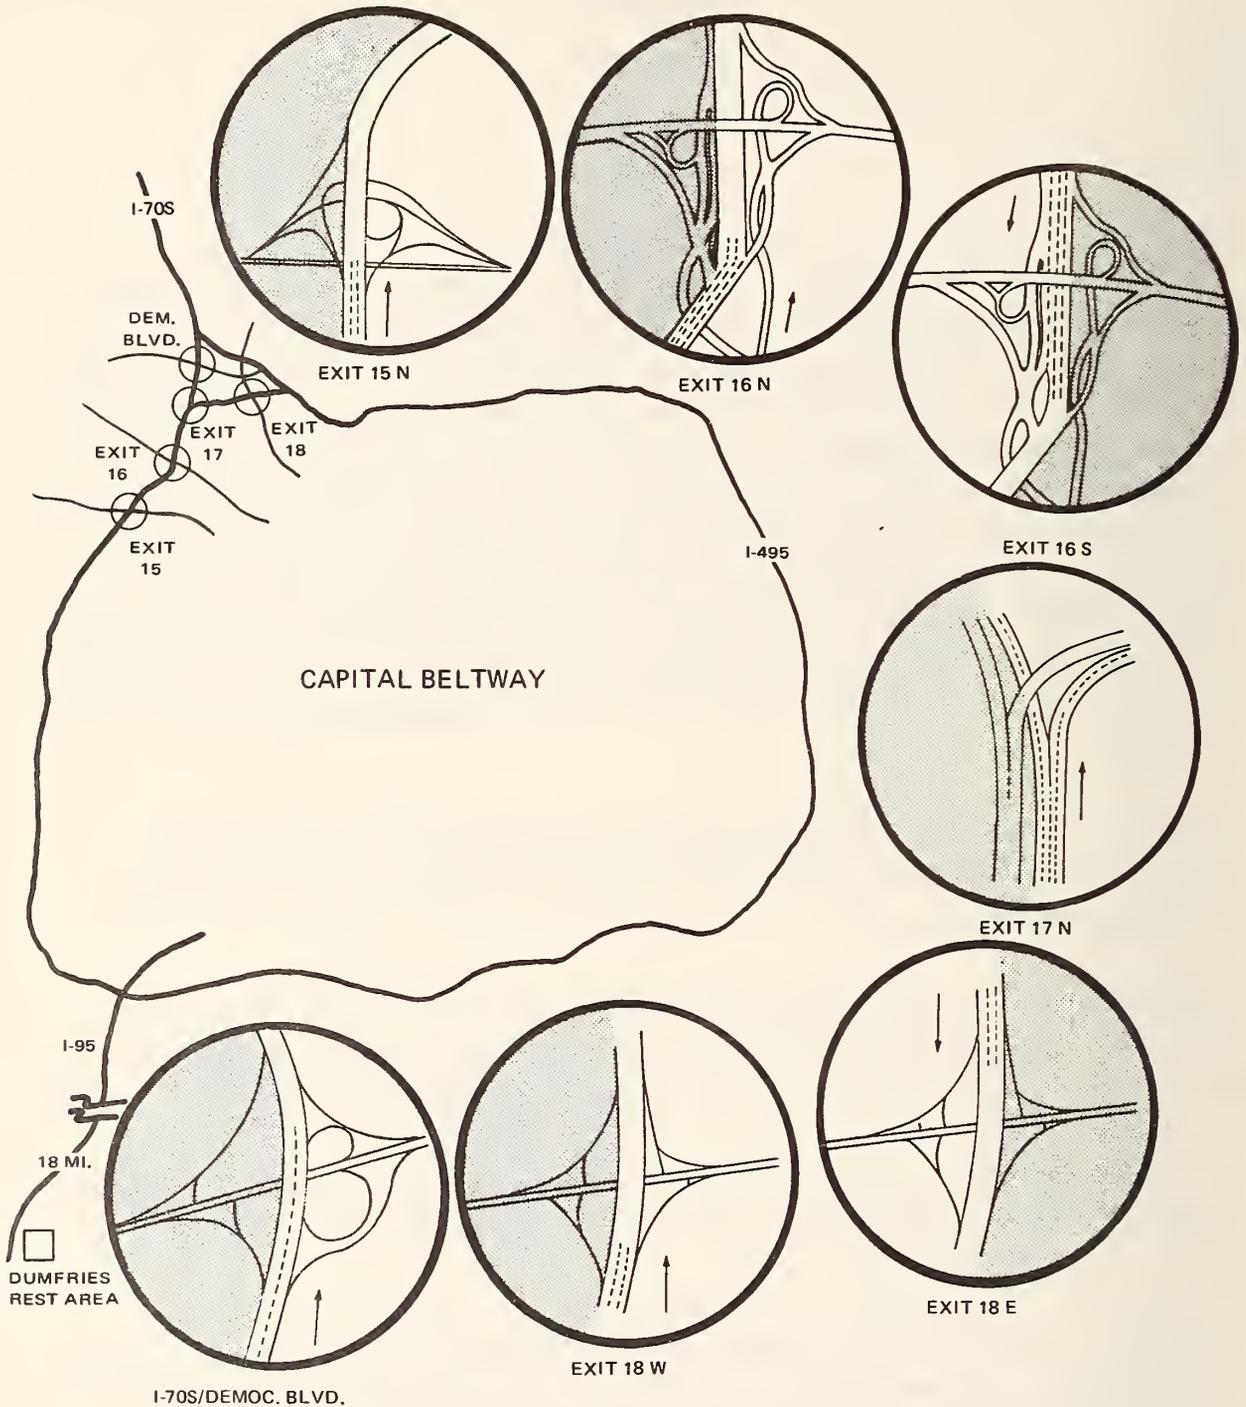
Figure 1. Location of study interchanges. White areas of inserts show each approach studied and the direction of traffic flow on that approach. (Through traffic lanes in the approach direction only are shown.) It will be noted that approaches vary from two to four lanes.

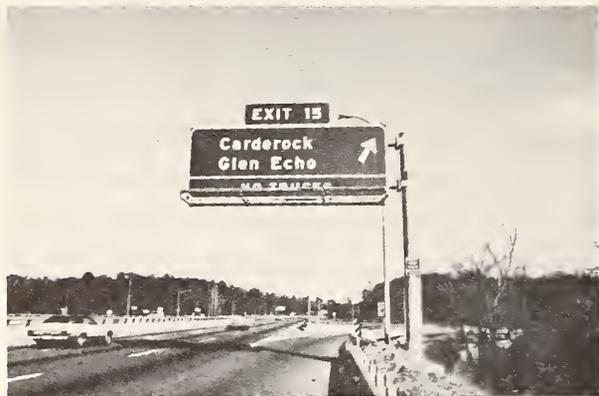
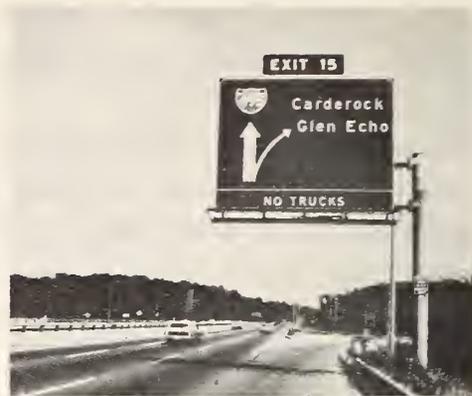
INTERCHANGE 15 GORE(EXIT) SIGN (No Advance Signs)

Figure 2. Before/After signs of Capital Beltway Interchanges 15, 16, 17, and 18 respectively, and the 70S/Democracy Boulevard Interchange.

Review of Table 1 indicates that in overall size, the new signs were generally larger than the old, sometimes by a considerable amount. Increases in height (as opposed to width) necessary to accommodate the diagrammatic were the major cause of the overall increase in area.

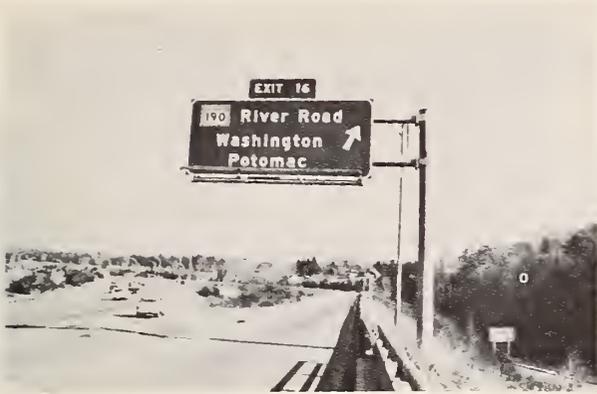
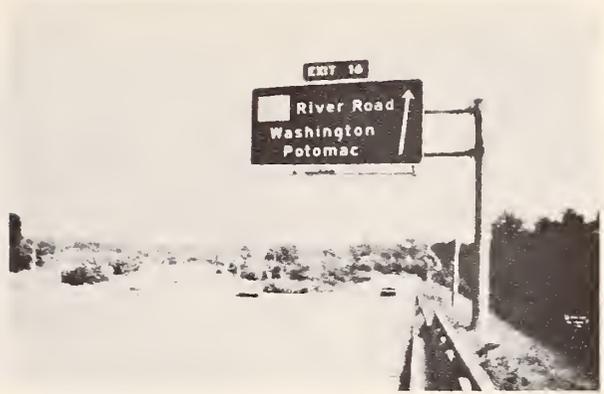
INTERCHANGE 16N GORE(EXIT) SIGN

Figure 2 (Cont'd.). Before/After signs of Capital Beltway Interchanges 15, 16, 17, and 18 respectively, and the 70S/Democracy Boulevard Interchange.

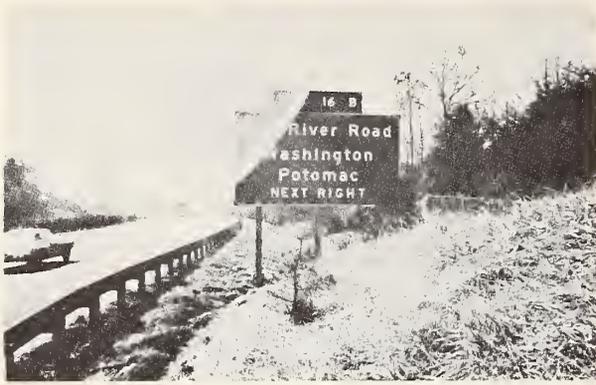
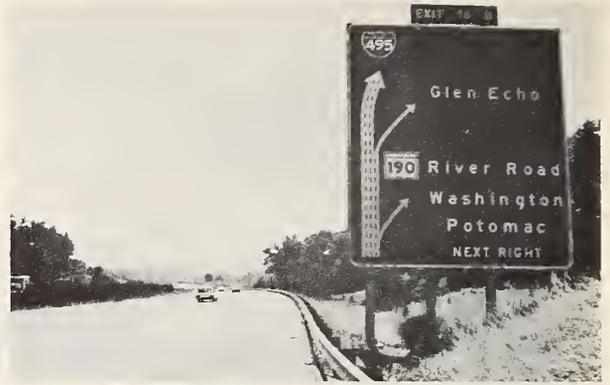
INTERCHANGE 16S EXIT DIRECTION SIGN (G-1 Location)

Figure 2 (Cont'd.). Before/After signs of Capital Beltway Interchanges 15, 16, 17, and 18 respectively, and the 70S/Democracy Boulevard Interchange.

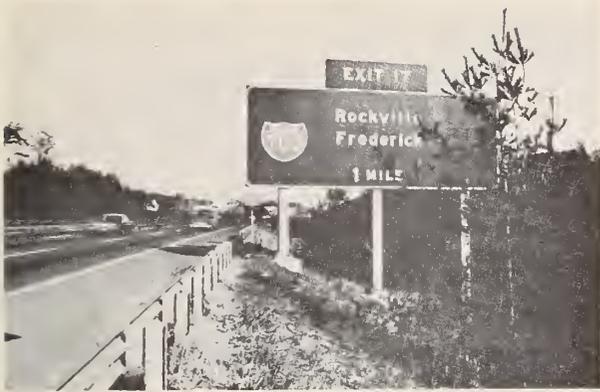
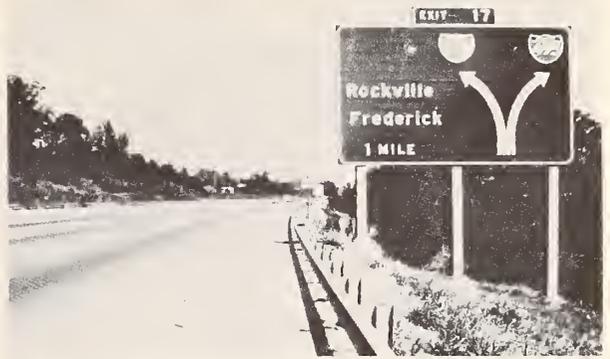
INTERCHANGE 17N ADVANCE SIGN (G-2 Location)

Figure 2 (Cont'd.). Before/After signs of Capital Beltway Interchanges 15, 16, 17, and 18 respectively, and the 70S/Democracy Boulevard Interchange.

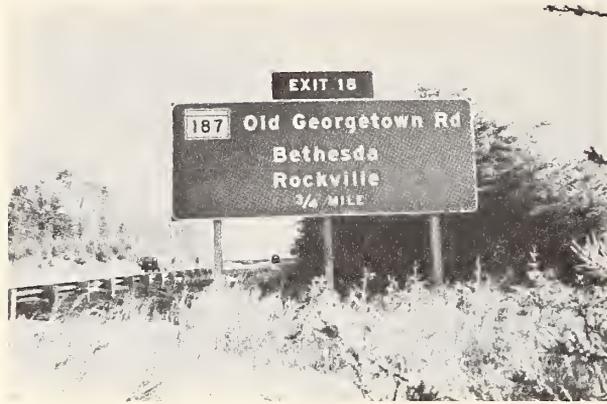
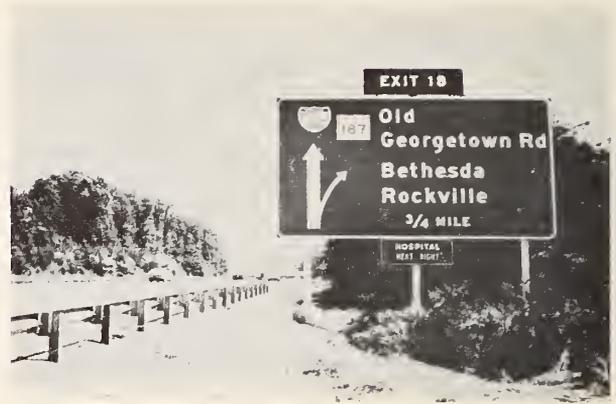
INTERCHANGE 18 E FIRST ADVANCE SIGN (G-2 Location)

Figure 2 (Cont'd.). Before/After signs of Capital Beltway Interchanges 15, 16, 17, and 18 respectively, and the 70S/Democracy Boulevard Interchange.

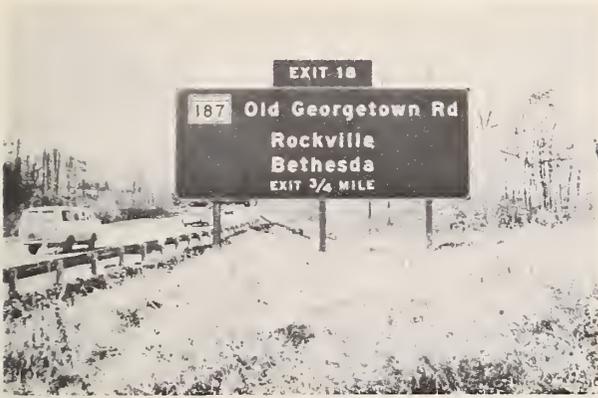
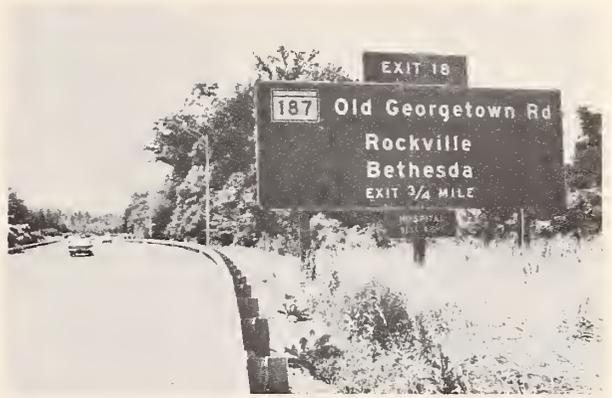
INTERCHANGE 18 W ADVANCE SIGN (G-2 Location)

Figure 2 (Cont'd.). Before/After signs of Capital Beltway Interchanges 15, 16, 17, and 18 respectively, and the 70S/Democracy Boulevard Interchange.

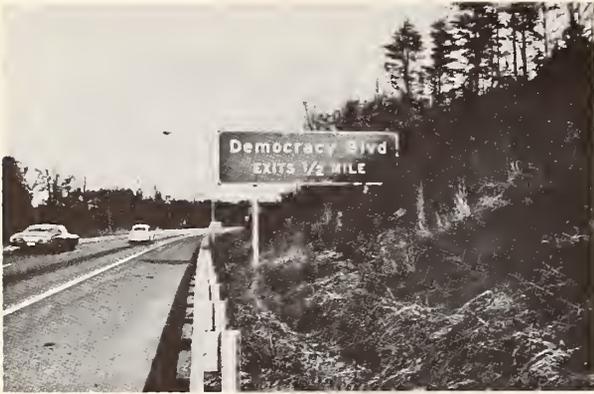
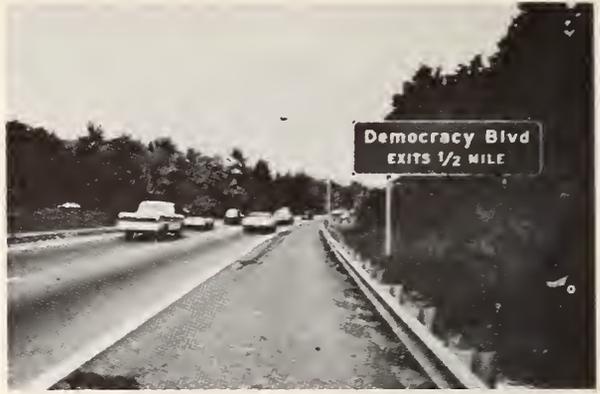
70S/DEMOCRACY BLVD ADVANCE SIGN (G-2 Location)

Figure 2 (Cont'd.). Before/After signs of Capital Beltway Interchanges 15, 16, 17, and 18 respectively, and the 70S/Democracy Boulevard Interchange.

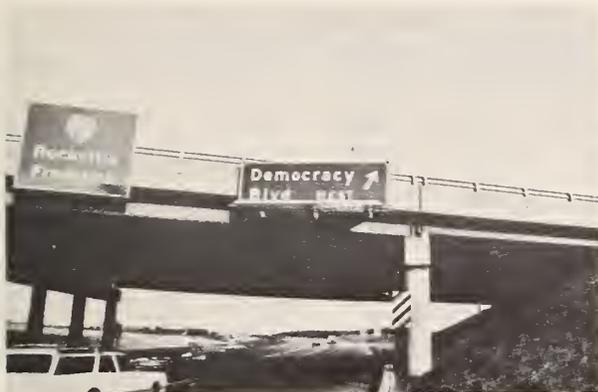
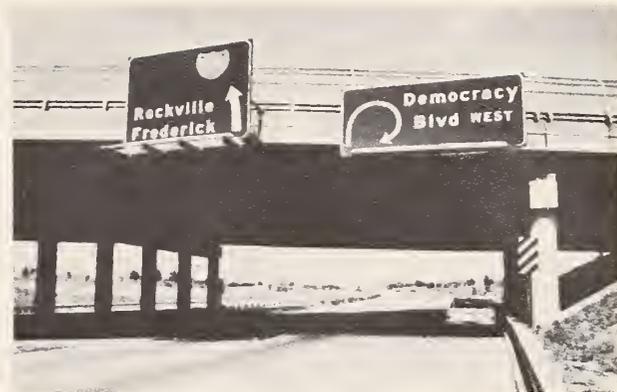
70S/DEMOCRACY BLVD GORE(EXIT)SIGN (First Gore) and EXIT DIRECTION SIGN (Second Gore)

Figure 2 (Cont'd.). Before/After signs of Capital Beltway Interchanges 15, 16, 17, and 18 respectively, and the 70S/Democracy Boulevard Interchange.

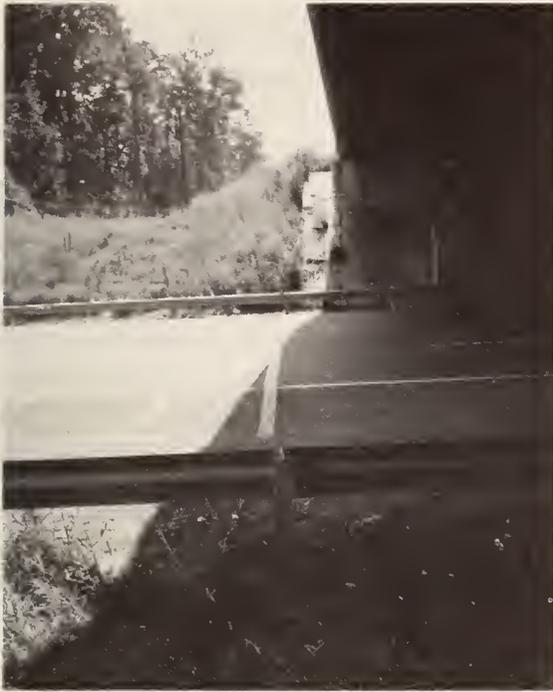
(a) Tapeswitches on the Beltway

Figure 3. The Traffic Evaluator.

Figure 3 on the following page illustrates the Traffic Evaluator System in operation in the field. Further information on the Traffic Evaluator System is provided in Appendix A.

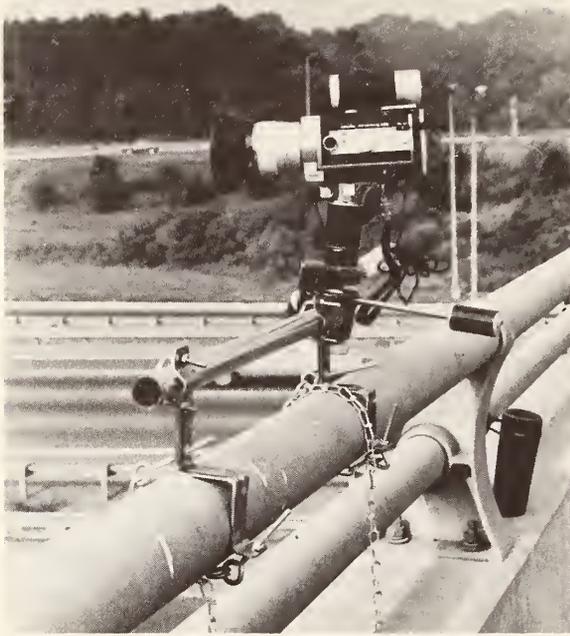
(a) Overpass Rail Mount

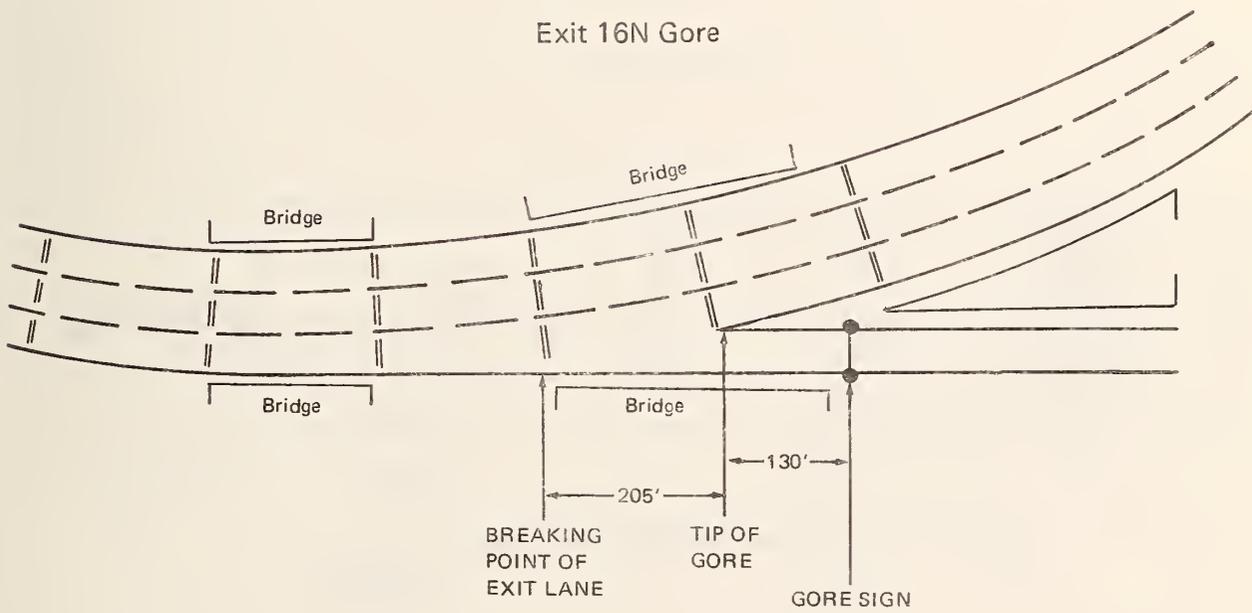
### Exit 16N Gore

Figure 5. Tapeswitch instrumentation at each gore. Tapeswitch pairs are separated by 300 feet and pair members are separated by 4 feet.

Table 5 on the following page summarizes the lanes instrumented with tapeswitches at each Traffic Evaluator System measurement site. Following the table, Figure 5 shows actual instrumentation of each gore site. It will be noted that Interchange 17 is exceptional. At this interchange, the distance from the tip of the painted gore to the physical barrier (guardrail) preventing passage over the gore is about 500 feet. Therefore, the sixth set of switches was located at this barrier, the end of a guardrail. It will be noted that the fifth set of switches is located within 150 feet of the gore sign, as holds true at all other gore area sites.

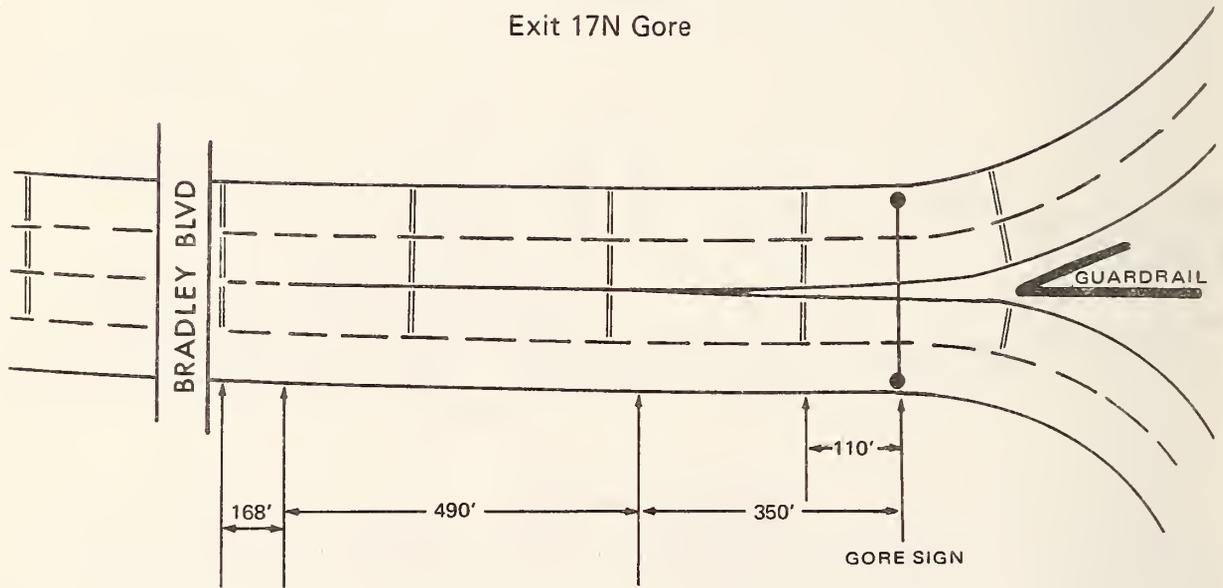
### Exit 17N Gore

Figure 5 (Cont'd.). Tapeswitch instrumentation at each gore. Tapeswitch pairs are separated by 300 feet and pair members are separated by 4 feet.

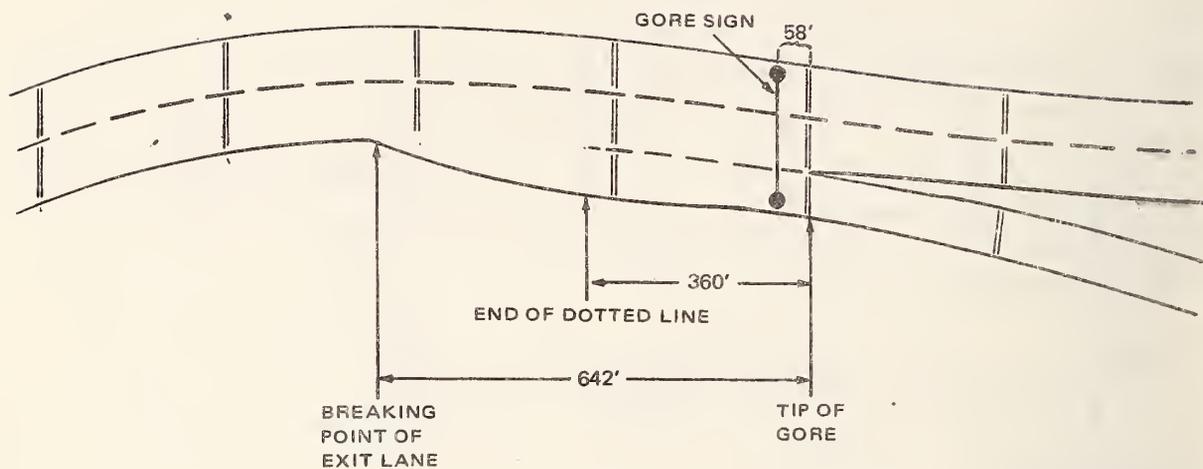
## Democracy Blvd. Gore

Figure 5 (Cont'd.). Tapeswitch instrumentation at each gore. Tapeswitch pairs are separated by 300 feet and pair members are separated by 4 feet.

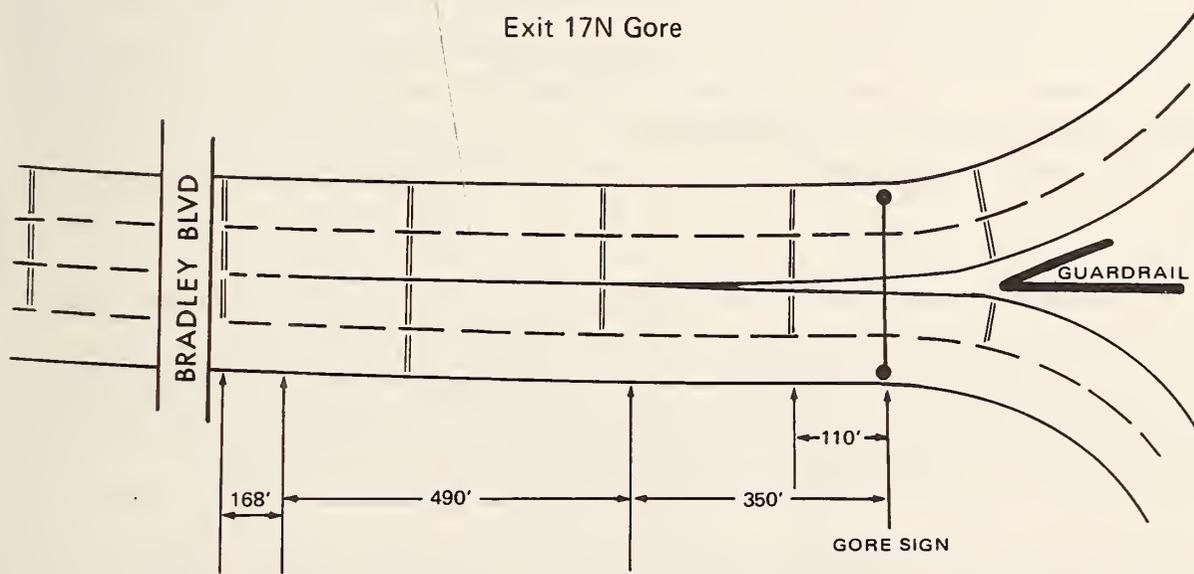
Figure 6. Tapeswitch instrumentation at gores in the Acclimation Phase. Compared to the Before/After study, an additional lane (Lane 3) at 16 South was fully instrumented. Also, one switch pair was deployed in the remaining uninstrumented lane at both 16 South and 17 North.

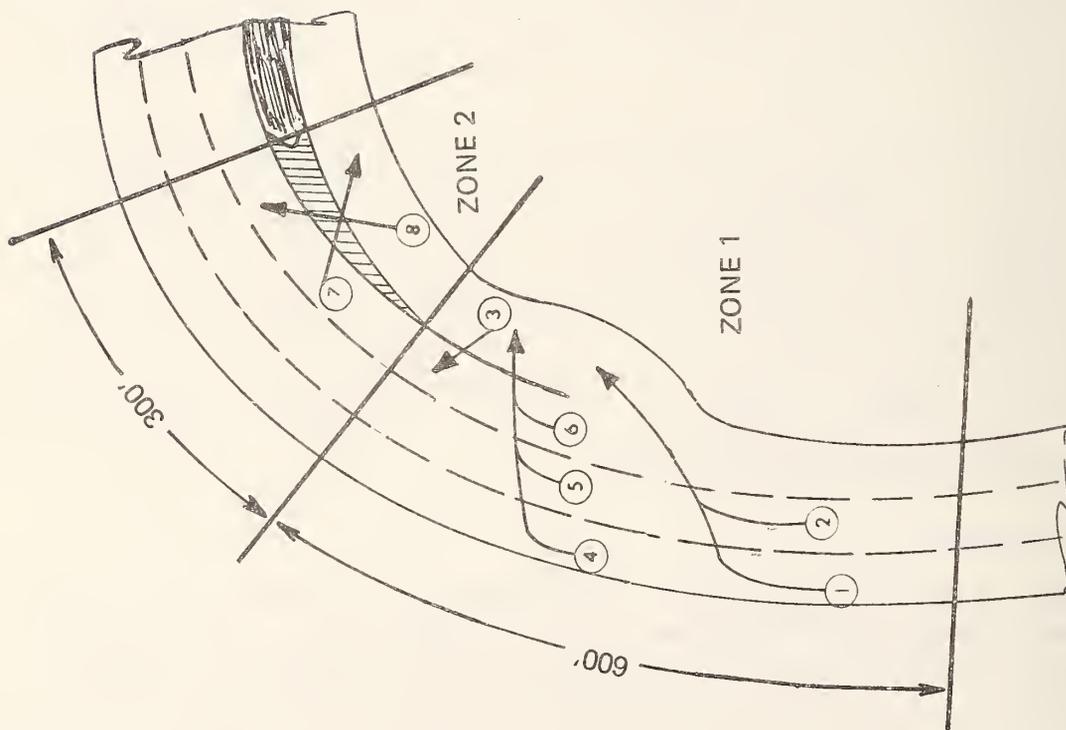
Figure 10. Zones and sample scoring pattern used in reducing film data. Numbers on maneuvers correspond to keyboard shown at right.

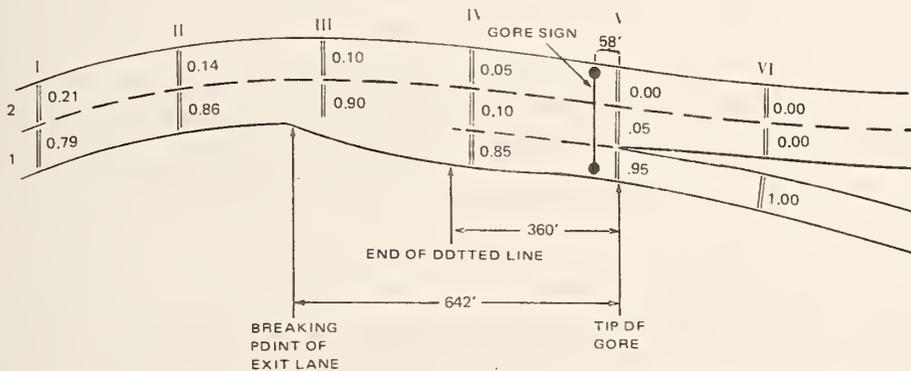
Figure 12 illustrates hypothetical data for exiting traffic at a right-exit interchange. Roman numerals refer to the TES traps at 300-foot intervals. The numbers beside the traps show the proportion of exiting vehicles crossing each trap. Because the sixth trap was always beyond the point where last minute maneuvers into and out of the exit ramp could be made, all exiting traffic must cross Trap 6 in the exit ramp.

Figure 12. Hypothetical lane placement of exiting traffic under a specific signing condition.

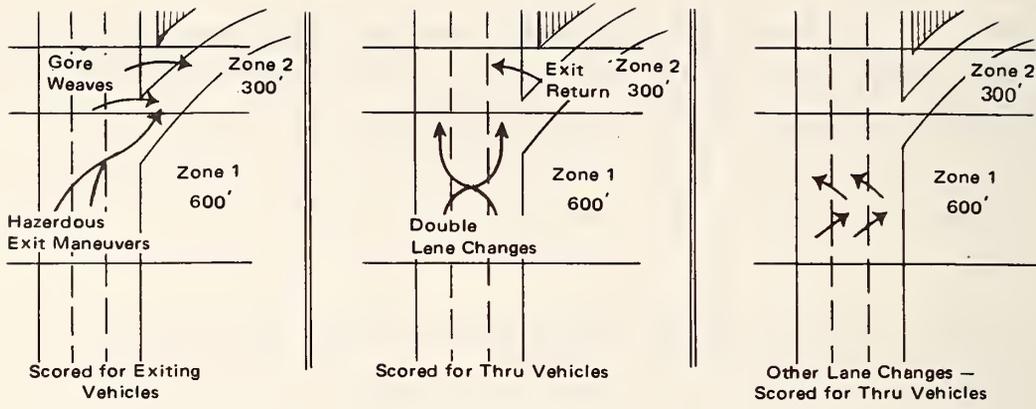
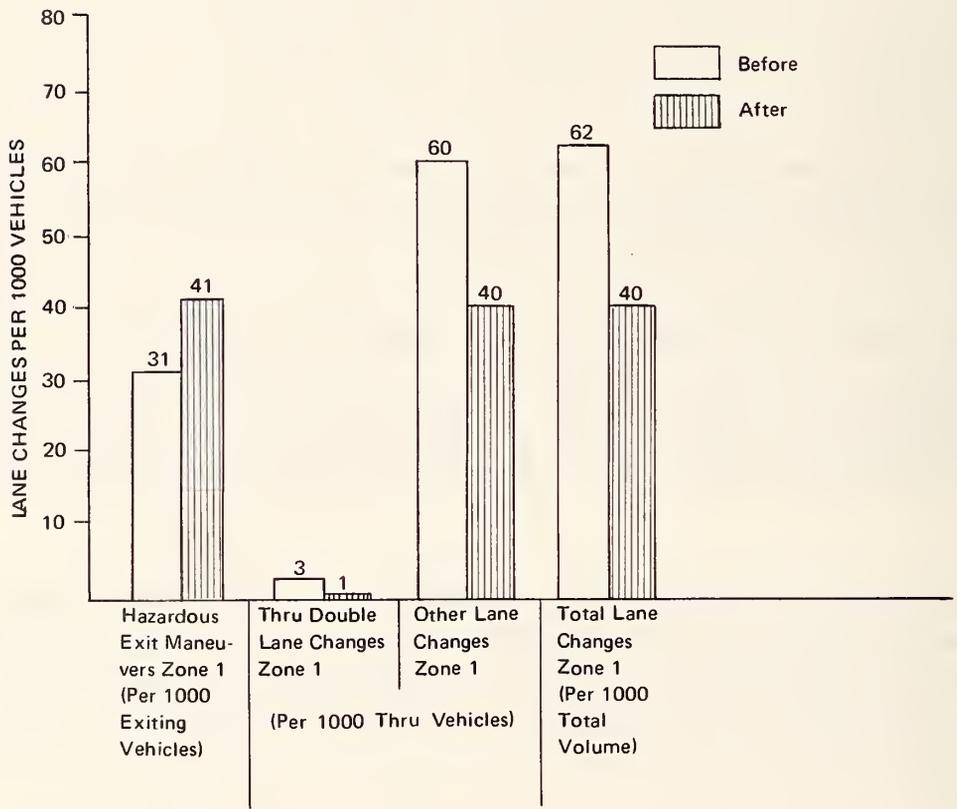
Figure 13. Lane changes at 15 North gore.

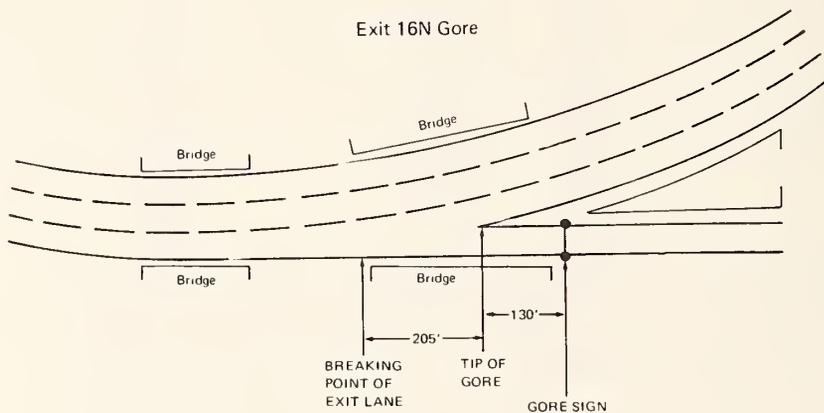
*Gore and Collector-Distributor.* A schematic diagram of the gore area is shown below. The tangential off ramp requires that the motorist make a positive steering action to the left to continue on the through traffic lanes. Failure to do so will result in exiting at this ramp.

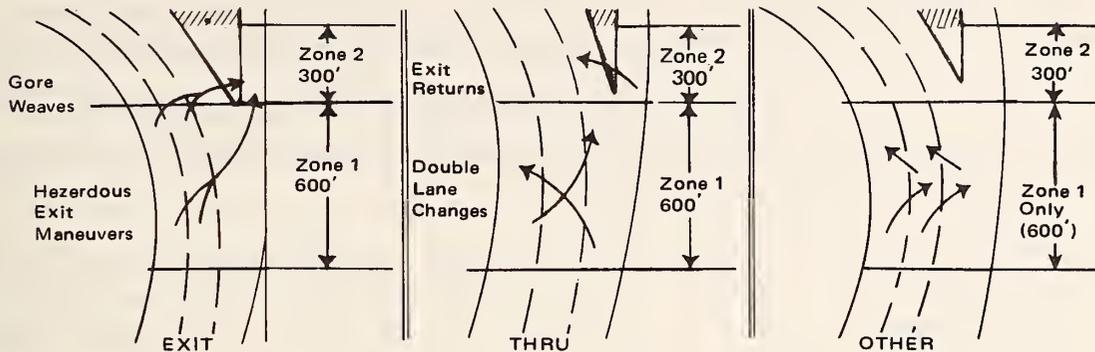
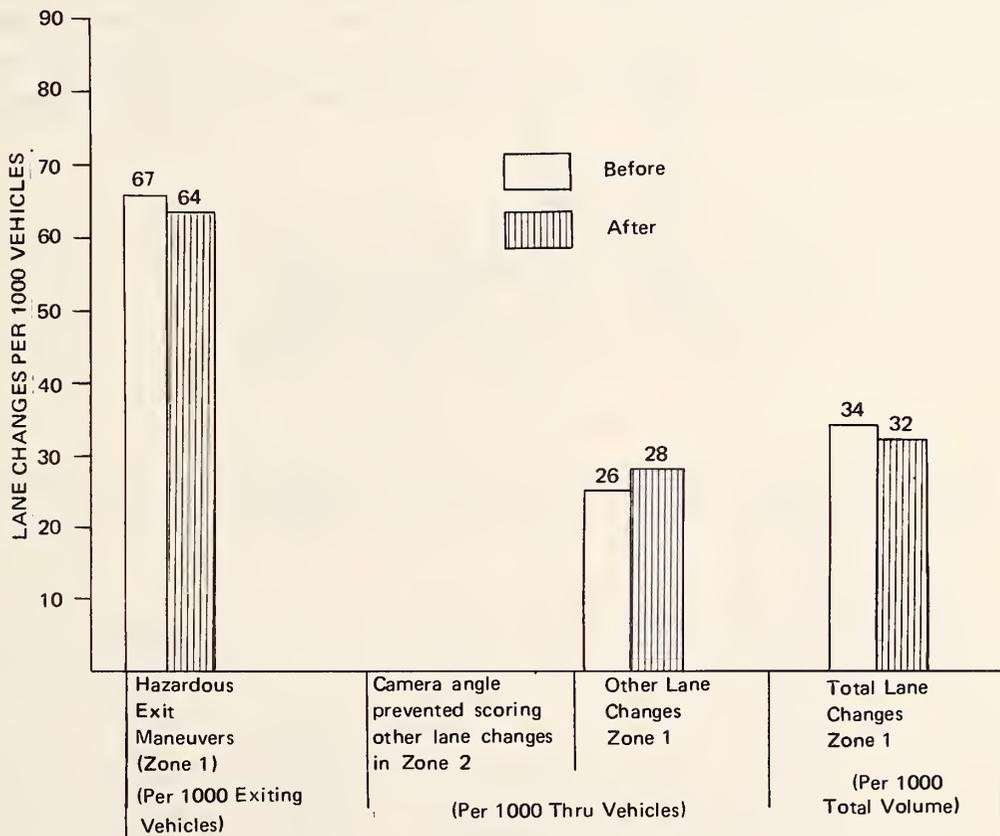
Two zones were scored in the vicinity of the gore. The zones were similar to those scored at Interchange 15 North. As was found at that interchange, there were very few gore weaves or exit returns (one or two per thousand vehicles) (see Figure 14).

Figure 14. Lane changes at 16 North gore.

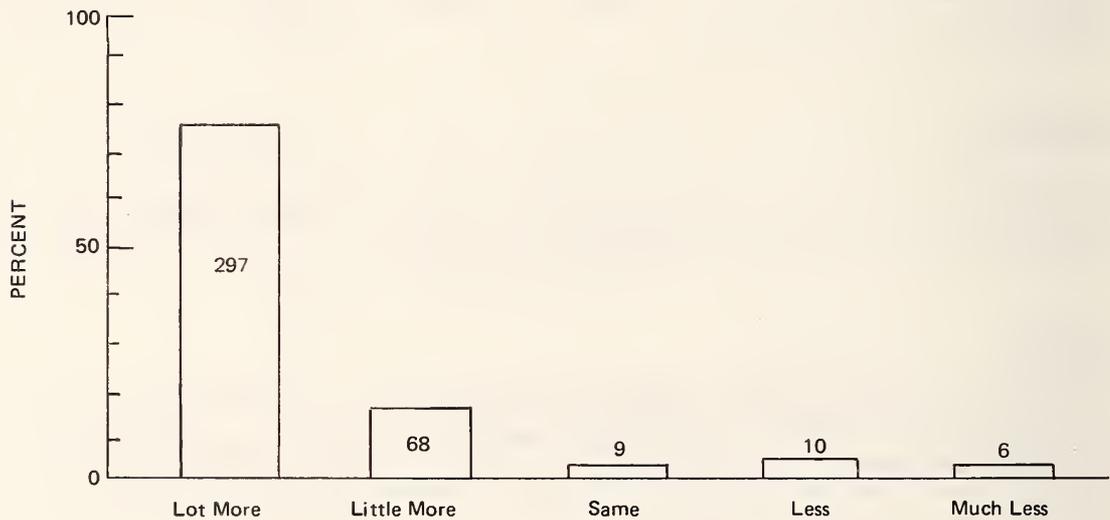
Figure 21. How much help are diagrammatic signs relative to conventional signs to the average motorist?

Respondents were also asked to indicate how much help they thought the diagrammatic signs were to the average motorist, i.e., everyone else besides themselves. Figure 21 shows that 93 percent thought that the diagrammatic signs were more helpful while five percent thought they were less helpful.

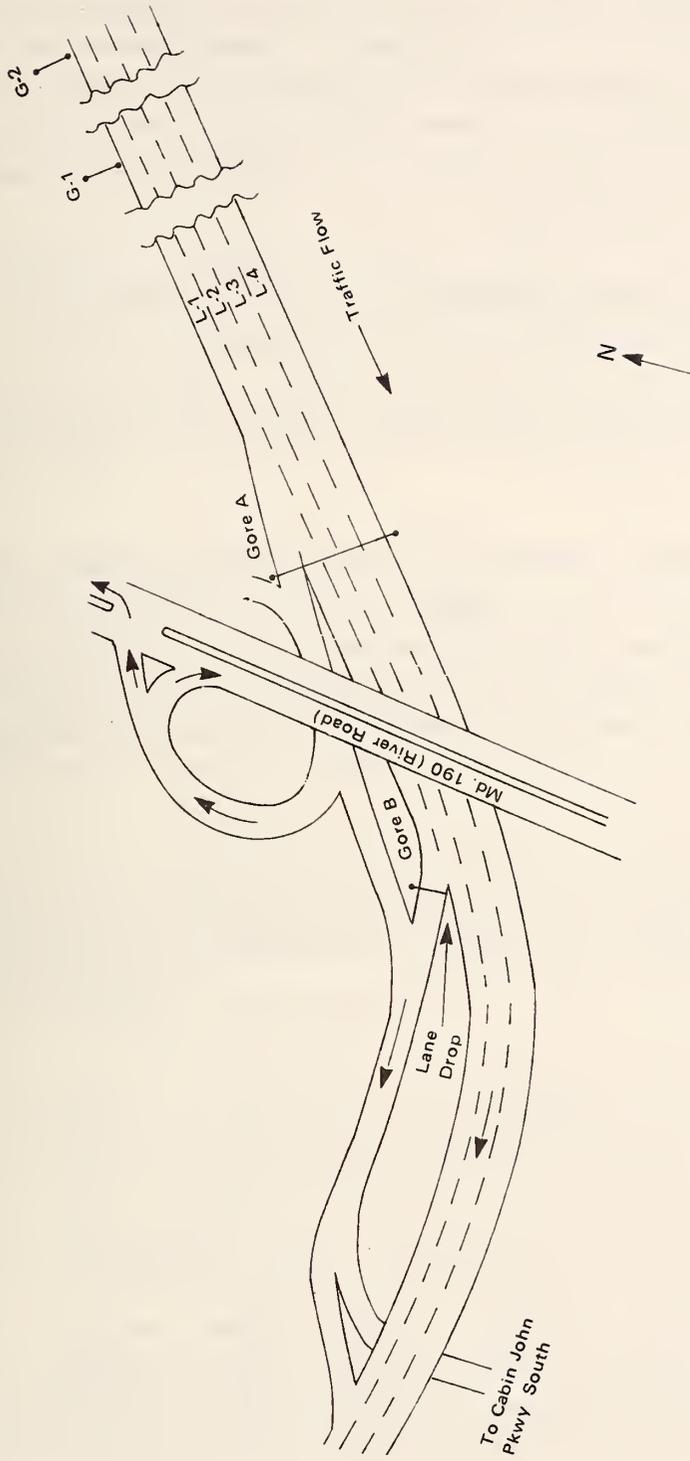
Figure 48. Simplified schematic representation of Interchange 16 South.

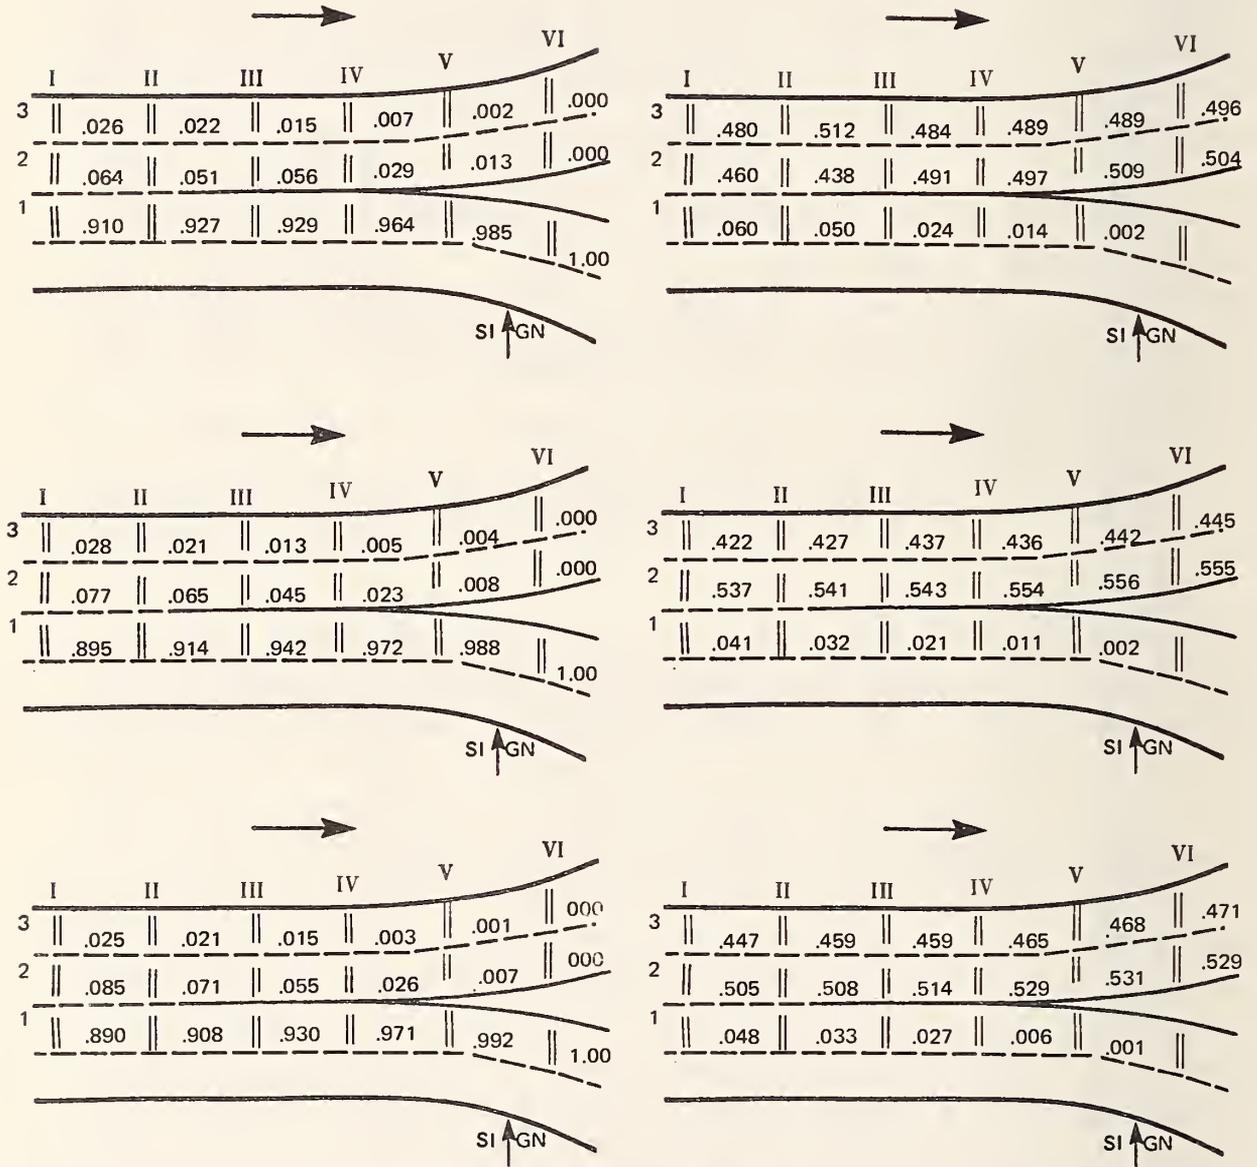
Figure 57. Proportional location of traffic during nonrush period at Interchange 17 North for three observation days in the Acclimation phase.

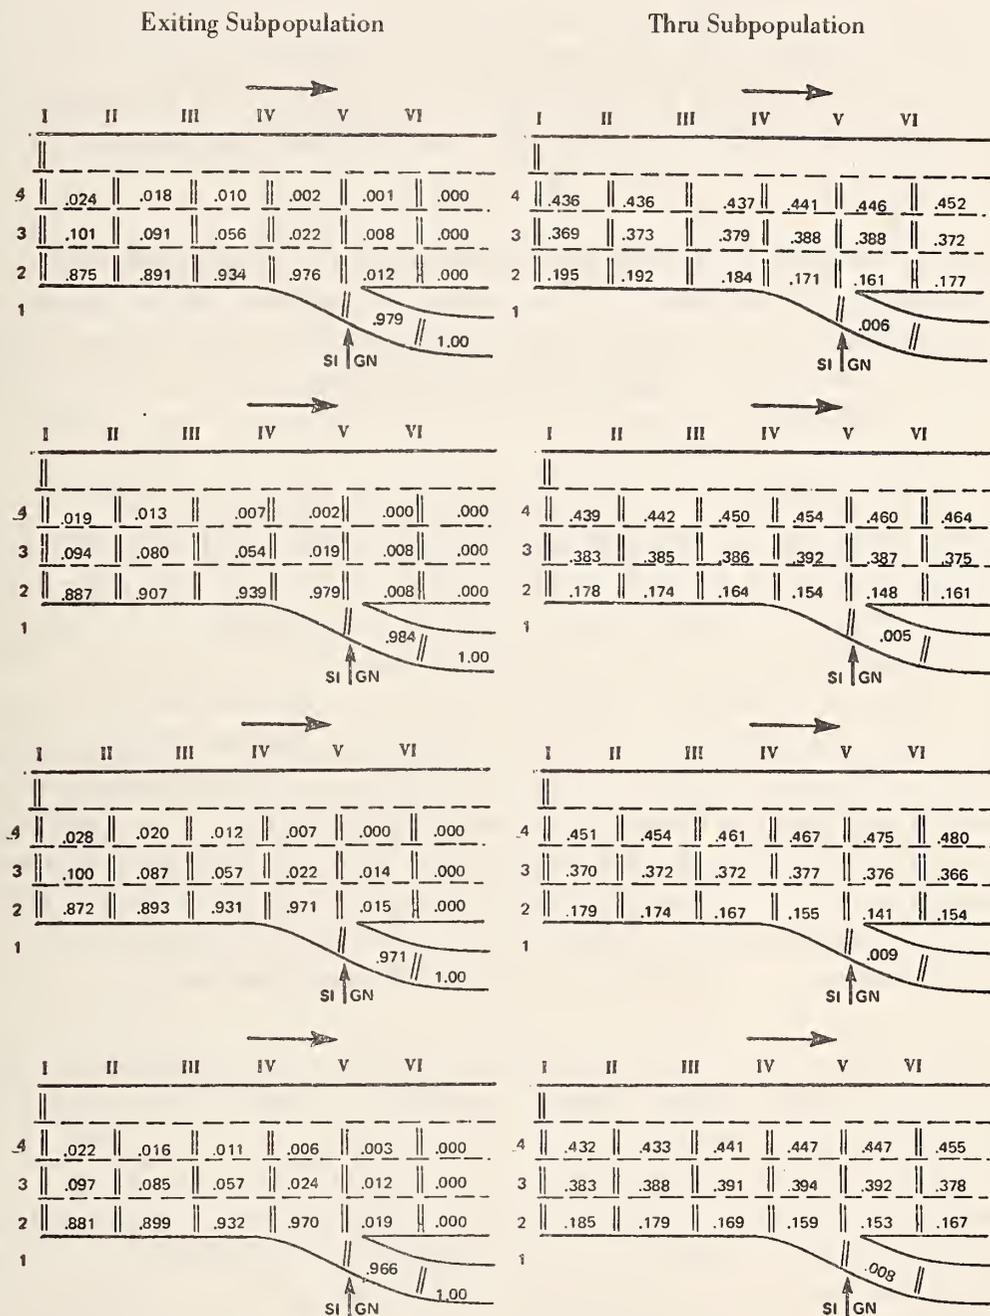
Figure 58. Proportional location of traffic during nonrush period at Interchange 16 South for four successive periods in the Acclimation phase.

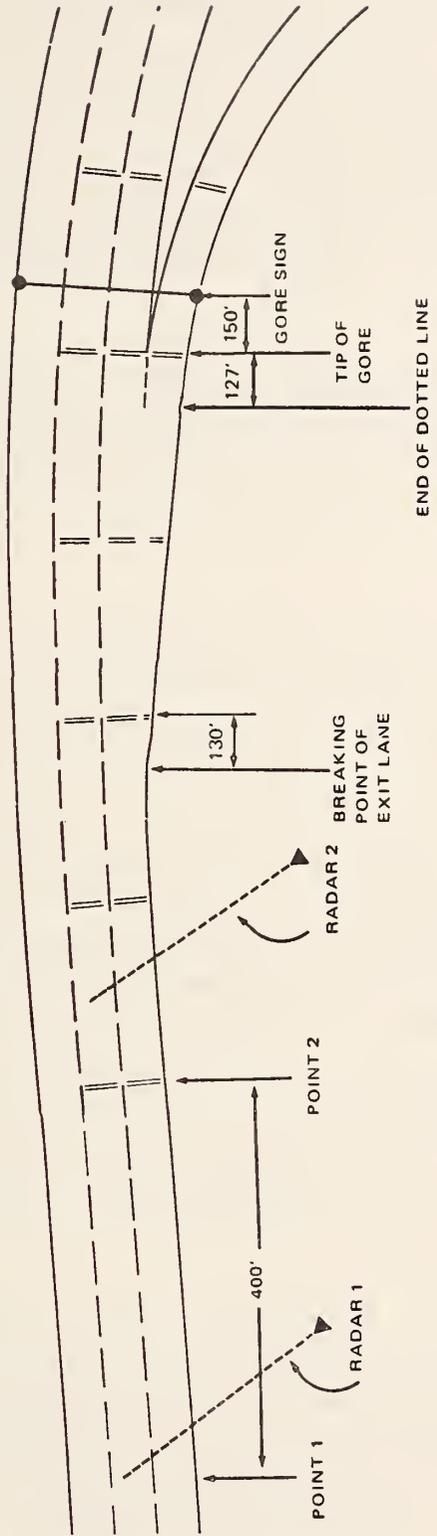
Figure 64. Locations of radar units used for speed comparisons.
