Downtown People Mover (DPM) Winterization Test Demonstration: Westinghouse

L.S. Boehmer
A.P. Holbrook

Westinghouse Electric Corporation
Transportation Division
2001 Lebanon Road
West Mifflin PA 15122

January 1982
Final Report

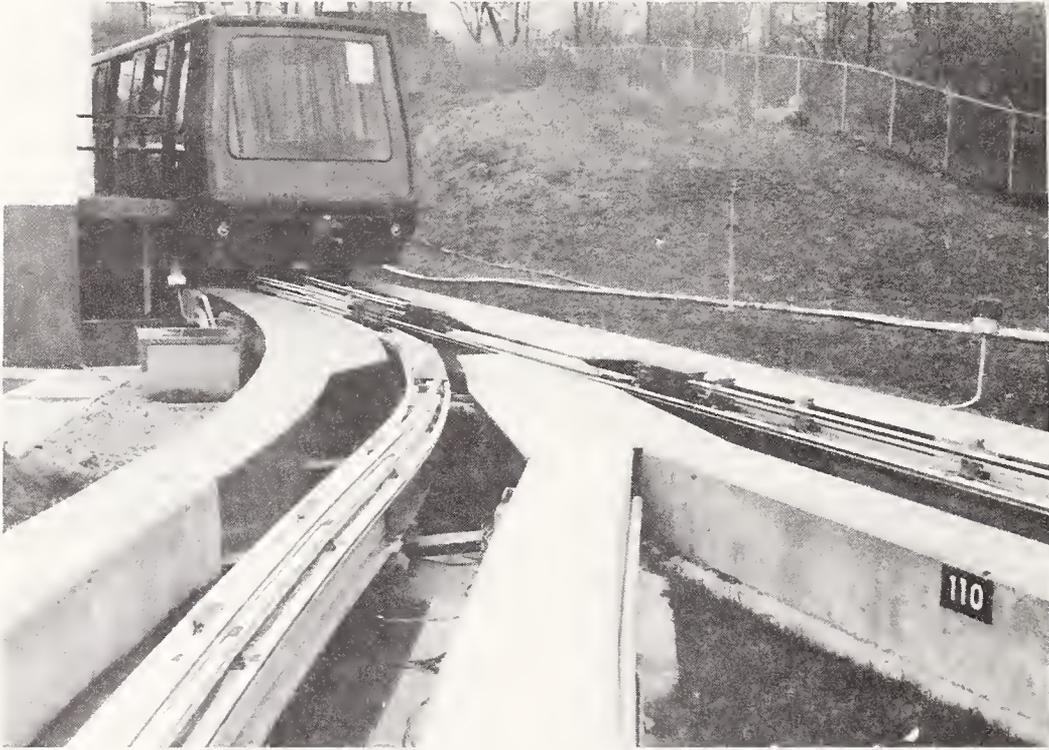
FIGURE 2-3. STANDARD GUIDEWAY SWITCH

A guideway switch (Figure 2-3) is utilized for traffic routing between the main track and the 130-foot spur leading into the manufacturing plant. The switch is the same as the thirteen switches used in the Atlanta Airport system.

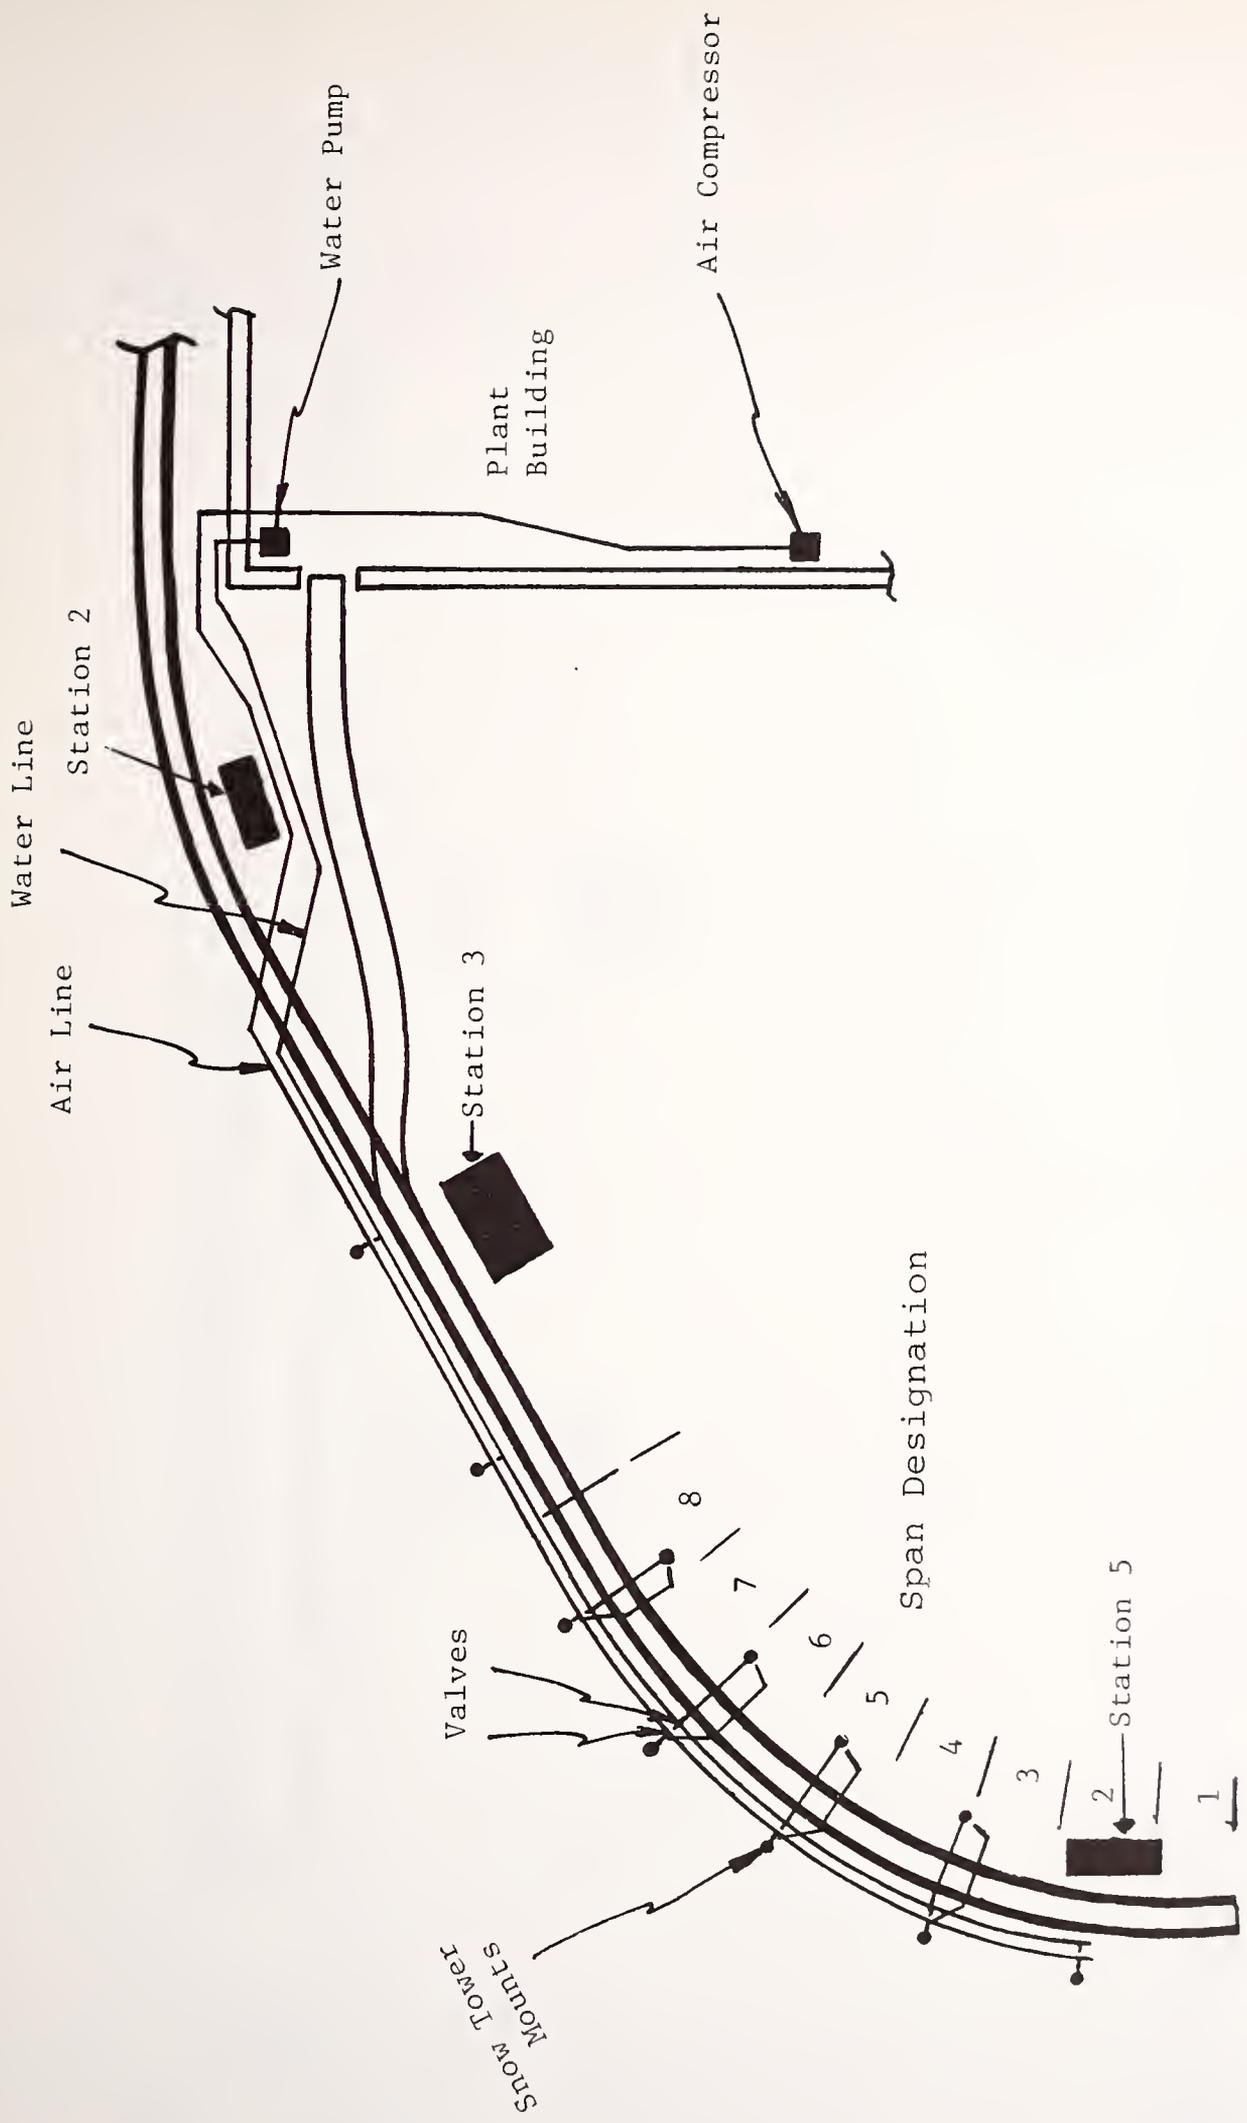
FIGURE 2-5. SNOW MAKING TOWERS AND OUTSIDE PIPING LAYOUT

During the initial check-out of the system, freeze-up of hosing and piping presented the biggest problem. Once the test personnel became familiar with the equipment and the winter conditions, and developed a standard operating procedure, the system could be operated for extended periods of time. With five (5) snow towers in operation, snow could be made when the ambient air temperature was below 26° F, at a rate of 2 inches per hour and at a density of approximately 0.40 grams per cubic centimeter. This 0.40 snow density was the lowest achieved during the test program. Efforts to reduce the snow density to that more representative of natural snow were unsuccessful. These efforts included varying the air and water flows and testing spray nozzles of different configurations.

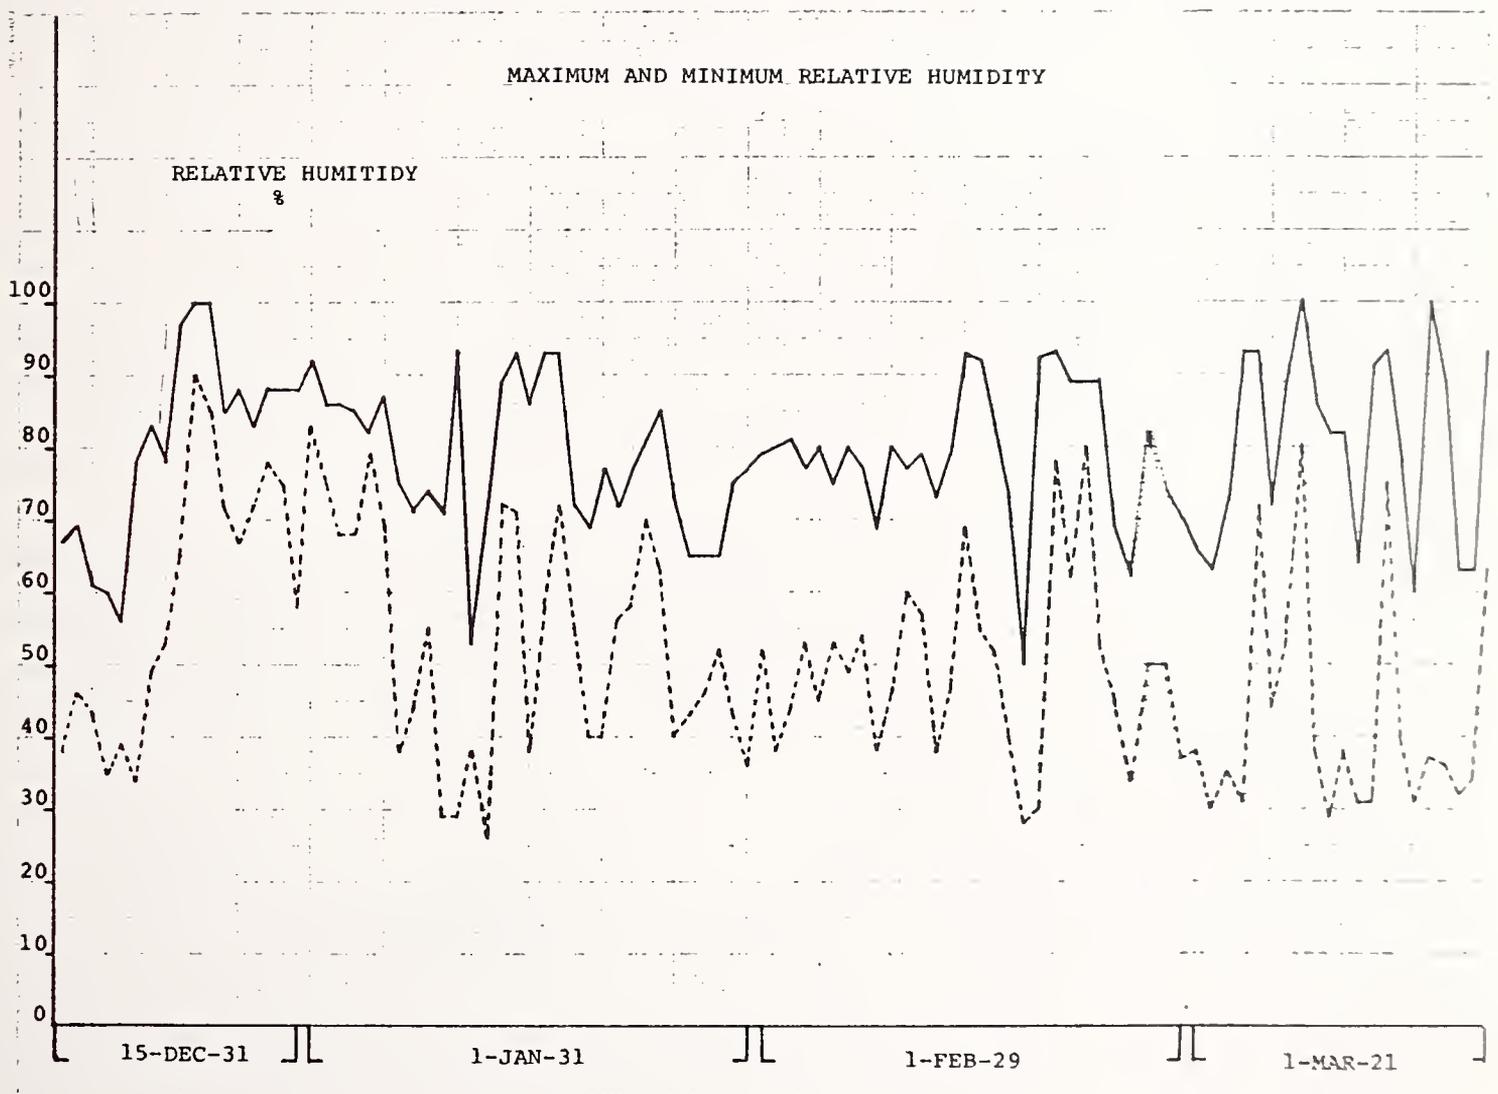
FIGURE 3-7. MINIMUM/MAXIMUM DAILY RELATIVE HUMIDITY (1979-1980)

Figure 3-7 shows maximum and minimum daily relative humidity values.

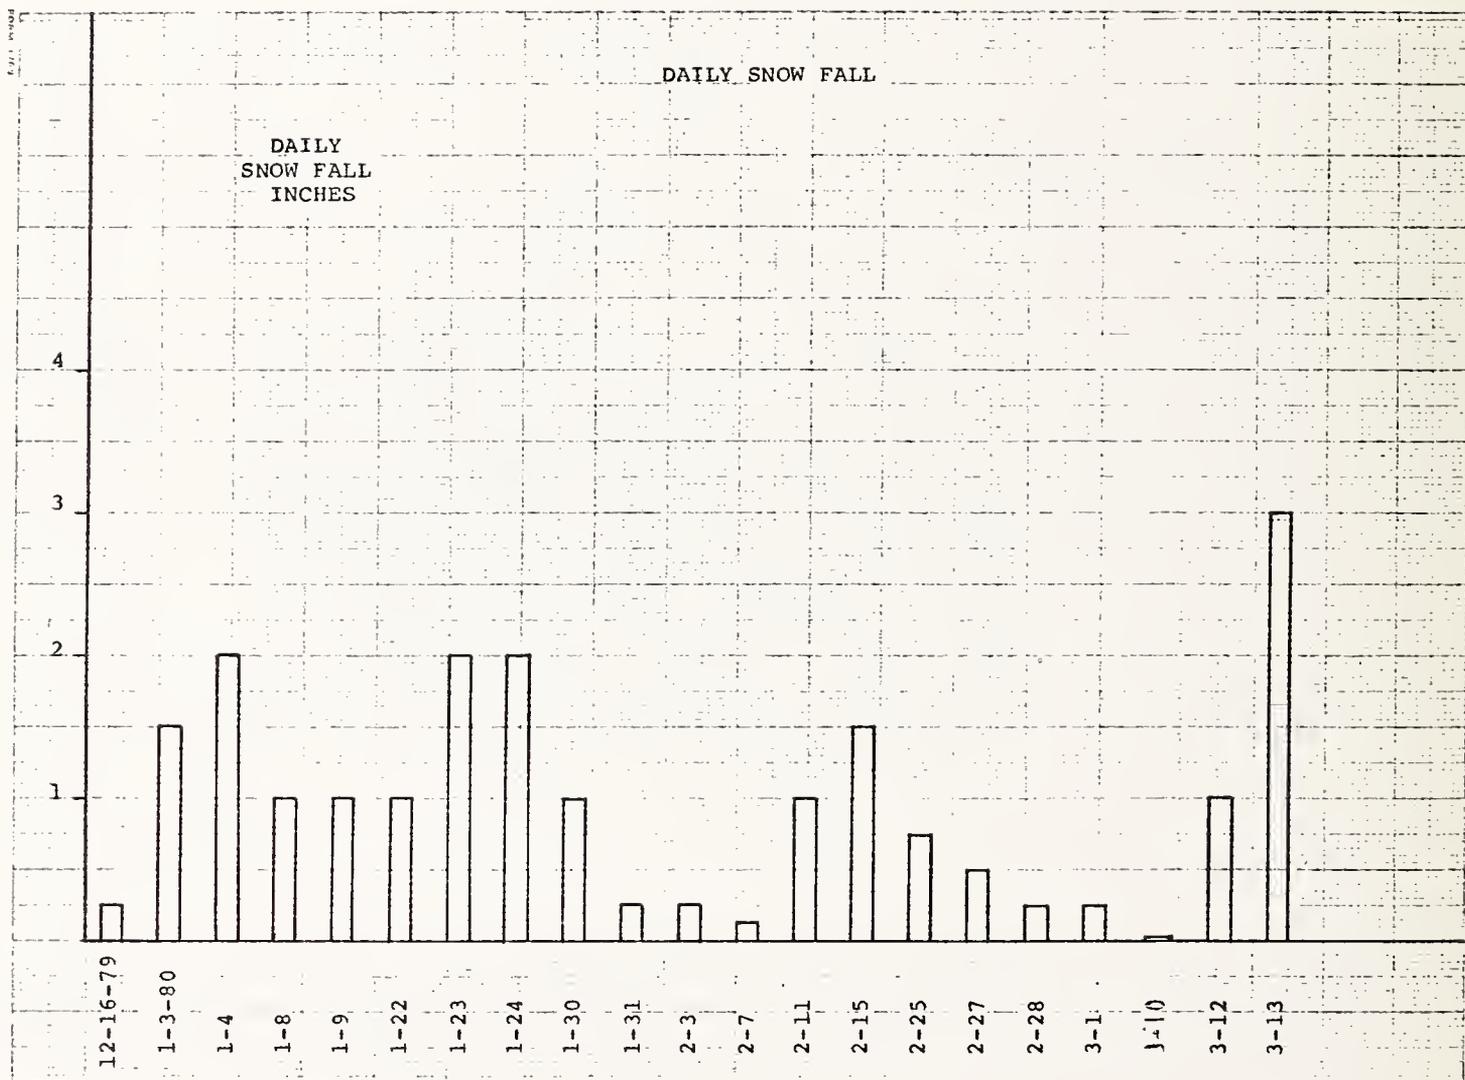
FIGURE 3-8. DAILY SNOW FALL (1979-1980)

The snow fall occurring during the 1979-80 winter is indicated on Figure 3-8. The greatest single snowfall was only 3 inches and that occurred on March 13. The snow fall on 24 separate occasions totaled only 22 inches. The wind velocities during the 79-80 test period reached speeds of up to 30 miles per hour.

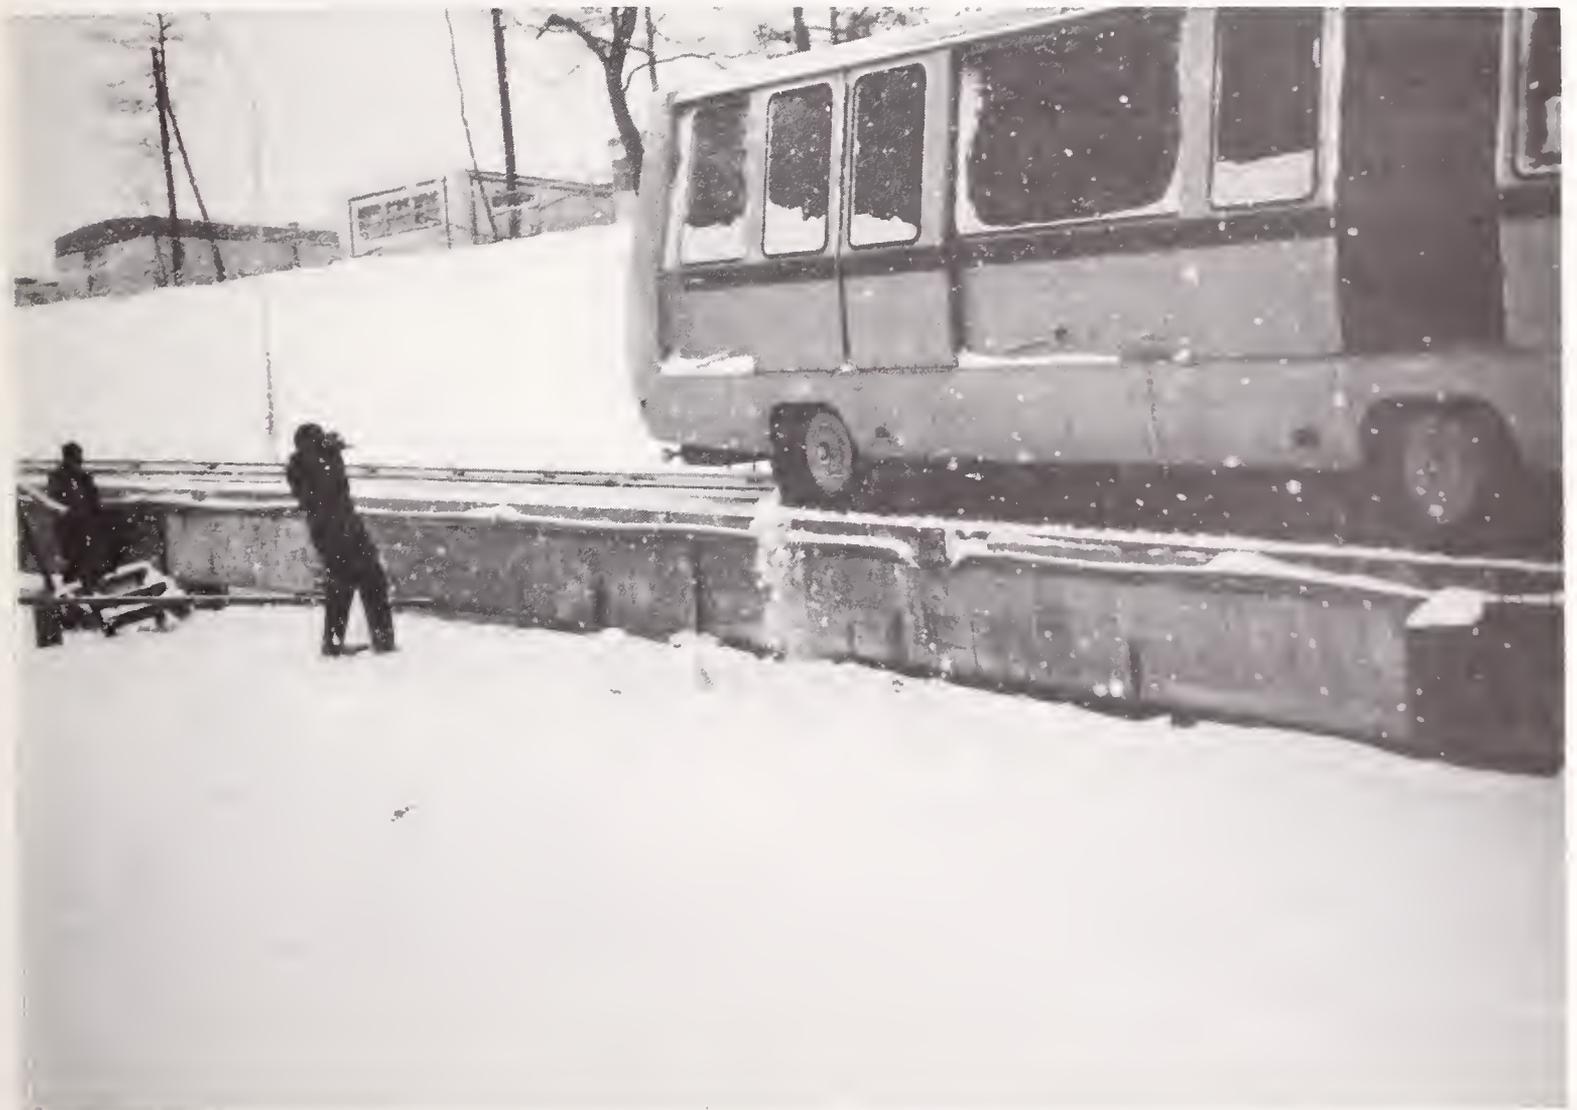
FIGURE 5-1. MECHANICAL SNOW REMOVAL UTILIZING SCRAPERS

Testing was conducted with the guideways covered with 1.5 inches of natural snow deposited over 1/8 inch of crusty ice to determine the capability of the snow scrapers to remove the accumulation. The snow on the guideways fell on the previous day. Weather conditions were; an ambient air temperature of +24°F, a wind velocity of 5-10 miles per hour, a snow density of 0.160 grams per cubic centimeter and zero snow fall rate. During the test the vehicle was operated in the manual mode. Figure 5-1 is a view of the guideways being scraped.

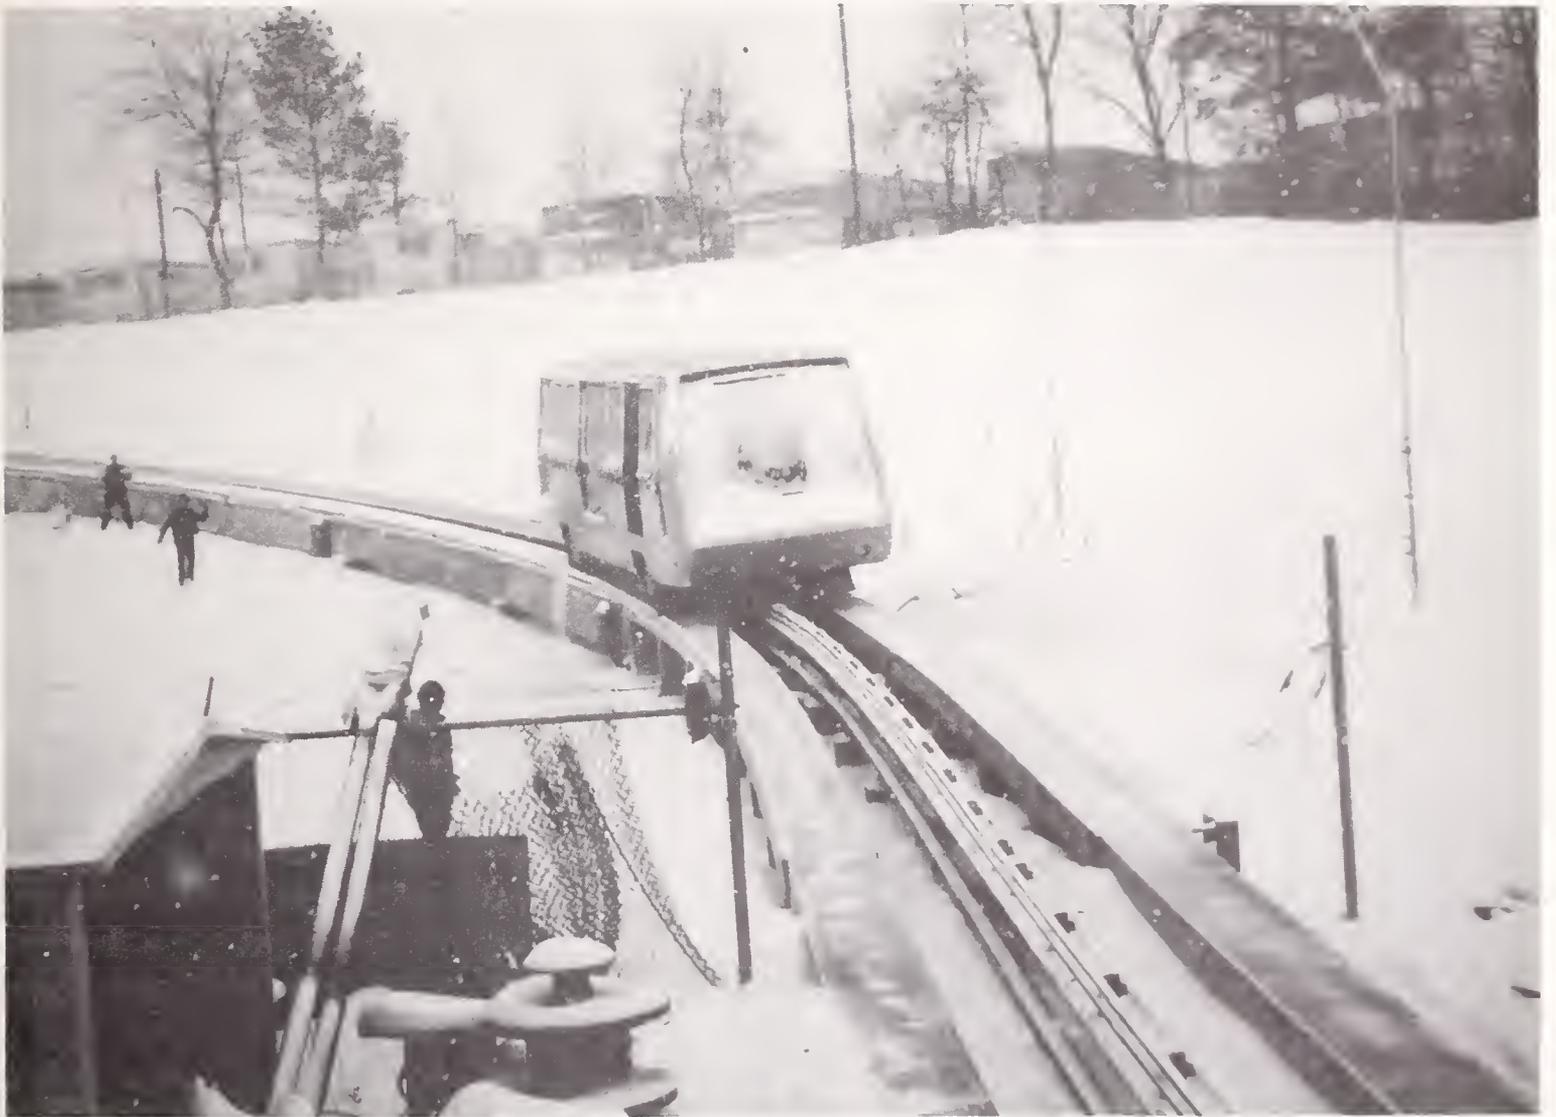
FIGURE 5-2. VIEW OF GUIDEWAY AFTER SCRAPING

No problems were experienced in removing the 1.5 inches of snow from the guideway. The 1/8" of crusty ice remained. However, the vehicle negotiated the 10% grade with no slippage of the wheels. A portion of the track was intentionally left unscraped and the vehicle wheels used to compact the snow. Again, no problems were experienced with the vehicle's movement over the guideway surfaces. Figure 5-2 is a view of the guideways after scraping.

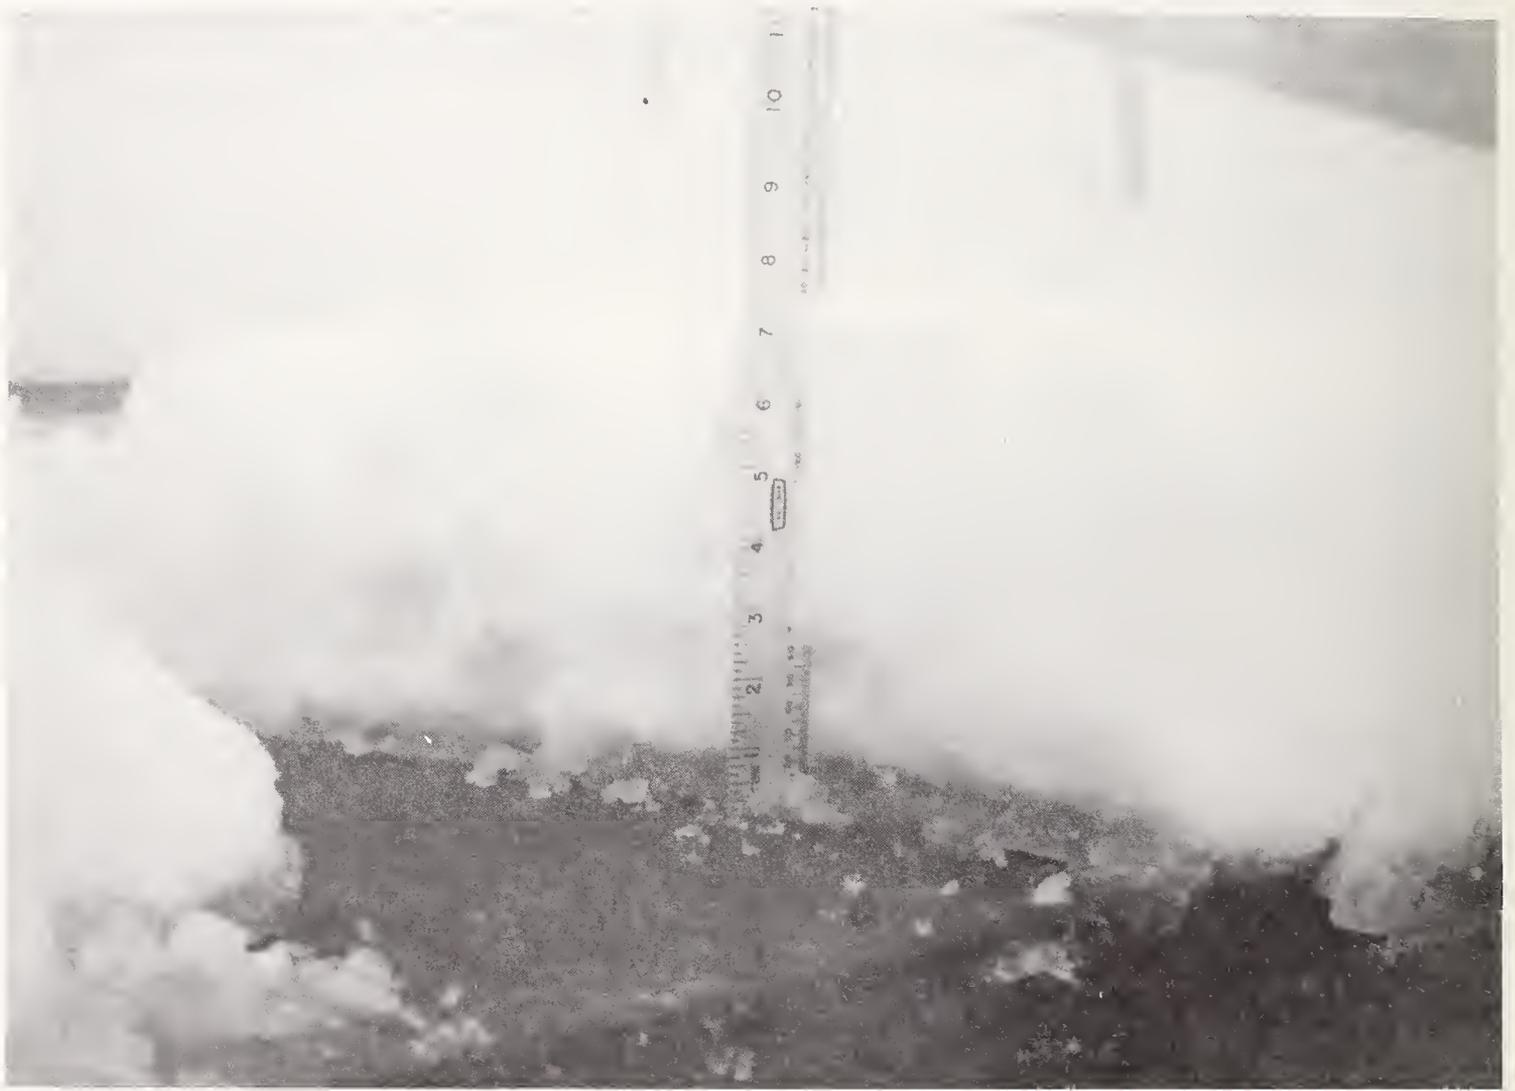
FIGURE 5-3 . MAN-MADE SNOW ACCUMULATION BEFORE TEST

Another test was run to determine the capability of the snow scrapers to remove a 6 inch depth of man-made snow with a density 0.48 grams per cubic centimeter. Weather conditions were; an ambient air temperature of +20°F, a wind velocity of 16-20 miles per hour and zero snow fall rate. The vehicle was operated in the manual mode.

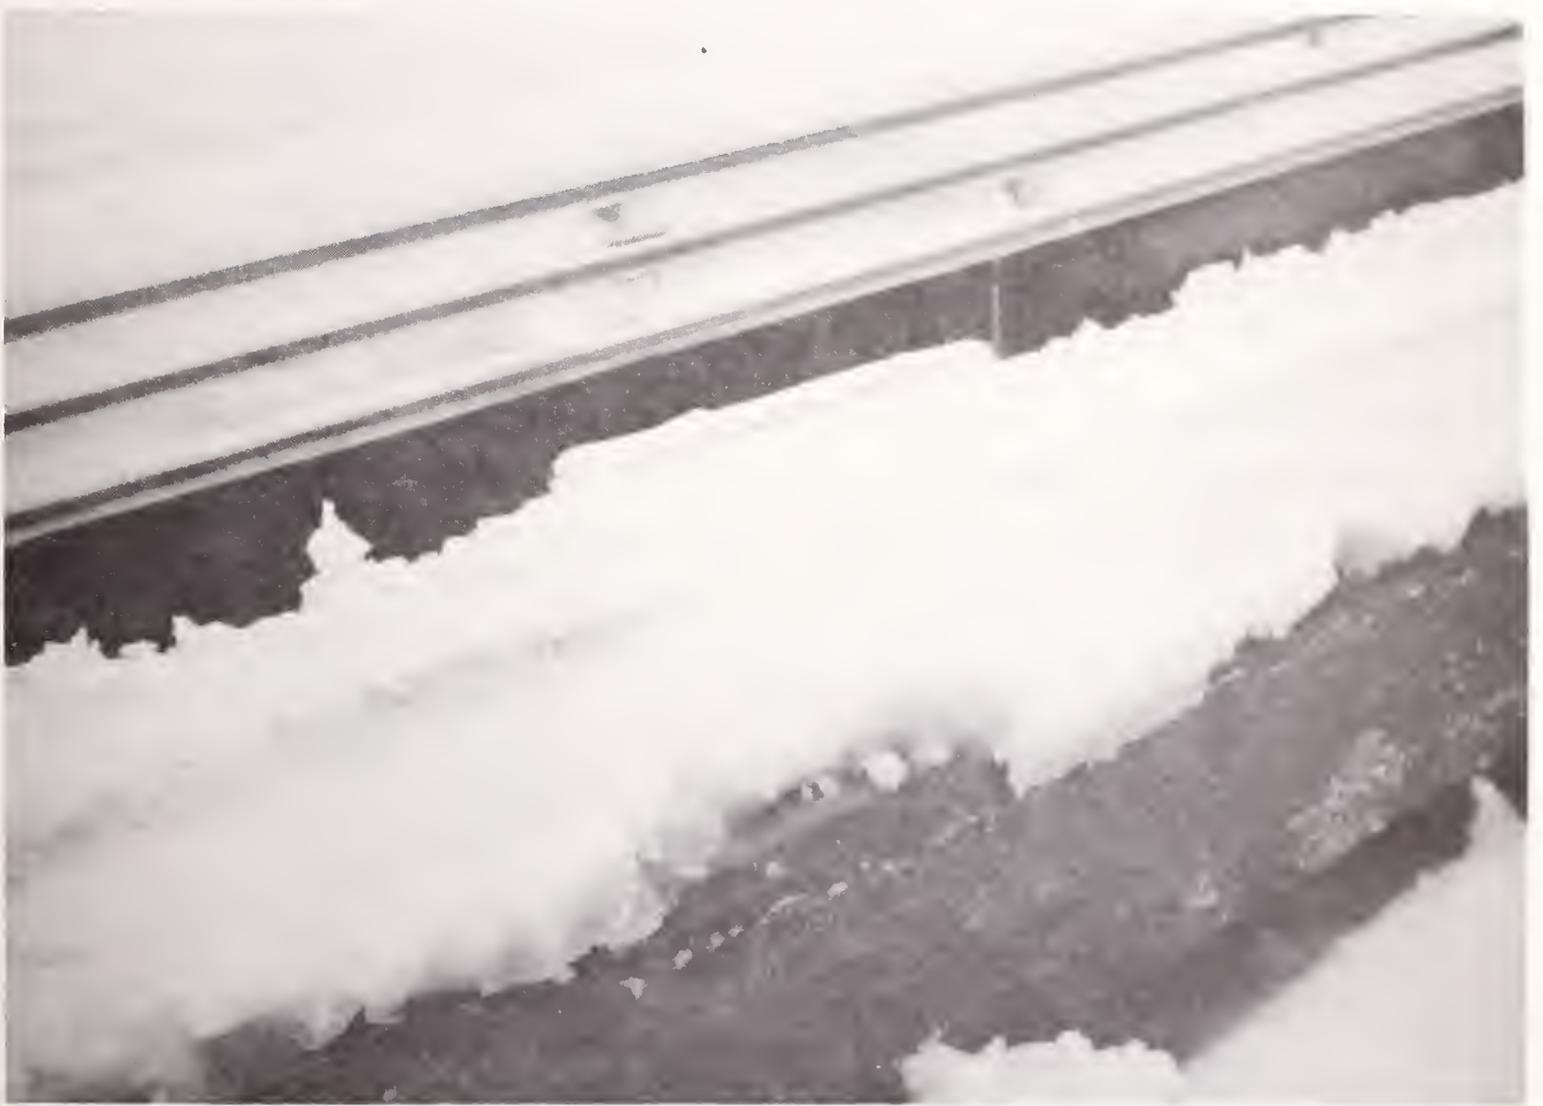
FIGURE 5-4. VIEW AFTER SCRAPING AND COMPACTING BY WHEELS

During the first, second, third and fourth scrapings, the snow scrapers did not completely remove the snow and any remaining accumulation was compacted by the vehicle wheels. Snow was also accumulating in the power and signal rails and caused a loss of power on the first scraping. For the fifth scraping, snow had accumulated to a level of 6 inches on the last one quarter length of the guideway surface and the snow scrapers were bending backwards with negligible snow being removed. The vehicle wheels were slipping and the guide axle safety discs were rubbing on the guidebeam flange due to the increased height of the compacted snow.

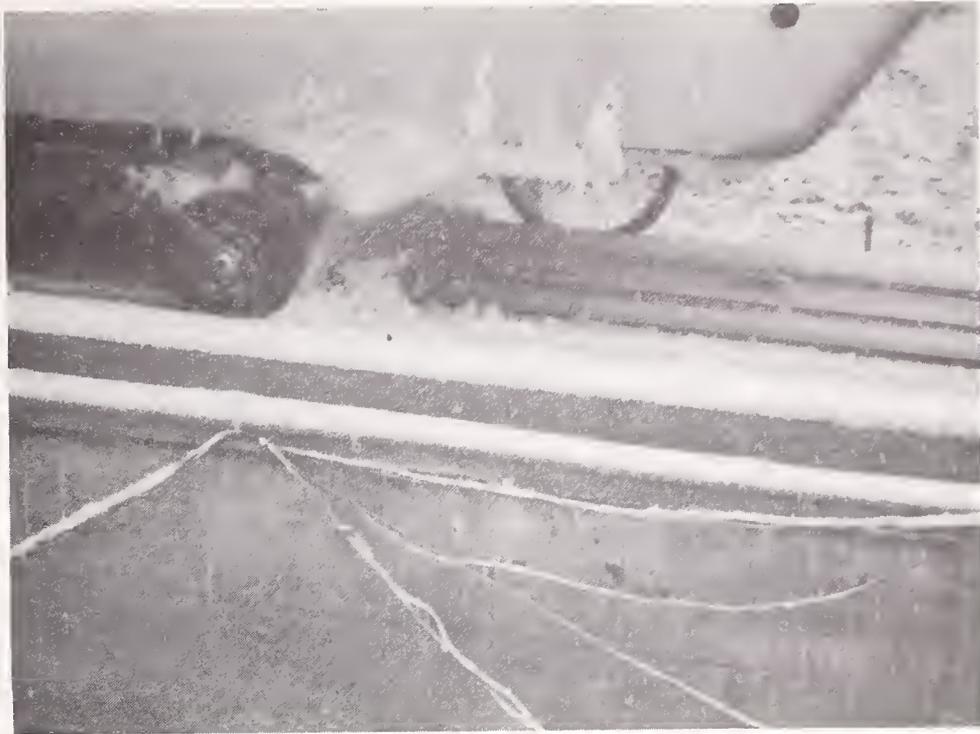
FIGURE 5-5. HORIZONTAL SNOW BRUSH UNIT

As a result of 1978-79 testing, the brushes used during the 1979-80 winter were the chain-driven, horizontal units equipped with removable plow/shroud attachments (Figures 5-9 through 5-12). For testing, three different sprocket ratios were available to produce brush speeds of 350, 525 and 700 RPM.

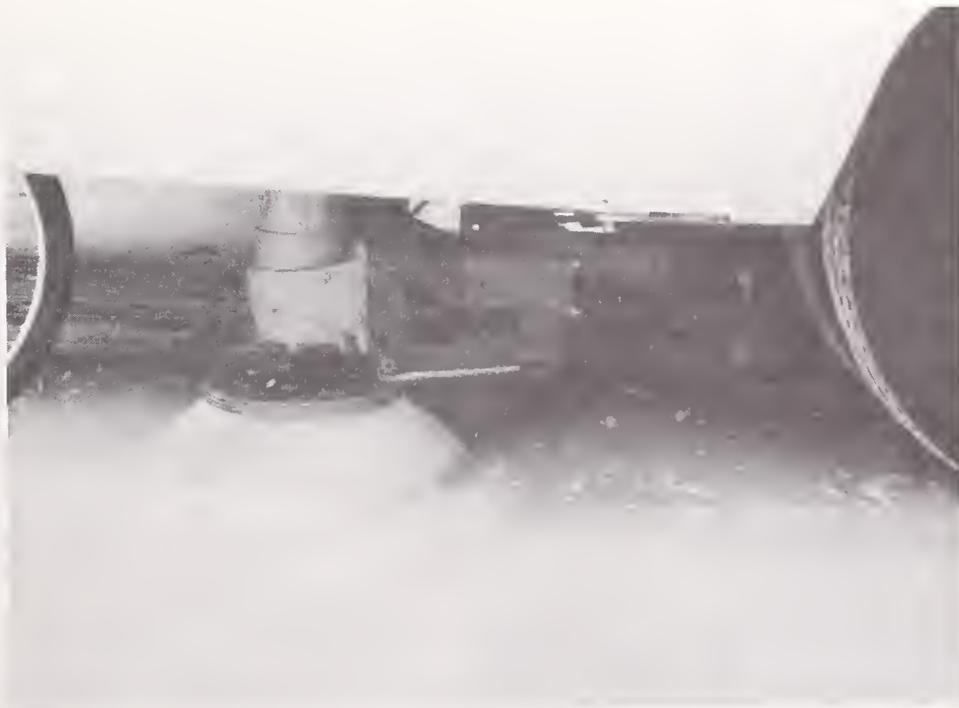
FIGURE 5-6. VERTICAL SNOW BRUSH UNIT

Both units were pneumatically raised and lowered and had means to adjust brush/surface pressures.

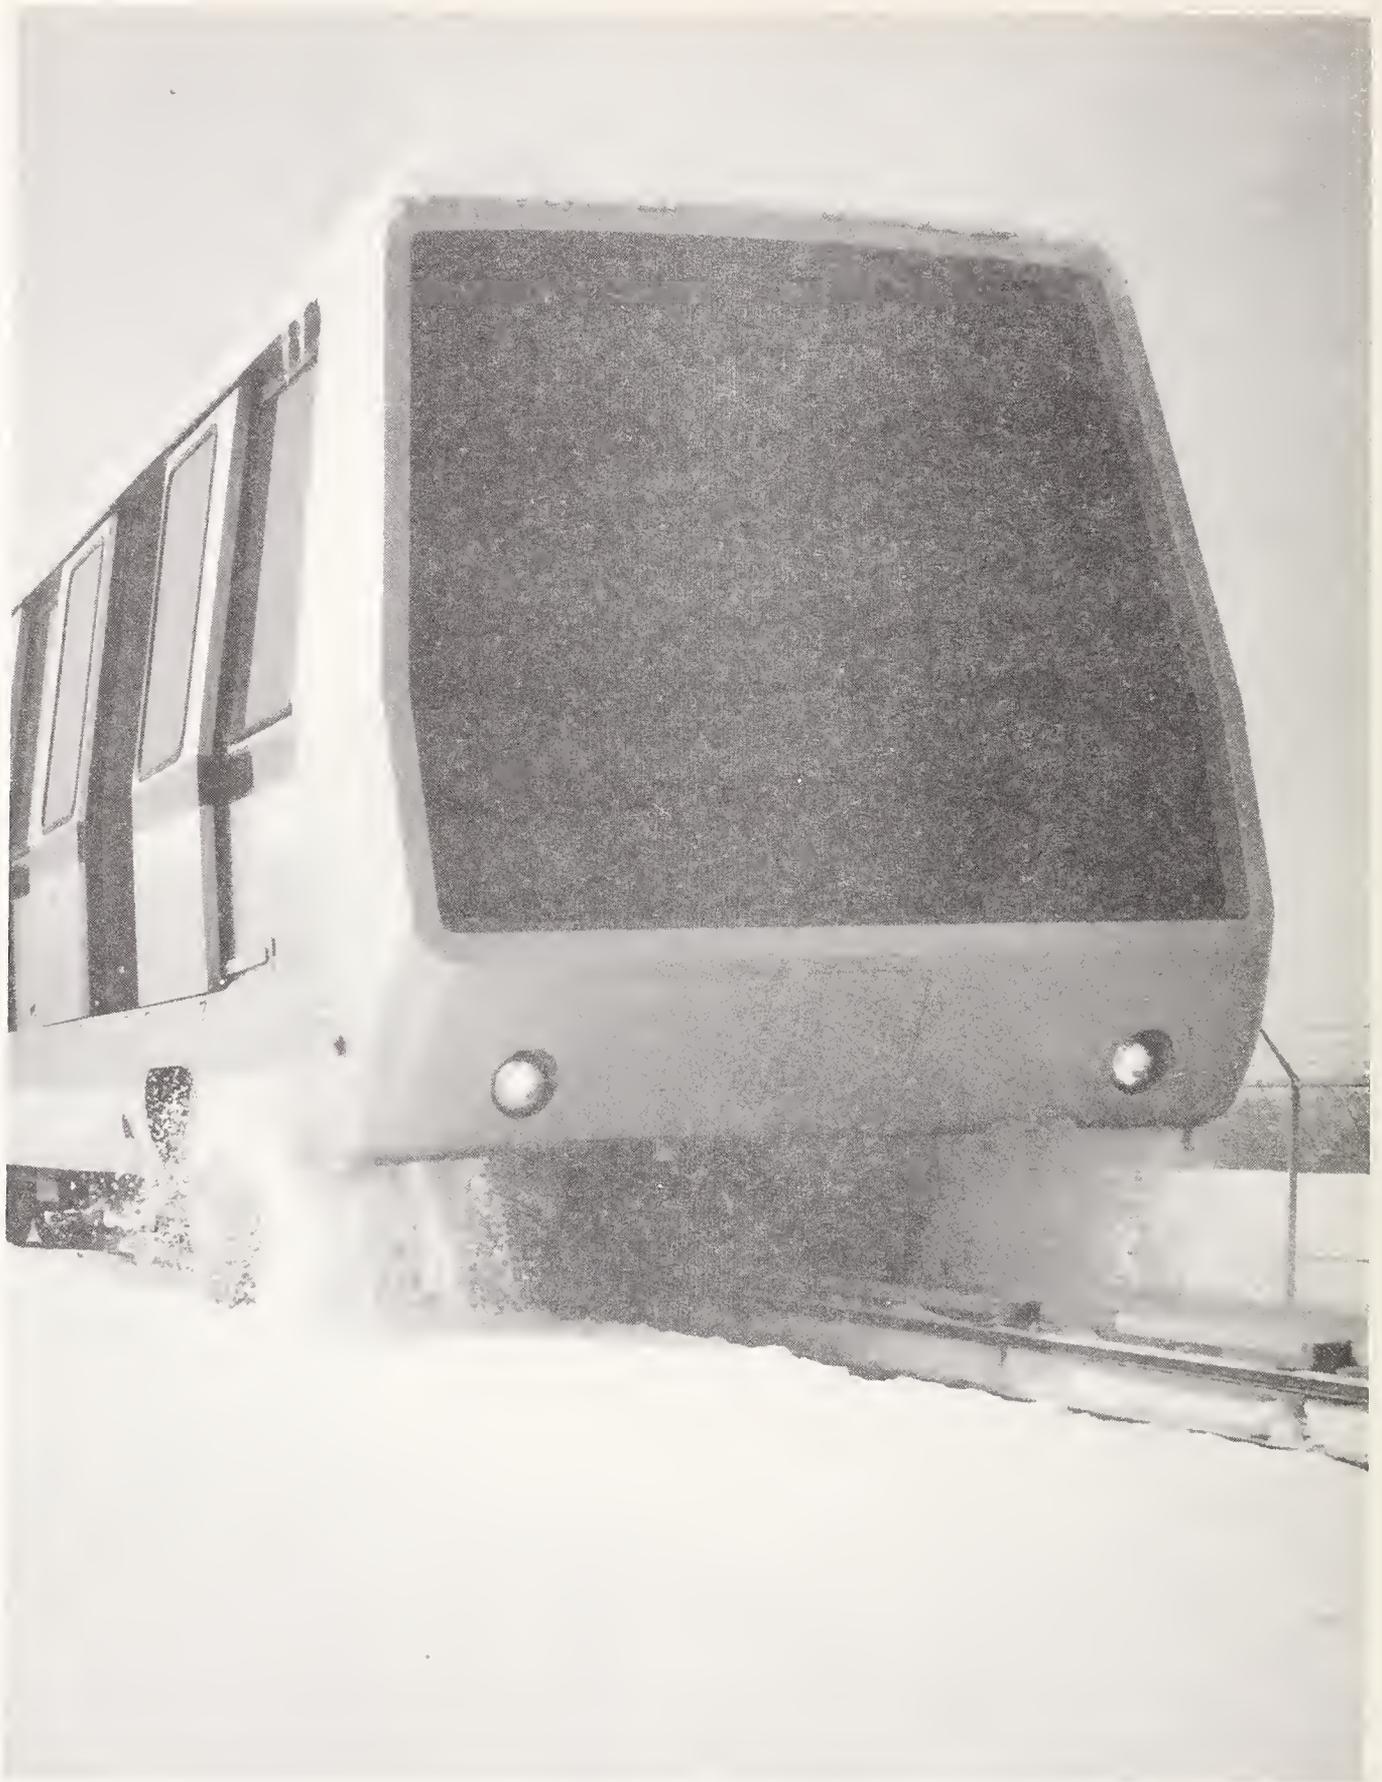
FIGURE 5-13. VIEW OF BRUSH ACTION

The vehicle was operated in a manual mode at varying speeds to observe the action of the brushes with different snow depths (see Figures 5-13 and 5-14).

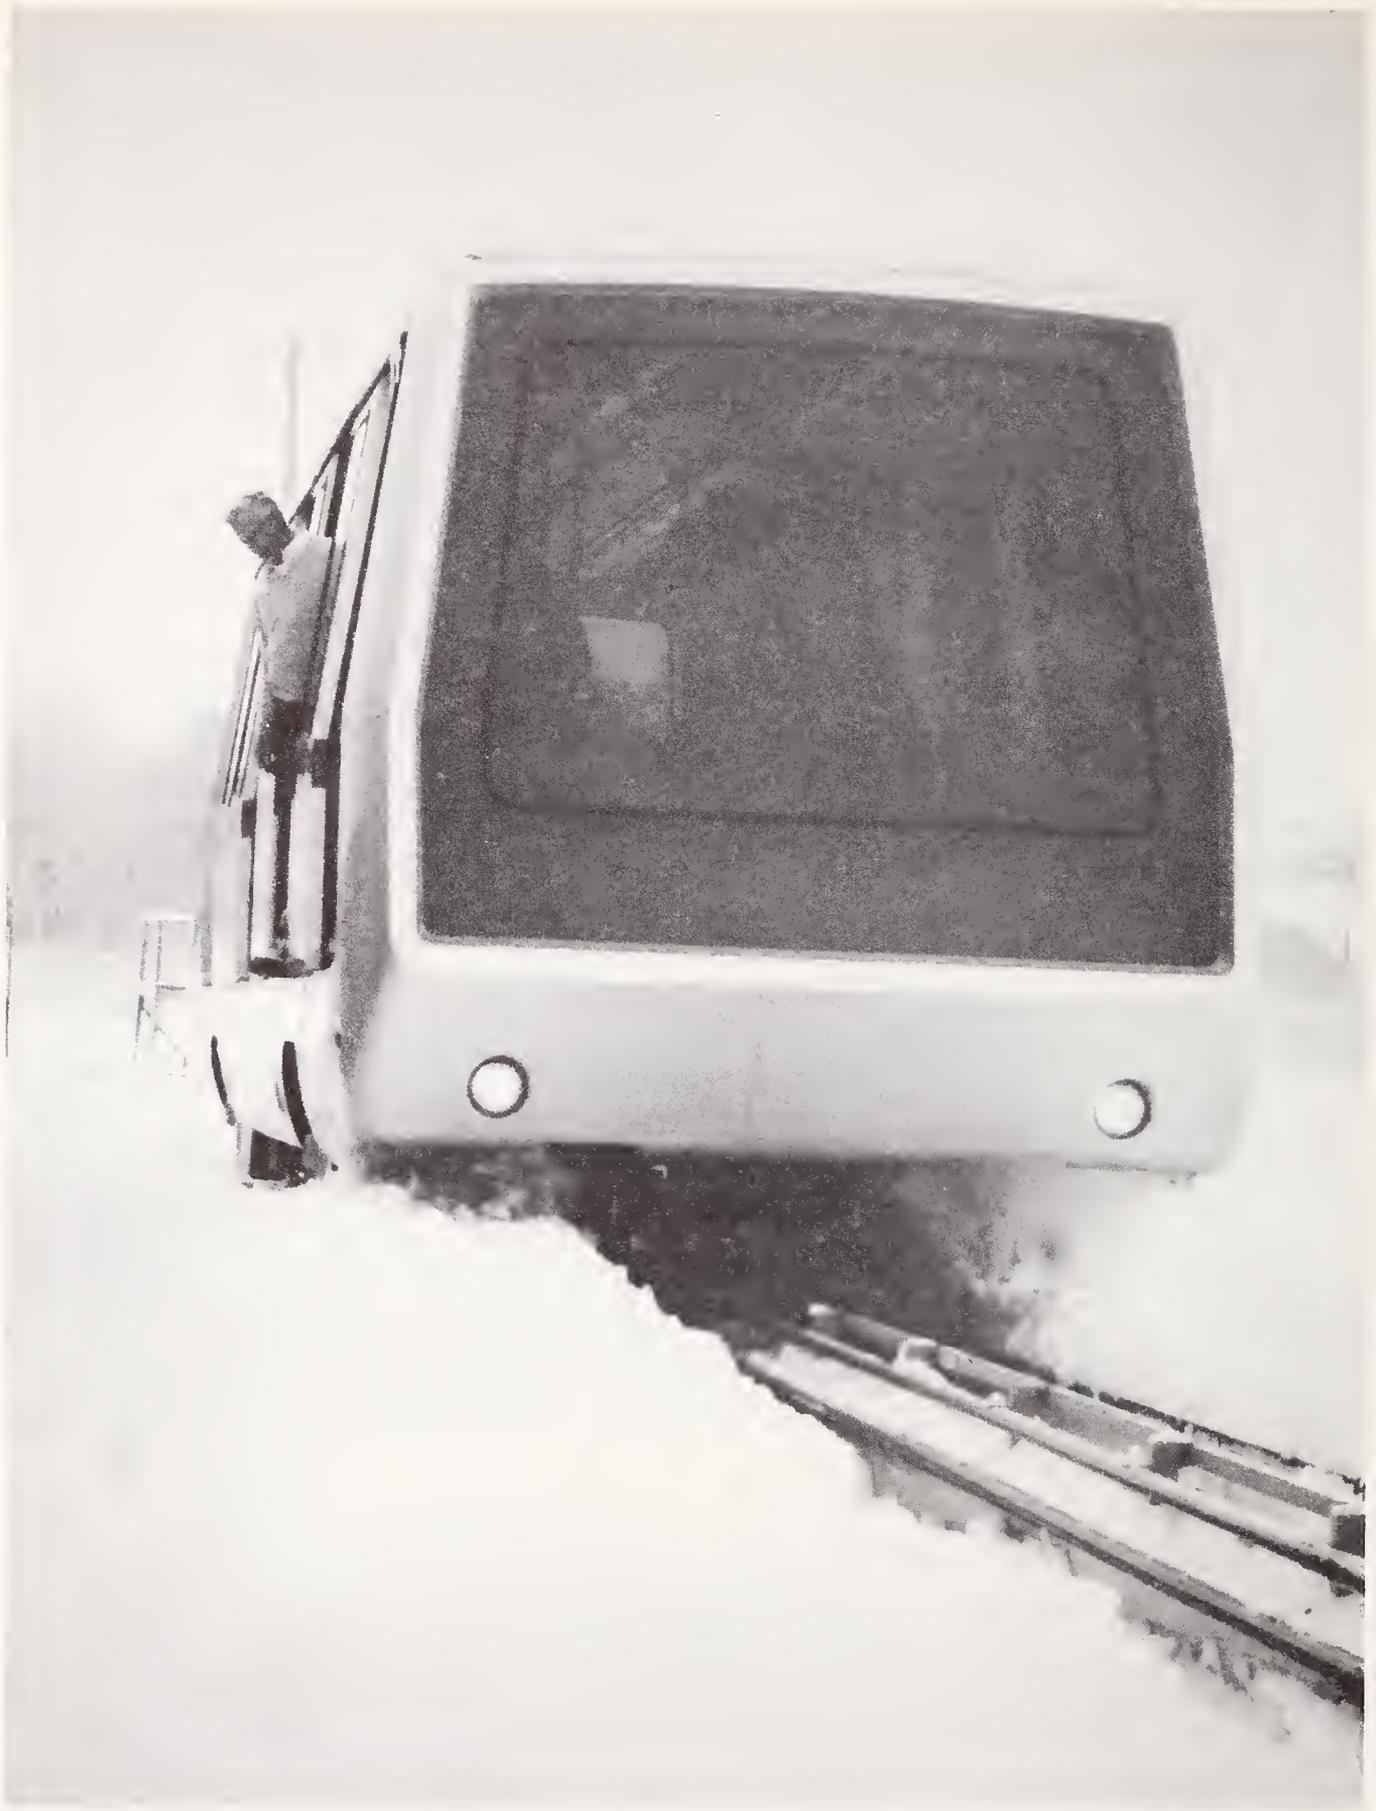
FIGURE 5-15. SNOW BRUSH ACTION DURING FIRST BRUSHING

Three passes were made over the track from Station 2 to Station 1. On the first run, when the snow was greater than the radius of the brushes, excess snow was carried up and over the brushes and deposited between the brushes and the tractive tires which then compacted the snow on the running surfaces (see Figure 5-15).

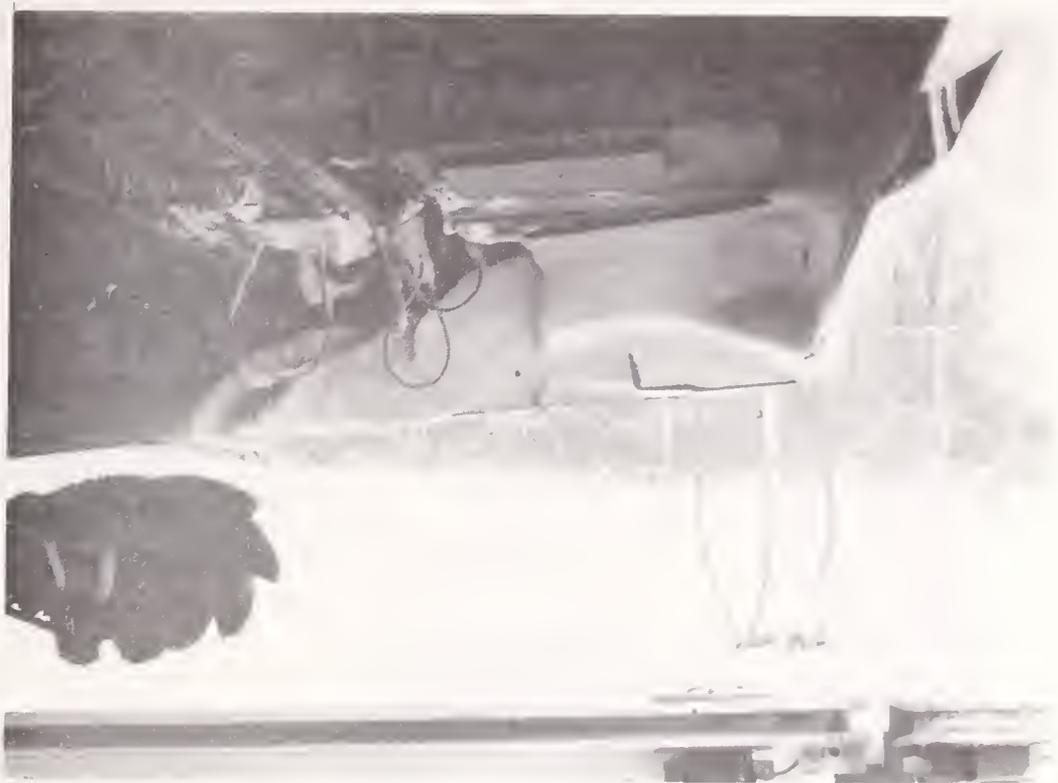
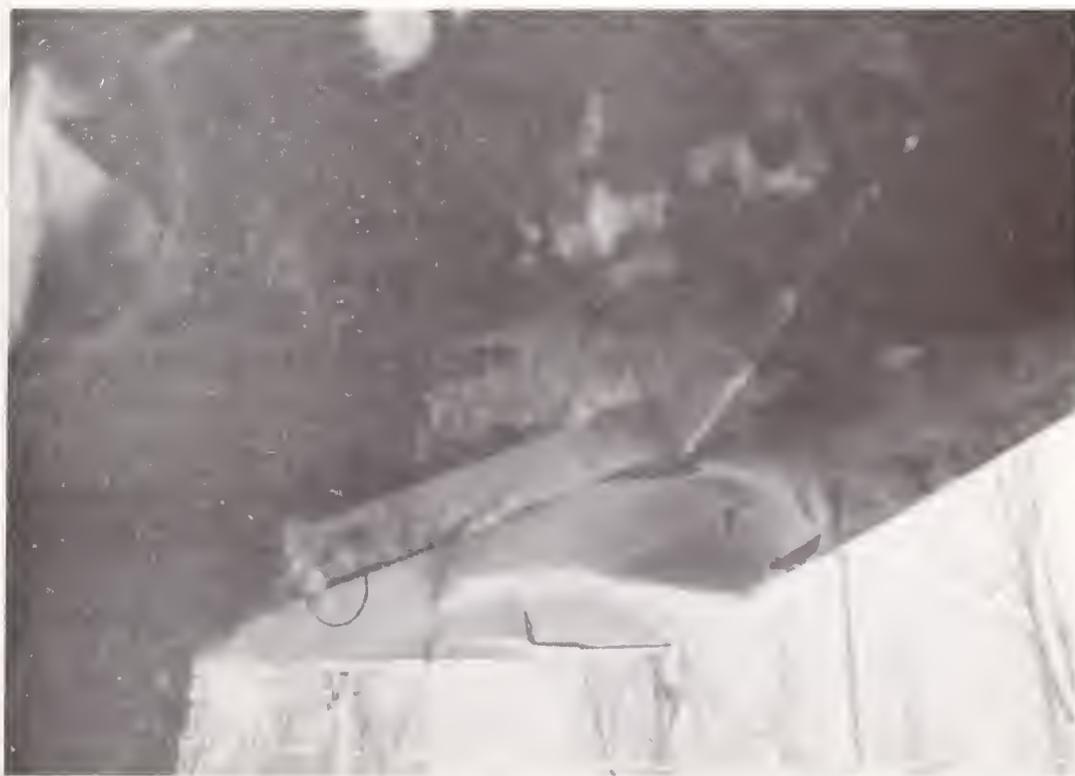
FIGURE 5-17. SNOW ACCUMULATION AFTER BRUSHING

This test was conducted to gather more information on the operation of the brushes with and without plow/shroud attachments. One inch of light snow covered most of the guideway surfaces. The vehicle was operated from Station 3 to Station 1 at 7 MPH. Again the brush without a plow/shroud attachment caused considerable snow to be thrown onto the underside of the vehicle, as well as the power signal rails (Figures 5-17 and 5-18).

1. The horizontal and vertical brush system had the ability to remove low density snow from the guideway surfaces, but difficulties were encountered in removing high density man-made snow and deep snow.
2. The vertical brush threw snow on the power/signal rails.
3. Horizontal brushes without the plow/shroud attachment did not divert the snow to the outside of the guideway, but instead, deposited snow on the vehicle underframe (Figure 5-19).
4. The brush assembly with plow/shroud attachment would not rise properly when laden with snow accumulations (Figure 5-20).
5. The plow/shroud attachment had clearance problems with vehicle body.
