Downtown People Mover (DPM) Winterization Test Demonstration: Westinghouse

L.S. Boehmer
A.P. Holbrook

Westinghouse Electric Corporation
Transportation Division
2001 Lebanon Road
West Mifflin PA 15122

January 1982
Final Report

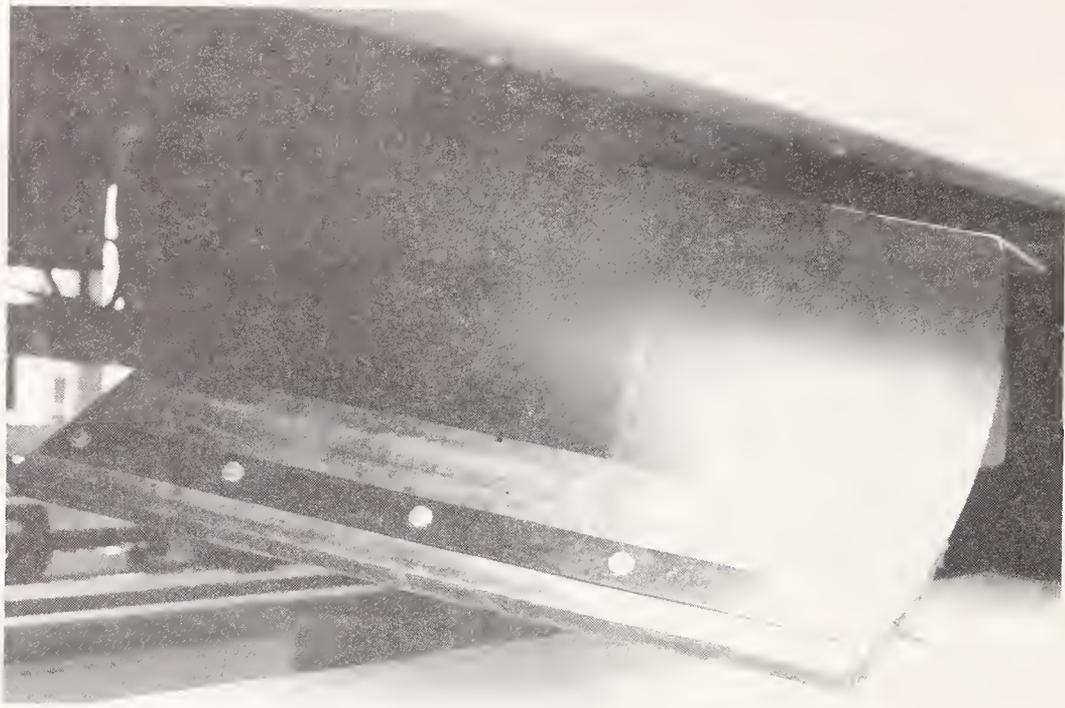
FIGURE 5-21. SNOW PLOW, FRONT VIEW

As a result of the testing performed with the snow scrapers during the 78-79 winter season, the interval between winter seasons was devoted to the design, fabrication and installation of snow plows on the Test Car. The new plow units were bogie mounted and electro/pneumatically operated (Figures 5-21 through 5-24). The plow blades were standard units modified to meet the guideway interface requirements. The blades were equipped with a flexible leading edge to enable a continuous contact with the running surfaces when in use. The objective was to determine the advantages or disadvantages of the plows, their ability to handle deep (10-20 inches) snow as well as ice, and the maintainability of the units. Test procedures were developed to determine proper downward pressures and plowing speed restrictions, if any.

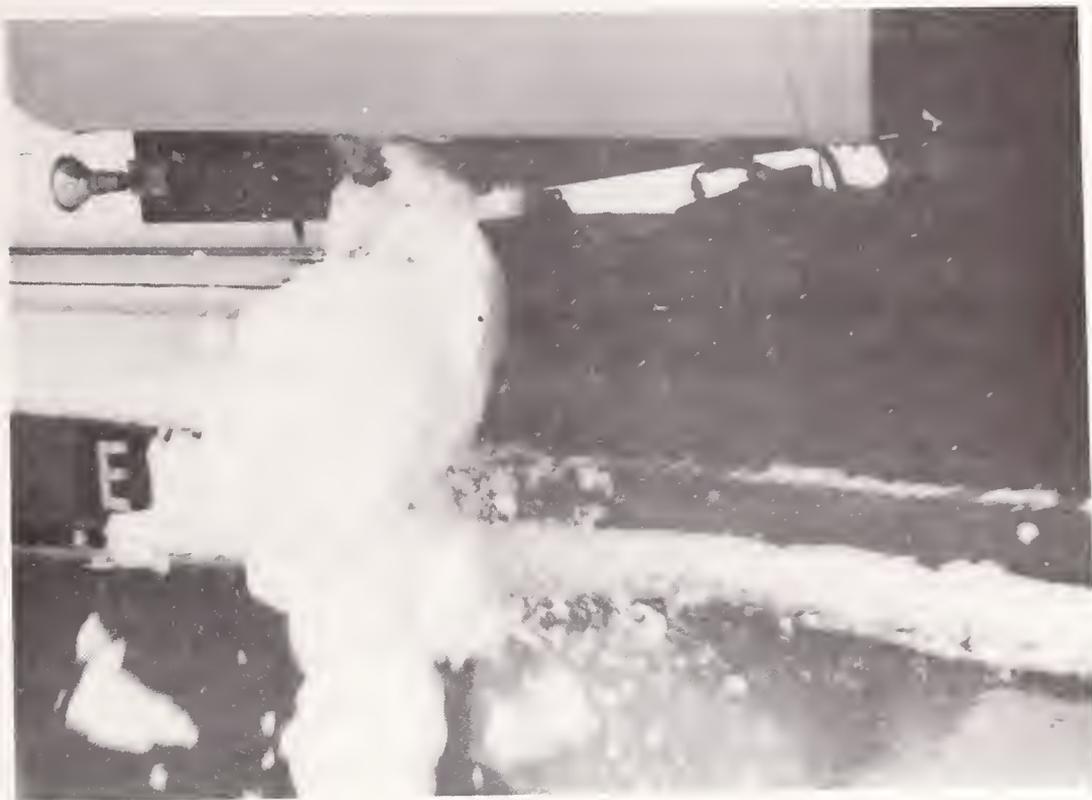
FIGURE 5-27. VEHICLE PLOWING MAN-MADE SNOW

The vehicle was frequently operated during snow making. Prior to this test, trips had been made every 10 minutes between Station 3 and Station 5 with the plows used once per hour. The vehicle had not traveled west of E160. From this point to E250, the western termination of the guideway, the snow depths varied from 1/2 inch to 16 1/2 inches at E202. The outer surface of the snow was ice encrusted. The vehicle was manually operated from Station 3 west until the plows reached E200. This was up the hill where the maximum grade of 10% is reached at E180. No problem was encountered. The vehicle was moved back towards Station 3 to allow on-board operators to view the plowed area. Again the vehicle was moved west until all snow was plowed to E220. Video records were made of the plowing of large chunks, 16" x 24" x 72", of snow/ice from the guideway. WTD does not recommend that this much snow be allowed to accumulate, because it would fall off the guideway in chunks. However, the WTD plows handle it easily.

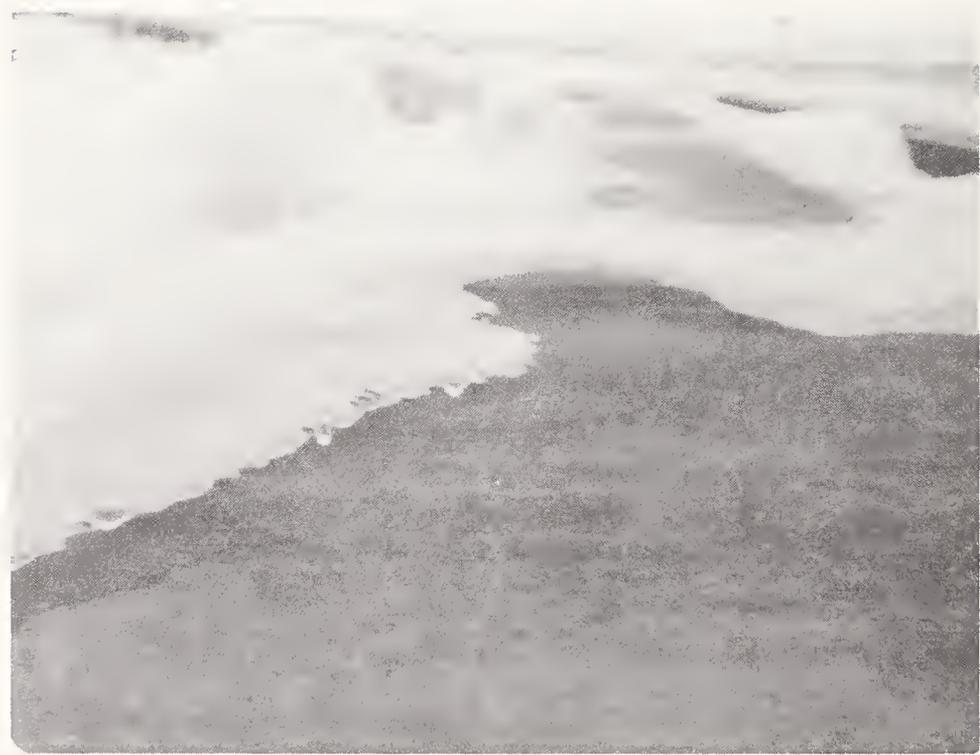
FIGURE 5-31. ELECTRICAL SNOW REMOVAL

Snow was still present on the guideways at the completion of testing. This was partially due to large air pockets being formed between the guideway surface and the snow. These pockets were formed by the snow melting on the surface and the water running off, leaving a space which insulated the snow and reduced the melting rate. Figure 5-31 shows the guideway surface air pocket condition.

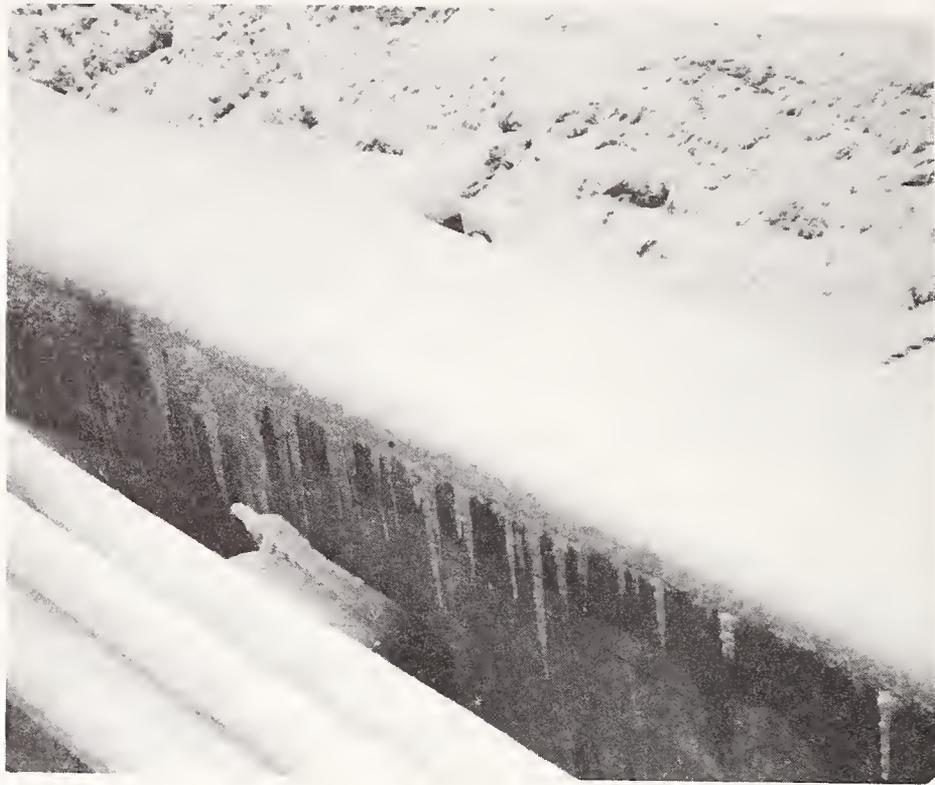
FIGURE 5-33. ELECTRICAL SNOW REMOVAL

Temperatures on the guideway surfaces at the start of the test were an average of +34°F with 1/2 to 1 inch depth of snow and slush deposited on the guideway surfaces. Figure 5-33 shows the guideway surface condition at the start of testing.

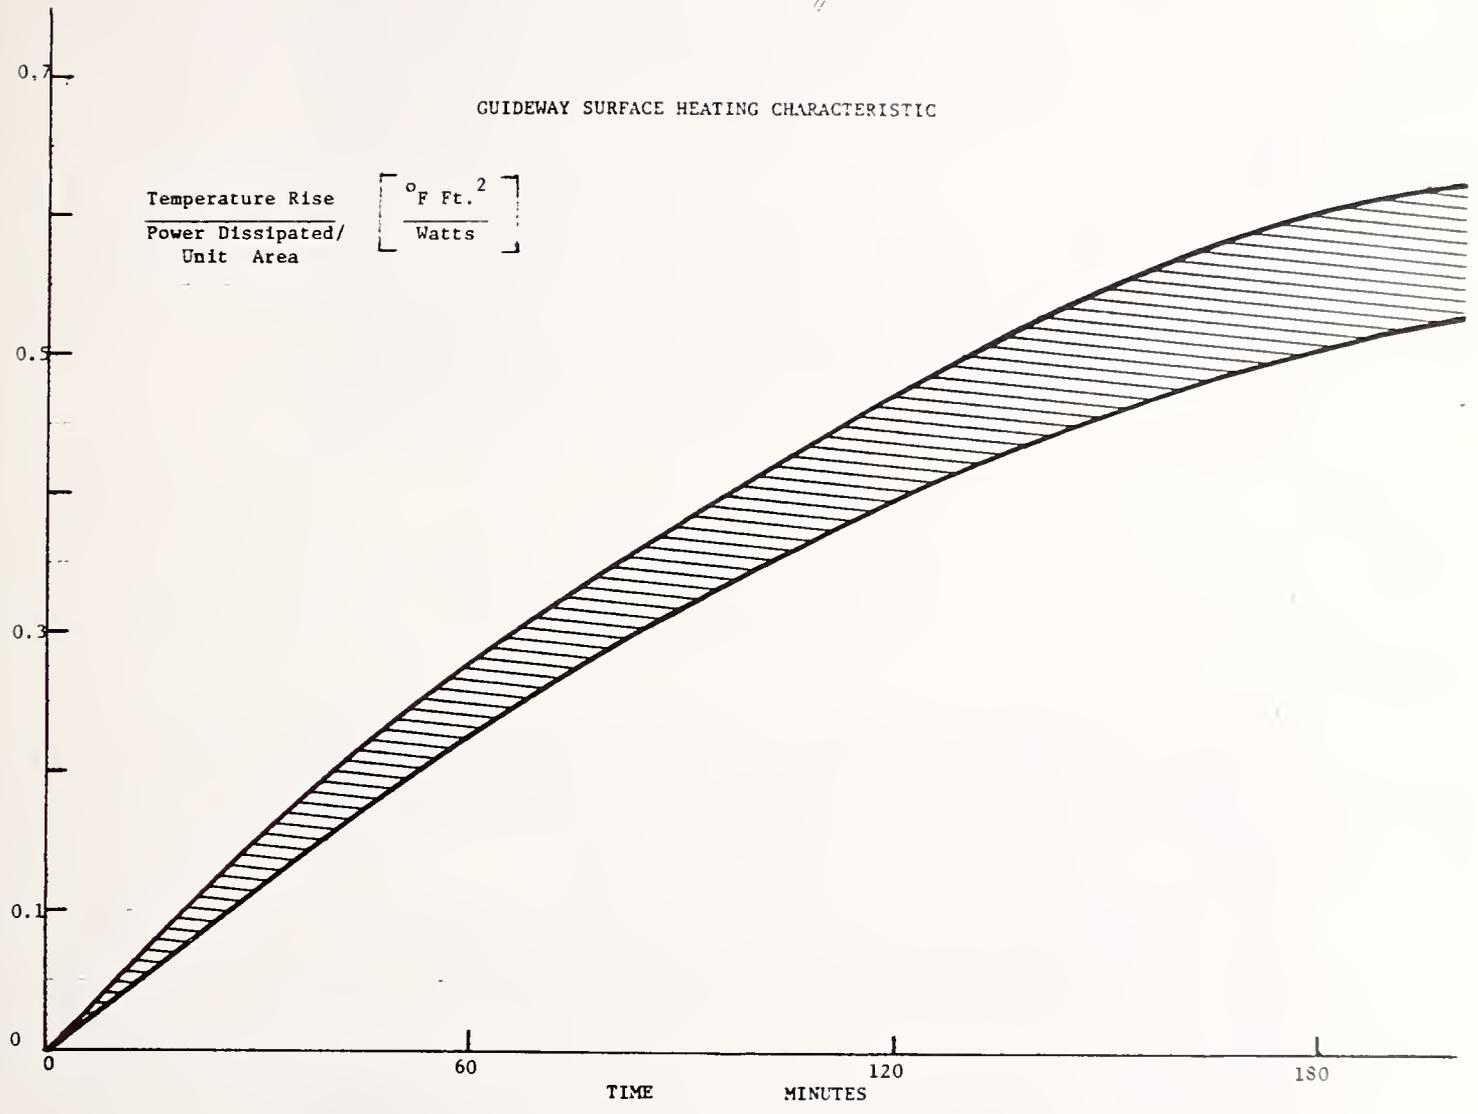
FIGURE 5-35. GUIDEWAY SURFACE HEATING CHARACTERISTIC

Figure 5-35 shows the guideway surface heating characteristic for the range of ambient conditions which occurred during testing. This data will assist in planning how far ahead of a predicted snow fall and at what power level setting the heating elements should be energized to maintain the guideway free of snow at minimum cost.

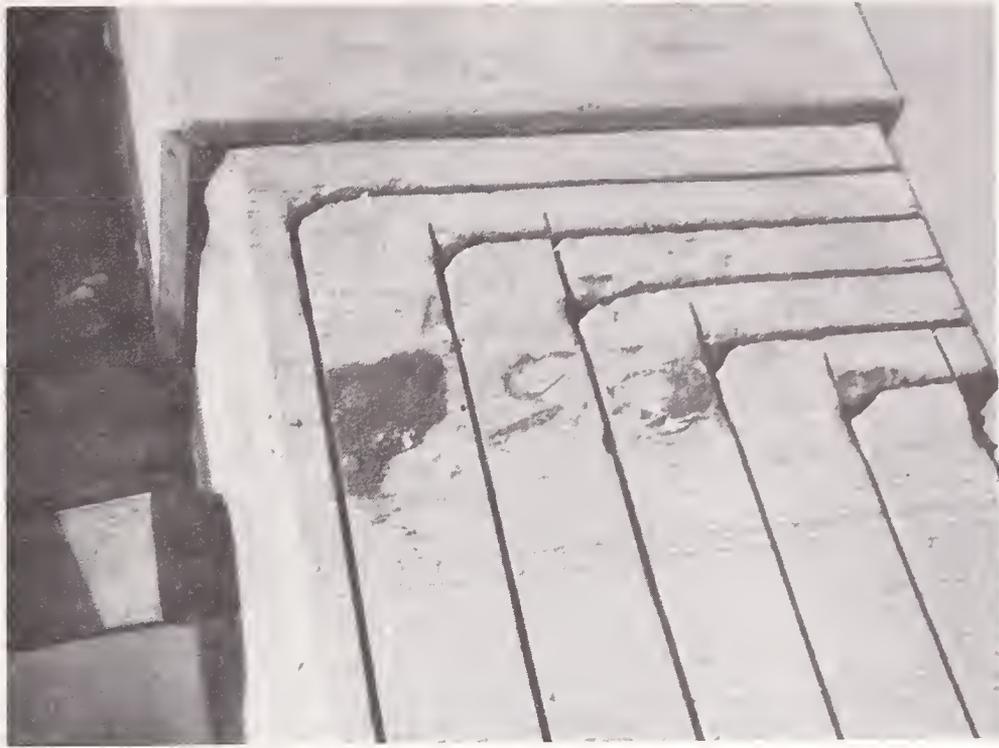
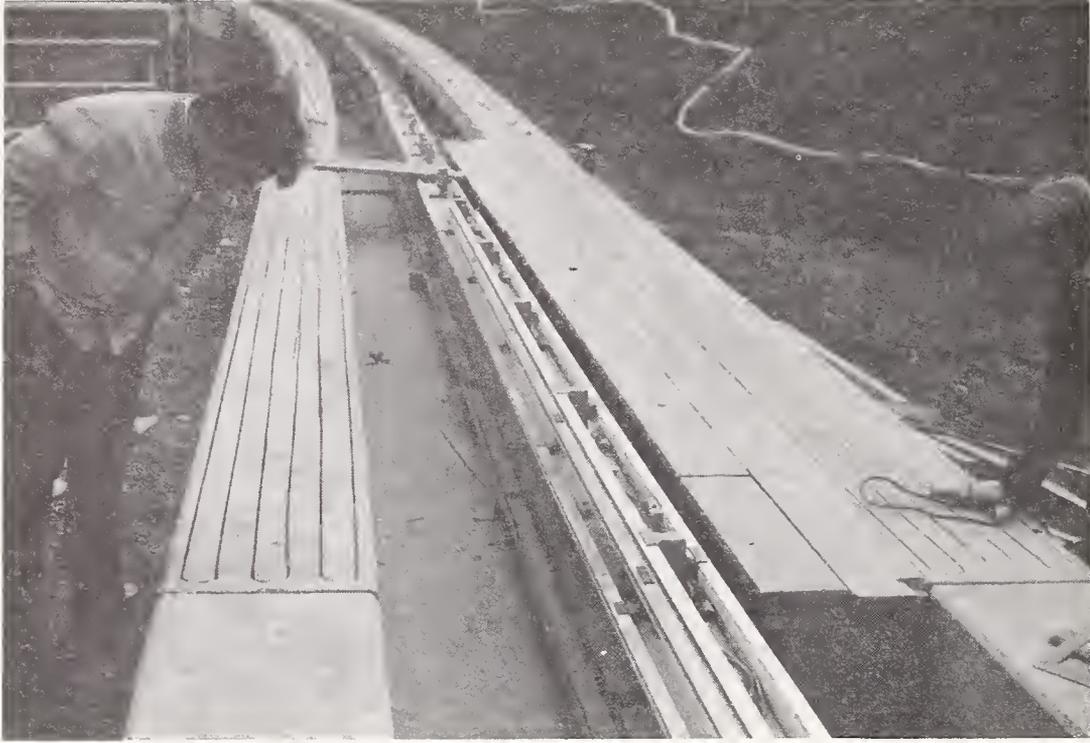
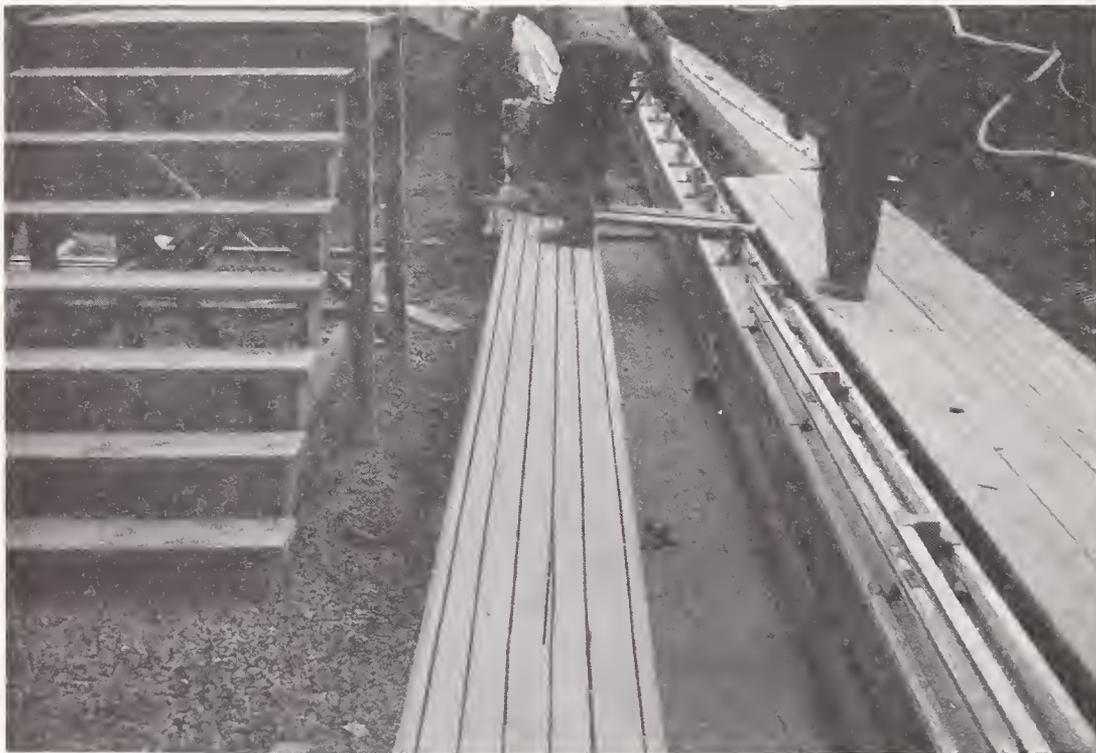
FIGURE 5-36. RETROFITTED HEATER GROOVES

The objective of these tests was to examine the capability of installing retrofitted heaters with the ultimate goal of providing proper heat distribution plus the ability to repair or replace entire units rapidly and efficiently. The technique could be adapted to the original construction of running surfaces as well as to existing set concrete.

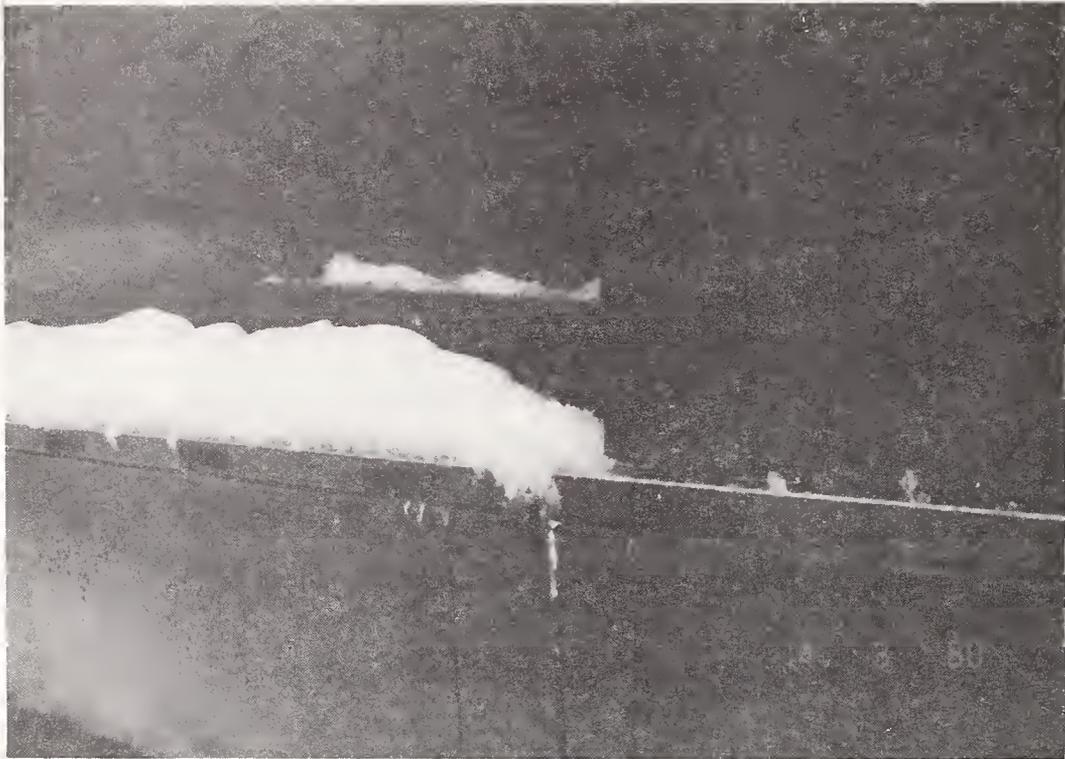
FIGURE 6-1. ATLANTA AIRPORT VEHICLE DOOR SILL

In previous years, door sills had become clogged with frozen snow and/or ice when the door tracks were not used for prolonged periods of time, such as overnight. During the times that the doors have been in normal use, no clogging or stoppages have occurred. The procedure was to allow the vehicle to remain stationary for overnight periods with all vehicle power turned off so no body heat would effect the test (Figures 6-4, 6-5 and 6-6). Whenever the vehicle was started for testing, a cold startup procedure was initiated wherein the doors were operated electrically and timed without any manual removal of snow and/or ice.

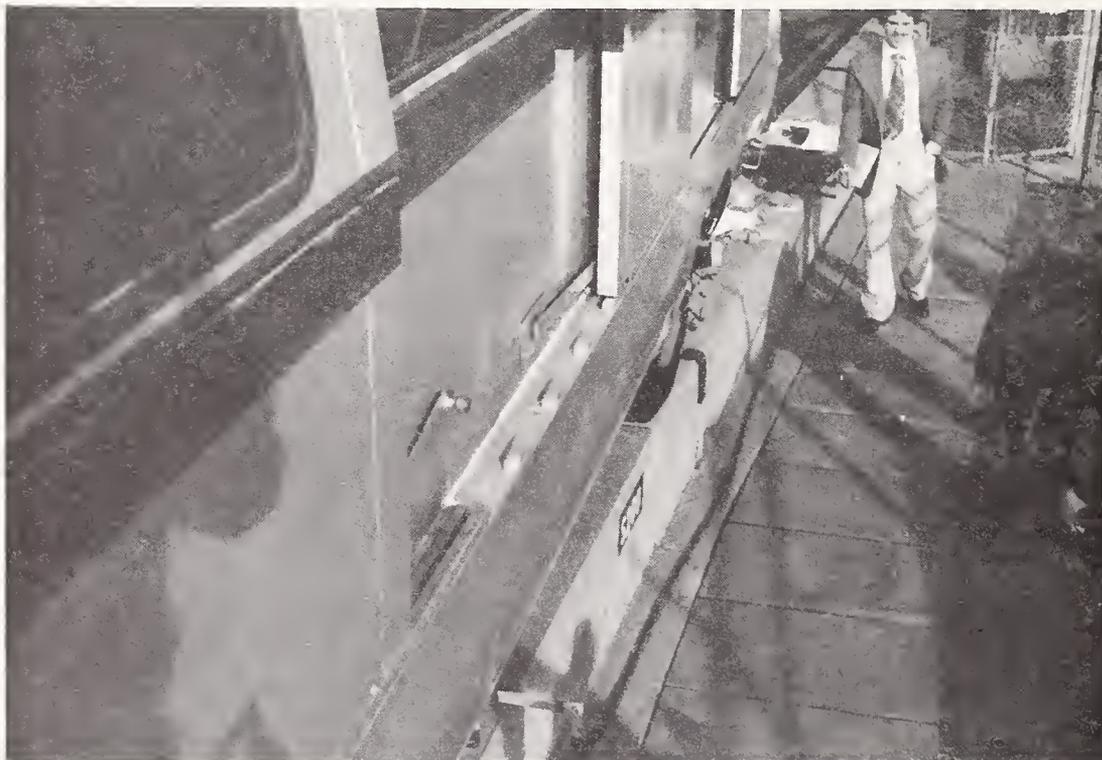
FIGURE 6-2. MODIFIED DOOR SILL, DOOR 6 UNCOATED

The standard lower door track available on all C-100 vehicles prior to the Atlanta Airport vehicle, and used for the 1978-79 test period, was an extrusion which guided the bottom of the vehicle doors during operation of the doors. The extrusion had a limited number of drain holes by which any accumulated water could escape. For the 1979-80 winter testing period a standard Atlanta Airport style sill (Figure 6-1), was modified and installed for doors 5 and 6 on the Engineering Test Car (Figures 6-2 and 6-3). One half of the modified unit was Teflon[®] coated while the other half was untreated.

The newly designed track was very successful in that it offered maximum area for snow and water to be drained or pushed away as doors opened.

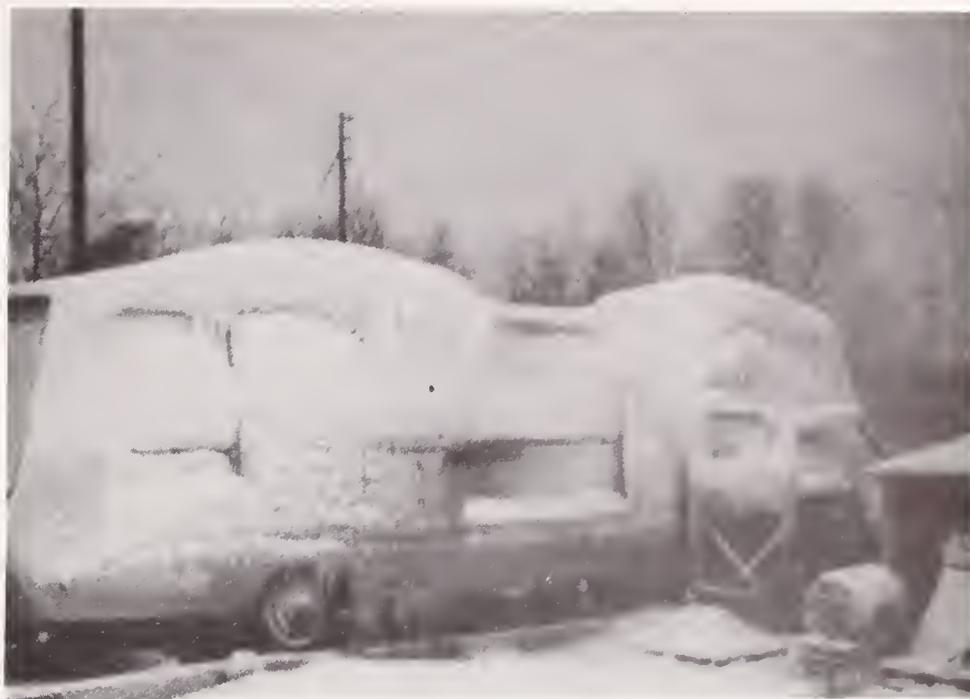
FIGURE 6-7. VEHICLE AFTER COLD SOAK

The conditions experienced are unrealistic and the failure was not related to the door sills. WTD does not recommend storing vehicles under the conditions described in this test. This test demonstrated the ability of door track heaters to function under extreme conditions, but sufficient test data was not collected to demonstrate a requirement for heating.

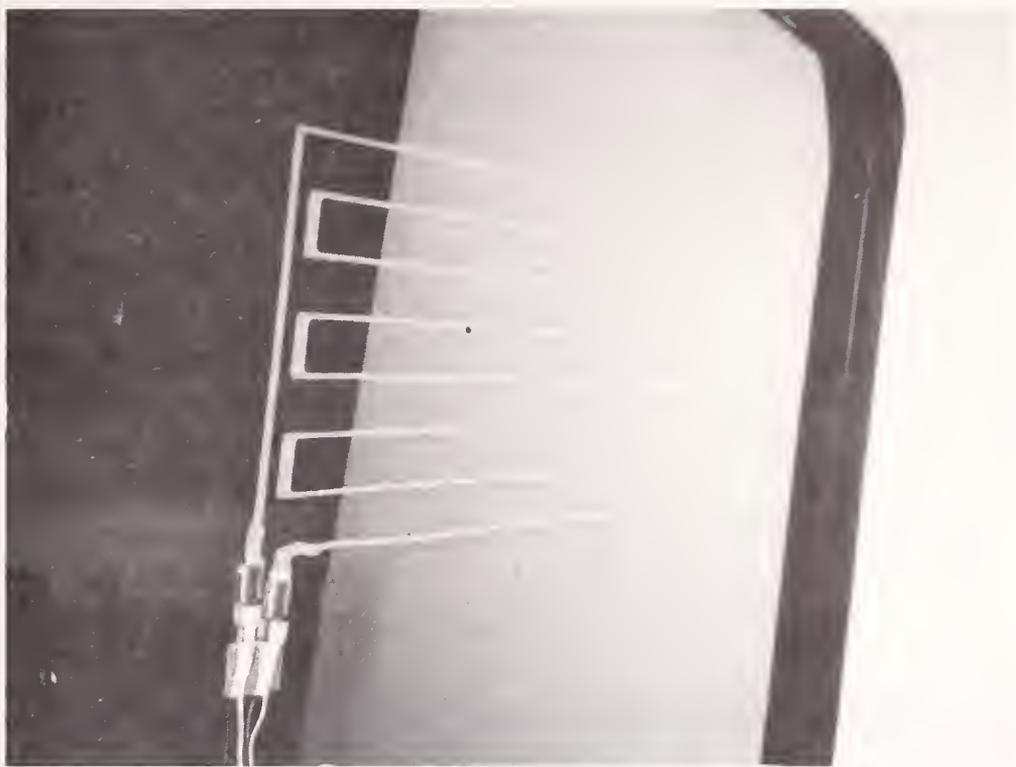
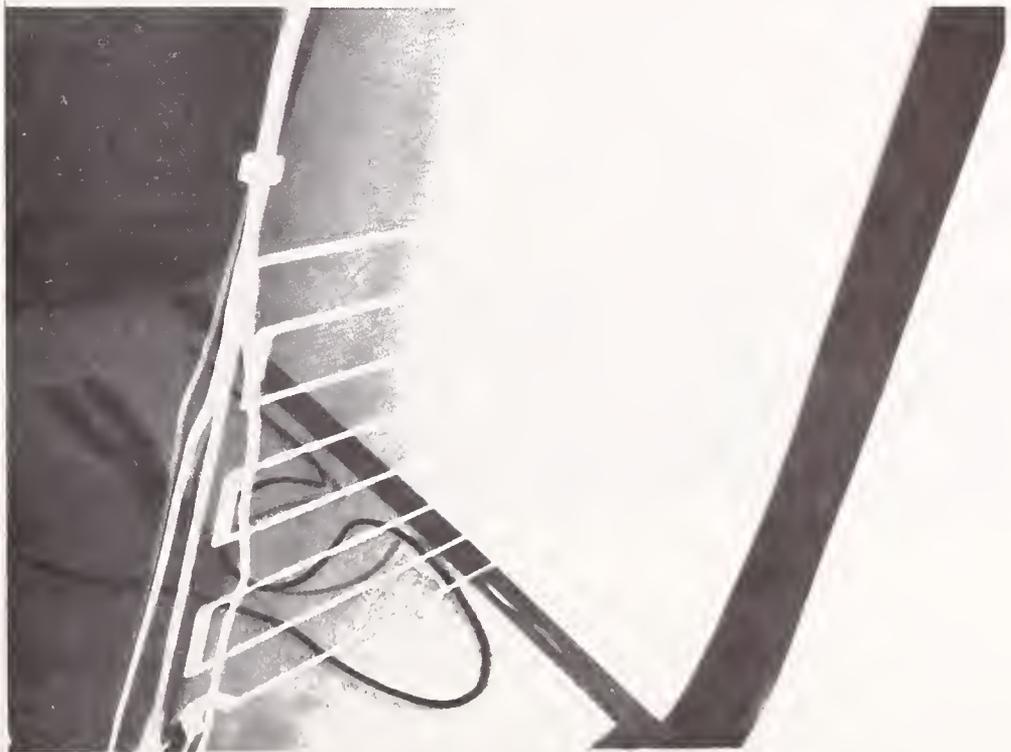
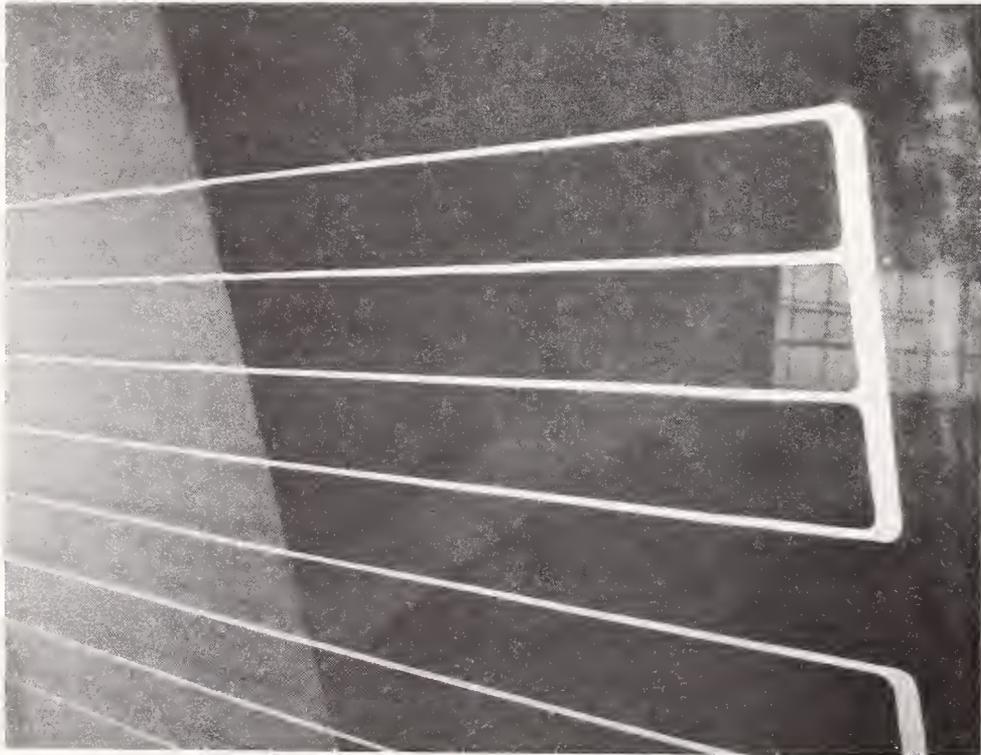
FIGURE 6-9. WINDOW DEICER

With light snow of a density of 0.15 covering the window at a depth of 1 inch at the bottom of the window to 1/4 inch at the top of the window, heater elements were energized for 30 minutes at 100 watts. Although the snow was light enough to brush off, it was decided to exercise the window deicers.
