Downtown People Mover (DPM) Winterization Test Demonstration: Westinghouse

L.S. Boehmer
A.P. Holbrook

Westinghouse Electric Corporation
Transportation Division
2001 Lebanon Road
West Mifflin PA 15122

January 1982
Final Report

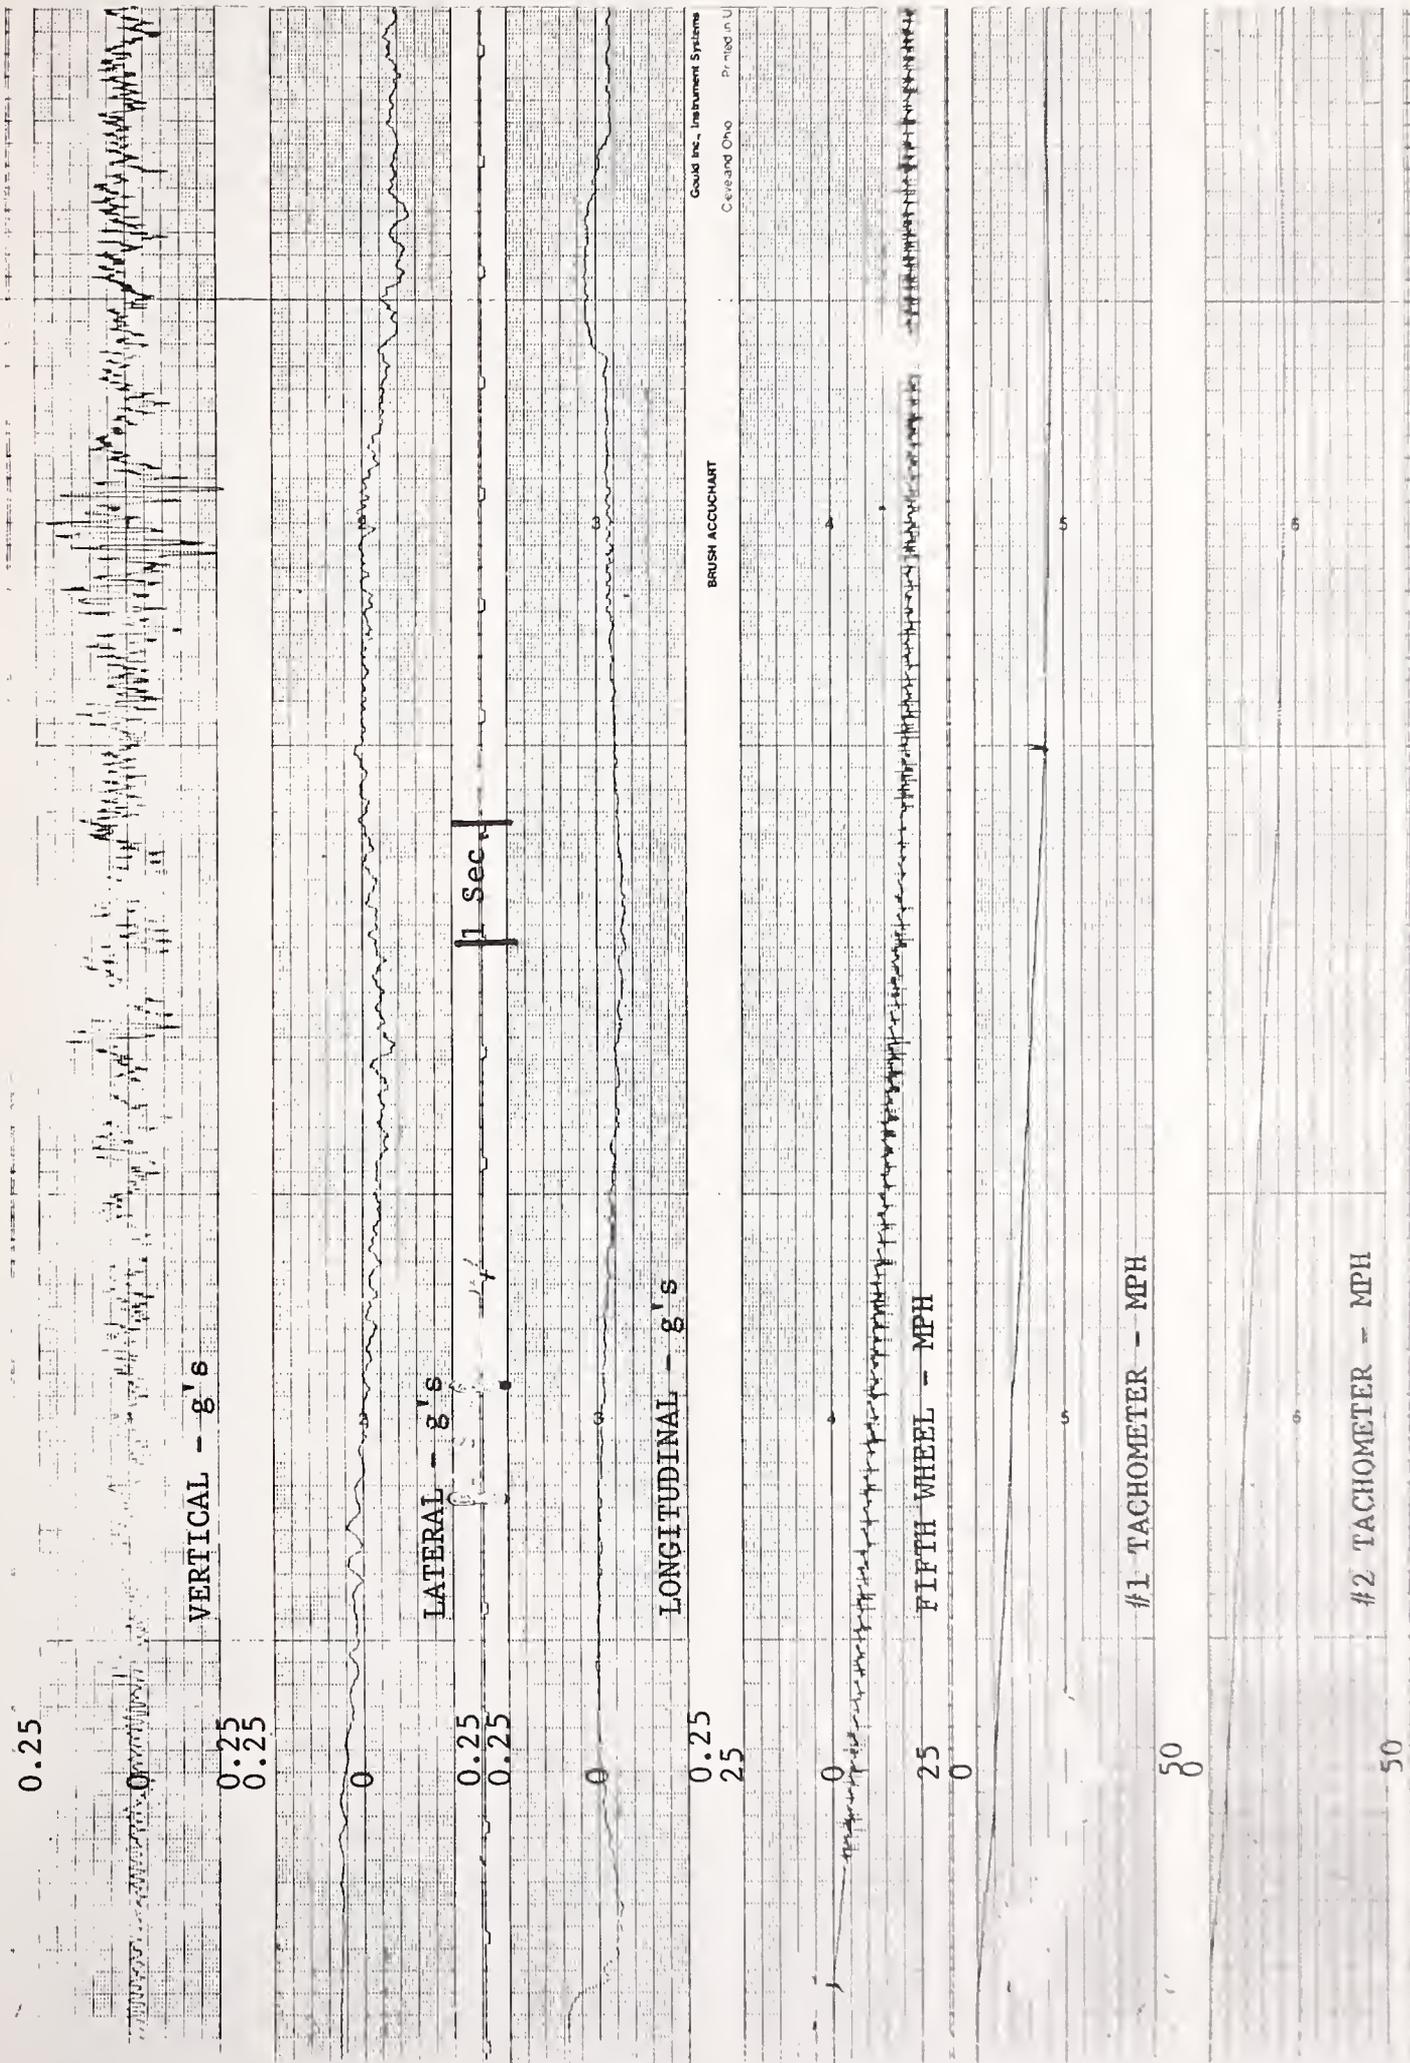
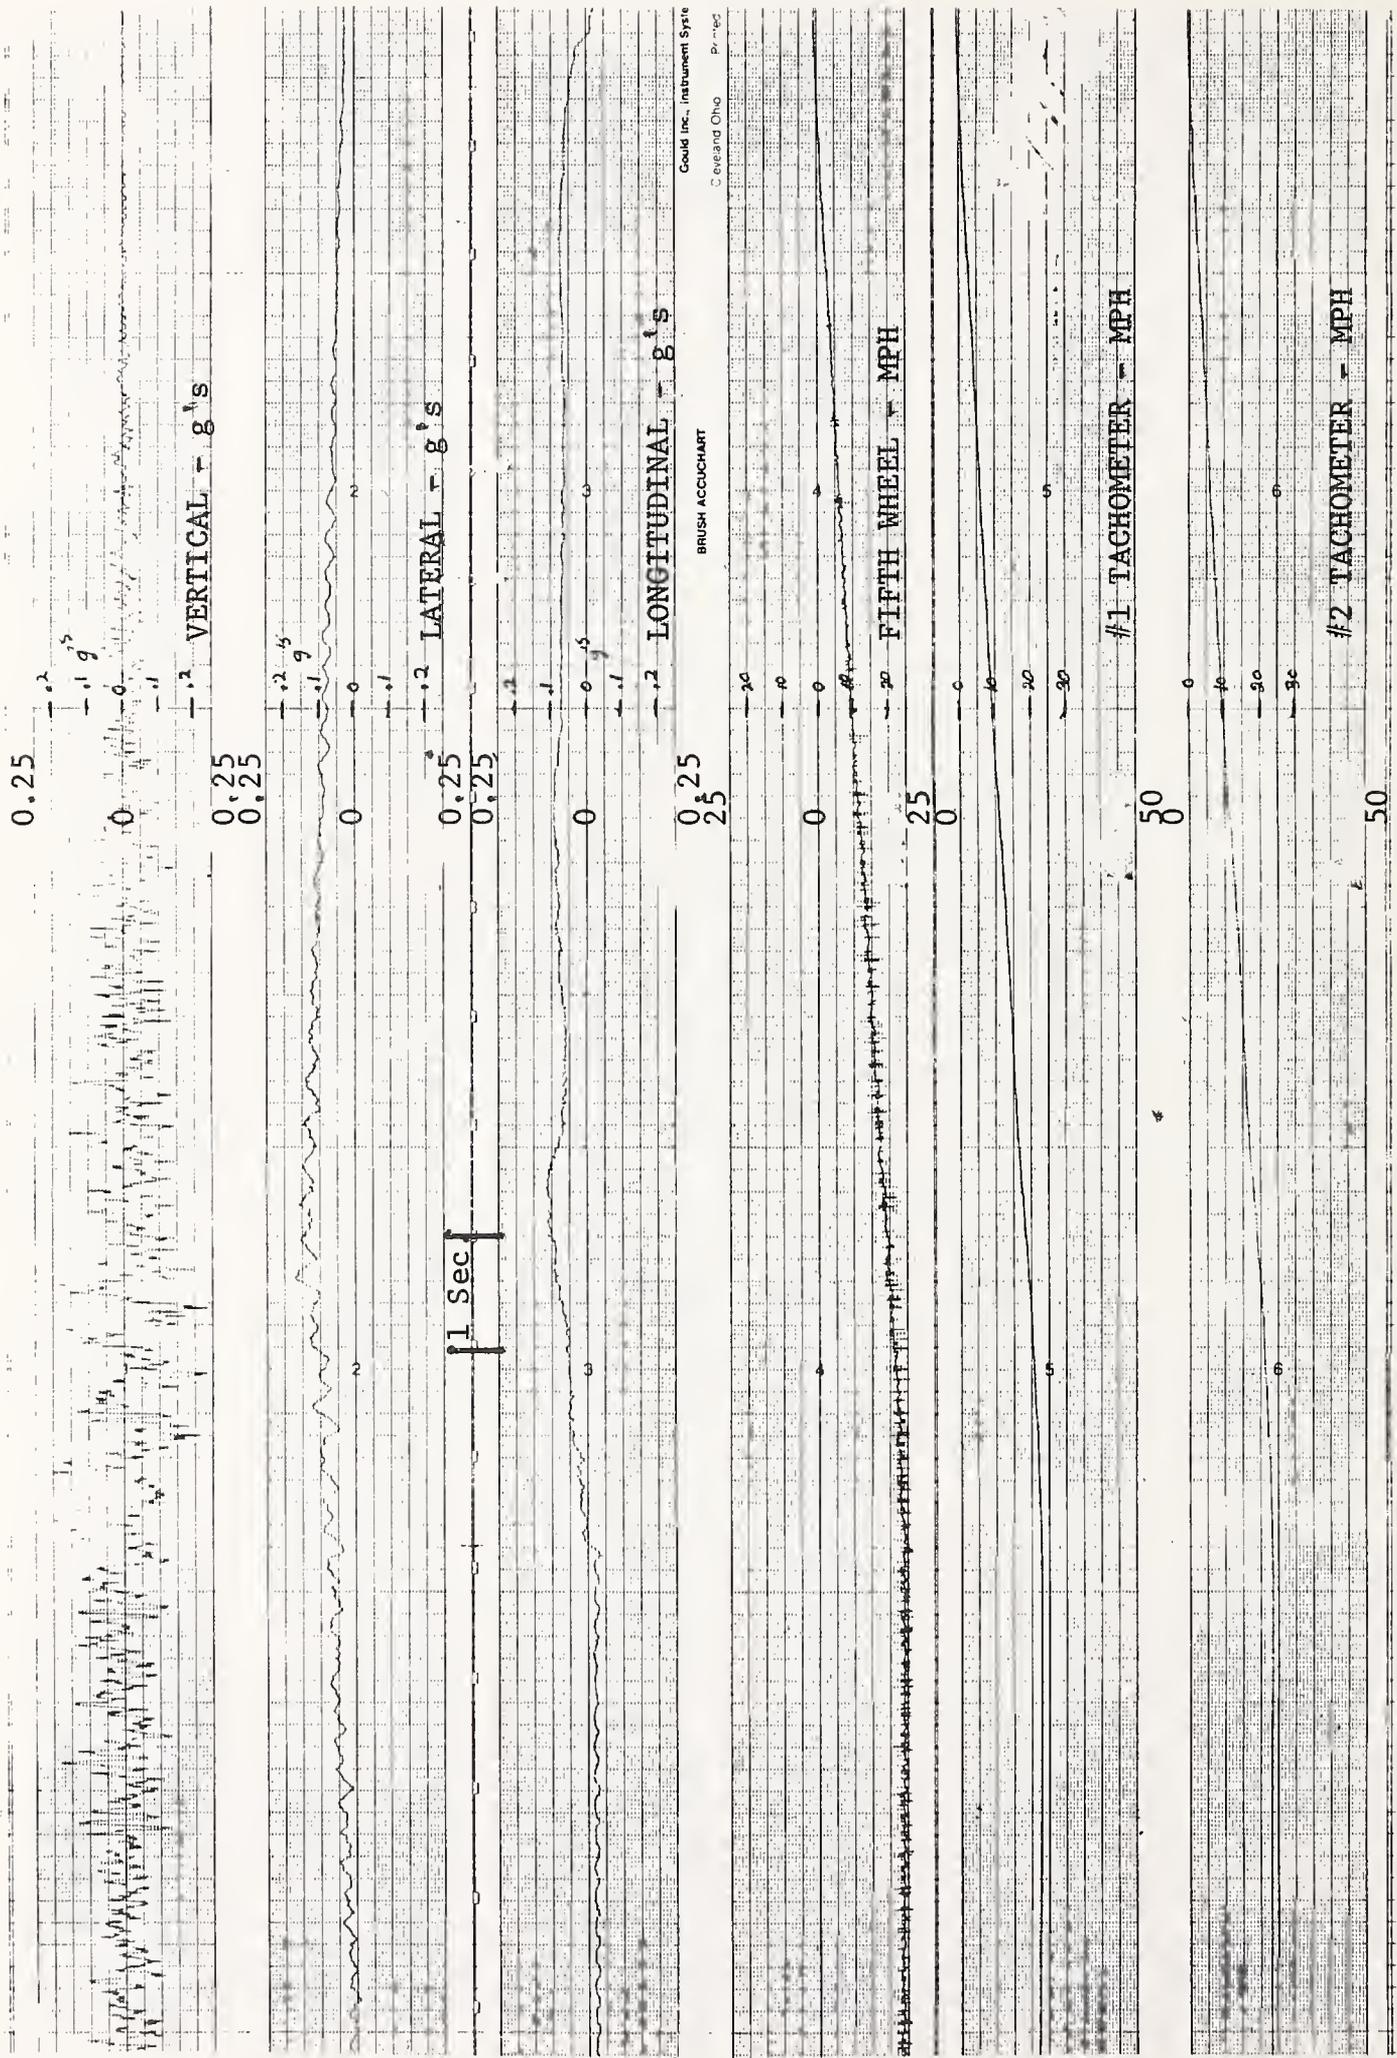
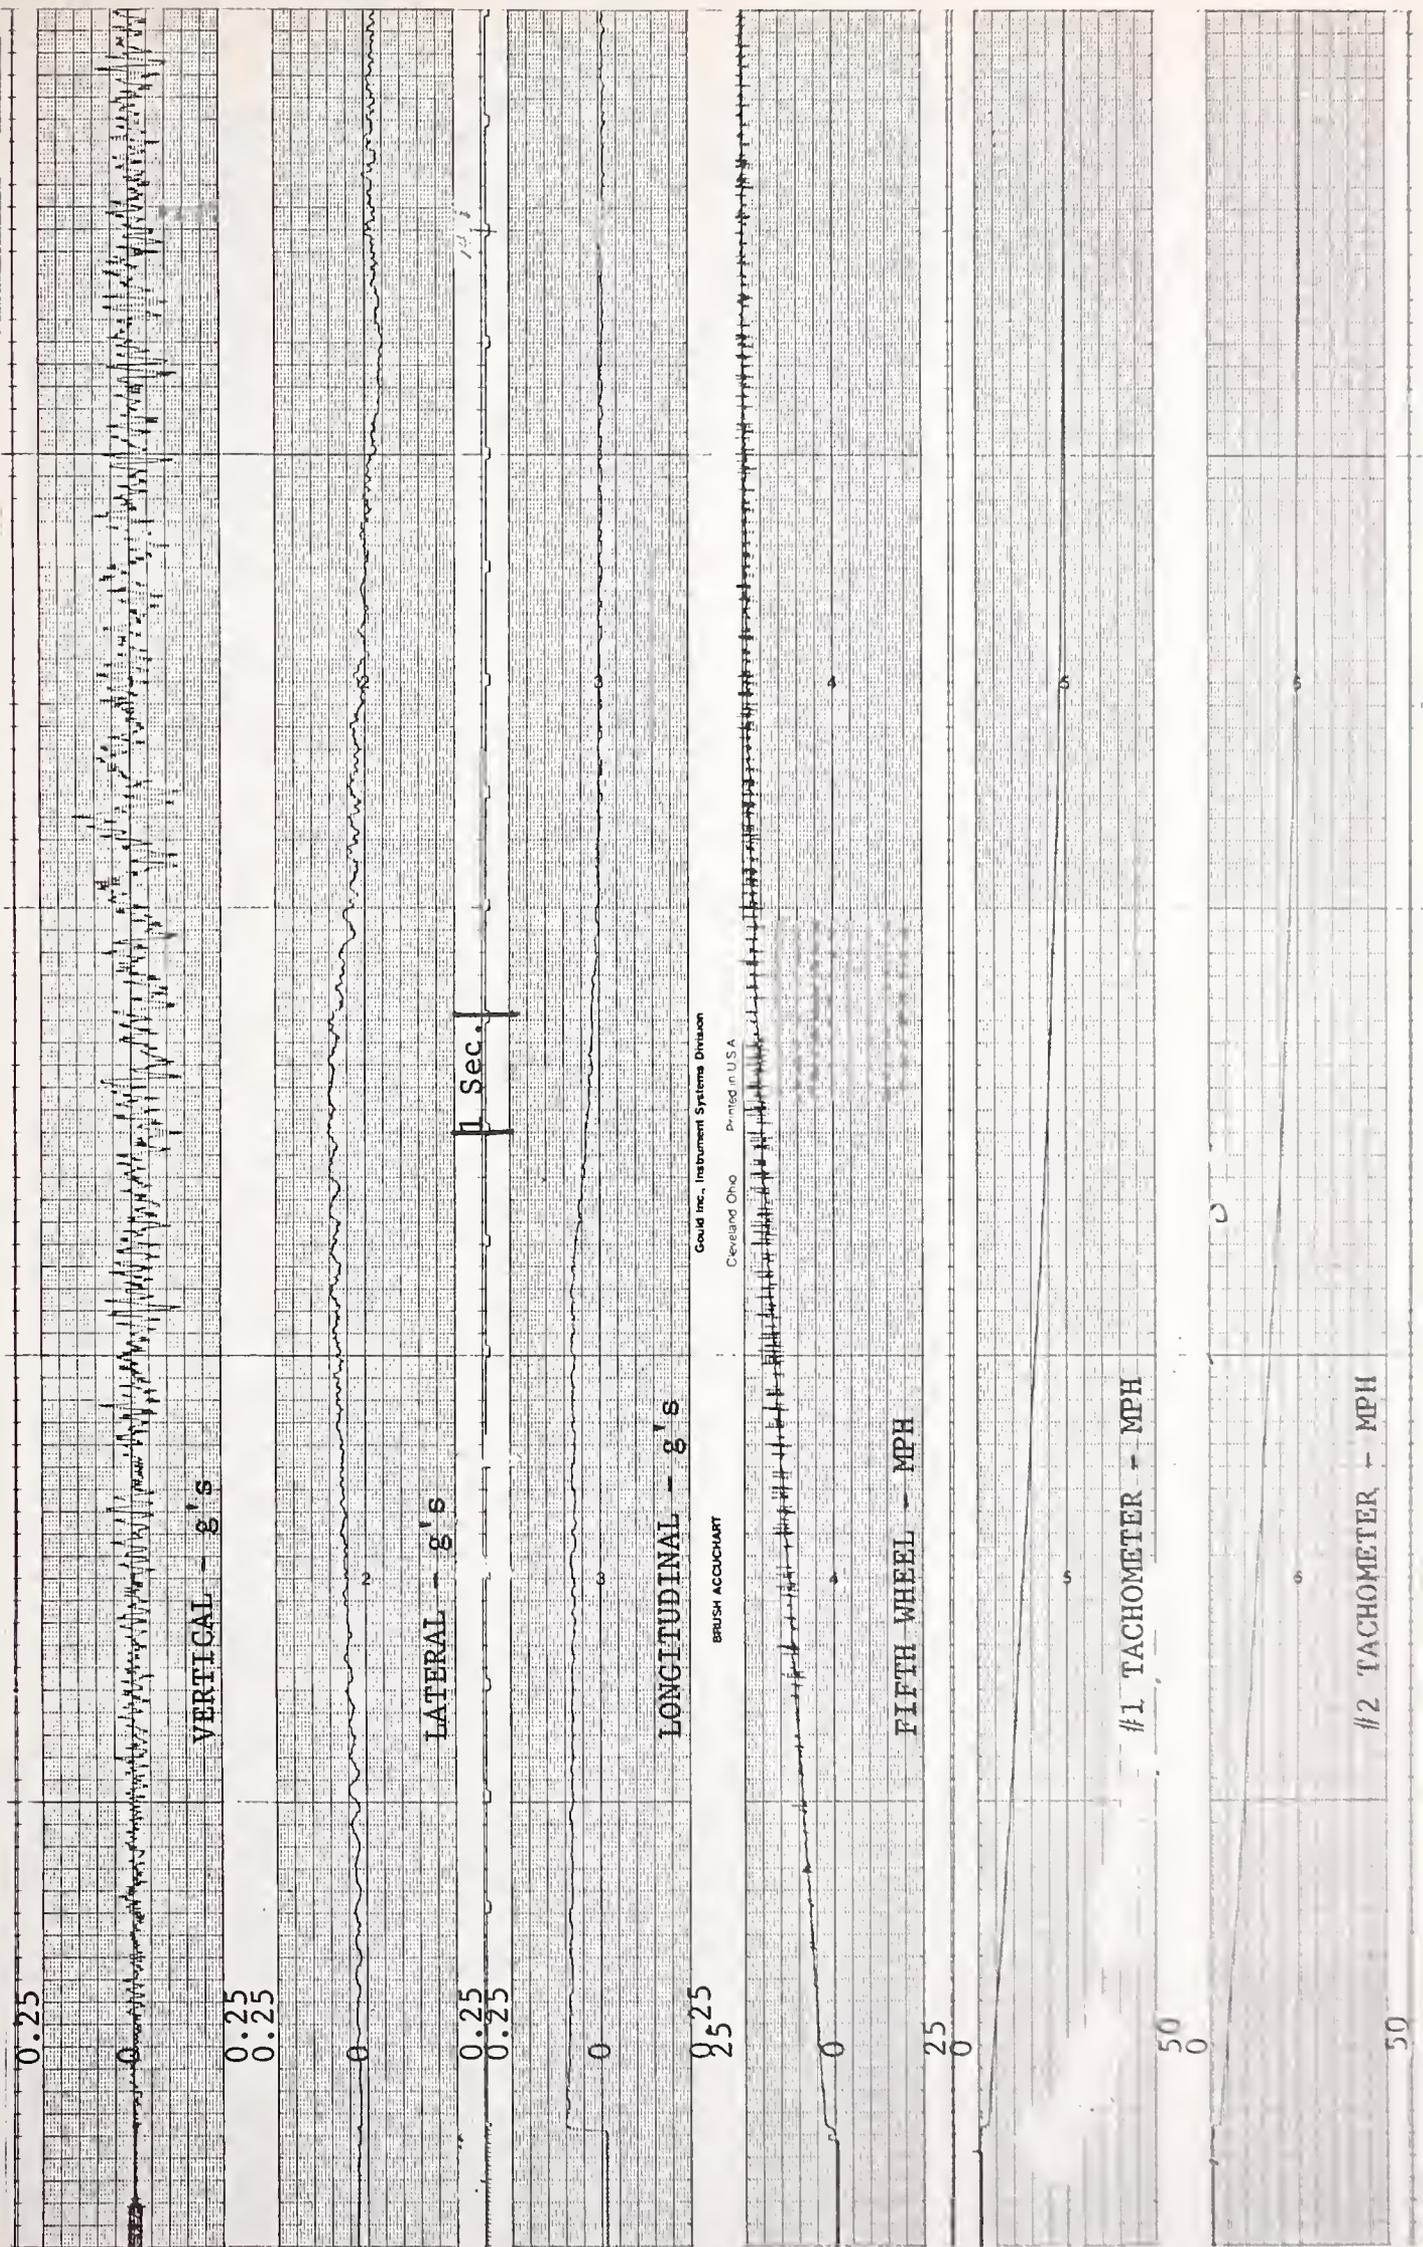
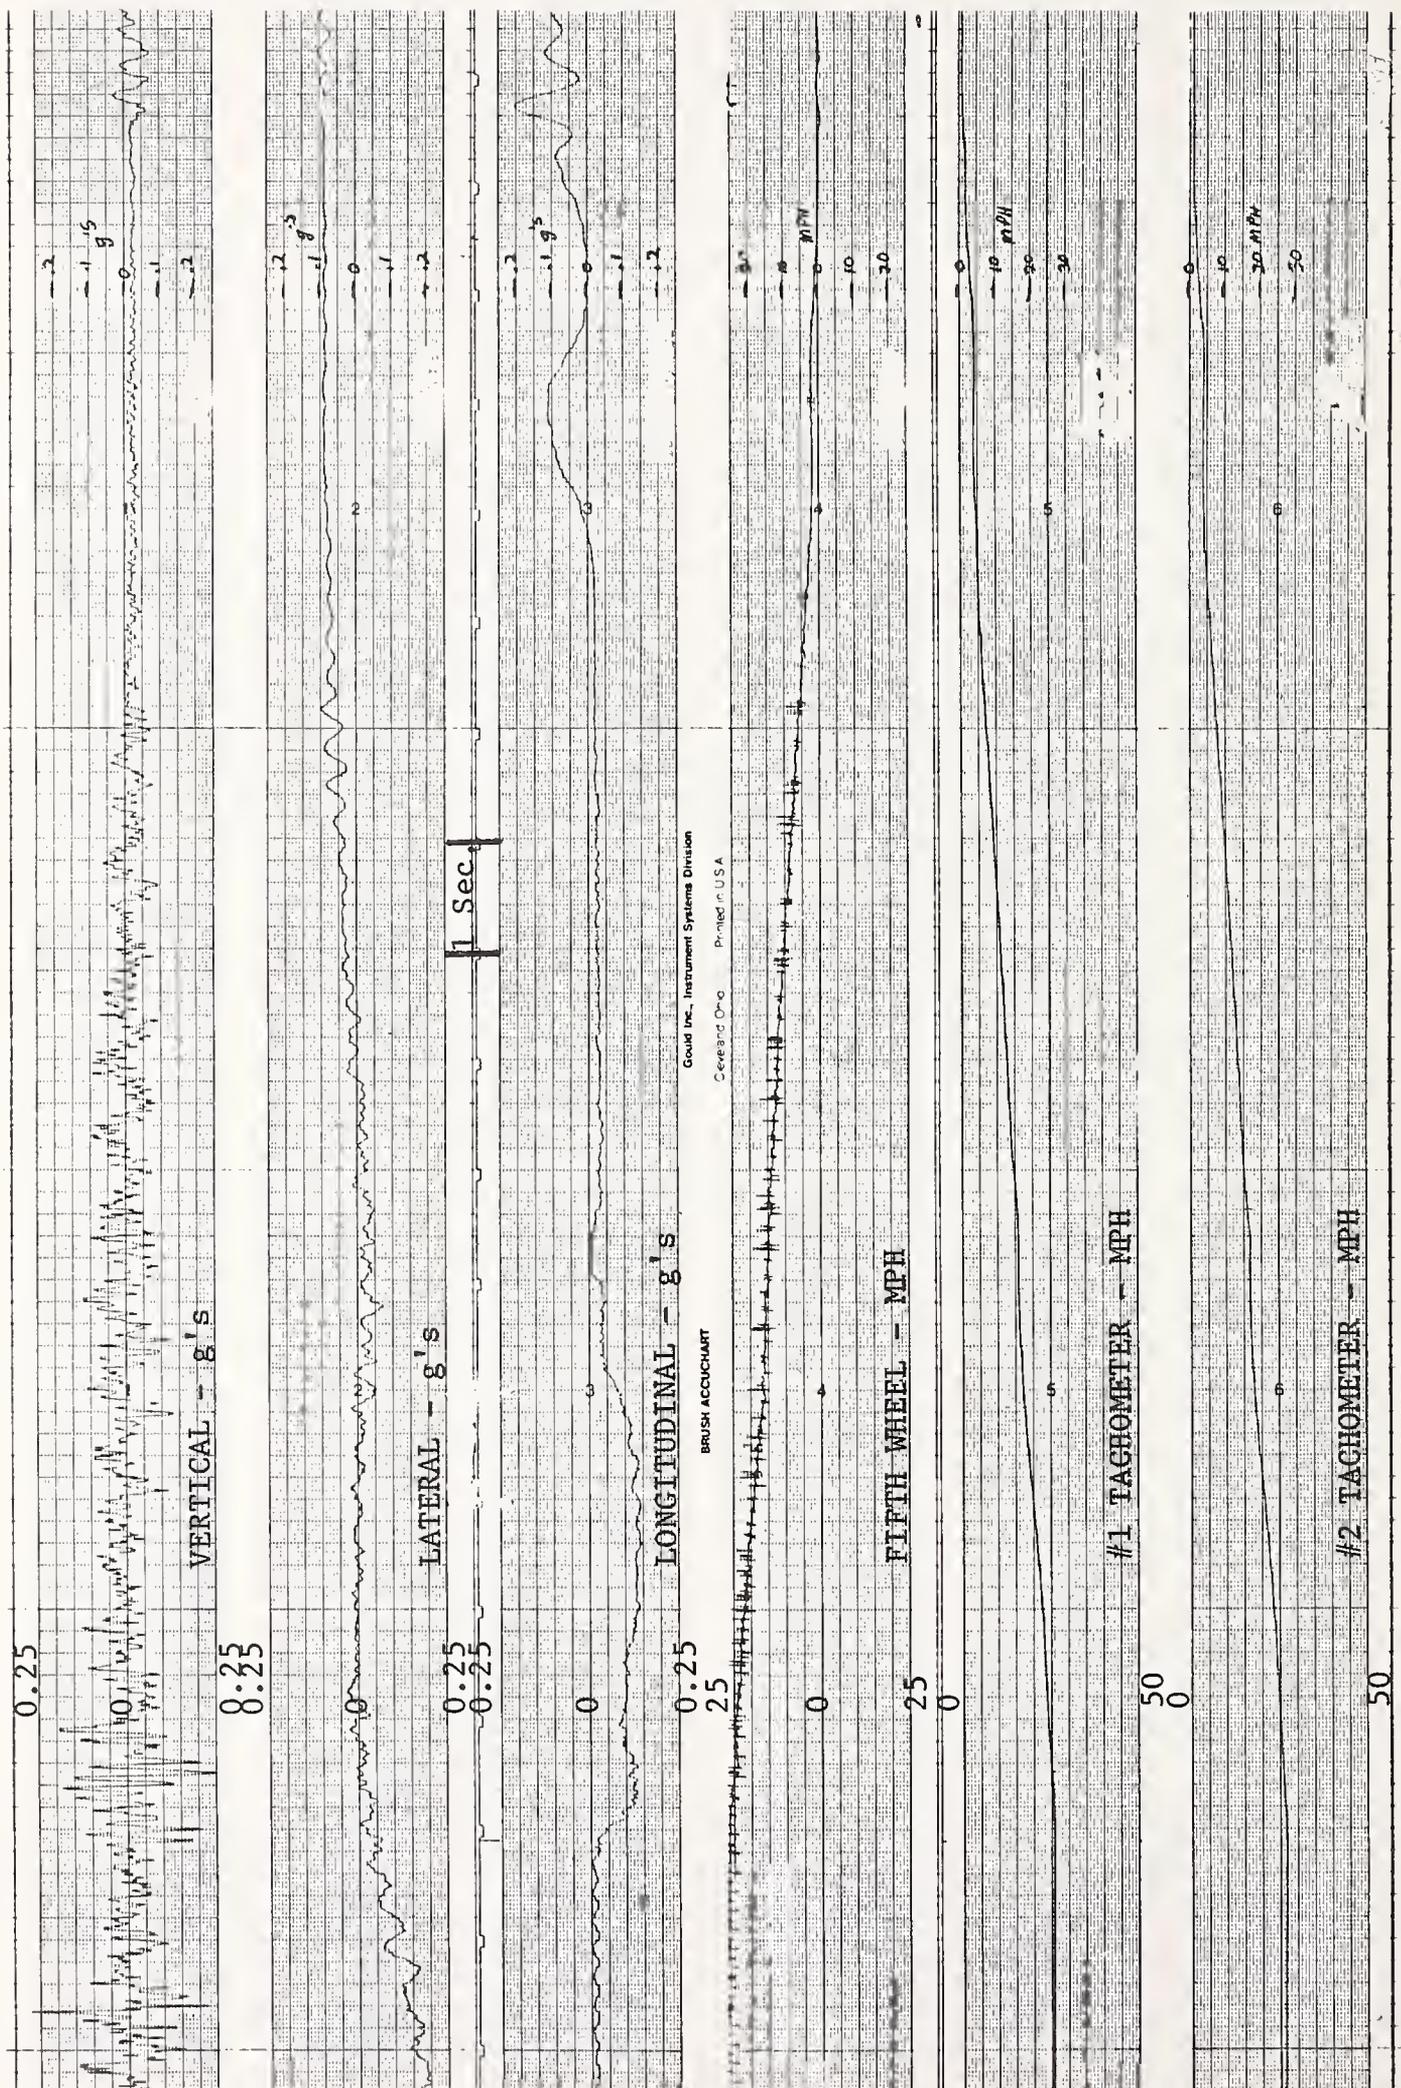
FIGURE 6-20. WET TRACK ACCELERATION, TEST 2.0, RUN 2.1

Figures 6-20 through 6-23 are recordings of speed and of the longitudinal, lateral and vertical accelerometer readings taken during Runs 2.1. and 2.2 for the purpose of comparison of the vehicle ride quality characteristics with the ISO 2631 specification.

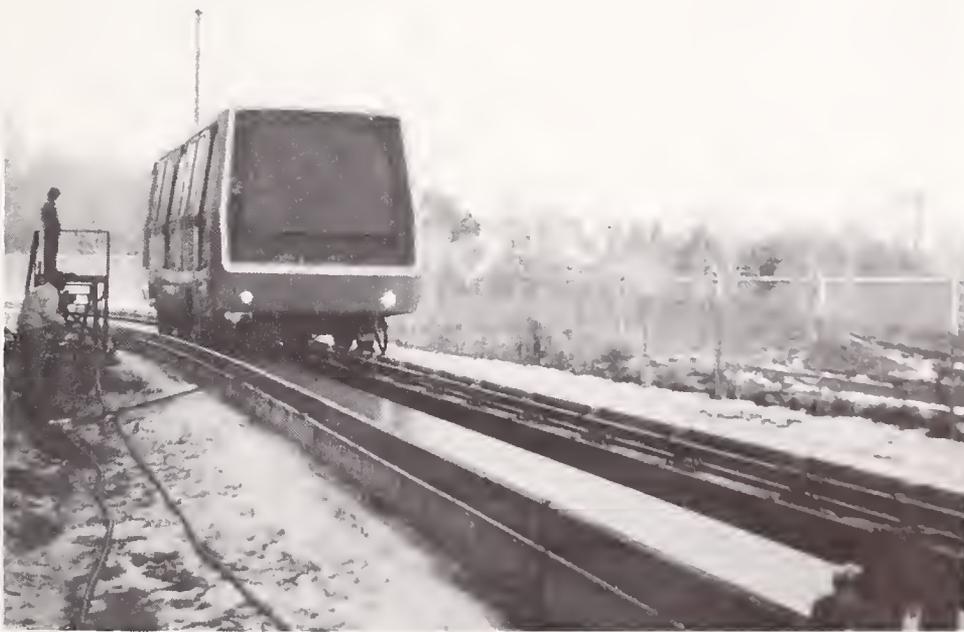
FIGURE 6-25. ICE COVERED GUIDEWAY SURFACES

The weather conditions during the test were: an ambient air temperature of between +22°F and +28°F, a wind velocity of 4 miles per hour and zero snow fall rate. A 1/16 inch layer of ice covered the guideway surface between the 150 foot and 615 foot marker at the start of testing. The smooth surfaces are shown in Figure 6-25.

RUN 3.3 Additional tests were run on the icy guideway surface with the objective of stopping the vehicle with precision under manual controlled braking. The vehicle proceeded from Station 1 at maximum speed of 25 miles per hour and by manual controlled braking, the vehicle was stopped accurately at Station 2. No locking or sliding of the vehicle wheels was observed during the tests.

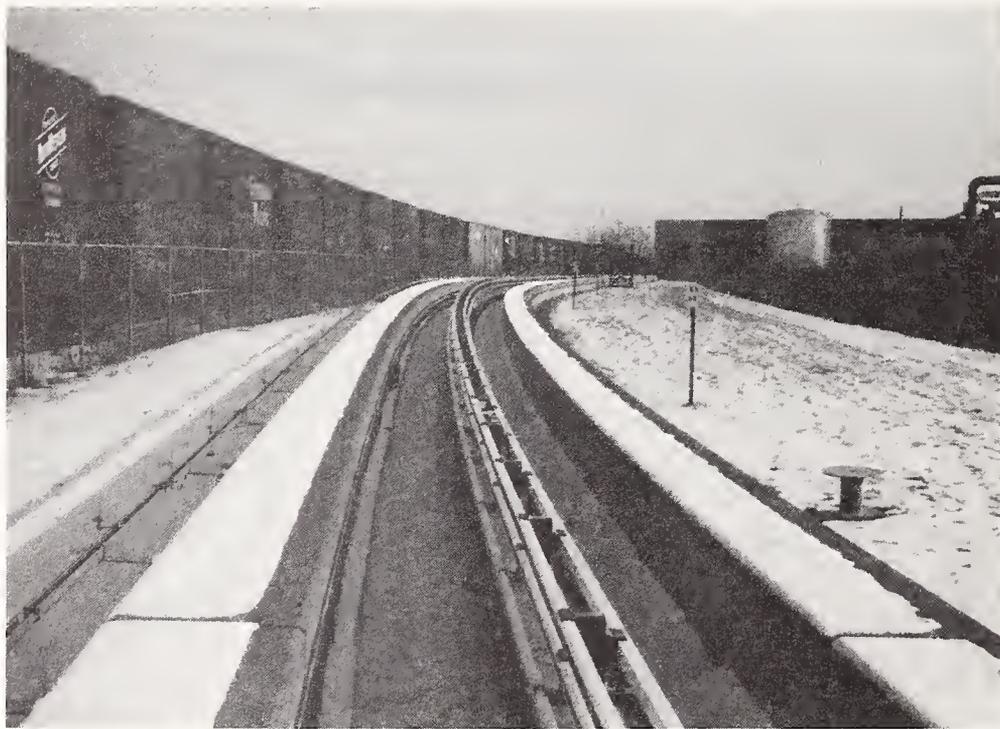
FIGURE 7-1. POWER AND SIGNAL RAIL CONFIGURATION

A test was run to determine the ability of the electric heaters to maintain the guideway power and signal rails free of snow with a natural snowfall rate of 0.3 inches per hour and at a density of 0.16 grams per cubic centimeter. Three inches of snow accumulated while testing. The ambient air temperature was +24°F and the wind velocity was 5 to 10 miles per hour. Power level to the heating elements was 5 watts per lineal foot. Under the test conditions,

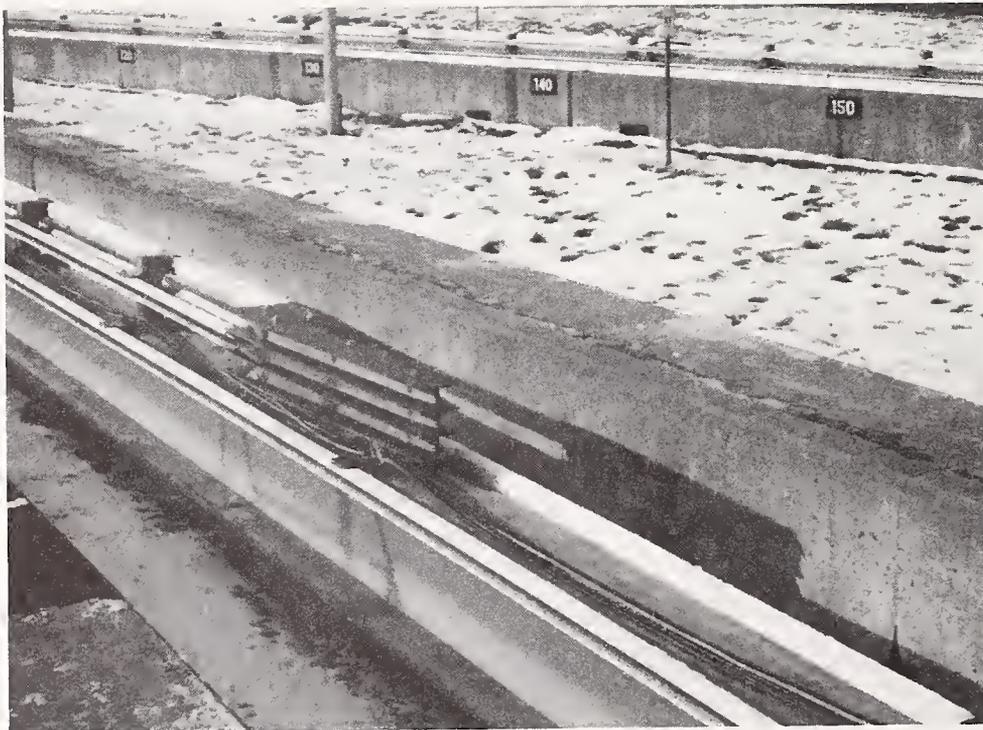
FIGURE 7-5. POWER FEED RAMPS

An electrical heating system was developed and tested over the two year period covered by the Winter Test Program. Figure 7-3 shows the basic rail heating design used throughout the test period. Two areas of change between 1978-79 testing and 1979-80 testing were the shape of the groove and the selection of the heater wire. For 1979-80 testing, the rail expansion joints (Figure 7-4) and power feed ramps (Figure 7-5) were also heated. Figure 7-6 shows detail at rail ends in the guideway switch area.

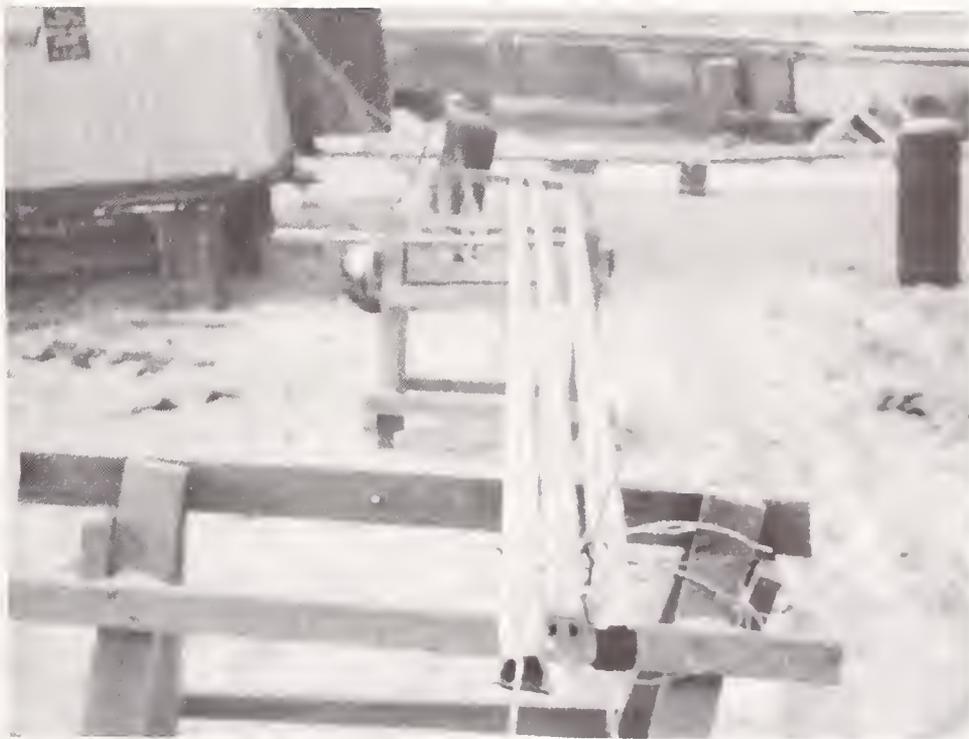
FIGURE 7-7. SNOW-FILLED TEST RAIL CHANNELS

During a test with ambient air temperature between +16°F and +21°F, a wind velocity of 3 to 7 miles per hour and a man-made snow fall rate of approximately 1 inch per hour and a snow density of 0.40 grams per cubic centimeter, the test rail heating wire was energized. Ice and snow from the previous day's precipitation completely filled the test rail channels as shown on Figure 7-7. Prior to the start of testing, average temperatures of the test rails were +22°F.

After 3 hours, the average temperature had increased to +55°F, +34°F, and +27°F for No. 1, No. 2, and No. 3 test rails, respectively. At this time the power to the heating wires was increased to 16.9, 8.4 and 4.2 watts per lineal foot for rails No. 1, No. 2, and No. 3, respectively. The test rail temperature stabilized at +56°F for the No. 1 test rail, +39°F for the No. 2 test rail, and +29°F for the No. 3 test rail. Figure 7-8 shows that approximately 50% of the snow and ice was melted on the No. 1 test rail and approximately 90% of both the No. 2 and No. 3 test rail surfaces were still

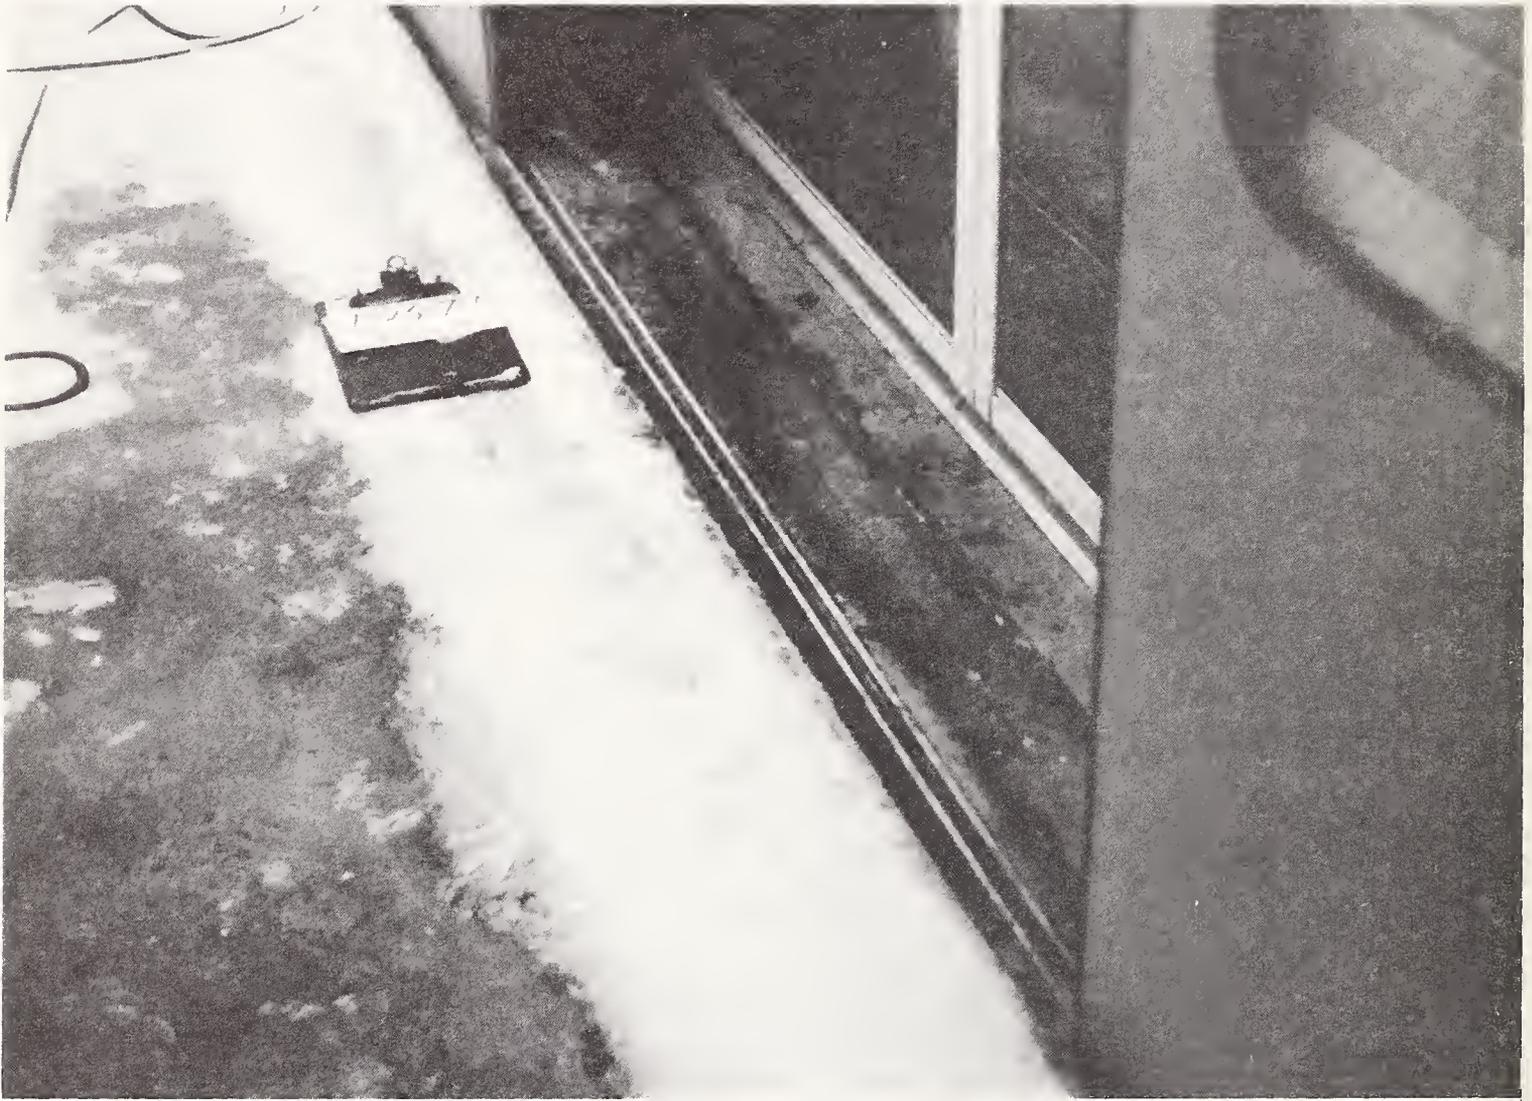
FIGURE 8-1 STATION DOOR TRACK HEATING

The door track was maintained free of accumulation. Temperatures of the middle and both ends of the door track were +38° F. It was also observed that 1" of concrete on either side of the door track was free of accumulation. Figure 8-1 shows the condition of the door track at the completion of testing.

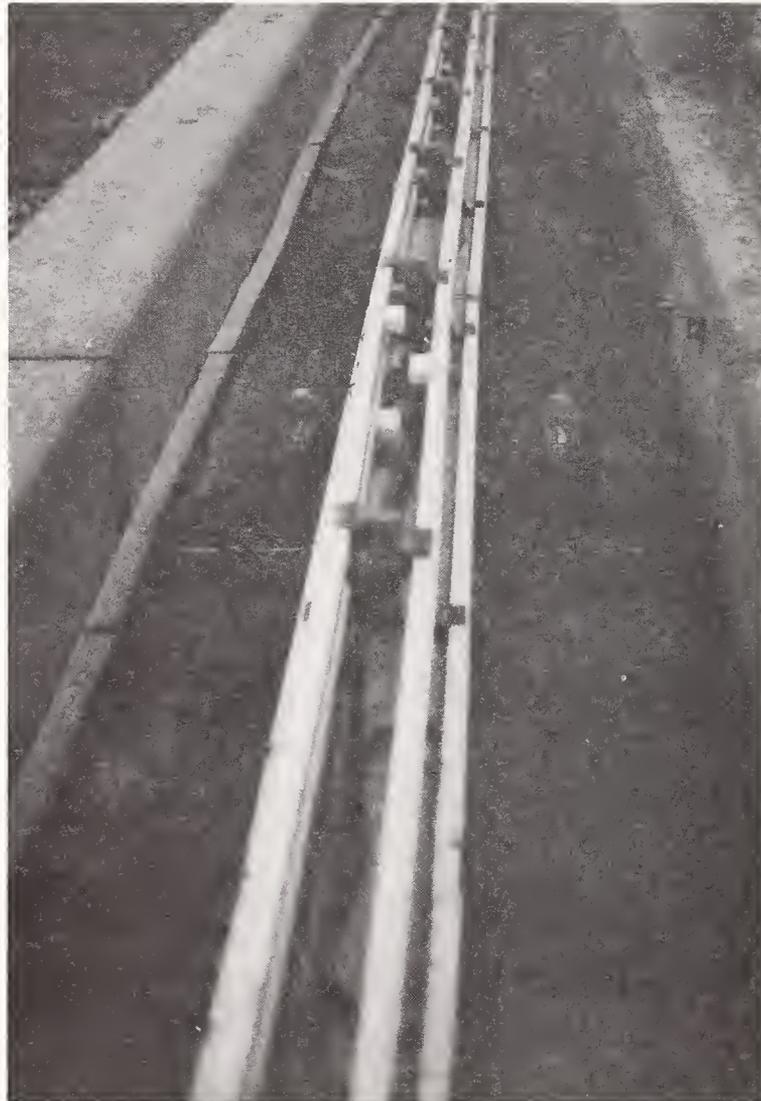
FIGURE 8-2. VEHICLE STORAGE AREA RADIANT HEATERS

A parking area was designated on the Test Track spur. Four chromolox radiant heaters, rated at 0.8 Kw each were installed in the parking area as shown in Figure 8-2. The heaters were controlled by a thermostat located in direct line of sight of the heaters, Figure 8-3. As a back-up, an additional

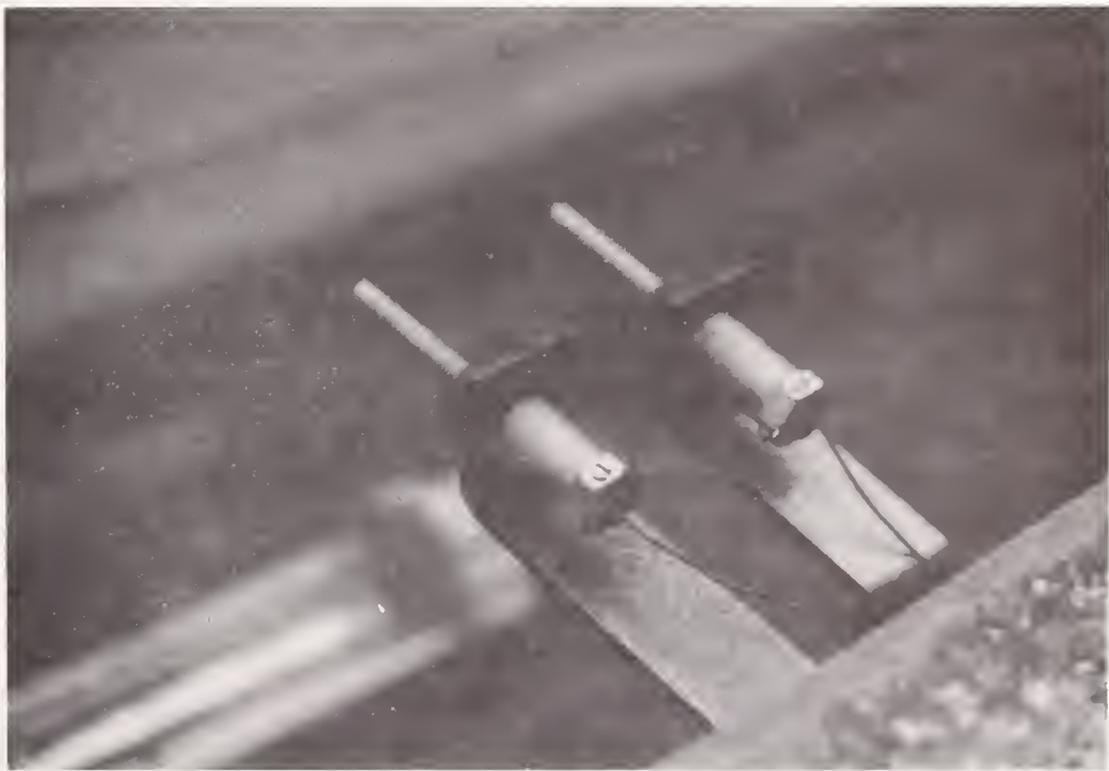
FIGURE 8-3. RADIANT HEATER THERMOSTATS

thermostat sensor was preset to shut off the heaters at 125° F in case of malfunction.

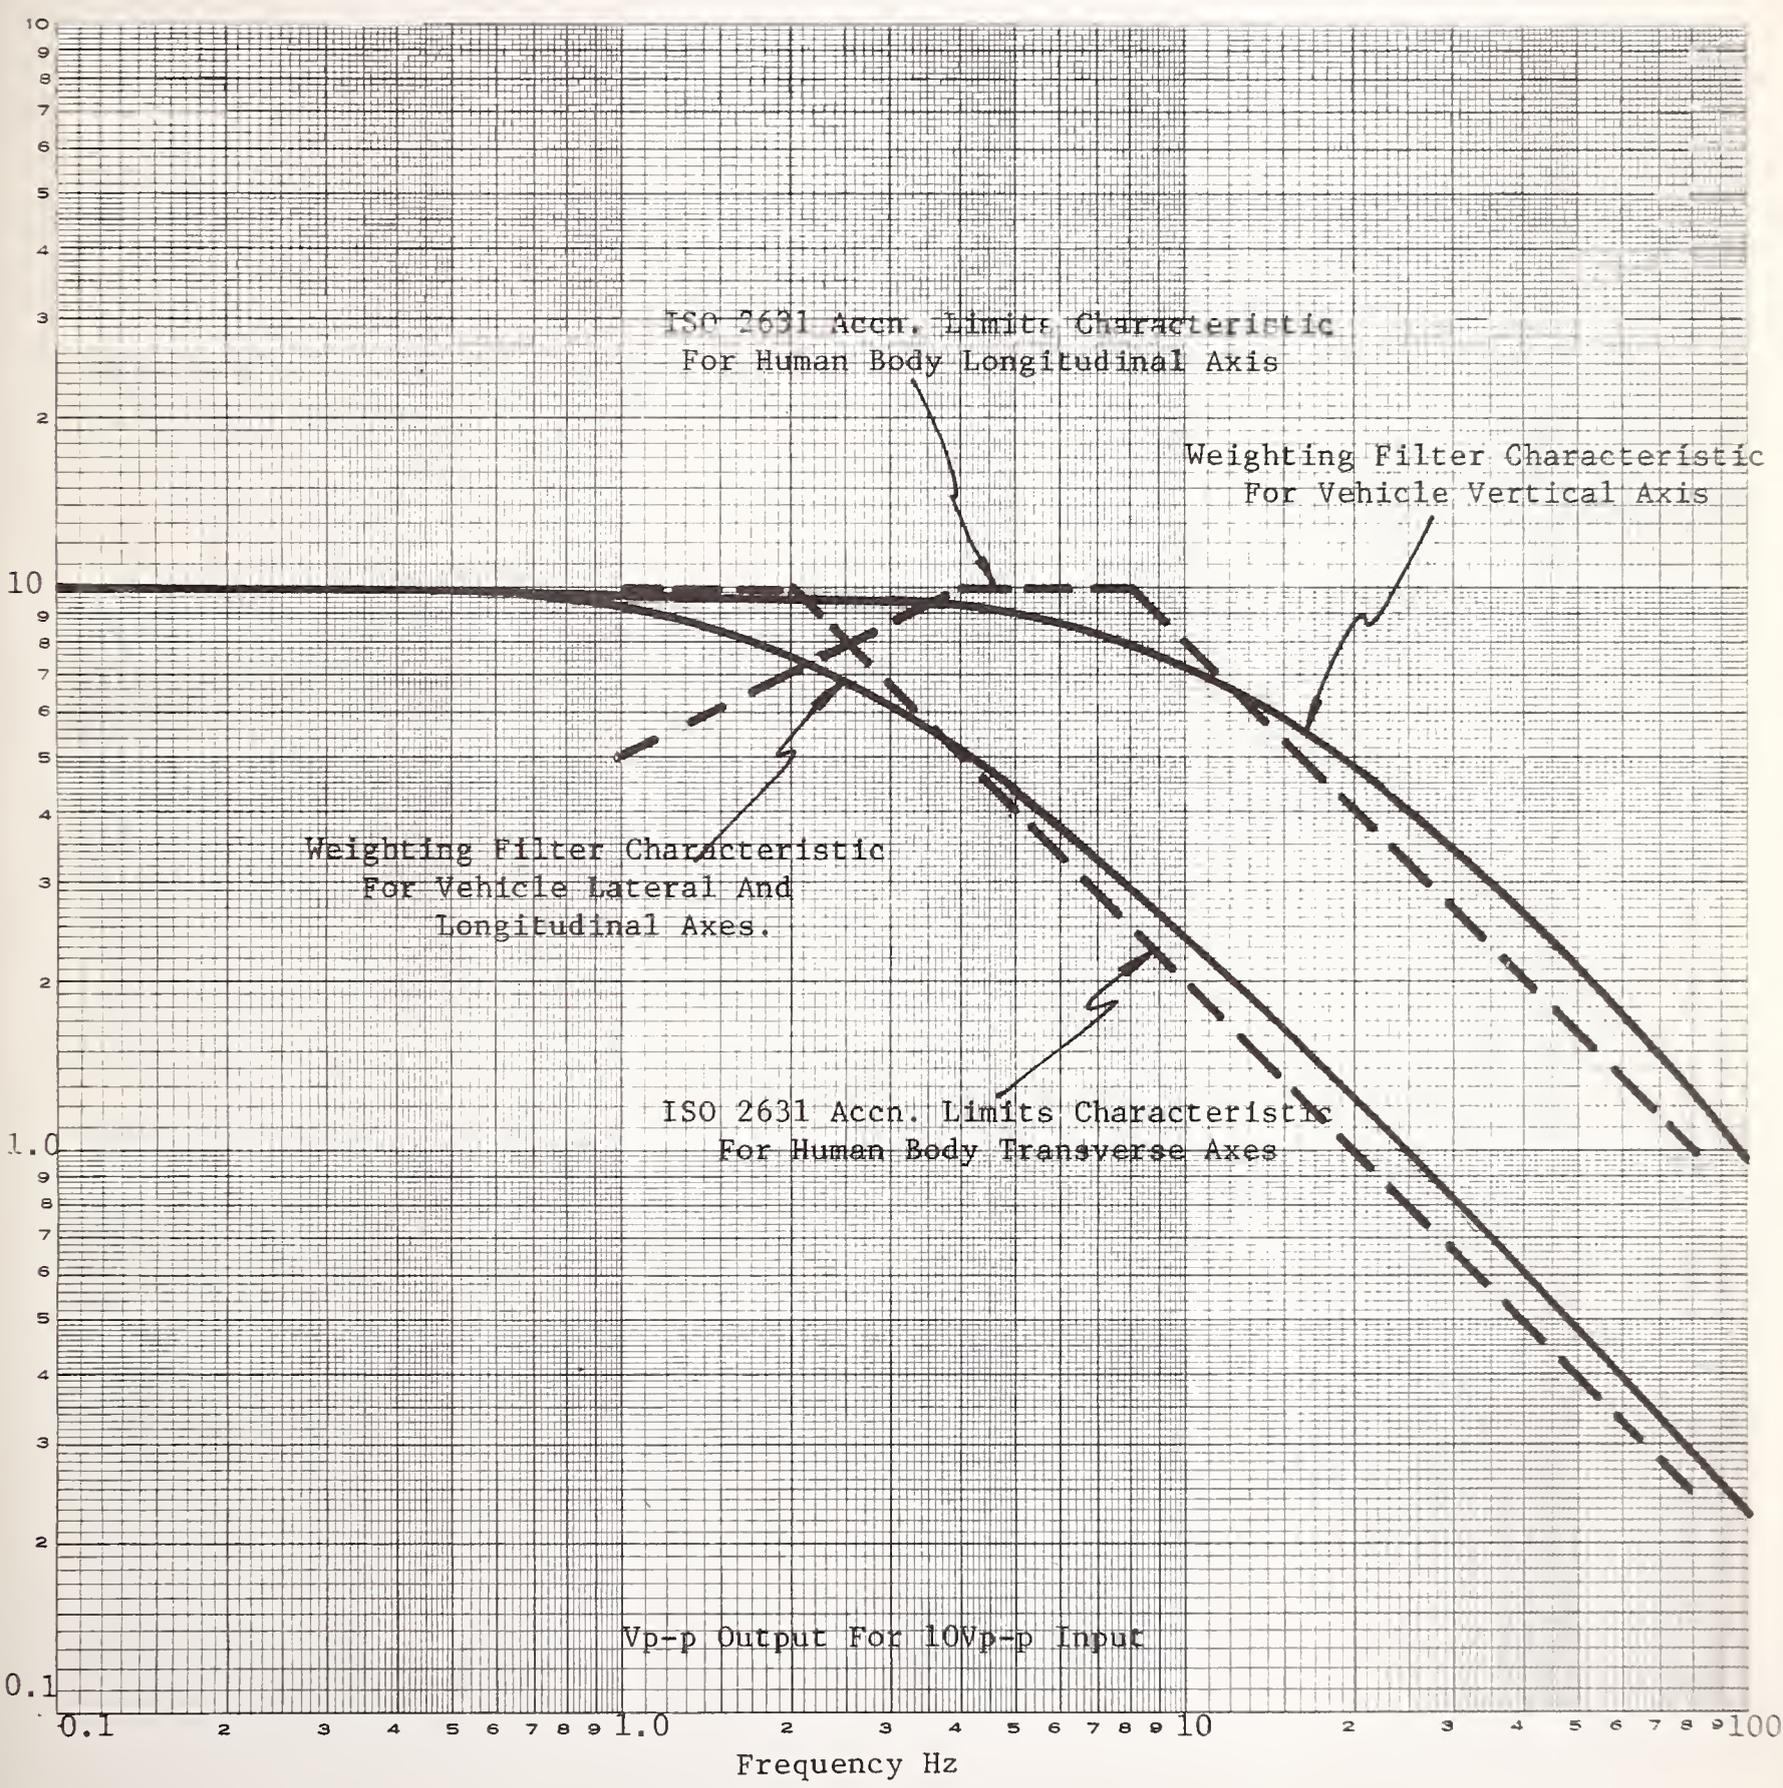
FIGURE 2. ACCELEROMETER WEIGHTING FILTER CHARACTERISTICS

The majority of the approximations made by using weighting filters result in a conservative assessment of the effects of the vibration, however the corner frequency errors of up to -1.5 dB beyond the ISO specification +1 dB tolerancy range are in a direction to yield permissible vibration levels up to 19% higher than with filter disigns which would meet the ISO tolerance specification. No account of this error was taken when quoting vibration performance against the ISO specification.
