# ENERGY ABSORBING BUMPERS FOR TRANSIT BUSES

## TRANSBUS PROGRAM

TRANSBUS DOCUMENT TR 76-003

MAY 1976

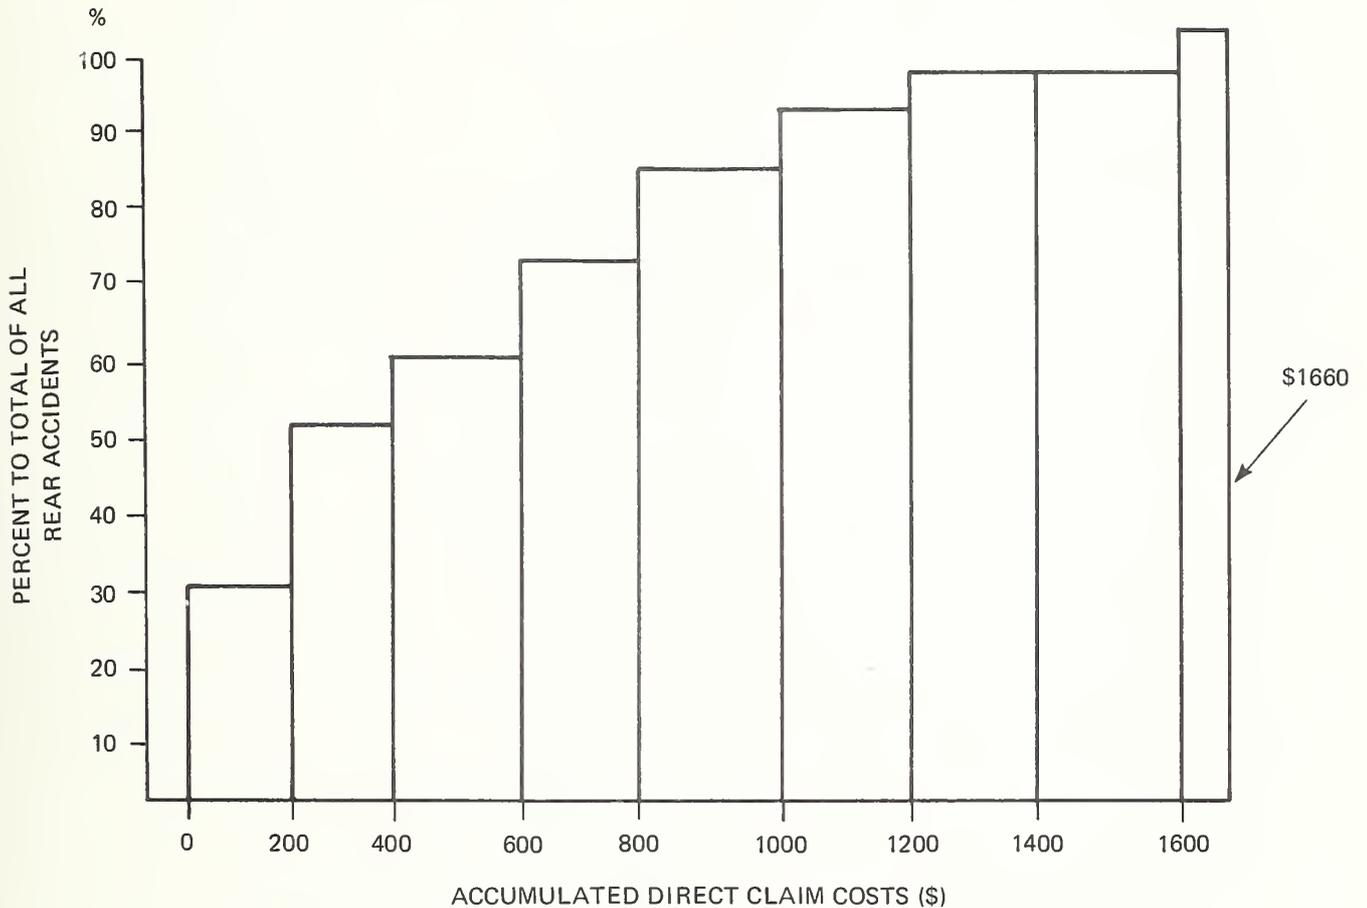
FIGURE 1. EXAMPLE OF DIRECT CLAIM COSTS — BUS STRIKES CAR ACCIDENTS

Figure 1 shows the result of an in-depth analysis of the 1969-to-1970 accident files of two major bus properties. (1) It displays the accumulation of other vehicle damage claims costs in the life of the transit bus for rear-end accidents only (bus strikes rear of car). The figure indicates that 50 percent of the accidents in which the bus strikes the rear of an automobile account for only \$400 in direct

claims costs. These are the low speed, low cost, accidents. The remaining 50 percent of the rear-end accidents account for \$1,260 in claims costs over the life of the bus. Current claims costs are estimated to be about double those shown in Figure 1.

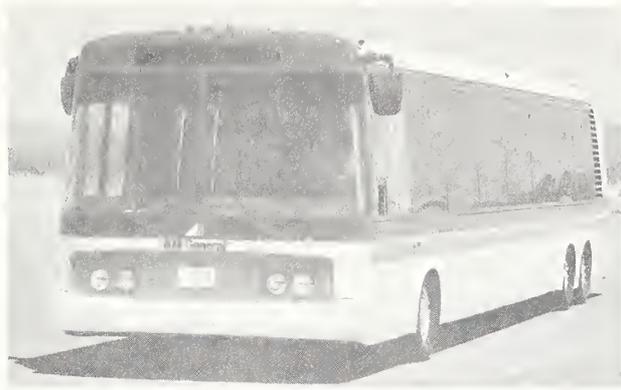
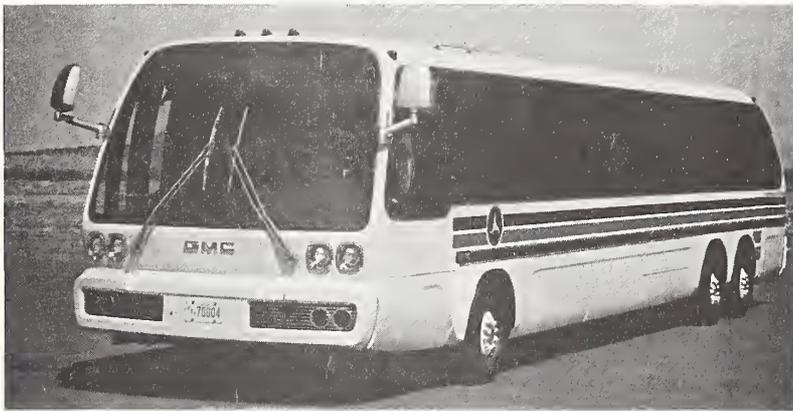
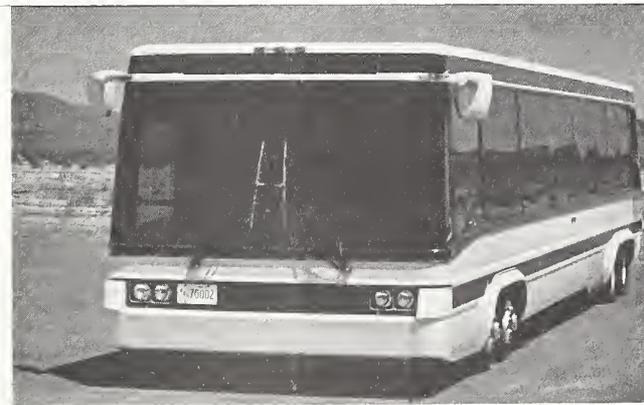
FIGURE 2. TRANSBUS PROTOTYPE COACHES

AM GENERAL TRANSBUS

GENERAL MOTORS TRANSBUS

ROHR TRANSBUS

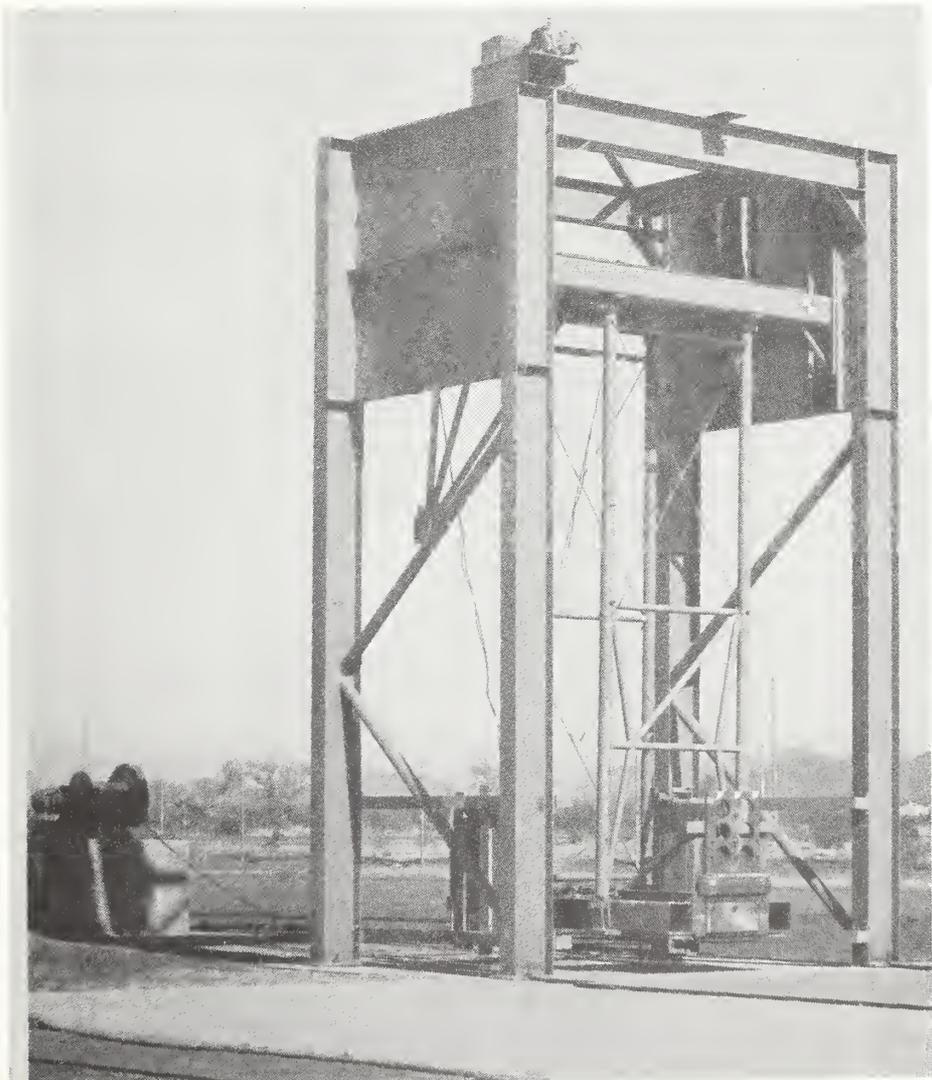
FIGURE 3. DYNAMIC SCIENCE PENDULUM STRIKE SYSTEMS

- b. Test Facility. The pendulum used at Dynamic Science, Figure 3, consisted of a striker mass assembly suspended by four 13-foot support arms. The front and rear arm pairs were structurally triangulated to provide torsional rigidity from asymmetrical impact loading. The pendulum (striker assembly and support arms) was mounted on a platform which was supported by a structural tower. Incorporated between the structural tower and platform, an electrically-operated screw-jack system allowed vertical positioning of the pendulum assembly.

The striker assembly employed a 4,000-pound mass with a faceplate attached to the front of the assembly which included the impact head specified in FMVSS-215 for the conduct of the bus bumper tests. The test area was designed to accommodate the mounting of a rigid barrier to support the test bumper.

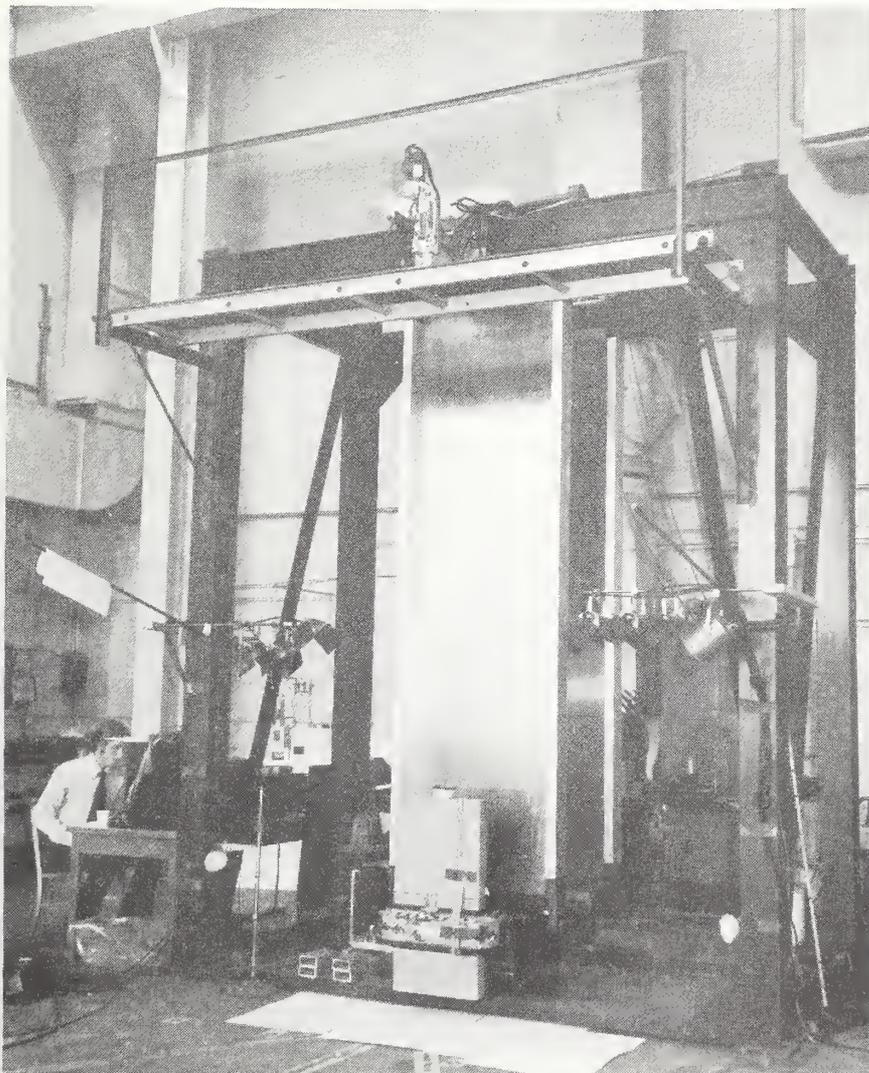
FIGURE 4. CALSPAN VEHICLE IMPACT PENDULUM

impact head specified in FMVSS-215 for the conduct of the TRANSAFE and HELP bumpers tests.

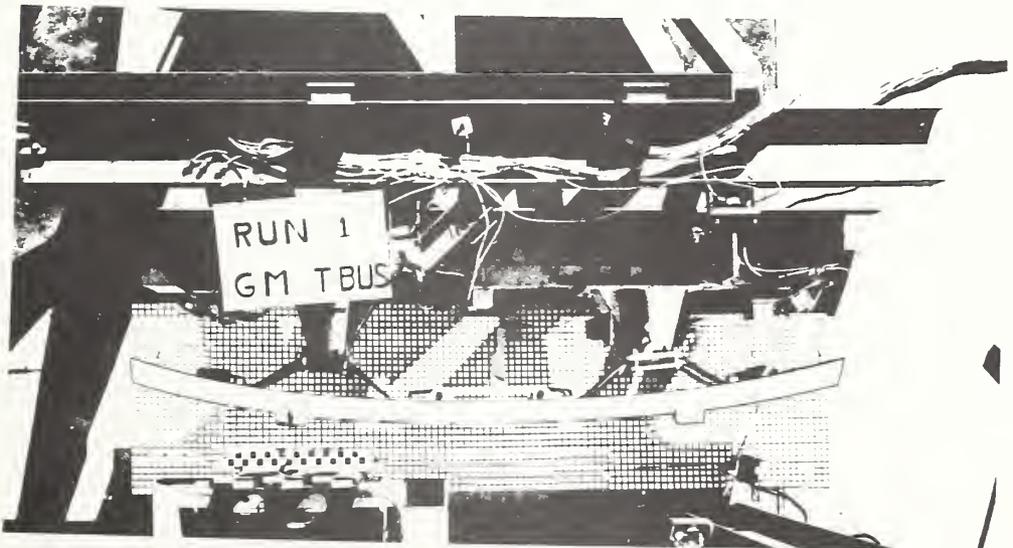
FIGURE 7. GMC TRANSBUS BUMPER—TYPICAL TOP VIEW OF LONGITUDINAL IMPACT CONFIGURATION

- (2) GMC Transbus Bumper. The GMC Transbus bumper consists of an aluminum alloy faceplate supported by four steel springs. Unlike the typical current production bus bumper, the energy absorbing springs are unique in that they are not attached to the faceplate in a fixed position, but instead have a lateral freedom of movement when experiencing an impact. Figure 7 is a typical overhead view of the GMC Transbus bumper undergoing testing. Figure 8 shows a front-end view of the GMC bumper installed on the GMC Transbus.

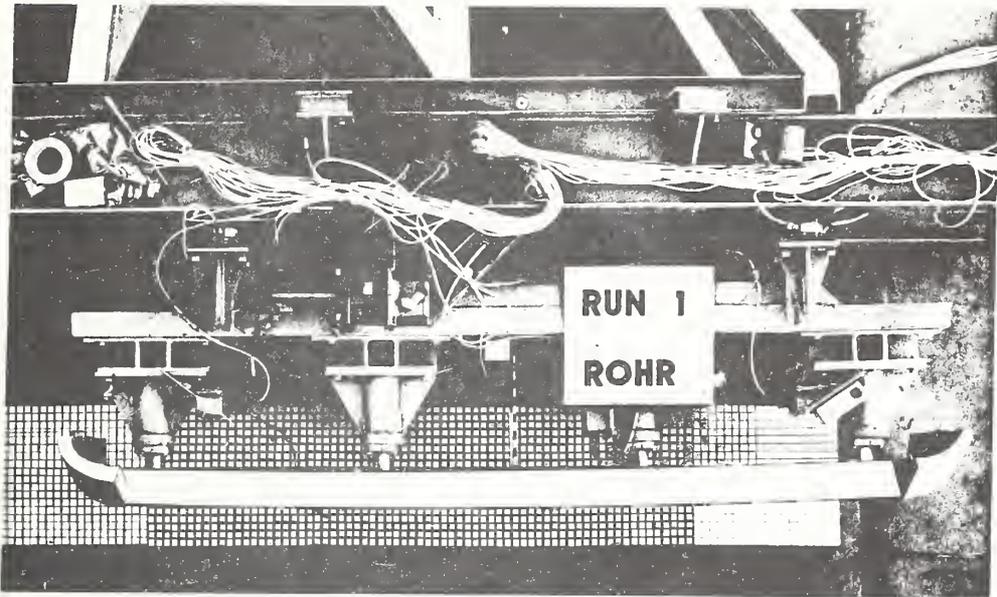
FIGURE 9. ROHR TRANSBUS BUMPER—TYPICAL LONGITUDINAL IMPACT CONFIGURATION

- (3) Rohr Transbus Bumper. The Rohr Industries Transbus bumper consists of a steel faceplate covered with an elastomer and four silicone-elastomer-filled shock isolators supplied by the Menasco Manufacturing Company. The shock isolator output characteristics are composed of two principal components: a spring or energy storing function, and a damping function.

The spring function is obtained by the stroking of a piston rod into a pressure vessel containing pressurized elastomer. This results in a reduction in elastomer volume which, in turn, causes its pressure to rise as a function of the piston rod stroke. The elastomer pressure reacts against the piston-rod-projected area to produce a typical spring-characteristic curve. After the piston has compressed the elastomer, it will return to its extended position by the stored energy in the spring function, thus forcing the elastomer back to its original position through orifices. Figure 9 is a typical overhead view of the Rohr Industries Transbus bumper undergoing

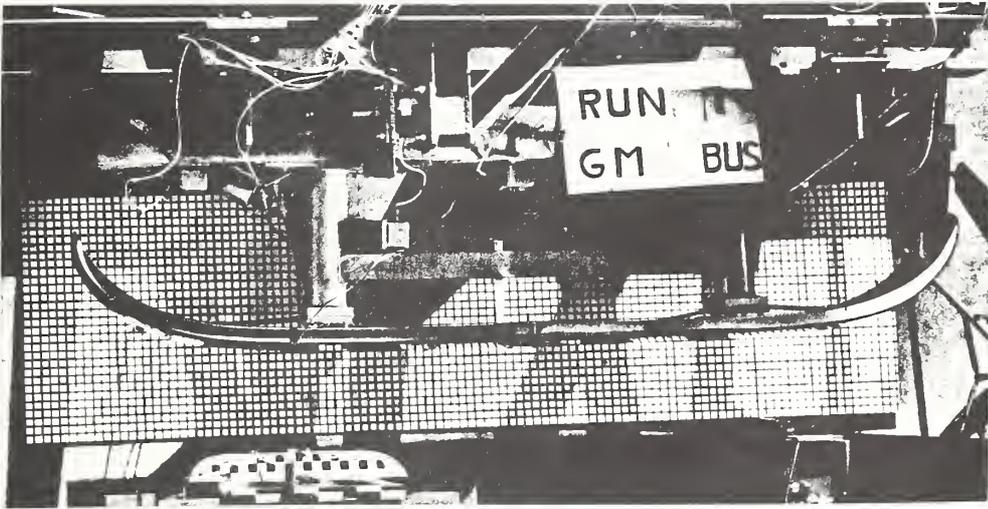
FIGURE 11. GMC PRODUCTION BUMPER— TYPICAL LONGITUDINAL IMPACT CONFIGURATION

- (4) GMC Production Bumper. The GMC production bumper is a standard rigid bumper, consisting of a steel faceplate supported by two leaf springs. Figure 11 is a typical overhead view of the GMC production bumper undergoing testing.

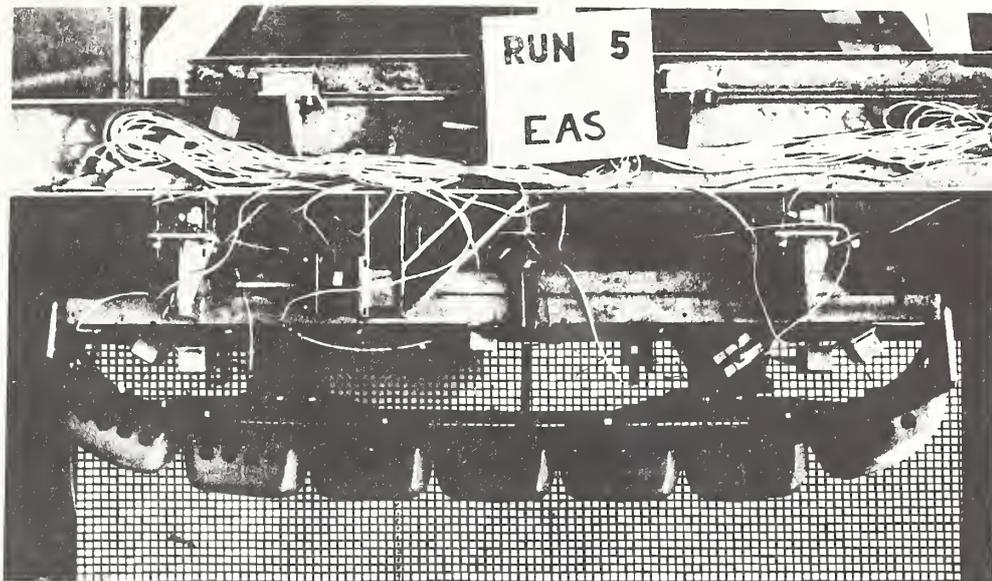
FIGURE 12. EAS WATER BUMPER—TYPICAL LONGITUDINAL IMPACT CONFIGURATION

- (5) EAS Water Bumper. The EAS water bumper is an impact-cushioning bumper and consists of seven specially designed water-filled vinyl modules with four (each) plastic release plugs, mounted on a solid flex beam. During impact, the plastic release plugs pop up, allowing water to escape through pressure-regulating orifices. This action absorbs a significant amount of the impact energy, considerably lessening the severity of the crash. Figure 12 is a typical overhead view of the EAS water bumper undergoing testing.

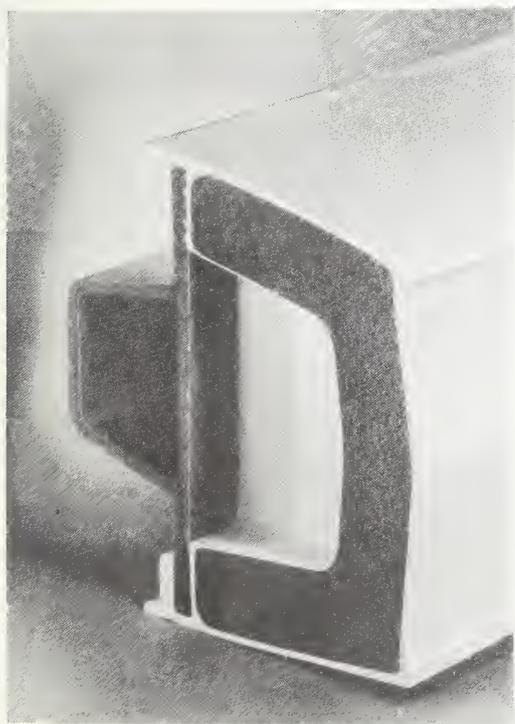
FIGURE 13. EAS TRANSAFE BUMPER—CUT-AWAY VIEW

The modules consist of a PVC shell filled with a polyurethane foam. The modules slide onto, and are mechanically attached to, the backup beam. The backup beam is a high-strength fiberglass-reinforced plastic beam. The entire setup is then attached to rigid mounting brackets which, in turn, are attached to the bus. The bumper is adapted to mount to either the front or rear of the vehicle. The bumper weight, as tested, was approximately 170 pounds.

Figure 13, a cut-away view, shows the interior construction of the TRANSAFE bumper. The Calspan Corporation performed a series of tests on the TRANSAFE bumper on June 17, 1975, employing procedures similar to those used for testing Transbus bumpers. Booz, Allen witnessed this test series. Figure 14 is a typical overhead view of the 102-inch bumper undergoing testing. Figure 15 shows a front-end view of the bumper mounted on a current production coach.

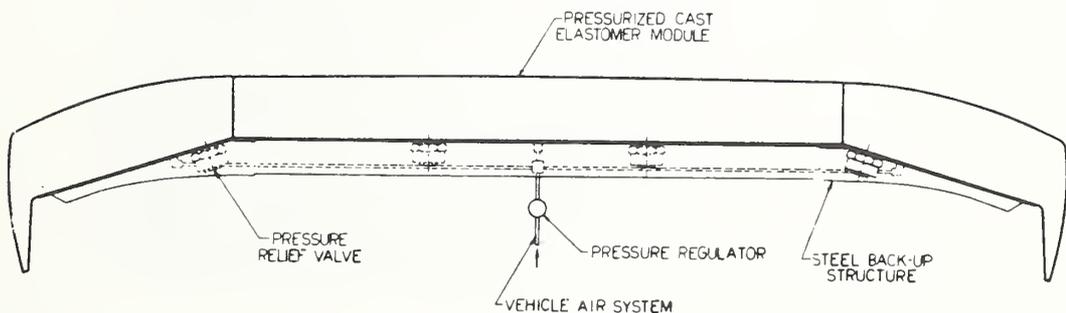
FIGURE 16. FIRESTONE HELP BUMPER — PNEUMATIC SYSTEM

Two types of HELP bumpers were tested: pneumatic and semi-pneumatic. The pneumatic bumper, Figure 16, is designed for direct connection through a pressure regulator to the vehicle's compressed air system. Upon impact, the air in the module is dissipated through high-volume relief valves. The semi-pneumatic bumper, Figure 17, is identical in external appearance to the pneumatic bumper. However, it does not require attachment to a compressed air system. Special valves provide ambient air pressure to the modules. These valves are rubber hemispheres (Figure 17) slit in two directions, so that they open like the petals of a flower when the bumper is impacted. After impact, there is a momentary vacuum in the module, thus decreasing rebound. Figure 18 is a typical overhead view of the HELP 96-inch bumper undergoing testing. Figure 19 shows a front-end view of the pneumatic bumper mounted on a current production coach.

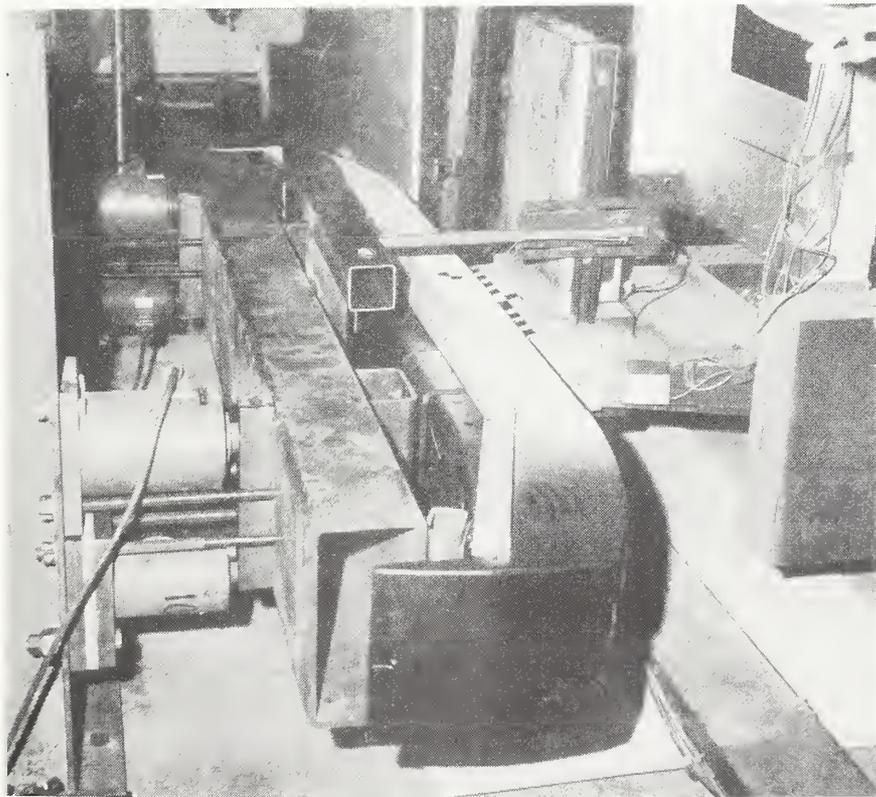
FIGURE 18. FIRESTONE HELP BUMPER—TYPICAL LONGITUDINAL IMPACT CONFIGURATION

- (7) Firestone HELP Bumpers. The Firestone new design HELP bumpers, also tested at Calspan, consist of three hermetically-sealed modules manufactured from nonreinforced elastomeric materials. These are mounted to a high-strength steel backup structure. The structure is designed for mounting on the vehicle frame with special brackets.

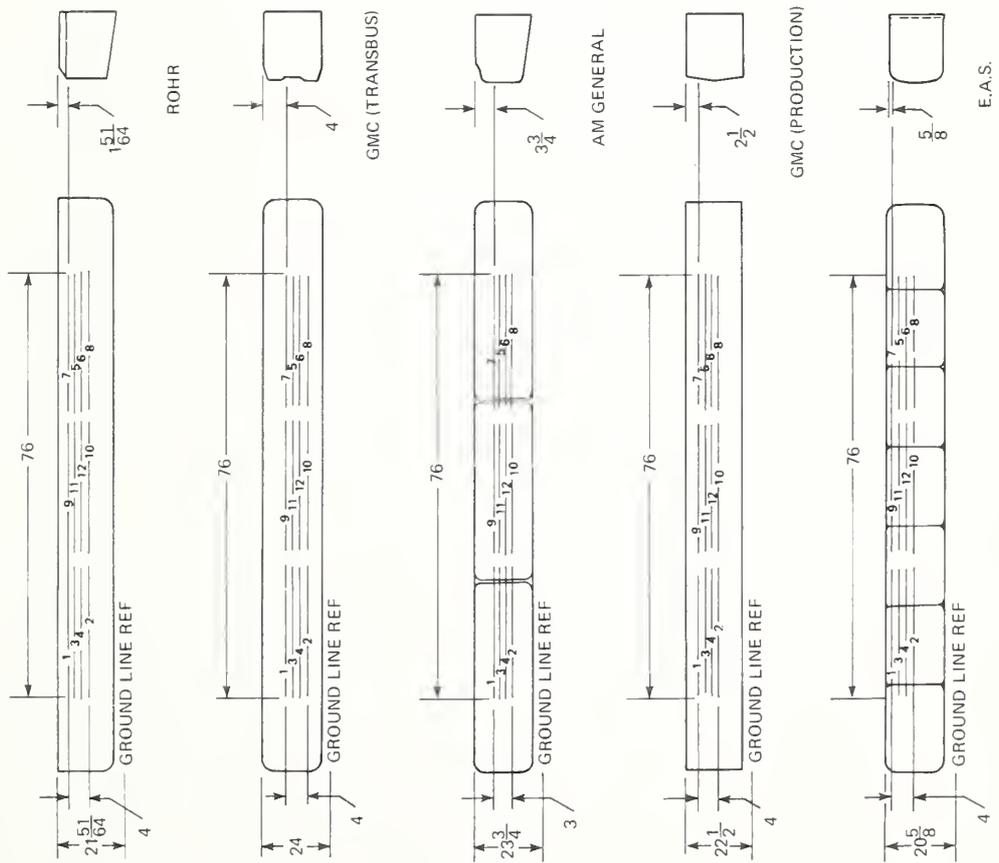
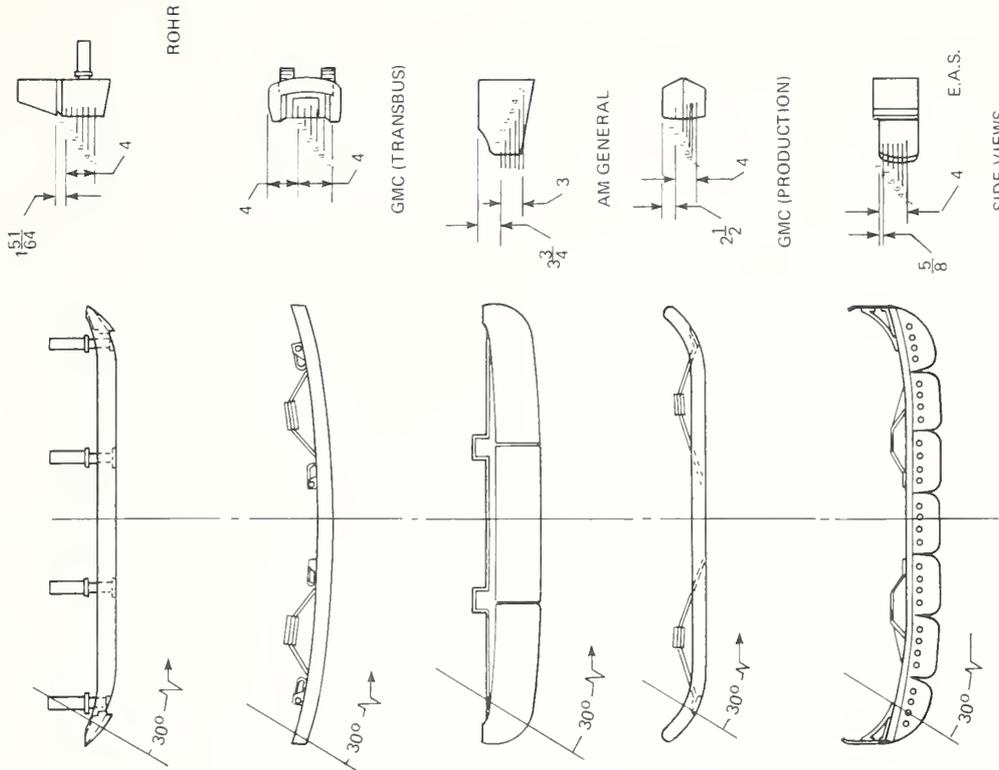
BUMPER IMPACT ZONES AND SEQUENCE SCHEDULES

LONGITUDINAL IMPACTS

ANGLE IMPACTS

- d. Test Procedures. Initial bumper impact tests were conducted outside at the test facility of Dynamic Science, a division of Ultrasystems, Inc., Phoenix, Arizona, during the fall of 1973. The intent of the Transbus bumper test program was to conduct a series of tests which closely simulated the environment to which bumpers are subjected in actual revenue service. The following criteria were selected:
- Striker weight of 4,000 pounds
  - Pendulum designed to strike with a force that simulated a passenger car mass
  - Impact velocity progressively increasing from 1.0 mph, in 0.5 mph increments, to a point when the bumper undergoing testing "bottomed out" on the hard surface of the bumper-mounting fixture or on the bumper system's own mounting/backing plate
