OXY STRIPING FOR IMPROVED DURABILITY

February 1978
Final Report

Prepared for
FEDERAL HIGHWAY ADMINISTRATION
Offices of Research & Development
Washington, D. C. 20590

1. Report No. FHWA-RD-78-156		2. Government Accession No.		3. Recipient's Catalog No.	
4. Title and Subtitle Epoxy Striping for Improved Durability				5. Report Date February 1978

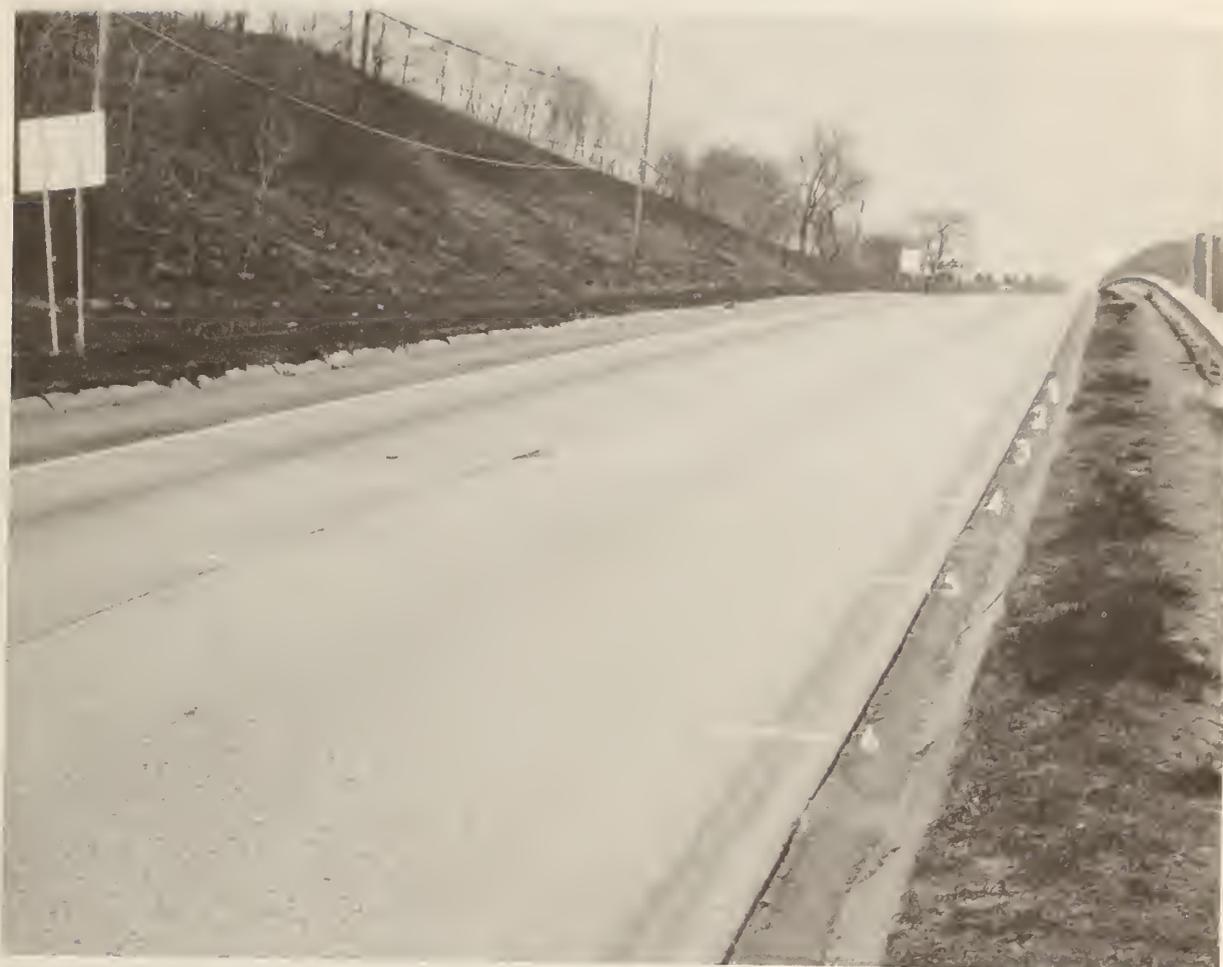
FIGURE 12. ROUTE 1 STRIPES (APRIL 6, 1976)

Composite view of first six stripes in first group on Route 1; facing northward. Listed in order, front to back:

Note superiority of #3, #2, and #1 over #6, #5, and #4.

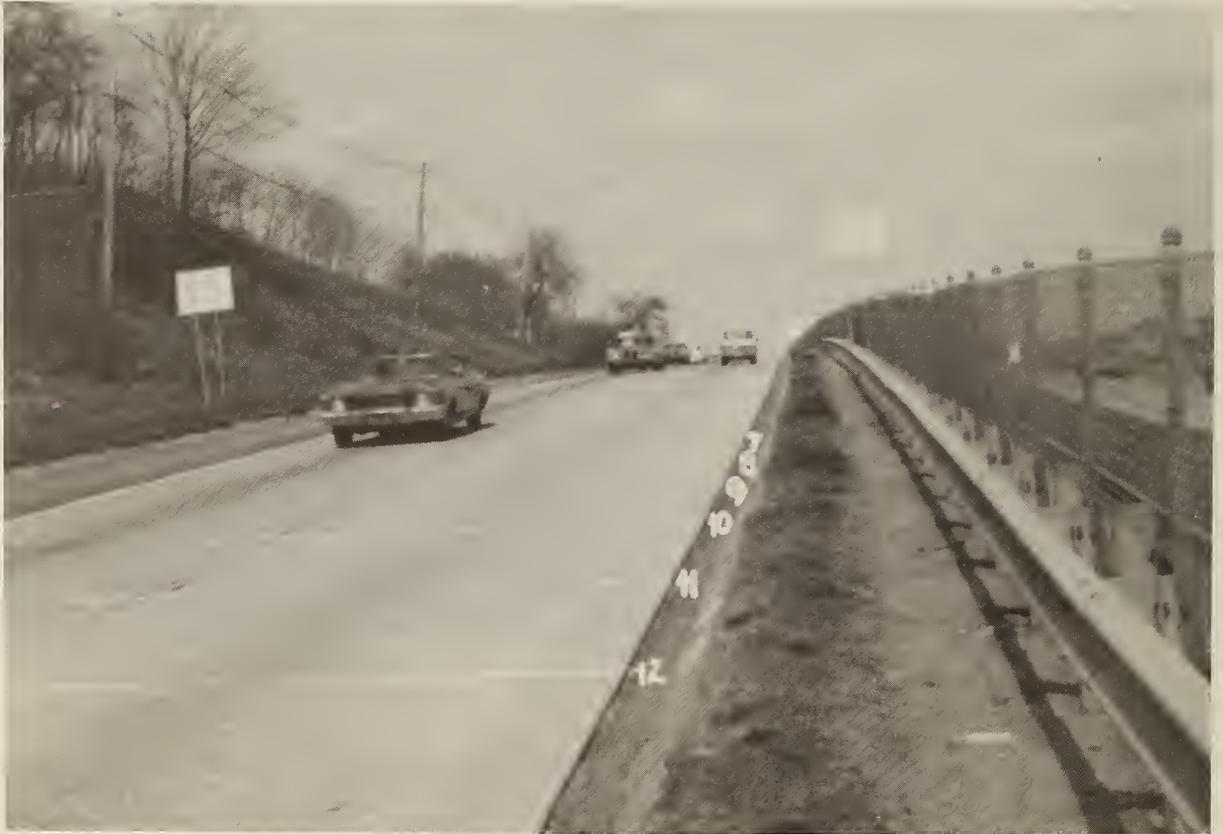
FIGURE 13. ROUTE 1 STRIPES (APRIL 6, 1976)

Composite view of all stripes in first group on Route 1; facing northward. These stripes listed in order, front to back:

#12 (closest) E-46; #11 E-45; #10 E-42; #9 E-26;
#8 Alkyd Gleem; #7 U-8; then pretty much indistinguishable.

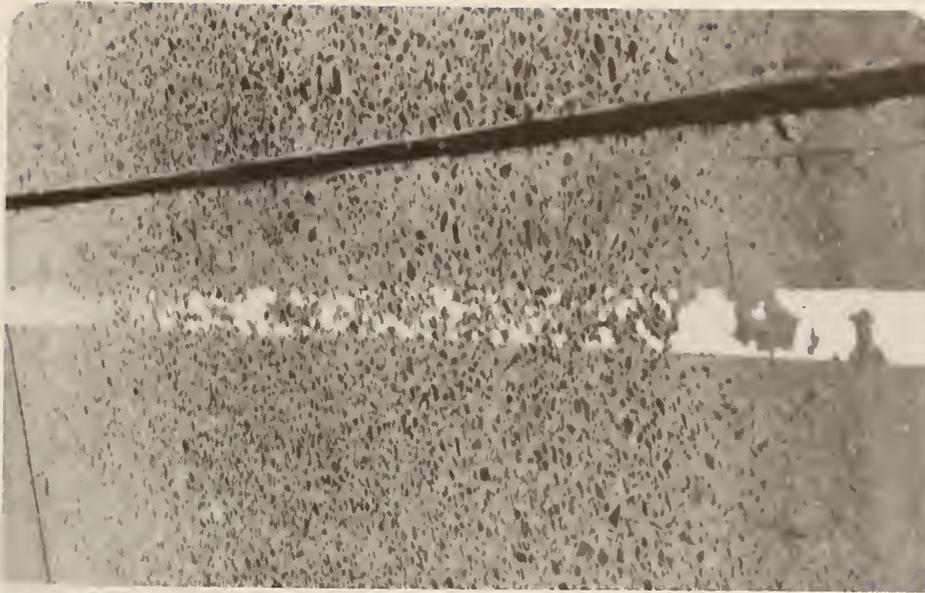
FIGURE 16. URETHANE STRIPE ON RT 1
Note loss of adhesion.

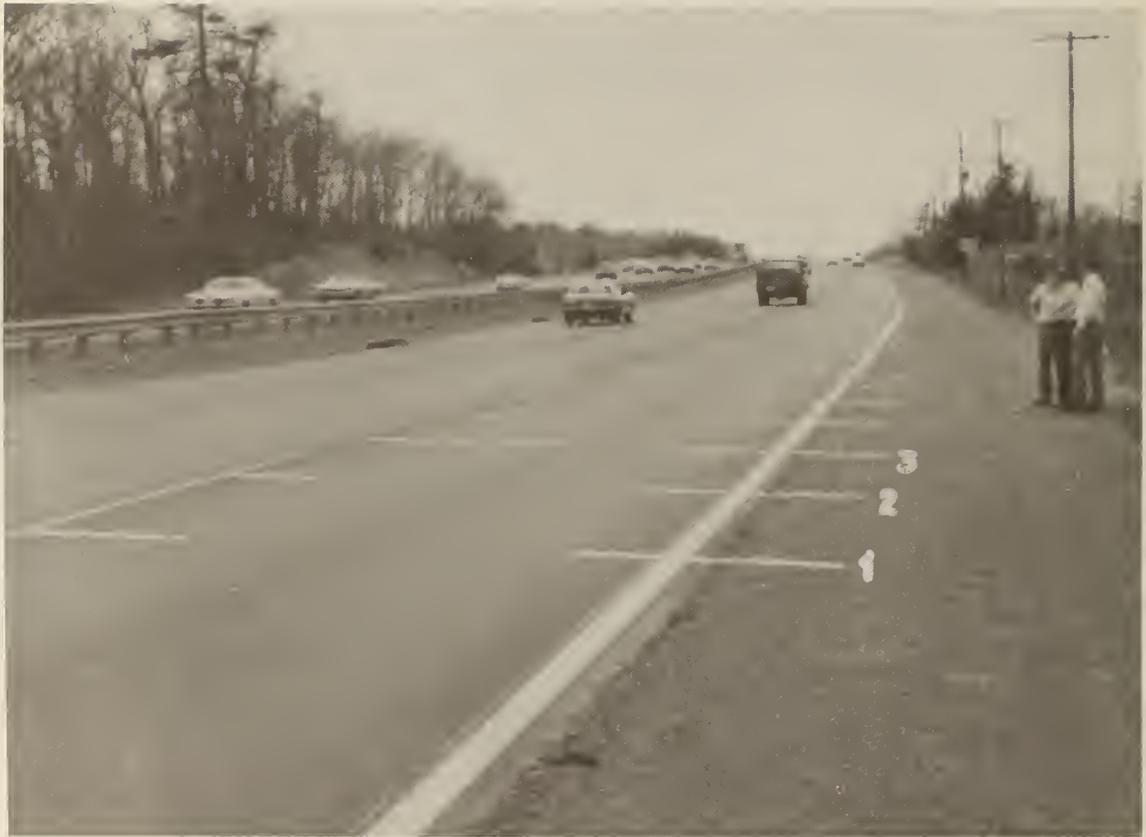
FIGURE 17: ROUTE 128 STRIPES (APRIL 6, 1976)

Composite view of first group of stripes on Route 128;
looking southward. Listed front to back:

#1 (closest) E-3; #2 E-10; #3 E-25;
#4 chlorinated rubber; then the urethanes

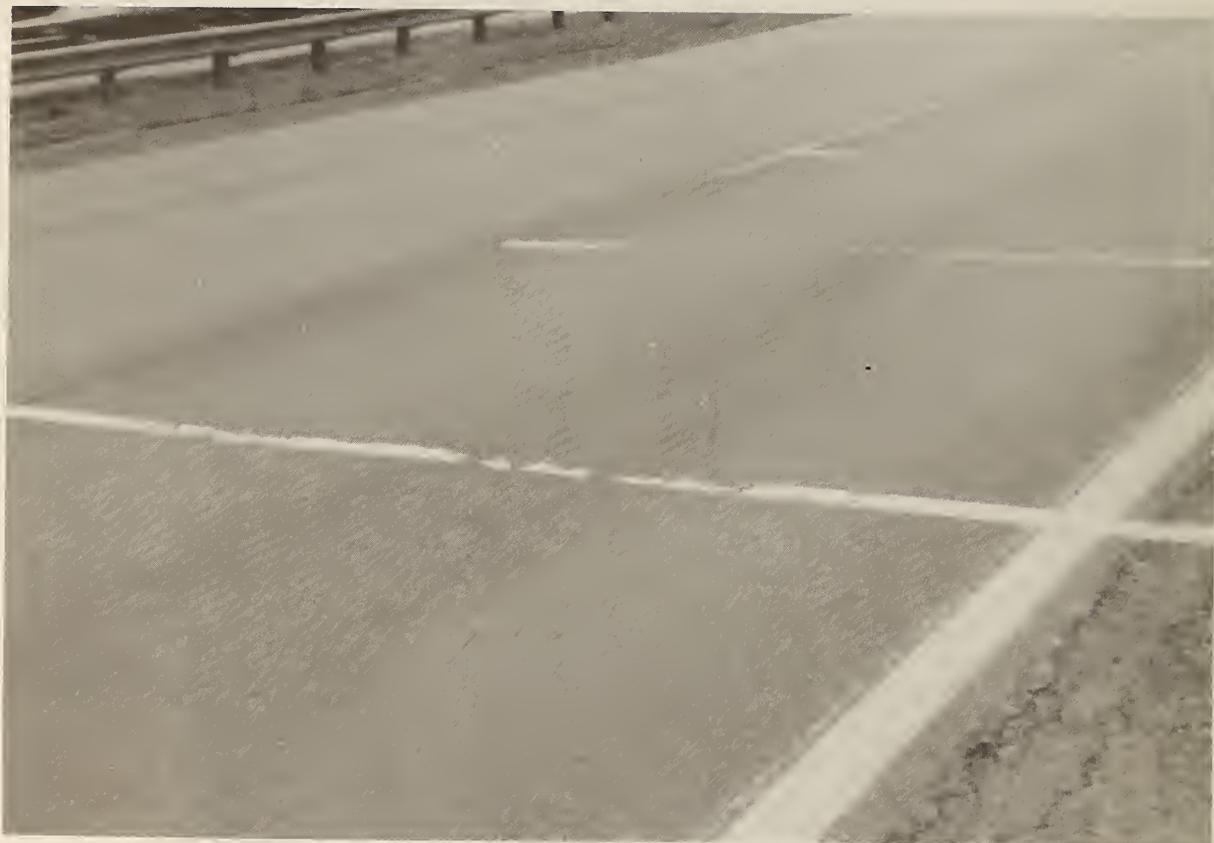
FIGURE 20: ROUTE 128 STRIPES (APRIL 6, 1976)

View of both Stripe #3 (E-25) and Stripe #4 (chlorinated rubber). Note also Stripes #5 and #6 (urethanes U-5 and U-6) at the top of the picture.

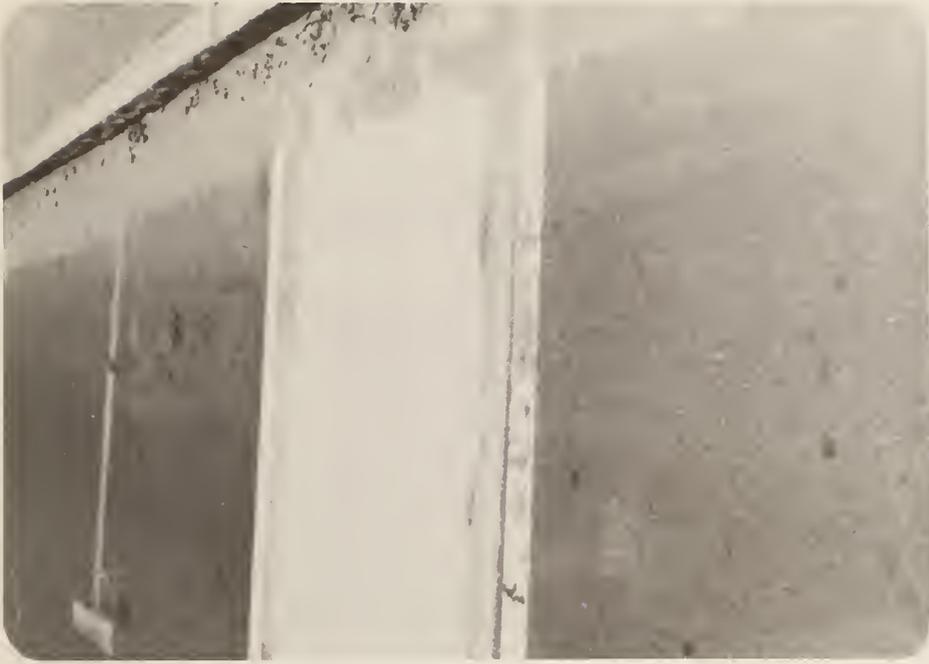
FIGURE 22: YORK BEACH STRIPE (E-10B)

Second crosswalk, stripes at oceanside (camera faces north). Nearest is Gleem Alkyd Rubber control; furthest away is E-10B. (April 21, 1976)

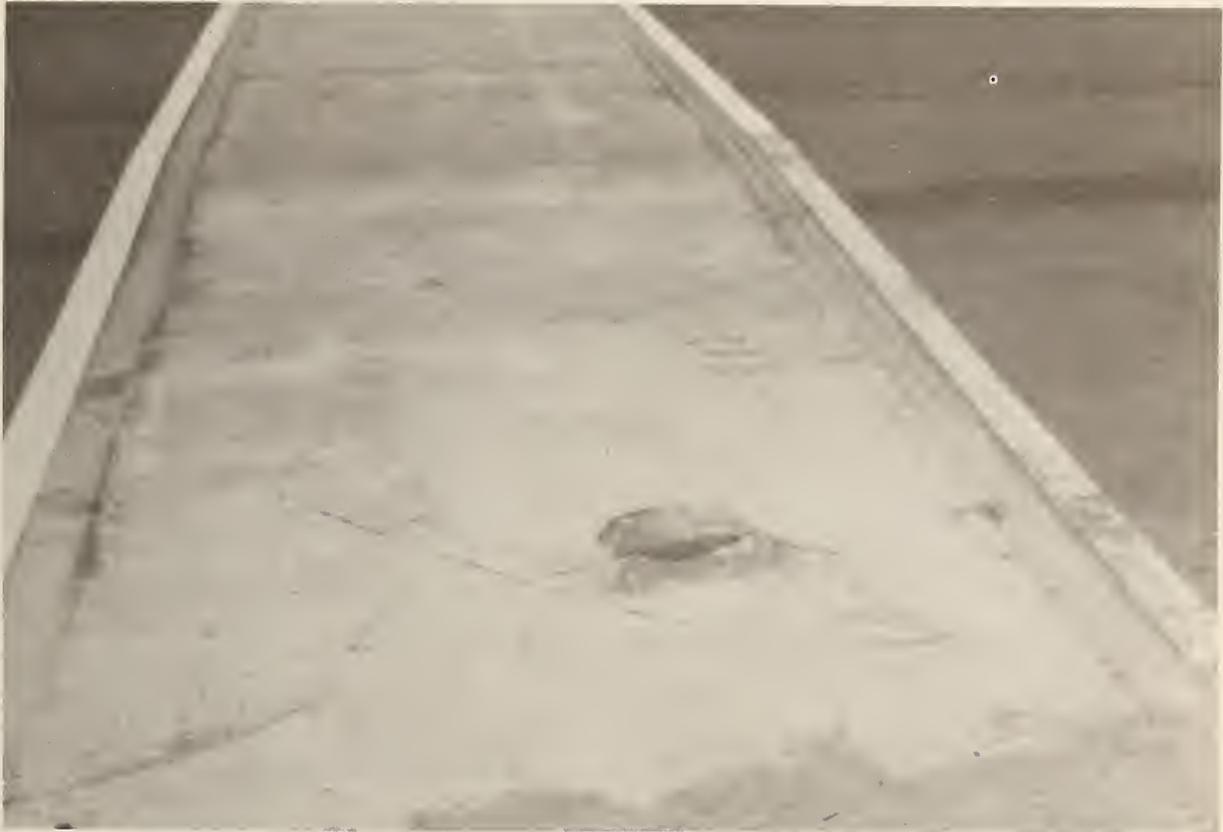
FIGURE 25: YORK BEACH CROSSWALK (APRIL 21, 1976)

Fifth crosswalk, looking across from the oceanside
across the road. Front-to-back listing:

- (1) Gleem (closest)
- (2) Chlorinated rubber
- (3) E-45

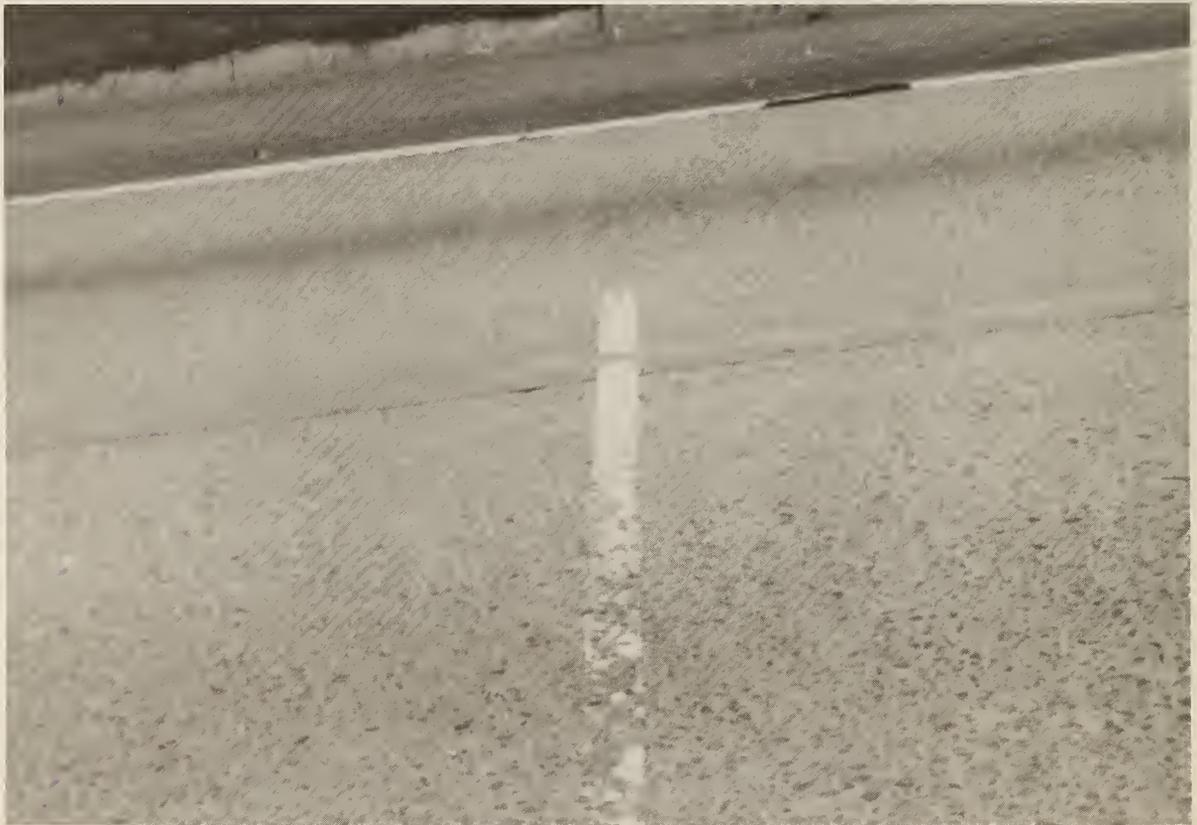
FIGURE 26: ROUTE 1 STRIPE OVER-PAINTING

Photograph illustrating failure at locus
of over-painting only (April 6, 1976)

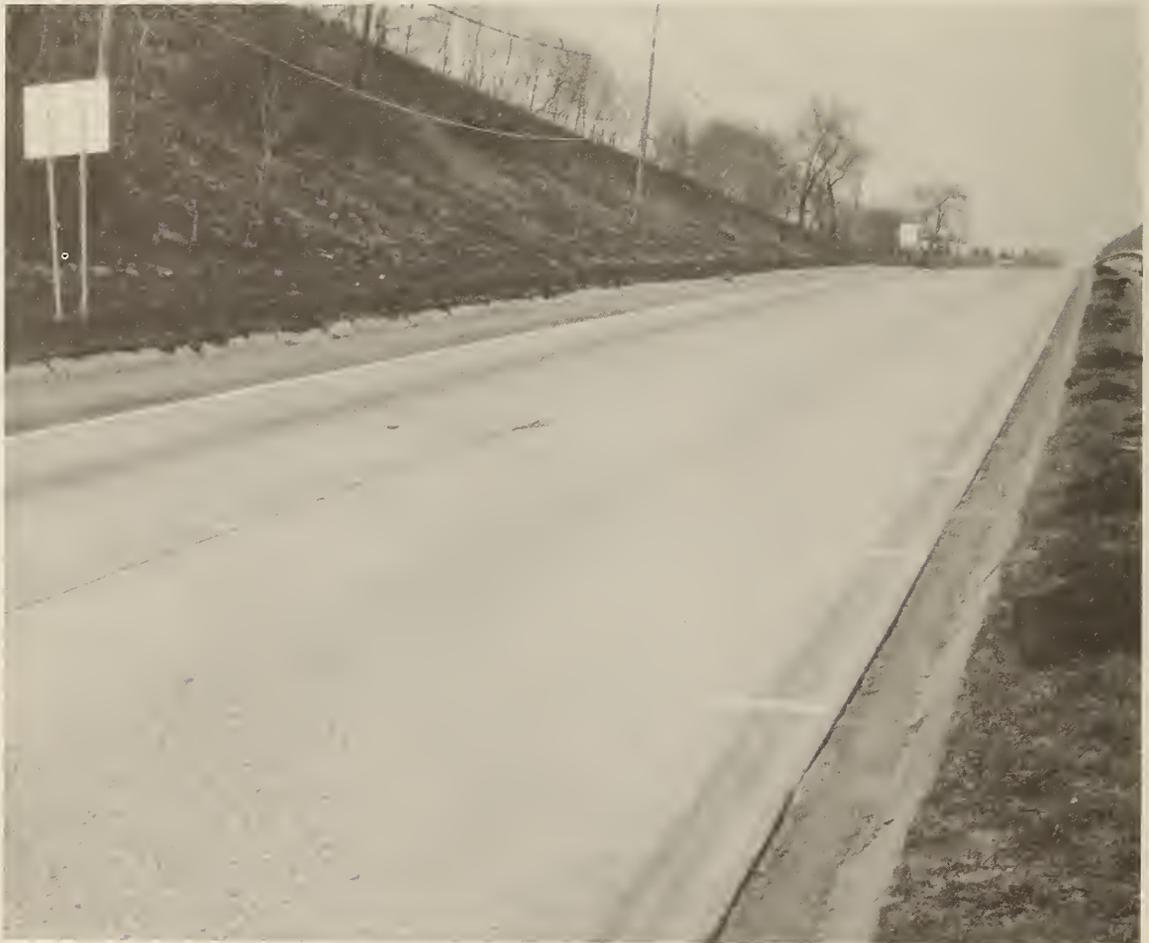
FIGURE 27: NON-BEADED STRIPES ON ROUTE 1 IN DANVERS (APRIL)

Stripes on Route 1 in Danvers (from back to front): E-3, E-10, E-25, and Chlorinated Rubber. Photographed on April 6 after six months of winter wear.

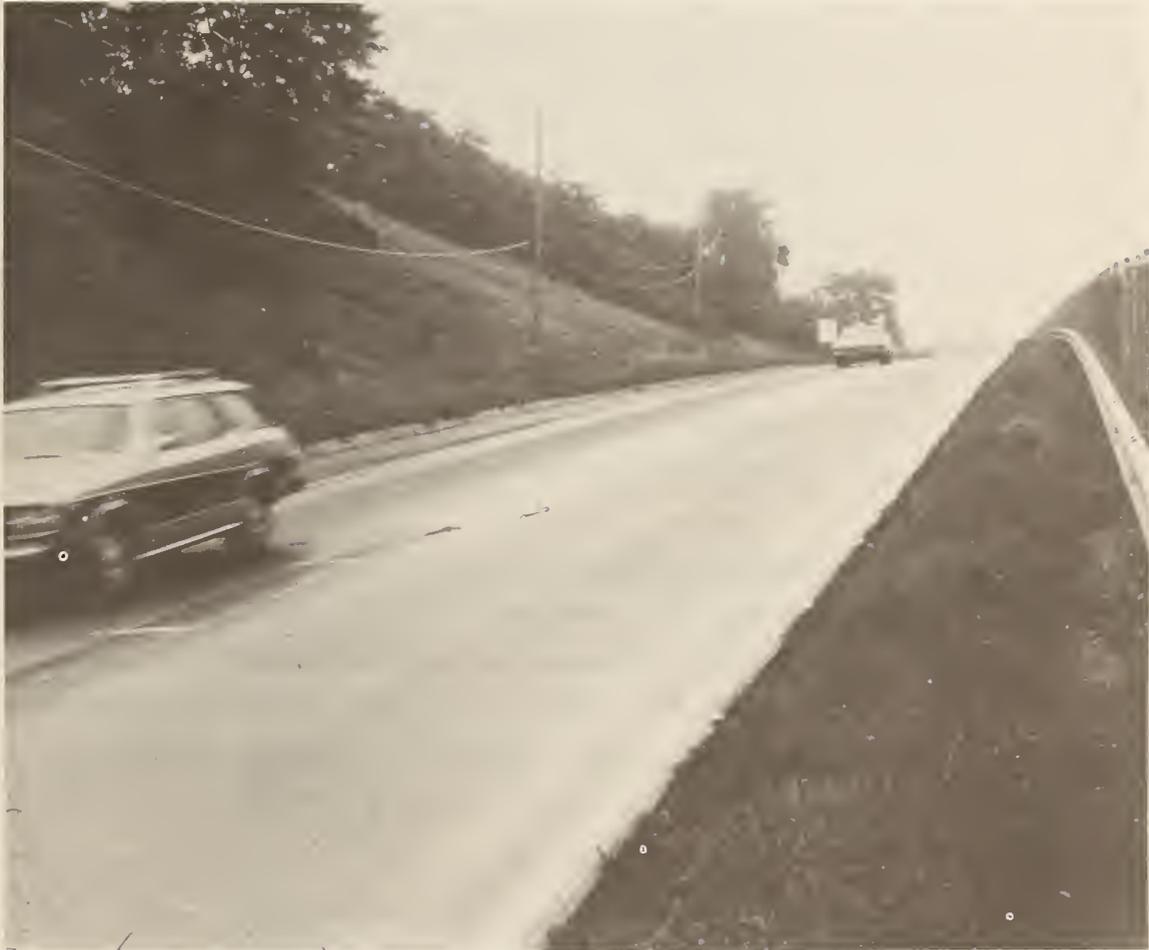
FIGURE 28: NON-BEADED STRIPES ON ROUTE 1 IN DANVERS (AUGUST)

Stripes (from back to front): E-3, E-10, E-25, and Chlorinated Rubber. Photographed on August 2, four months after Photo 1. The sky was overcast and pavement damp during this observation.
