**EXPERIMENT IN ASSESSING  
FOR SEPARATION TECHNIQUES  
FOR IDENTIFYING SMALL DENSITY  
VARIATIONS IN TIRES**

**Department of Transportation  
Transportation Systems Center  
55 Broadway  
Cambridge, Mass. 02142**

**Contract No HS 303  
July 1972  
Interim Report**

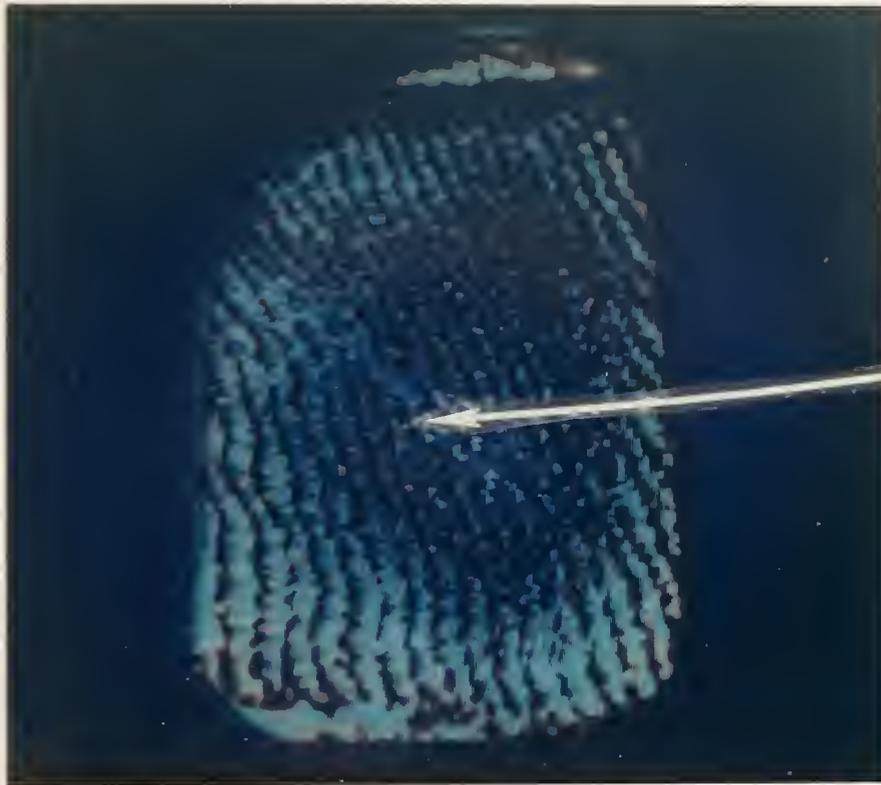
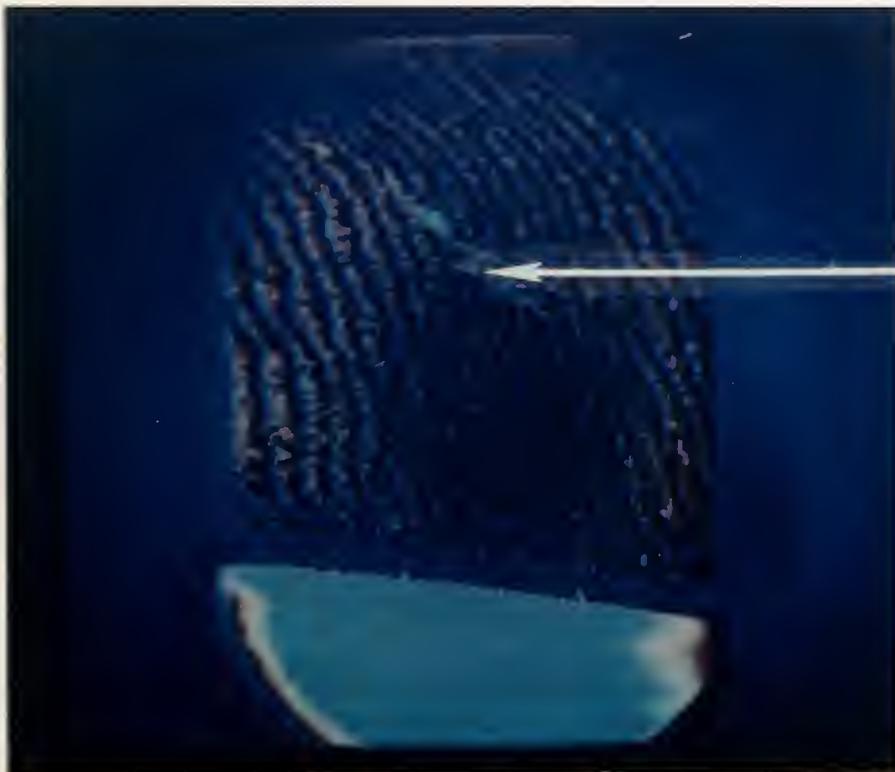
SEVERE  
TREAD  
CRACK

Figure 4-1. Tread Area Showing Severe Tread Crack (Glass Belted Polyester Tire)-Two Level Adjustments.

The number of tires with known defects was scanned and shown in Figures 4-1 through 4-5. The tires used were in poor condition and while the photographs are dramatic the defects were substantial. Subtle flaws could be identified as in Figure 4-6, only after a moderate amount of adjustment.

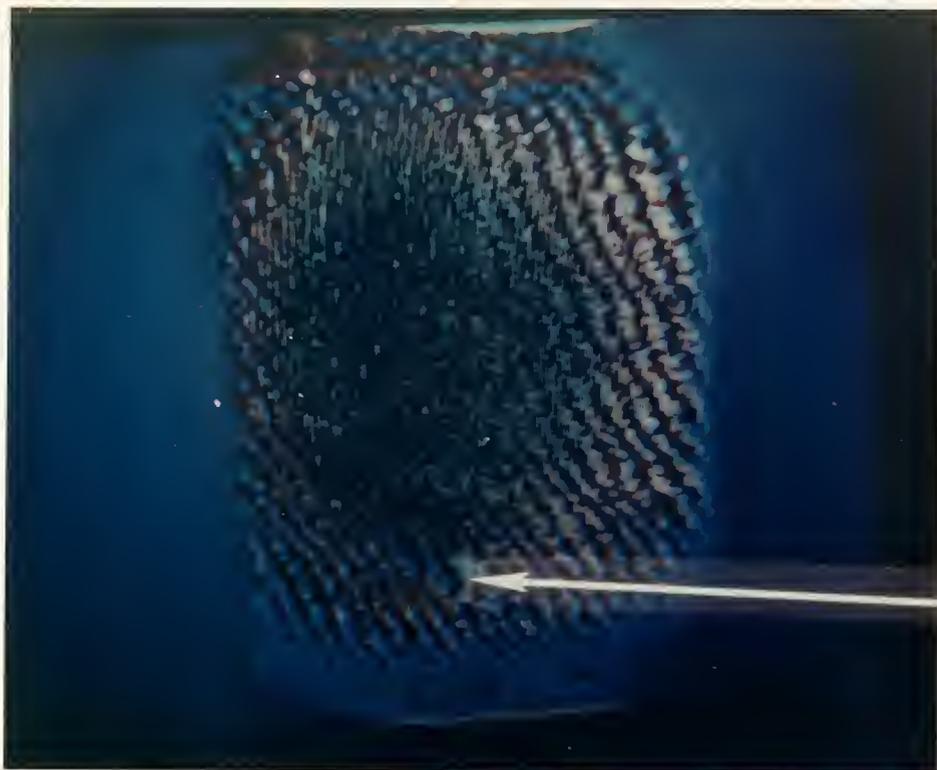
FLAW

Figure 4-6. Flaw in Belt Area
