DOT HS 807 436  
Final Report

# **Final Report of 270° Contoured Moving Barrier Impact into a 1985 Nissan Sentra 2-Door Coupe in Support of Crash III Damage Algorithm Reformation**

The purpose of the three 270° contoured moving barrier impact tests was for research and development in support of the CRASH III damage algorithm reformulation.

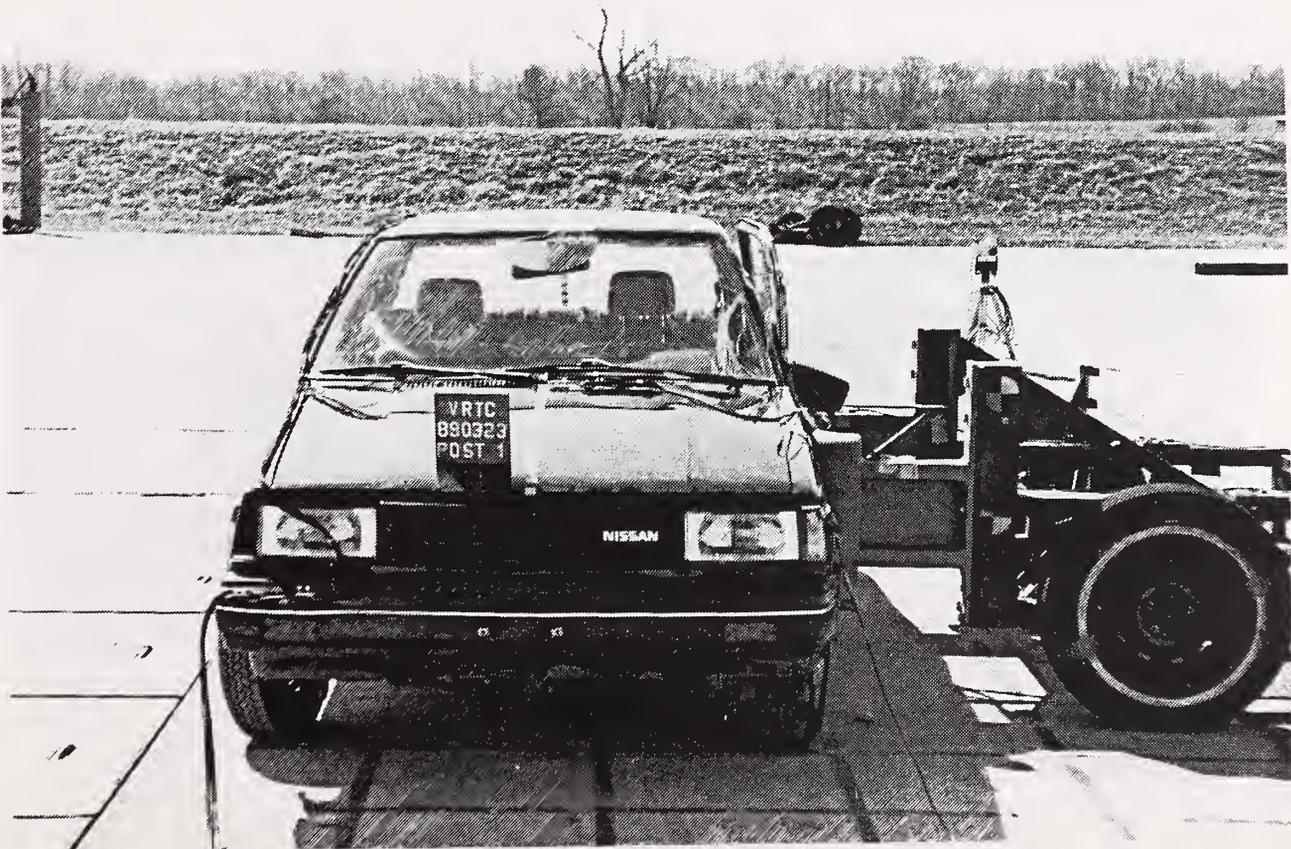
Figure A-2. POST-TEST OVERALL FRONT VIEW

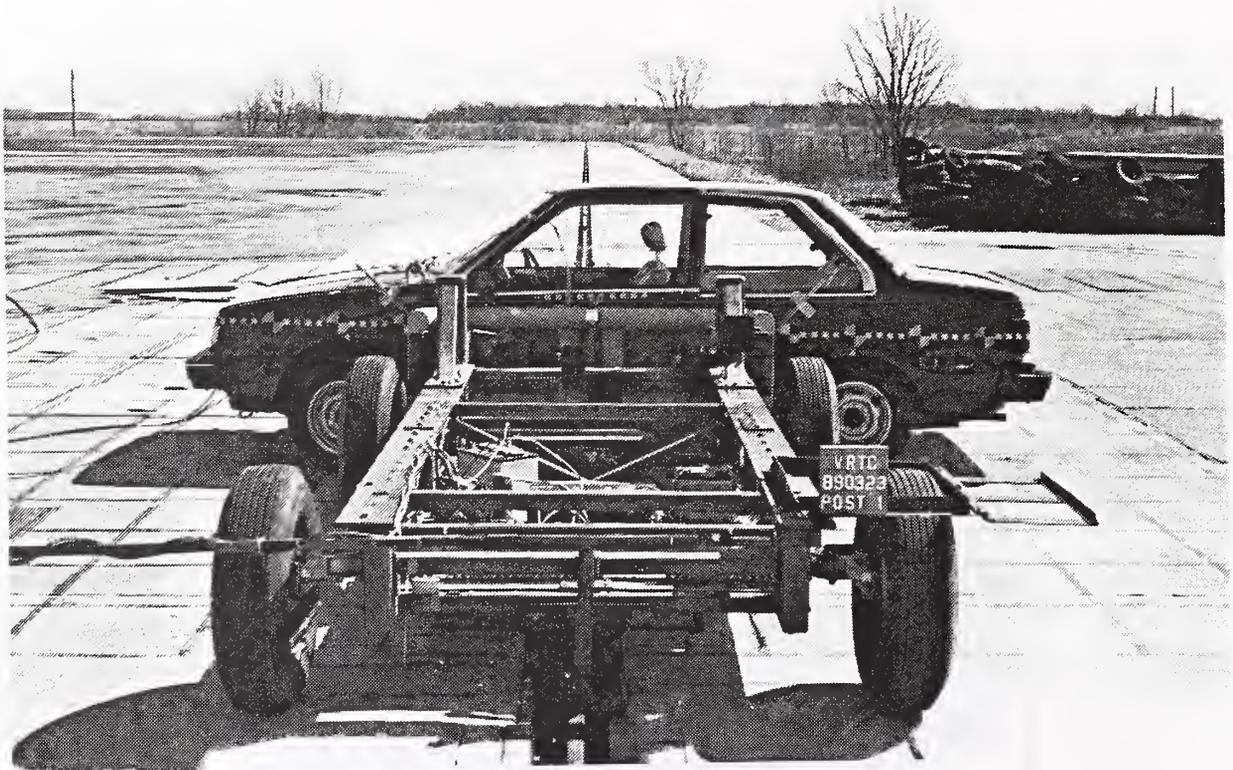
Figure A-4. POST-TEST OVERALL LEFT SIDE - VIEW 1

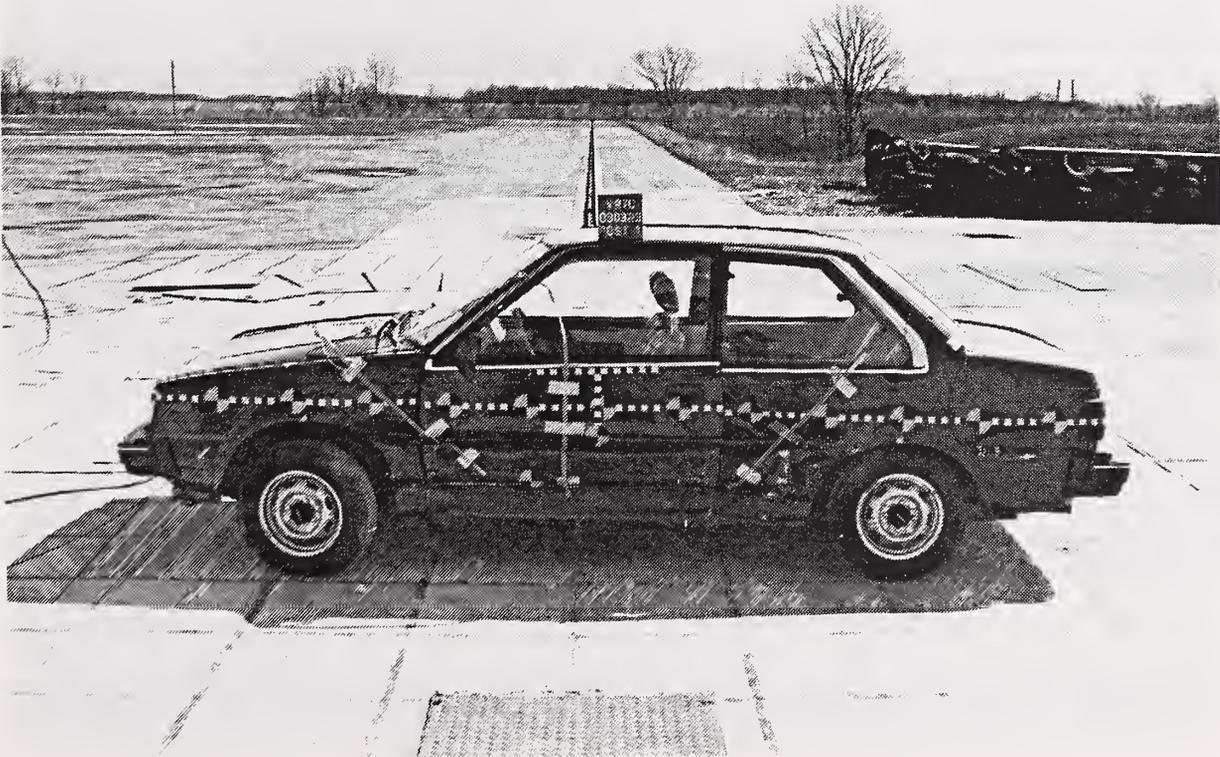
Figure A-6. POST-TEST OVERALL LEFT SIDE - VIEW 2

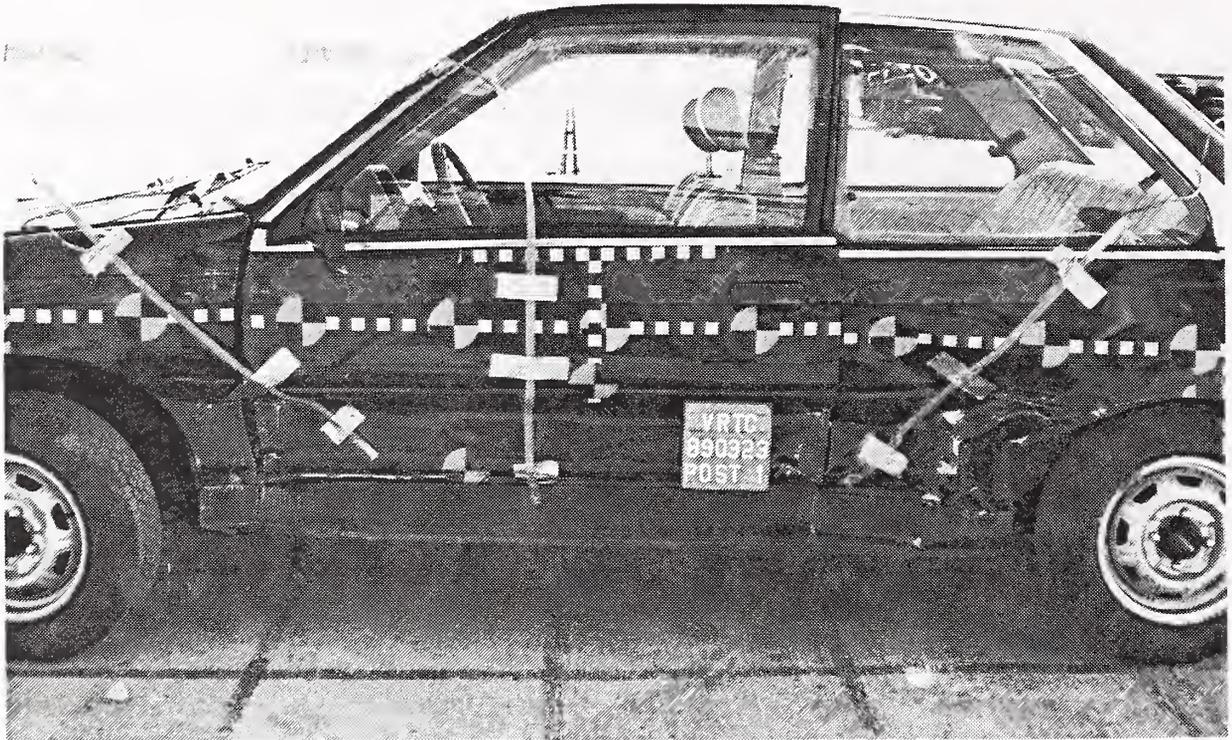
Figure A-7. POST-TEST CLOSE-UP LEFT SIDE VIEW

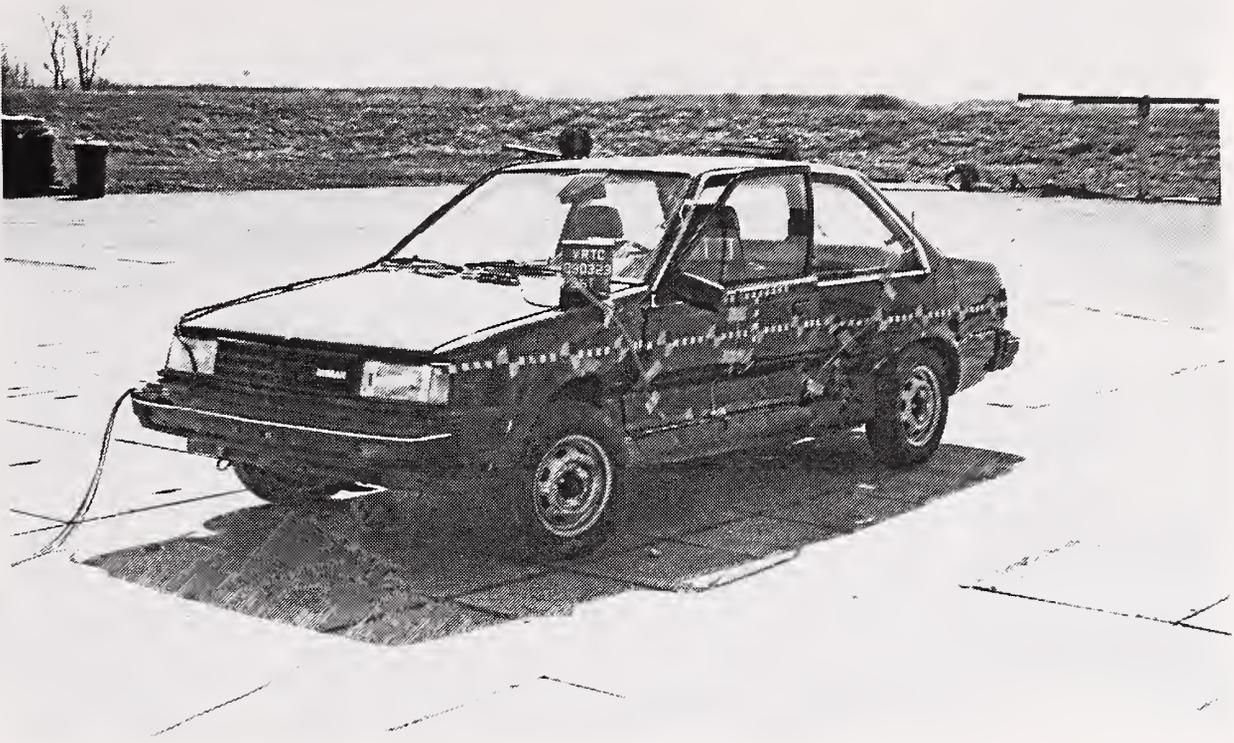
Figure A-13. POST-TEST LEFT FRONT VIEW

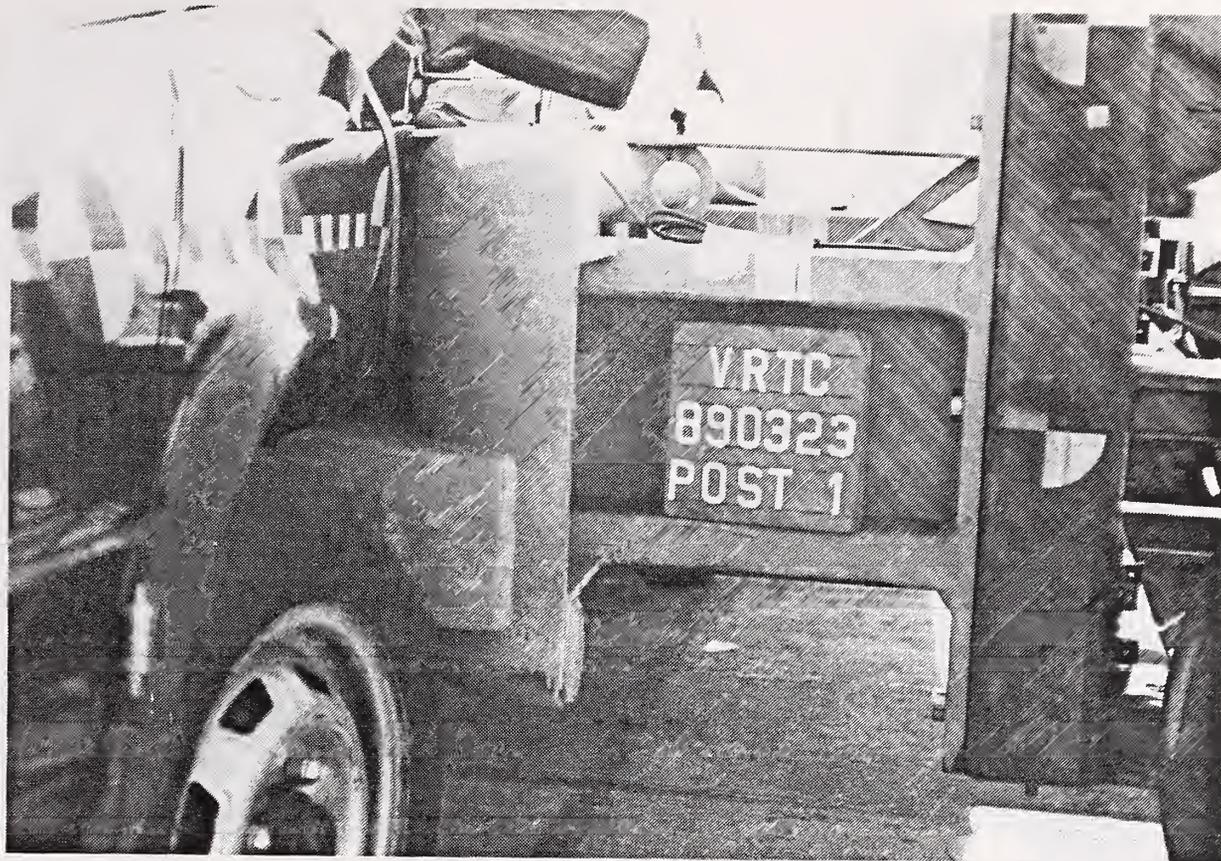
Figure A-17. POST-TEST CLOSE-UP LEFT FRONT VIEW

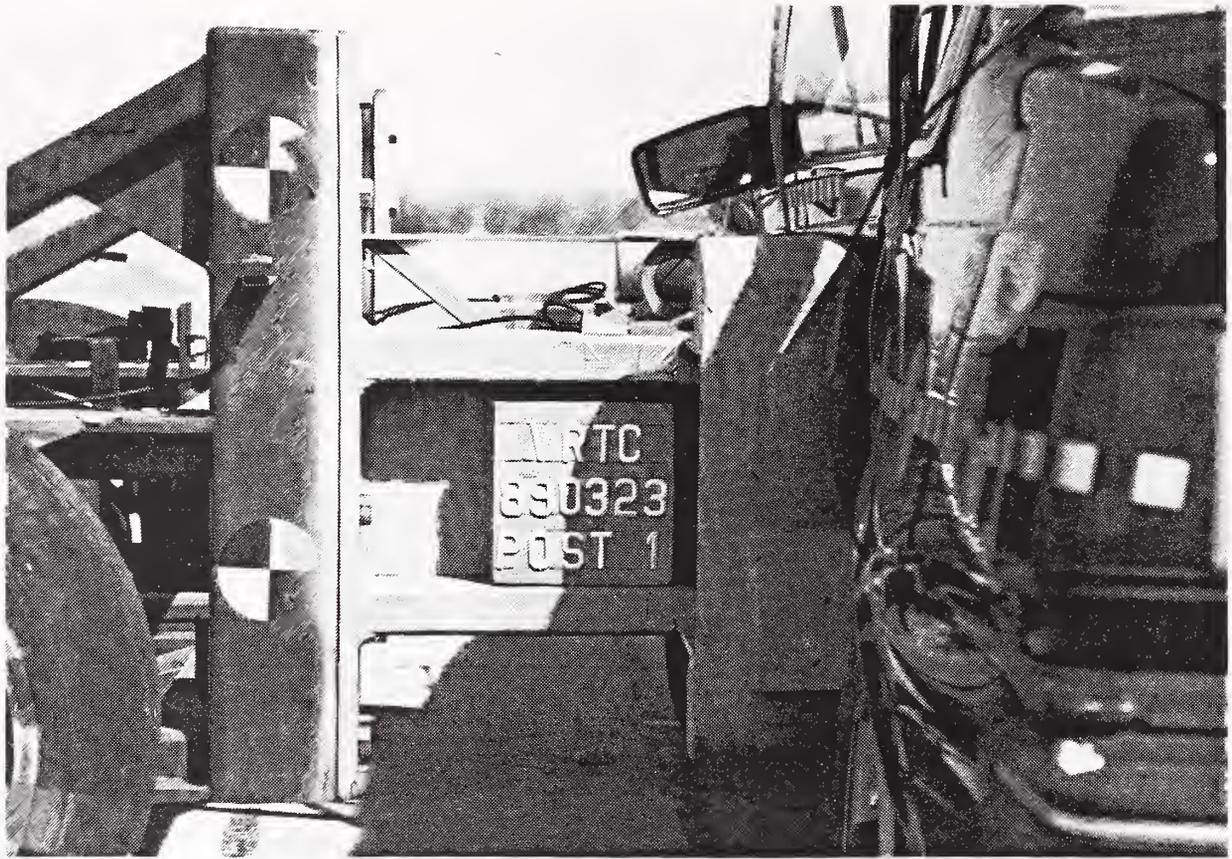
Figure A-19. POST-TEST CLOSE-UP LEFT REAR VIEW

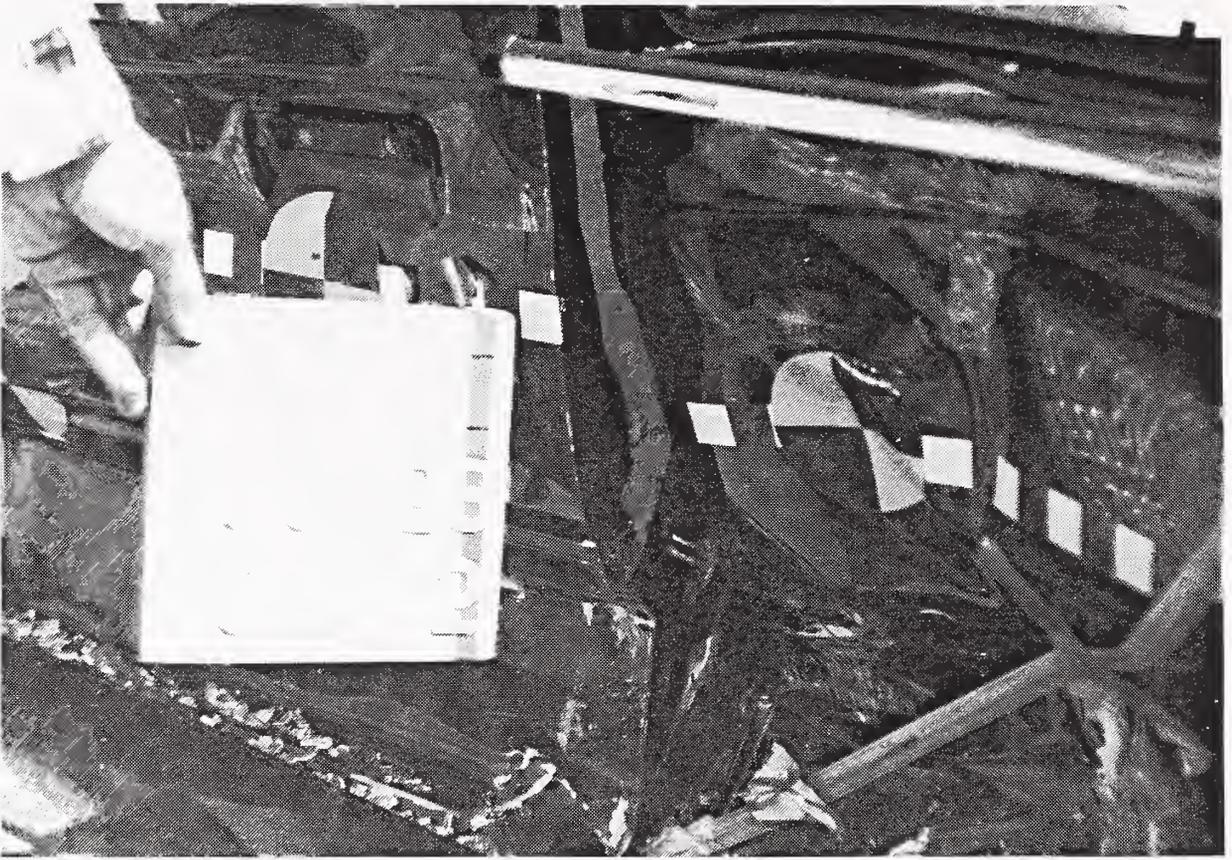
Figure A-32. POST-TEST LEFT DOOR LATCH VIEW

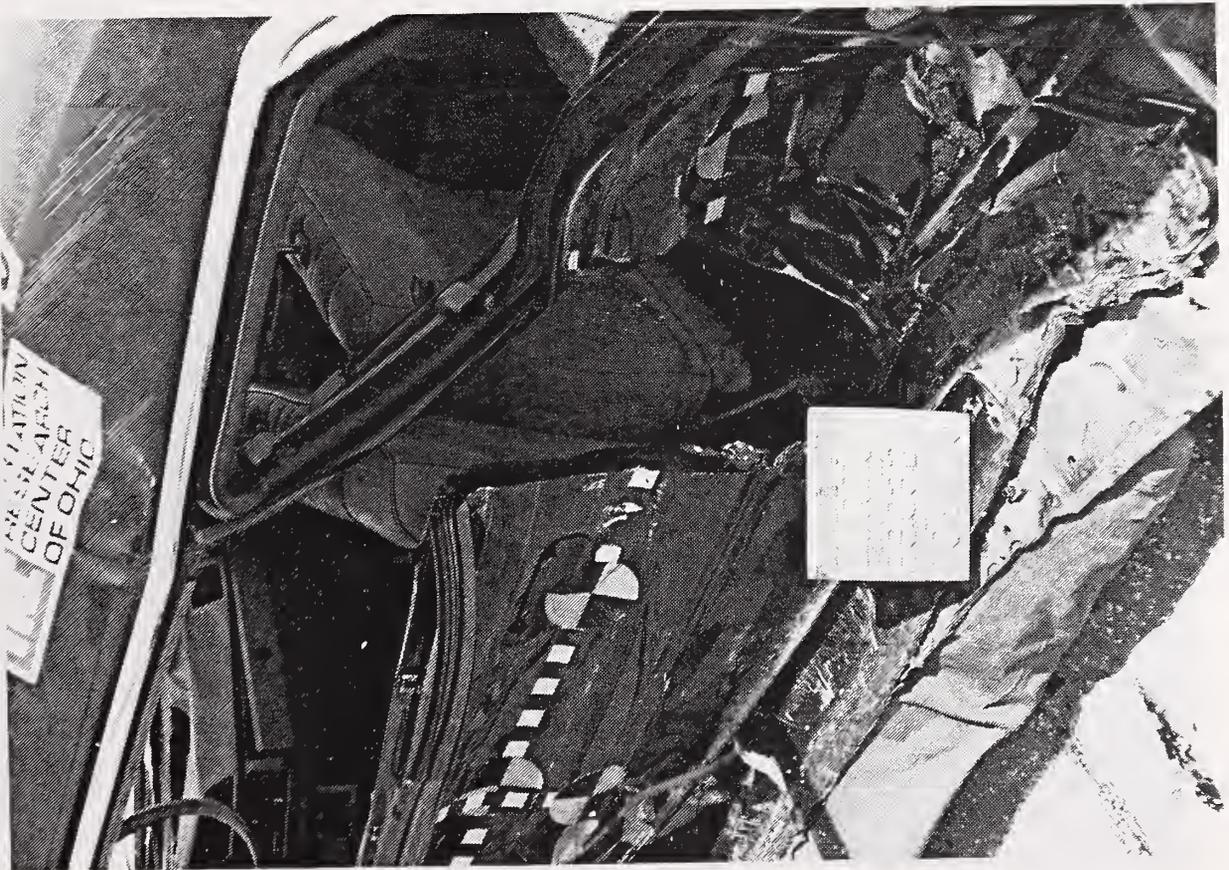
Figure A-42. POST-TEST LEFT DOOR LATCH VIEW

Door latch, hinge, or pillar did fail (See Page 1-2).

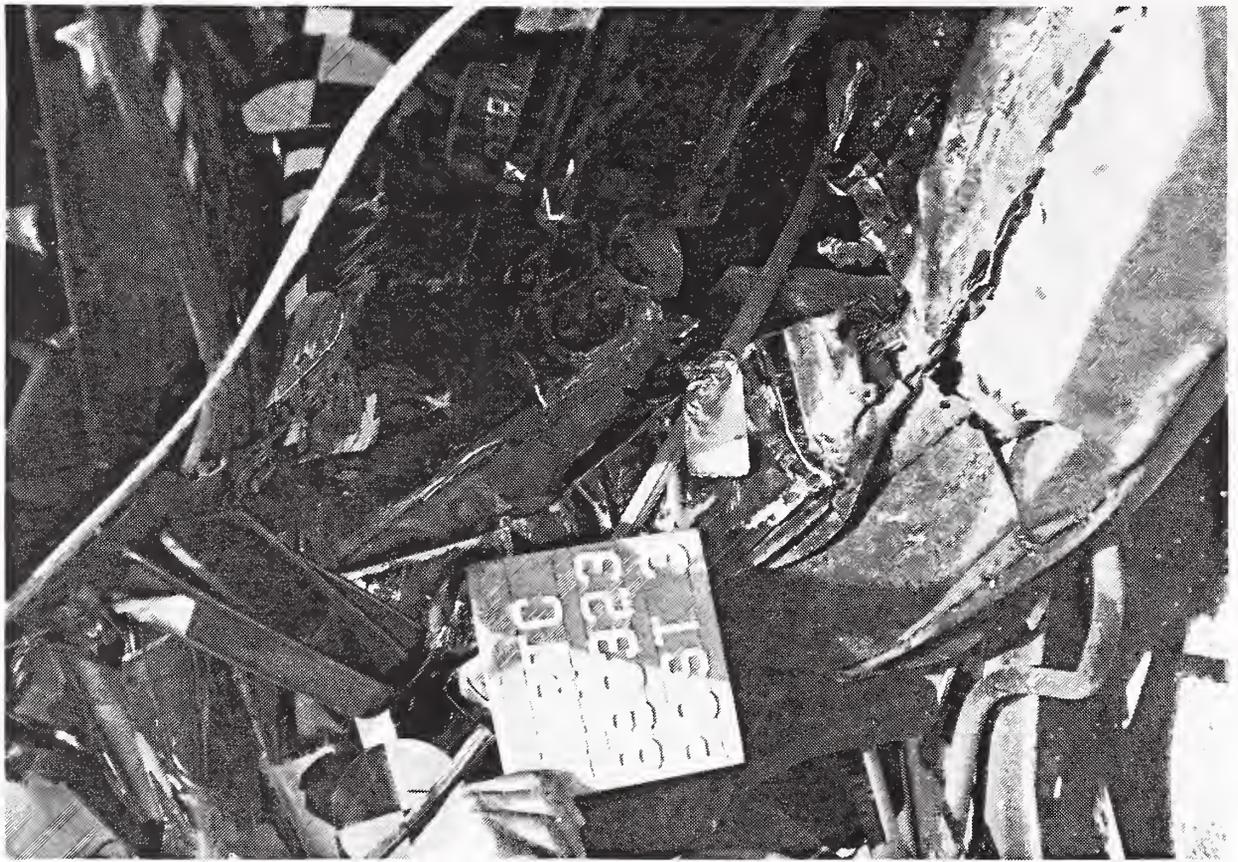
Figure A-43. POST-TEST LEFT DOOR HINGES VIEW

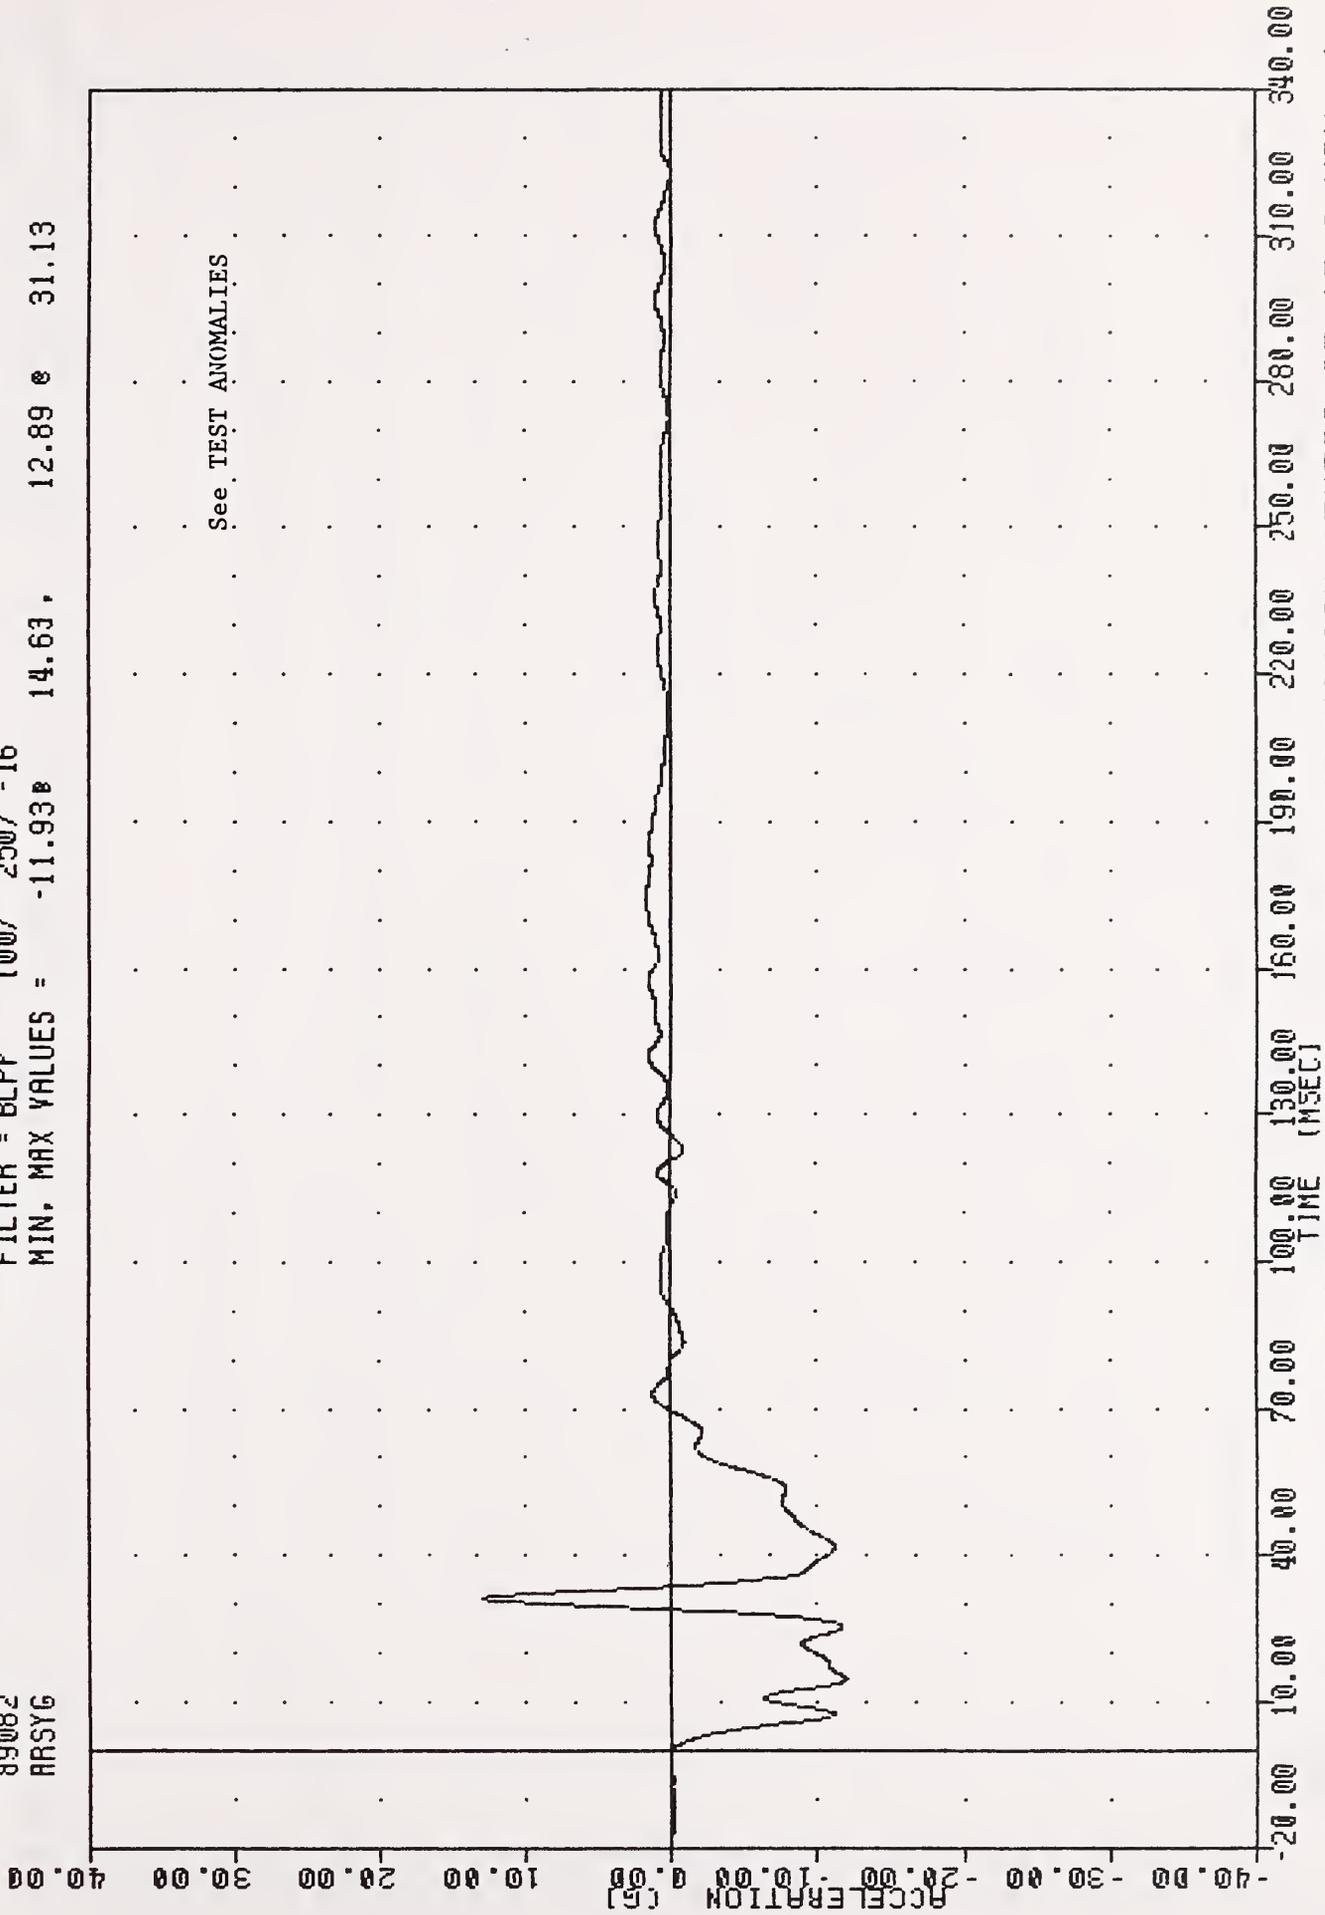
FILTER = BLPP 100/ 250/ -16  
MIN, MAX VALUES = -11.93B 14.63, 12.89 e 31.13

CONTOURED MOVING BARRIER INTO 90 DEG 1985 NISSAN SENTRA AT 17.6 MPH #1  
RIGHT REAR SILL Y AXIS ACCELERATION

Right rear sill Y-axis accelerometer, RRSYG, data contains a spike at 31.1 milliseconds, cause unknown.

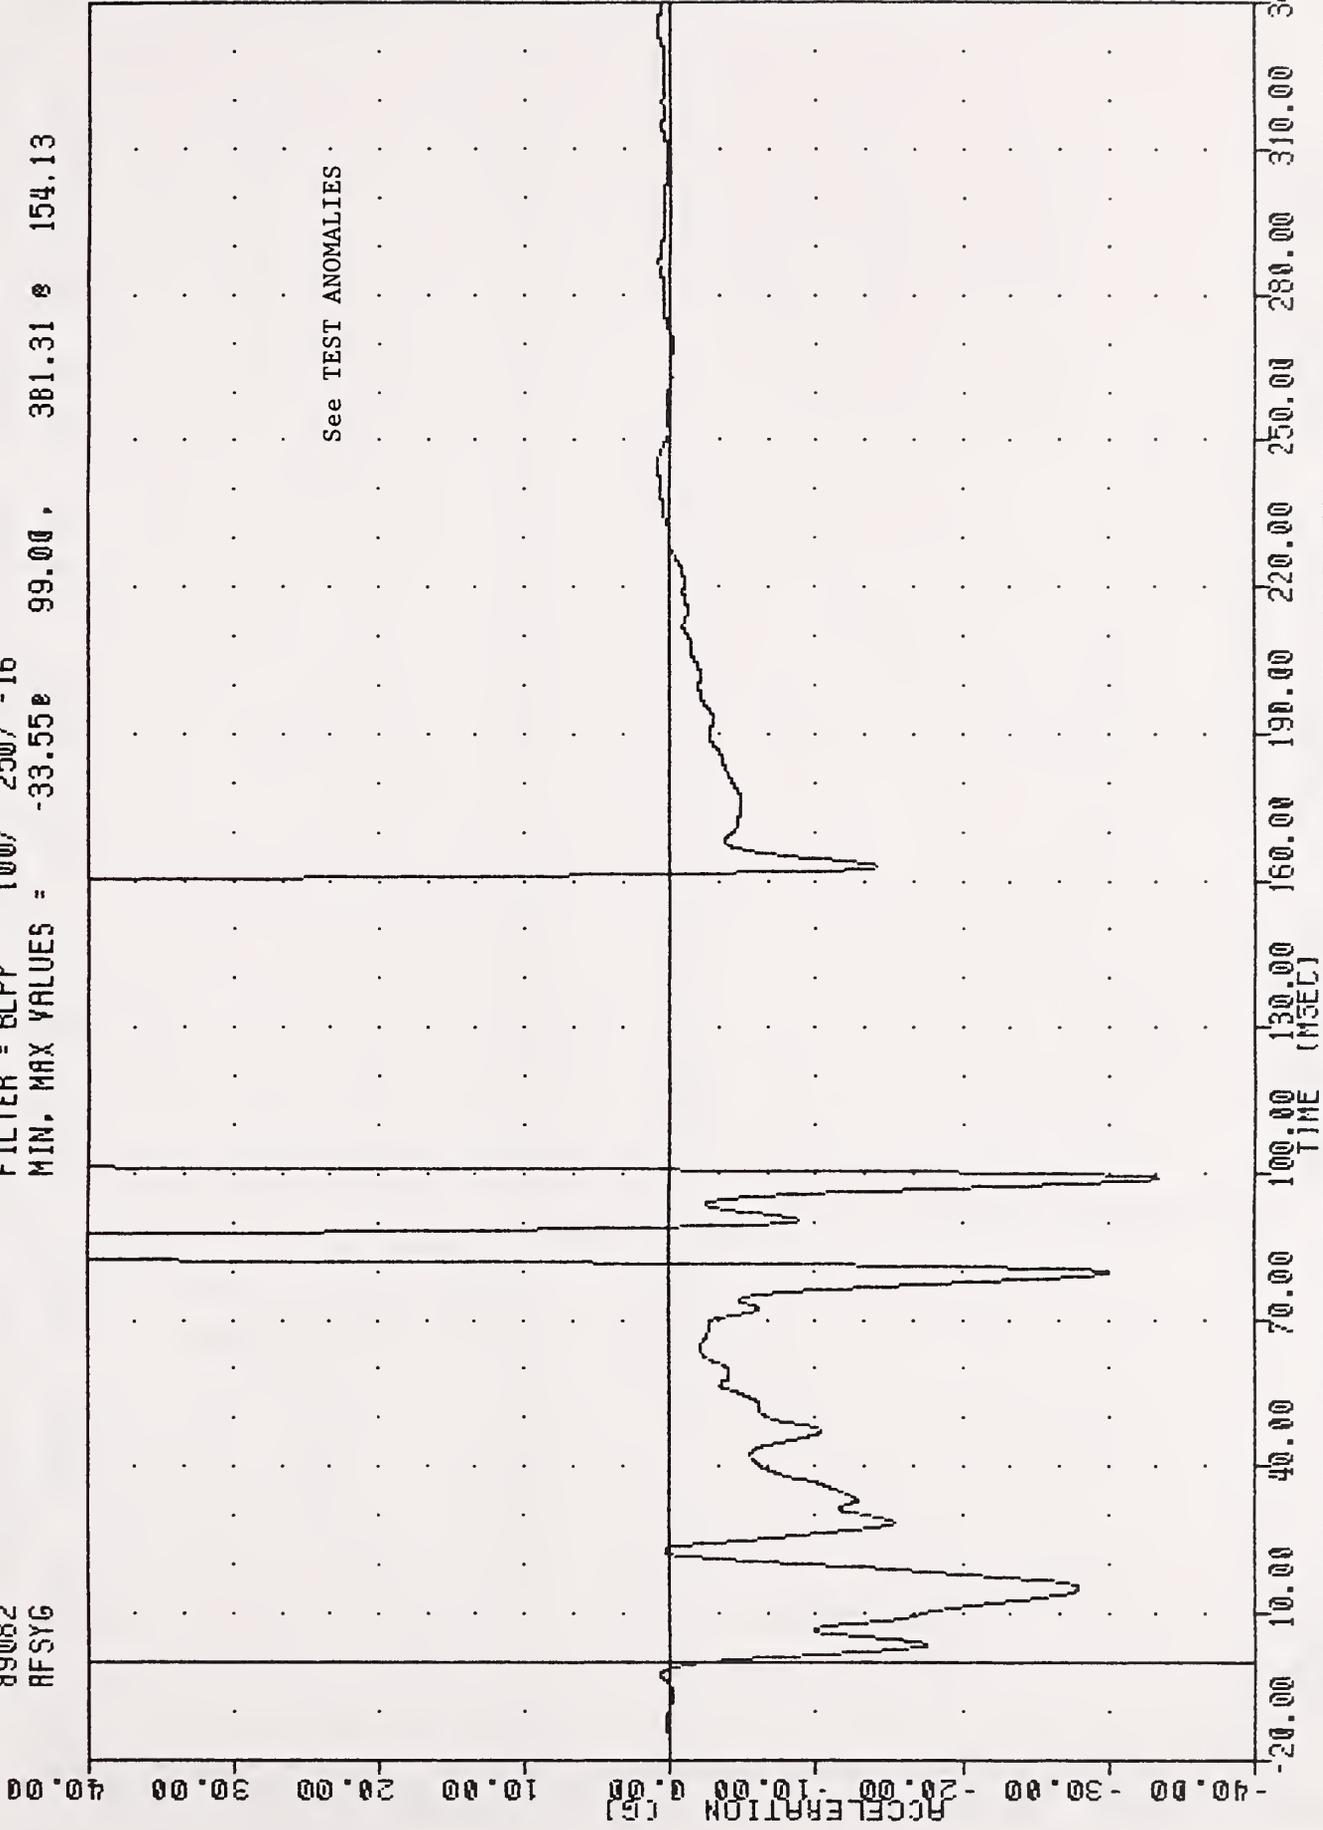
FILTER = 8LPP 100/ 250/ -16  
MIN. MAX VALUES = -33.55e 99.00 , 381.31 e 154.13

CONTOURED MOVING BARRIER INTO 90 DEG 1985 NISSAN SENTRA AT 26.4 MPH \*2  
RIGHT FRONT SILL Y AXIS ACCELERATION

Right front sill Y-axis accelerometer, RFSYG, data was lost between 80.5 and 160.0 milliseconds, cause unknown.

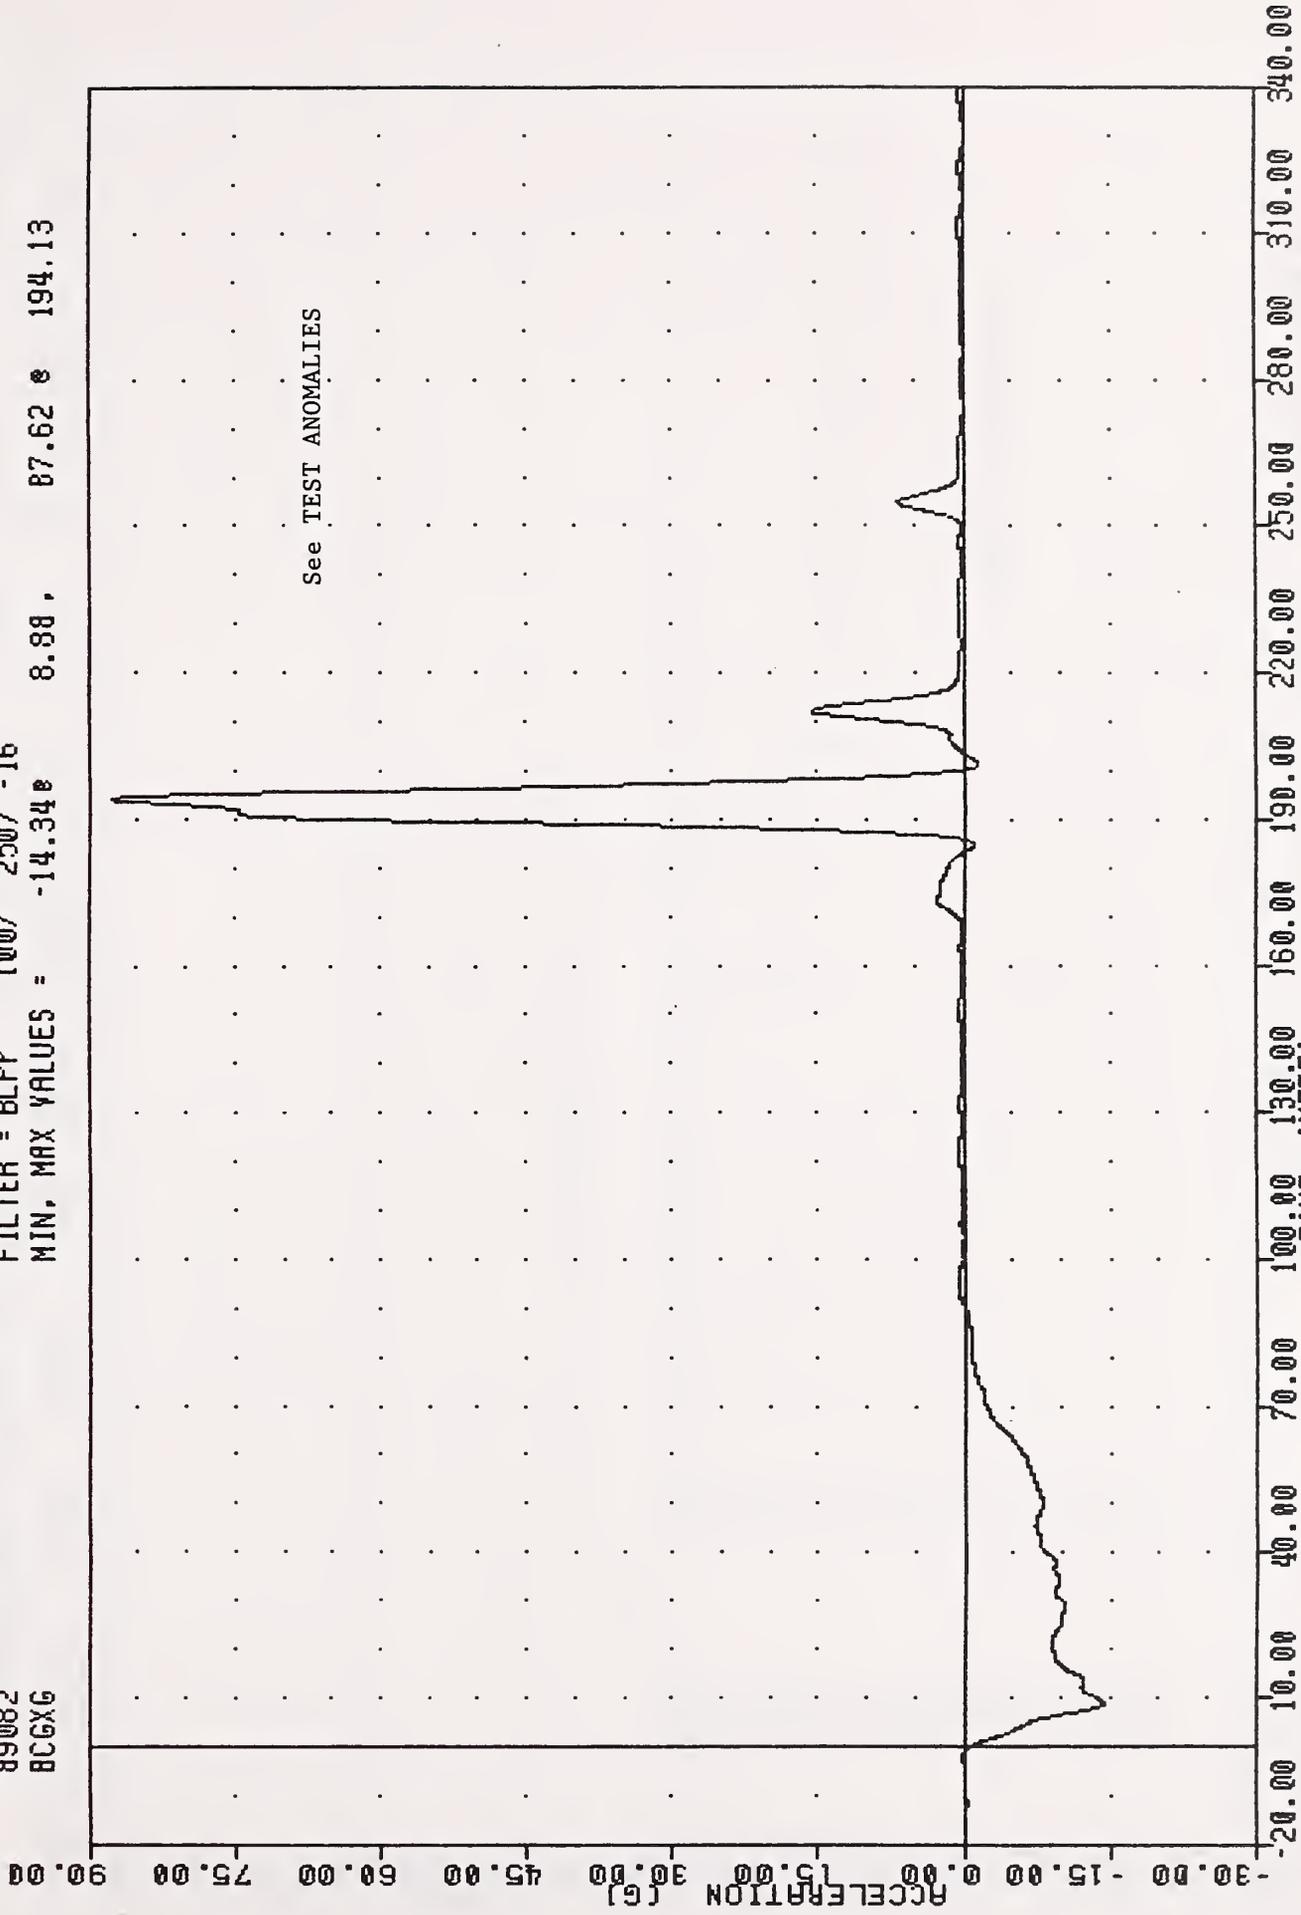
FILTER = BLFP 100/ 250/ -16  
MIN, MAX VALUES = -14.34e 8.88 , 87.62 e 194.13

CONTOURED MOVING BARRIER INTO 90 DEG 1985 NISSAN SENTRA AT 26.4 MPH #2  
CONTOURED MOVING BARRIER CENTER OF GRAVITY X AXIS ACCELERATION

Contoured moving barrier center of gravity X-axis accelerometer, BCGXG, data contains spikes at 194.1, 211.8 and 254.5 milliseconds, cause unknown.

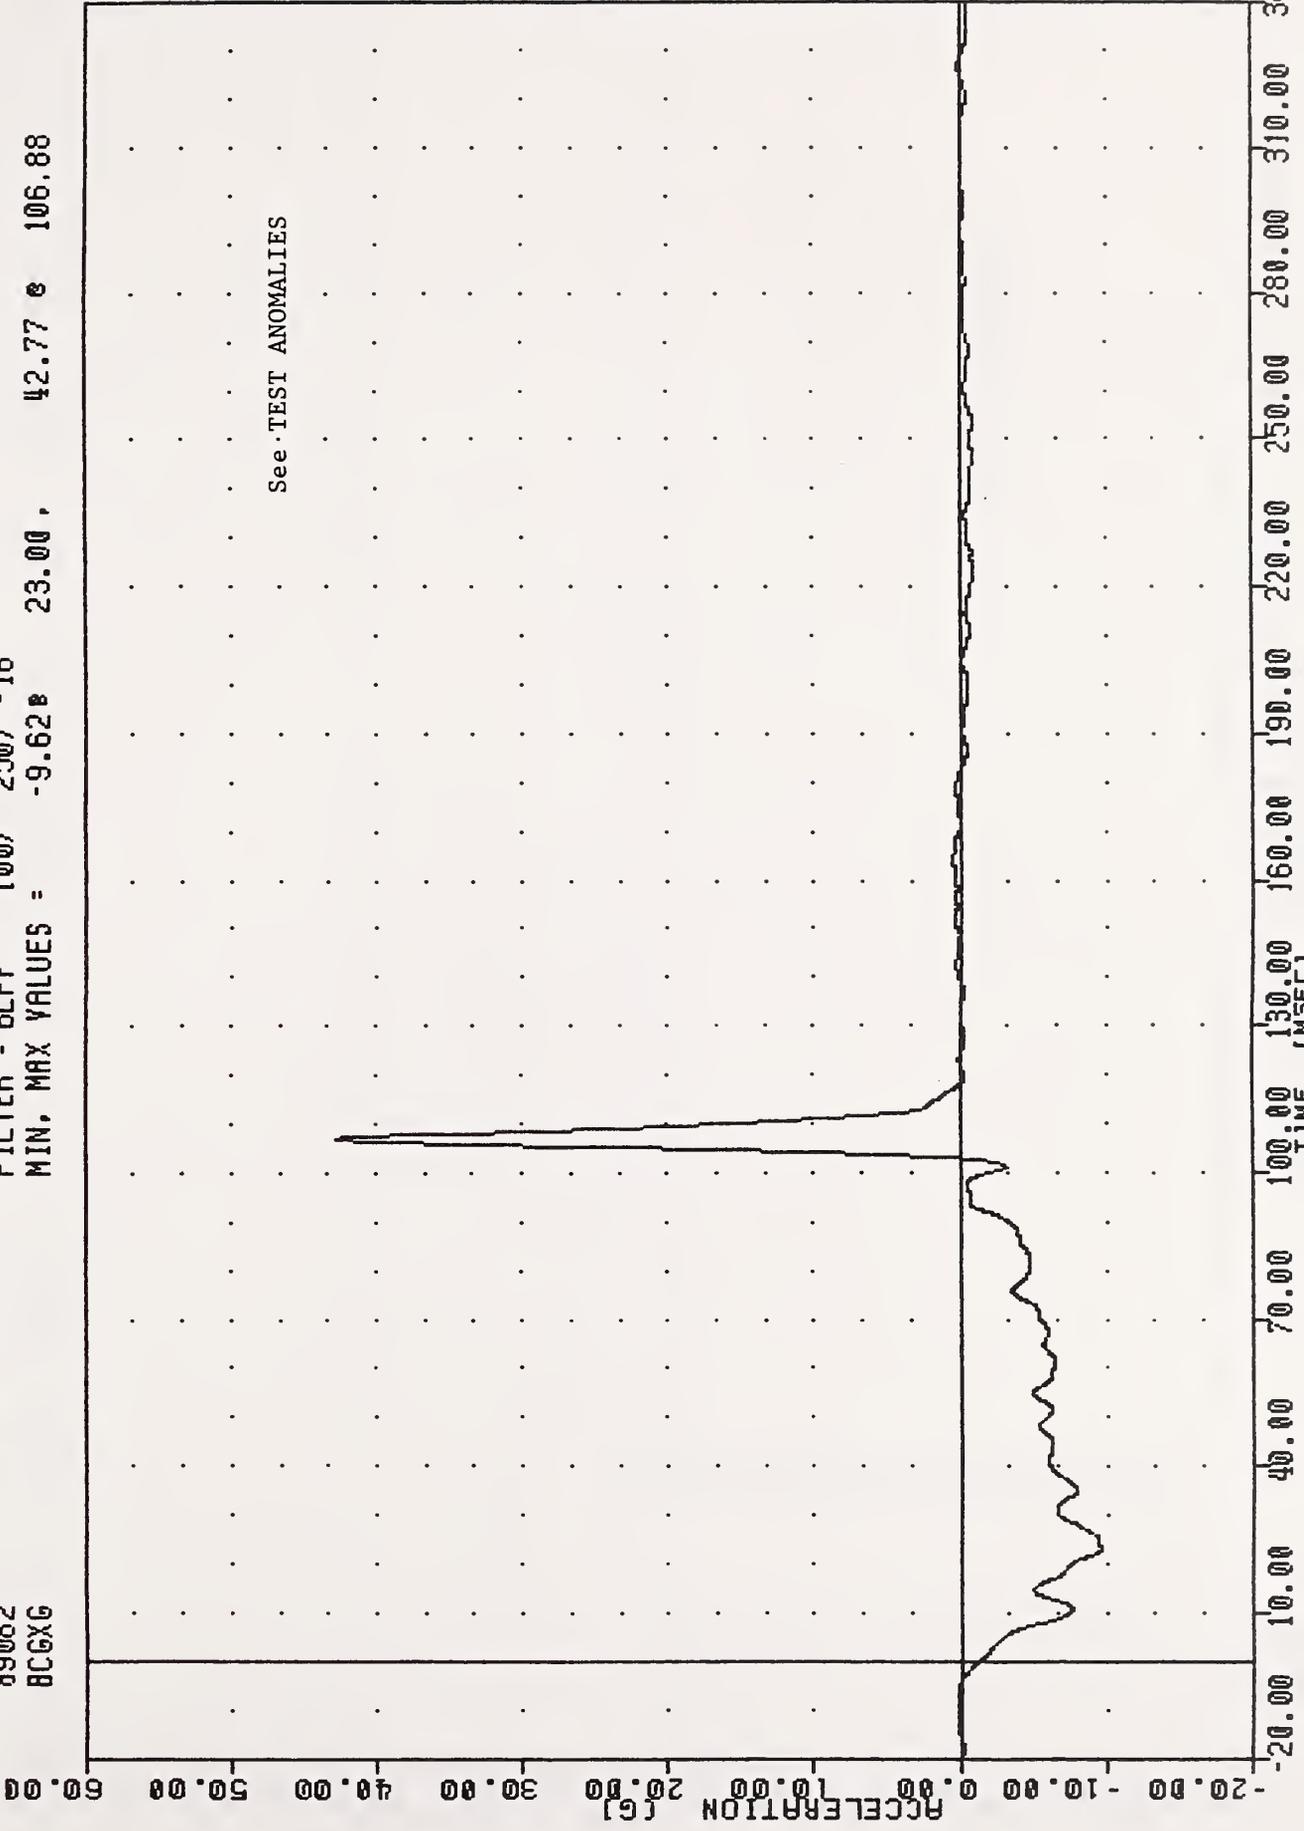
FILTER = BLPP 100/ 250/ -16  
MIN, MAX VALUES = -9.62 23.00 , 42.77 106.88

CONTOURED MOVING BARRIER INTO 90 DEG 1985 NISSAN SENTRA AT 26.4 MPH #3  
CONTOURED MOVING BARRIER CENTER OF GRAVITY X AXIS ACCELERATION

Contoured moving barrier center of gravity X-axis accelerometer, BCGXG, data contains spike at 106.9 milliseconds, cause unknown.

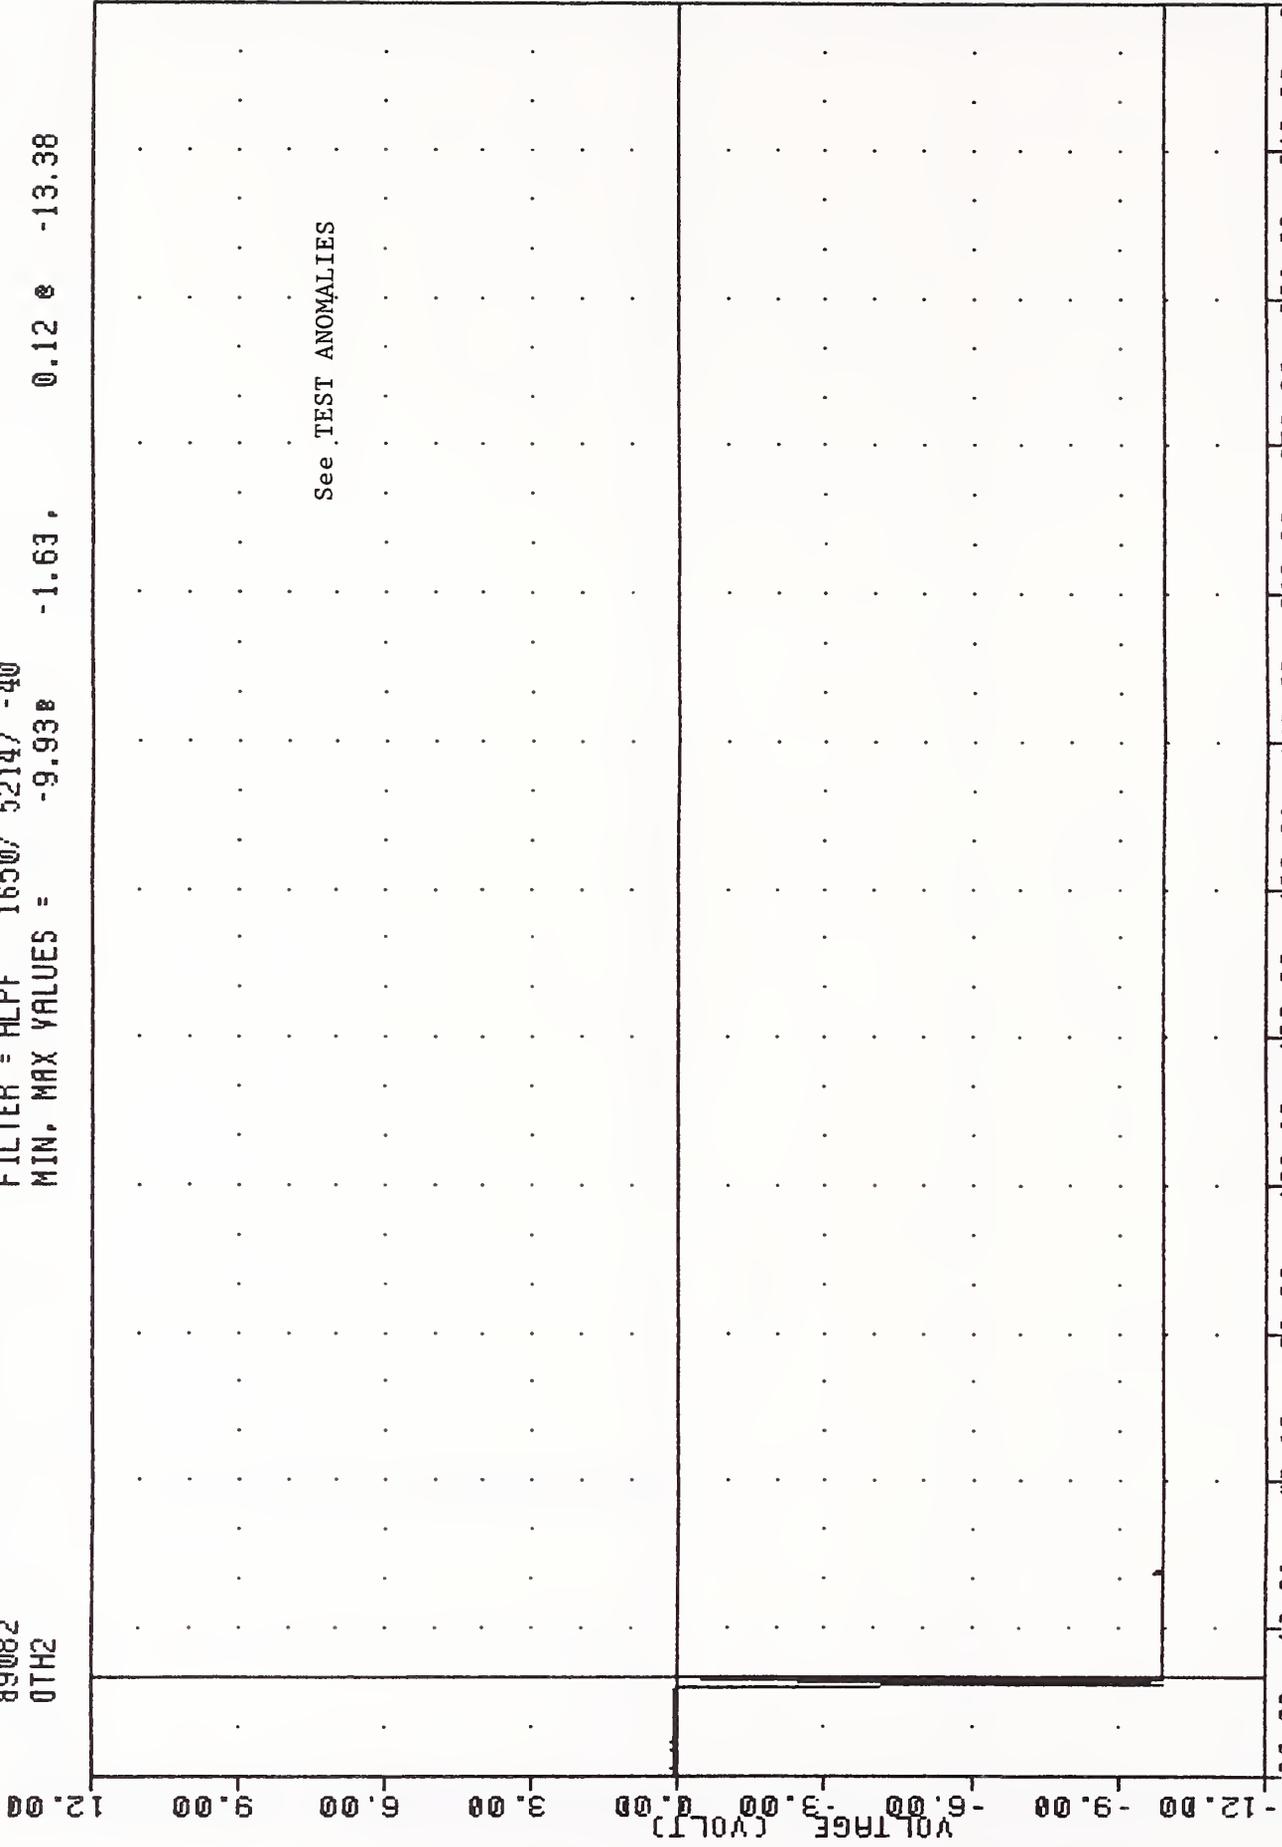
FILTER = ALPF 1650/ 5214/ -40  
 MIN, MAX VALUES = -9.938 -1.63, 0.12 e -13.38

-20.00 10.00 40.00 70.00 100.00 130.00 160.00 190.00 220.00 250.00 280.00 310.00 340.00  
 TIME (MSEC)  
 CONTOURED MOVING BARRIER INTO 90 DEG 1985 NISSAN SENTRA AT 26.4 MPH #3  
 VEHICLE CONTACT SWITCH - REAR

Vehicle contact switch - rear, OTH2, stayed closed, due to a cut switch.
