TL  
242  
.E6546  
1989

U.S. Department  
of Transportation  
**National Highway  
Traffic Safety  
Administration**

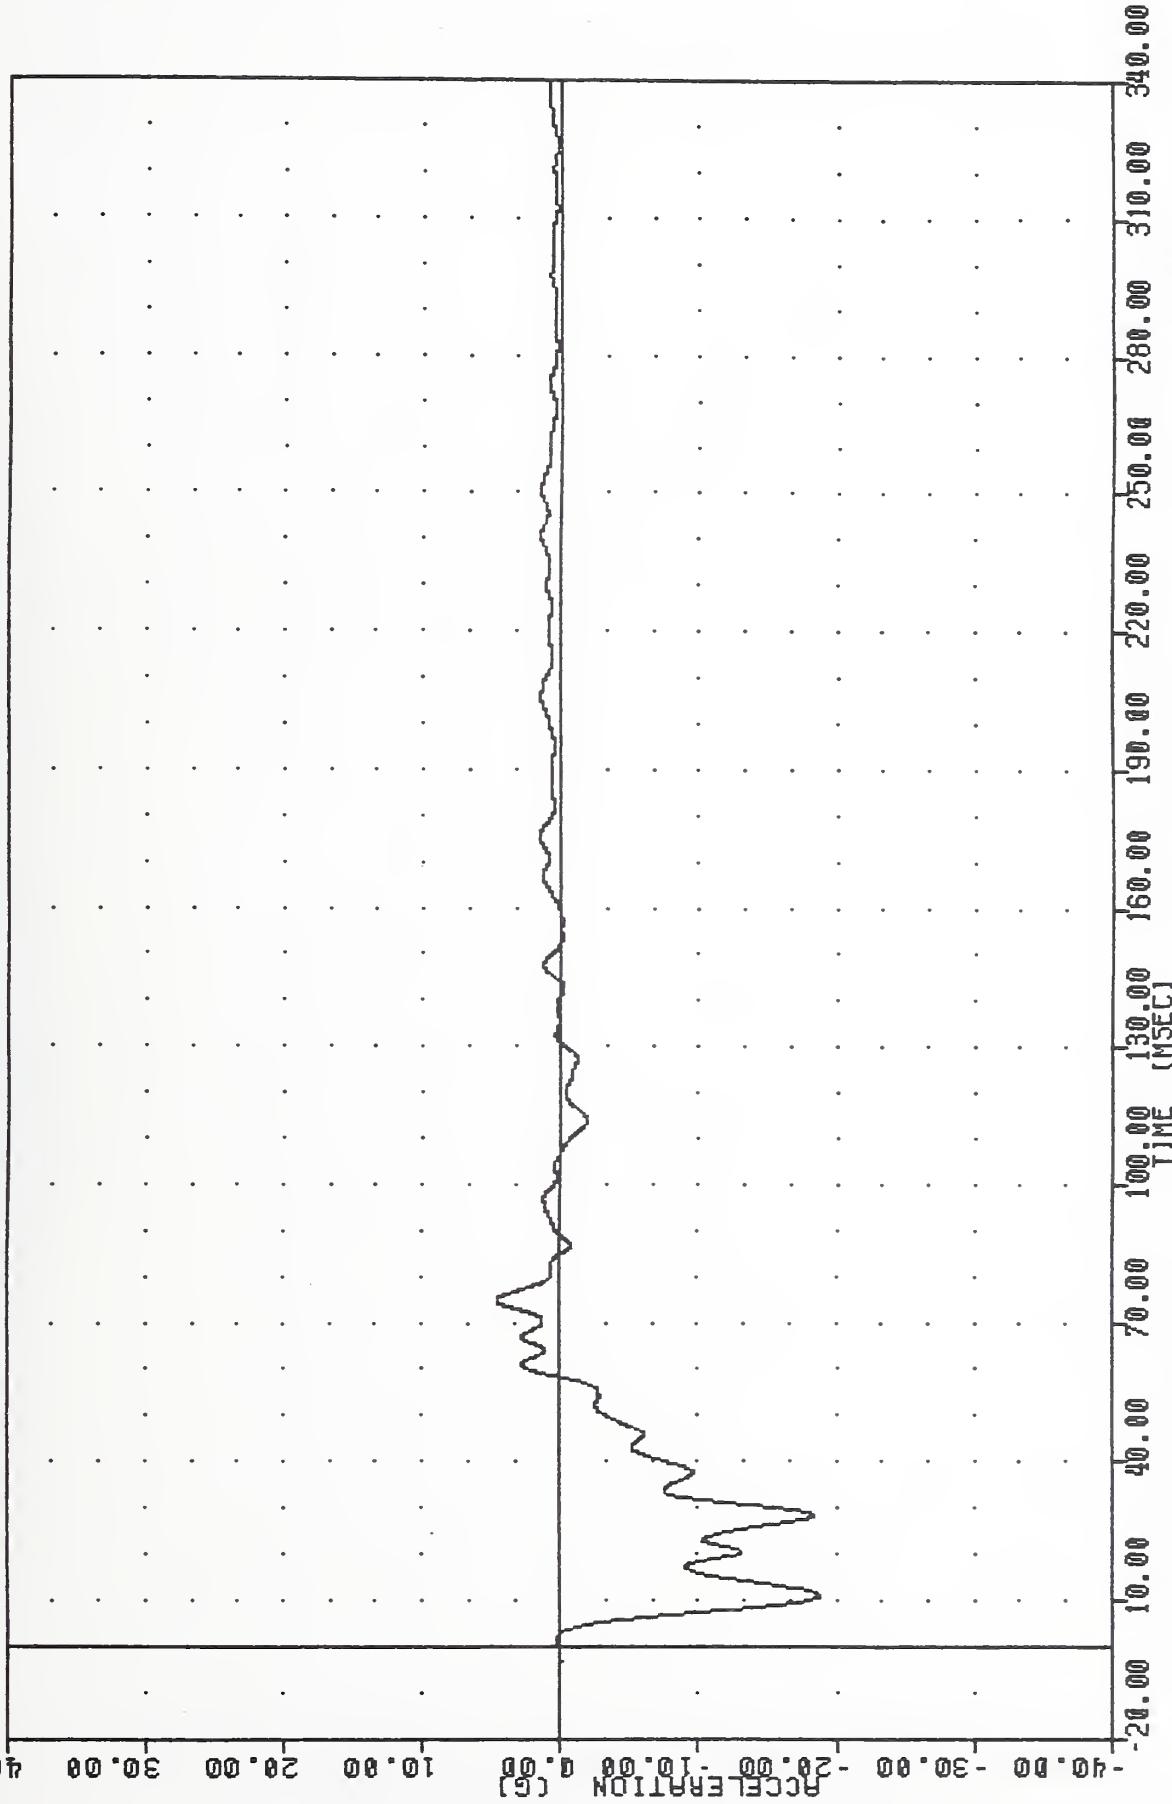
CONTOURED BARRIER INTO 90 DEG 1985 CHEVROLET CELEBRITY AT 20.3 MPH #1  
 VEHICLE RIGHT FRONT SILL Y AXIS ACCELERATION

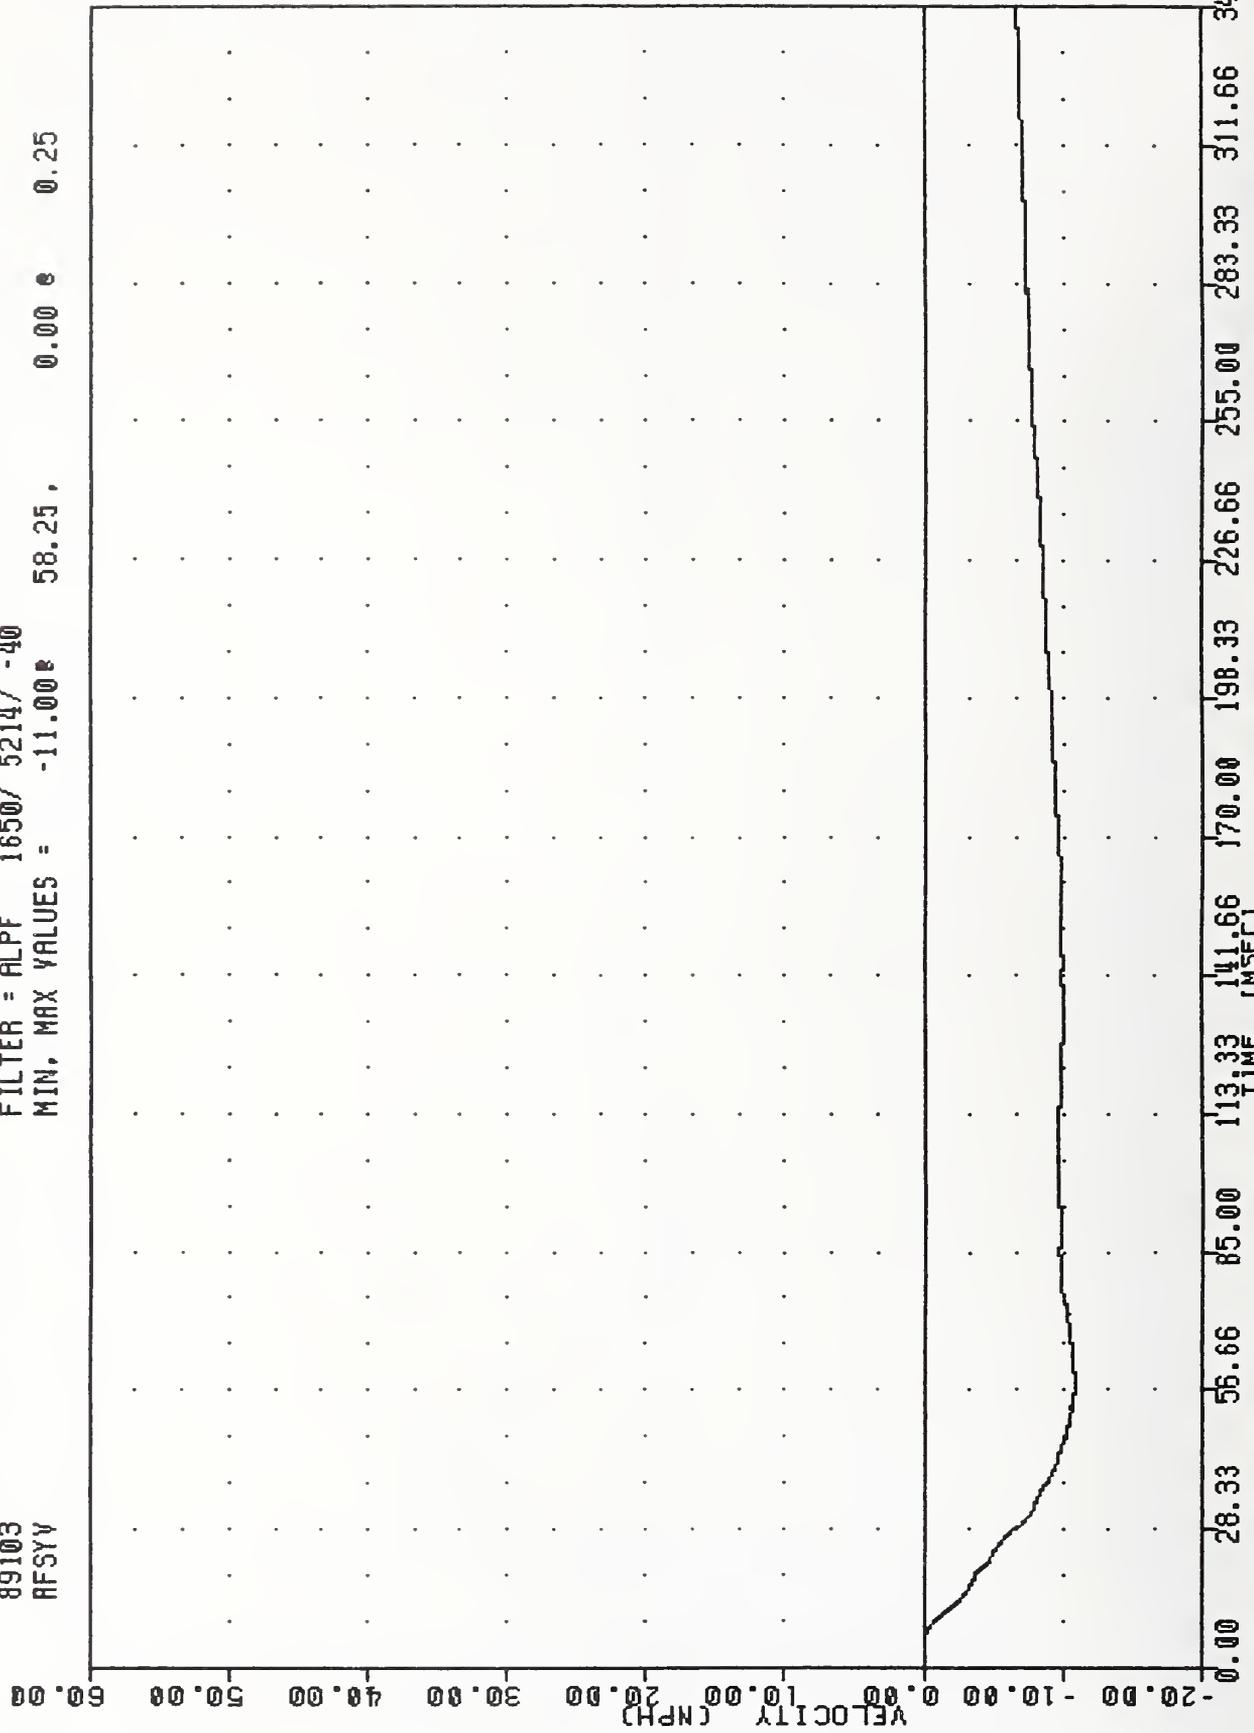
CONTOURED BARRIER INTO 90 DEG 1985 CHEVROLET CELEBRITY AT 20.3 MPH #1  
 VEHICLE RIGHT FRONT SILL Y AXIS VELOCITY

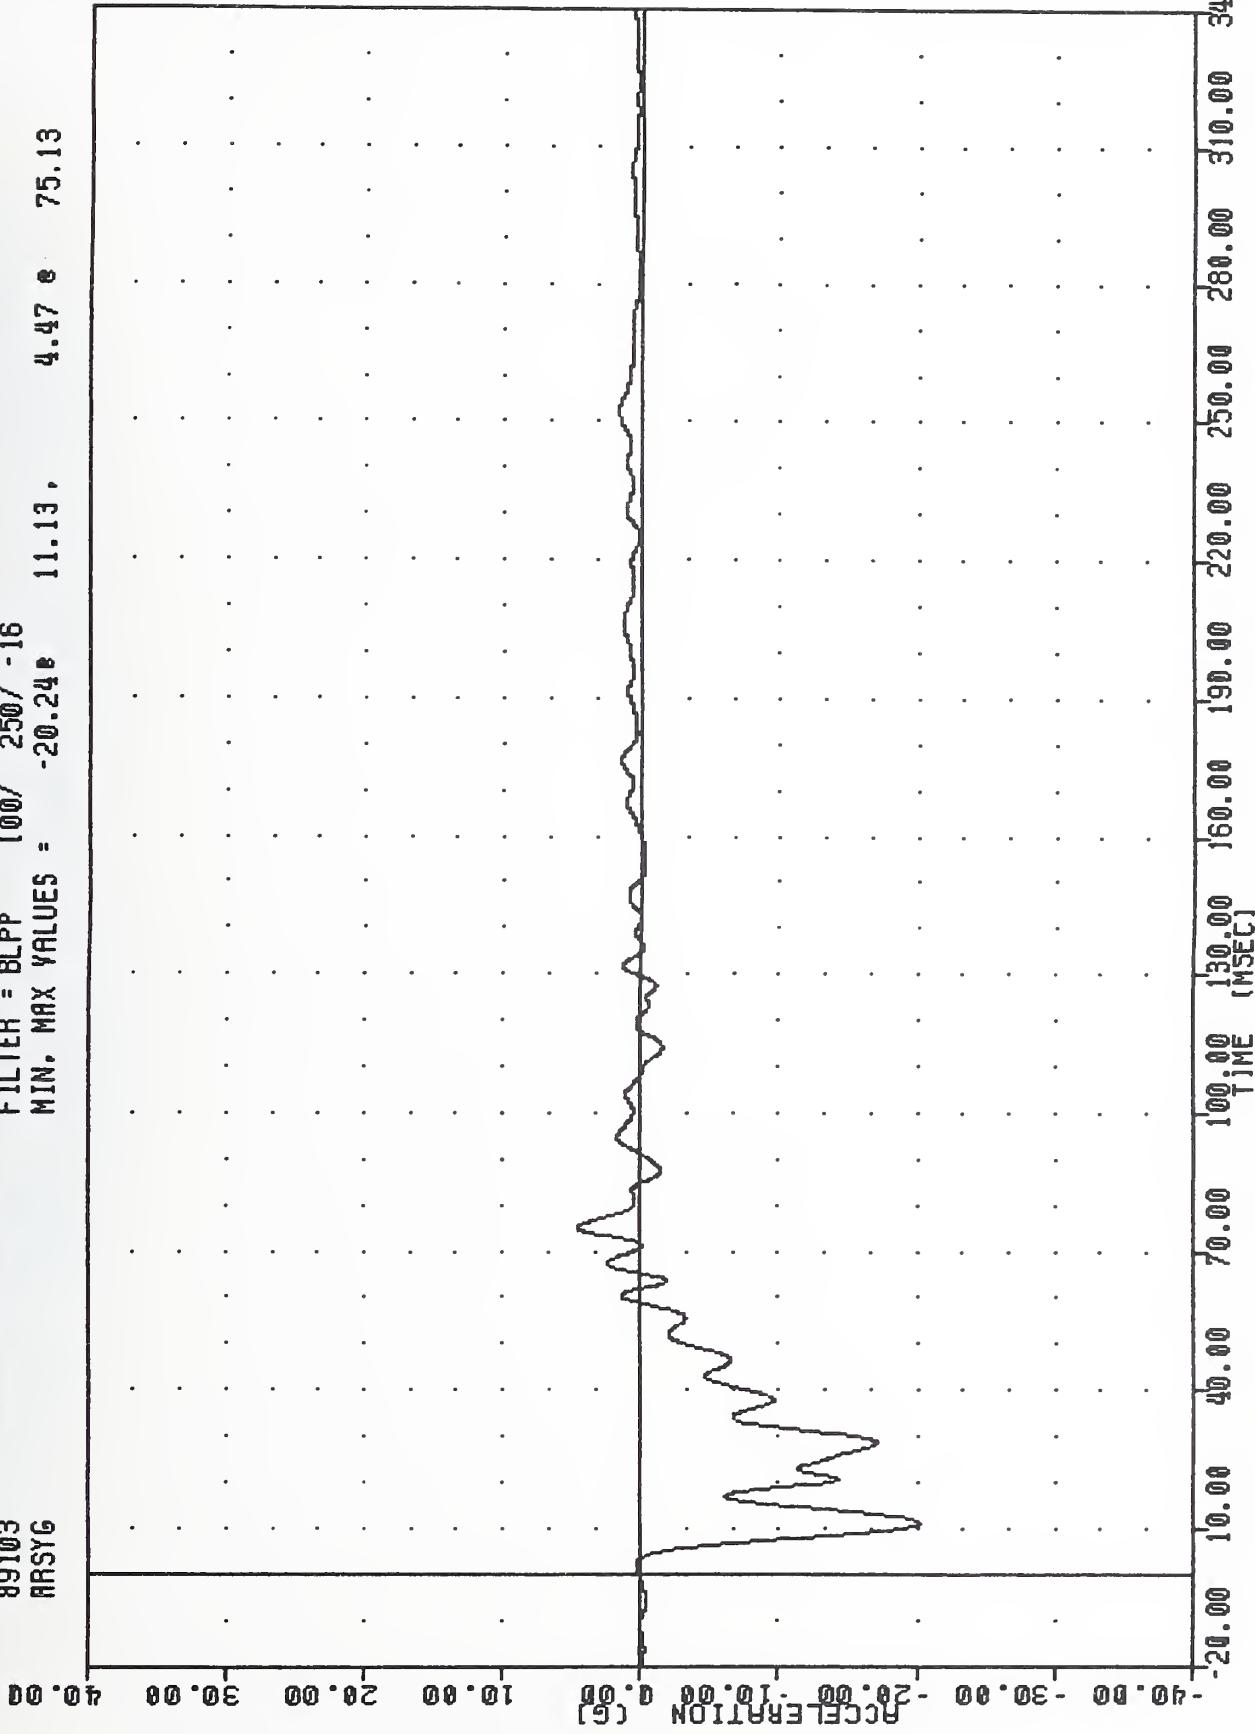
CONTOURED BARRIER INTO 90 DEG 1985 CHEVROLET CELEBRITY AT 20.3 MPH #1  
VEHICLE RIGHT REAR SILL Y AXIS ACCELERATION

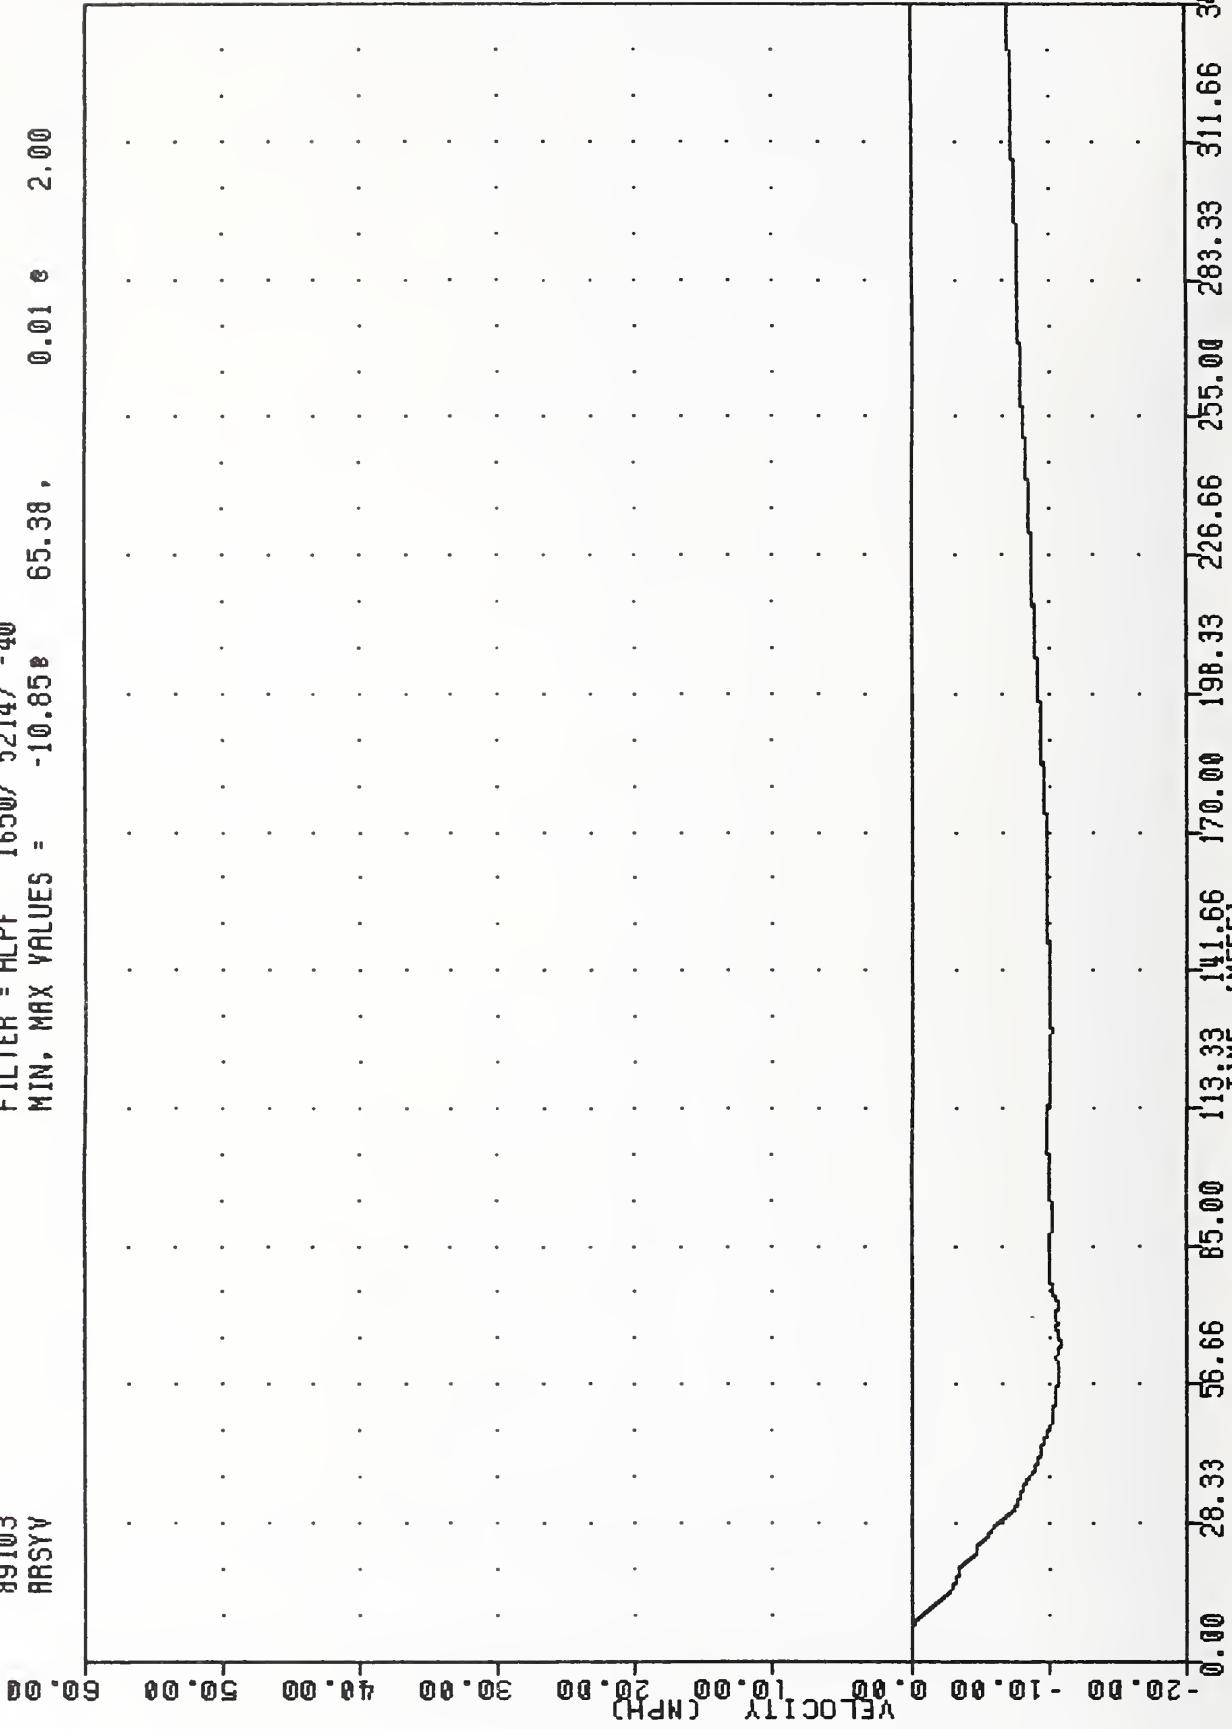
CONTOURED BARRIER INTO 90 DEG 1985 CHEVROLET CELEBRITY AT 20.3 MPH #1  
 VEHICLE RIGHT REAR SILL Y AXIS VELOCITY

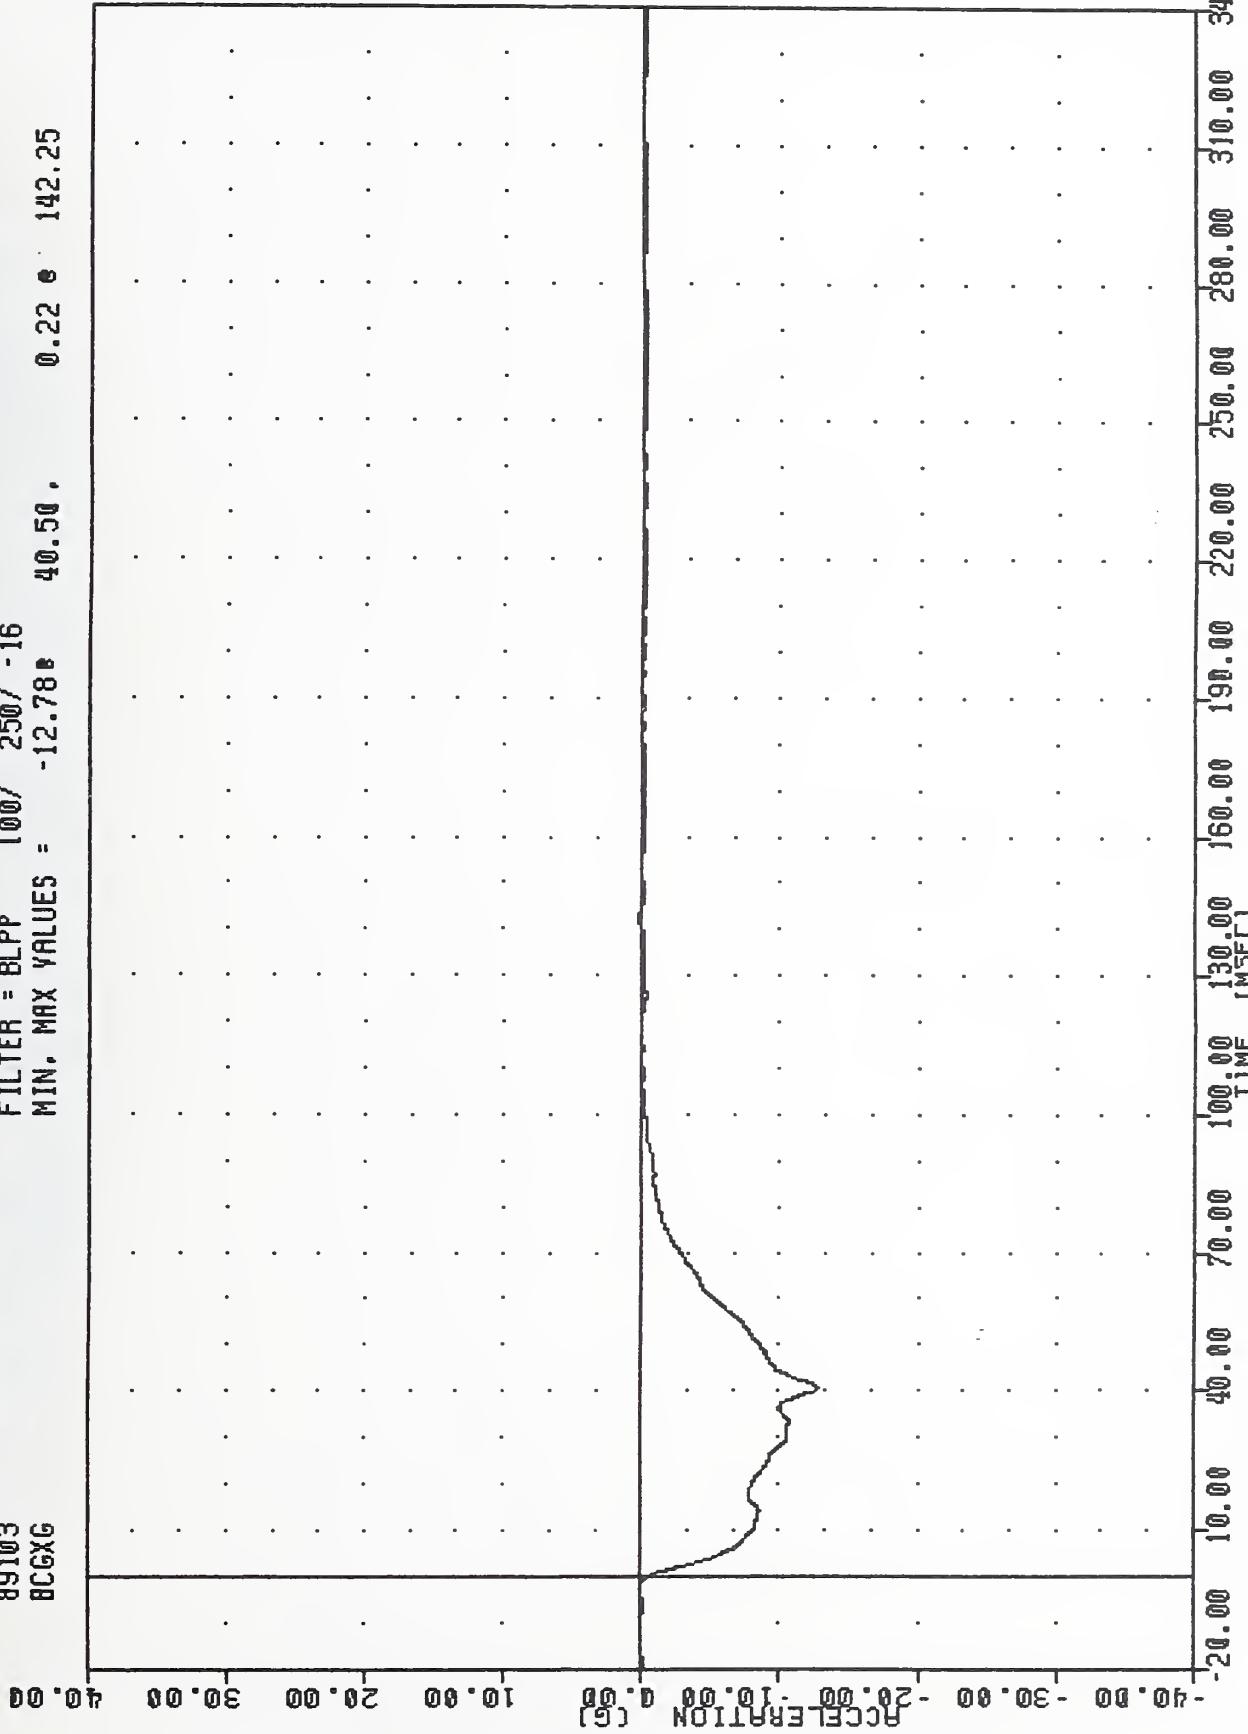
CONTOURED BARRIER INTO 90 DEG 1985 CHEVROLET CELEBRITY AT 20.3 MPH #1  
CONTOURED BARRIER CENTER OF GRAVITY X AXIS ACCELERATION

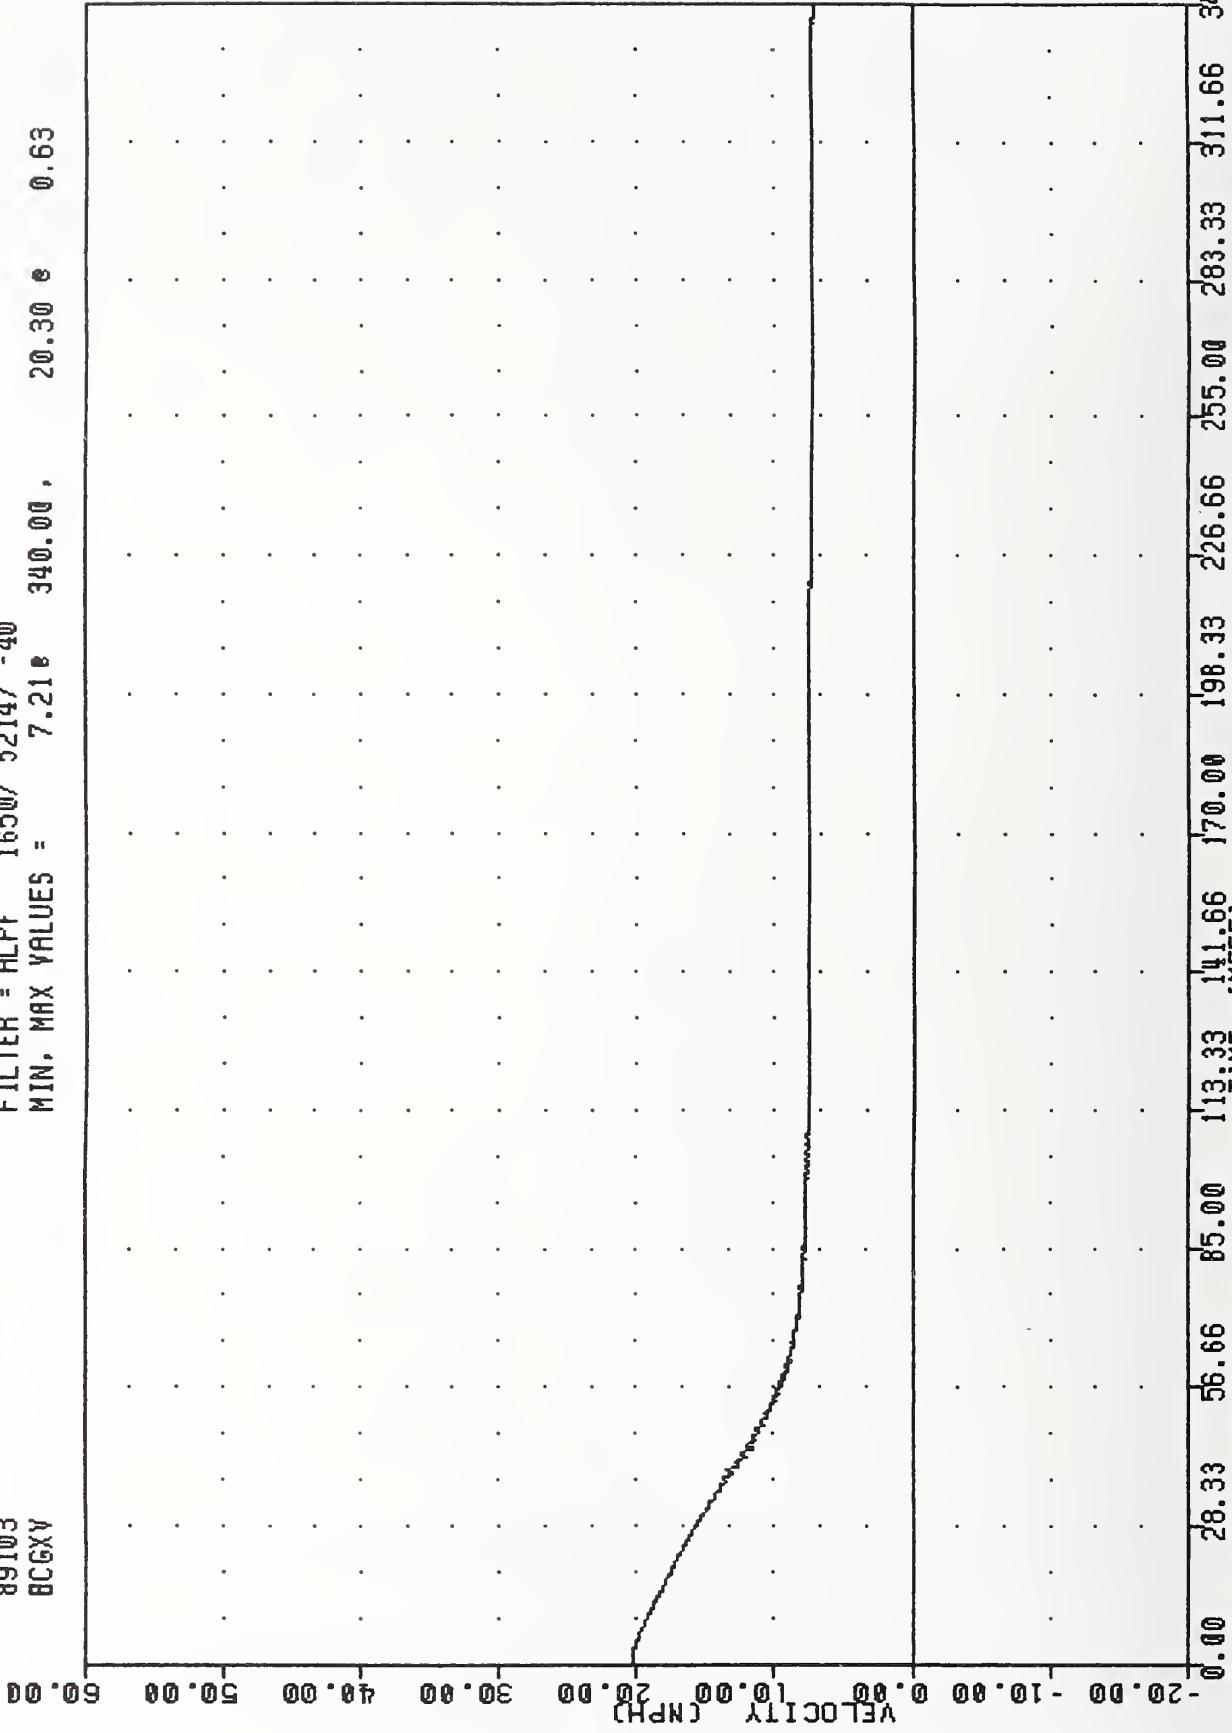
0.00 28.33 56.66 85.00 113.33 141.66 170.00 198.33 226.66 255.00 283.33 311.66 340.00  
 CONTOURED BARRIER INTO 90 DEG 1985 CHEVROLET CELEBRITY AT 20.3 MPH #1  
 CONTOURED MOVING BARRIER CENTER OF GRAVITY X AXIS VELOCITY

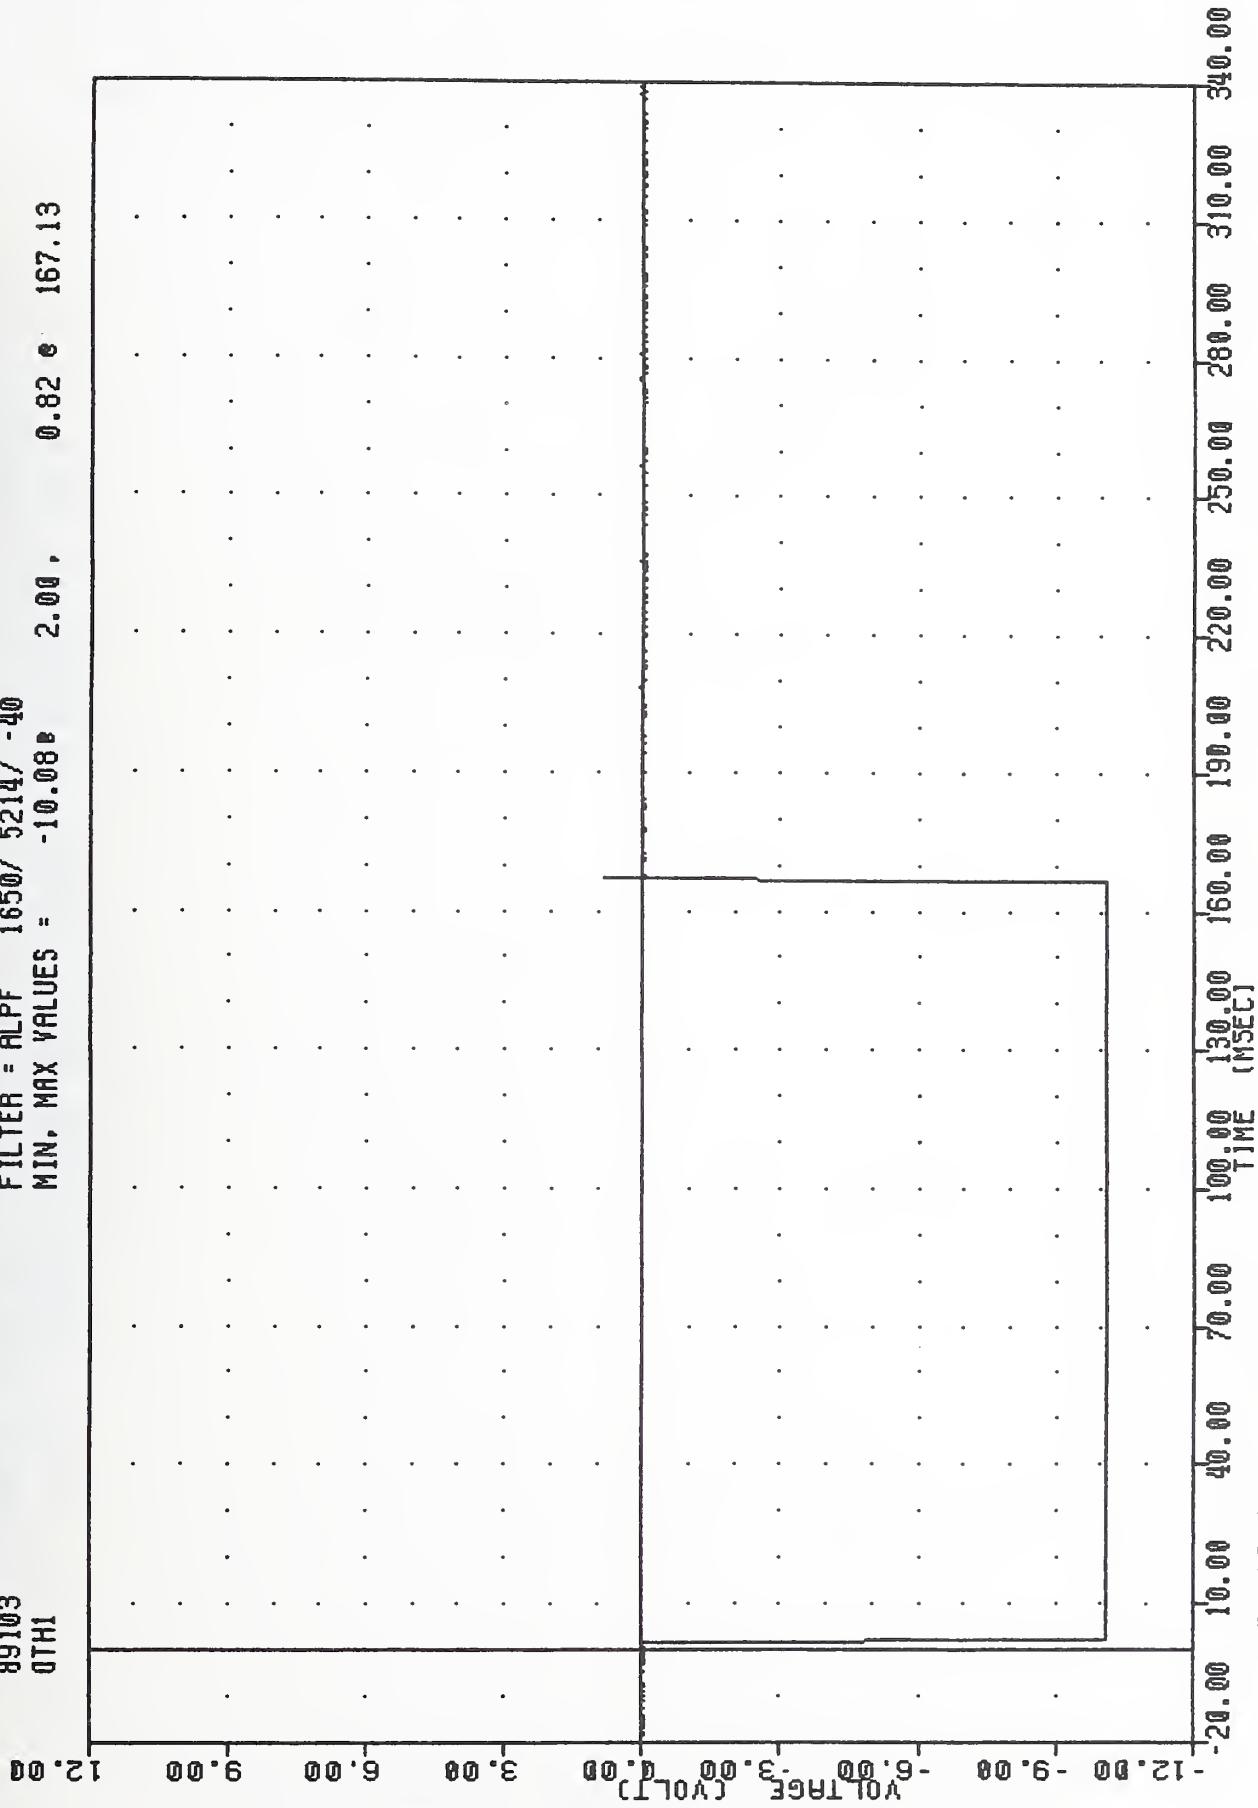
CONToured BARRIER INTO 90 DEG 1985 CHEVROLET CELEBRITY AT 20.3 MPH #1  
 VEHICLE CONTACT SWITCH - FRONT

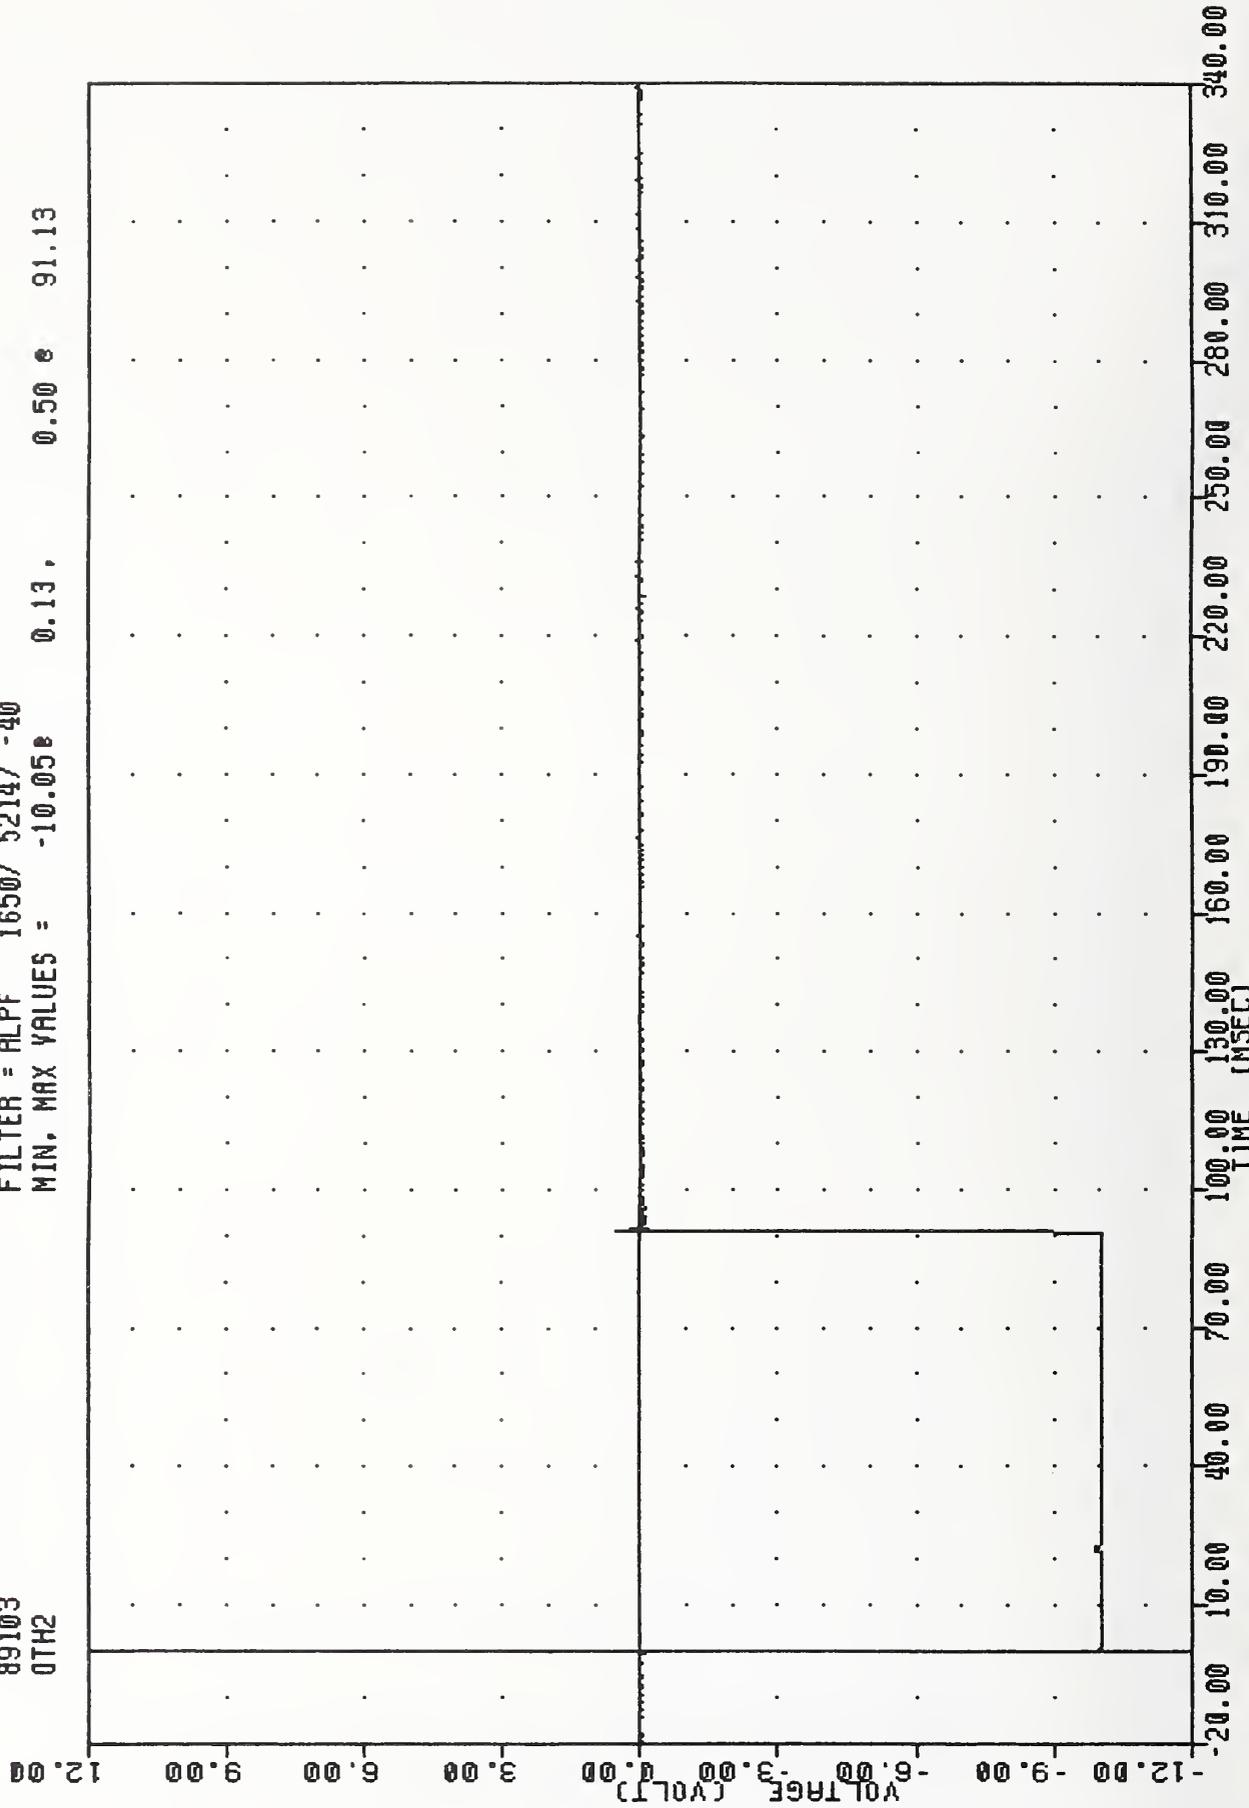
CONTOURED BARRIER INTO 90 DEG 1985 CHEVROLET CELEBRITY AT 20.3 MPH #1  
 VEHICLE CONTACT SWITCH - REAR

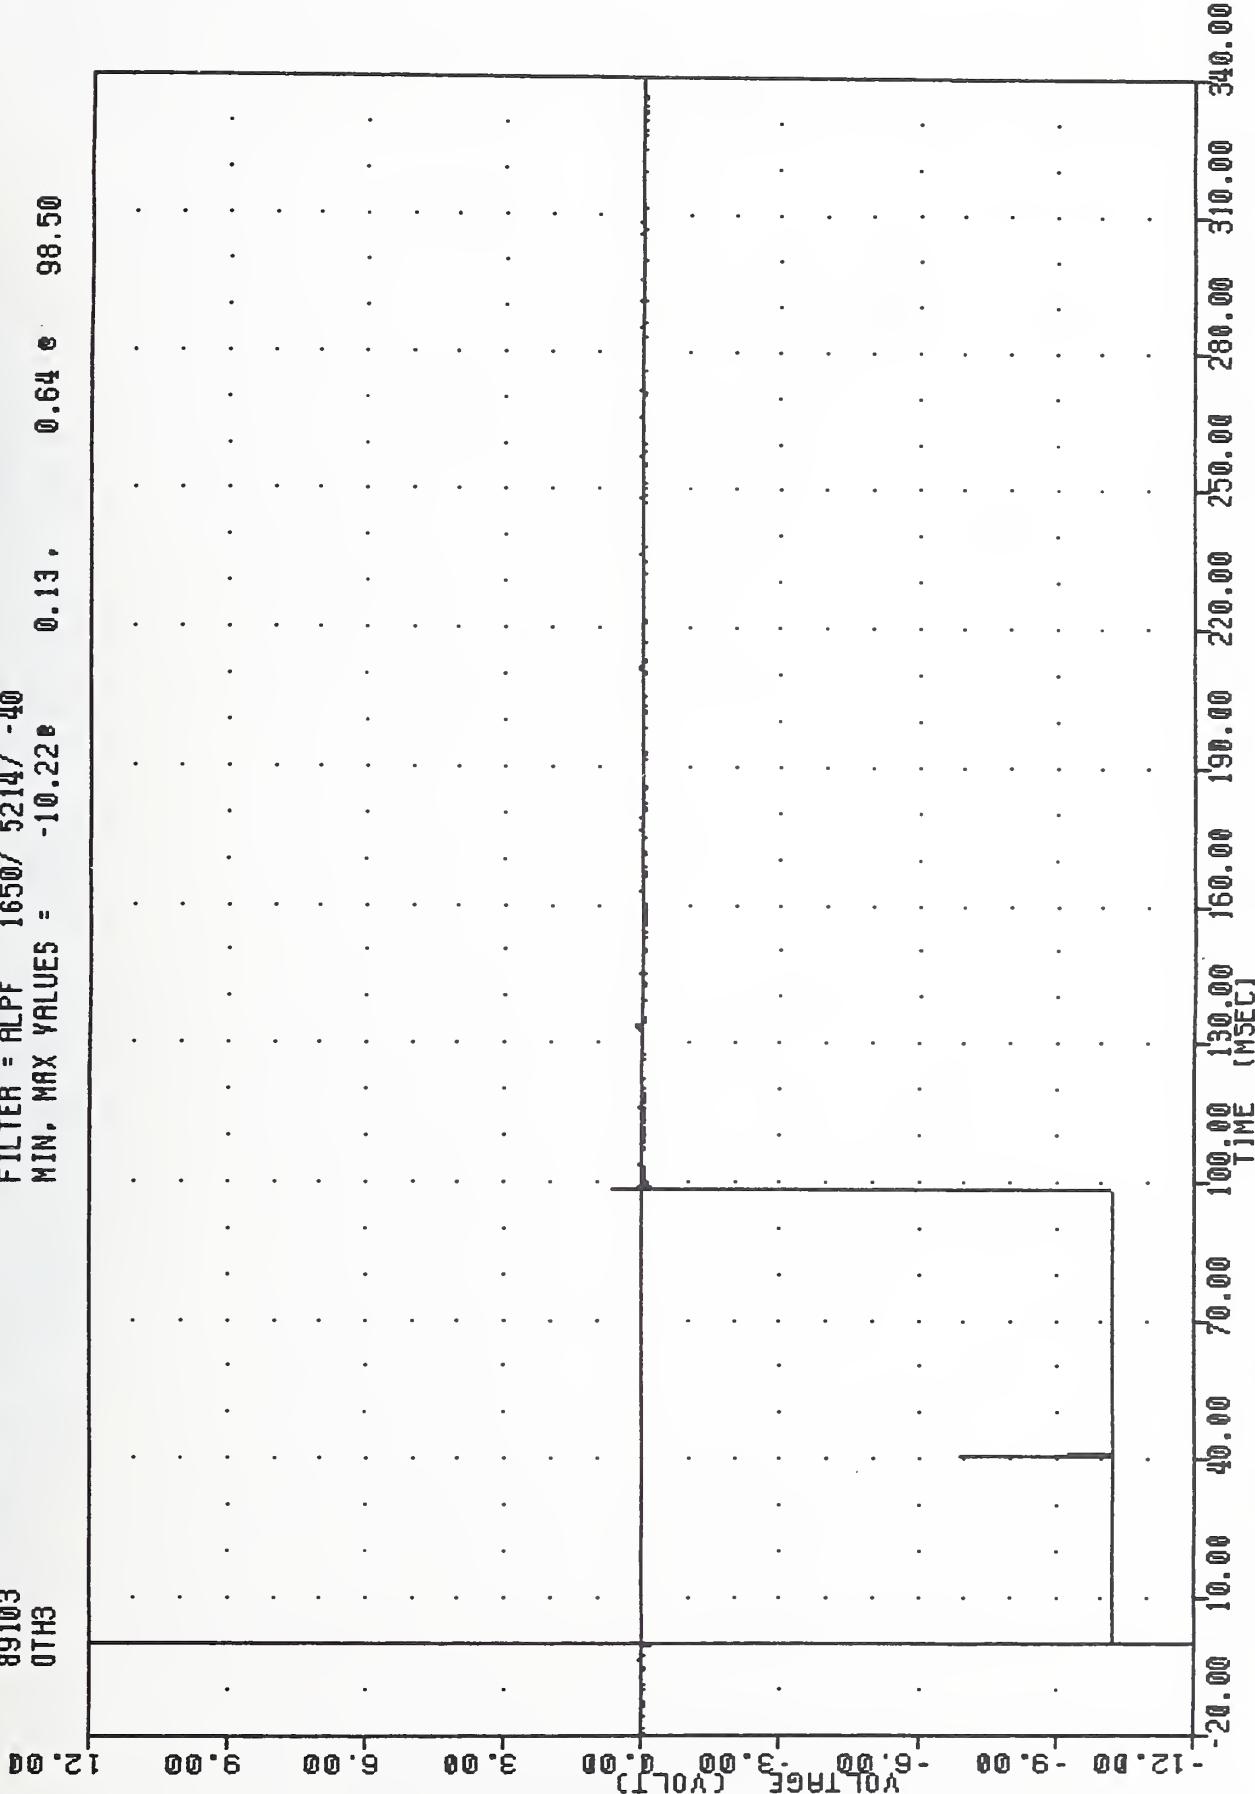
CONToured BARRIER INTO 90 DEG 1985 CHEVROLET CELEBRITY AT 20.3 MPH #1  
 BARRIER CONTACT SWITCH - RIGHT

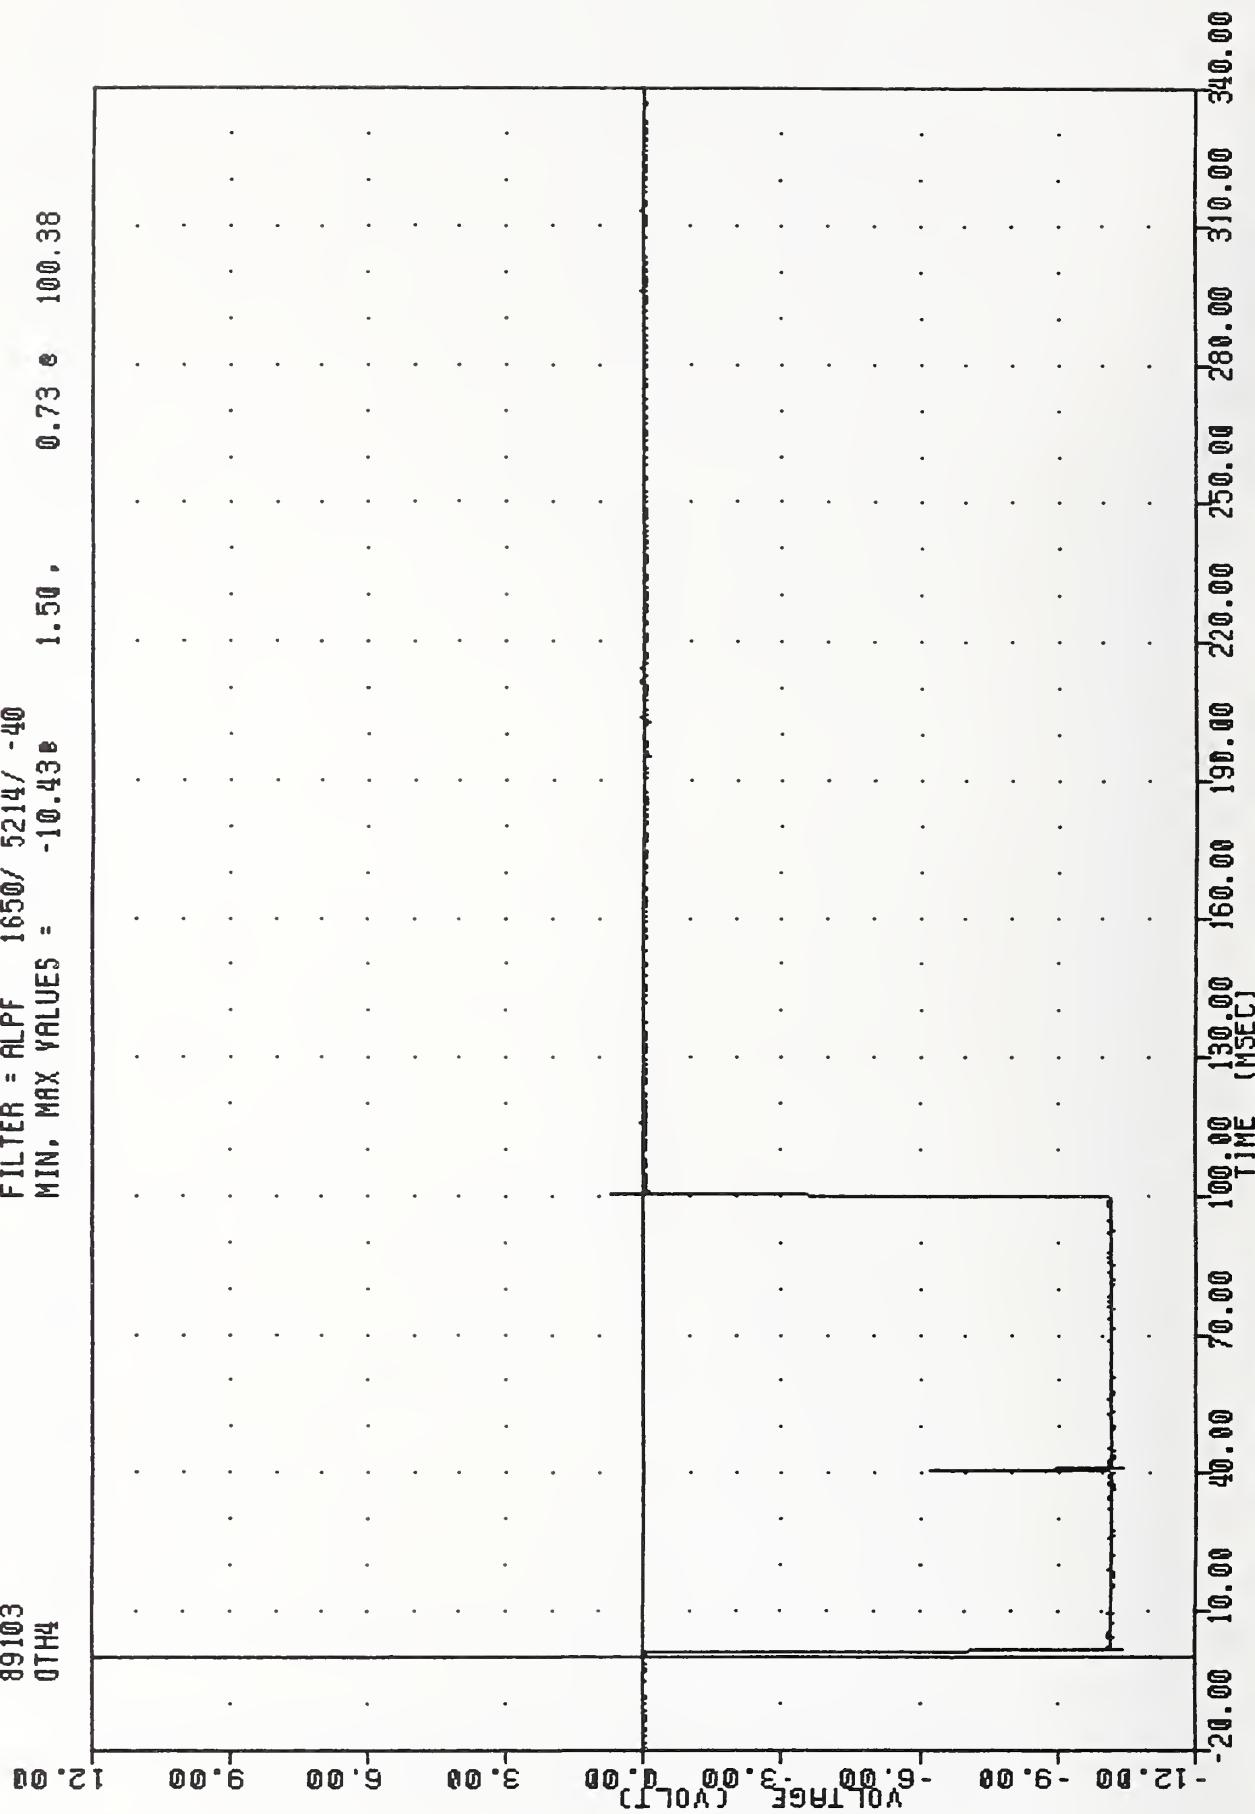
CONTOURED BARRIER INTO 90 DEG CHEVROLET CELEBRITY AT 20.3 MPH #1  
BARRIER CONTACT SWITCH - LEFT
