TL  
242  
.E6546  
1989

U.S. Department  
of Transportation  
**National Highway  
Traffic Safety  
Administration**

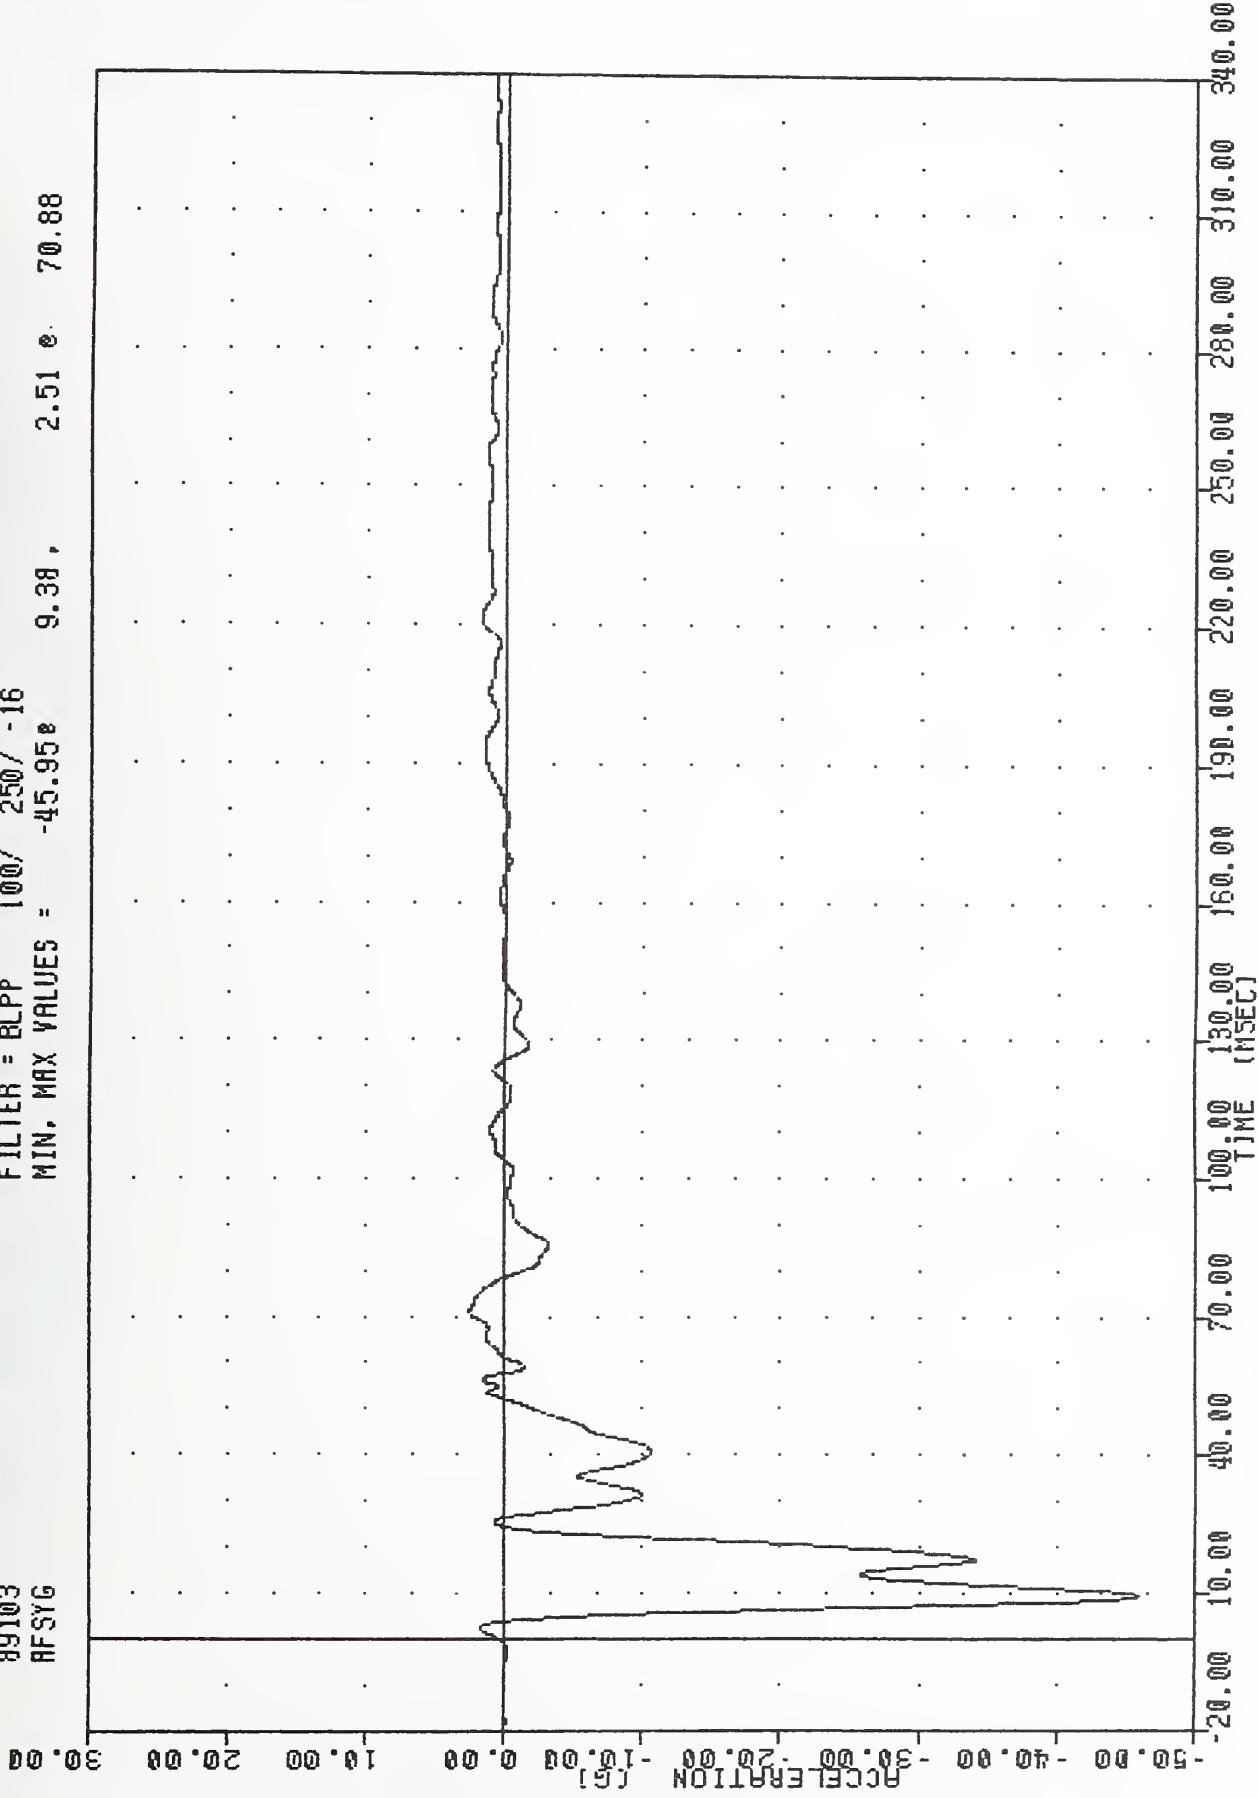
CONTOURED BARRIER INTO 90 DEG 1985 CHEVROLET CELEBRITY AT 30.1 MPH #2  
VEHICLE RIGHT FRONT SILL Y AXIS ACCELERATION

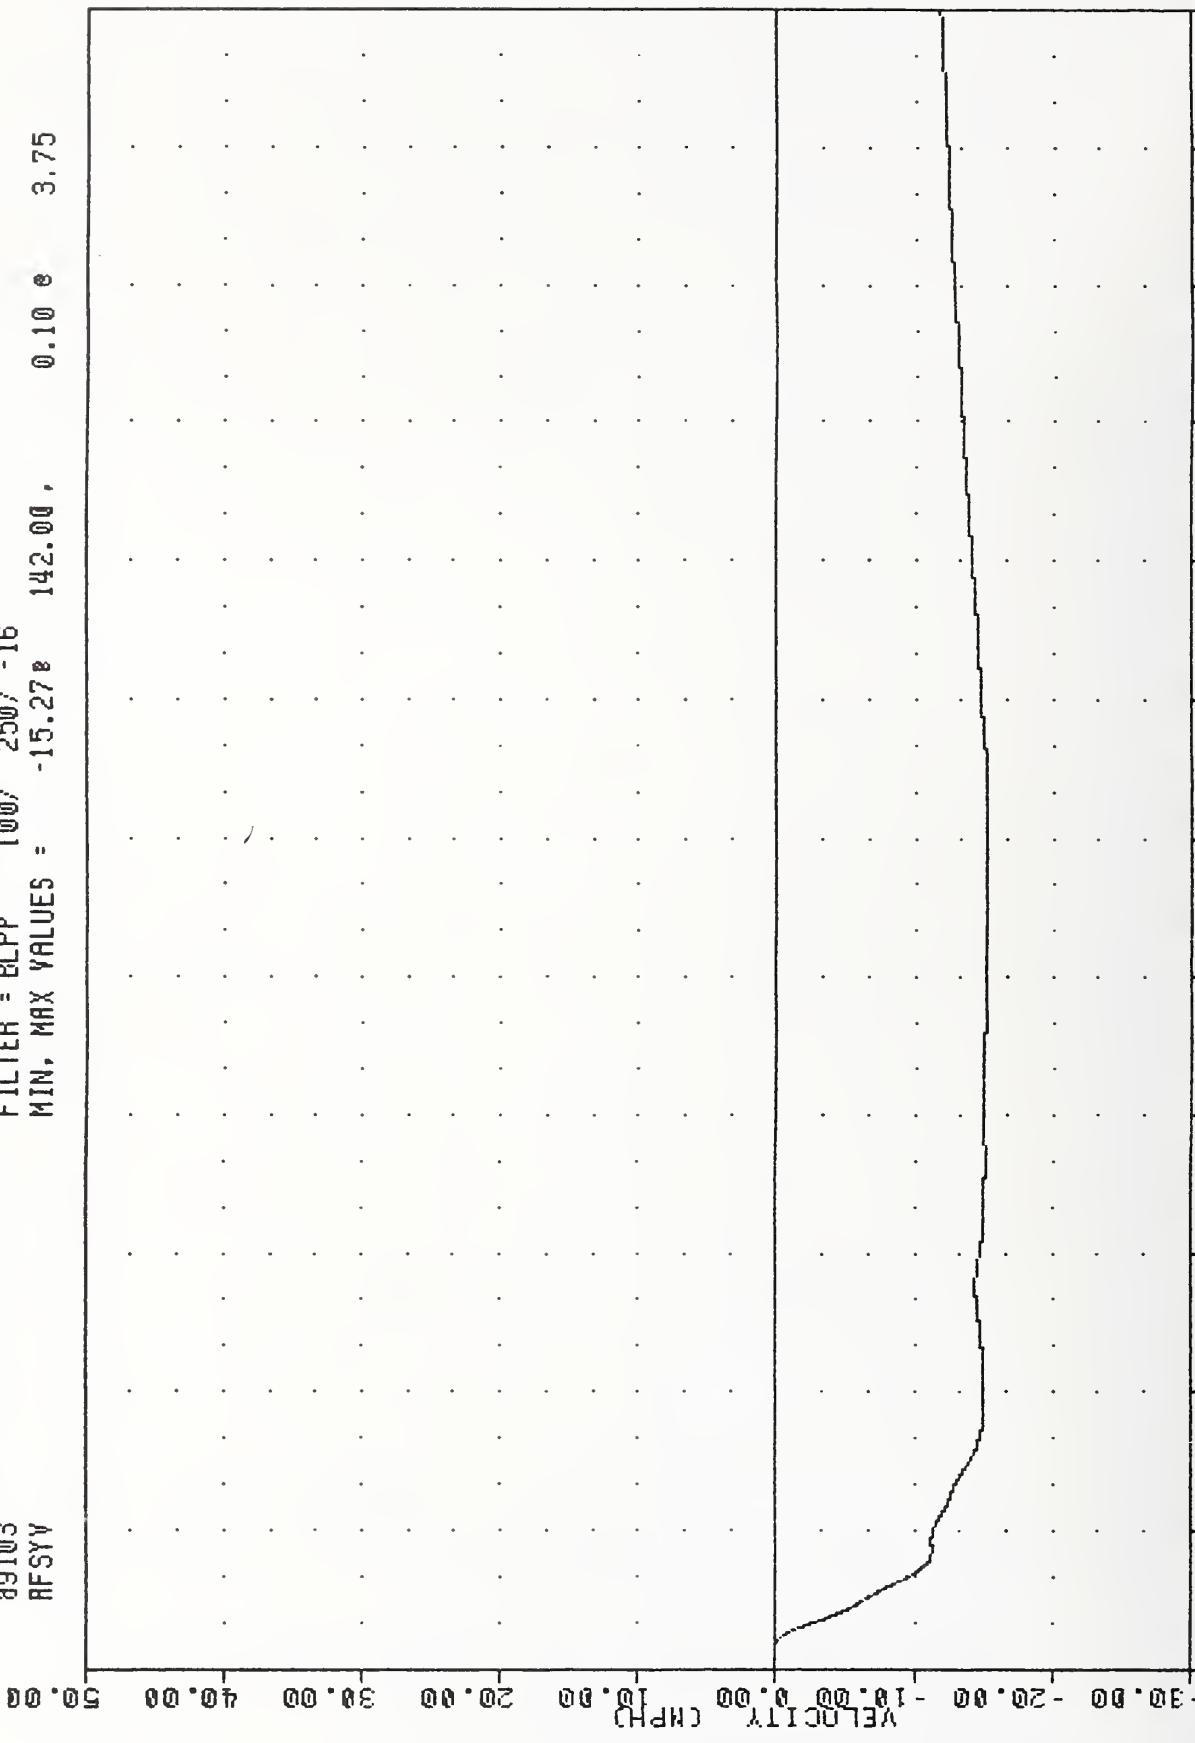
0.00 28.33 56.66 85.00 113.33 141.66 170.00 198.33 226.66 255.00 283.33 311.66 340.00  
 VELOCITY (CMPH)  
 TIME (MSEC)  
 CONTOURED BARRIER INTO 90 DEG 1985 CHEVROLET CELEBRITY AT 30.1 MPH #2  
 VEHICLE RIGHT FRONT SILL Y AXIS VELOCITY

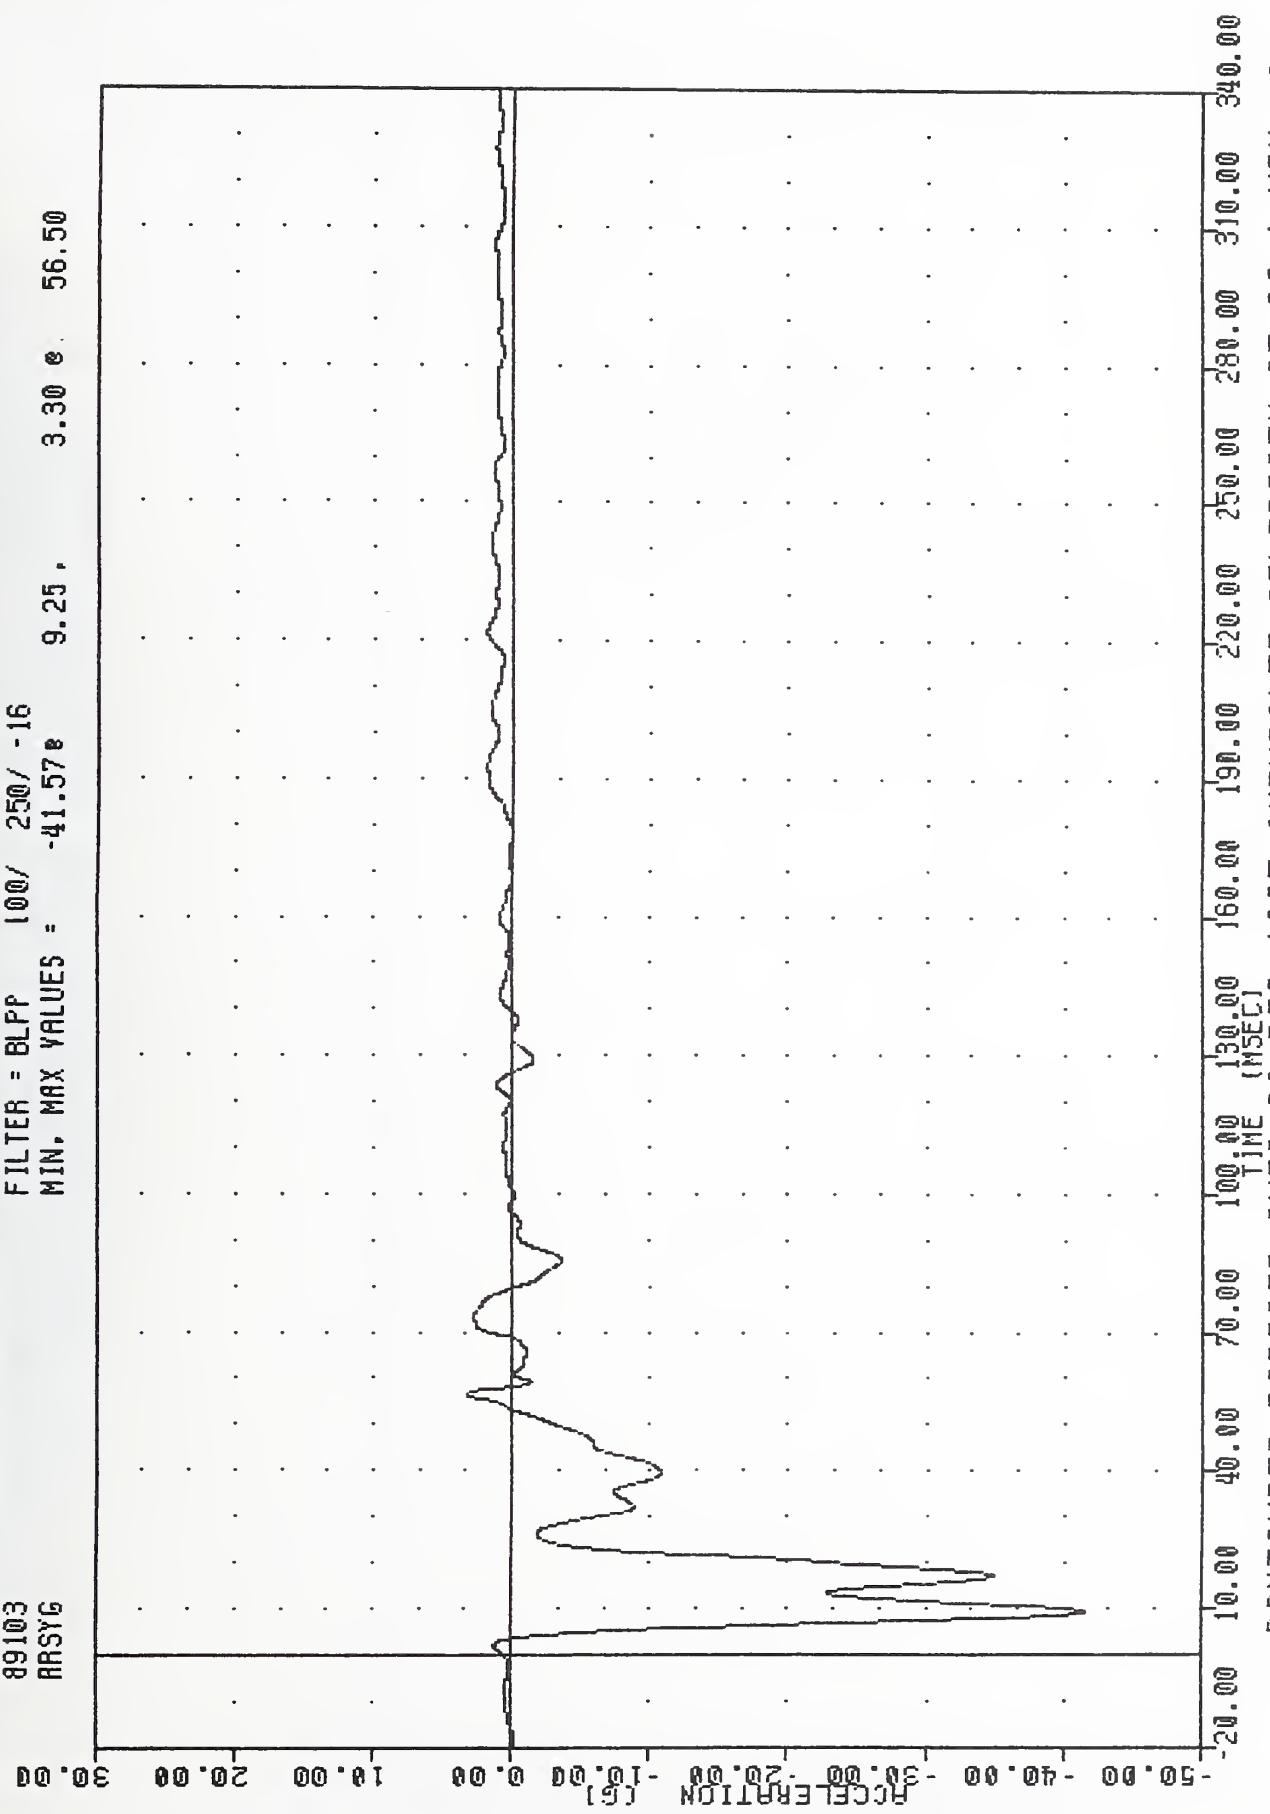
CONTOURED BARRIER INTO 90 DEG 1985 CHEVROLET CELEBRITY AT 30.1 MPH #2  
 VEHICLE RIGHT REAR SILL Y AXIS ACCELERATION

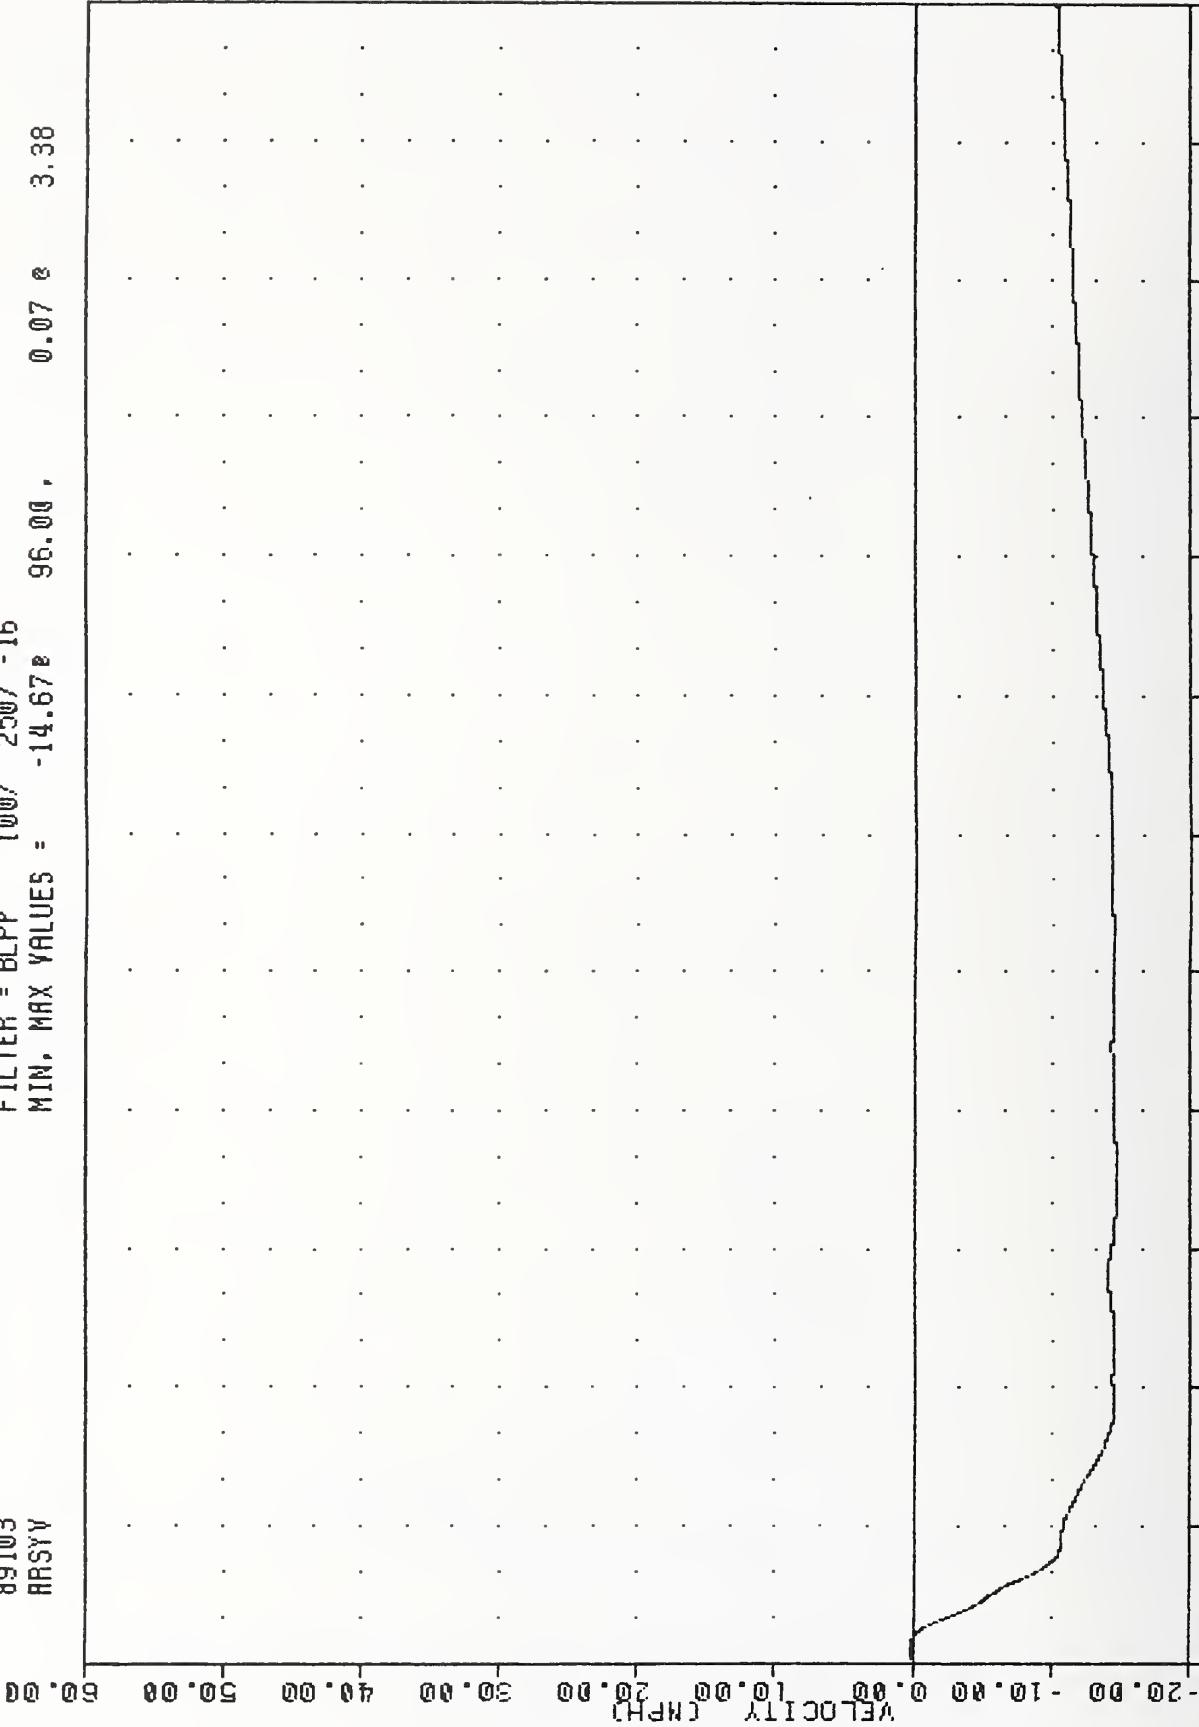
0.00 28.33 56.66 85.00 113.33 141.66 170.00 196.33 226.66 255.00 283.33 311.66 340.00  
 TIME (MSEC)  
 CONTOURED BARRIER INTO 90 DEG 1985 CHEVROLET CELEBRITY AT 30.1 MPH #2  
 VEHICLE RIGHT REAR SILL Y AXIS VELOCITY

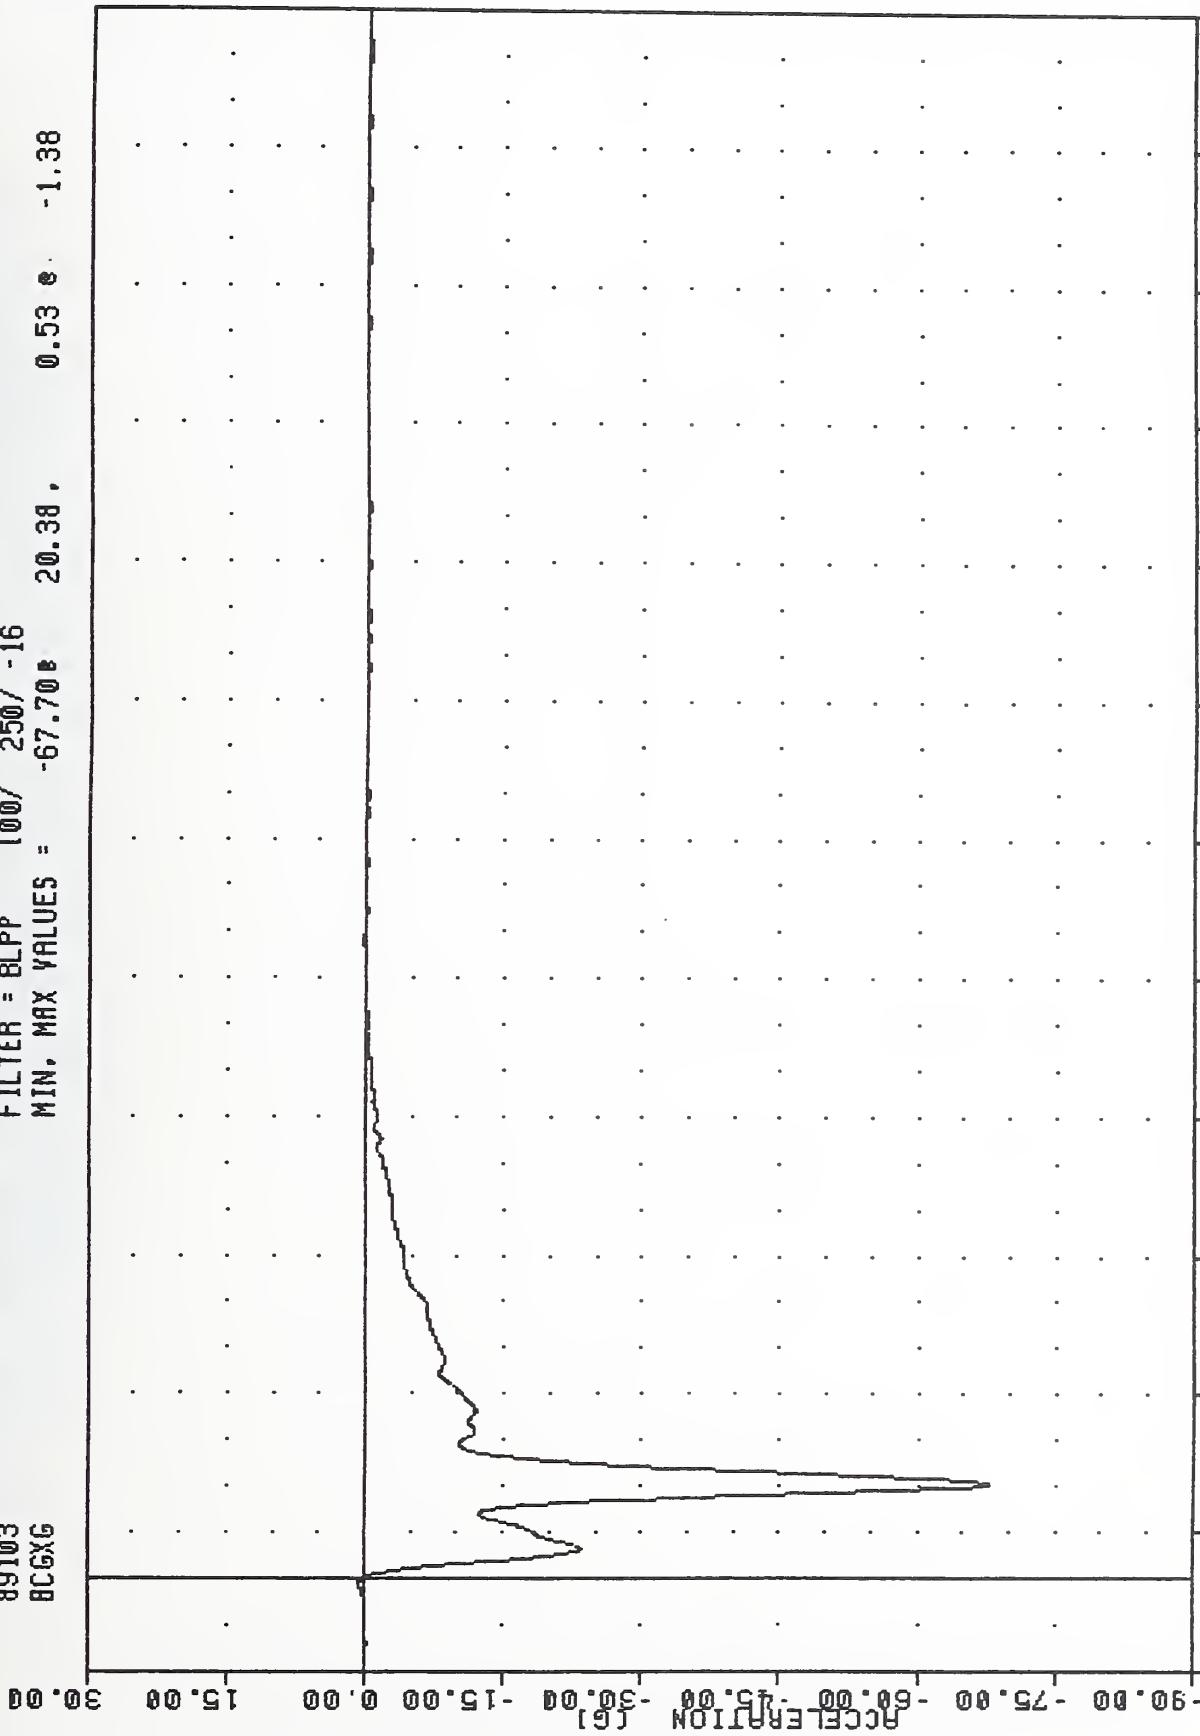
CONTOURED BARRIER INTO 90 DEG CHEVROLET CELEBRITY AT 30.1 MPH #2  
 CONTOURED MOVING BARRIER CENTER OF GRAVITY X AXIS ACCELERATION

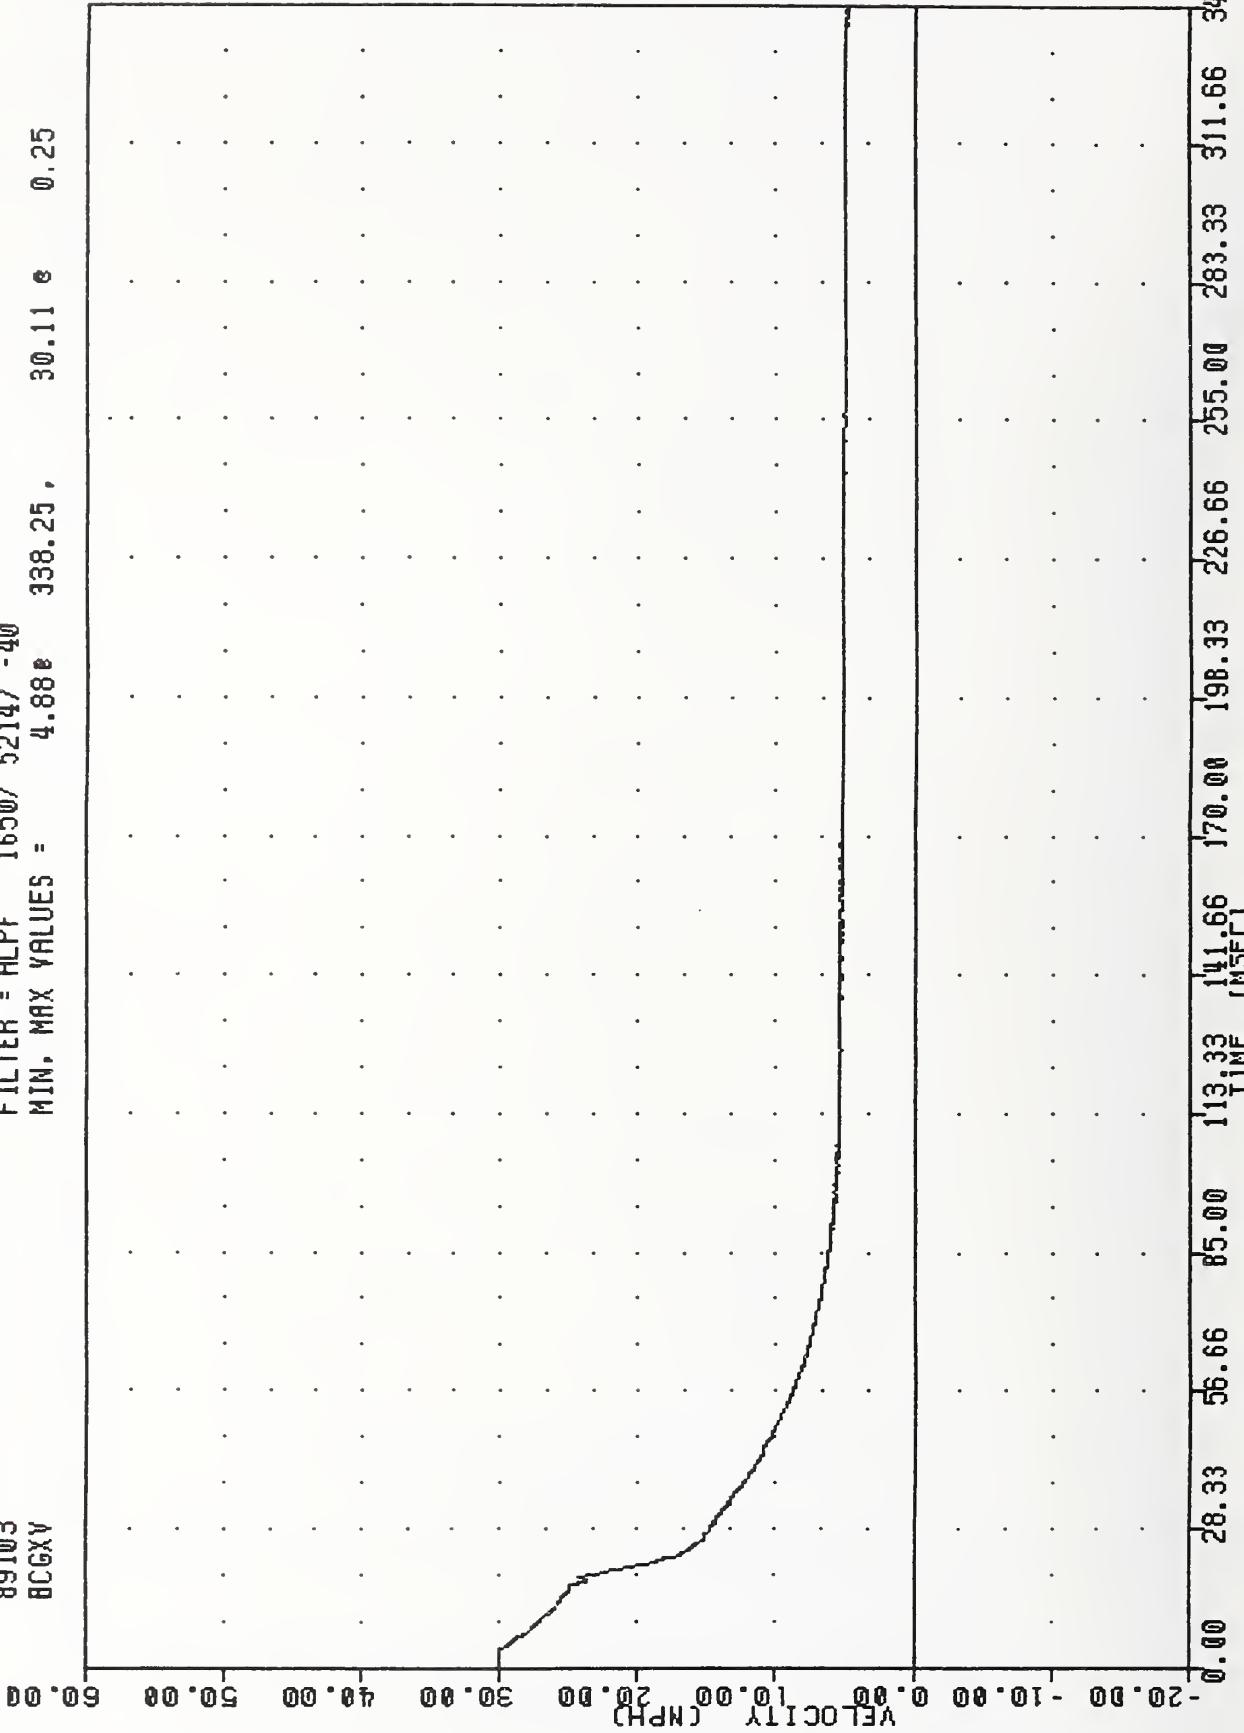
CONTOURED BARRIER INTO 90 DEG 1985 CHEVROLET CELEBRITY AT 30.1 MPH #2  
 CONTOURED MOVING BARRIER CENTER OF GRAVITY X AXIS VELOCITY

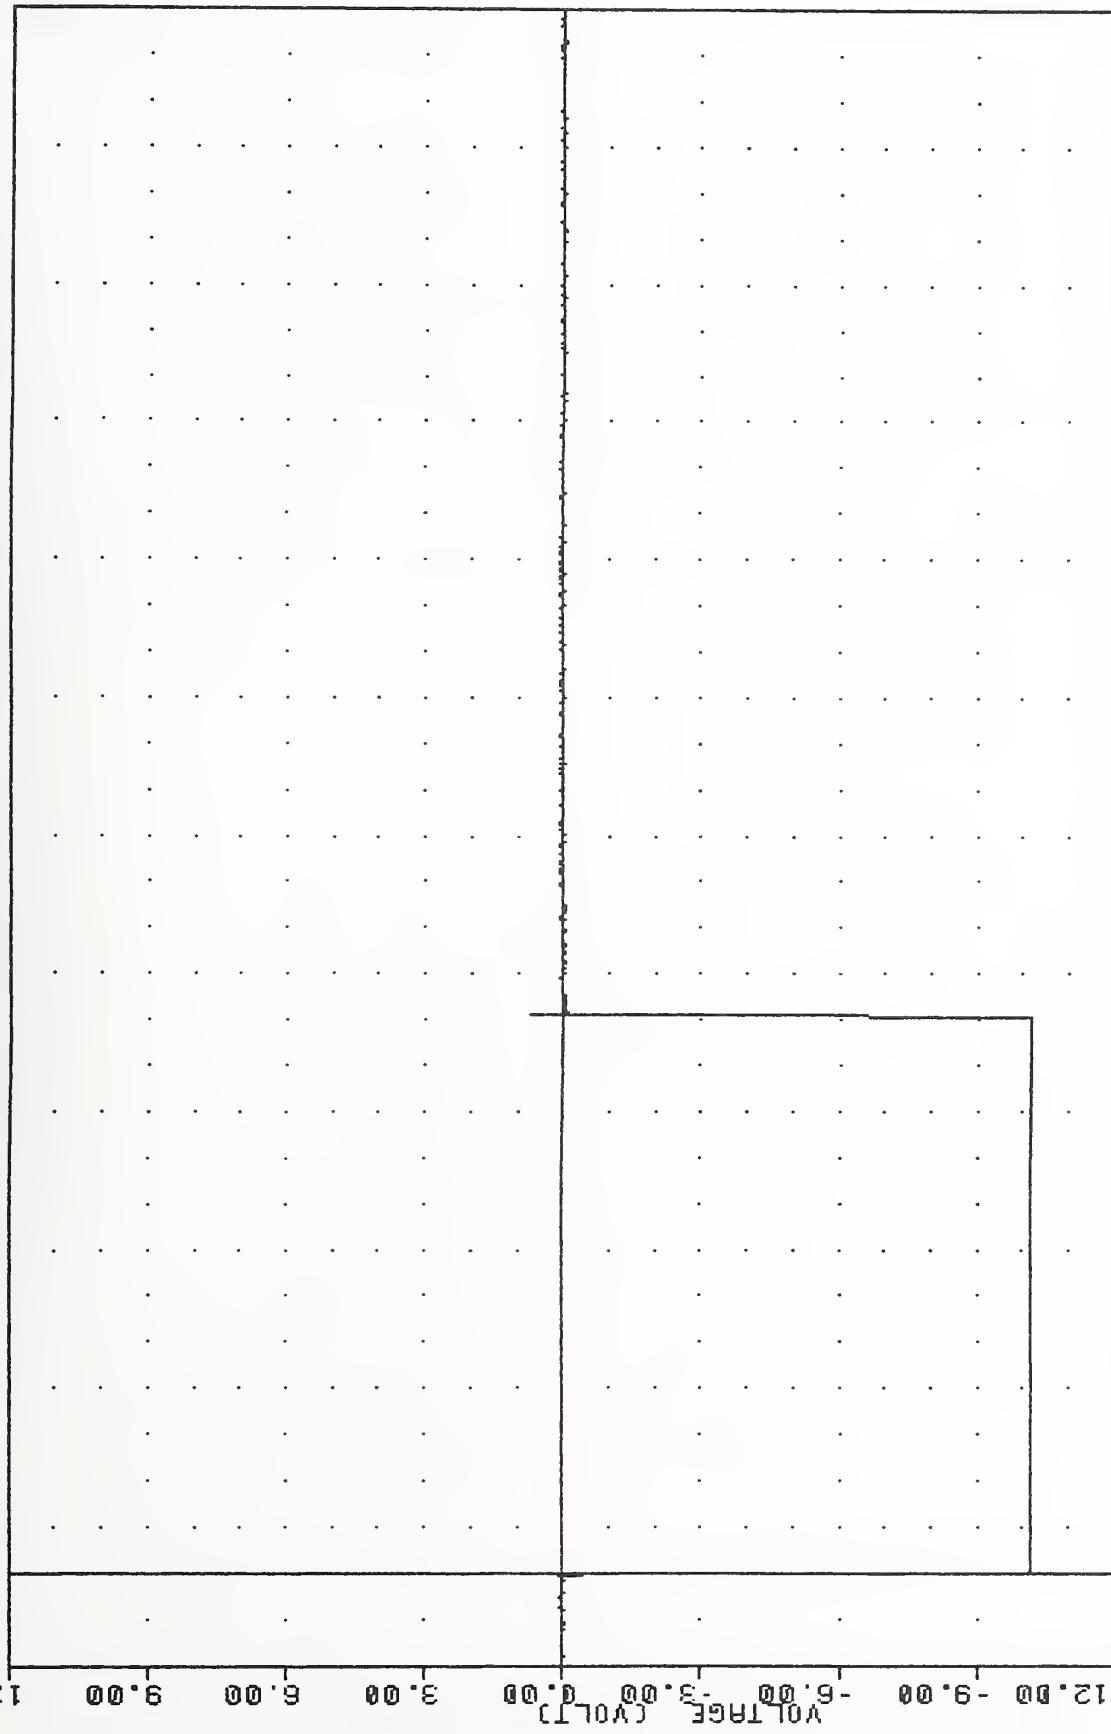
-12.00 10.00 40.00 70.00 100.00 130.00 160.00 190.00 220.00 250.00 280.00 310.00 340.00  
 TIME (MSEC)  
 CONTOURED BARRIER INTO 90 DEG 1985 CHEVROLET CELEBRITY AT 30.1 MPH #2  
 VEHICLE CONTACT SWITCH - FRONT

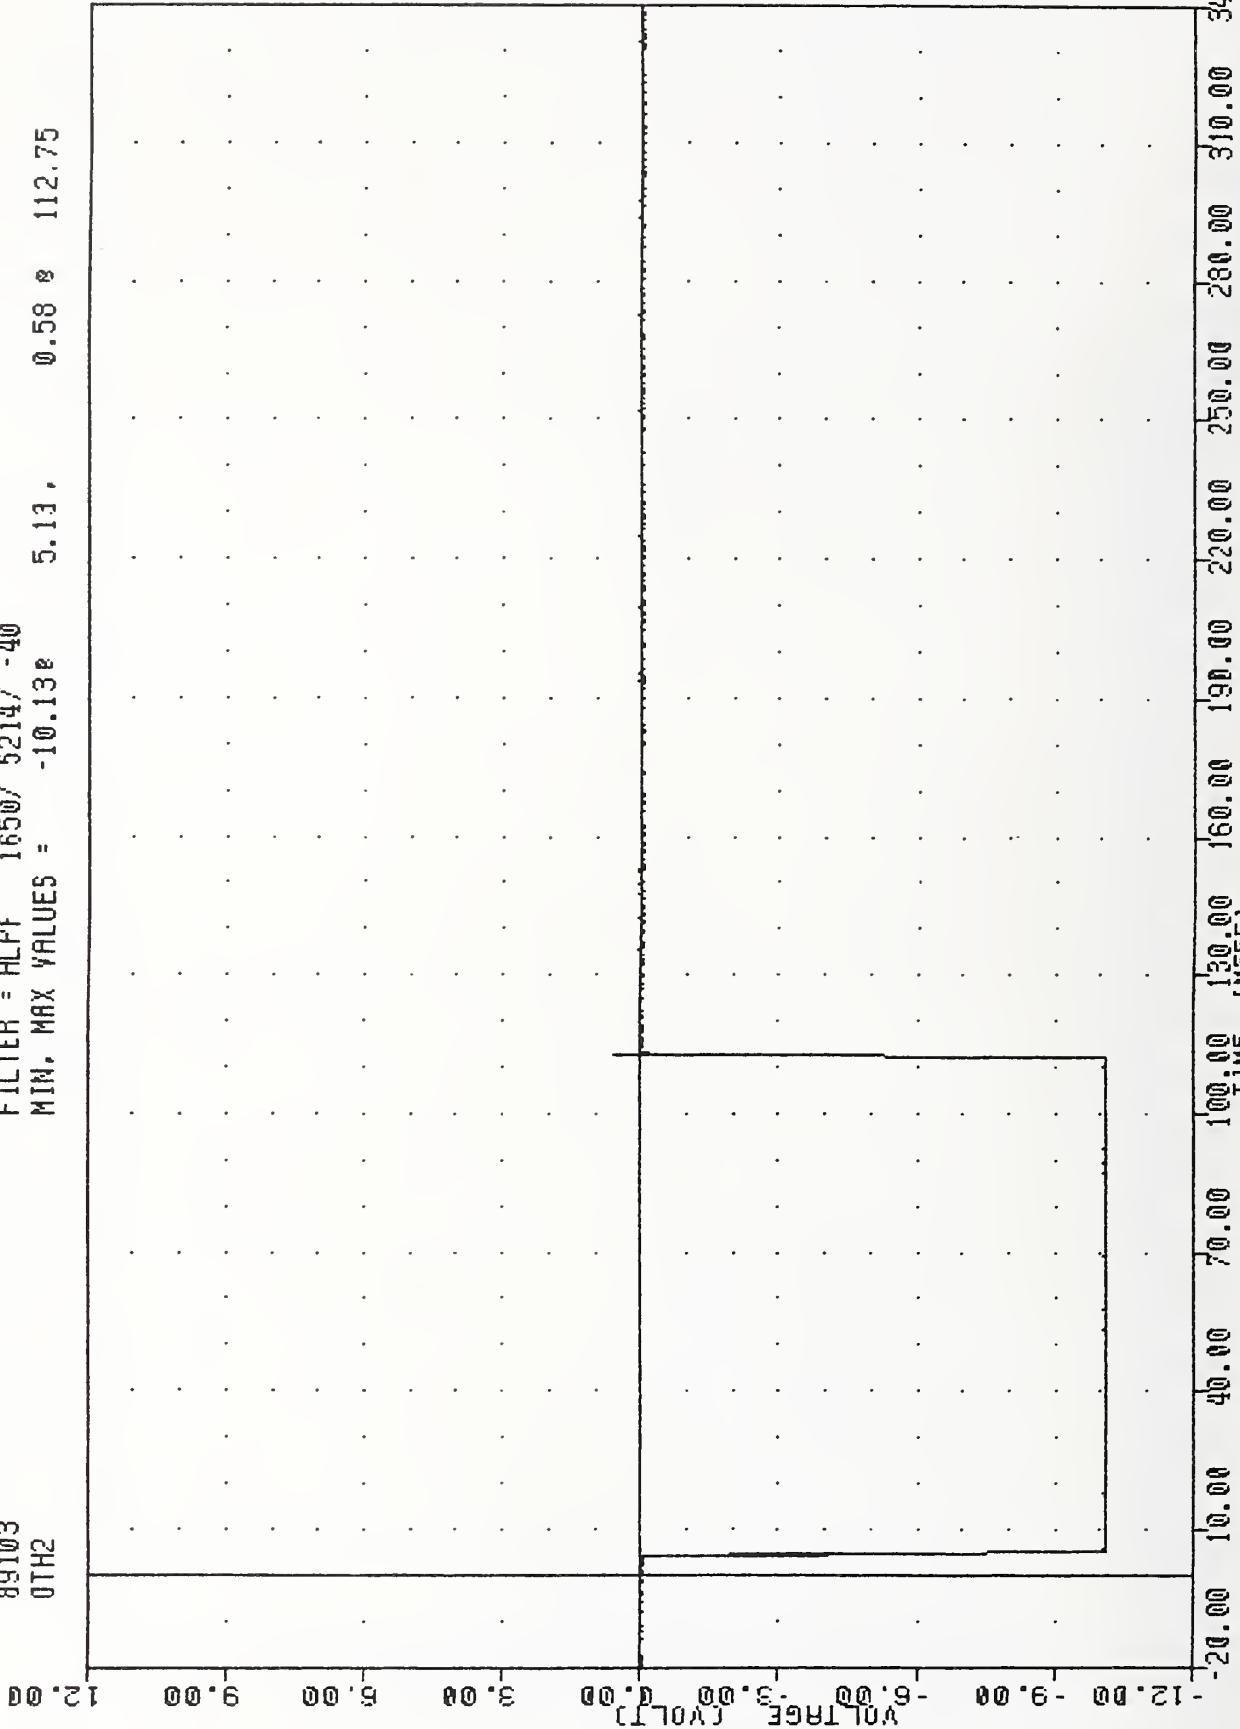
CONTOURED BARRIER INTO 90 DEG 1985 CHEVROLET CELEBRITY AT 30.1 MPH #2  
 VEHICLE CONTACT SWITCH - REAR

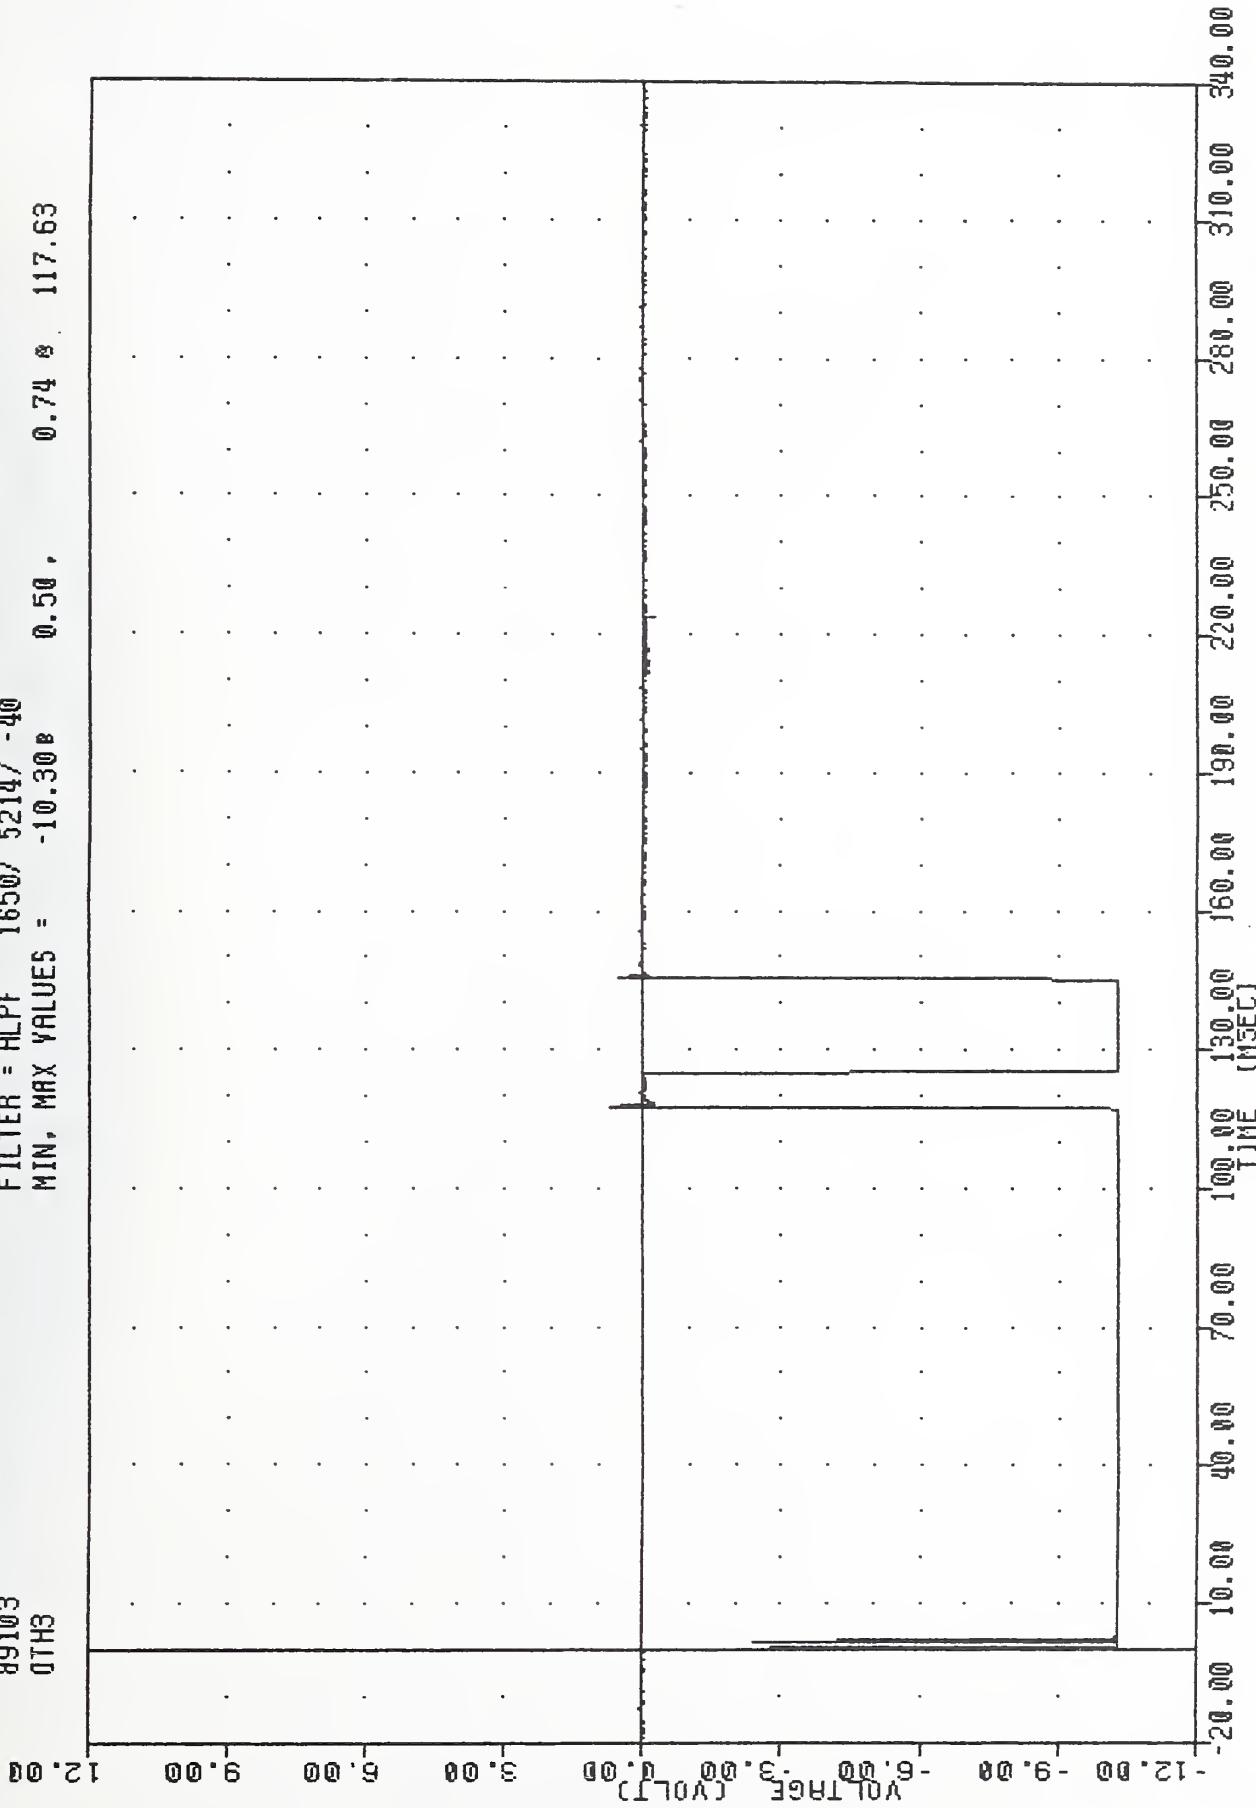
CONToured BARRIER INTO 90 DEG 1985 CHEVROLET CELEBRITY AT 30.1 MPH #2  
 BARRIER CONTACT SWITCH - RIGHT

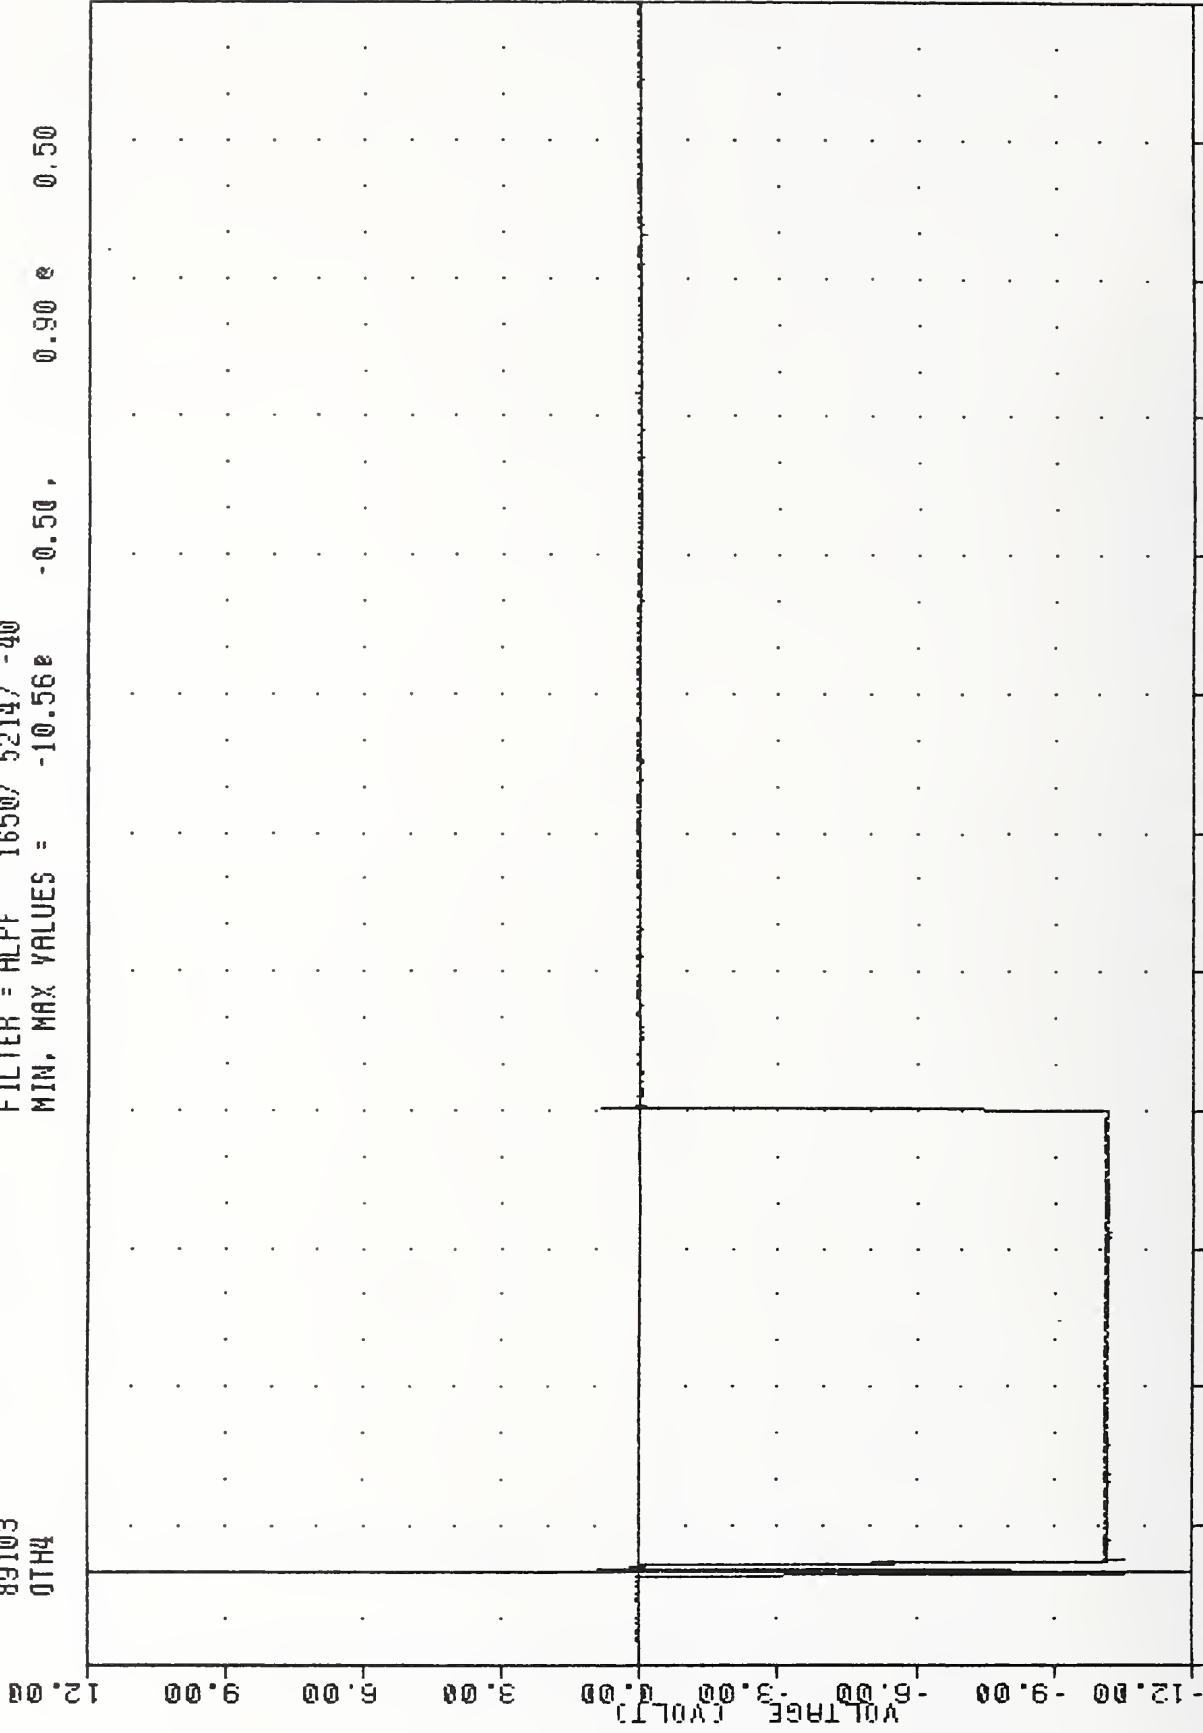
CONTOURED BARRIER INTO 90 DEG CHEVROLET CELEBRITY AT 30.1 MPH #2  
 BARRIER CONTACT SWITCH - LEFT
