TL  
242  
.E6546  
1989

U.S. Department  
of Transportation  
**National Highway  
Traffic Safety  
Administration**

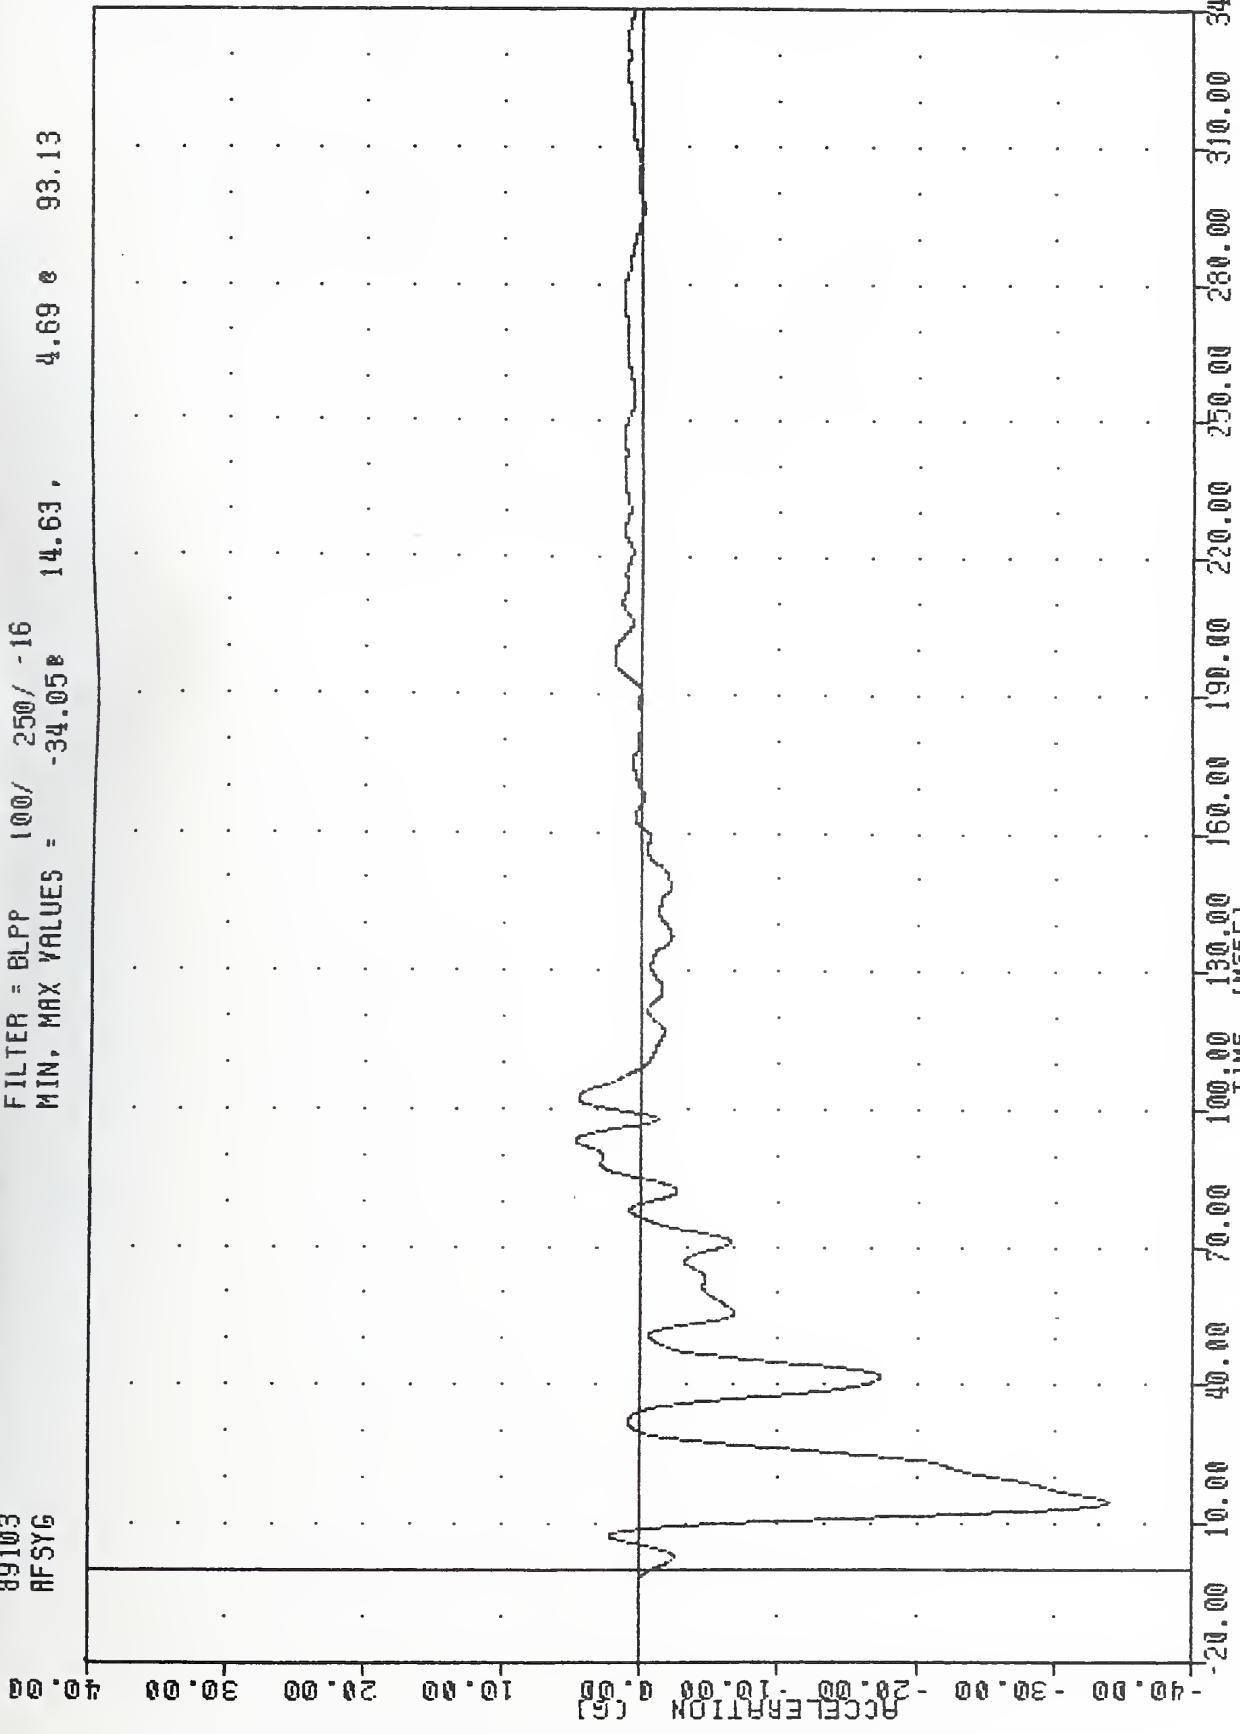
CONTOURED BARRIER INTO 90 DEG 1985 CHEVROLET CELEBRITY AT 30.3 MPH #3  
 VEHICLE RIGHT FRONT SILL Y AXIS ACCELERATION

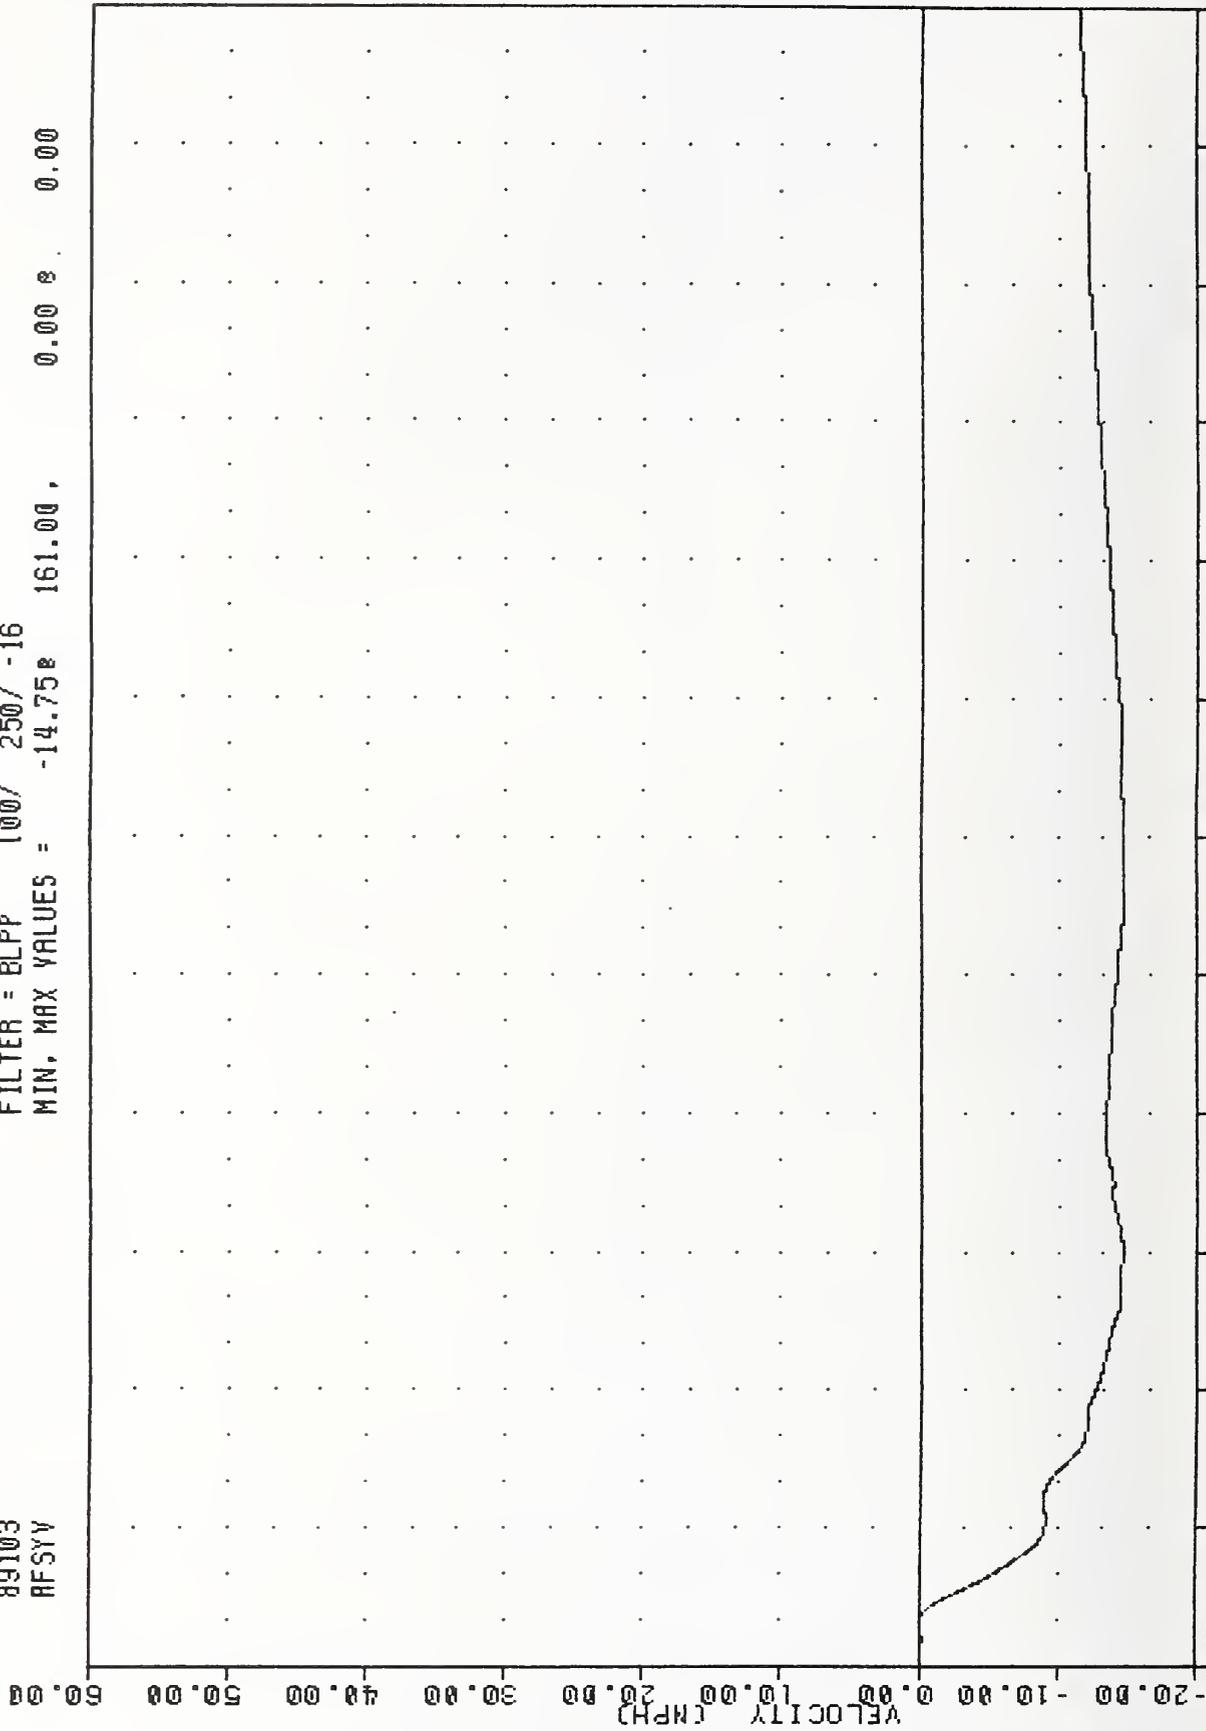
CONTOURED BARRIER INTO 90 DEG 1985 CHEVROLET CELEBRITY AT 30.3 MPH #3  
 VEHICLE RIGHT FRONT STILL Y OVTC VELOCITY

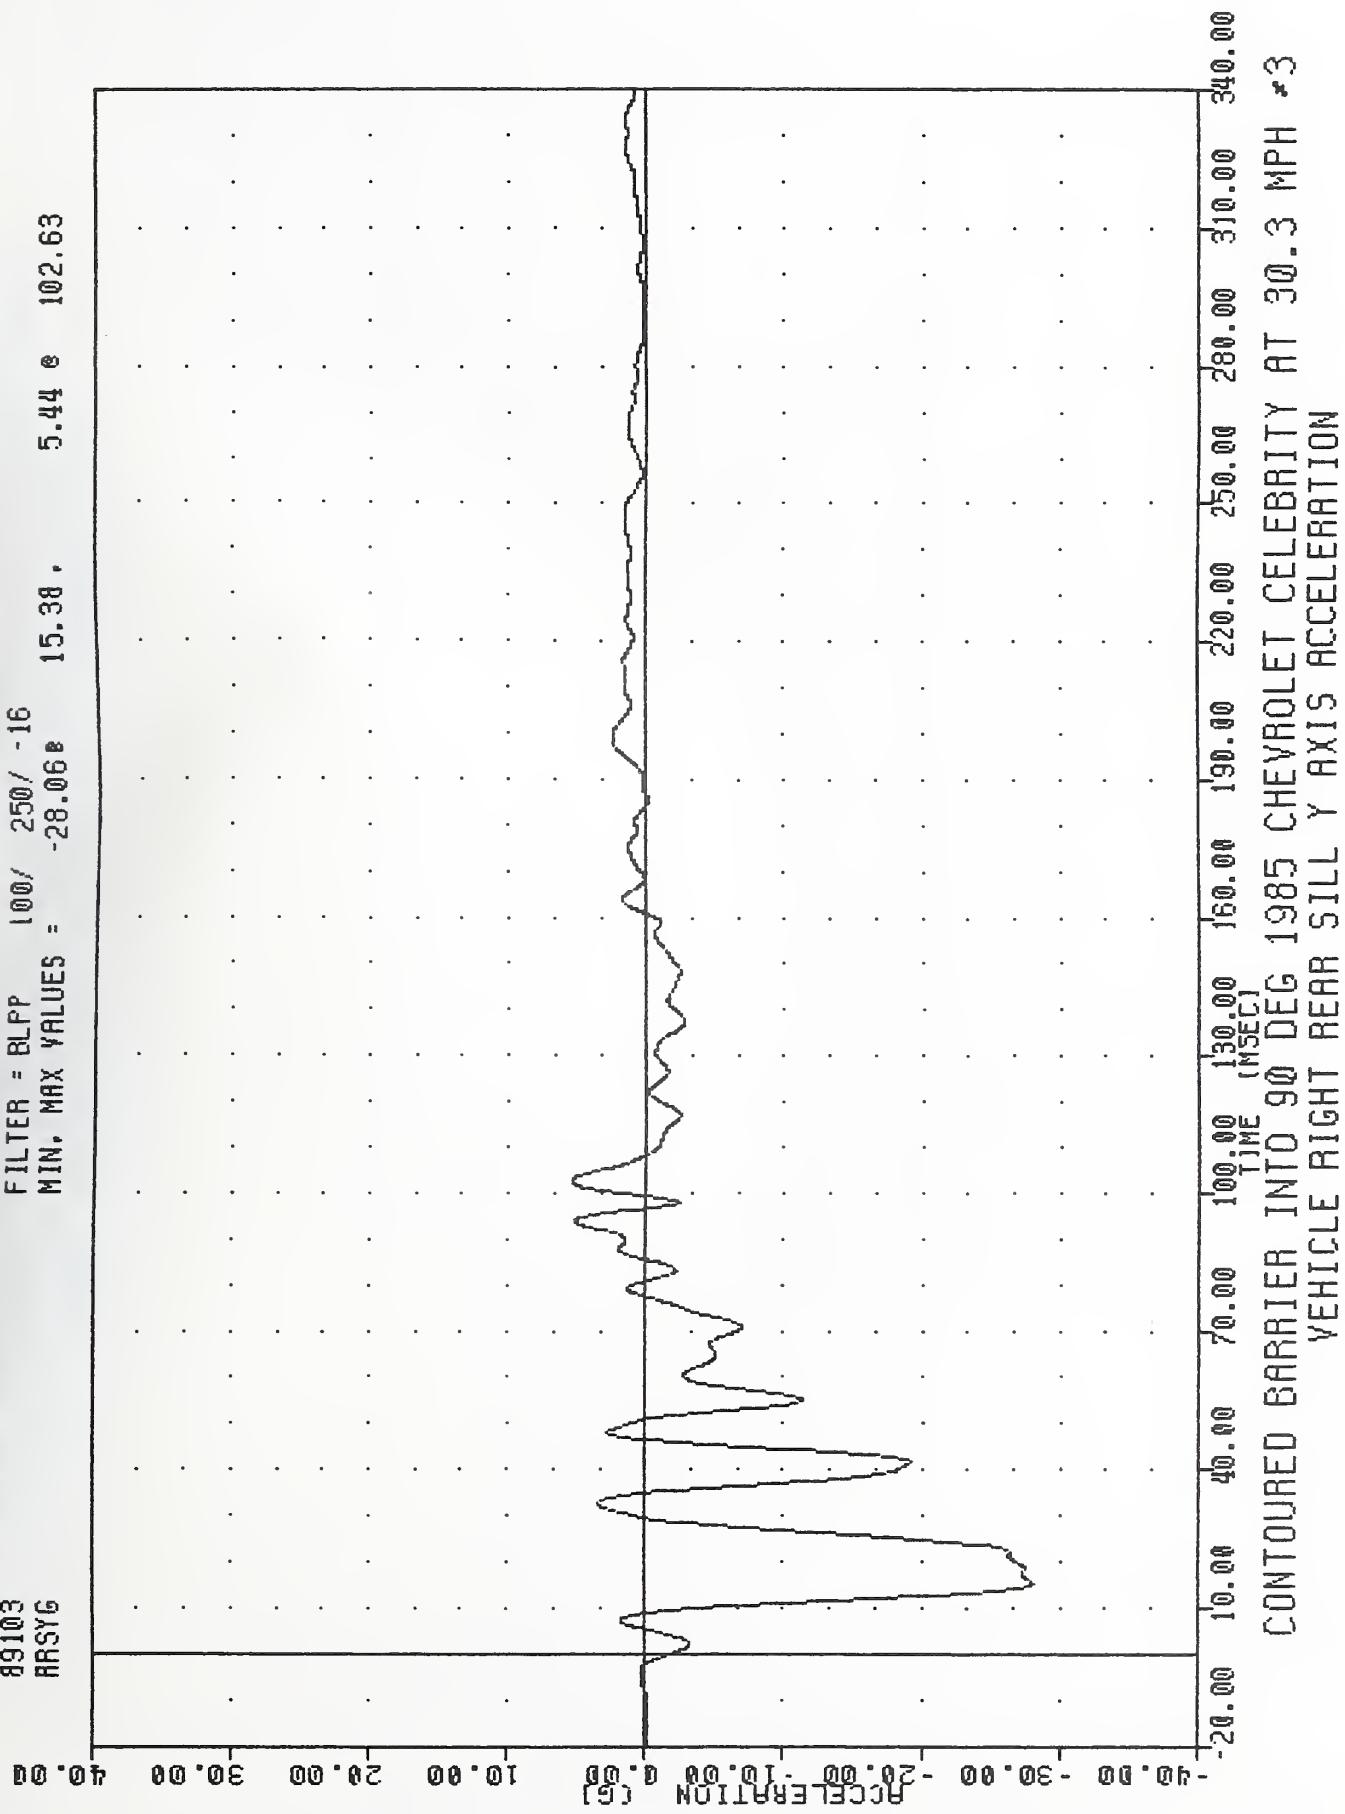
CONTOURED BARRIER INTO 90 DEG 1985 CHEVROLET CELEBRITY AT 30.3 MPH #3  
VEHICLE RIGHT REAR SILL Y AXIS ACCELERATION

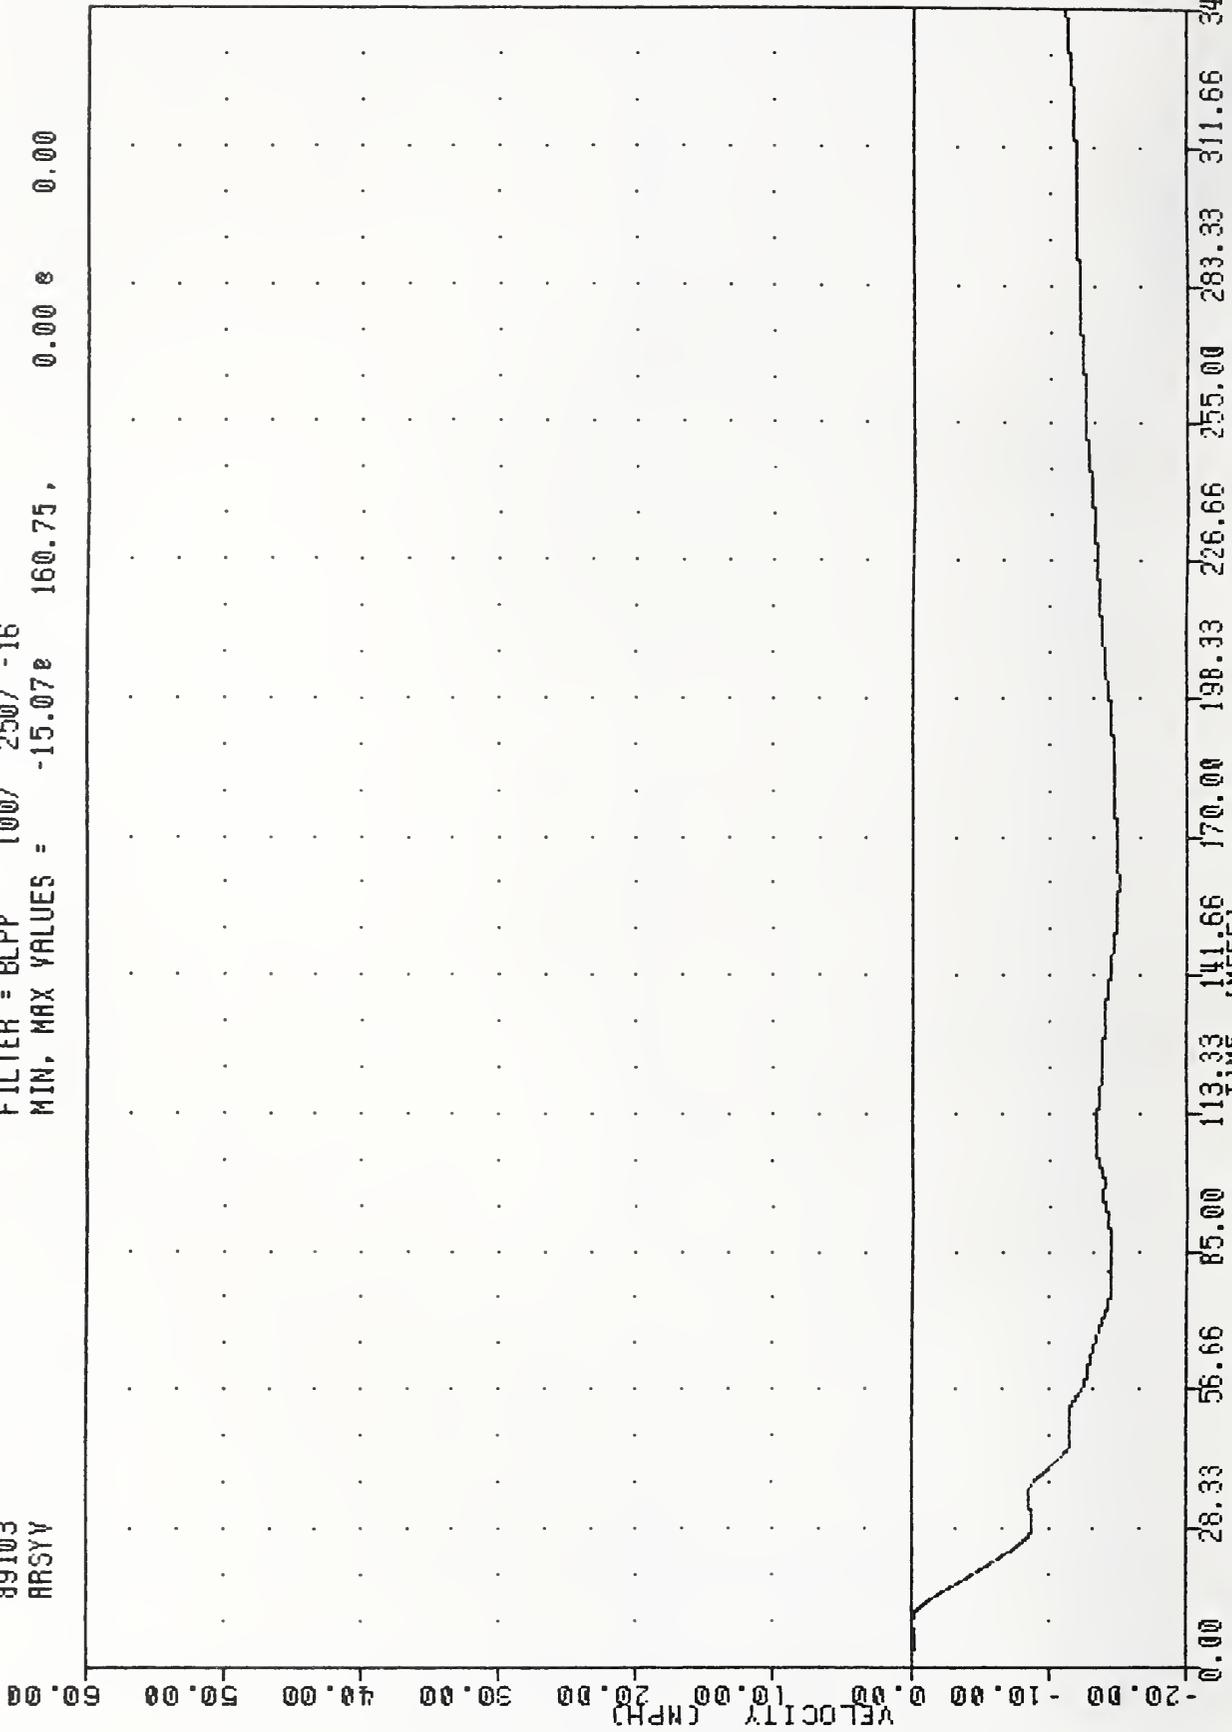
CONToured BARRIER INTO 90 DEG 1985 CHEVROLET CELEBRITY AT 30.3 MPH #3  
 VEHICLE RIGHT REAR STII Y AYTC VELOCITY

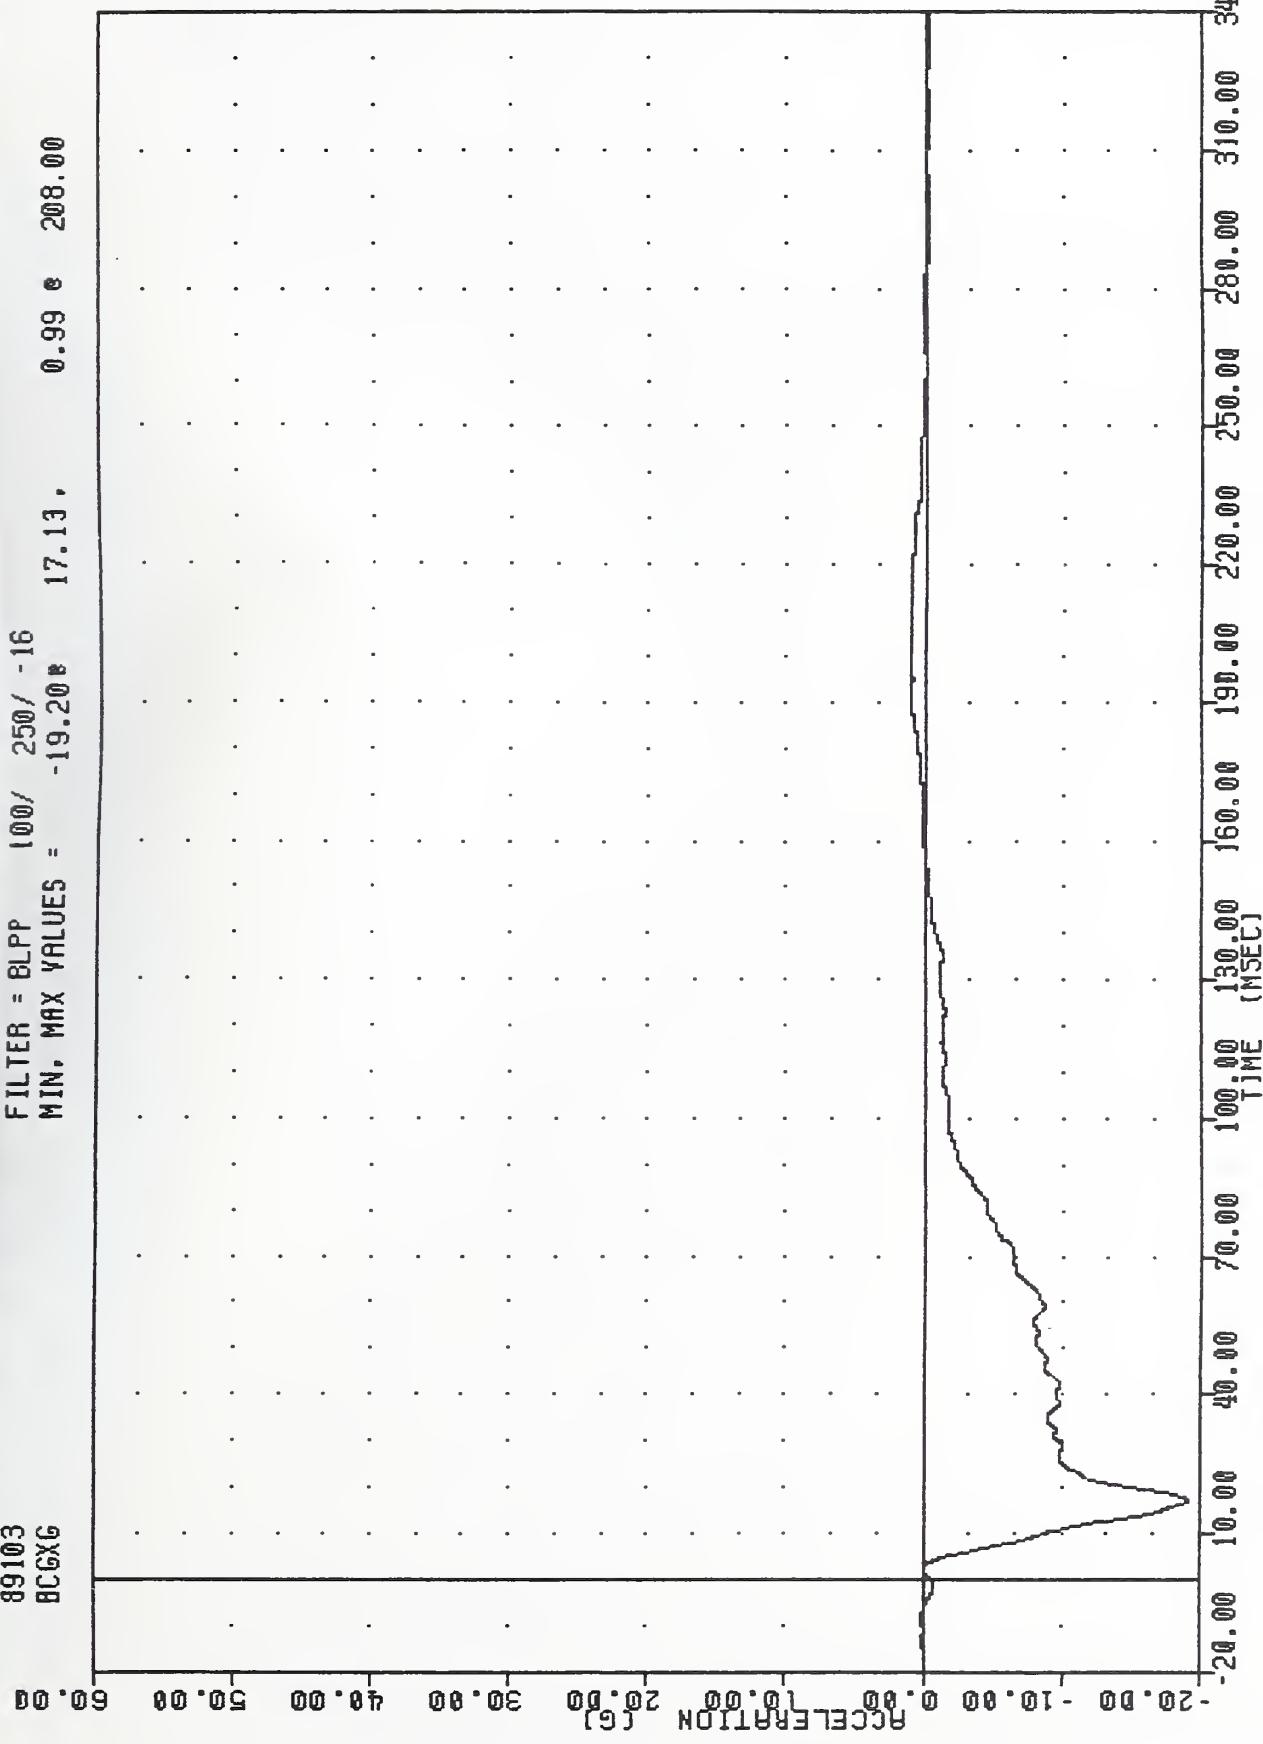
CONTOURED BARRIER INTO 90 DEG 1985 CHEVROLET CELEBRITY AT 30.3 MPH #3  
CONTOURED MOVING BARRIER CENTER OF GRAVITY X AXIS ACCELERATION

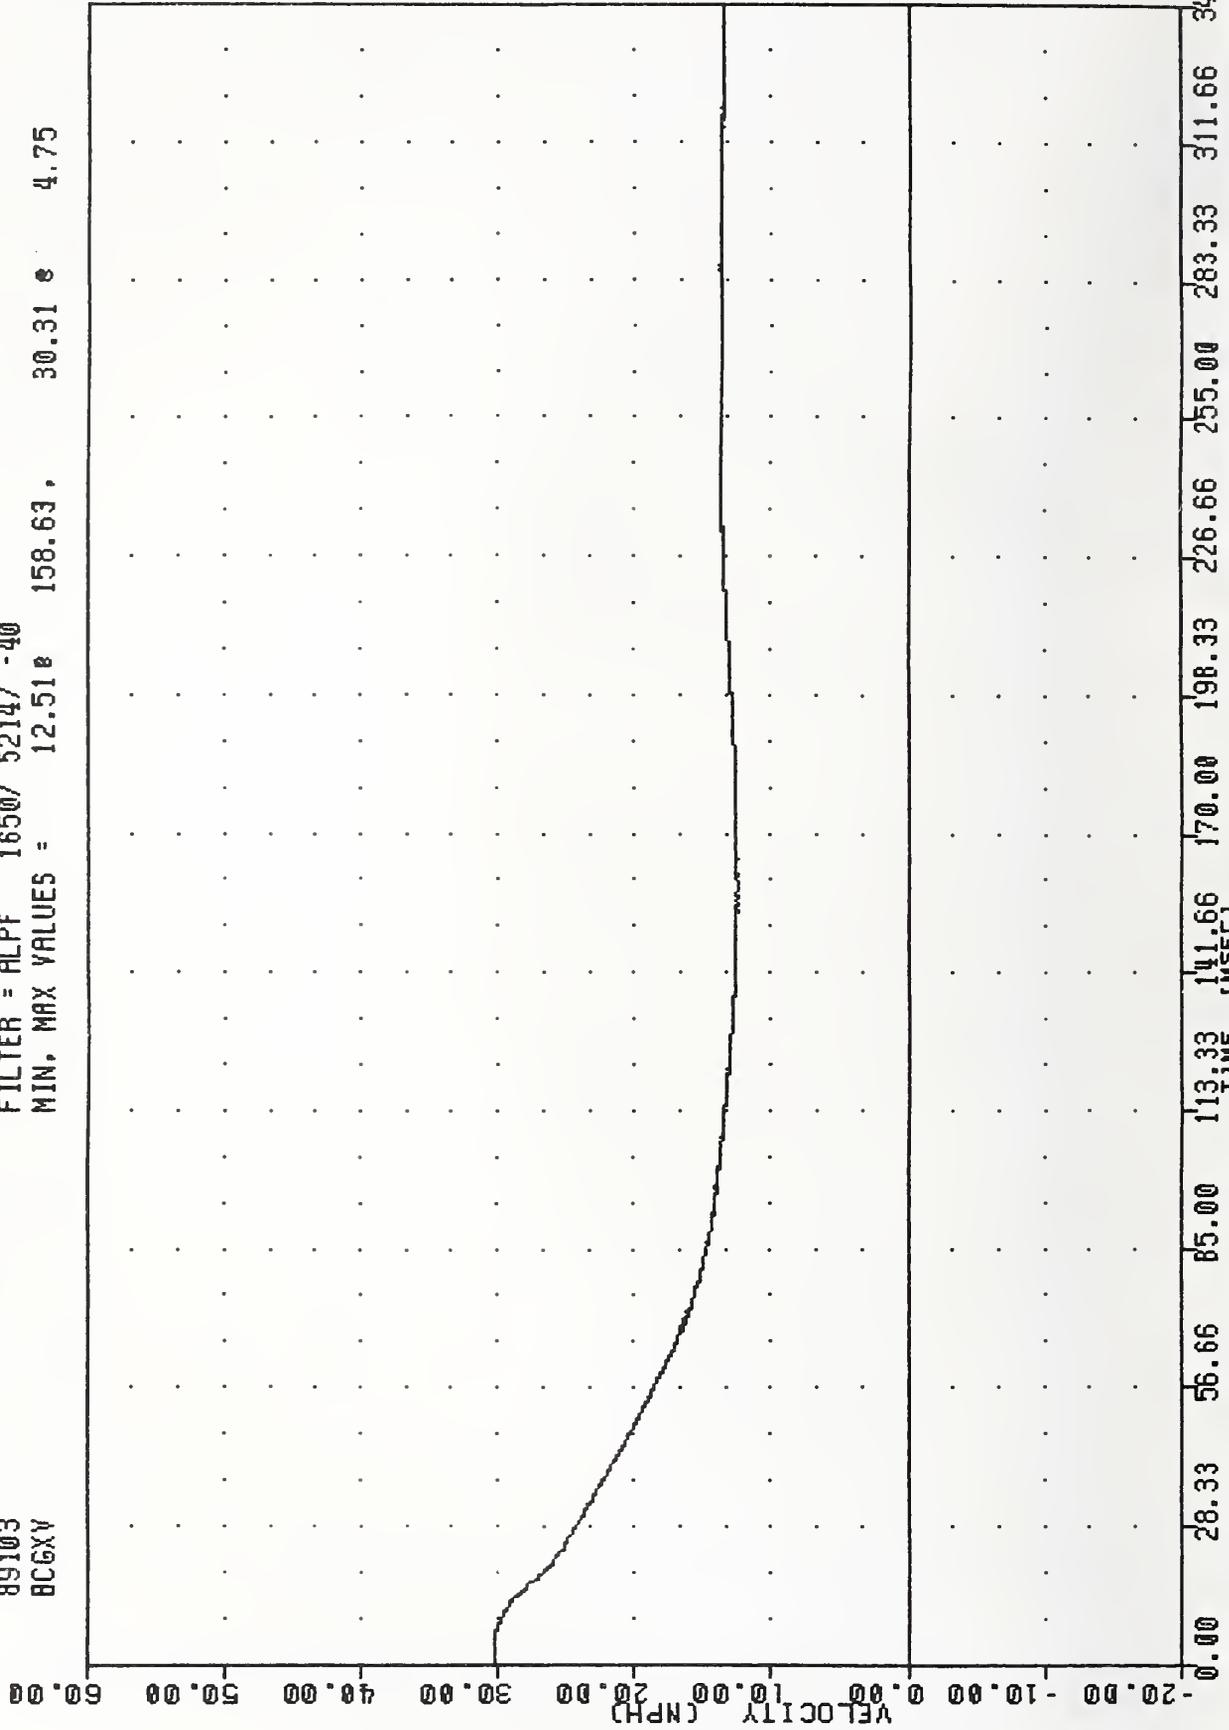
CONTOURED BARRIER INTO 90 DEG 1985 CHEVRON FT CELFRITY AT 90 A UNIT  
 COUNTS WITH UP VELOCITY X BYTS VELOCITY

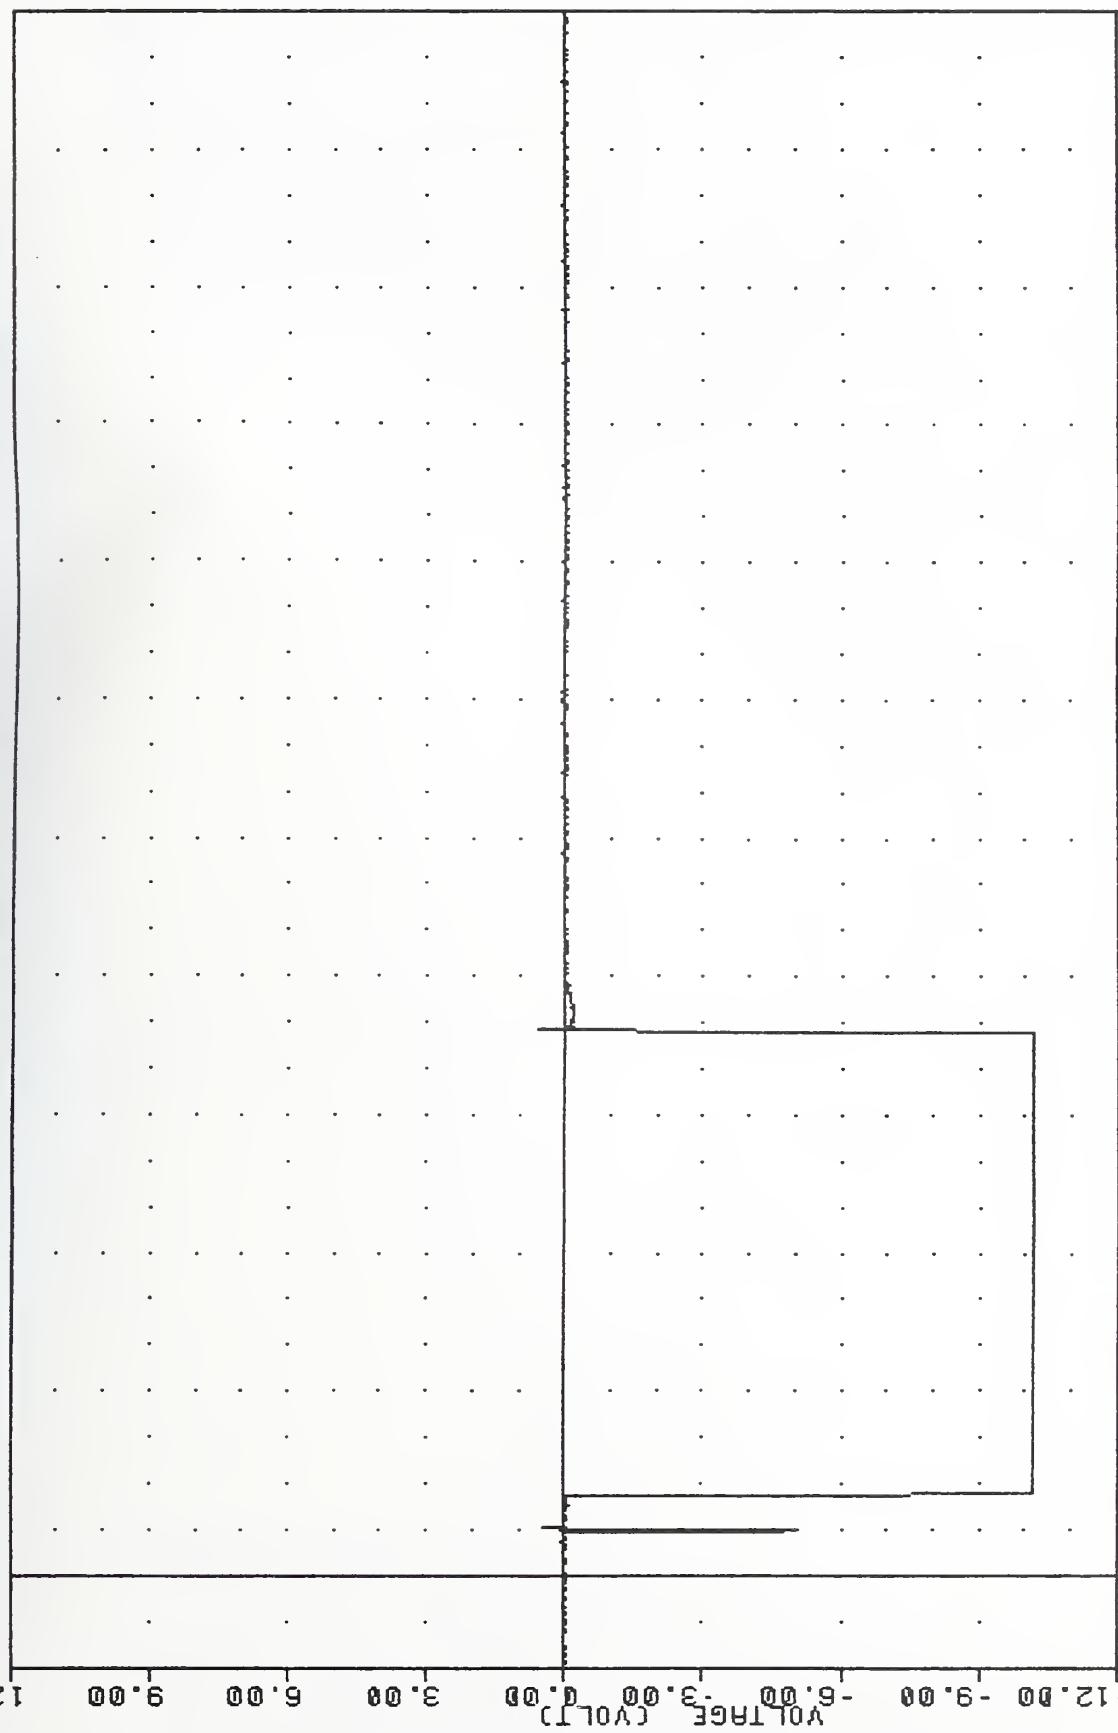
-20.00 10.00 40.00 70.00 100.00 130.00 160.00 190.00 220.00 250.00 280.00 310.00 340.00  
TIME (MSEC)  
CONTOURED BARRIER INTO 90 DEG 1985 CHEVROLET CELEBRITY AT 30.3 MPH #3  
VEHICLE CONTACT SWITCH - FRONT

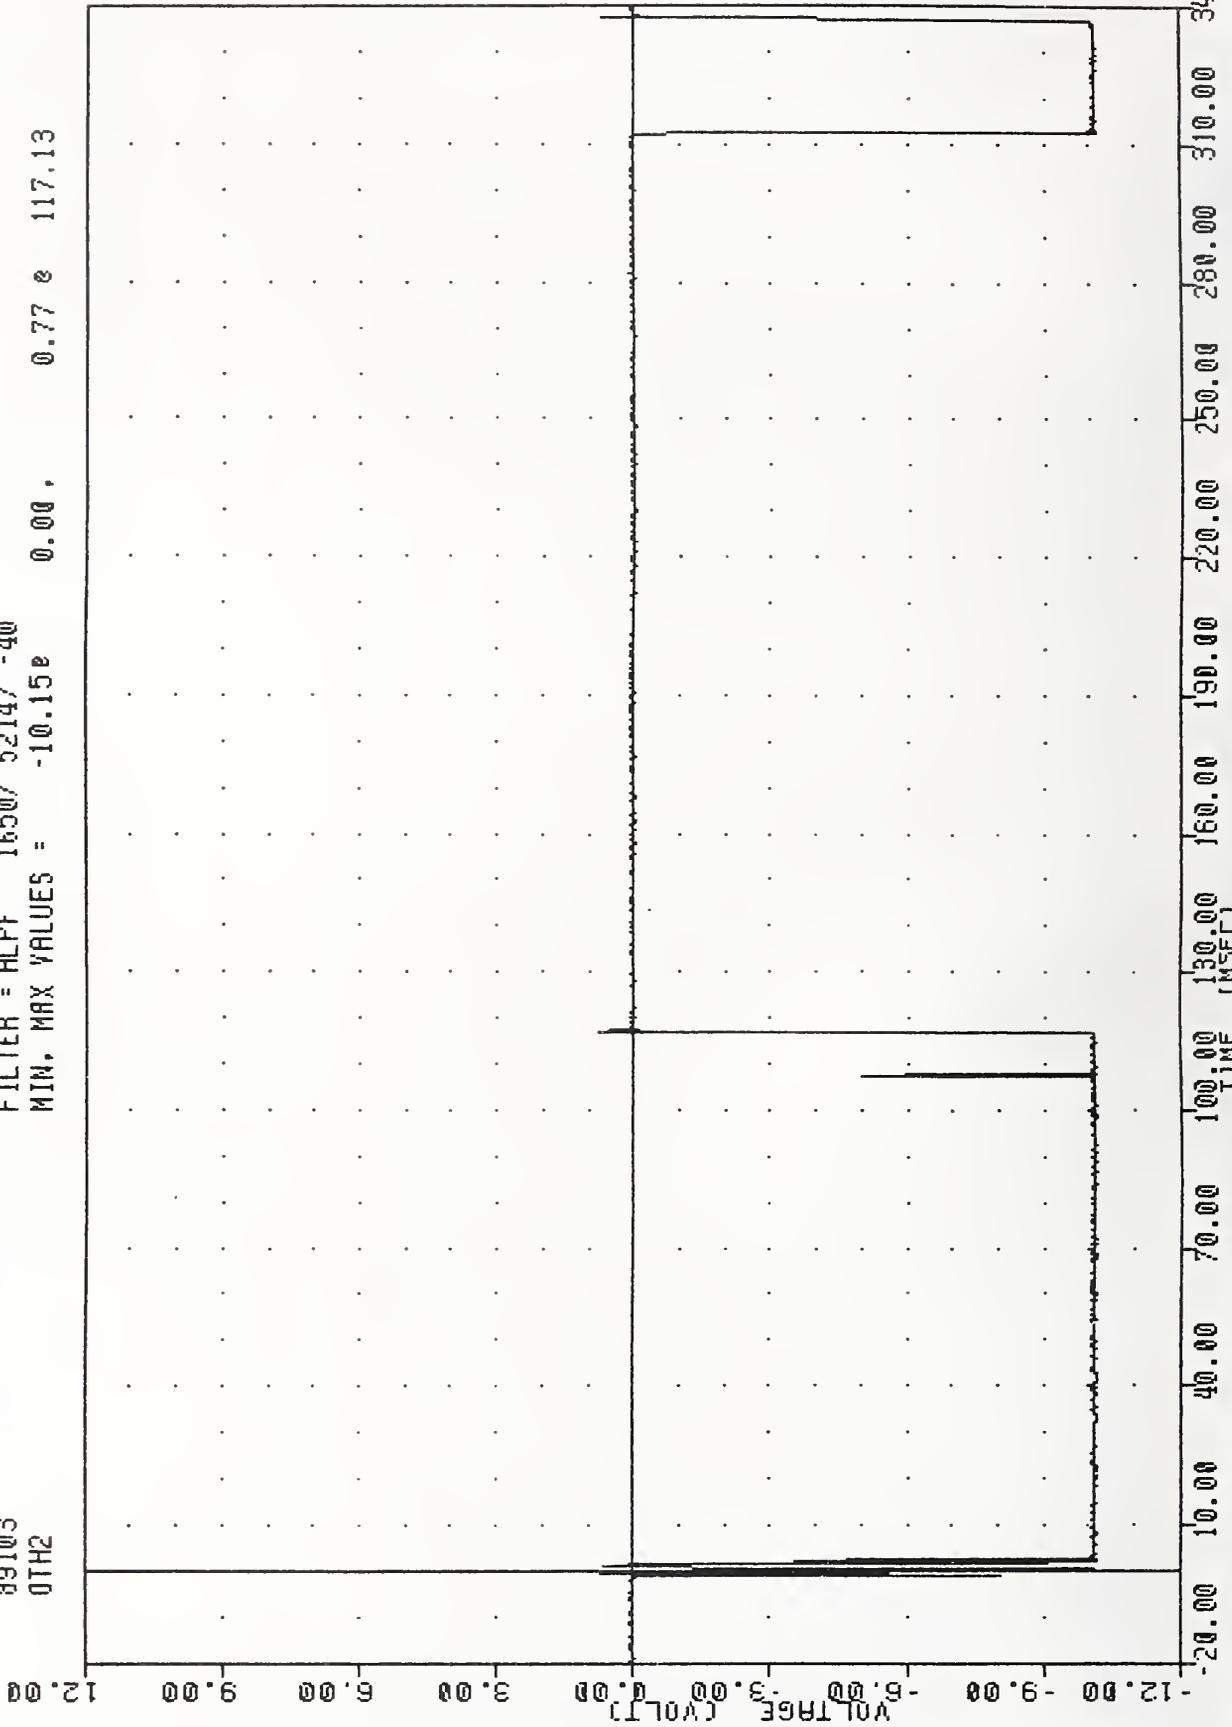
CONToured BARRIER INTO 90 DEG 1985 CHEVROLET CELEBRITY AT 30.3 MPH #3  
 VEHICLE CONTACT SWITCH - REAR

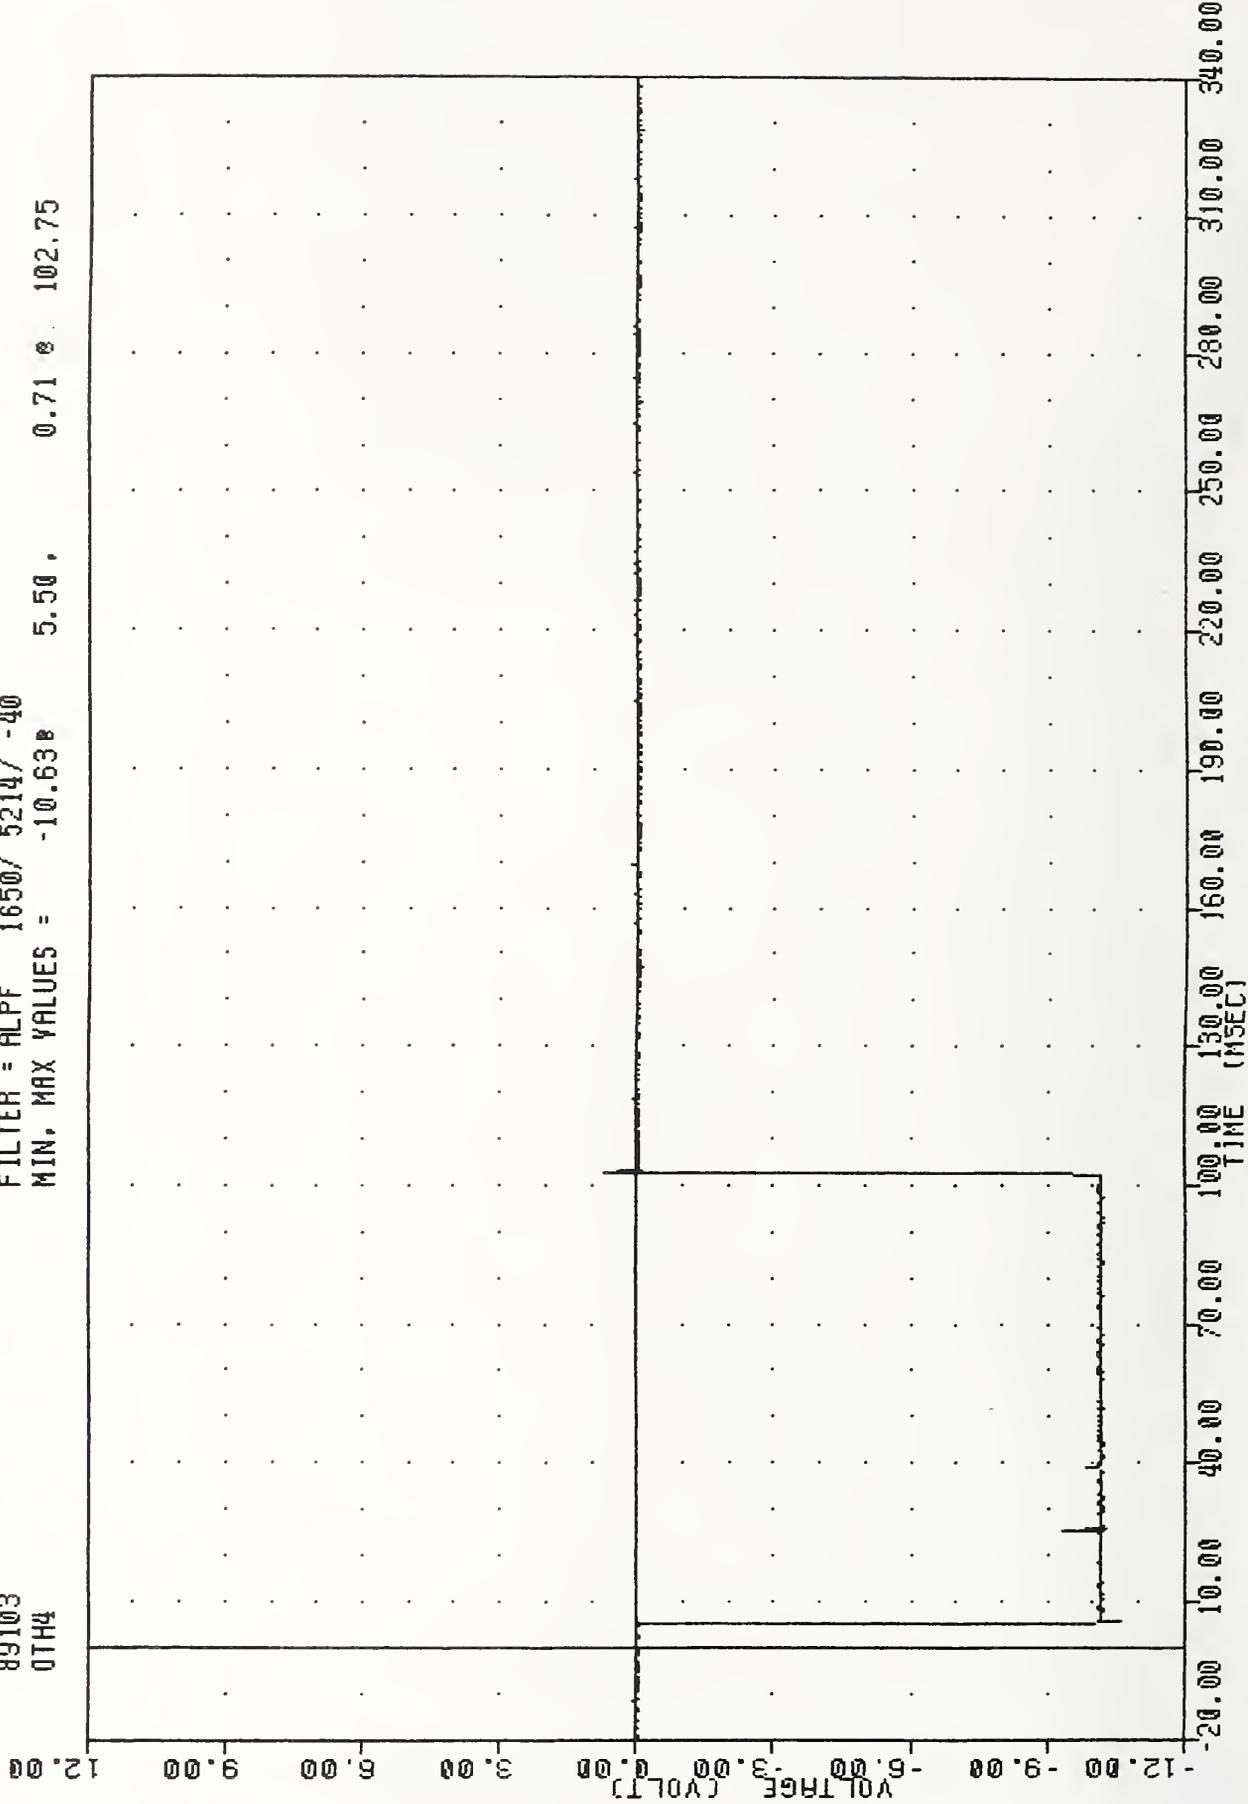
CONToured BARRIER INTO 90 DEG 1985 CHEVROLET CELEBRITY AT 30.3 MPH #3  
 BARRIER CONTACT SWITCH - LEFT
