# INFRARED EXPERIMENT A ROAD WHEEL DURING AN FMVSS 109 TYPE COMPLIANCE TEST

**Contract No. DOT-TSC-NHTSA-72-3**  
**June 1972**  
**Interim Report**

U.S. DEPARTMENT OF TRANSPORTATION  
NATIONAL HIGHWAY TRAFFIC SAFETY ADMINISTRATION  
WASHINGTON, D.C. 20590

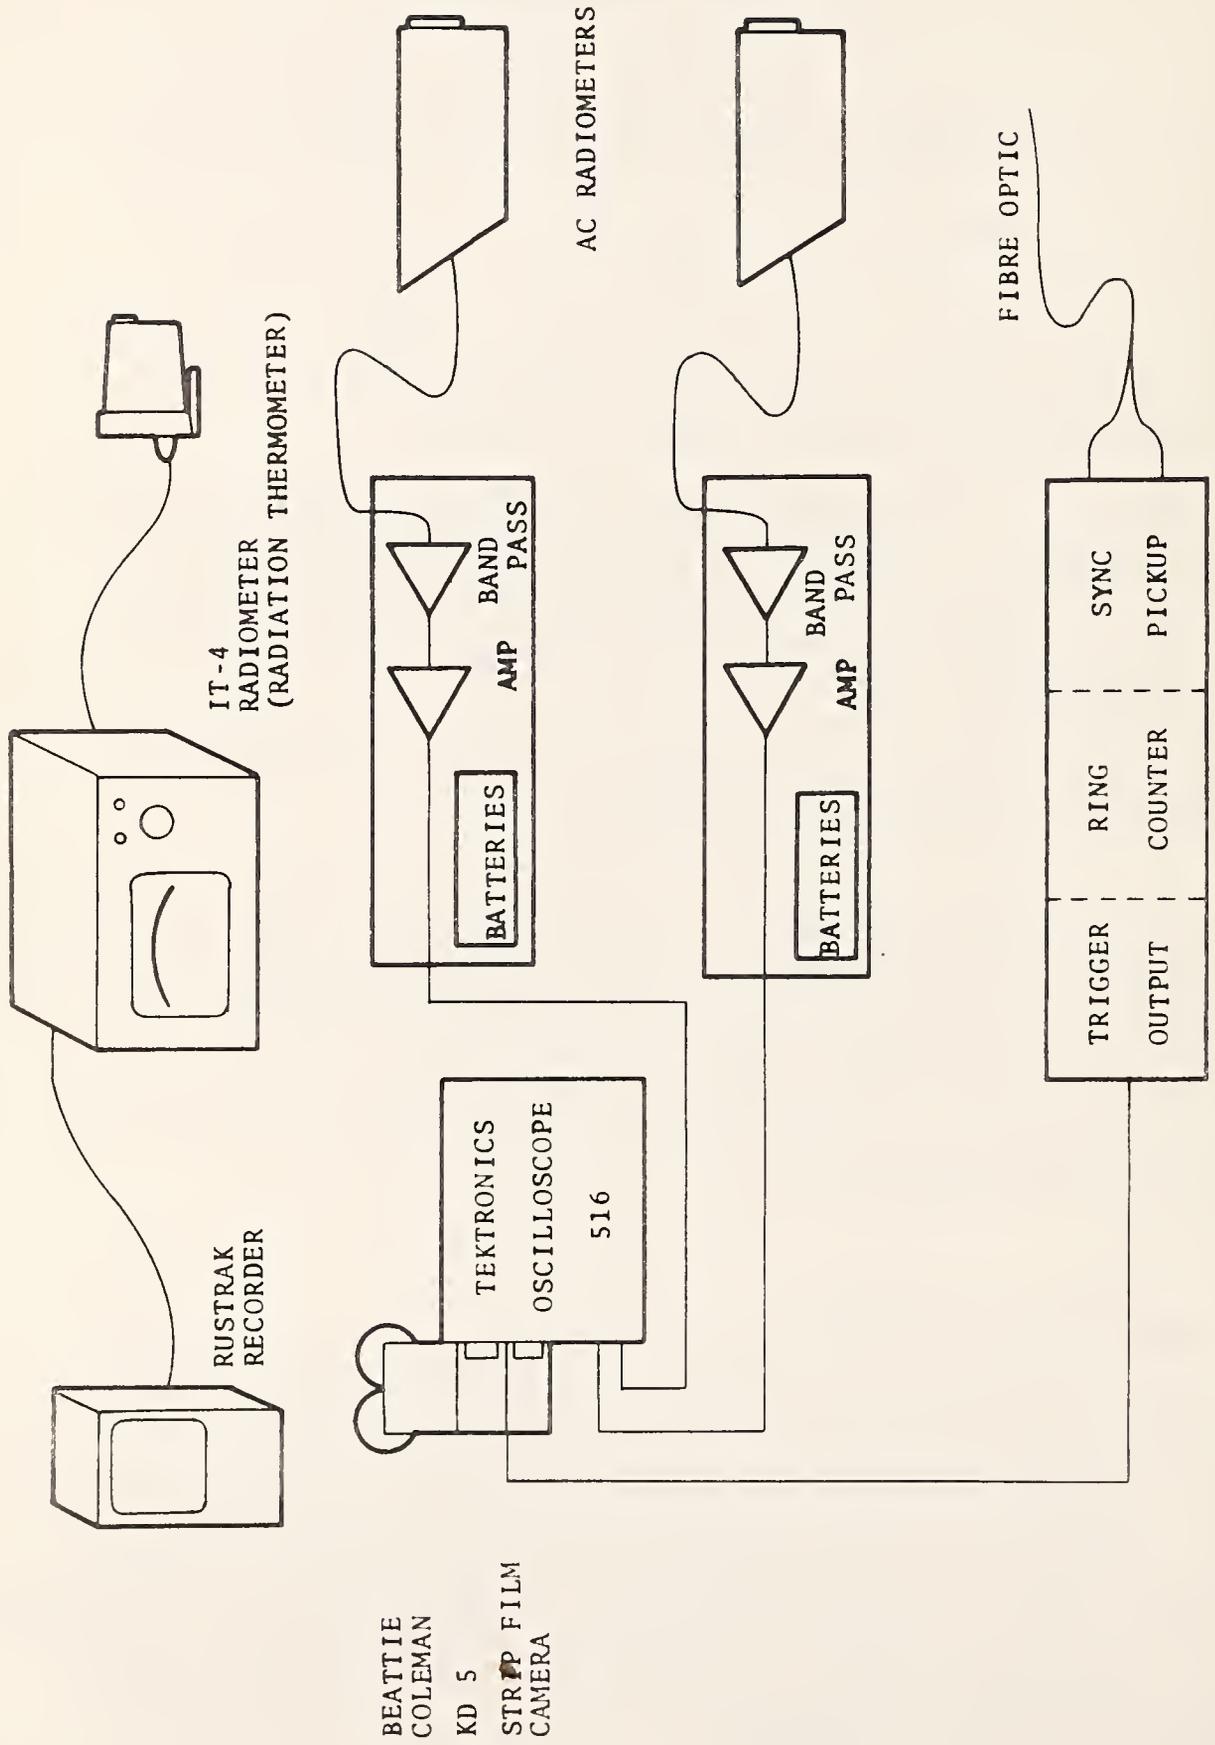
Figure 1. Field Infrared Tire Inspection System

The system consisted of one Barnes IT4 infrared thermometer, two transient radiometers, a sync pickup with a binary spacing counter and a readout package. Figure 1 is a block diagram of the complete instrumentation package used in the experiment.

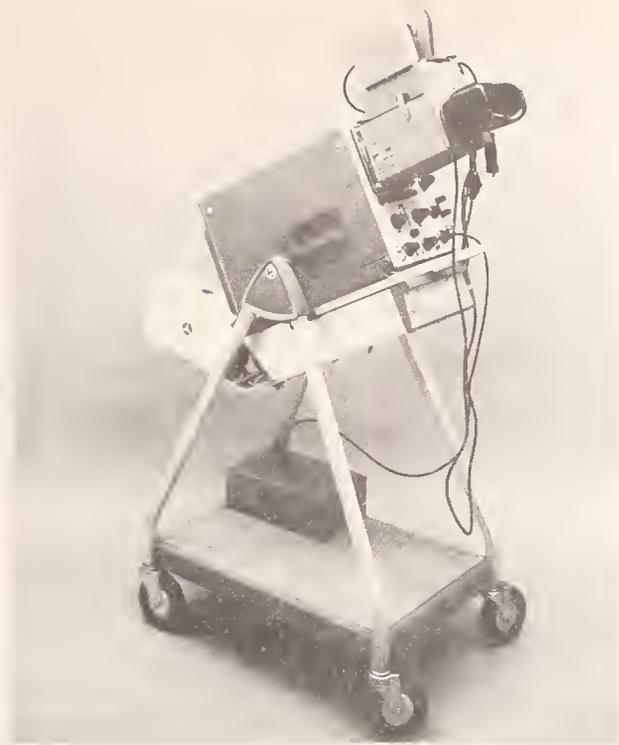
Figure 2. Field Infrared Tire Inspection System (FITIS) Mounted on Scope Cart

The readout package was made up of a Tektronics dual channel oscilloscope, Model 516, onto which a modified Beatty Coleman K-D-5 strip film oscilloscope camera is mounted.

Figure 2 is a photograph of one transient radiometer and the readout equipment. Figure 3 is a photograph of the radiometers set up on a standard DOT test wheel at the compliance center. Optical and response data for the transient radiometer may be found in Appendix A.

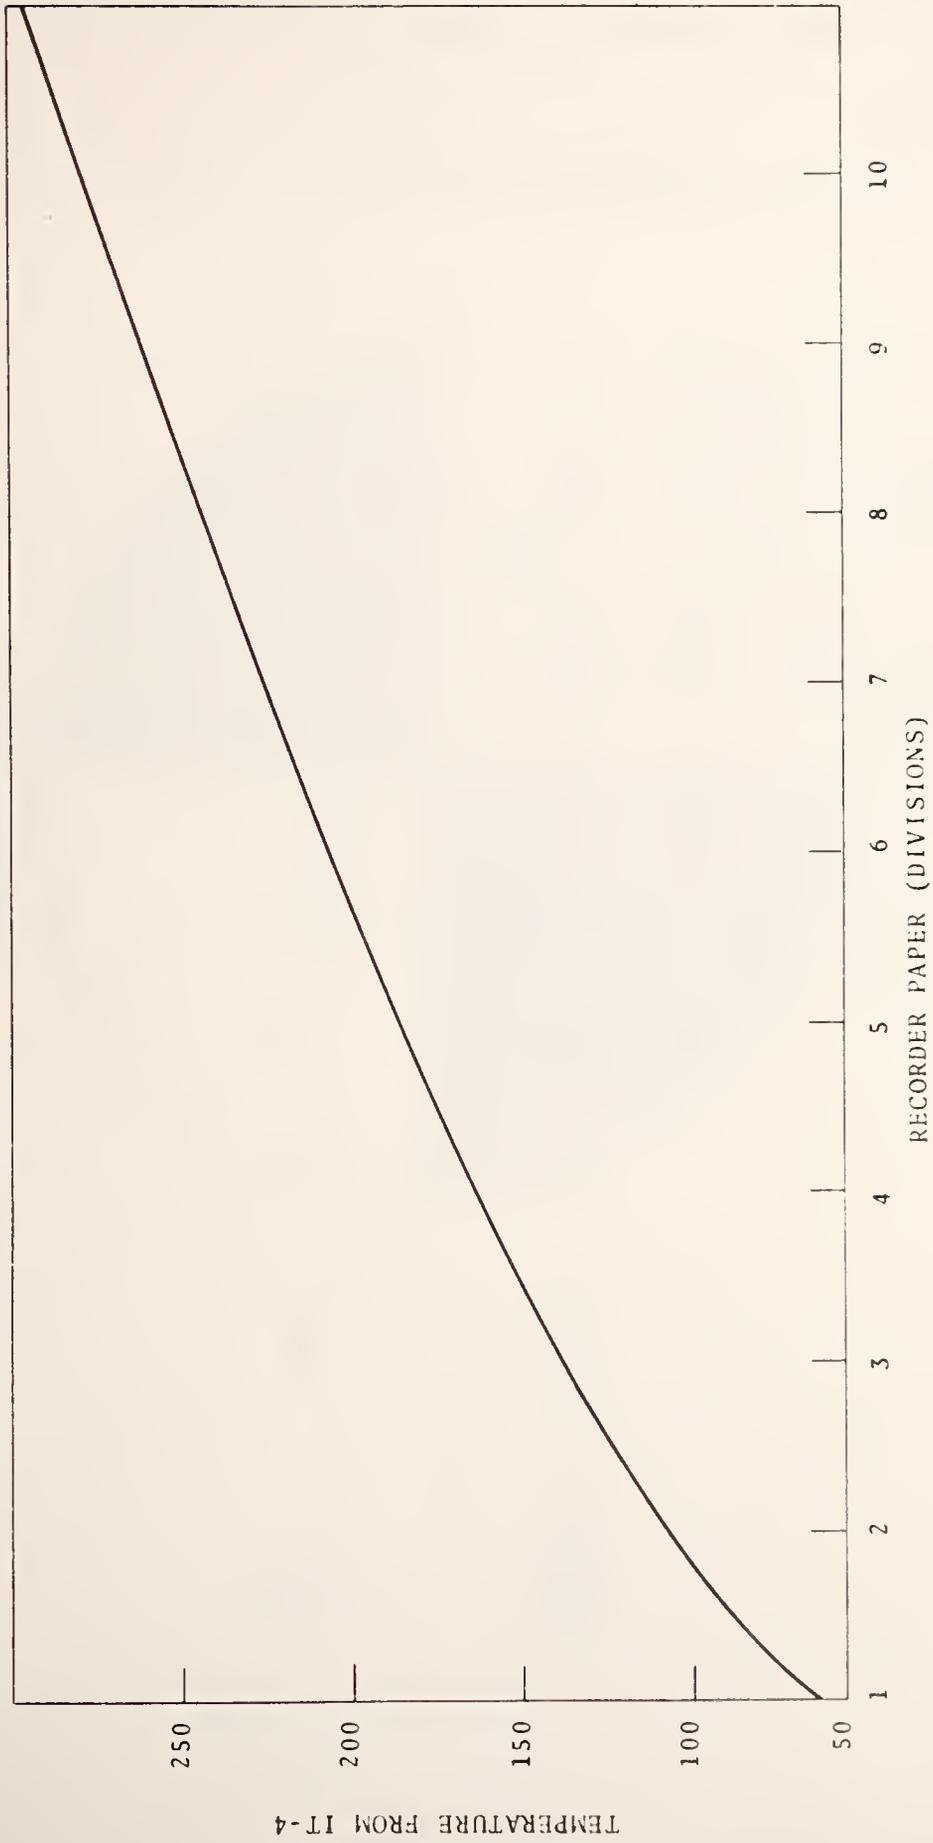
Figure 4. IT-4 Temperature Vs Recorder Chart Division

A temperature-sensing radiometer, the IT4, was used; its 2° field of view is focused on a 1.5-inch circle at the center of the tread. Output from this unit is fed to a conventional Rustrack recorder with a chart speed of approximately 1" per hour and an accuracy of ~ 2°F. No provision is made for emissivity compensation on tires since they are assumed to be uniform and almost black. A recorder temperature curve is given in Figure 4.

IT4 - TEMP. VS RECORDER CHART DIVISIONS  
DEPT. OF TRANSPORTATION TIRE TESTING PROGRAM

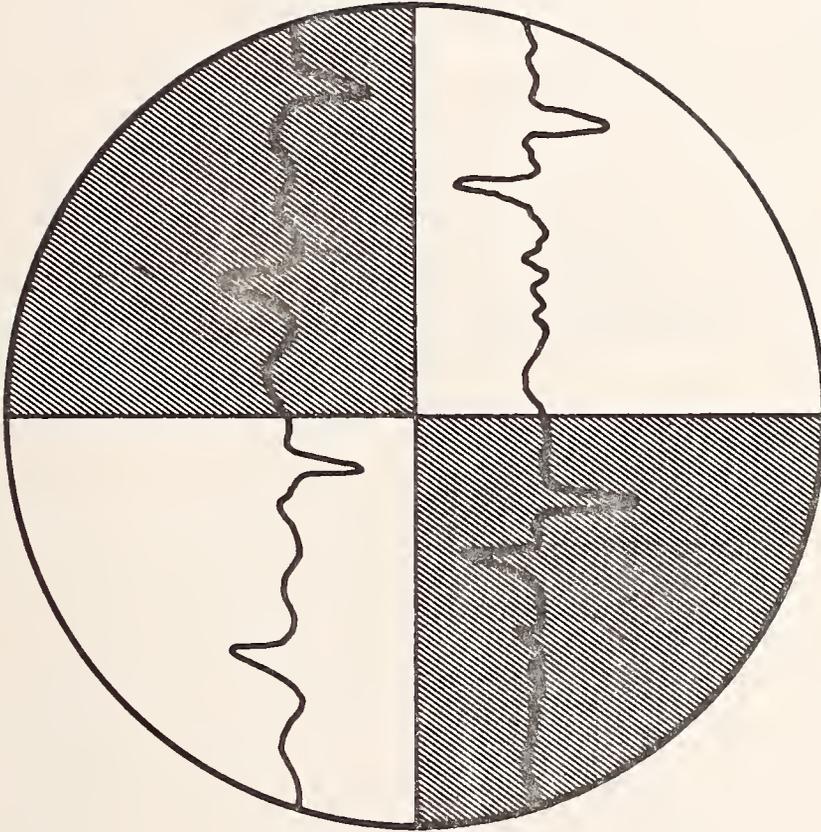
Figure 5. Display (FITIS)

Readout is accomplished by feeding the output of each transient radiometer to one channel of the scope. Scope timing is then adjusted, using the uncalibrated vernier, until output from two complete tire rotations may be viewed on the scope face. Next, a mask is placed over the scope face in the manner shown in Figure 5. Then this display represents temperature excursions in the Y direction versus rotational position around the tire. The left trace is the inside tire shoulder and the right trace is the outside or whitewall shoulder.

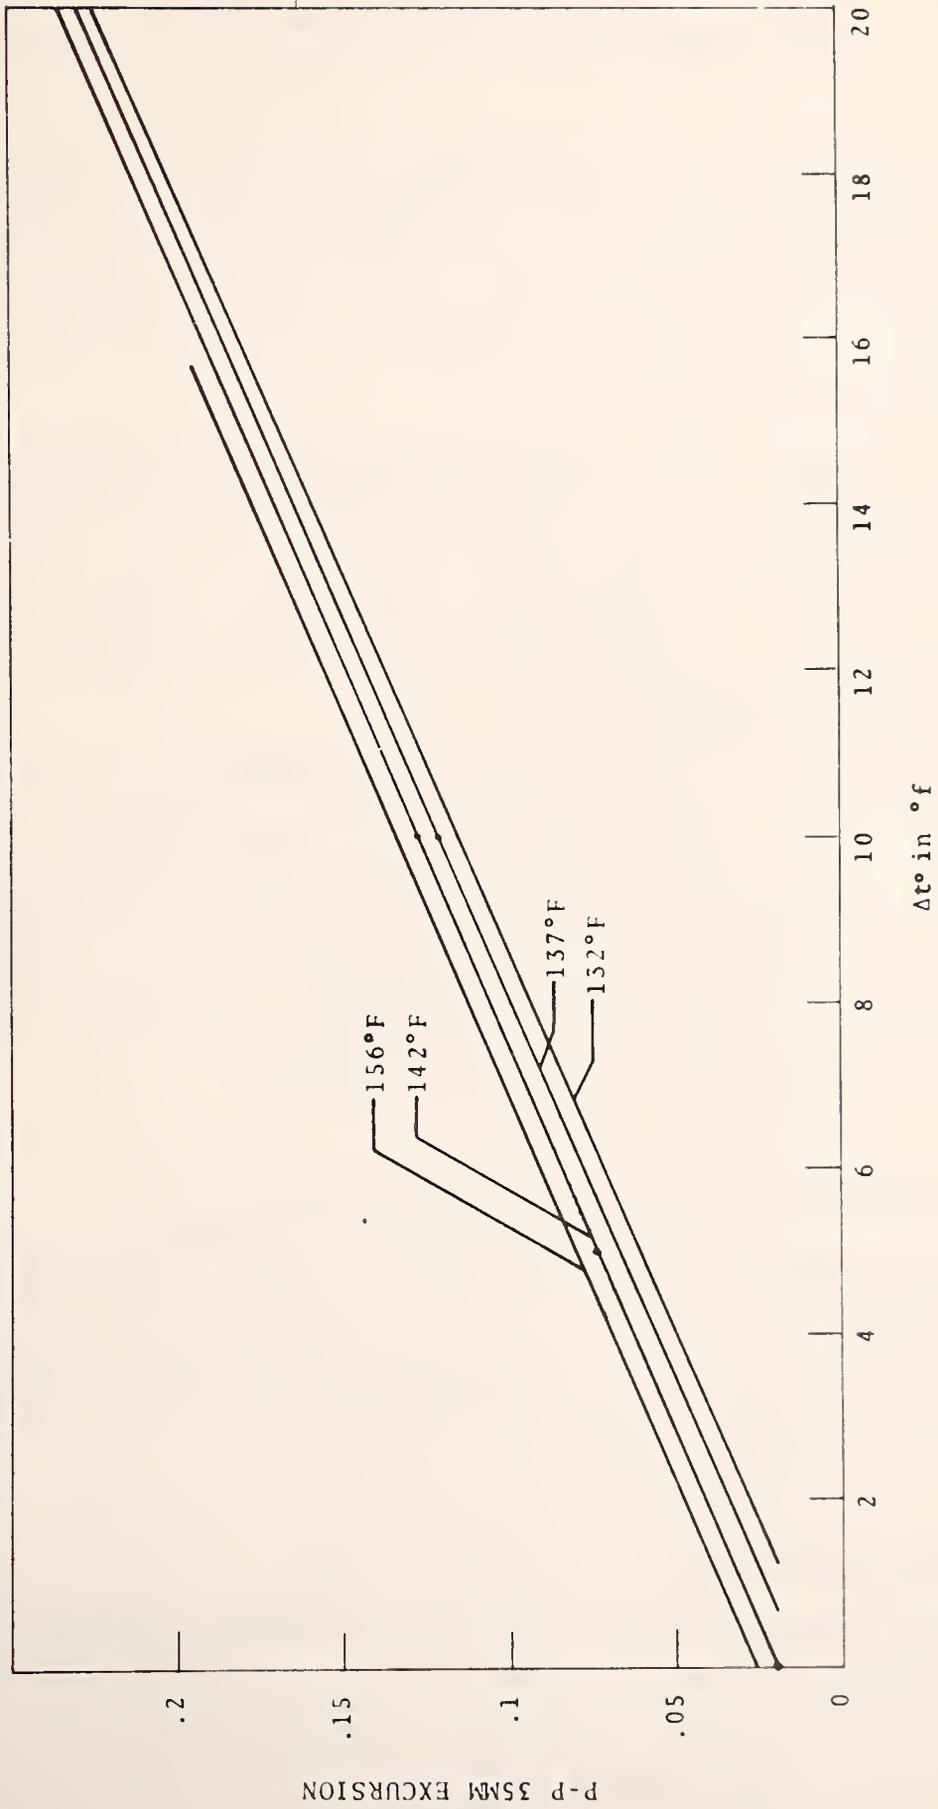
Figure 6. P-P Trace Amplitude Vs P-P Temperature Variation

P-P TRACE AMPLITUDE VS P-P TEMPERATURE VARIATION

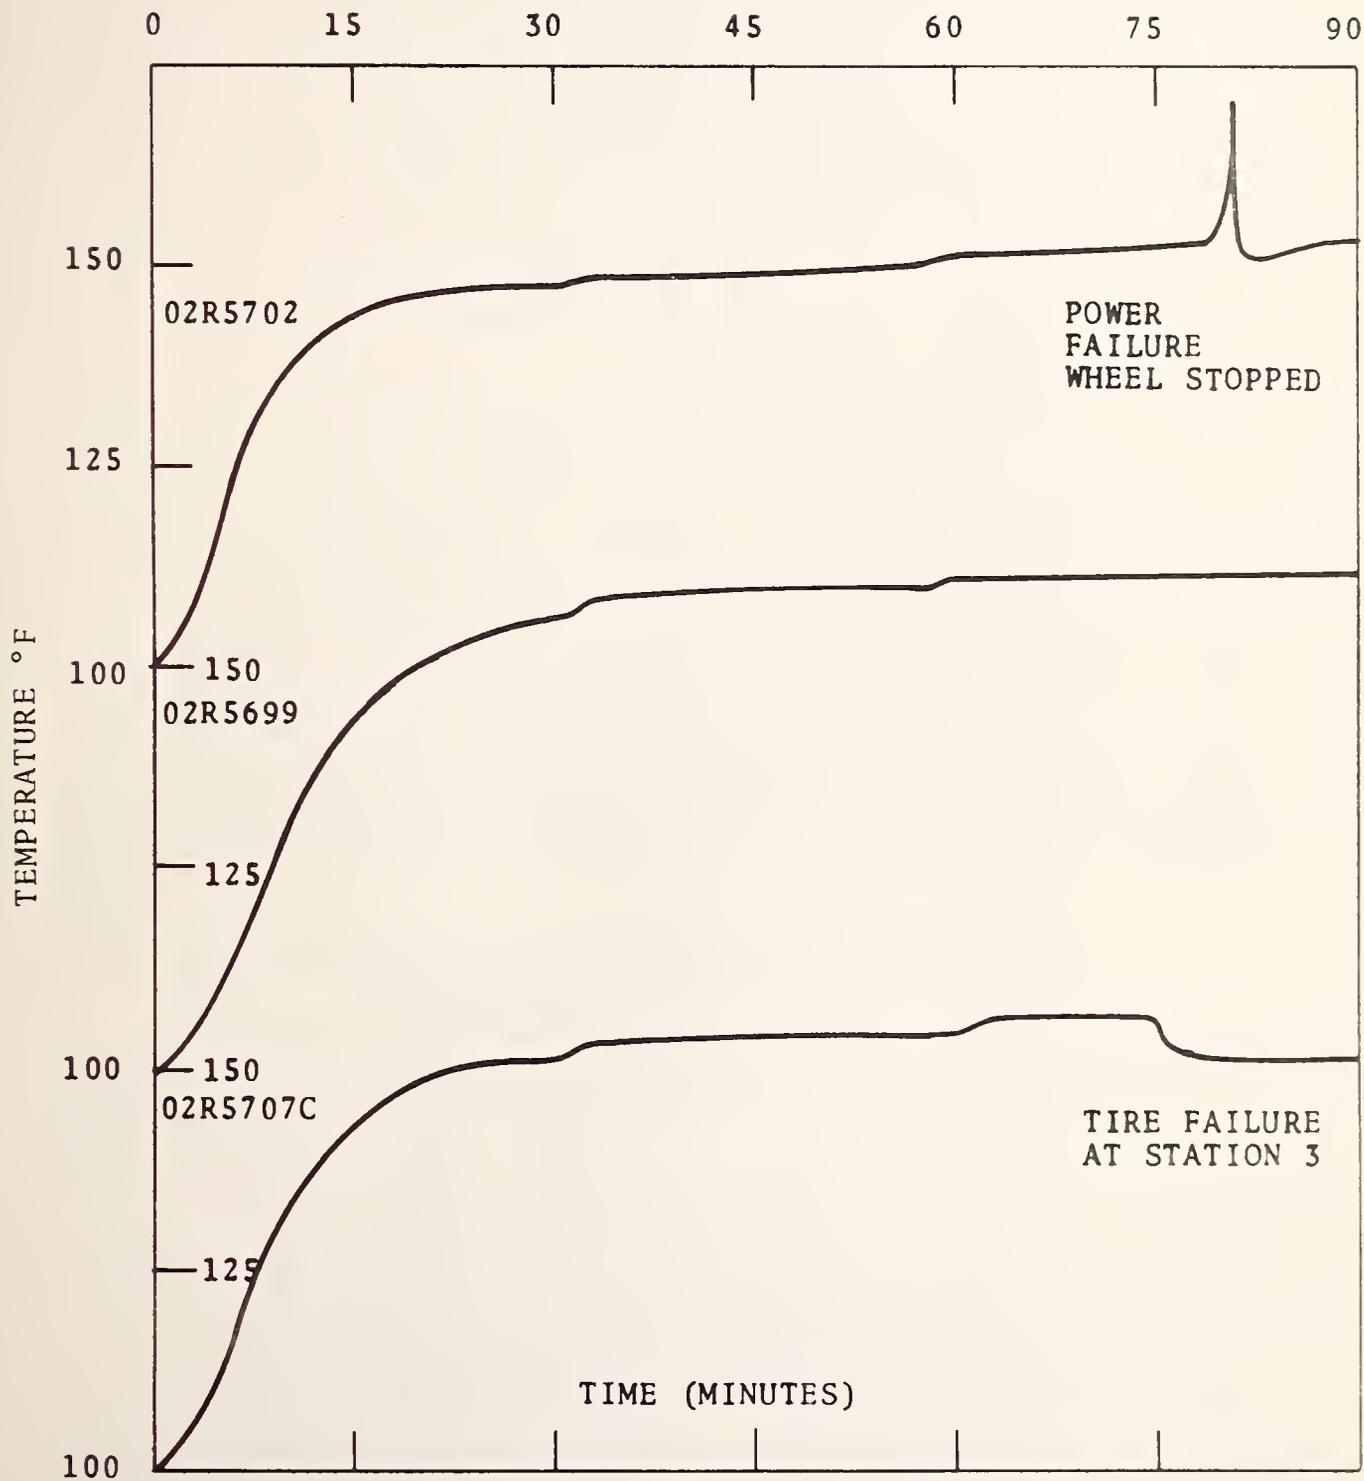
Figure 7. Temperature Vs Run Time High Speed Test

Tread temperature as a function of time is shown for all six tires in Figures 7 and 8. Some elements of the data should be explained. In Figure 7 the sharp increments correspond to speed changes. These represent increasing differentials of roughly 5°F.

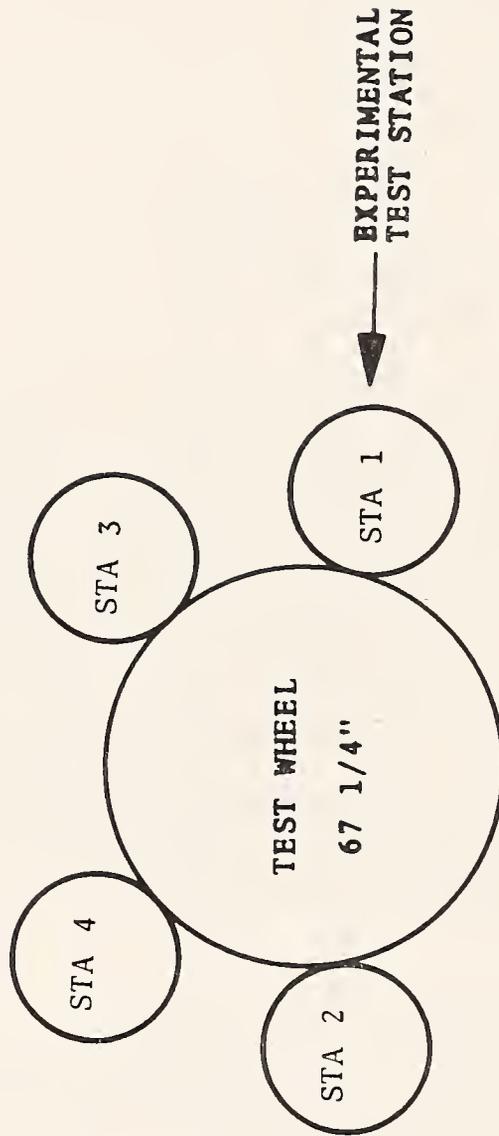
Figure 9. Tire Location on Test Wheel

Wheel stoppage at any time during the test results in a very rapid rise in temperature probably caused by the removal of the cooling effects of the draft of air across the tire during rotation, combined with diffusion of the tire inner temperature to the surface. On the other hand, failure of one of the other three tires being run had the effect of reducing the tire temperature seven degrees. Figure 9 is a schematic showing the approximate location of the various stations around the road wheel.

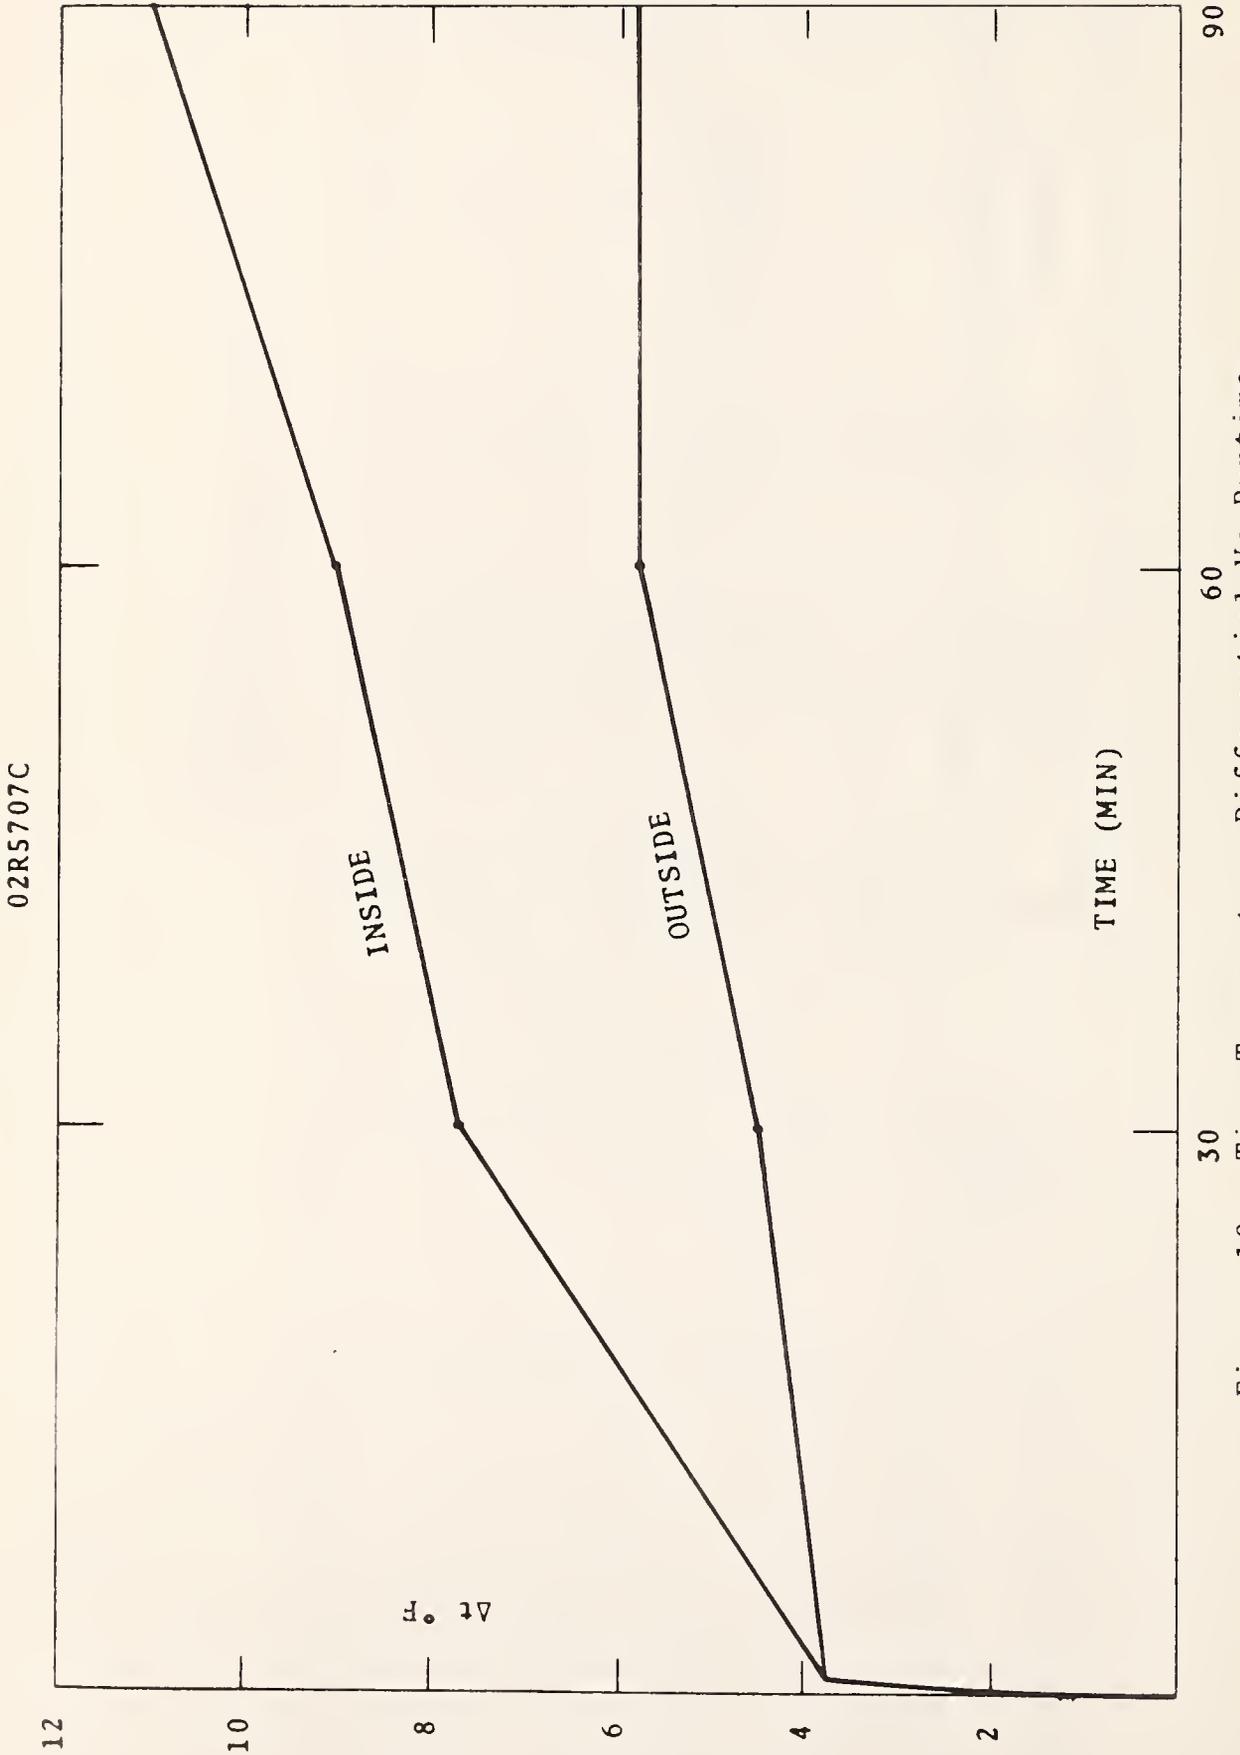
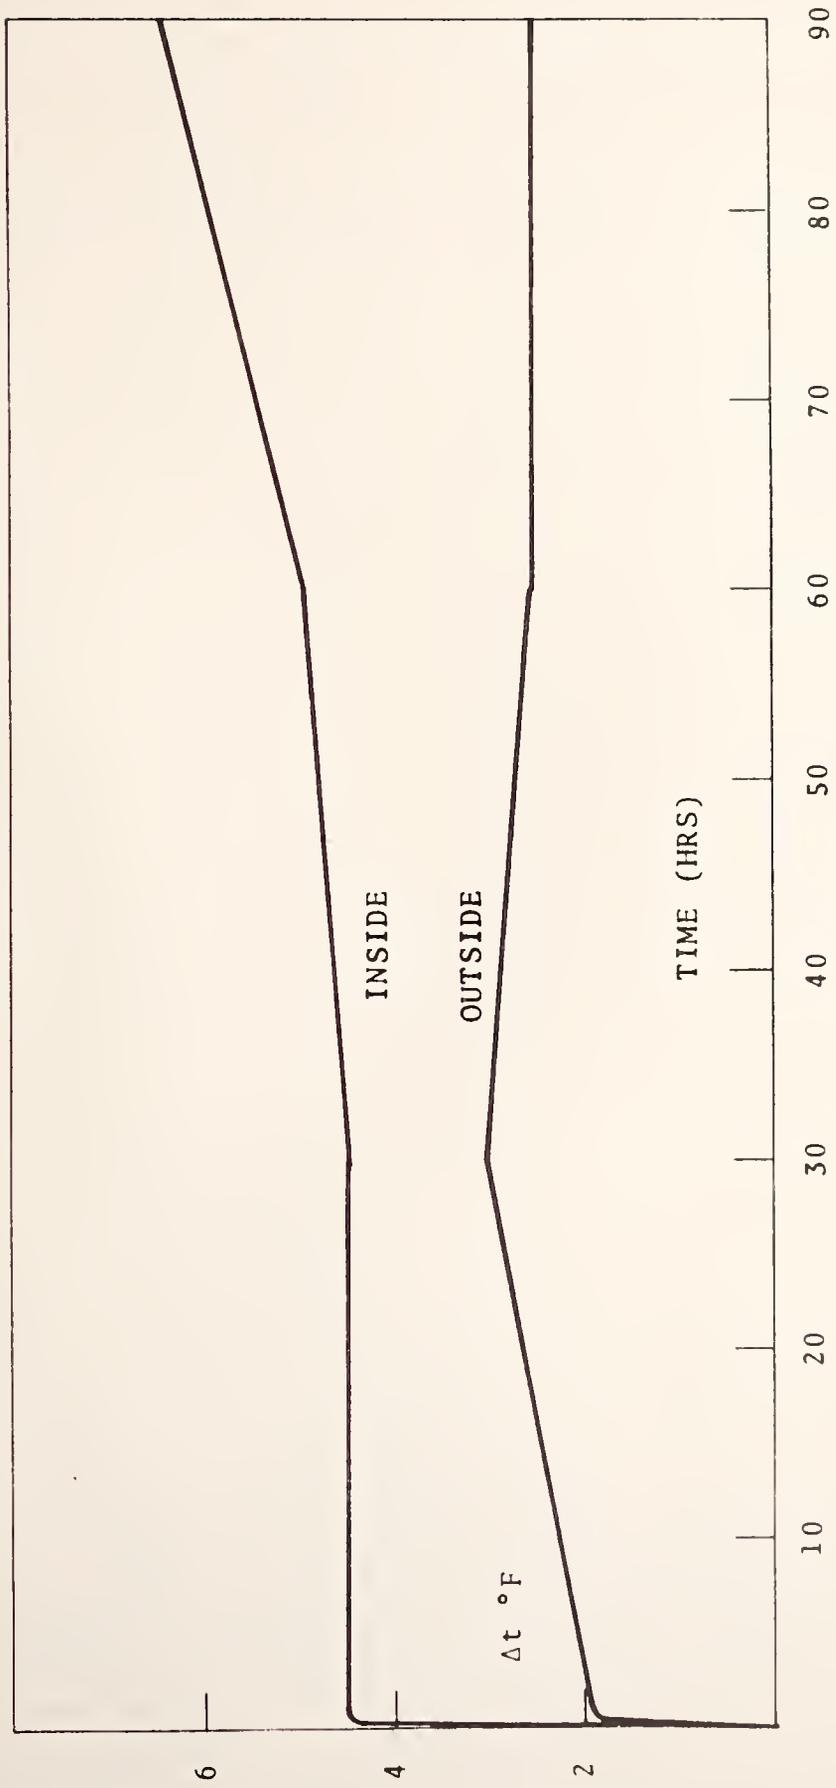
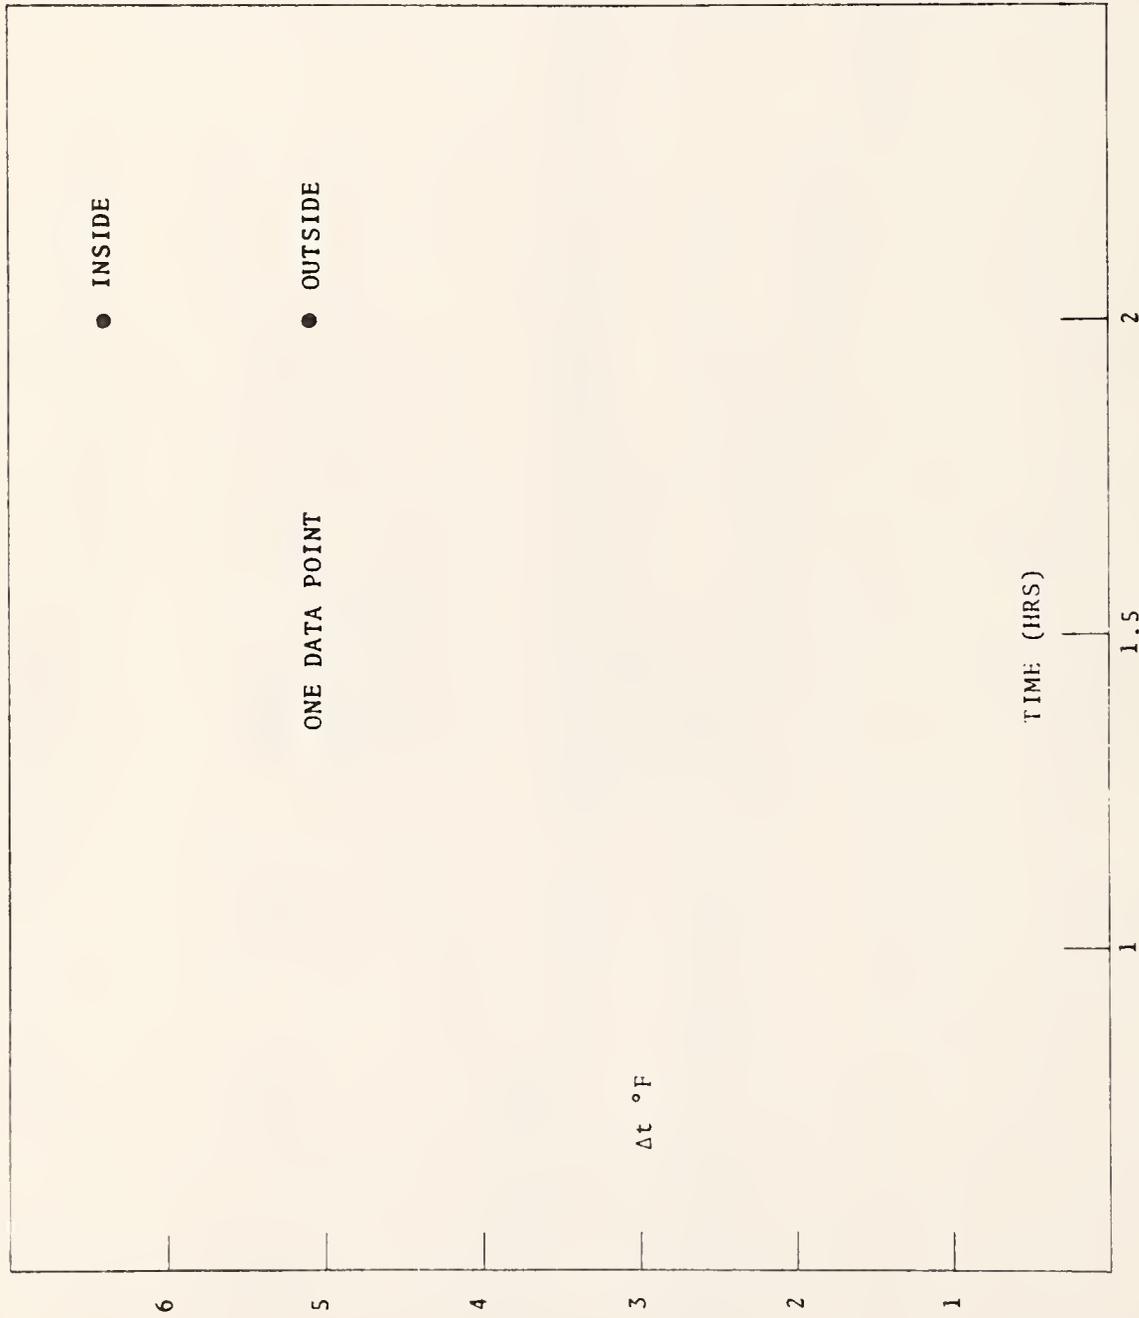
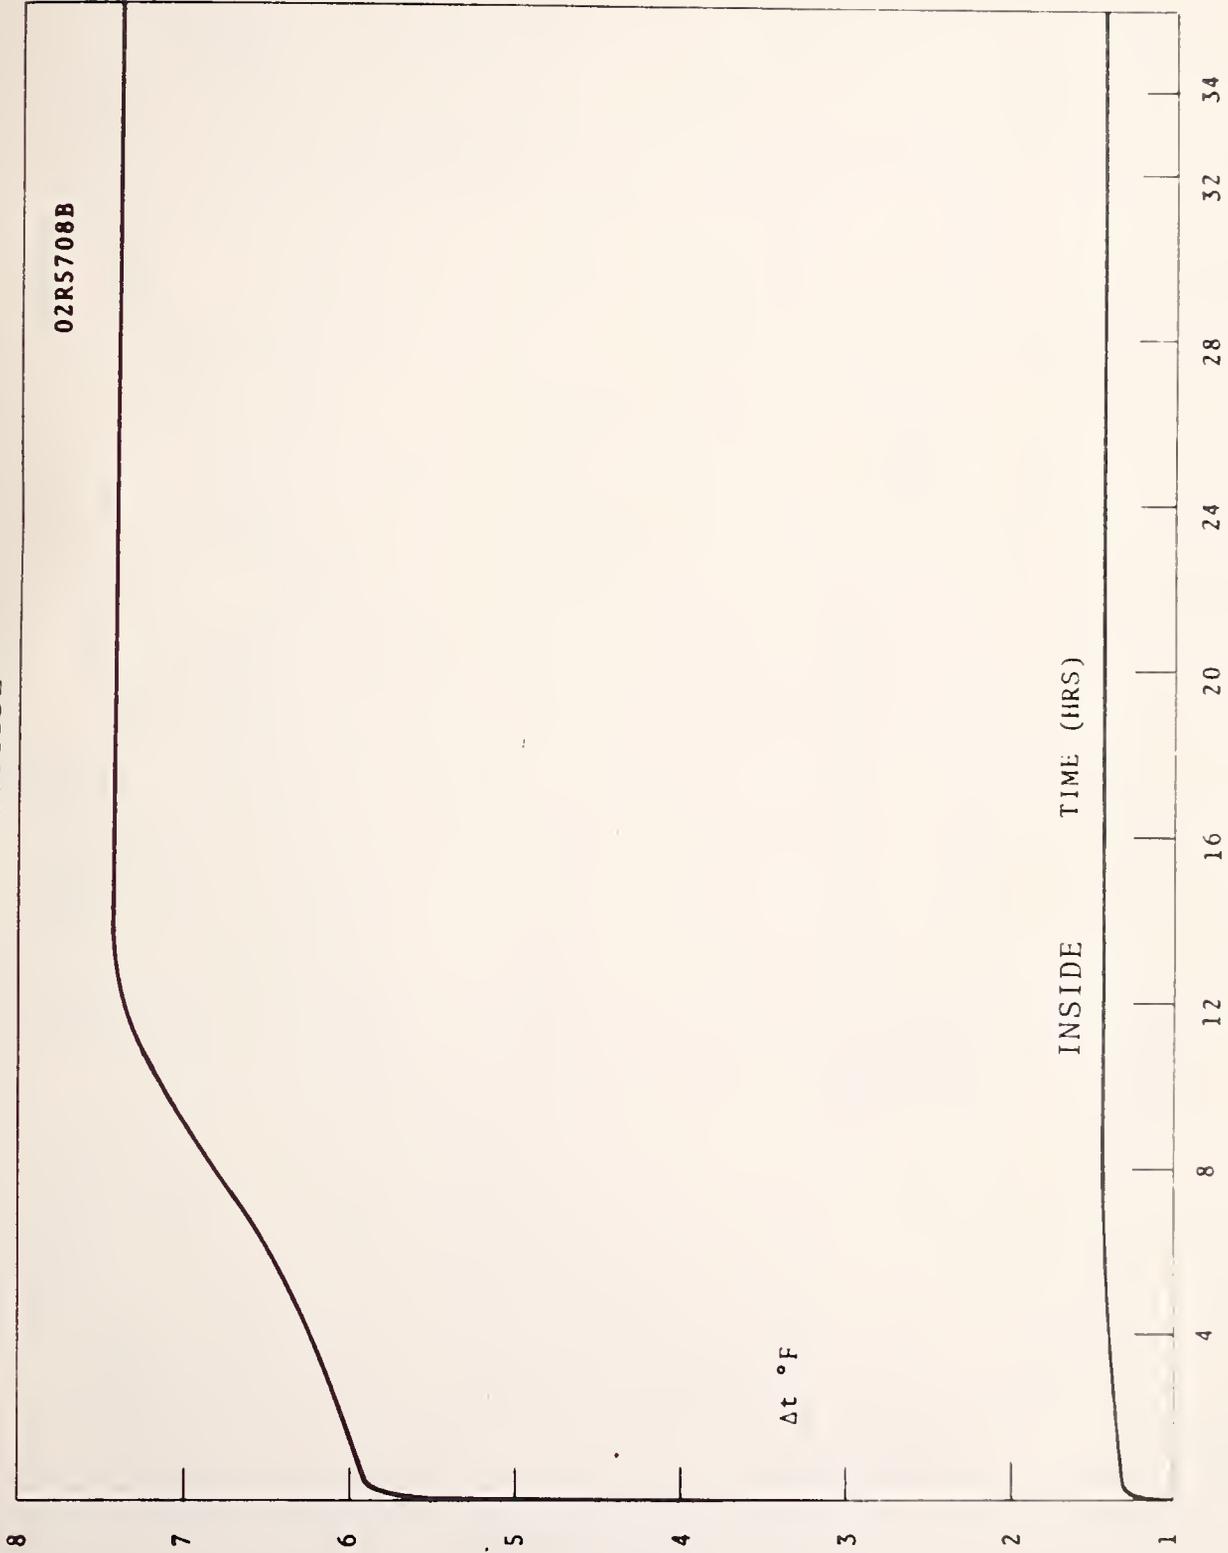
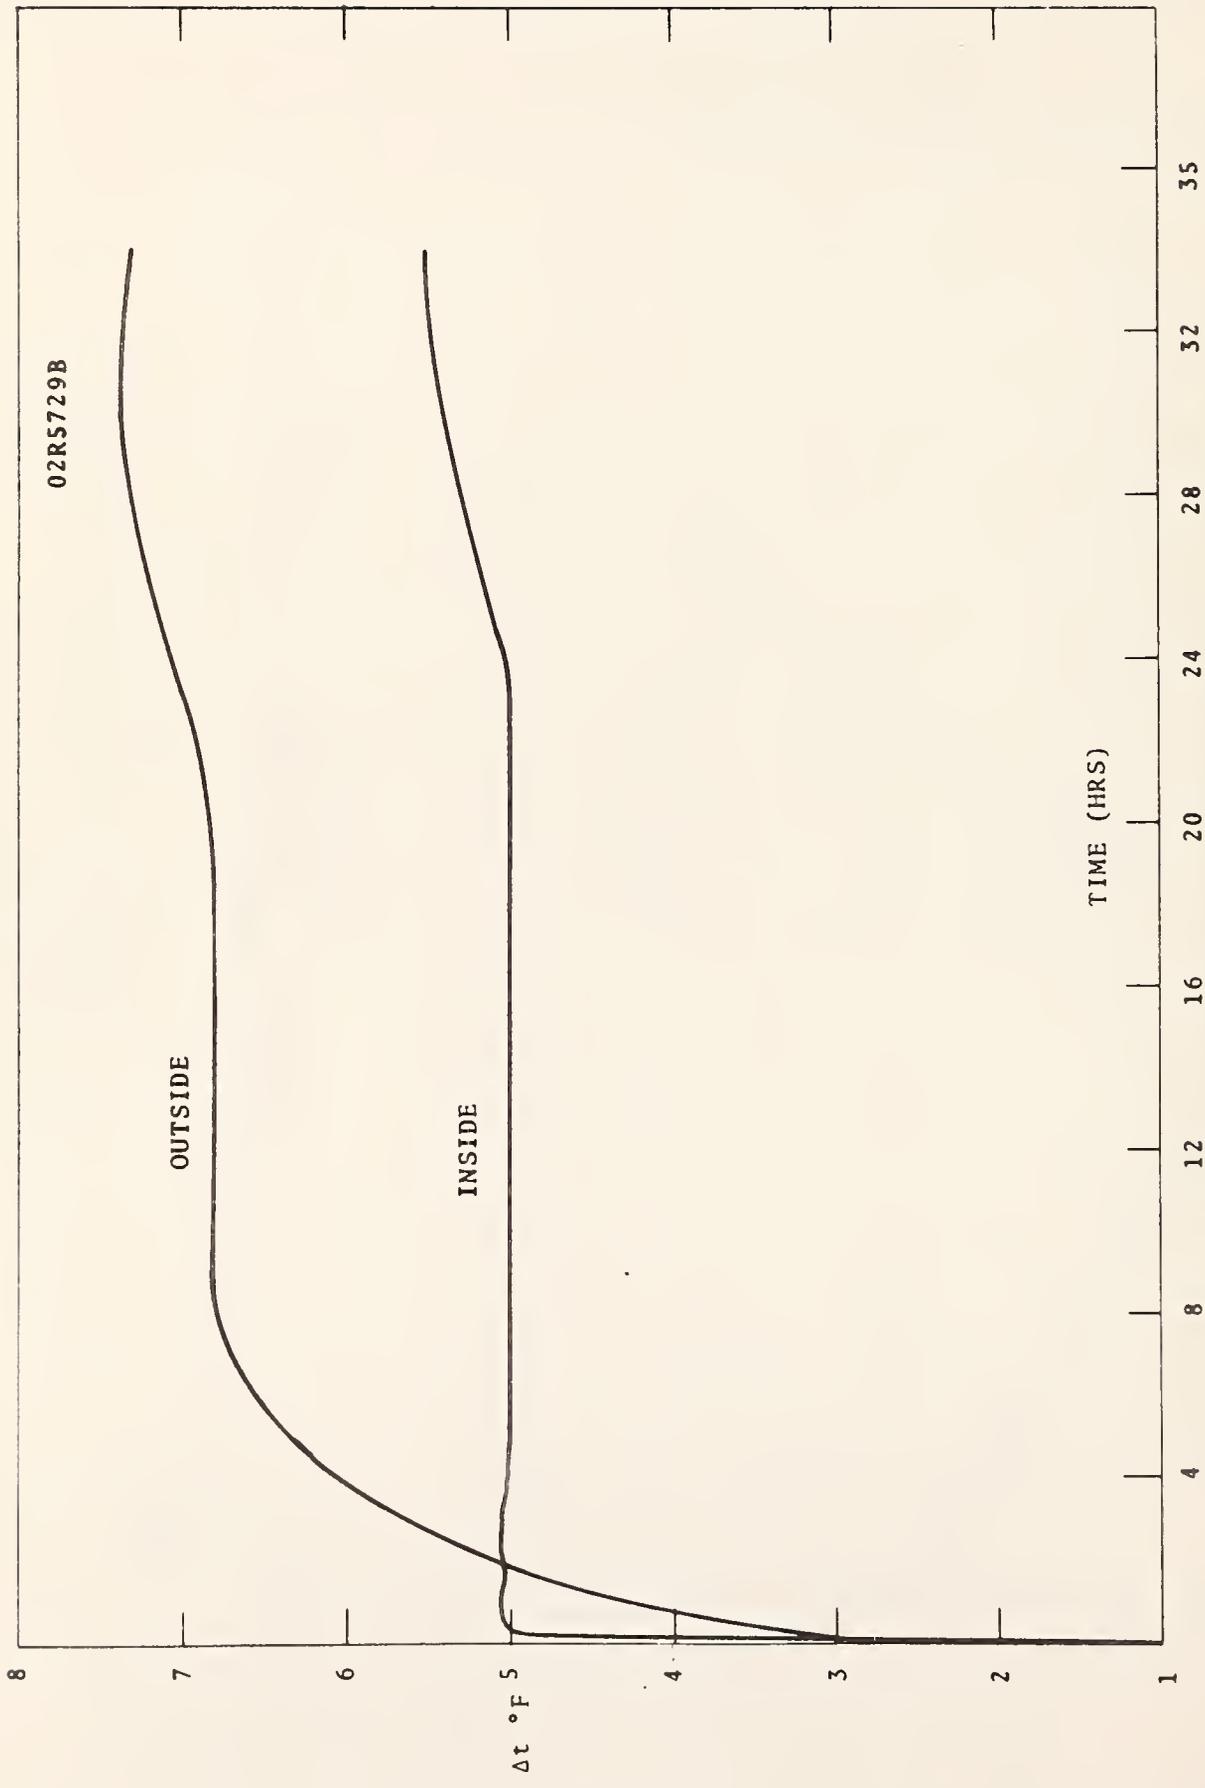
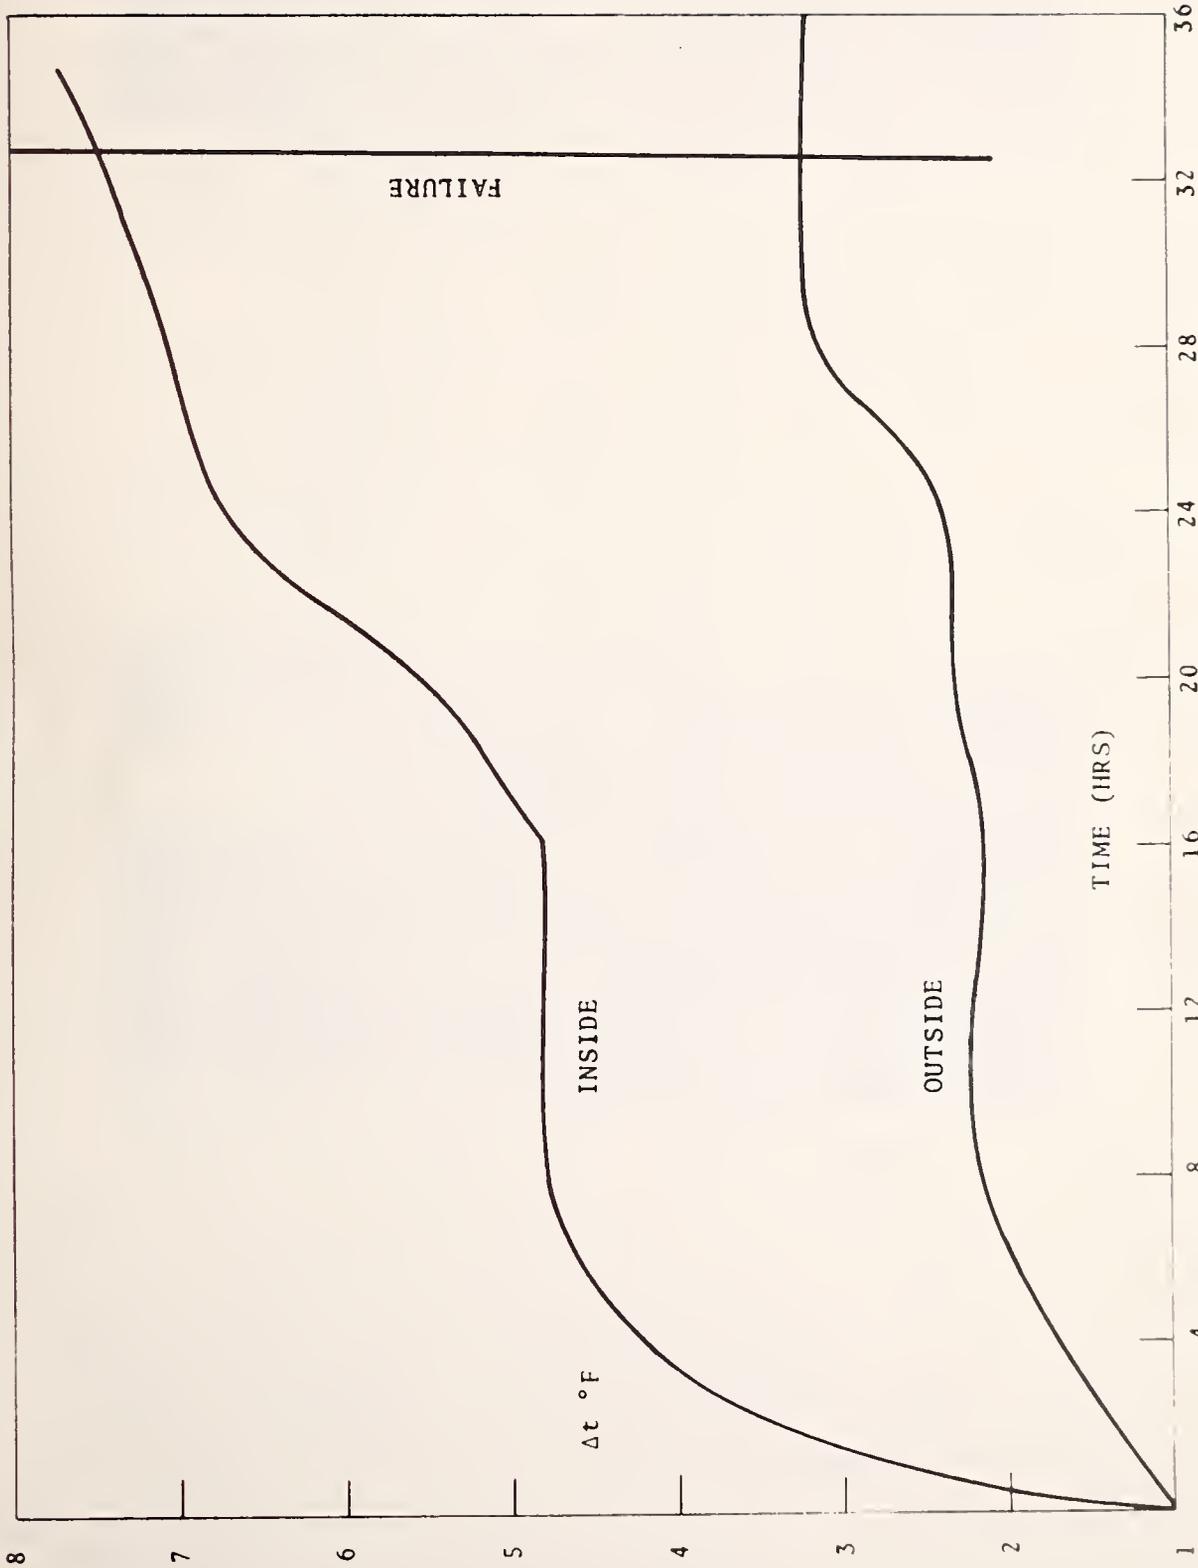
Temperature excursions around the tire shoulder are shown in Figures 10 through 15. Explanations are required concerning the data as follows:

- a. The abscissa is time in hours for endurance and minutes for high speed with the ordinate as peak-to-peak temperature difference obtained by dimension measurements by an optical comparator from the data contourograph (Figure 16) converted to degrees F by data in Figure 6.
- b. The thermal time constant for a tire under change of wheel conditions (i.e., force, inflation pressure, or speed changes) is less than 15 minutes and could not be observed readily in the contourograms from which the graphs were taken. Instantaneous changes may therefore

have been plotted as flattened trend lines. A more careful review of the data would probably identify these step functions as is done in the absolute temperature data. This suggests a peak to peak differentiation circuit for recording on a slow recorder as a function of time rather than a contourograph of the entire trace.

- c. On tire #02R5720C an equipment failure resulted in the accumulation of about 15 minutes of data at the end of the run. No changes were observed.

It is interesting to note that the only tire which exhibited radical variations > 50% in the latter part of its run did fail.
