# INFRARED EXPERIMENT A ROAD WHEEL DURING AN FMVSS 109 TYPE COMPLIANCE TEST

**Contract No. DOT-TSC-NHTSA-72-3**  
**June 1972**  
**Interim Report**

U.S. DEPARTMENT OF TRANSPORTATION  
NATIONAL HIGHWAY TRAFFIC SAFETY ADMINISTRATION  
WASHINGTON, D.C. 20590

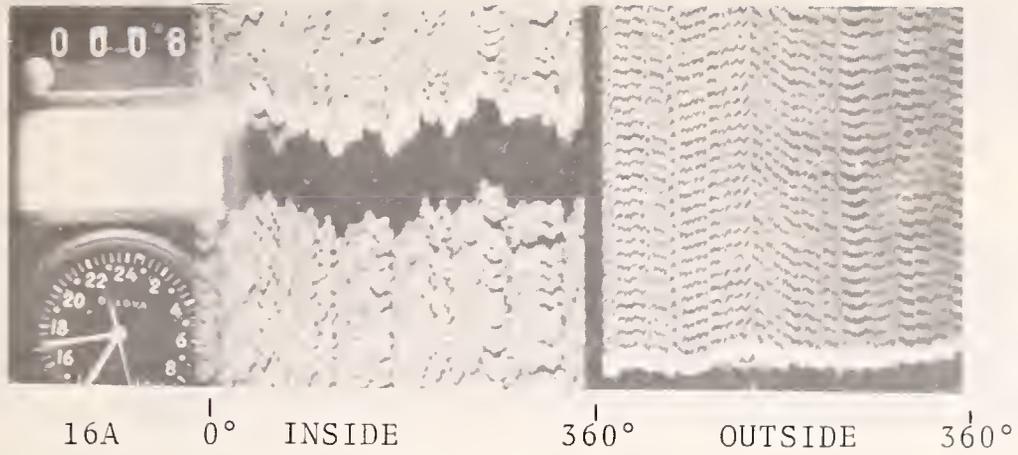
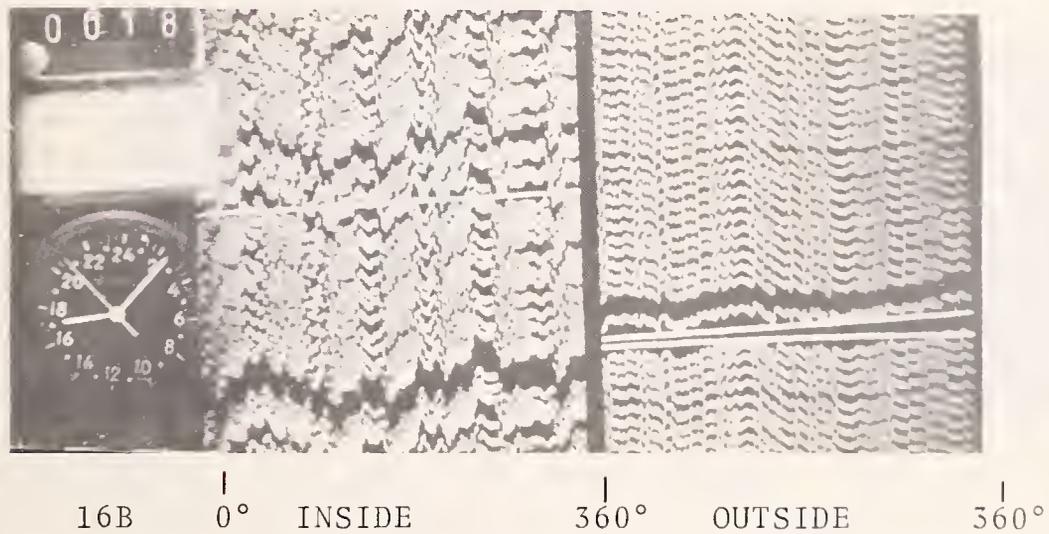
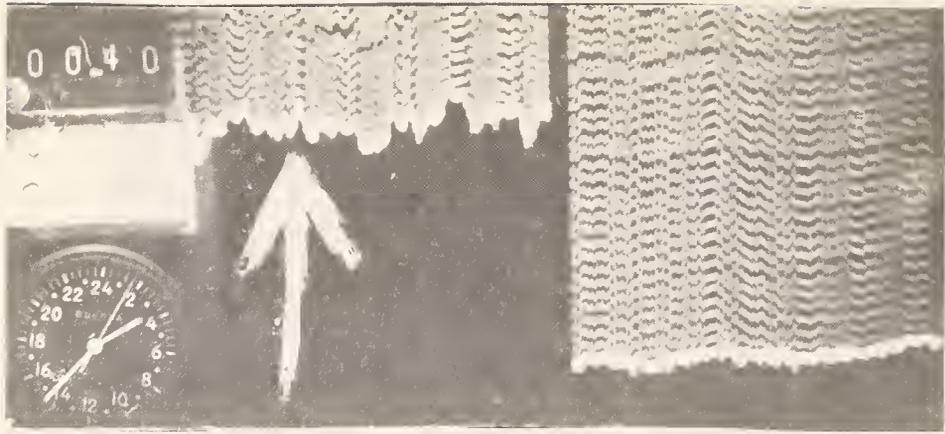
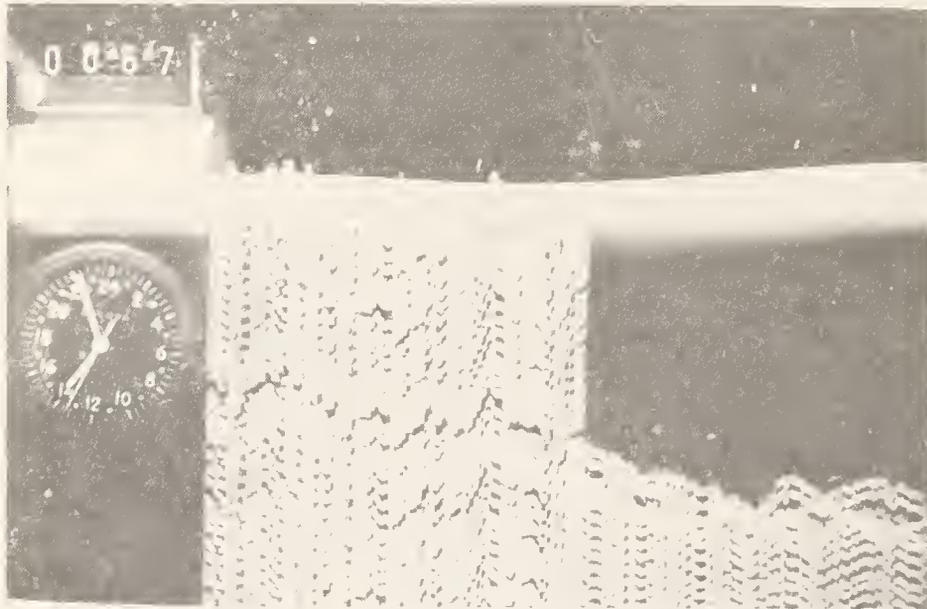
Figure 16. Contourographs of Tire Temperature

An examination of the specific contourographs is appropriate. In certain instances, however, the data obtained is in poor condition because it is sometimes difficult to read. The set up was taken to the field without any real means of setting parameters, gain stages etc. Since there is very little data in the literature about tire surface temperatures<sup>3</sup>, temperature ranges were set excessively wide with the result that signal fluctuations were rather small. Moreover, the early data contained a variety of film exposure and trace isometry experiments which tend to obscure the primary information. Figure 16 shows the contourograph for the failed tire 02R5703B which started at 0811 on April 17, 1972. It failed at 1353 the following day. The tire constantly ran with the inside shoulder about five degrees hotter than the outside. At about midnight, the inside shoulder developed a hot spot about a third of the way from the left edge of the inside trace. Figure 16C shows this at time 0336 AM. The left edge is obscured by the identification tab but superposition of trace 16C with trace 16A or 16B shows a definite rise of about 3°F at the arrow. By the time of failure both traces had shown radical excursions (about 2° outside, 5° inside) and failure occurred immediately thereafter.

INSIDE P-P  $\Delta t = 0.070'' = 4.4^\circ$

OUTSIDE  $\Delta t = .03 = 1.9^\circ$

INSIDE      .1" = 6.4°f

OUTSIDE      .05" = 2.2°

FAILURE OCCURRED AT 1353

The data presented indicate that tires follow a fairly predictable thermal pattern during compliance tests and that departures from this pattern may be precursors of failure. Examination of the one failed tire indicated that the cause of failure was a fabric rupture in the plies that was not observed prior to re-treading. Reversion occurred in the rubber around this area which was adjacent to the hottest tread location; consequently conditions were conducive to failure.

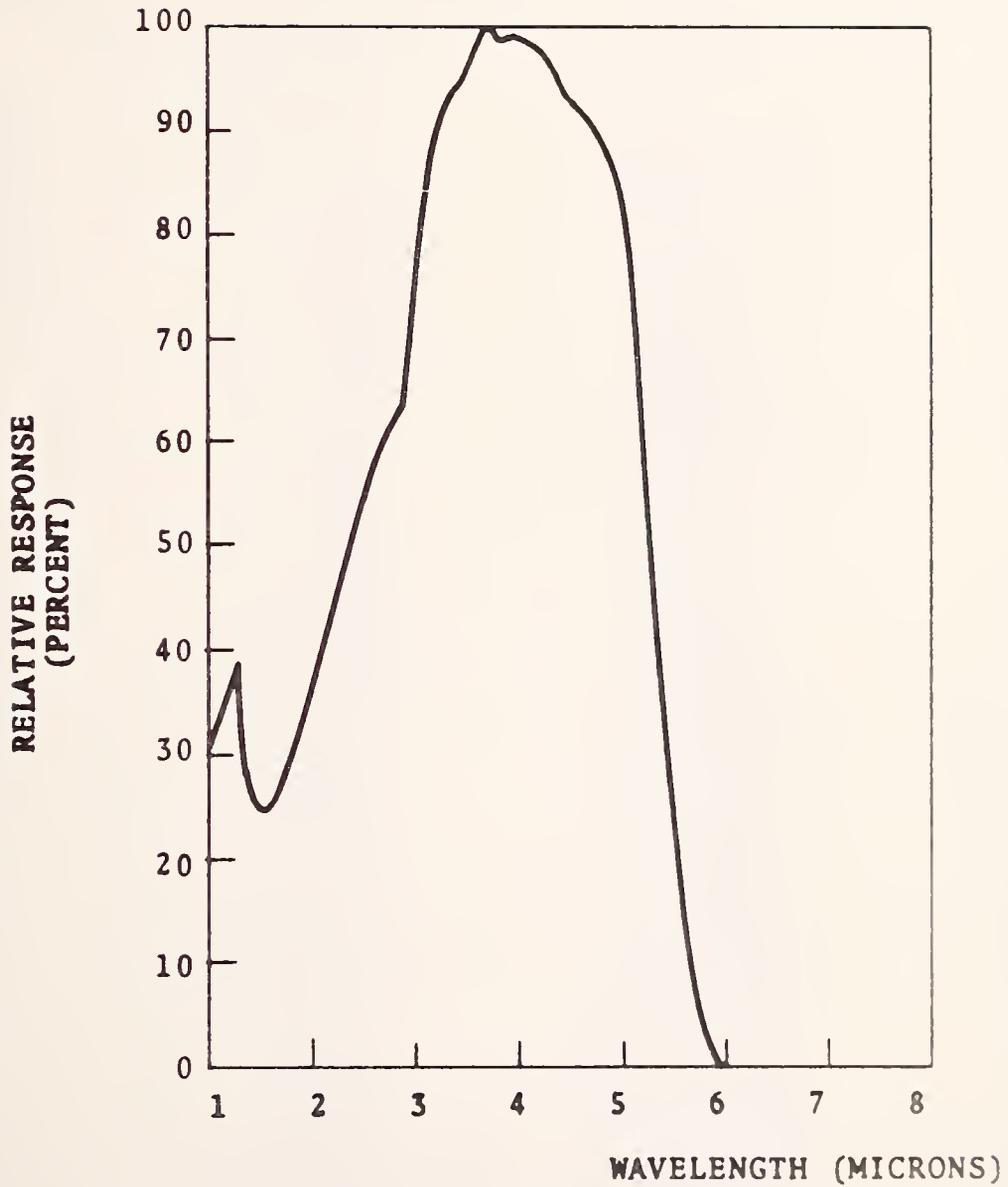
Figure A-3. Spectral Response

Spectral Composite of InSb  
 Detector (77°K) As<sub>2</sub> As<sub>3</sub>  
 objective lens, Silicon
