# Installation of Existing Lift Systems for the Handicapped on Light Rail Vehicles

Prepared by  
The Budd Company

May 1985  
Final Report

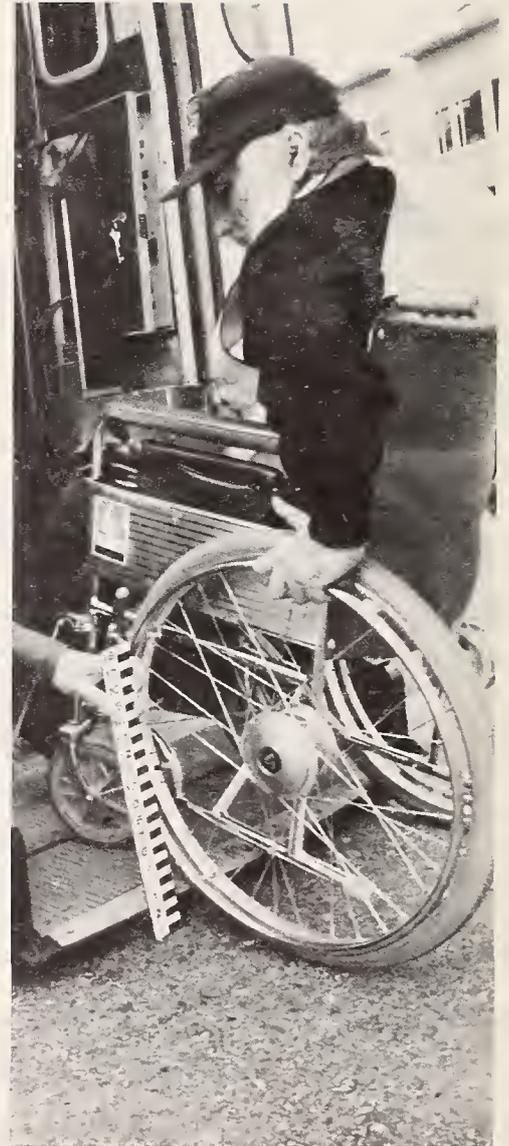
FIGURE 5-5. WHEELCHAIR USERS NEGOTIATING 2" GAPS

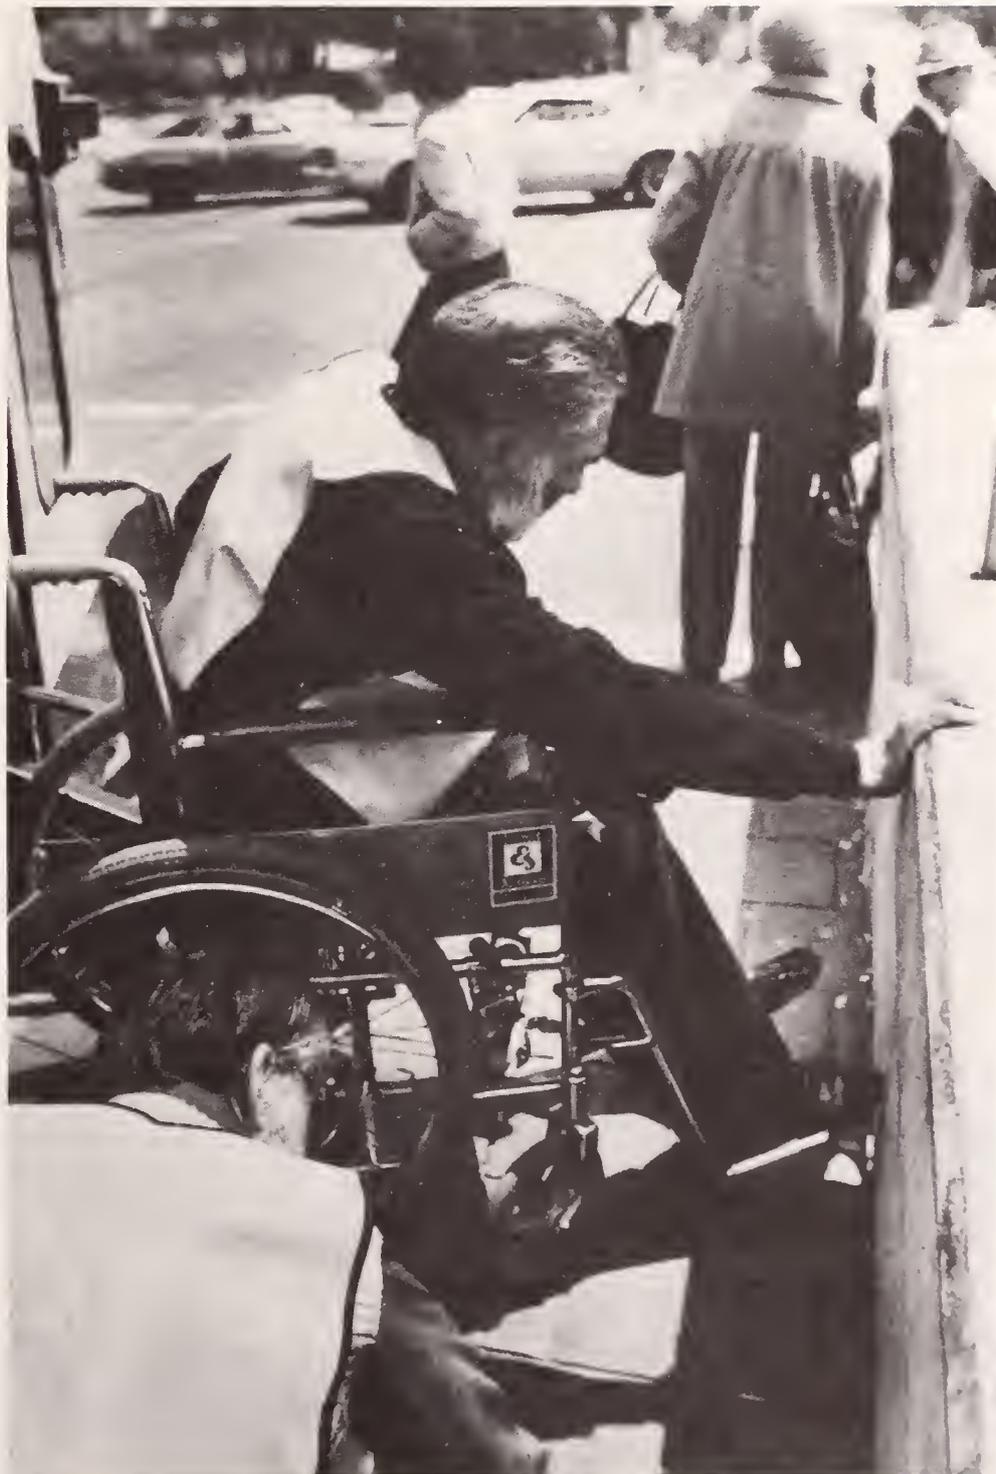
FIGURE 5-8. LIMITATIONS OF NARROW PASSENGER ISLANDS

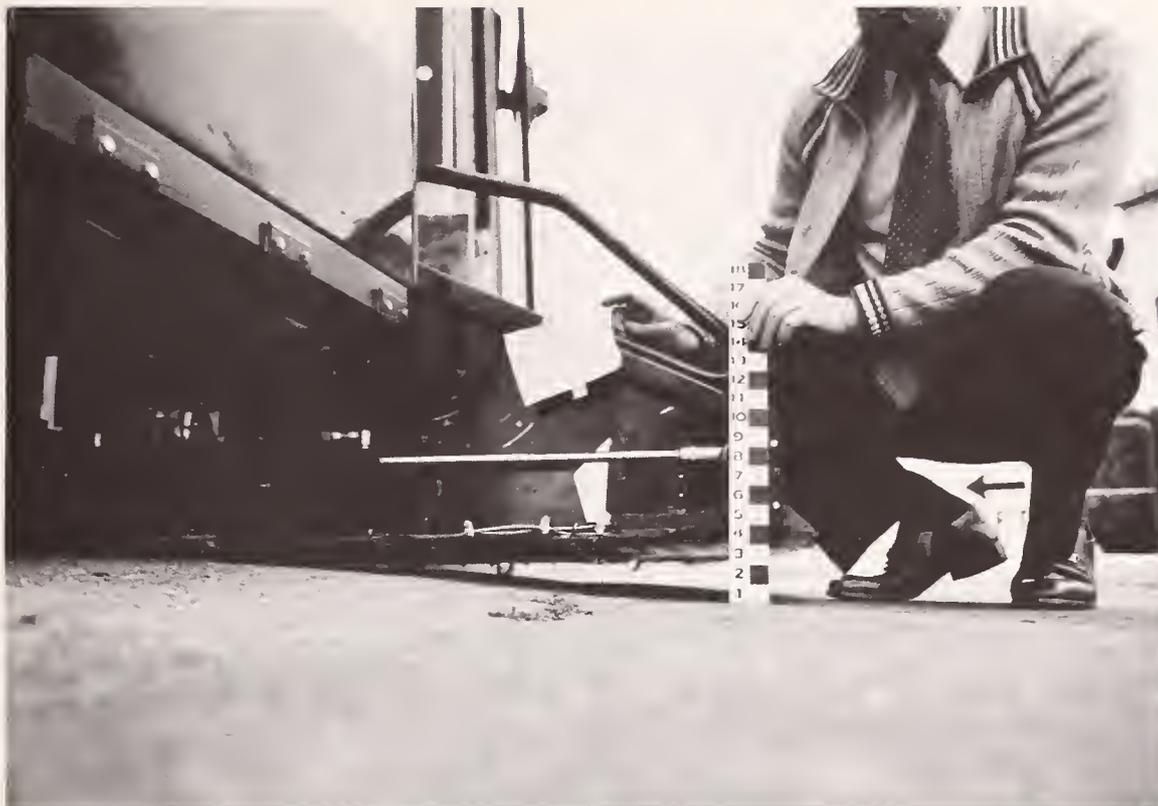
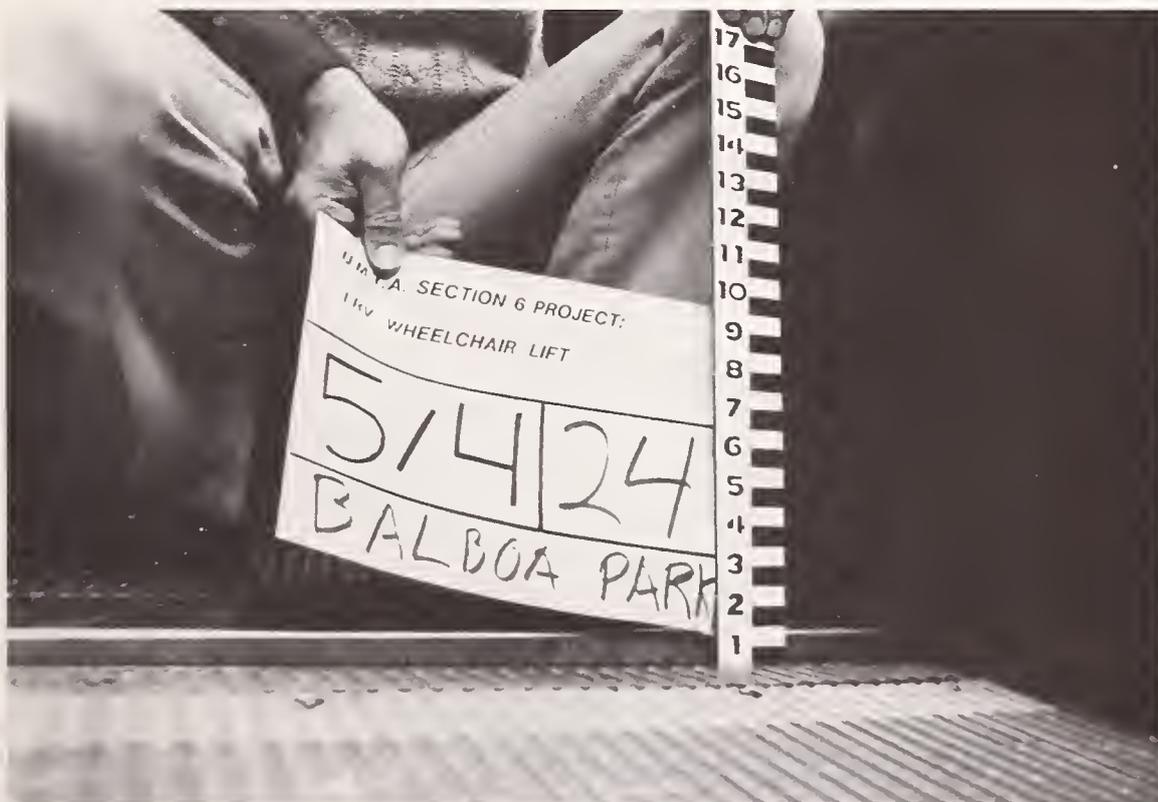
FIGURE D1-9. IMPACT OF EXCESSIVE STREET CROWN (TOP) INSTANCE OF RAISED PLATFORM UNDER LOAD NOT FLUSH WITH LRV FLOOR (BOTTOM)

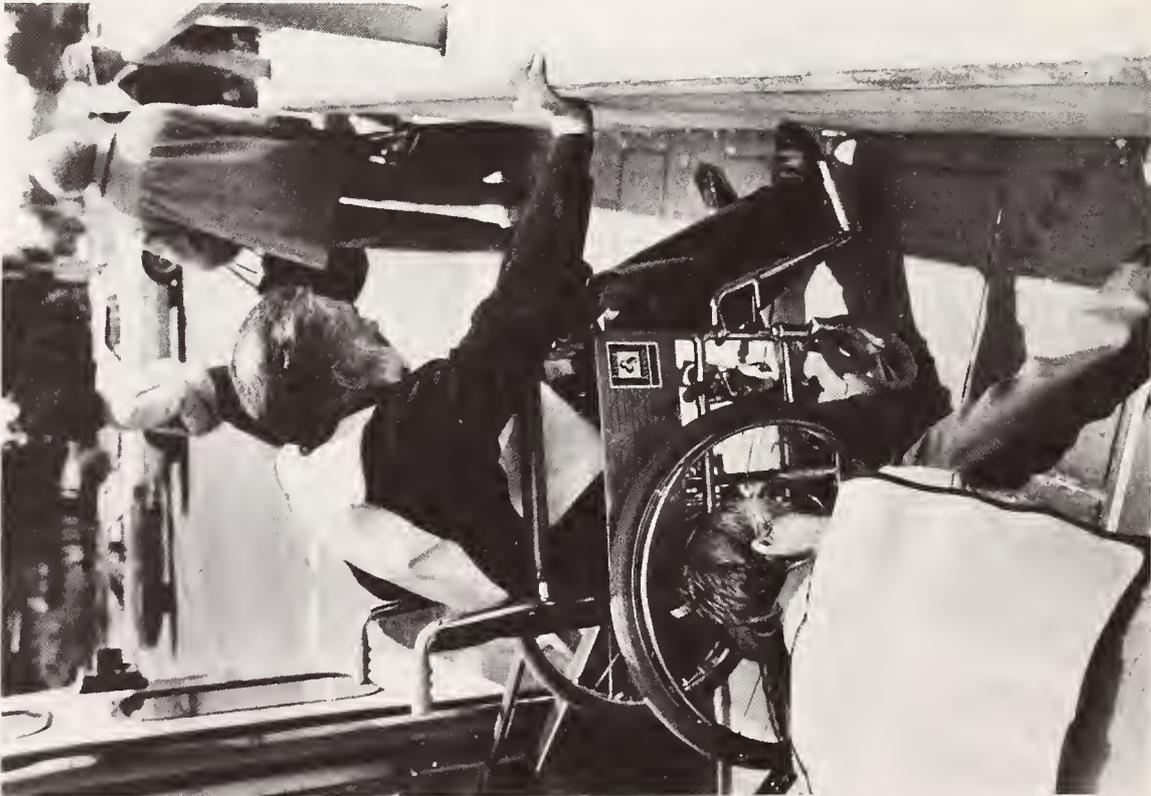
Photographs courtesy San Francisco Public Utilities Commission Photo Division  
FIGURE D1-10. a. VOLUNTEER CANNOT DEBOARD ON 45" WIDE PASSENGER ISLAND  
b. SILOUETTE OF LIFT WHILE BEING STOWED (MAKING STEPS):  
NOTE NEED FOR SAFETY COLORS (BOTTOM)
