**FINAL PROJECT
REPORT #00042134-04-103
Volume III**

**FRP Reinforcement for
Concrete: Performance
Assessment and New
Construction**

**Volume III: Construction and
Monitoring of the Innovation Bridge**

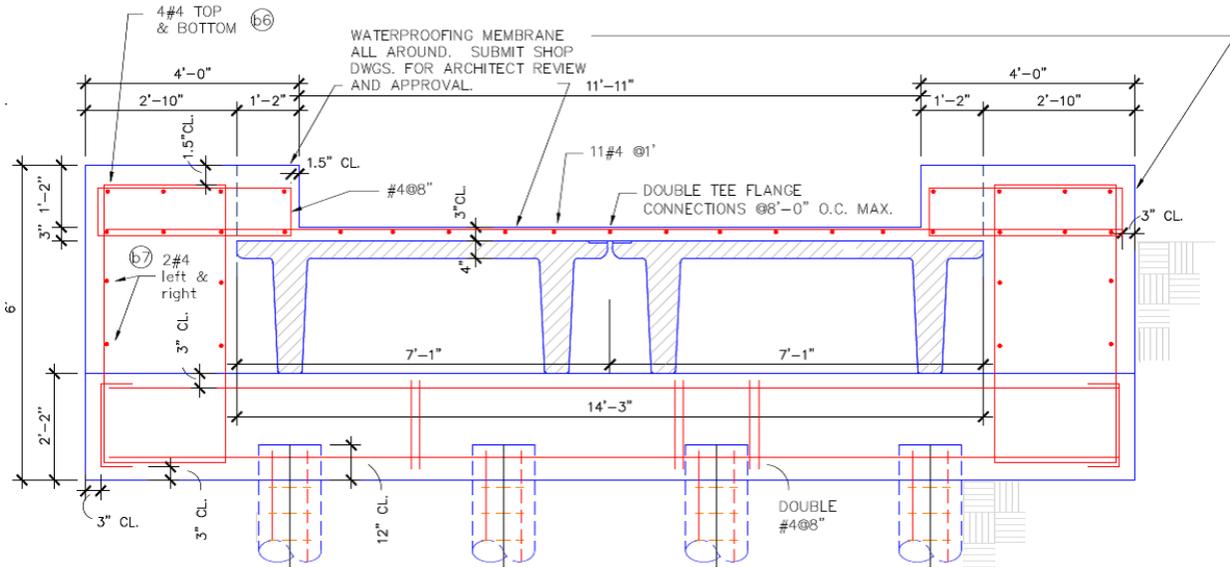
Figure 1: Bridge cross-section at pile cap

Figure 1 shows a cross-section of the bridge over the pile cap. The drawing reports dimensions and some reinforcement details for the main elements of the structure that are presented and discussed in the photographs to follow according to the construction sequence. Appendix 1 illustrates in more detail the construction phases through a sequence of pictures taken on-site.

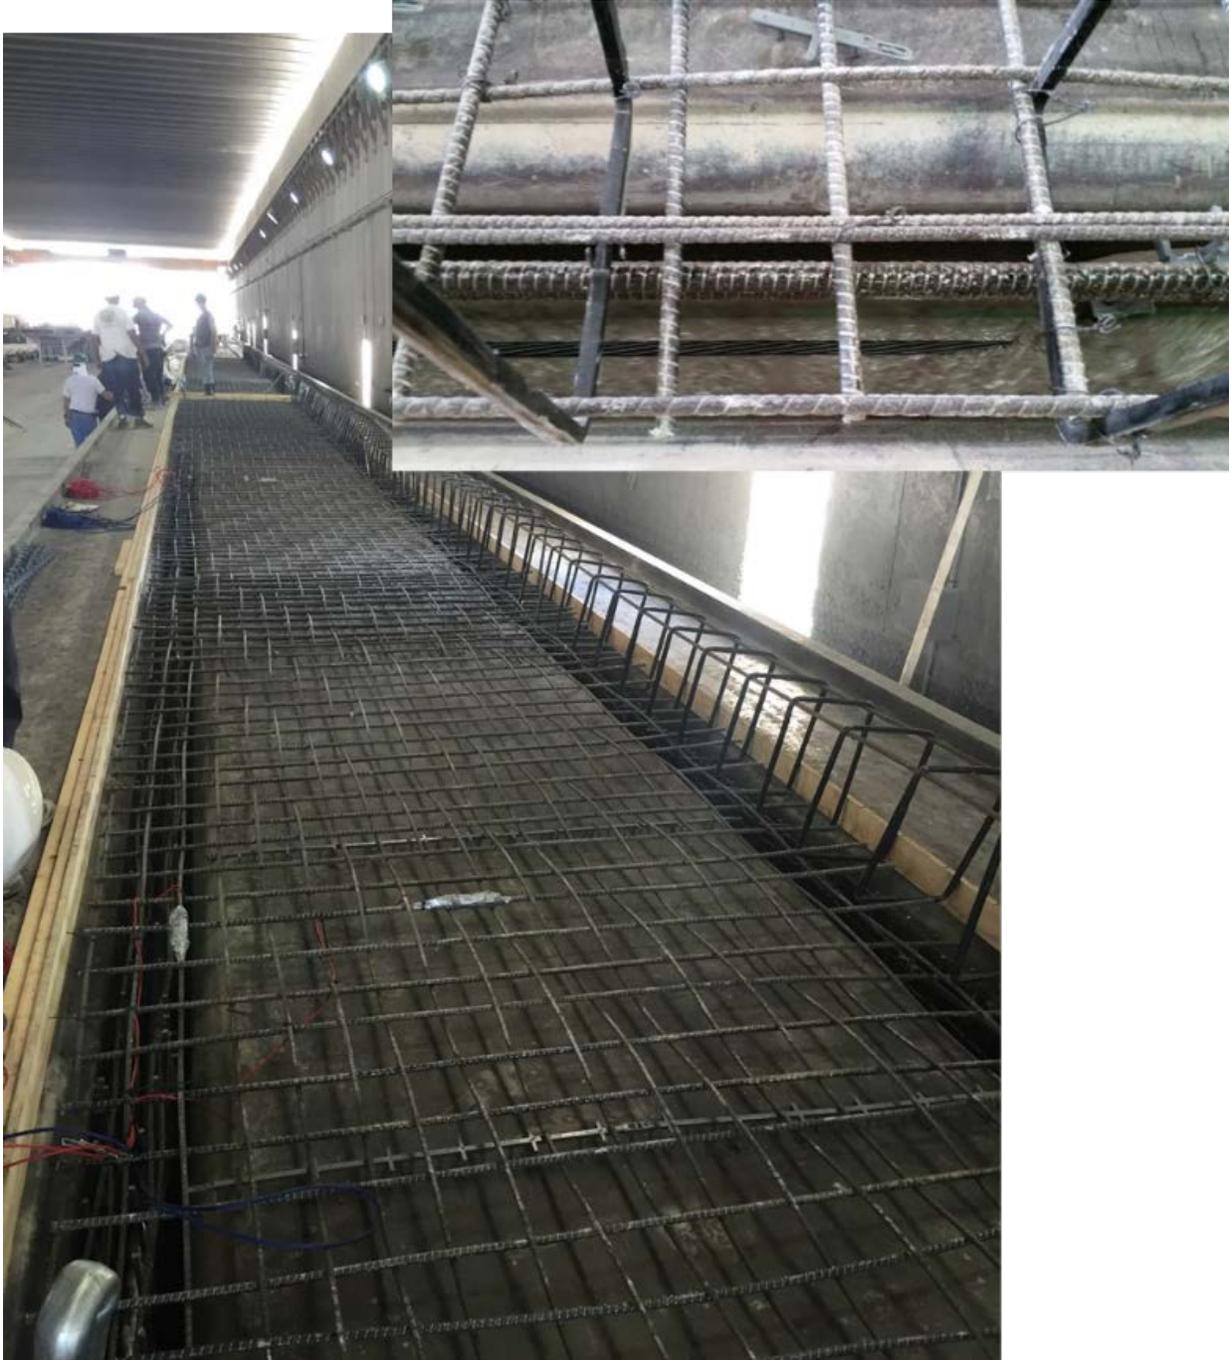
Figure 2: Double-tees casting bed and detail of BFRP reinforcement at casting

The reinforcement grids for both stems and flange were made of pre-assembled interwoven BFRP bars (#3 and #4 at spacing 6 in. o.c., respectively). Figure 2 shows the casting bed for the two in-line DTs after the CFRP tendons were prestressed and all BFRP reinforcement was in place. Visible in the photograph are the continuous close stirrups to reinforce the curbs to be cast-in-place at the site. Also visible are two VWGs encapsulated in a protection shield and installed on the BFRP bars over the stem (longitudinal direction) and across the mid flange (transverse direction). The top insert is a close up view of the reinforcement over the stem while the self-consolidating concrete is being poured. Visible are: the top 7-wire CFRP strand; the supplemental top #7 BFRP bar over the stem; the BFRP top mat; and, the continuous close stirrup.

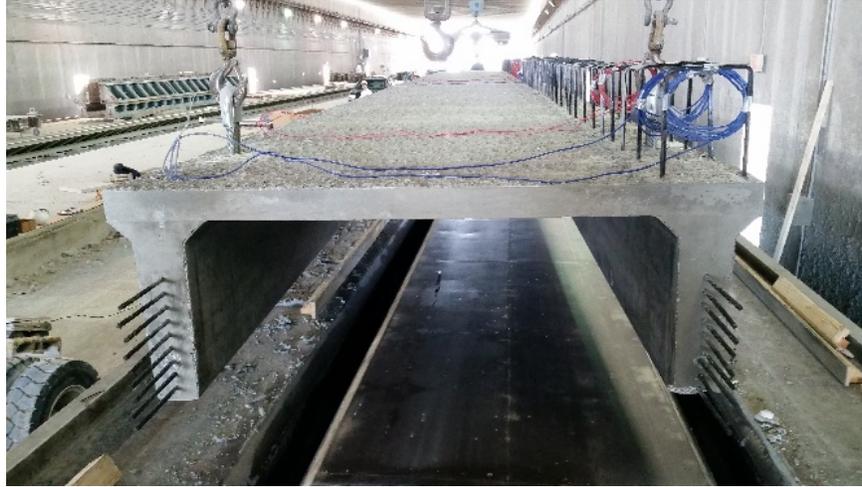
Figure 3: Double-tee being lifted from the casting bed

Figure 3 shows one of the DTs being lifted from the bed a day after casting. Visible are the nine plus nine CFRP tendon terminations and the continuous close stirrups for curb reinforcement. The red and blue cables connect the VWGs installed on tendons, reinforcing bars and concrete. The VWGs in the tendons helped confirming the degree of prestressing at tensioning and following stages.

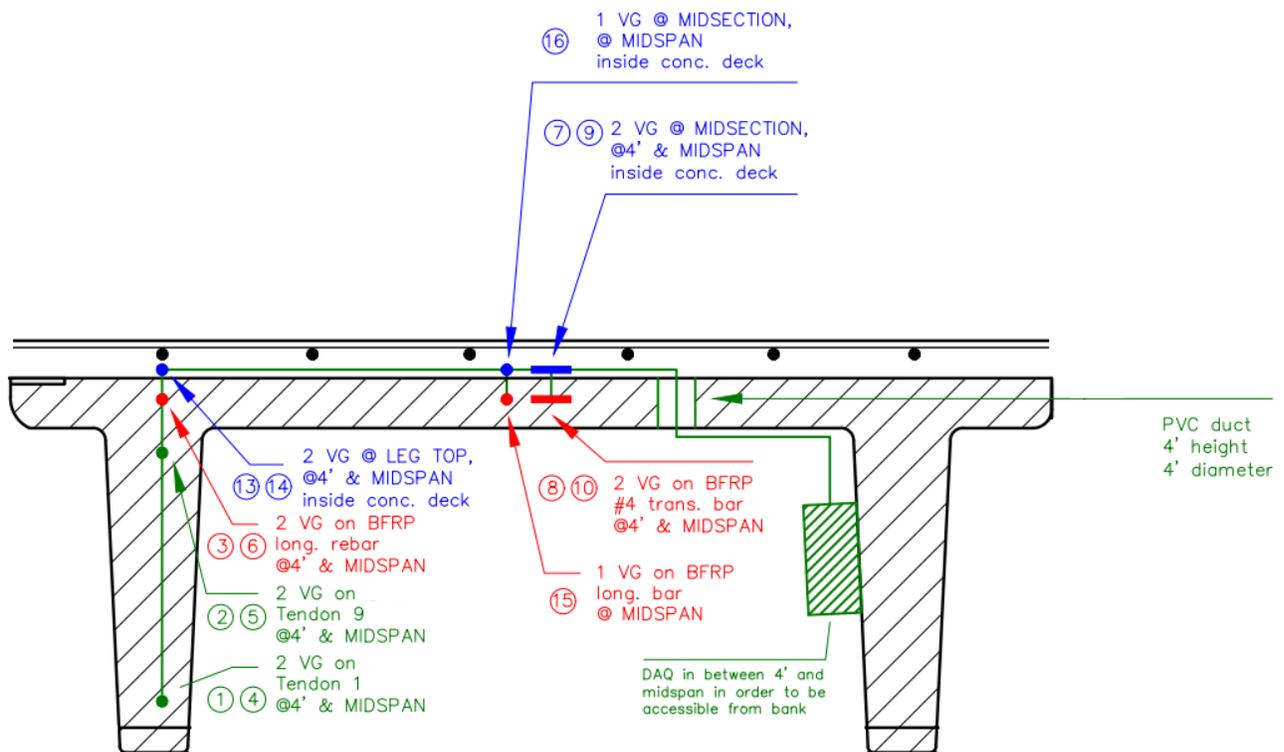
Figure 4: Double-tee cross-section and instrument locations

The cross-section of the girder presenting location of strain gauges is shown in Figure 4. The schematic drawing illustrates the different type of strain gauges installed prior pre-casting and their location along the span length and with respect to the controller box installed on-site after conclusion of construction process. Appendix 2 presents a detailed report on the PC girders.

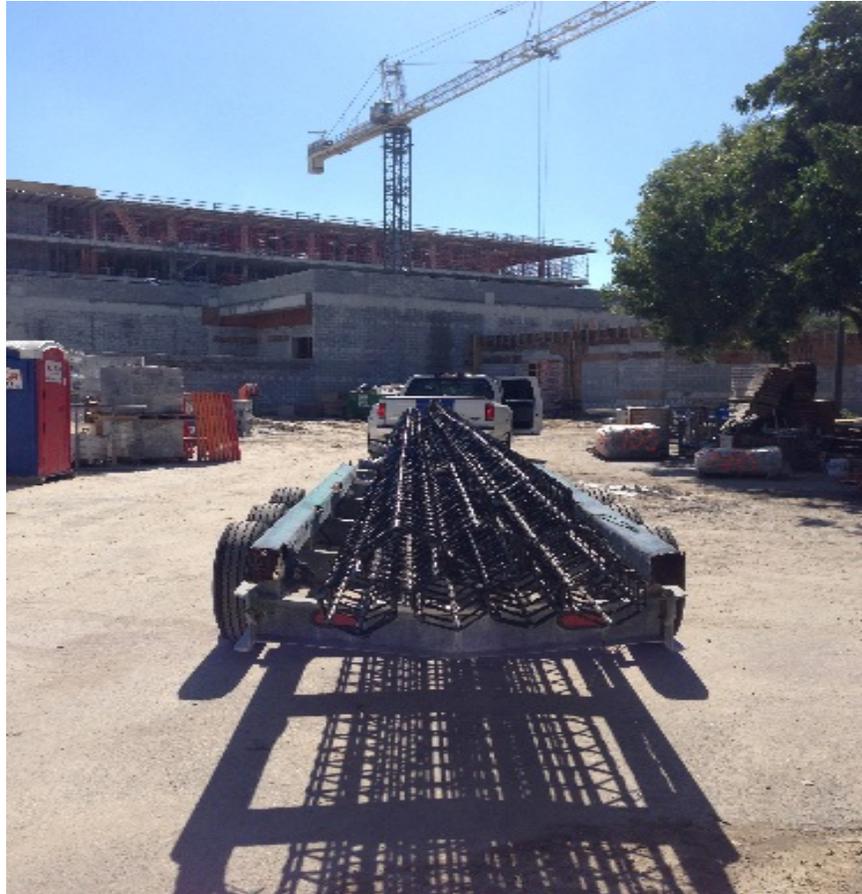
Figure 5: Delivery of BFRP pile cages at the site

The eight, 16-in. diameter, 40 foot-long auger-cast piles were reinforced with a prefabricated cage of six #6 BFRP bars and #3-equivalent BFRP spirals. The cages (in the shape of hexagons) were prefabricated at the composites manufacturer's plant and delivered to the site, ready for installation as shown in Figure 5. The factory prefabrication ensured high product precision and speed of on-site installation. Each cage was light enough to be picked up by two workers and moved without the use of any equipment. This application is a world "first" and takes advantage of precision manufacturing.

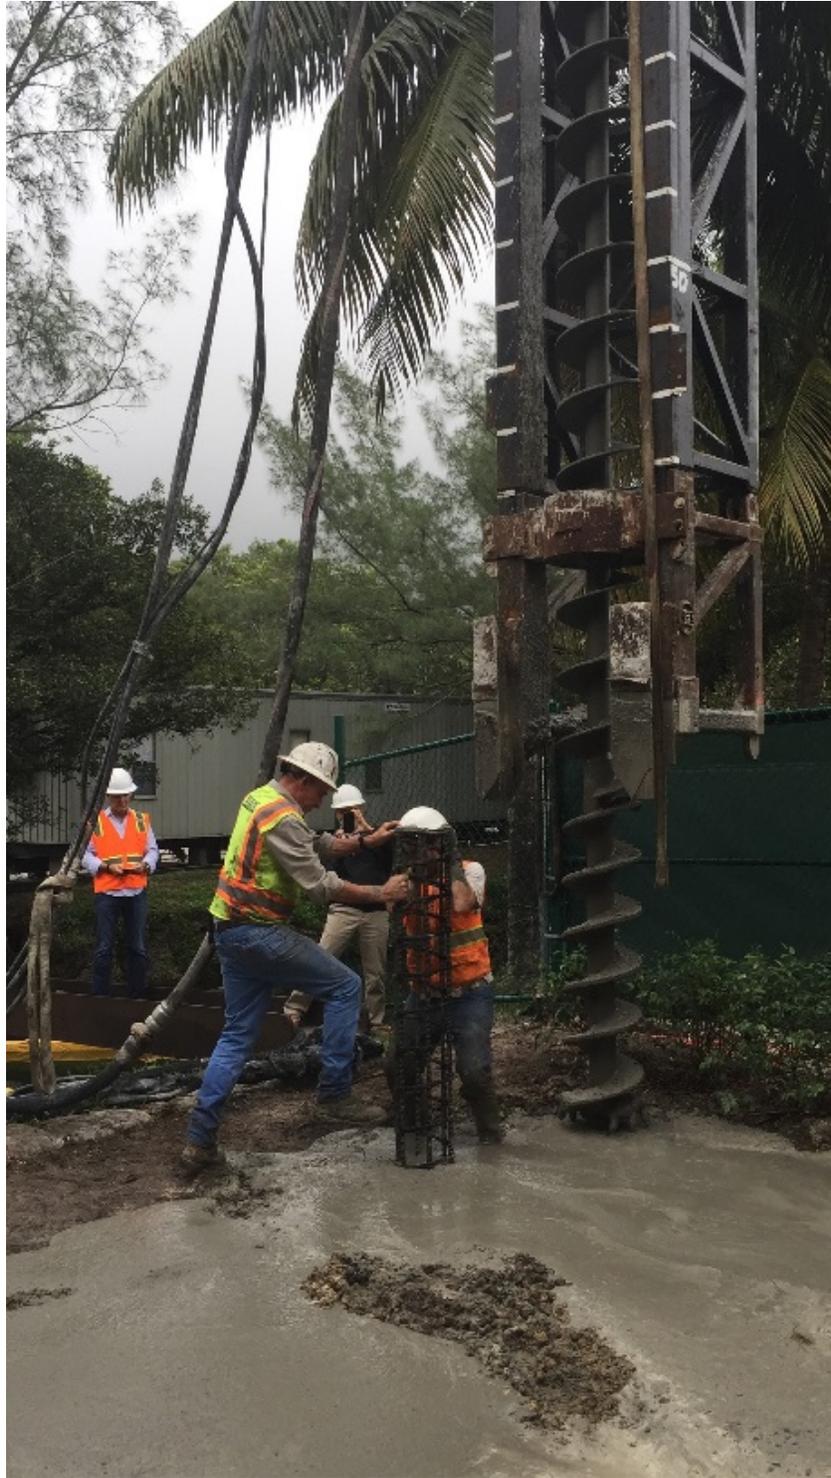
Figure 6: Construction of auger-cast pile

The final phase of construction of one of the piles is shown in the photograph of Figure 6 where workers are seen pushing down into the grout-filled hole the last 5 feet of the reinforcement cage. Since the FRP weight is approximately one fourth that of steel, the cage did not spontaneously sink in and workers had applied some direct force. This could have easily been done by using the scoop of the backhoe or by climbing onto the spiral as shown in the photograph. The latter was possible given the excellent chemical adhesion of the spiral to the longitudinal bars.

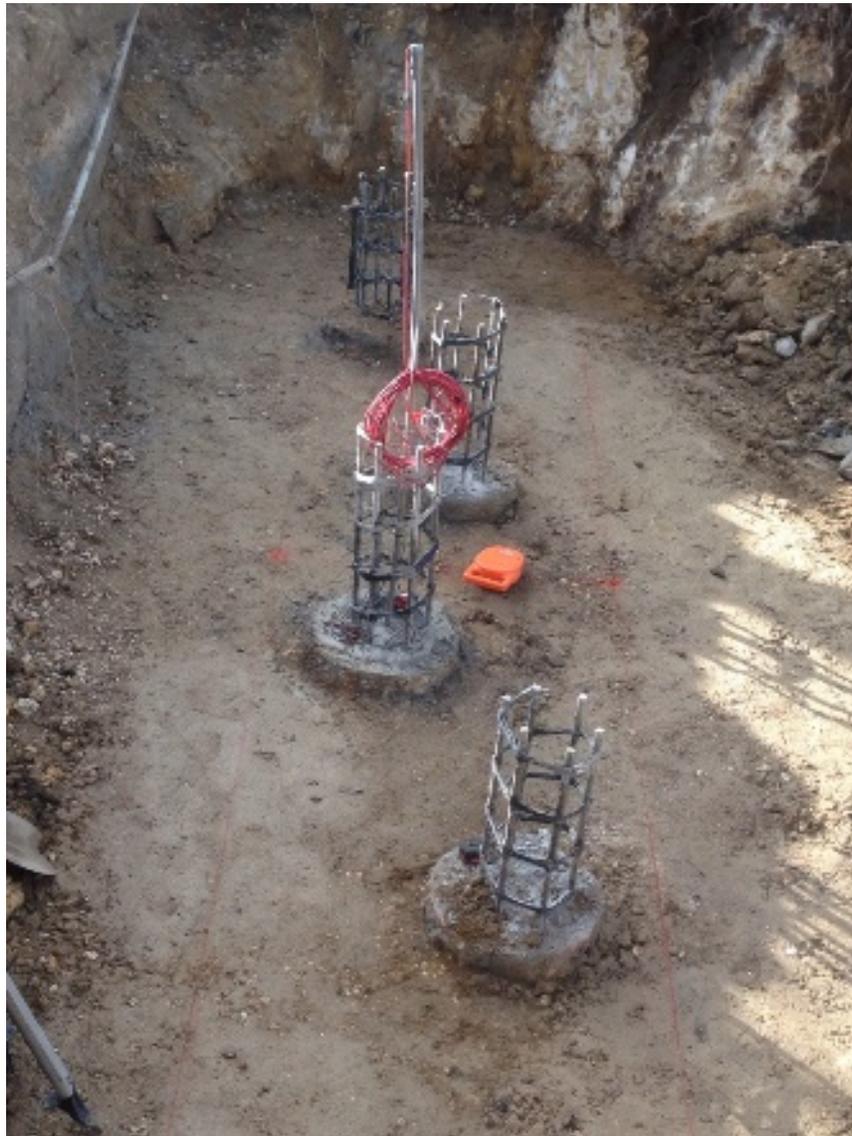
Figure 7: Exposed reinforcement in piles

Figure 7 shows the termination of the four piles at one abutment with exposed reinforcement after grout removal. This operation was simple and did not cause any damage to the BFRP cage. Exposing the pile reinforcement was not a design requirement since conventional bridge practice for pinned pile connection to the cap simply requires the pile to be cut flush and extend one foot

into the cap. Exposing the reinforcement was selected to demonstrate the feasibility of the grout demolition process and the resilience of the FRP reinforcement. The red cable coming out of the second pile in the photograph connects to two VWGs installed on the pile longitudinal bars.

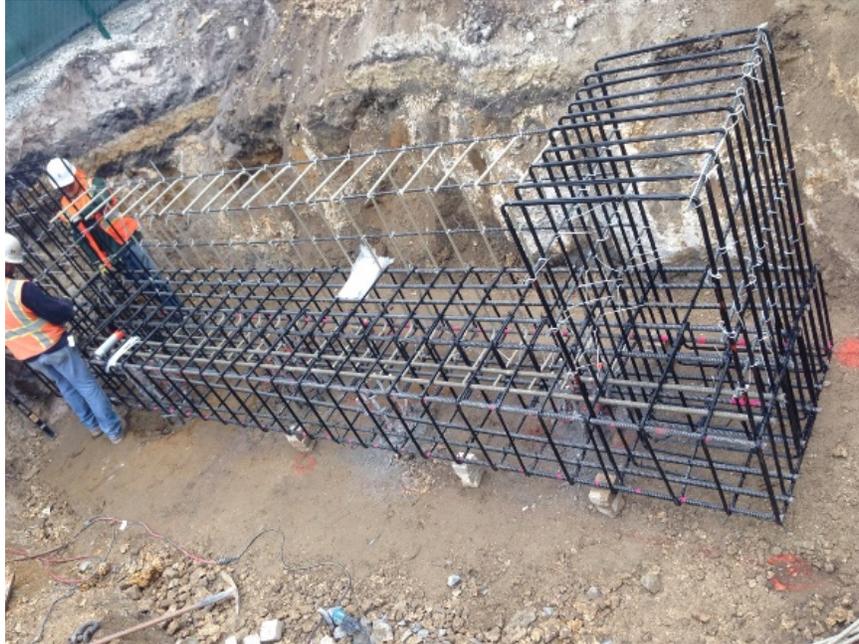
Figure 8: Reinforcement cage for pile cap, side blocks and back-wall

The pile caps, side blocks (to support the lampposts) and back-walls are made of concrete reinforced with straight BFRP bars, bent GFRP bars and continuous close BFRP stirrups. The application of continuous close BFRP stirrups is a U.S. “first” which takes advantage of performance efficiency of the composite reinforcement when continuity of the fibers is assured. Because of their geometry, close stirrups do not require surface deformation to provide a mechanical bond to concrete. Additionally, the radius of curvature of the bend can be tighter as fibers need not slide over each other as required when bending a straight pultruded bar before the resin polymerizes. Figure 8 shows the completed assembly of the reinforcement cage for pile cap, side blocks and back-wall. The “U-shaped” deformed GFRP bars were used as the reinforcement for the back wall and were spliced into the deck reinforcement.

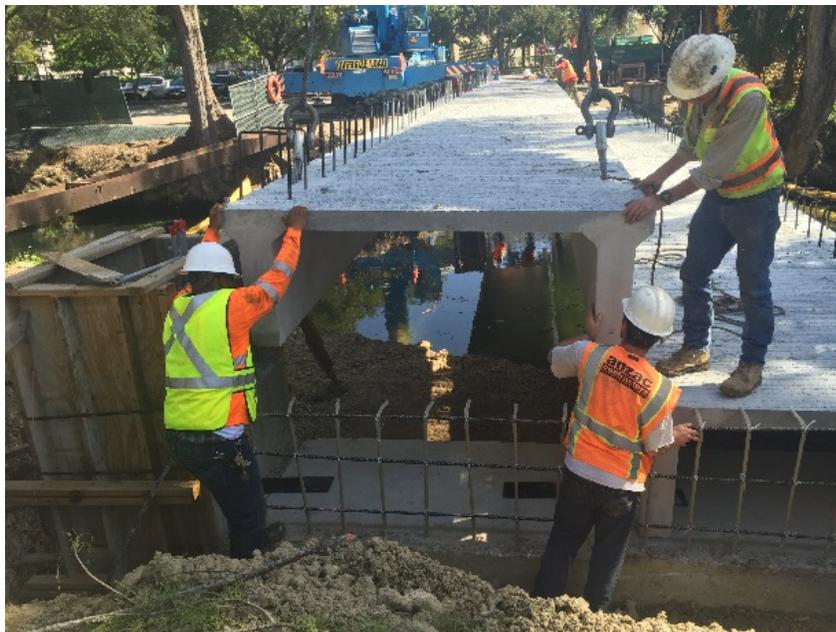
Figure 9: Installation of girder

The installation of the second bridge girder is depicted in the photograph of Figure 9. Visible are the two neoprene rubber pads over the cap to provide contact with the stainless steel bearing plates mounted in each stem. Also visible is the back-wall reinforcement.

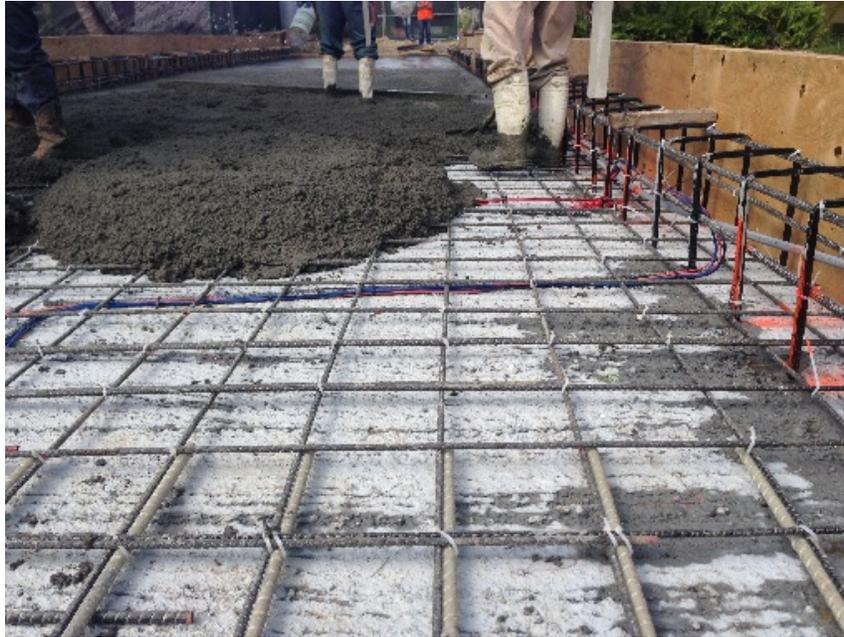
Figure 10: Casting of the deck topping

The cast-in-place, 3-in. concrete deck topping was reinforced with a grid of BFRP bars (#3 at 8 in. spacing in both directions).

topping over the BFRP mat. Visible to the right are the stirrups for the curb reinforcement. In the foreground are the GFRP bars used to splice the back-wall U-shaped GFRP deformed reinforcement.

The blue and red cables connect the VWGs installed on the BFRP mat.

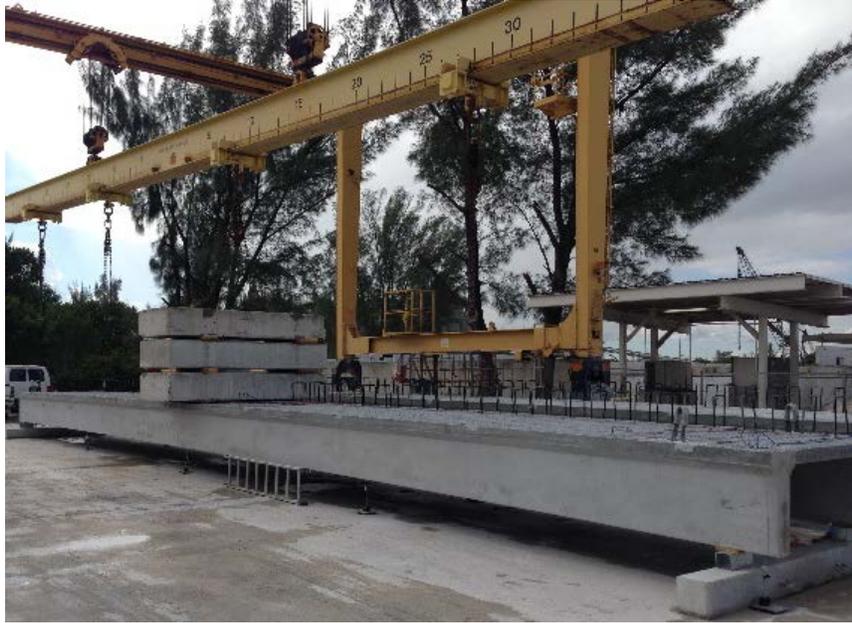
Figure 11: Double-tee static load test at precast yard

The simply supported girder was loaded with three concrete blocks at its mid-span for a total load of 27 kip plus self-weight. The total dead and live load corresponded to a maximum mid-span moment of 785 ft.-kip, which corresponded to 85% of the first-crack moment computed as 922 ft.-kip.

The results of the load test in terms of strains in the reinforcement and concrete and quarter-span/mid-span deflections measured with linear variable differential transformers (LVDTs) matched the analytical prediction. Appendix 2 provides detailed load test results.

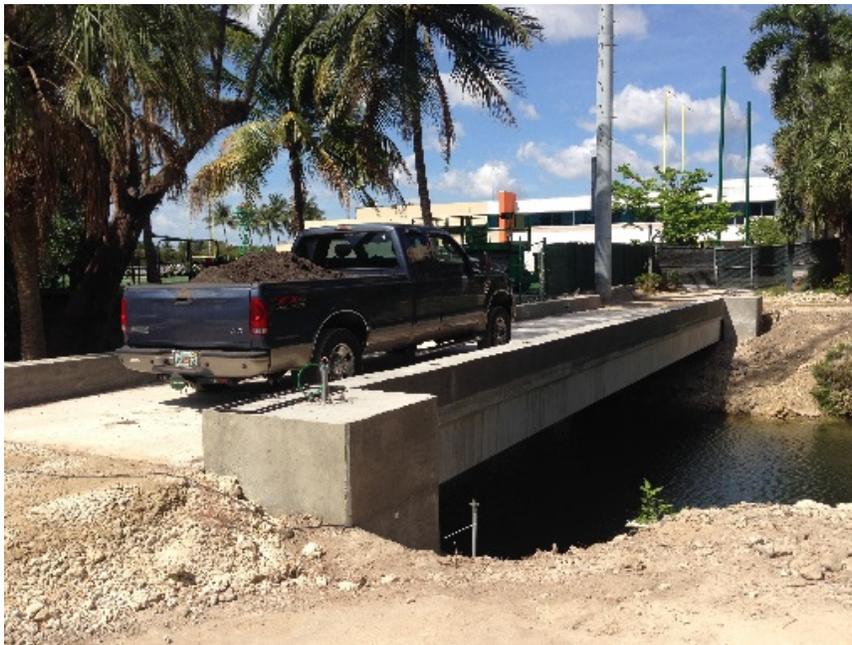
Figure 12: Load test at completion of superstructure construction

Figure 12 shows the fully loaded pick-up truck used for the first field load tests. The total weight of the vehicle was 12,080 lb. with the heavier axle weighing 7,720 lb. The mid-span moment generated by the vehicle for load position one (maximum moment) including self-weight (i.e., two girders, decks and curbs) was equal to 1,402 ft.-kip, while the shear at the support for load position two (maximum shear) including self-weight was 84.8 kip. The bridge is designed for a distributed live load of 100 psf. Exceptional transit of a service vehicle is limited to 1,000 lb. wheel load.

Strains and deflections measured during the test were consistent with the analytical predictions. The strain in structural elements was recorded using VWGs attached to reinforcement. The strain in concrete and BFRP rebars were negligible while 30 micro-strain was recorded in one of the instrumented CFRP tendons. Additionally, no crack was observed in the bridge after the load test. Deflections are measured with a total station theodolite directed to permanently mounted targets on one of the exposed stem sides. Similar tests are planned at intervals of one year to monitor the bridge performance over time. Appendix 3 features a detailed report on deflection measurements at different stages of the research program.

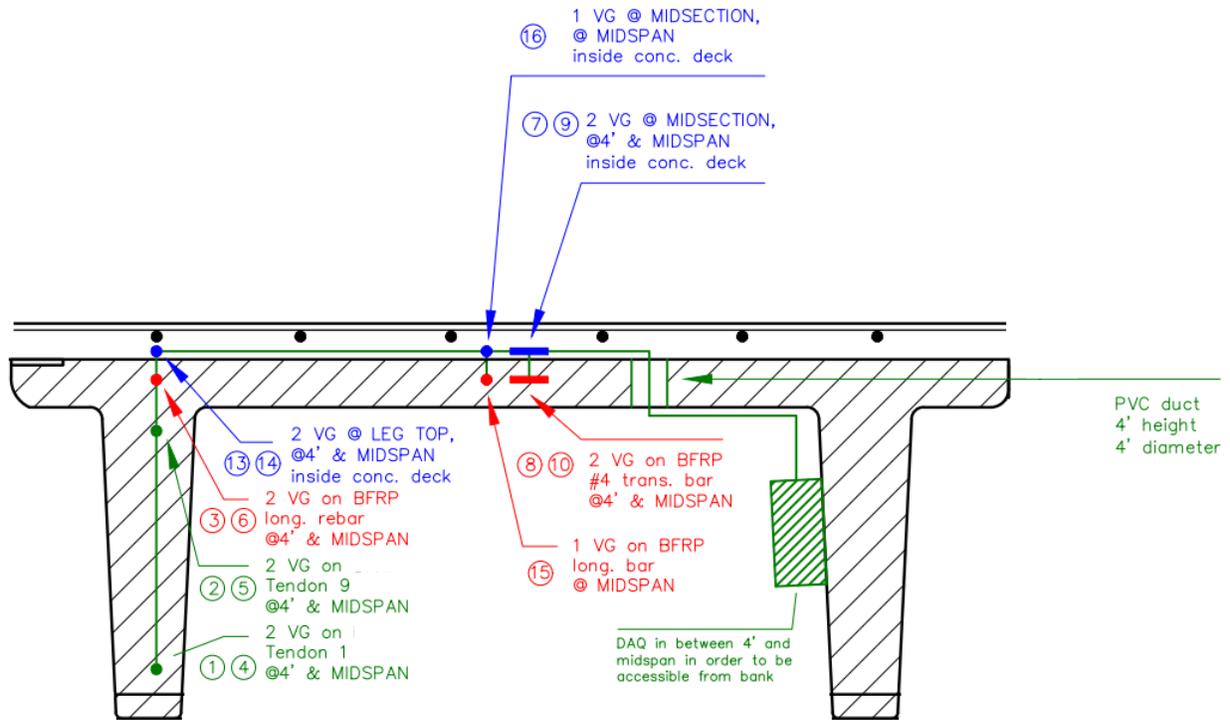
Figure 1: Cross-section of the DT girder

The cross-section of a DT girder is shown in Figure 1, while Figure 2 partially shows the top view of the girder. The total depth of the precast section is 30 in., with a flange thickness of 4 in. The total width of the flange is 7¼ in. at the top and 6 in. at the bottom. The length of the girders is 68 ft 8 in., with the clear span being 66 ft. The girders are aimed to be completed on-site with a 3 in. topping and, on one side, with a 14 in. x 14 in. curb, both cast with a 4,500 psi specified strength concrete. Since the DTs need to be installed in parallel, the curb is supposed to be cast on a different side for the two girders. Each stem of the DTs includes nine CFRP (1x7 15.2Ø) tendons, tensioned with an initial prestressing force of 41.25 kip per strand before losses. Hence, a total tensile force of about 370 kip with a 10.7 in. eccentricity is intended to be applied to each of the DT stems.

A “safety” #7 BFRP bar is also positioned at the end each span. In addition, the reinforcement consists of two BFRP reinforcing meshes. The first mesh is acting as longitudinal (#4 @ 6 in.) and transverse reinforcement (#4 @ 6 in.) in the flange. The second mesh (#3 @ 4 in. longitudinal and #3 @ 6 in. transversal direction) is placed on both sides of the CFRP in the stems to reinforce the transfer-length region of the stems. Finally, #4 BFRP closed stirrups were partially embedded on one side of the flange of both DTs, to act as transverse reinforcement in the concrete curbs.

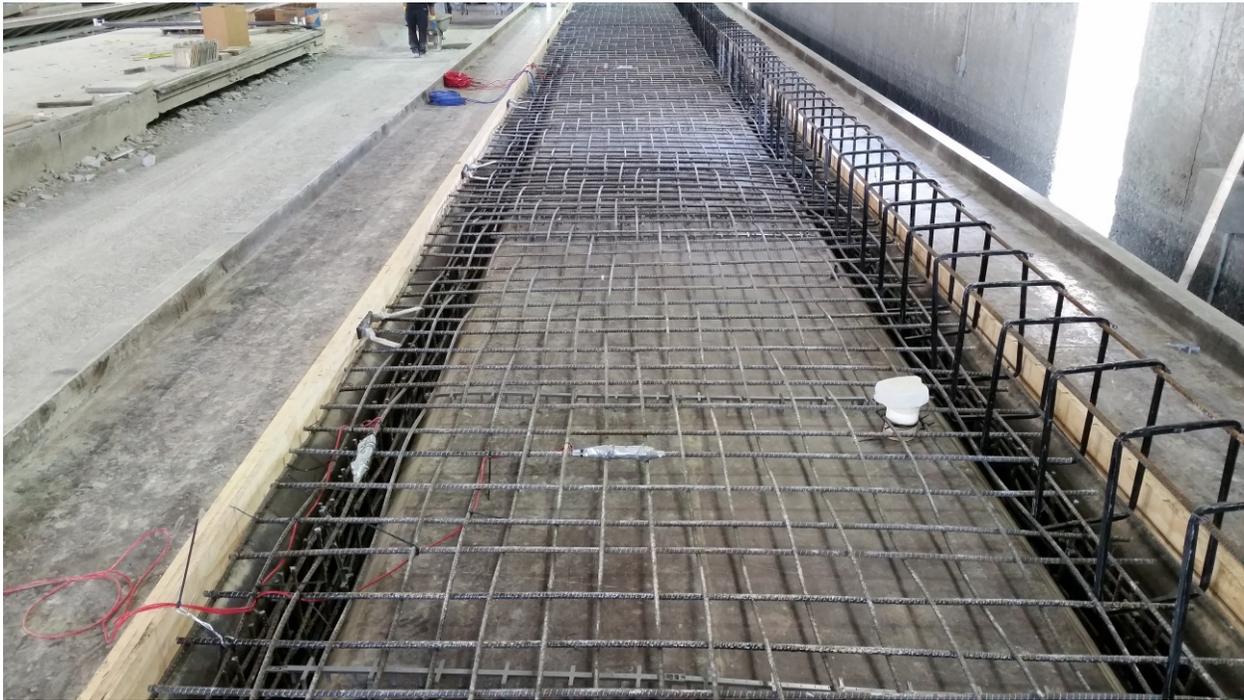
Figure 3: BFRP reinforcement and CFRP tendons arranged in the Coreslab prestressing bed

Two DT precast girders were constructed and instrumented at the Coreslab plant of Miami, adopting a pre-stressing bed and equipment available for conventional DT girders. CFRP strands and the BFRP reinforcement were arranged and positioned before the CFRP tensioning phases took place (Figure 3).

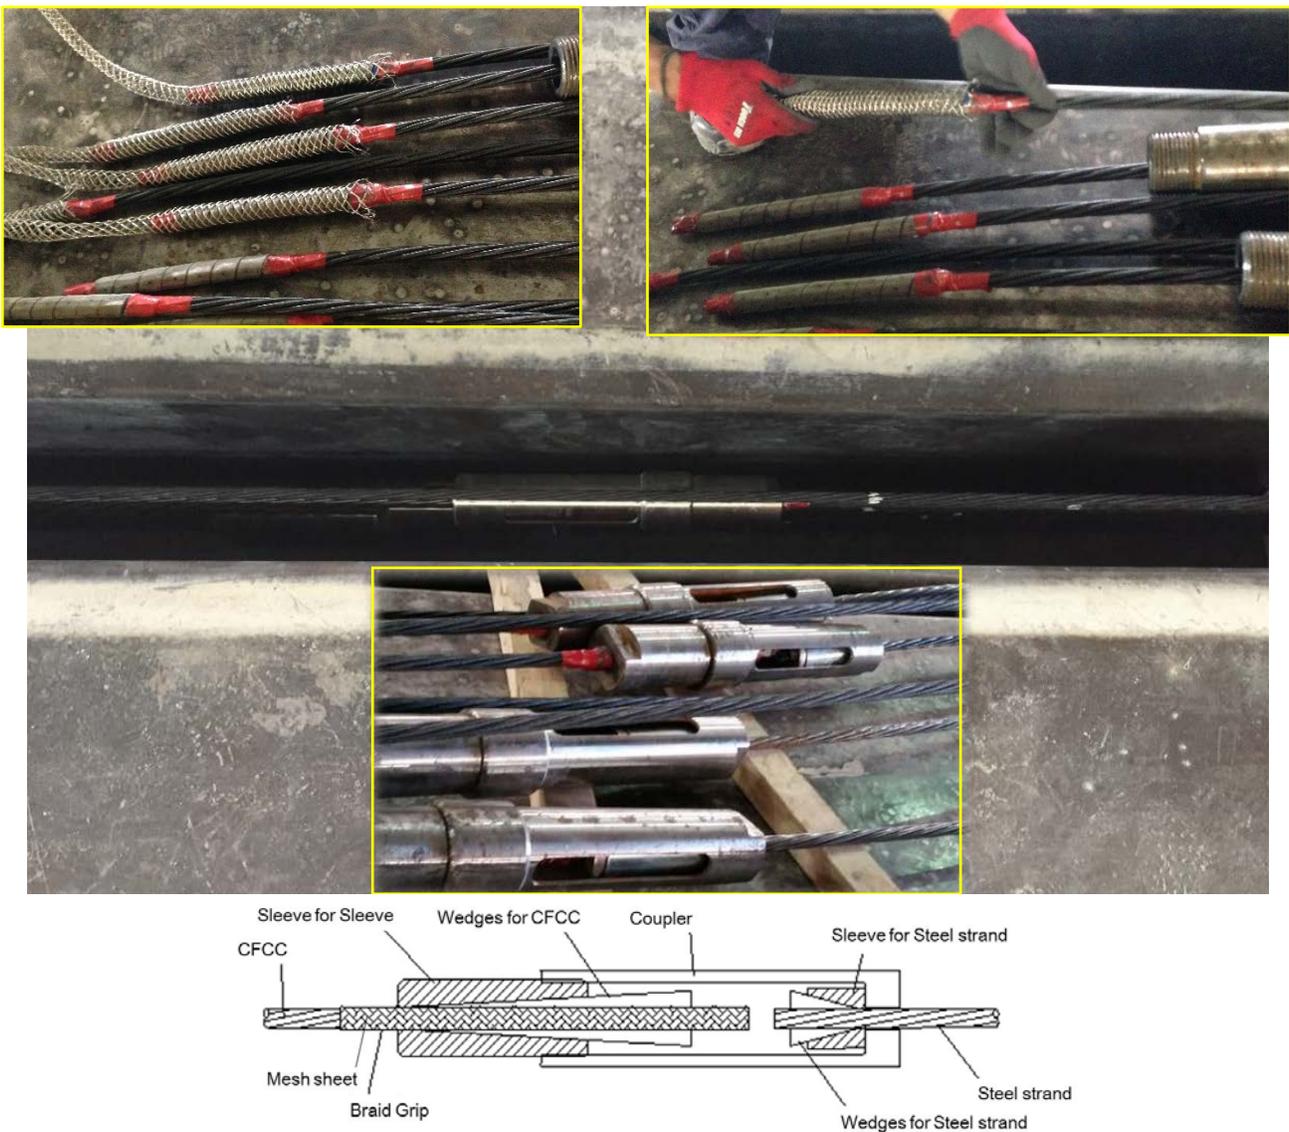
Figure 4: CFCC strand anchorage system

The CFRP strands were attached to steel cables with a proprietary mechanical anchorage system to facilitate pulling of the strands without damaging their ends. This anchorage system consisted of sleeve for CFRP, wedges, joint coupler, mesh sheet, braided grip, and wedges for attaching the steel strand. Figure 4 shows the anchorage system for CFRP strands. After prestressing the strands, SCC was poured (Figure 5).

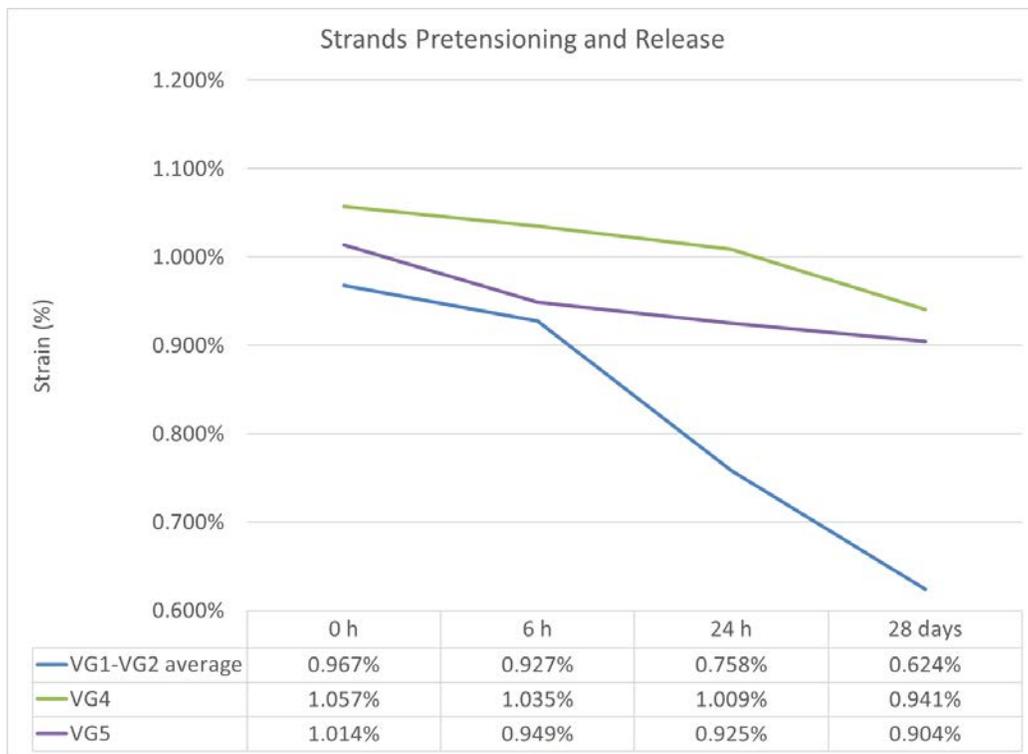
Figure 7: Strains in tendons after tensioning, casting, releasing and curing phases

Figure 7 shows the strain measurements performed on the top and bottom tendons: a) after the tensioning phases (0 hours); b) after the concrete pouring (6 hours); c) after the release of prestressing forces (24 hours); and, d) after the demolding and complete curing of the PC girders (28 days). The first strain loss (b-a) deals with the pretensioning apparatus settlement (i.e., CFRP and steel cables anchorage systems). The second loss (c-b) is due to the elastic shortening of concrete at the time of the release. The third loss is caused by concrete creep/CFRP relaxation during the 28 days of curing.

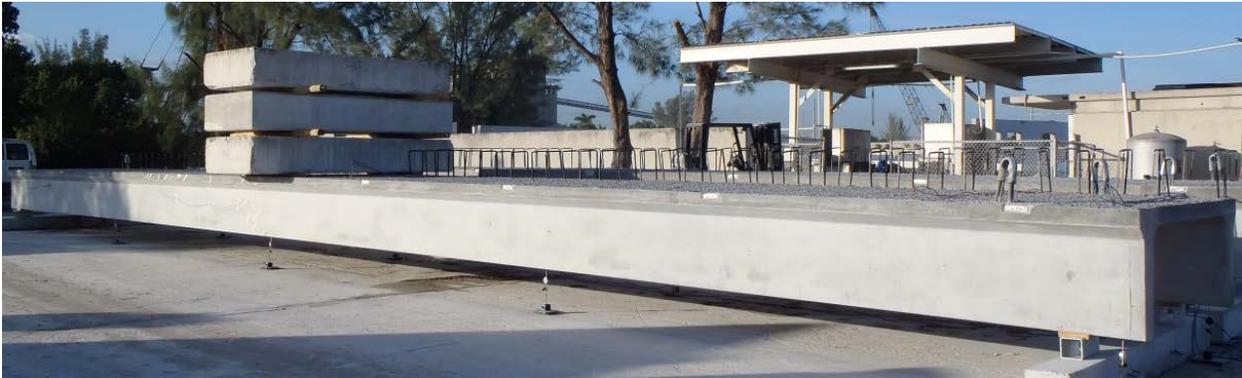
Figure 8: DT girder loaded under a three-point-load setup

In order to analyze the flexural response near service conditions, a load test was carried out on the instrumented DT girder before its installation on-site. The girder was loaded under a three-point-load setup, over the 66 ft effective span of the bridge model (Figure 8). Four rectangular hollow steel tubes placed over prismatic concrete elements were used as supports. A soft wood interface was provided between the supports and the girder bearing plates to help the levelling procedure and prevent stress concentration during the test. Three rectangular concrete blocks, each of them weighting 9 kip, were used to apply the intended load by mean of a crane (Figure 9).

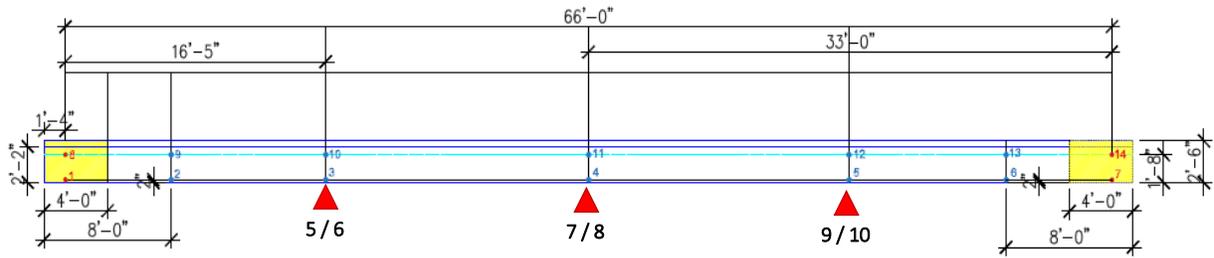
Figure 10: Dial gauges location

The DT girder displacements were monitored using 10 analogic dial gauges, installed in correspondence of the two stems and located, along the girder length, as shown in Figure 10. Dial Gauges 1, 2, 3 and 4 were used to monitor the supports settlement and deformation; Dial Gauges 7 and 8 were aimed to measure the DT deflection at midspan whereas Dial Gauges 5, 6, 9, and 10, were positioned at quarter span.

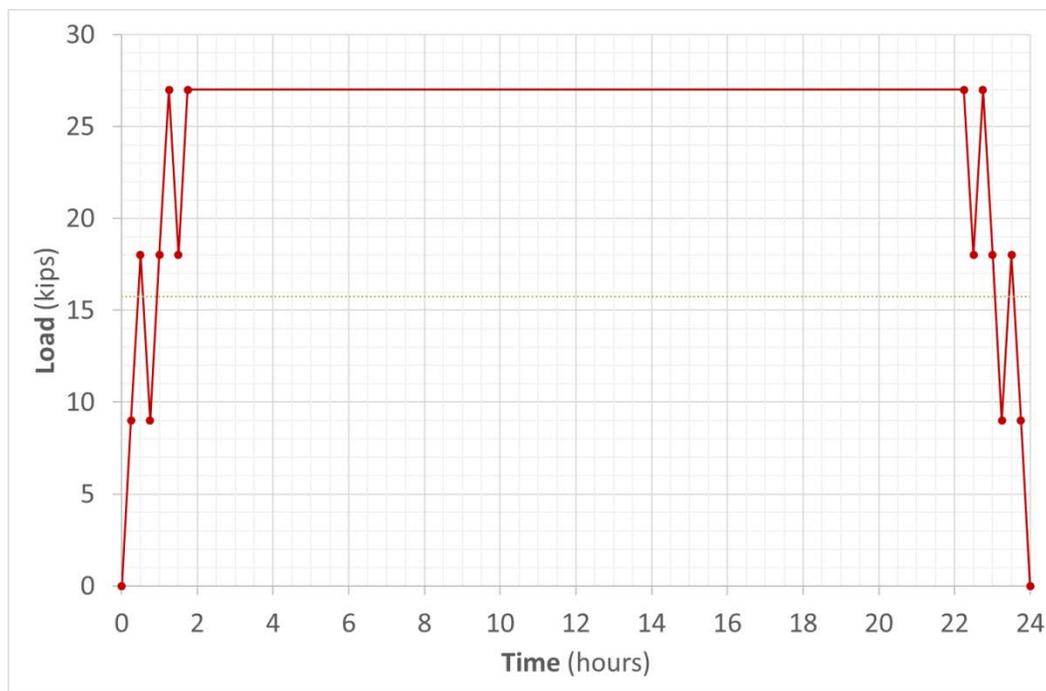
Figure 11: Loading cycles

For the purpose of this study, the service limit state was defined by the state at which the girders remained un-cracked. A total load of 27 kip was applied in three loading steps. The second and third concrete blocks were positioned on the DT girder, successively removed and then permanently repositioned on the girder midspan. The total load was finally applied over a 24 hours period. The loading and unloading phases took about 2 hours each. The dial gauges measurements were monitored at each load step.

A diagram of the adopted loading cycles is detailed in Figure 11.

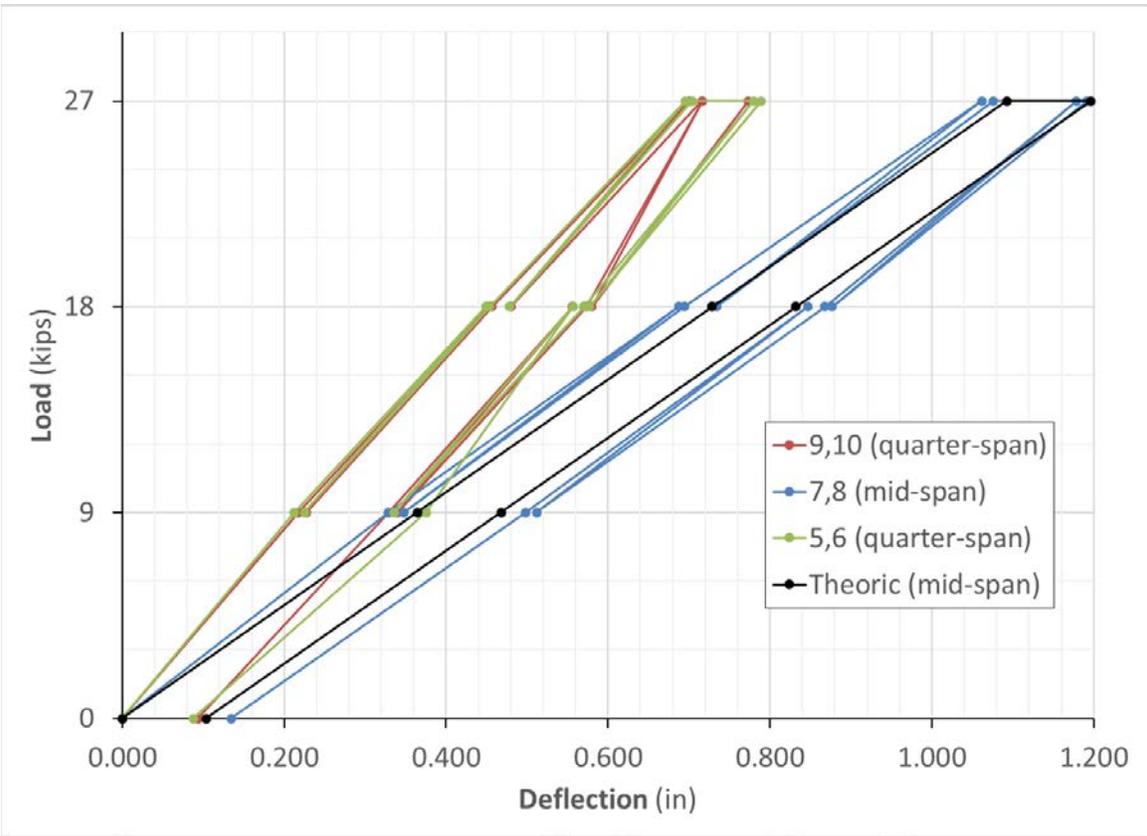
Figure 12: Load-deflection diagrams

The girder exhibited the elastic performance expected at the serviceability limit state, with no cracks being visually detected. Due to the 24 hours sustained 27-kip load, it was possible to observe

some considerable creep effects and compare them with theoretical predictions. These are computed by additively considering the long-term deformation caused by sustained loading on both concrete and CFRP tendons (Table 5).

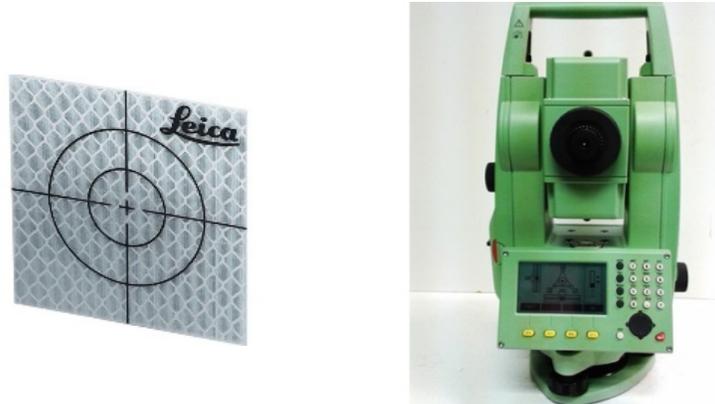
Figure 2: LEICA target and total station

The total station is an electronic theodolite (transit) electronic/optical instrument for surveying integrated with an electronic distance meter (EDM) to read slopes and distances from the instrument to a particular point, a target, in this case (see Figure 2).

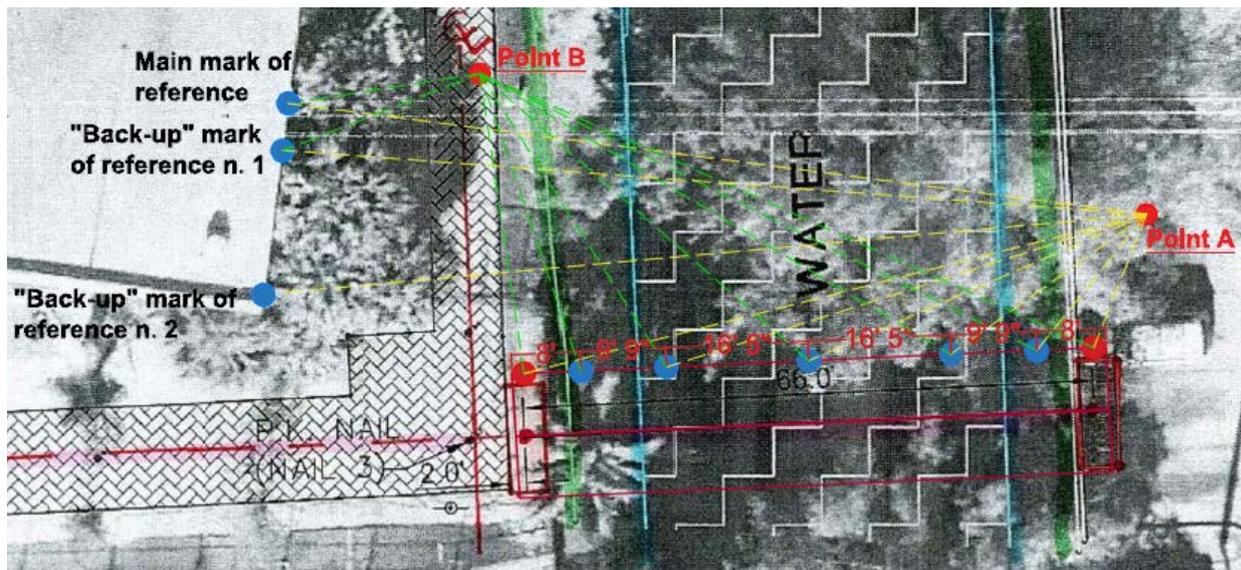
Figure 3: On-site plan view

Figures 3 and 4 show, respectively, the on-site plan view of the area where the bridge was built, and the profile view with the location of every target initially installed onto the instrumented girder.

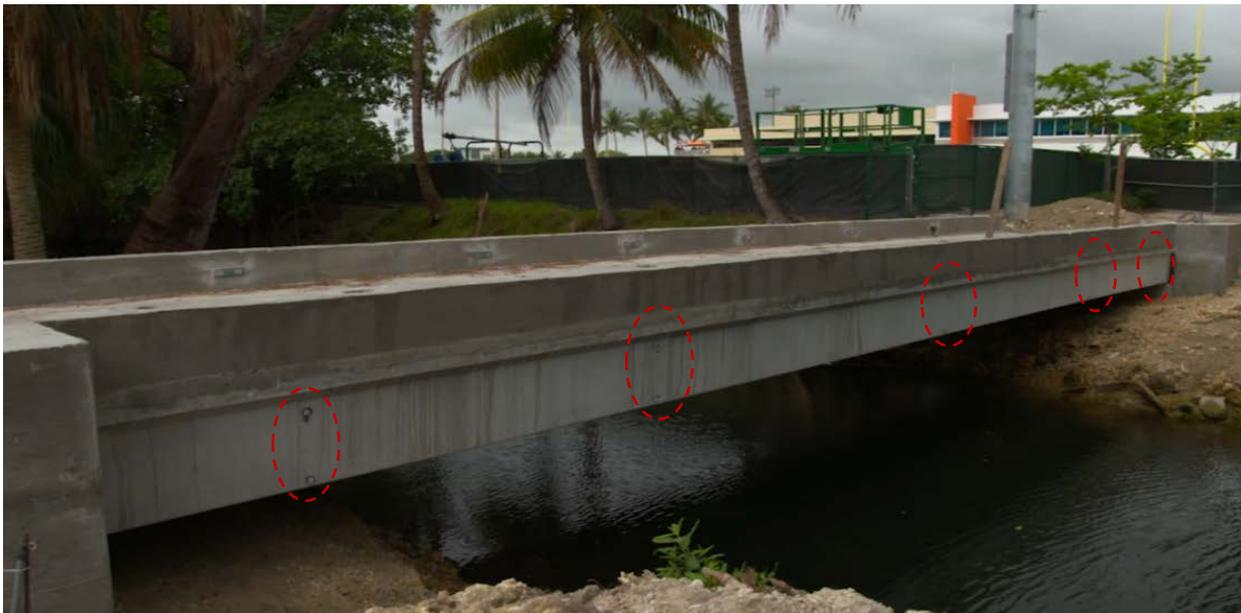
Figure 5: Targets view from Point A

Figure 5 shows a photograph of the girder stem with targets visible from the survey Point A.

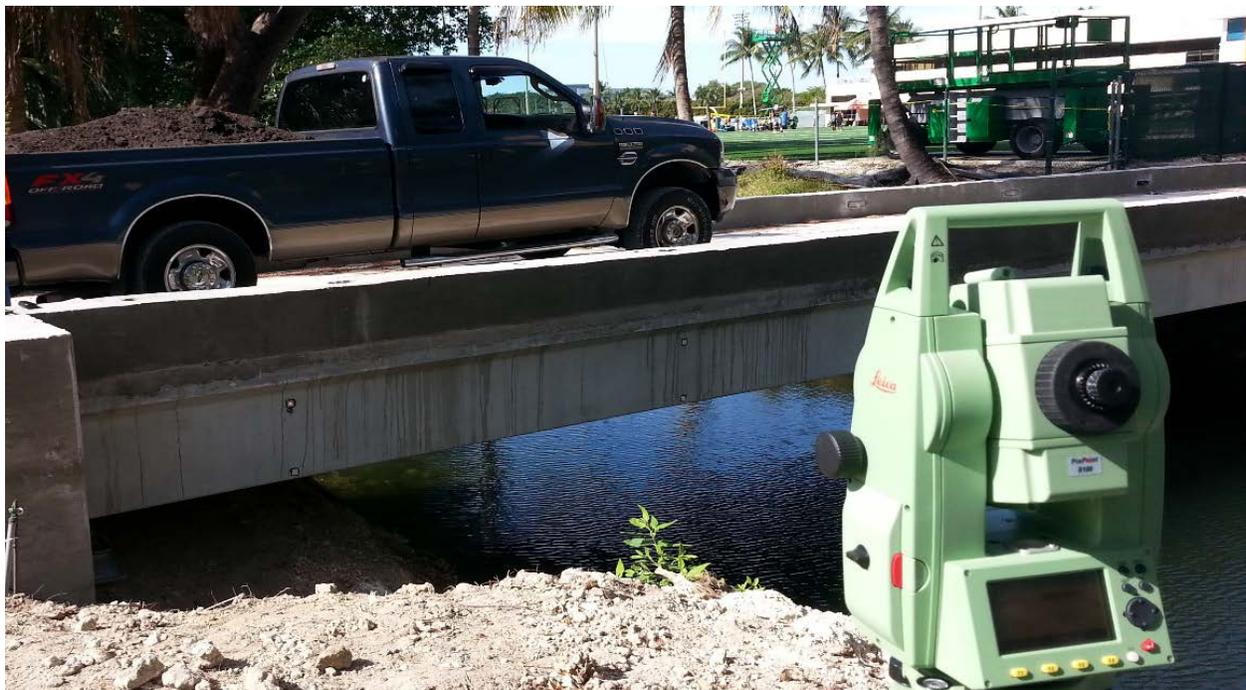
Figure 7: On-site load test

The load test was conducted in two parts: as a maximum moment test and a maximum shear test. For the first one, the truck was longitudinally centered facing the parking lot in order to measure strains and deflections. In this way, the front axle of the truck was positioned at a distance of 117 in. (3 m) from the left end (parking lot), while the rear axle was positioned at a distance of 275 in. (7 m) again from the left end. The total weight of the vehicle and its cargo was 12.08 kip (54 kN), with the heavier axle weighing 7.72 kip (34 kN). The mid-span moment generated by the vehicle for load position one (maximum moment) and including self-weight (two girders, decks, and curbs) was equal to 1,418 kip·ft (1922 kN·m), while the shear at the support for load position two (maximum shear) including self-weight was 85 kip (380 kN). The bridge is designed for a distributed live load of 100 psf (4.8 kN/m²), which will result in a service maximum moment of 1,894 kip·ft (2,568 kN·m) and a maximum shear of 115 kip (511 kN). Figure 7 shows the truck moving over the bridge.
