**FINAL PROJECT
REPORT #00042134-04-103
Volume III**

**FRP Reinforcement for
Concrete: Performance
Assessment and New
Construction**

**Volume III: Construction and
Monitoring of the Innovation Bridge**

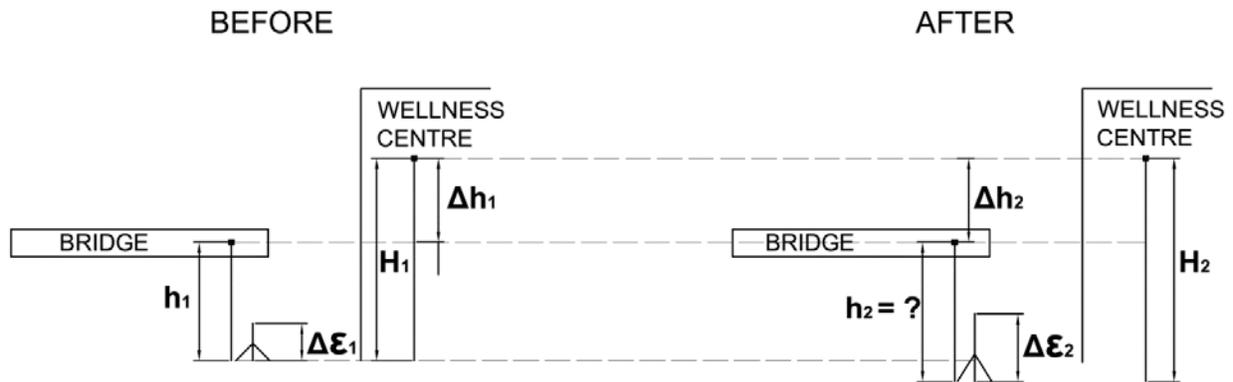
Figure 8: Before and after targets replacing

- $H_1, H_2 =$ reference point heights measured before and after replacement
- $h_1, h_2 =$ target heights measured before and after replacement
- $\Delta\varepsilon_1, \Delta\varepsilon_2 =$ errors intrinsically present in the measures

Figure 8 is a sketch of the situation before and after the targets replacement showing that the only unknown is h_2 , the height where the target has to be positioned.

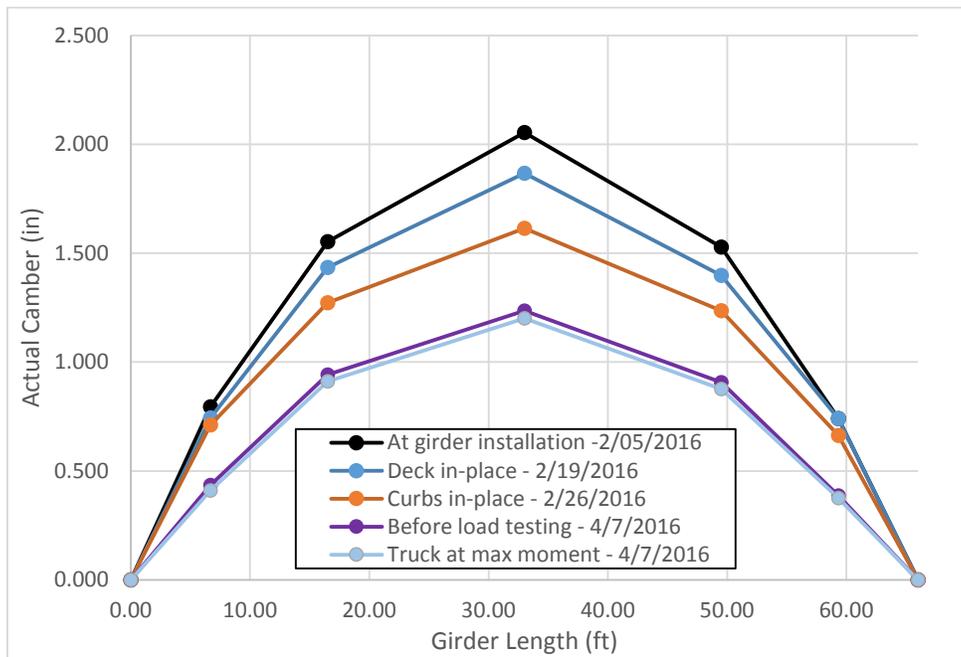
Figure 9: Camber values measured at centroid-height targets

- Girder camber. In Figure 9, five curves are shown starting from the one recorded at the time of girder installation through the one during the load test with truck positioned to generate the maximum moment. Plotting the net camber data over the girder length, a consistent symmetric shape can be clearly identified as well as a consistent deflection increment (i.e., reduction in camber) at increasing load.

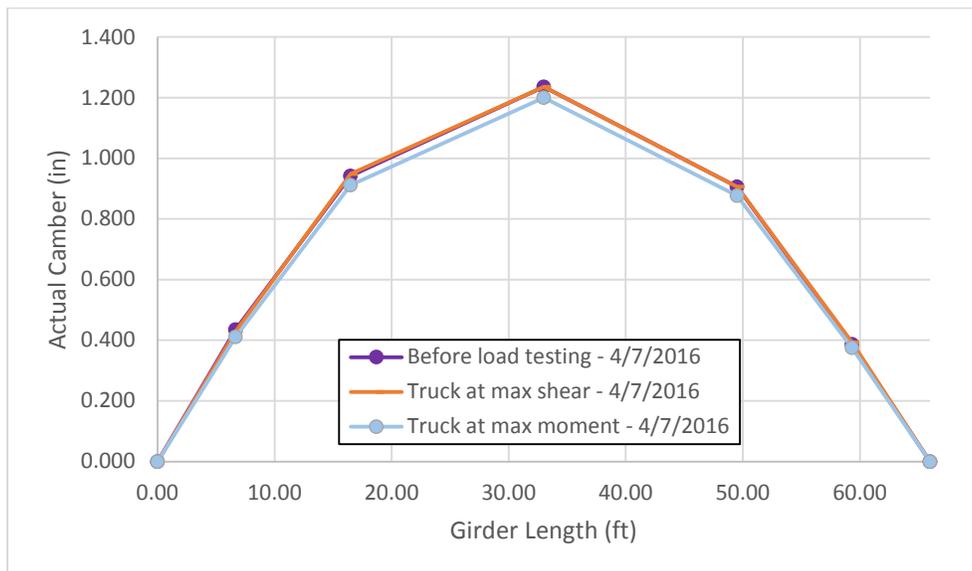
Figure 10: Camber values for on-site load test

- On-site load test. Figure 10 shows the results obtained from the truck positioned at maximum shear and at maximum moment locations. For the maximum shear test, the camber trend line does not vary from the reference line (unloaded condition), whereas the trend line for the maximum moment test shows a slight reduction in camber.

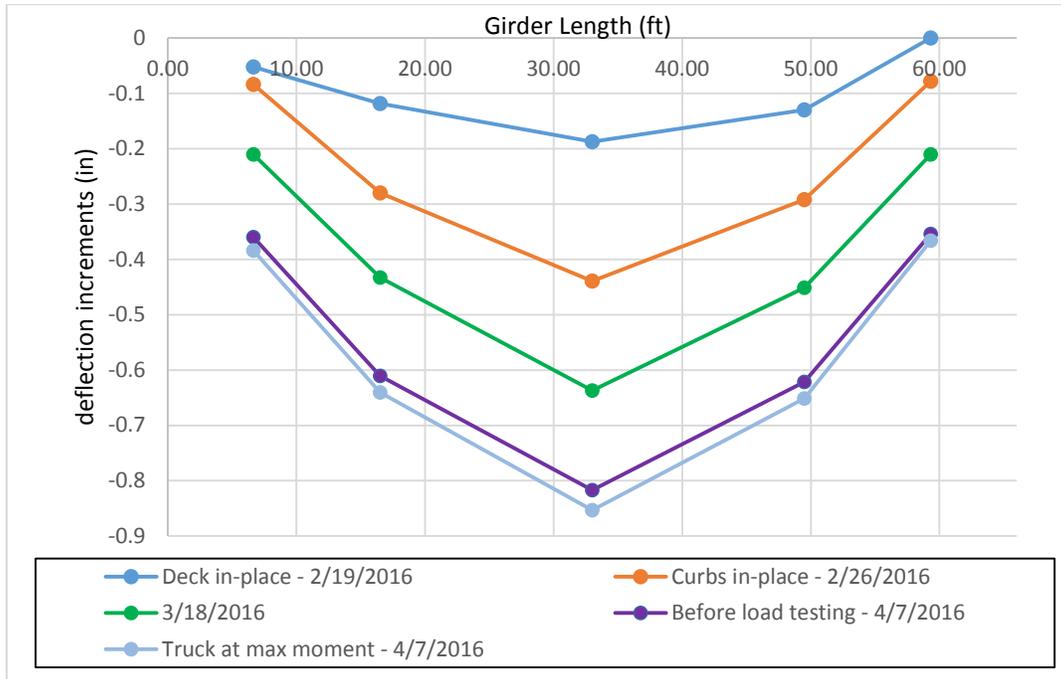
Figure 11: Deflection from initial on-site camber - increments – refined

Figure 11 shows the deflection increments as a result of loading rather than the reduction in camber. The reference line (zero line) is the deflection at the time of girder installation. An almost perfectly symmetric shape of the deflections increments is apparent.

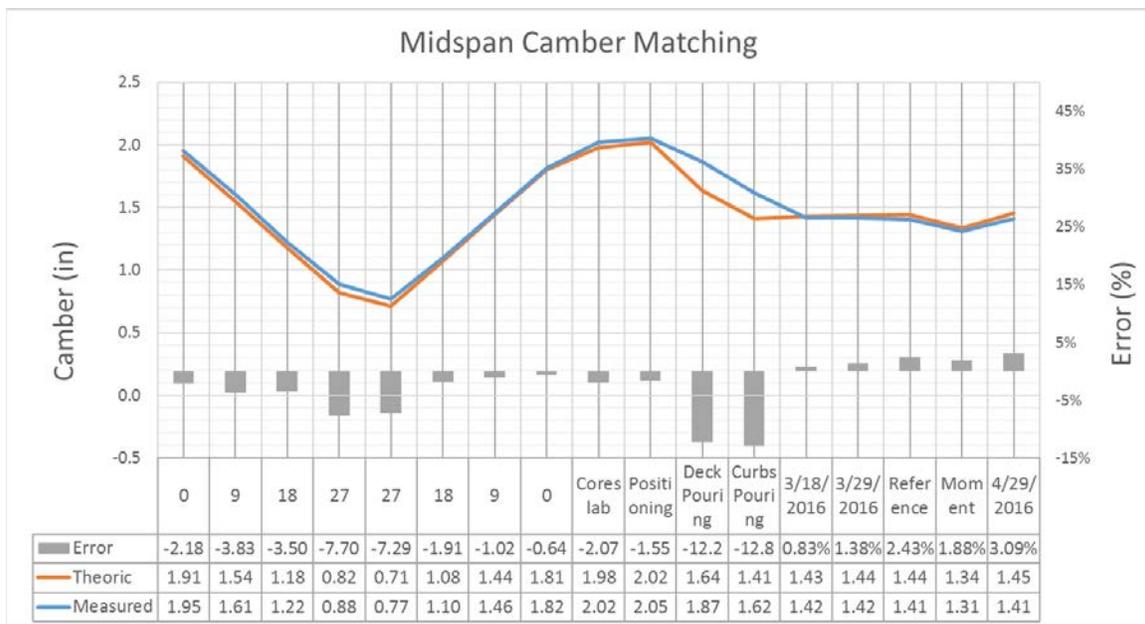
Figure 12: Camber values over the girder load history

Figure 12 shows the theoretical/experimental camber values over the girder load and construction history up to the end of April 2016.
