GEORGIA DOT RESEARCH PROJECT 10-08

**A REMOTE SENSING AND GIS-ENABLED HIGHWAY
ASSET MANAGEMENT SYSTEM**

1. Report No.: GA-15-1008	2. Government Accession No.:	3. Recipient's Catalog No.:	
4. Title and Subtitle: A Remote Sensing and GIS-Enabled Highway Asset Management System		5. Report Date: April 2016

Final Report

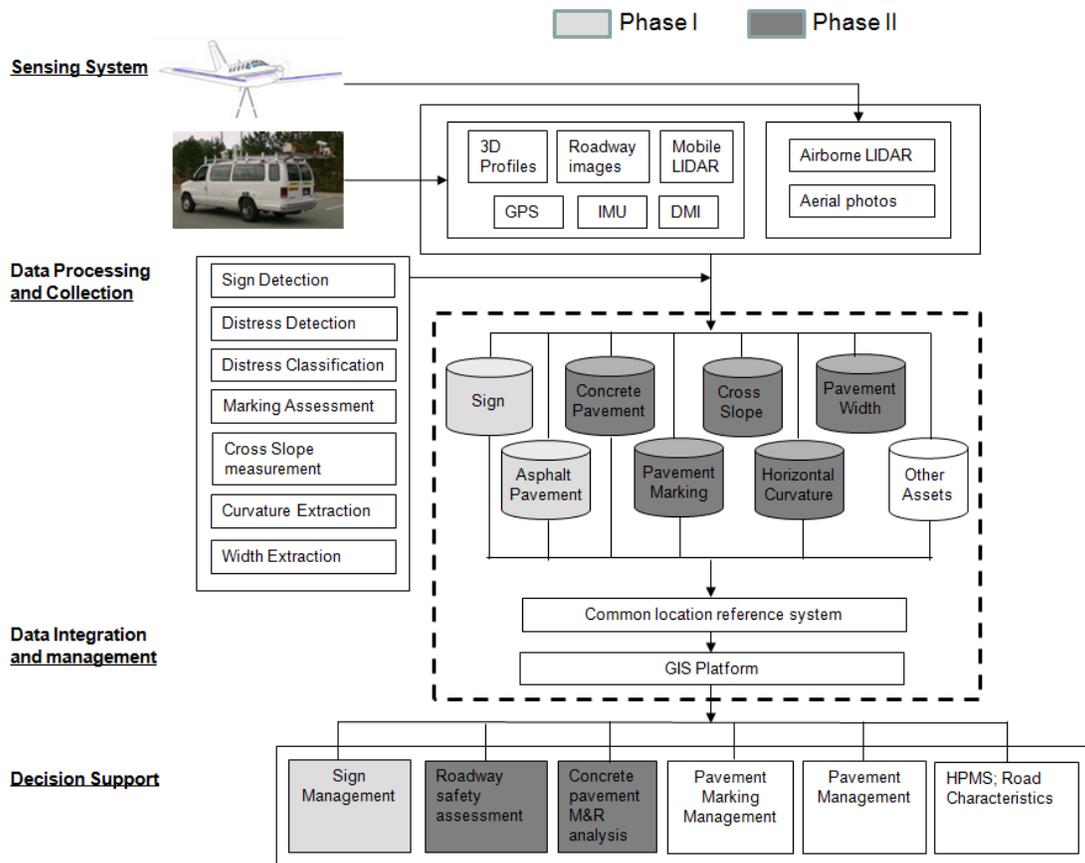
Figure 1.1 RS-GAMS Architecture

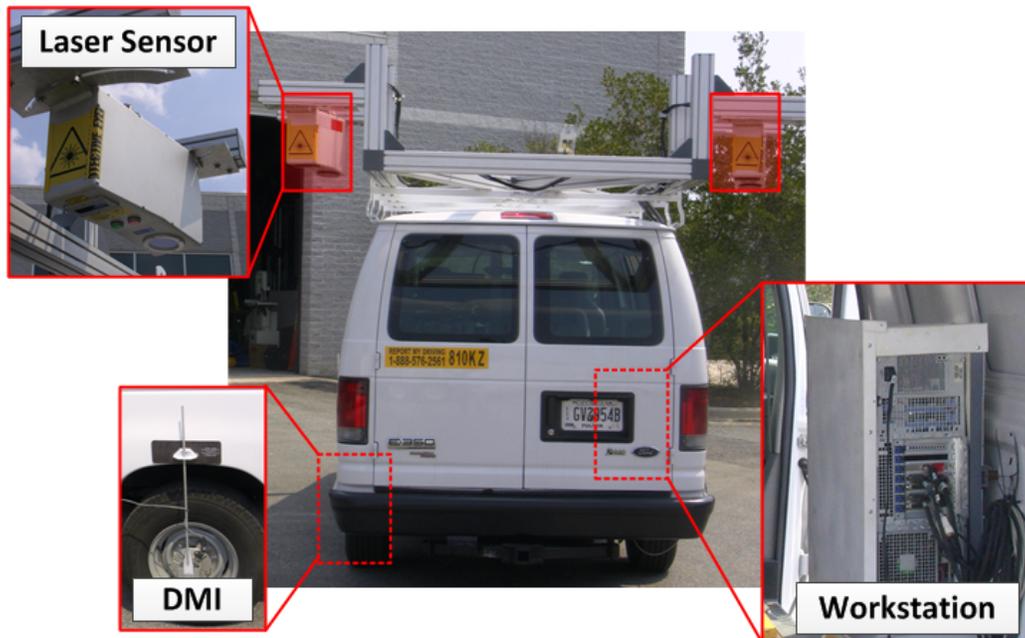
The integrated 3D laser system is developed by INO, a leading company headquartered in Canada, and marketed by the Pavemetrics System Inc. The 3D laser consists of three primary components, including the imaging component, the distance measuring component, and the data processing component. The imaging component is used to capture the pavement texture data using external infrared laser illumination and the spatial high intensity camera. This component consists of two separate laser sensors to cover a full-lane width. Each laser sensor includes a dedicated infrared laser illumination and a high-intensity area scanning camera. The distance measuring component provides a data-capturing signal by using a Distance Measurement Instrument (DMI), which is user-customizable. The data processing component computes the captured data into 3D range results using a high performance workstation. Figure 1.3 illustrates the 3D laser on the GTSV.

Figure 1.3 Components of 3D Line Laser System Integrated on the GTSV

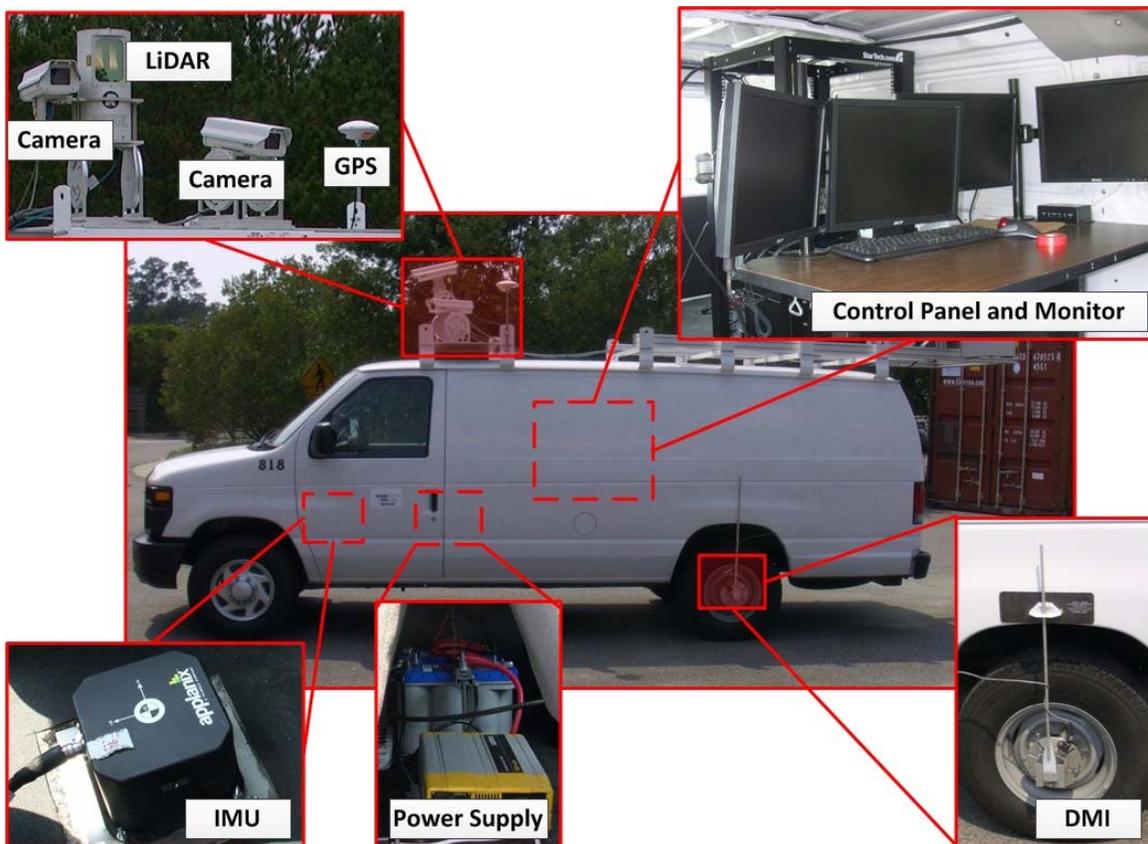
The mobile LiDAR system integrated on GTSV consists of three primary components, including the LiDAR sensor, the precise positioning system, and the imaging system. The LiDAR sensor is used to acquire the point cloud of the target, e.g. a traffic sign. Each point includes the accurate distance from the sensor to the target, the relative angle of the laser beam with respect to the LiDAR sensor, and the corresponding reflectance intensity. The precise positioning system is used to acquire accurate GPS coordinates and poses for the LiDAR sensor. Thus, the GPS coordinates for each point from the LiDAR sensor can be derived. To acquire the precise GPS coordinates, the positioning system is composed of a GPS, an Inertial Measurement Unit (IMU), and a DMI. As most of the LiDAR sensors can only acquire point cloud data without any color information, the imaging system is typically integrated with the LiDAR sensor to provide corresponding color images. Figure 1.5 illustrates the mobile LiDAR system integrated on GTSV.

Figure 1.5 Mobile LiDAR System Integrated on the Georgia Tech Sensing Vehicle

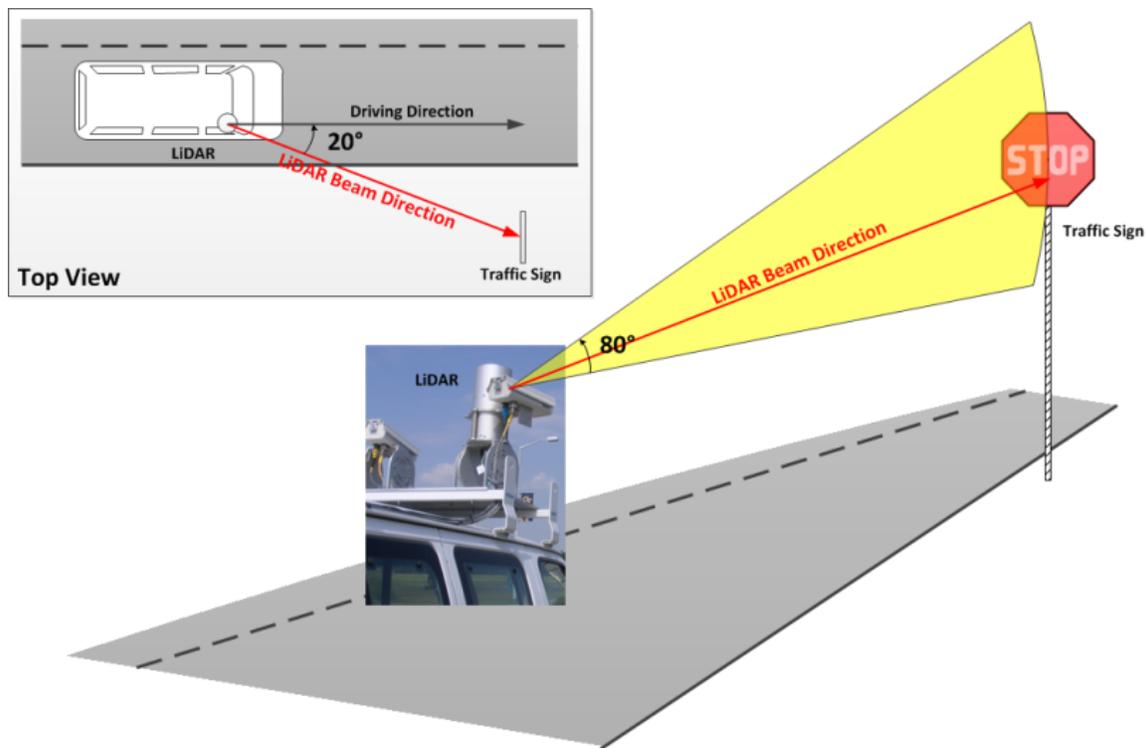
LiDAR sensors can be configured with different orientations for different targets. In this project, the purpose of introducing the mobile LiDAR system is to identify the feasibility of this technology for traffic sign asset data collection, including traffic sign inventory and condition assessment. Therefore, the LiDAR system is vertically oriented on the sensing vehicle and has a parallel line scanning pattern. Figure 1.6 shows this configuration and the scanning mechanism. This system can produce 10,000 laser points per second. As the vehicle moves in the longitudinal direction, the scanning line of the LiDAR system is aligned perpendicularly to the ground. The scanning range is $\pm 40^\circ$ to the horizontal direction, which produces an 80° fan covering the roadside. Currently, the frequency of the LiDAR system is configured at 100 Hz and 100 points within each scan, while the LiDAR heading angle is configured at 20° . Figure 1.6 shows the data acquisition. For example, if a standard 48 in. \times 60 in. speed limit sign is mounted on the roadside with a lateral offset of 12 ft. (3.6 m) to the edge of the road, the current configuration will be able to acquire a point cloud containing approximately 12×8 points at 60 mph (100 km/h). As previously mentioned, the configuration can be adjusted to accommodate different data collection scenarios.

Figure 1.6 Configuration of the Mobile LiDAR System and Scanning Mechanism

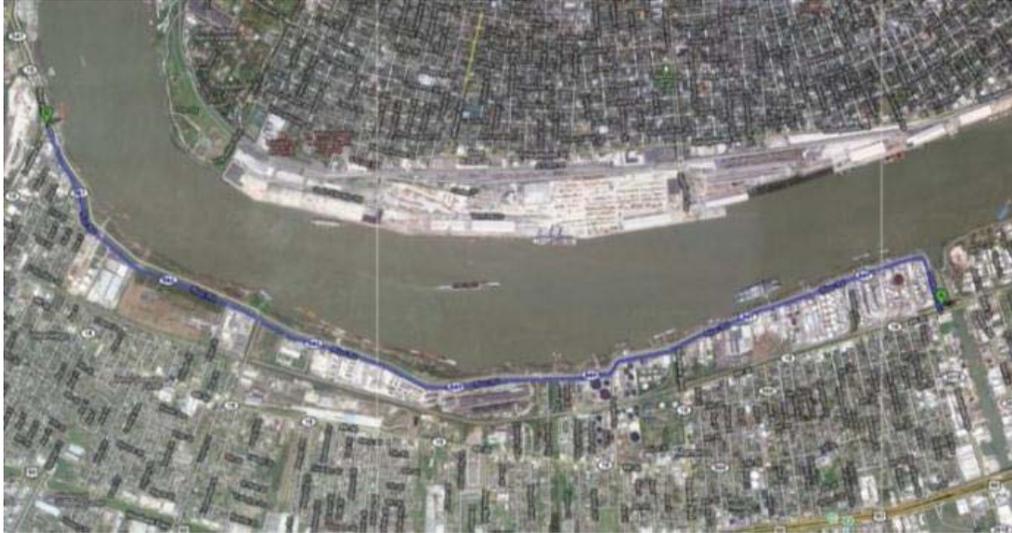
Figure 2.3 Data Collection Routes in Westwego, Louisiana for the Generalized Automatic Traffic Sign Detection Algorithm

The dataset for the generalized traffic sign detection algorithm was retrieved from the roadway video log image dataset provided by LaDOTD. The selected section was on Louisiana SR 541, covering 4.1 miles of the industrial area in Westwego, Louisiana, and contained 2,100 images. In this dataset, 64 traffic signs with different types were manually extracted as the ground truth. Figure 2.3 shows the data collection location. An additional dataset for the generalized traffic sign detection algorithm was retrieved from the roadway data collection in 2009-2010 by Roadware Company in Nashville, Tennessee. The selected section covered 5.0 miles of suburban area in Nashville and contained 1,320 images. In this dataset, 112 traffic signs of different types were extracted for ground truth.

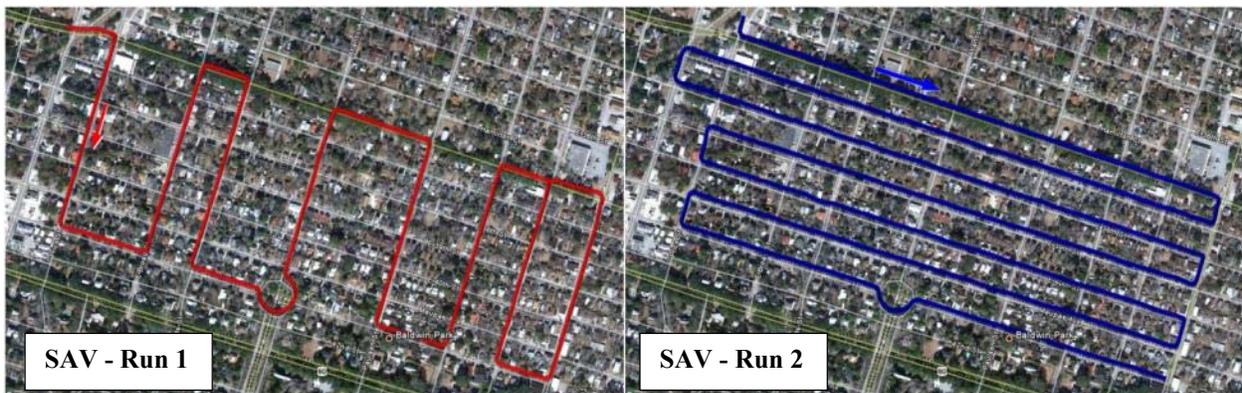
Figure 2.4 Data Collection Routes in Savannah, Georgia for the Automatic Stop Sign and Speed Limit Sign Recognition

The dataset for the specific traffic sign recognition was collected using the GTSV. The video log images were purposely collected on the streets that cover several blocks of residential area that contained a sufficient sample of stop signs and speed limit signs. The selected test roadway section was in the area of 37th street in downtown Savannah, Georgia, covering 8 miles of residential area. To populate the samples, two runs of data collection were conducted in different directions within the area. Figure 2.4 shows the direction of the two runs. In this dataset, 53 stop signs and 28 speed limit signs were manually extracted as the ground truth.

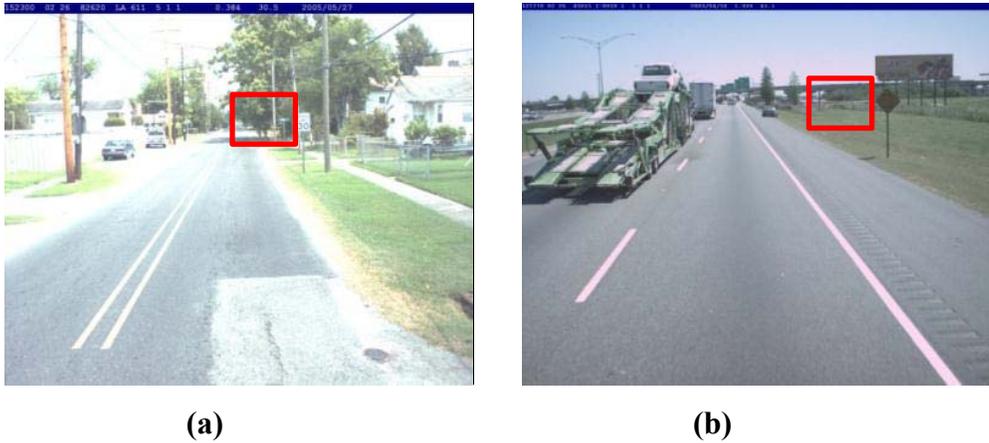
background region. These cases can potentially be eliminated during the data collection by appropriately adjusting the camera settings, e.g. shutter speed and exposure time. However, due to the constant changes in driving directions and unpredictable weather conditions, many adjustments are hard to apply in time. An improvement in the color segmentation can potentially reduce the FN cases due to the lighting changes during the data processing. LiDAR technology can also be applied to reduce the FN cases caused by lighting changes.

Figure 2.5 Examples of two FN Cases Due to Lighting Changes: a) Overexposure; b) Backlighting

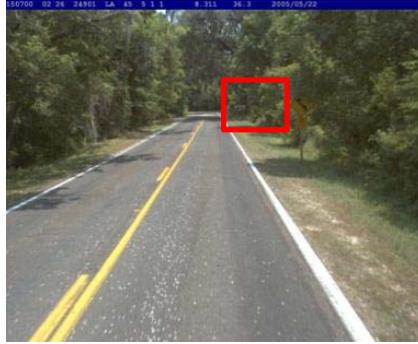
Figure 2.6 Example of an FN Case Due to Discontinuous Boundary

- **Discontinuous Boundary:** Some FN cases are produced due to the discontinuous traffic sign boundaries captured in a video log image because the discontinuous boundary cannot be estimated as a closed traffic sign shape using the detected edges. The discontinuity is typically produced by partial occlusion, casting shadows over the traffic signs, multiple traffic signs on the same post with adjacent boundaries, etc. Figure 2.6 shows an FN case that is due to occlusion by tree branches. These cases can potentially be minimized by applying some active contour-based methods.

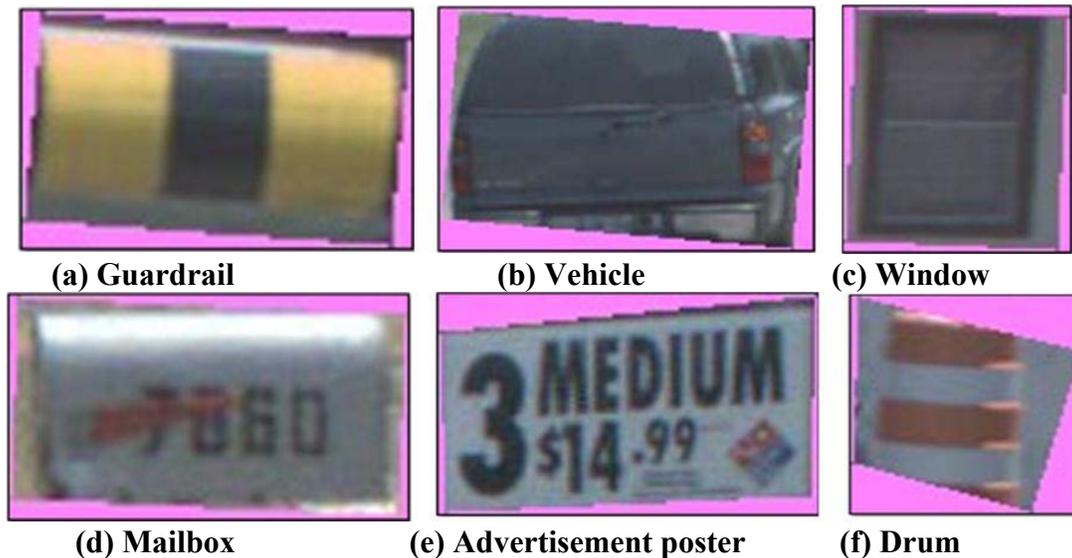
Figure 2.8 Sample of FP Cases Identified in the Assessment Test

As presented in the literature review, the color feature and shape features are used in the current algorithm. However, these two features are not sufficient for traffic signs, as there are many other objects sharing characteristics similar to the traffic signs in terms of color and shape. Many of these objects are detected as FP cases in the test, including mailboxes, advertisement posters, drums, guardrails, vehicle bodies, windows, etc. Figure 2.8 shows

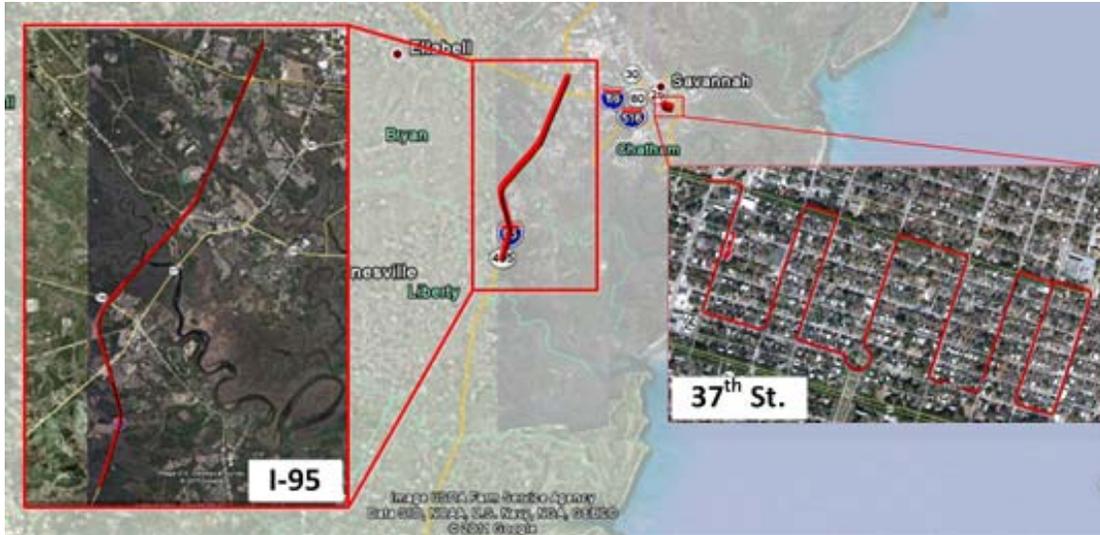
Figure 2.11 The Selected Data Collection Sections for Experimental Test

The dataset collected on I-95 covers 17.5 miles of roadway containing 127 traffic signs with different attributes. The data was collected on the outer lane of the three-lane road at the speed of 60 mph (100 km/h). The dataset collected on 37th Street covers 2.9 miles of roadway containing 115 traffic signs with different attributes. The data was collected at the speed of 30 mph (50 km/h). Both of the datasets were collected using the same LiDAR heading angle of 20° and scanning frequency of 100 Hz. The ground truth was manually extracted using the video log images that were synchronized with the LiDAR data. Figure 2.11 shows the map of the road sections for the data collection.

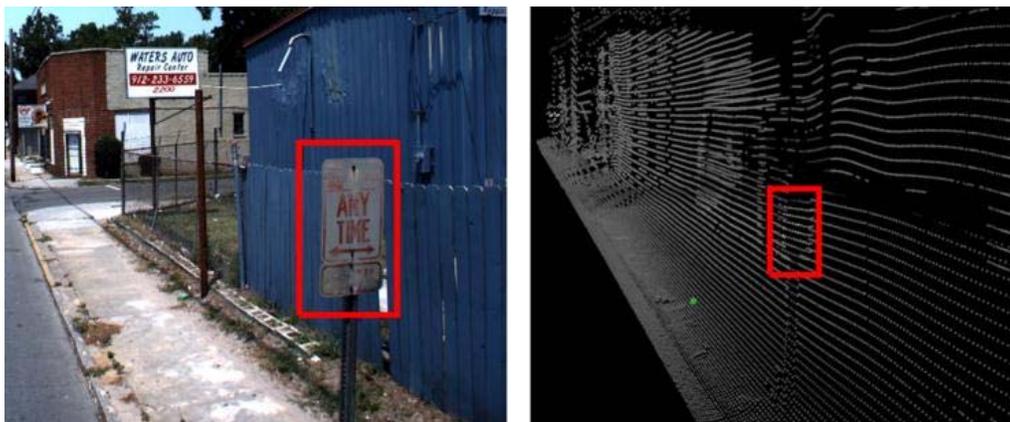
Several such FN cases were identified on 37th Street, where the retroreflectivity condition of the traffic signs is relatively poor. In contrast, this FN case was not identified on I-95, where the traffic signs are maintained in a timely manner. Figure 2.12 shows an example of a FN case containing a traffic sign with poor retroreflectivity condition on 37th Street. It can be observed in the video log image that the no-parking sign has severely deteriorated. In the corresponding LiDAR point cloud data, the retro-intensity values of the points within the no-parking sign region are much smaller than the set parameter value of minimum retro-intensity as 0.65. Therefore, the traffic sign region will not be detected from the background. Further investigation finds that the average of the retro-intensity values in the traffic sign regions is approximately 0.45. By further reducing the parameter value of retro-intensity to below 0.45, this traffic sign can be correctly detected. However, many FP cases are detected using such a small retro-intensity parameter value.

Figure 2.12 Example of FN Case with a Traffic Sign with Poor Retroreflectivity on 37th Street

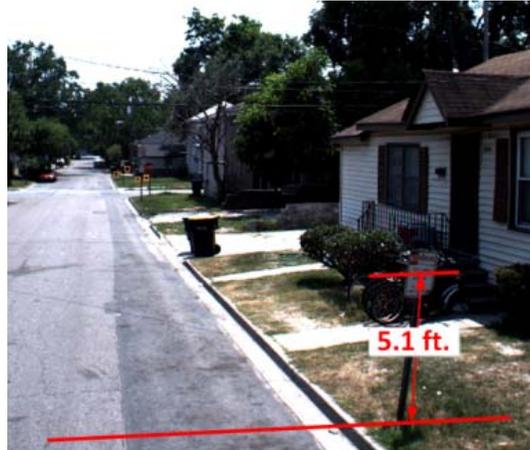
value of minimum elevation as 6ft. (1.8m). Therefore, the traffic sign region was rejected. By further reducing the parameter value of elevation to below 5ft. (1.5m), this traffic sign can be correctly detected. However, several additional FP cases were detected, such as the reflective stickers on the mailbox, etc.

Figure 2.13 Example of a FN Case with a Traffic Sign with Insufficient Height on 37th Street

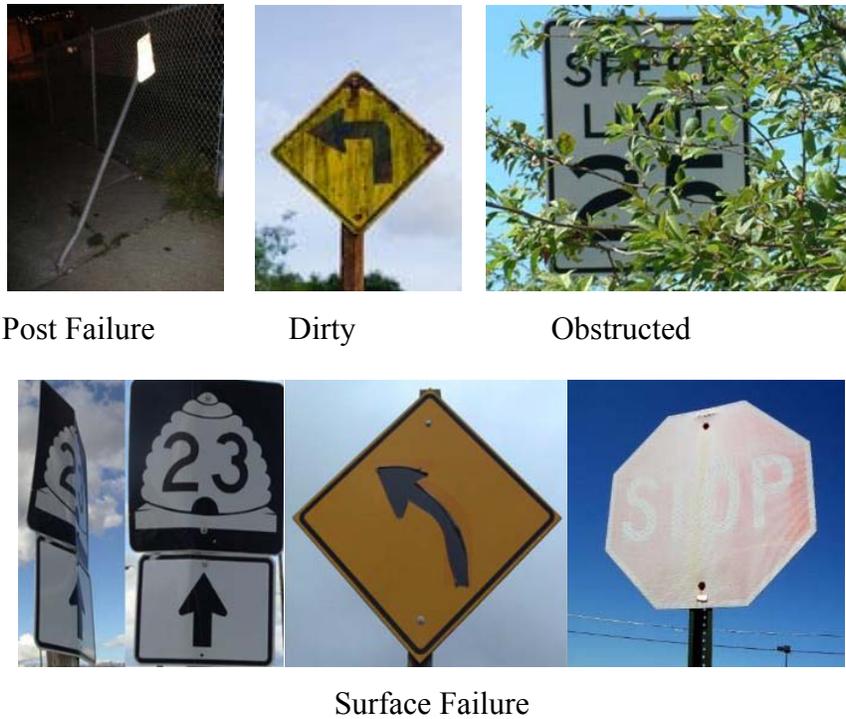
Figure 3.1 Examples of four categories of poor sign conditions

Sign Condition: Traffic sign condition is represented by the sign's visual defects and the sign's retroreflectivity. This study used video log images captured during the daytime to identify visual defects. Four categories of poor sign conditions are defined in this study: post failure, dirty, obstructed, and surface failure. Based on the Signs Chapter of the GDOT's Foreman's Academy (2008), the four categories of poor sign conditions correspond to four maintenance actions defined by the Highway Maintenance Management System (HMMS) (Hensing & Rowshan, 2005), including straightening, cleaning, vegetation trimming, and replacing. Figure 3.1 shows several examples signs in poor condition in each category. Appendix I lists all the traffic signs in poor conditions and their locations on I-285.

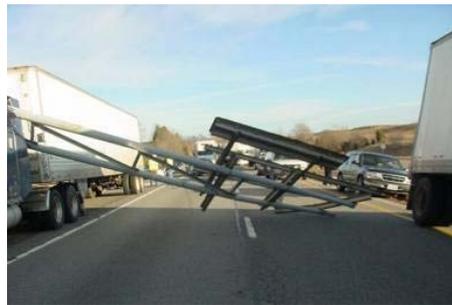
Figure 3.2 Example of overhead sign failure (FHWA 2013)

Overhead Sign: Overhead signs are considered separately from ground-mounted traffic signs. Although overhead signs are only a small portion of the whole sign population, the damage to these signs and/or their corresponding supports, e.g. panel failure or structural failure, etc., may lead to serious roadway hazards, as illustrated in Figure 3.2.

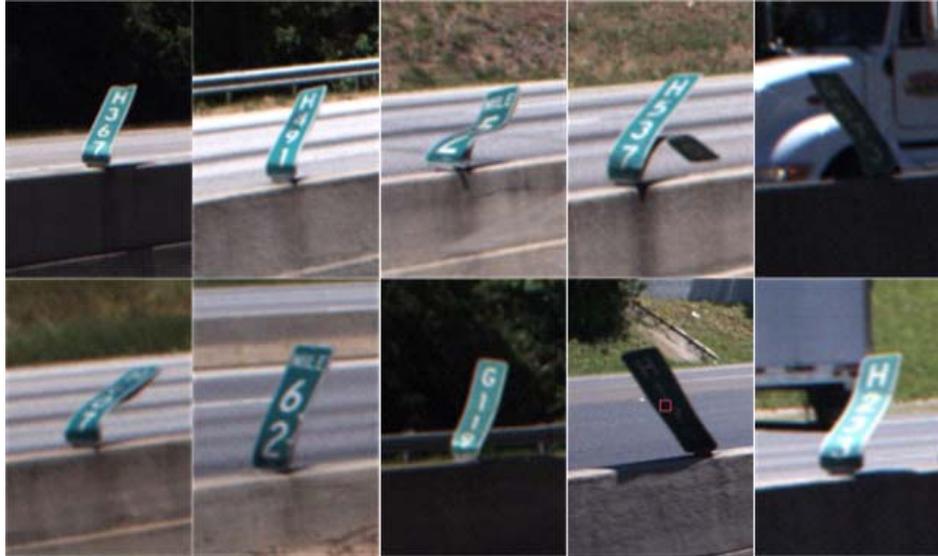
Of the 252 signs in poor condition, 108 signs are identified as being damaged by truck gusts. This type primarily includes milepost traffic signs that are mounted on concrete medians. The surfaces of the damaged signs are bent or wrapped parallel to the driving directions, as shown in Figure 3.8. From the video log images, it was observed that although the signs are damaged on the median, the median itself doesn't show any evidence of crash or impact. While further investigation is still required to reveal the cause of such sign damage, the preliminary inspection showed that the signs are (probably) damaged by the strong truck gust that is created by fast-moving trucks. While the truck passes by the traffic sign, the frontal area of the sign tends to bear extra gust loads that can potentially bend the sheeting. In addition, it was observed that the majority of the median-mounted traffic signs are not designed with a metal post. Instead, one end of such traffic sign is mounted on a fixed connection attached to the concrete as shown in Figure 3.8, while the whole sign surface stands by the strength of the aluminum sheeting. Such a design may synergize with the truck gusts and facilitate the damage. Adding a square or u-shape sign post may effectively avoid such damage to the median-mounted traffic signs (McGee, 2010).

Figure 3.8 Examples of the damaged signs due to truck gust on median

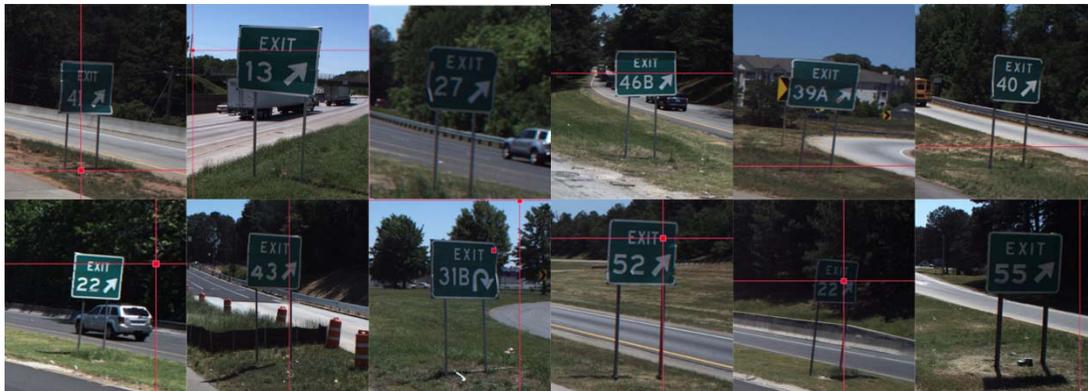
Of the 252 signs in poor condition, 21 are identified as having dual post damages. This type includes, primarily, the off-ramp signs that are mounted using dual posts to hold multi-panels. The dual posts indicate that the sign is supported by two parallel square or u-shaped sign posts, while the multi-panel indicates that the surface of the sign consists of multiple, elongated sign panels instead of a single panel. It was observed that the surface of the damaged signs shows waviness and unevenness, while the two posts of the damaged signs are no longer parallel to each other. Figure 3.9 shows several examples of such damaged signs. The preliminary inspection showed that such damage is caused by the unbalanced vibration of the dual posts, which shakes the multi-panels so that the surface becomes wavy and uneven. The unbalanced vibration can be produced by the gusts from the passing vehicles and ground support defects. Reinforcing the dual-post using an I-beam steel post with a slip base may effectively avoid such damage (McGee, 2010).

Figure 3.9 Examples of the damaged signs due to dual-post

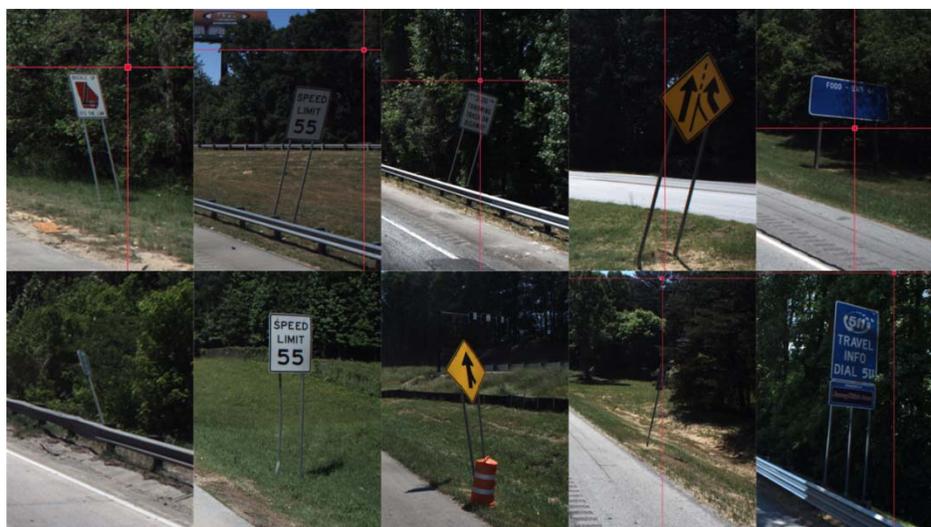
Of the 252 signs in poor condition, 73 signs are identified as having post failure. This type primarily includes traffic signs with incorrect facing due to the sign post failure. The preliminary inspection showed that the majority of these sign post failures can be caused by direct impact, which deforms the shape of the post, while the rest can be caused by a soft base or poor ground support. Figure 3.10 shows several examples of such damaged signs. Direct replacement will be needed for this damage type to maintain these signs' visibility during the daytime and nighttime. However, if field inspection identifies that the post failure is caused by a soft base, reinforcing the sign post with a slip base may also be required to avoid such damage, especially for large message sign panels (McGee, 2010; Bligh et al., 2001).

Figure 3.10 Examples of the damaged signs due to post failure

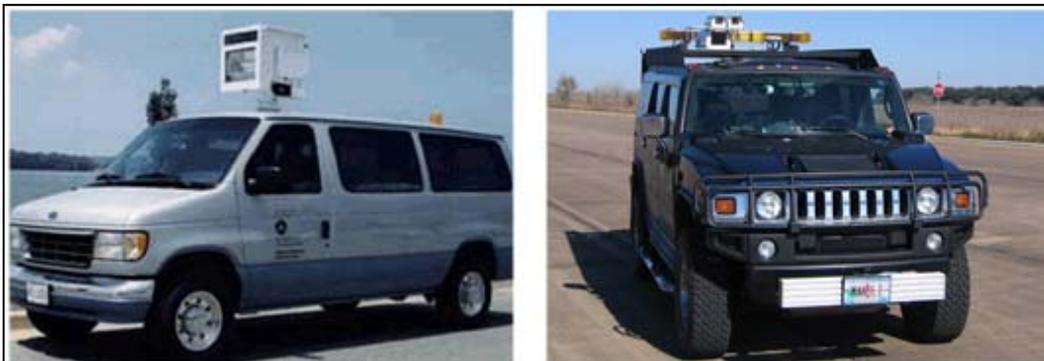
Figure 4.1 The Outlooks and the Schematic Flow of the Systems

Using correlations established between the image intensity and the retroreflectivity, several image-based traffic sign retroreflectivity condition assessment systems have been developed. A Sign Management and Retroreflectivity Tracking System (SMARTS) van was first developed by FHWA in 1999, as shown in Figure 4.1(a). The pilot test was conducted by Alaska DOT (Smith

& Fletcher, 2001). An external light-emitting diode (LED) was used to provide lighting to a traffic sign with known luminance to mimic a vehicle's headlight, while a single camera was used to collect video log images of the illuminated traffic signs. However, the results from the SMARTS van demonstrated that the image-based results had poor correlations with the retroreflectometer measurement results. Facet Inc. and Mandli[®] Communications Inc. developed a similar system called RetroView. External infrared lighting was used instead of an LED to avoid the impact from the ambient lighting. Two camera systems were used to separately collect low and high levels of intensity (Retterath & Laumeyer, 2008, 2011), as shown Figure 4.1(b). Several pilot tests have been conducted by the Tennessee Department of Transportation (TDOT) and the Texas DOT (TxDOT) using the RetroView system. The results indicate that the system is potentially a cost-effective method for traffic sign condition assessment. In Europe, the VISUAL Inspection of Sign and panEL (VISUALISE) system was developed by Gonzales et al. (2011). The VISUALISE system was tested on 500 traffic signs in Spain, and 91% of the traffic signs were correctly assessed. To avoid ambient lighting, the system was operated during the nighttime. The primary reasons of some erroneous assessments included inclined traffic signs and small traffic signs.

(a) FHWA SMARTS system (b) Mandli/Facet RetroView system

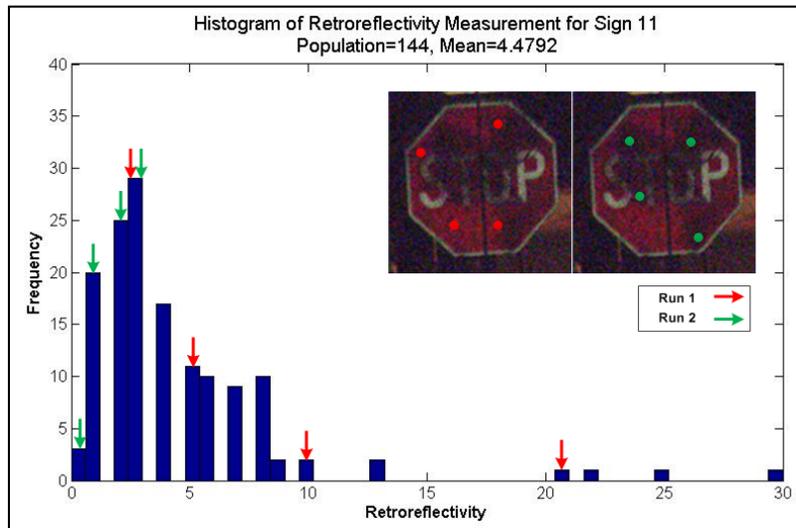
From Table 7.2, it is observed that the retroreflectometer measurement results using the average value of all the measurement points are consistent with the results using the tested method. However, the assessment result from Run 1 of the four-point measurement is different from other runs. The average is much higher than the rest of the runs. To further identify the different results, we investigated the distribution of the retroreflectivity from the retroreflectometer measurement.

Figure 4.3 Distribution for the Retroreflectivity Measurement

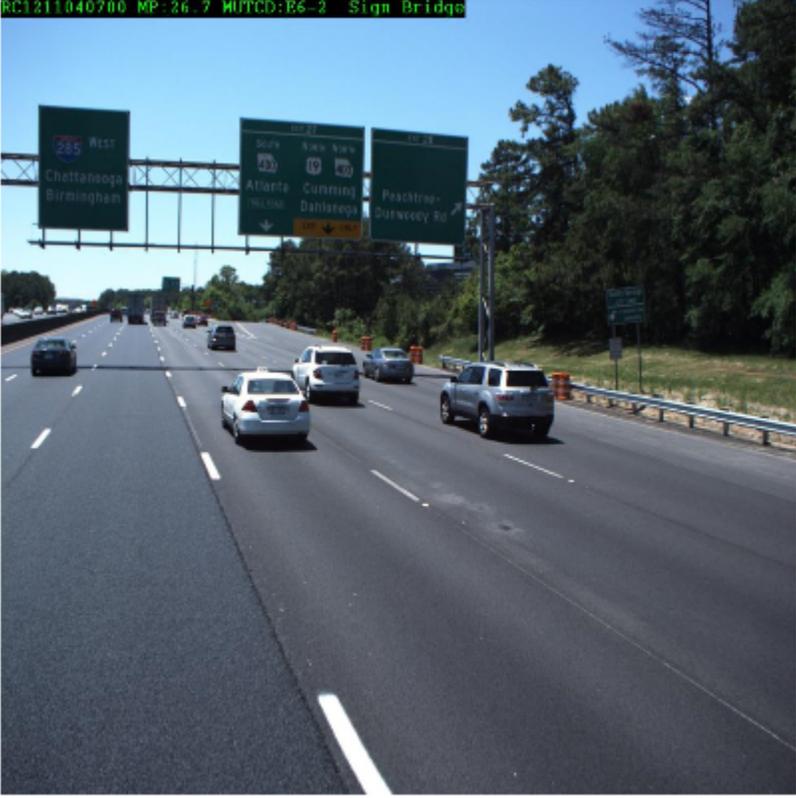
Figure 5.4 Individual Sign Information Window

Sign Information	
Longitude	-84.34831
Latitude	33.91493
Id	2778
RCLINK	1211040700
Milepoint	26.655
MUTCD	E6-2
Damaged_Type	<Null>
Overhead_Type	Sign Bridge

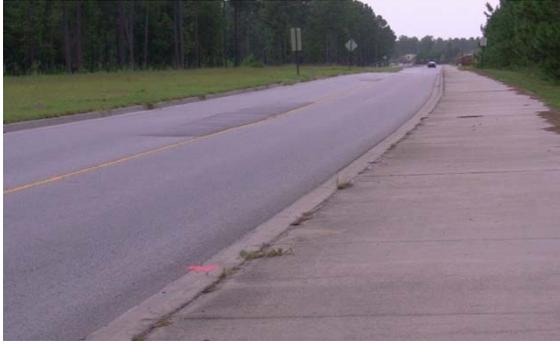
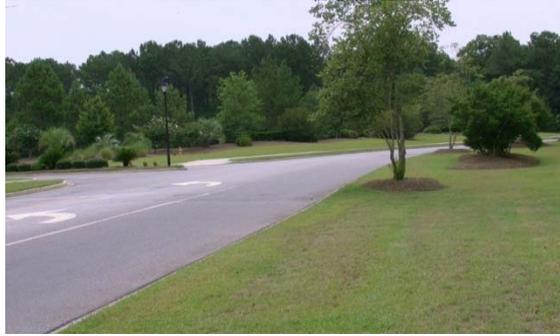
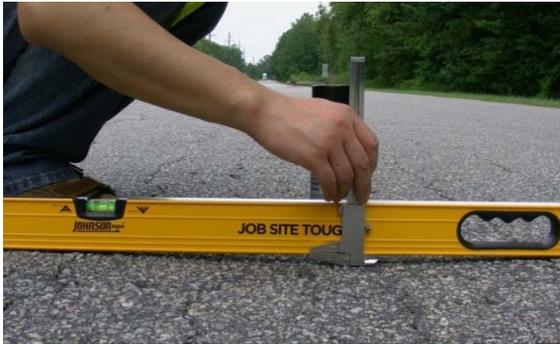
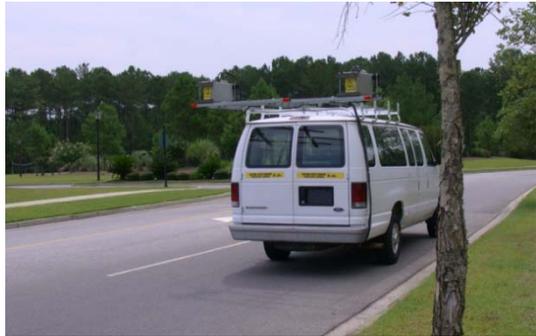
Figure 6.5 Field Test: (a) Test Site on Benton Blvd.; (b) Test Site on Towne Center Ct.; (c) 1.8m Straightedge Method; (d) Survey using 3D laser System

Two roadway sections were selected in Pooler, Georgia. As shown in Figure 6.5(a), a 725m roadway section was chosen on Benton Boulevard. A 45m roadway section was selected on Towne Center Ct., shown in Figure 6.5(b). There were six test transverse profiles marked with paint, which can be seen from the laser intensity data, on the Benton Blvd. test section. On the Towne Center Ct. test section, 4 test profiles were marked. These test profiles are non-uniformly distributed over the test section.

To establish the rut depth ground truth of those 10 test profiles, a 1.8m straightedge method was performed as shown in Figure 6.5(c). The same measurement procedure was followed as that in the laboratory test, which was repeated 3 times for each transverse profile. The average rut depth for each transverse profile was considered as the ground truth.

The 3D laser was mounted on the GTSV as shown in Figure 6.5(d). The sensing vehicle drove on both test sections for three runs and collected 3D continuous transverse profile data. The mean vehicle speeds for the first test section were 37.8mph (mi/hr), 34.4mph, and 32.8mph, respectively; they were 13.5mph, 17.8mph, and 15.3mph for the second test section. Because the road sections were chosen on local roads to facilitate the manual measurement, no highway speed, higher than 60mph, was tested in this study. Figure 6.6 shows two typical transverse profiles obtained by the 3D laser. The measured profiles were then used to calculate the corresponding rut depth.

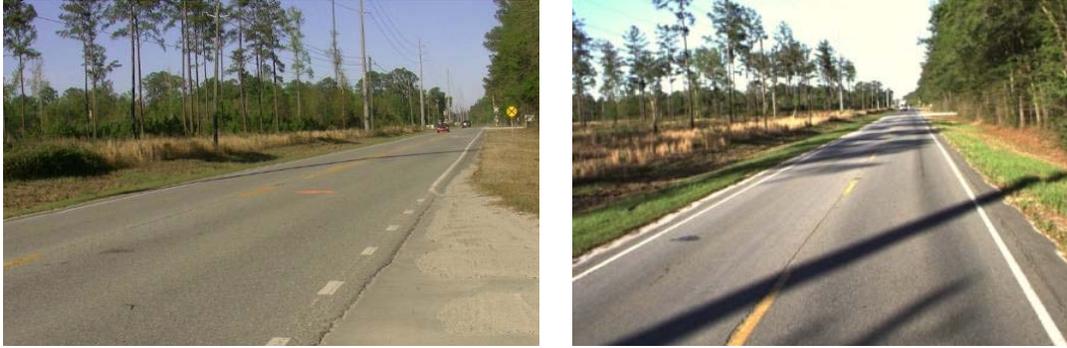
Another field test was conducted on a GDOT-monitored project on SR 275 near Savannah, Georgia, to assess the rut depth measurement accuracy. Figure 6.7 (a) shows the roadway environment on SR 275. This 2-lane road is 5.53 mi long. The overall PACES rating is 80 in Fiscal Year 2011 (FY2011). Table 6.7 summarizes the PACES ratings for each segment of SR 275. As shown in Table 6.7, only the segment between milepost 0 and milepost 1 has relatively severe rutting, which might have been caused by localized material problems, structural problems, and/or the heavy truck traffic on this section.

(a) (b)
Figure 6.7 Field Test on SR 275: (a) Test Site; (b) Rutting

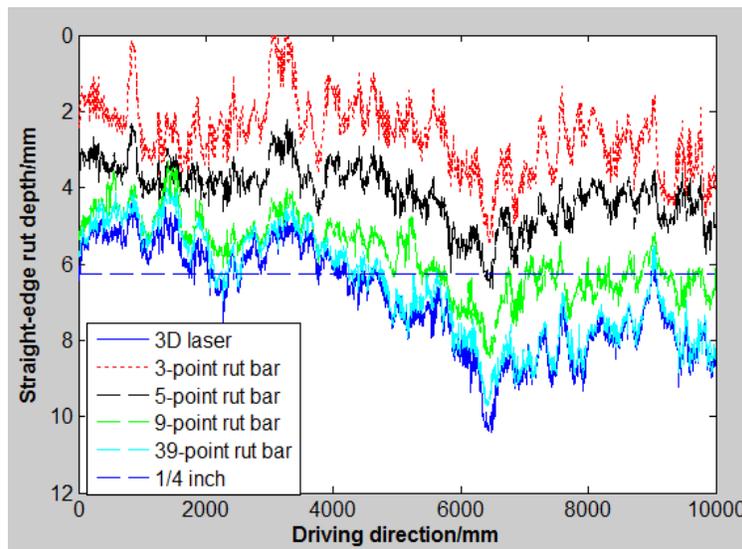
To further assess the measurement error caused by using point-based rut bar systems with different numbers of sensors, the histograms of measurement errors along the driving direction were analyzed. They are presented in Figure 6.19. The corresponding means of errors for all point-based rut bar systems are reduced with the increasing number of sensors. For 3-point and 5-point rut bar systems, the average measurement errors are about 63% and 44%. When the sensor number increases to 9, the mean error becomes 24%, although the variation of error does not change much. If the number of sensors increases to 39, the average measurement error is lowered to about 8%. The variation of error also decreases.

Figure 6.18 Rut Depth Profile along Driving Direction

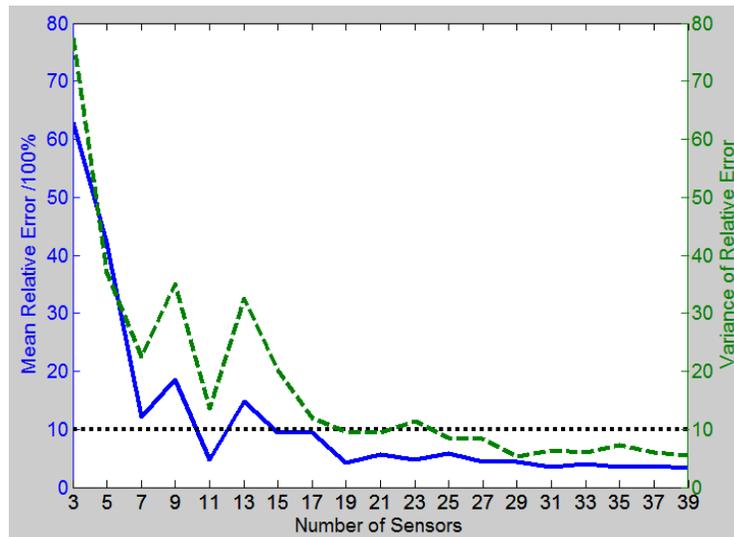
Figure 6.20 Relationships between Mean and Variance of Relative Measurement Errors and Number of Sensors

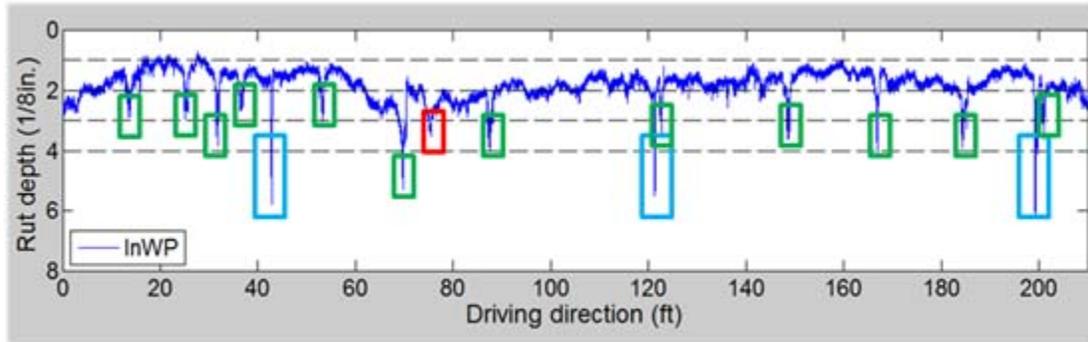
■ A single transverse crack
 ■ A raised pavement marker
 ■ An isolated rut

Figure 6.23 Causes of Outliers

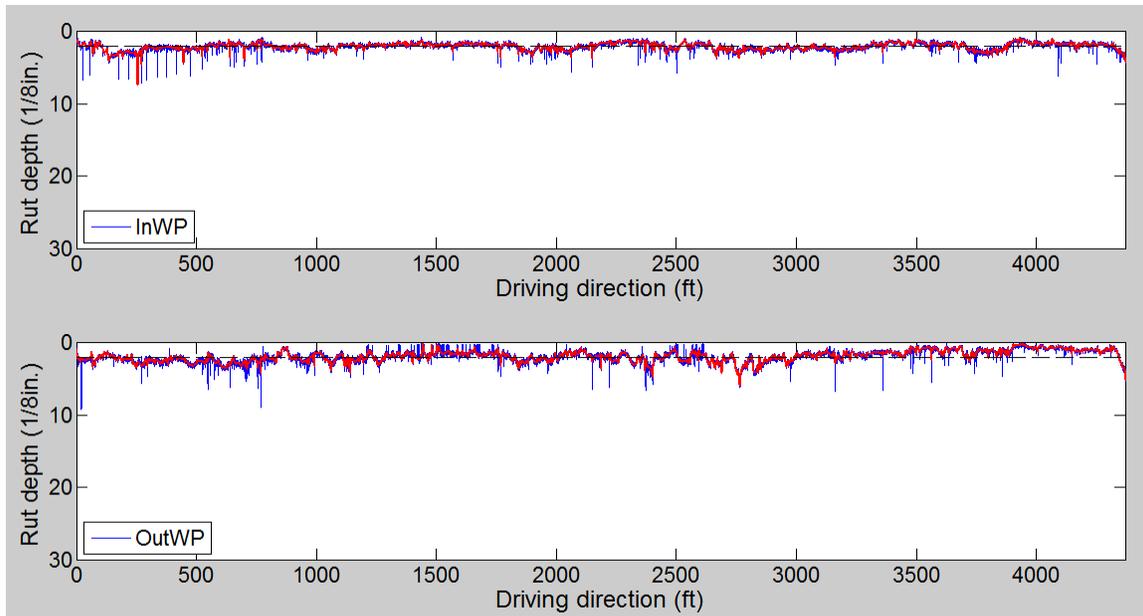
Figure 6.28 Raw (Blue) and Filtered Data (Red) (SR275 SB from MP 0.8 to MP 0)

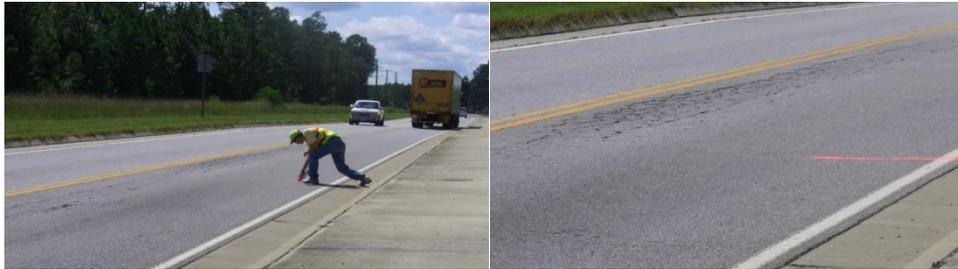
Similar analyses have been done to a road section of Benton Blvd. Figure 6.30(a) shows the roadway environment, and Figure 6.30(b) shows a short section with severe rutting and alligator cracking. The 3D laser data collected from Benton Blvd. was processed. The raw rut depth data is presented in Figure 6.31. As seen from the figure, the rutting condition within this mile is less uniform. The rut depth ranges from 1/4 in. to 2 in. Also, the rut depth data is noisy because the severe rutting on this road section is accompanied by alligator cracking, as shown in Figure 6.30(b). After applying the noise removal algorithm, the outliers were removed. The filtered data is shown in Figure 6.32. Then, statistical analysis was carried out. The results are presented in Figure 6.33 and Table 6.25. As shown in the table, the standard deviation of the rut depths in this test section is relative high, greater than 1/8 in. The representative mode is 3.0 and 1.8 for inside and outside wheelpaths. The maximum percentage is only 31% and 39%. This concurs with previous observation that the rutting condition within this section is less uniform.

(a) (b)
Figure 6.30 Roadway Environment (Benton Blvd.)

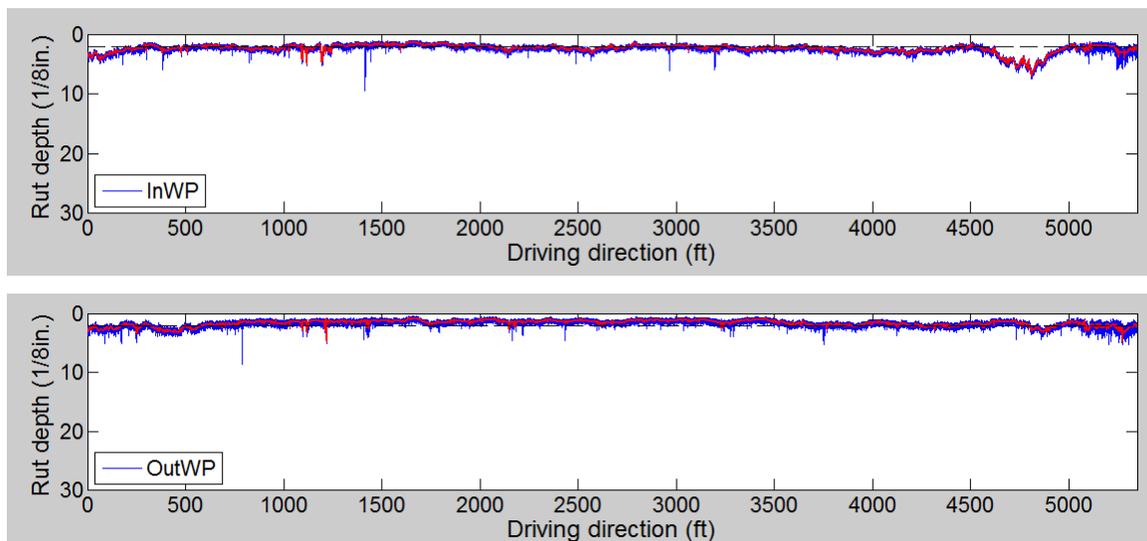
Figure 6.35 Raw (Blue) and Filtered Data (Red) (I-95)

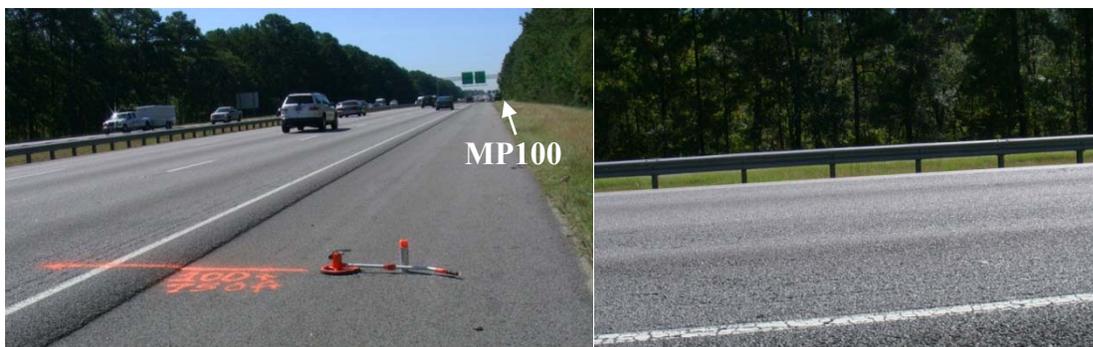
Figure 6.50 Isolated Rut Verification in Field (I-95)

A windshield survey confirmed that this highway section does not show much rutting, and only a short section is shown in Figure 6.50 (b); approaching the end of this mile on the inside wheel path, it exhibits an isolated rut. This isolated rut could cause the risk of hydroplaning. However, it is tedious and difficult to locate it through the manual survey. In contrast, the method developed in this section is capable of finding spots with high hydroplaning potential automatically for the whole roadway network at highway speed. Therefore, it is very valuable and can dramatically improve existing survey and pavement maintenance practices.

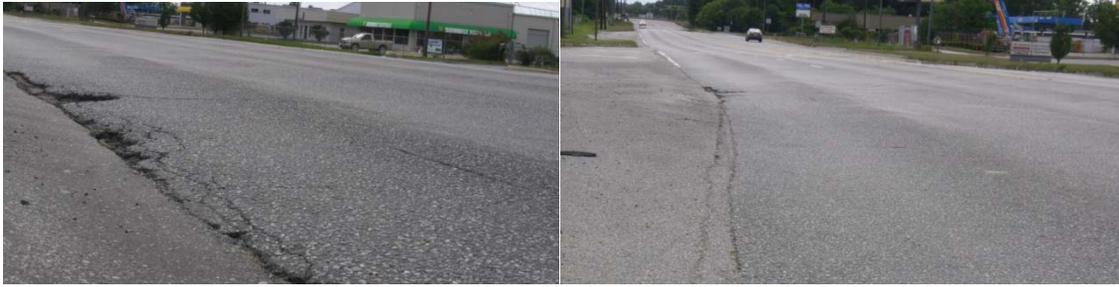
Figure 6.56 An Isolated Rut (Spot #2) on SR 307

The detection results were verified in the field by engineers from GDOT. Figure 6.55 shows the field verification results. Isolated ruts 4 and 6 can be clearly observed in the field since the depth is more than 1/2 in. deep. Some images taken from the field are shown in Figure 6.56. However, it is difficult to locate ruts 1, 2, and 3 in the field. The isolated rut 5 is at the railroad cross-section.

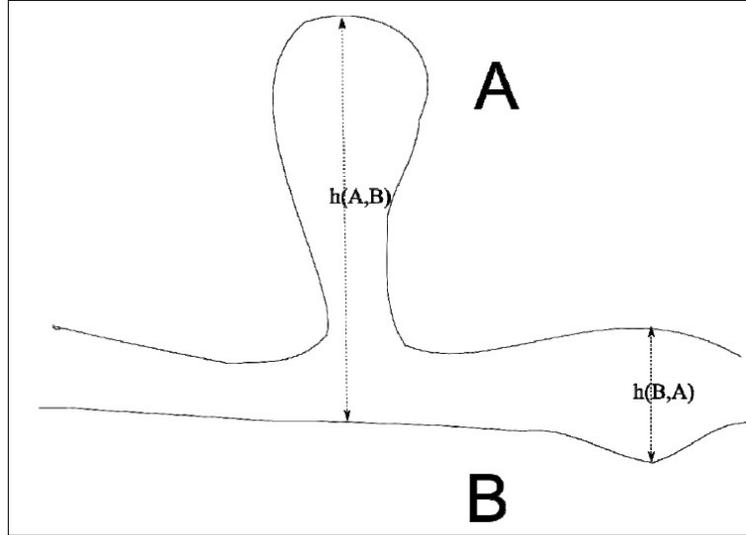
Figure 7.1 Illustration of Hausdorff Distance
