GEORGIA DOT RESEARCH PROJECT 10-08

**A REMOTE SENSING AND GIS-ENABLED HIGHWAY
ASSET MANAGEMENT SYSTEM**

1. Report No.: GA-15-1008	2. Government Accession No.:	3. Recipient's Catalog No.:	
4. Title and Subtitle: A Remote Sensing and GIS-Enabled Highway Asset Management System		5. Report Date: April 2016

Final Report

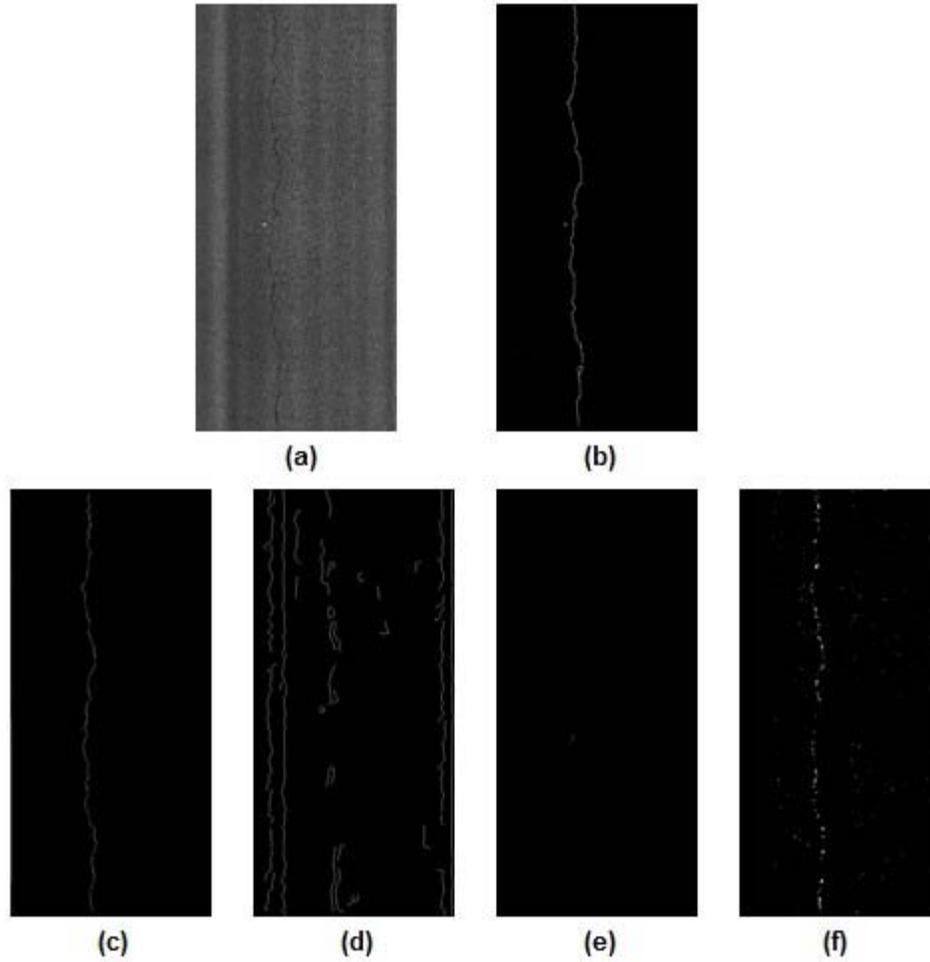
Figure 7.5 (a) Original Image; (b) Ground Truth Crack Map; (c) Dynamic Optimization Results (Score: 92.4423); (d) Canny Edge Detection Results (Score: 14.9668); (e) Crack Seed Verification Results (Score: 3.1376); (f) Iterated Clipping Results (Score: 64.0048)

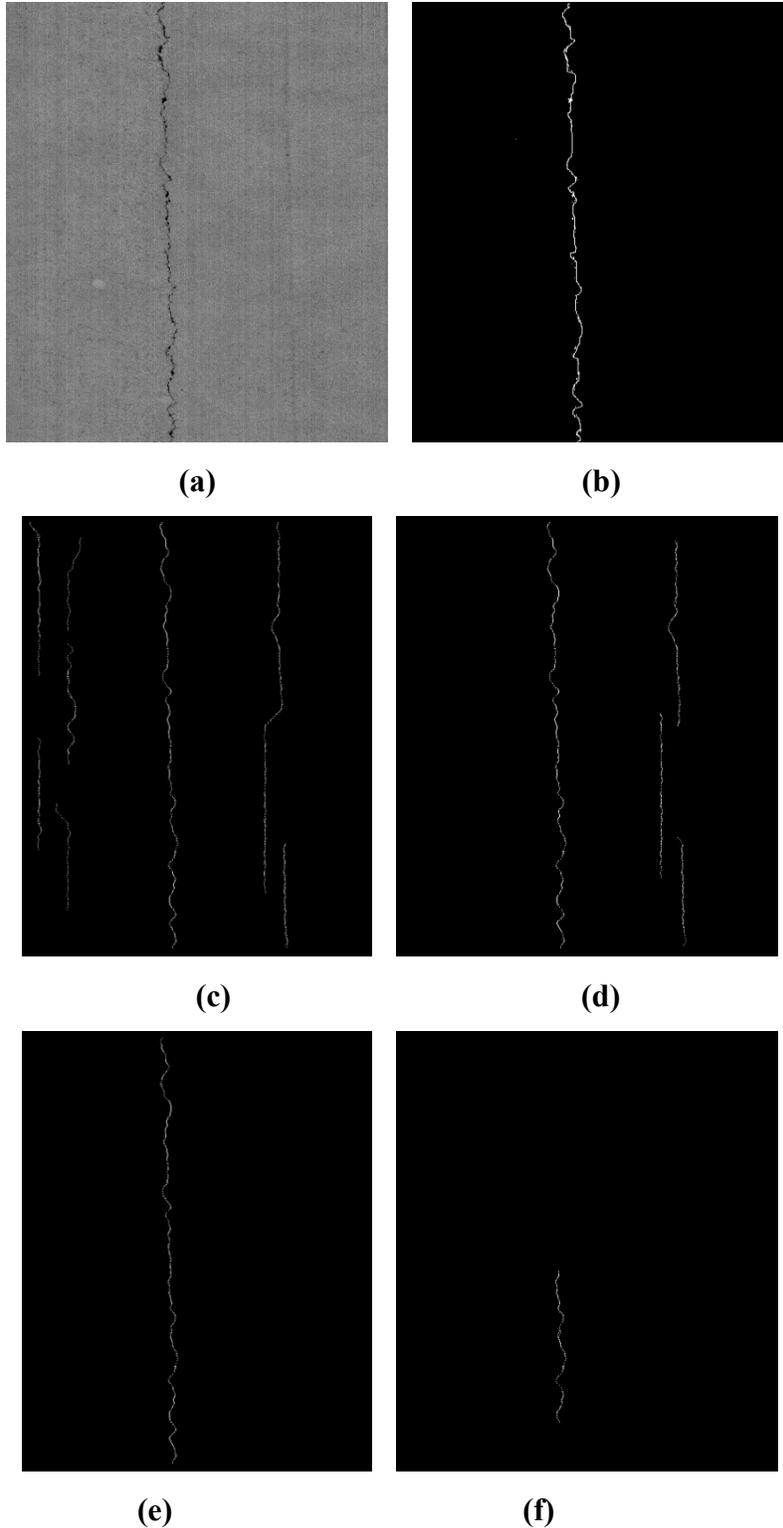
Figure 7.14 (a) Original Range Image; (b) Ground Truth Crack Map; (c) Detected Cracks at 0.78 (Score: 32.7443); (d) Detected Cracks at 0.84 (Score: 51.6057); (e) Detected Cracks at 0.90 (Score: 96.3730); (f) Detected Cracks at 0.96 (Score: 38.7939).

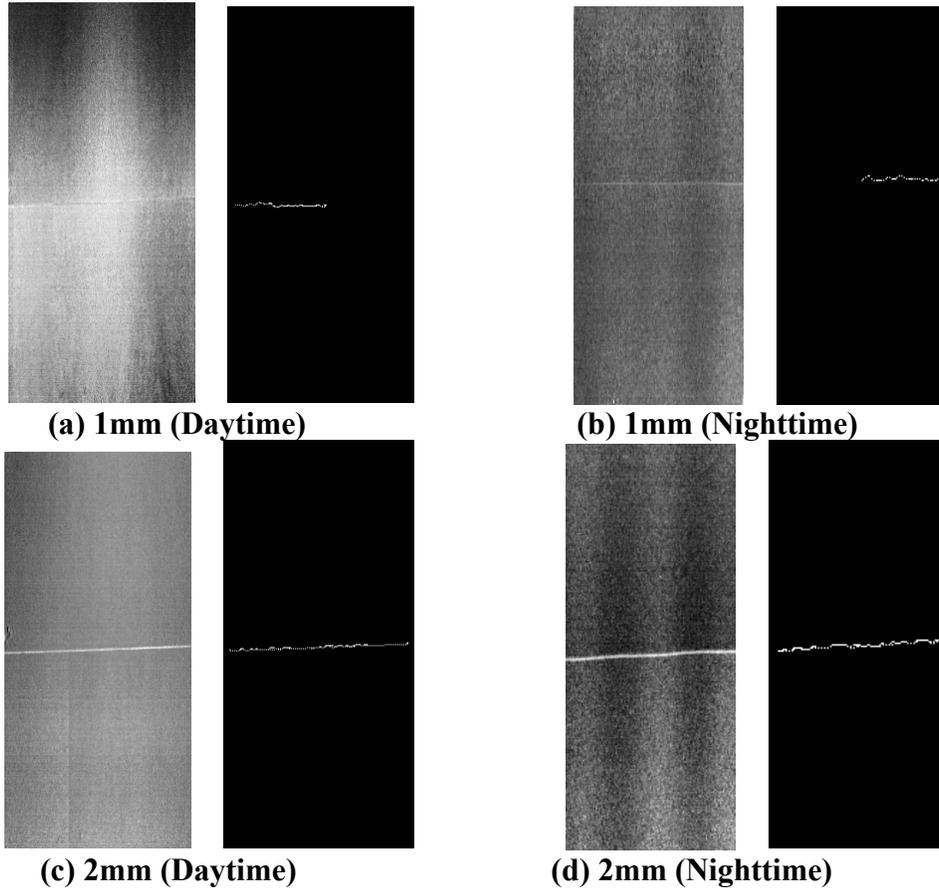
Figure 8.3 Crack Segmentation Results on Simulated Cracks: the One on the Left is Raw 3D Data, and the One on the Right is the Crack-Segmented Results (Tsai, 2010)

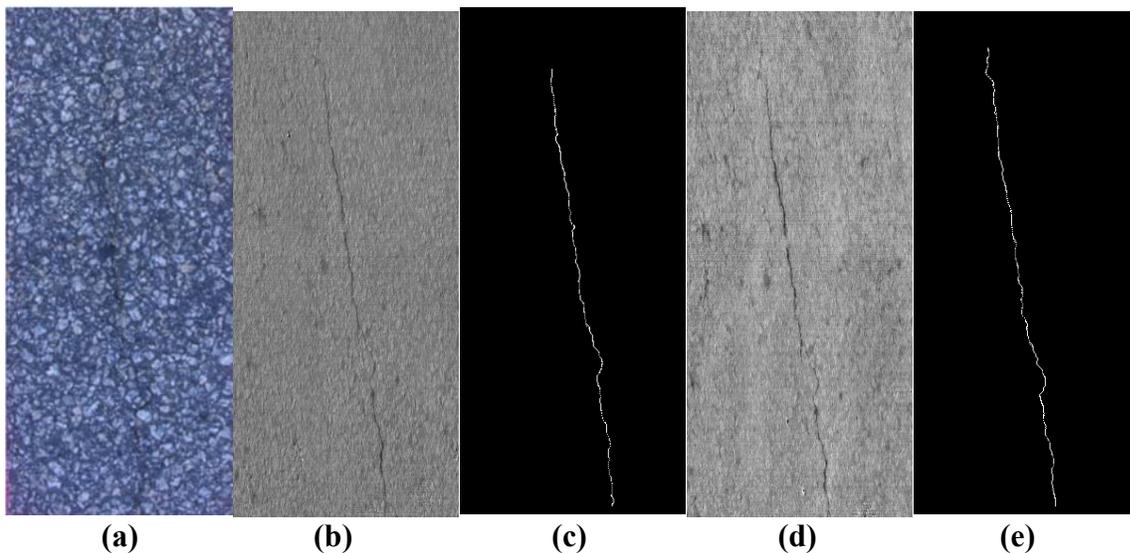
Figure 8.4 Test Results on Crack with Low-Intensity Contrast: (a) Roadway Image; (b) 3D Laser Data Collected during the Daytime; (c) Crack Segmentation Result (Daytime; Score = 98.3); (d) 3D Laser Data Collected during the Nighttime; (e) Crack Segmentation Result (Nighttime; Score = 98.0) (Tsai, 2010)

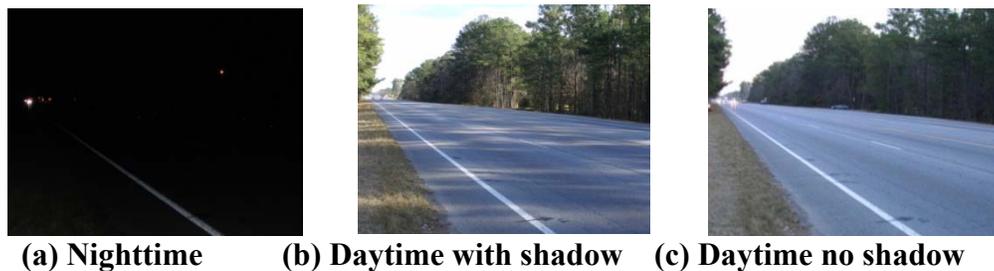
Figure 8.5 Examples of Three Lighting Conditions

The second field test was conducted on SR 80 to evaluate the consistency of using the 3D laser system to detect cracks under three different lighting conditions: nighttime, daytime with shadows, and daytime without shadows. Eleven test segments, including ten longitudinal cracks (cracks A to J) and a transverse crack (crack T), were labeled in the field. Examples of the three lighting conditions are shown in Figure 8.5. All eleven crack segments were analyzed using the dynamic optimization-based crack segmentation algorithm. Figure 8.6 shows the example of 3D raw data collected under three lighting conditions and the corresponding crack segmentation results for the crack J. Each sub-figure contains the 3D raw data on the left and the segmented crack on the right. Visual observation shows that the crack can be clearly captured by the 3D laser system and well segmented using the dynamic optimization-based method.

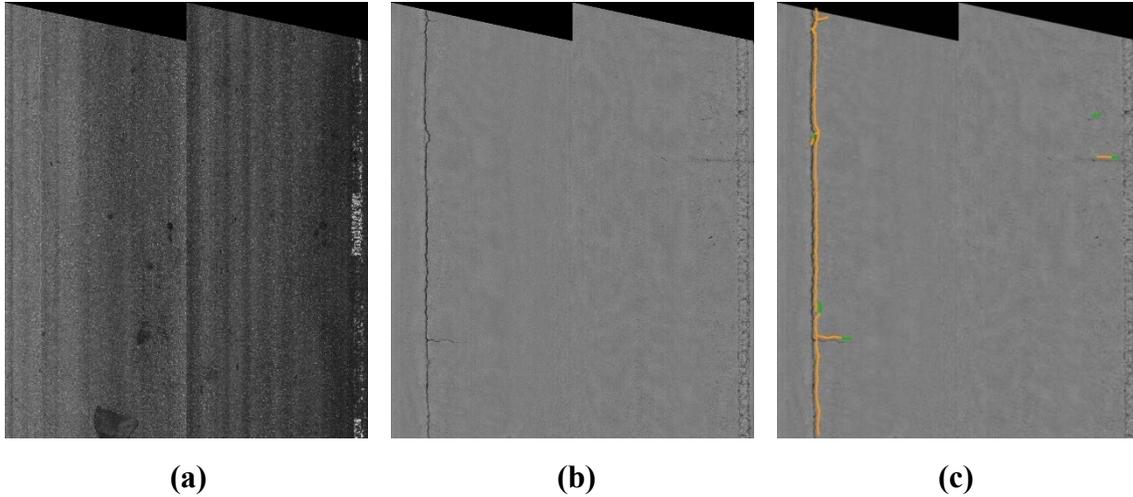
Figure 8.7 Pavement Images with Oil Stain:
(a) Intensity image; (b) Range image; (c) Crack detection results

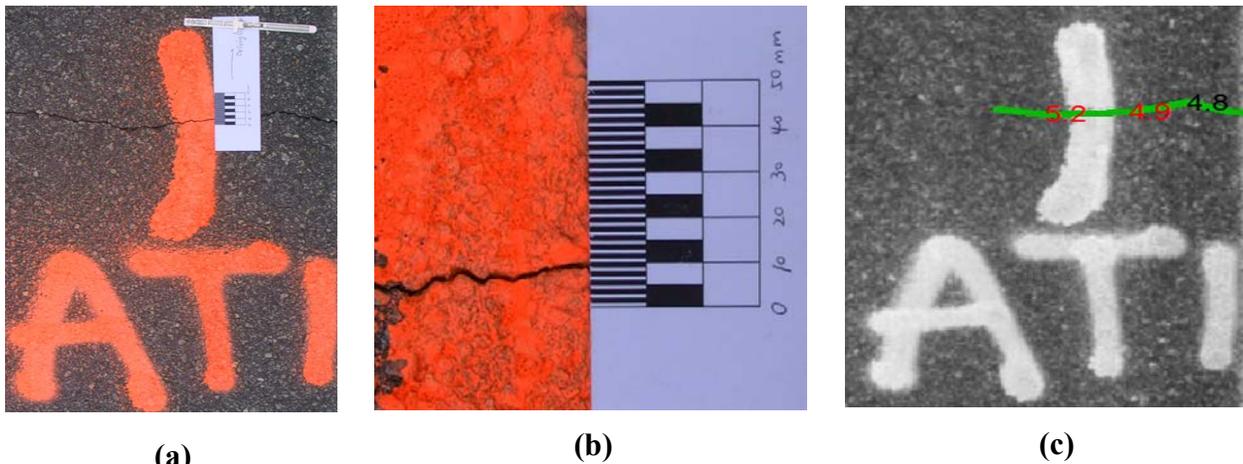
Figure 8.14 Measurement of Transverse Crack Width

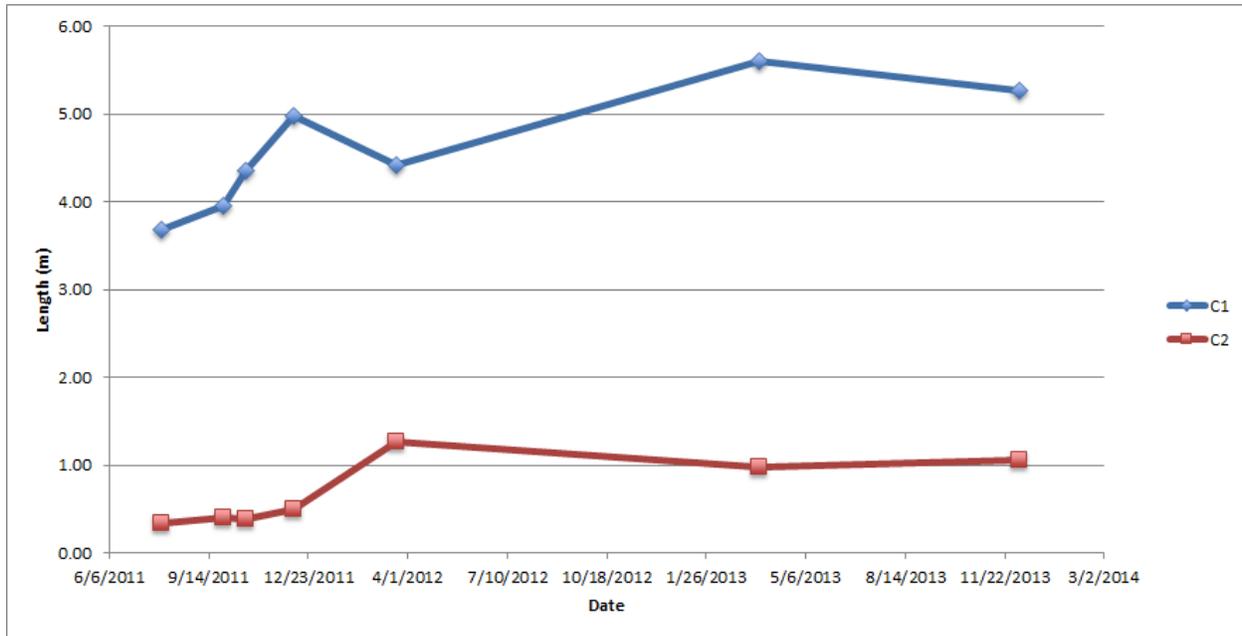
Figure 9.5 Trend of Total Length of Selected Cracks

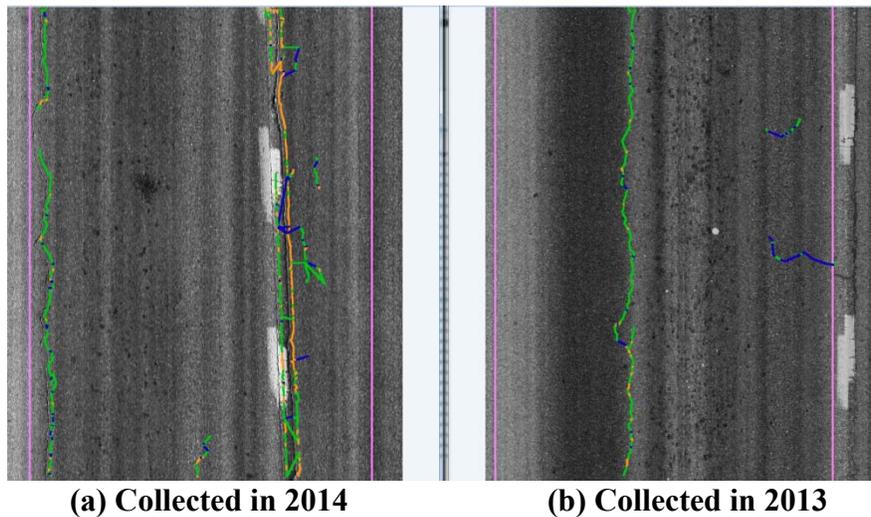
Figure 9.12 Inconsistent Sampling Area/Region Caused by Vehicle Wandering

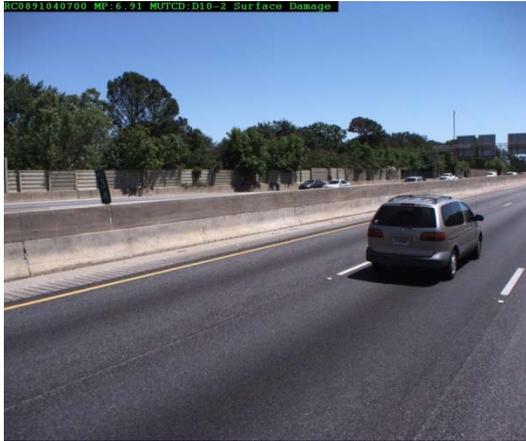
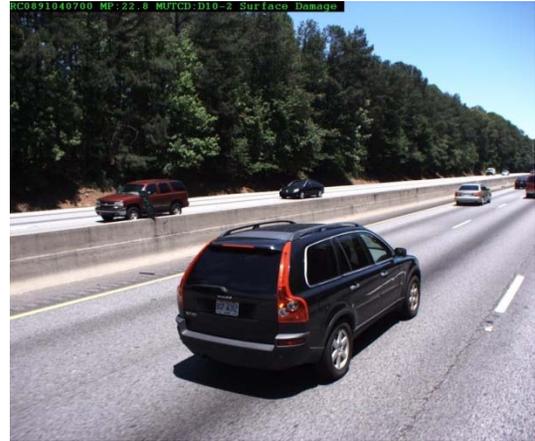
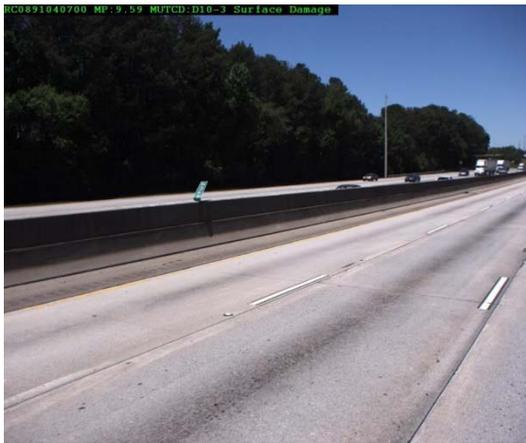
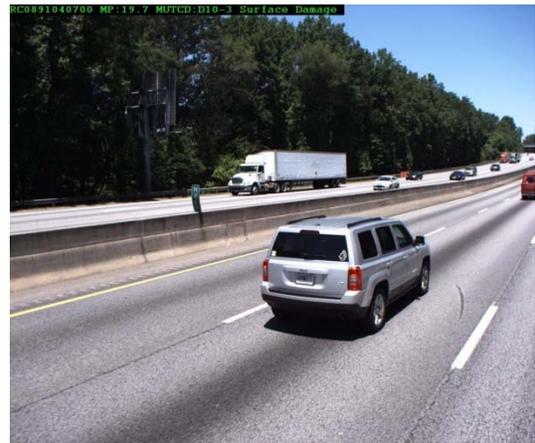
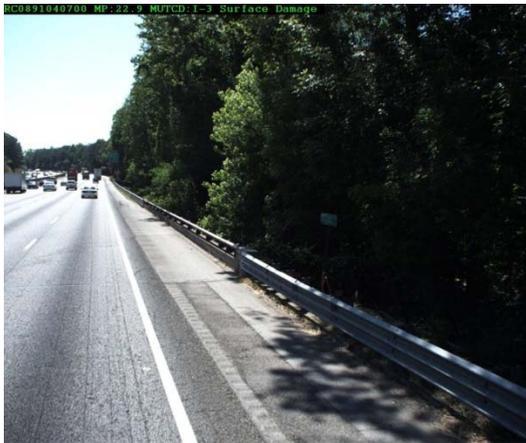
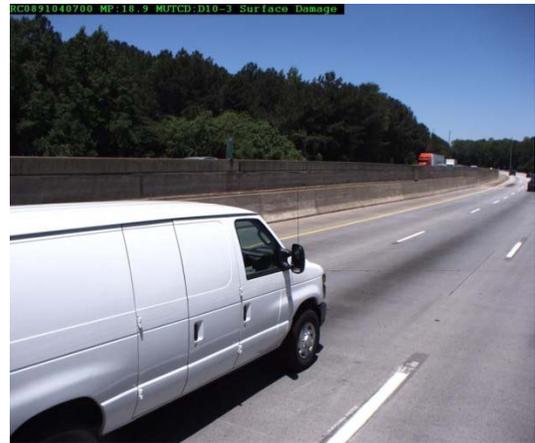
Surface Failure (150 Cases)

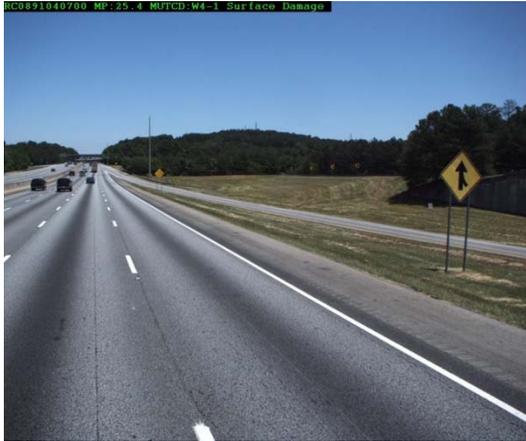
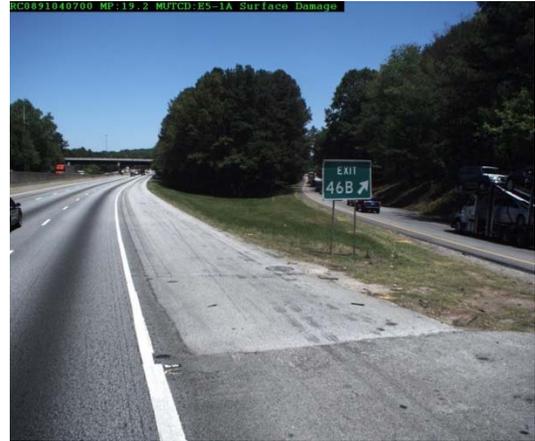
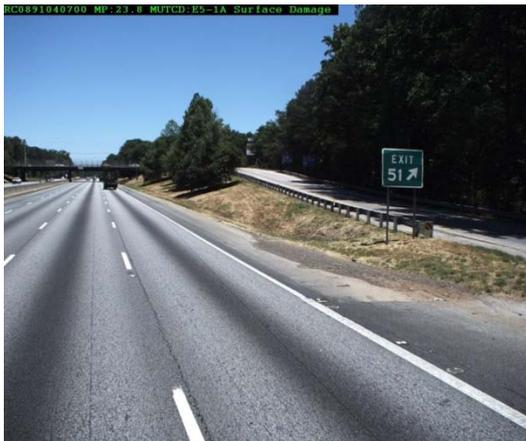
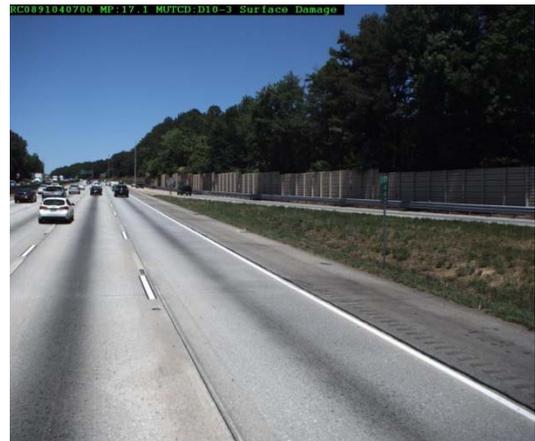
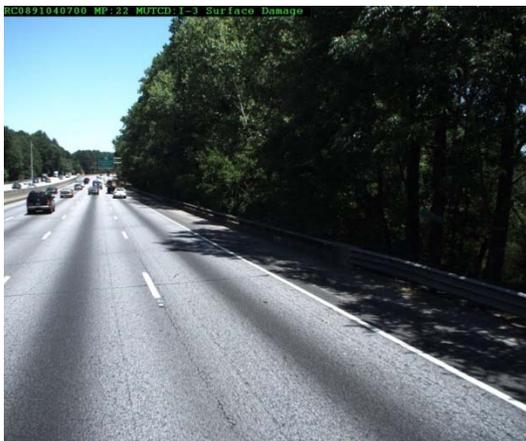
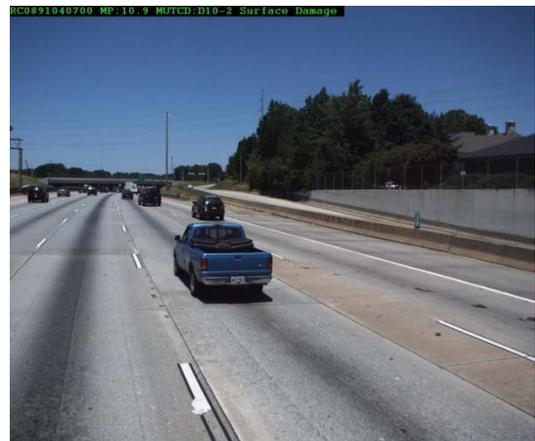
Appendix I: List of Poor Condition Signs on I-285

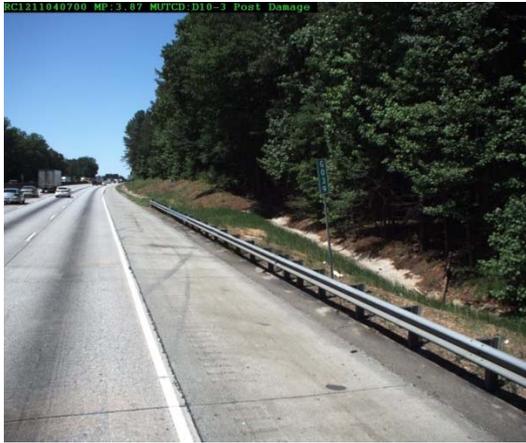
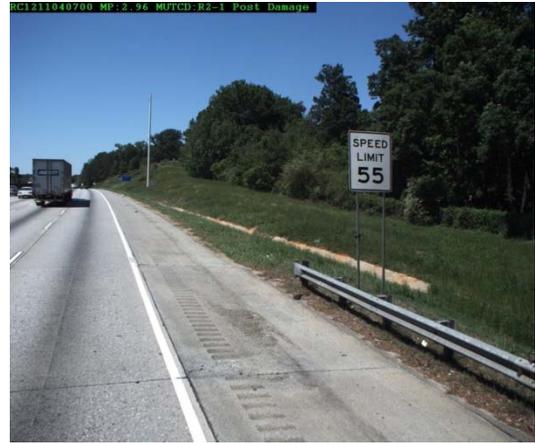
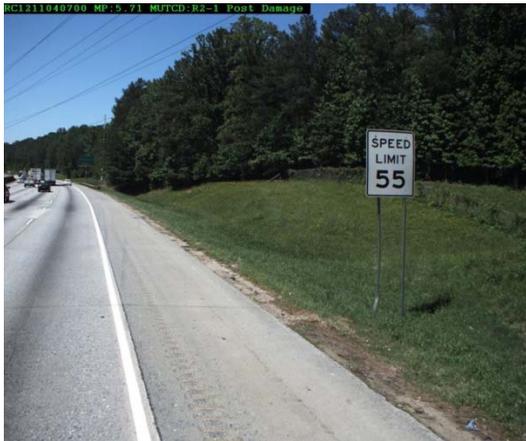
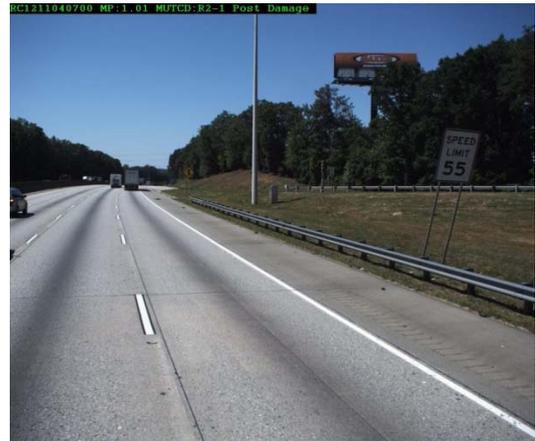
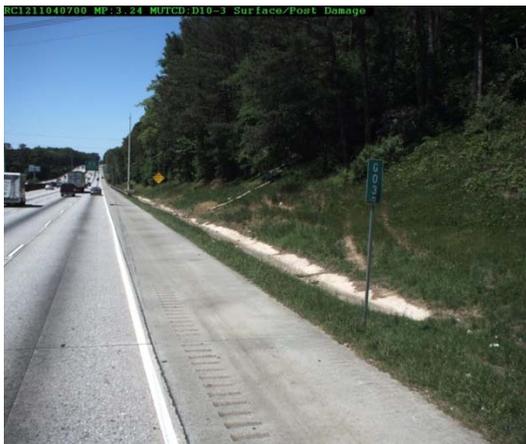
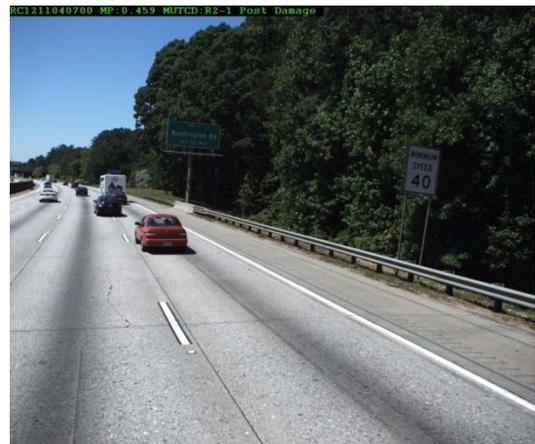
Post Failure (73 Cases)

1211040700	8.929	D10-1	Surface Failure
1211040700	6.931	D10-1	Surface Failure
1211040700	9.210	ClickIt	Surface Failure
0891040700	3.552	BuckleUp	Surface Failure
0891040700	18.639	W9-1	Post Failure
0891040700	17.978	W8-13	Post Failure
0891040700	24.919	W8-13	Post Failure
0631040700	2.551	W8-13	Post Failure
1211040700	25.996	W4-3	Post Failure
0891040700	19.366	W4-3	Post Failure
0891040700	23.797	W4-3	Post Failure
1211040700	62.348	W4-3	Post Failure
0891040700	5.060	W4-2	Post Failure
1211040700	26.227	W4-1	Post Failure
0891040700	16.160	W4-1	Post Failure
1211040700	6.813	W4-1	Post Failure
0891040700	3.669	W1-1	Post Failure
1211040700	13.131	ThrowingTrash	Post Failure
0891040700	6.057	ThrowingTrash	Post Failure

RCLINK	Milepoint	MUTCD	Visual Condition
0891040700	20.411	ThrowingTrash	Post Failure
1211040700	54.620	ThrowingTrash	Post Failure
1211040700	53.453	ThrowingTrash	Post Failure
1211040700	25.725	RightLaneExitOnly	Post Failure
1211040700	9.670	RightLaneExitOnly	Post Failure
1211040700	6.245	R2-4	Post Failure
0671040700	6.361	R2-4	Post Failure
1211040700	0.459	R2-1	Post Failure
1211040700	1.013	R2-1	Post Failure
1211040700	2.958	R2-1	Post Failure
1211040700	5.710	R2-1	Post Failure
1211040700	7.674	R2-1	Post Failure
1211040700	25.290	R2-1	Post Failure
0891040700	22.878	NoDUI	Post Failure
1211040700	8.616	M3-3	Post Failure
0891040700	23.230	M3-2	Post Failure
1211040700	8.616	M1-1	Post Failure
0891040700	16.679	M1-1	Post Failure
1211040700	11.204	I13-A	Post Failure
0631040700	0.686	GAHero	Post Failure
1211040700	9.489	E5-1a	Post Failure
1211040700	22.994	E5-1	Post Failure
0891040700	11.163	E5-1	Post Failure
1211040700	11.329	E5-1	Post Failure

0891040700	13.223	D12-5	Post Failure
0891040700	23.264	D12-5	Post Failure
1211040700	22.803	D10-3	Post Failure
1211040700	12.221	D10-3	Post Failure
1211040700	22.912	D10-3	Post Failure
1211040700	26.000	D10-3	Post Failure
0891040700	8.004	D10-3	Post Failure
0891040700	10.179	D10-3	Post Failure
0891040700	13.349	D10-3	Post Failure
0891040700	21.666	D10-3	Post Failure
0891040700	22.458	D10-3	Post Failure
0891040700	24.440	D10-3	Post Failure
1211040700	3.872	D10-3	Post Failure
1211040700	8.984	D10-3	Post Failure
1211040700	11.260	D10-3	Post Failure
1211040700	5.849	D10-3	Post Failure
1211040700	2.614	D10-3	Post Failure
0631040700	4.748	D10-3	Post Failure

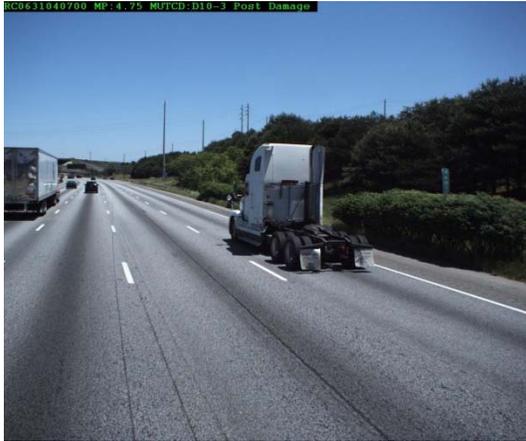
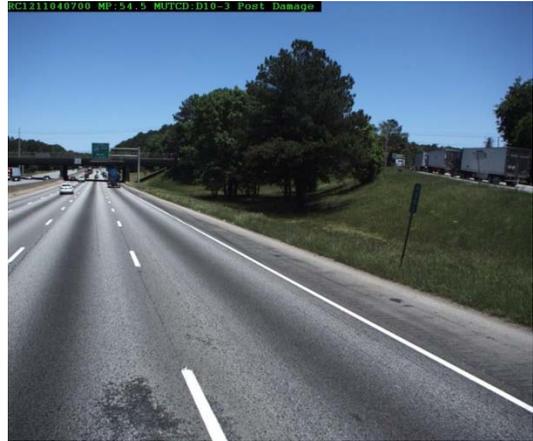
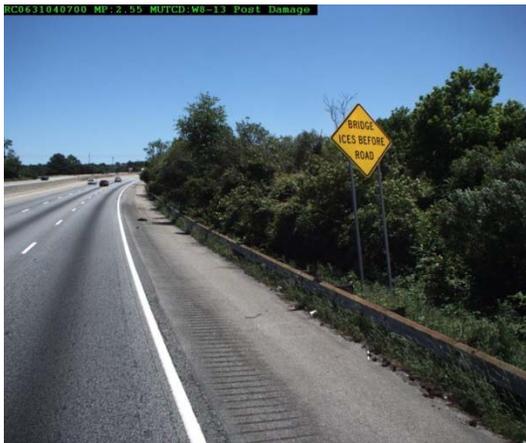
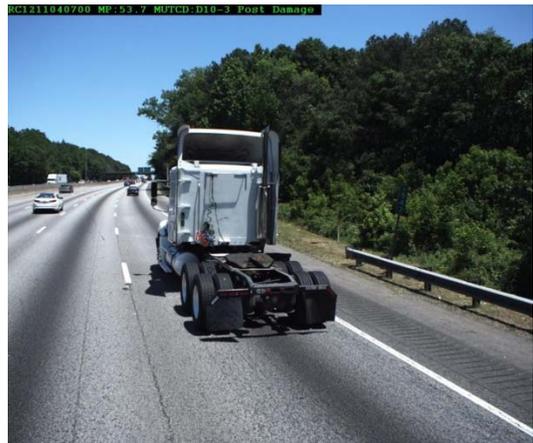
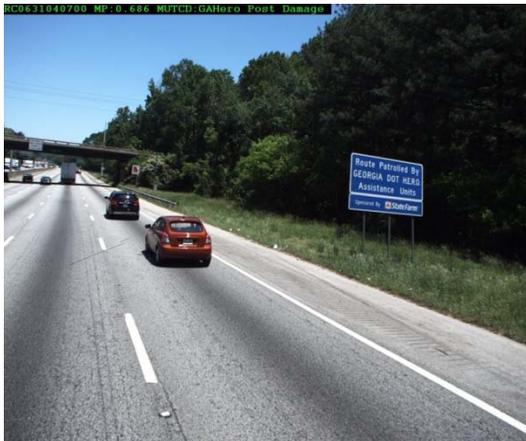
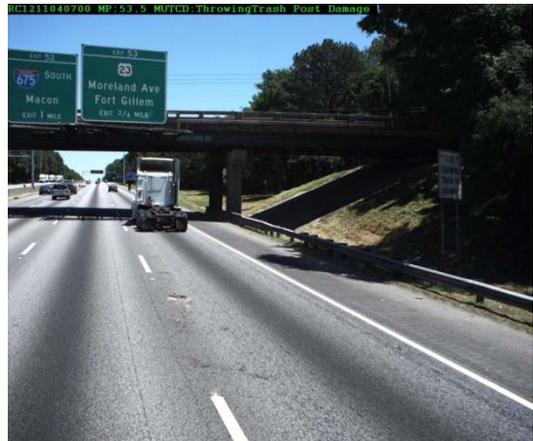
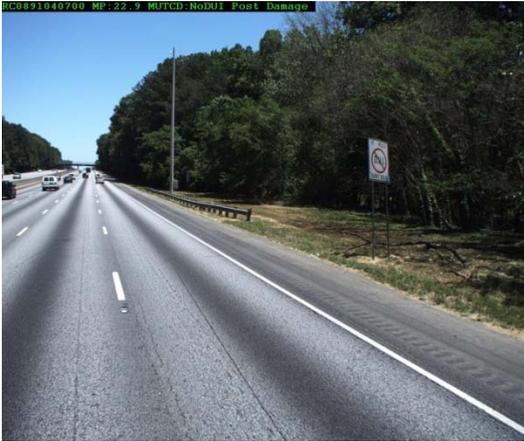
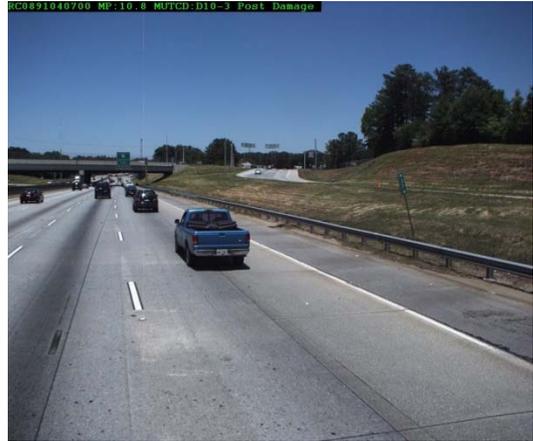
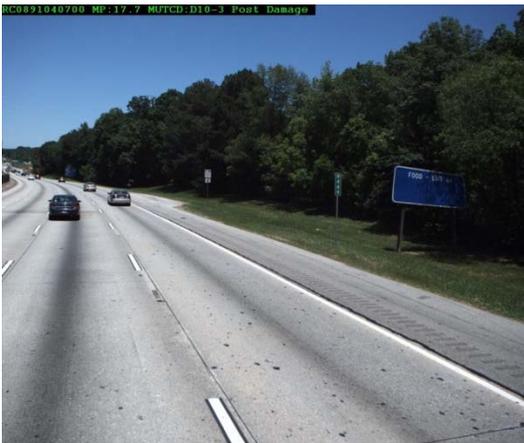
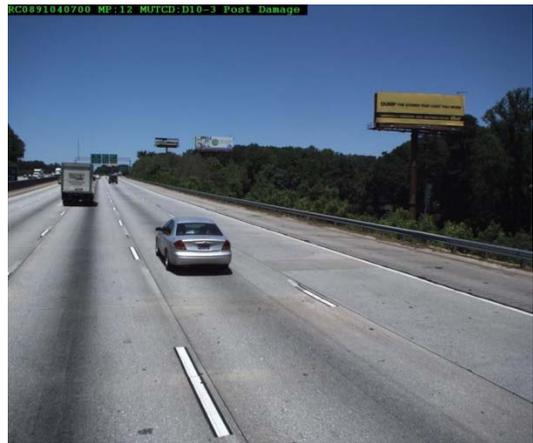
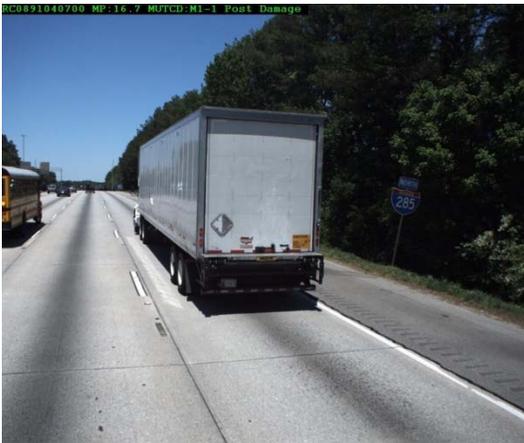
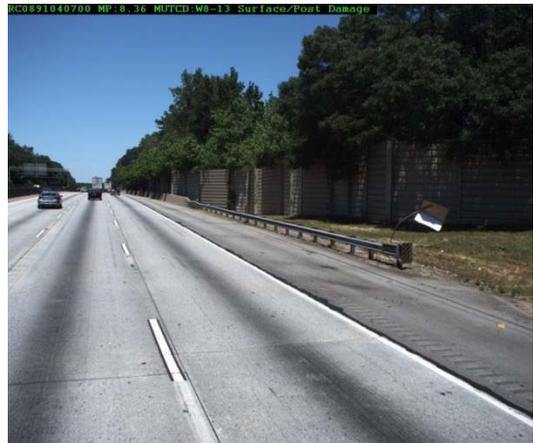
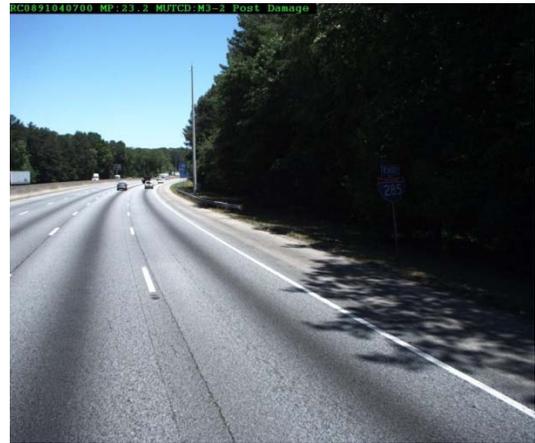
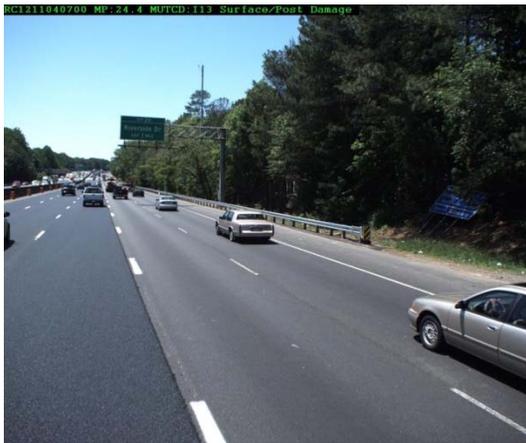
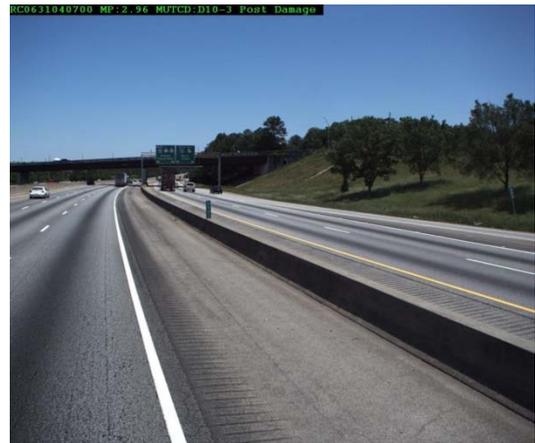
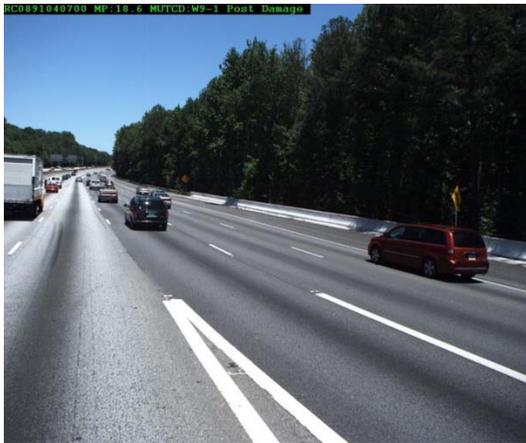
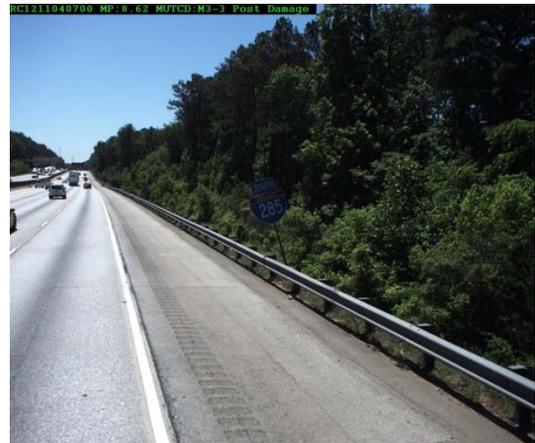
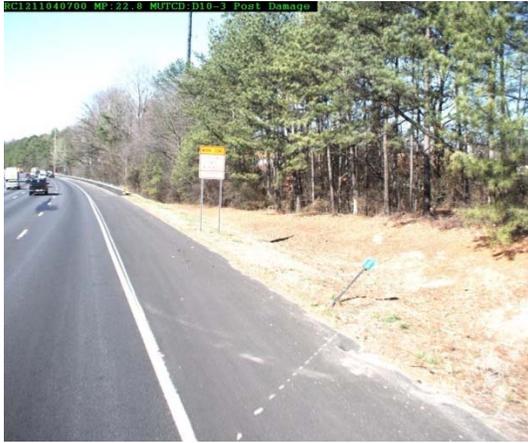
RCLINK	Milepoint	MUTCD	Visual Condition
0631040700	2.958	D10-3	Post Failure
1211040700	54.489	D10-3	Post Failure
1211040700	53.710	D10-3	Post Failure
0891040700	17.706	D10-3	Post Failure
0891040700	11.967	D10-3	Post Failure
0891040700	10.774	D10-3	Post Failure
1211040700	21.506	D10-3	Post Failure
1211040700	6.050	D10-3	Post Failure
1211040700	9.875	D10-2	Post Failure
1211040700	1.987	D10-1	Post Failure
1211040700	25.969	ClickIt	Post Failure
1211040700	10.538	BuckleUp	Post Failure
1211040700	8.780	BuckleUp	Post Failure
0631040700	2.124	W8-13	Obstructed
0671040700	6.690	W8-13	Obstructed
0891040700	18.712	W4-1	Obstructed
0891040700	3.759	W13-3	Obstructed
0891040700	18.948	W13-2	Obstructed
0891040700	19.026	ThrowingTrash	Obstructed
0891040700	4.804	R2-1	Obstructed
0891040700	17.907	R2-1	Obstructed
0891040700	5.695	NoDUI	Obstructed
0891040700	18.052	M3-1	Obstructed
0891040700	18.052	M1-1	Obstructed
0891040700	18.840	I-3	Obstructed

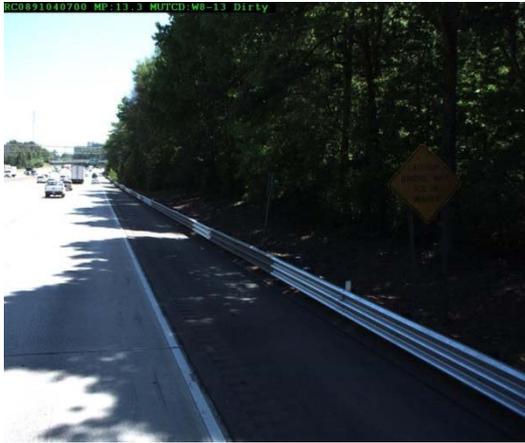
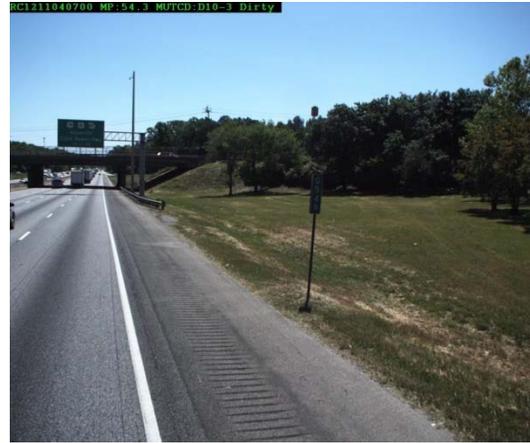
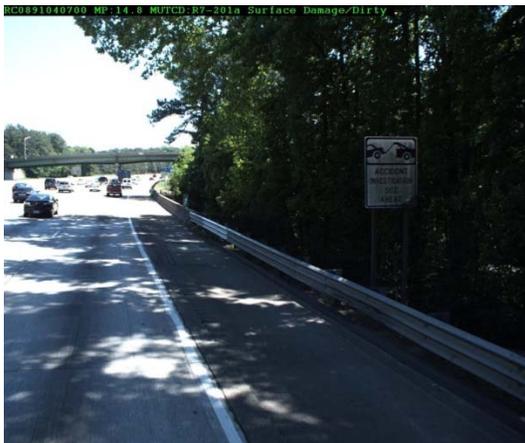
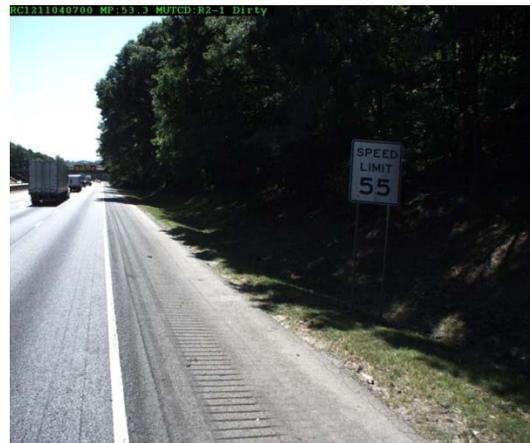
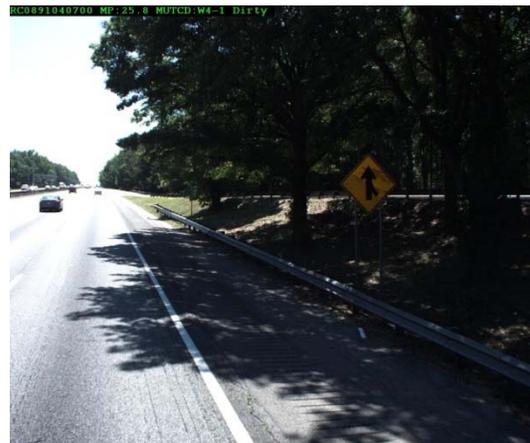
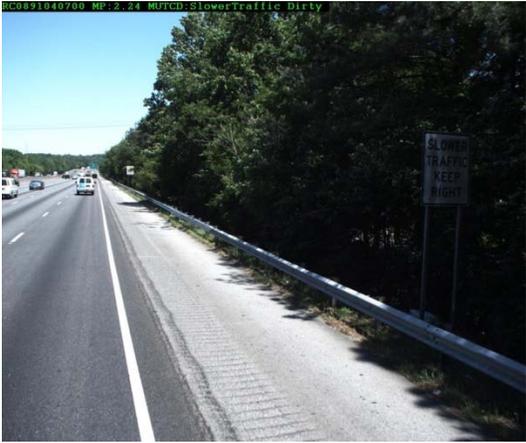
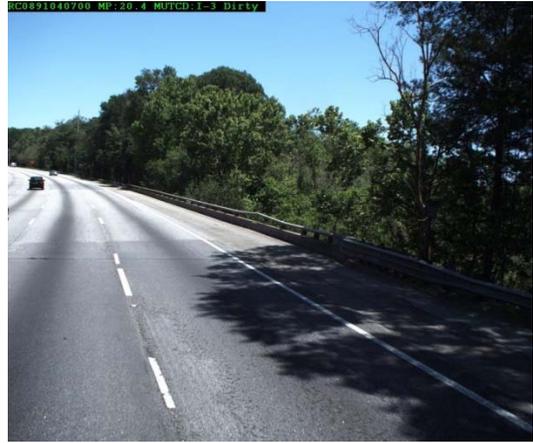
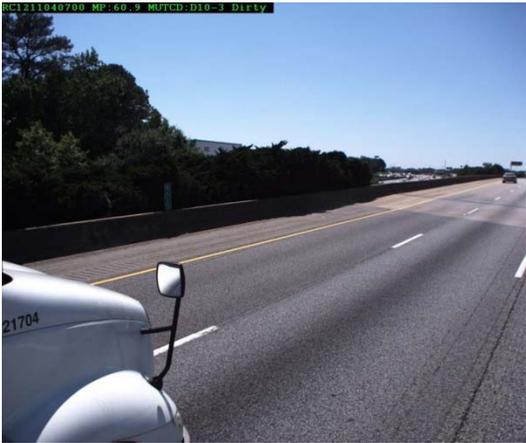
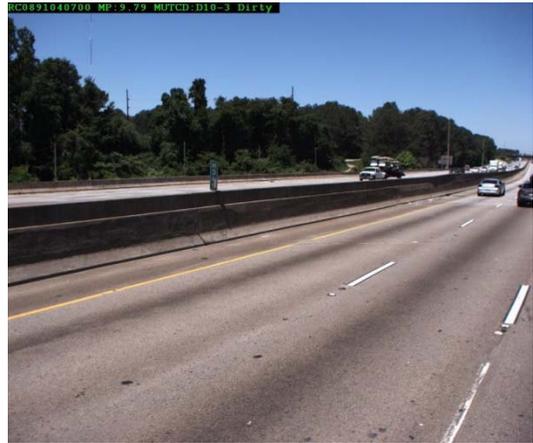
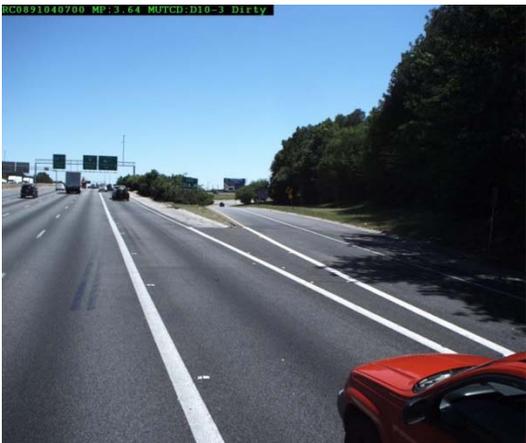
Dirty (11 Cases)

RCLINK	Milepoint	MUTCD	Visual Condition
0891040700	3.644	D10-3	Dirty
1211040700	54.311	D10-3	Dirty
0631040700	0.585	D10-3	Dirty
